WICA GIP Report

NPS Guardwall/Rail Inventory Program Wind Cave National Park

**Federal Lands Highway
Road Inventory Program**

Data Collection Date: August 2010
Report Date: November 2015

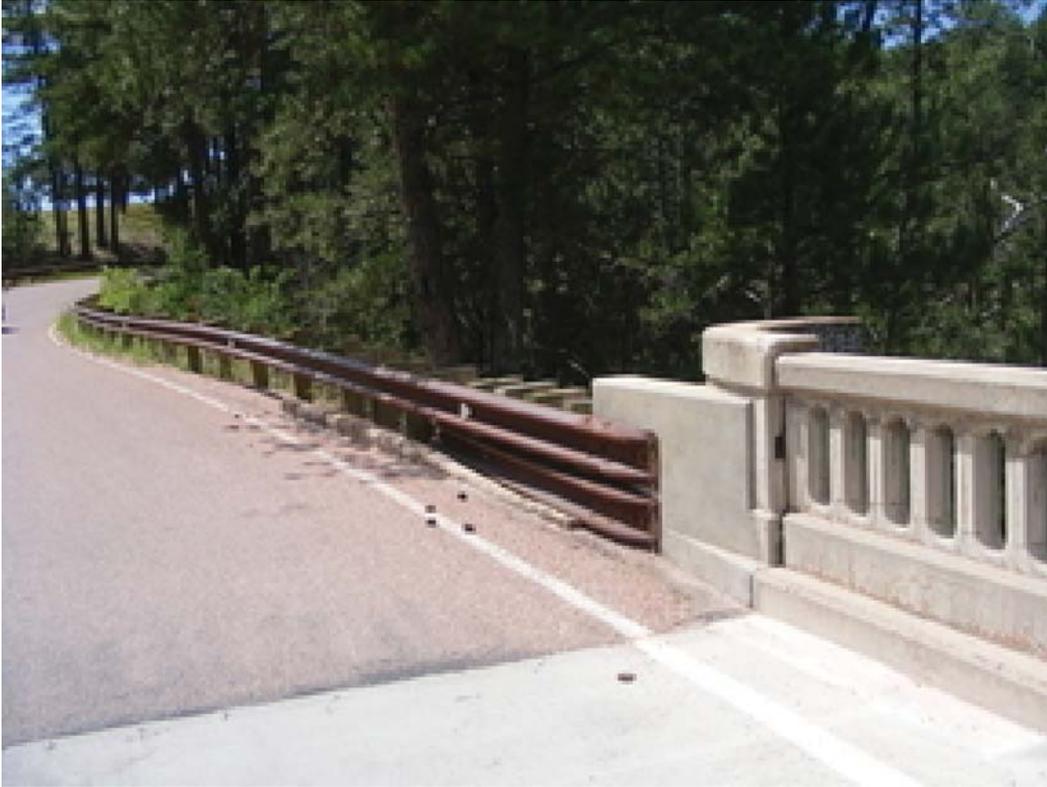
WICA_0012_1.244_L_1.JPG

Barrier ID:	WICA-0012-1.244-L				
Route Name:	NORTH ENTRANCE ROAD (STATE HIGHWAY 87)				
Inspection Date:	08/13/2010	Barrier Rating:	28.00		
Barrier Description					
Type:	W-BEAM STRONG POST	Barrier Function:	TRAFFIC		
Barrier Material:	WEATHERING STEEL/CORTEN	Post Material:	WOOD		
Blockout Type:	WOOD	Length (ft.):	182		
Speed Limit (MPH):	35	Placement with Respect to Road:	BOTH INSIDE AND OUTSIDE		
Hazard Behind Barrier:	MEDIUM				
Barrier Crashworthiness					
Appropriate Test Level:	TL-2	Barrier Test Level:	TL-3	Is Barrier Crashworthy?:	YES
Beg. End Trtmt Type:	NONE	Is Beg. End Trtmt Crashworthy?:	N/A	Approach Transition Type:	BRIDGE RAIL W-BEAM
Ending End Trtmt Type:	W-BEAM TANGENT 350	Ending End Trtmt Crashworthy?:	YES		
Average Measurements					
Design Height (In.):	27	Width (In.):	0.0	Post Spacing (In.):	74.5
Height (In.):	27.2	Lateral Offset (In.):	29.0	Road Grade (%):	2.70
Physical Condition

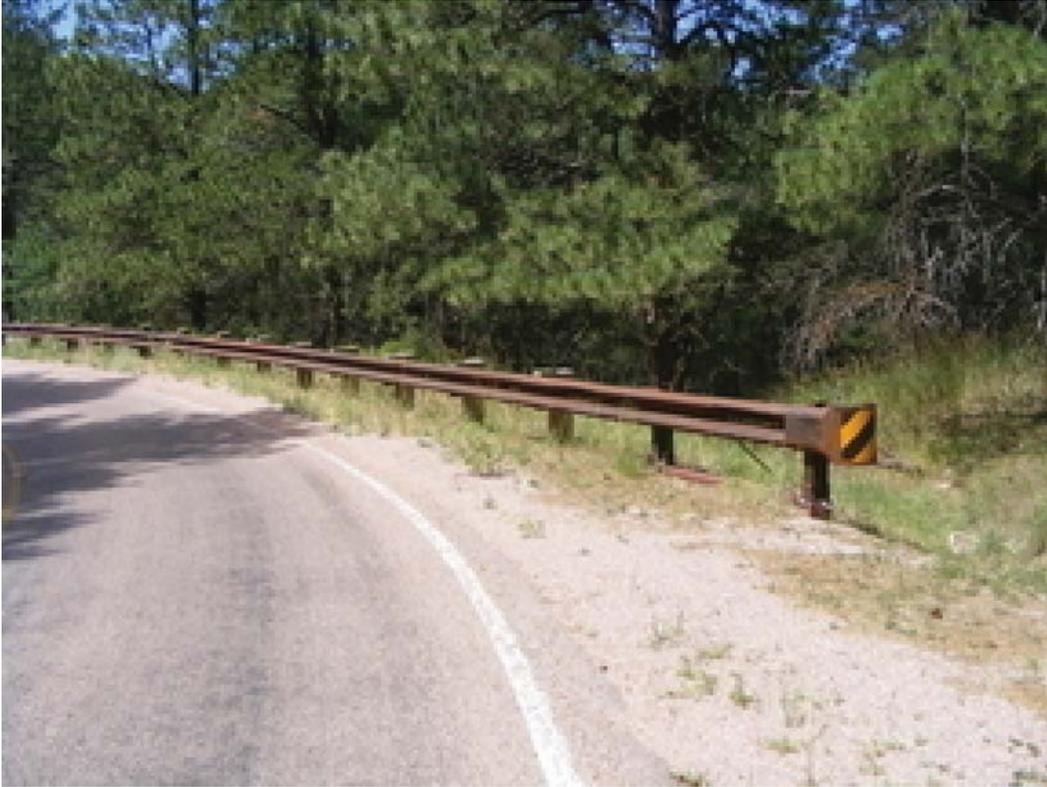
WICA_0012_1.322_L_1.JPG

Barrier ID:	WICA-0012-1.322-L				
Route Name:	NORTH ENTRANCE ROAD (STATE HIGHWAY 87)				
Inspection Date:	08/13/2010	Barrier Rating:	34.00		
Barrier Description					
Type:	W-BEAM STRONG POST	Barrier Function:	TRAFFIC		
Barrier Material:	WEATHERING STEEL/CORTEN	Post Material:	WOOD		
Blockout Type:	WOOD	Length (ft.):	461		
Speed Limit (MPH):	35	Placement with Respect to Road:	BOTH INSIDE AND OUTSIDE		
Hazard Behind Barrier:	HIGH				
Barrier Crashworthiness					
Appropriate Test Level:	TL-2	Barrier Test Level:	TL-3	Is Barrier Crashworthy?:	YES
Beg. End Trtmt Type:	W-BEAM TANGENT 350	Is Beg. End Trtmt Crashworthy?:	YES	Approach Transition Type:	BRIDGE RAIL W-BEAM
Ending End Trtmt Type:	NONE	Ending End Trtmt Crashworthy?:	N/A		
Average Measurements					
Design Height (In.):	27	Width (In.):	0.0	Post Spacing (In.):	75.0
Height (In.):	28.0	Lateral Offset (In.):	57.0	Road Grade (%):	5.90
Physical Condition					
Barrier	Alignment and Height:	Alignment acceptable. Height is 0-2in. above 27-in. design height.

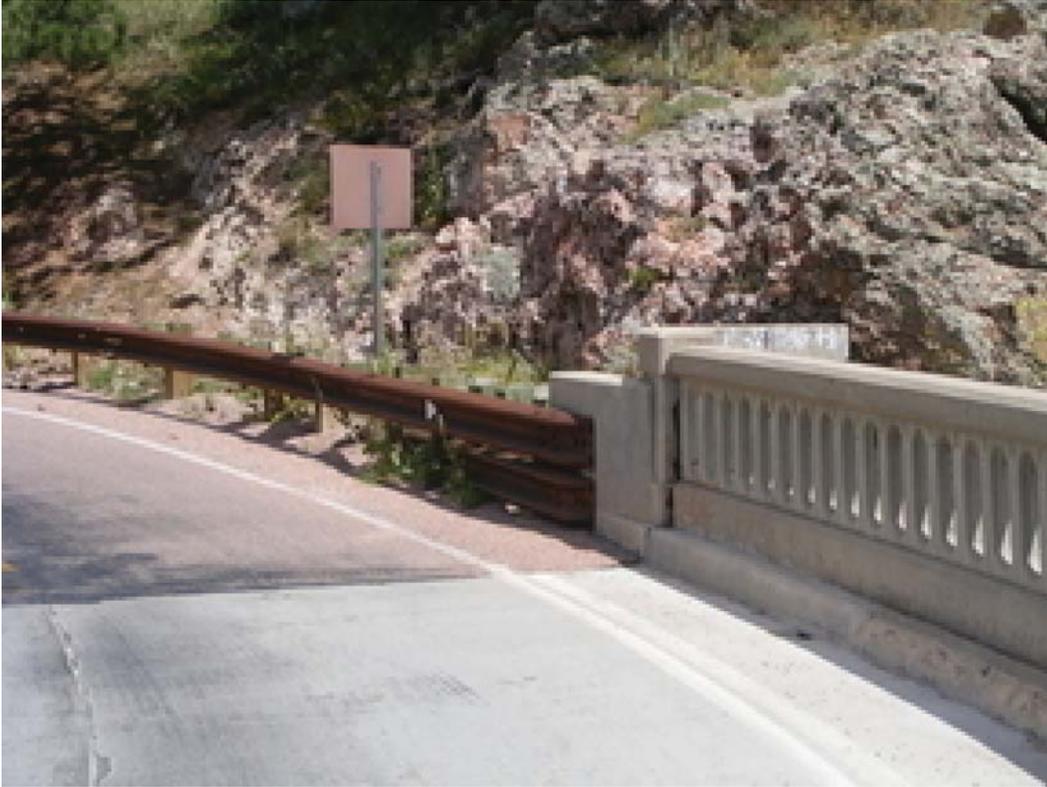
WICA_0012_1.323_R_1.JPG

Barrier ID:	WICA-0012-1.323-R				
Route Name:	NORTH ENTRANCE ROAD (STATE HIGHWAY 87)				
Inspection Date:	08/13/2010	Barrier Rating:	25.50		
Barrier Description					
Type:	W-BEAM STRONG POST	Barrier Function:	TRAFFIC		
Barrier Material:	WEATHERING STEEL/CORTEN	Post Material:	WOOD		
Blockout Type:	WOOD	Length (ft.):	54		
Speed Limit (MPH):	35	Placement with Respect to Road:	OUTSIDE OF CURVE		
Hazard Behind Barrier:	LOW				
Barrier Crashworthiness					
Appropriate Test Level:	TL-2	Barrier Test Level:	TL-3	Is Barrier Crashworthy?:	YES
Beg. End Trtmt Type:	NONE	Is Beg. End Trtmt Crashworthy?:	N/A	Approach Transition Type:	BRIDGE RAIL W-BEAM
Ending End Trtmt Type:	W-BEAM TANGENT 350	Ending End Trtmt Crashworthy?:	YES		
Average Measurements					
Design Height (In.):	27	Width (In.):	0.0	Post Spacing (In.):	74.5
Height (In.):	28.0	Lateral Offset (In.):	33.5	Road Grade (%):	2.90
Physical Condition					
Barrier	Alignment and Height:	Alignment acceptable. Height within 1-in of 27-in design height.

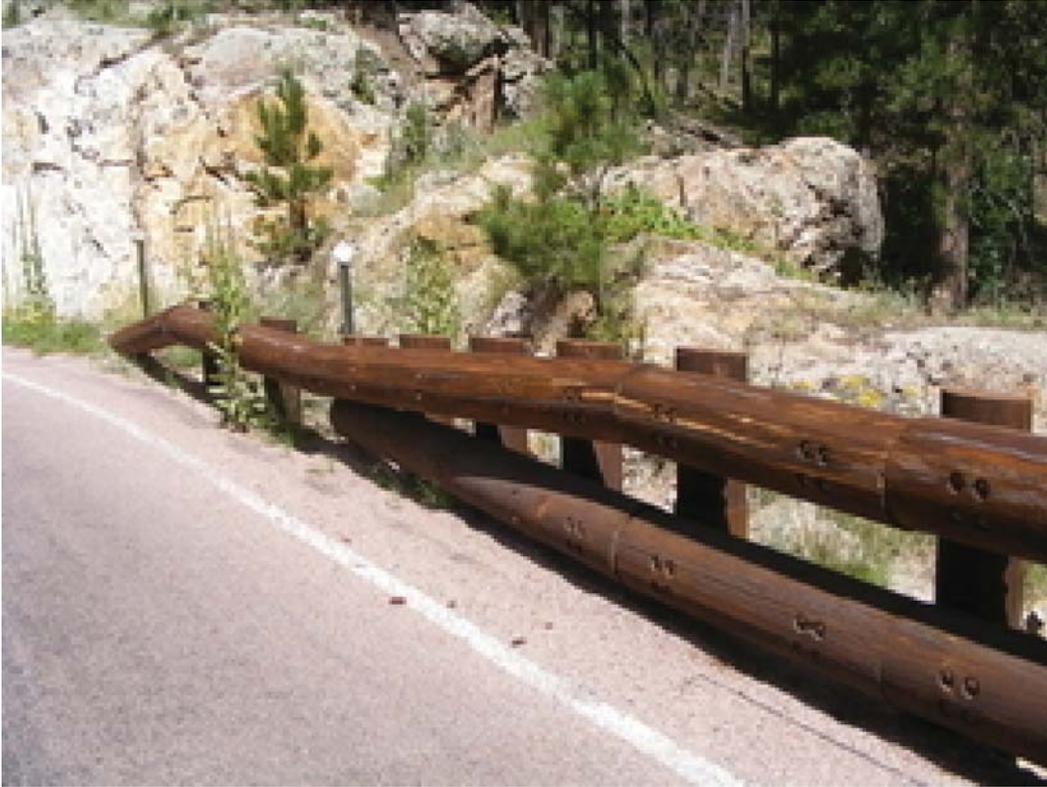
WICA_0012_2.897_R_1.JPG

Barrier ID:	WICA-0012-2.897-R				
Route Name:	NORTH ENTRANCE ROAD (STATE HIGHWAY 87)				
Inspection Date:	08/13/2010	Barrier Rating:	39.70		
Barrier Description					
Type:	OTHER: LOG RAIL ON LOG POSTS	Barrier Function:	TRAFFIC		
Barrier Material:	LOG/TIMBER/WOOD	Post Material:	OTHER: LOG		
Blockout Type:	N/A	Length (ft.):	157		
Speed Limit (MPH):	35	Placement with Respect to Road:	OUTSIDE OF CURVE		
Hazard Behind Barrier:	HIGH				
Barrier Crashworthiness					
Appropriate Test Level:	TL-2	Barrier Test Level:	NCW	Is Barrier Crashworthy?:	NO
Beg. End Trtmt Type:	OTHER: LOG BURIED	Is Beg. End Trtmt Crashworthy?:	NO	Approach Transition Type:	OTHER: BRIDGE RAIL LOG
Ending End Trtmt Type:	NONE	Ending End Trtmt Crashworthy?:	N/A		
Average Measurements					
Design Height (In.):	27	Width (In.):	12.0	Post Spacing (In.):	120.5
Height (In.):	26.2	Lateral Offset (In.):	24.7	Road Grade (%):	4.80
Physical Condition

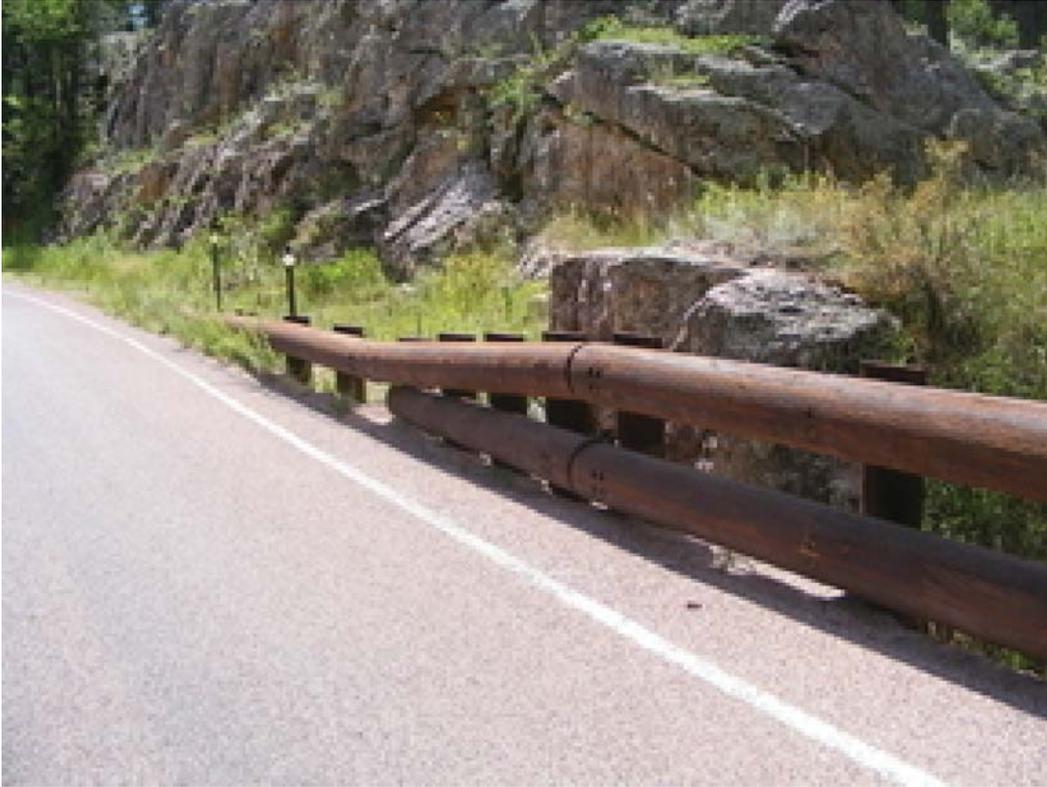
WICA_0012_2.921_L_1.JPG

Barrier ID:	WICA-0012-2.921-L				
Route Name:	NORTH ENTRANCE ROAD (STATE HIGHWAY 87)				
Inspection Date:	08/13/2010	Barrier Rating:	29.70		
Barrier Description					
Type:	OTHER: LOG RAIL ON LOG POSTS	Barrier Function:	TRAFFIC		
Barrier Material:	LOG/TIMBER/WOOD	Post Material:	OTHER: LOG		
Blockout Type:	N/A	Length (ft.):	45		
Speed Limit (MPH):	35	Placement with Respect to Road:	TANGENT		
Hazard Behind Barrier:	HIGH				
Barrier Crashworthiness					
Appropriate Test Level:	TL-2	Barrier Test Level:	NCW	Is Barrier Crashworthy?:	NO
Beg. End Trtmt Type:	NONE	Is Beg. End Trtmt Crashworthy?:	N/A	Approach Transition Type:	OTHER: BRIDGE RAIL LOG
Ending End Trtmt Type:	OTHER: LOG BURIED	Ending End Trtmt Crashworthy?:	NO		
Average Measurements					
Design Height (In.):	27	Width (In.):	12.0	Post Spacing (In.):	59.5
Height (In.):	25.0	Lateral Offset (In.):	21.2	Road Grade (%):	1.80
Physical Condition					
Barrier	Alignment and Height:	End treatment and transition only.

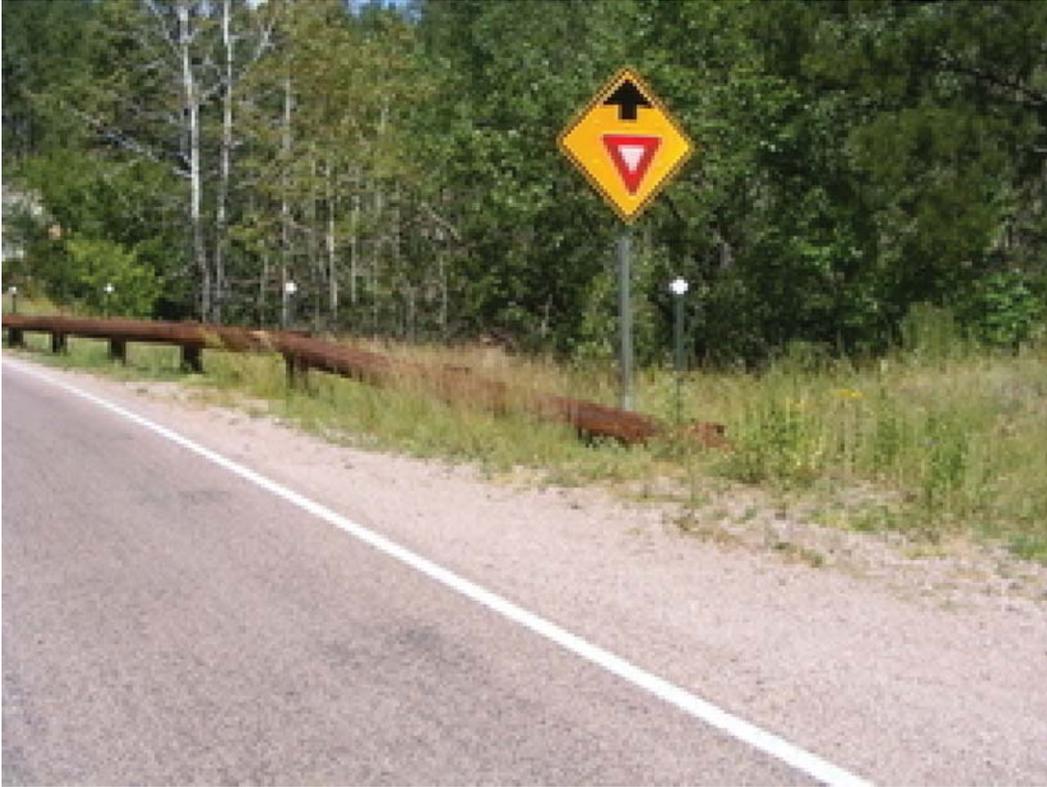
WICA_0012_2.944_R_1.JPG

Barrier ID:	WICA-0012-2.944-R				
Route Name:	NORTH ENTRANCE ROAD (STATE HIGHWAY 87)				
Inspection Date:	08/13/2010	Barrier Rating:	38.20		
Barrier Description					
Type:	OTHER: LOG RAIL ON LOG POSTS	Barrier Function:	TRAFFIC		
Barrier Material:	LOG/TIMBER/WOOD	Post Material:	OTHER: LOG		
Blockout Type:	N/A	Length (ft.):	35		
Speed Limit (MPH):	35	Placement with Respect to Road:	OUTSIDE OF CURVE		
Hazard Behind Barrier:	HIGH				
Barrier Crashworthiness					
Appropriate Test Level:	TL-2	Barrier Test Level:	NCW	Is Barrier Crashworthy?:	NO
Beg. End Trtmt Type:	NONE	Is Beg. End Trtmt Crashworthy?:	N/A	Approach Transition Type:	OTHER: BRIDGE RAIL LOG
Ending End Trtmt Type:	OTHER: LOG BURIED	Ending End Trtmt Crashworthy?:	NO		
Average Measurements					
Design Height (In.):	27	Width (In.):	12.0	Post Spacing (In.):	60.0
Height (In.):	28.0	Lateral Offset (In.):	19.2	Road Grade (%):	0.40
Physical Condition					
Barrier	Alignment and Height:	End treatment and transition only.

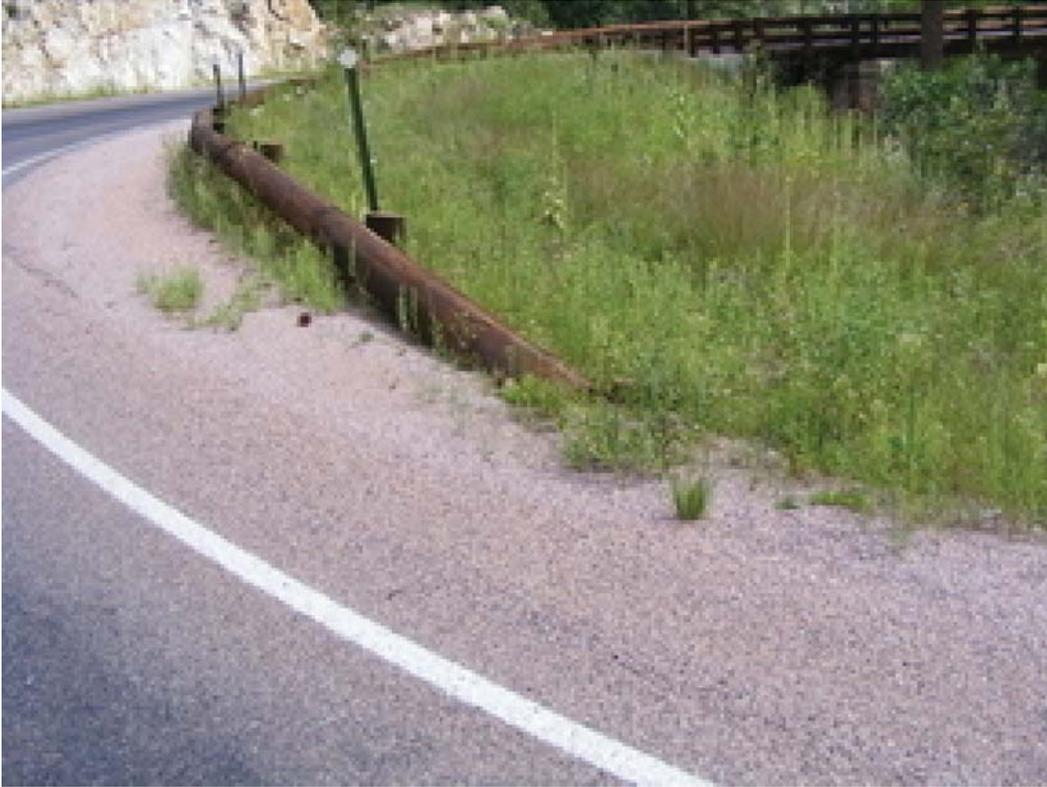
WICA_0012_2.953_L_1.JPG

Barrier ID:	WICA-0012-2.953-L				
Route Name:	NORTH ENTRANCE ROAD (STATE HIGHWAY 87)				
Inspection Date:	08/13/2010	Barrier Rating:	26.80		
Barrier Description					
Type:	OTHER: LOG RAIL ON LOG POSTS	Barrier Function:	TRAFFIC		
Barrier Material:	LOG/TIMBER/WOOD	Post Material:	OTHER: LOG		
Blockout Type:	N/A	Length (ft.):	138		
Speed Limit (MPH):	35	Placement with Respect to Road:	INSIDE OF CURVE		
Hazard Behind Barrier:	HIGH				
Barrier Crashworthiness					
Appropriate Test Level:	TL-2	Barrier Test Level:	NCW	Is Barrier Crashworthy?:	NO
Beg. End Trtmt Type:	OTHER: LOG BURIED	Is Beg. End Trtmt Crashworthy?:	NO	Approach Transition Type:	OTHER: BRIDGE RAIL LOG
Ending End Trtmt Type:	NONE	Ending End Trtmt Crashworthy?:	N/A		
Average Measurements					
Design Height (In.):	27	Width (In.):	12.0	Post Spacing (In.):	119.0
Height (In.):	28.7	Lateral Offset (In.):	78.0	Road Grade (%):	0.80
Physical Condition					
Barrier	Alignment and Height:	Alignment acceptable. Height is 0-3in. above 27-in. design height. Minor impact does not affect alignment.

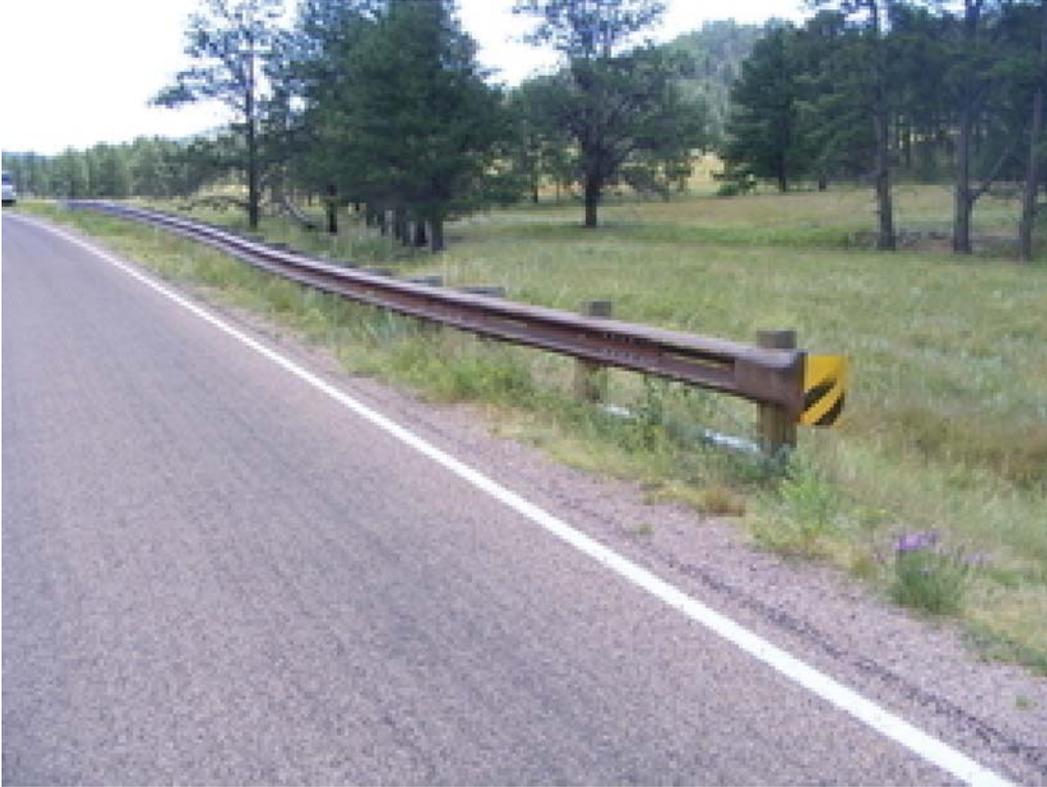
WICA_0012_6.116_R_1.JPG

Barrier ID:	WICA-0012-6.116-R				
Route Name:	NORTH ENTRANCE ROAD (STATE HIGHWAY 87)				
Inspection Date:	08/13/2010	Barrier Rating:	25.10		
Barrier Description					
Type:	W-BEAM STRONG POST	Barrier Function:	TRAFFIC		
Barrier Material:	WEATHERING STEEL/CORTEN	Post Material:	WOOD		
Blockout Type:	WOOD	Length (ft.):	190		
Speed Limit (MPH):	35	Placement with Respect to Road:	OUTSIDE OF CURVE		
Hazard Behind Barrier:	MEDIUM				
Barrier Crashworthiness					
Appropriate Test Level:	TL-2	Barrier Test Level:	TL-3	Is Barrier Crashworthy?:	YES
Beg. End Trtmt Type:	W-BEAM FLARED 350 COMPLIANT	Is Beg. End Trtmt Crashworthy?:	YES	Approach Transition Type:	NONE
Ending End Trtmt Type:	W-BEAM FLARED 350 COMPLIANT	Ending End Trtmt Crashworthy?:	YES		
Average Measurements					
Design Height (In.):	27	Width (In.):	0.0	Post Spacing (In.):	74.3
Height (In.):	28.6	Lateral Offset (In.):	74.5	Road Grade (%):	0.70
Physical Condition

Barrier	Alignment and Height:	Alignment acceptable. Height within 1-in of 27-in design height.			
	Breaking and Cracking:	No cracked or broken barrier elements.			
	Missing Elements:	No missing barrier elements.			
	Corrosion and Weathering:	No major weathering or corrosion of the barrier.			
End Treatments	Alignment and Height:	Alignment acceptable. Height within 1-in of 27-in design height.			
	Breaking and Cracking:	No major breaking or cracking of the end treatments.			
	Missing Elements:	No missing end treatment elements.			
	Corrosion and Weathering:	No major weathering of the end treatments.

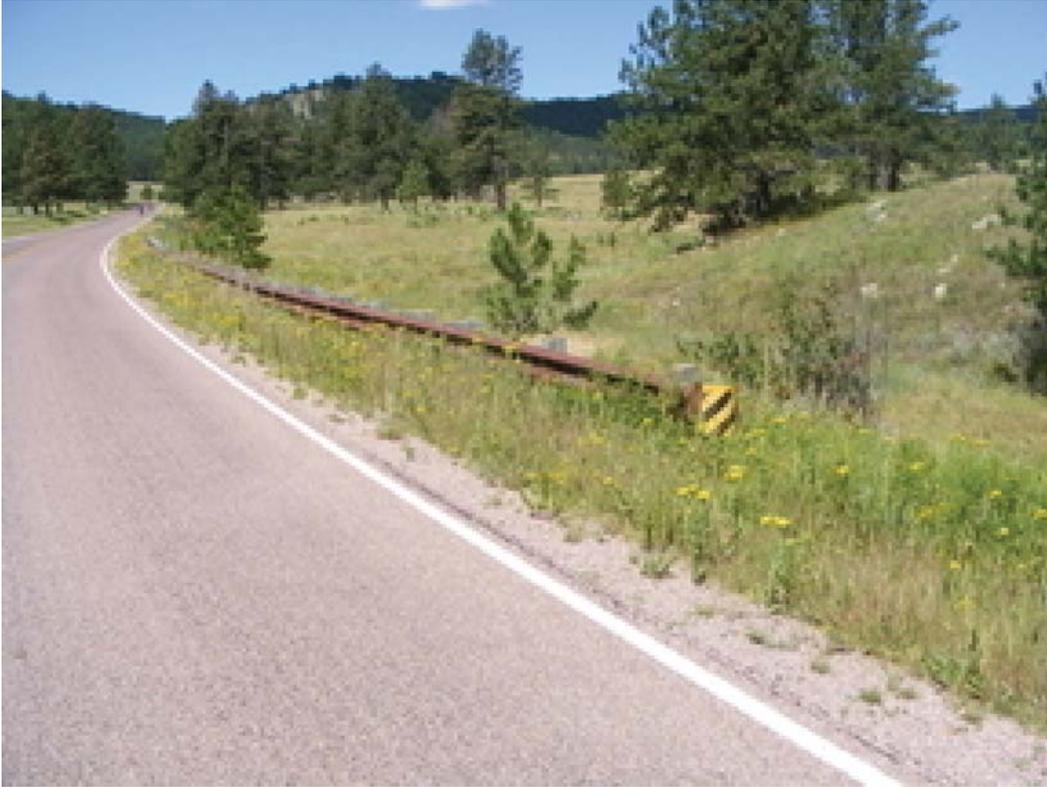
WICA_0012_6.127_L_1.JPG

Barrier ID:	WICA-0012-6.127-L				
Route Name:	NORTH ENTRANCE ROAD (STATE HIGHWAY 87)				
Inspection Date:	08/13/2010	Barrier Rating:	19.30		
Barrier Description					
Type:	W-BEAM STRONG POST	Barrier Function:	TRAFFIC		
Barrier Material:	WEATHERING STEEL/CORTEN	Post Material:	WOOD		
Blockout Type:	WOOD	Length (ft.):	193		
Speed Limit (MPH):	35	Placement with Respect to Road:	INSIDE OF CURVE		
Hazard Behind Barrier:	MEDIUM				
Barrier Crashworthiness					
Appropriate Test Level:	TL-2	Barrier Test Level:	TL-3	Is Barrier Crashworthy?:	YES
Beg. End Trtmt Type:	W-BEAM TANGENT 350	Is Beg. End Trtmt Crashworthy?:	YES	Approach Transition Type:	NONE
Ending End Trtmt Type:	W-BEAM FLARED 350 COMPLIANT	Ending End Trtmt Crashworthy?:	YES		
Average Measurements					
Design Height (In.):	27	Width (In.):	0.0	Post Spacing (In.):	75.5
Height (In.):	26.6	Lateral Offset (In.):	65.5	Road Grade (%):	0.50
Physical Condition

Barrier	Alignment and Height:	Alignment acceptable. Height within 1-in of 27-in design height.			
	Breaking and Cracking:	No cracked or broken barrier elements.			
	Missing Elements:	No missing barrier elements.			
	Corrosion and Weathering:	No major weathering or corrosion of the barrier.			
End Treatments	Alignment and Height:	Alignment acceptable. Height within 1-in of 27-in design height.			
	Breaking and Cracking:	No major breaking or cracking of the end treatments.			
	Missing Elements:	No missing end treatment elements.			
	Corrosion and Weathering:	No major weathering of the end treatments.

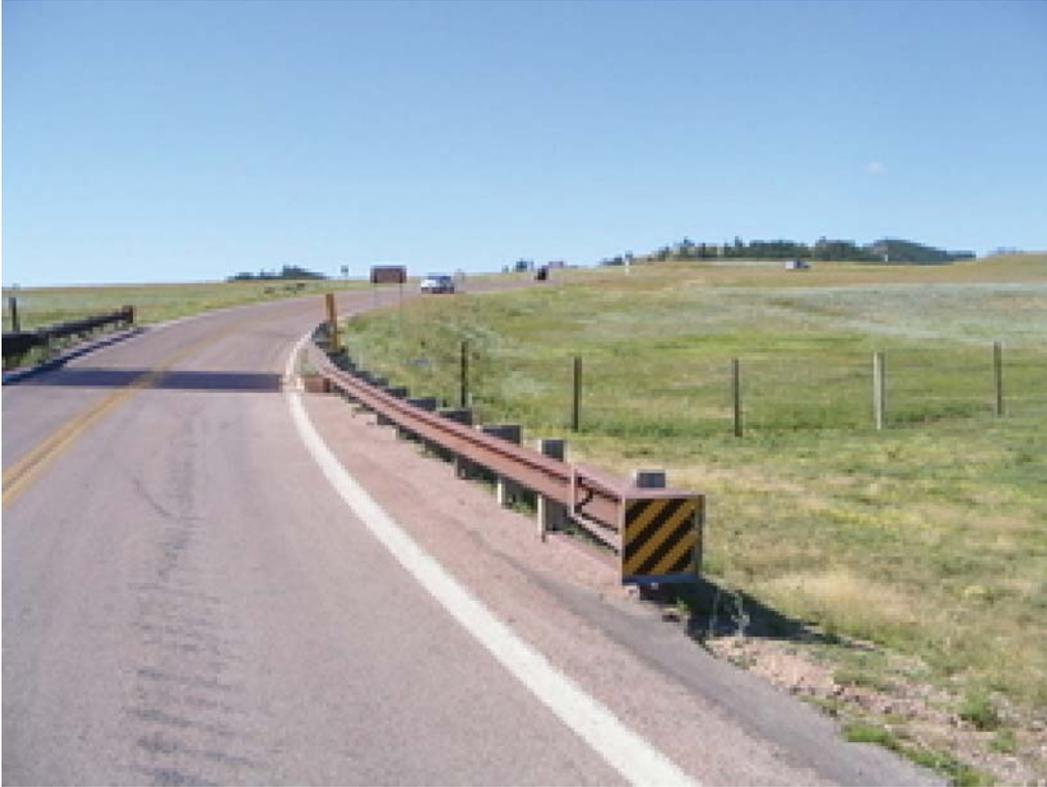
WICA_0012_7.137_L_1.JPG

Barrier ID:	WICA-0012-7.137-L				
Route Name:	NORTH ENTRANCE ROAD (STATE HIGHWAY 87)				
Inspection Date:	08/13/2010	Barrier Rating:	41.70		
Barrier Description					
Type:	THRIE BEAM/MODIFIED THRIE BEAM	Barrier Function:	TRAFFIC		
Barrier Material:	WEATHERING STEEL/CORTEN	Post Material:	WOOD		
Blockout Type:	WOOD	Length (ft.):	136		
Speed Limit (MPH):	35	Placement with Respect to Road:	INSIDE OF CURVE		
Hazard Behind Barrier:	MEDIUM				
Barrier Crashworthiness					
Appropriate Test Level:	TL-2	Barrier Test Level:	TL-3	Is Barrier Crashworthy?:	YES
Beg. End Trtmt Type:	W-BEAM TANGENT 350	Is Beg. End Trtmt Crashworthy?:	YES	Approach Transition Type:	OTHER: W-BEAM TO THRIE BEAM
Ending End Trtmt Type:	W-BEAM TANGENT 350	Ending End Trtmt Crashworthy?:	YES		
Average Measurements					
Design Height (In.):	35	Width (In.):	0.0	Post Spacing (In.):	75.5
Height (In.):	25.6	Lateral Offset (In.):	25.0	Road Grade (%):	5.20

Physical Condition					
Barrier	Alignment and Height:	Alignment acceptable. Height was 8 to 10-in below the 35-in design height.			
	Breaking and Cracking:	No cracked or broken barrier elements.			
	Missing Elements:	No missing barrier elements.			
	Corrosion and Weathering:	No major weathering or corrosion of the barrier.			
End Treatments	Alignment and Height:	Alignment acceptable. Height was 8 to 10-in below the 35-in design height.			
	Breaking and Cracking:	No major breaking or cracking of the end treatments.			
	Missing Elements:	No missing end treatment elements.			
	Corrosion and Weathering:	No major weathering of the end treatments.

Repair Action:	REPAIR	FMSS Work Type:	DEFERRED MAINTENANCE	Repair Cost:	\$2184
Brief Workorder:	Raise beginning end treatment to the design height of 27 inches.				
Workorder:	Adjust Guardrail at \$10- per -Lin. Ft. for 51 LF = \$510. Raise beginning end treatment to the design height of 27 inches. Low Speed Traffic Control at \$1475- per -Day for 1 Day(s) = \$1475.

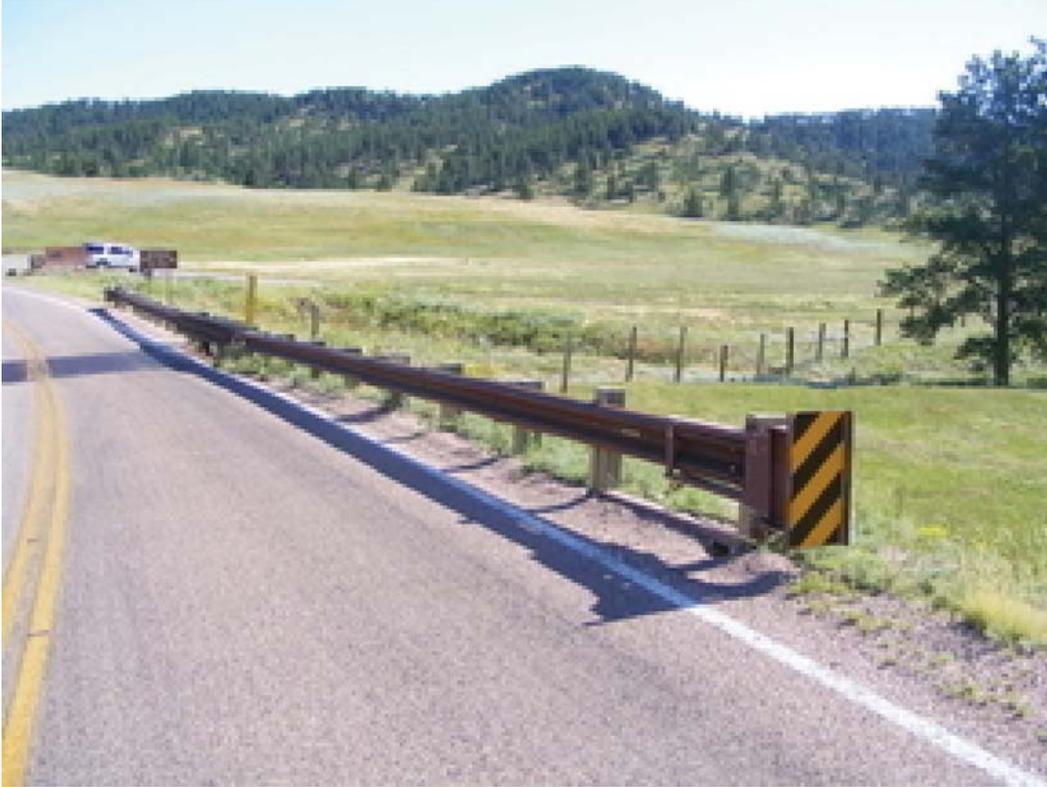
WICA_0012_7.139_R_1.JPG

Barrier ID:	WICA-0012-7.139-R				
Route Name:	NORTH ENTRANCE ROAD (STATE HIGHWAY 87)				
Inspection Date:	08/13/2010	Barrier Rating:	54.50		
Barrier Description					
Type:	THRIE BEAM/MODIFIED THRIE BEAM	Barrier Function:	TRAFFIC		
Barrier Material:	WEATHERING STEEL/CORTEN	Post Material:	WOOD		
Blockout Type:	WOOD	Length (ft.):	136		
Speed Limit (MPH):	35	Placement with Respect to Road:	OUTSIDE OF CURVE		
Hazard Behind Barrier:	MEDIUM				
Barrier Crashworthiness					
Appropriate Test Level:	TL-2	Barrier Test Level:	TL-3	Is Barrier Crashworthy?:	YES
Beg. End Trtmt Type:	W-BEAM TANGENT 350	Is Beg. End Trtmt Crashworthy?:	YES	Approach Transition Type:	OTHER: W-BEAM TO THRIE BEAM
Ending End Trtmt Type:	W-BEAM TANGENT 350	Ending End Trtmt Crashworthy?:	YES		
Average Measurements					
Design Height (In.):	35	Width (In.):	0.0	Post Spacing (In.):	75.5
Height (In.):	25.6	Lateral Offset (In.):	19.2	Road Grade (%):	6.00

Physical Condition					
Barrier	Alignment and Height:	Alignment acceptable. Height was 6 to 8-in below the 35-in design height.			
	Breaking and Cracking:	No cracked or broken barrier elements.			
	Missing Elements:	No missing barrier elements.			
	Corrosion and Weathering:	No major weathering or corrosion of the barrier.			
End Treatments	Alignment and Height:	Alignment acceptable. Height was 6 to 8-in below the 35-in design height.			
	Breaking and Cracking:	Cable loose on one end. No major breaking or cracking of the end treatments.			
	Missing Elements:	No missing end treatment elements.			
	Corrosion and Weathering:	No major weathering of the end treatments.

Repair Action:	REPAIR	FMSS Work Type:	DEFERRED MAINTENANCE	Repair Cost:	\$264
Brief Workorder:	Re-attach cable on 350 compliant end terminal.				
Workorder:	Labor at \$60- per -Hour for 4 Hrs = \$240. Reattach cable on 350 compliant end terminal.
