**GIP Report**

**NPS Guardwall/Rail Inventory Program  
Yosemite National Park**

**Federal Lands Highway  
Road Inventory Program**

**Data Collection Date: October 2009  
Report Date: December 2015**

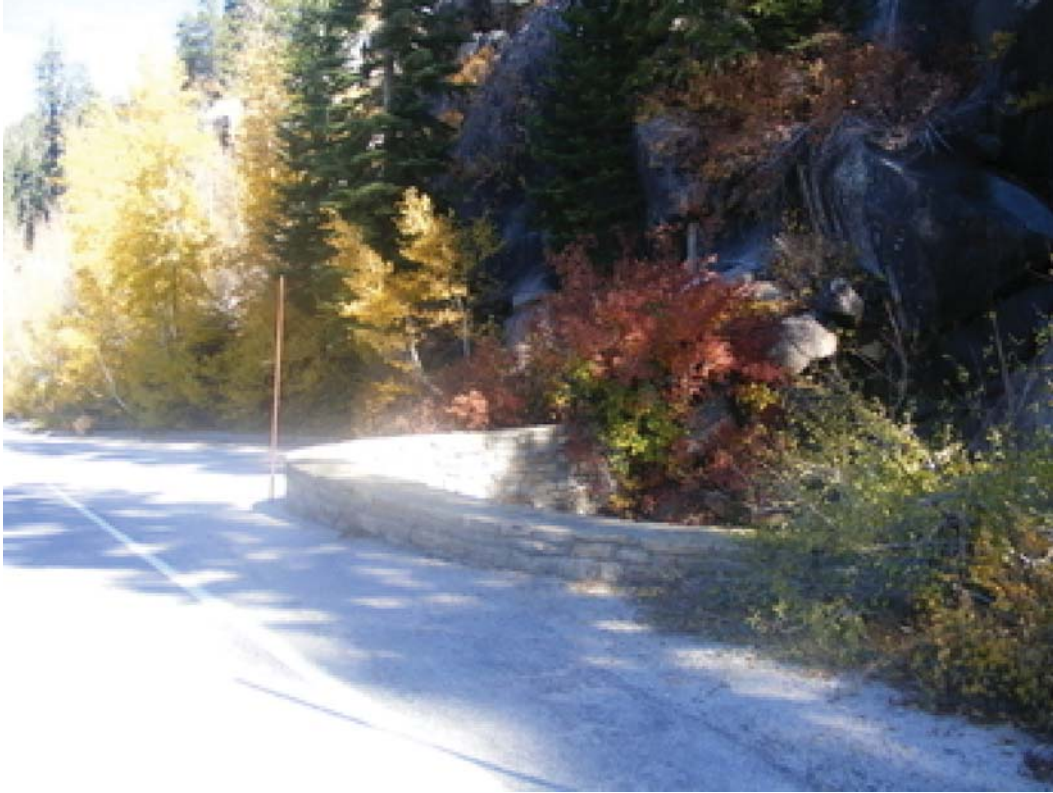
YOSE\_0017\_20.251\_L\_1.JPG

<b>Barrier ID:</b>	YOSE-0017-20.251-L				
<b>Route Name:</b>	TIOGA ROAD				
<b>Inspection Date:</b>	10/26/2009	<b>Barrier Rating:</b>	52.40		
<b>Barrier Description</b>					
<b>Type:</b>	STONE MASONRY WITHOUT CONCRETE CORE WALL	<b>Barrier Function:</b>	TRAFFIC		
<b>Barrier Material:</b>	STONE	<b>Post Material:</b>	N/A		
<b>Blockout Type:</b>	N/A	<b>Length (ft.):</b>	50		
<b>Speed Limit (MPH):</b>	45	<b>Placement with Respect to Road:</b>	TANGENT		
<b>Hazard Behind Barrier:</b>	MEDIUM				
<b>Barrier Crashworthiness</b>					
<b>Appropriate Test Level:</b>	TL-2	<b>Barrier Test Level:</b>	NCW	<b>Is Barrier Crashworthy?:</b>	NO
<b>Beg. End Trtmt Type:</b>	NONE	<b>Is Beg. End Trtmt Crashworthy?:</b>	N/A	<b>Approach Transition Type:</b>	NONE
<b>Ending End Trtmt Type:</b>	NONE	<b>Ending End Trtmt Crashworthy?:</b>	N/A		
<b>Average Measurements</b>					
<b>Design Height (In.):</b>	24	<b>Width (In.):</b>	24.6	<b>Post Spacing (In.):</b>	0.0

<b>Height (In.):</b>	19.6	<b>Lateral Offset (In.):</b>	76.0	<b>Road Grade (%):</b>	7.70
<b>Physical Condition</b>					
<b>Barrier</b>	<b>Alignment and Height:</b>	Alignment is acceptable. A 1/2 circle around a culvert inlet. 25ft. is 9in lower than the 24" design height and 4ft. is between 3"-6" lower than the design height. Level w/ inlet/ not road grade.			
	<b>Breaking and Cracking:</b>	No breaking or cracking was observed.			
	<b>Missing Elements:</b>	No missing elements.			
	<b>Corrosion and Weathering:</b>	No corrosion or weathering.			
<b>End Treatments</b>	<b>Alignment and Height:</b>				
	<b>Breaking and Cracking:</b>				
	<b>Missing Elements:</b>				
	<b>Corrosion and Weathering:</b>

<b>Repair Action:</b>	REPAIR	<b>FMSS Work Type:</b>	DEFERRED MAINTENANCE	<b>Repair Cost:</b>	\$32140
<b>Brief Workorder:</b>	Raise guardwall 6-in. Remove and reset 25-ft. stone masonry guardwall on concrete footer to design height of 24-in.				
<b>Workorder:</b>	Remove & reset stone masonry guardwall at \$250- per -Cu. Ft. for 100 CF = \$25000. Reset to 24 inches. [(2ft)(2ft)(25ft)] = 100 CF. Structural Concrete at \$1000- per -Cu. Yd. for 1 CY = \$1000. Concrete leveling pad. [(2ft)(0.5ft)(25ft)] /27 = .9 CY. Low Speed Traffic Control at \$1475- per -Day for 2 Day(s) = \$2950. 1 day removal 1 day installation.

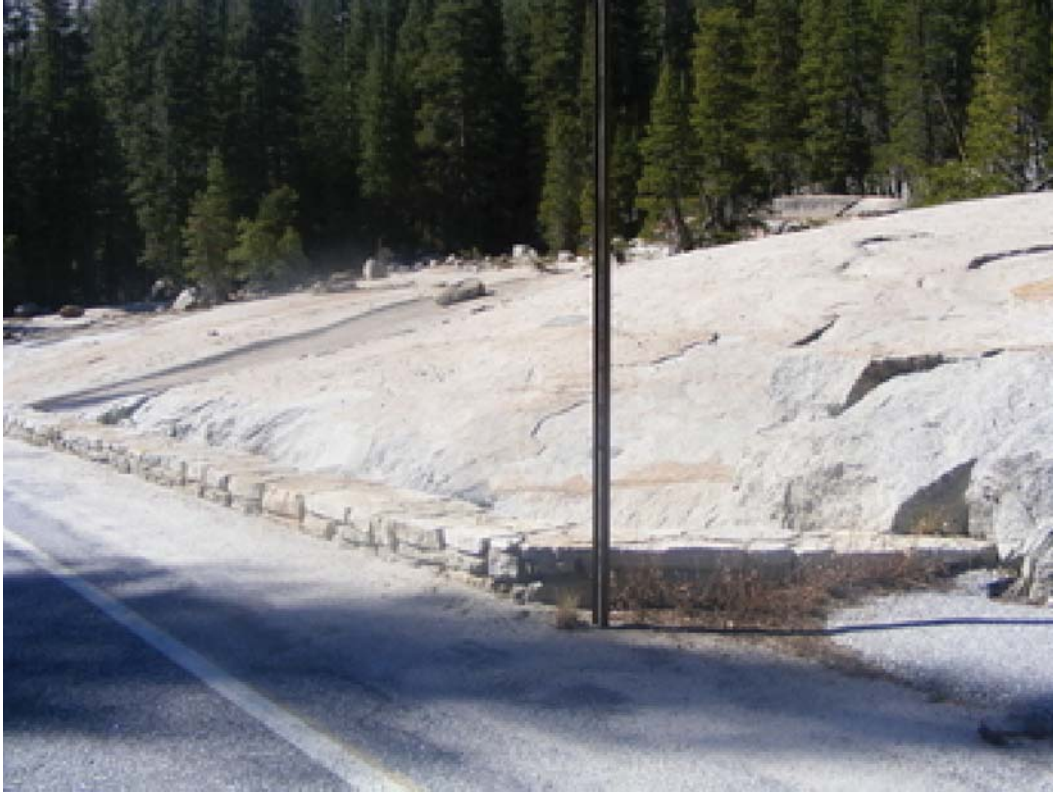
YOSE\_0017\_30.410\_L\_1.JPG

<b>Barrier ID:</b>	YOSE-0017-30.410-L				
<b>Route Name:</b>	TIOGA ROAD				
<b>Inspection Date:</b>	10/26/2009	<b>Barrier Rating:</b>	54.20		
<b>Barrier Description</b>					
<b>Type:</b>	STONE MASONRY WITHOUT CONCRETE CORE WALL	<b>Barrier Function:</b>	TRAFFIC		
<b>Barrier Material:</b>	STONE	<b>Post Material:</b>	N/A		
<b>Blockout Type:</b>	N/A	<b>Length (ft.):</b>	89		
<b>Speed Limit (MPH):</b>	35	<b>Placement with Respect to Road:</b>	OUTSIDE OF CURVE		
<b>Hazard Behind Barrier:</b>	LOW				
<b>Barrier Crashworthiness</b>					
<b>Appropriate Test Level:</b>	TL-2	<b>Barrier Test Level:</b>	NCW	<b>Is Barrier Crashworthy?:</b>	NO
<b>Beg. End Trtmt Type:</b>	NONE	<b>Is Beg. End Trtmt Crashworthy?:</b>	N/A	<b>Approach Transition Type:</b>	NONE
<b>Ending End Trtmt Type:</b>	NONE	<b>Ending End Trtmt Crashworthy?:</b>	N/A		
<b>Average Measurements</b>					
<b>Design Height (In.):</b>	24	<b>Width (In.):</b>	25.2	<b>Post Spacing (In.):</b>	0.0

<b>Height (In.):</b>	11.3	<b>Lateral Offset (In.):</b>	54.0	<b>Road Grade (%):</b>	0.40
<b>Physical Condition</b>					
<b>Barrier</b>	<b>Alignment and Height:</b>	Alignment is acceptable. Height is 12in or more under the 24-in. design height.			
	<b>Breaking and Cracking:</b>	No evidence of impact. No breaking or cracking. Newer construction.			
	<b>Missing Elements:</b>	No missing elements.			
	<b>Corrosion and Weathering:</b>	No corrosion or weathering.			
<b>End Treatments</b>	<b>Alignment and Height:</b>				
	<b>Breaking and Cracking:</b>				
	<b>Missing Elements:</b>				
	<b>Corrosion and Weathering:</b>

<b>Repair Action:</b>	REPAIR	<b>FMSS Work Type:</b>	DEFERRED MAINTENANCE	<b>Repair Cost:</b>	\$118663
<b>Brief Workorder:</b>	Raise guardwall 12-in. Remove and reset 89-ft. stone masonry guardwall on concrete footer to design height of 24-in.				
<b>Workorder:</b>	<p>Remove &amp; reset stone masonry guardwall at \$250- per -Cu. Ft. for 374 CF = \$93500.  <math>[(2.1\text{ft})(2\text{ft})(89\text{ft})] = 373.8 \text{ CF. Round to } 374 \text{ CF.}</math>          Structural Concrete at \$1000- per -Cu. Yd. for 7 CY = \$7000. Concrete leveling pad.  <math>[(2.1\text{ft})(1\text{ft})(89\text{ft})] / 27 = 6.9 \text{ CY.}</math>          Low Speed Traffic Control at \$1475- per -Day for 5 Day(s) = \$7375. 1 day removal 4 days installation.</p>

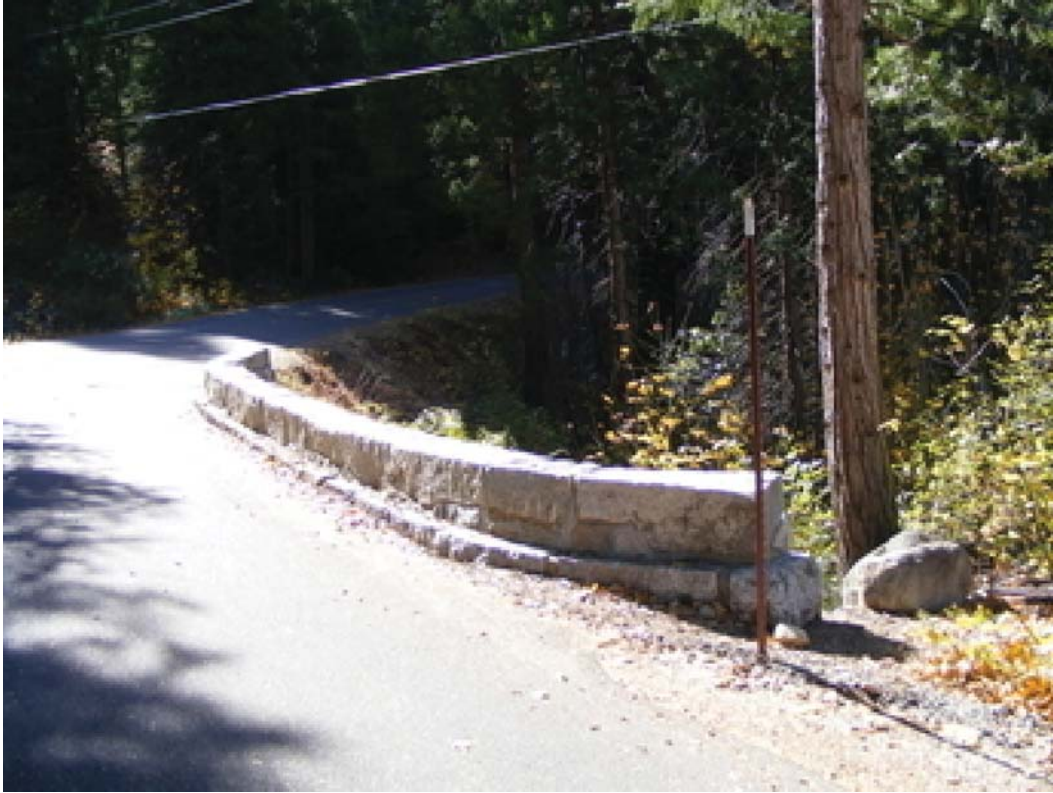
**YOSE\_0100\_4.591\_L\_1.JPG**

<b>Barrier ID:</b>	YOSE-0100-4.591-L				
<b>Route Name:</b>	HETCH HETCHY ROAD				
<b>Inspection Date:</b>	10/28/2009	<b>Barrier Rating:</b>	28.00		
<b>Barrier Description</b>					
<b>Type:</b>	STONE MASONRY WITHOUT CONCRETE CORE WALL	<b>Barrier Function:</b>	TRAFFIC		
<b>Barrier Material:</b>	STONE	<b>Post Material:</b>	N/A		
<b>Blockout Type:</b>	N/A	<b>Length (ft.):</b>	61		
<b>Speed Limit (MPH):</b>	25	<b>Placement with Respect to Road:</b>	INSIDE OF CURVE		
<b>Hazard Behind Barrier:</b>	MEDIUM				
<b>Barrier Crashworthiness</b>					
<b>Appropriate Test Level:</b>	TL-1	<b>Barrier Test Level:</b>	NCW	<b>Is Barrier Crashworthy?:</b>	NO
<b>Beg. End Trtmt Type:</b>	NONE	<b>Is Beg. End Trtmt Crashworthy?:</b>	N/A	<b>Approach Transition Type:</b>	NONE
<b>Ending End Trtmt Type:</b>	NONE	<b>Ending End Trtmt Crashworthy?:</b>	N/A		
<b>Average Measurements</b>					
<b>Design Height (In.):</b>	24	<b>Width (In.):</b>	18.2	<b>Post Spacing (In.):</b>	0.0

<b>Height (In.):</b>	21.2	<b>Lateral Offset (In.):</b>	0.0	<b>Road Grade (%):</b>	4.10
<b>Physical Condition</b>					
<b>Barrier</b>	<b>Alignment and Height:</b>	Alignment is acceptable. Height is within 3-in of 24-in. design height.			
	<b>Breaking and Cracking:</b>	Minor cracking of mortar (< 1/4in).			
	<b>Missing Elements:</b>	No missing elements.			
	<b>Corrosion and Weathering:</b>	No erosion behind barrier.			
<b>End Treatments</b>	<b>Alignment and Height:</b>				
	<b>Breaking and Cracking:</b>				
	<b>Missing Elements:</b>				
	<b>Corrosion and Weathering:</b>

<b>Repair Action:</b>	NO ACTION	<b>FMSS Work Type:</b>	N/A	<b>Repair Cost:</b>	\$0
<b>Brief Workorder:</b>	N/A				
<b>Workorder:</b>

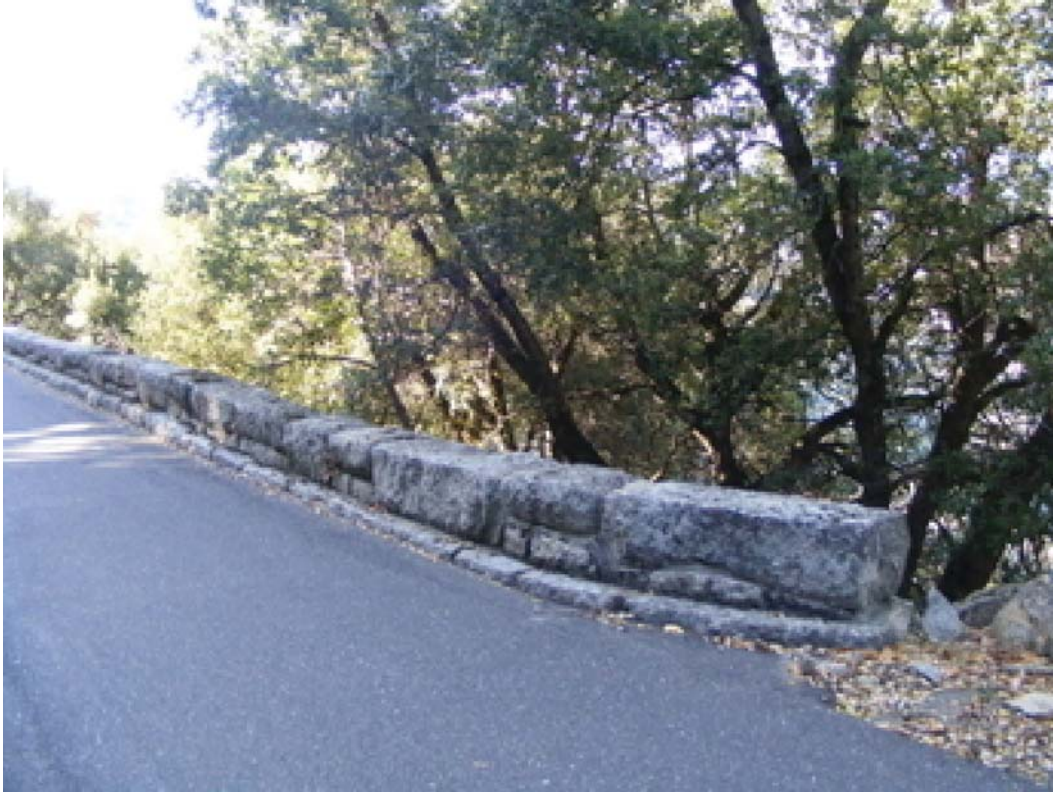
**YOSE\_0100\_5.032\_L\_1.JPG**

<b>Barrier ID:</b>	YOSE-0100-5.032-L				
<b>Route Name:</b>	HETCH HETCHY ROAD				
<b>Inspection Date:</b>	10/28/2009	<b>Barrier Rating:</b>	35.70		
<b>Barrier Description</b>					
<b>Type:</b>	STONE MASONRY WITHOUT CONCRETE CORE WALL	<b>Barrier Function:</b>	TRAFFIC		
<b>Barrier Material:</b>	STONE	<b>Post Material:</b>	N/A		
<b>Blockout Type:</b>	N/A	<b>Length (ft.):</b>	281		
<b>Speed Limit (MPH):</b>	25	<b>Placement with Respect to Road:</b>	OUTSIDE OF CURVE		
<b>Hazard Behind Barrier:</b>	EXTREME				
<b>Barrier Crashworthiness</b>					
<b>Appropriate Test Level:</b>	TL-1	<b>Barrier Test Level:</b>	NCW	<b>Is Barrier Crashworthy?:</b>	NO
<b>Beg. End Trtmt Type:</b>	NONE	<b>Is Beg. End Trtmt Crashworthy?:</b>	N/A	<b>Approach Transition Type:</b>	NONE
<b>Ending End Trtmt Type:</b>	NONE	<b>Ending End Trtmt Crashworthy?:</b>	N/A		
<b>Average Measurements</b>					
<b>Design Height (In.):</b>	24	<b>Width (In.):</b>	20.0	<b>Post Spacing (In.):</b>	0.0

<b>Height (In.):</b>	23.7	<b>Lateral Offset (In.):</b>	0.0	<b>Road Grade (%):</b>	4.00
<b>Physical Condition</b>					
<b>Barrier</b>	<b>Alignment and Height:</b>	Alignment is acceptable. Height is within 3-in of 24-in. design height.			
	<b>Breaking and Cracking:</b>	Minor cracking of mortar (<1/4in).			
	<b>Missing Elements:</b>	No missing elements.			
	<b>Corrosion and Weathering:</b>	No erosion behind barrier.			
<b>End Treatments</b>	<b>Alignment and Height:</b>				
	<b>Breaking and Cracking:</b>				
	<b>Missing Elements:</b>				
	<b>Corrosion and Weathering:</b>

<b>Repair Action:</b>	NO ACTION	<b>FMSS Work Type:</b>	N/A	<b>Repair Cost:</b>	\$0
<b>Brief Workorder:</b>	N/A				
<b>Workorder:</b>

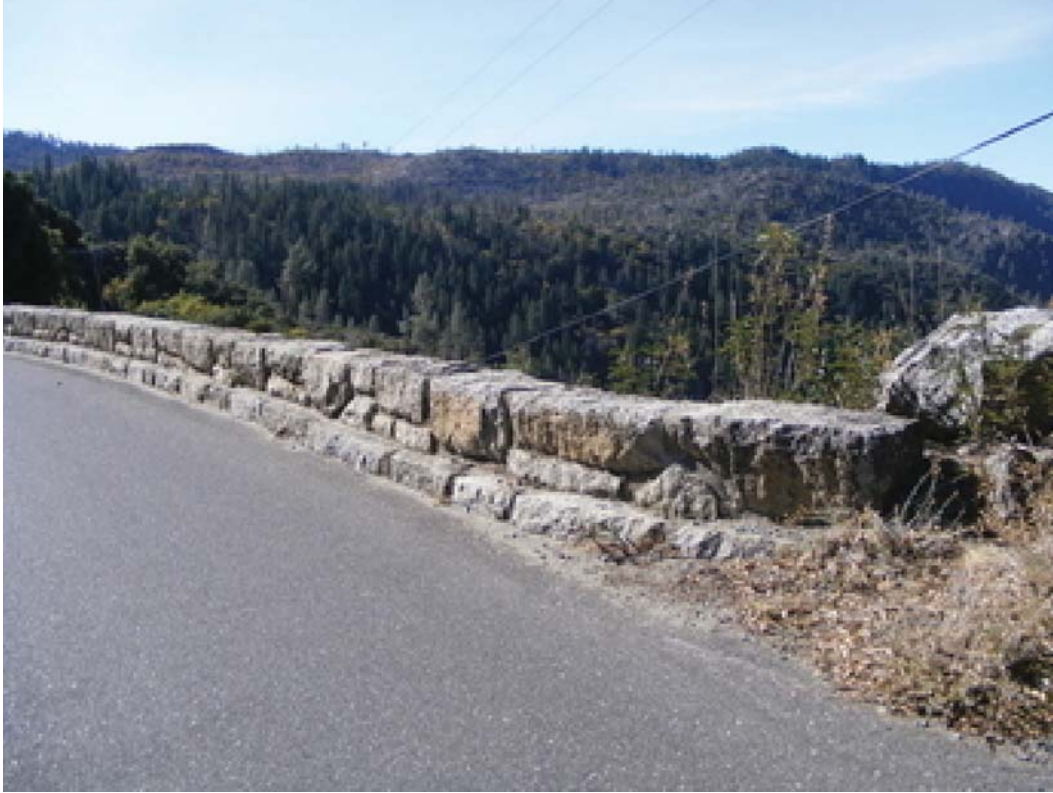
**YOSE\_0100\_5.095\_L\_1.JPG**

<b>Barrier ID:</b>	YOSE-0100-5.095-L				
<b>Route Name:</b>	HETCH HETCHY ROAD				
<b>Inspection Date:</b>	10/28/2009	<b>Barrier Rating:</b>	40.00		
<b>Barrier Description</b>					
<b>Type:</b>	STONE MASONRY WITHOUT CONCRETE CORE WALL	<b>Barrier Function:</b>	TRAFFIC		
<b>Barrier Material:</b>	STONE	<b>Post Material:</b>	N/A		
<b>Blockout Type:</b>	N/A	<b>Length (ft.):</b>	286		
<b>Speed Limit (MPH):</b>	25	<b>Placement with Respect to Road:</b>	BOTH INSIDE AND OUTSIDE		
<b>Hazard Behind Barrier:</b>	EXTREME				
<b>Barrier Crashworthiness</b>					
<b>Appropriate Test Level:</b>	TL-1	<b>Barrier Test Level:</b>	NCW	<b>Is Barrier Crashworthy?:</b>	NO
<b>Beg. End Trtmt Type:</b>	NONE	<b>Is Beg. End Trtmt Crashworthy?:</b>	N/A	<b>Approach Transition Type:</b>	NONE
<b>Ending End Trtmt Type:</b>	NONE	<b>Ending End Trtmt Crashworthy?:</b>	N/A		
<b>Average Measurements</b>					
<b>Design Height (In.):</b>	24	<b>Width (In.):</b>	19.0	<b>Post Spacing (In.):</b>	0.0

<b>Height (In.):</b>	21.7	<b>Lateral Offset (In.):</b>	0.0	<b>Road Grade (%):</b>	4.10
<b>Physical Condition</b>					
<b>Barrier</b>	<b>Alignment and Height:</b>	Alignment is acceptable. 40ft. of barrier is 3in-6" lower than the 24" design height. 246ft. is no more than 3" less than the design height.			
	<b>Breaking and Cracking:</b>	Minor cracking of mortar (<1/4in).			
	<b>Missing Elements:</b>	No missing elements.			
	<b>Corrosion and Weathering:</b>	Vegetation growing along face of barrier.			
<b>End Treatments</b>	<b>Alignment and Height:</b>				
	<b>Breaking and Cracking:</b>				
	<b>Missing Elements:</b>				
	<b>Corrosion and Weathering:</b>

<b>Repair Action:</b>	REPAIR	<b>FMSS Work Type:</b>	DEFERRED MAINTENANCE	<b>Repair Cost:</b>	\$330
<b>Brief Workorder:</b>	Remove vegetation growing along the barrier face which is destabilizing the barrier.				
<b>Workorder:</b>	Lump Sum - Remove vegetation along barrier face at \$300.

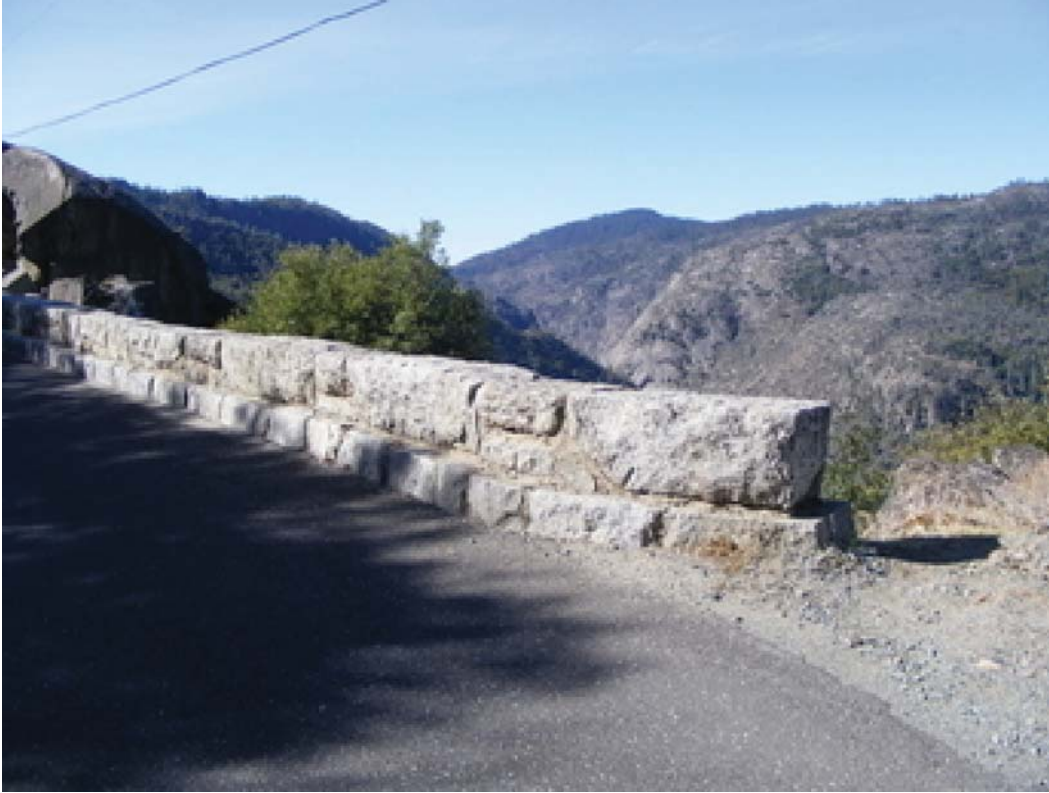
**YOSE\_0100\_5.160\_L\_1.JPG**

<b>Barrier ID:</b>	YOSE-0100-5.160-L				
<b>Route Name:</b>	HETCH HETCHY ROAD				
<b>Inspection Date:</b>	10/28/2009	<b>Barrier Rating:</b>	32.70		
<b>Barrier Description</b>					
<b>Type:</b>	STONE MASONRY WITHOUT CONCRETE CORE WALL	<b>Barrier Function:</b>	TRAFFIC		
<b>Barrier Material:</b>	STONE	<b>Post Material:</b>	N/A		
<b>Blockout Type:</b>	N/A	<b>Length (ft.):</b>	63		
<b>Speed Limit (MPH):</b>	25	<b>Placement with Respect to Road:</b>	OUTSIDE OF CURVE		
<b>Hazard Behind Barrier:</b>	EXTREME				
<b>Barrier Crashworthiness</b>					
<b>Appropriate Test Level:</b>	TL-1	<b>Barrier Test Level:</b>	NCW	<b>Is Barrier Crashworthy?:</b>	NO
<b>Beg. End Trtmt Type:</b>	NONE	<b>Is Beg. End Trtmt Crashworthy?:</b>	N/A	<b>Approach Transition Type:</b>	NONE
<b>Ending End Trtmt Type:</b>	NONE	<b>Ending End Trtmt Crashworthy?:</b>	N/A		
<b>Average Measurements</b>					
<b>Design Height (In.):</b>	24	<b>Width (In.):</b>	18.7	<b>Post Spacing (In.):</b>	0.0

<b>Height (In.):</b>	24.7	<b>Lateral Offset (In.):</b>	0.0	<b>Road Grade (%):</b>	3.70
<b>Physical Condition</b>					
<b>Barrier</b>	<b>Alignment and Height:</b>	Alignment is acceptable. Height is within 3-in of 24-in. design height. No evidence of prior impact.			
	<b>Breaking and Cracking:</b>	Minor cracking of mortar (< 1/4in).			
	<b>Missing Elements:</b>	No missing elements.			
	<b>Corrosion and Weathering:</b>	No erosion on back side of barrier.			
<b>End Treatments</b>	<b>Alignment and Height:</b>				
	<b>Breaking and Cracking:</b>				
	<b>Missing Elements:</b>				
	<b>Corrosion and Weathering:</b>

<b>Repair Action:</b>	NO ACTION	<b>FMSS Work Type:</b>	N/A	<b>Repair Cost:</b>	\$0
<b>Brief Workorder:</b>	N/A				
<b>Workorder:</b>

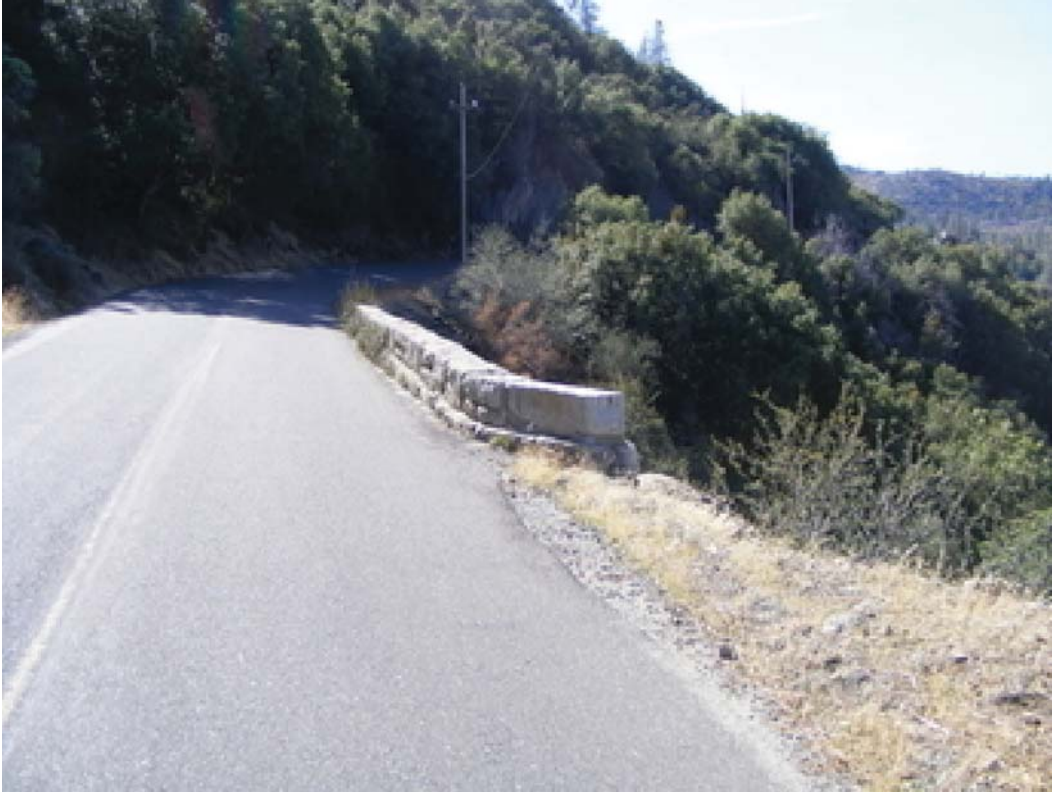
**YOSE\_0100\_5.281\_L\_1.JPG**

<b>Barrier ID:</b>	YOSE-0100-5.281-L				
<b>Route Name:</b>	HETCH HETCHY ROAD				
<b>Inspection Date:</b>	10/28/2009	<b>Barrier Rating:</b>	35.50		
<b>Barrier Description</b>					
<b>Type:</b>	STONE MASONRY WITHOUT CONCRETE CORE WALL	<b>Barrier Function:</b>	TRAFFIC		
<b>Barrier Material:</b>	STONE	<b>Post Material:</b>	N/A		
<b>Blockout Type:</b>	N/A	<b>Length (ft.):</b>	61		
<b>Speed Limit (MPH):</b>	25	<b>Placement with Respect to Road:</b>	OUTSIDE OF CURVE		
<b>Hazard Behind Barrier:</b>	HIGH				
<b>Barrier Crashworthiness</b>					
<b>Appropriate Test Level:</b>	TL-1	<b>Barrier Test Level:</b>	NCW	<b>Is Barrier Crashworthy?:</b>	NO
<b>Beg. End Trtmt Type:</b>	NONE	<b>Is Beg. End Trtmt Crashworthy?:</b>	N/A	<b>Approach Transition Type:</b>	NONE
<b>Ending End Trtmt Type:</b>	NONE	<b>Ending End Trtmt Crashworthy?:</b>	N/A		
<b>Average Measurements</b>					
<b>Design Height (In.):</b>	24	<b>Width (In.):</b>	19.2	<b>Post Spacing (In.):</b>	0.0

<b>Height (In.):</b>	21.2	<b>Lateral Offset (In.):</b>	0.0	<b>Road Grade (%):</b>	1.90
<b>Physical Condition</b>					
<b>Barrier</b>	<b>Alignment and Height:</b>	Alignment is acceptable. Height is between 3in-6" below 24-in. design height.			
	<b>Breaking and Cracking:</b>	No breaking or cracking was observed.			
	<b>Missing Elements:</b>	No missing elements.			
	<b>Corrosion and Weathering:</b>	No corrosion or weathering.			
<b>End Treatments</b>	<b>Alignment and Height:</b>				
	<b>Breaking and Cracking:</b>				
	<b>Missing Elements:</b>				
	<b>Corrosion and Weathering:</b>

<b>Barrier ID:</b>	YOSE-0100-5.281-L				
<b>Route Name:</b>	HETCH HETCHY ROAD				
<b>Inspection Date:</b>	10/28/2009	<b>Barrier Rating:</b>		35.50	
<b>Repair Recommendations</b>					
<b>Repair Action:</b>	NO ACTION	<b>FMSS Work Type:</b>	N/A	<b>Repair Cost:</b>	\$0
<b>Brief Workorder:</b>	N/A				
<b>Workorder:</b>

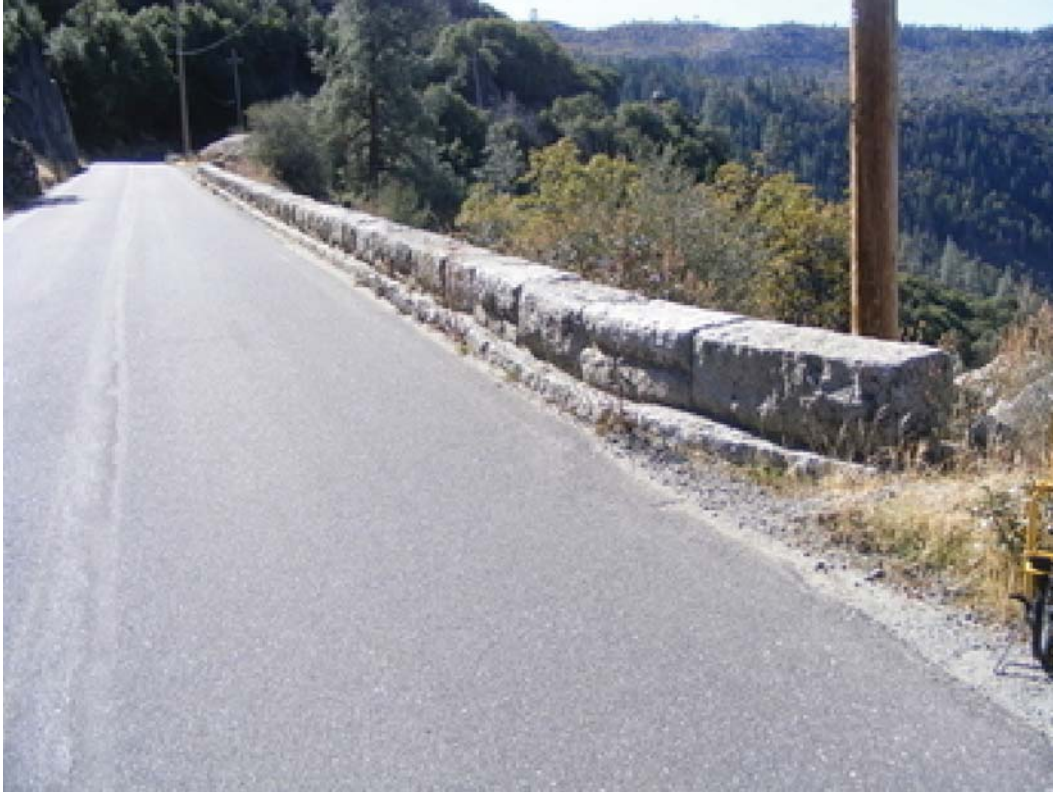
**YOSE\_0100\_5.310\_L\_1.JPG**

<b>Barrier ID:</b>	YOSE-0100-5.310-L				
<b>Route Name:</b>	HETCH HETCHY ROAD				
<b>Inspection Date:</b>	10/28/2009	<b>Barrier Rating:</b>	35.50		
<b>Barrier Description</b>					
<b>Type:</b>	STONE MASONRY WITHOUT CONCRETE CORE WALL	<b>Barrier Function:</b>	TRAFFIC		
<b>Barrier Material:</b>	STONE	<b>Post Material:</b>	N/A		
<b>Blockout Type:</b>	N/A	<b>Length (ft.):</b>	158		
<b>Speed Limit (MPH):</b>	25	<b>Placement with Respect to Road:</b>	OUTSIDE OF CURVE		
<b>Hazard Behind Barrier:</b>	HIGH				
<b>Barrier Crashworthiness</b>					
<b>Appropriate Test Level:</b>	TL-1	<b>Barrier Test Level:</b>	NCW	<b>Is Barrier Crashworthy?:</b>	NO
<b>Beg. End Trtmt Type:</b>	NONE	<b>Is Beg. End Trtmt Crashworthy?:</b>	N/A	<b>Approach Transition Type:</b>	NONE
<b>Ending End Trtmt Type:</b>	NONE	<b>Ending End Trtmt Crashworthy?:</b>	N/A		
<b>Average Measurements</b>					
<b>Design Height (In.):</b>	24	<b>Width (In.):</b>	20.0	<b>Post Spacing (In.):</b>	0.0

<b>Height (In.):</b>	22.0	<b>Lateral Offset (In.):</b>	0.0	<b>Road Grade (%):</b>	2.30
<b>Physical Condition</b>					
<b>Barrier</b>	<b>Alignment and Height:</b>	Alignment is acceptable. Height is within 3-in of 24-in. design height.			
	<b>Breaking and Cracking:</b>	No breaking or cracking was observed.			
	<b>Missing Elements:</b>	No missing elements.			
	<b>Corrosion and Weathering:</b>	No corrosion or weathering.			
<b>End Treatments</b>	<b>Alignment and Height:</b>				
	<b>Breaking and Cracking:</b>				
	<b>Missing Elements:</b>				
	<b>Corrosion and Weathering:</b>

<b>Repair Action:</b>	NO ACTION	<b>FMSS Work Type:</b>	N/A	<b>Repair Cost:</b>	\$0
<b>Brief Workorder:</b>	N/A				
<b>Workorder:</b>

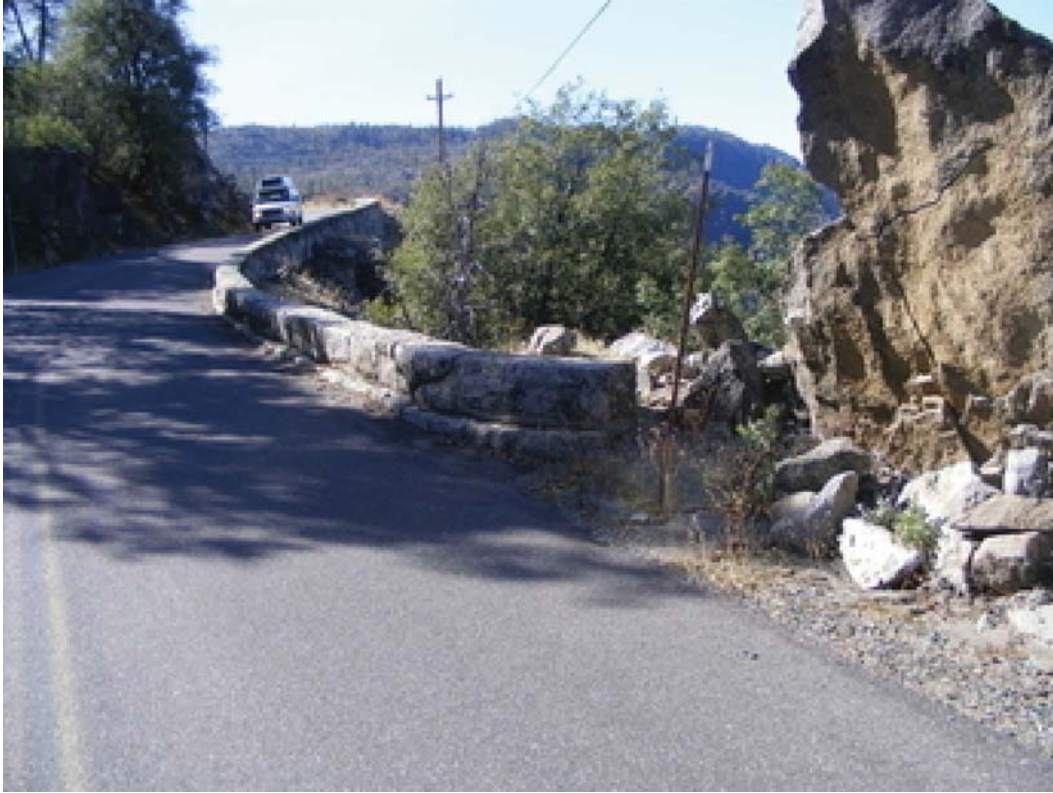
**YOSE\_0100\_5.357\_L\_1.JPG**

<b>Barrier ID:</b>	YOSE-0100-5.357-L				
<b>Route Name:</b>	HETCH HETCHY ROAD				
<b>Inspection Date:</b>	10/28/2009	<b>Barrier Rating:</b>	31.10		
<b>Barrier Description</b>					
<b>Type:</b>	STONE MASONRY WITHOUT CONCRETE CORE WALL	<b>Barrier Function:</b>	TRAFFIC		
<b>Barrier Material:</b>	STONE	<b>Post Material:</b>	N/A		
<b>Blockout Type:</b>	N/A	<b>Length (ft.):</b>	245		
<b>Speed Limit (MPH):</b>	25	<b>Placement with Respect to Road:</b>	BOTH INSIDE AND OUTSIDE		
<b>Hazard Behind Barrier:</b>	HIGH				
<b>Barrier Crashworthiness</b>					
<b>Appropriate Test Level:</b>	TL-1	<b>Barrier Test Level:</b>	NCW	<b>Is Barrier Crashworthy?:</b>	NO
<b>Beg. End Trtmt Type:</b>	NONE	<b>Is Beg. End Trtmt Crashworthy?:</b>	N/A	<b>Approach Transition Type:</b>	NONE
<b>Ending End Trtmt Type:</b>	NONE	<b>Ending End Trtmt Crashworthy?:</b>	N/A		
<b>Average Measurements</b>					
<b>Design Height (In.):</b>	24	<b>Width (In.):</b>	20.6	<b>Post Spacing (In.):</b>	0.0

<b>Height (In.):</b>	23.0	<b>Lateral Offset (In.):</b>	0.0	<b>Road Grade (%):</b>	2.60
<b>Physical Condition</b>					
<b>Barrier</b>	<b>Alignment and Height:</b>	Alignment is acceptable. Height is within 3-in of 24-in. design height.			
	<b>Breaking and Cracking:</b>	No breaking or cracking was observed.			
	<b>Missing Elements:</b>	No missing elements.			
	<b>Corrosion and Weathering:</b>	No corrosion or weathering.			
<b>End Treatments</b>	<b>Alignment and Height:</b>				
	<b>Breaking and Cracking:</b>				
	<b>Missing Elements:</b>				
	<b>Corrosion and Weathering:</b>

<b>Barrier ID:</b>	YOSE-0100-5.357-L				
<b>Route Name:</b>	HETCH HETCHY ROAD				
<b>Inspection Date:</b>	10/28/2009	<b>Barrier Rating:</b>		31.10	
<b>Repair Recommendations</b>					
<b>Repair Action:</b>	NO ACTION	<b>FMSS Work Type:</b>	N/A	<b>Repair Cost:</b>	\$0
<b>Brief Workorder:</b>	N/A				
<b>Workorder:</b>

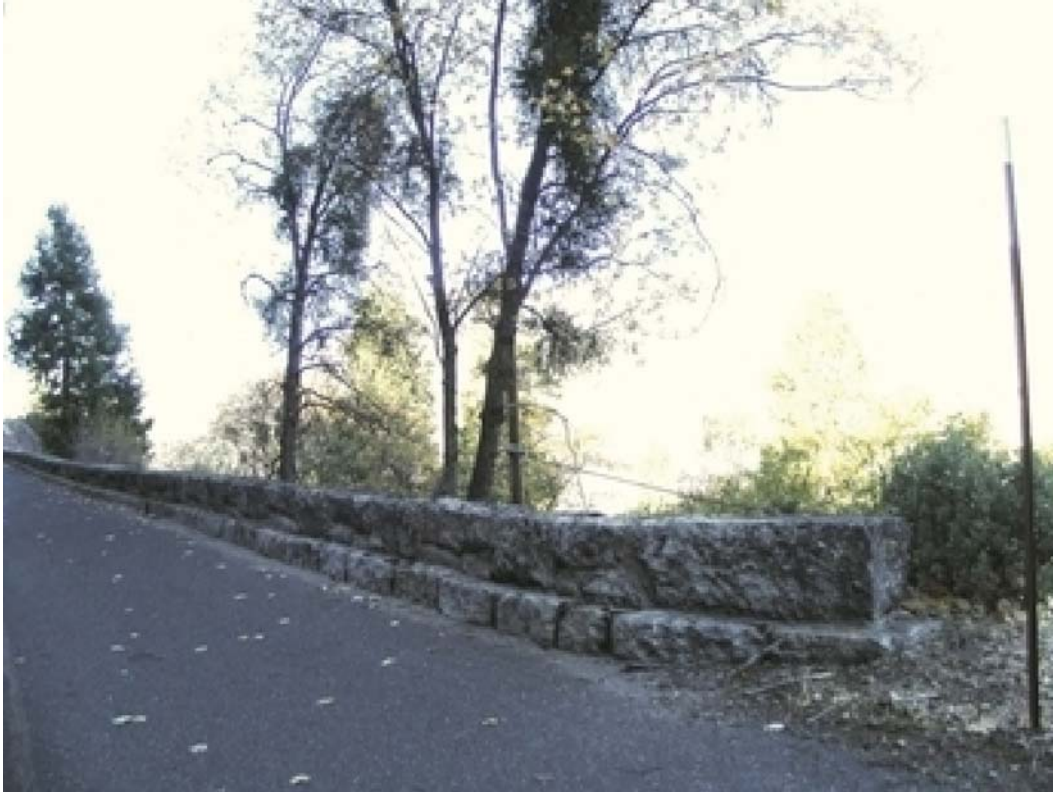
**YOSE\_0100\_5.626\_L\_1.JPG**

<b>Barrier ID:</b>	YOSE-0100-5.626-L				
<b>Route Name:</b>	HETCH HETCHY ROAD				
<b>Inspection Date:</b>	10/28/2009	<b>Barrier Rating:</b>	38.40		
<b>Barrier Description</b>					
<b>Type:</b>	STONE MASONRY WITHOUT CONCRETE CORE WALL	<b>Barrier Function:</b>	TRAFFIC		
<b>Barrier Material:</b>	STONE	<b>Post Material:</b>	N/A		
<b>Blockout Type:</b>	N/A	<b>Length (ft.):</b>	320		
<b>Speed Limit (MPH):</b>	25	<b>Placement with Respect to Road:</b>	OUTSIDE OF CURVE		
<b>Hazard Behind Barrier:</b>	HIGH				
<b>Barrier Crashworthiness</b>					
<b>Appropriate Test Level:</b>	TL-1	<b>Barrier Test Level:</b>	NCW	<b>Is Barrier Crashworthy?:</b>	NO
<b>Beg. End Trtmt Type:</b>	NONE	<b>Is Beg. End Trtmt Crashworthy?:</b>	N/A	<b>Approach Transition Type:</b>	NONE
<b>Ending End Trtmt Type:</b>	NONE	<b>Ending End Trtmt Crashworthy?:</b>	N/A		
<b>Average Measurements</b>					
<b>Design Height (In.):</b>	24	<b>Width (In.):</b>	19.2	<b>Post Spacing (In.):</b>	0.0

<b>Height (In.):</b>	22.0	<b>Lateral Offset (In.):</b>	0.0	<b>Road Grade (%):</b>	3.90
<b>Physical Condition</b>					
<b>Barrier</b>	<b>Alignment and Height:</b>	Alignment is acceptable. Height is within 3-in of 24-in. design height.			
	<b>Breaking and Cracking:</b>	No breaking or cracking was observed.			
	<b>Missing Elements:</b>	No missing elements.			
	<b>Corrosion and Weathering:</b>	Minor weathering on grout.			
<b>End Treatments</b>	<b>Alignment and Height:</b>				
	<b>Breaking and Cracking:</b>				
	<b>Missing Elements:</b>				
	<b>Corrosion and Weathering:</b>

<b>Repair Action:</b>	NO ACTION	<b>FMSS Work Type:</b>	N/A	<b>Repair Cost:</b>	\$0
<b>Brief Workorder:</b>	N/A				
<b>Workorder:</b>

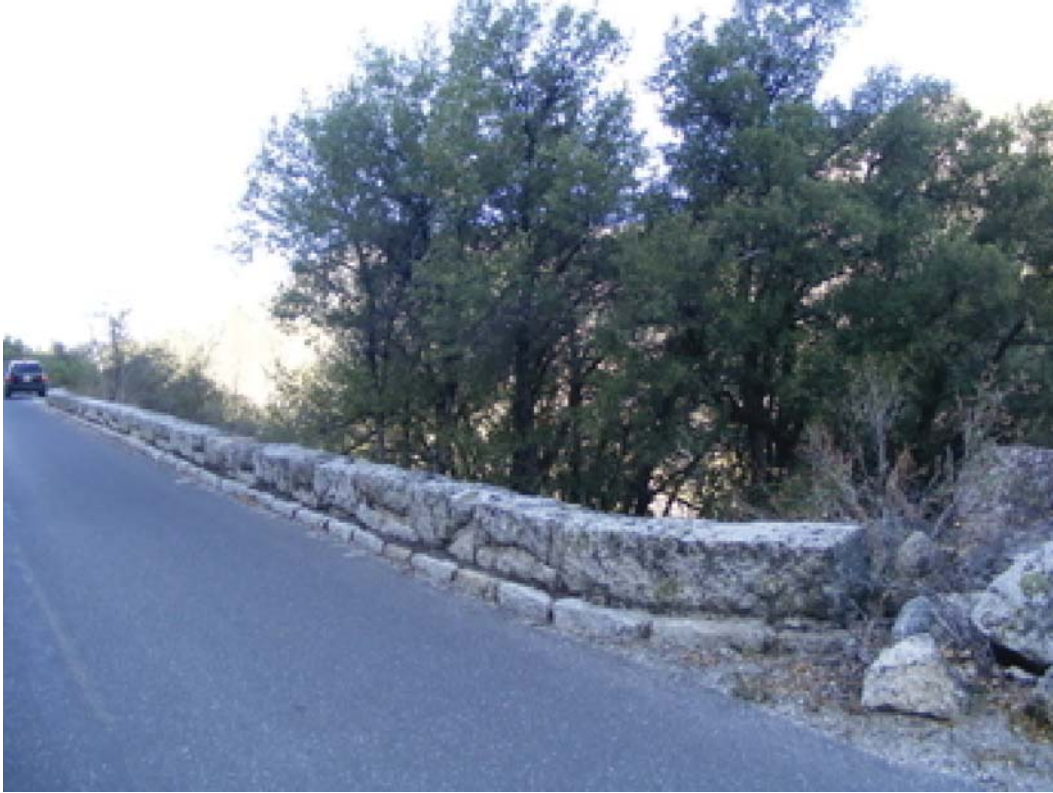
**YOSE\_0100\_6.954\_L\_1.JPG**

<b>Barrier ID:</b>	YOSE-0100-6.954-L				
<b>Route Name:</b>	HETCH HETCHY ROAD				
<b>Inspection Date:</b>	10/28/2009	<b>Barrier Rating:</b>	33.00		
<b>Barrier Description</b>					
<b>Type:</b>	STONE MASONRY WITHOUT CONCRETE CORE WALL	<b>Barrier Function:</b>	TRAFFIC		
<b>Barrier Material:</b>	STONE	<b>Post Material:</b>	N/A		
<b>Blockout Type:</b>	N/A	<b>Length (ft.):</b>	135		
<b>Speed Limit (MPH):</b>	25	<b>Placement with Respect to Road:</b>	TANGENT		
<b>Hazard Behind Barrier:</b>	EXTREME				
<b>Barrier Crashworthiness</b>					
<b>Appropriate Test Level:</b>	TL-1	<b>Barrier Test Level:</b>	NCW	<b>Is Barrier Crashworthy?:</b>	NO
<b>Beg. End Trtmt Type:</b>	NONE	<b>Is Beg. End Trtmt Crashworthy?:</b>	N/A	<b>Approach Transition Type:</b>	NONE
<b>Ending End Trtmt Type:</b>	NONE	<b>Ending End Trtmt Crashworthy?:</b>	N/A		
<b>Average Measurements</b>					
<b>Design Height (In.):</b>	24	<b>Width (In.):</b>	20.0	<b>Post Spacing (In.):</b>	0.0

<b>Height (In.):</b>	20.2	<b>Lateral Offset (In.):</b>	0.0	<b>Road Grade (%):</b>	4.50
<b>Physical Condition</b>					
<b>Barrier</b>	<b>Alignment and Height:</b>	Alignment is acceptable. No evidence of impact. Height is between 3in-6" below 24-in. design height.			
	<b>Breaking and Cracking:</b>	No breaking or cracking was observed.			
	<b>Missing Elements:</b>	Only one small area of missing mortar (about 1 sf).			
	<b>Corrosion and Weathering:</b>	No erosion at back of barrier.			
<b>End Treatments</b>	<b>Alignment and Height:</b>				
	<b>Breaking and Cracking:</b>				
	<b>Missing Elements:</b>				
	<b>Corrosion and Weathering:</b>

<b>Repair Action:</b>	REPAIR	<b>FMSS Work Type:</b>	DEFERRED MAINTENANCE	<b>Repair Cost:</b>	\$154
<b>Brief Workorder:</b>	Repoint 1 S.F. of mortar.				
<b>Workorder:</b>	Re-point masonry barrier at \$140- per -Sq. Yd. for 1 SY = \$140. No traffic control - work from back side.

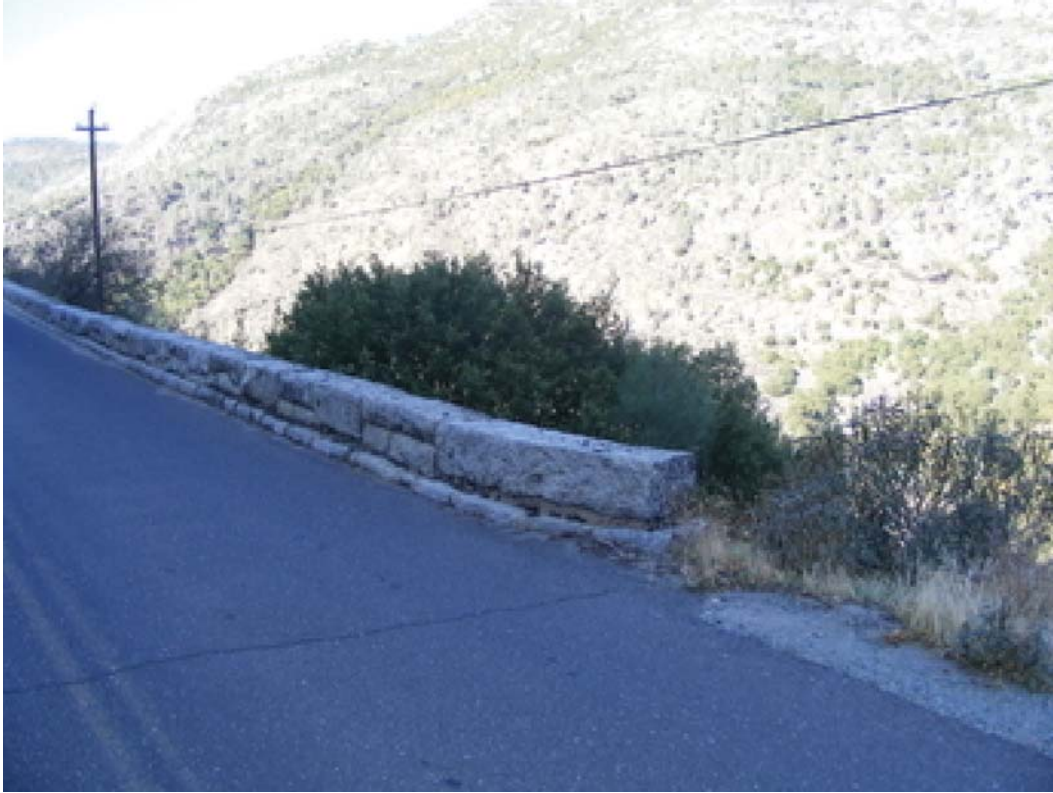
**YOSE\_0100\_7.237\_L\_1.JPG**

<b>Barrier ID:</b>	YOSE-0100-7.237-L				
<b>Route Name:</b>	HETCH HETCHY ROAD				
<b>Inspection Date:</b>	10/28/2009	<b>Barrier Rating:</b>	40.00		
<b>Barrier Description</b>					
<b>Type:</b>	STONE MASONRY WITHOUT CONCRETE CORE WALL	<b>Barrier Function:</b>	TRAFFIC		
<b>Barrier Material:</b>	STONE	<b>Post Material:</b>	N/A		
<b>Blockout Type:</b>	N/A	<b>Length (ft.):</b>	360		
<b>Speed Limit (MPH):</b>	25	<b>Placement with Respect to Road:</b>	OUTSIDE OF CURVE		
<b>Hazard Behind Barrier:</b>	EXTREME				
<b>Barrier Crashworthiness</b>					
<b>Appropriate Test Level:</b>	TL-1	<b>Barrier Test Level:</b>	NCW	<b>Is Barrier Crashworthy?:</b>	NO
<b>Beg. End Trtmt Type:</b>	NONE	<b>Is Beg. End Trtmt Crashworthy?:</b>	N/A	<b>Approach Transition Type:</b>	NONE
<b>Ending End Trtmt Type:</b>	NONE	<b>Ending End Trtmt Crashworthy?:</b>	N/A		
<b>Average Measurements</b>					
<b>Design Height (In.):</b>	24	<b>Width (In.):</b>	19.0	<b>Post Spacing (In.):</b>	0.0

<b>Height (In.):</b>	21.2	<b>Lateral Offset (In.):</b>	0.0	<b>Road Grade (%):</b>	4.20
<b>Physical Condition</b>					
<b>Barrier</b>	<b>Alignment and Height:</b>	Alignment is acceptable. No sign of impact. 25ft. is 3in-6" below 24-in. design height. Remainder of barrier is 1"-3" below 24-in. design height.			
	<b>Breaking and Cracking:</b>	Cracking of mortar between blocks most is less than 1/4in.			
	<b>Missing Elements:</b>	No missing elements.			
	<b>Corrosion and Weathering:</b>	No erosion behind barrier.			
<b>End Treatments</b>	<b>Alignment and Height:</b>				
	<b>Breaking and Cracking:</b>				
	<b>Missing Elements:</b>				
	<b>Corrosion and Weathering:</b>

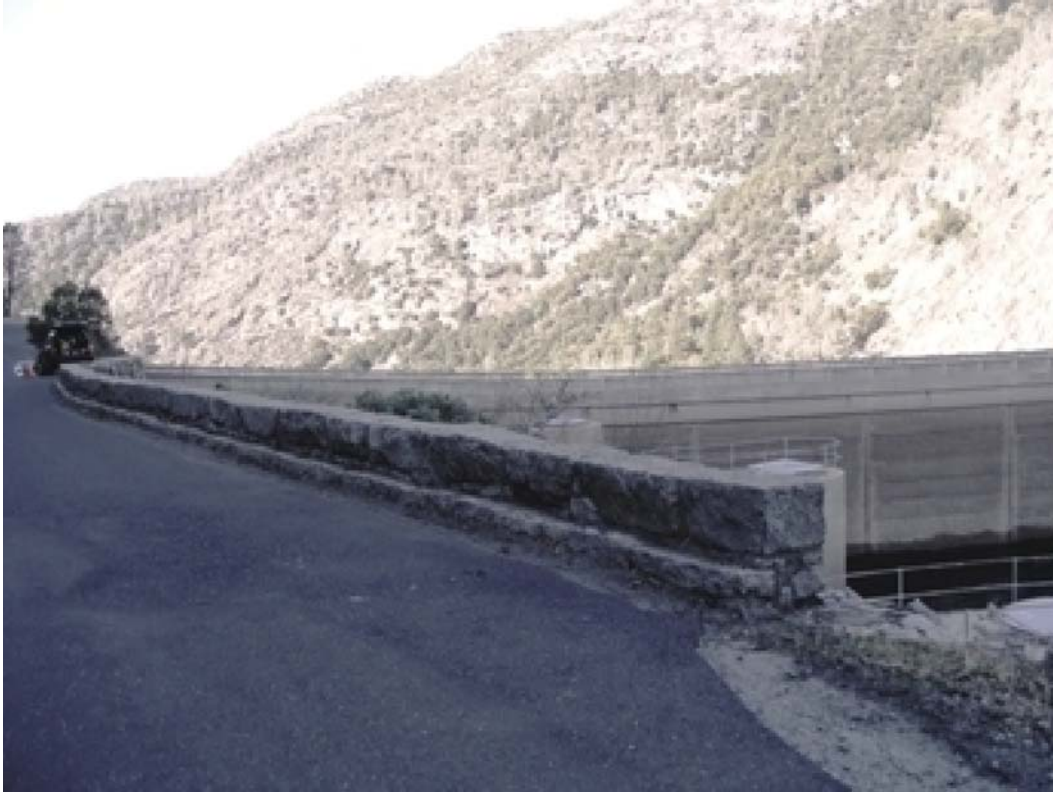
**YOSE\_0100\_8.177\_R\_1.JPG**

<b>Barrier ID:</b>	YOSE-0100-8.177-R				
<b>Route Name:</b>	HETCH HETCHY ROAD				
<b>Inspection Date:</b>	10/28/2009	<b>Barrier Rating:</b>	26.80		
<b>Barrier Description</b>					
<b>Type:</b>	STONE MASONRY WITHOUT CONCRETE CORE WALL	<b>Barrier Function:</b>	TRAFFIC		
<b>Barrier Material:</b>	STONE	<b>Post Material:</b>	N/A		
<b>Blockout Type:</b>	N/A	<b>Length (ft.):</b>	322		
<b>Speed Limit (MPH):</b>	15	<b>Placement with Respect to Road:</b>	INSIDE OF CURVE		
<b>Hazard Behind Barrier:</b>	HIGH				
<b>Barrier Crashworthiness</b>					
<b>Appropriate Test Level:</b>	TL-1	<b>Barrier Test Level:</b>	NCW	<b>Is Barrier Crashworthy?:</b>	NO
<b>Beg. End Trtmt Type:</b>	NONE	<b>Is Beg. End Trtmt Crashworthy?:</b>	N/A	<b>Approach Transition Type:</b>	NONE
<b>Ending End Trtmt Type:</b>	NONE	<b>Ending End Trtmt Crashworthy?:</b>	N/A		
<b>Average Measurements</b>					
<b>Design Height (In.):</b>	24	<b>Width (In.):</b>	19.0	<b>Post Spacing (In.):</b>	0.0

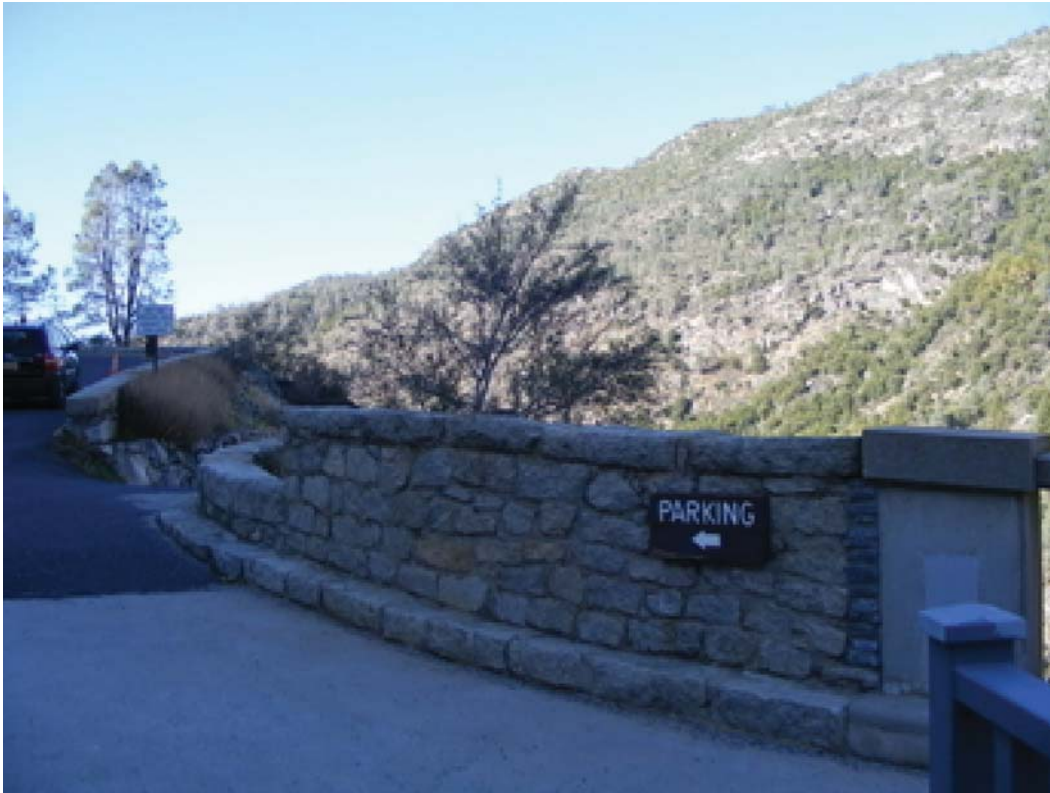
**YOSE\_0100\_8.244\_R\_1.JPG**

<b>Barrier ID:</b>	YOSE-0100-8.244-R				
<b>Route Name:</b>	HETCH HETCHY ROAD				
<b>Inspection Date:</b>	10/28/2009	<b>Barrier Rating:</b>	19.70		
<b>Barrier Description</b>					
<b>Type:</b>	STONE MASONRY WITHOUT CONCRETE CORE WALL	<b>Barrier Function:</b>	TRAFFIC		
<b>Barrier Material:</b>	STONE	<b>Post Material:</b>	N/A		
<b>Blockout Type:</b>	N/A	<b>Length (ft.):</b>	41		
<b>Speed Limit (MPH):</b>	15	<b>Placement with Respect to Road:</b>	INSIDE OF CURVE		
<b>Hazard Behind Barrier:</b>	HIGH				
<b>Barrier Crashworthiness</b>					
<b>Appropriate Test Level:</b>	TL-1	<b>Barrier Test Level:</b>	NCW	<b>Is Barrier Crashworthy?:</b>	NO
<b>Beg. End Trtmt Type:</b>	NONE	<b>Is Beg. End Trtmt Crashworthy?:</b>	N/A	<b>Approach Transition Type:</b>	NONE
<b>Ending End Trtmt Type:</b>	NONE	<b>Ending End Trtmt Crashworthy?:</b>	N/A		
<b>Average Measurements</b>					
<b>Design Height (In.):</b>	24	<b>Width (In.):</b>	19.7	<b>Post Spacing (In.):</b>	0.0

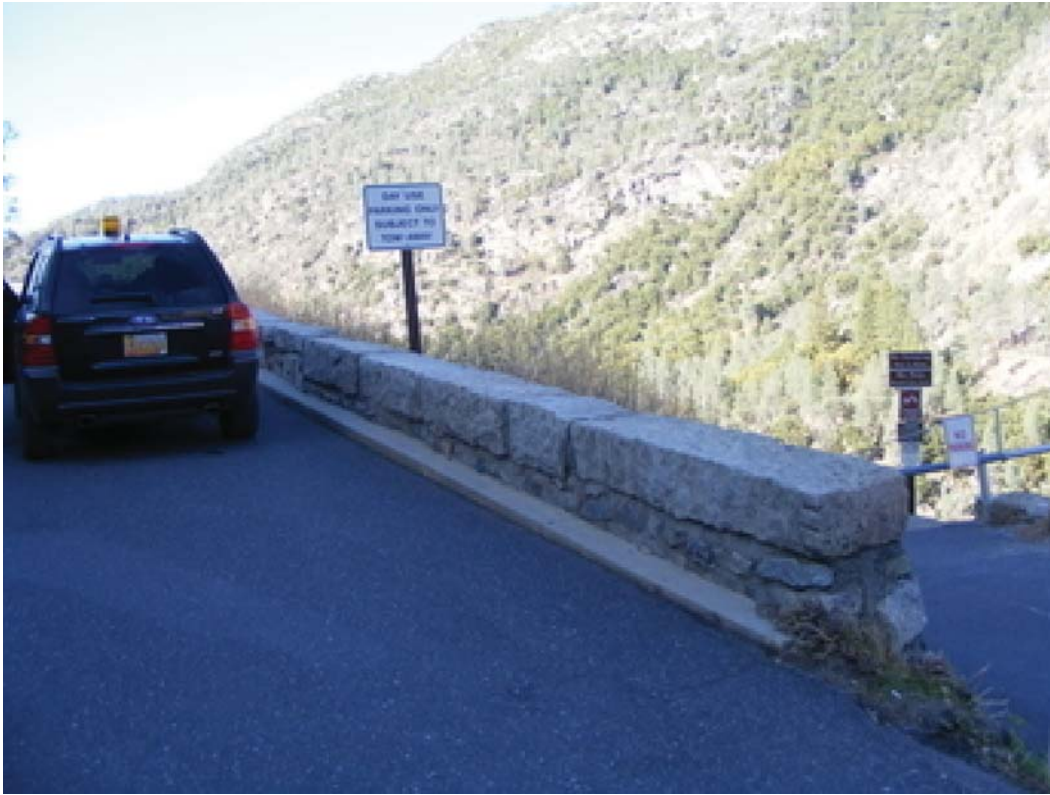
YOSE\_0100\_8.252\_R\_1.JPG

<b>Barrier ID:</b>	YOSE-0100-8.252-R				
<b>Route Name:</b>	HETCH HETCHY ROAD				
<b>Inspection Date:</b>	10/28/2009	<b>Barrier Rating:</b>	25.30		
<b>Barrier Description</b>					
<b>Type:</b>	STONE MASONRY WITHOUT CONCRETE CORE WALL	<b>Barrier Function:</b>	TRAFFIC		
<b>Barrier Material:</b>	STONE	<b>Post Material:</b>	N/A		
<b>Blockout Type:</b>	N/A	<b>Length (ft.):</b>	89		
<b>Speed Limit (MPH):</b>	15	<b>Placement with Respect to Road:</b>	OUTSIDE OF CURVE		
<b>Hazard Behind Barrier:</b>	HIGH				
<b>Barrier Crashworthiness</b>					
<b>Appropriate Test Level:</b>	TL-1	<b>Barrier Test Level:</b>	NCW	<b>Is Barrier Crashworthy?:</b>	NO
<b>Beg. End Trtmt Type:</b>	NONE	<b>Is Beg. End Trtmt Crashworthy?:</b>	N/A	<b>Approach Transition Type:</b>	NONE
<b>Ending End Trtmt Type:</b>	NONE	<b>Ending End Trtmt Crashworthy?:</b>	N/A		
<b>Average Measurements</b>					
<b>Design Height (In.):</b>	24	<b>Width (In.):</b>	19.6	<b>Post Spacing (In.):</b>	0.0

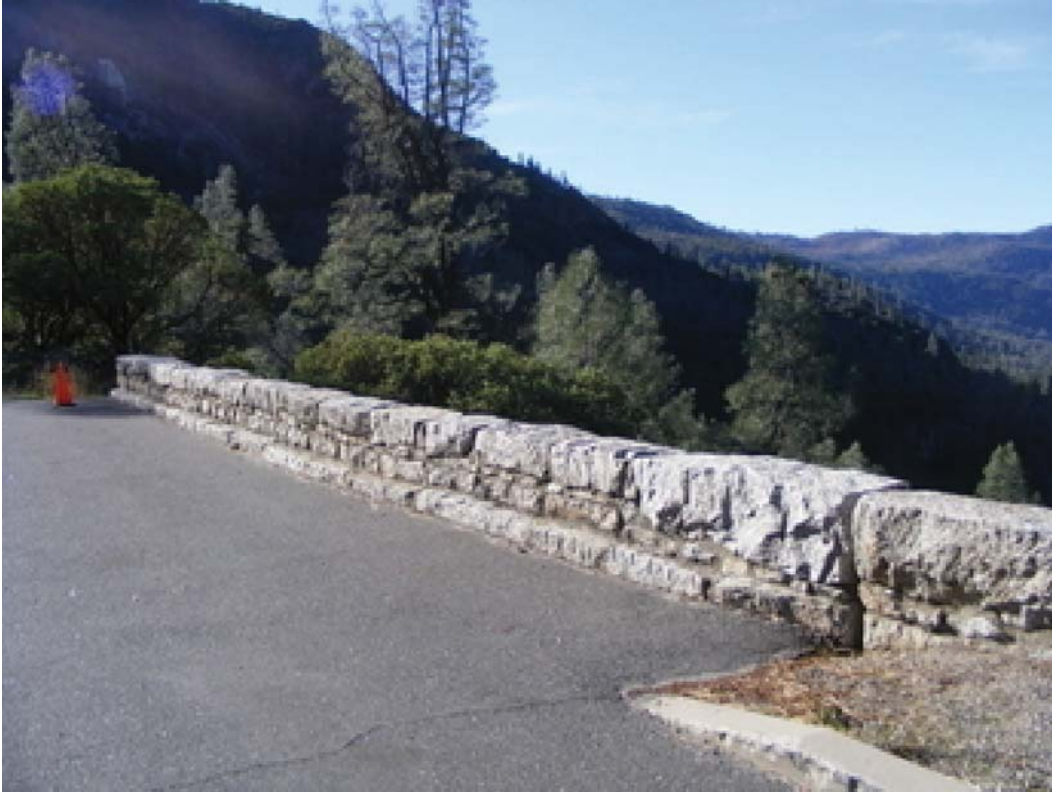
**YOSE\_0100\_8.332\_R\_1.JPG**

<b>Barrier ID:</b>	YOSE-0100-8.332-R				
<b>Route Name:</b>	HETCH HETCHY ROAD				
<b>Inspection Date:</b>	10/28/2009	<b>Barrier Rating:</b>	12.60		
<b>Barrier Description</b>					
<b>Type:</b>	STONE MASONRY WITHOUT CONCRETE CORE WALL	<b>Barrier Function:</b>	TRAFFIC		
<b>Barrier Material:</b>	STONE	<b>Post Material:</b>	N/A		
<b>Blockout Type:</b>	N/A	<b>Length (ft.):</b>	58		
<b>Speed Limit (MPH):</b>	15	<b>Placement with Respect to Road:</b>	TANGENT		
<b>Hazard Behind Barrier:</b>	HIGH				
<b>Barrier Crashworthiness</b>					
<b>Appropriate Test Level:</b>	TL-1	<b>Barrier Test Level:</b>	NCW	<b>Is Barrier Crashworthy?:</b>	NO
<b>Beg. End Trtmt Type:</b>	NONE	<b>Is Beg. End Trtmt Crashworthy?:</b>	N/A	<b>Approach Transition Type:</b>	NONE
<b>Ending End Trtmt Type:</b>	NONE	<b>Ending End Trtmt Crashworthy?:</b>	N/A		
<b>Average Measurements</b>					
<b>Design Height (In.):</b>	24	<b>Width (In.):</b>	19.0	<b>Post Spacing (In.):</b>	0.0

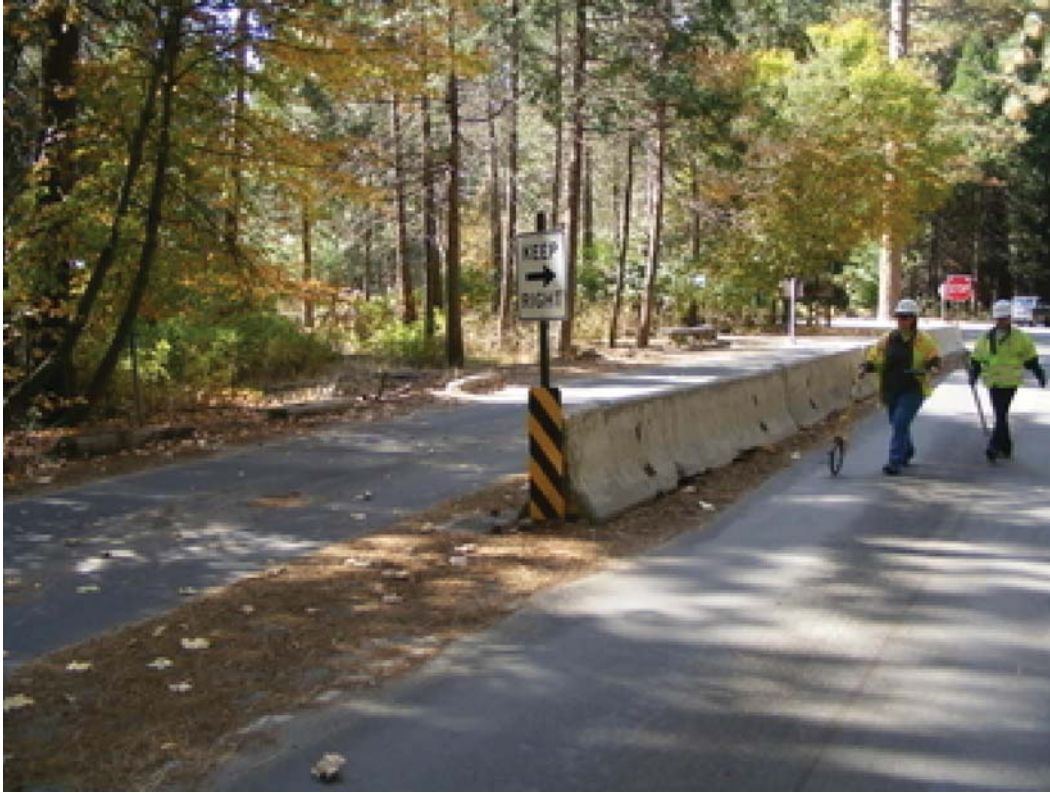
YOSE\_0500\_7.558\_R\_1.JPG

<b>Barrier ID:</b>	YOSE-0500-7.558-R				
<b>Route Name:</b>	VALLEY LOOP ROAD				
<b>Inspection Date:</b>	10/27/2009	<b>Barrier Rating:</b>	12.60		
<b>Barrier Description</b>					
<b>Type:</b>	CONCRETE BARRIER	<b>Barrier Function:</b>	TRAFFIC		
<b>Barrier Material:</b>	CONCRETE	<b>Post Material:</b>	N/A		
<b>Blockout Type:</b>	N/A	<b>Length (ft.):</b>	101		
<b>Speed Limit (MPH):</b>	25	<b>Placement with Respect to Road:</b>	TANGENT		
<b>Hazard Behind Barrier:</b>	LOW				
<b>Barrier Crashworthiness</b>					
<b>Appropriate Test Level:</b>	TL-1	<b>Barrier Test Level:</b>	TL-3	<b>Is Barrier Crashworthy?:</b>	YES
<b>Beg. End Trtmt Type:</b>	NONE	<b>Is Beg. End Trtmt Crashworthy?:</b>	N/A	<b>Approach Transition Type:</b>	NONE
<b>Ending End Trtmt Type:</b>	NONE	<b>Ending End Trtmt Crashworthy?:</b>	N/A		
<b>Average Measurements</b>					
<b>Design Height (In.):</b>	33	<b>Width (In.):</b>	6.0	<b>Post Spacing (In.):</b>	0.0
