GIP Report

NPS Guardwall/Rail Inventory Program Zion National Park

**Federal Lands Highway
Road Inventory Program**

**Data Collection Date: April 2010
Report Date: November 2015**

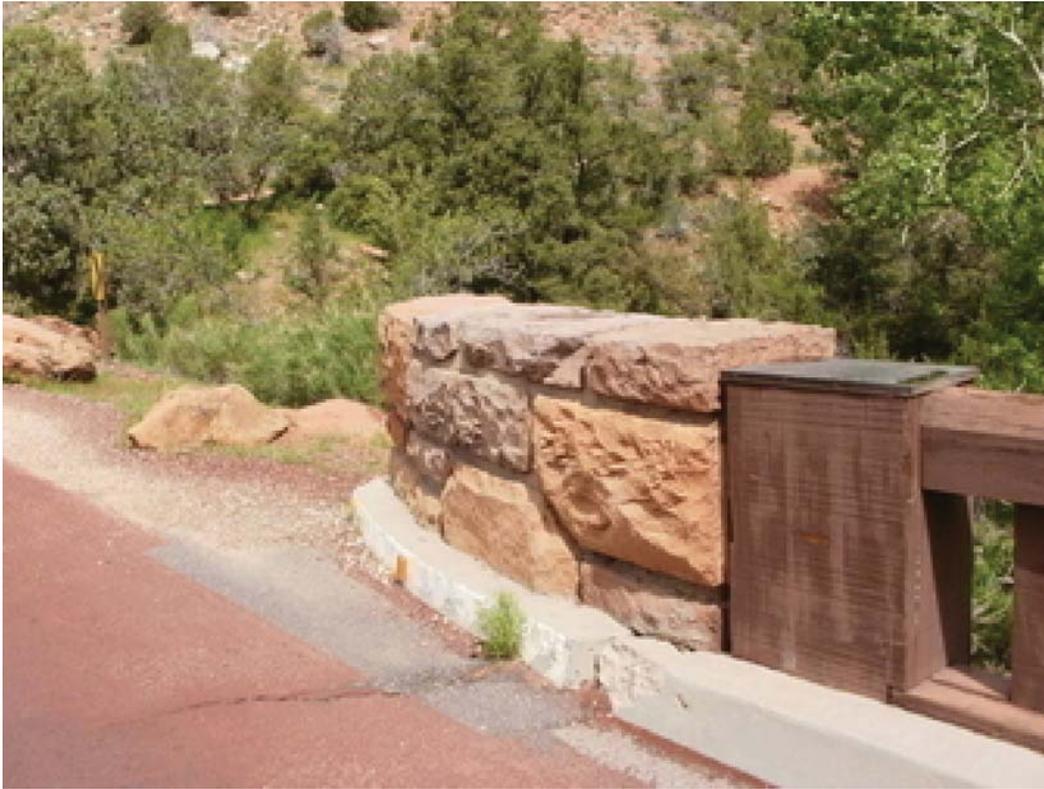
ZION_0010_1.478_L_1.JPG

Barrier ID:	ZION-0010-1.478-L				
Route Name:	ZION-MT CARMEL HIGHWAY				
Inspection Date:	04/29/2010	Barrier Rating:	33.70		
Barrier Description					
Type:	STONE MASONRY WITHOUT CONCRETE CORE WALL	Barrier Function:	TRAFFIC		
Barrier Material:	STONE	Post Material:	N/A		
Blockout Type:	N/A	Length (ft.):	10		
Speed Limit (MPH):	35	Placement with Respect to Road:	OUTSIDE OF CURVE		
Hazard Behind Barrier:	MEDIUM				
Barrier Crashworthiness					
Appropriate Test Level:	TL-2	Barrier Test Level:	NCW	Is Barrier Crashworthy?:	NO
Beg. End Trtmt Type:	NONE	Is Beg. End Trtmt Crashworthy?:	N/A	Approach Transition Type:	NONE
Ending End Trtmt Type:	NONE	Ending End Trtmt Crashworthy?:	N/A		
Average Measurements					
Design Height (In.):	24	Width (In.):	25.2	Post Spacing (In.):	0.0
Height (In.):	42.0	Lateral Offset (In.):	34.5	Road Grade (%):	2.00
Physical Condition					
Barrier	Alignment and Height:	Abutment alignment was correct. Abutment height was 43 to 44 in high.

Breaking and Cracking:	No breaking or cracking of abutment.			
	Missing Elements:	No missing elements in the abutment.			
	Corrosion and Weathering:	No major weathering of the abutment.			
End Treatments	Alignment and Height:	N/A			
	Breaking and Cracking:	N/A			
	Missing Elements:	N/A			
	Corrosion and Weathering:	N/A

Repair Action:	NO ACTION	FMSS Work Type:	N/A	Repair Cost:	\$0
Brief Workorder:	N/A				
Workorder:

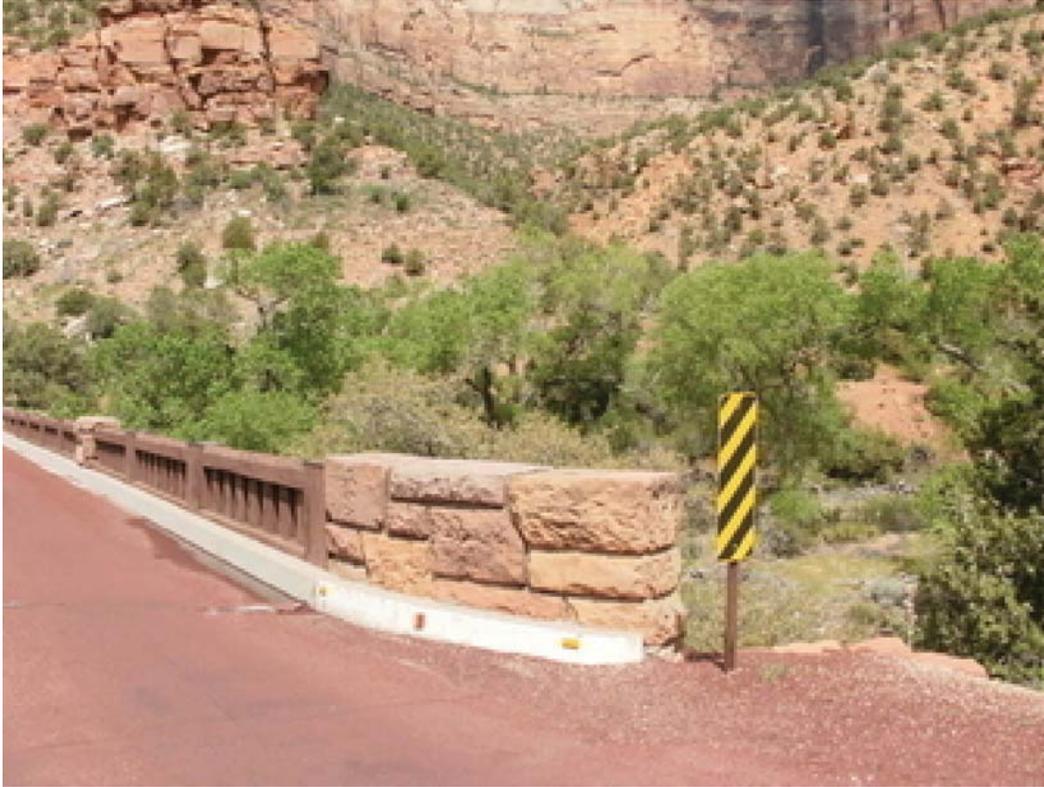
ZION_0010_1.514_L_1.JPG

Barrier ID:	ZION-0010-1.514-L				
Route Name:	ZION-MT CARMEL HIGHWAY				
Inspection Date:	04/29/2010	Barrier Rating:	28.60		
Barrier Description					
Type:	STONE MASONRY WITHOUT CONCRETE CORE WALL	Barrier Function:	TRAFFIC		
Barrier Material:	STONE	Post Material:	N/A		
Blockout Type:	N/A	Length (ft.):	10		
Speed Limit (MPH):	35	Placement with Respect to Road:	TANGENT		
Hazard Behind Barrier:	EXTREME				
Barrier Crashworthiness					
Appropriate Test Level:	TL-2	Barrier Test Level:	NCW	Is Barrier Crashworthy?:	NO
Beg. End Trtmt Type:	NONE	Is Beg. End Trtmt Crashworthy?:	N/A	Approach Transition Type:	NONE
Ending End Trtmt Type:	NONE	Ending End Trtmt Crashworthy?:	N/A		
Average Measurements					
Design Height (In.):	24	Width (In.):	25.7	Post Spacing (In.):	0.0
Height (In.):	42.0	Lateral Offset (In.):	32.7	Road Grade (%):	0.30
Physical Condition					
Barrier	Alignment and Height:	Barrier was in alignment and was greater than 24 in design height by 20 in for entire length. Appeared to be bridge abutment.

Breaking and Cracking:	No breaking or cracking in barrier.			
	Missing Elements:	No missing elements in barrier.			
	Corrosion and Weathering:	No weathering observed in barrier.			
End Treatments	Alignment and Height:	N/A			
	Breaking and Cracking:	N/A			
	Missing Elements:	N/A			
	Corrosion and Weathering:	N/A

Repair Action:	NO ACTION	FMSS Work Type:	N/A	Repair Cost:	\$0
Brief Workorder:	N/A				
Workorder:

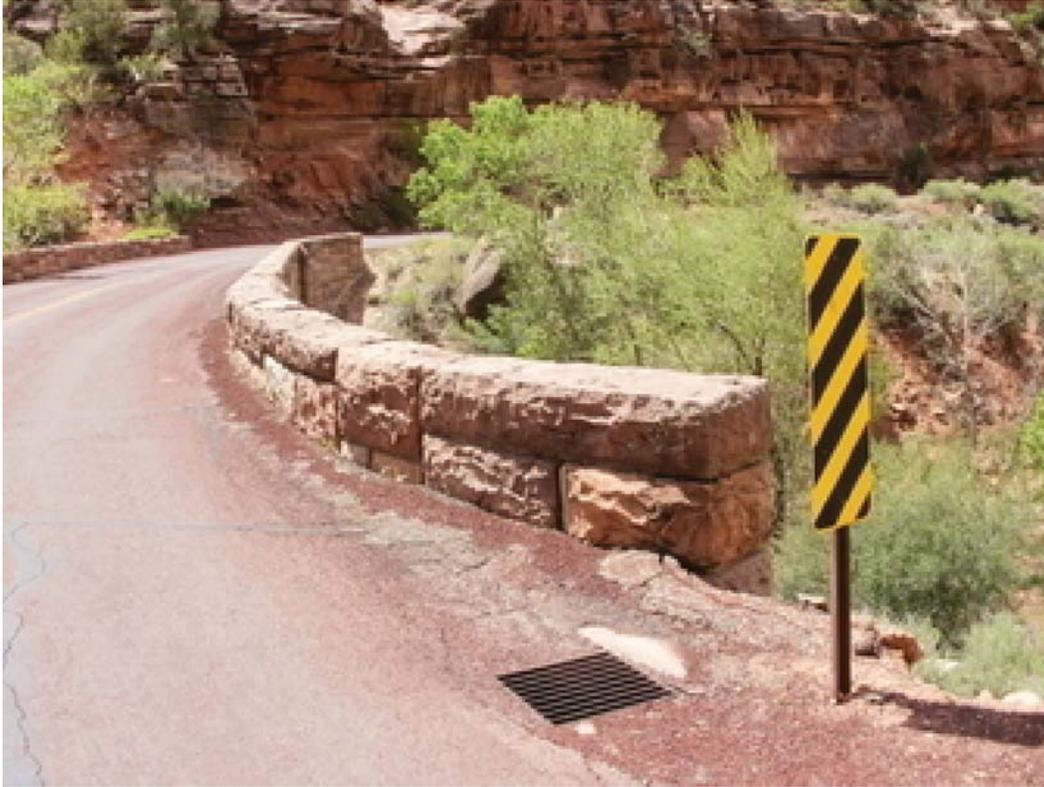
ZION_0010_2.049_R_1.JPG

Barrier ID:	ZION-0010-2.049-R				
Route Name:	ZION-MT CARMEL HIGHWAY				
Inspection Date:	04/29/2010	Barrier Rating:	30.70		
Barrier Description					
Type:	STONE MASONRY WITHOUT CONCRETE CORE WALL	Barrier Function:	TRAFFIC		
Barrier Material:	STONE	Post Material:	N/A		
Blockout Type:	N/A	Length (ft.):	36		
Speed Limit (MPH):	35	Placement with Respect to Road:	INSIDE OF CURVE		
Hazard Behind Barrier:	MEDIUM				
Barrier Crashworthiness					
Appropriate Test Level:	TL-2	Barrier Test Level:	NCW	Is Barrier Crashworthy?:	NO
Beg. End Trtmt Type:	NONE	Is Beg. End Trtmt Crashworthy?:	N/A	Approach Transition Type:	NONE
Ending End Trtmt Type:	NONE	Ending End Trtmt Crashworthy?:	N/A		
Average Measurements					
Design Height (In.):	24	Width (In.):	21.2	Post Spacing (In.):	0.0
Height (In.):	29.0	Lateral Offset (In.):	12.3	Road Grade (%):	2.10
Physical Condition					
Barrier	Alignment and Height:	Alignment acceptable. Height was 3-8in. above the 24-in. design height.

Breaking and Cracking:	No breaking or cracking of bridge abutment.			
	Missing Elements:	No missing elements in abutment.			
	Corrosion and Weathering:	No major weathering of the bridge abutment.			
End Treatments	Alignment and Height:	N/A			
	Breaking and Cracking:	N/A			
	Missing Elements:	N/A			
	Corrosion and Weathering:	N/A

Repair Action:	NO ACTION	FMSS Work Type:	N/A	Repair Cost:	\$0
Brief Workorder:	N/A				
Workorder:

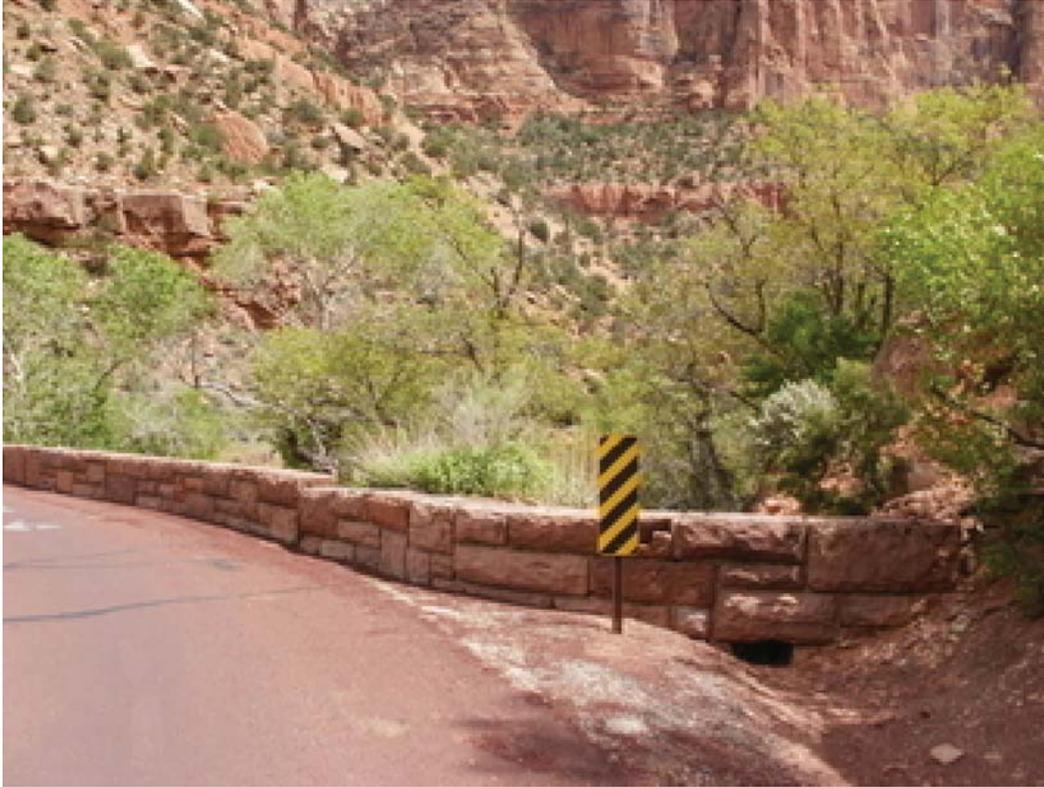
ZION_0010_2.070_L_1.JPG

Barrier ID:	ZION-0010-2.070-L				
Route Name:	ZION-MT CARMEL HIGHWAY				
Inspection Date:	04/29/2010	Barrier Rating:	35.50		
Barrier Description					
Type:	STONE MASONRY WITHOUT CONCRETE CORE WALL	Barrier Function:	TRAFFIC		
Barrier Material:	STONE	Post Material:	N/A		
Blockout Type:	N/A	Length (ft.):	65		
Speed Limit (MPH):	35	Placement with Respect to Road:	OUTSIDE OF CURVE		
Hazard Behind Barrier:	HIGH				
Barrier Crashworthiness					
Appropriate Test Level:	TL-2	Barrier Test Level:	NCW	Is Barrier Crashworthy?:	NO
Beg. End Trtmt Type:	NONE	Is Beg. End Trtmt Crashworthy?:	N/A	Approach Transition Type:	NONE
Ending End Trtmt Type:	NONE	Ending End Trtmt Crashworthy?:	N/A		
Average Measurements					
Design Height (In.):	24	Width (In.):	21.7	Post Spacing (In.):	0.0
Height (In.):	32.2	Lateral Offset (In.):	46.0	Road Grade (%):	1.80
Physical Condition					
Barrier	Alignment and Height:	Alignment acceptable. Height was 6-11 in. above the 24-in. design height.

Breaking and Cracking:	Cracks greater than 1/2 in wide are apparent in various locations of the barrier totaling approximately 16s.f.			
	Missing Elements:	No missing elements in barrier.			
	Corrosion and Weathering:	No weathering observed in barrier.			
End Treatments	Alignment and Height:	N/A			
	Breaking and Cracking:	N/A			
	Missing Elements:	N/A			
	Corrosion and Weathering:	N/A

Repair Action:	REPAIR	FMSS Work Type:	DEFERRED MAINTENANCE	Repair Cost:	\$1931
Brief Workorder:	Repoint 16 square feet of barrier.				
Workorder:	Re-Point Masonry Barrier at \$140- per -Sq. Yd. for 2 SY = \$280. Repoint masonry where grout has separated from rock. 165ft. / 9 = 1.8 SY.. Low Speed Traffic Control at \$1475- per -Day for 1 Day(s) = \$1475.

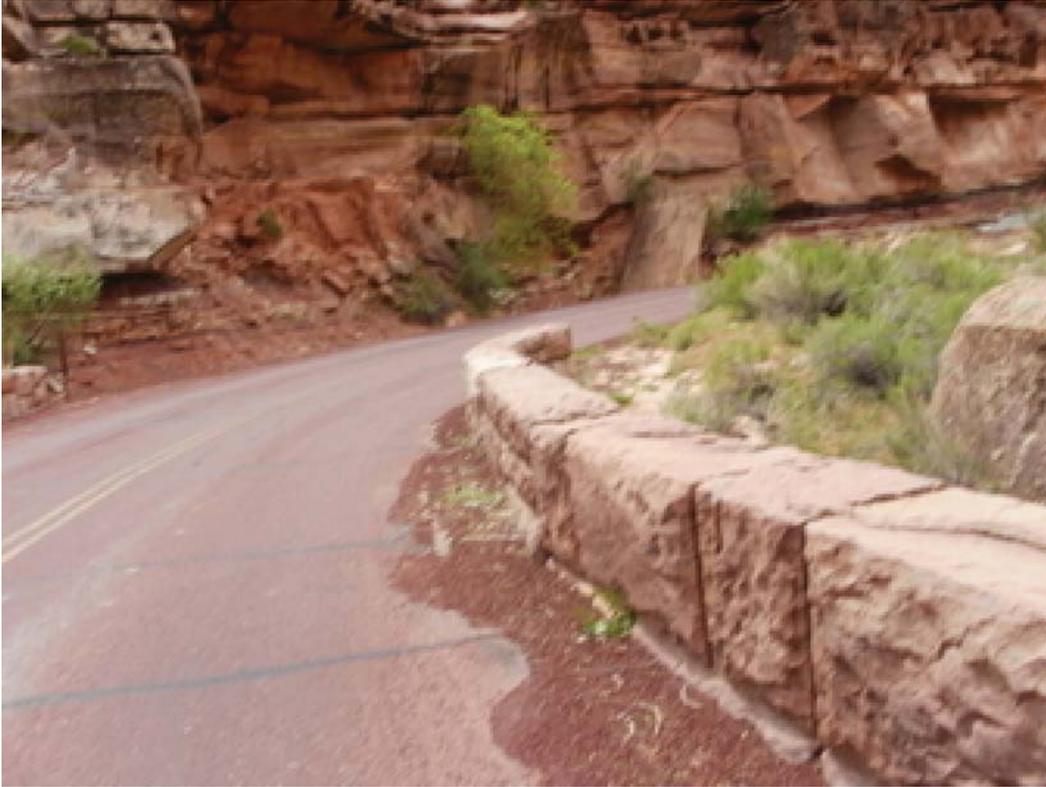
ZION_0010_2.075_R_1.JPG

Barrier ID:	ZION-0010-2.075-R				
Route Name:	ZION-MT CARMEL HIGHWAY				
Inspection Date:	04/29/2010	Barrier Rating:	29.70		
Barrier Description					
Type:	STONE MASONRY WITHOUT CONCRETE CORE WALL	Barrier Function:	TRAFFIC		
Barrier Material:	STONE	Post Material:	N/A		
Blockout Type:	N/A	Length (ft.):	40		
Speed Limit (MPH):	35	Placement with Respect to Road:	TANGENT		
Hazard Behind Barrier:	HIGH				
Barrier Crashworthiness					
Appropriate Test Level:	TL-2	Barrier Test Level:	NCW	Is Barrier Crashworthy?:	NO
Beg. End Trtmt Type:	NONE	Is Beg. End Trtmt Crashworthy?:	N/A	Approach Transition Type:	NONE
Ending End Trtmt Type:	NONE	Ending End Trtmt Crashworthy?:	N/A		
Average Measurements					
Design Height (In.):	24	Width (In.):	21.2	Post Spacing (In.):	0.0
Height (In.):	33.2	Lateral Offset (In.):	22.7	Road Grade (%):	0.70
Physical Condition					
Barrier	Alignment and Height:	Alignment acceptable. Height was 8-11 in. above the 24-in. design height.

Breaking and Cracking:	1 chip in rock face.			
	Missing Elements:	No missing elements in barrier.			
	Corrosion and Weathering:	No weathering observed in barrier.			
End Treatments	Alignment and Height:	N/A			
	Breaking and Cracking:	N/A			
	Missing Elements:	N/A			
	Corrosion and Weathering:	N/A

Repair Action:	NO ACTION	FMSS Work Type:	N/A	Repair Cost:	\$0
Brief Workorder:	N/A				
Workorder:

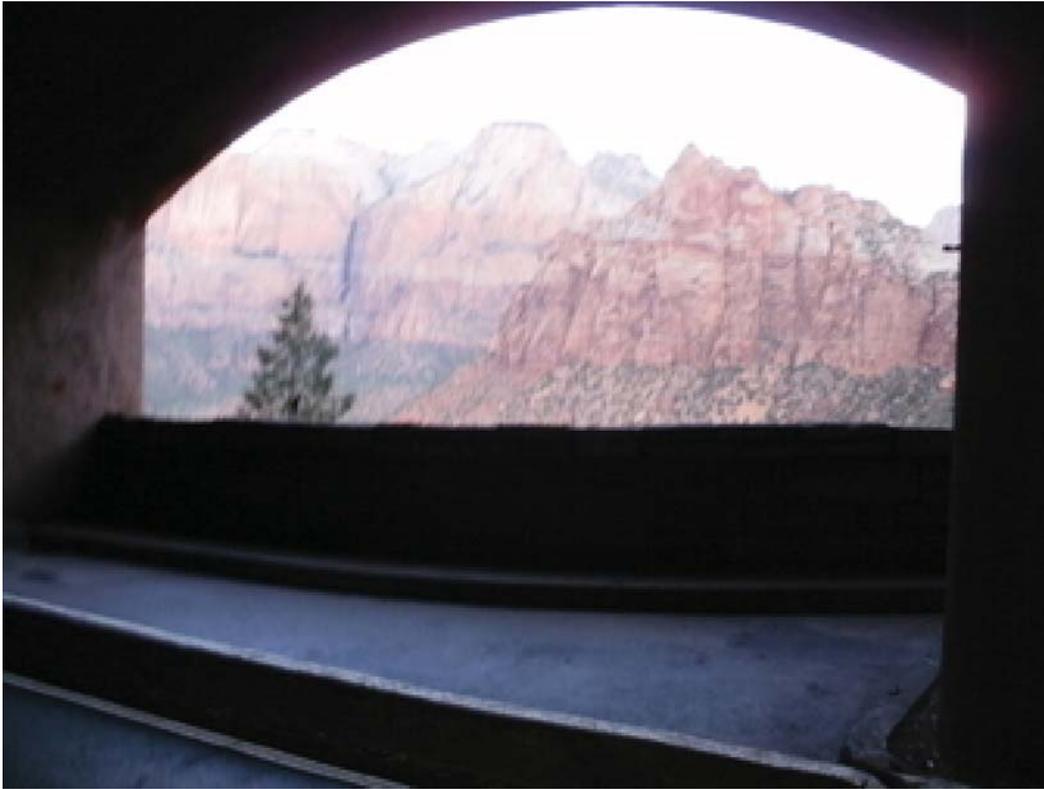
ZION_0010_5.254_L_1.JPG

Barrier ID:	ZION-0010-5.254-L				
Route Name:	ZION-MT CARMEL HIGHWAY				
Inspection Date:	04/29/2010	Barrier Rating:	0.00		
Barrier Description					
Type:	STONE MASONRY WITHOUT CONCRETE CORE WALL	Barrier Function:	NON-TRAFFIC		
Barrier Material:	STONE	Post Material:	N/A		
Blockout Type:	N/A	Length (ft.):	31		
Speed Limit (MPH):	25	Placement with Respect to Road:	NON-TRAFFIC BARRIER		
Hazard Behind Barrier:	N/A				
Barrier Crashworthiness					
Appropriate Test Level:	TL-2	Barrier Test Level:	N/A	Is Barrier Crashworthy?:	N/A
Beg. End Trtmt Type:	NONE	Is Beg. End Trtmt Crashworthy?:	N/A	Approach Transition Type:	NONE
Ending End Trtmt Type:	NONE	Ending End Trtmt Crashworthy?:	N/A		
Average Measurements					
Design Height (In.):	24	Width (In.):	18.6	Post Spacing (In.):	0.0
Height (In.):	41.2	Lateral Offset (In.):	0.0	Road Grade (%):	0.00
Physical Condition					
Barrier	Alignment and Height:	Alignment acceptable. Height was 17-18in. above the 24-in. design height.

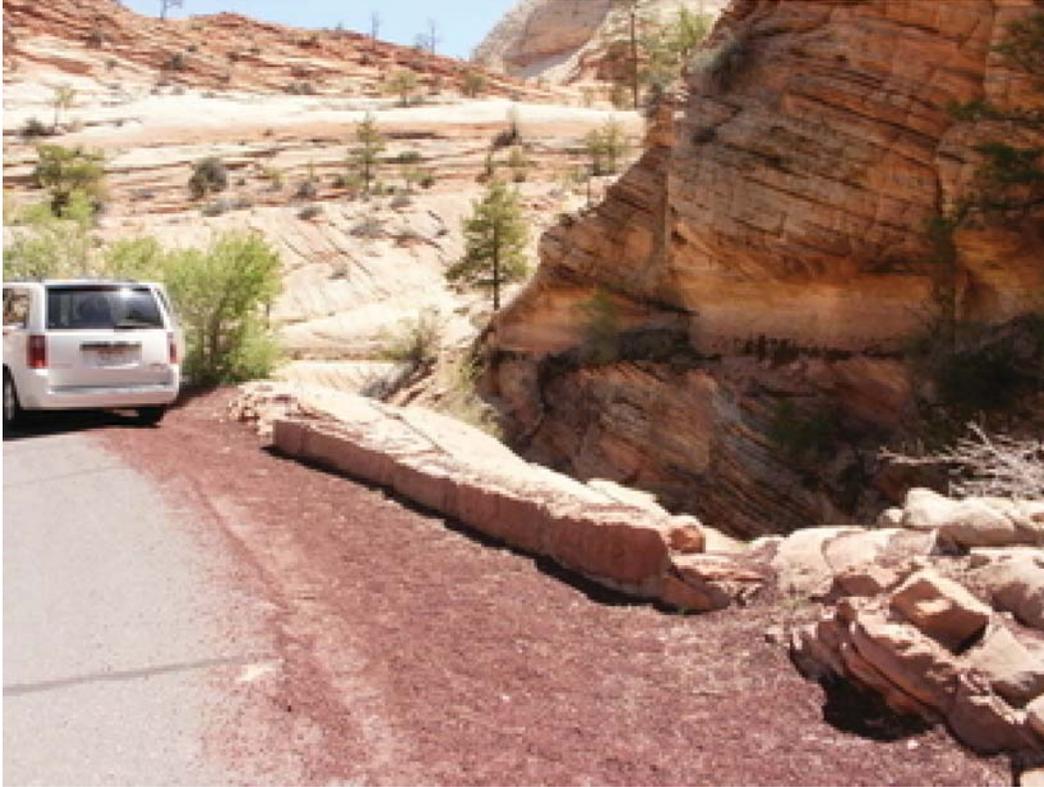
ZION_0010_9.632_R_1.JPG

Barrier ID:	ZION-0010-9.632-R				
Route Name:	ZION-MT CARMEL HIGHWAY				
Inspection Date:	04/28/2010	Barrier Rating:	52.00		
Barrier Description					
Type:	STONE MASONRY WITHOUT CONCRETE CORE WALL	Barrier Function:	TRAFFIC		
Barrier Material:	STONE	Post Material:	N/A		
Blockout Type:	N/A	Length (ft.):	21		
Speed Limit (MPH):	35	Placement with Respect to Road:	OUTSIDE OF CURVE		
Hazard Behind Barrier:	HIGH				
Barrier Crashworthiness					
Appropriate Test Level:	TL-2	Barrier Test Level:	NCW	Is Barrier Crashworthy?:	NO
Beg. End Trtmt Type:	NONE	Is Beg. End Trtmt Crashworthy?:	N/A	Approach Transition Type:	NONE
Ending End Trtmt Type:	NONE	Ending End Trtmt Crashworthy?:	N/A		
Average Measurements					
Design Height (In.):	24	Width (In.):	15.6	Post Spacing (In.):	0.0
Height (In.):	12.6	Lateral Offset (In.):	90.0	Road Grade (%):	2.30
Physical Condition					
Barrier	Alignment and Height:	Alignment acceptable. Height was 10-11 in. below the 24-in. design height.

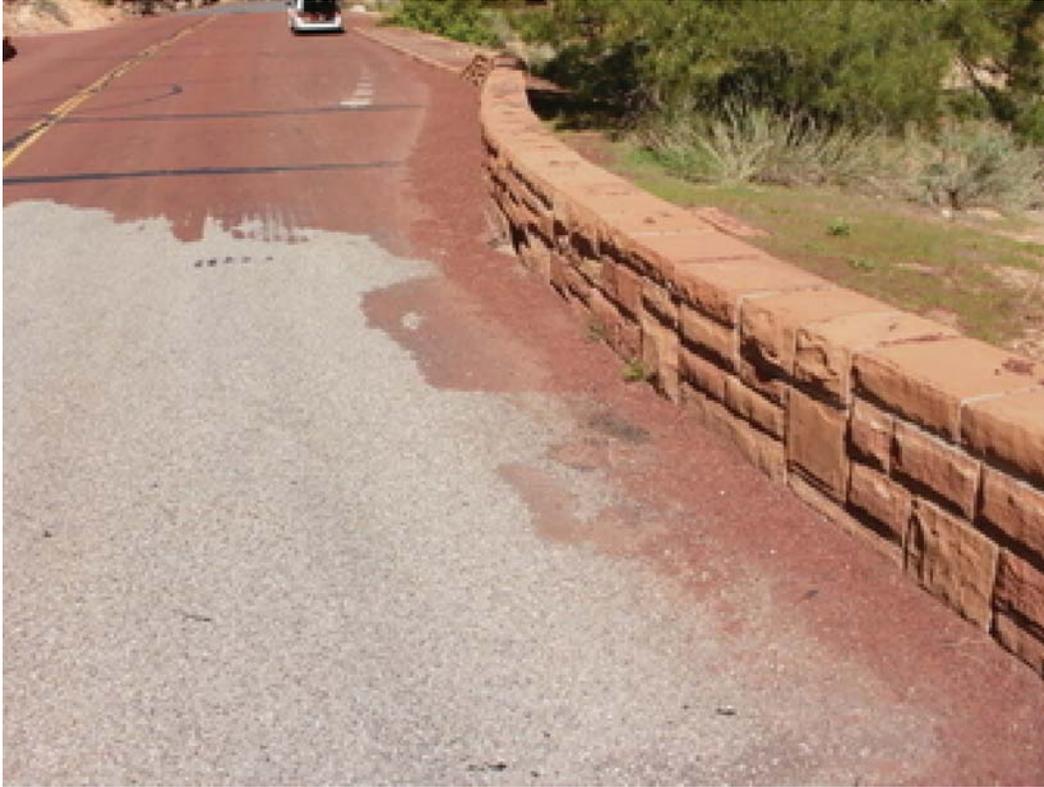
ZION_0010_10.086_L_1.JPG

Barrier ID:	ZION-0010-10.086-L				
Route Name:	ZION-MT CARMEL HIGHWAY				
Inspection Date:	04/28/2010	Barrier Rating:	16.50		
Barrier Description					
Type:	STONE MASONRY WITH CONCRETE CORE WALL	Barrier Function:	TRAFFIC		
Barrier Material:	CONCRETE	Post Material:	N/A		
Blockout Type:	N/A	Length (ft.):	64		
Speed Limit (MPH):	35	Placement with Respect to Road:	TANGENT		
Hazard Behind Barrier:	MEDIUM				
Barrier Crashworthiness					
Appropriate Test Level:	TL-2	Barrier Test Level:	TL-2	Is Barrier Crashworthy?:	YES
Beg. End Trtmt Type:	NONE	Is Beg. End Trtmt Crashworthy?:	N/A	Approach Transition Type:	NONE
Ending End Trtmt Type:	NONE	Ending End Trtmt Crashworthy?:	N/A		
Average Measurements					
Design Height (In.):	27	Width (In.):	19.0	Post Spacing (In.):	0.0
Height (In.):	26.7	Lateral Offset (In.):	83.6	Road Grade (%):	0.80
Physical Condition					
Barrier	Alignment and Height:	Alignment acceptable. Height within 3in. of 27-in design height.

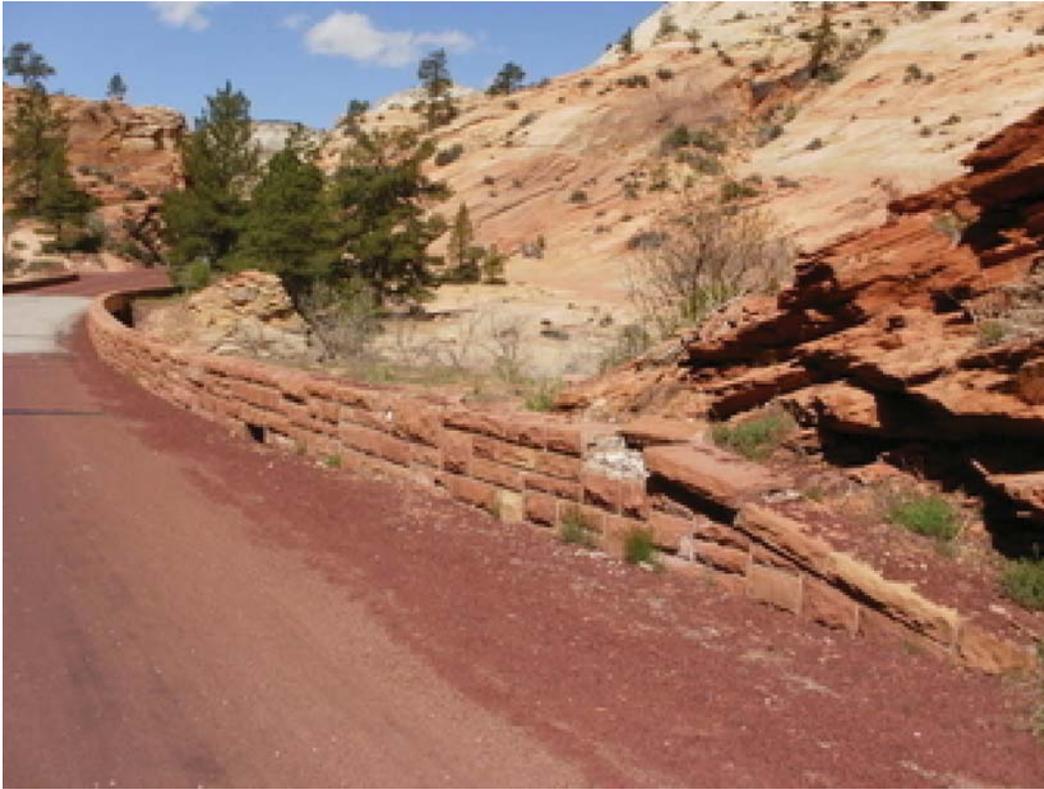
ZION_0010_10.124_L_1.JPG

Barrier ID:	ZION-0010-10.124-L				
Route Name:	ZION-MT CARMEL HIGHWAY				
Inspection Date:	04/28/2010	Barrier Rating:	26.70		
Barrier Description					
Type:	STONE MASONRY WITH CONCRETE CORE WALL	Barrier Function:	TRAFFIC		
Barrier Material:	CONCRETE	Post Material:	N/A		
Blockout Type:	N/A	Length (ft.):	81		
Speed Limit (MPH):	35	Placement with Respect to Road:	INSIDE OF CURVE		
Hazard Behind Barrier:	MEDIUM				
Barrier Crashworthiness					
Appropriate Test Level:	TL-2	Barrier Test Level:	TL-3	Is Barrier Crashworthy?:	YES
Beg. End Trtmt Type:	NONE	Is Beg. End Trtmt Crashworthy?:	N/A	Approach Transition Type:	NONE
Ending End Trtmt Type:	NONE	Ending End Trtmt Crashworthy?:	N/A		
Average Measurements					
Design Height (In.):	27	Width (In.):	18.2	Post Spacing (In.):	0.0
Height (In.):	24.2	Lateral Offset (In.):	43.2	Road Grade (%):	1.20
Physical Condition					
Barrier	Alignment and Height:	Alignment acceptable. Height within 3in. of 27-in design height.

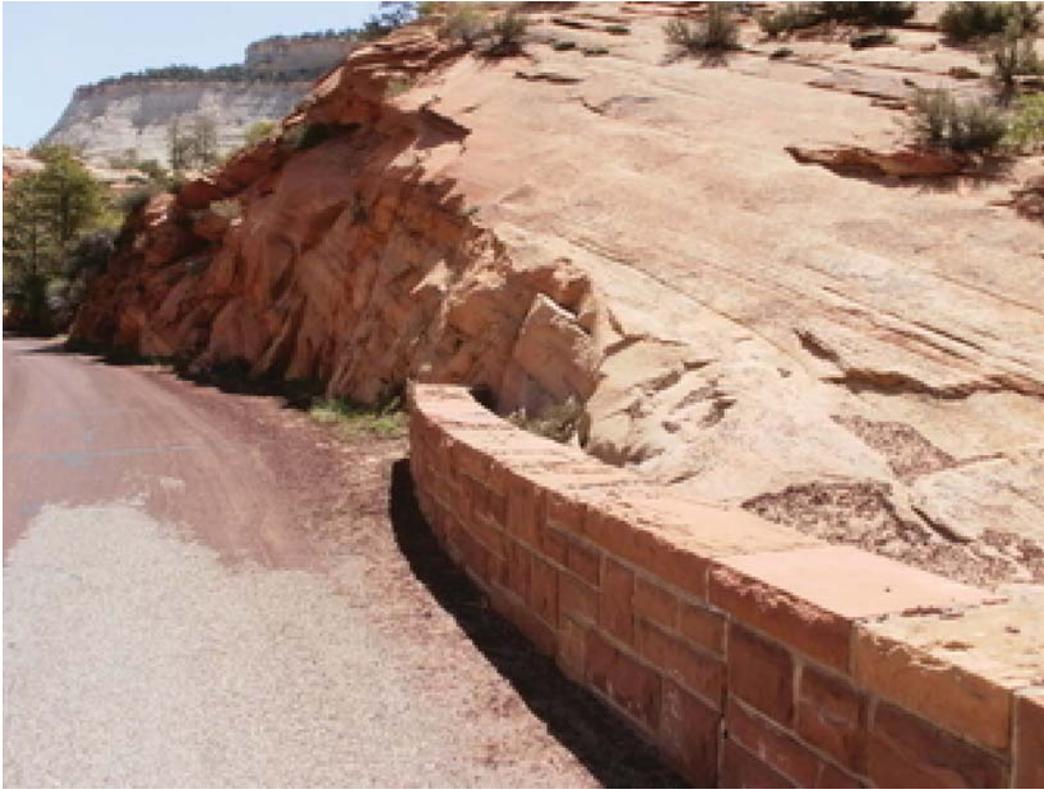
ZION_0010_10.124_R_1.JPG

Barrier ID:	ZION-0010-10.124-R				
Route Name:	ZION-MT CARMEL HIGHWAY				
Inspection Date:	04/28/2010	Barrier Rating:	28.00		
Barrier Description					
Type:	STONE MASONRY WITH CONCRETE CORE WALL	Barrier Function:	TRAFFIC		
Barrier Material:	CONCRETE	Post Material:	N/A		
Blockout Type:	N/A	Length (ft.):	27		
Speed Limit (MPH):	35	Placement with Respect to Road:	OUTSIDE OF CURVE		
Hazard Behind Barrier:	MEDIUM				
Barrier Crashworthiness					
Appropriate Test Level:	TL-2	Barrier Test Level:	TL-3	Is Barrier Crashworthy?:	YES
Beg. End Trtmt Type:	NONE	Is Beg. End Trtmt Crashworthy?:	N/A	Approach Transition Type:	NONE
Ending End Trtmt Type:	NONE	Ending End Trtmt Crashworthy?:	N/A		
Average Measurements					
Design Height (In.):	27	Width (In.):	19.0	Post Spacing (In.):	0.0
Height (In.):	27.0	Lateral Offset (In.):	31.7	Road Grade (%):	0.70
Physical Condition					
Barrier	Alignment and Height:	Alignment acceptable. Height within 3in. of 27-in design height.

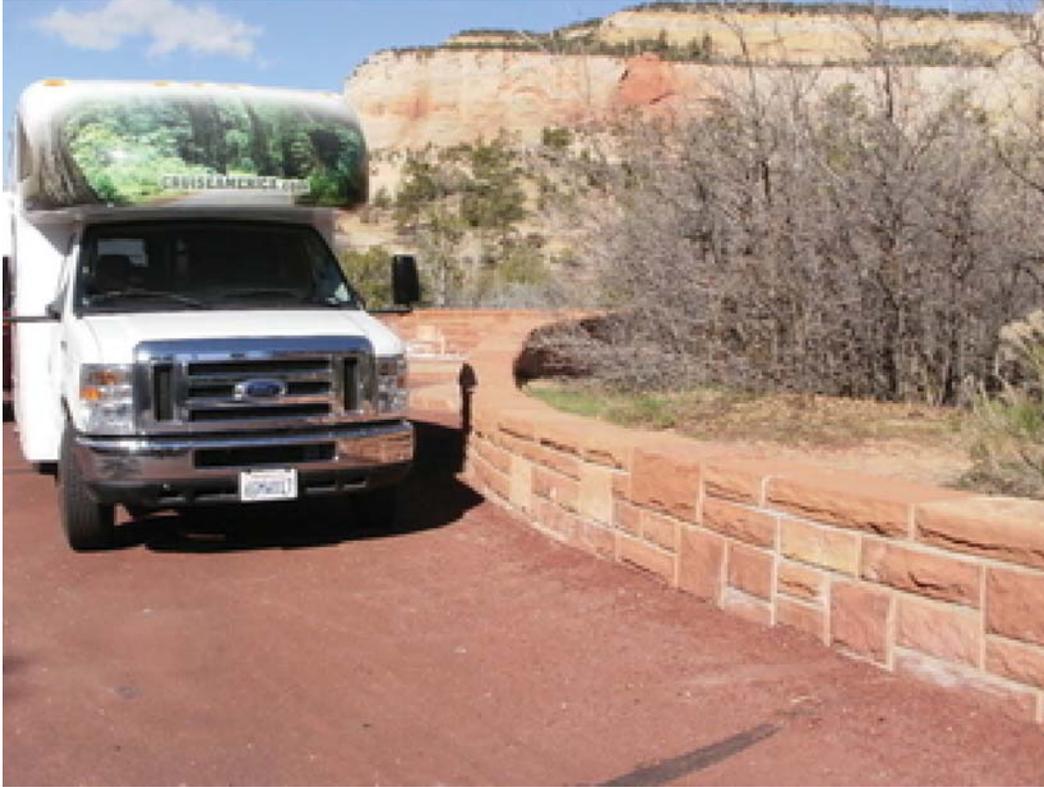
ZION_0010_11.135_L_1.JPG

Barrier ID:	ZION-0010-11.135-L				
Route Name:	ZION-MT CARMEL HIGHWAY				
Inspection Date:	04/28/2010	Barrier Rating:	0.00		
Barrier Description					
Type:	STONE MASONRY WITH CONCRETE CORE WALL	Barrier Function:	NON-TRAFFIC		
Barrier Material:	CONCRETE	Post Material:	N/A		
Blockout Type:	N/A	Length (ft.):	39		
Speed Limit (MPH):	35	Placement with Respect to Road:	NON-TRAFFIC BARRIER		
Hazard Behind Barrier:	N/A				
Barrier Crashworthiness					
Appropriate Test Level:	TL-2	Barrier Test Level:	N/A	Is Barrier Crashworthy?:	N/A
Beg. End Trtmt Type:	NONE	Is Beg. End Trtmt Crashworthy?:	N/A	Approach Transition Type:	NONE
Ending End Trtmt Type:	NONE	Ending End Trtmt Crashworthy?:	N/A		
Average Measurements					
Design Height (In.):	27	Width (In.):	18.2	Post Spacing (In.):	0.0
Height (In.):	30.7	Lateral Offset (In.):	0.0	Road Grade (%):	0.00
Physical Condition					
Barrier	Alignment and Height:	Alignment acceptable. Entire barrier is between 2in. below to 17in. above the 27in. design height.

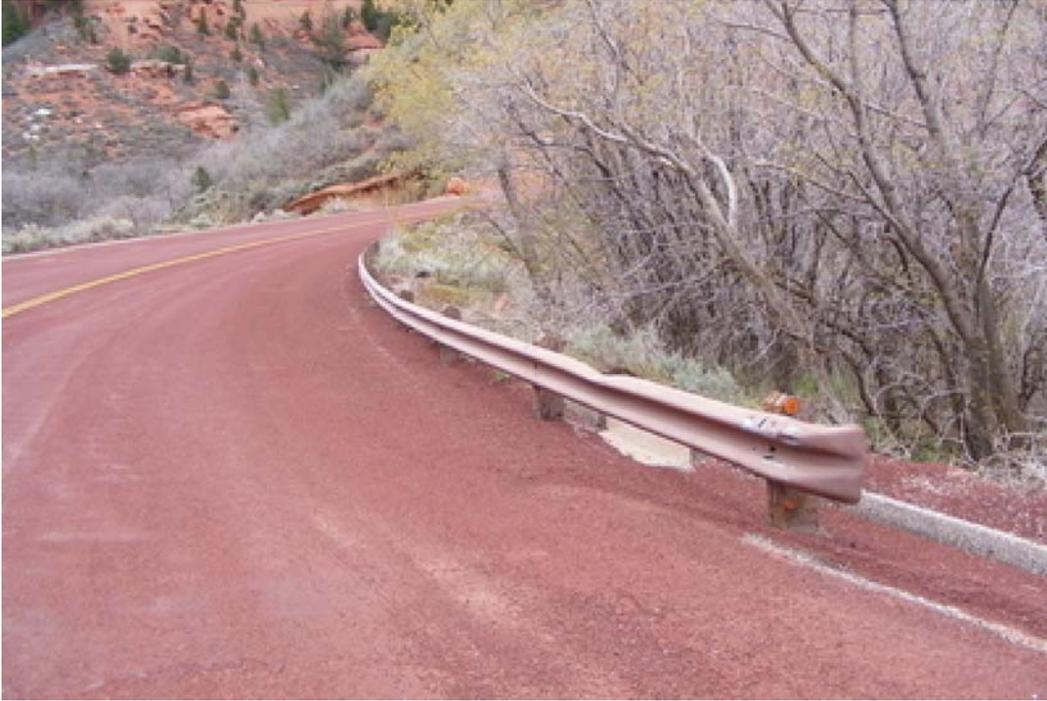
ZION_0013_3.279_R_1.JPG

Barrier ID:	ZION-0013-3.279-R				
Route Name:	KOLOB CANYON ROAD				
Inspection Date:	04/27/2010	Barrier Rating:	42.70		
Barrier Description					
Type:	W-BEAM WEAK POST	Barrier Function:	TRAFFIC		
Barrier Material:	OTHER: PAINTED STEEL	Post Material:	WOOD		
Blockout Type:	N/A	Length (ft.):	397		
Speed Limit (MPH):	35	Placement with Respect to Road:	INSIDE OF CURVE		
Hazard Behind Barrier:	HIGH				
Barrier Crashworthiness					
Appropriate Test Level:	TL-2	Barrier Test Level:	TL-2	Is Barrier Crashworthy?:	YES
Beg. End Trtmt Type:	NONE	Is Beg. End Trtmt Crashworthy?:	N/A	Approach Transition Type:	NONE
Ending End Trtmt Type:	NONE	Ending End Trtmt Crashworthy?:	N/A		
Average Measurements					
Design Height (In.):	27	Width (In.):	0.0	Post Spacing (In.):	149.6
Height (In.):	20.2	Lateral Offset (In.):	71.3	Road Grade (%):	2.50
Physical Condition					
Barrier	Alignment and Height:	Alignment acceptable. Entire barrier is between 5-9in. below the 27in. design height.

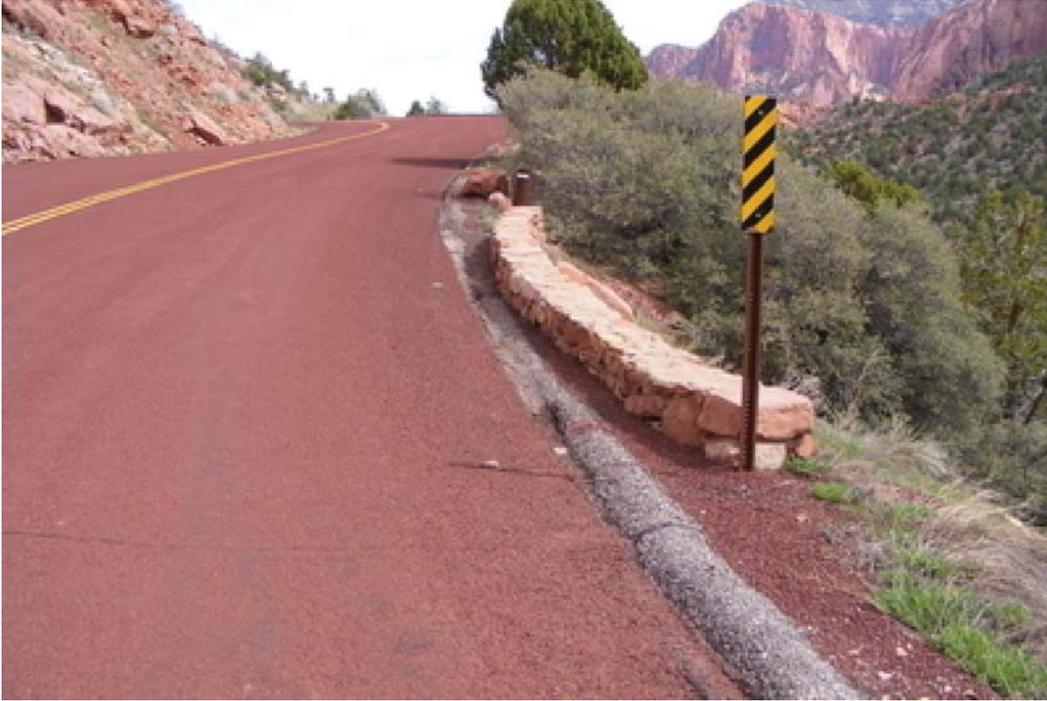
ZION_0013_4.265_L_1.JPG

Barrier ID:	ZION-0013-4.265-L				
Route Name:	KOLOB CANYON ROAD				
Inspection Date:	04/27/2010	Barrier Rating:	43.00		
Barrier Description					
Type:	STONE MASONRY WITHOUT CONCRETE CORE WALL	Barrier Function:	TRAFFIC		
Barrier Material:	STONE	Post Material:	N/A		
Blockout Type:	N/A	Length (ft.):	38		
Speed Limit (MPH):	35	Placement with Respect to Road:	TANGENT		
Hazard Behind Barrier:	MEDIUM				
Barrier Crashworthiness					
Appropriate Test Level:	TL-2	Barrier Test Level:	NCW	Is Barrier Crashworthy?:	NO
Beg. End Trtmt Type:	NONE	Is Beg. End Trtmt Crashworthy?:	N/A	Approach Transition Type:	NONE
Ending End Trtmt Type:	NONE	Ending End Trtmt Crashworthy?:	N/A		
Average Measurements					
Design Height (In.):	24	Width (In.):	16.0	Post Spacing (In.):	0.0
Height (In.):	14.3	Lateral Offset (In.):	59.0	Road Grade (%):	7.60
Physical Condition					
Barrier	Alignment and Height:	Alignment acceptable. Height was 7-12in. below the 24-in. design height.
