**The Road Inventory
of
Santa Monica Mountains National
Recreation Area
SAMO - 8540**

Road Inventory Program

Prepared By:
Federal Highway Administration
Eastern Federal Lands Highway Division
Cycle 3

Santa Monica Mountains National in California

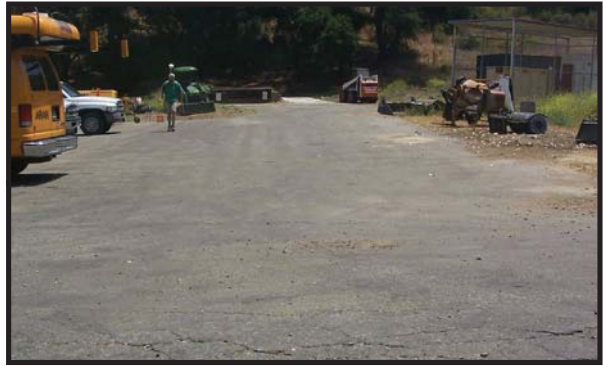
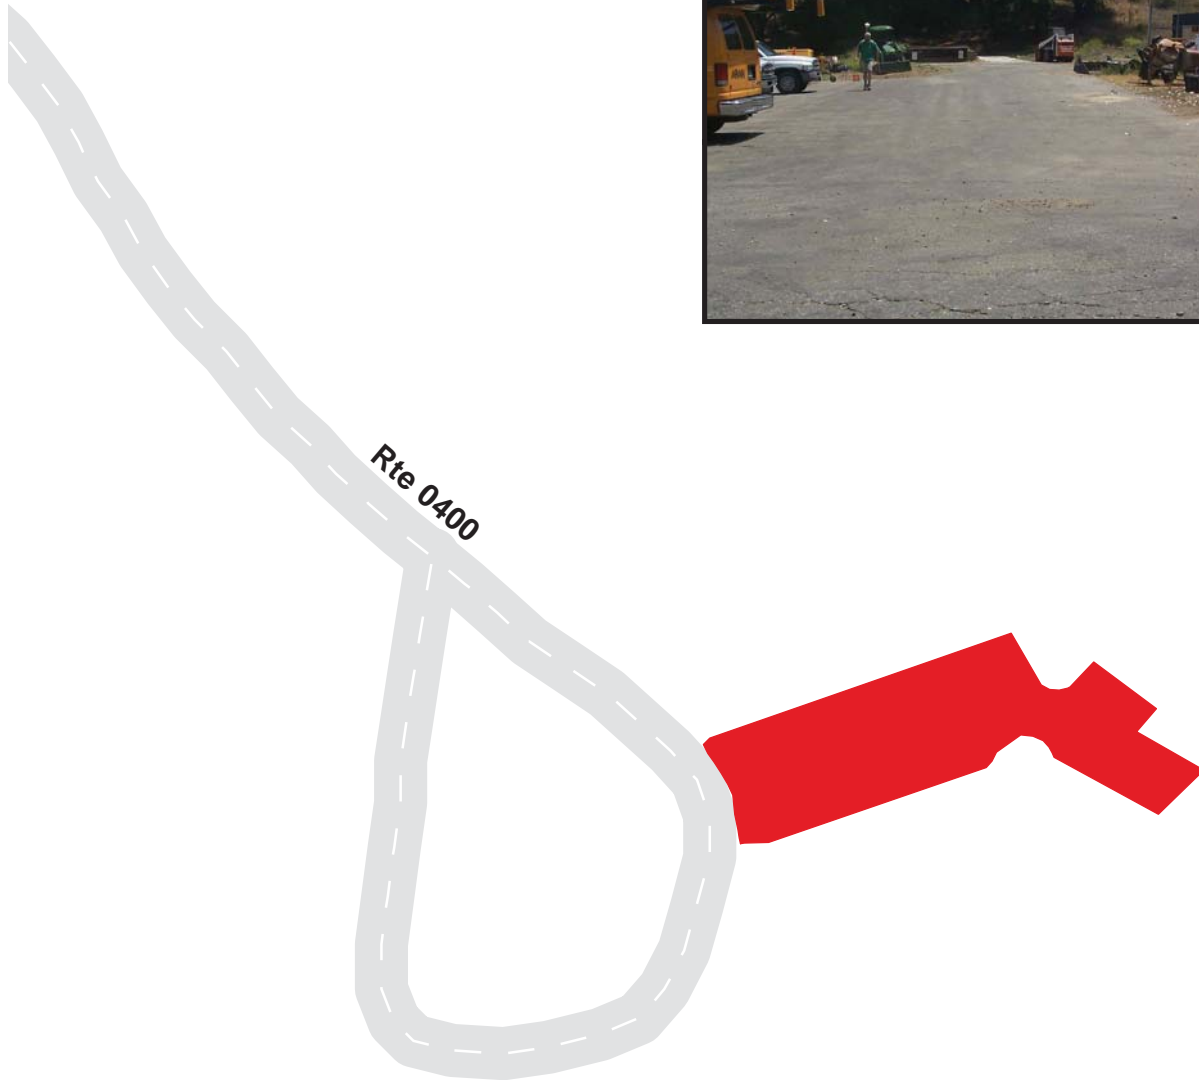
Route 0901

Route	Public / NonPublic	Date Visited	Area (sq ft)	Lane Miles *	Surface Type	Condition / PCR
0901	NonPublic	6/8/2001	7753	0.13	AS	GOOD / 90

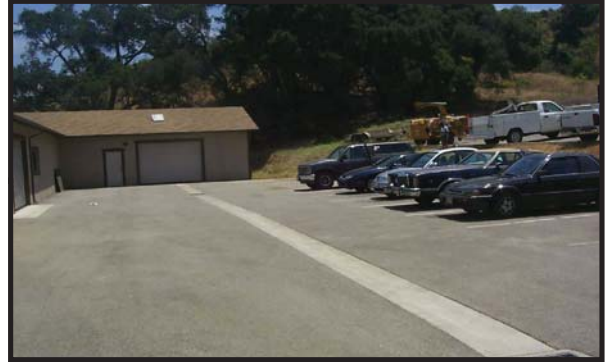
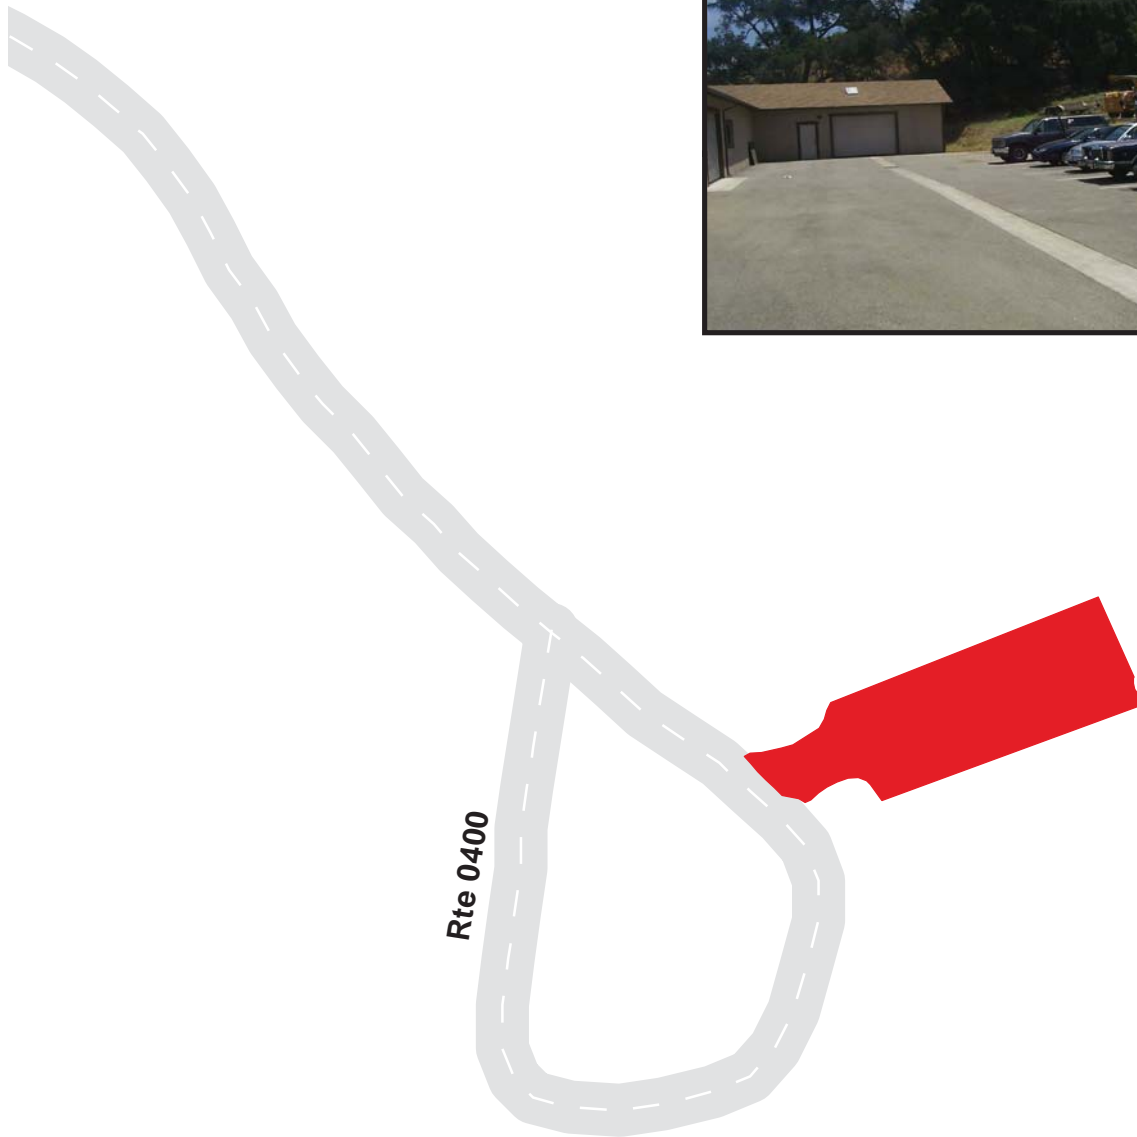
Route 0902

Route	Public / NonPublic	Date Visited	Area (sq ft)	Lane Miles *	Surface Type	Condition / PCR
0902	NonPublic	6/8/2001	6284	0.11	AS	GOOD / 90

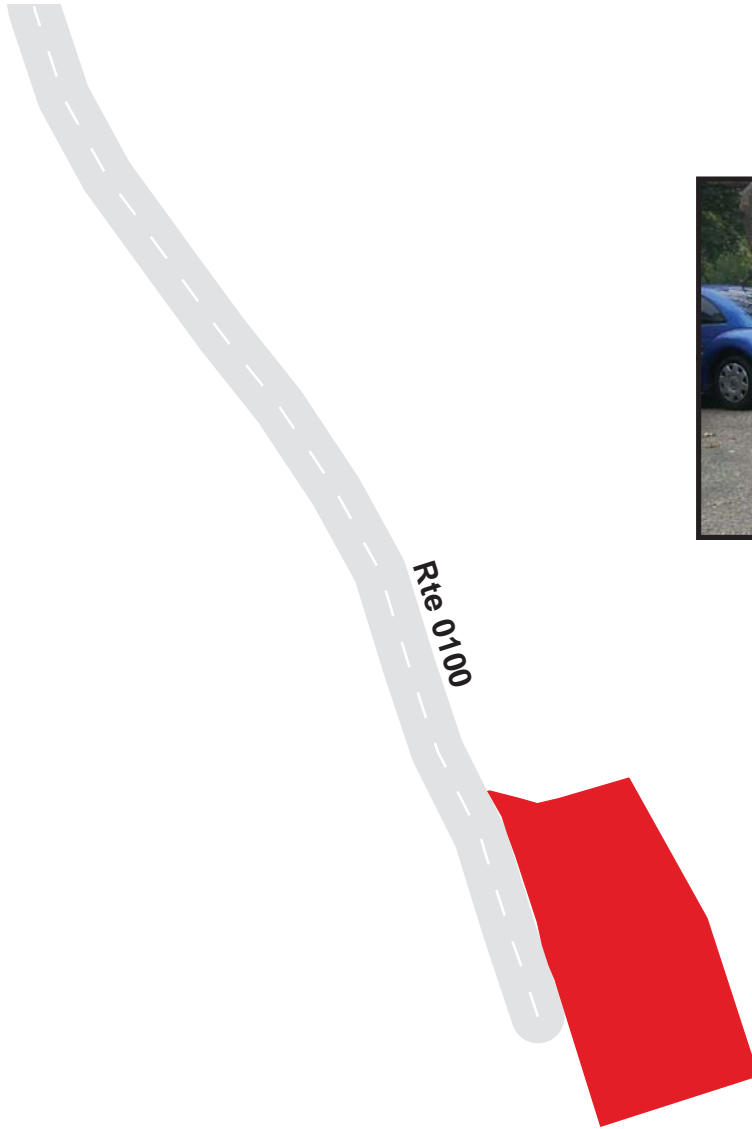
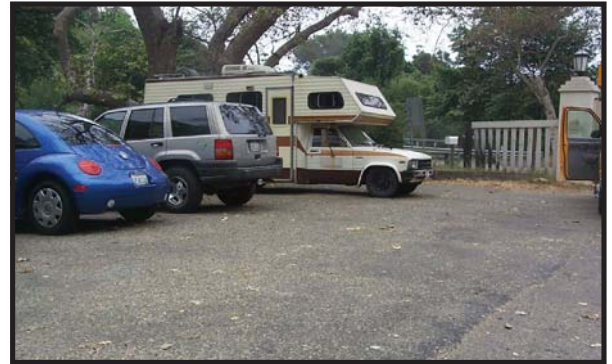
Route 0903

Route	Public / NonPublic	Date Visited	Area (sq ft)	Lane Miles *	Surface Type	Condition / PCR
0903	Public	6/9/2001	1592	0.03	AS	GOOD / 90

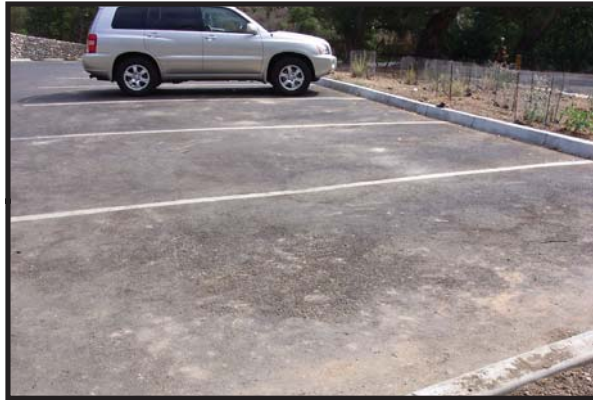
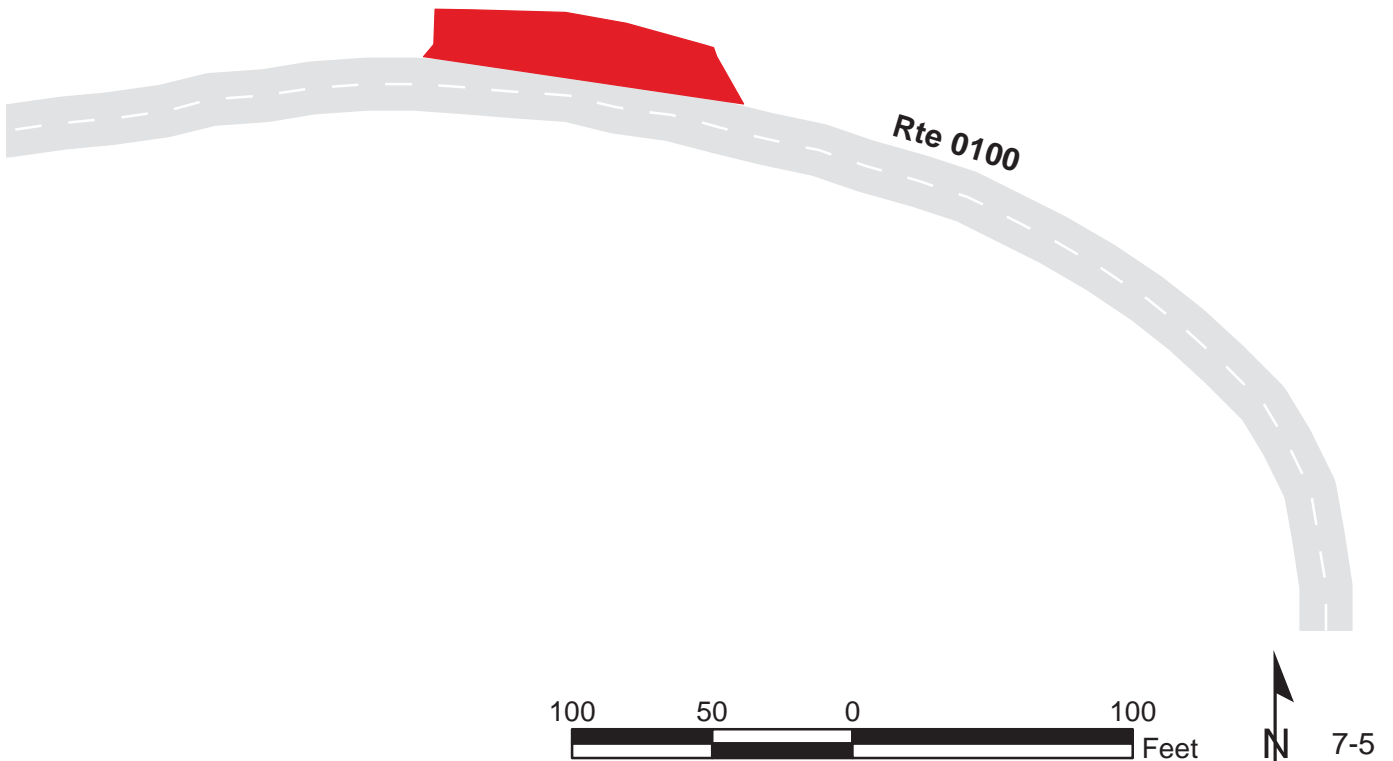
Route 0904A

Route	Public / NonPublic	Date Visited	Area (sq ft)	Lane Miles *	Surface Type	Condition / PCR
0904A	Public	9/26/2003	1822	0.03	AS	GOOD / 90

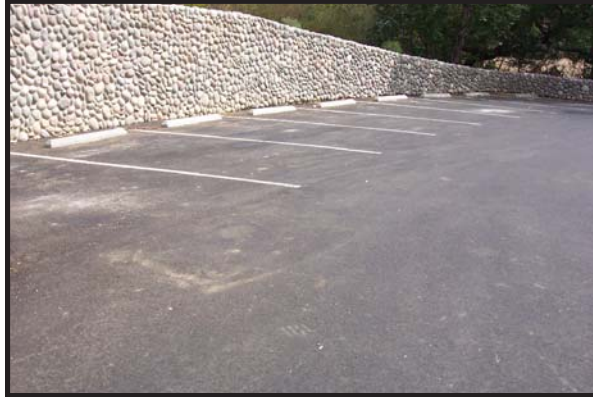
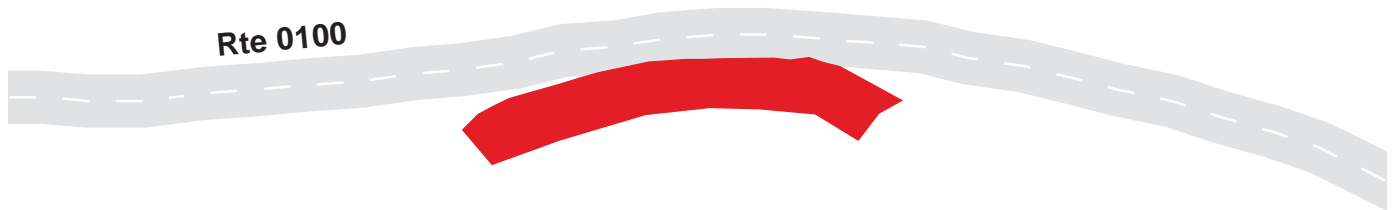
Route 0904B

Route	Public / NonPublic	Date Visited	Area (sq ft)	Lane Miles *	Surface Type	Condition / PCR
0904B	Public	9/26/2003	2315	0.04	AS	GOOD / 90

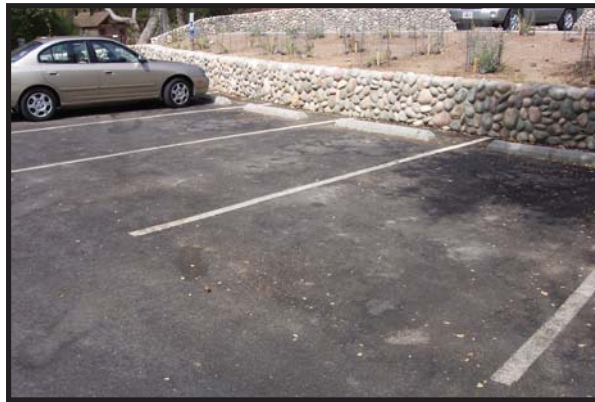
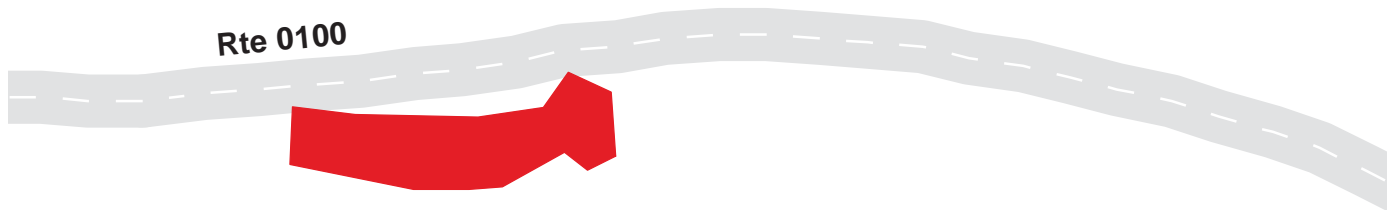
Route 0904C

Route	Public / NonPublic	Date Visited	Area (sq ft)	Lane Miles *	Surface Type	Condition / PCR
0904C	Public	9/26/2003	2349	0.04	AS	GOOD / 90

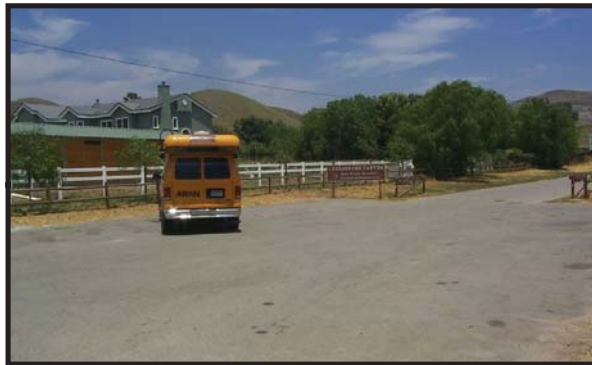
Route 0909B

Route	Public / NonPublic	Date Visited	Area (sq ft)	Lane Miles *	Surface Type	Condition / PCR
0909B	Public	6/8/2001	1561	0.03	AS	GOOD / 90
