Federal Lands Highway Road Inventory Program

Road Inventory and Condition Assessment

Bandelier National Monument BAND

Cycle 5 Report

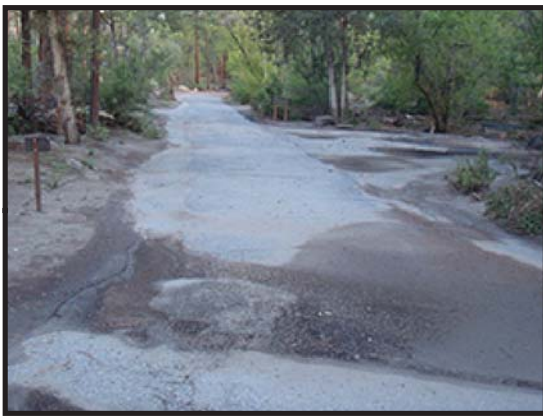
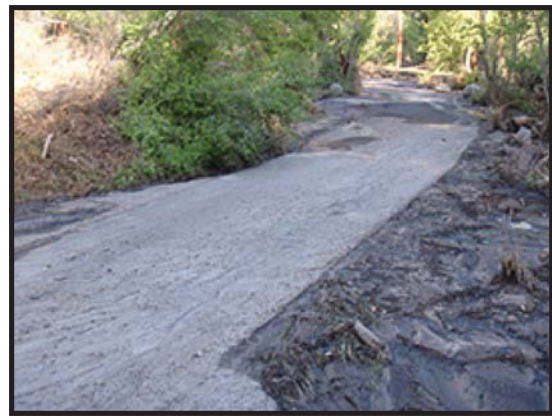
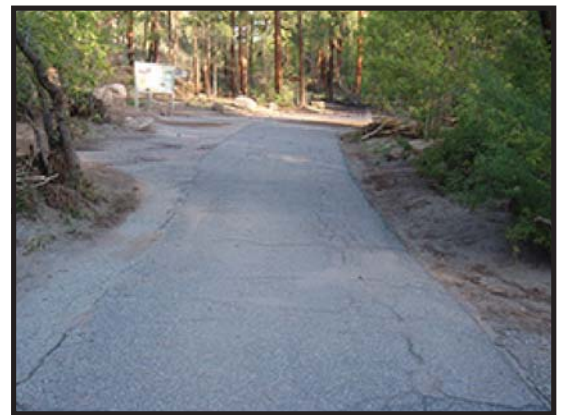
Route 0201

Route Number	Public / NonPublic	Date Visited	Area (sq ft)	Lane Miles *	Paved Length (mi)	Paved Width (ft)
0201	PUBLIC	9/6/2011	18,495	0.32	0.25	13.9
Culverts	Drop Inlets	Gates	Curb & Gutter	Curb	PCR	Surface Type
0	0	0	NO CURB AND GUTTER	NO CURB	POOR/45	AS

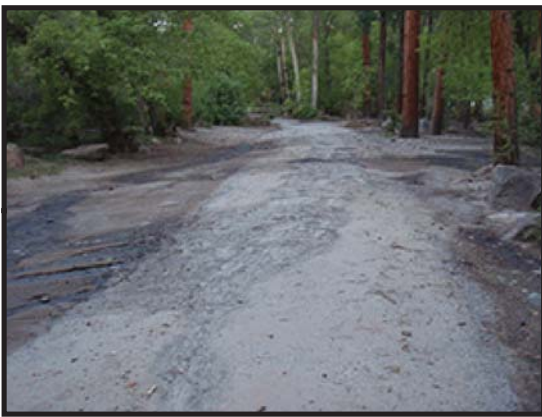
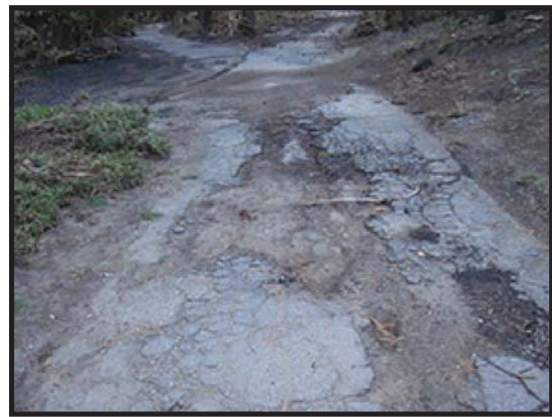
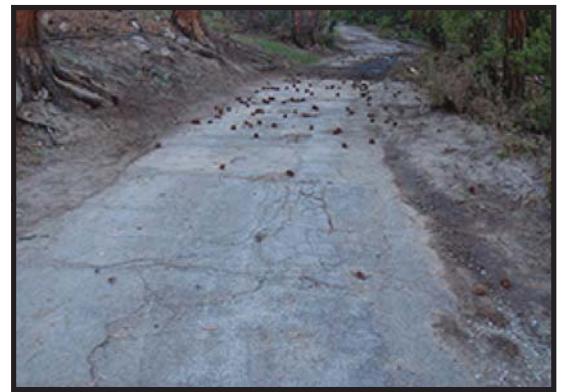
Route 0202

Route Number	Public / NonPublic	Date Visited	Area (sq ft)	Lane Miles *	Paved Length (mi)	Paved Width (ft)
0202	PUBLIC	9/6/2011	17,163	0.30	0.20	16.5
Culverts	Drop Inlets	Gates	Curb & Gutter	Curb	PCR	Surface Type
0	0	0	NO CURB AND GUTTER	NO CURB	POOR/45	AS

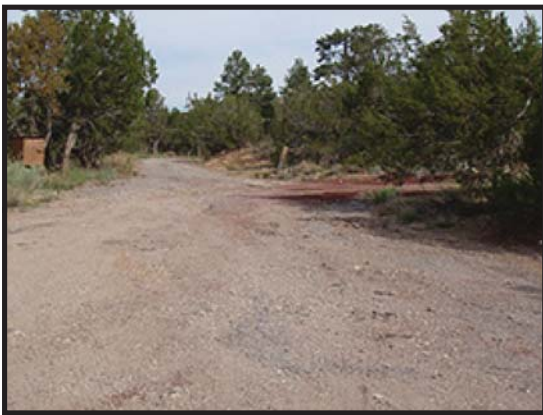
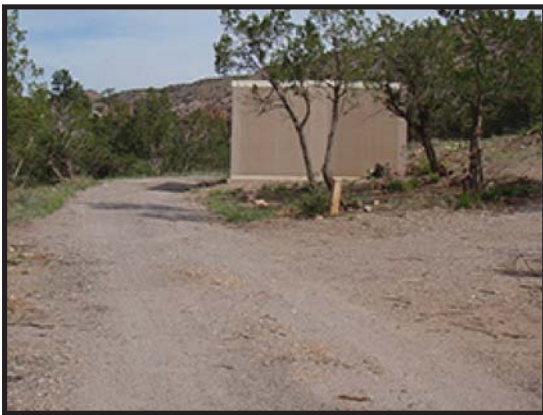
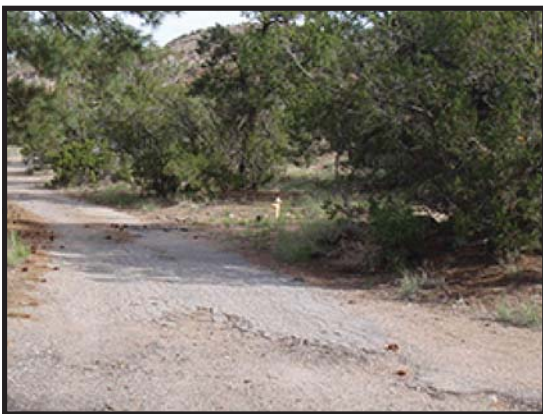
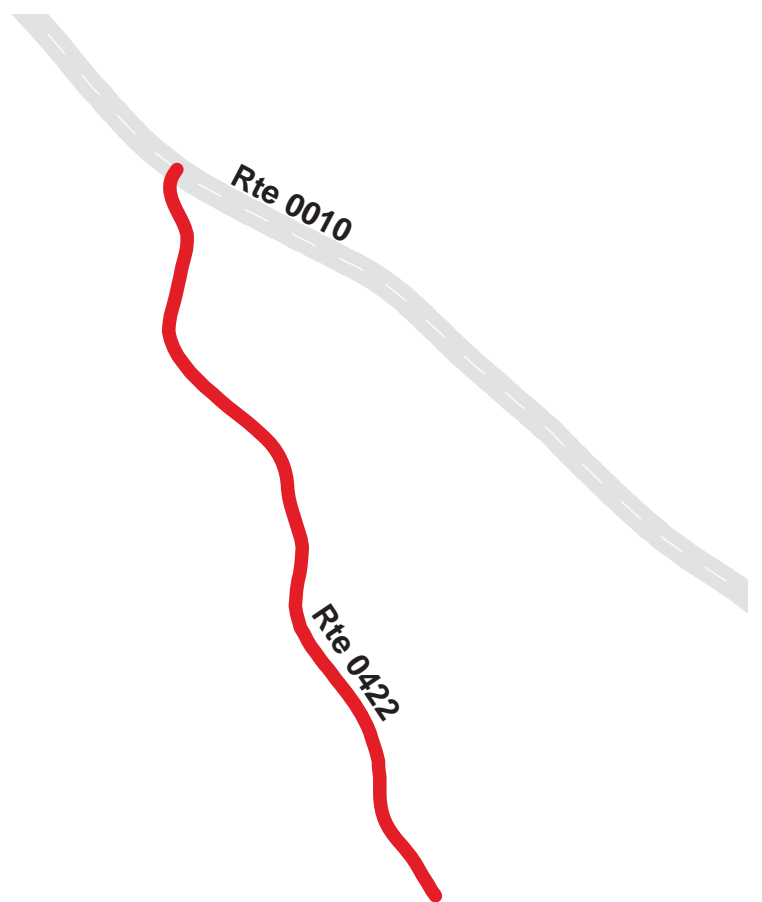
Route Number	Public / NonPublic	Date Visited	Area (sq ft)	Lane Miles *	Paved Length (mi)	Paved Width (ft)
0422	NONPUBLIC	9/6/2011	18,881	0.33	0.30	12
Culverts	Drop Inlets	Gates	Curb & Gutter	Curb	PCR	Surface Type
0	0	0	NO CURB AND GUTTER	NO CURB	POOR/45	AS

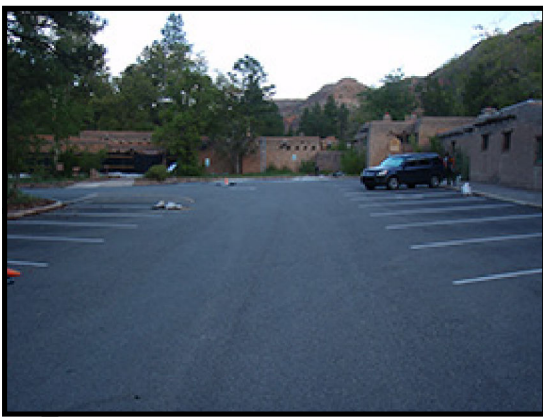
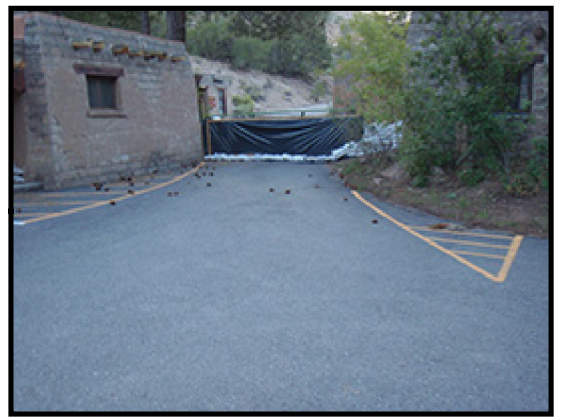
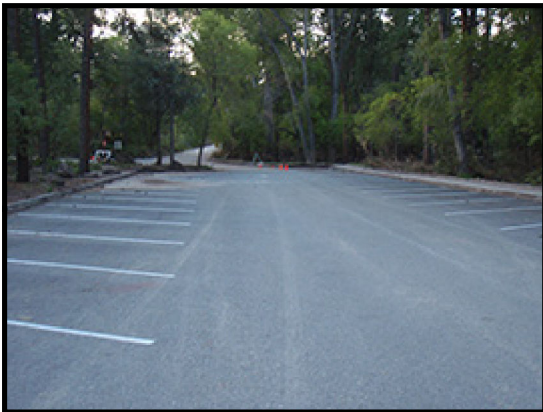
Route Number	Public / NonPublic	Date Visited	Area (sq ft)	Lane Miles *	Surface Type
0900	PUBLIC	9/6/2011	32,780	0.56	AS
Culverts	Drop Inlets	Gates	Curb & Gutter	Curb	PCR
0	2	0	NO CURB AND GUTTER	STONE CURB	GOOD/90

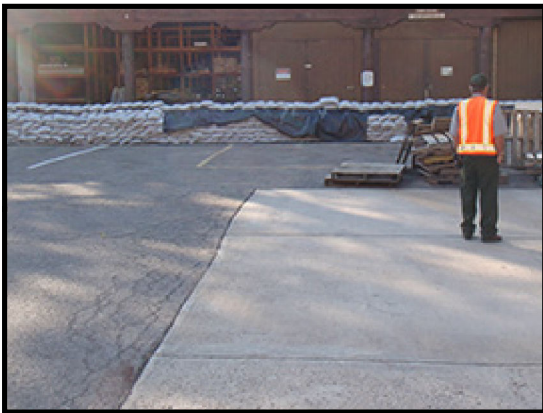
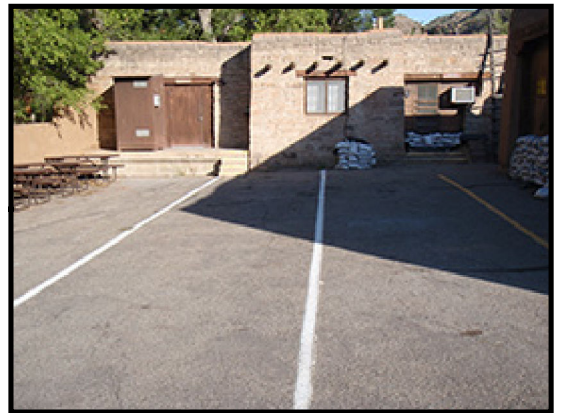
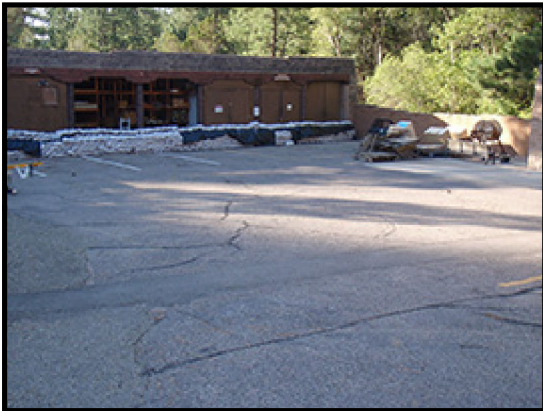
Route 0901

Route Number	Public / NonPublic	Date Visited	Area (sq ft)	Lane Miles *	Surface Type
0901	NONPUBLIC	9/6/2011	8,705	0.15	AS
Culverts	Drop Inlets	Gates	Curb & Gutter	Curb	PCR
0	0	0	NO CURB AND GUTTER	NO CURB	POOR/45

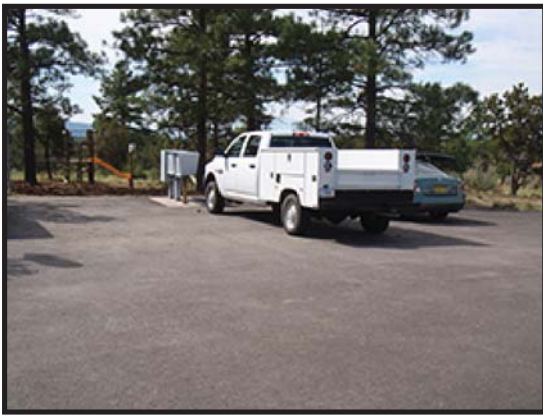
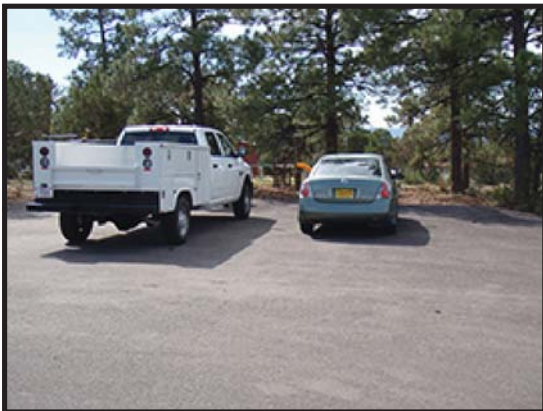
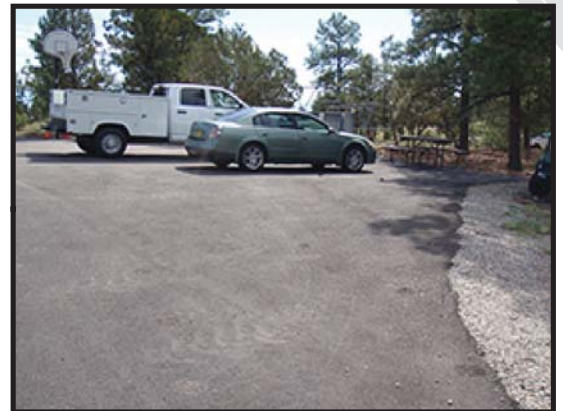
Route Number	Public / NonPublic	Date Visited	Area (sq ft)	Lane Miles *	Surface Type
0902AZ	NONPUBLIC	9/6/2011	2,640	0.05	AS
Culverts	Drop Inlets	Gates	Curb & Gutter	Curb	PCR
0	0	0	NO CURB AND GUTTER	NO CURB	EXCELLENT/97

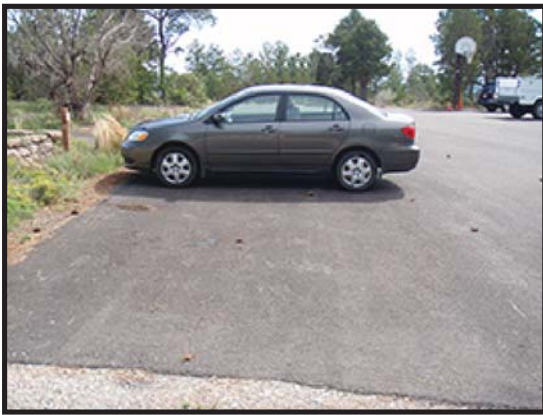
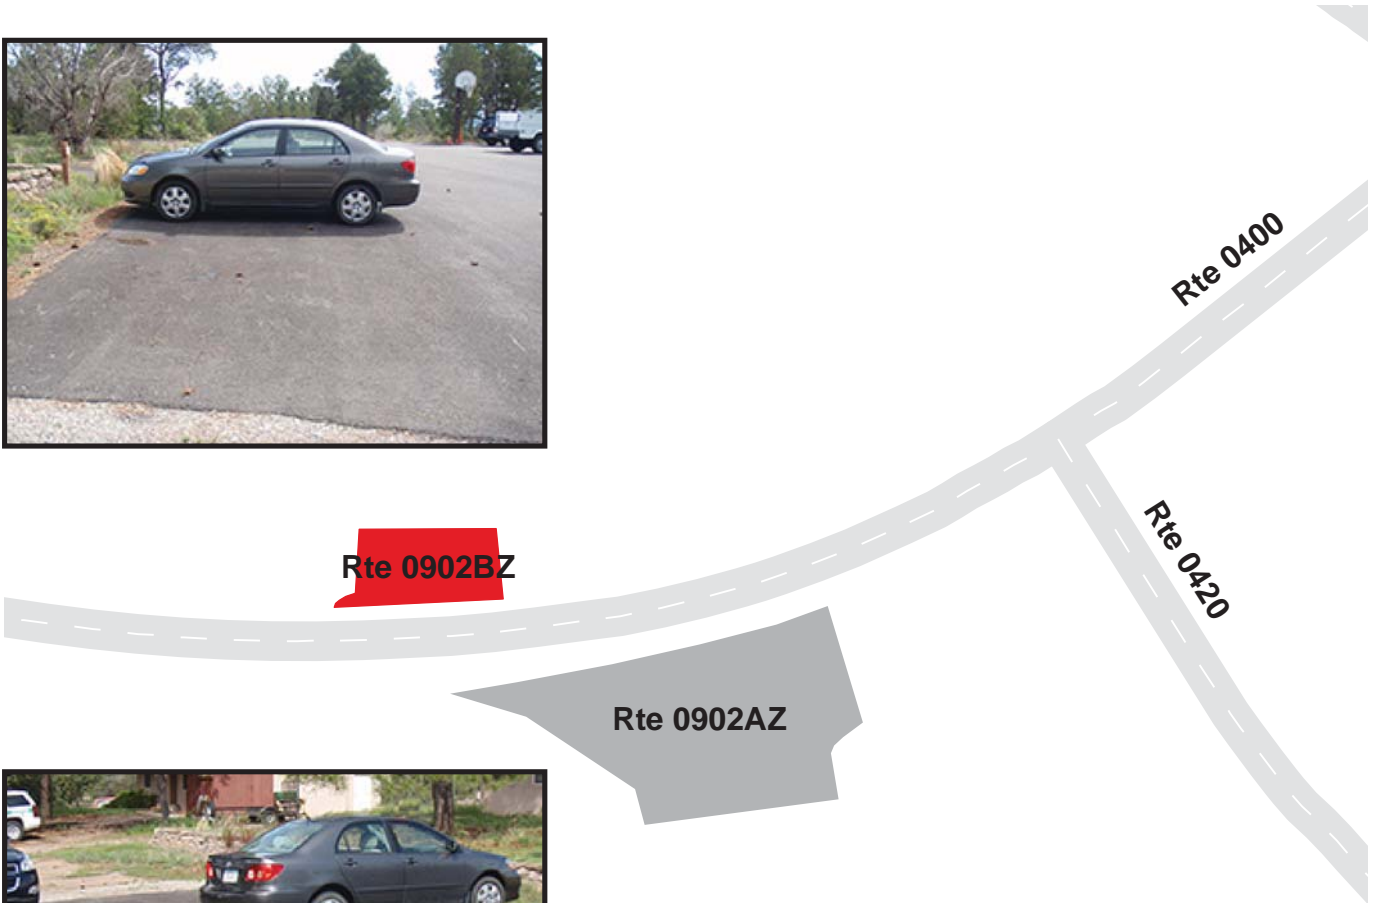
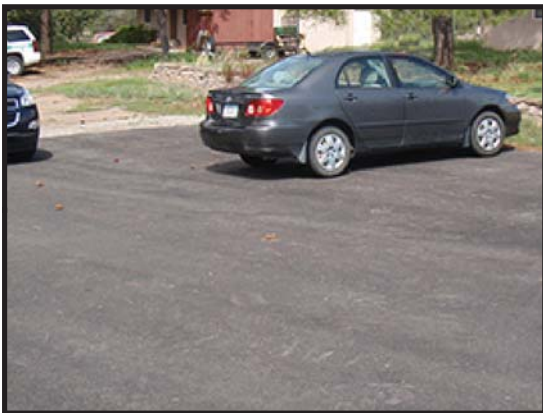
Route 0902BZ

Route Number	Public / NonPublic	Date Visited	Area (sq ft)	Lane Miles *	Surface Type
0902BZ	NONPUBLIC	9/6/2011	594	0.01	AS
Culverts	Drop Inlets	Gates	Curb & Gutter	Curb	PCR
0	0	0	NO CURB AND GUTTER	NO CURB	EXCELLENT/97

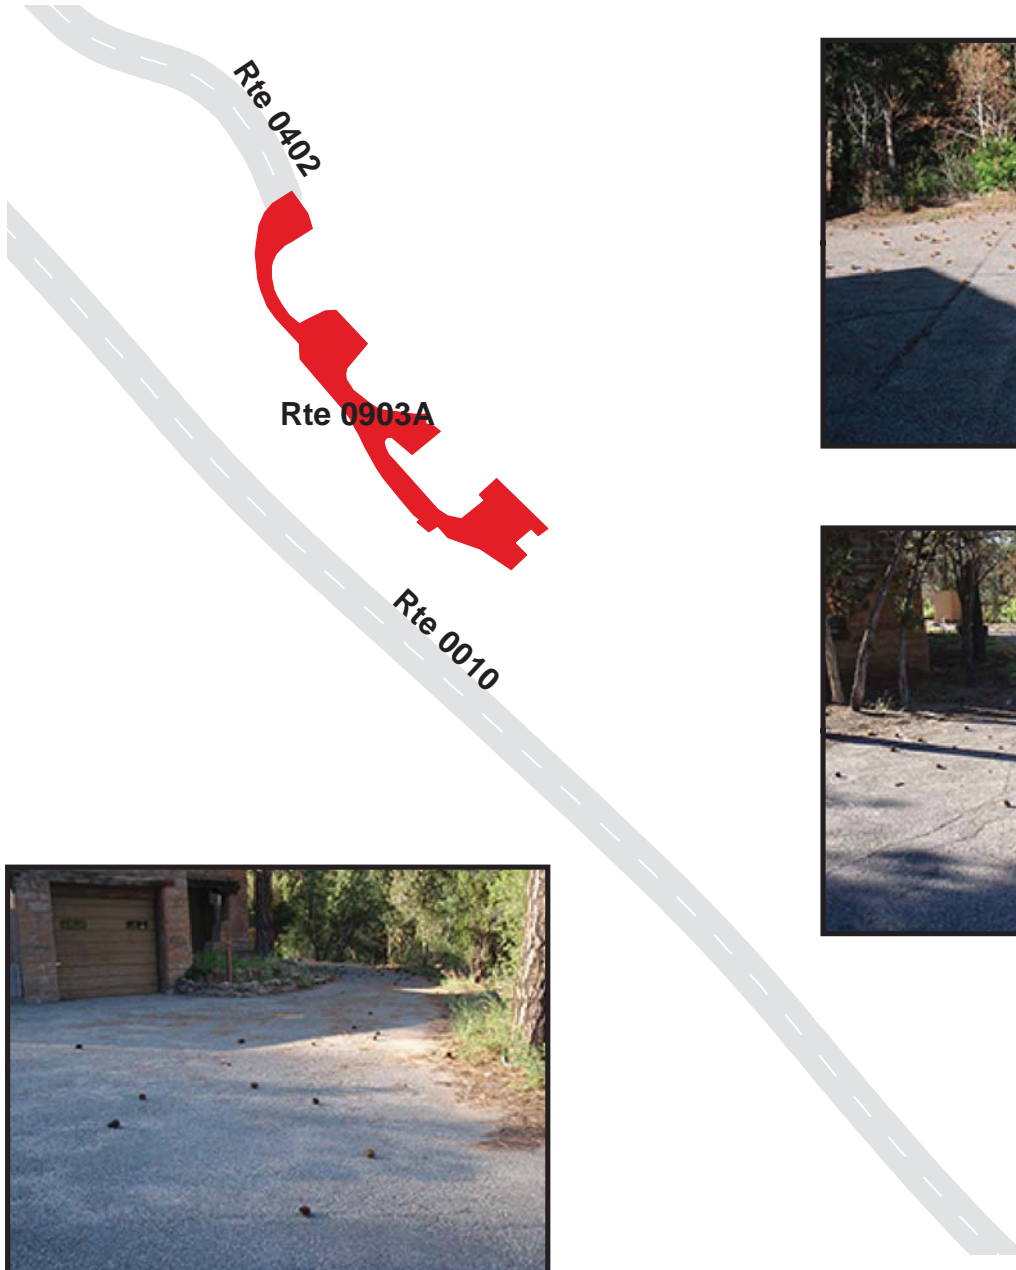
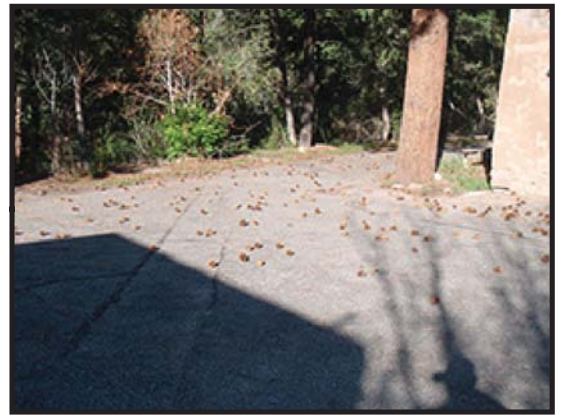
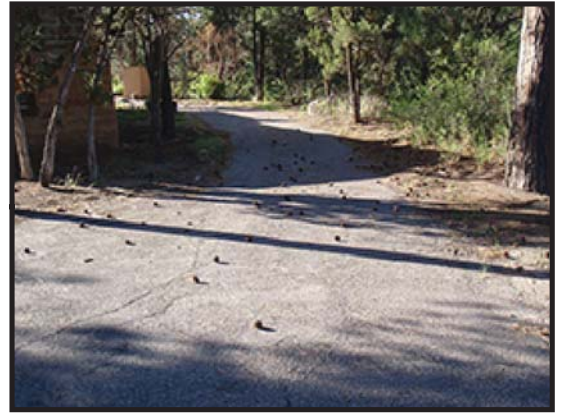
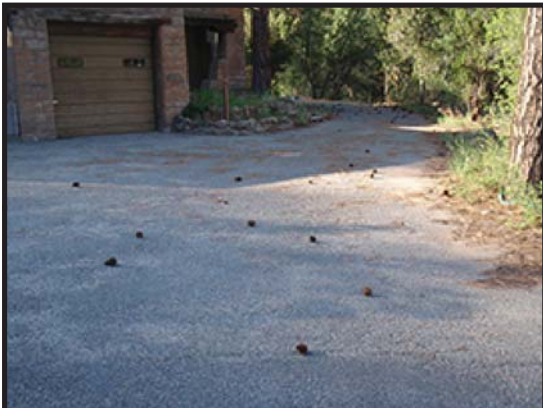
Route 0903A

Route Number	Public / NonPublic	Date Visited	Area (sq ft)	Lane Miles *	Surface Type
0903A	NONPUBLIC	9/6/2011	9,149	0.16	AS
Culverts	Drop Inlets	Gates	Curb & Gutter	Curb	PCR
0	0	0	NO CURB AND GUTTER	STONE CURB	POOR/45

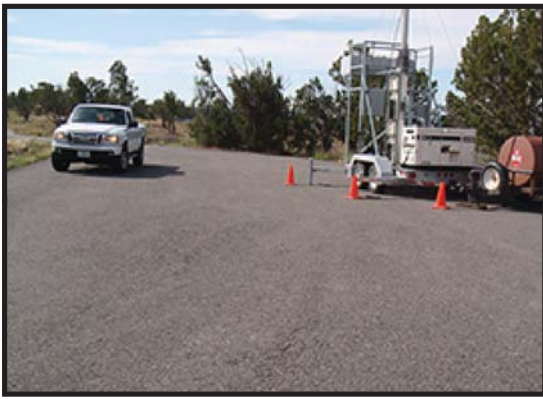
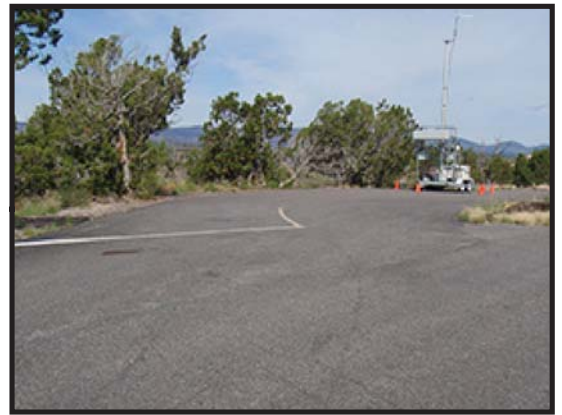
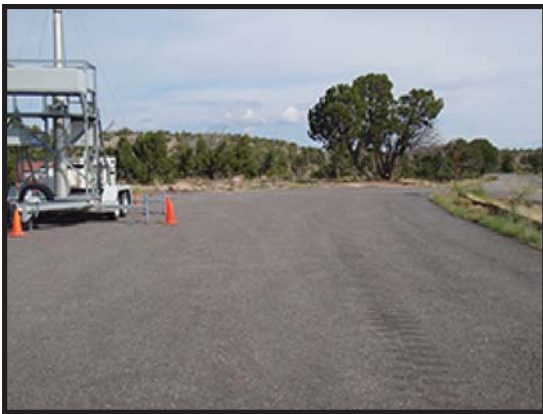
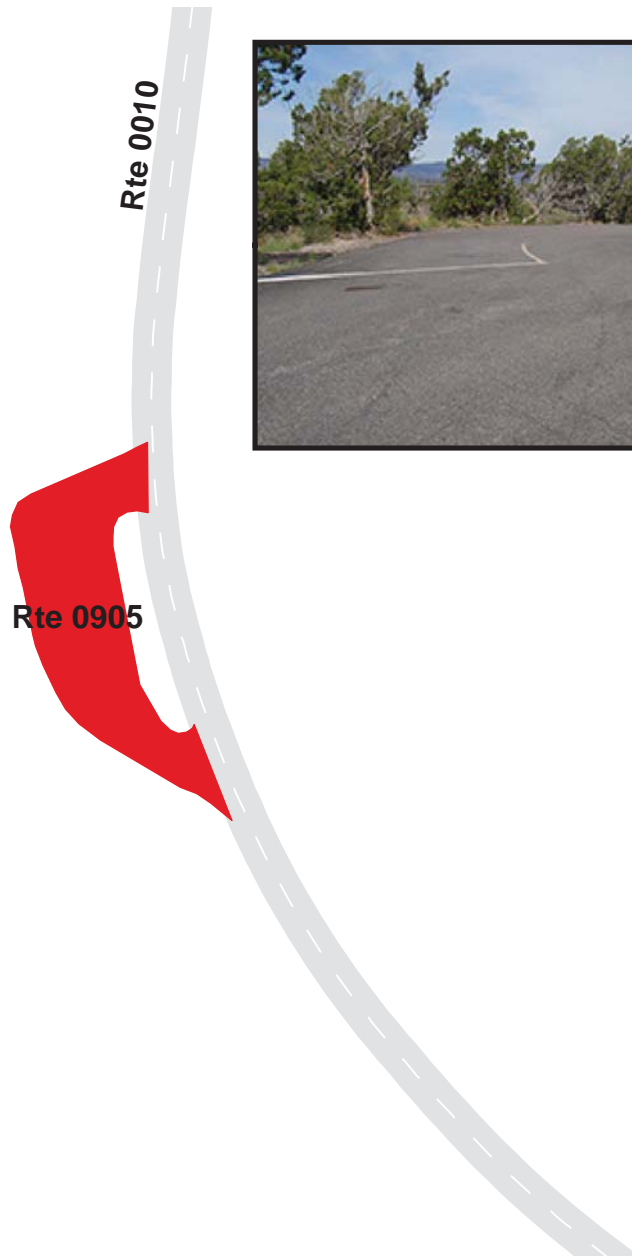
Route 0905

Route Number	Public / NonPublic	Date Visited	Area (sq ft)	Lane Miles *	Surface Type
0905	PUBLIC	9/6/2011	6,052	0.10	AS
Culverts	Drop Inlets	Gates	Curb & Gutter	Curb	PCR
0	0	0	NO CURB AND GUTTER	NO CURB	GOOD/90

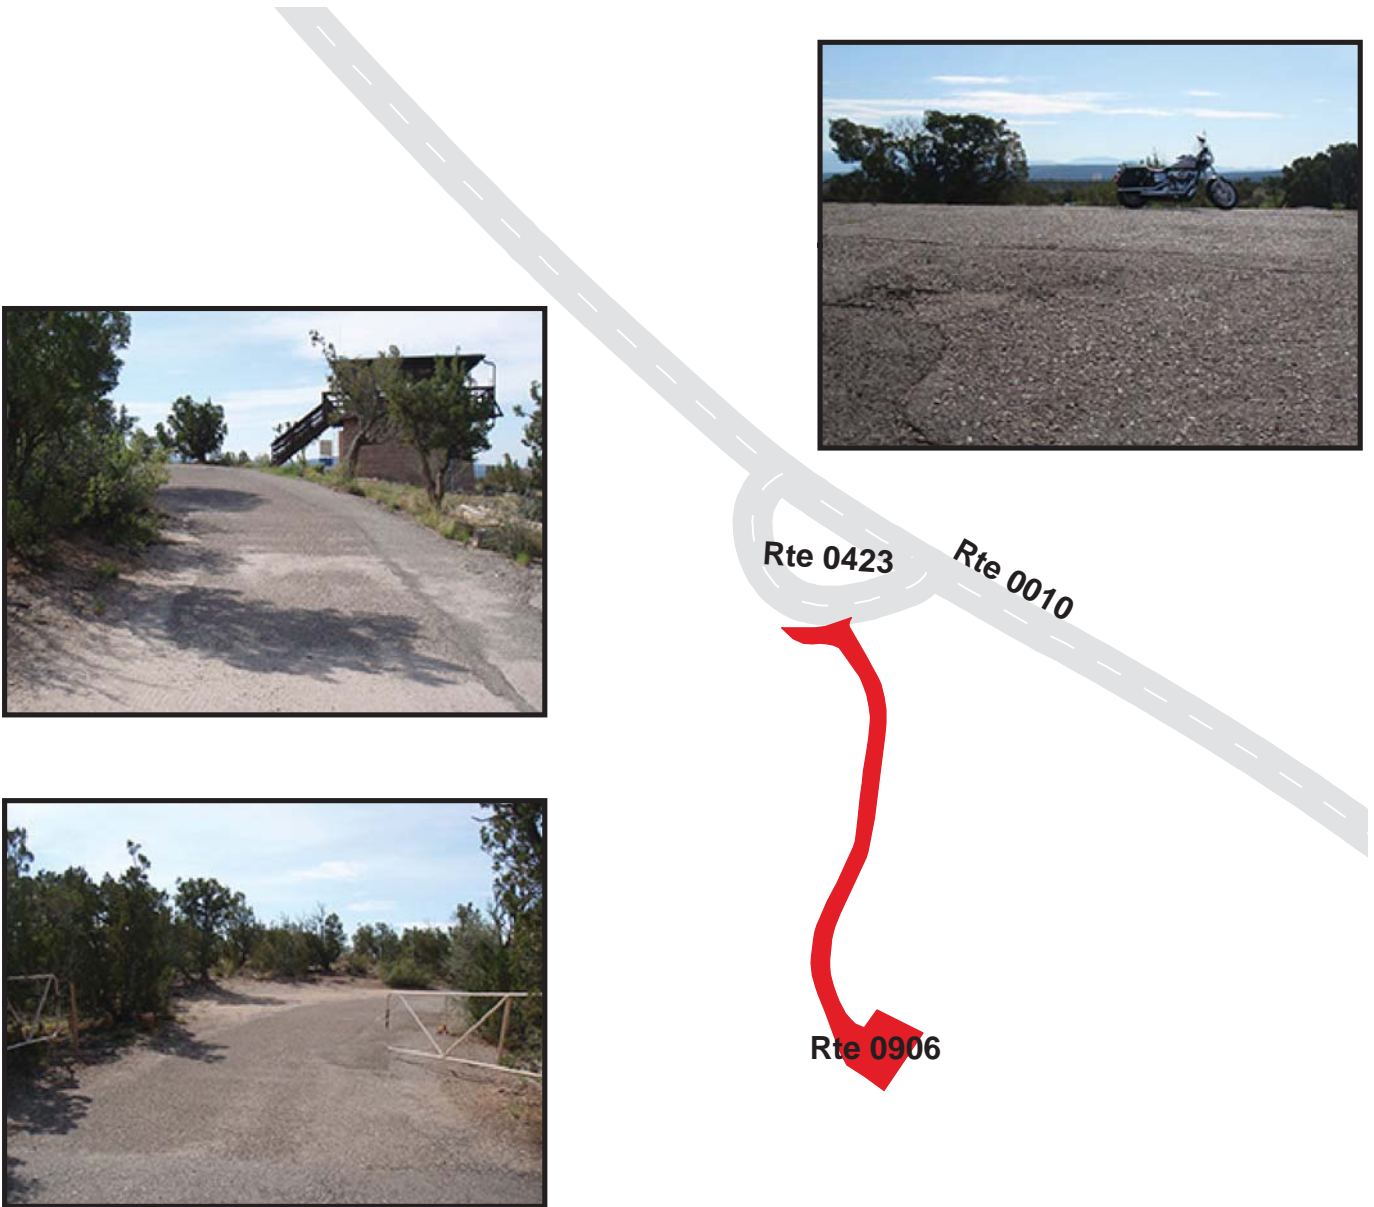
Route 0906

Route Number	Public / NonPublic	Date Visited	Area (sq ft)	Lane Miles *	Surface Type
0906	NONPUBLIC	9/6/2011	6,558	0.11	AS
Culverts	Drop Inlets	Gates	Curb & Gutter	Curb	PCR
0	0	1	NO CURB AND GUTTER	NO CURB	POOR/45

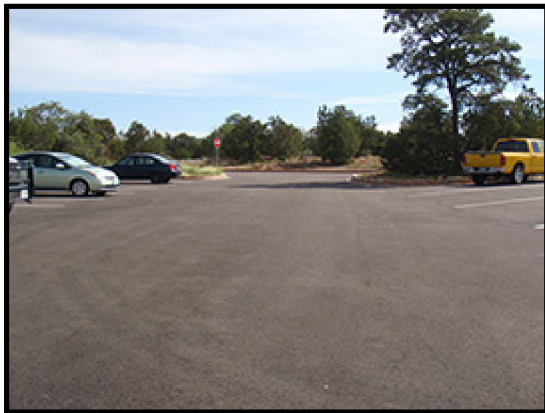
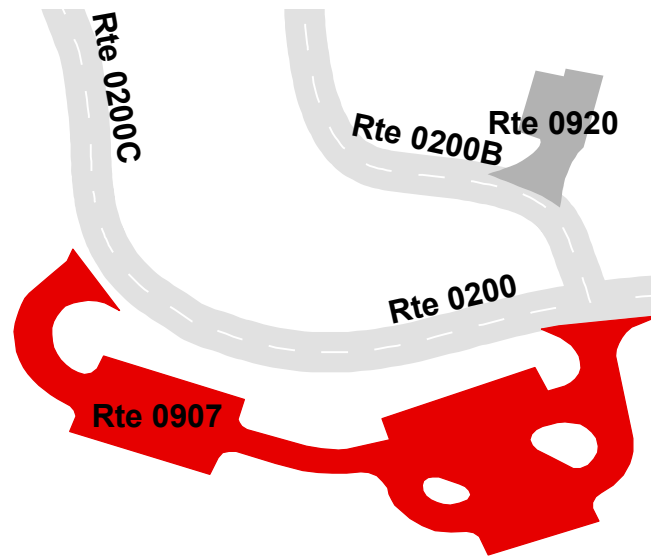
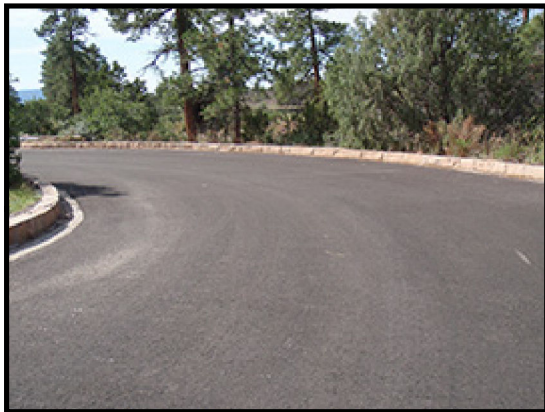
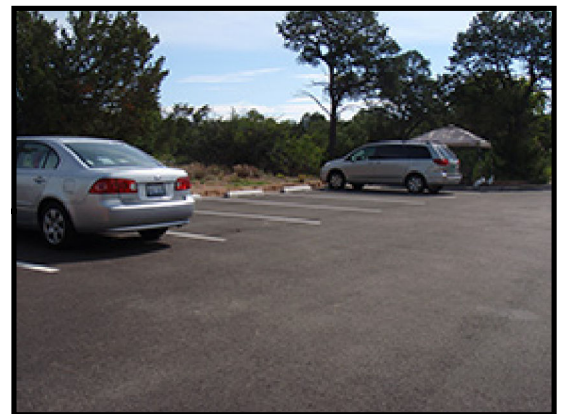
Route 0907

Route Number	Public / NonPublic	Date Visited	Area (sq ft)	Lane Miles *	Surface Type
0907	PUBLIC	9/6/2011	29,942	0.52	AS
Culverts	Drop Inlets	Gates	Curb & Gutter	Curb	PCR
0	1	0	STONE CURB AND CONCRETE GUTTER	NO CURB	EXCELLENT/97

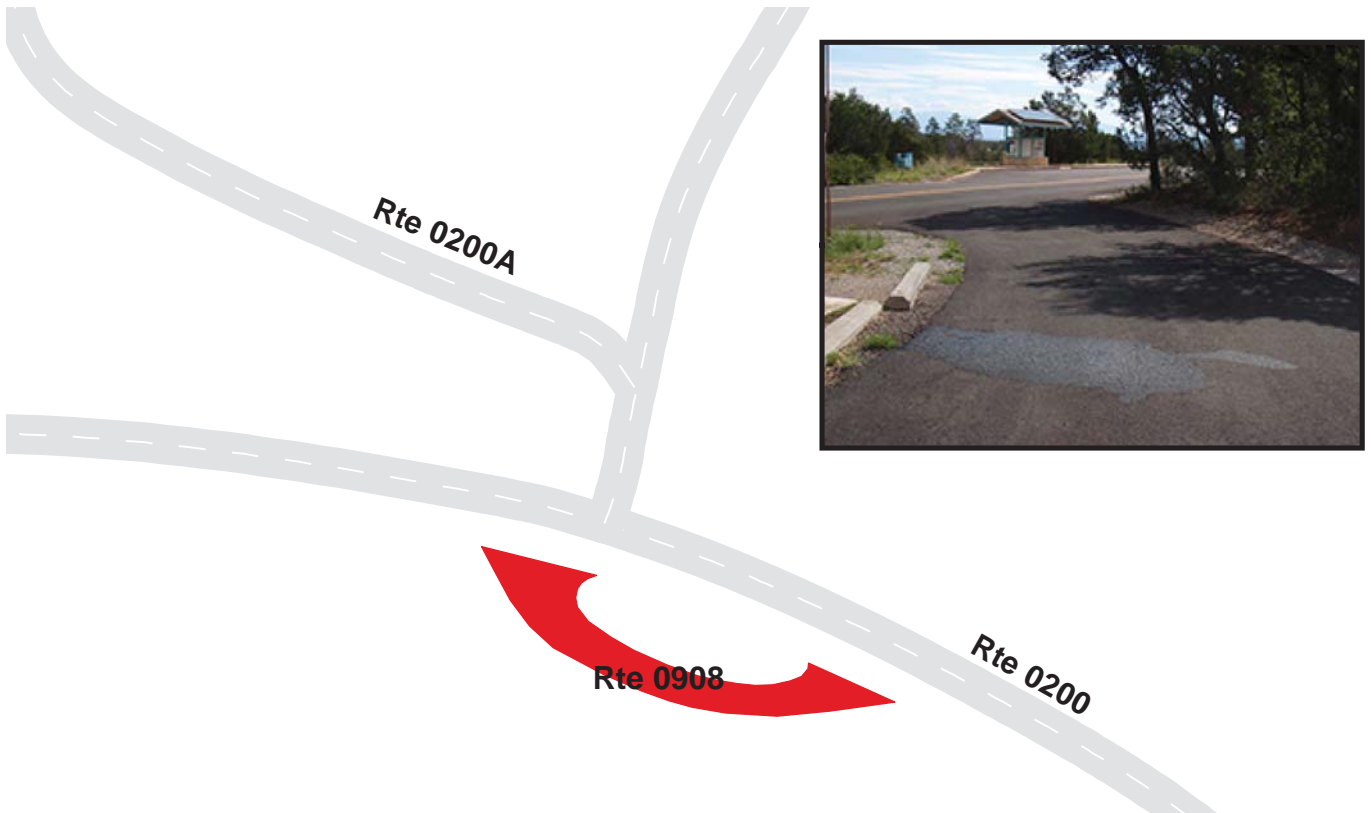
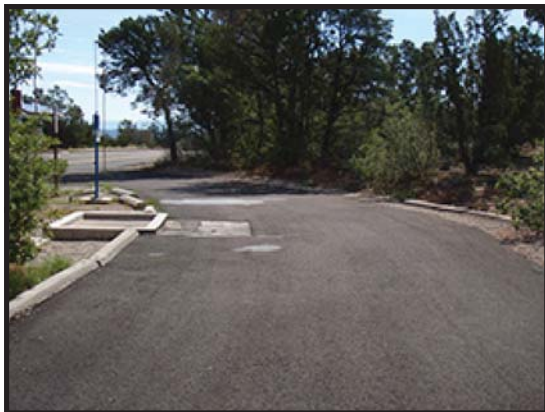
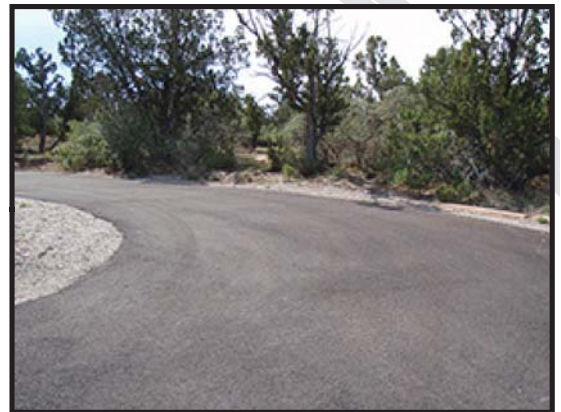
Route 0908

Route Number	Public / NonPublic	Date Visited	Area (sq ft)	Lane Miles *	Surface Type
0908	PUBLIC	9/6/2011	1,883	0.03	AS
Culverts	Drop Inlets	Gates	Curb & Gutter	Curb	PCR
0	0	0	NO CURB AND GUTTER	NO CURB	EXCELLENT/97

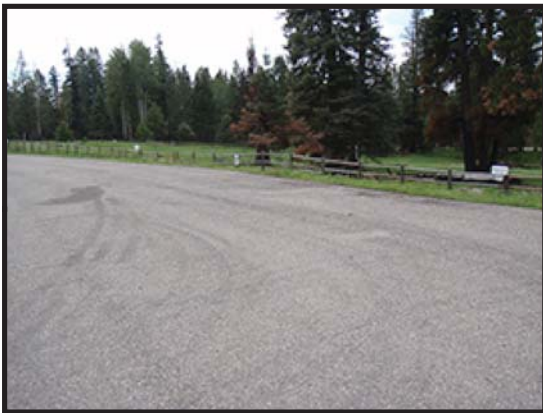
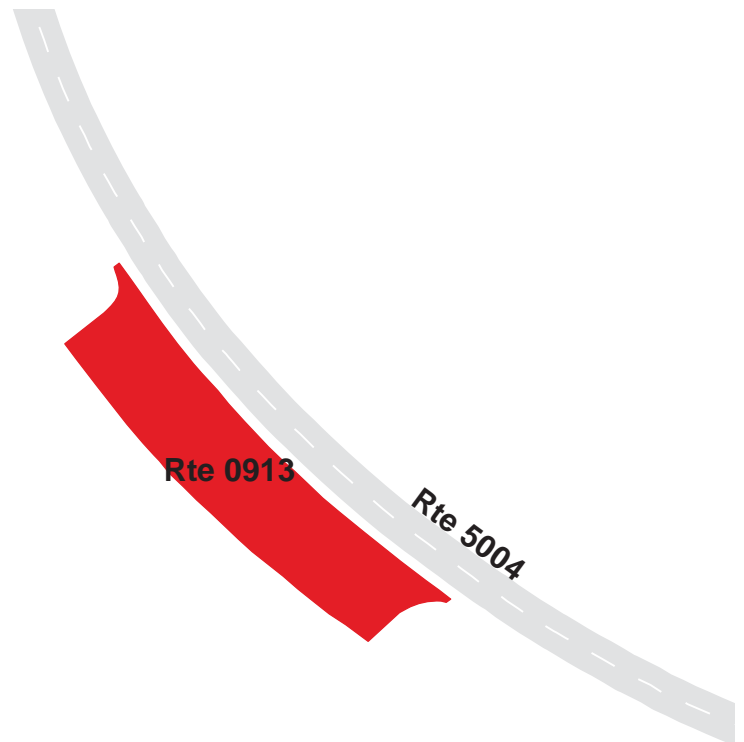
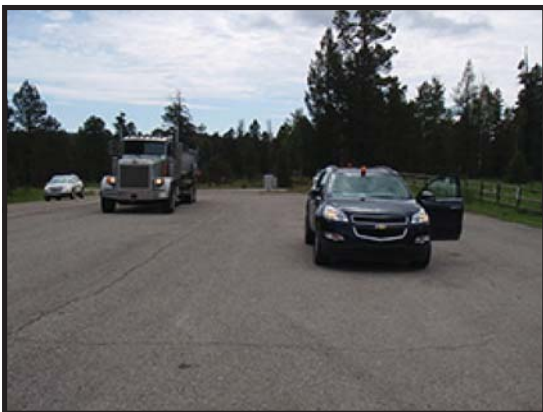
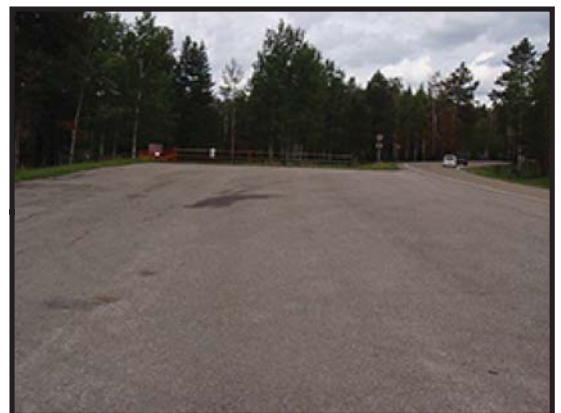
Route 0913

Route Number	Public / NonPublic	Date Visited	Area (sq ft)	Lane Miles *	Surface Type
0913	PUBLIC	9/6/2011	17,348	0.30	AS
Culverts	Drop Inlets	Gates	Curb & Gutter	Curb	PCR
0	0	0	NO CURB AND GUTTER	NO CURB	FAIR/73

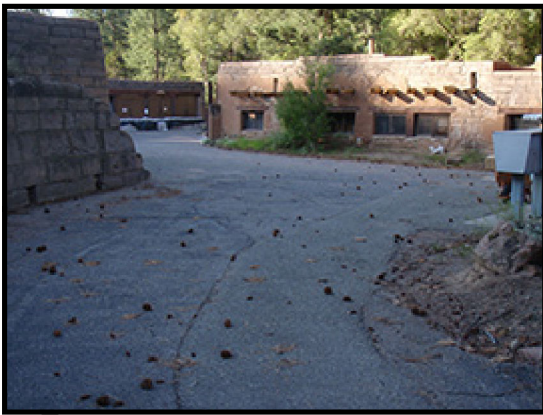
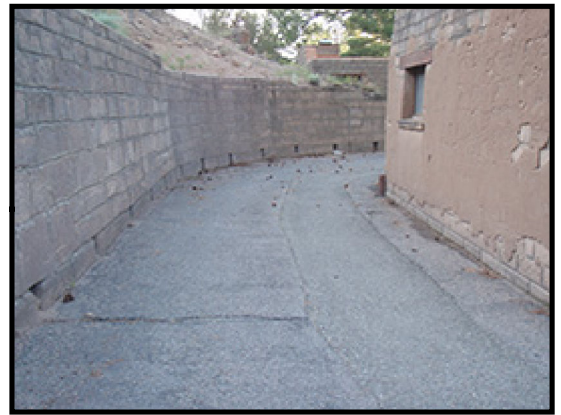
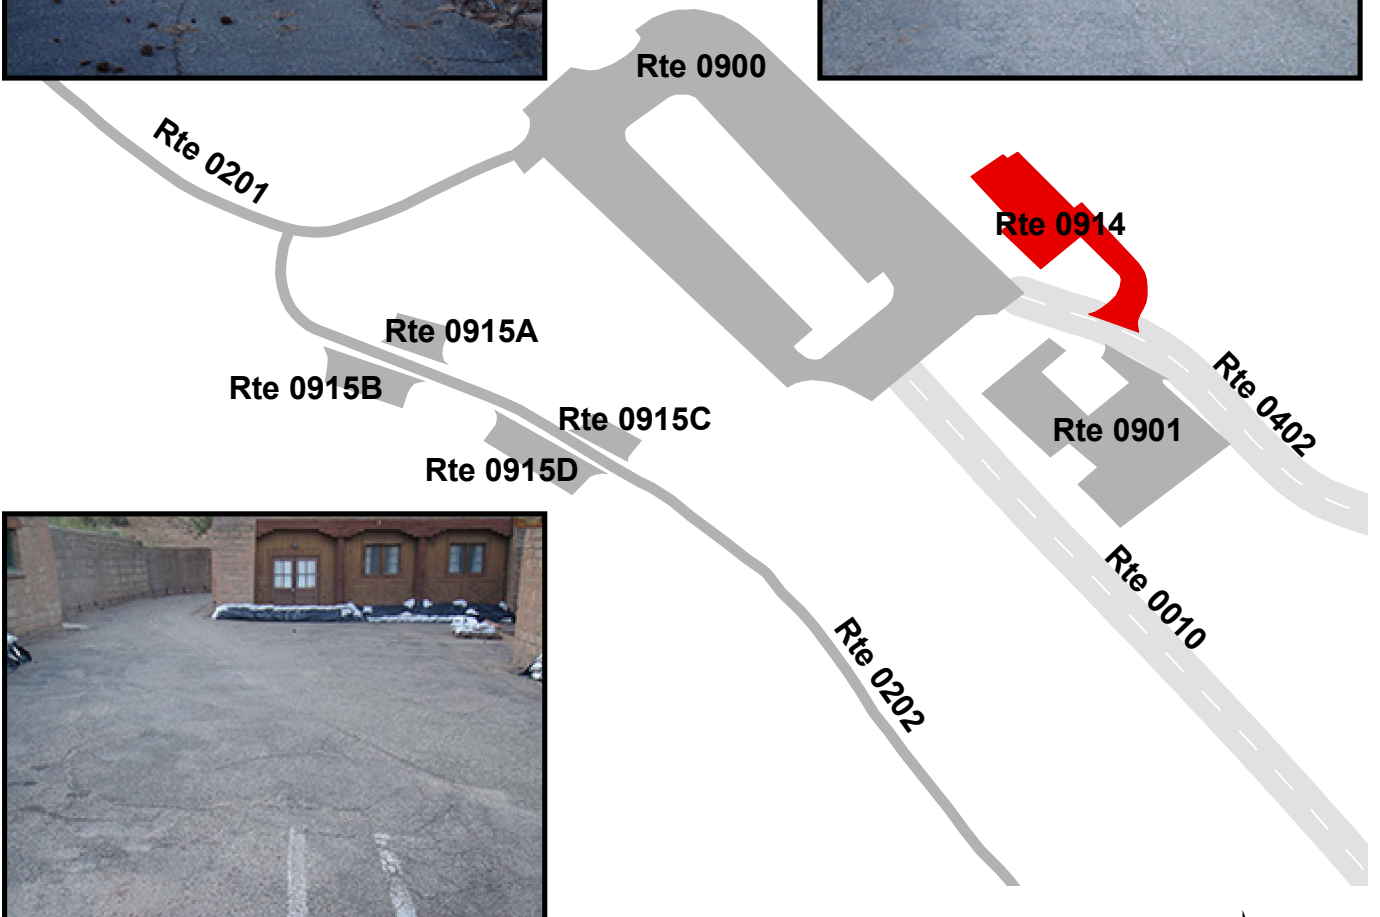
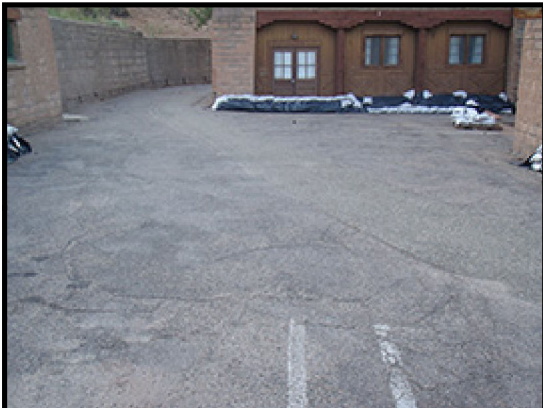
Route Number	Public / NonPublic	Date Visited	Area (sq ft)	Lane Miles *	Surface Type
0914	NONPUBLIC	9/6/2011	4,276	0.07	AS
Culverts	Drop Inlets	Gates	Curb & Gutter	Curb	PCR
0	1	0	NO CURB AND GUTTER	NO CURB	POOR/45

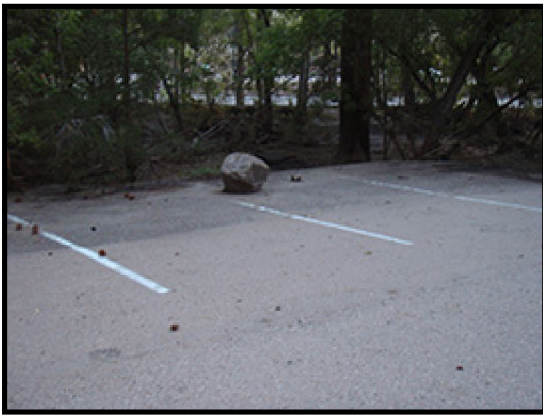
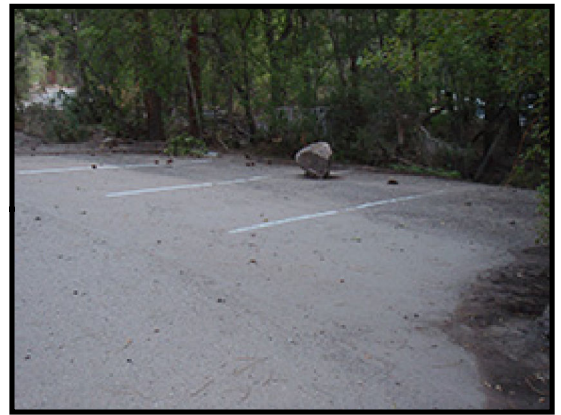
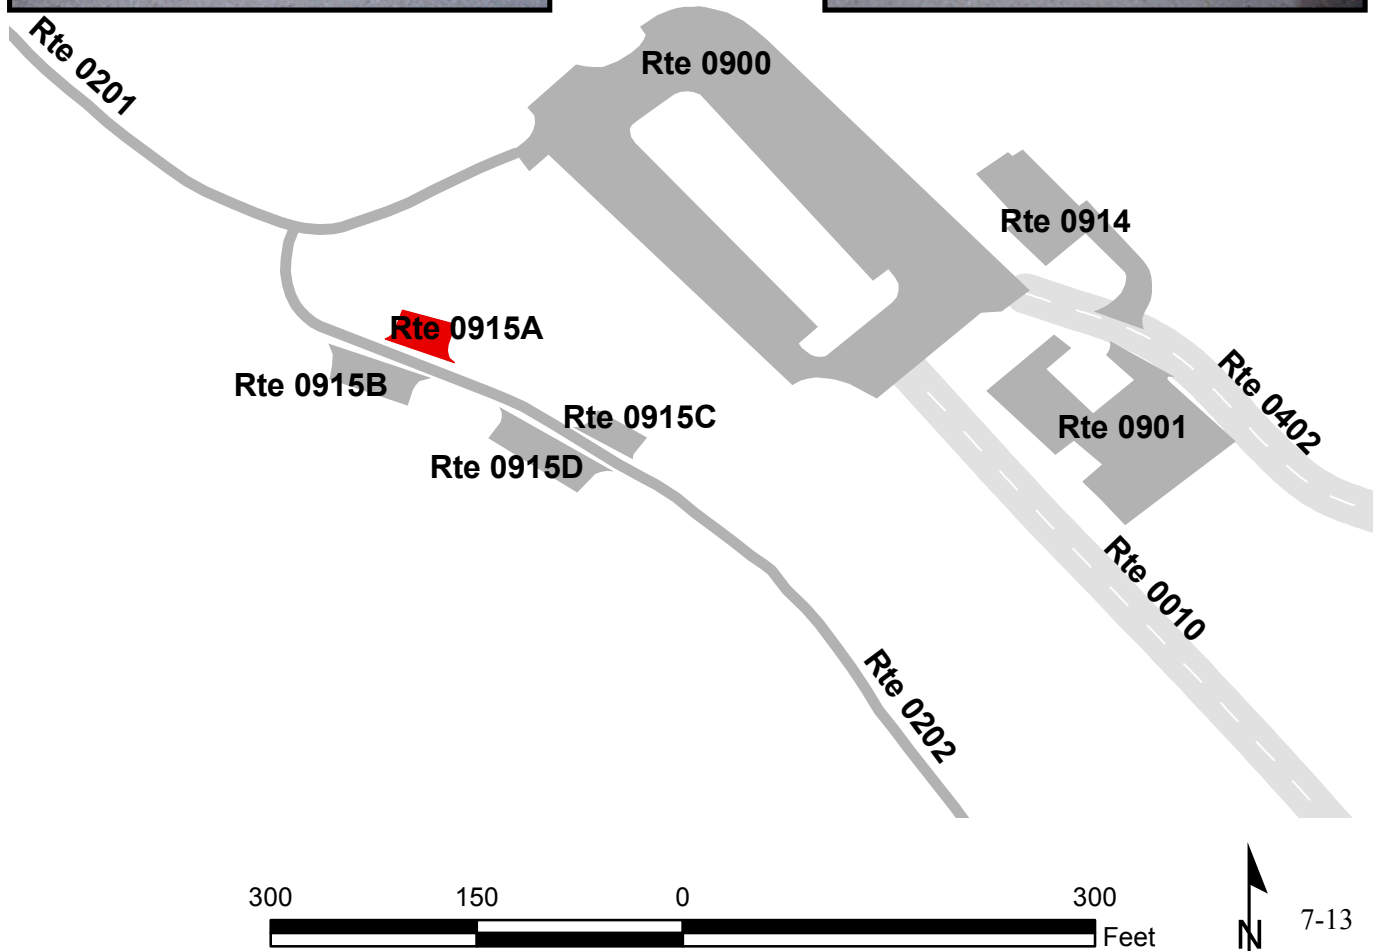
Route 0915A

Route Number	Public / NonPublic	Date Visited	Area (sq ft)	Lane Miles *	Surface Type
0915A	PUBLIC	9/6/2011	848	0.02	AS
Culverts	Drop Inlets	Gates	Curb & Gutter	Curb	PCR
0	0	0	NO CURB AND GUTTER	NO CURB	FAIR/73

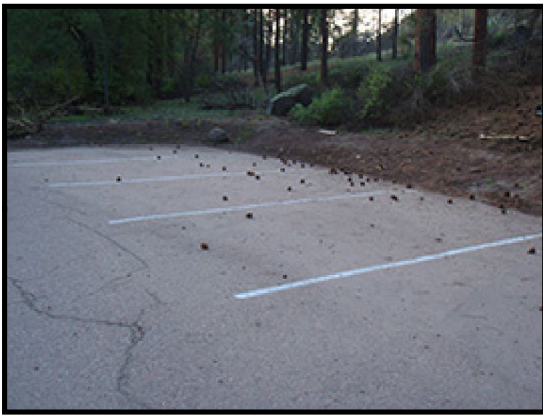
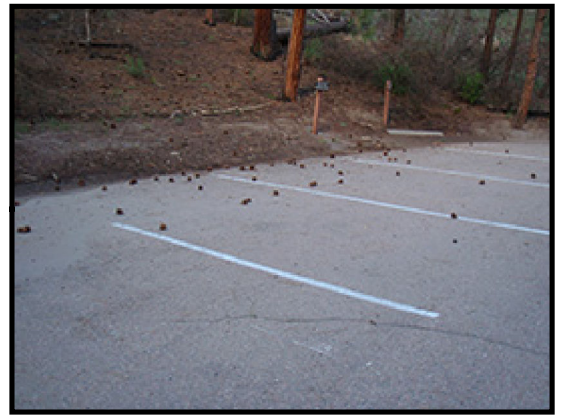
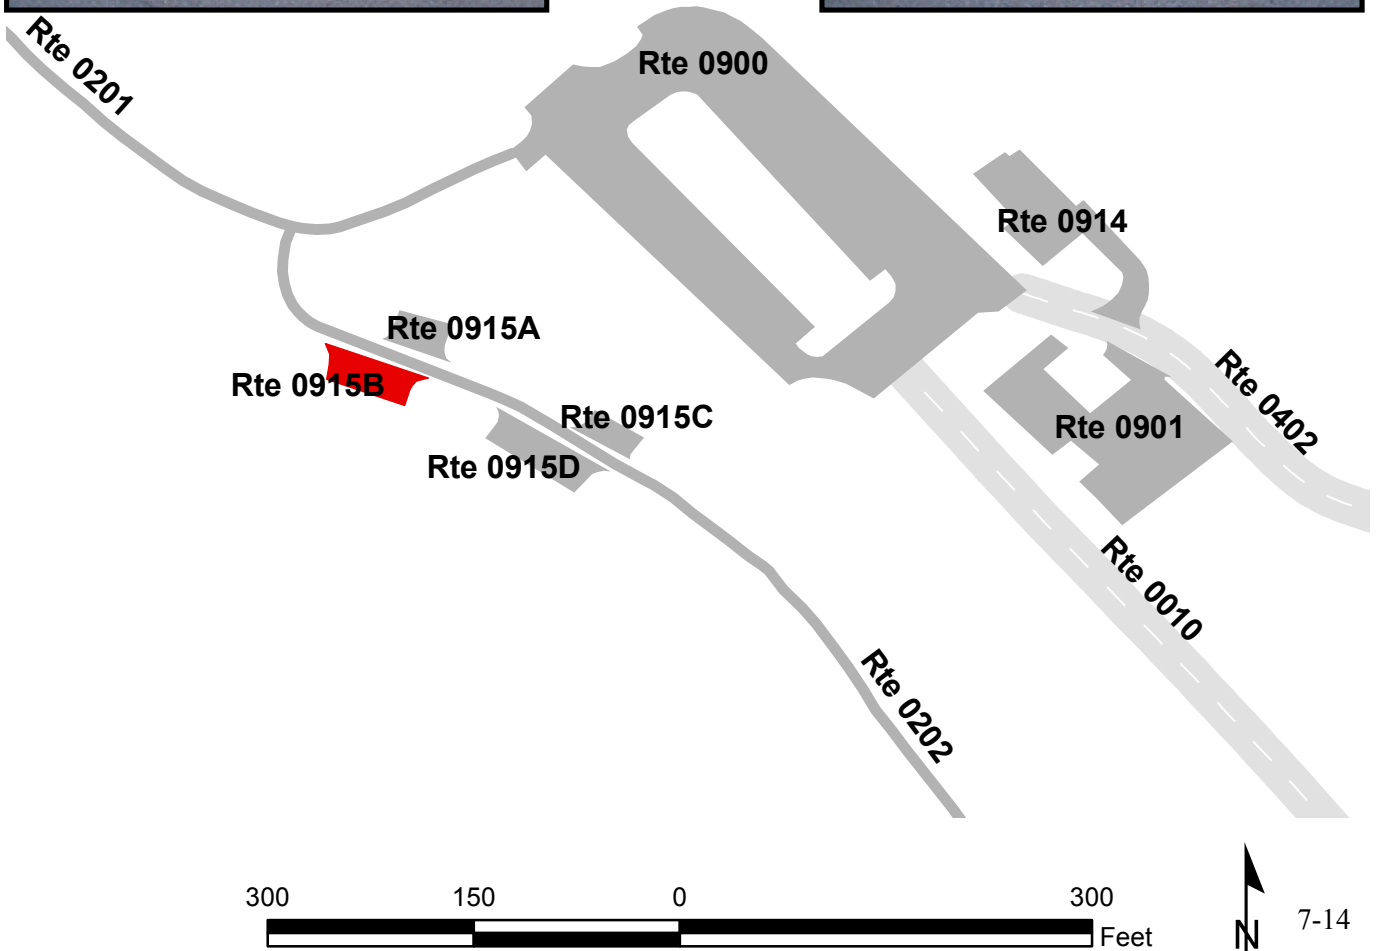
Route 0915B

Route Number	Public / NonPublic	Date Visited	Area (sq ft)	Lane Miles *	Surface Type
0915B	PUBLIC	9/6/2011	1,266	0.02	AS
Culverts	Drop Inlets	Gates	Curb & Gutter	Curb	PCR
0	0	0	NO CURB AND GUTTER	NO CURB	FAIR/73
