Federal Lands Highway Road Inventory Program

Road Inventory and Condition Assessment

Bandelier National Monument BAND

Cycle 5 Report

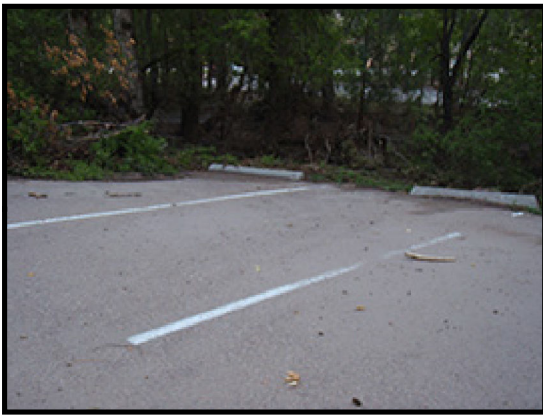
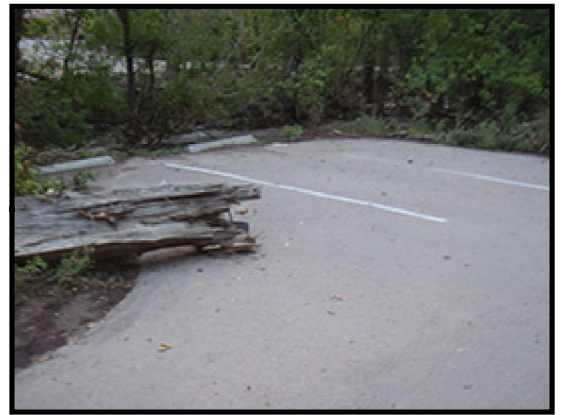
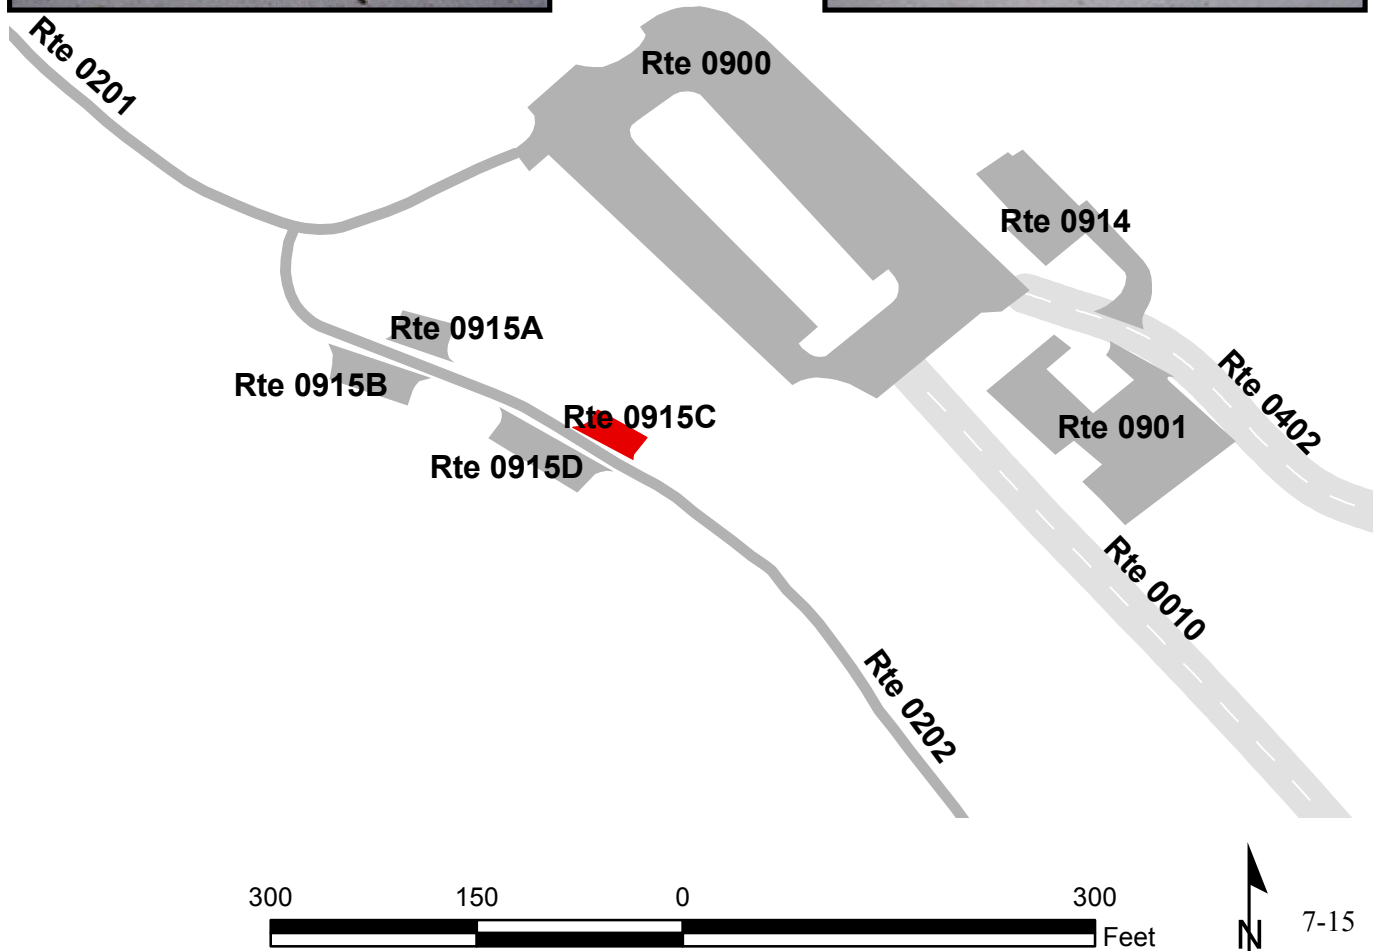
Route 0915C

Route Number	Public / NonPublic	Date Visited	Area (sq ft)	Lane Miles *	Surface Type
0915C	PUBLIC	9/6/2011	658	0.01	AS
Culverts	Drop Inlets	Gates	Curb & Gutter	Curb	PCR
0	0	0	NO CURB AND GUTTER	NO CURB	FAIR/73

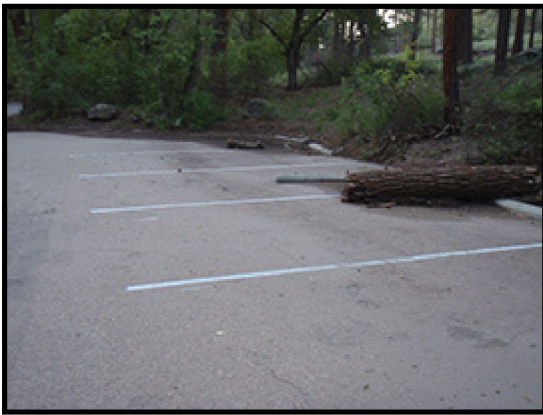
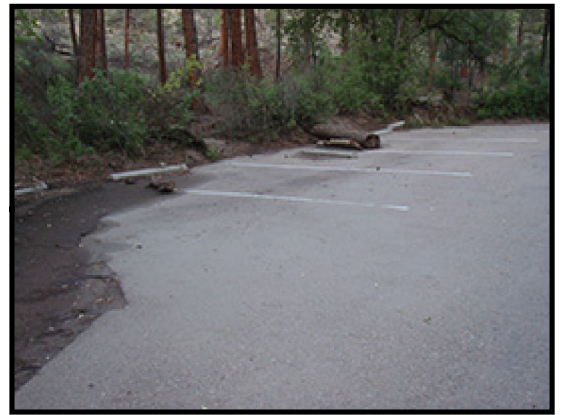
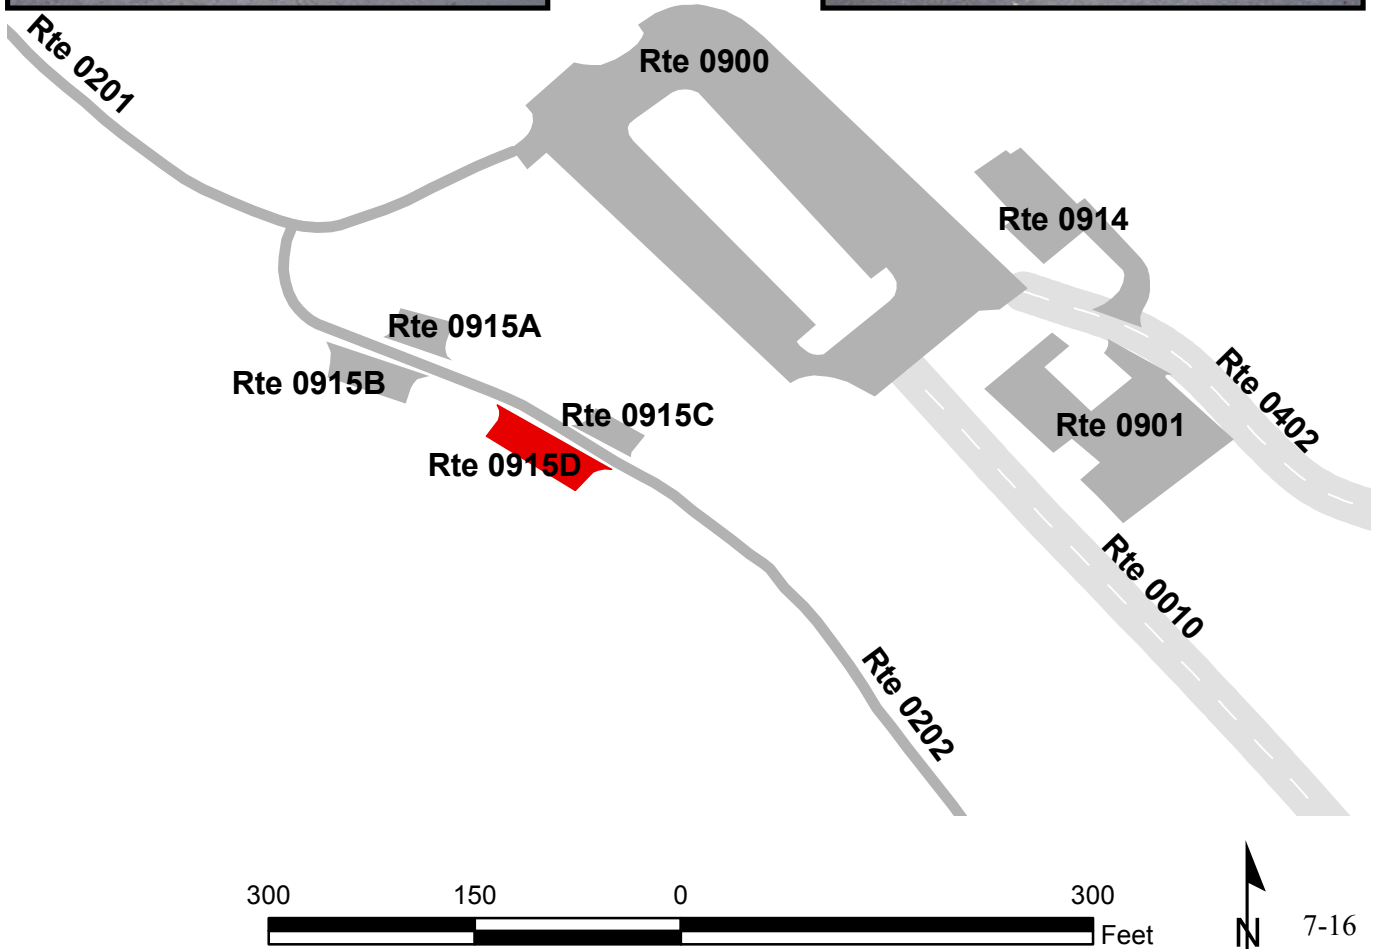
Route 0915D

Route Number	Public / NonPublic	Date Visited	Area (sq ft)	Lane Miles *	Surface Type
0915D	PUBLIC	9/6/2011	1,643	0.03	AS
Culverts	Drop Inlets	Gates	Curb & Gutter	Curb	PCR
0	0	0	NO CURB AND GUTTER	NO CURB	FAIR/73

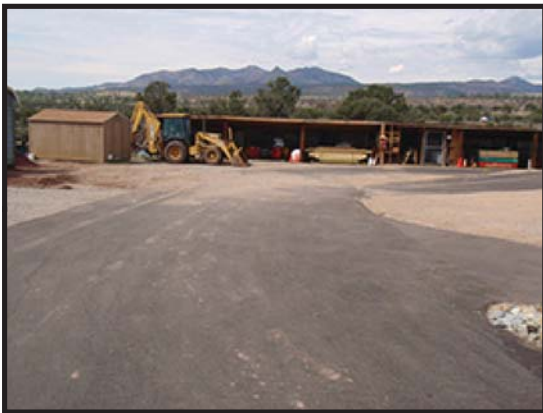
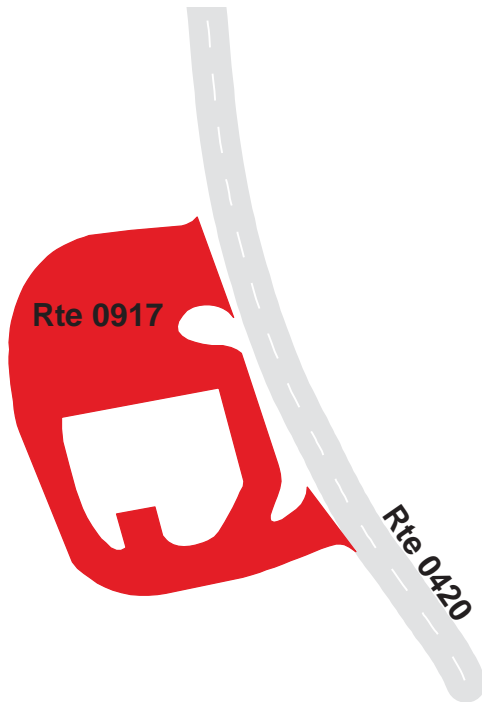
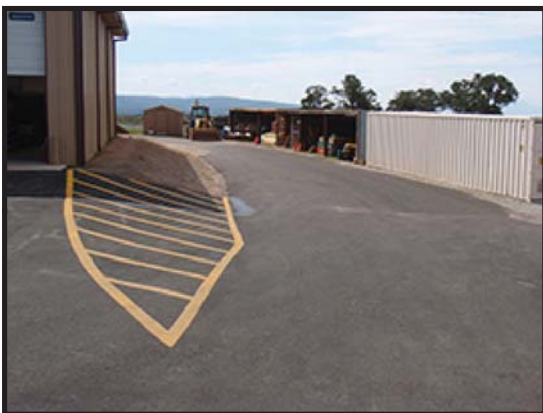
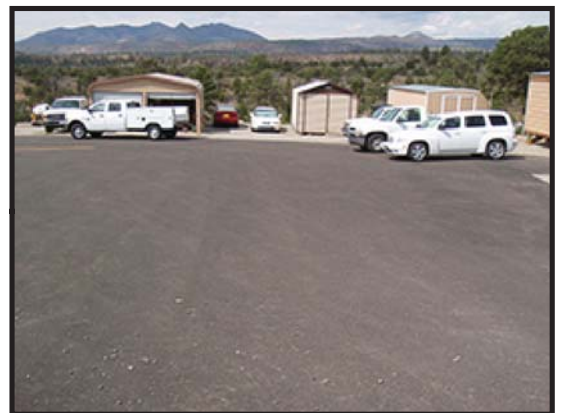
Route 0917

Route Number	Public / NonPublic	Date Visited	Area (sq ft)	Lane Miles *	Surface Type
0917	NONPUBLIC	9/6/2011	18,627	0.32	AS
Culverts	Drop Inlets	Gates	Curb & Gutter	Curb	PCR
0	0	0	NO CURB AND GUTTER	NO CURB	EXCELLENT/97

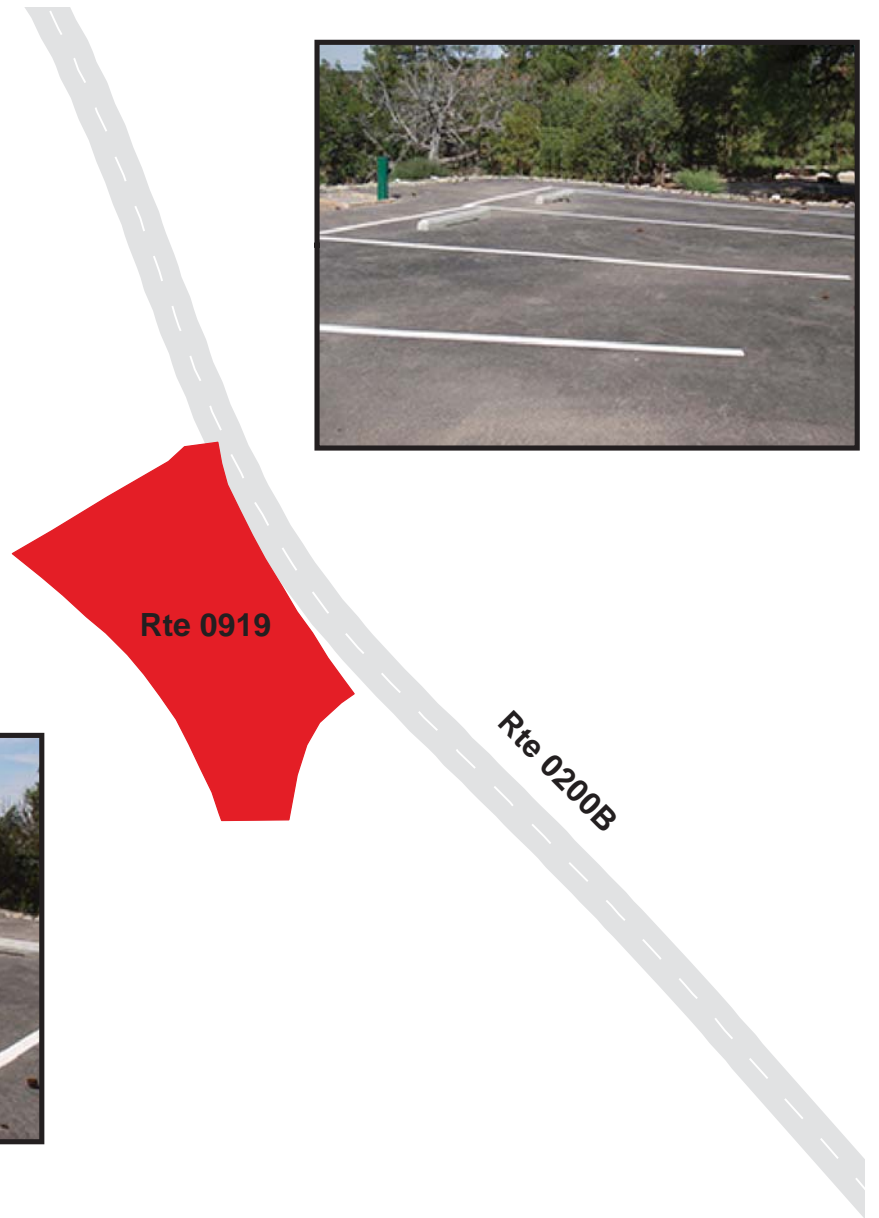
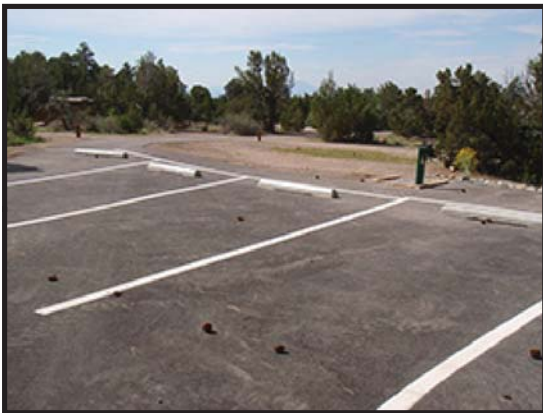
Route 0919

Route Number	Public / NonPublic	Date Visited	Area (sq ft)	Lane Miles *	Surface Type
0919	PUBLIC	9/6/2011	1,332	0.02	AS
Culverts	Drop Inlets	Gates	Curb & Gutter	Curb	PCR
0	0	0	NO CURB AND GUTTER	NO CURB	GOOD/90

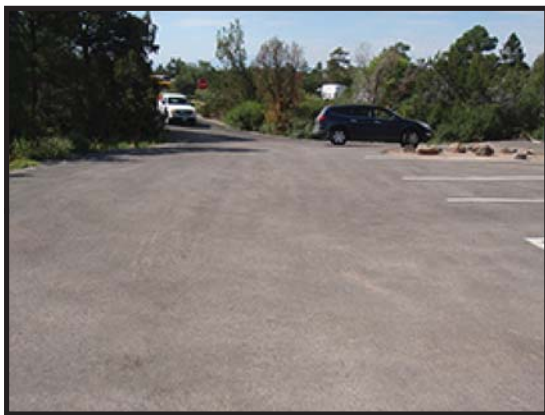
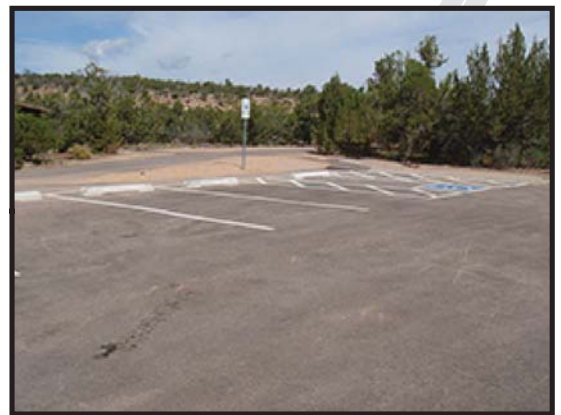
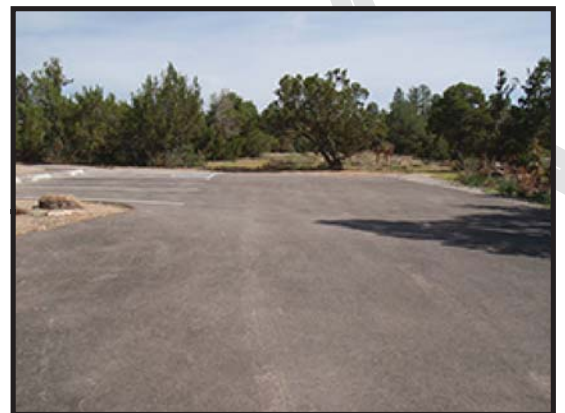
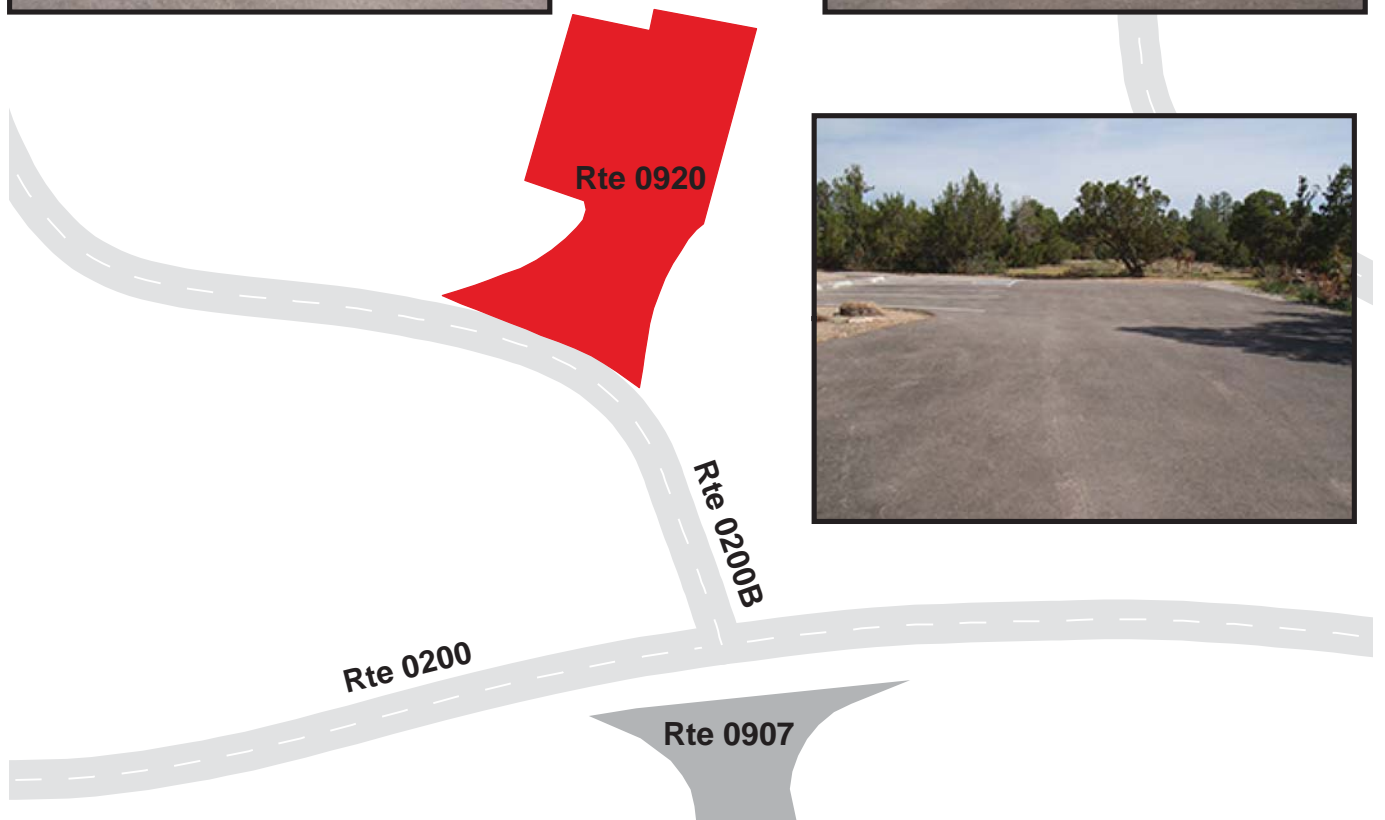
Route 0920

Route Number	Public / NonPublic	Date Visited	Area (sq ft)	Lane Miles *	Surface Type
0920	PUBLIC	9/6/2011	4,033	0.07	AS
Culverts	Drop Inlets	Gates	Curb & Gutter	Curb	PCR
0	0	0	NO CURB AND GUTTER	NO CURB	GOOD/90

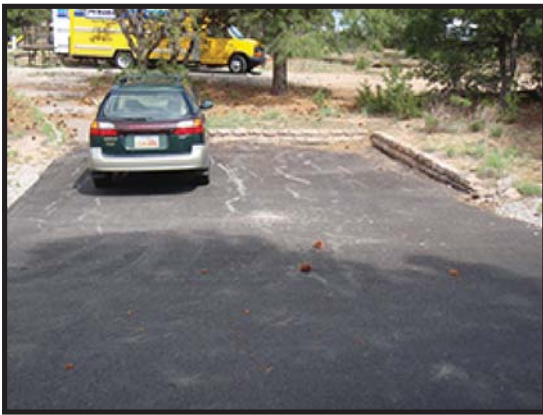
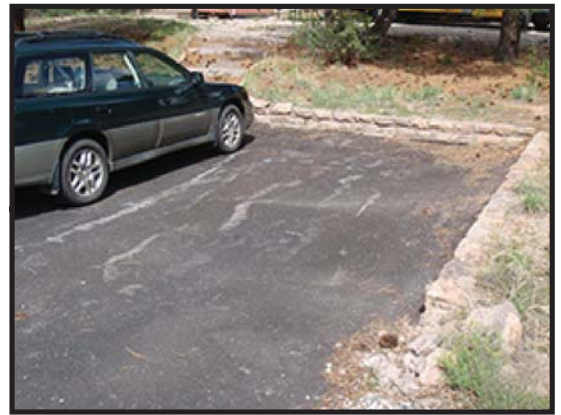
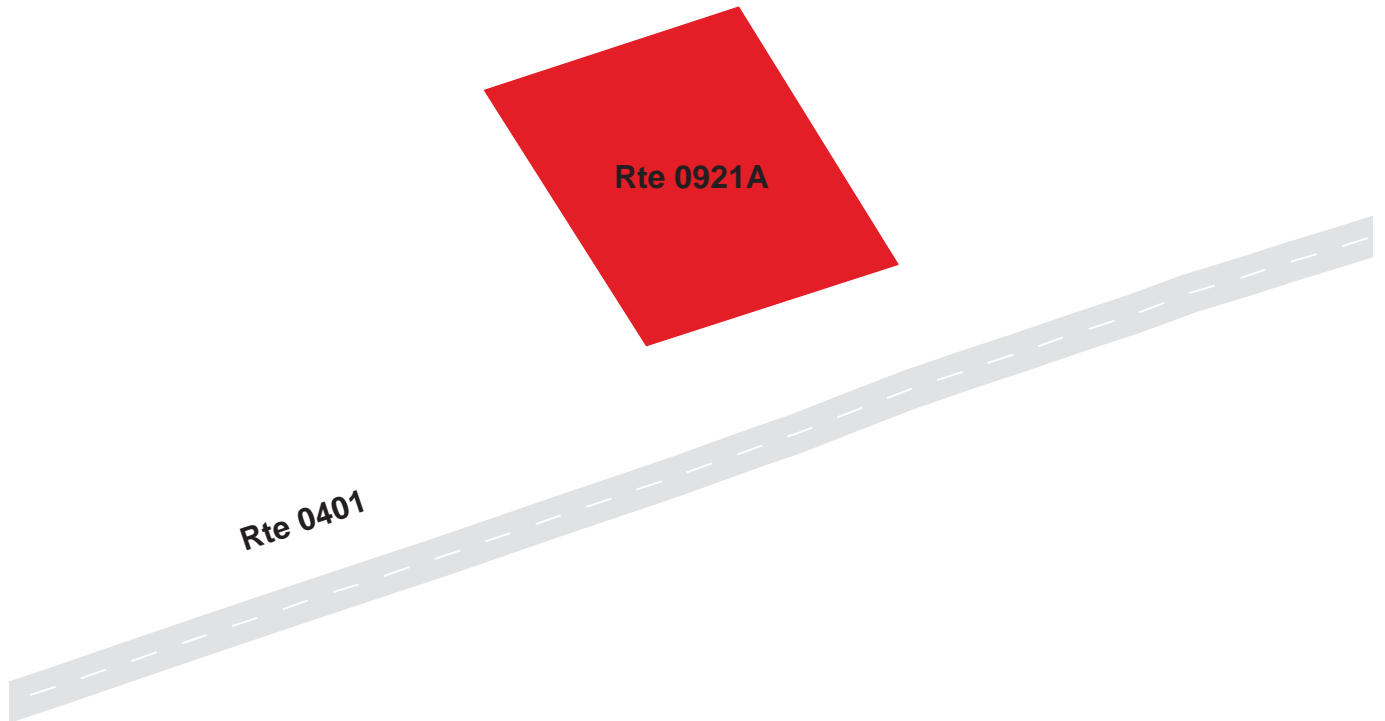
Route 0921A

Route Number	Public / NonPublic	Date Visited	Area (sq ft)	Lane Miles *	Surface Type
0921A	NONPUBLIC	9/6/2011	641	0.01	AS
Culverts	Drop Inlets	Gates	Curb & Gutter	Curb	PCR
0	0	0	NO CURB AND GUTTER	STONE CURB	EXCELLENT/97

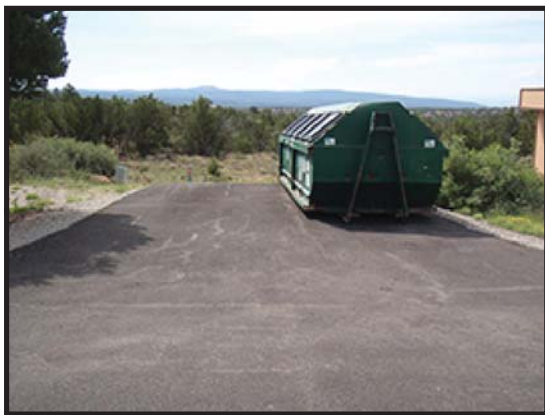
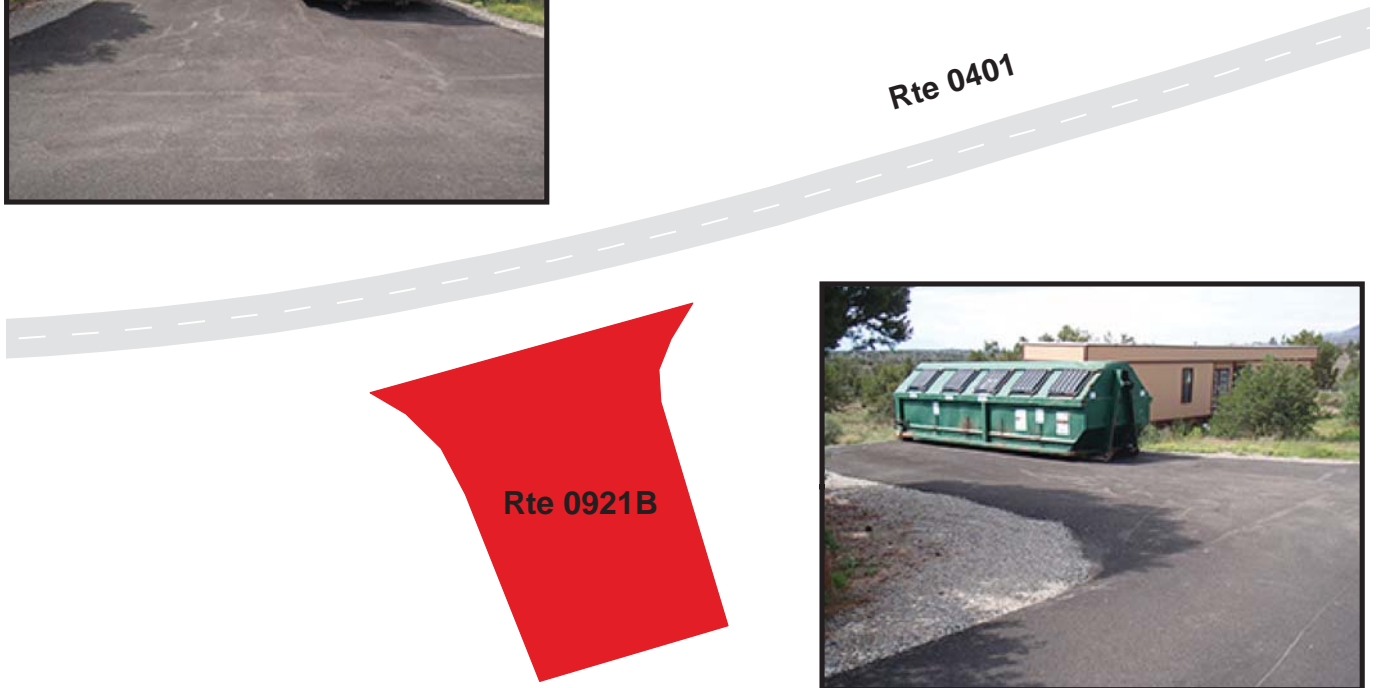
Route 0921B

Route Number	Public / NonPublic	Date Visited	Area (sq ft)	Lane Miles *	Surface Type
0921B	NONPUBLIC	9/6/2011	822	0.01	AS
Culverts	Drop Inlets	Gates	Curb & Gutter	Curb	PCR
0	0	0	NO CURB AND GUTTER	NO CURB	EXCELLENT/97

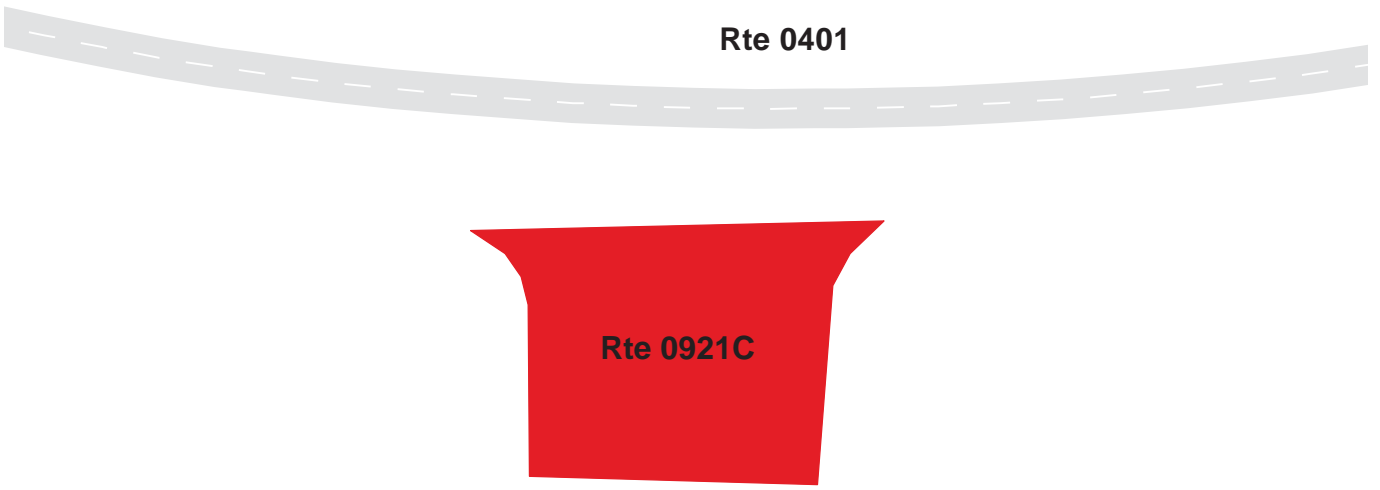
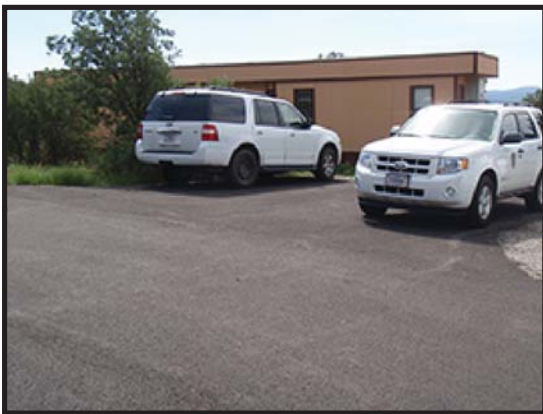
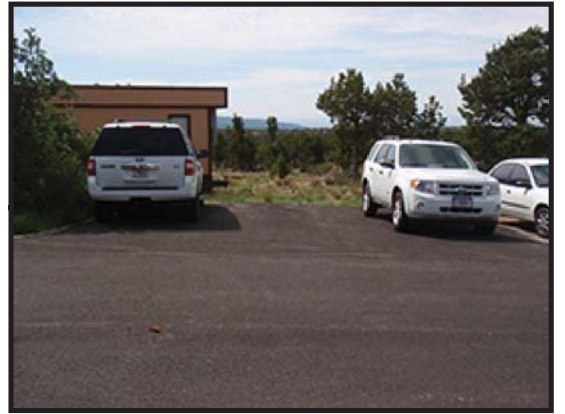
Route 0921C

Route Number	Public / NonPublic	Date Visited	Area (sq ft)	Lane Miles *	Surface Type
0921C	NONPUBLIC	9/6/2011	740	0.01	AS
Culverts	Drop Inlets	Gates	Curb & Gutter	Curb	PCR
0	0	0	NO CURB AND GUTTER	NO CURB	EXCELLENT/97

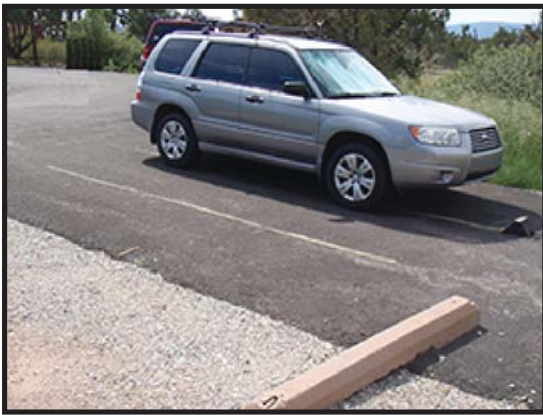
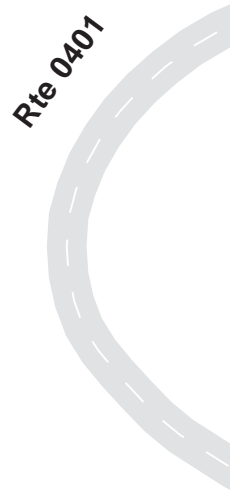
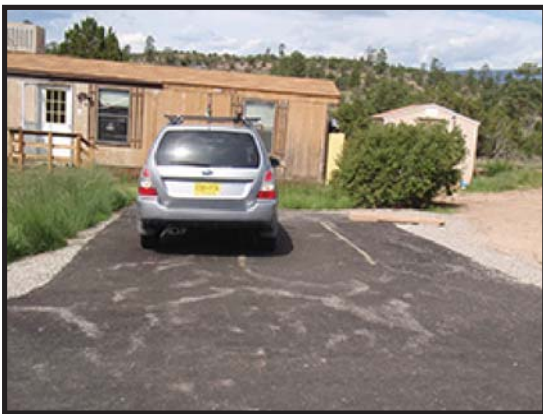
Route 0921D

Route Number	Public / NonPublic	Date Visited	Area (sq ft)	Lane Miles *	Surface Type
0921D	NONPUBLIC	9/6/2011	559	0.01	AS
Culverts	Drop Inlets	Gates	Curb & Gutter	Curb	PCR
1	0	0	NO CURB AND GUTTER	NO CURB	EXCELLENT/97

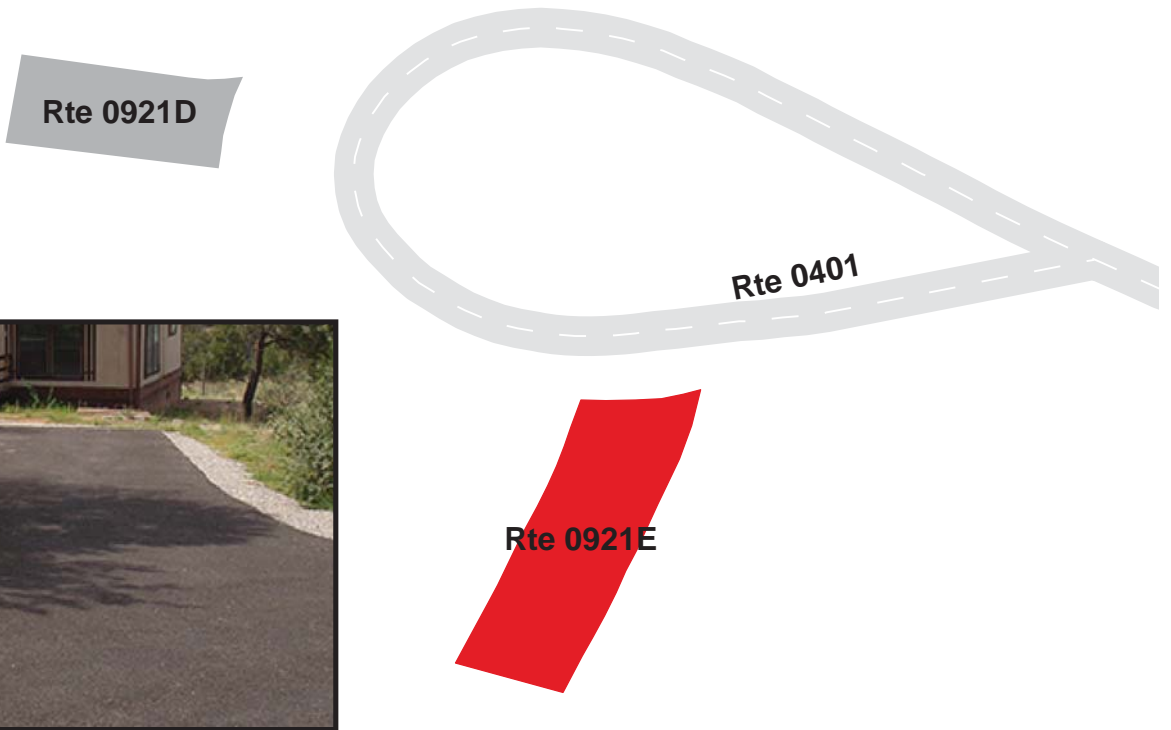
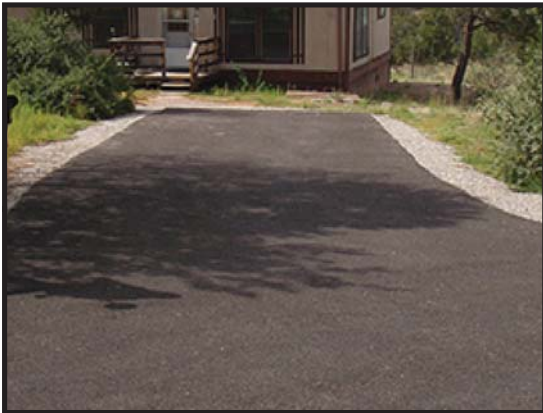
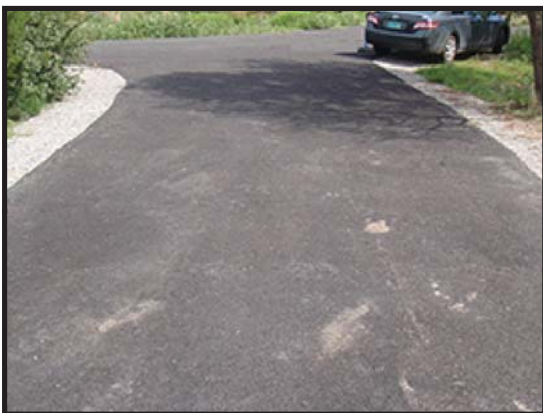
Route 0921E

Route Number	Public / NonPublic	Date Visited	Area (sq ft)	Lane Miles *	Surface Type
0921E	NONPUBLIC	9/6/2011	996	0.02	AS
Culverts	Drop Inlets	Gates	Curb & Gutter	Curb	PCR
1	0	0	NO CURB AND GUTTER	NO CURB	EXCELLENT/97
