Federal Lands Highway Road Inventory Program

Road Inventory and Condition Assessment

Buffalo National River BUFF - 7150

Cycle 5 Report

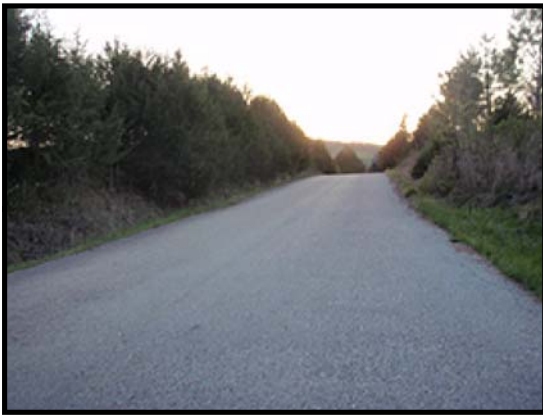
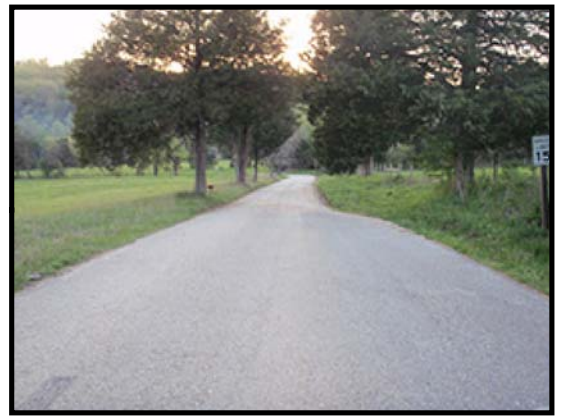
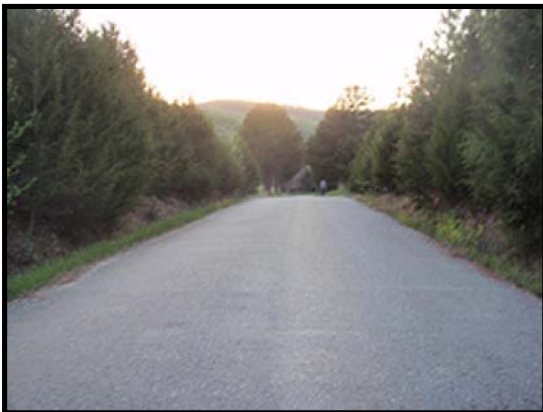
Route Number	Public / NonPublic	Date Visited	Area (sq ft)	Lane Miles *	Paved Length (mi)	Paved Width (ft)
0215	PUBLIC	4/16/2011	6,729	0.12	0.12	10.8
Culverts	Drop Inlets	Gates	Curb & Gutter	Curb	PCR	Surface Type
0	0	0	NO CURB AND GUTTER	NO CURB	POOR/45	AS

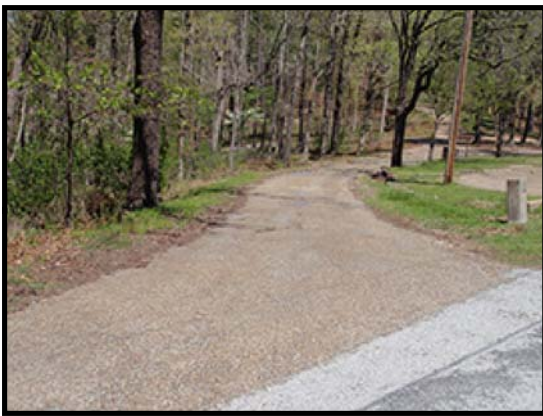
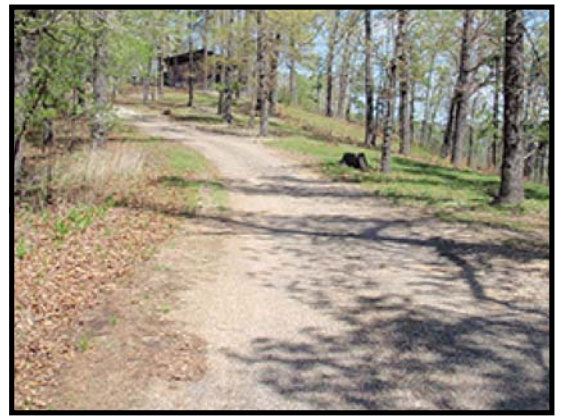
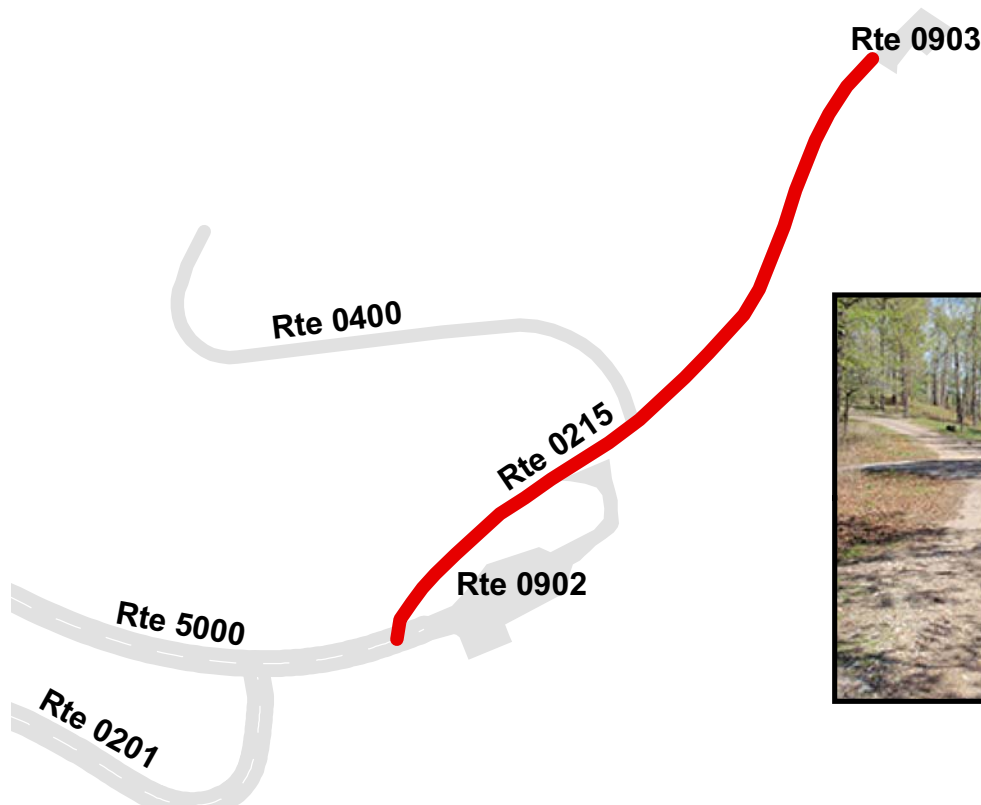
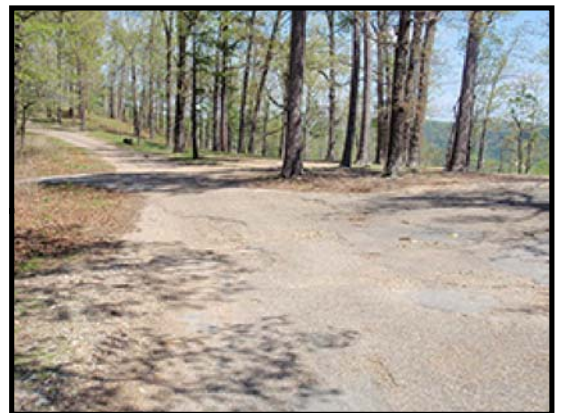
Route Number	Public / NonPublic	Date Visited	Area (sq ft)	Lane Miles *	Paved Length (mi)	Paved Width (ft)
0216	PUBLIC	4/16/2011	6,209	0.11	0.08	14
Culverts	Drop Inlets	Gates	Curb & Gutter	Curb	PCR	Surface Type
0	0	0	NO CURB AND GUTTER	NO CURB	FAIR/73	AS

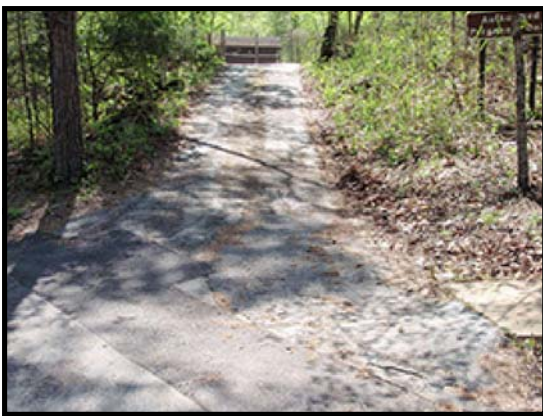
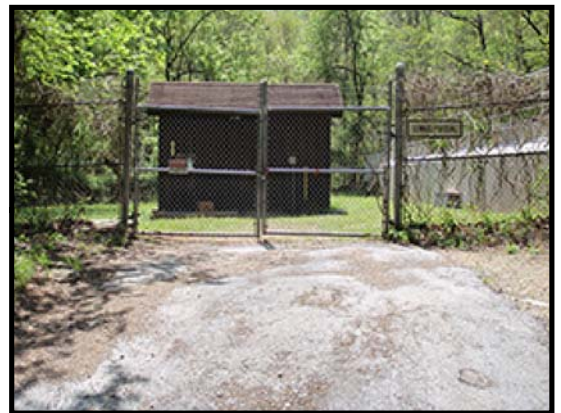
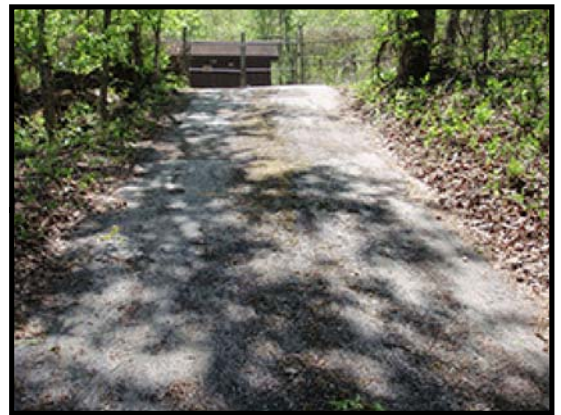
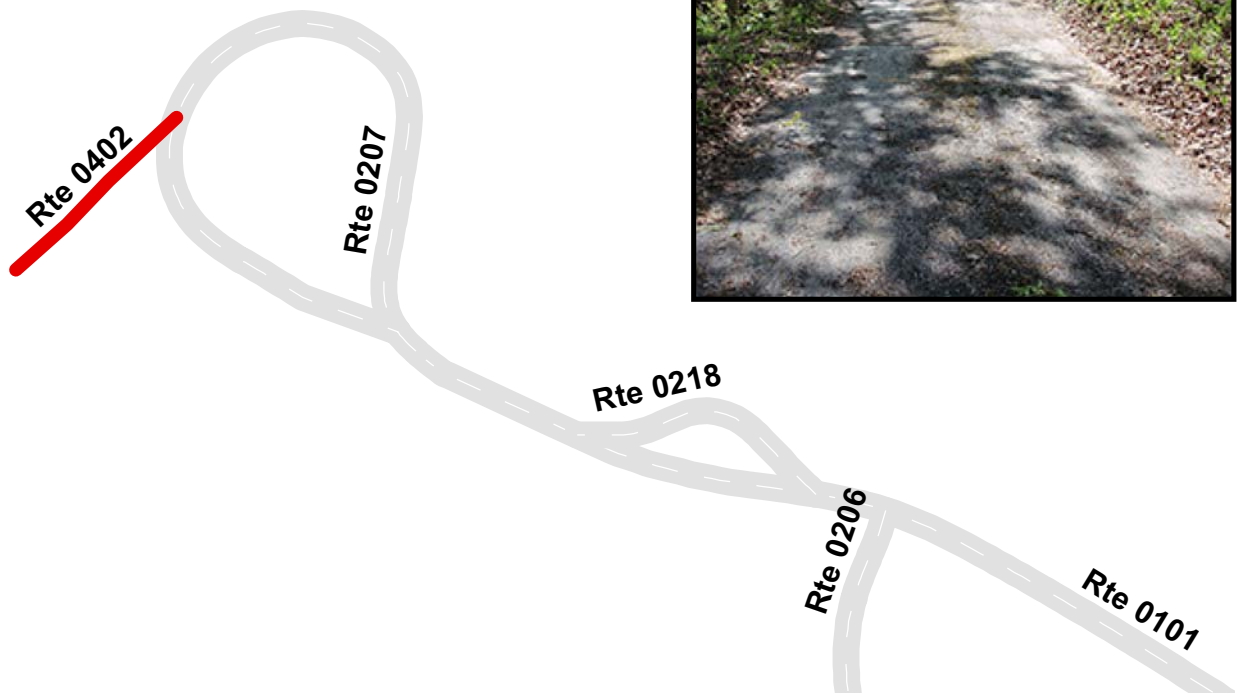
Route Number	Public / NonPublic	Date Visited	Area (sq ft)	Lane Miles *	Surface Type
0900	PUBLIC	4/16/2011	1,931	0.03	AS
Culverts	Drop Inlets	Gates	Curb & Gutter	Curb	PCR
0	0	0	NO CURB AND GUTTER	NO CURB	FAIR/73

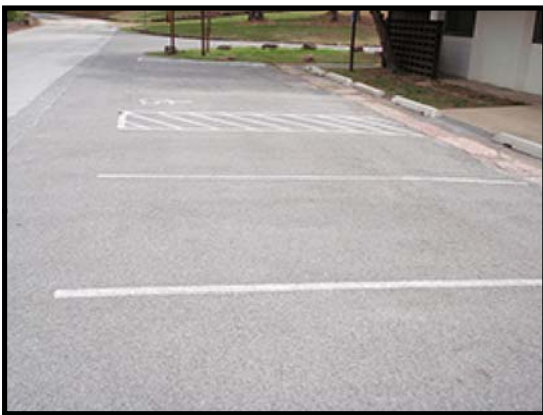
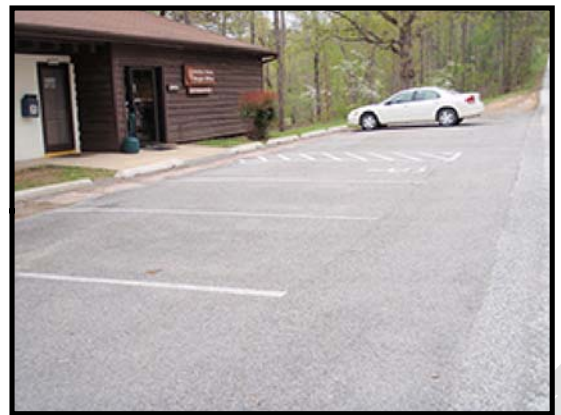
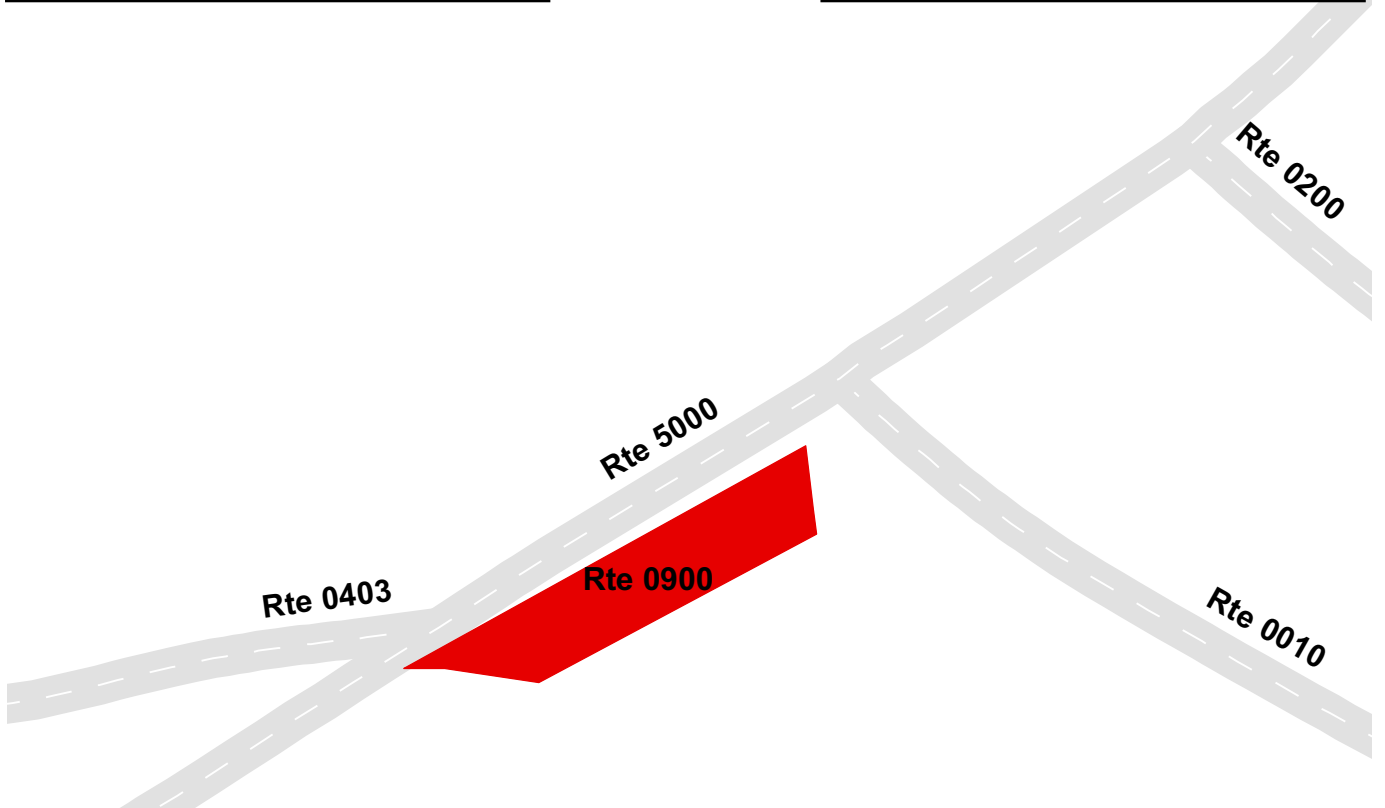
Route Number	Public / NonPublic	Date Visited	Area (sq ft)	Lane Miles *	Surface Type
0901	PUBLIC	4/16/2011	3,463	0.06	AS
Culverts	Drop Inlets	Gates	Curb & Gutter	Curb	PCR
0	0	0	NO CURB AND GUTTER	NO CURB	POOR/45

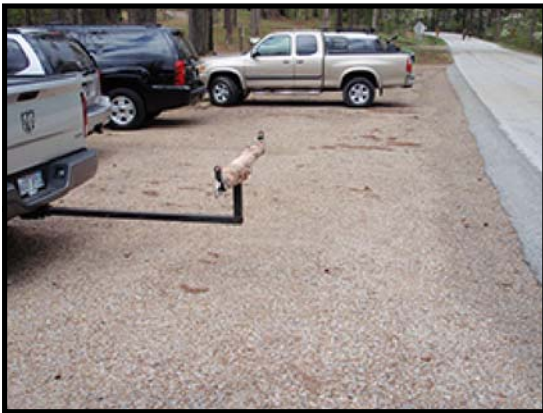
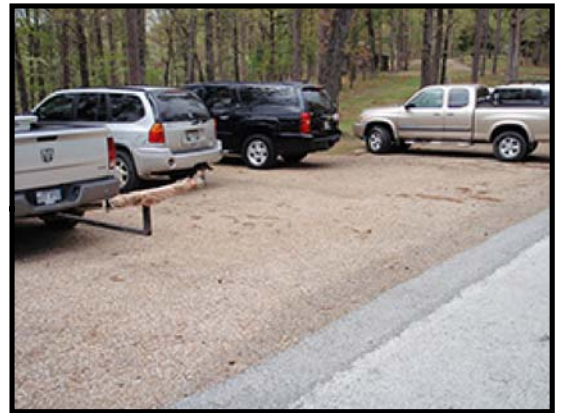
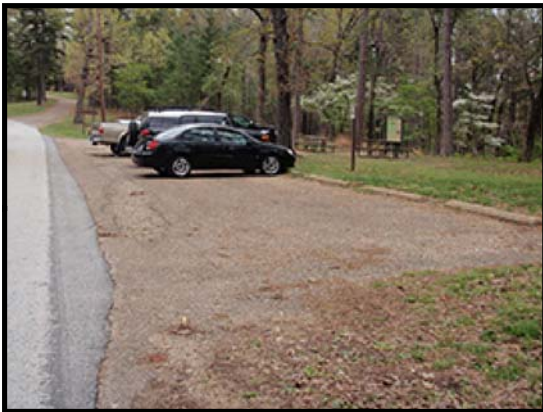
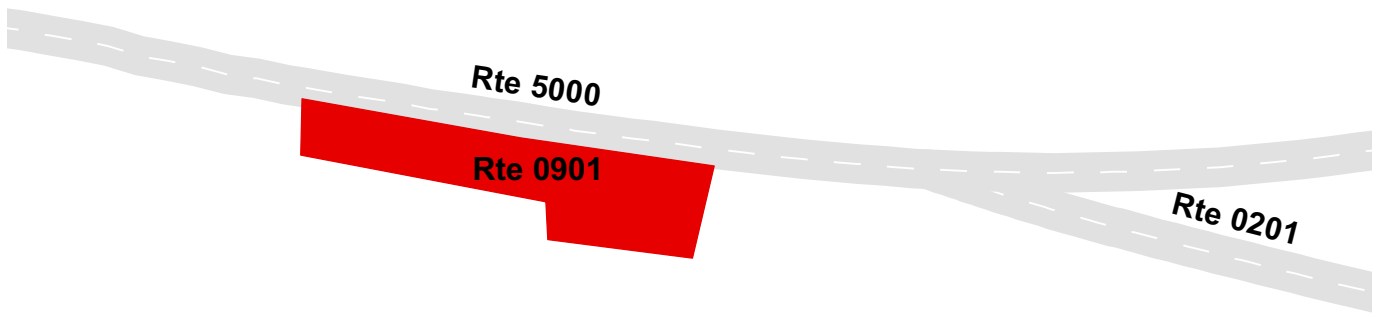
Route Number	Public / NonPublic	Date Visited	Area (sq ft)	Lane Miles *	Surface Type
0902	PUBLIC	4/16/2011	7,115	0.12	AS
Culverts	Drop Inlets	Gates	Curb & Gutter	Curb	PCR
1	0	0	NO CURB AND GUTTER	CONCRETE CURB	POOR/45

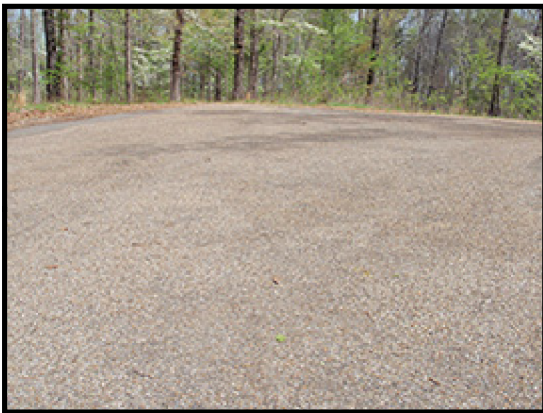
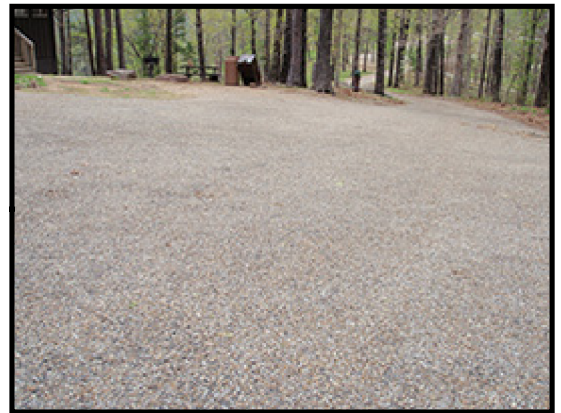
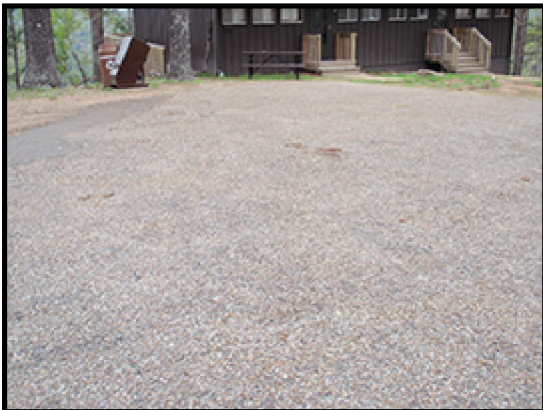
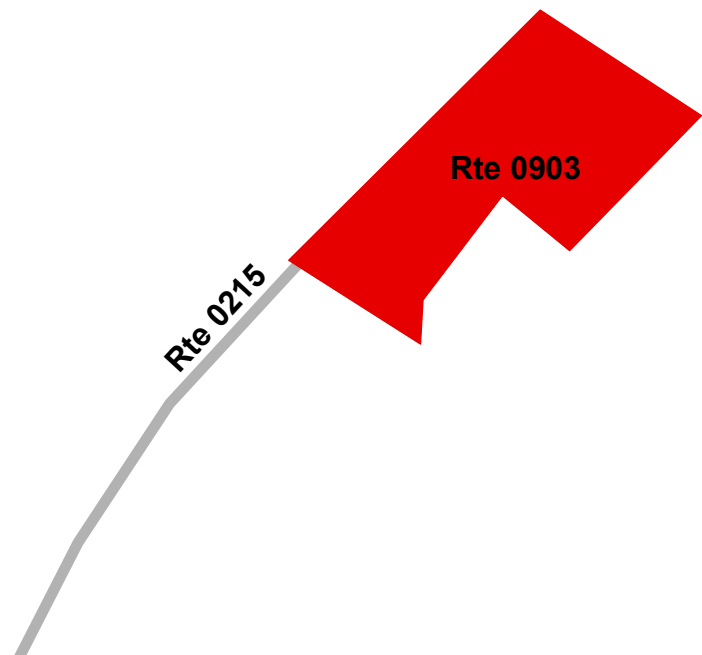
Route Number	Public / NonPublic	Date Visited	Area (sq ft)	Lane Miles *	Surface Type
0904	PUBLIC	4/16/2011	950	0.02	AS
Culverts	Drop Inlets	Gates	Curb & Gutter	Curb	PCR
0	0	0	NO CURB AND GUTTER	NO CURB	POOR/45

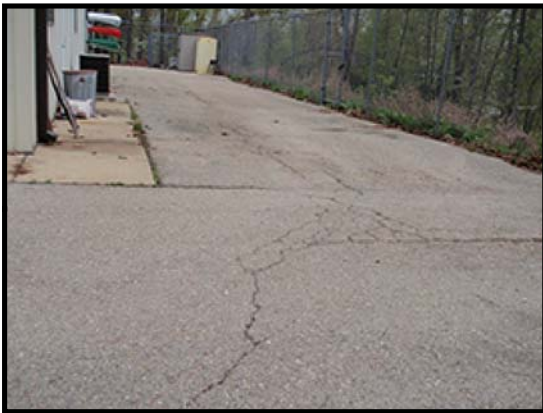
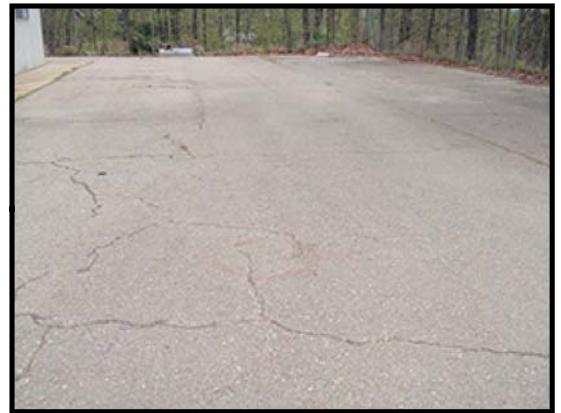
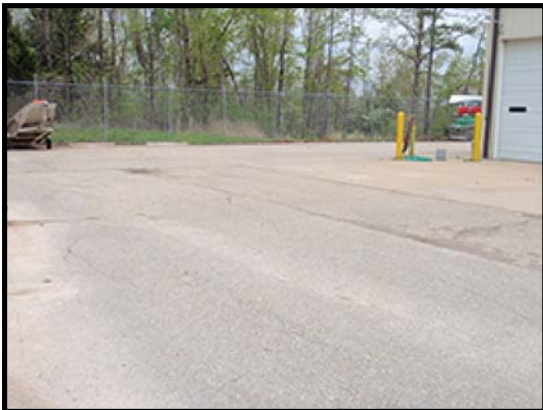
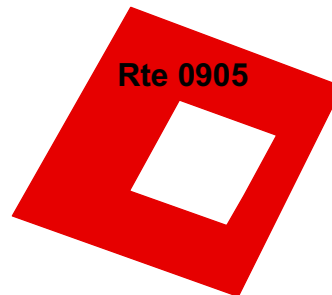
Route Number	Public / NonPublic	Date Visited	Area (sq ft)	Lane Miles *	Surface Type
0905	NONPUBLIC	4/16/2011	13,726	0.24	AS
Culverts	Drop Inlets	Gates	Curb & Gutter	Curb	PCR
0	0	1	NO CURB AND GUTTER	NO CURB	FAIR/73

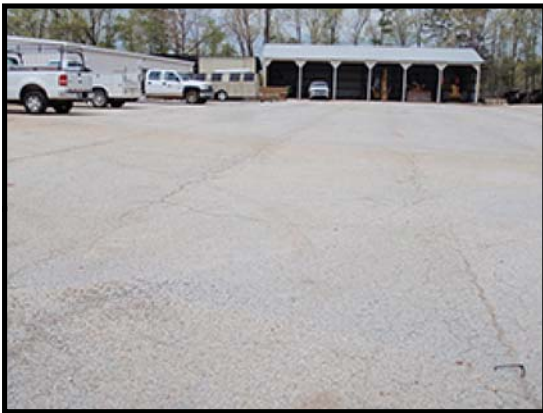
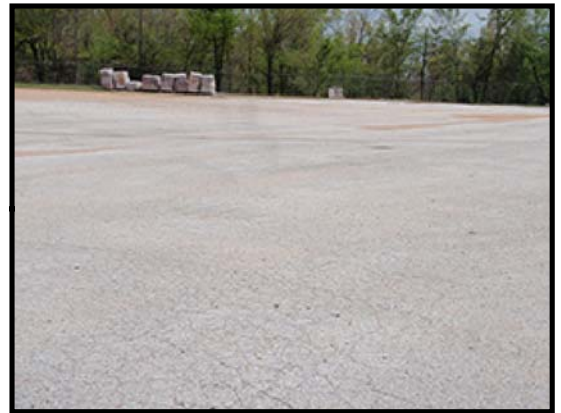
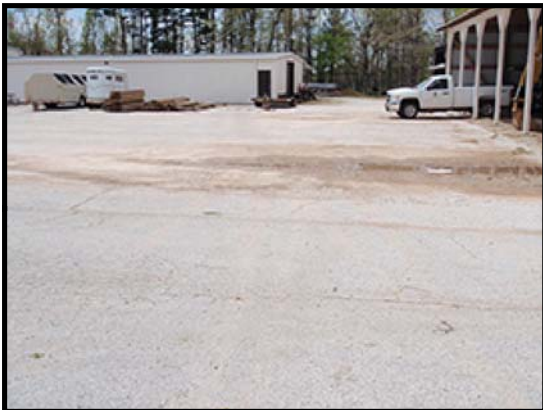
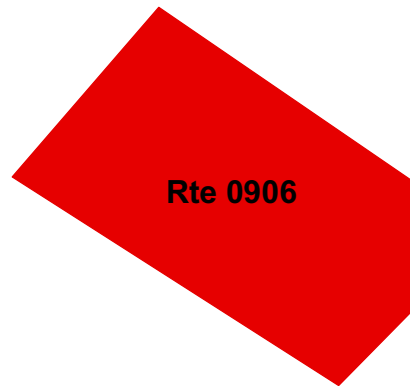
Route 0906

Route Number	Public / NonPublic	Date Visited	Area (sq ft)	Lane Miles *	Surface Type
0906	NONPUBLIC	4/16/2011	34,836	0.60	AS
Culverts	Drop Inlets	Gates	Curb & Gutter	Curb	PCR
0	1	0	NO CURB AND GUTTER	NO CURB	POOR/45

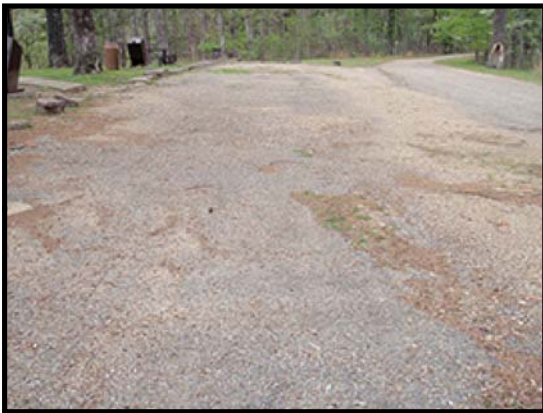
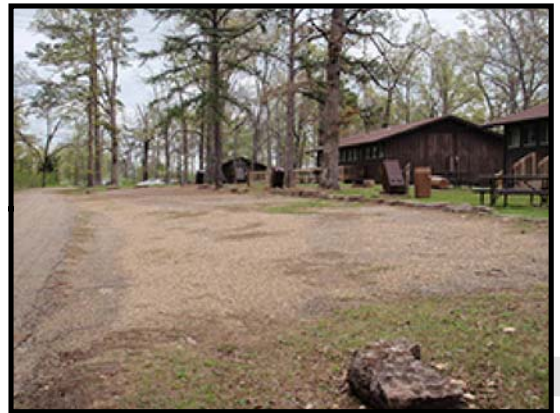
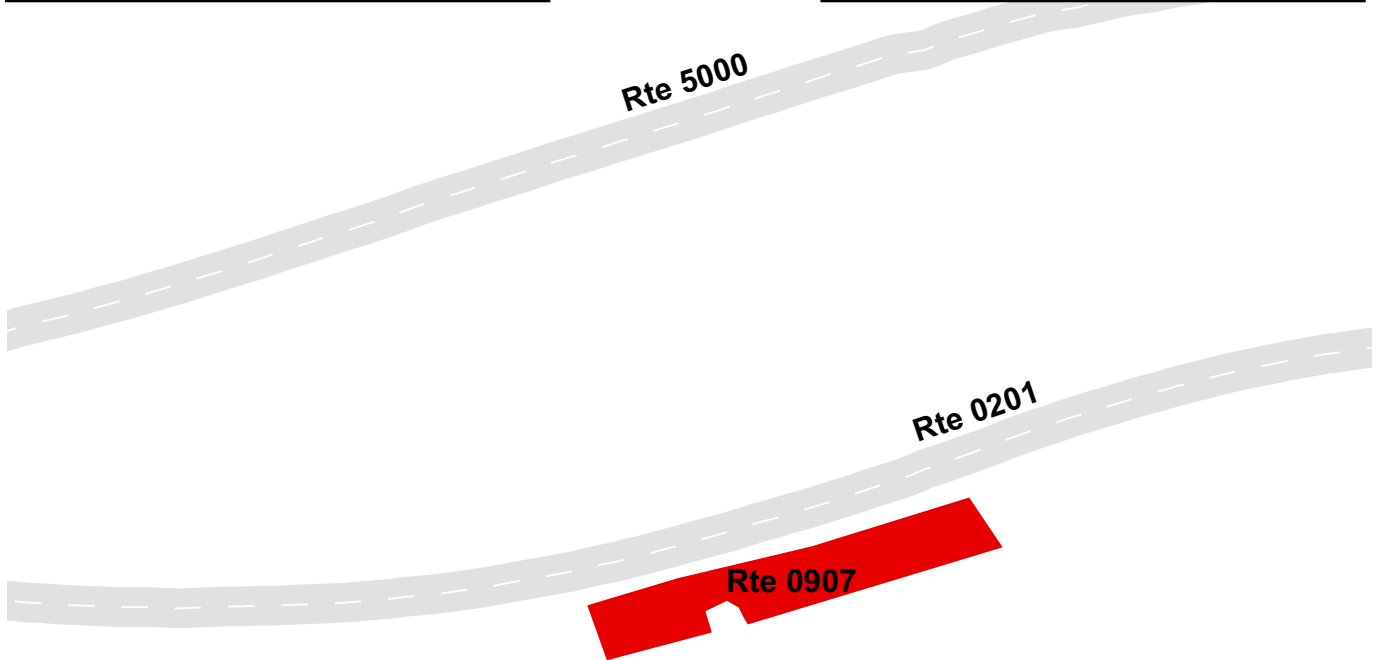
Route 0907

Route Number	Public / NonPublic	Date Visited	Area (sq ft)	Lane Miles *	Surface Type
0907	PUBLIC	4/16/2011	2,973	0.05	AS
Culverts	Drop Inlets	Gates	Curb & Gutter	Curb	PCR
0	0	0	NO CURB AND GUTTER	NO CURB	POOR/45

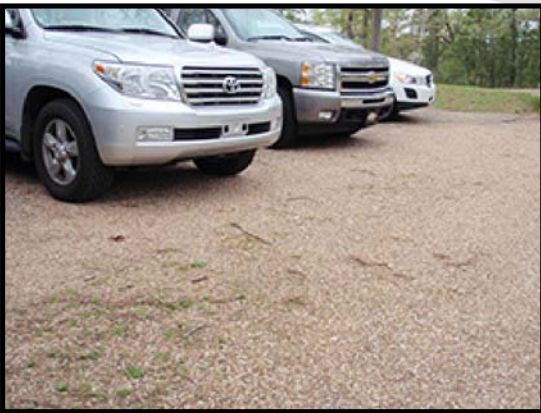
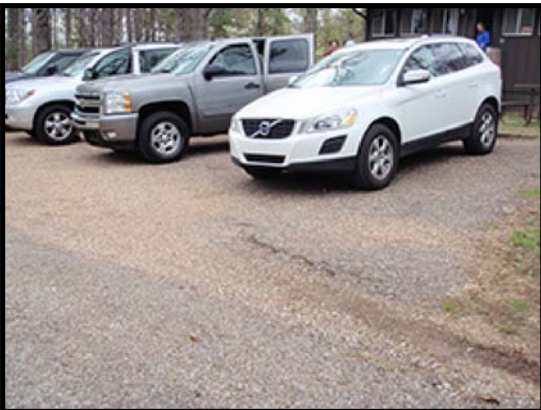
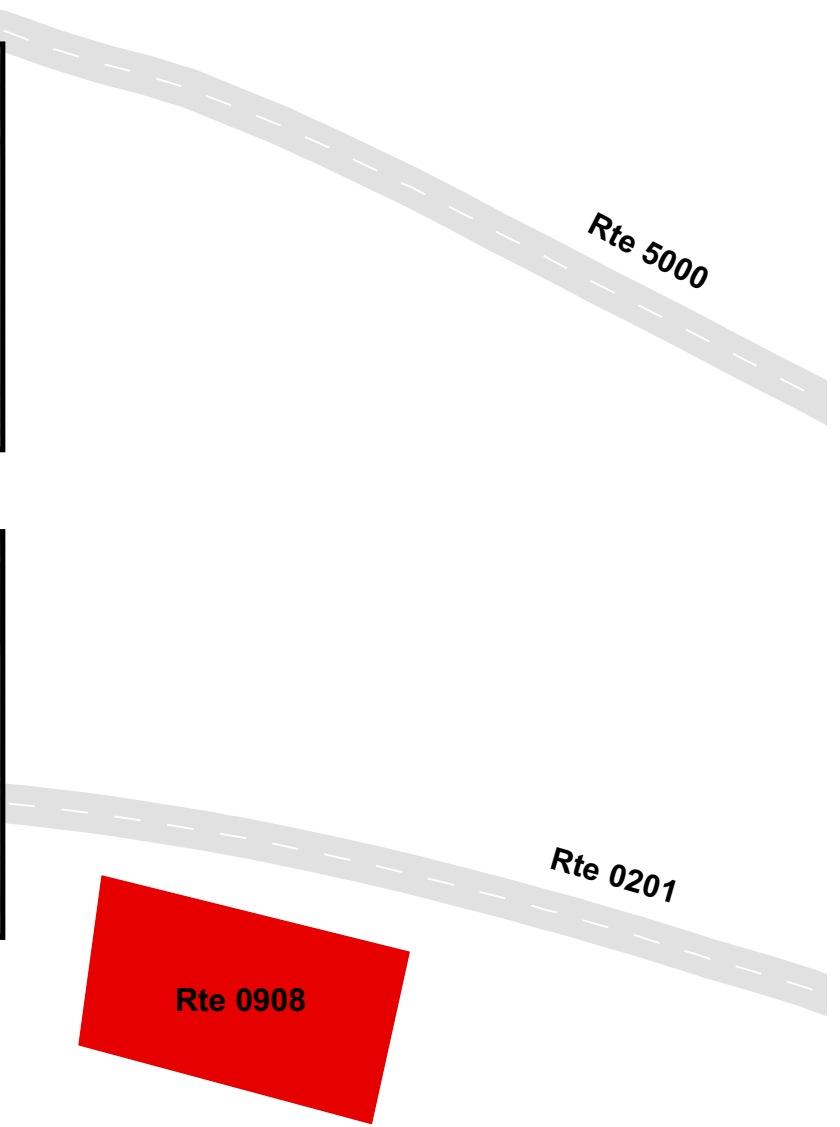
Route 0908

Route Number	Public / NonPublic	Date Visited	Area (sq ft)	Lane Miles *	Surface Type
0908	PUBLIC	4/16/2011	1,592	0.03	AS
Culverts	Drop Inlets	Gates	Curb & Gutter	Curb	PCR
0	0	0	NO CURB AND GUTTER	NO CURB	POOR/45

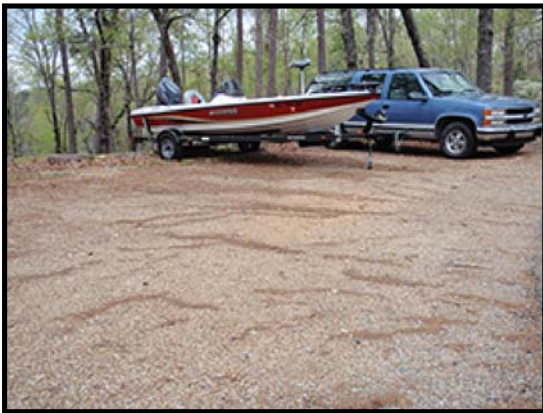
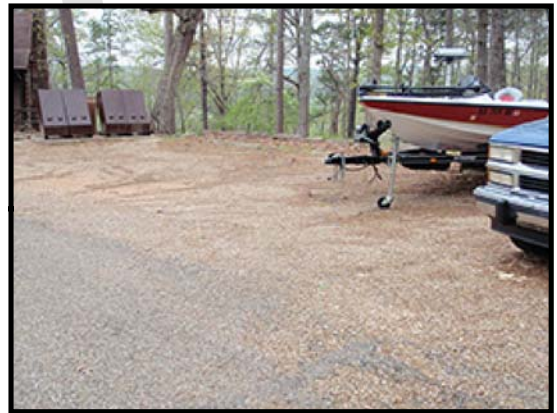
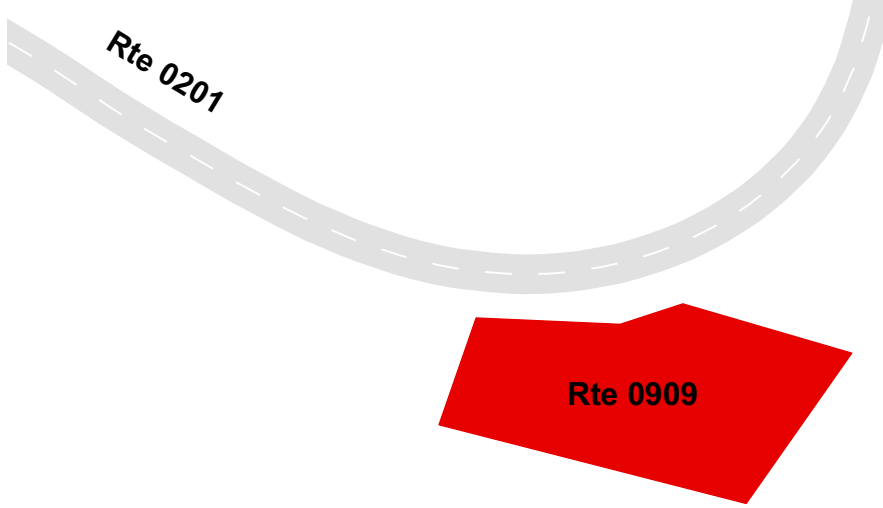
Route 0909

Route Number	Public / NonPublic	Date Visited	Area (sq ft)	Lane Miles *	Surface Type
0909	PUBLIC	4/16/2011	1,157	0.02	AS
Culverts	Drop Inlets	Gates	Curb & Gutter	Curb	PCR
0	0	0	NO CURB AND GUTTER	NO CURB	POOR/45

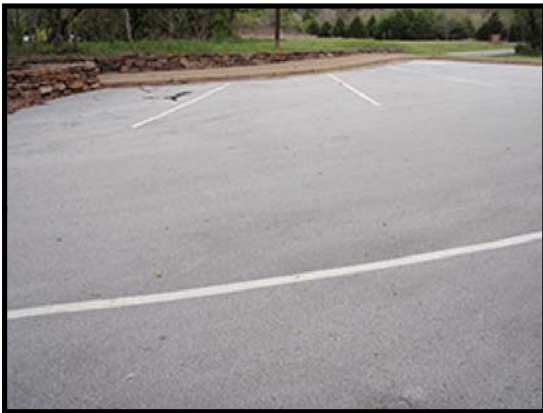
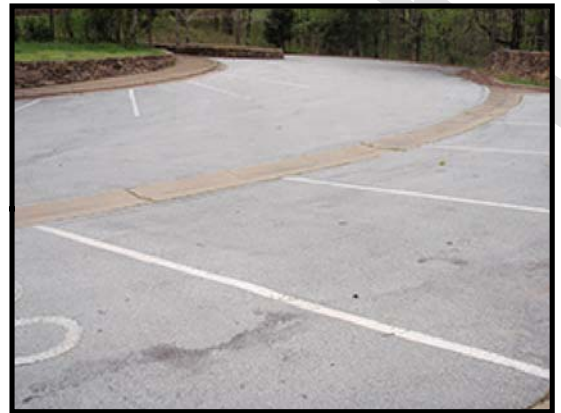
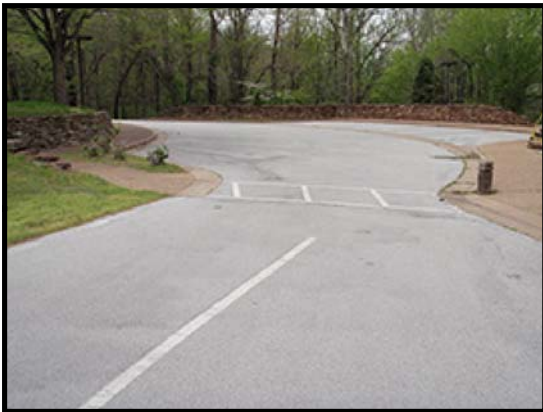
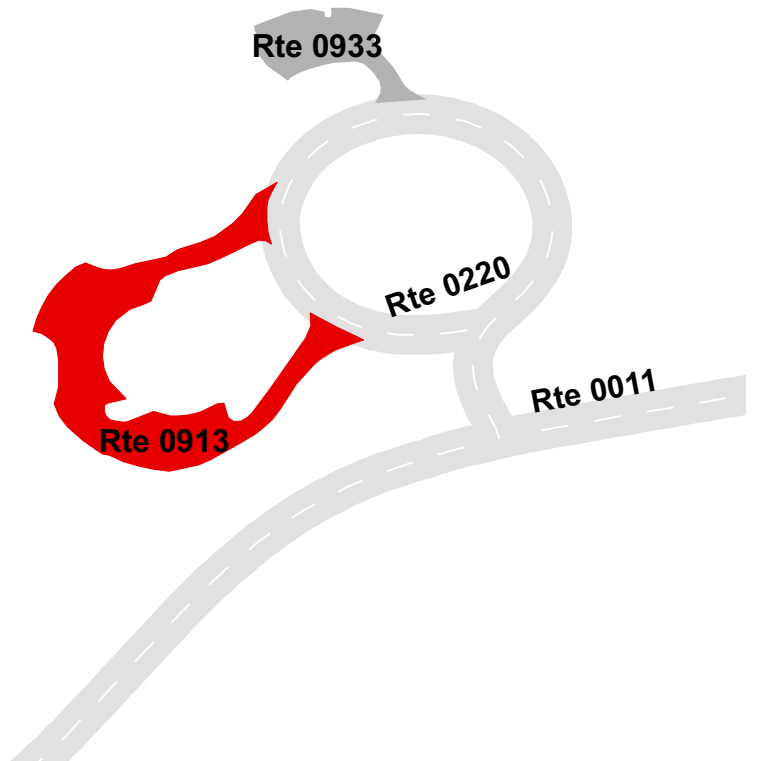
Route 0913

Route Number	Public / NonPublic	Date Visited	Area (sq ft)	Lane Miles *	Surface Type
0913	PUBLIC	4/15/2011	14,428	0.25	AS
Culverts	Drop Inlets	Gates	Curb & Gutter	Curb	PCR
0	2	0	CONCRETE CURB AND GUTTER	NO CURB	GOOD/90

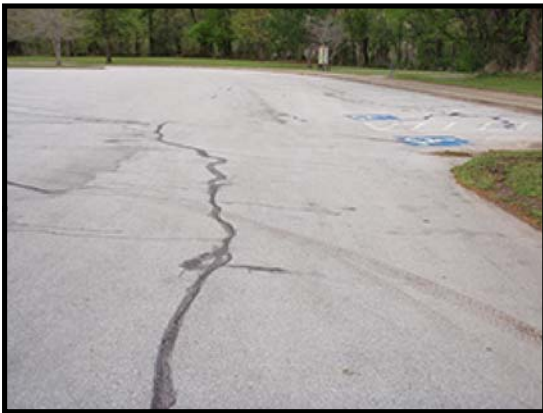
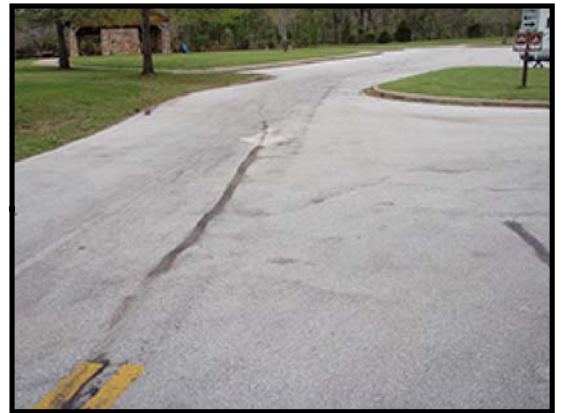
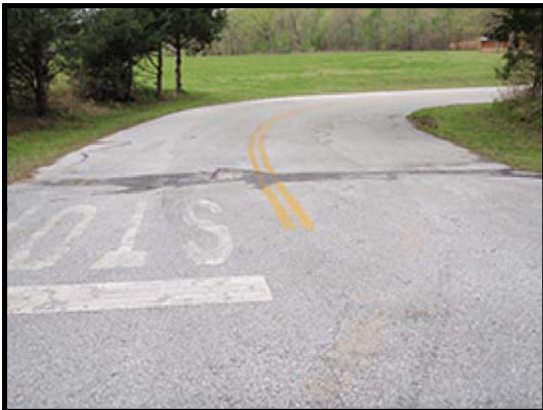
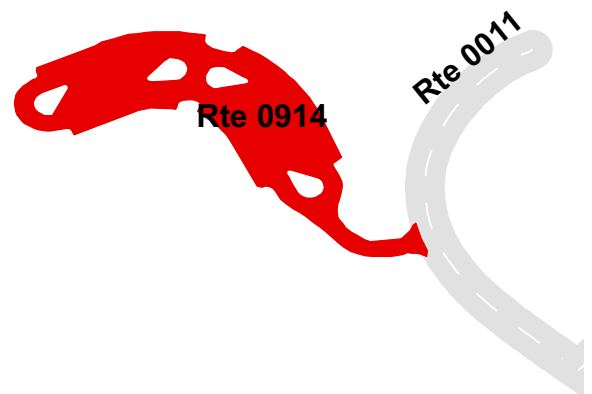
Route 0914

Route Number	Public / NonPublic	Date Visited	Area (sq ft)	Lane Miles *	Surface Type
0914	PUBLIC	4/15/2011	59,243	1.02	AS
Culverts	Drop Inlets	Gates	Curb & Gutter	Curb	PCR
0	0	0	CONCRETE CURB AND GUTTER	NO CURB	FAIR/73

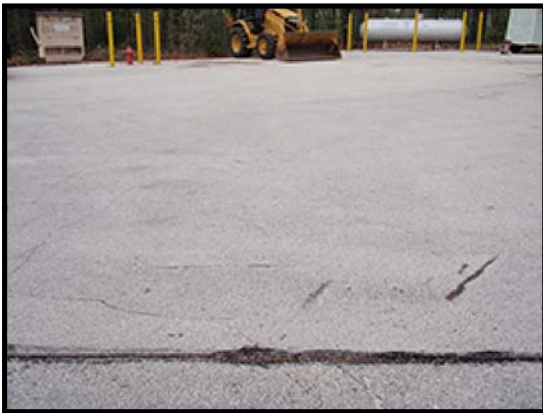
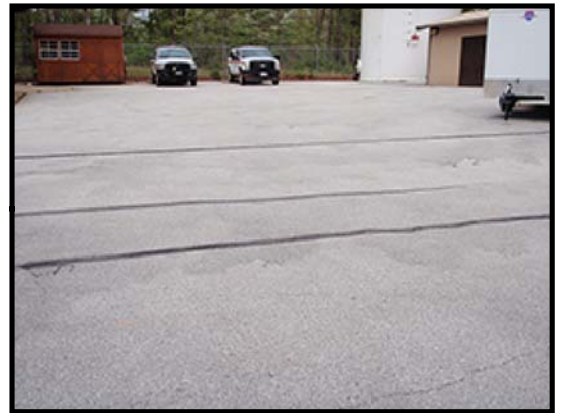
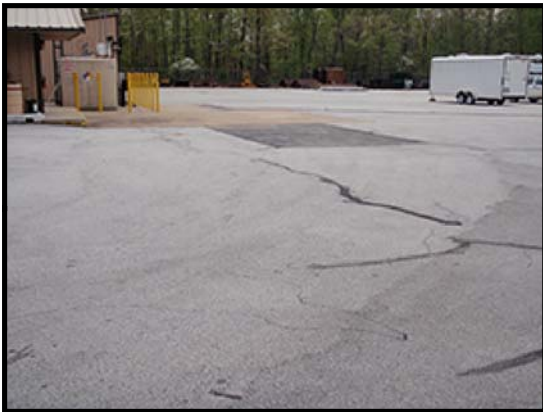
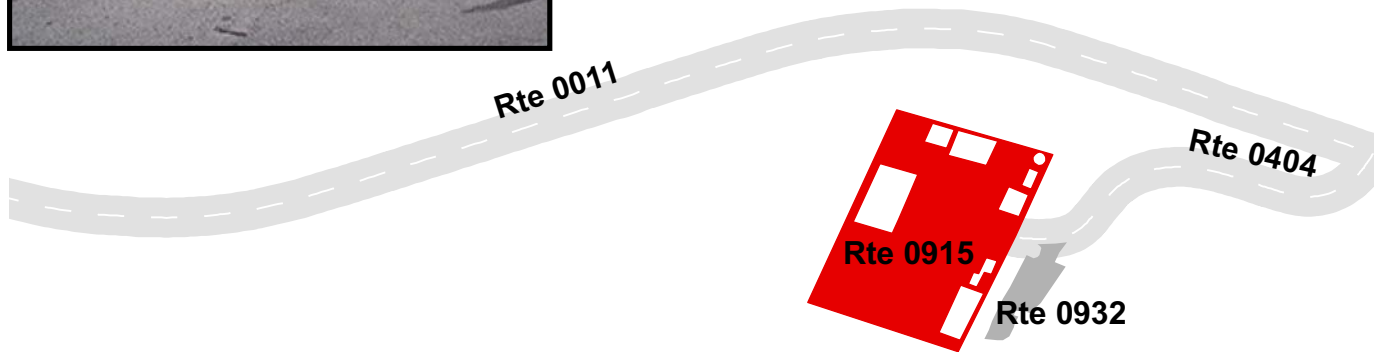
Route 0915

Route Number	Public / NonPublic	Date Visited	Area (sq ft)	Lane Miles *	Surface Type
0915	NONPUBLIC	4/15/2011	76,282	1.31	AS
Culverts	Drop Inlets	Gates	Curb & Gutter	Curb	PCR
0	1	2	NO CURB AND GUTTER	NO CURB	FAIR/73

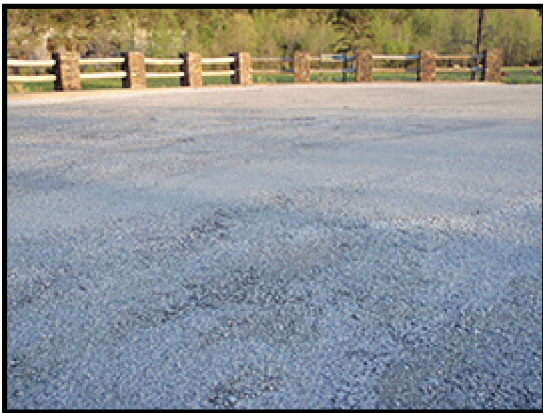
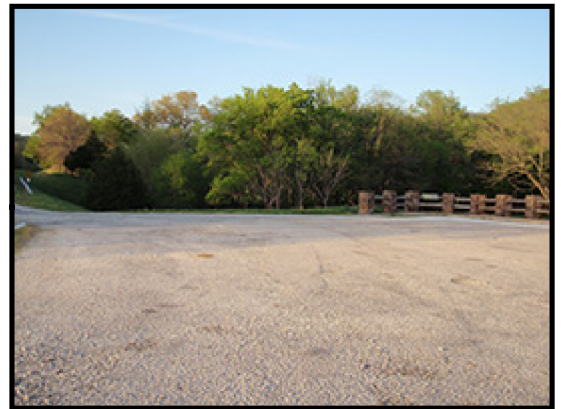
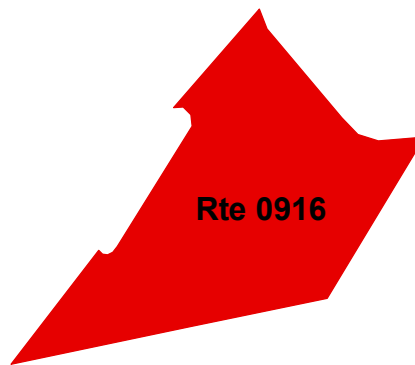
Route 0916

Route Number	Public / NonPublic	Date Visited	Area (sq ft)	Lane Miles *	Surface Type
0916	PUBLIC	4/16/2011	8,061	0.14	AS
Culverts	Drop Inlets	Gates	Curb & Gutter	Curb	PCR
0	0	0	NO CURB AND GUTTER	CONCRETE CURB	POOR/45

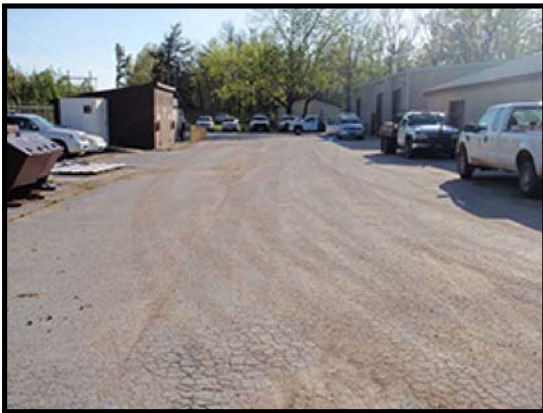
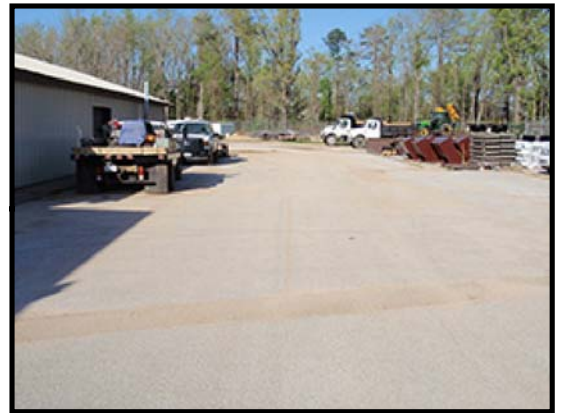
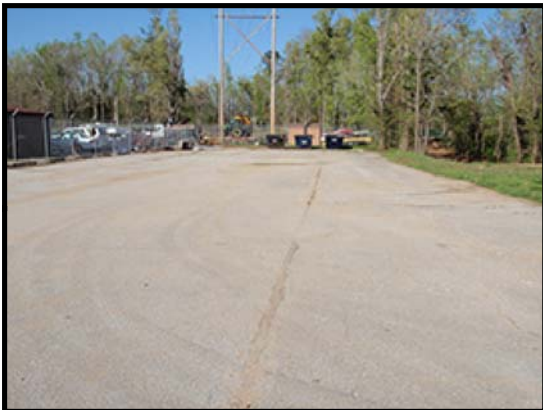
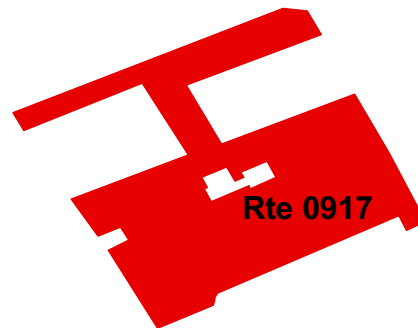
Route 0917

Route Number	Public / NonPublic	Date Visited	Area (sq ft)	Lane Miles *	Surface Type
0917	NONPUBLIC	4/16/2011	35,878	0.62	AS
Culverts	Drop Inlets	Gates	Curb & Gutter	Curb	PCR
0	0	1	NO CURB AND GUTTER	NO CURB	FAIR/73

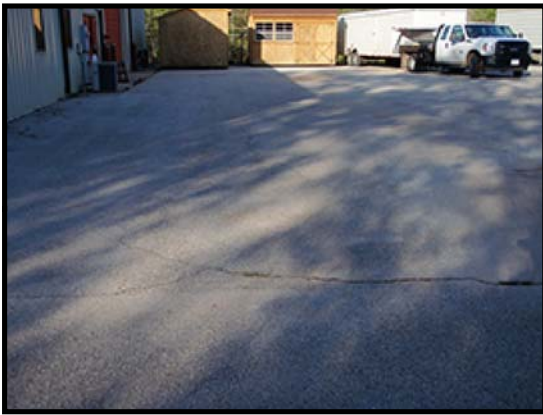
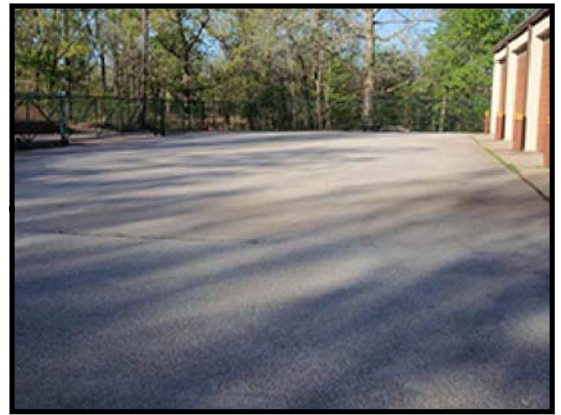
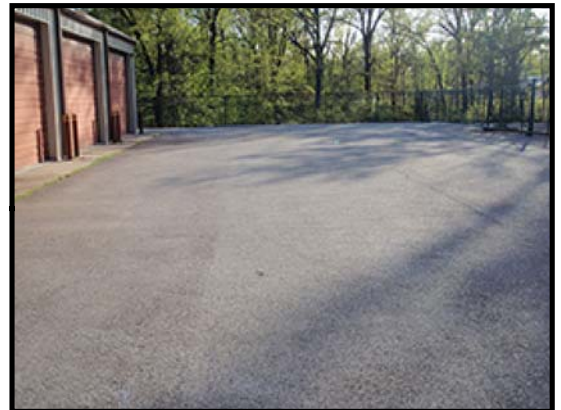
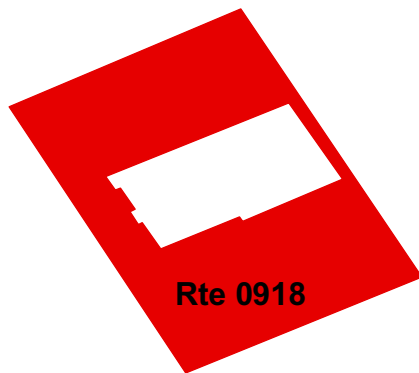
Route 0918

Route Number	Public / NonPublic	Date Visited	Area (sq ft)	Lane Miles *	Surface Type
0918	NONPUBLIC	4/16/2011	18,474	0.32	AS
Culverts	Drop Inlets	Gates	Curb & Gutter	Curb	PCR
0	0	2	NO CURB AND GUTTER	NO CURB	FAIR/73

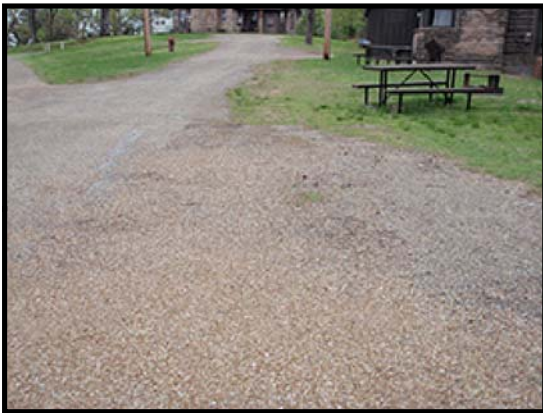
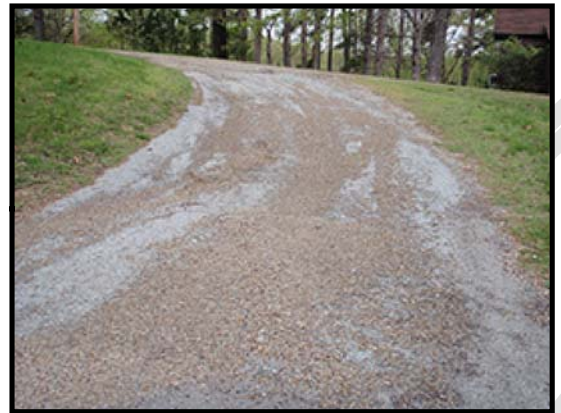
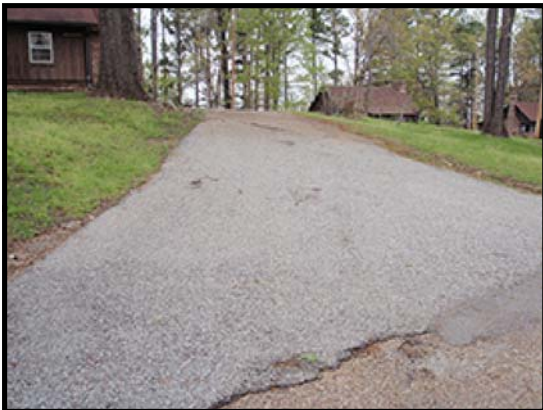
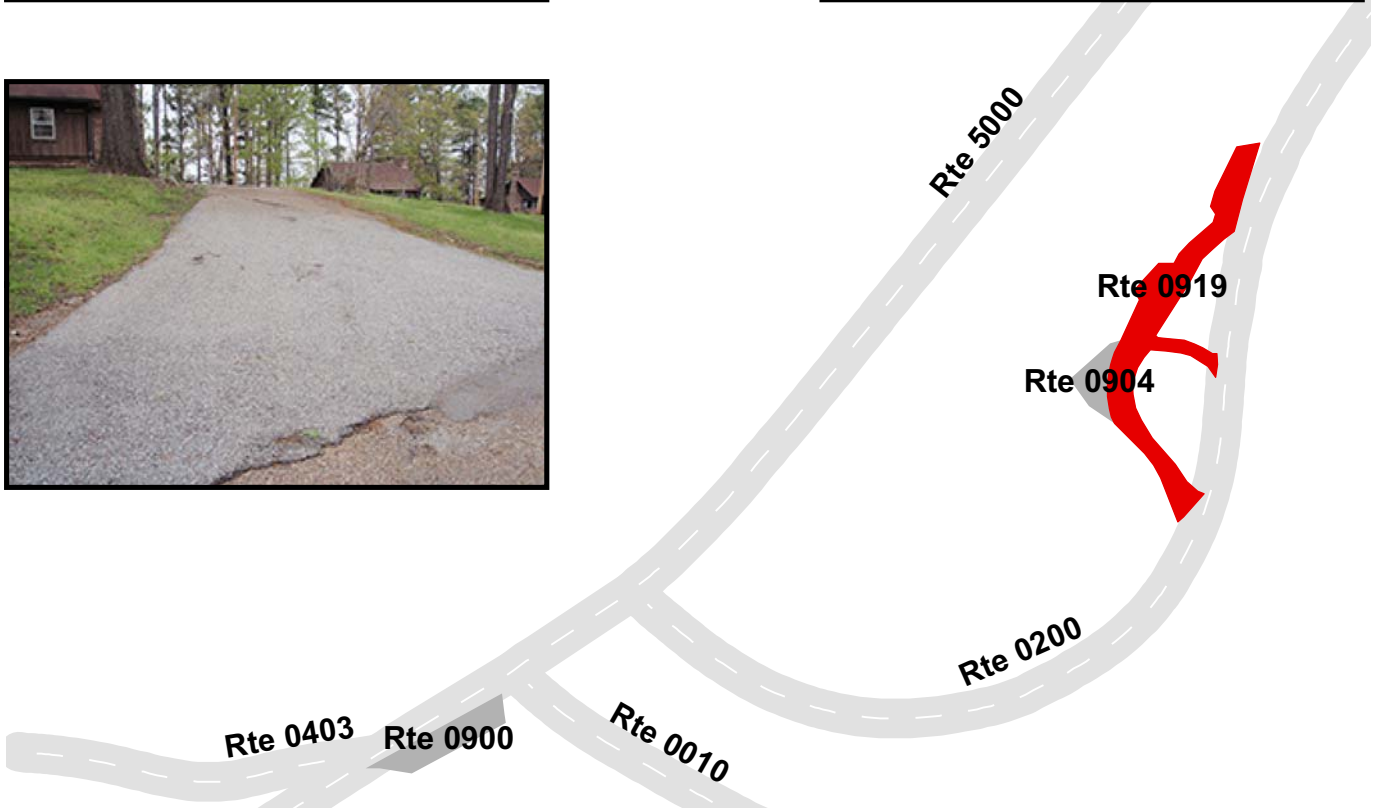
Route Number	Public / NonPublic	Date Visited	Area (sq ft)	Lane Miles *	Surface Type
0919	PUBLIC	4/16/2011	6,503	0.11	AS
Culverts	Drop Inlets	Gates	Curb & Gutter	Curb	PCR
0	0	0	NO CURB AND GUTTER	NO CURB	POOR/45

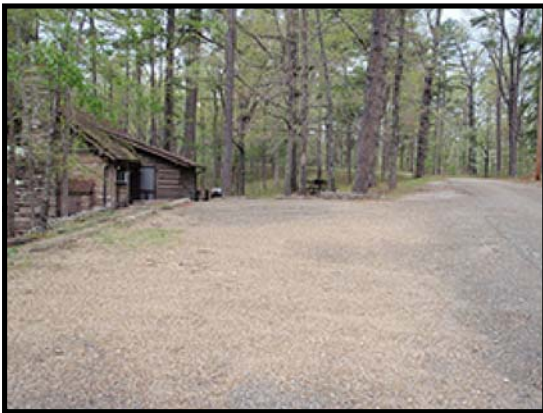
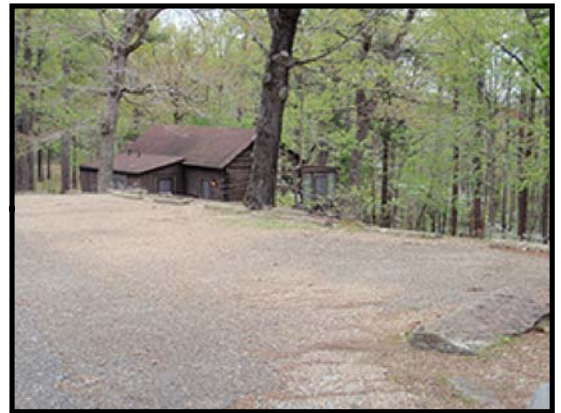
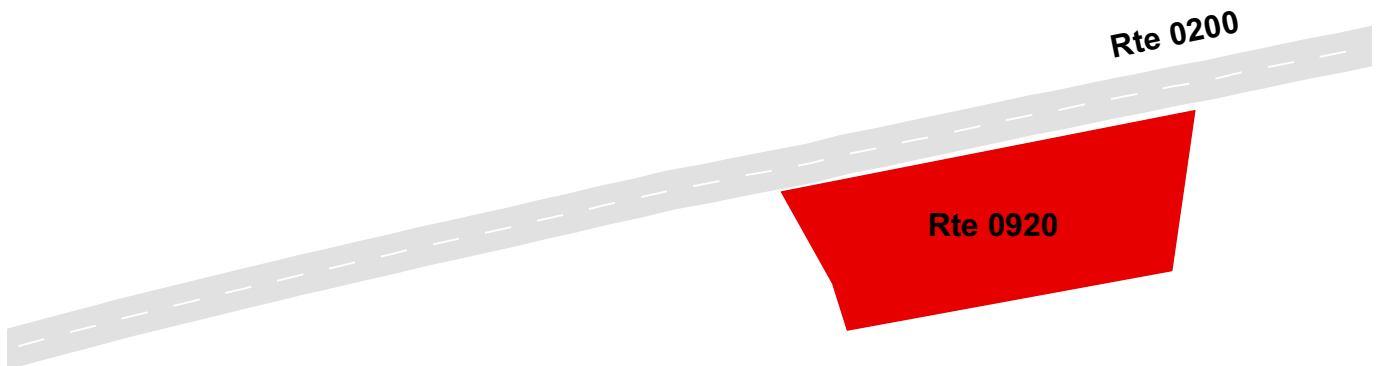
Route 0920

RUSTIC CABINS 1, 2 AND 3 PARKING AREA
ADJACENT TO ROUTE 0200 (RUSTIC CABIN LOOP)

Route Number	Public / NonPublic	Date Visited	Area (sq ft)	Lane Miles *	Surface Type
0920	PUBLIC	4/16/2011	1,762	0.03	AS
Culverts	Drop Inlets	Gates	Curb & Gutter	Curb	PCR
0	0	0	NO CURB AND GUTTER	NO CURB	POOR/45
