Federal Lands Highway Road Inventory Program

Road Inventory and Condition Assessment

Buffalo National River BUFF - 7150

Cycle 5 Report

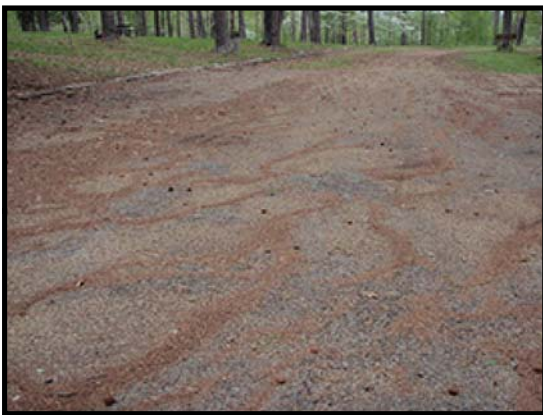
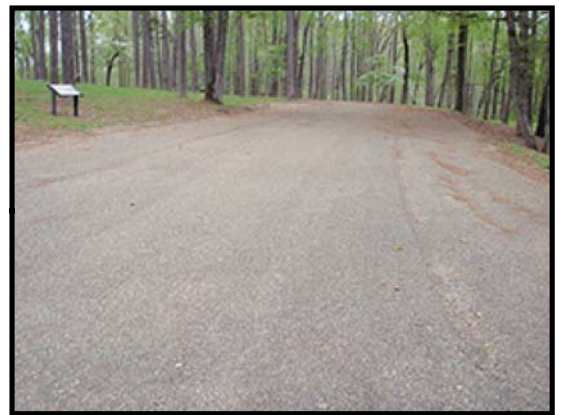
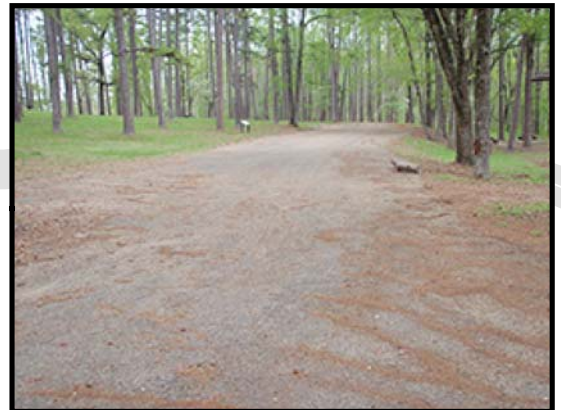
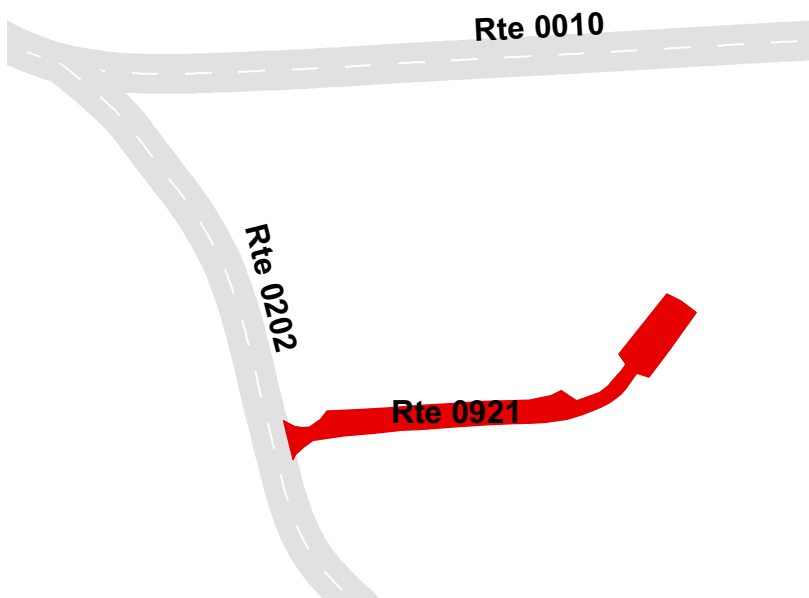
Route 0921

Route Number	Public / NonPublic	Date Visited	Area (sq ft)	Lane Miles *	Surface Type
0921	PUBLIC	4/16/2011	13,384	0.23	AS
Culverts	Drop Inlets	Gates	Curb & Gutter	Curb	PCR
0	0	0	NO CURB AND GUTTER	STONE CURB	POOR/45

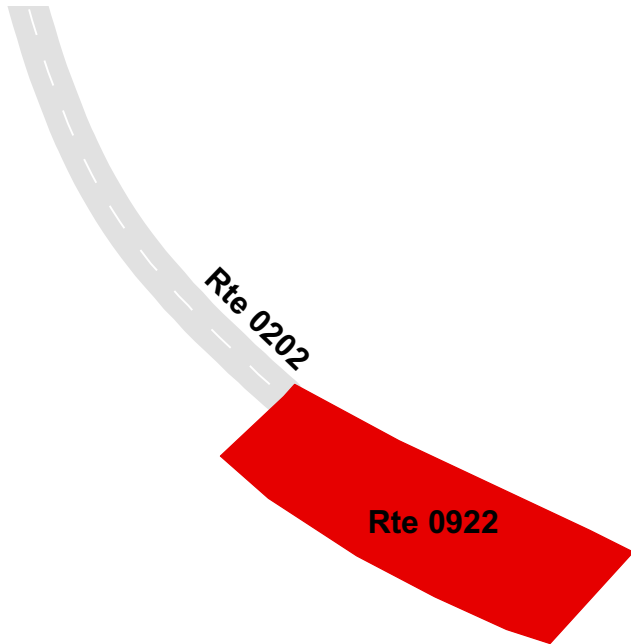
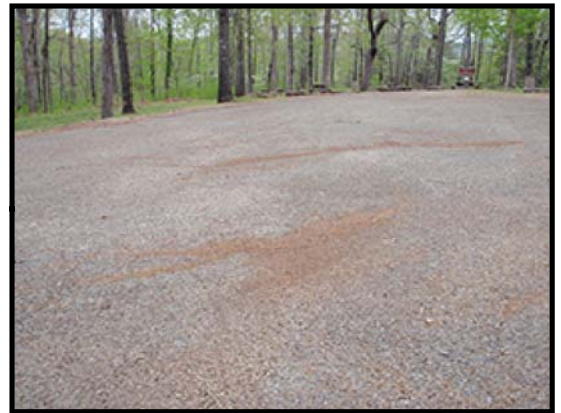
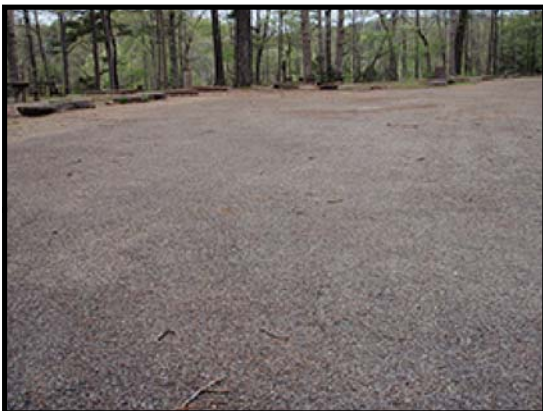
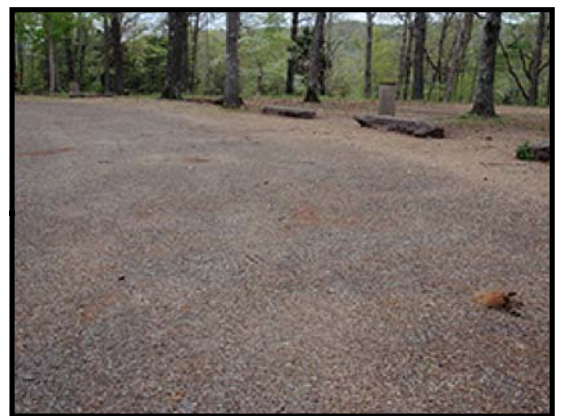
Route 0922

Route Number	Public / NonPublic	Date Visited	Area (sq ft)	Lane Miles *	Surface Type
0922	PUBLIC	4/16/2011	5,316	0.09	AS
Culverts	Drop Inlets	Gates	Curb & Gutter	Curb	PCR
0	0	0	NO CURB AND GUTTER	NO CURB	POOR/45

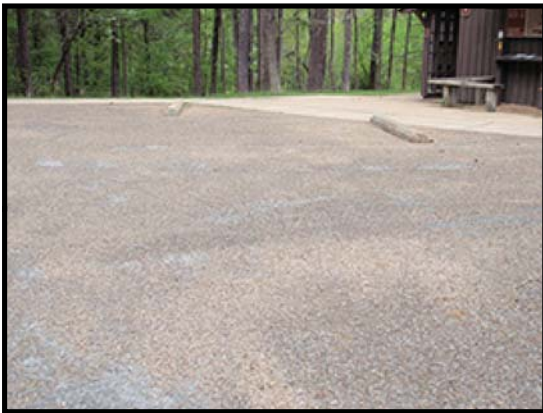
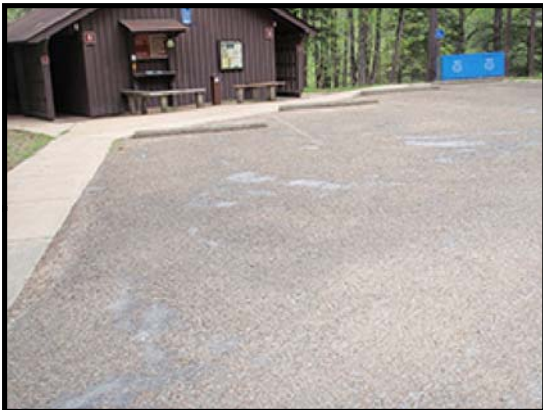
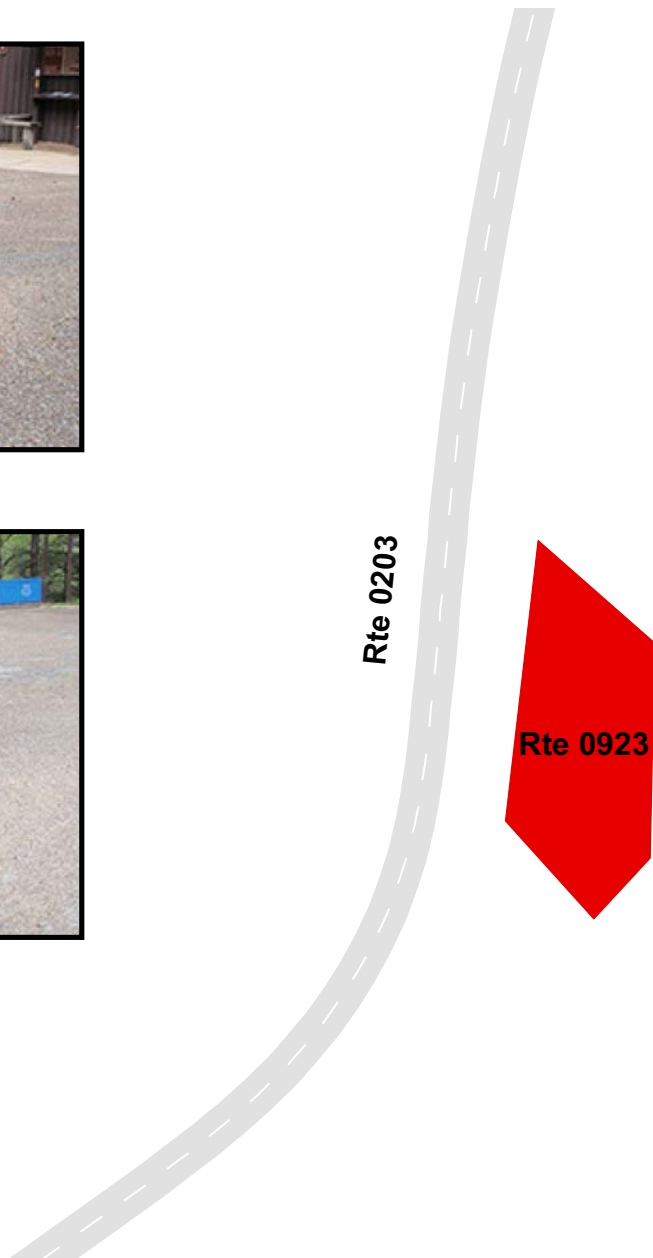
Route 0923

Route Number	Public / NonPublic	Date Visited	Area (sq ft)	Lane Miles *	Surface Type
0923	PUBLIC	4/16/2011	508	0.01	AS
Culverts	Drop Inlets	Gates	Curb & Gutter	Curb	PCR
0	0	0	NO CURB AND GUTTER	NO CURB	POOR/45

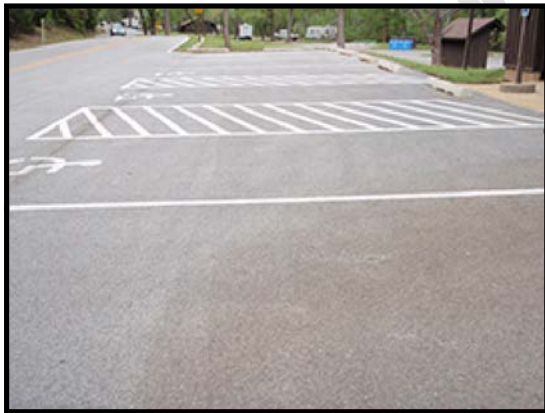
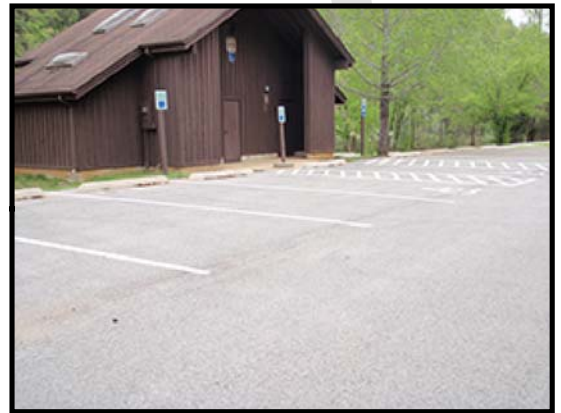
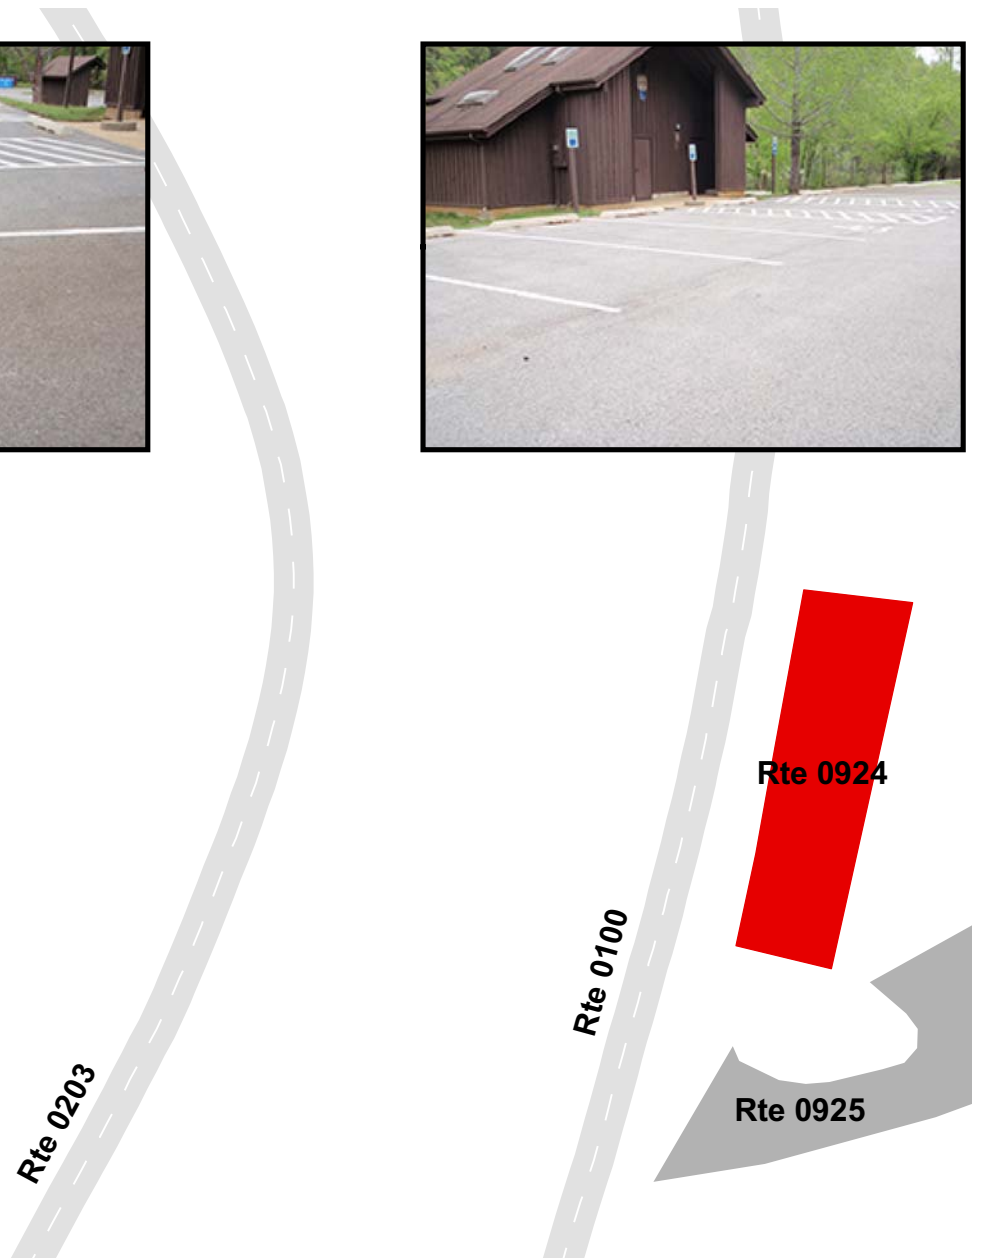
Route 0924

Route Number	Public / NonPublic	Date Visited	Area (sq ft)	Lane Miles *	Surface Type
0924	PUBLIC	4/16/2011	2,285	0.04	AS
Culverts	Drop Inlets	Gates	Curb & Gutter	Curb	PCR
0	0	0	NO CURB AND GUTTER	NO CURB	FAIR/73

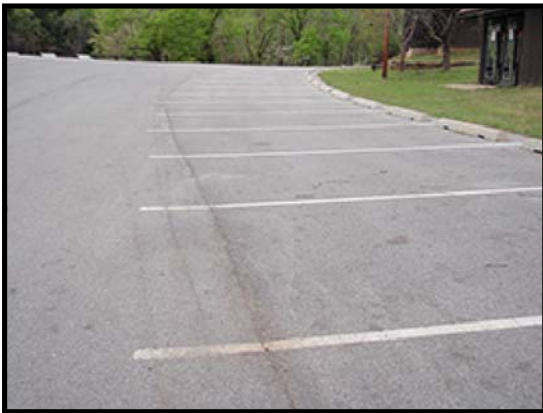
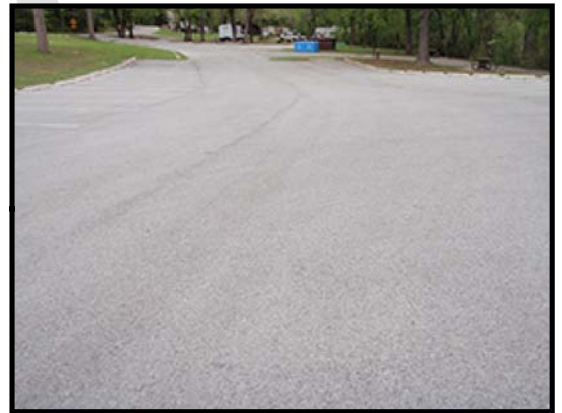
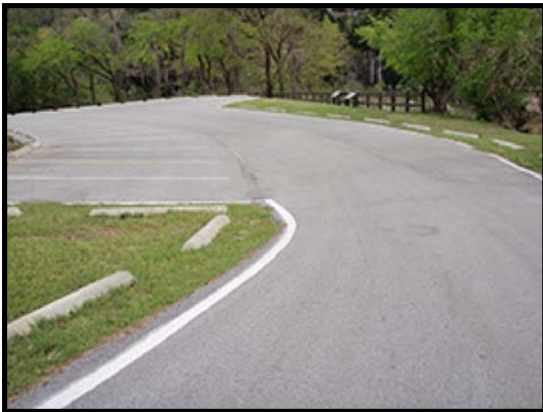
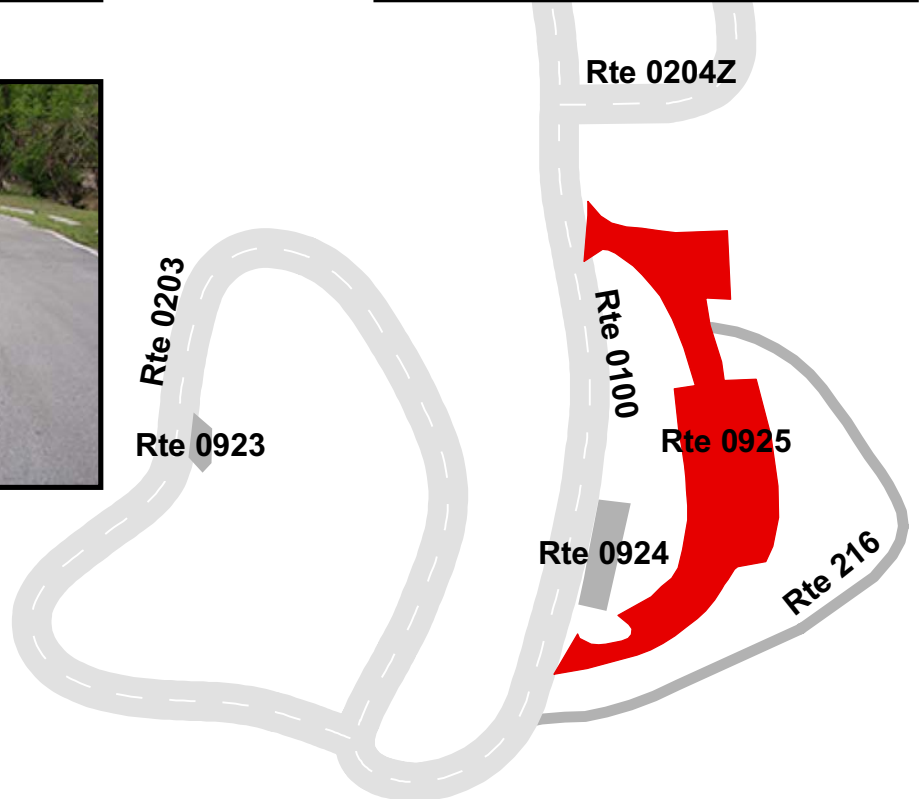
Route 0925

Route Number	Public / NonPublic	Date Visited	Area (sq ft)	Lane Miles *	Surface Type
0925	PUBLIC	4/16/2011	23,418	0.40	AS
Culverts	Drop Inlets	Gates	Curb & Gutter	Curb	PCR
0	0	0	NO CURB AND GUTTER	NO CURB	FAIR/73

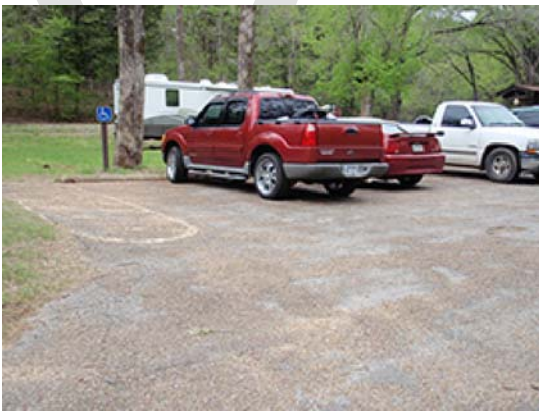
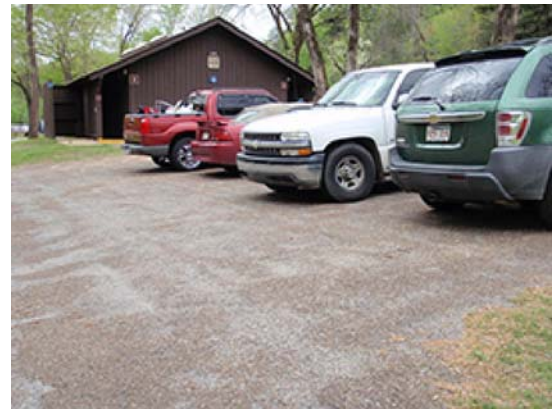
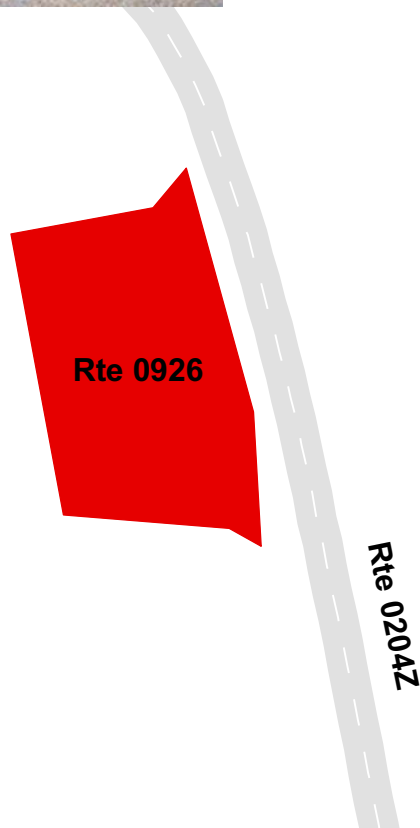
Route 0926

Route Number	Public / NonPublic	Date Visited	Area (sq ft)	Lane Miles *	Surface Type
0926	PUBLIC	4/16/2011	1,515	0.03	AS
Culverts	Drop Inlets	Gates	Curb & Gutter	Curb	PCR
0	0	0	NO CURB AND GUTTER	NO CURB	POOR/45

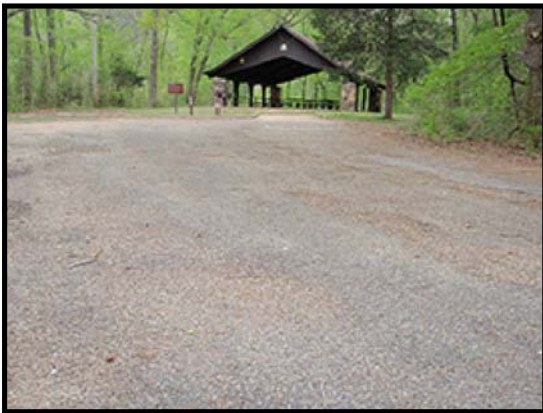
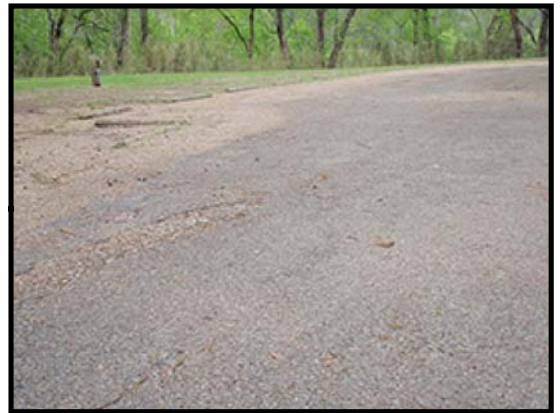
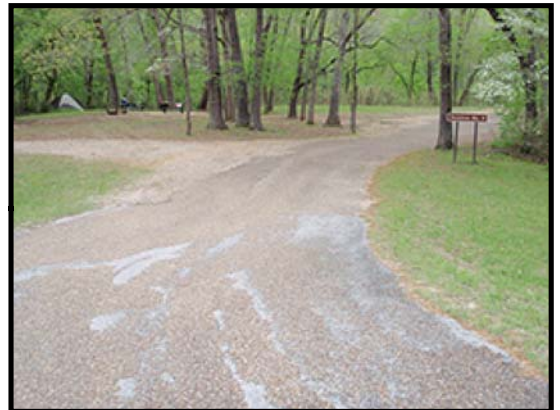
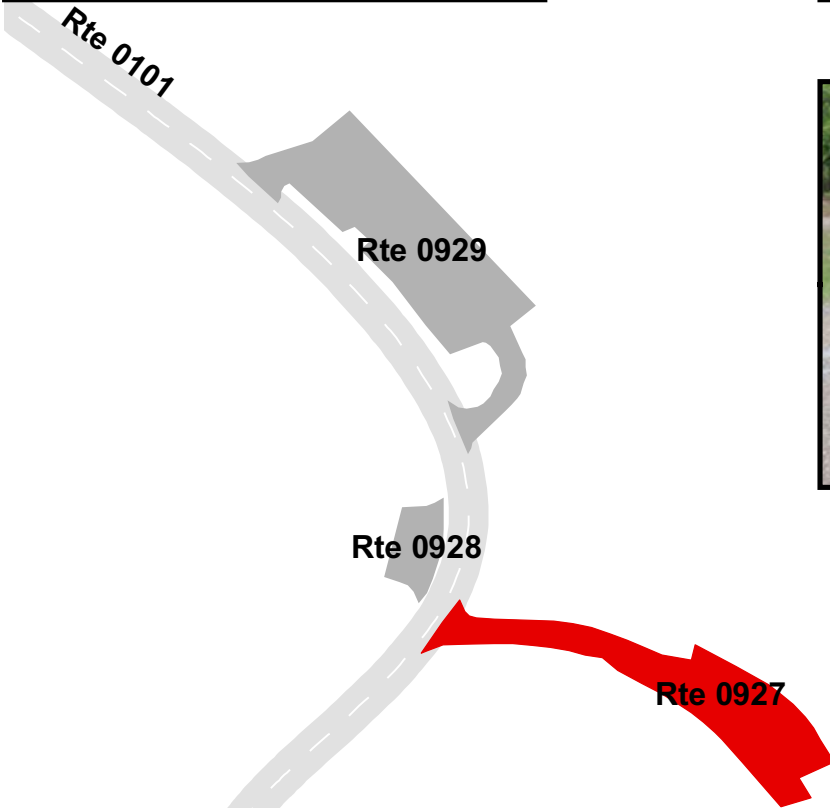
Route 0927

Route Number	Public / NonPublic	Date Visited	Area (sq ft)	Lane Miles *	Surface Type
0927	PUBLIC	4/16/2011	8,880	0.15	AS
Culverts	Drop Inlets	Gates	Curb & Gutter	Curb	PCR
0	0	0	NO CURB AND GUTTER	NO CURB	POOR/45

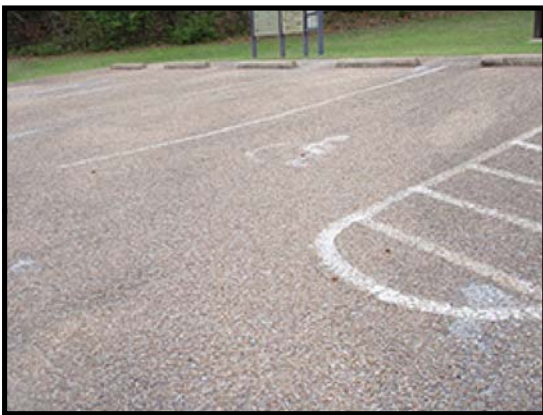
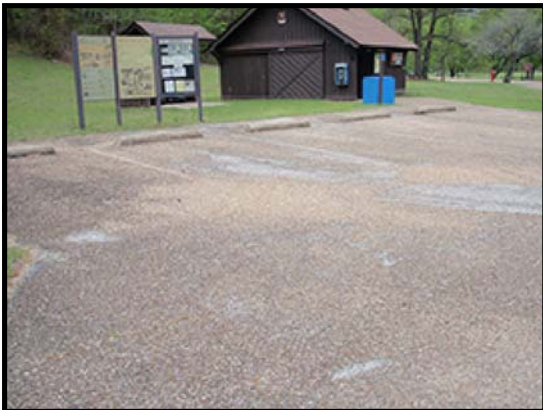
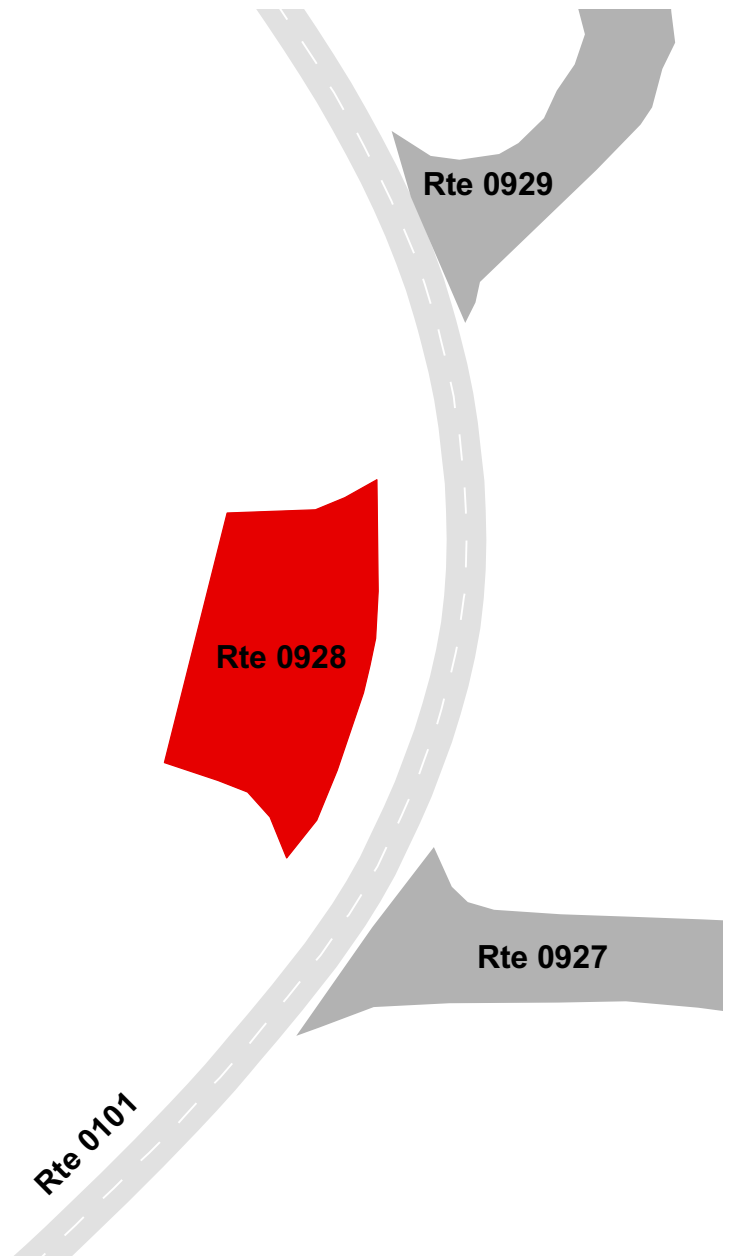
Route 0928

Route Number	Public / NonPublic	Date Visited	Area (sq ft)	Lane Miles *	Surface Type
0928	PUBLIC	4/16/2011	1,819	0.03	AS
Culverts	Drop Inlets	Gates	Curb & Gutter	Curb	PCR
0	0	0	NO CURB AND GUTTER	NO CURB	FAIR/73

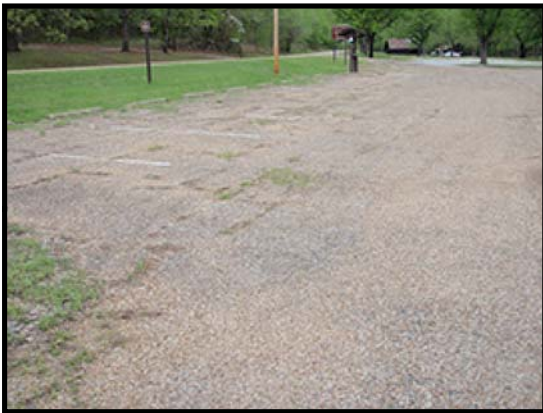
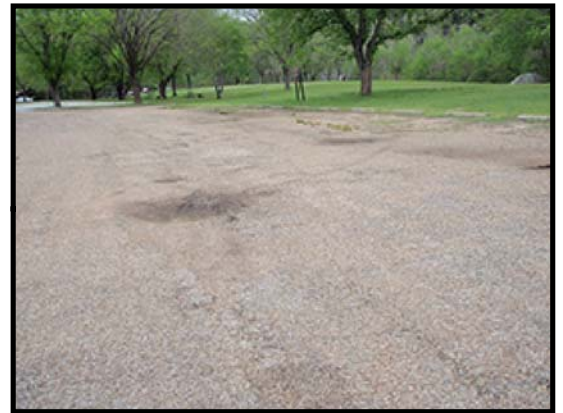
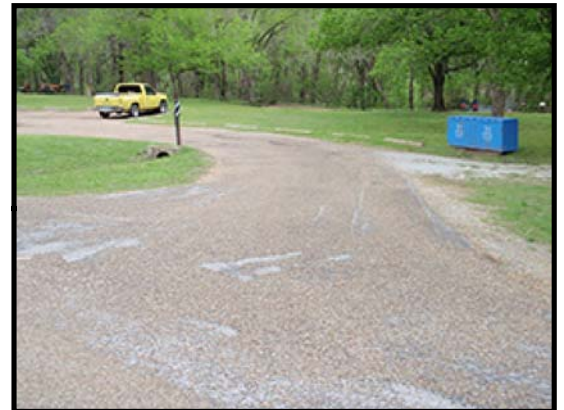
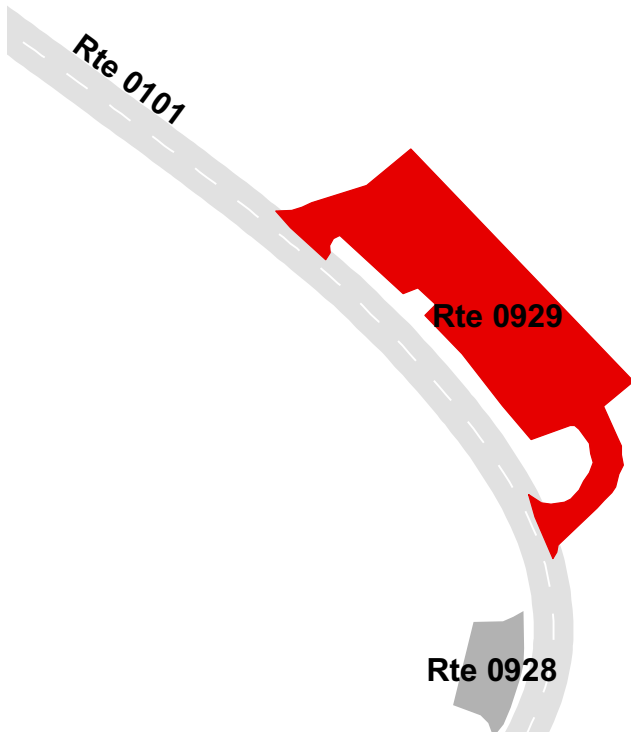
Route 0929

Route Number	Public / NonPublic	Date Visited	Area (sq ft)	Lane Miles *	Surface Type
0929	PUBLIC	4/16/2011	13,196	0.23	AS
Culverts	Drop Inlets	Gates	Curb & Gutter	Curb	PCR
0	0	0	NO CURB AND GUTTER	NO CURB	POOR/45

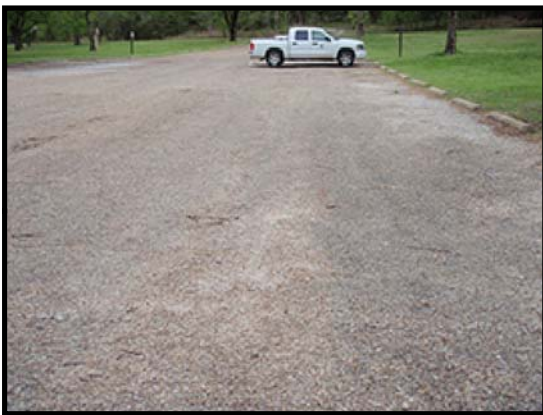
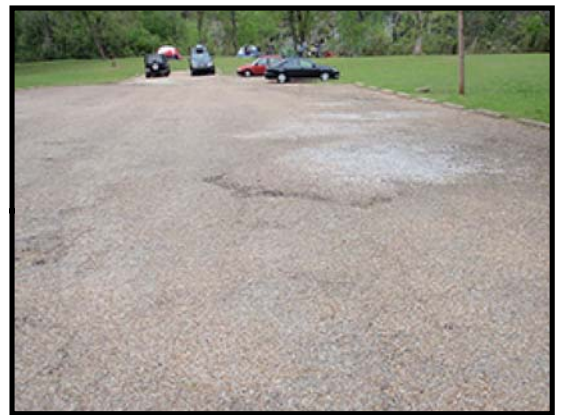
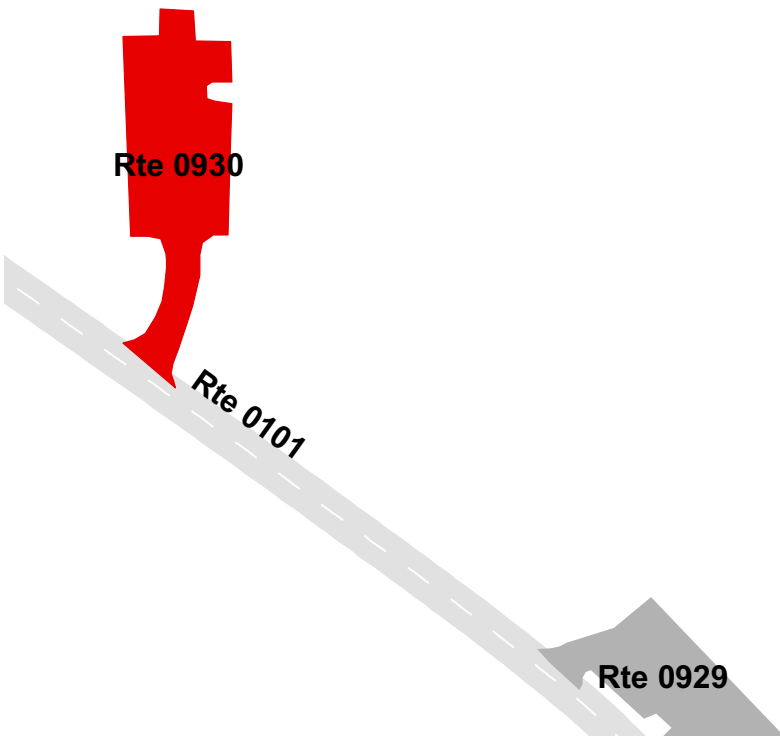
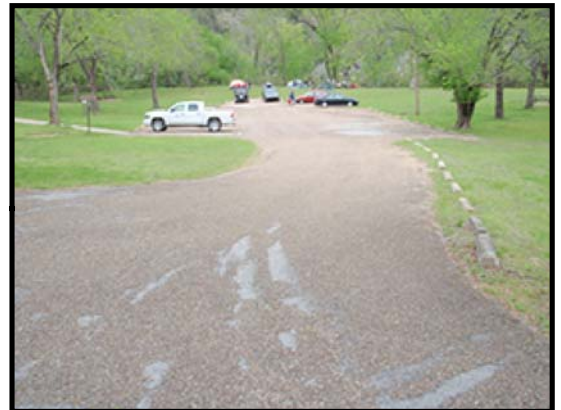
Route Number	Public / NonPublic	Date Visited	Area (sq ft)	Lane Miles *	Surface Type
0930	PUBLIC	4/16/2011	11,775	0.20	AS
Culverts	Drop Inlets	Gates	Curb & Gutter	Curb	PCR
1	0	0	NO CURB AND GUTTER	NO CURB	POOR/45

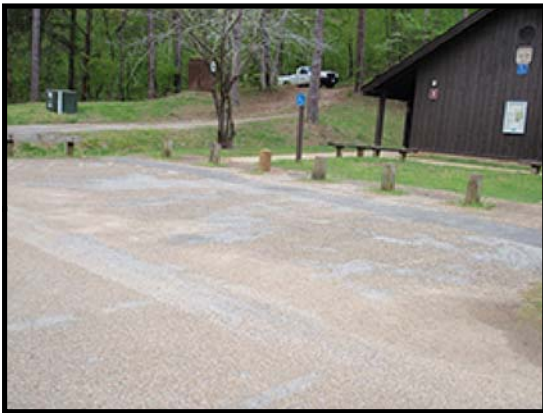
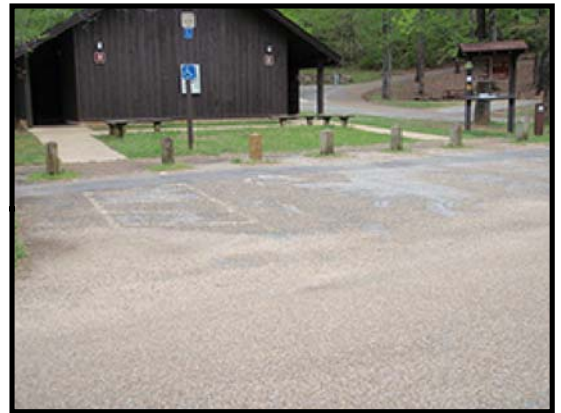
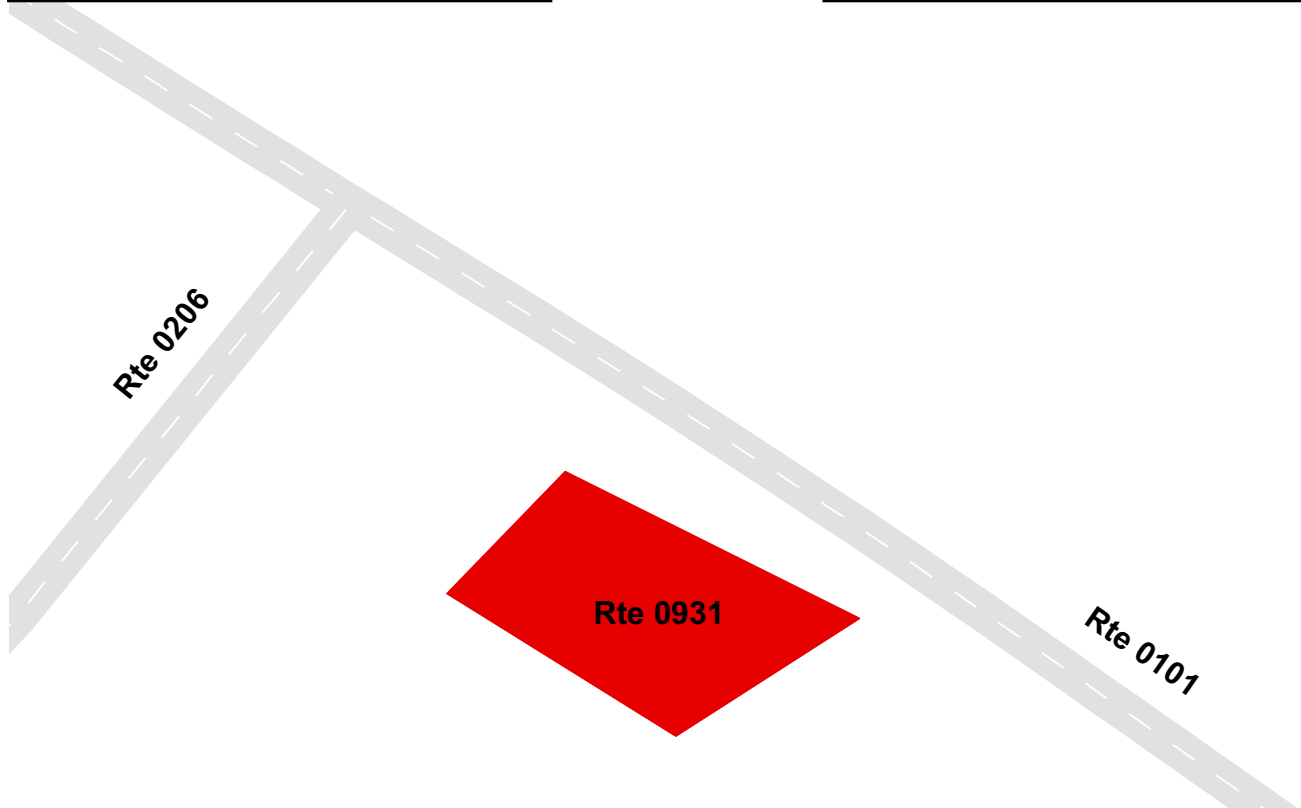
Route 0931

Route Number	Public / NonPublic	Date Visited	Area (sq ft)	Lane Miles *	Surface Type
0931	PUBLIC	4/16/2011	1,015	0.02	AS
Culverts	Drop Inlets	Gates	Curb & Gutter	Curb	PCR
0	0	0	NO CURB AND GUTTER	NO CURB	FAIR/73

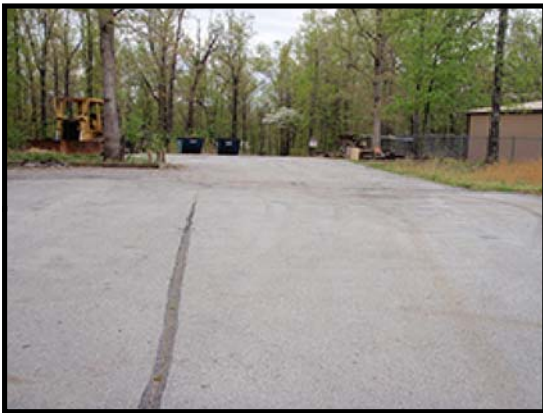
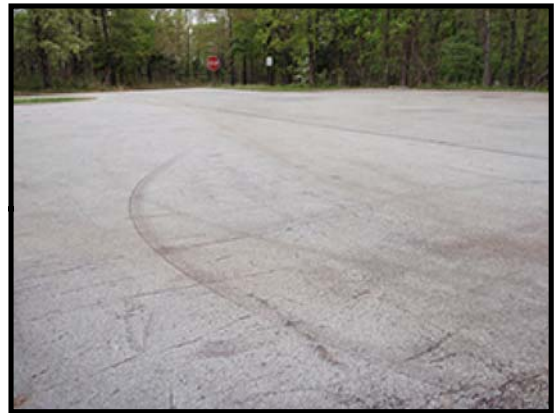
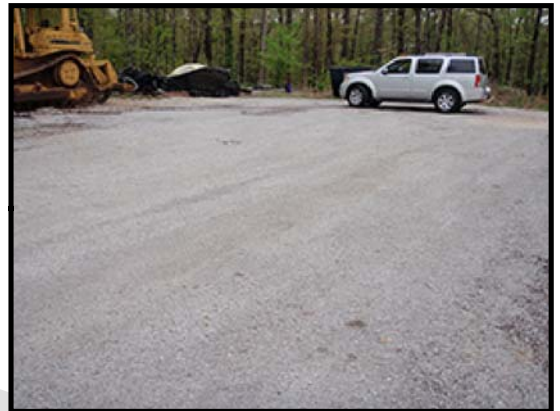
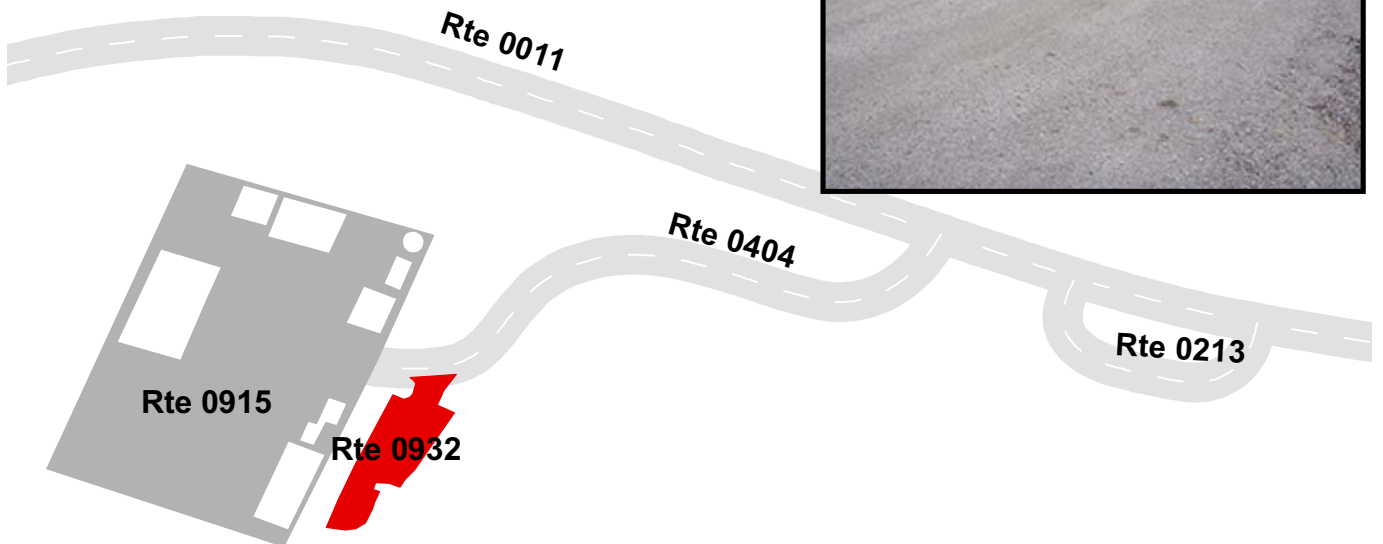
Route 0932

Route Number	Public / NonPublic	Date Visited	Area (sq ft)	Lane Miles *	Surface Type
0932	NONPUBLIC	4/15/2011	8,687	0.15	AS
Culverts	Drop Inlets	Gates	Curb & Gutter	Curb	PCR
0	0	0	NO CURB AND GUTTER	WOOD CURB	POOR/45

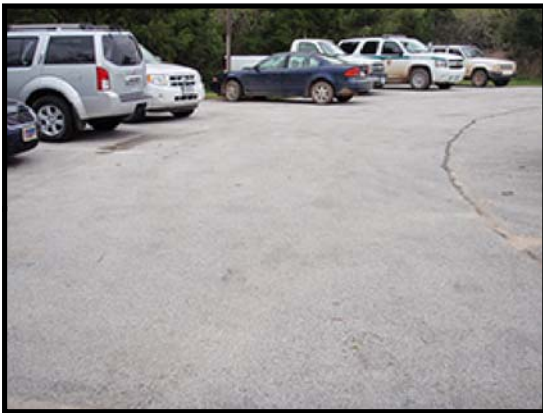
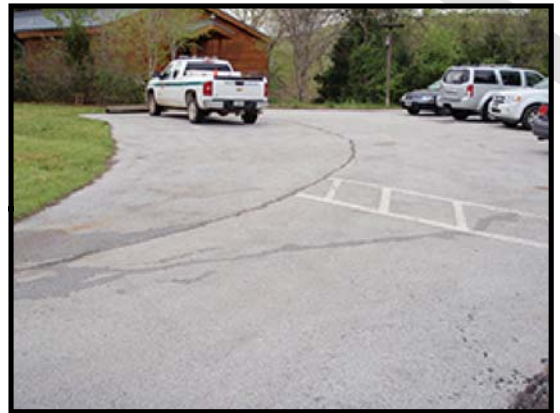
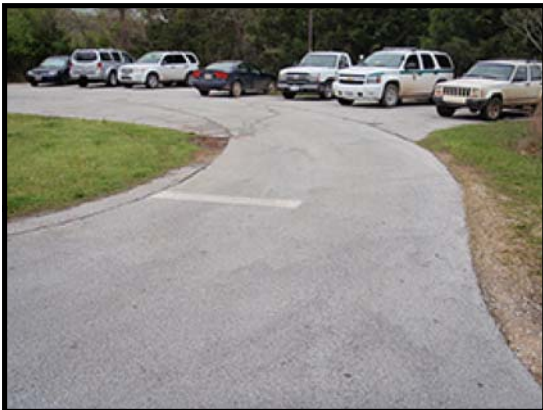
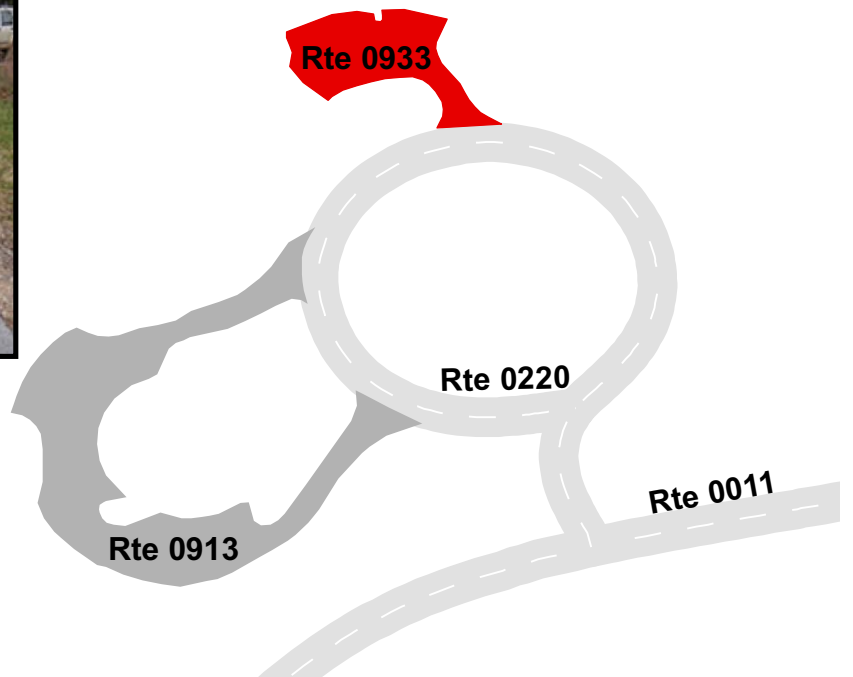
Route 0933

Route Number	Public / NonPublic	Date Visited	Area (sq ft)	Lane Miles *	Surface Type
0933	NONPUBLIC	4/15/2011	4,579	0.08	AS
Culverts	Drop Inlets	Gates	Curb & Gutter	Curb	PCR
0	0	0	NO CURB AND GUTTER	NO CURB	FAIR/73

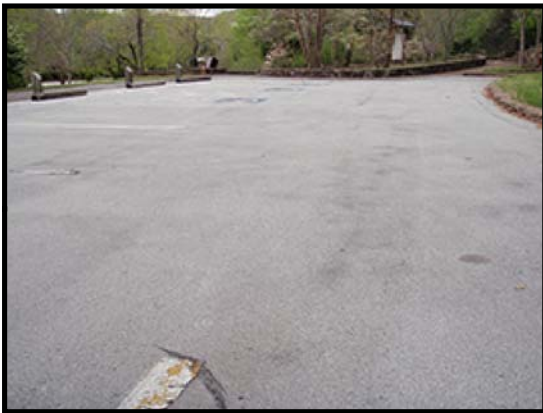
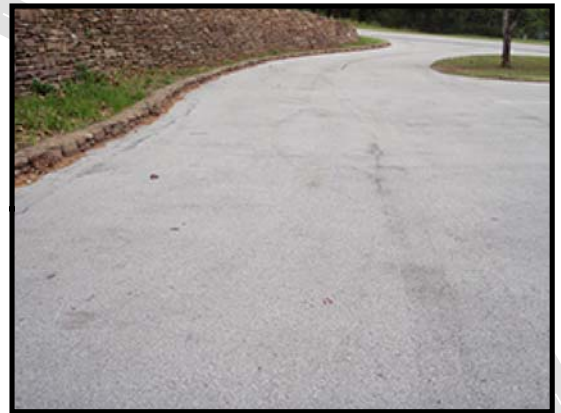
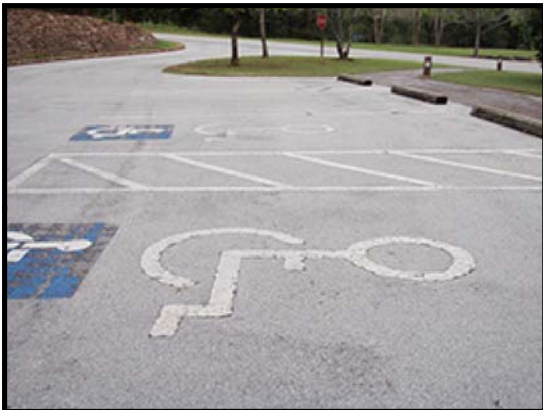
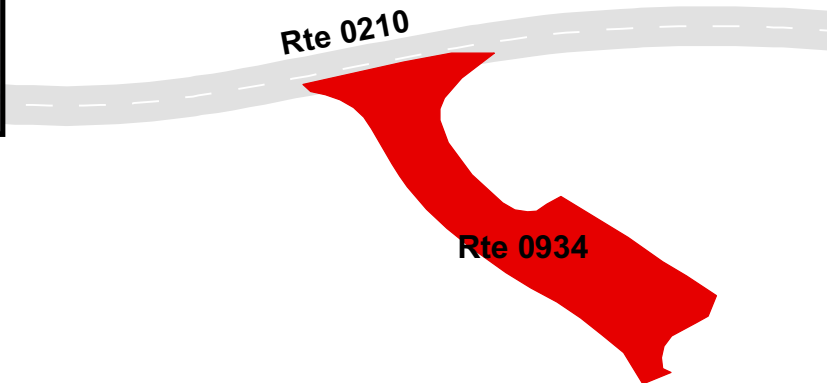
Route 0934

Route Number	Public / NonPublic	Date Visited	Area (sq ft)	Lane Miles *	Surface Type
0934	PUBLIC	4/15/2011	5,280	0.09	AS
Culverts	Drop Inlets	Gates	Curb & Gutter	Curb	PCR
0	0	0	NO CURB AND GUTTER	STONE CURB	FAIR/73

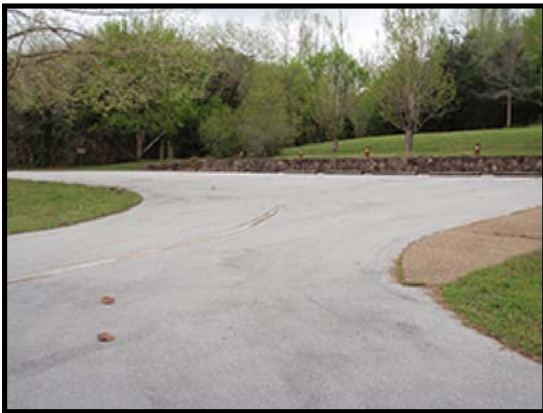
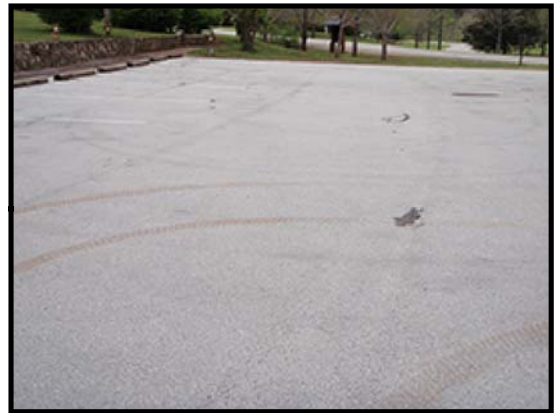
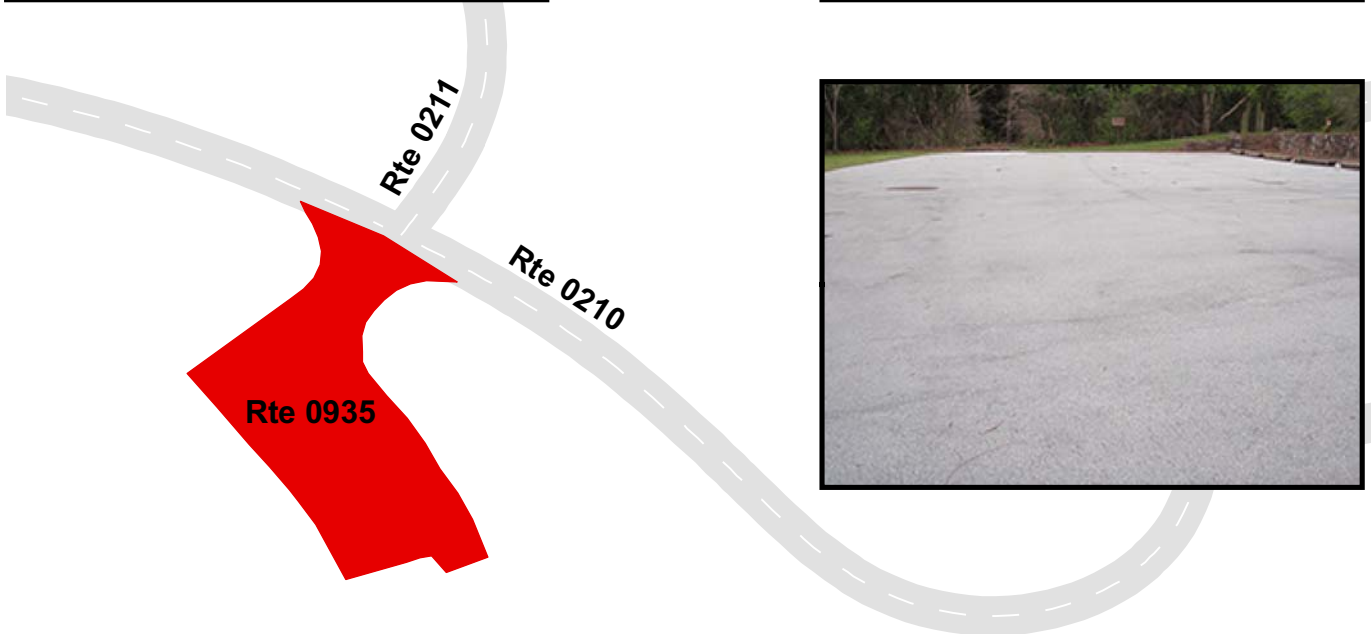
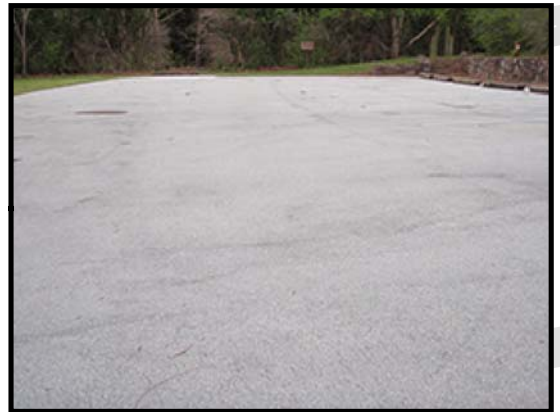
Route 0935

Route Number	Public / NonPublic	Date Visited	Area (sq ft)	Lane Miles *	Surface Type
0935	PUBLIC	4/15/2011	6,771	0.12	AS
Culverts	Drop Inlets	Gates	Curb & Gutter	Curb	PCR
1	0	0	NO CURB AND GUTTER	NO CURB	FAIR/73

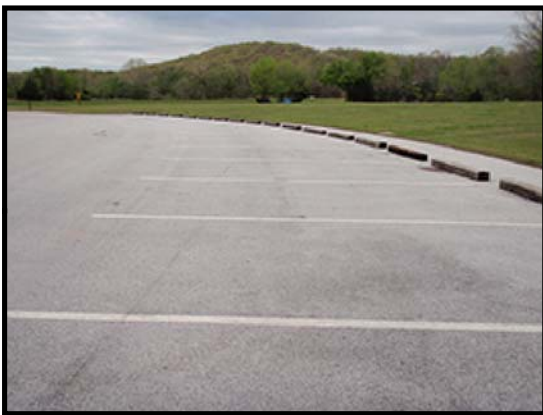
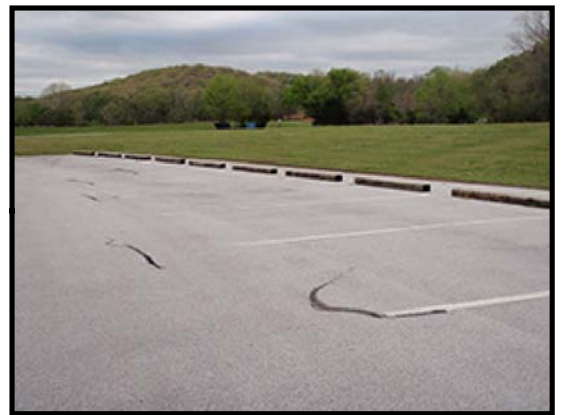
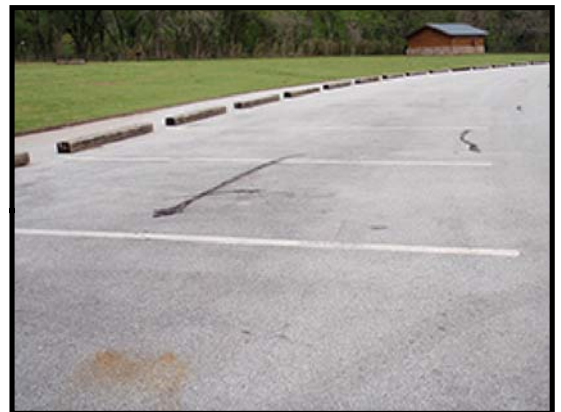
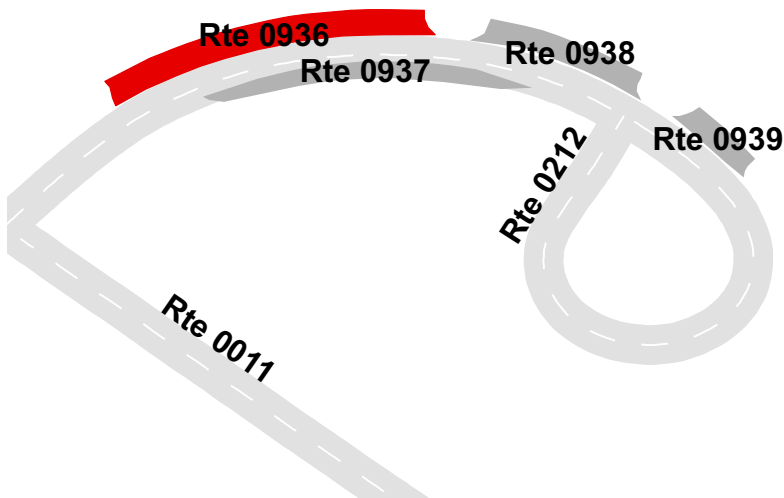
Route 0936

Route Number	Public / NonPublic	Date Visited	Area (sq ft)	Lane Miles *	Surface Type
0936	PUBLIC	4/15/2011	4,098	0.07	AS
Culverts	Drop Inlets	Gates	Curb & Gutter	Curb	PCR
0	0	0	NO CURB AND GUTTER	NO CURB	GOOD/90

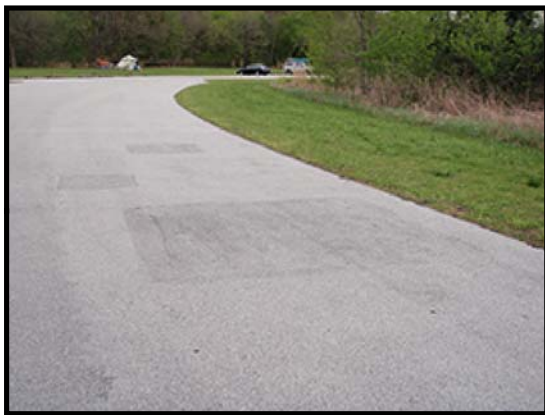
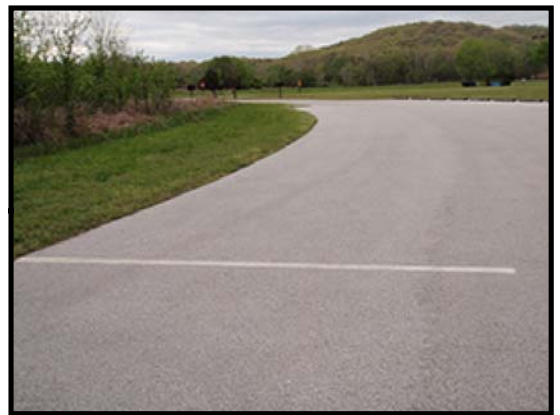
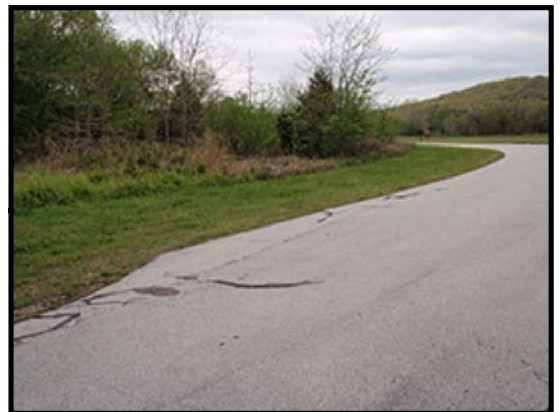
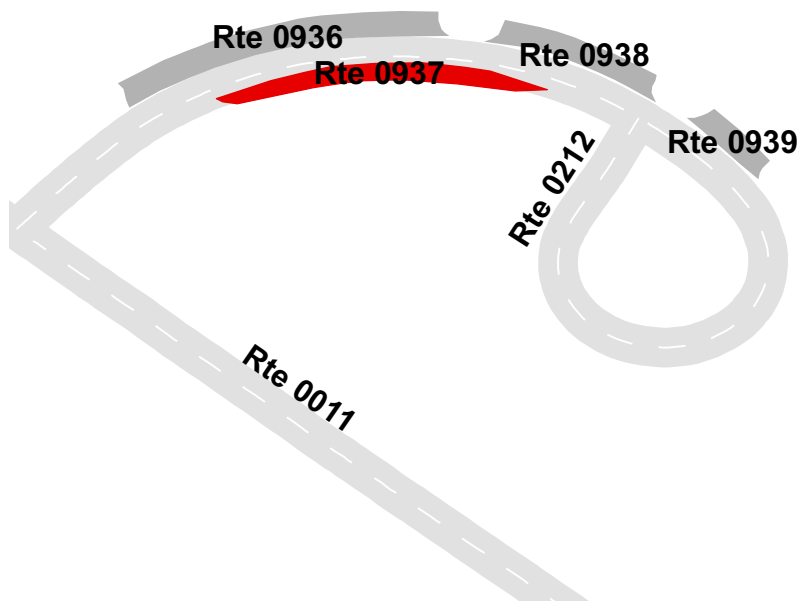
Route 0937

Route Number	Public / NonPublic	Date Visited	Area (sq ft)	Lane Miles *	Surface Type
0937	PUBLIC	4/15/2011	2,378	0.04	AS
Culverts	Drop Inlets	Gates	Curb & Gutter	Curb	PCR
0	0	0	NO CURB AND GUTTER	NO CURB	GOOD/90
