Federal Lands Highway Road Inventory Program

Road Inventory and Condition Assessment

Buffalo National River BUFF - 7150

Cycle 5 Report

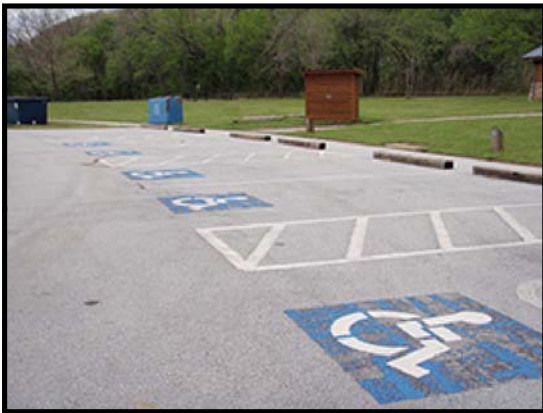
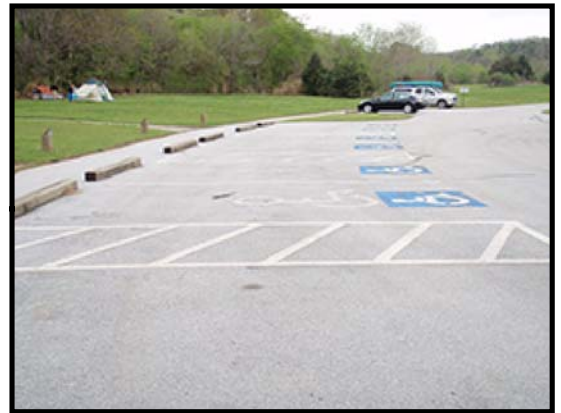
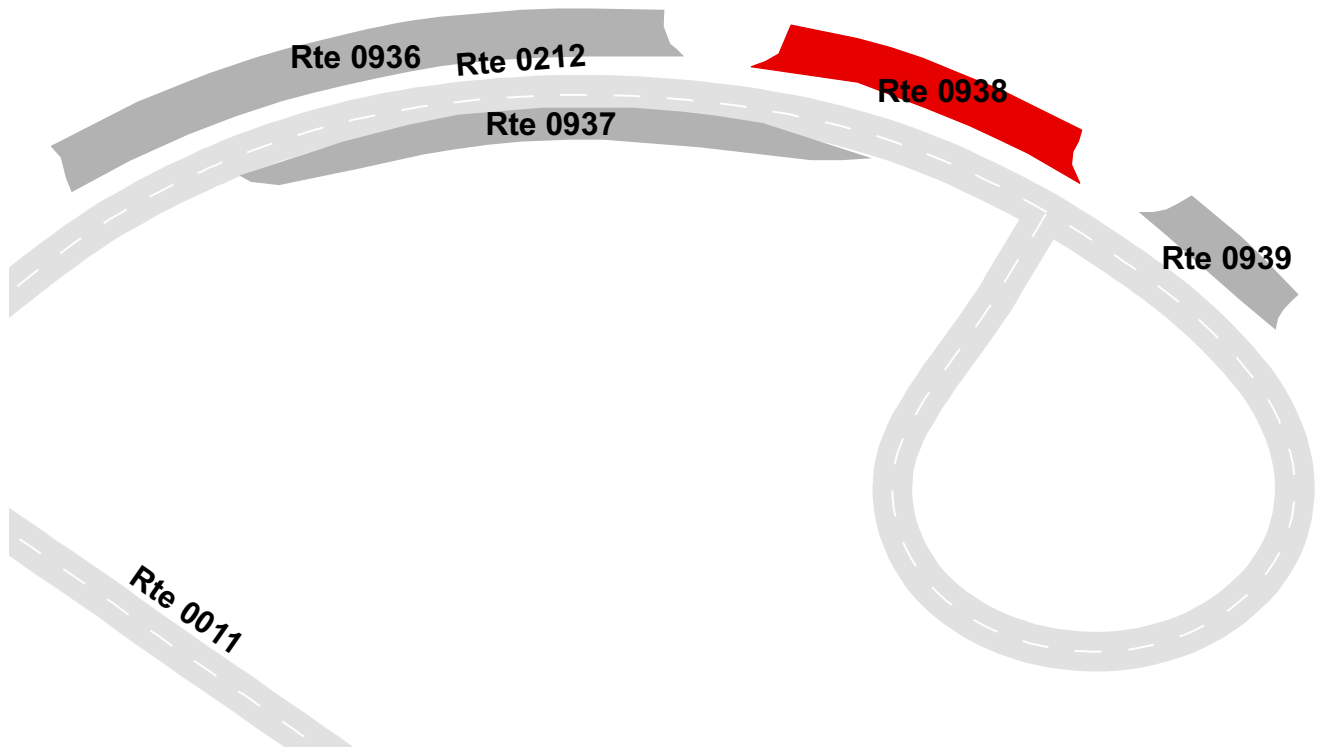
Route 0938

Route Number	Public / NonPublic	Date Visited	Area (sq ft)	Lane Miles *	Surface Type
0938	PUBLIC	4/15/2011	1,879	0.03	AS
Culverts	Drop Inlets	Gates	Curb & Gutter	Curb	PCR
0	0	0	NO CURB AND GUTTER	NO CURB	FAIR/73

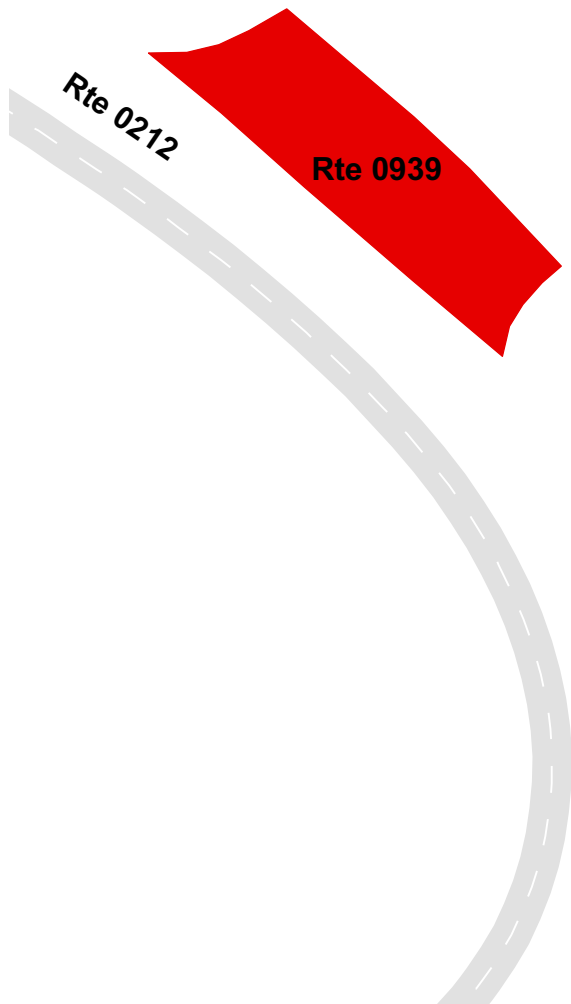
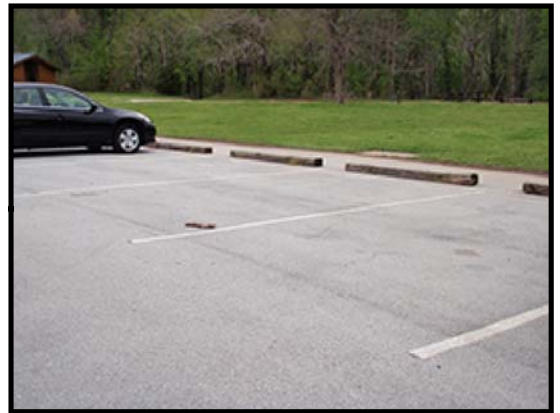
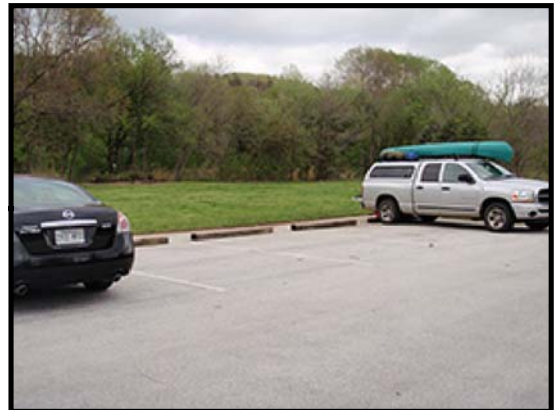
Route 0939

Route Number	Public / NonPublic	Date Visited	Area (sq ft)	Lane Miles *	Surface Type
0939	PUBLIC	4/15/2011	966	0.02	AS
Culverts	Drop Inlets	Gates	Curb & Gutter	Curb	PCR
0	0	0	NO CURB AND GUTTER	NO CURB	FAIR/73

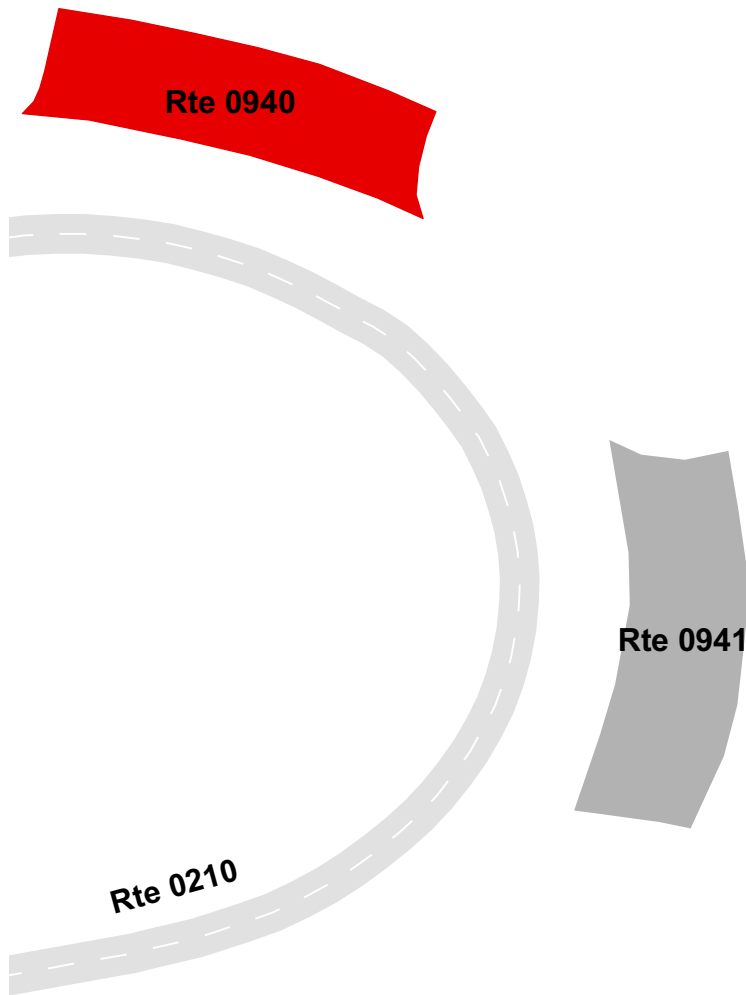
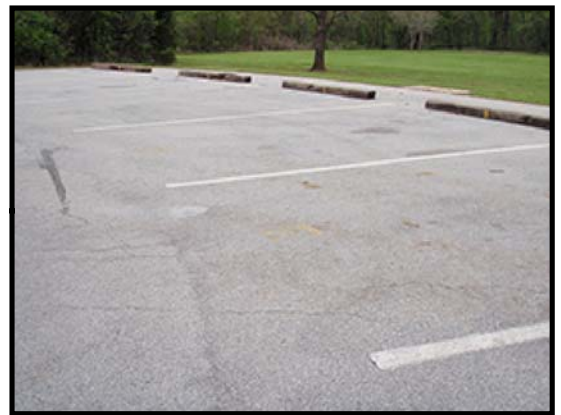
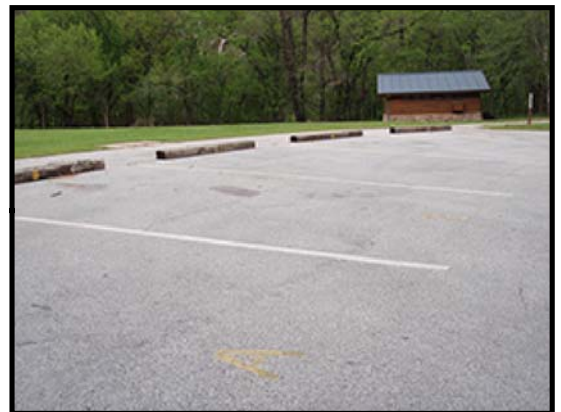
Route 0940

Route Number	Public / NonPublic	Date Visited	Area (sq ft)	Lane Miles *	Surface Type
0940	PUBLIC	4/15/2011	1,068	0.02	AS
Culverts	Drop Inlets	Gates	Curb & Gutter	Curb	PCR
0	0	0	NO CURB AND GUTTER	NO CURB	FAIR/73

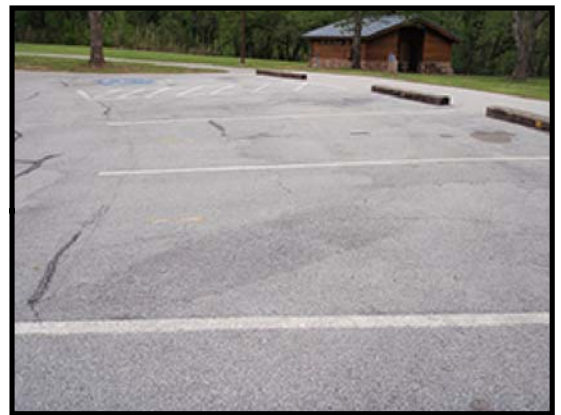
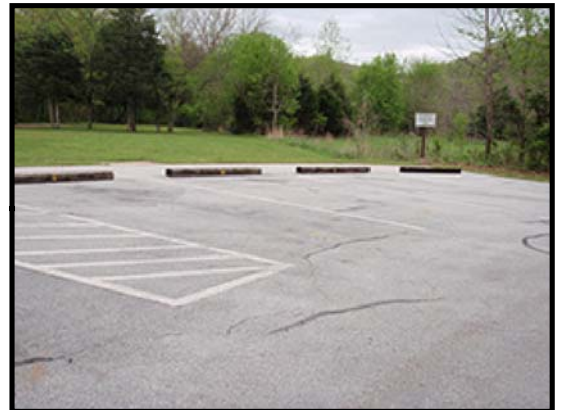
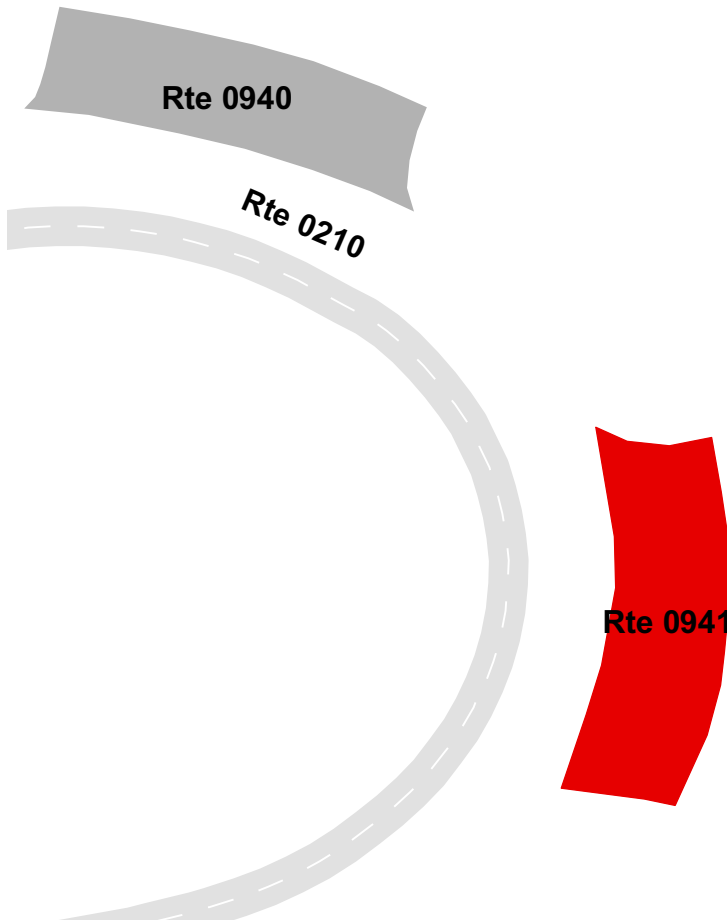
Route Number	Public / NonPublic	Date Visited	Area (sq ft)	Lane Miles *	Surface Type
0941	PUBLIC	4/15/2011	1,149	0.02	AS
Culverts	Drop Inlets	Gates	Curb & Gutter	Curb	PCR
0	0	0	NO CURB AND GUTTER	NO CURB	FAIR/73

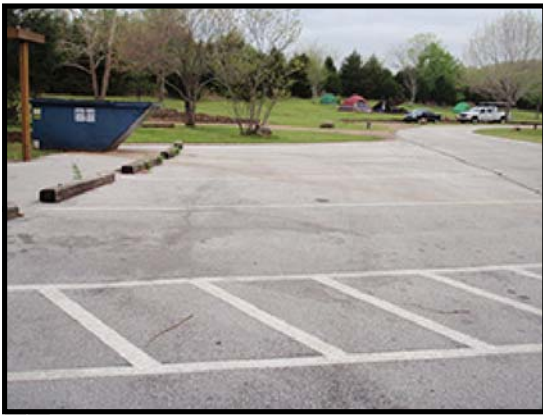
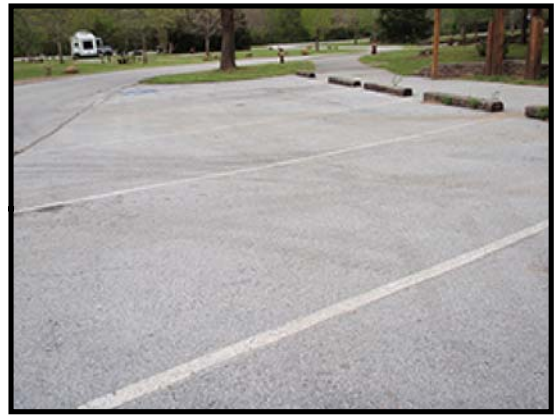
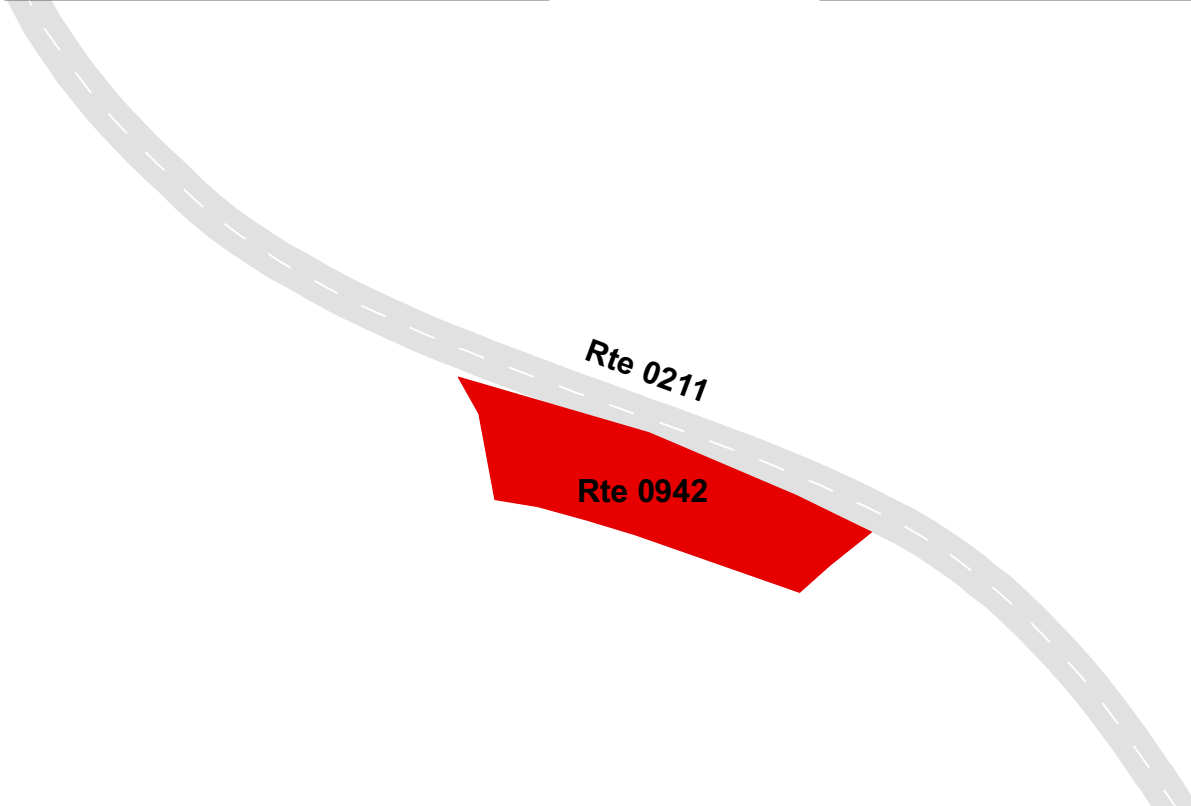
Route 0942

Route Number	Public / NonPublic	Date Visited	Area (sq ft)	Lane Miles *	Surface Type
0942	PUBLIC	4/15/2011	1,995	0.03	AS
Culverts	Drop Inlets	Gates	Curb & Gutter	Curb	PCR
0	0	0	NO CURB AND GUTTER	NO CURB	GOOD/90
