Federal Lands Highway Road Inventory Program

Road Inventory and Condition Assessment

Canyon de Chelly National Monument CACH

Cycle 5 Report

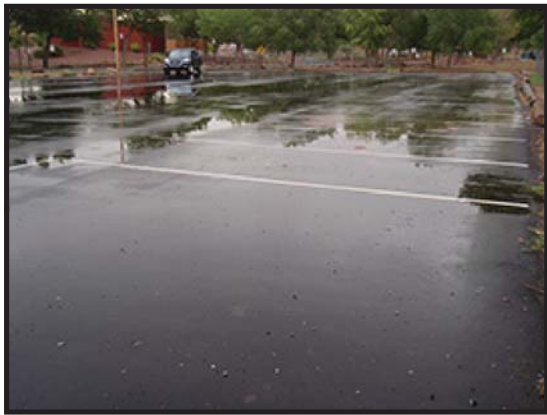
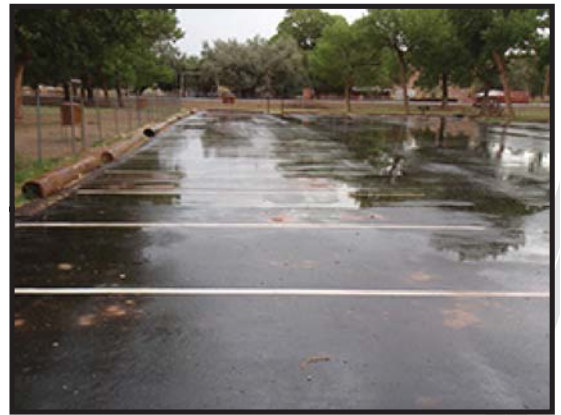
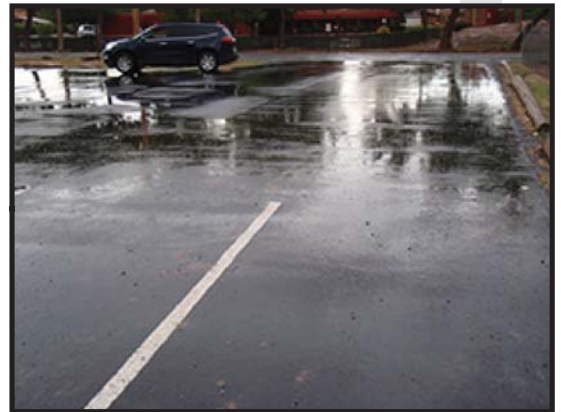
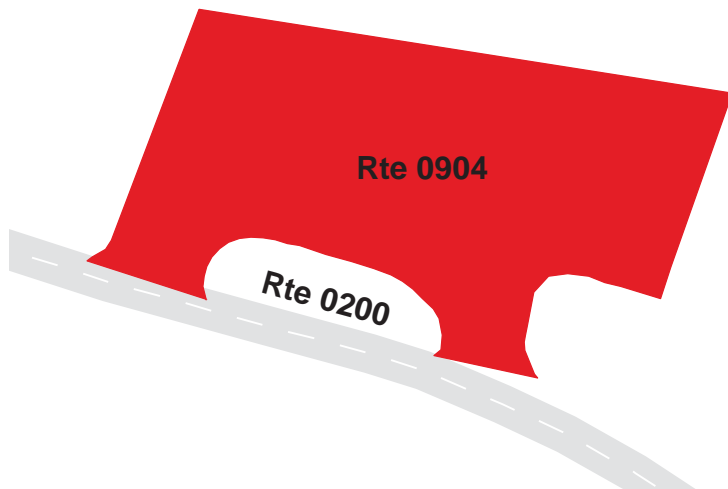
Route Number	Public / NonPublic	Date Visited	Area (sq ft)	Lane Miles *	Surface Type
0904	PUBLIC	9/1/2011	16,437	0.28	AS
Culverts	Drop Inlets	Gates	Curb & Gutter	Curb	PCR
0	0	0	NO CURB AND GUTTER	NO CURB	EXCELLENT/97
