# Federal Lands Highway Road Inventory Program

Road Inventory and Condition Assessment

## Castillo de San Marcos National Monument CASA

### Cycle 5 Report

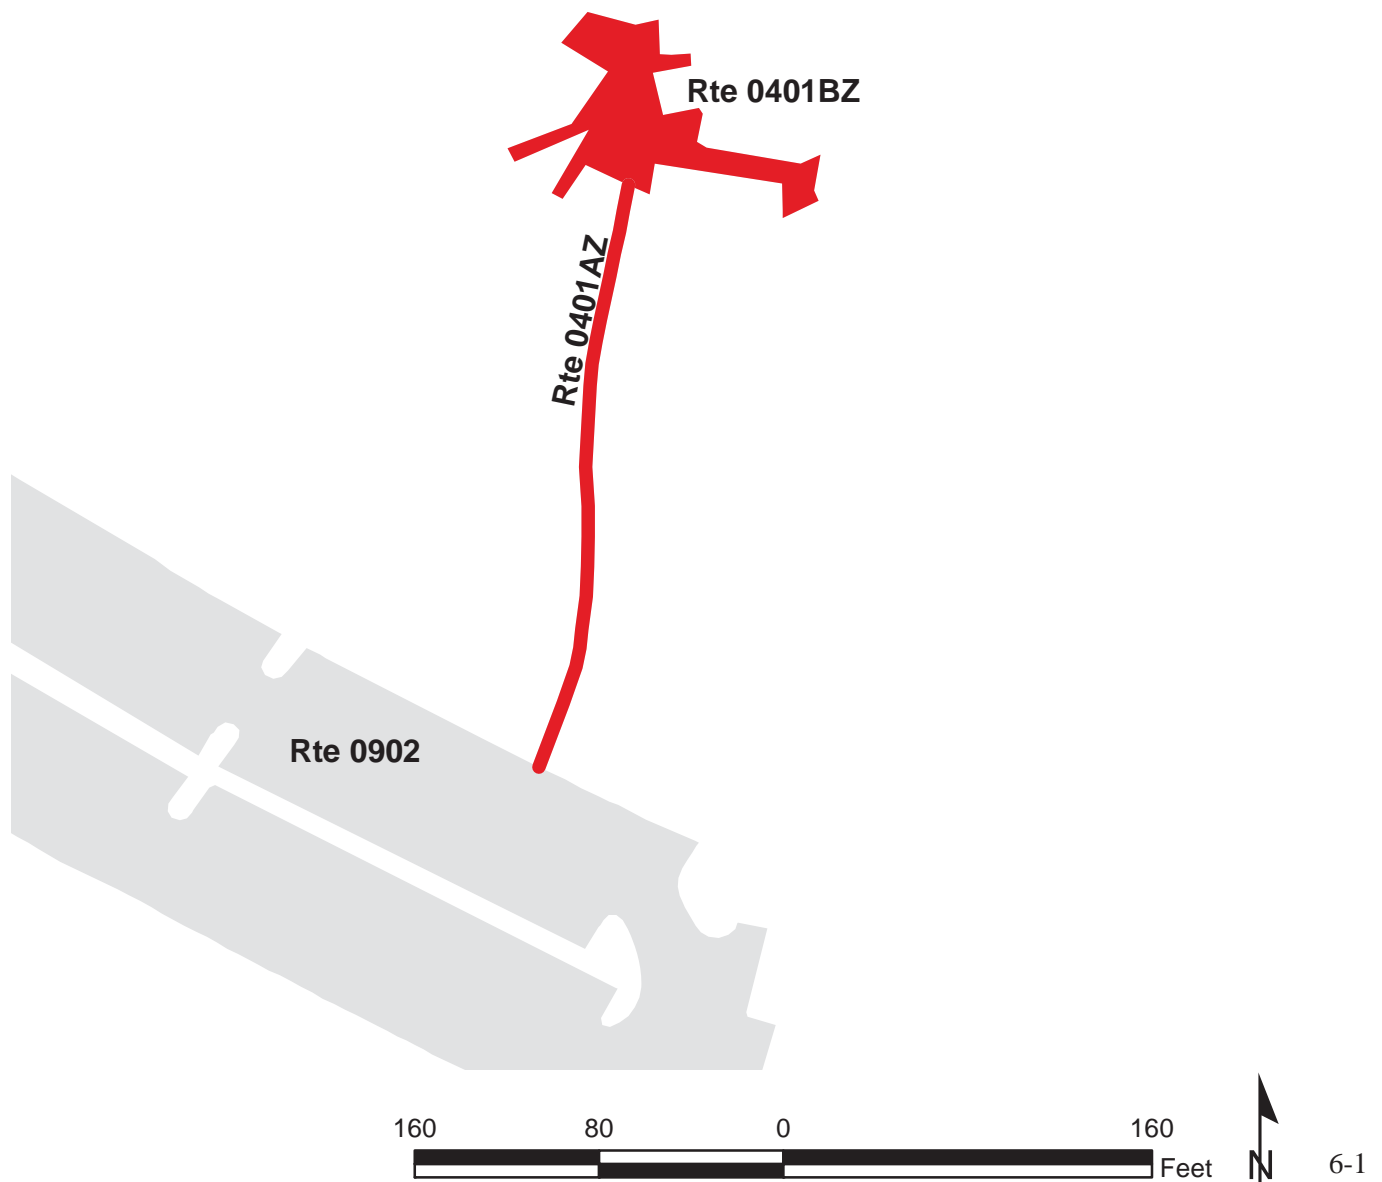
## Route 0401AZ

Route Number	Public / NonPublic	Date Visited	Area (sq ft)	Lane Miles *	Paved Length (mi)	Paved Width (ft)
0401ZZ	PUBLIC	4/16/2013	5,683	0.10	0.05	23.4
Culverts	Drop Inlets	Gates	Curb & Gutter	Curb	PCR	Surface Type
0	0	1	NO CURB AND GUTTER	NO CURB	SUMMARY/90	CO

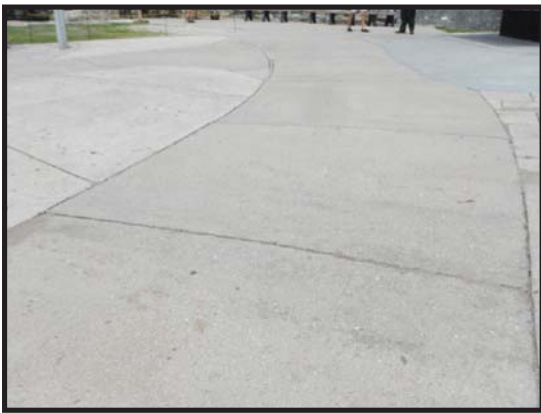
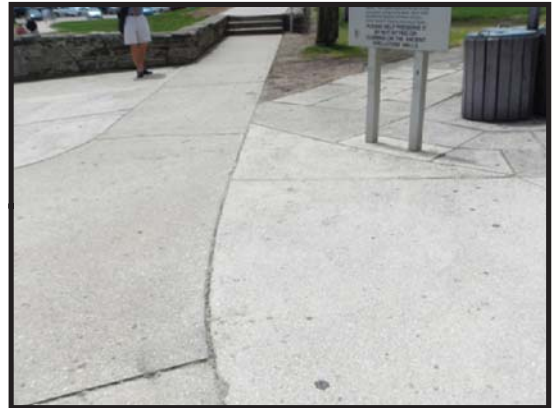
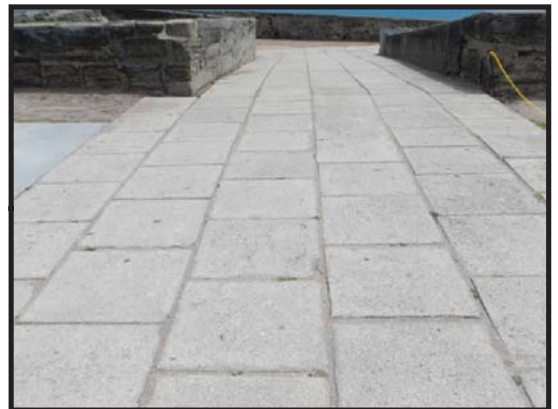
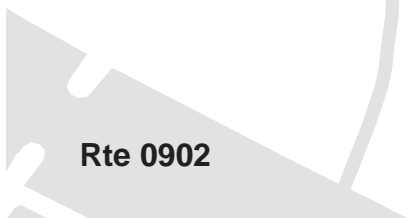
Route Number	Public / NonPublic	Date Visited	Area (sq ft)	Lane Miles *	Surface Type
0401BZ	PUBLIC	4/16/2013	3,254	0.06	CO
Culverts	Drop Inlets	Gates	Curb & Gutter	Curb	PCR
0	0	1	NO CURB AND GUTTER	NO CURB	GOOD/90

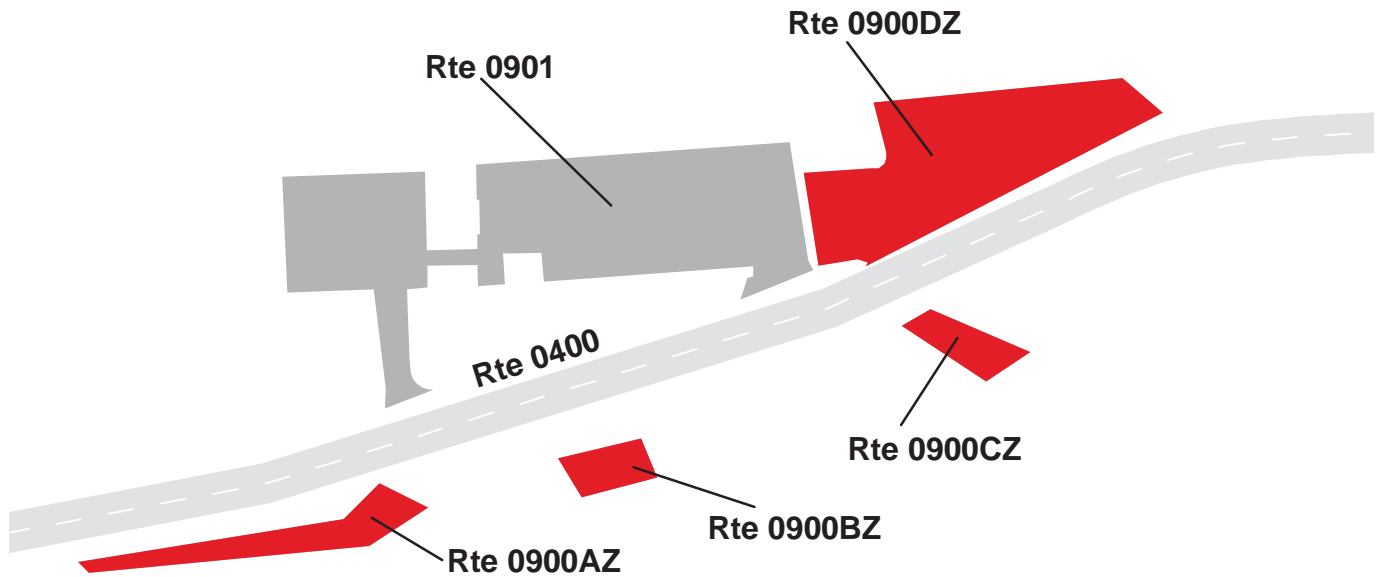
## Route 0900AZ

Route Number	Public / NonPublic	Date Visited	Area (sq ft)	Lane Miles *	Surface Type
0900ZZ	NONPUBLIC	4/16/2013	5,113	0.09	AS
Culverts	Drop Inlets	Gates	Curb & Gutter	Curb	PCR
0	2	0	NO CURB AND GUTTER	CONCRETE CURB	SUMMARY/86

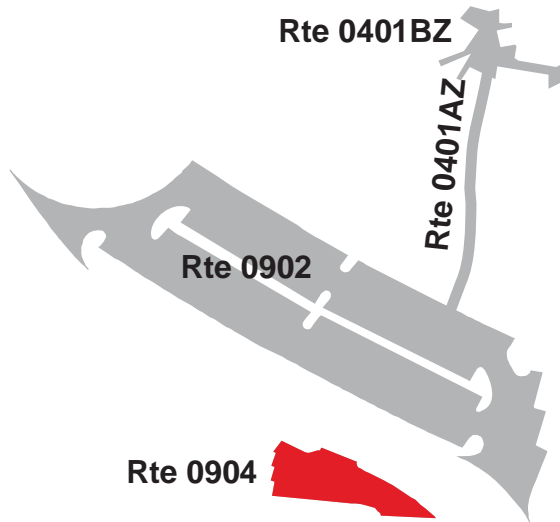
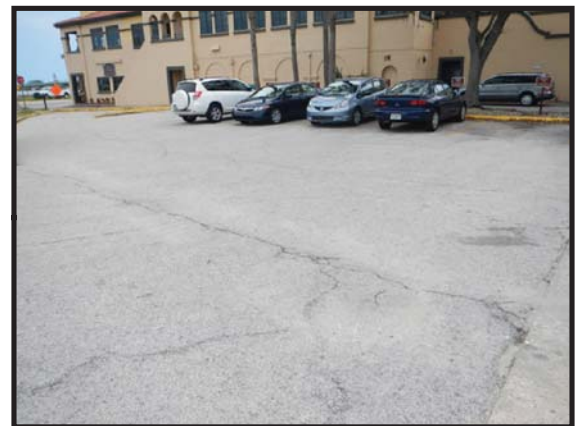
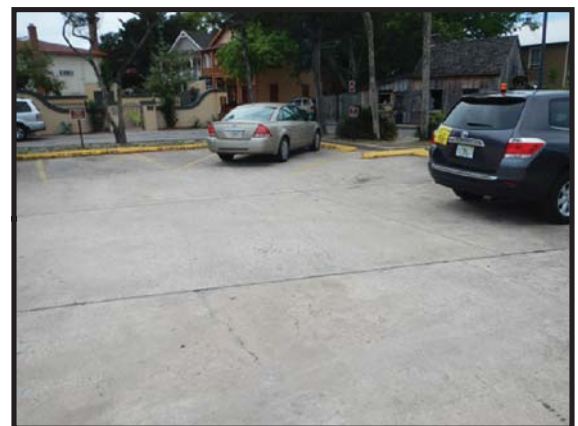
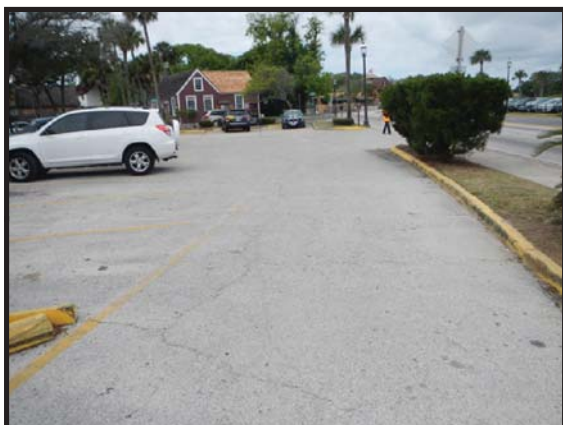
Route Number	Public / NonPublic	Date Visited	Area (sq ft)	Lane Miles *	Surface Type
0904	NONPUBLIC	4/16/2013	6,159	0.11	AS
Culverts	Drop Inlets	Gates	Curb & Gutter	Curb	PCR
0	1	0	NO CURB AND GUTTER	CONCRETE CURB	FAIR/73
