Federal Lands Highway Road Inventory Program

Road Inventory and Condition Assessment

Cedar Breaks National Monument CEBR

Cycle 5 Report

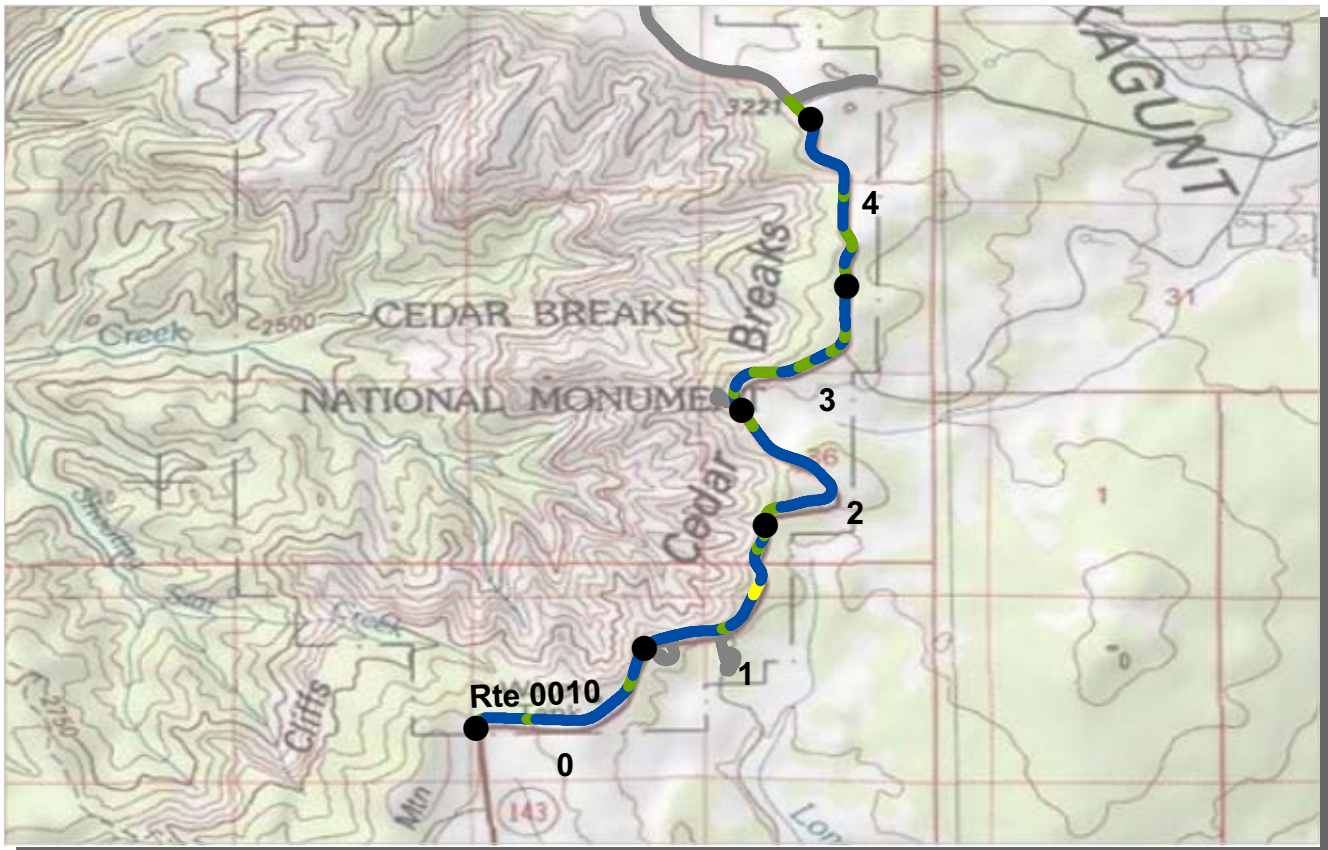
ROUTE: 0010 MAIN SCENIC DRIVE

<i>Section Number</i>	0	1	2	3	4
<i>Section Length (mi)</i>	1.00	1.00	1.00	1.00	1.00
<i>Cross Section Information</i>					
Number of Lanes	2	2	2	2	2
Paved Width (ft)	23	24	24	23	24
Lane Width (ft)	10	9	10	10	9
<i>Roadway Condition Information</i>					
SCR (Surface Condition Rating)	97	97	96	94	97
PCR (Pavement Condition Rating)	96	98	98	96	98
<i>Distress Index Values</i>					
Structural Crack Index	99	100	100	100	100
Transverse Cracking Index	99	99	99	100	100
Patching Index	100	100	100	100	100
Rutting Index	97	97	96	94	97
Roughness Condition Index (RCI)	95	99	100	100	99

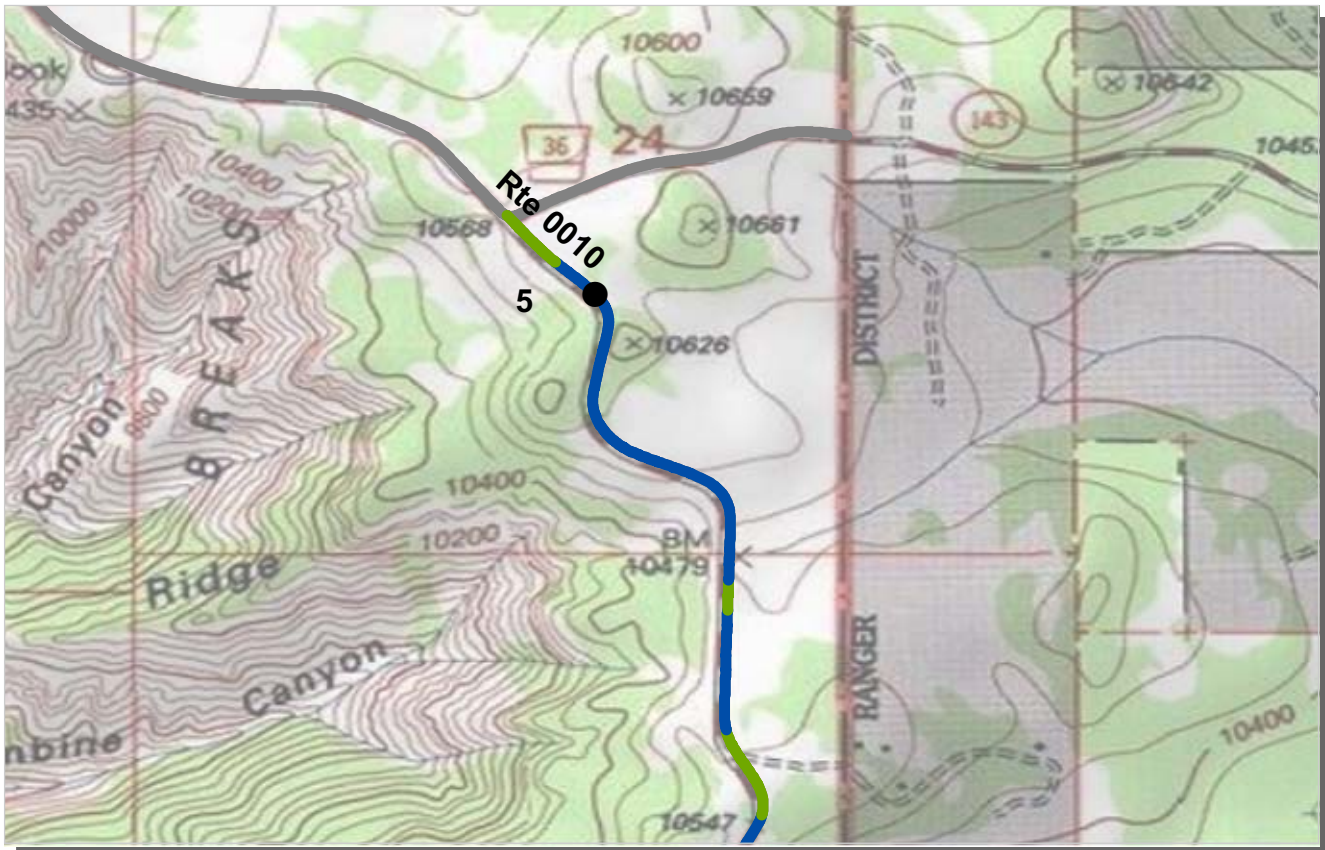
ROUTE: 0010 MAIN SCENIC DRIVE

Section Number	5				
Section Length (mi)	0.13				
Cross Section Information					
Number of Lanes	2				
Paved Width (ft)	25				
Lane Width (ft)	9				
Roadway Condition Information					
SCR (Surface Condition Rating)	99				
PCR (Pavement Condition Rating)	94				
Distress Index Values					
Structural Crack Index	100				
Transverse Cracking Index	99				
Patching Index	100				
Rutting Index	99				
Roughness Condition Index (RCI)	86

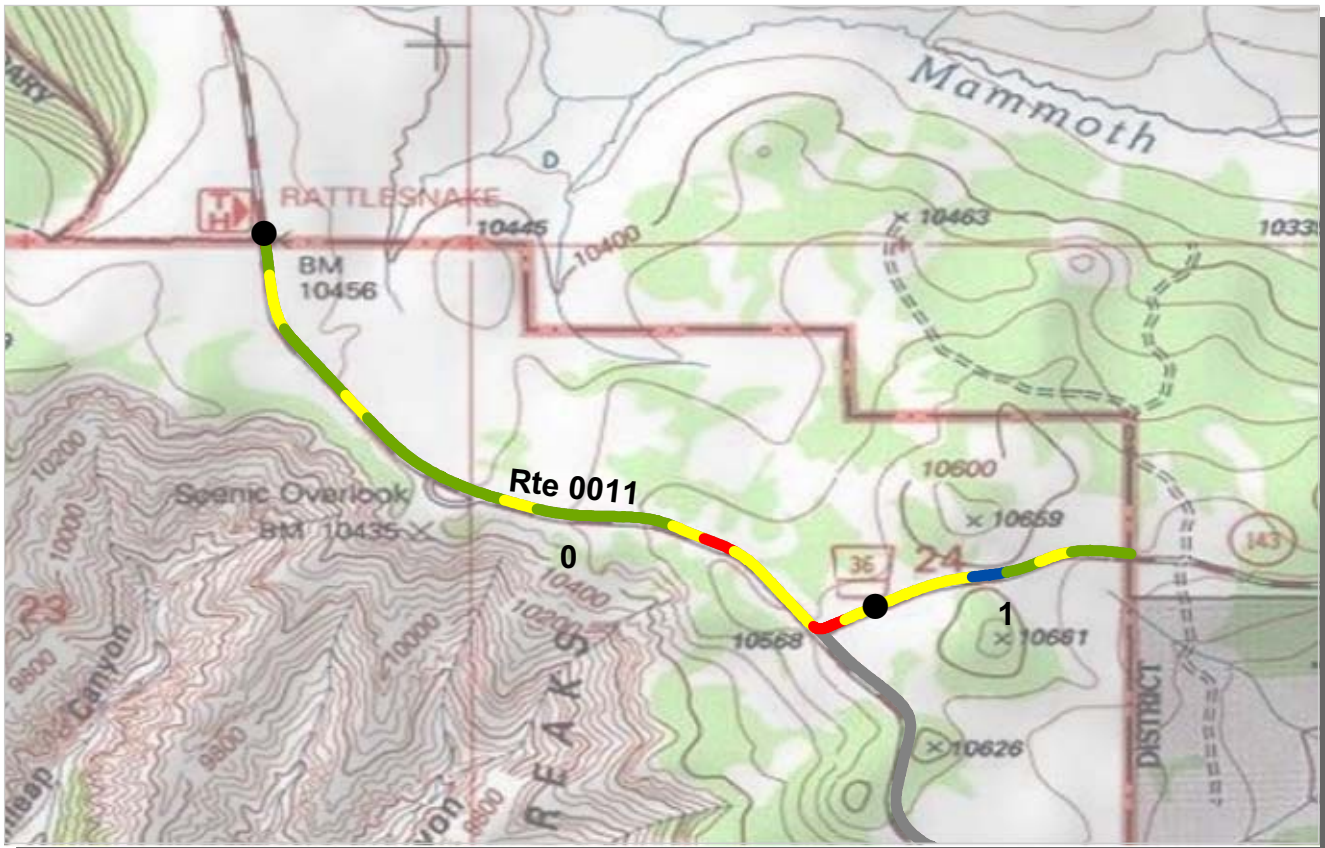
ROUTE: 0011 STATE HIGHWAY 143

<i>Section Number</i>	0	1			
<i>Section Length (mi)</i>	1.00	0.31			
<i>Cross Section Information</i>					
Number of Lanes	2	2			
Paved Width (ft)	25	26			
Lane Width (ft)	10	10			
<i>Roadway Condition Information</i>					
SCR (Surface Condition Rating)	67	79			
PCR (Pavement Condition Rating)	74	86			
<i>Distress Index Values</i>					
Structural Crack Index	67	79			
Transverse Cracking Index	88	90			
Patching Index	100	100			
Rutting Index	93	93			
Roughness Condition Index (RCI)	84	97

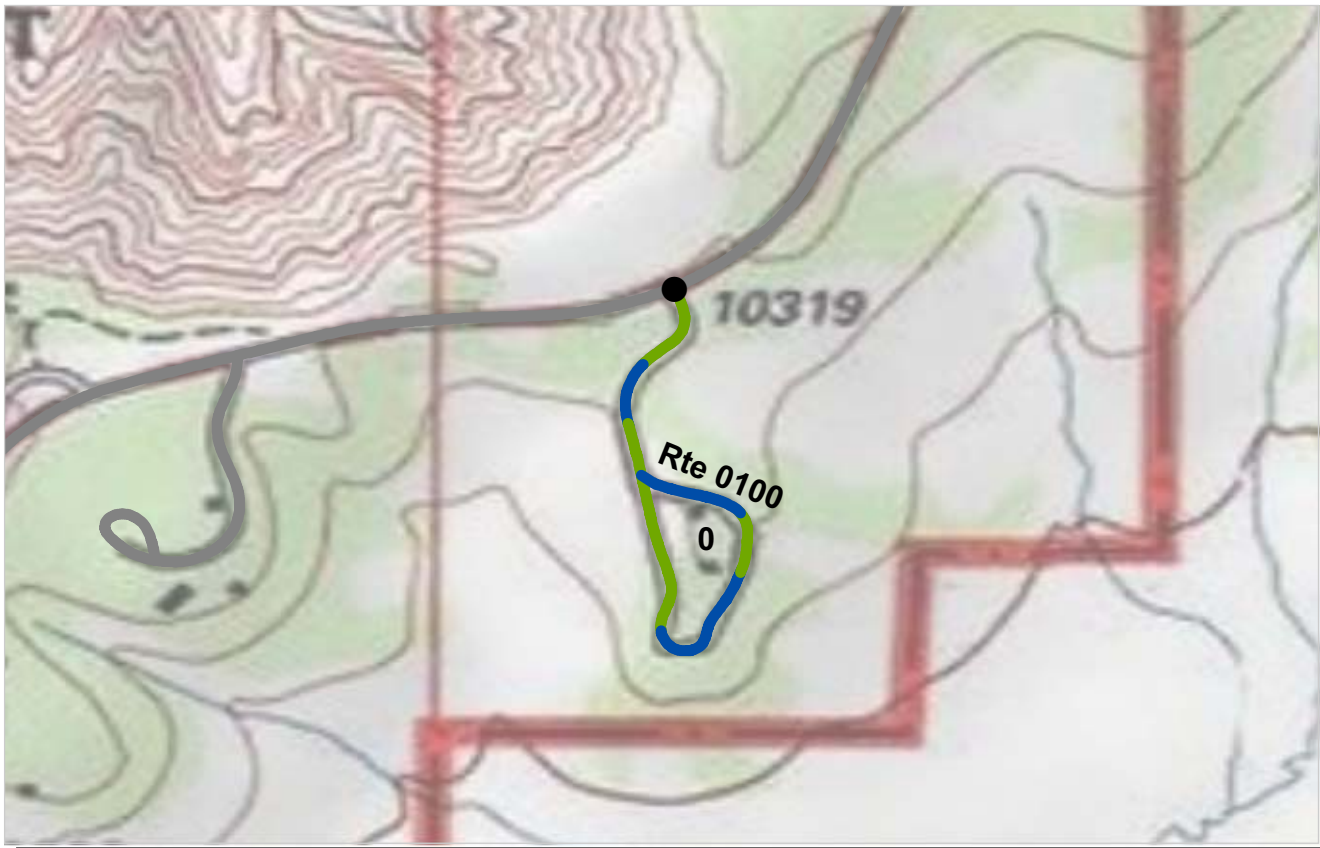
ROUTE: 0100 POINT SUPREME CAMPGROUND LOOP

Section Number	0				
Section Length (mi)	0.41				
Cross Section Information					
Number of Lanes	1				
Paved Width (ft)	16				
Lane Width (ft)	11				
Roadway Condition Information					
SCR (Surface Condition Rating)	92				
PCR (Pavement Condition Rating)	92				
Distress Index Values					
Structural Crack Index	99				
Transverse Cracking Index	99				
Patching Index	100				
Rutting Index	92				
Roughness Condition Index (RCI)	NC

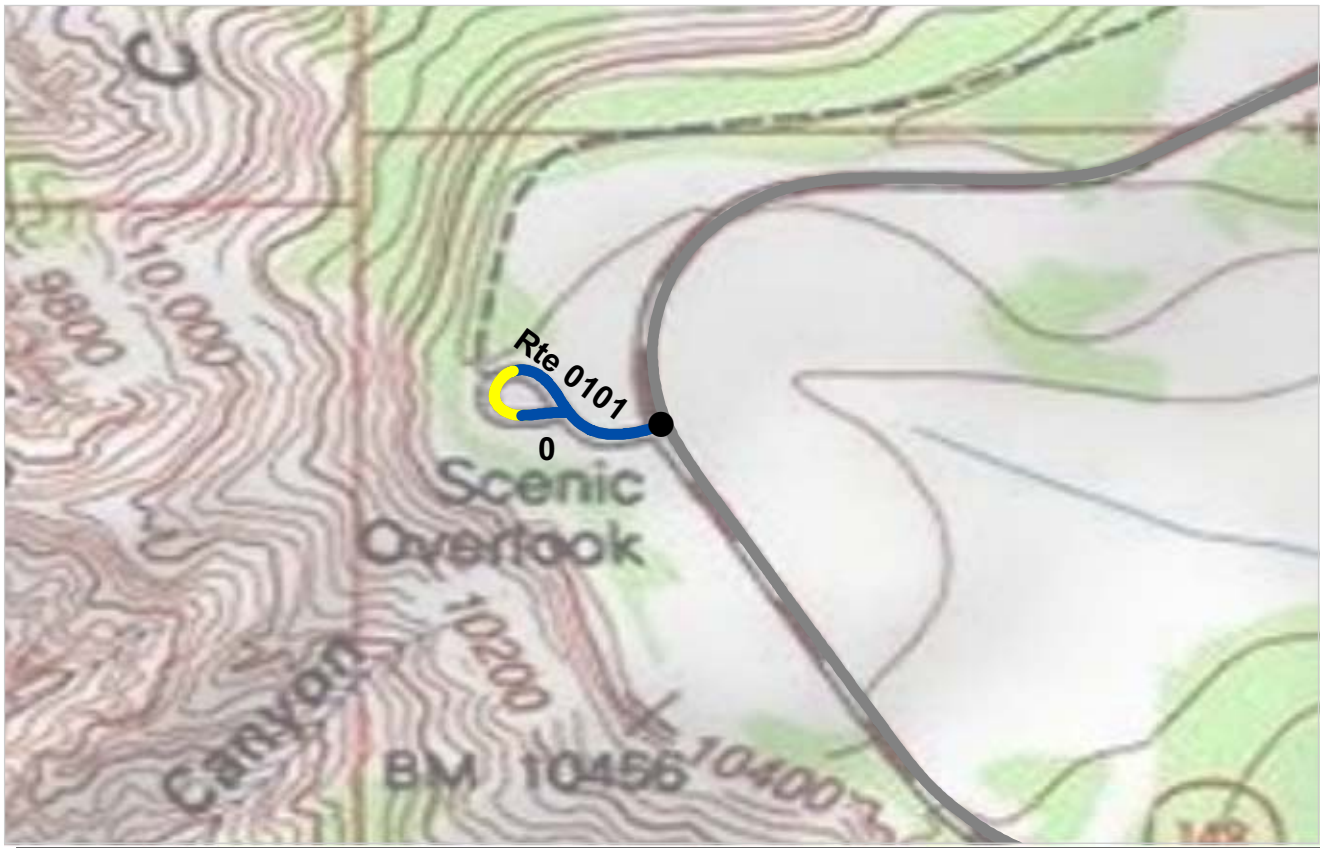
ROUTE: 0101 CHESSMAN OVERLOOK ACCESS ROAD

Section Number	0				
Section Length (mi)	0.16				
Cross Section Information					
Number of Lanes	2				
Paved Width (ft)	26				
Lane Width (ft)	13				
Roadway Condition Information					
SCR (Surface Condition Rating)	90				
PCR (Pavement Condition Rating)	90				
Distress Index Values					
Structural Crack Index	90				
Transverse Cracking Index	98				
Patching Index	100				
Rutting Index	95				
Roughness Condition Index (RCI)	NC

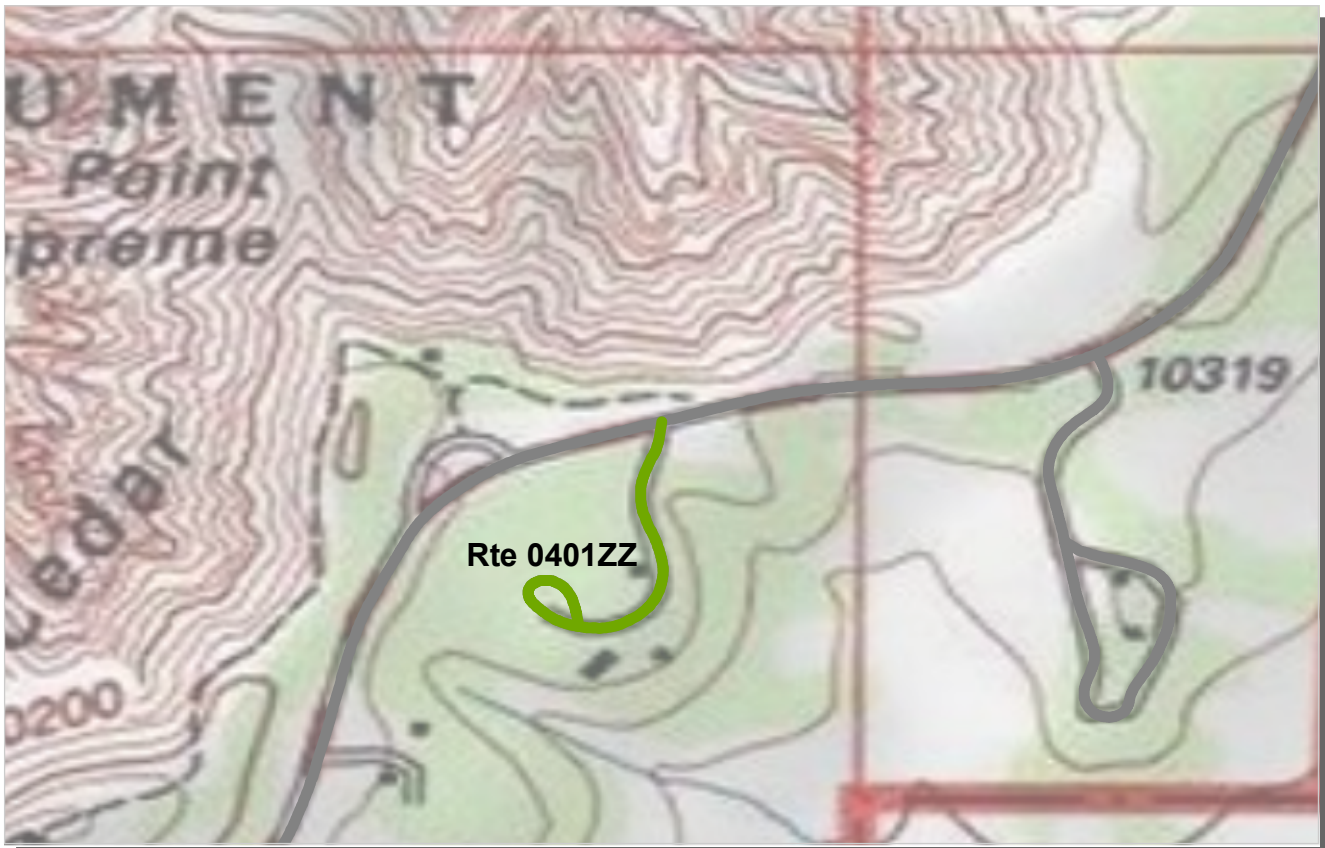
ROUTE: 0401ZZ MAINTENANCE AREA SERVICE ROADS

Section Number					
Section Length (mi)					
Cross Section Information					
Number of Lanes	N/A				
Paved Width (ft)	N/A				
Lane Width (ft)	N/A				
Roadway Condition Information					
SCR (Surface Condition Rating)	91				
PCR (Pavement Condition Rating)	91				
Distress Index Values					
Structural Crack Index	N/A				
Transverse Cracking Index	N/A				
Patching Index	N/A				
Rutting Index	N/A				
Roughness Condition Index (RCI)	N/A

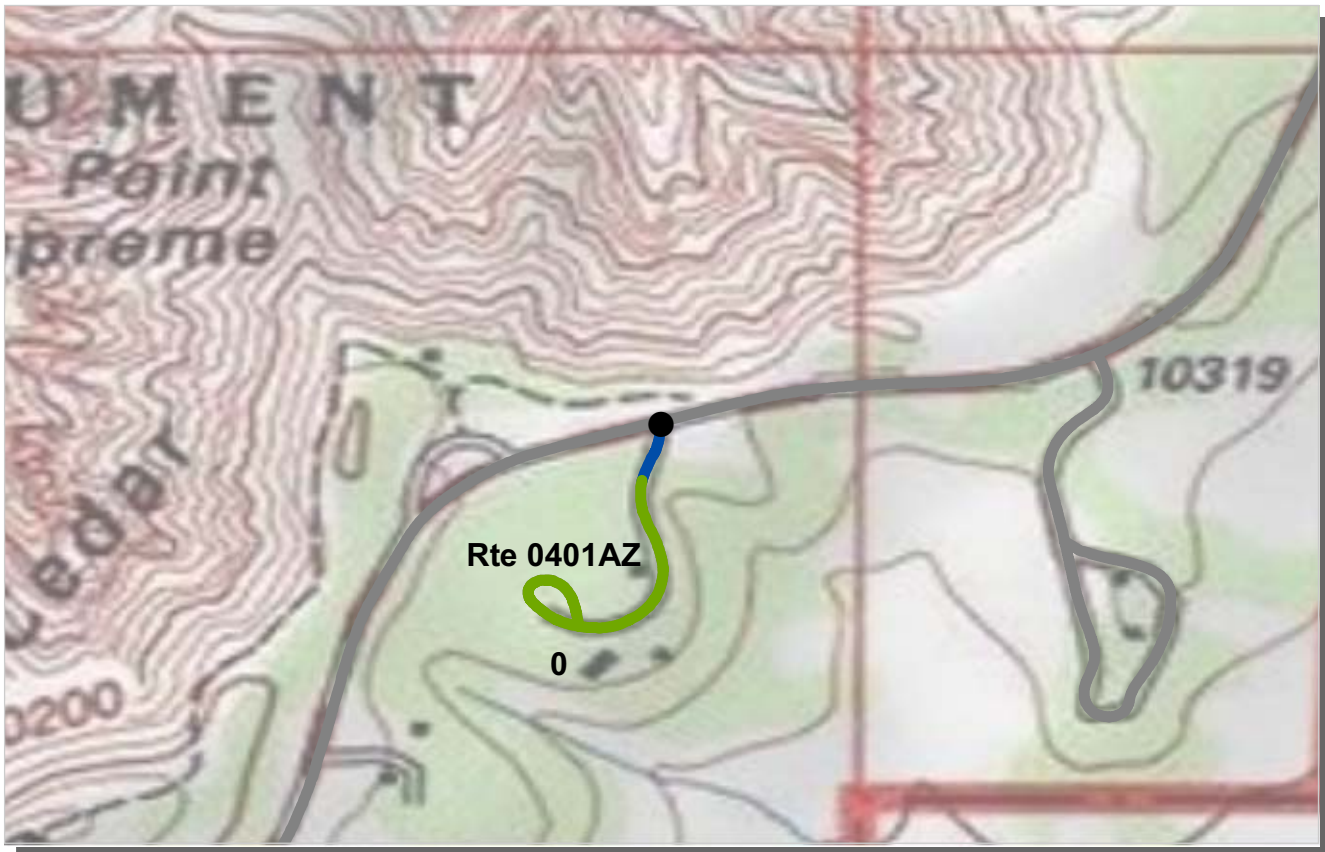
ROUTE: 0401AZ MAINTENANCE AREA SERVICE ROAD

Section Number	0				
Section Length (mi)	0.26				
Cross Section Information					
Number of Lanes	2				
Paved Width (ft)	18				
Lane Width (ft)	9				
Roadway Condition Information					
SCR (Surface Condition Rating)	91				
PCR (Pavement Condition Rating)	91				
Distress Index Values					
Structural Crack Index	92				
Transverse Cracking Index	99				
Patching Index	100				
Rutting Index	91				
Roughness Condition Index (RCI)	NC
