Federal Lands Highway Road Inventory Program

Road Inventory and Condition Assessment

Everglades National Park EVER

Cycle 5 Report

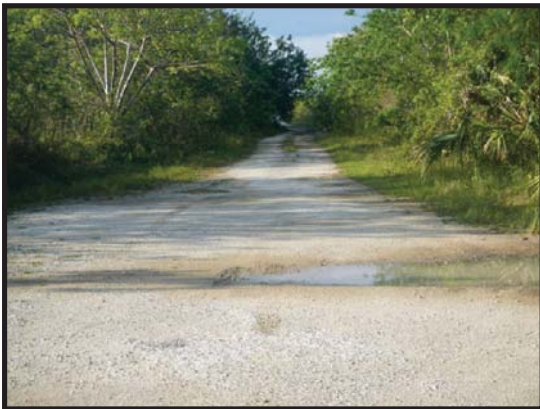
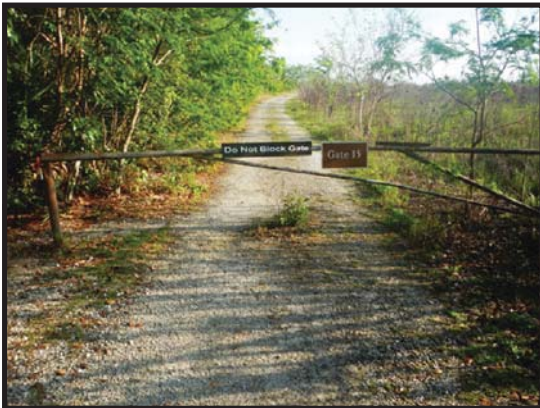
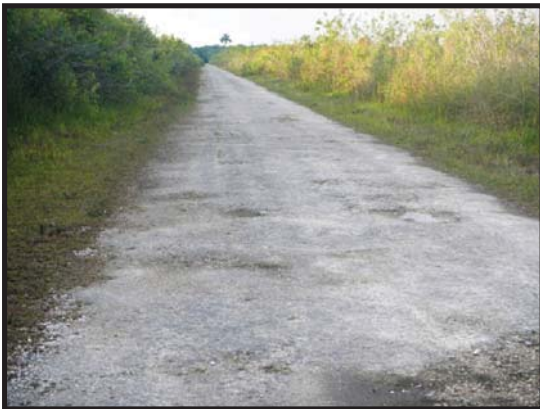
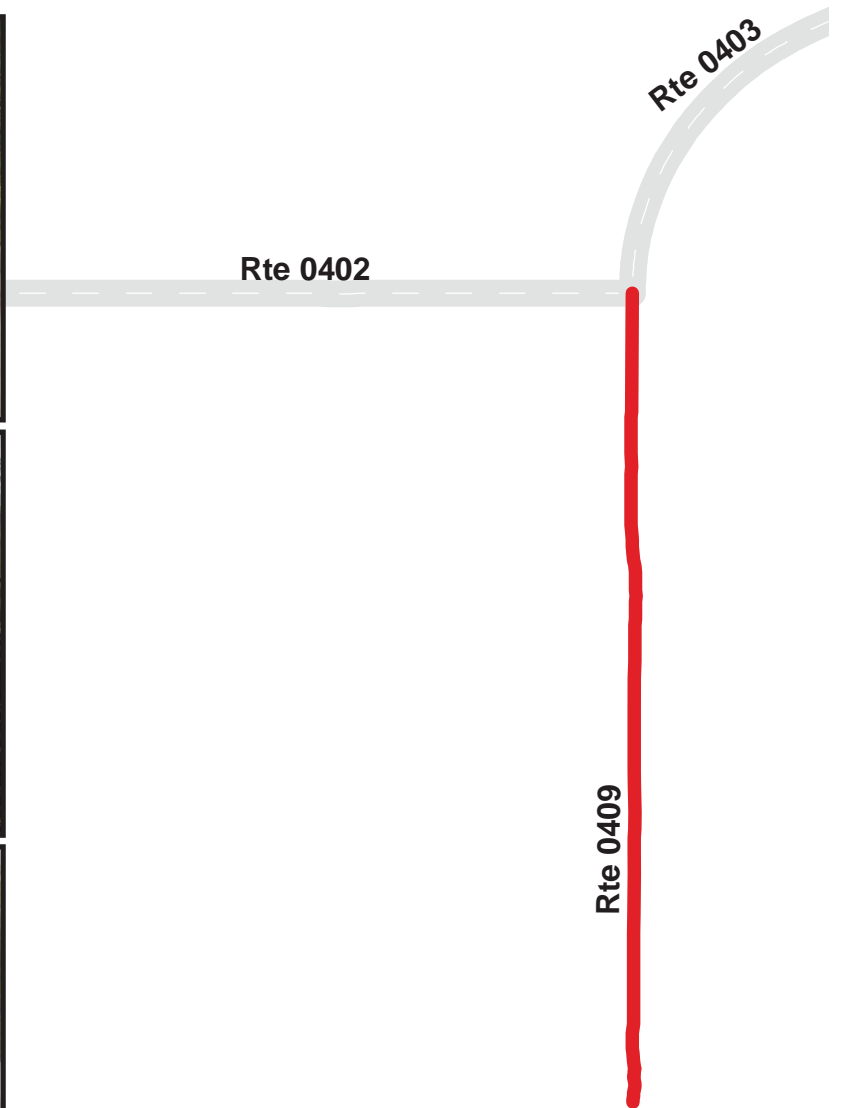
Route Number	Public / NonPublic	Date Visited	Area (sq ft)	Lane Miles *	Paved Length (mi)	Paved Width (ft)
0409	NONPUBLIC	4/20/2013	141,134	2.43	0.99	27
Culverts	Drop Inlets	Gates	Curb & Gutter	Curb	PCR	Surface Type
0	0	3	NO CURB AND GUTTER	NO CURB	POOR/45	AS

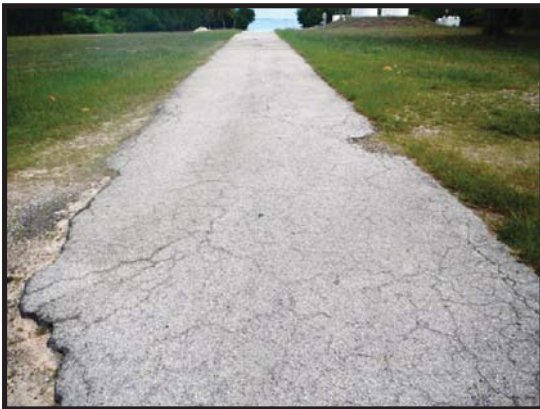
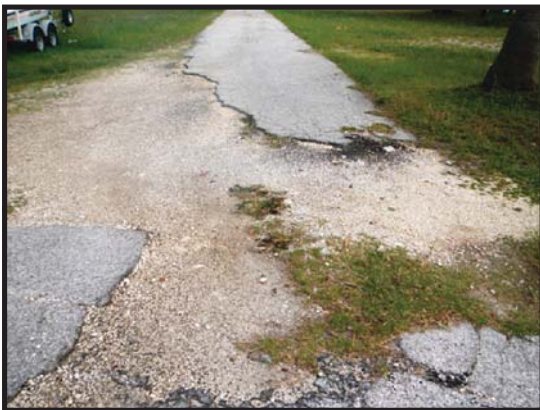
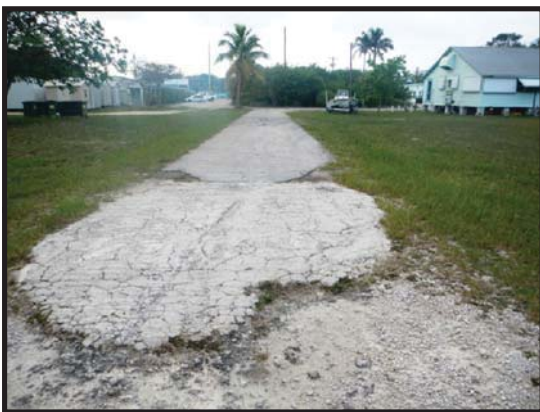
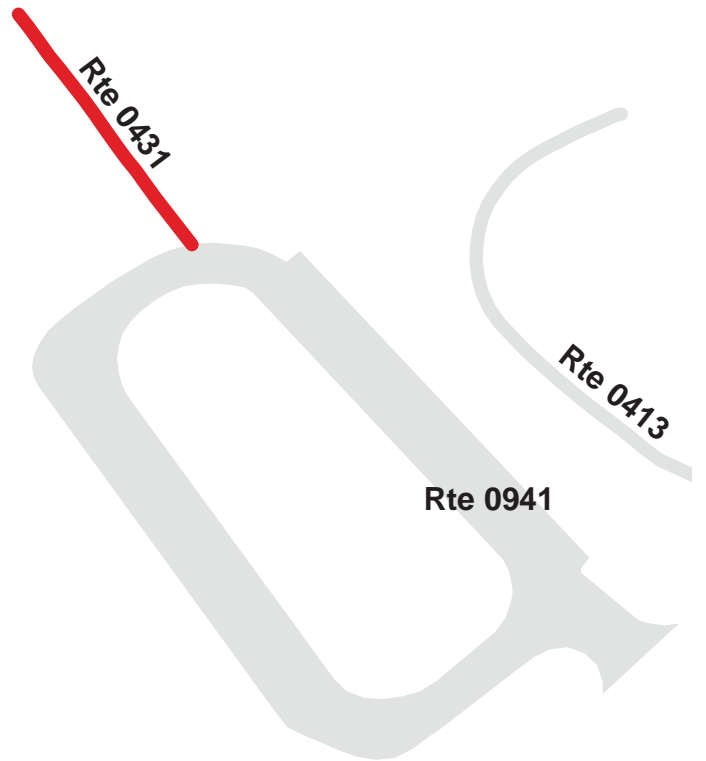
Route 0431

Route Number	Public / NonPublic	Date Visited	Area (sq ft)	Lane Miles *	Paved Length (mi)	Paved Width (ft)
0431	NONPUBLIC	4/20/2013	1,584	0.03	0.03	10
Culverts	Drop Inlets	Gates	Curb & Gutter	Curb	PCR	Surface Type
0	0	0	NO CURB AND GUTTER	NO CURB	POOR/45	AS

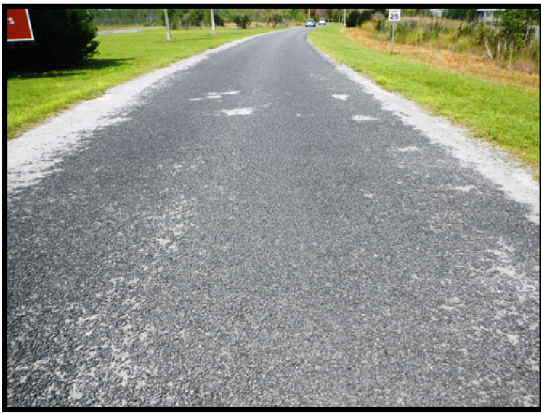
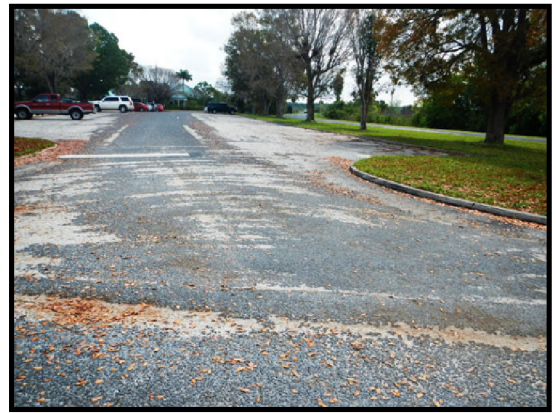
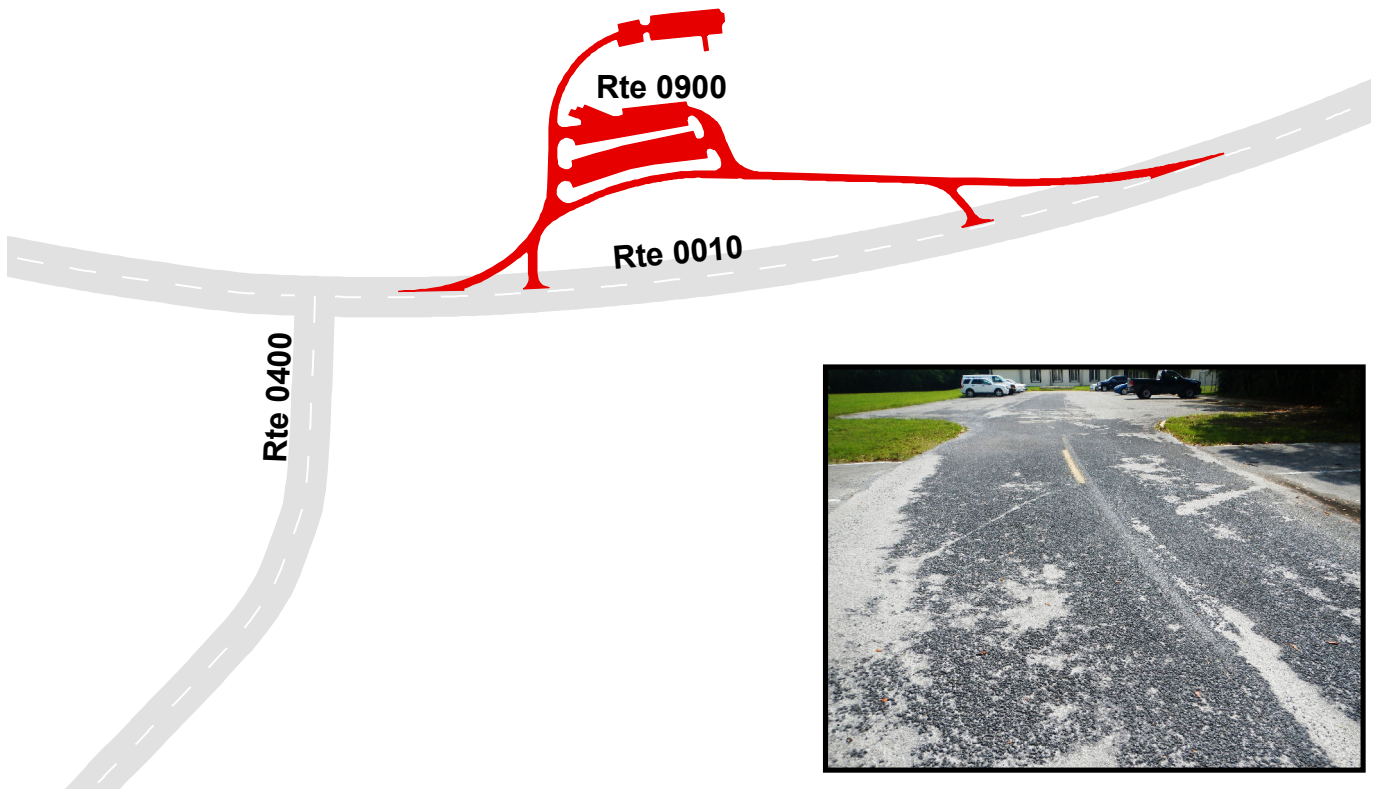
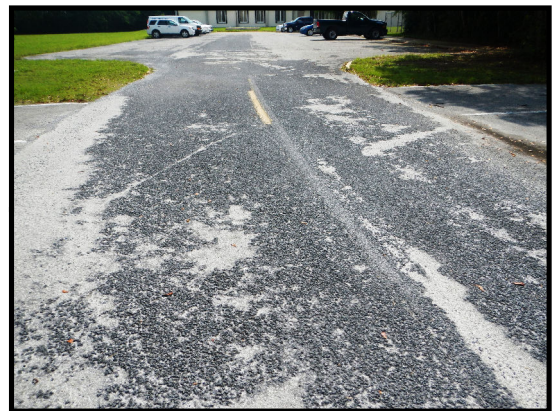
Route Number	Public / NonPublic	Date Visited	Area (sq ft)	Lane Miles *	Surface Type
0900	PUBLIC	4/21/2013	109,481	1.89	AS
Culverts	Drop Inlets	Gates	Curb & Gutter	Curb	PCR
0	9	0	NO CURB AND GUTTER	CONCRETE CURB	FAIR/73

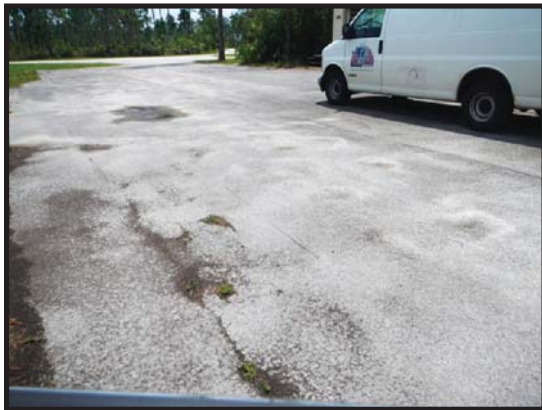
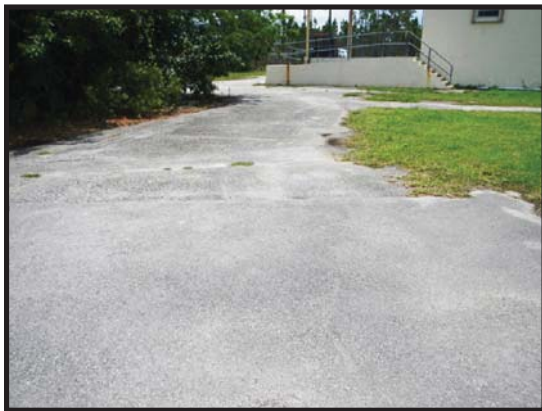
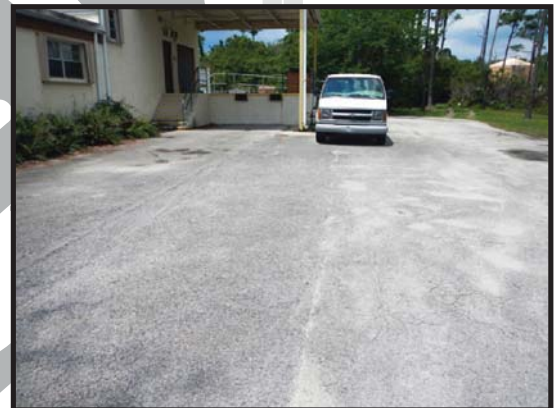
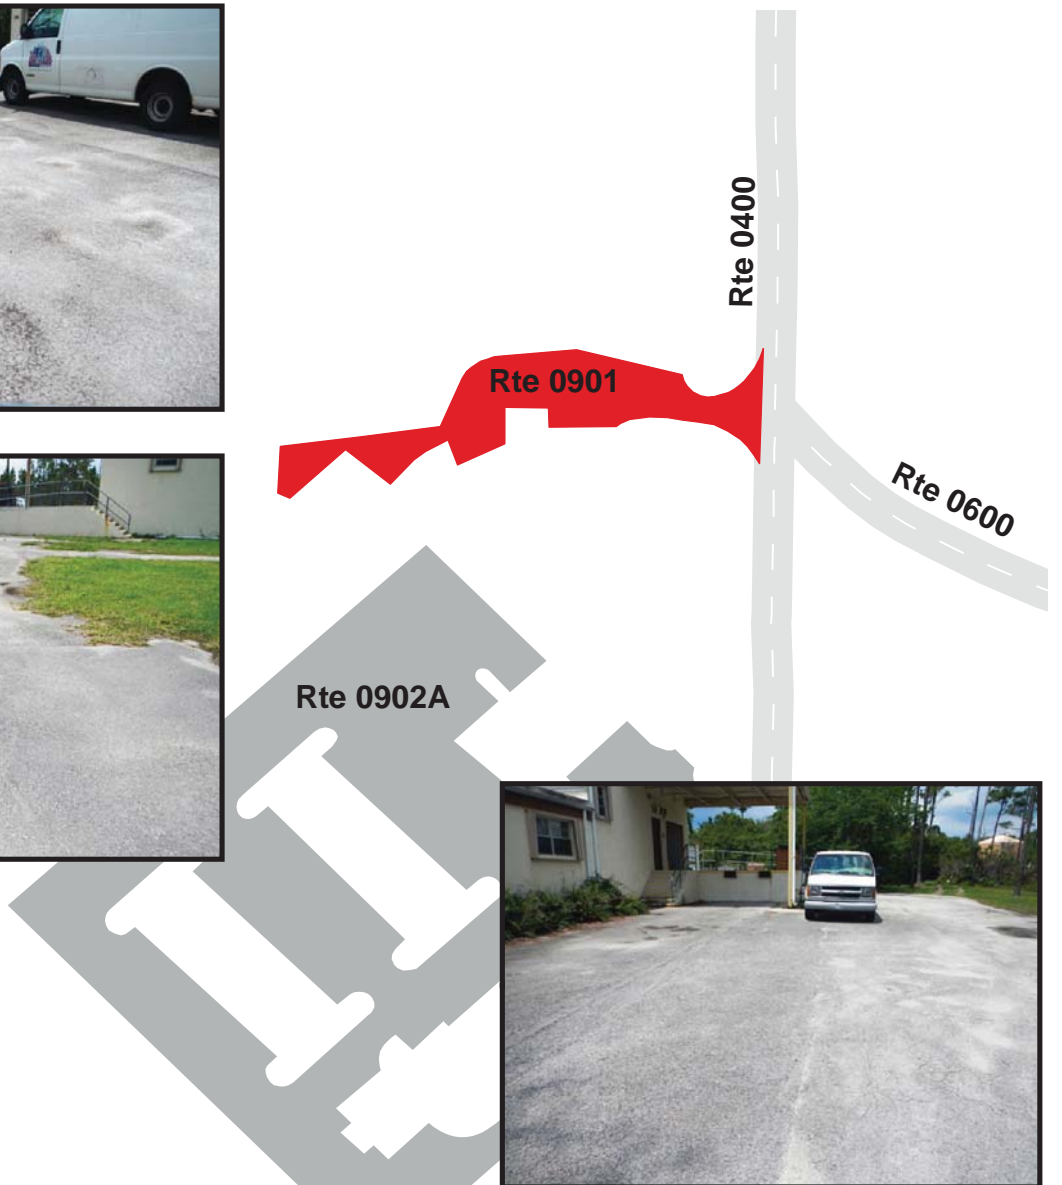
Route 0901

Route Number	Public / NonPublic	Date Visited	Area (sq ft)	Lane Miles *	Surface Type
0901	PUBLIC	4/21/2013	9,430	0.16	AS
Culverts	Drop Inlets	Gates	Curb & Gutter	Curb	PCR
0	0	0	NO CURB AND GUTTER	NO CURB	POOR/45

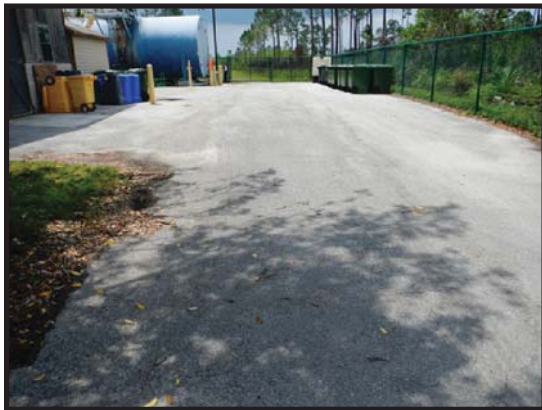
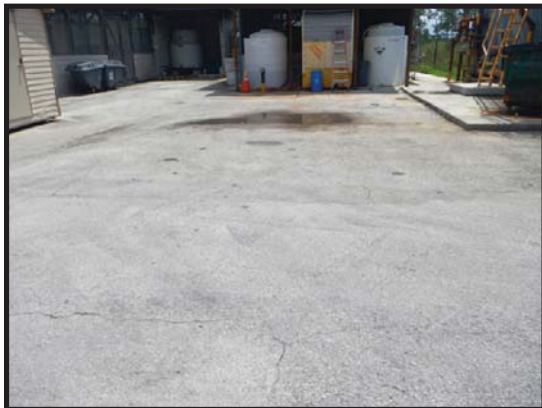
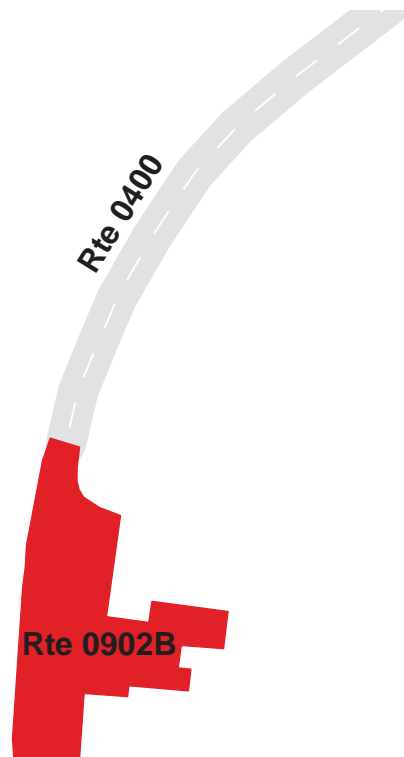
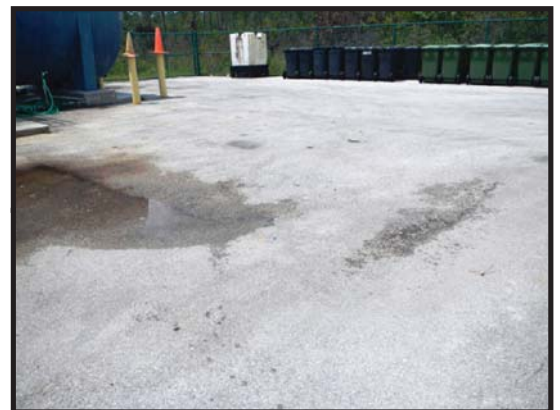
Route 0902B

Route Number	Public / NonPublic	Date Visited	Area (sq ft)	Lane Miles *	Surface Type
0902B	NONPUBLIC	4/21/2013	3,382	0.06	AS
Culverts	Drop Inlets	Gates	Curb & Gutter	Curb	PCR
0	0	2	NO CURB AND GUTTER	NO CURB	FAIR/73

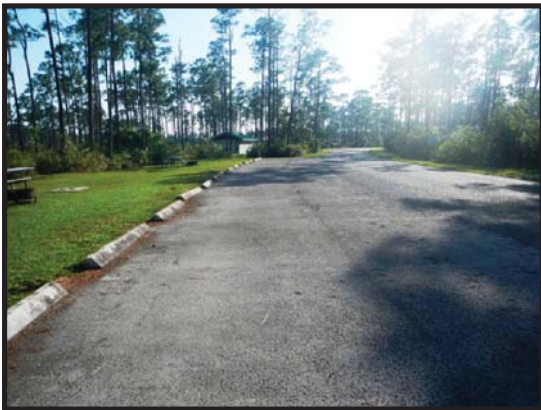
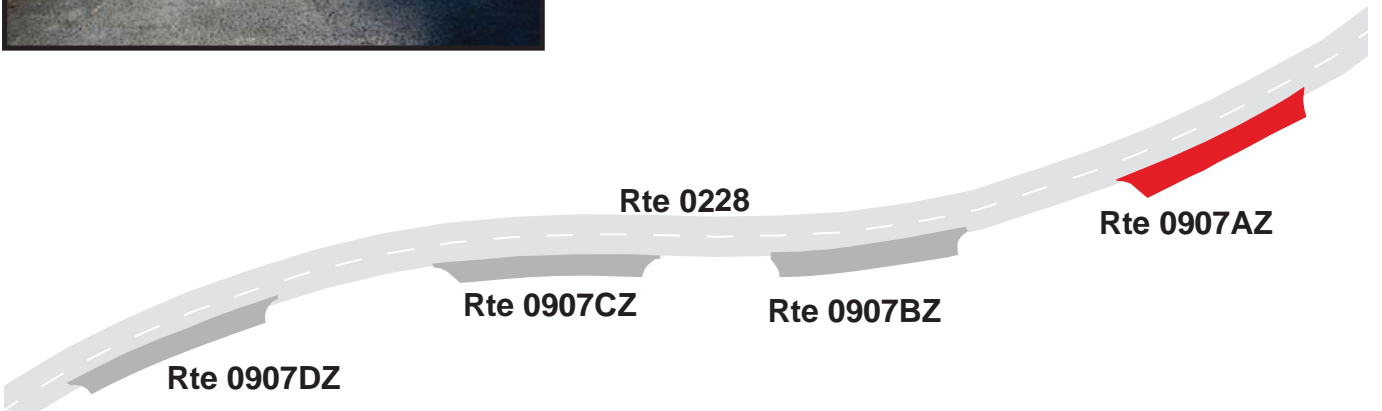
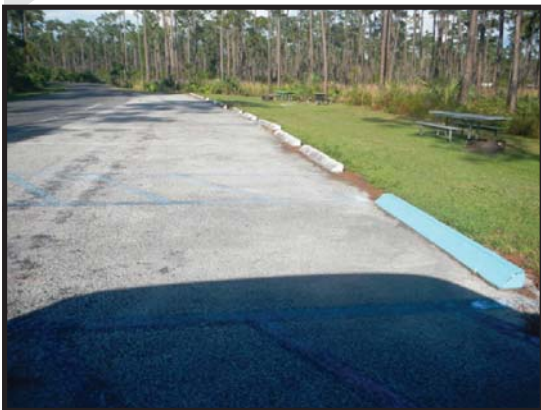
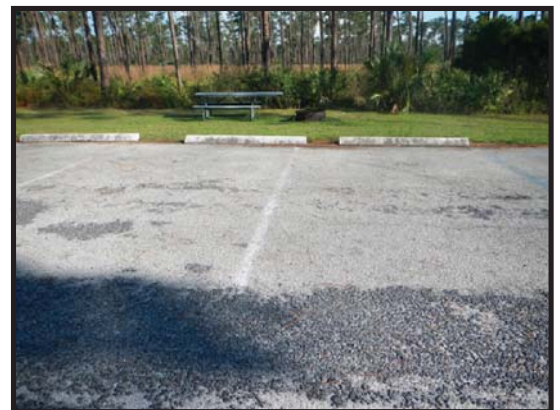
Route 0907AZ

Route Number	Public / NonPublic	Date Visited	Area (sq ft)	Lane Miles *	Surface Type
0907AZ	PUBLIC	4/20/2013	3,185	0.06	AS
Culverts	Drop Inlets	Gates	Curb & Gutter	Curb	PCR
0	0	0	NO CURB AND GUTTER	NO CURB	GOOD/90

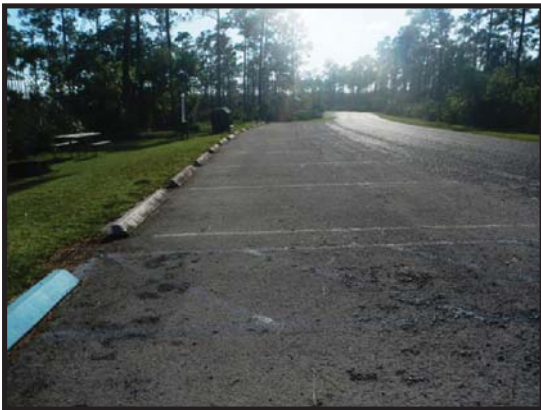
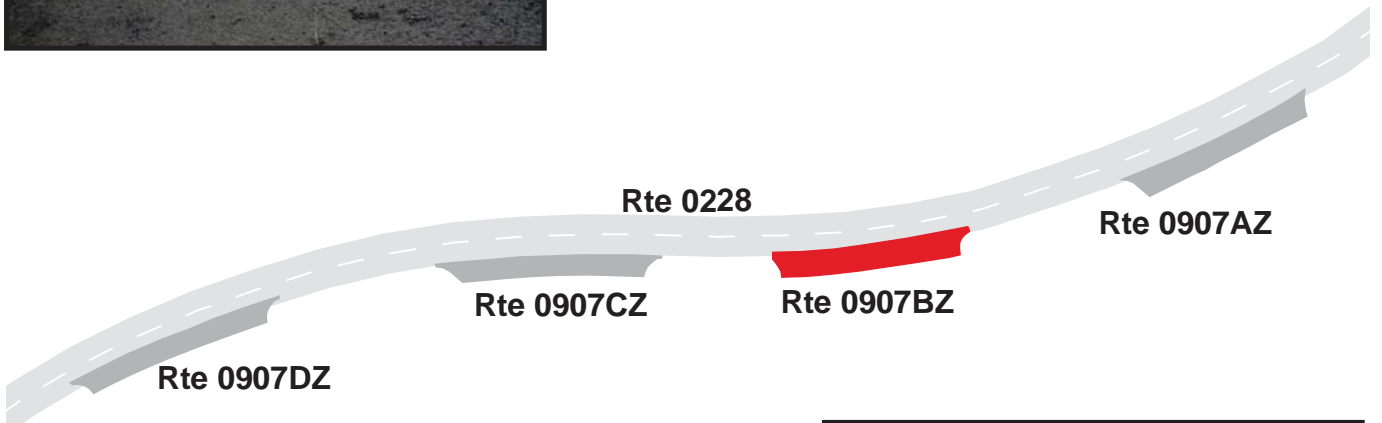
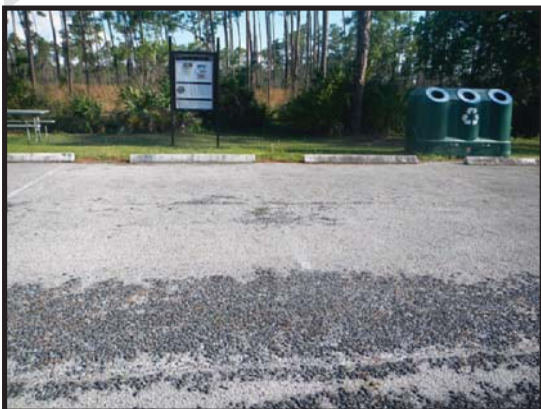
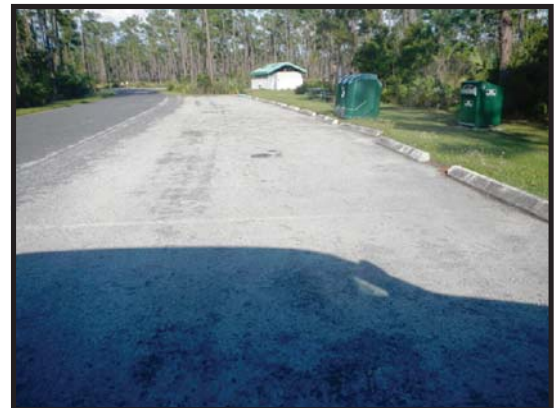
Route 0907BZ

Route Number	Public / NonPublic	Date Visited	Area (sq ft)	Lane Miles *	Surface Type
0907BZ	PUBLIC	4/20/2013	3,317	0.06	AS
Culverts	Drop Inlets	Gates	Curb & Gutter	Curb	PCR
0	0	0	NO CURB AND GUTTER	NO CURB	GOOD/90

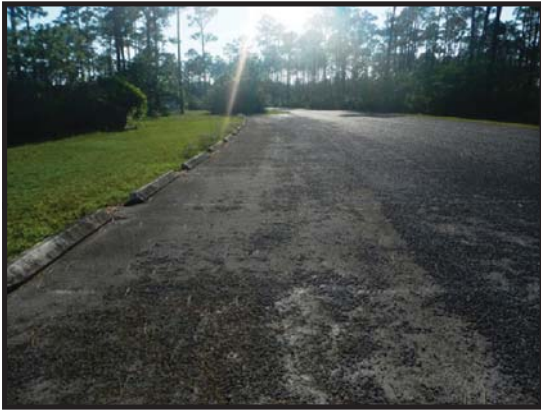
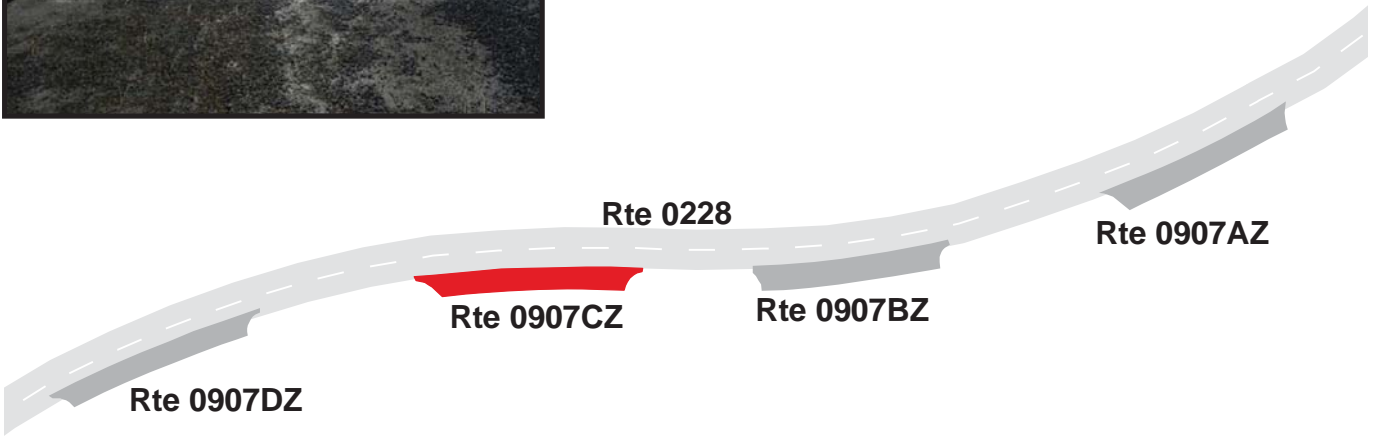
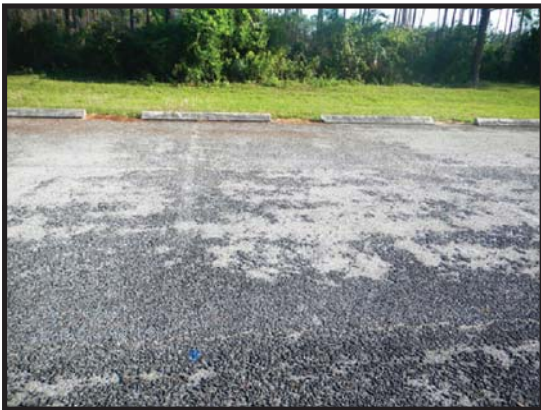
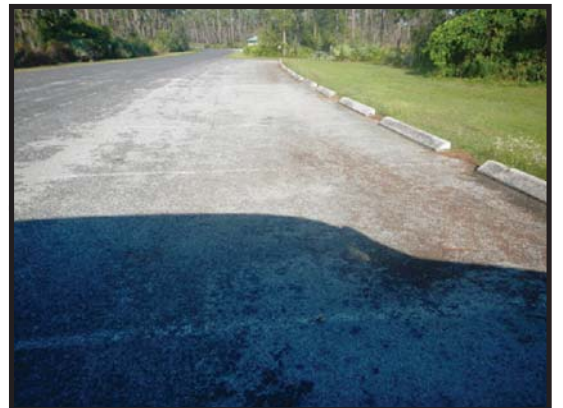
EVERGLADES NATIONAL PARK
Route 0907CZ
 LONG PINE KEY PICNIC PARKING AREA C
 ADJACENT TO ROUTE 0228 (LONG PINE KEY ROAD)

Route Number	Public / NonPublic	Date Visited	Area (sq ft)	Lane Miles *	Surface Type
0907CZ	PUBLIC	4/20/2013	3,065	0.05	AS
Culverts	Drop Inlets	Gates	Curb & Gutter	Curb	PCR
0	0	0	NO CURB AND GUTTER	NO CURB	GOOD/90

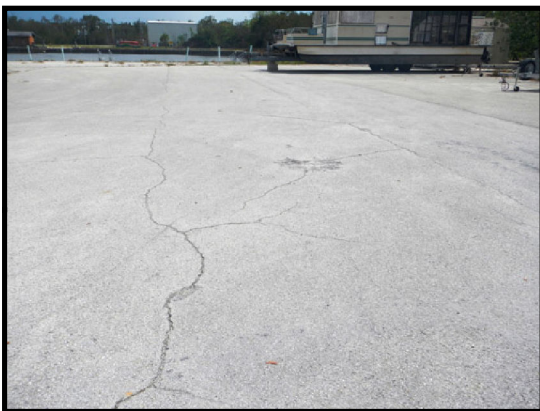
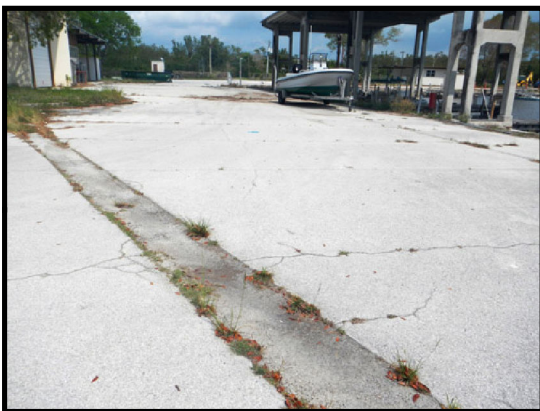
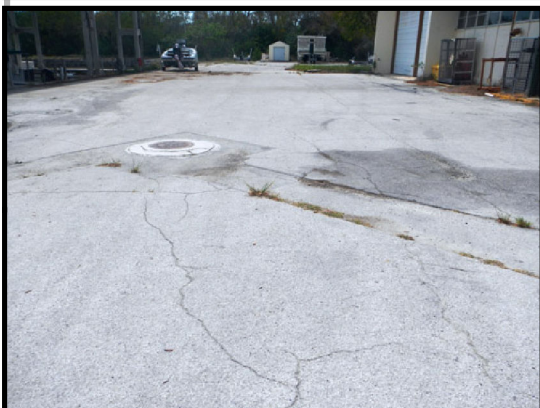
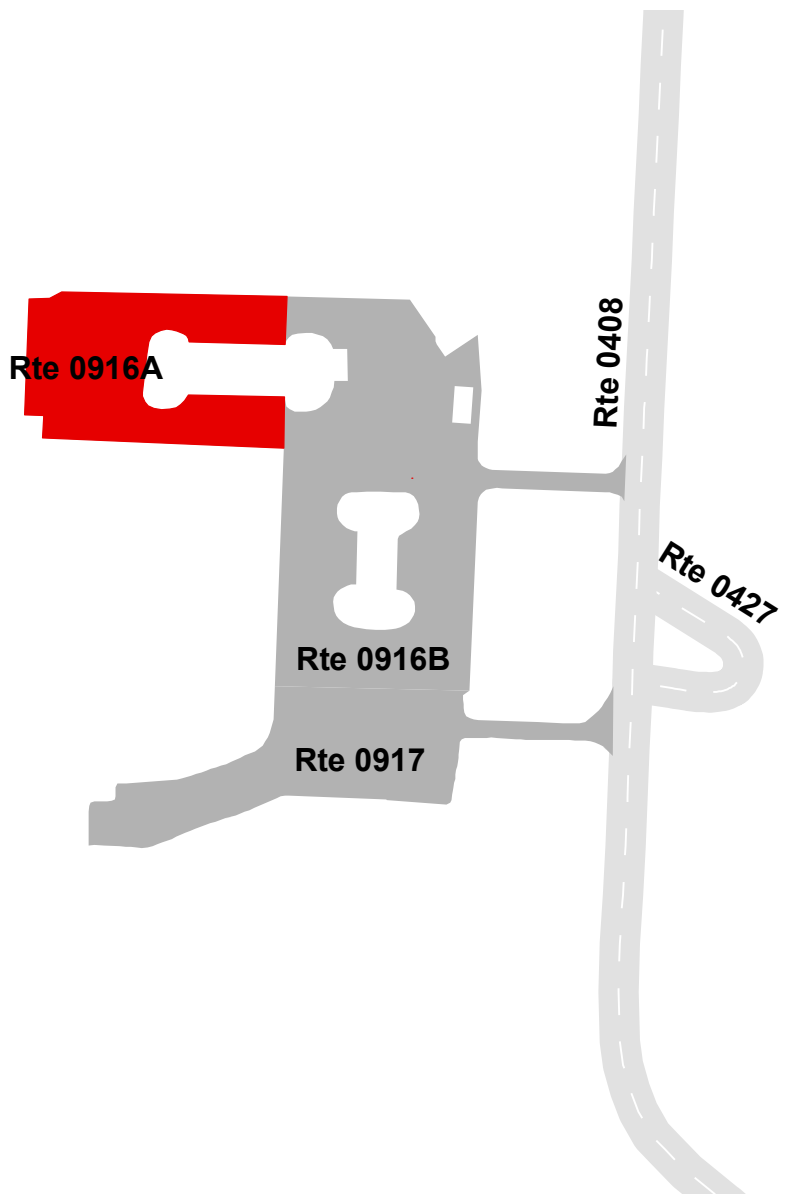
Route 0916A

Route Number	Public / NonPublic	Date Visited	Area (sq ft)	Lane Miles *	Surface Type
0916A	NONPUBLIC	4/20/2013	31,457	0.54	AS
Culverts	Drop Inlets	Gates	Curb & Gutter	Curb	PCR
0	0	0	NO CURB AND GUTTER	CONCRETE CURB	POOR/45

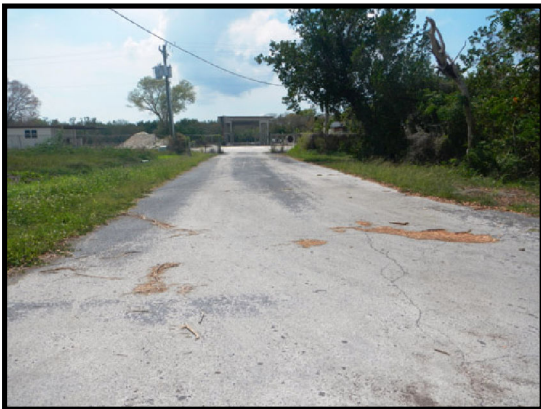
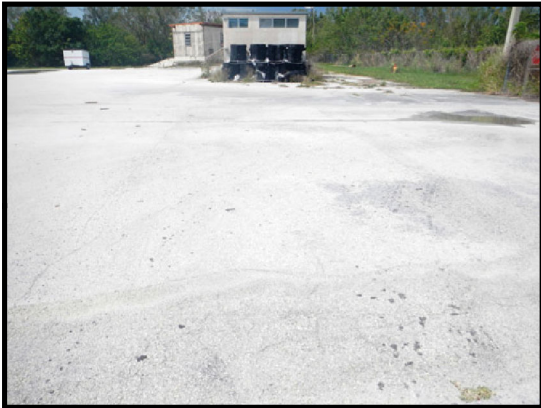
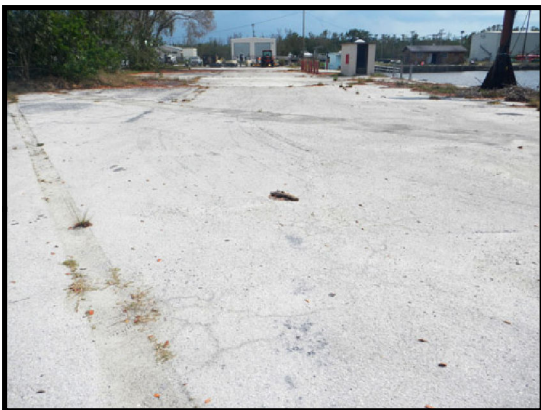
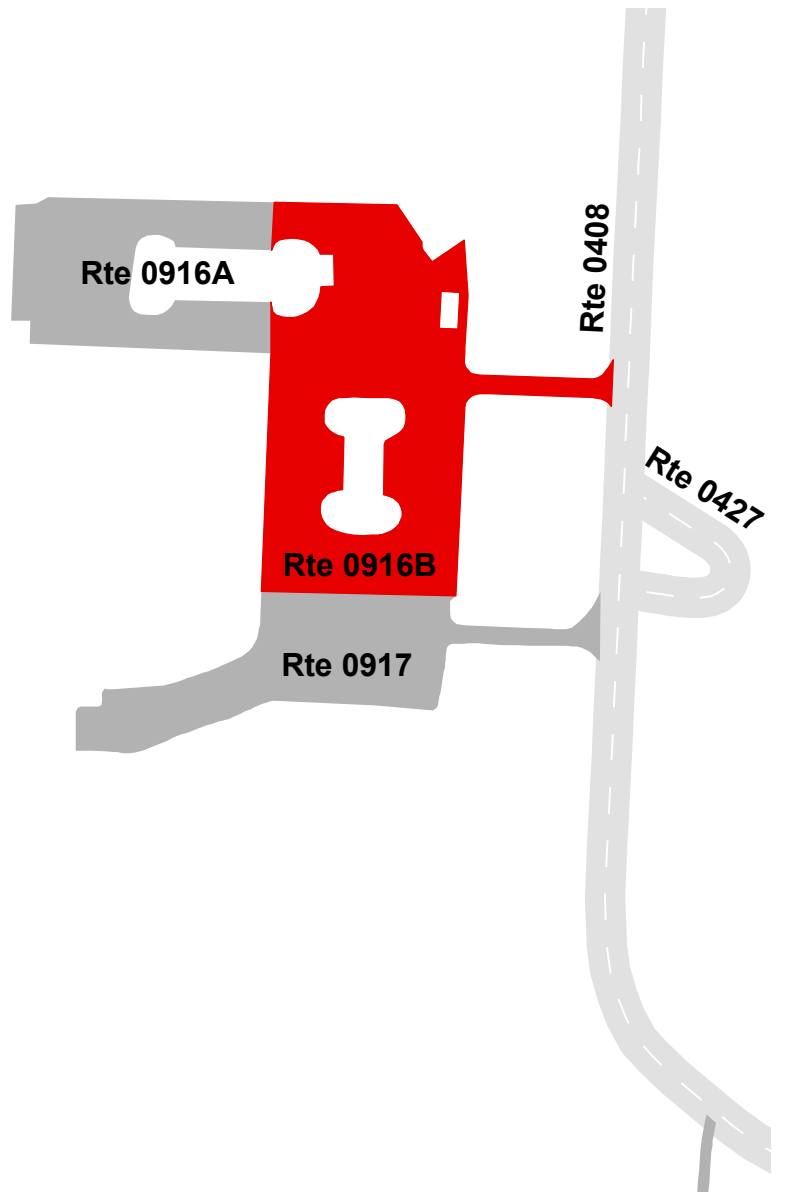
Route 0916B

Route Number	Public / NonPublic	Date Visited	Area (sq ft)	Lane Miles *	Surface Type
0916B	NONPUBLIC	4/20/2013	67,536	1.16	AS
Culverts	Drop Inlets	Gates	Curb & Gutter	Curb	PCR
0	0	0	NO CURB AND GUTTER	CONCRETE CURB	POOR/45

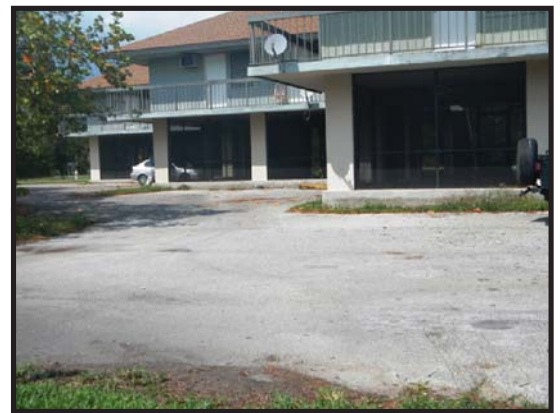
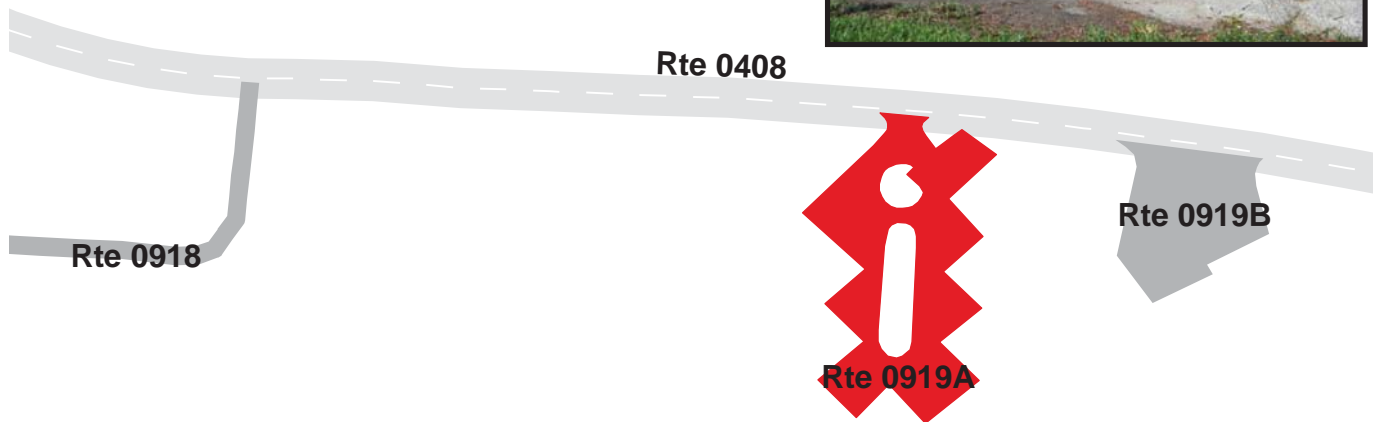
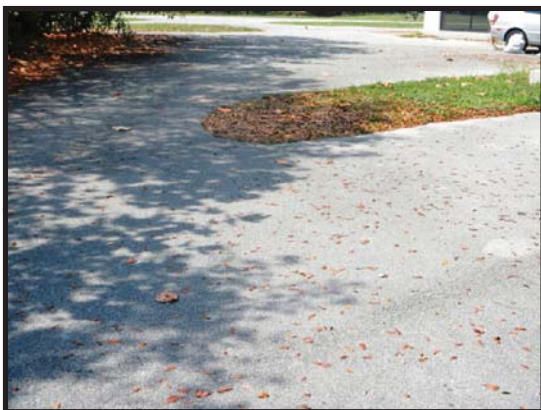
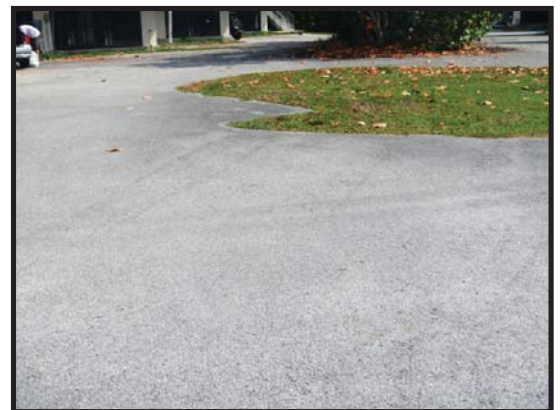
Route 0919A

Route Number	Public / NonPublic	Date Visited	Area (sq ft)	Lane Miles *	Surface Type
0919A	PUBLIC	4/19/2013	11,039	0.19	AS
Culverts	Drop Inlets	Gates	Curb & Gutter	Curb	PCR
0	0	0	NO CURB AND GUTTER	NO CURB	GOOD/90

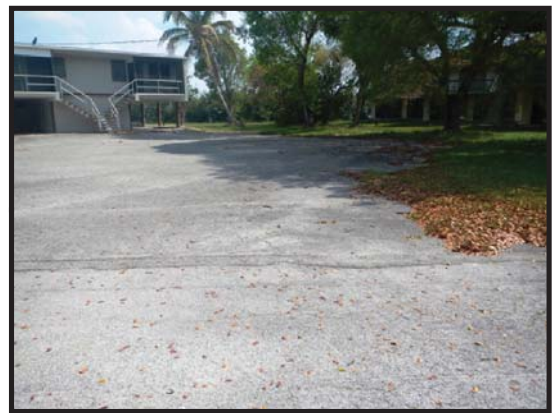
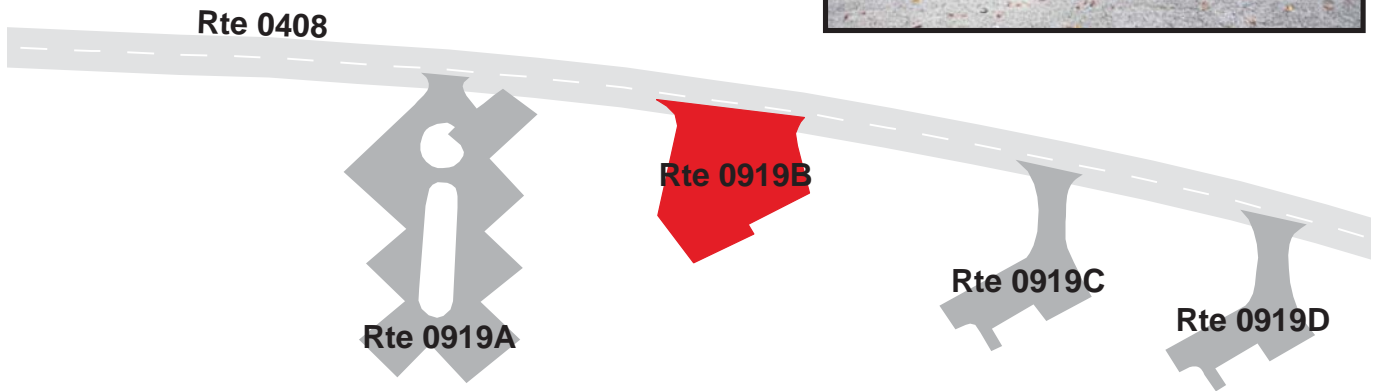
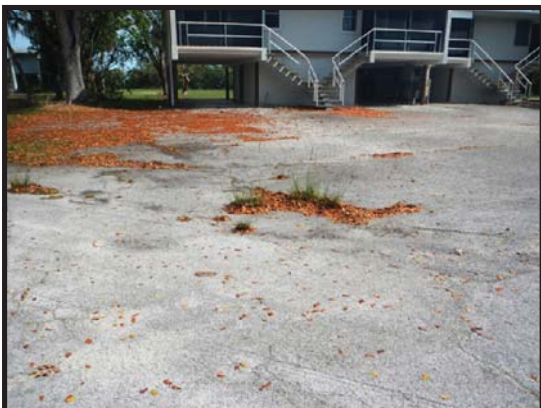
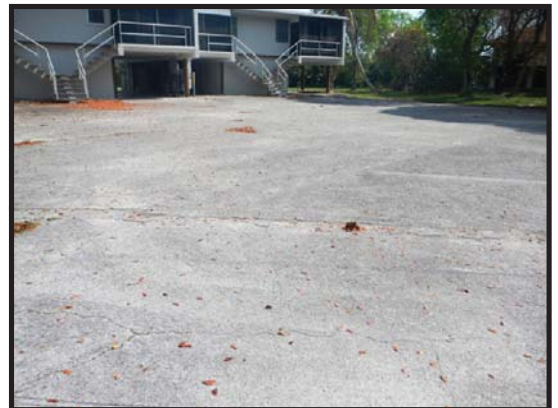
Route 0919B

Route Number	Public / NonPublic	Date Visited	Area (sq ft)	Lane Miles *	Surface Type
0919B	PUBLIC	4/19/2013	6,376	0.11	AS
Culverts	Drop Inlets	Gates	Curb & Gutter	Curb	PCR
0	0	0	NO CURB AND GUTTER	NO CURB	FAIR/73

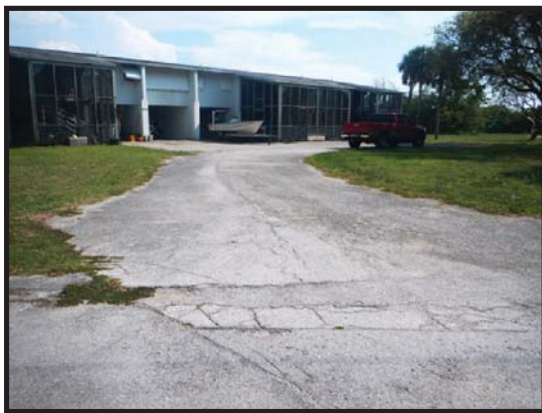
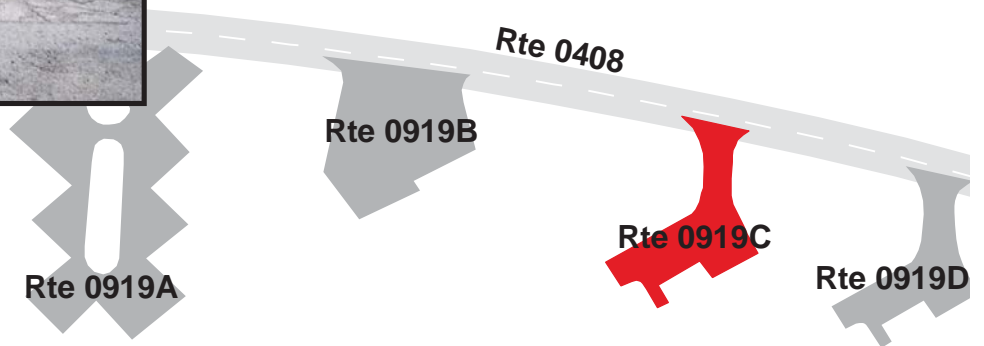
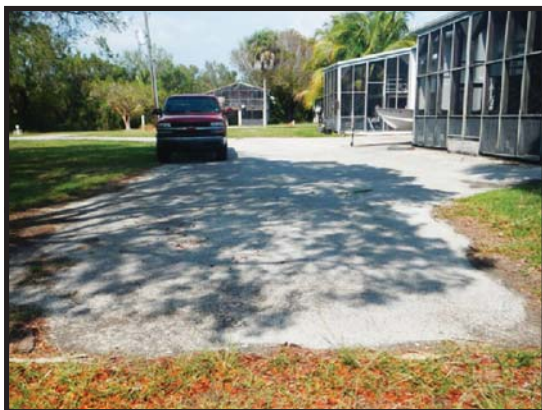
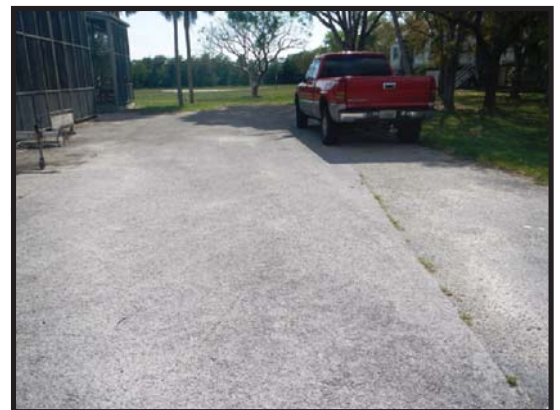
Route 0919C

Route Number	Public / NonPublic	Date Visited	Area (sq ft)	Lane Miles *	Surface Type
0919C	PUBLIC	4/19/2013	3,780	0.07	AS
Culverts	Drop Inlets	Gates	Curb & Gutter	Curb	PCR
0	0	0	NO CURB AND GUTTER	NO CURB	POOR/45

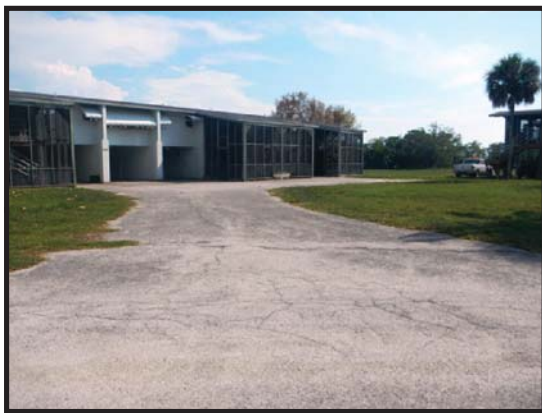
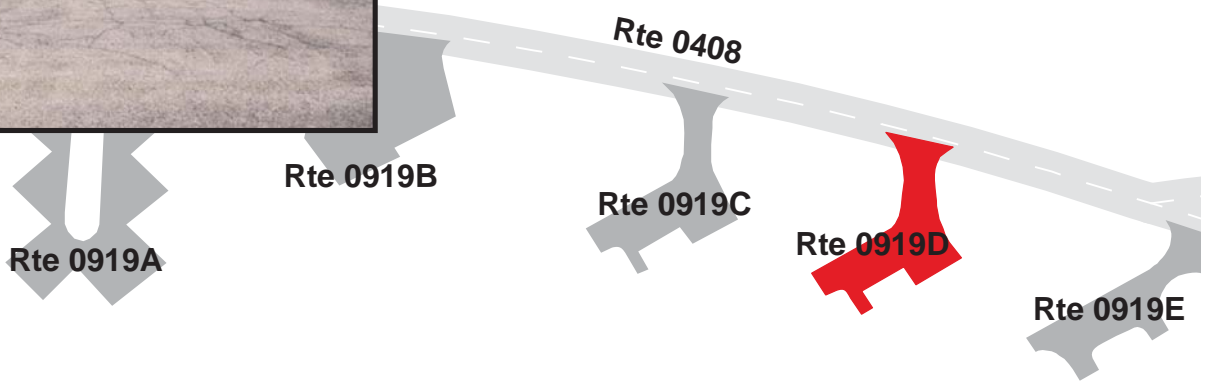
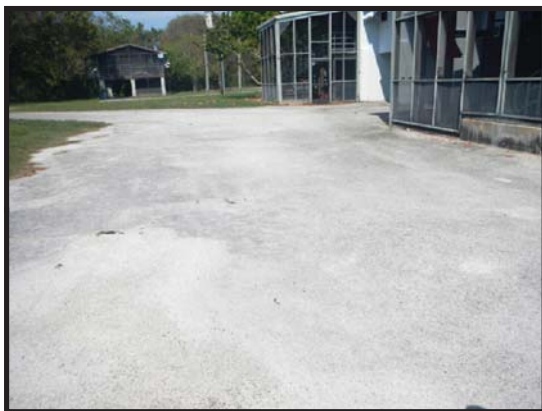
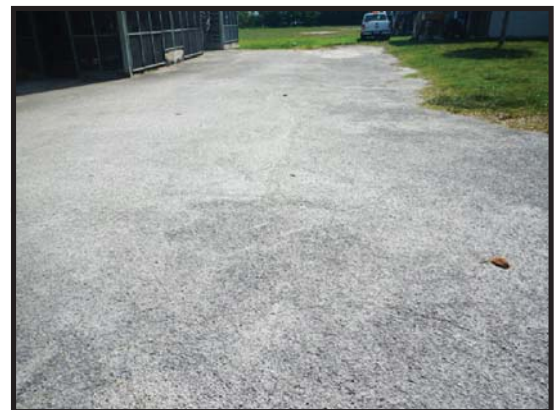
Route 0919D

Route Number	Public / NonPublic	Date Visited	Area (sq ft)	Lane Miles *	Surface Type
0919D	PUBLIC	4/19/2013	3,549	0.06	AS
Culverts	Drop Inlets	Gates	Curb & Gutter	Curb	PCR
0	0	0	NO CURB AND GUTTER	NO CURB	FAIR/73

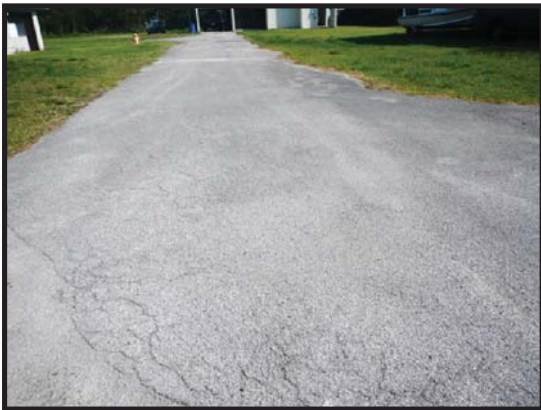
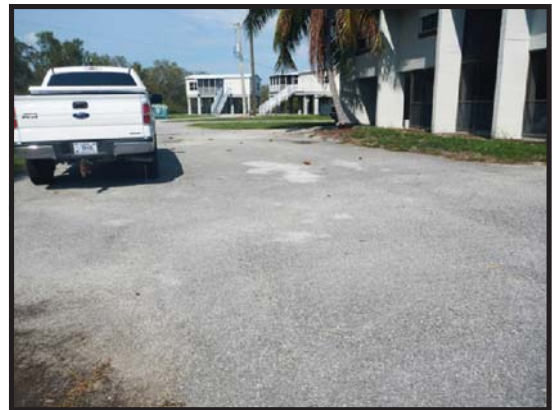
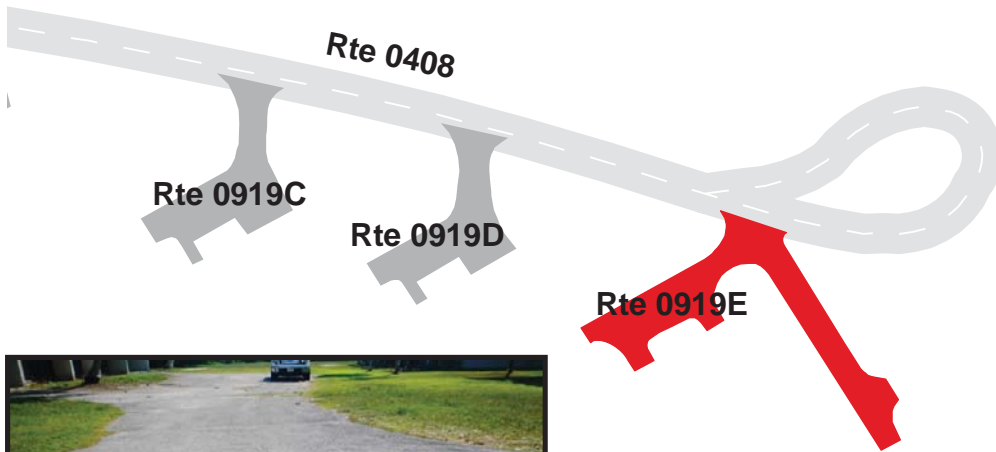
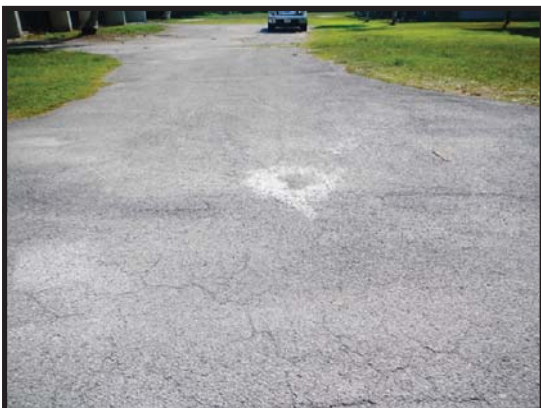
Route 0919E

Route Number	Public / NonPublic	Date Visited	Area (sq ft)	Lane Miles *	Surface Type
0919E	PUBLIC	4/19/2013	5,973	0.10	AS
Culverts	Drop Inlets	Gates	Curb & Gutter	Curb	PCR
0	0	0	NO CURB AND GUTTER	NO CURB	POOR/45

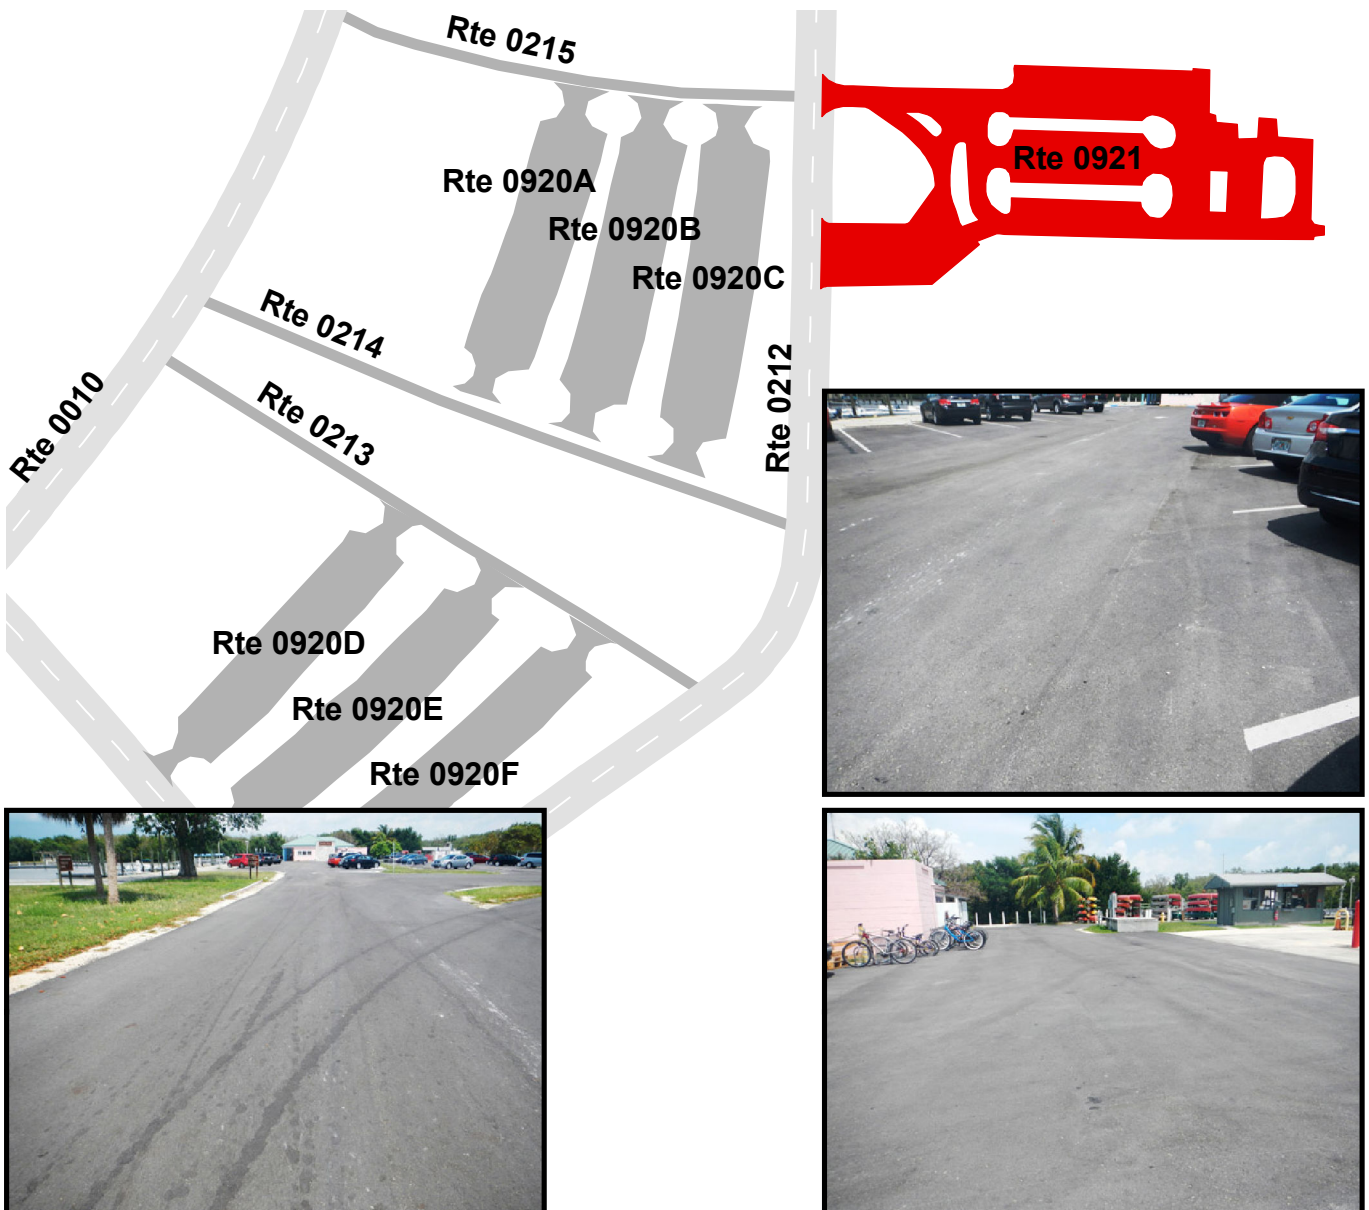
Route 0921

Route Number	Public / NonPublic	Date Visited	Area (sq ft)	Lane Miles *	Surface Type
0921	PUBLIC	4/20/2013	60,110	1.04	AS
Culverts	Drop Inlets	Gates	Curb & Gutter	Curb	PCR
0	0	0	NO CURB AND GUTTER	ASPHALT & CONCRETE	EXCELLENT/97
