Federal Lands Highway Road Inventory Program

Road Inventory and Condition Assessment

Everglades National Park EVER

Cycle 5 Report

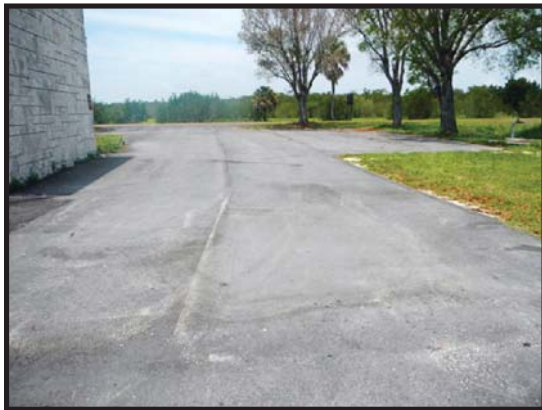
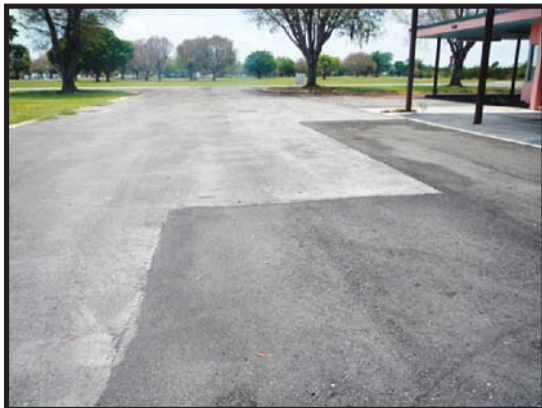
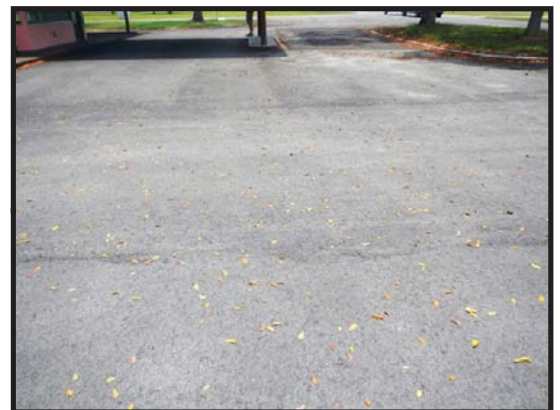
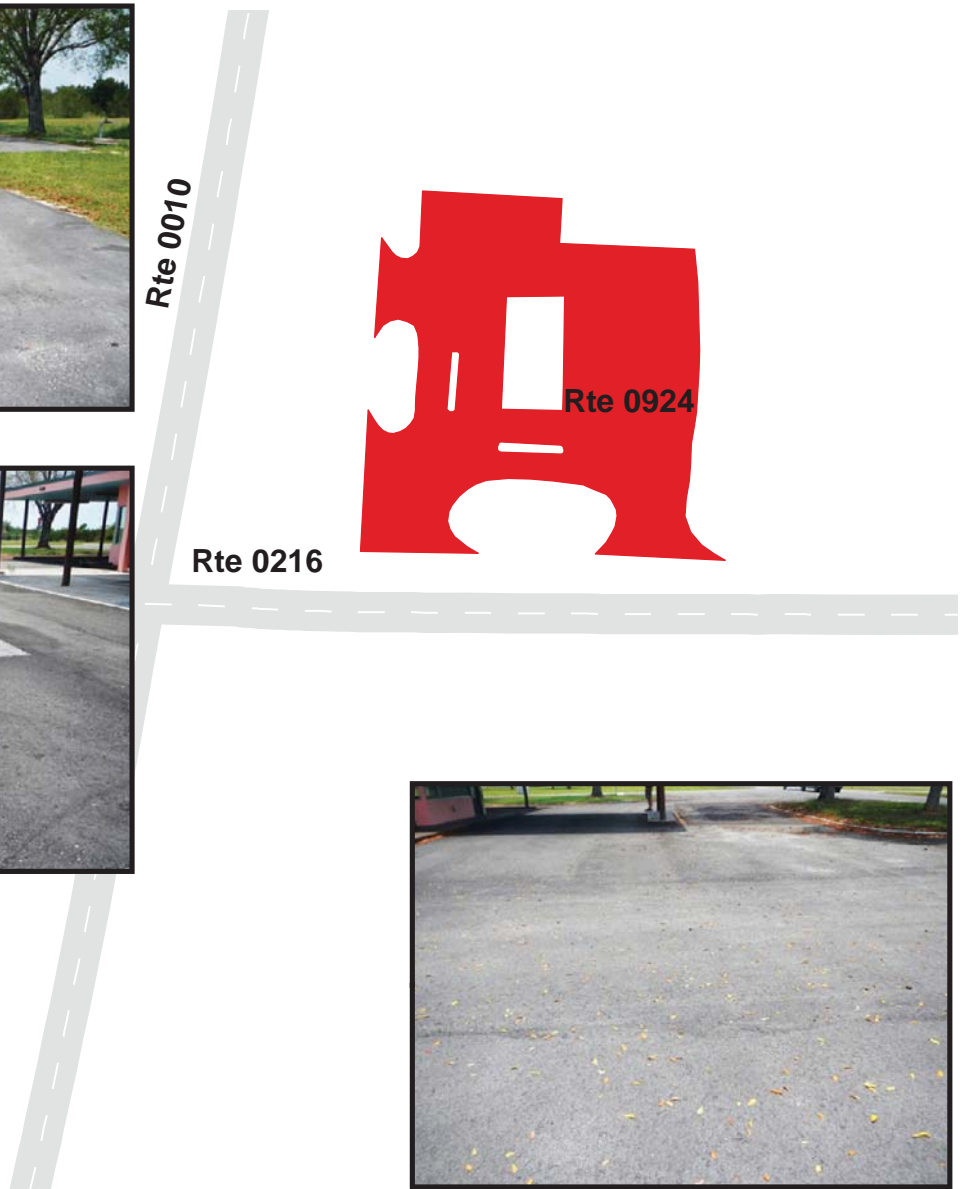
Route 0924

Route Number	Public / NonPublic	Date Visited	Area (sq ft)	Lane Miles *	Surface Type
0924	PUBLIC	4/20/2013	14,203	0.25	AS
Culverts	Drop Inlets	Gates	Curb & Gutter	Curb	PCR
0	0	0	NO CURB AND GUTTER	CONCRETE CURB	GOOD/90

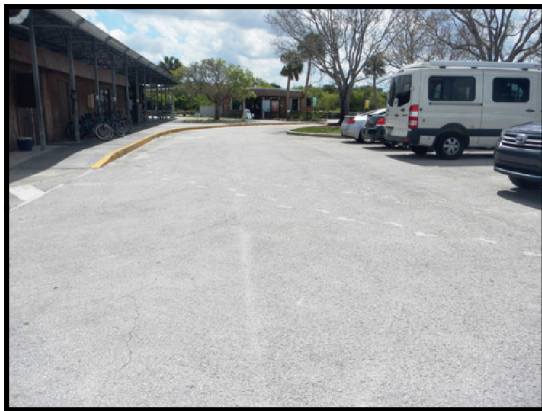
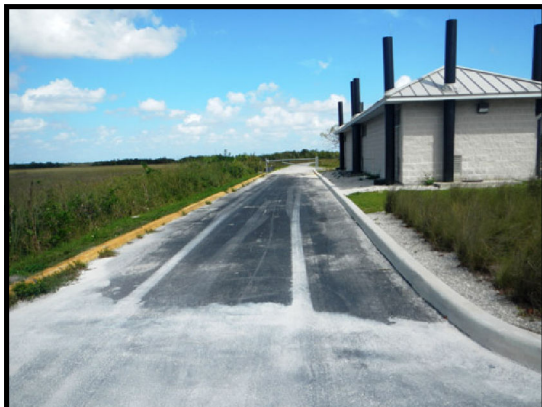
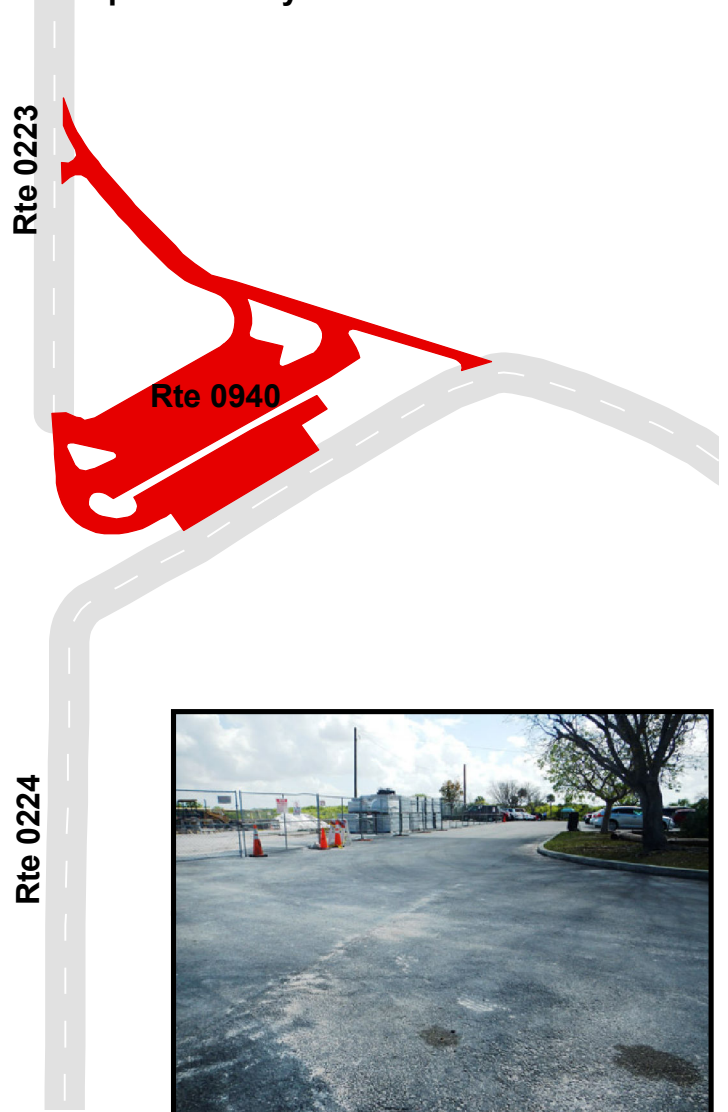
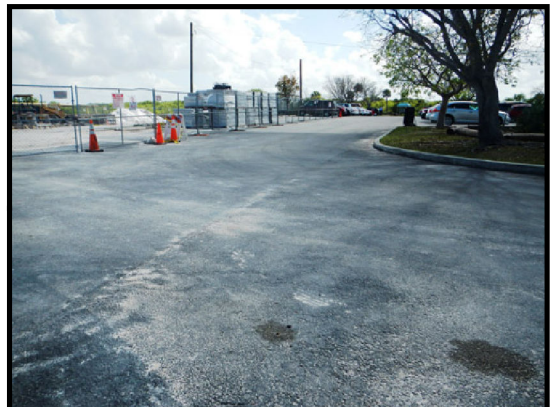
Route 0940

NOTE: A portion of this parking area was removed / reconstructed in Cycle-5 in preparation for the new visitor center at this location. The construction was still in progress during the site visit and GPS will be updated in Cycle-6.

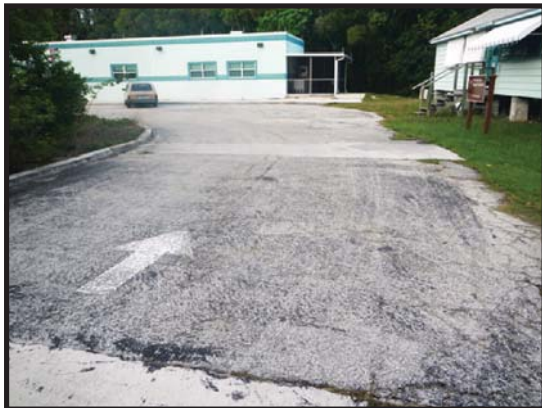
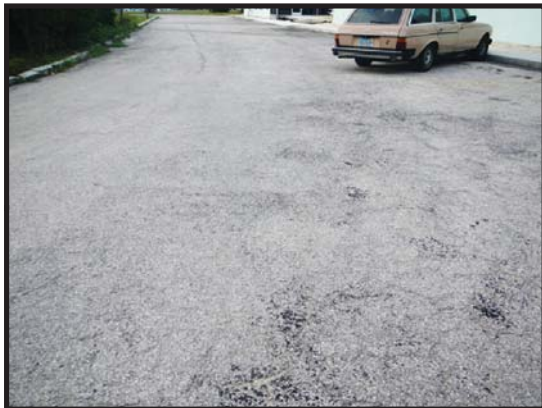
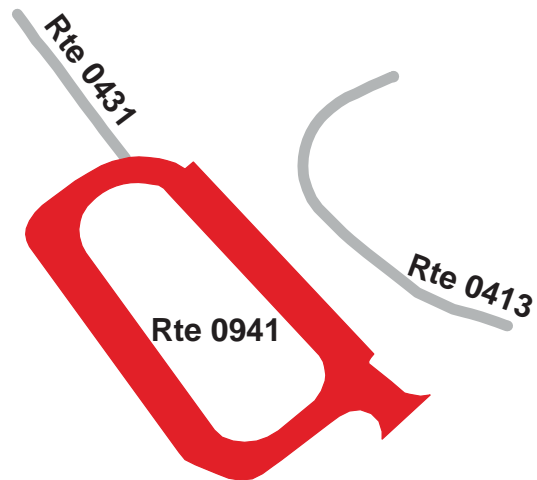
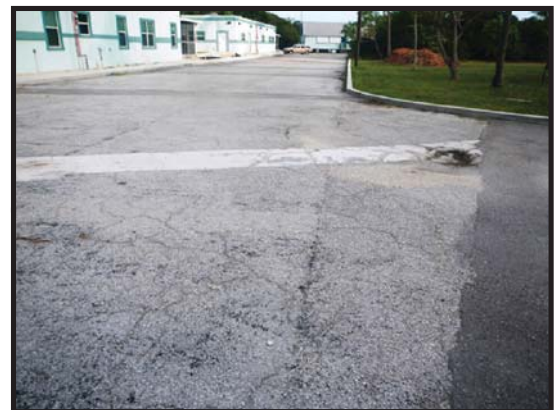
Route 0941

Route Number	Public / NonPublic	Date Visited	Area (sq ft)	Lane Miles *	Surface Type
0941	NONPUBLIC	4/20/2013	23,416	0.40	AS
Culverts	Drop Inlets	Gates	Curb & Gutter	Curb	PCR
0	0	0	NO CURB AND GUTTER	CONCRETE CURB	POOR/45
