Federal Lands Highway Road Inventory Program

Road Inventory and Condition Assessment

Herbert Hoover National Historic Site HEHO

Cycle 5 Report

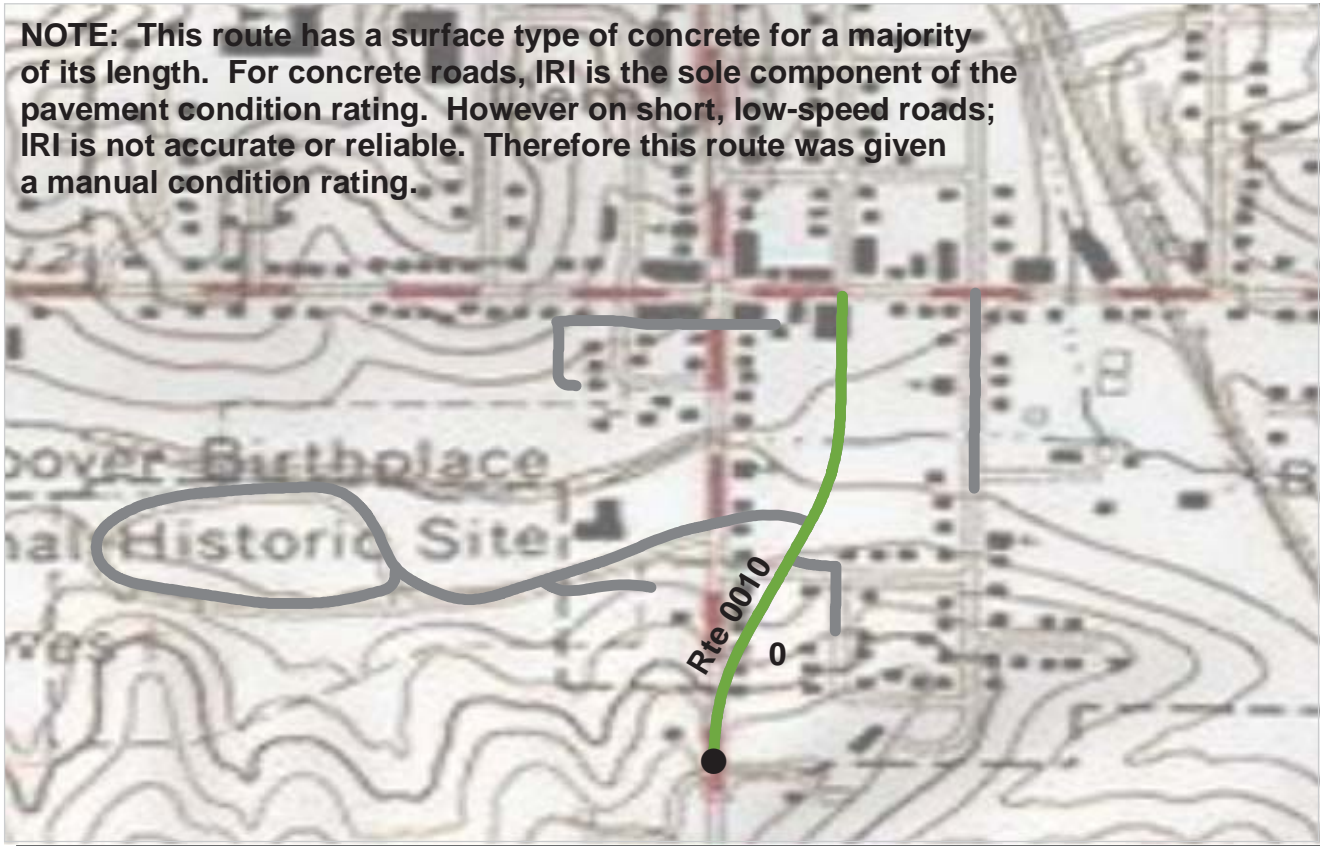
ROUTE: 0010 PARKSIDE DRIVE

NOTE: This route has a surface type of concrete for a majority of its length. For concrete roads, IRI is the sole component of the pavement condition rating. However on short, low-speed roads; IRI is not accurate or reliable. Therefore this route was given a manual condition rating.

Section Number	0				
Section Length (mi)	0.32				
Cross Section Information					
Number of Lanes	2				
Paved Width (ft)	35				
Lane Width (ft)	11				
Roadway Condition Information					
SCR (Surface Condition Rating)	NC				
PCR (Pavement Condition Rating)	90				
Distress Index Values					
Structural Crack Index	NC				
Transverse Cracking Index	NC				
Patching Index	NC				
Rutting Index	NC				
Roughness Condition Index (RCI)	NC

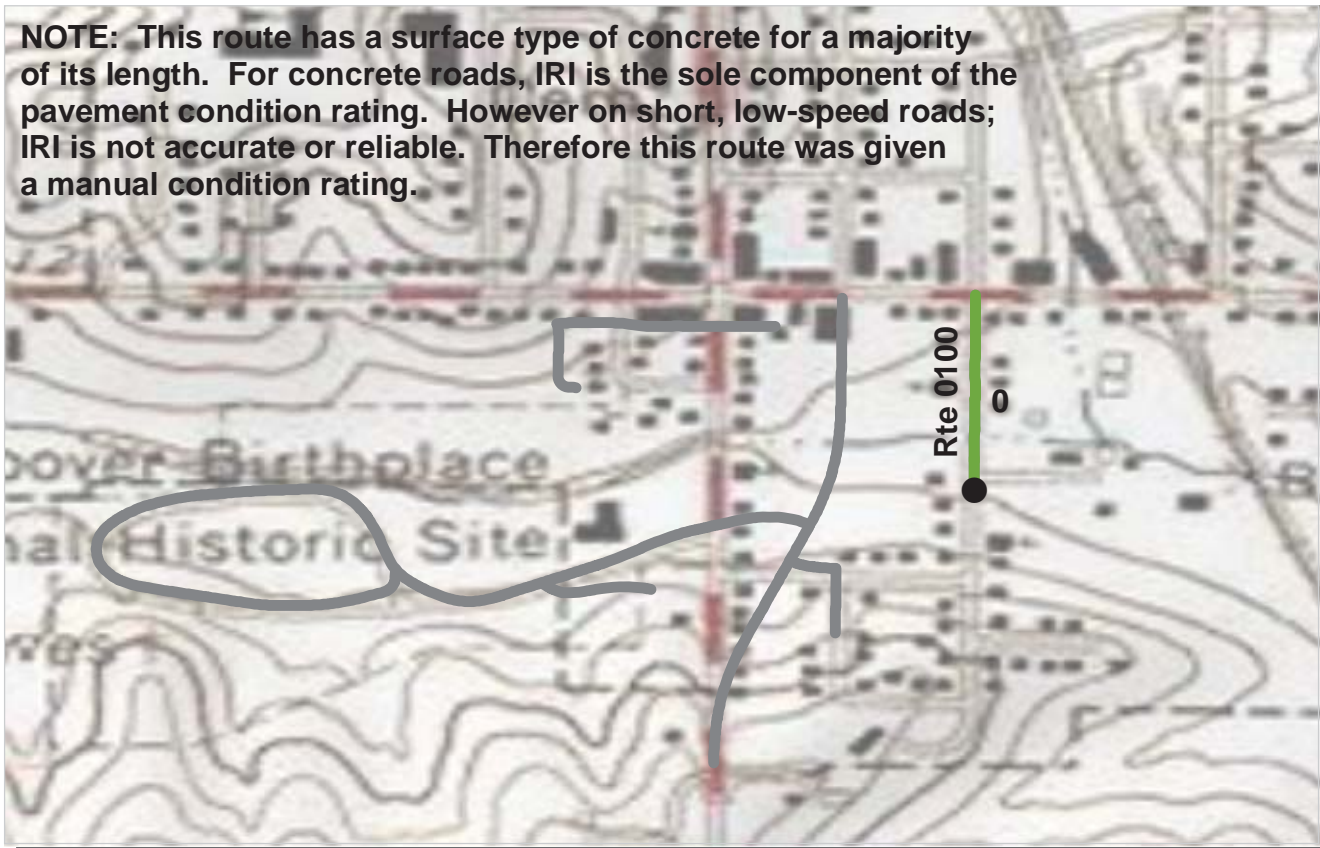
ROUTE: 0100 SECOND STREET

NOTE: This route has a surface type of concrete for a majority of its length. For concrete roads, IRI is the sole component of the pavement condition rating. However on short, low-speed roads; IRI is not accurate or reliable. Therefore this route was given a manual condition rating.

Section Number	0				
Section Length (mi)	0.13				
Cross Section Information					
Number of Lanes	2				
Paved Width (ft)	29				
Lane Width (ft)	15				
Roadway Condition Information					
SCR (Surface Condition Rating)	NC				
PCR (Pavement Condition Rating)	90				
Distress Index Values					
Structural Crack Index	NC				
Transverse Cracking Index	NC				
Patching Index	NC				
Rutting Index	NC				
Roughness Condition Index (RCI)	NC

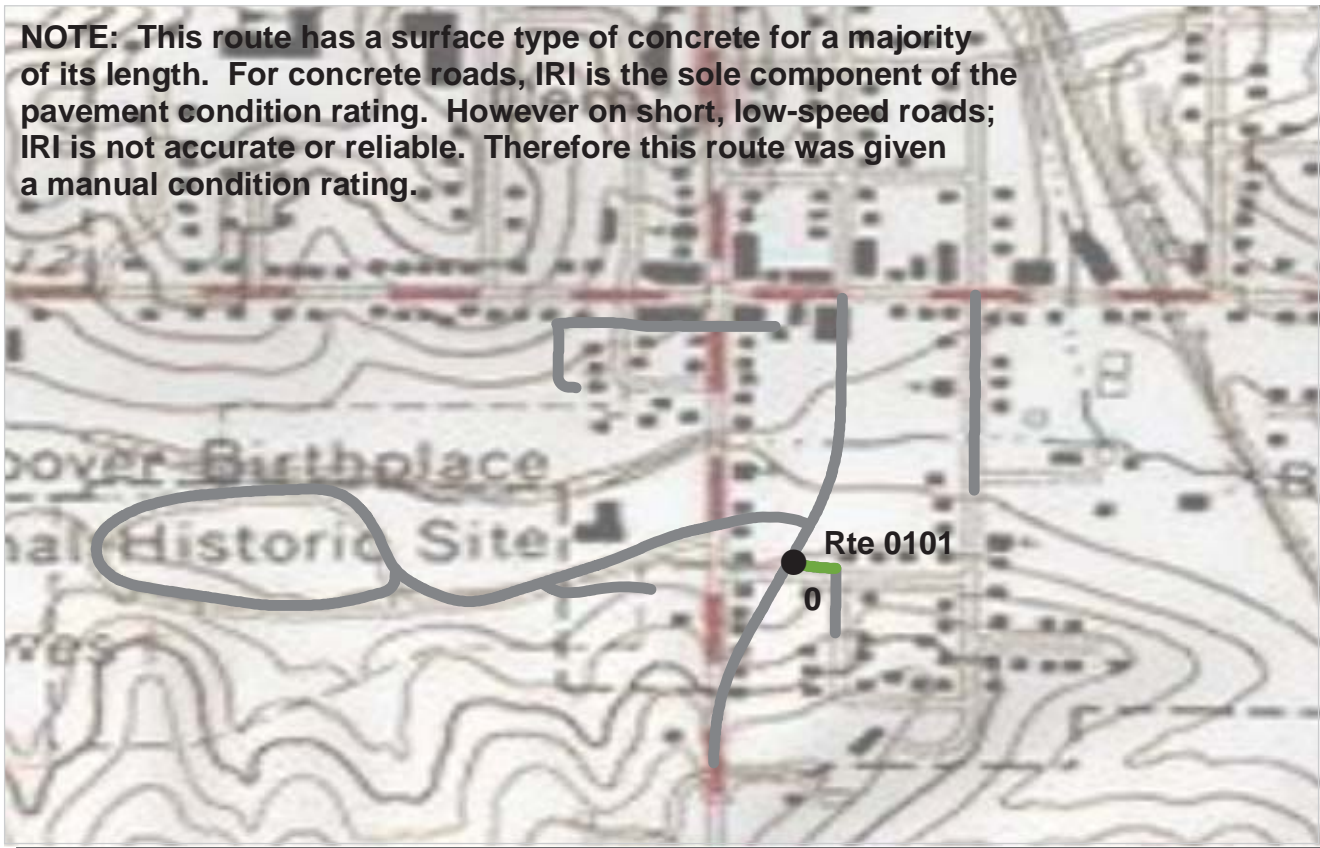
ROUTE: 0101 CEDAR STREET

NOTE: This route has a surface type of concrete for a majority of its length. For concrete roads, IRI is the sole component of the pavement condition rating. However on short, low-speed roads; IRI is not accurate or reliable. Therefore this route was given a manual condition rating.

Section Number	0				
Section Length (mi)	0.02				
Cross Section Information					
Number of Lanes	2				
Paved Width (ft)	26				
Lane Width (ft)	13				
Roadway Condition Information					
SCR (Surface Condition Rating)	NC				
PCR (Pavement Condition Rating)	90				
Distress Index Values					
Structural Crack Index	NC				
Transverse Cracking Index	NC				
Patching Index	NC				
Rutting Index	NC				
Roughness Condition Index (RCI)	NC

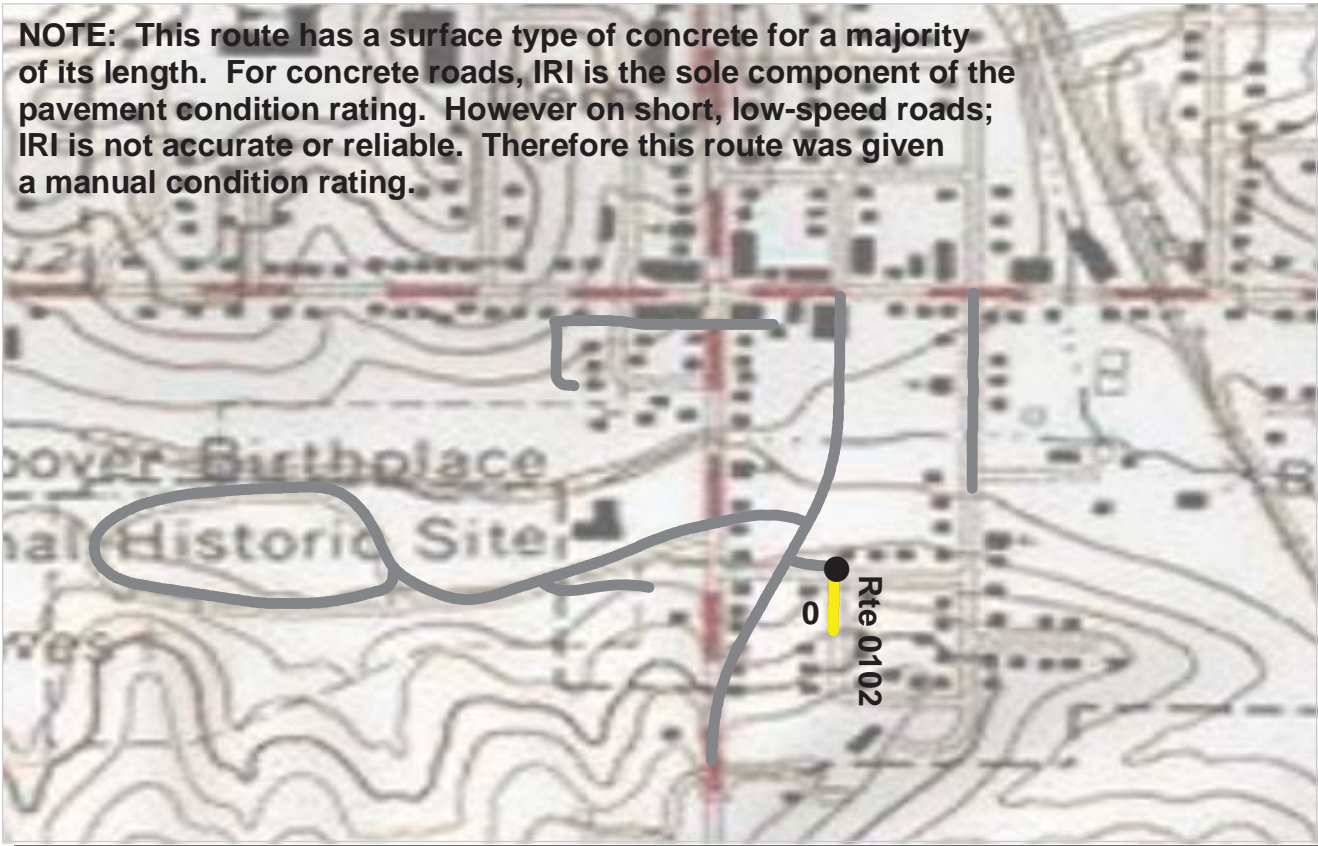
ROUTE: 0102 1ST STREET

NOTE: This route has a surface type of concrete for a majority of its length. For concrete roads, IRI is the sole component of the pavement condition rating. However on short, low-speed roads; IRI is not accurate or reliable. Therefore this route was given a manual condition rating.

Section Number	0				
Section Length (mi)	0.04				
Cross Section Information					
Number of Lanes	2				
Paved Width (ft)	25				
Lane Width (ft)	12				
Roadway Condition Information					
SCR (Surface Condition Rating)	NC				
PCR (Pavement Condition Rating)	73				
Distress Index Values					
Structural Crack Index	NC				
Transverse Cracking Index	NC				
Patching Index	NC				
Rutting Index	NC				
Roughness Condition Index (RCI)	NC

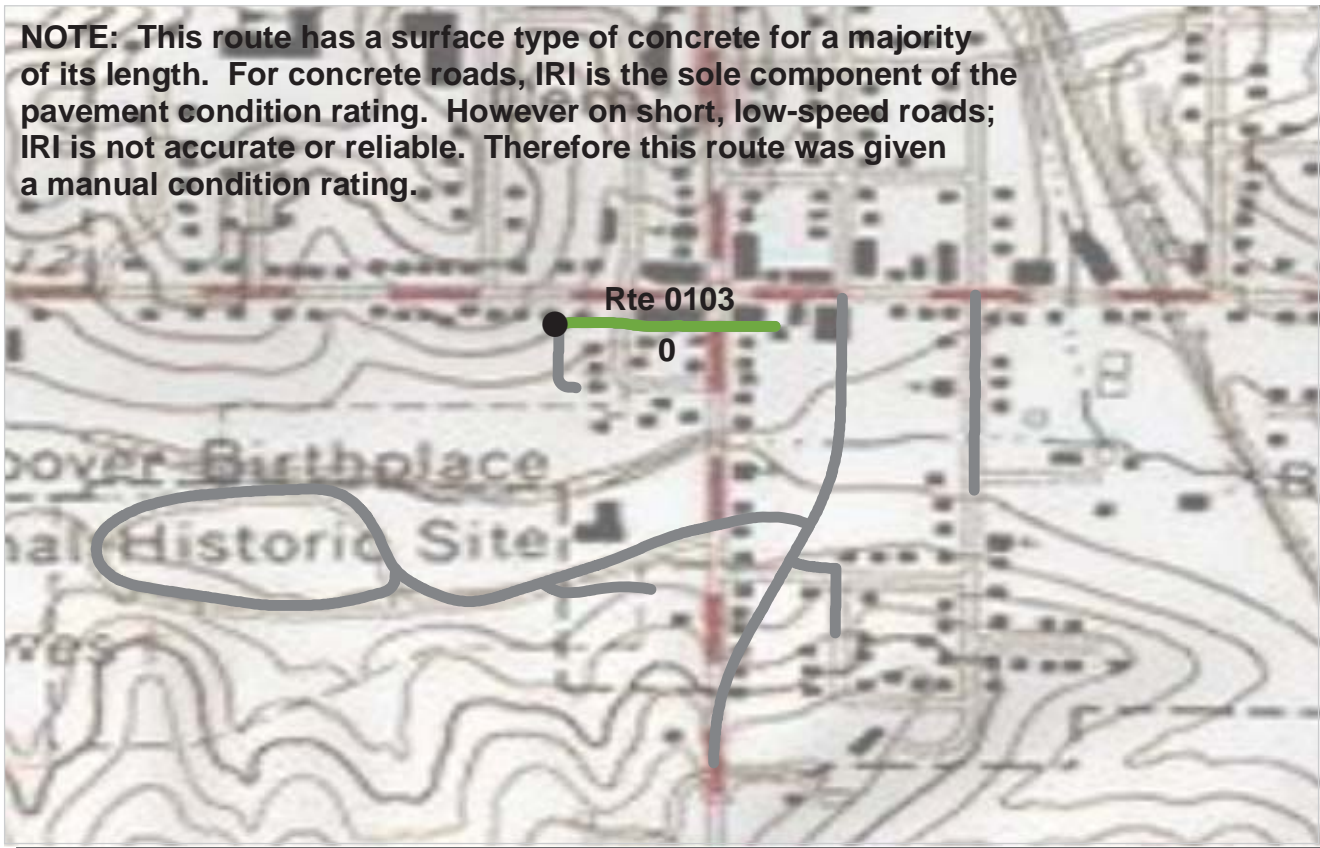
ROUTE: 0103 WETHERELL STREET

NOTE: This route has a surface type of concrete for a majority of its length. For concrete roads, IRI is the sole component of the pavement condition rating. However on short, low-speed roads; IRI is not accurate or reliable. Therefore this route was given a manual condition rating.

Section Number	0				
Section Length (mi)	0.11				
Cross Section Information					
Number of Lanes	2				
Paved Width (ft)	22				
Lane Width (ft)	15				
Roadway Condition Information					
SCR (Surface Condition Rating)	NC				
PCR (Pavement Condition Rating)	90				
Distress Index Values					
Structural Crack Index	NC				
Transverse Cracking Index	NC				
Patching Index	NC				
Rutting Index	NC				
Roughness Condition Index (RCI)	NC

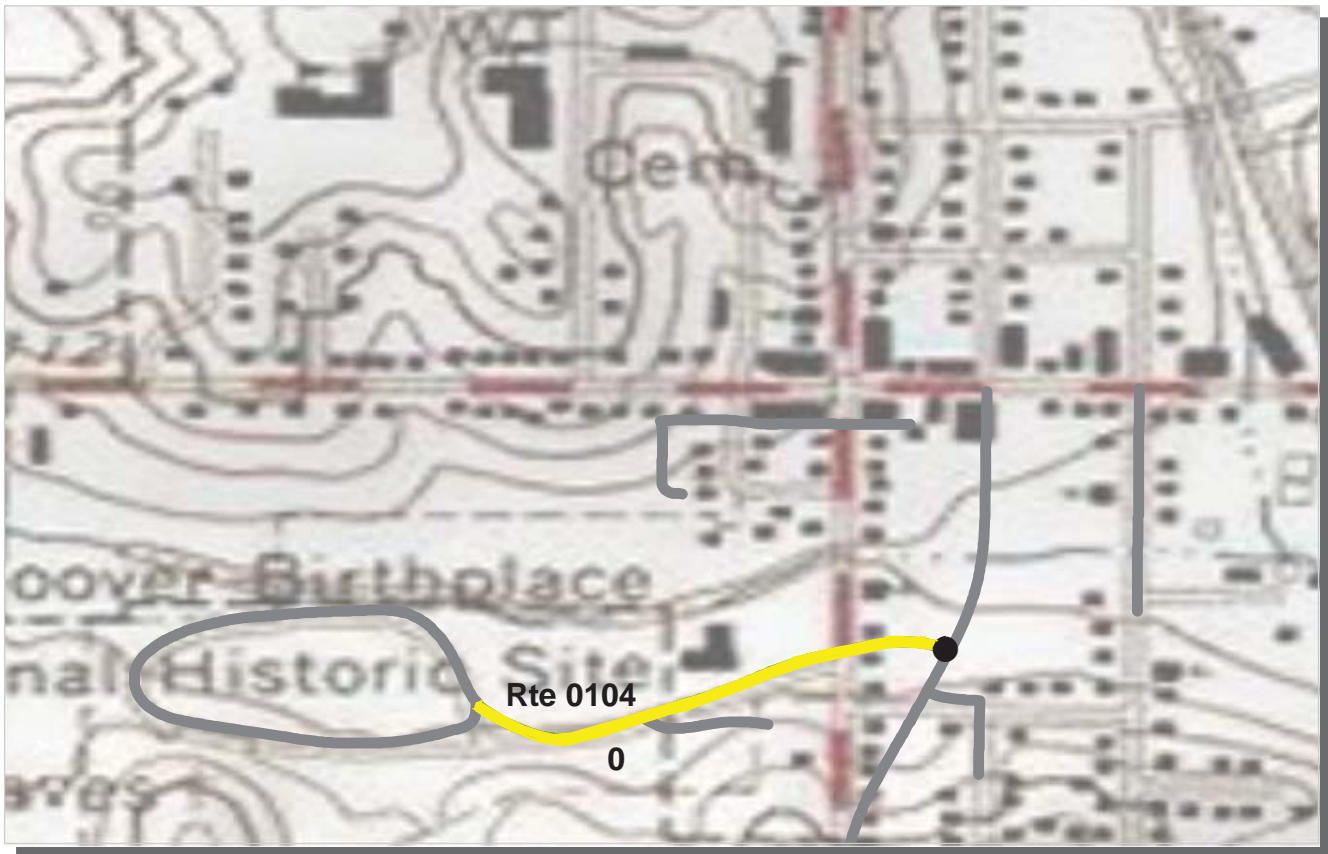
ROUTE: 0104 LIBRARY DRIVE

Section Number	0				
Section Length (mi)	0.22				
Cross Section Information					
Number of Lanes	2				
Paved Width (ft)	20				
Lane Width (ft)	9				
Roadway Condition Information					
SCR (Surface Condition Rating)	82				
PCR (Pavement Condition Rating)	82				
Distress Index Values					
Structural Crack Index	82				
Transverse Cracking Index	98				
Patching Index	100				
Rutting Index	98				
Roughness Condition Index (RCI)	NC

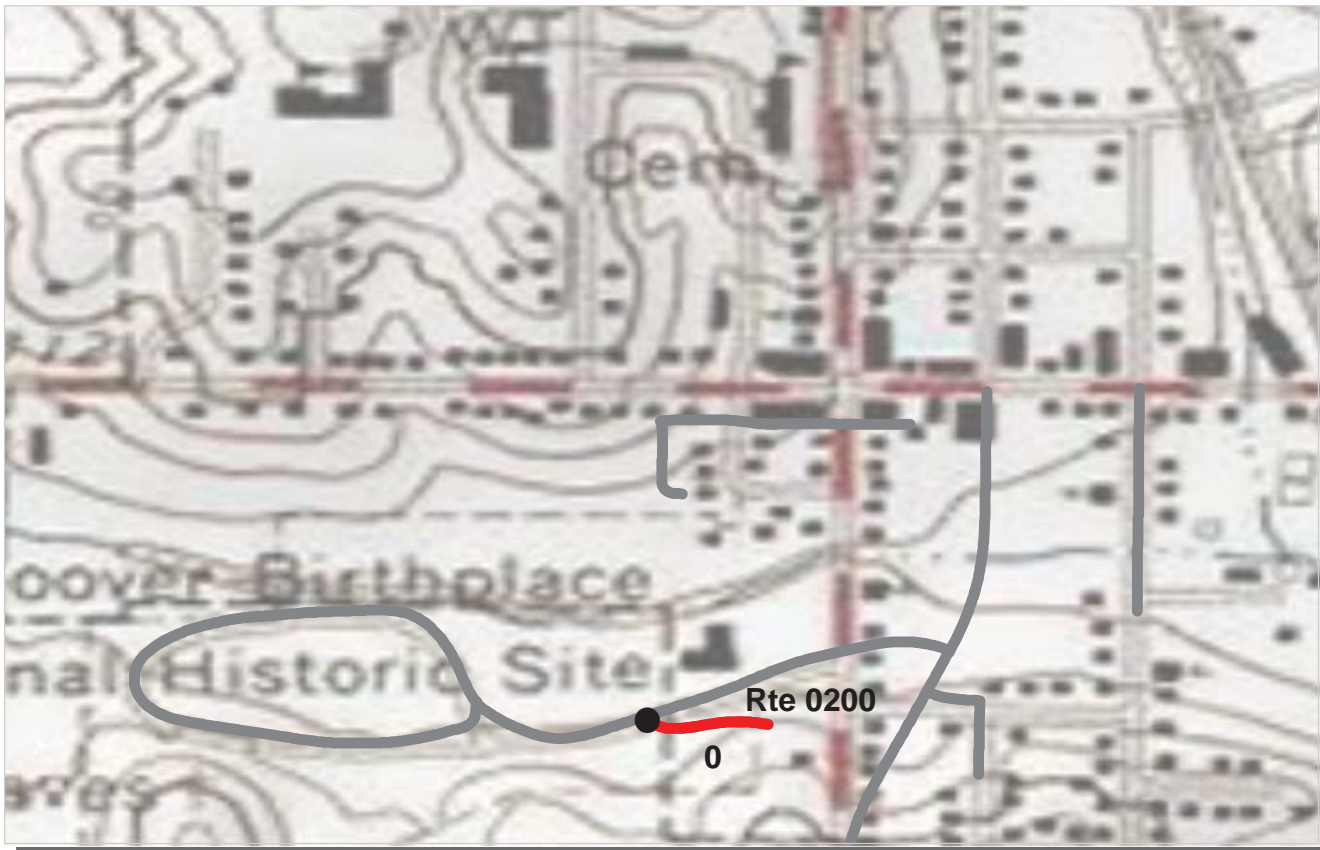
ROUTE: 0200 ASSOCIATION DRIVE

Section Number	0				
Section Length (mi)	0.05				
Cross Section Information					
Number of Lanes	1				
Paved Width (ft)	11				
Lane Width (ft)	11				
Roadway Condition Information					
SCR (Surface Condition Rating)	0				
PCR (Pavement Condition Rating)	0				
Distress Index Values					
Structural Crack Index	0				
Transverse Cracking Index	97				
Patching Index	100				
Rutting Index	85				
Roughness Condition Index (RCI)	NC

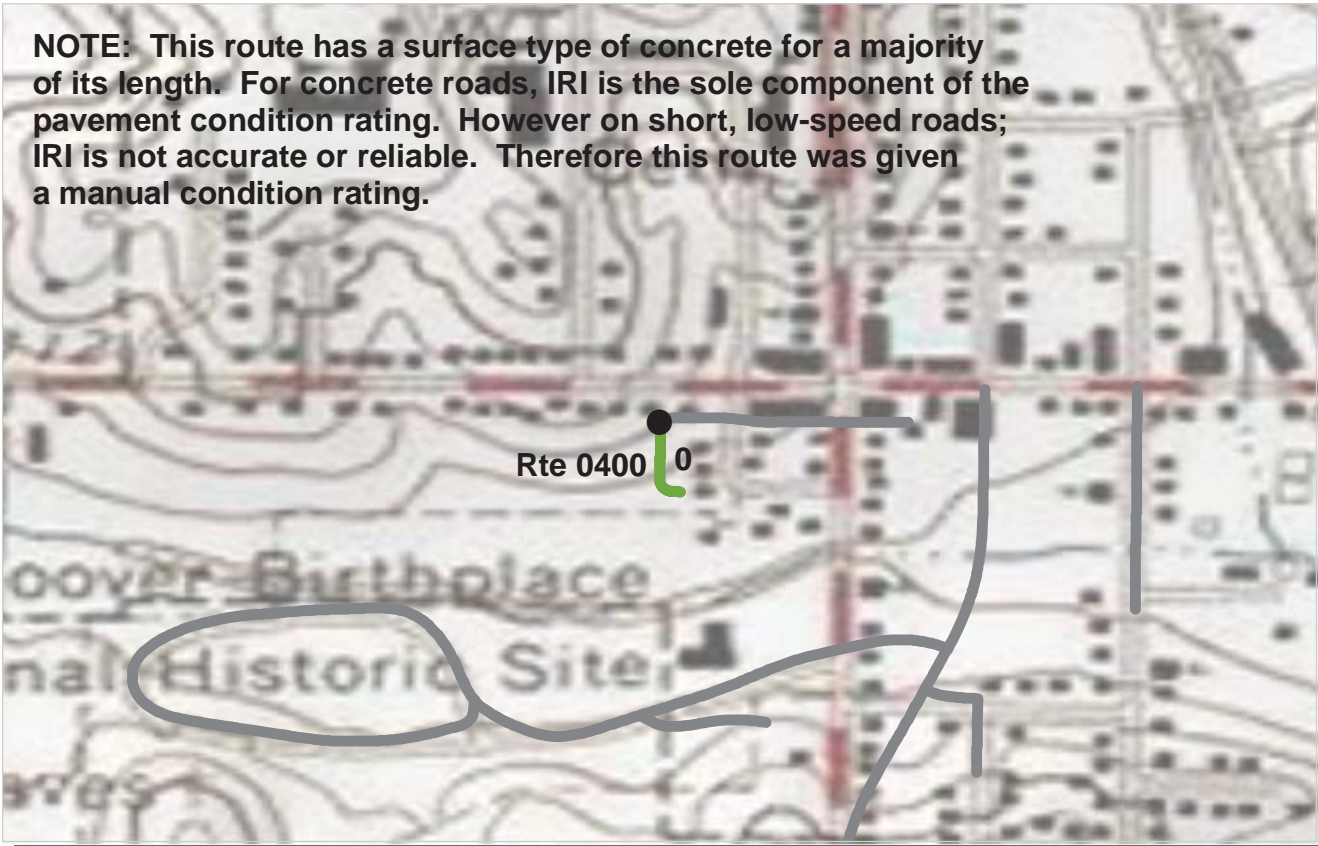
ROUTE: 0400 MAINTENANCE SERVICE ROAD

NOTE: This route has a surface type of concrete for a majority of its length. For concrete roads, IRI is the sole component of the pavement condition rating. However on short, low-speed roads; IRI is not accurate or reliable. Therefore this route was given a manual condition rating.

Section Number	0				
Section Length (mi)	0.05				
Cross Section Information					
Number of Lanes	1				
Paved Width (ft)	13				
Lane Width (ft)	13				
Roadway Condition Information					
SCR (Surface Condition Rating)	NC				
PCR (Pavement Condition Rating)	90				
Distress Index Values					
Structural Crack Index	NC				
Transverse Cracking Index	NC				
Patching Index	NC				
Rutting Index	NC				
Roughness Condition Index (RCI)	NC

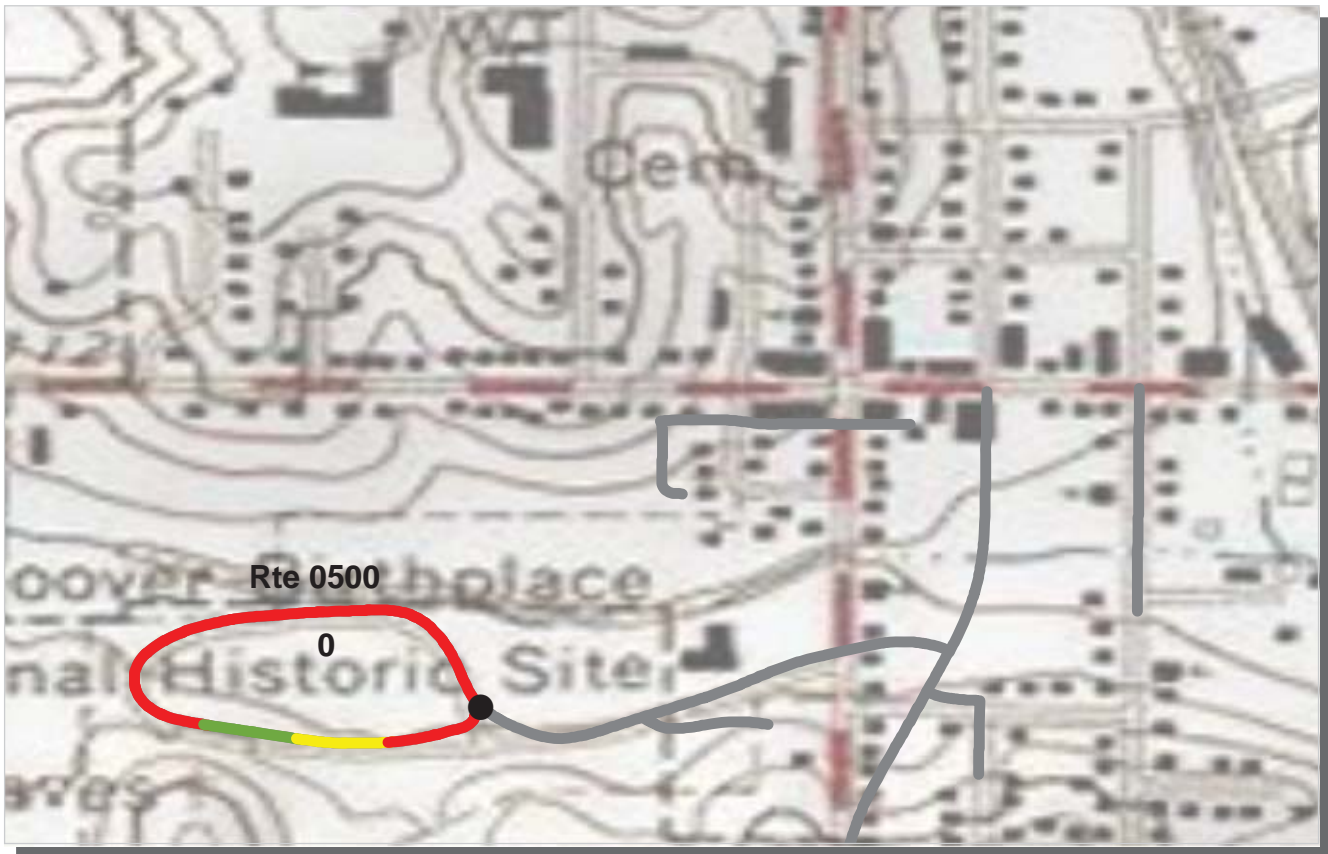
ROUTE: 0500 HS-48 LOOP ROAD

Section Number	0				
Section Length (mi)	0.37				
Cross Section Information					
Number of Lanes	1				
Paved Width (ft)	12				
Lane Width (ft)	11				
Roadway Condition Information					
SCR (Surface Condition Rating)	0				
PCR (Pavement Condition Rating)	0				
Distress Index Values					
Structural Crack Index	0				
Transverse Cracking Index	94				
Patching Index	100				
Rutting Index	97				
Roughness Condition Index (RCI)	NC
