Federal Lands Highway Road Inventory Program

Road Inventory and Condition Assessment

Lassen Volcanic National Park

Cycle 5 Report

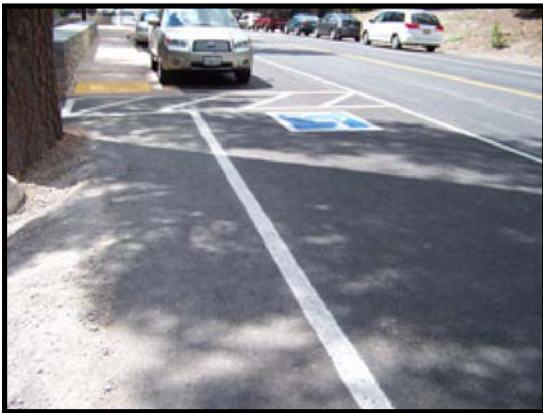
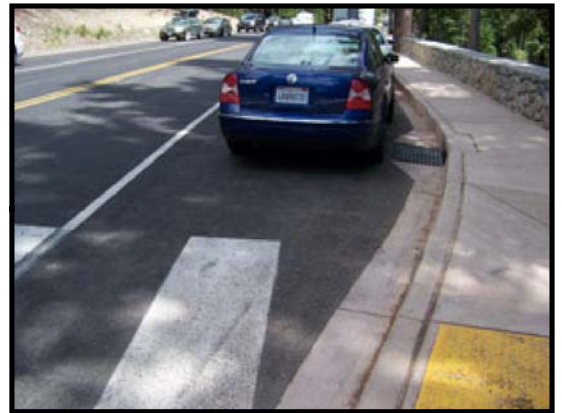
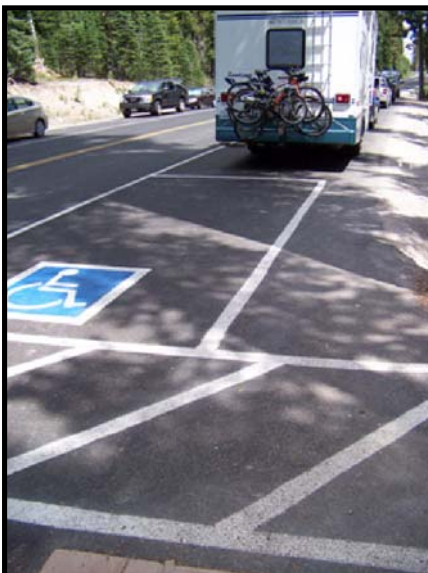
Route Number	Public / NonPublic	Date Visited	Area (sq ft)	Lane Miles *	Surface Type
0938AZ	PUBLIC	8/15/2010	3,821	0.07	AS
Culverts	Drop Inlets	Gates	Curb & Gutter	Curb	PCR
0	1	0	CONCRETE CURB AND GUTTER	NO CURB	EXCELLENT/97

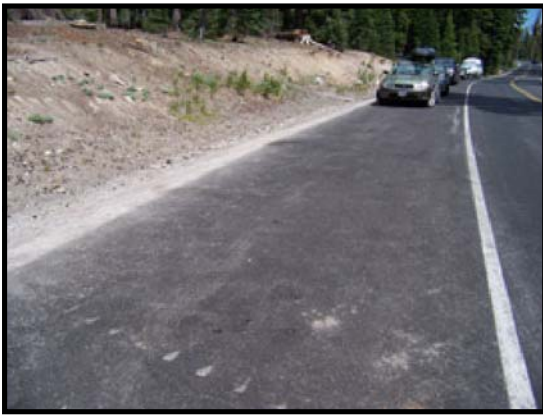
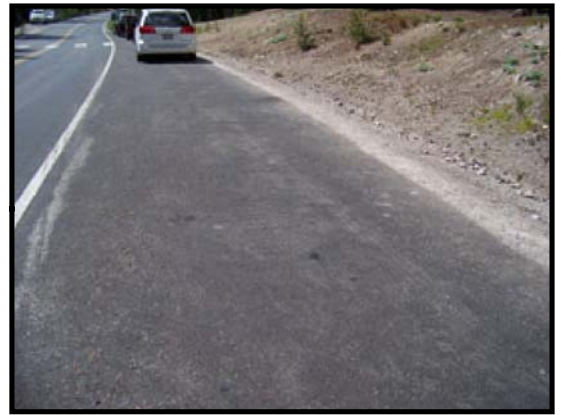
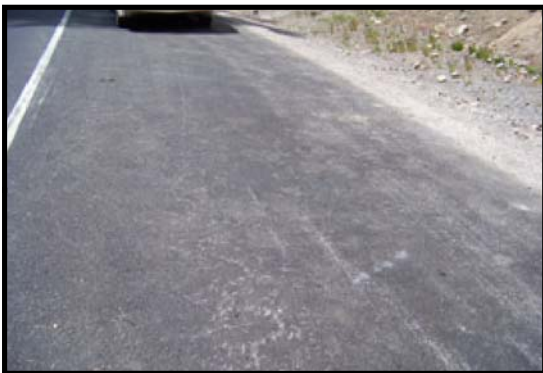
Route 0938BZ

Route Number	Public / NonPublic	Date Visited	Area (sq ft)	Lane Miles *	Surface Type
0938BZ	PUBLIC	8/15/2010	3,761	0.07	AS
Culverts	Drop Inlets	Gates	Curb & Gutter	Curb	PCR
0	0	0	NO CURB AND GUTTER	NO CURB	EXCELLENT/97
