Federal Lands Highway Road Inventory Program

Road Inventory and Condition Assessment

Padre Island National Seashore
PAIS - 7490

Cycle 5 Report

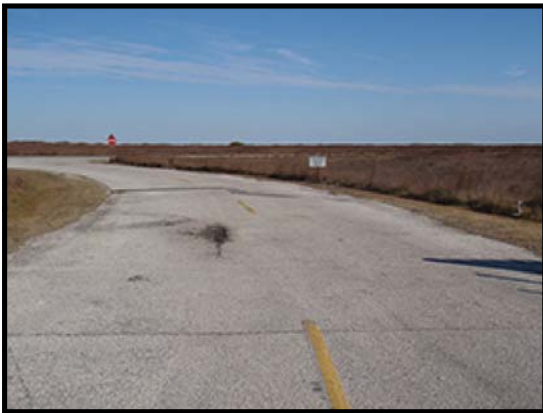
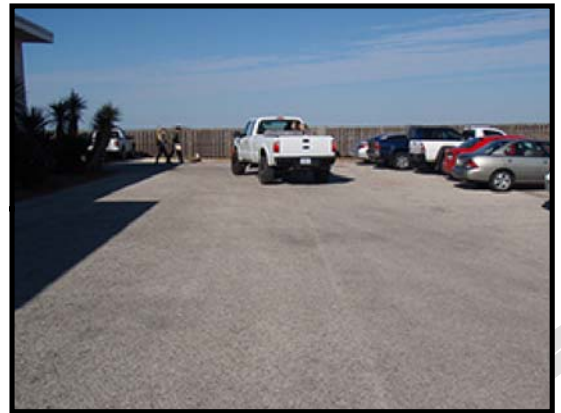
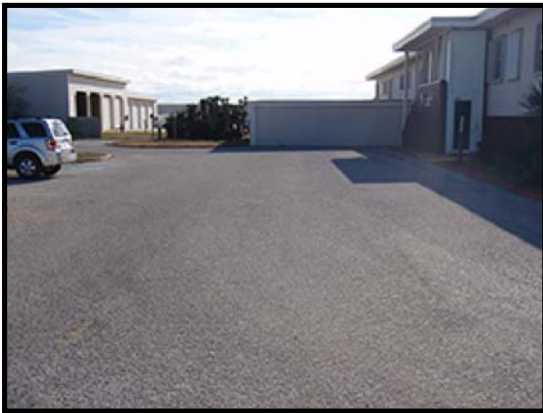
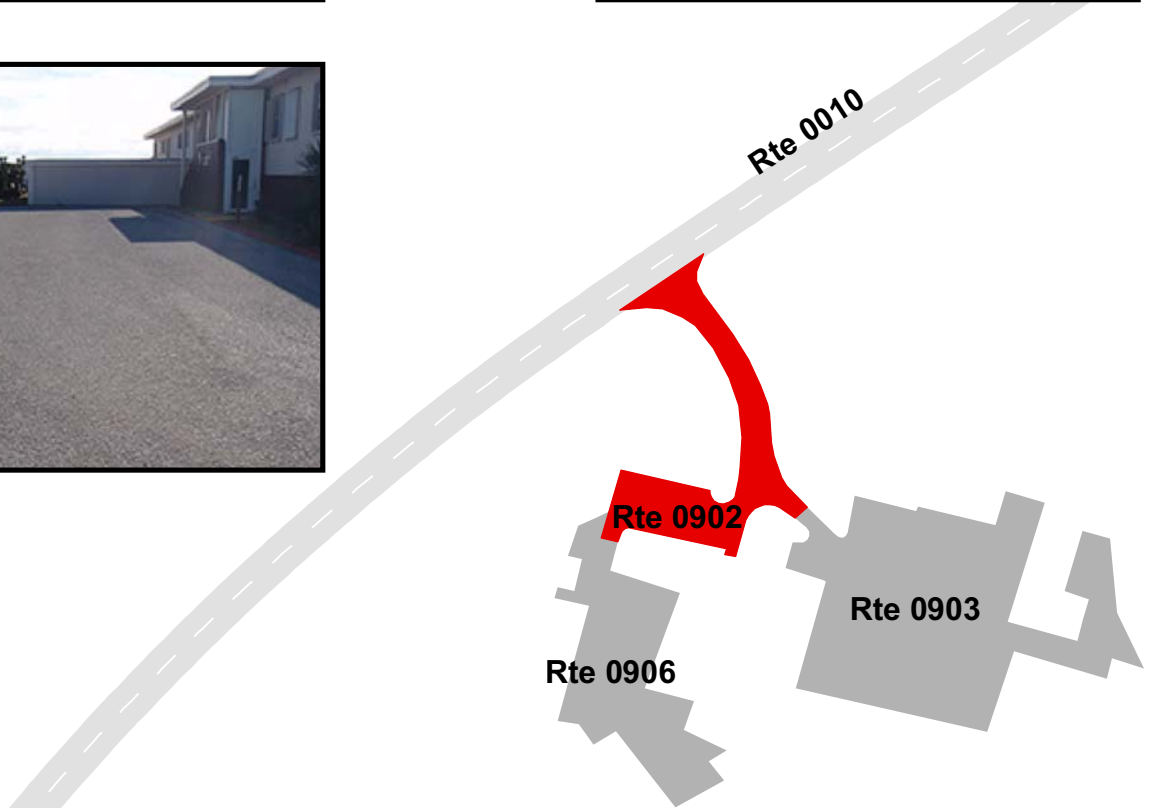
Route Number	Public / NonPublic	Date Visited	Area (sq ft)	Lane Miles *	Surface Type
0902	PUBLIC	2/10/2011	14,058	0.24	AS
Culverts	Drop Inlets	Gates	Curb & Gutter	Curb	PCR
0	0	1	NO CURB AND GUTTER	CONCRETE CURB	FAIR/73

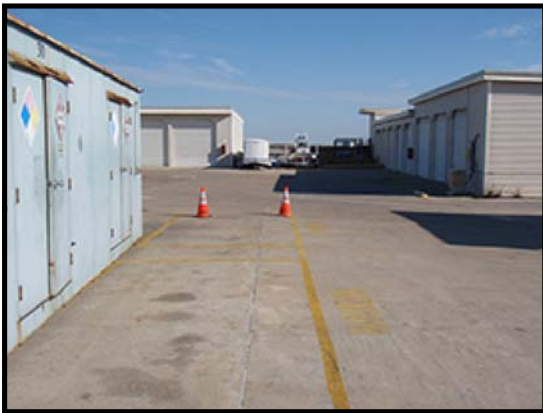
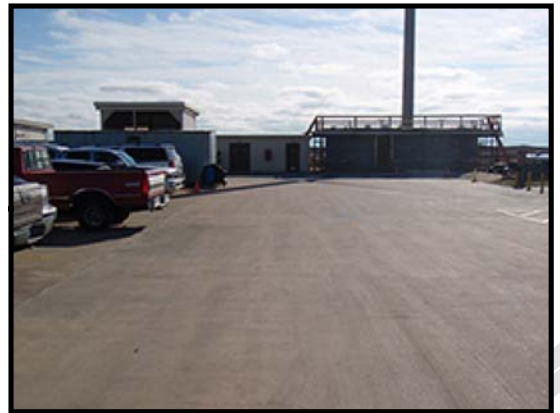
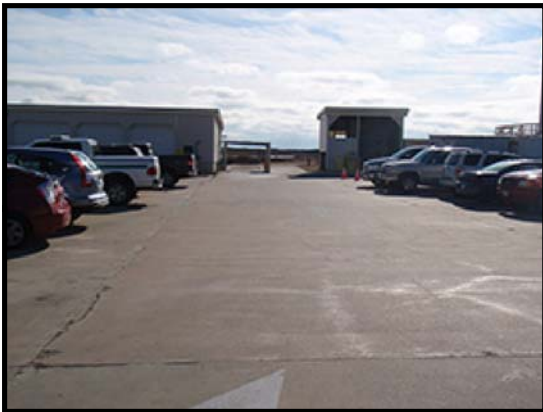
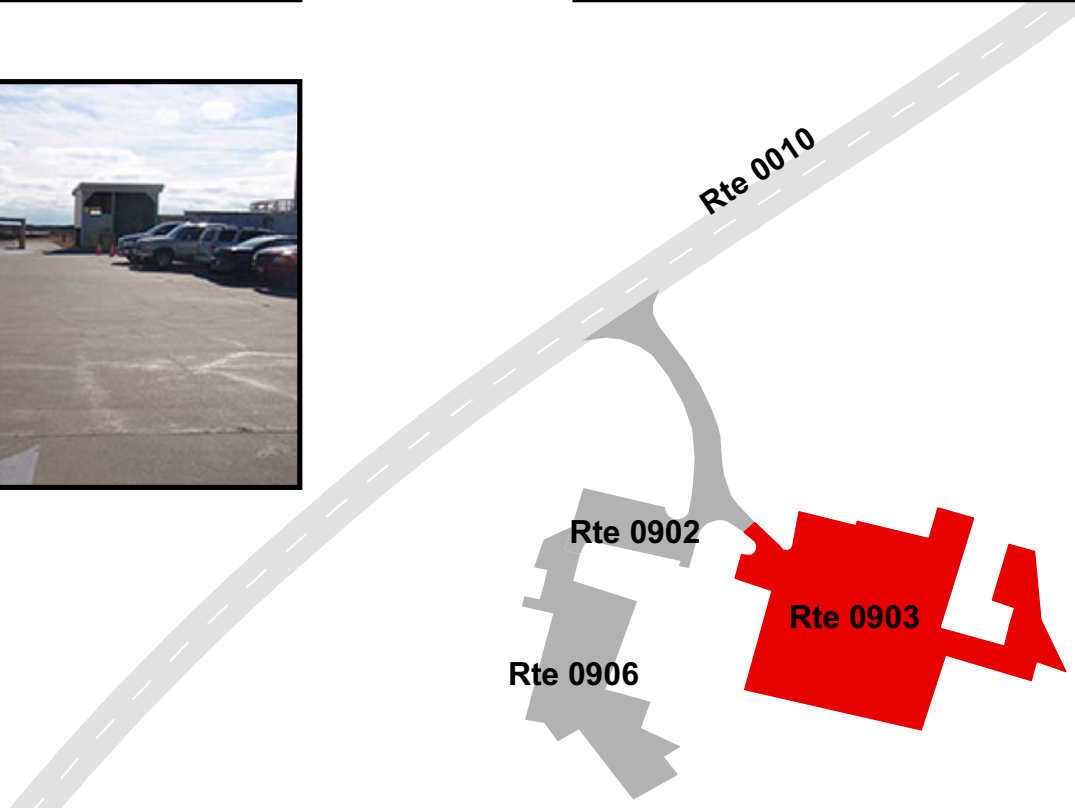
Route 0903

Route Number	Public / NonPublic	Date Visited	Area (sq ft)	Lane Miles *	Surface Type
0903	NONPUBLIC	2/10/2011	42,588	0.73	CO
Culverts	Drop Inlets	Gates	Curb & Gutter	Curb	PCR
0	2	0	NO CURB AND GUTTER	CONCRETE CURB	FAIR/73

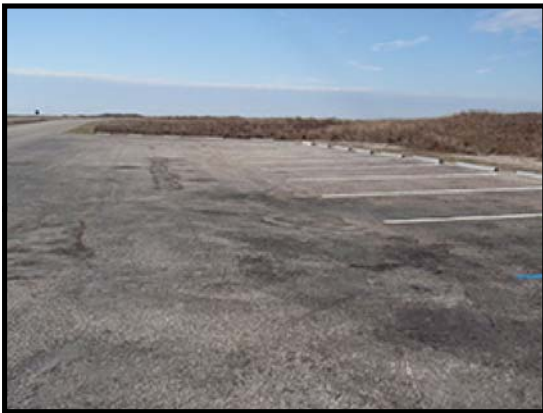
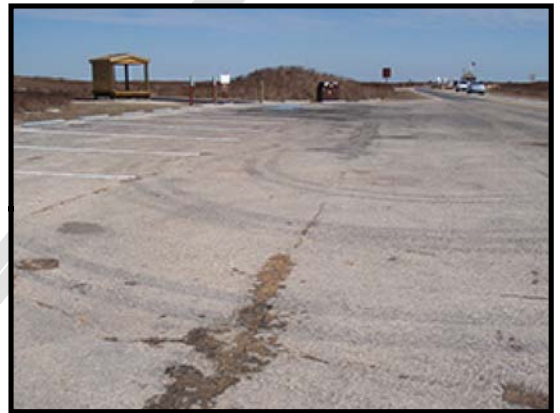
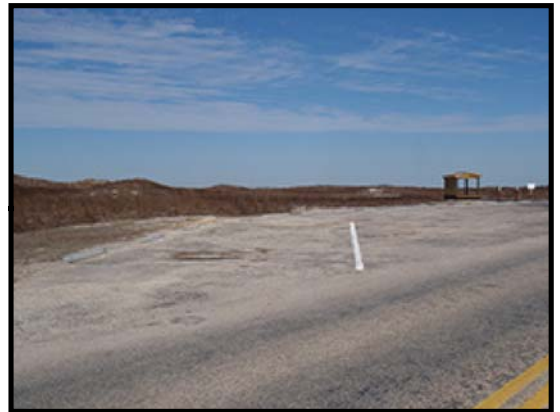
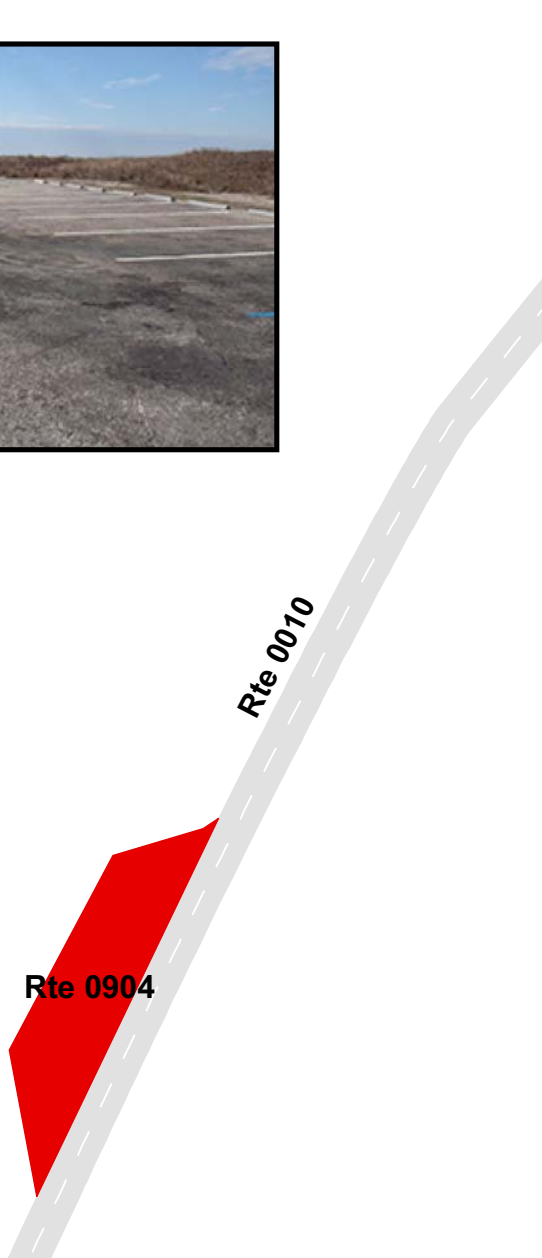
Route 0904

Route Number	Public / NonPublic	Date Visited	Area (sq ft)	Lane Miles *	Surface Type
0904	PUBLIC	2/10/2011	7,604	0.13	AS
Culverts	Drop Inlets	Gates	Curb & Gutter	Curb	PCR
0	0	0	NO CURB AND GUTTER	NO CURB	FAIR/73

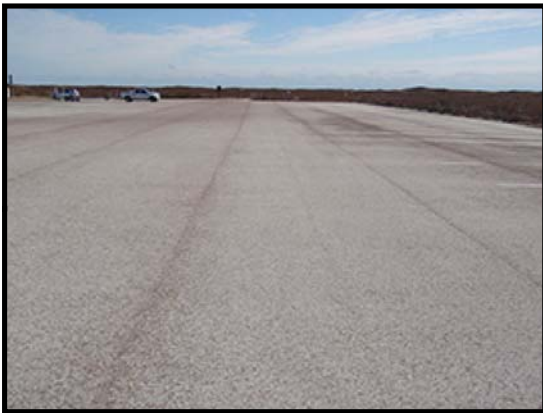
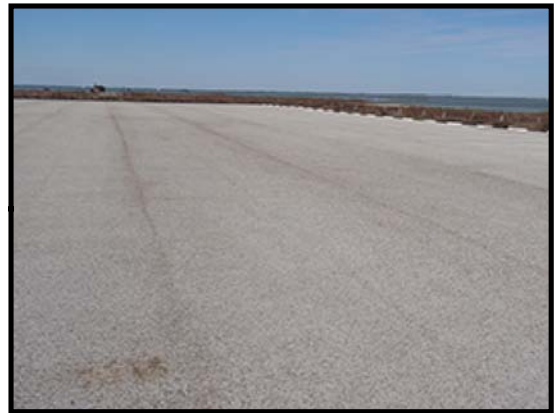
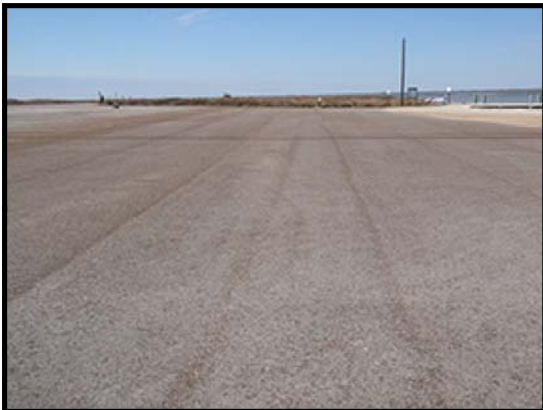
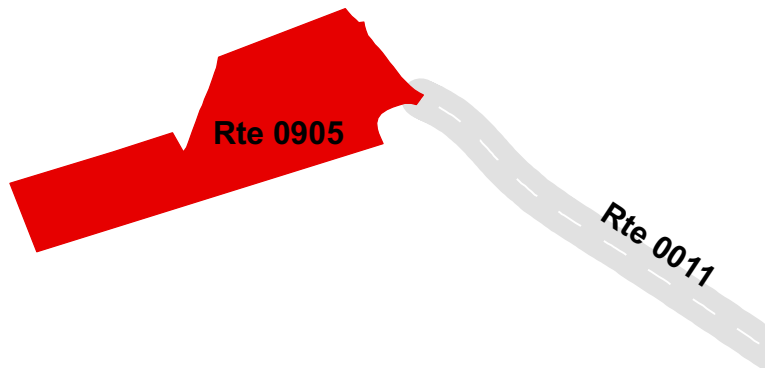
Route 0905

Route Number	Public / NonPublic	Date Visited	Area (sq ft)	Lane Miles *	Surface Type
0905	PUBLIC	2/10/2011	122,121	2.10	AS
Culverts	Drop Inlets	Gates	Curb & Gutter	Curb	PCR
0	0	0	NO CURB AND GUTTER	NO CURB	FAIR/73

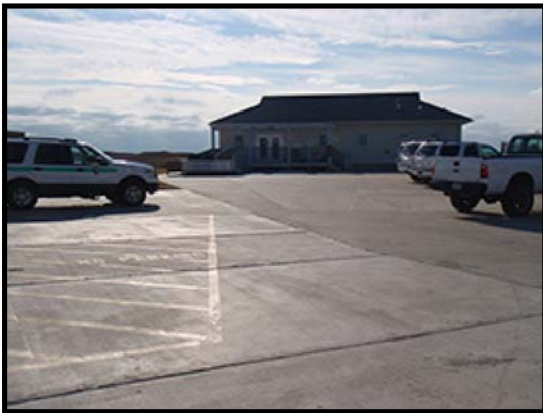
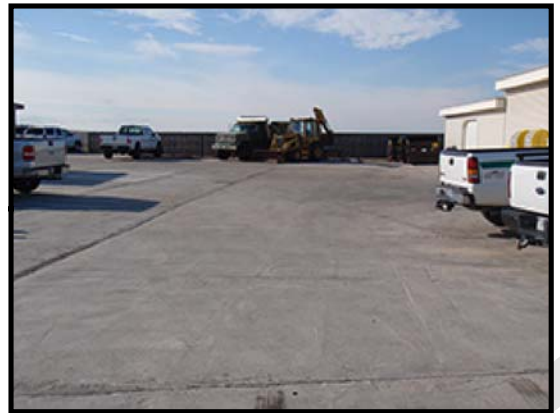
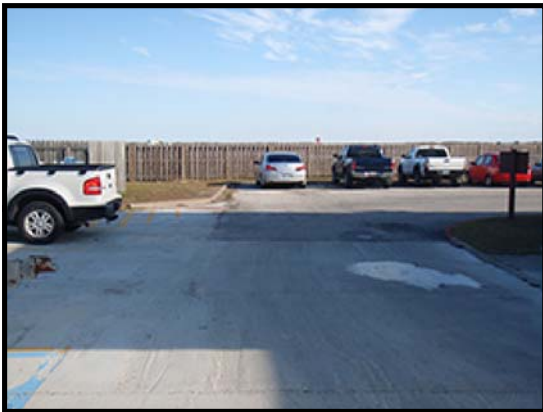
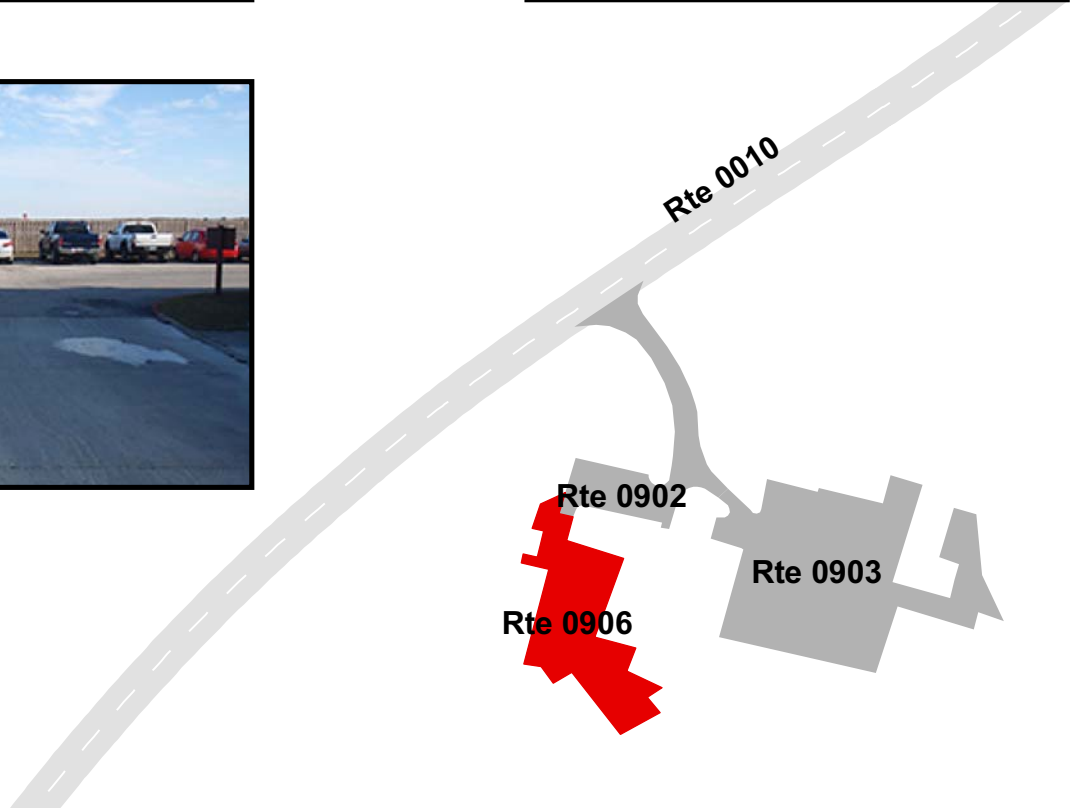
Route 0906

Route Number	Public / NonPublic	Date Visited	Area (sq ft)	Lane Miles *	Surface Type
0906	NONPUBLIC	2/10/2011	18,368	0.32	CO
Culverts	Drop Inlets	Gates	Curb & Gutter	Curb	PCR
0	2	0	NO CURB AND GUTTER	NO CURB	GOOD/90
