# Federal Lands Highway Road Inventory Program

Road Inventory and Condition Assessment

**Presidio of San Francisco**  
**PRES - 8150**

**Cycle 5 Report**

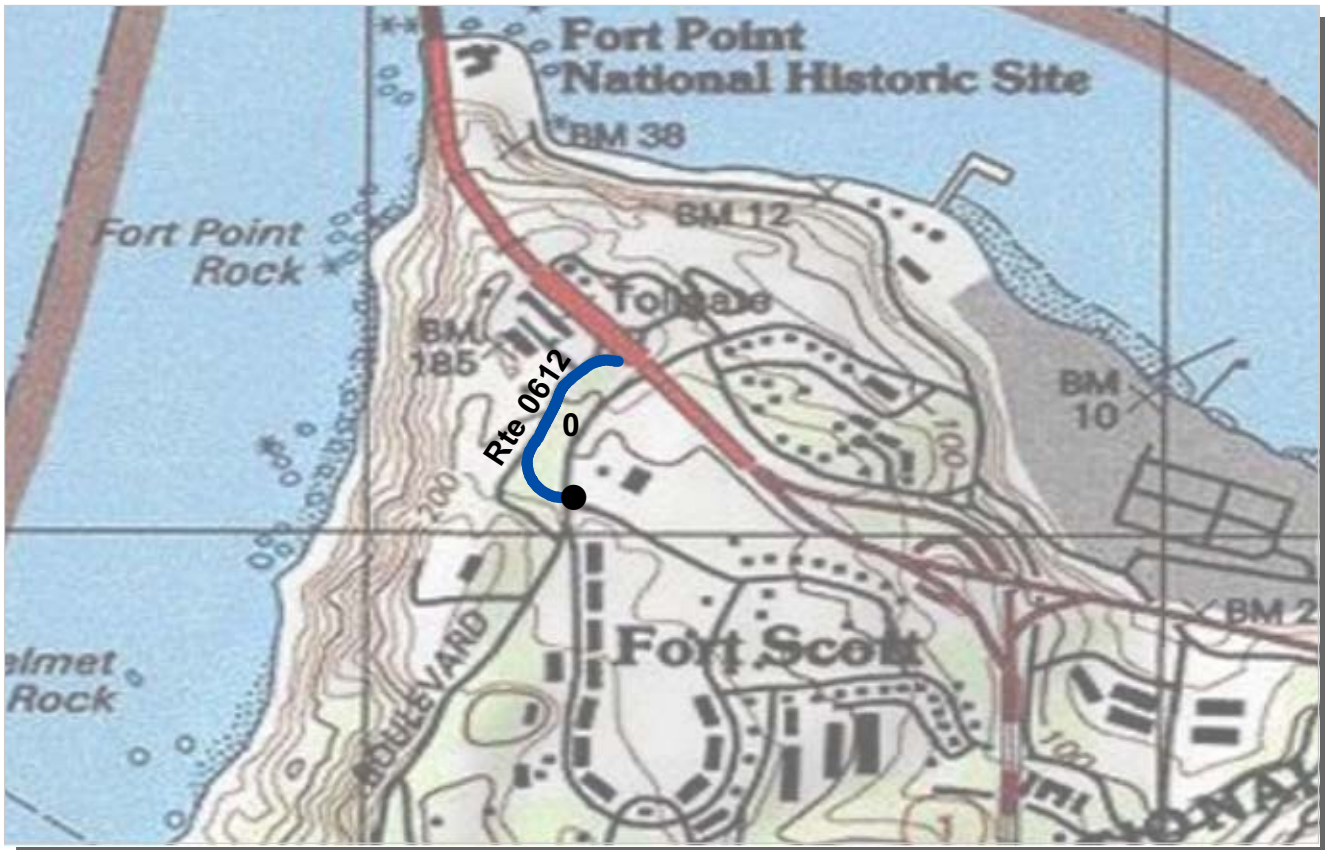
<b>Section Number</b>	0				
<b>Section Length (mi)</b>	0.19				
<b>Cross Section Information</b>					
Number of Lanes	3				
Paved Width (ft)	35				
Lane Width (ft)	12				
<b>Roadway Condition Information</b>					
SCR (Surface Condition Rating)	99				
PCR (Pavement Condition Rating)	99				
<b>Distress Index Values</b>					
Structural Crack Index	100				
Transverse Cracking Index	100				
Patching Index	100				
Rutting Index	99				
Roughness Condition Index (RCI)	NC
