Road Inventory and Condition Assessment

Steamtown National Historic Site STE A

Cycle 5 Report

**Prepared By: Federal Highway Administration
Road Inventory Program (RIP)
Data Collected: 04/2013
Report Date: 11/2013**

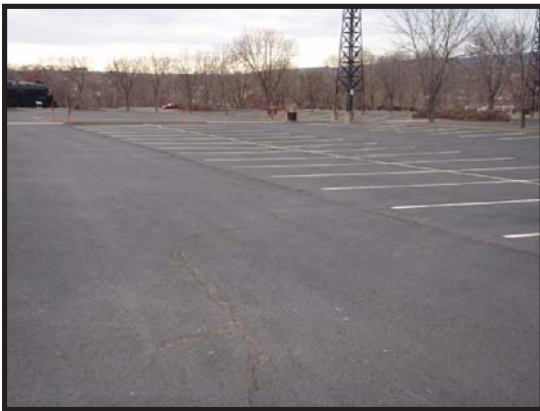
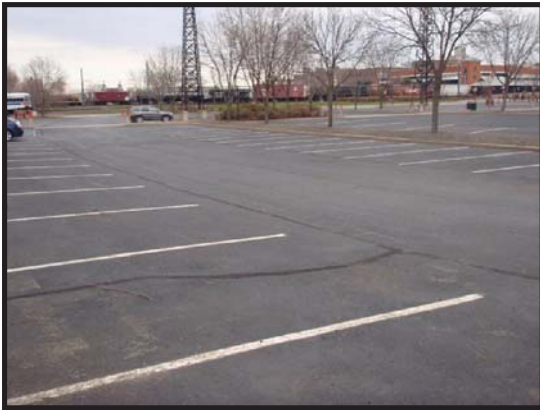
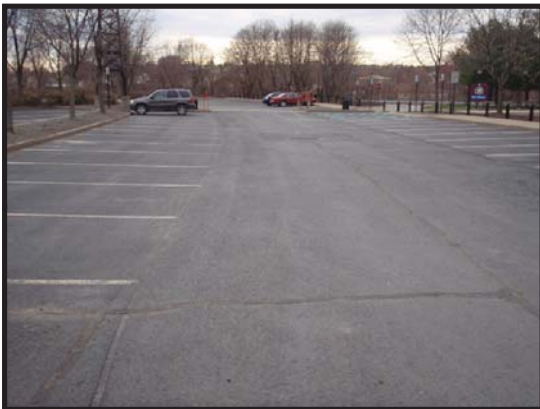
Route Number	Public / NonPublic	Date Visited	Area (sq ft)	Lane Miles *	Surface Type
0900	PUBLIC	4/15/2013	151,773	2.61	AS
Culverts	Drop Inlets	Gates	Curb & Gutter	Curb	PCR
0	10	0	NO CURB AND GUTTER	CONCRETE CURB	FAIR/73
