Federal Lands Highway Road Inventory Program

Road Inventory and Condition Assessment

National Capital Parks - East Suitland Parkway SUIT

Cycle 5 Report

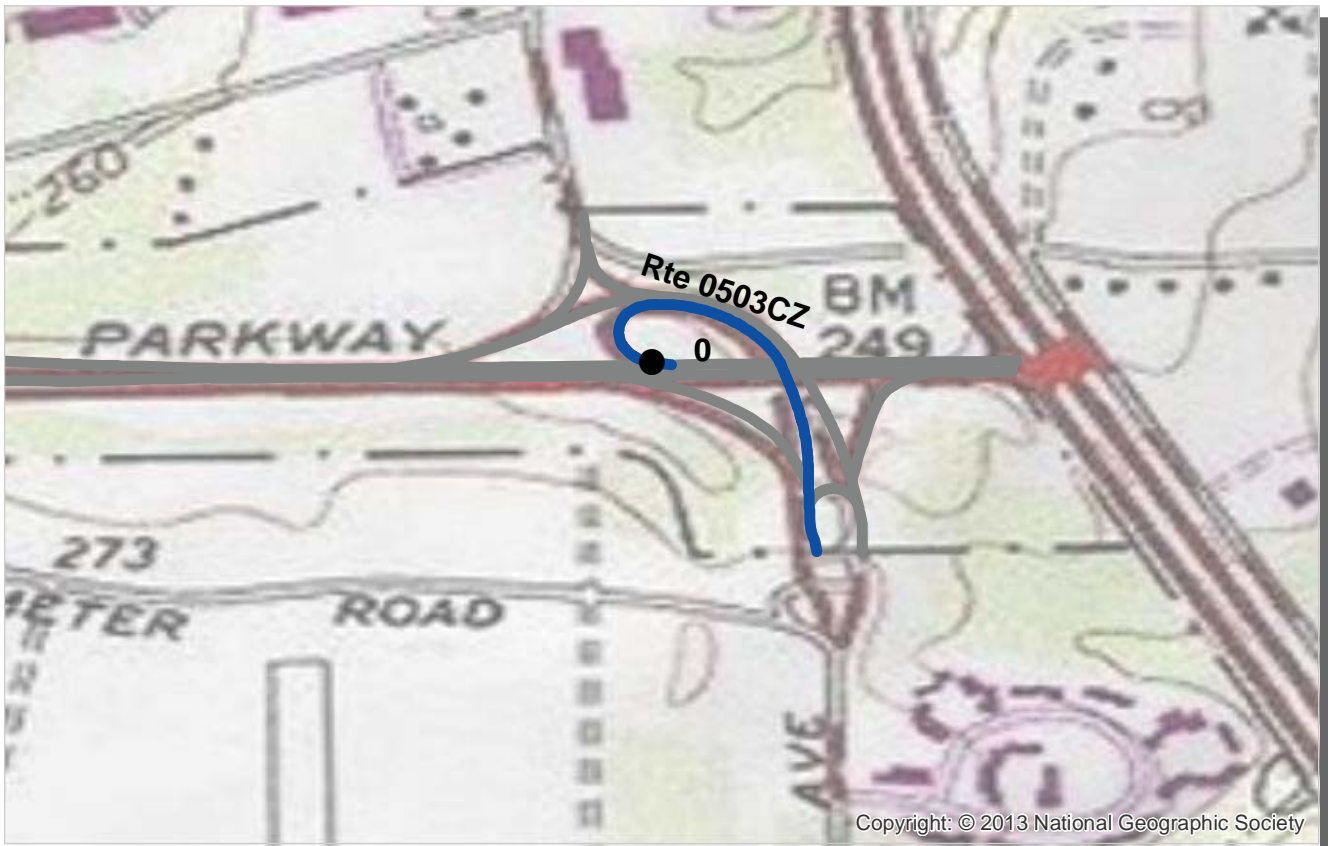
ROUTE: 0503CZ WB SUTLAND PARKWAY RAMP TO ANDREWS AFB NORTH GATE

Section Number	0				
Section Length (mi)	0.27				
Cross Section Information					
Number of Lanes	1				
Paved Width (ft)	25				
Lane Width (ft)	23				
Roadway Condition Information					
SCR (Surface Condition Rating)	100				
PCR (Pavement Condition Rating)	100				
Distress Index Values					
Structural Crack Index	100				
Transverse Cracking Index	100				
Patching Index	100				
Rutting Index	100				
Roughness Condition Index (RCI)	NC

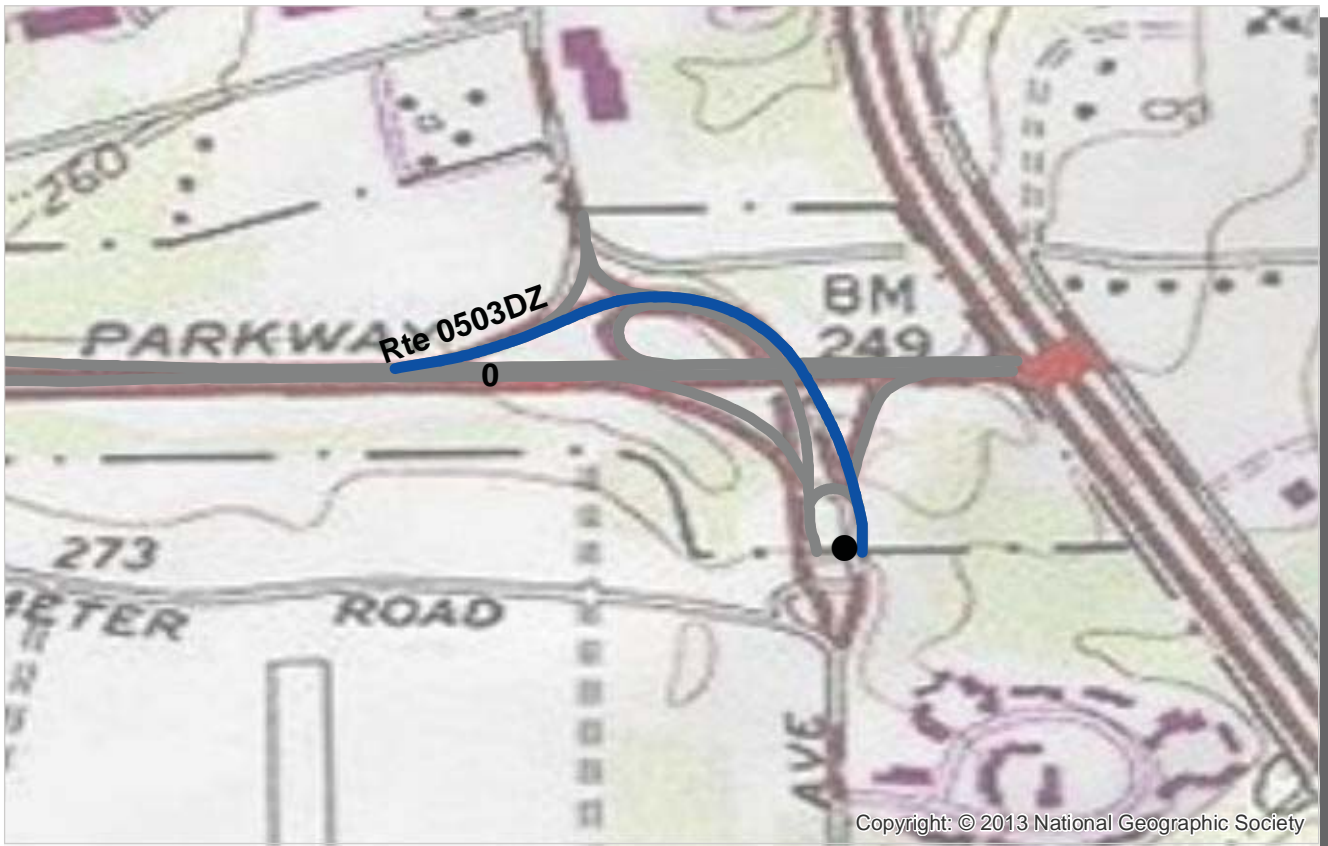
Section Number	0				
Section Length (mi)	0.35				
Cross Section Information					
Number of Lanes	1				
Paved Width (ft)	23				
Lane Width (ft)	22				
Roadway Condition Information					
SCR (Surface Condition Rating)	99				
PCR (Pavement Condition Rating)	99				
Distress Index Values					
Structural Crack Index	100				
Transverse Cracking Index	100				
Patching Index	100				
Rutting Index	99				
Roughness Condition Index (RCI)	NC
