Federal Lands Highway Road Inventory Program

Road Inventory and Condition Assessment

Voyageurs National Park
VOYA

Cycle 5 Report

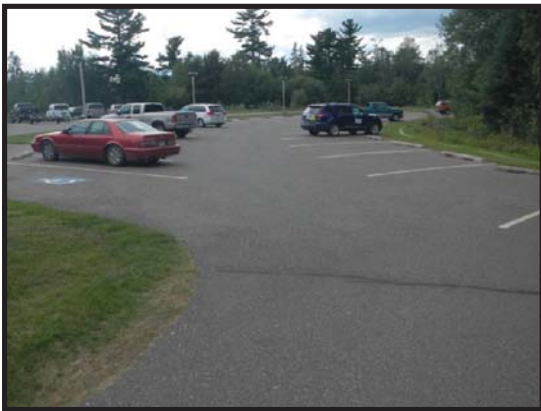
Route Number	Public / NonPublic	Date Visited	Area (sq ft)	Lane Miles *	Surface Type
0900	PUBLIC	8/13/2012	57,759	0.99	AS
Culverts	Drop Inlets	Gates	Curb & Gutter	Curb	PCR
1	0	2	NO CURB AND GUTTER	NO CURB	FAIR/73

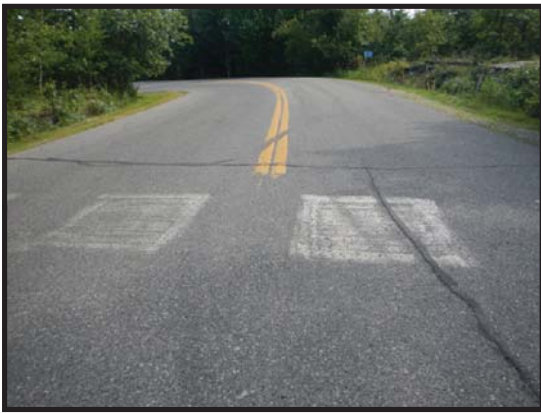
Route 0901

Route Number	Public / NonPublic	Date Visited	Area (sq ft)	Lane Miles *	Surface Type
0901	PUBLIC	8/13/2012	65,686	1.13	AS
Culverts	Drop Inlets	Gates	Curb & Gutter	Curb	PCR
0	0	0	NO CURB AND GUTTER	WOOD CURB	POOR/45

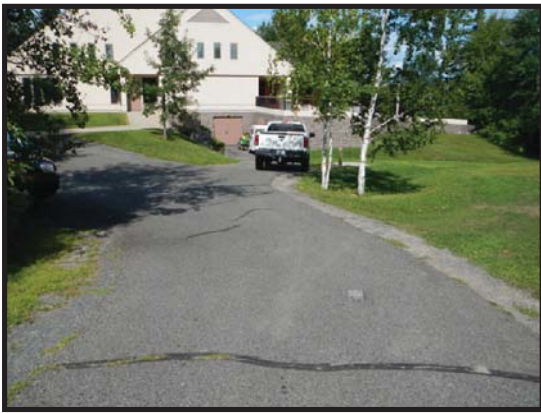
Route 0902

Route Number	Public / NonPublic	Date Visited	Area (sq ft)	Lane Miles *	Surface Type
0902	NONPUBLIC	8/13/2012	3,253	0.06	AS
Culverts	Drop Inlets	Gates	Curb & Gutter	Curb	PCR
1	1	0	NO CURB AND GUTTER	NO CURB	FAIR/73

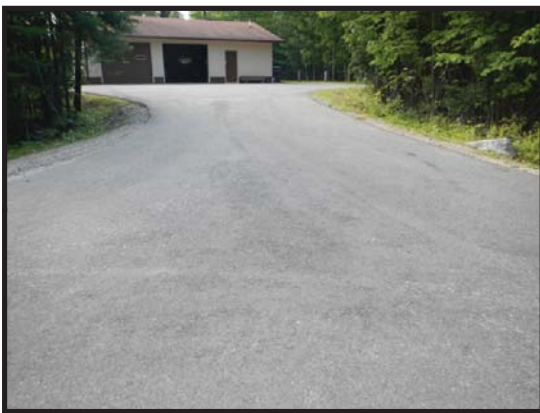
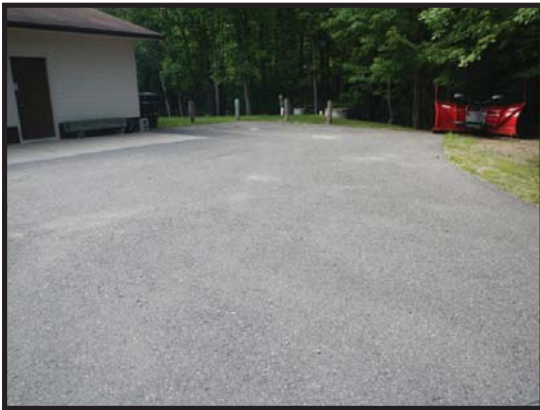
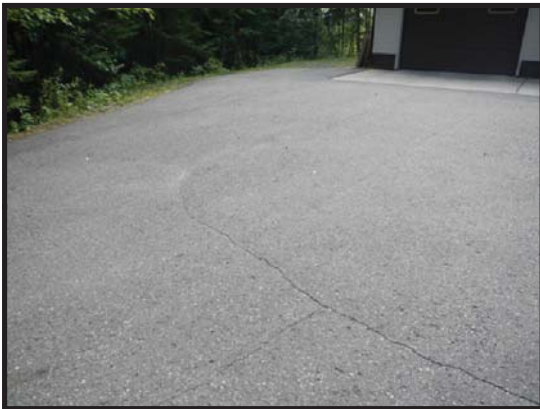
Route 0903

Route Number	Public / NonPublic	Date Visited	Area (sq ft)	Lane Miles *	Surface Type
0903	NONPUBLIC	8/13/2012	3,432	0.06	AS
Culverts	Drop Inlets	Gates	Curb & Gutter	Curb	PCR
0	0	0	NO CURB AND GUTTER	NO CURB	GOOD/90

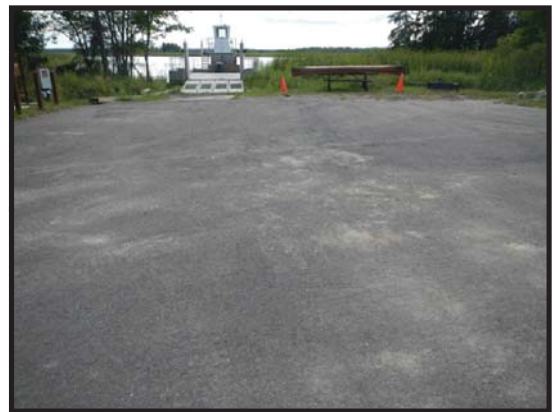
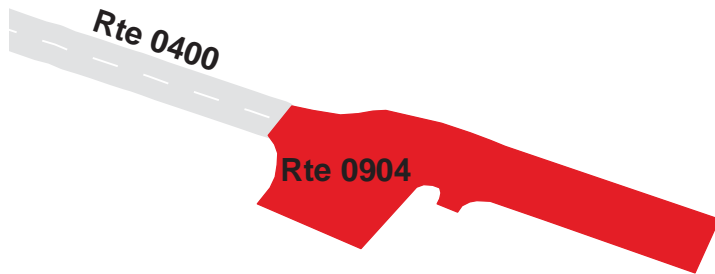
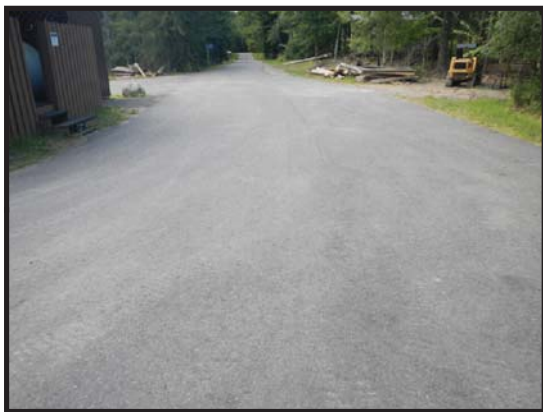
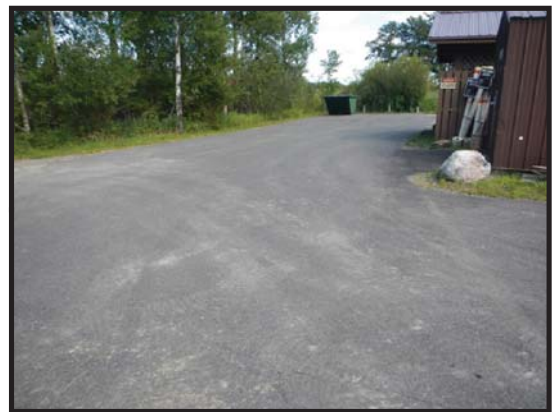
Route 0904

Route Number	Public / NonPublic	Date Visited	Area (sq ft)	Lane Miles *	Surface Type
0904	NONPUBLIC	8/13/2012	4,336	0.08	AS
Culverts	Drop Inlets	Gates	Curb & Gutter	Curb	PCR
0	0	0	NO CURB AND GUTTER	NO CURB	GOOD/90

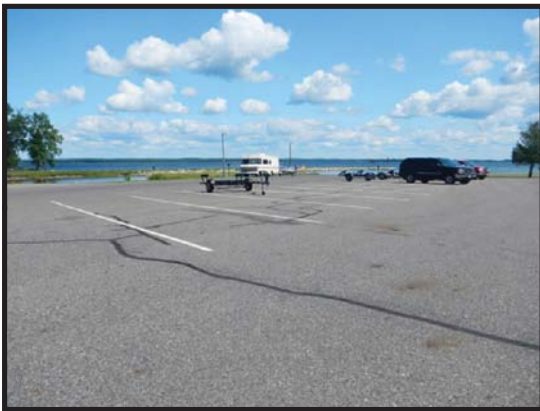
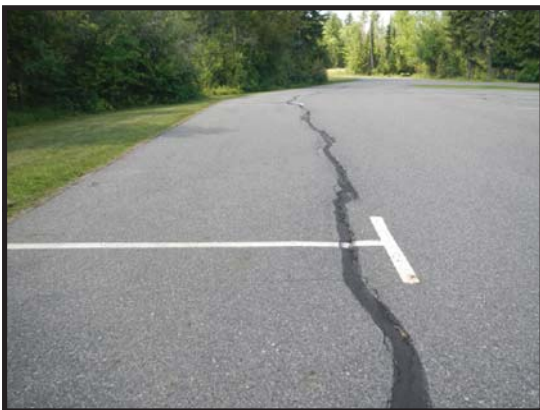
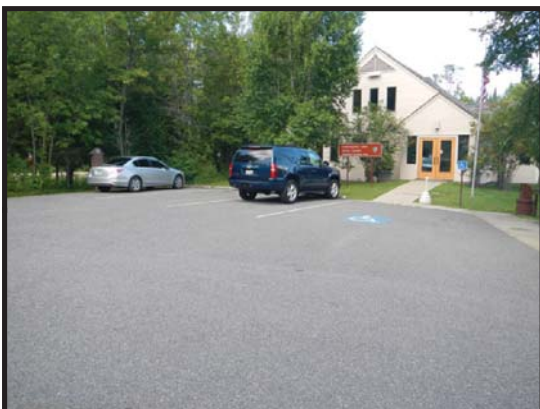
Route 0905

Route Number	Public / NonPublic	Date Visited	Area (sq ft)	Lane Miles *	Surface Type
0905	PUBLIC	8/13/2012	55,330	0.95	AS
Culverts	Drop Inlets	Gates	Curb & Gutter	Curb	PCR
4	0	0	NO CURB AND GUTTER	NO CURB	FAIR/73

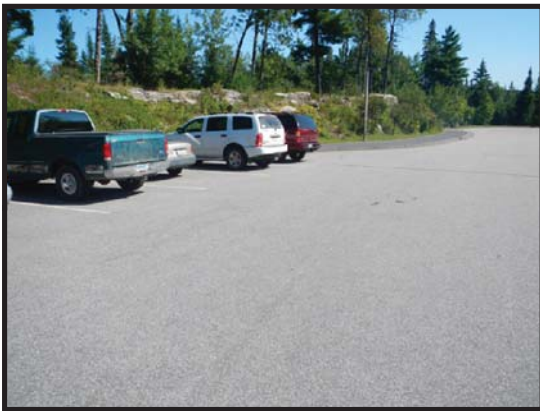
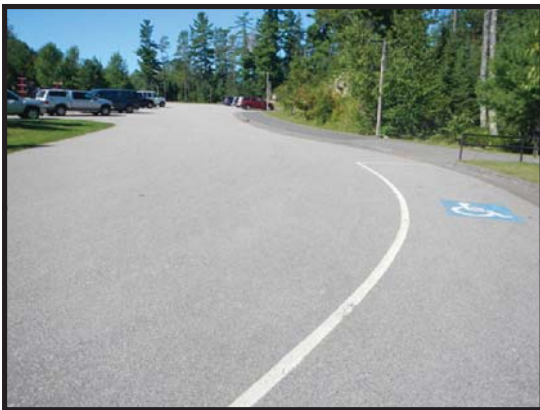
Route 0907

Route Number	Public / NonPublic	Date Visited	Area (sq ft)	Lane Miles *	Surface Type
0907	PUBLIC	8/13/2012	39,469	0.68	AS
Culverts	Drop Inlets	Gates	Curb & Gutter	Curb	PCR
0	4	0	CONCRETE CURB AND GUTTER	NO CURB	FAIR/73

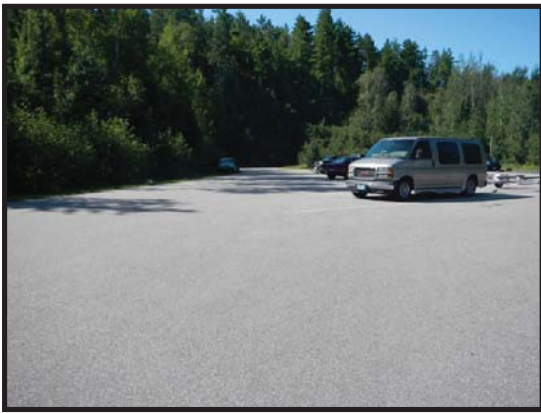
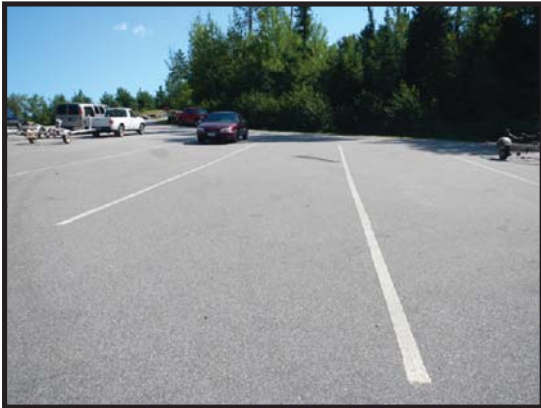
Route Number	Public / NonPublic	Date Visited	Area (sq ft)	Lane Miles *	Surface Type
0908	PUBLIC	8/13/2012	30,817	0.53	AS
Culverts	Drop Inlets	Gates	Curb & Gutter	Curb	PCR
0	5	0	CONCRETE CURB AND GUTTER	NO CURB	GOOD/90

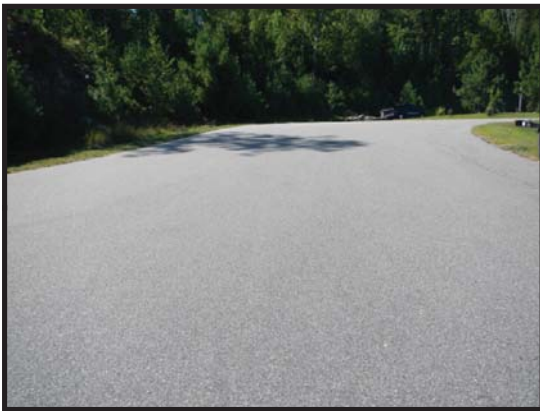
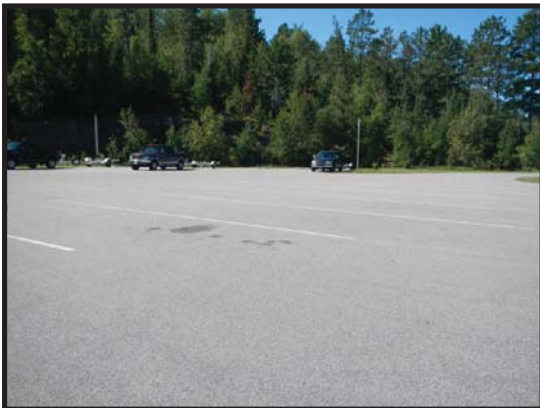
Route Number	Public / NonPublic	Date Visited	Area (sq ft)	Lane Miles *	Surface Type
0909	PUBLIC	8/13/2012	38,164	0.66	AS
Culverts	Drop Inlets	Gates	Curb & Gutter	Curb	PCR
1	0	0	NO CURB AND GUTTER	NO CURB	GOOD/90

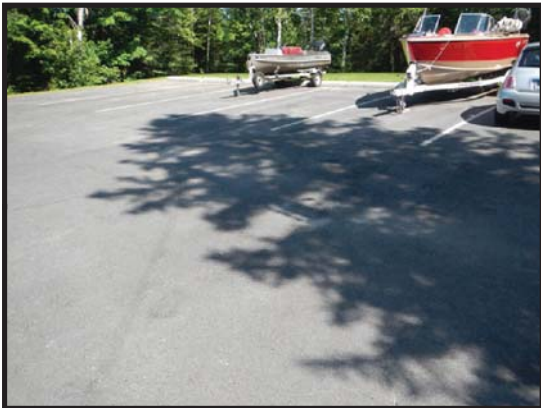
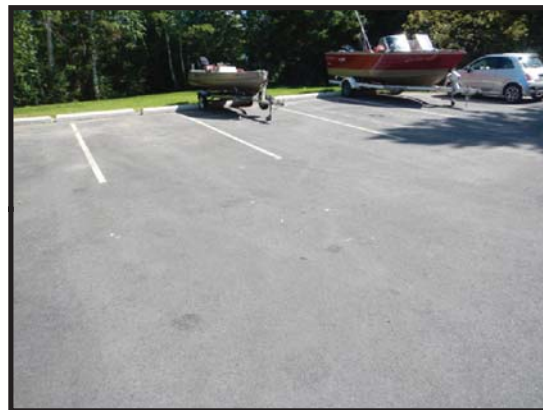
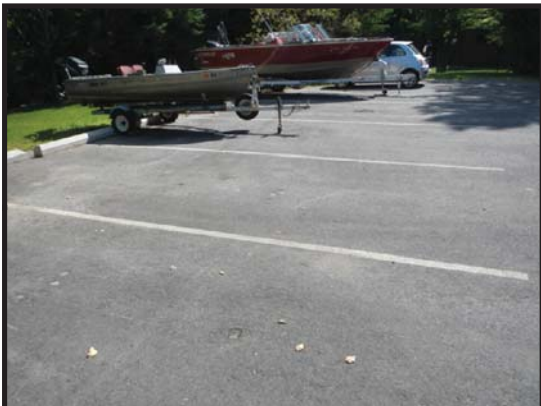
Route Number	Public / NonPublic	Date Visited	Area (sq ft)	Lane Miles *	Surface Type
0910AZ	NONPUBLIC	8/13/2012	2,839	0.05	AS
Culverts	Drop Inlets	Gates	Curb & Gutter	Curb	PCR
0	0	0	NO CURB AND GUTTER	NO CURB	GOOD/90

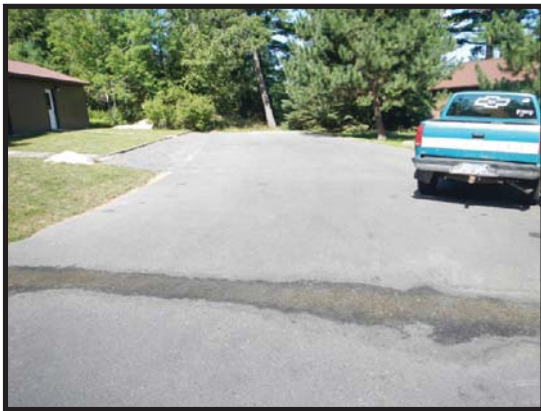
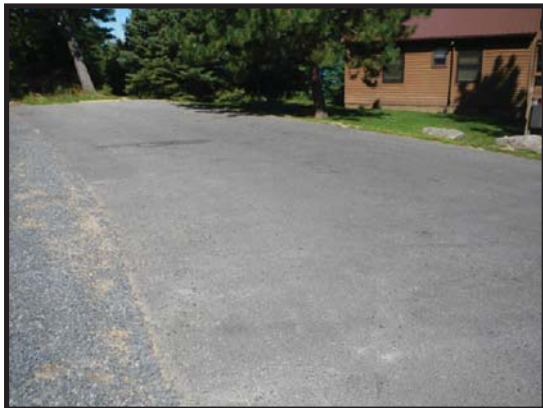
Route Number	Public / NonPublic	Date Visited	Area (sq ft)	Lane Miles *	Surface Type
0910BZ	NONPUBLIC	8/13/2012	2,417	0.04	AS
Culverts	Drop Inlets	Gates	Curb & Gutter	Curb	PCR
0	0	0	NO CURB AND GUTTER	WOOD CURB	GOOD/90

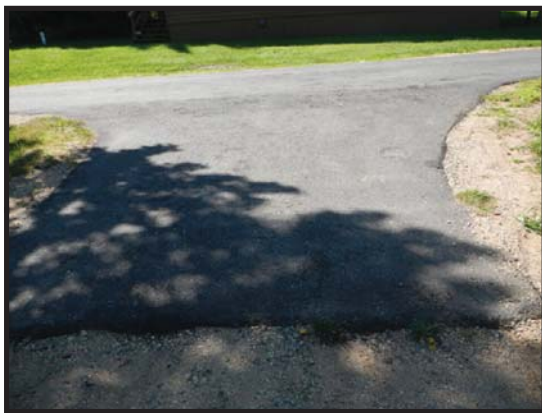
Route Number	Public / NonPublic	Date Visited	Area (sq ft)	Lane Miles *	Surface Type
0910CZ	NONPUBLIC	8/13/2012	248	0.00	AS
Culverts	Drop Inlets	Gates	Curb & Gutter	Curb	PCR
0	0	0	NO CURB AND GUTTER	NO CURB	GOOD/90

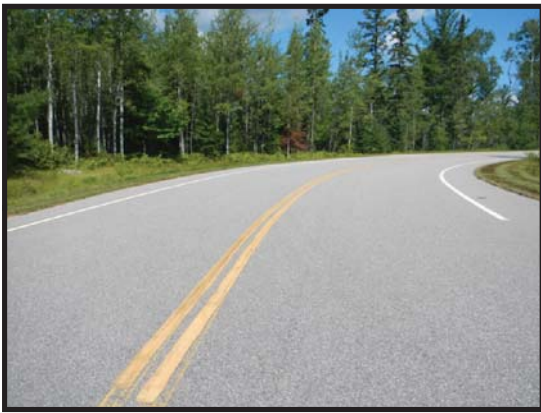
Route Number	Public / NonPublic	Date Visited	Area (sq ft)	Lane Miles *	Surface Type
0911	PUBLIC	8/13/2012	27,181	0.47	AS
Culverts	Drop Inlets	Gates	Curb & Gutter	Curb	PCR
0	0	0	NO CURB AND GUTTER	NO CURB	GOOD/90

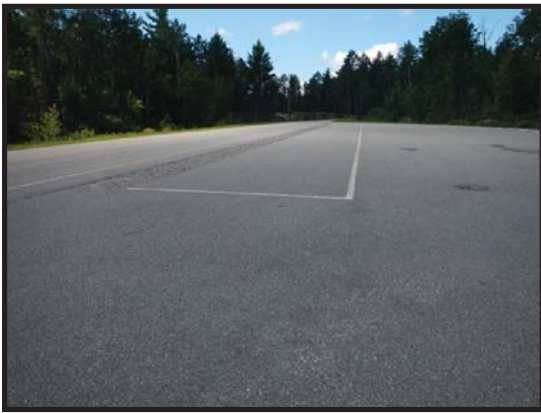
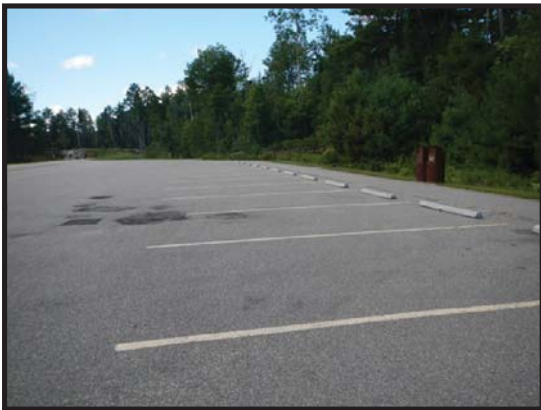
Route Number	Public / NonPublic	Date Visited	Area (sq ft)	Lane Miles *	Surface Type
0912	PUBLIC	8/13/2012	11,448	0.20	AS
Culverts	Drop Inlets	Gates	Curb & Gutter	Curb	PCR
0	0	0	NO CURB AND GUTTER	NO CURB	GOOD/90

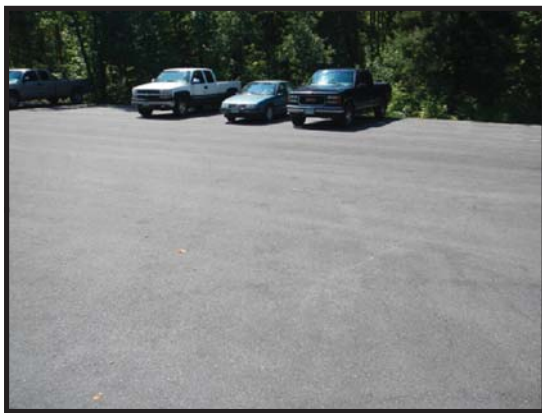
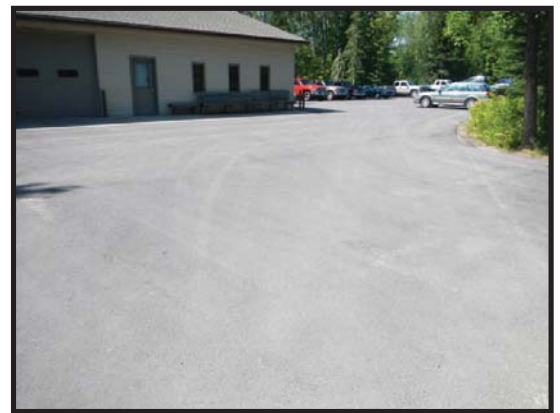
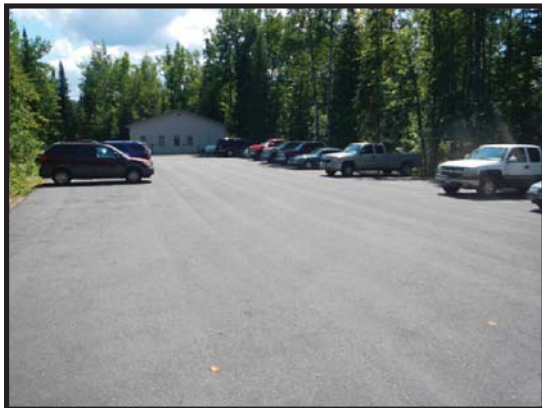
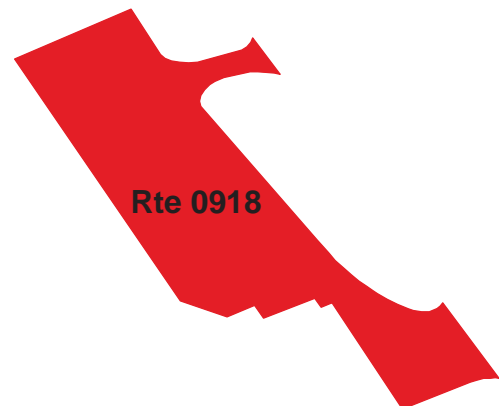
Route Number	Public / NonPublic	Date Visited	Area (sq ft)	Lane Miles *	Surface Type
0918	NONPUBLIC	8/13/2012	16,442	0.28	AS
Culverts	Drop Inlets	Gates	Curb & Gutter	Curb	PCR
0	0	0	NO CURB AND GUTTER	NO CURB	GOOD/90
