# AMIS Cycle 6

## Final Report

### Road Inventory and Condition Assessment of Paved Routes Amistad National Recreation Area

**Report Date: September 2017**

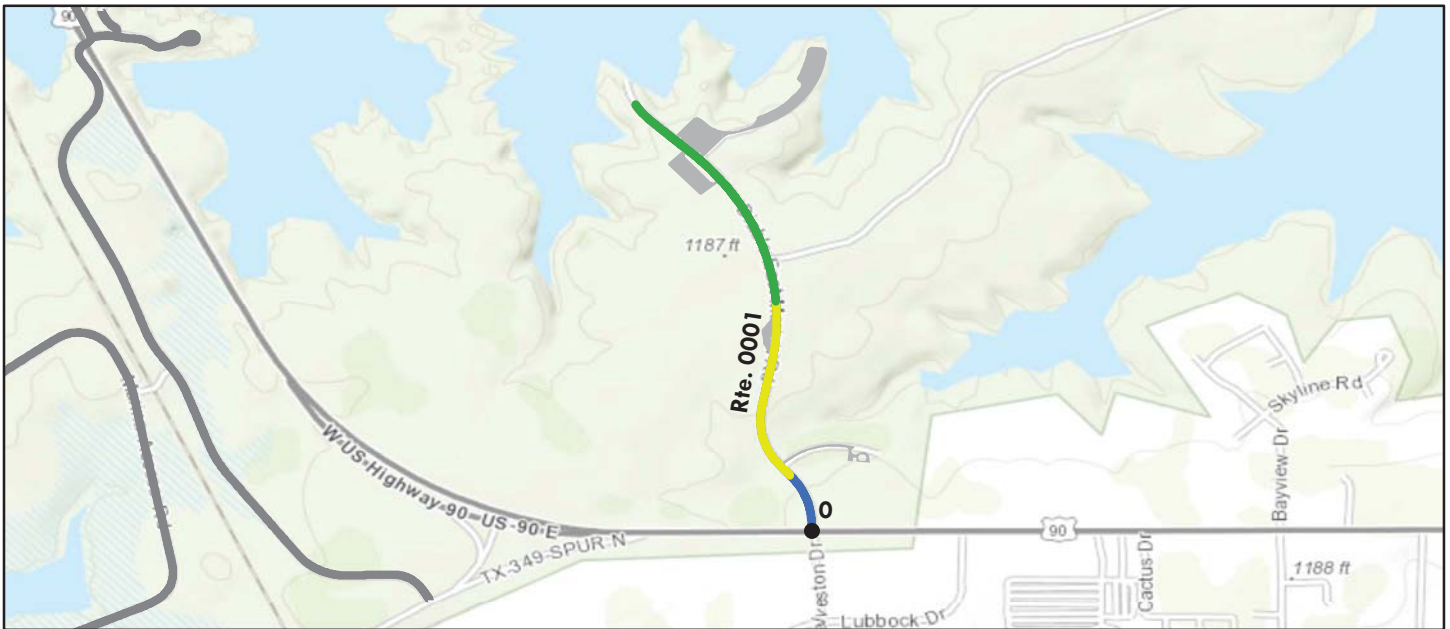
## ROUTE 0001: DIABLO EAST ENTRANCE ROAD

<b>Inspection Date:</b> 3/18/2017	<b>Beginning Section MP</b>	0				
<b>Paved Length (Miles):</b> 0.79	<b>Section Length (MI)</b>	0.79				
<b>Surface Type:</b> ASPHALT	<b>Route Summary</b>					
<b>Roadway Condition Information</b>						
Pavement Condition Rating (PCR)	84	84				
Surface Condition Rating (SCR)	87	87				
Roughness Condition Index (RCI)	80	80				
<b>Distress Index Values</b>						
Structural Crack Index	95	95				
Alligator Crack Index	100	100				
Longitudinal Crack Index	95	95				
Transverse Cracking Index	87	87				
Patching Index	100	100				
Rutting Index	94	94				
International Roughness Index (IRI)	168	168				
<b>Lane &amp; Width Information</b>						
Number of Lanes	2	2				
Paved Width (ft)	23.7	23.7				
Lane Width (ft)	11.5	11.5

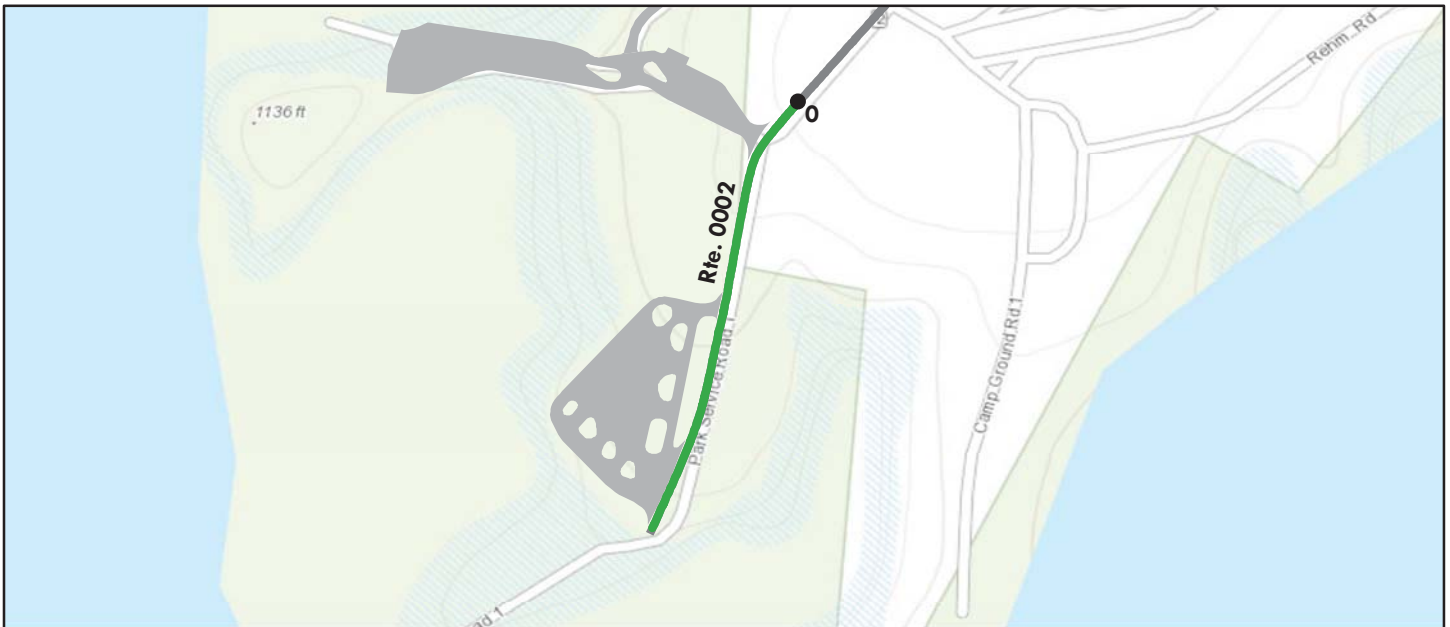
## ROUTE 0002: ROUGH CANYON ENTRANCE ROAD

Route Condition Legend – Pavement Condition Rating (PCR)						
Poor (0 - 60)	Fair (61- 84)	Good (85 - 94)	Excellent (95 - 100)	Not Rated		
See Appendix for definitions and formulas						
<b>Inspection Date:</b> 3/18/2017	<b>Beginning Section MP</b>	0				
<b>Paved Length (Miles):</b> 0.20	<b>Section Length (MI)</b>	0.20				
<b>Surface Type:</b> ASPHALT	<b>Route Summary</b>					
<b>Roadway Condition Information</b>						
Pavement Condition Rating (PCR)	89	89				
Surface Condition Rating (SCR)	89	89				
Roughness Condition Index (RCI)	N/A	N/A				
<b>Distress Index Values</b>						
Structural Crack Index	93	93				
Alligator Crack Index	100	100				
Longitudinal Crack Index	93	93				
Transverse Cracking Index	89	89				
Patching Index	100	100				
Rutting Index	93	93				
International Roughness Index (IRI)	N/A	N/A				
<b>Lane &amp; Width Information</b>						
Number of Lanes	2	2				
Paved Width (ft)	22.8	22.8				
Lane Width (ft)	12.3	12.3

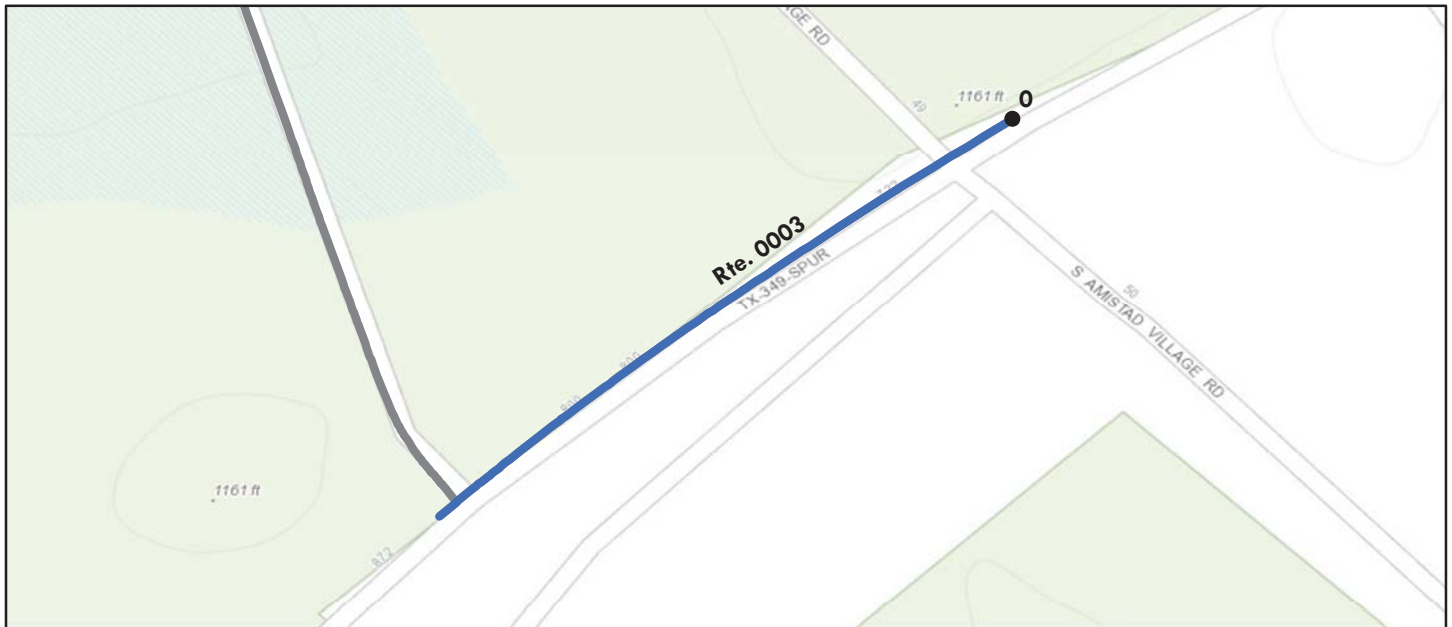
## ROUTE 0003: DAM ROAD

Route Condition Legend – Pavement Condition Rating (PCR)						
Poor (0 - 60)	Fair (61- 84)	Good (85 - 94)	Excellent (95 - 100)	Not Rated		
See Appendix for definitions and formulas						
<b>Inspection Date:</b> 3/18/2017	<b>Beginning Section MP</b>	0				
<b>Paved Length (Miles):</b> 0.15	<b>Section Length (MI)</b>	0.15				
<b>Surface Type:</b> ASPHALT	<b>Route Summary</b>					
<b>Roadway Condition Information</b>						
Pavement Condition Rating (PCR)	99	99				
Surface Condition Rating (SCR)	99	99				
Roughness Condition Index (RCI)	N/A	N/A				
<b>Distress Index Values</b>						
Structural Crack Index	100	100				
Alligator Crack Index	100	100				
Longitudinal Crack Index	100	100				
Transverse Cracking Index	100	100				
Patching Index	100	100				
Rutting Index	99	99				
International Roughness Index (IRI)	N/A	N/A				
<b>Lane &amp; Width Information</b>						
Number of Lanes	2	2				
Paved Width (ft)	22.6	22.6

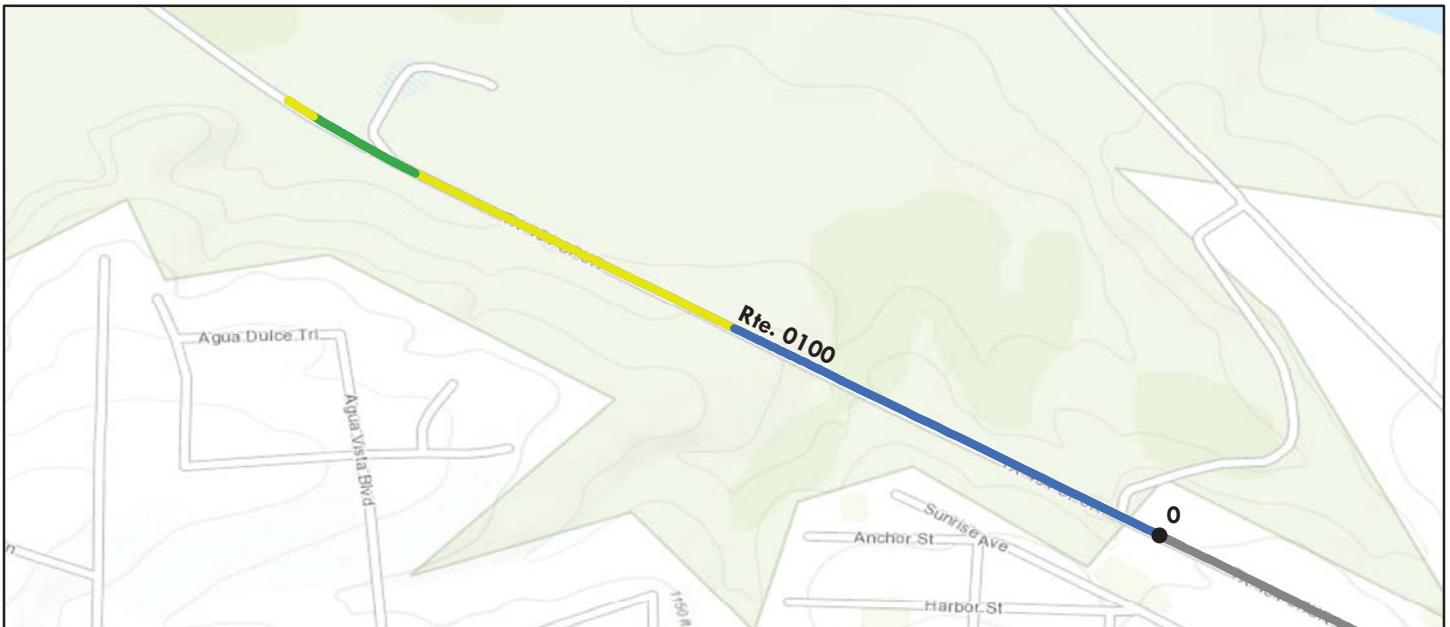
## ROUTE 0100: SPUR 454 ROAD

<b>Inspection Date:</b> 3/18/2017	<b>Beginning Section MP</b>	0				
<b>Paved Length (Miles):</b> 0.83	<b>Section Length (MI)</b>	0.83				
<b>Surface Type:</b> ASPHALT	<b>Route Summary</b>					
<b>Roadway Condition Information</b>						
Pavement Condition Rating (PCR)	89	89				
Surface Condition Rating (SCR)	95	95				
Roughness Condition Index (RCI)	79	79				
<b>Distress Index Values</b>						
Structural Crack Index	100	100				
Alligator Crack Index	100	100				
Longitudinal Crack Index	100	100				
Transverse Cracking Index	100	100				
Patching Index	100	100				
Rutting Index	95	95				
International Roughness Index (IRI)	173	172				
<b>Lane &amp; Width Information</b>						
Number of Lanes	2	2				
Paved Width (ft)	28	28				
Lane Width (ft)	13.7	13.7

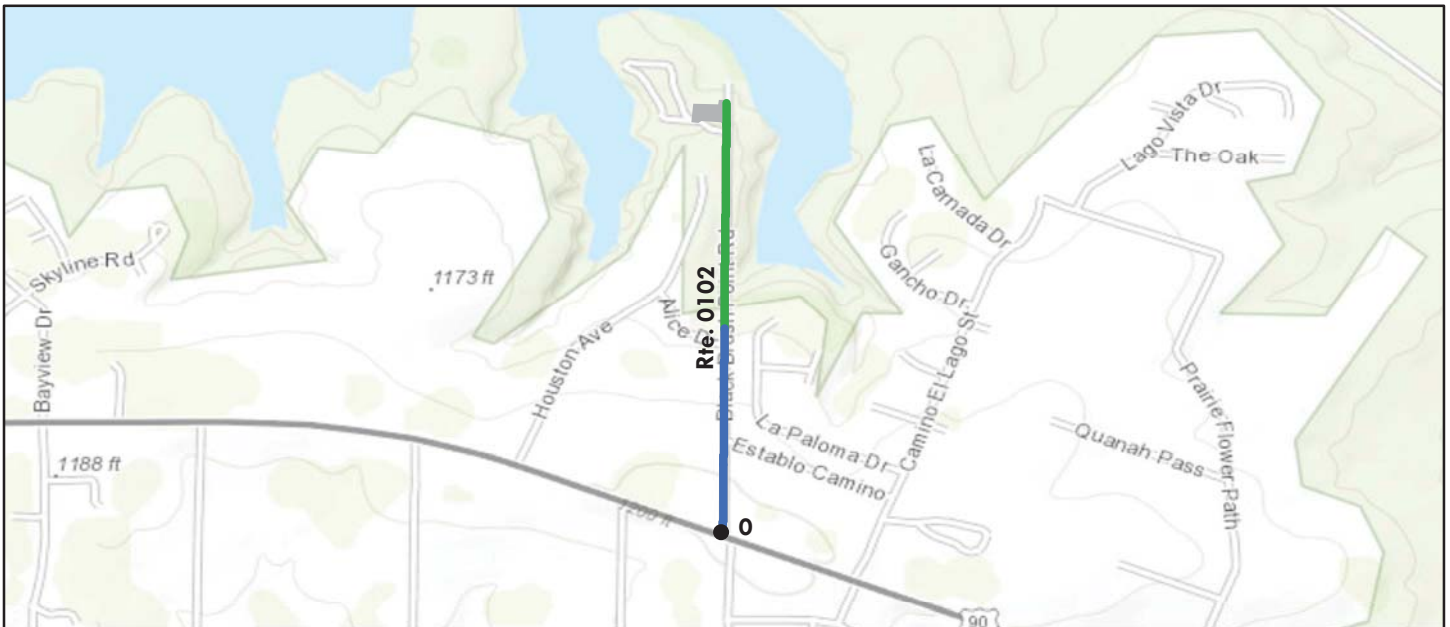
## ROUTE 0102: BLACK BRUSH ROAD

<b>Inspection Date:</b> 3/18/2017	<b>Beginning Section MP</b>	0				
<b>Paved Length (Miles):</b> 0.63	<b>Section Length (MI)</b>	0.63				
<b>Surface Type:</b> ASPHALT	<b>Route Summary</b>					
<b>Roadway Condition Information</b>						
Pavement Condition Rating (PCR)	95	95				
Surface Condition Rating (SCR)	94	94				
Roughness Condition Index (RCI)	97	97				
<b>Distress Index Values</b>						
Structural Crack Index	99	99				
Alligator Crack Index	100	100				
Longitudinal Crack Index	99	99				
Transverse Cracking Index	94	94				
Patching Index	100	100				
Rutting Index	98	98				
International Roughness Index (IRI)	123	123				
<b>Lane &amp; Width Information</b>						
Number of Lanes	2	2				
Paved Width (ft)	21.8	21.8				
Lane Width (ft)	11	11

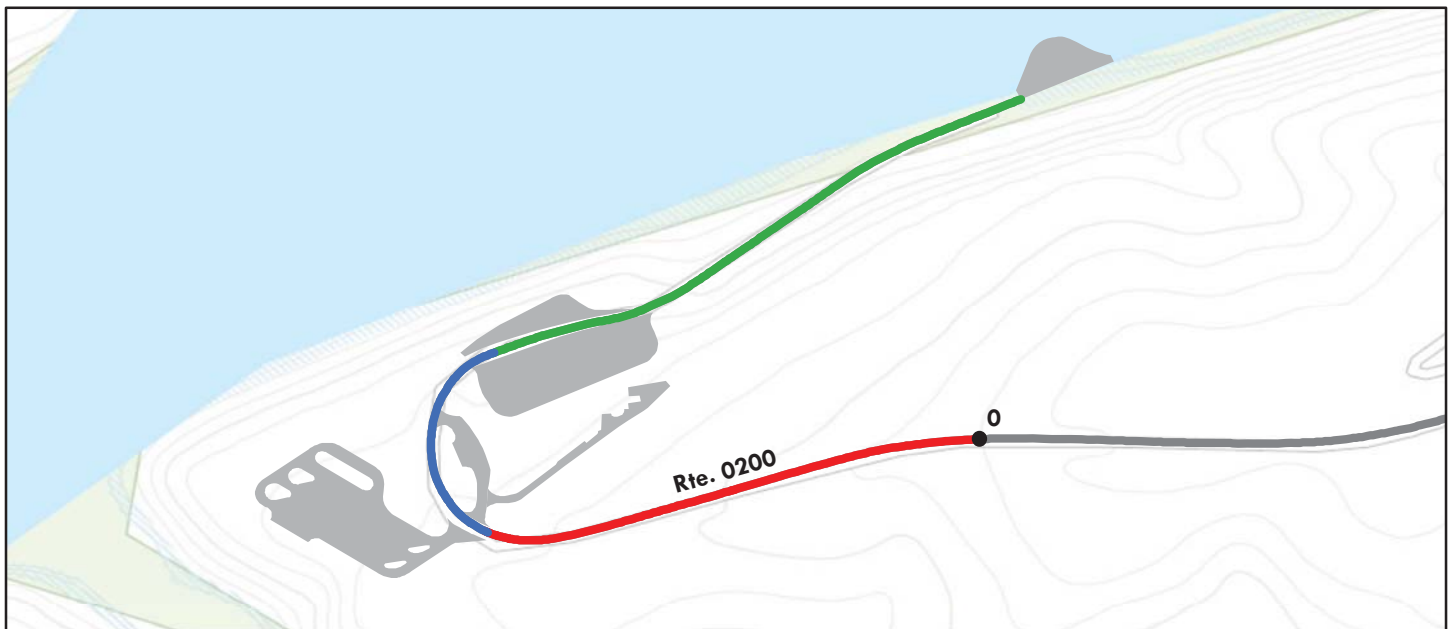
## ROUTE 0200: PECOS ROAD

Route Condition Legend – Pavement Condition Rating (PCR)						
Poor (0 - 60)	Fair (61- 84)	Good (85 - 94)	Excellent (95 - 100)	Not Rated		
See Appendix for definitions and formulas						
<b>Inspection Date:</b> 3/18/2017	<b>Beginning Section MP</b>	0				
<b>Paved Length (Miles):</b> 0.54	<b>Section Length (MI)</b>	0.54				
<b>Surface Type:</b> ASPHALT	<b>Route Summary</b>					
<b>Roadway Condition Information</b>						
Pavement Condition Rating (PCR)	45	45				
Surface Condition Rating (SCR)	45	45				
Roughness Condition Index (RCI)	N/A	N/A				
<b>Distress Index Values</b>						
Structural Crack Index	45	45				
Alligator Crack Index	49	49				
Longitudinal Crack Index	96	96				
Transverse Cracking Index	90	90				
Patching Index	100	100				
Rutting Index	96	96				
International Roughness Index (IRI)	N/A	N/A				
<b>Lane &amp; Width Information</b>						
Number of Lanes	2	2				
Paved Width (ft)	21.3	21.3				
Lane Width (ft)	9.5	9.5

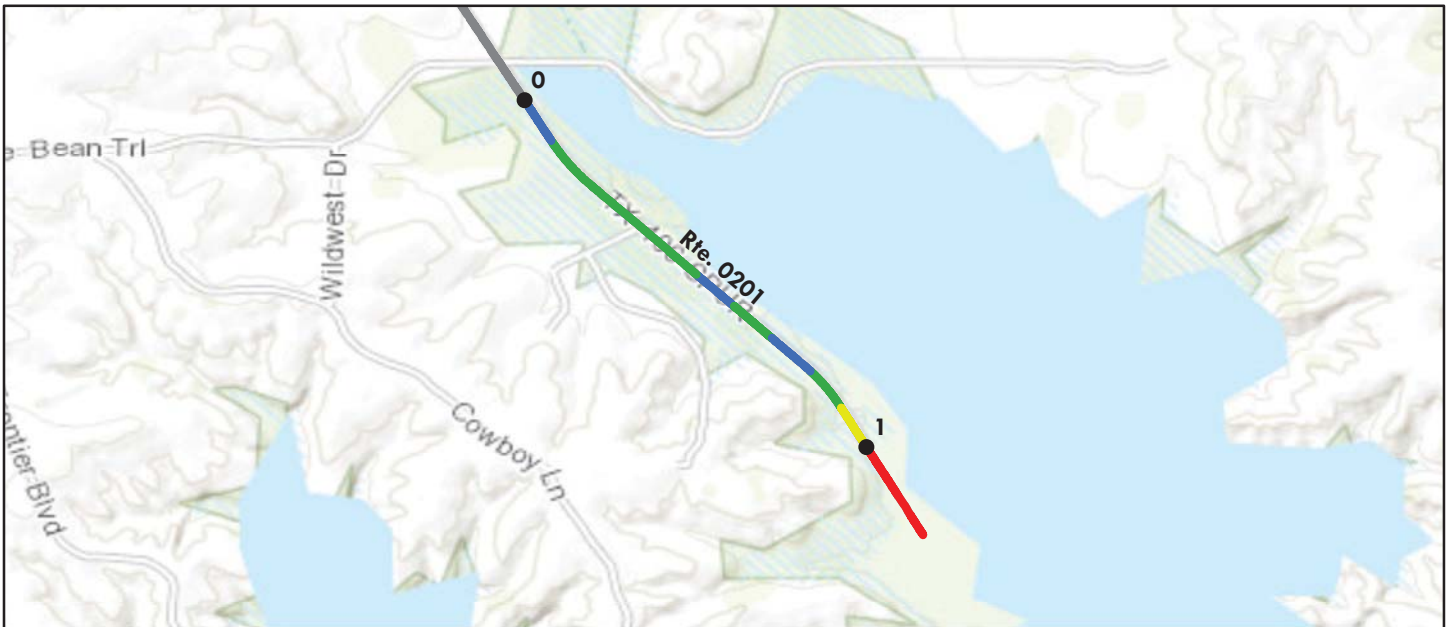
## ROUTE 0201: SPUR 406 ENTRANCE ROAD

Route Condition Legend – Pavement Condition Rating (PCR)						
Poor (0 - 60)	Fair (61- 84)	Good (85 - 94)	Excellent (95 - 100)	Not Rated		
See Appendix for definitions and formulas						
<b>Inspection Date:</b> 3/18/2017	<b>Beginning Section MP</b>	0	1			
<b>Paved Length (Miles):</b> 1.22	<b>Section Length (MI)</b>	1	0.22			
<b>Surface Type:</b> ASPHALT	<b>Route Summary</b>					
<b>Roadway Condition Information</b>						
Pavement Condition Rating (PCR)	74	93	38			
Surface Condition Rating (SCR)	62	95	0			
Roughness Condition Index (RCI)	91	90	96			
<b>Distress Index Values</b>						
Structural Crack Index	76	98	0			
Alligator Crack Index	92	98	64			
Longitudinal Crack Index	84	100	10			
Transverse Cracking Index	62	100	0			
Patching Index	100	100	100			
Rutting Index	95	95	95			
International Roughness Index (IRI)	137	139	125			
<b>Lane &amp; Width Information</b>						
Number of Lanes	2	2	2			
Paved Width (ft)	27.1	27.8	23.7

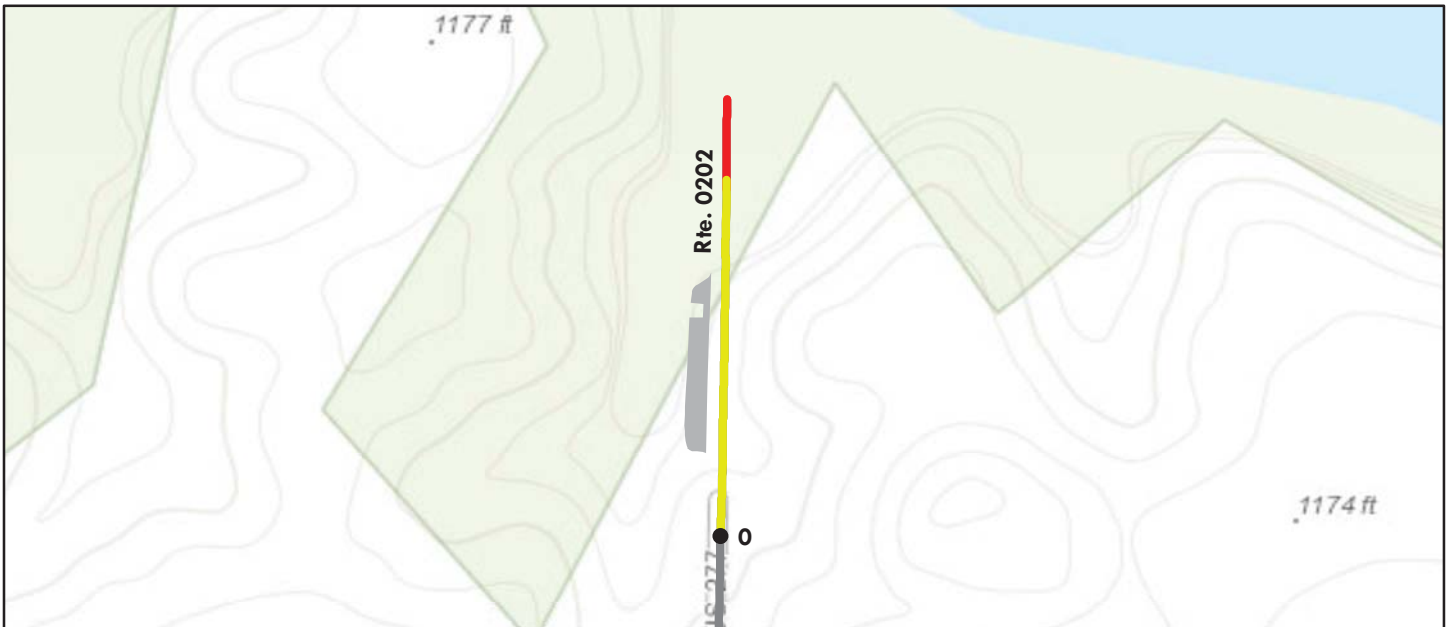
## ROUTE 0202: SPUR 277 SOUTH ENTRANCE ROAD

Route Condition Legend – Pavement Condition Rating (PCR)						
Poor (0 - 60)	Fair (61- 84)	Good (85 - 94)	Excellent (95 - 100)	Not Rated		
See Appendix for definitions and formulas						
<b>Inspection Date:</b> 3/18/2017	<b>Beginning Section MP</b>	0				
<b>Paved Length (Miles):</b> 0.13	<b>Section Length (MI)</b>	0.13				
<b>Surface Type:</b> ASPHALT	<b>Route Summary</b>					
<b>Roadway Condition Information</b>						
Pavement Condition Rating (PCR)	47	47				
Surface Condition Rating (SCR)	47	47				
Roughness Condition Index (RCI)	N/A	N/A				
<b>Distress Index Values</b>						
Structural Crack Index	68	68				
Alligator Crack Index	100	100				
Longitudinal Crack Index	68	68				
Transverse Cracking Index	47	47				
Patching Index	97	97				
Rutting Index	95	95				
International Roughness Index (IRI)	N/A	N/A				
<b>Lane &amp; Width Information</b>						
Number of Lanes	2	2				
Paved Width (ft)	23.2	23.2				
Lane Width (ft)	11.6	11.6

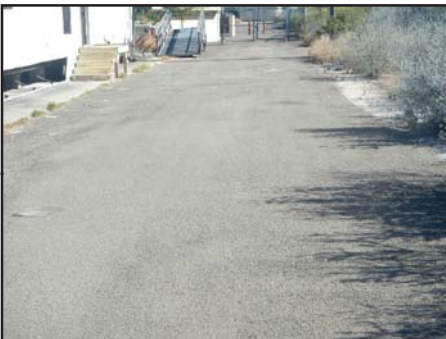
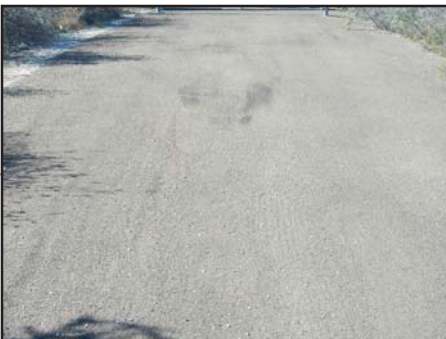
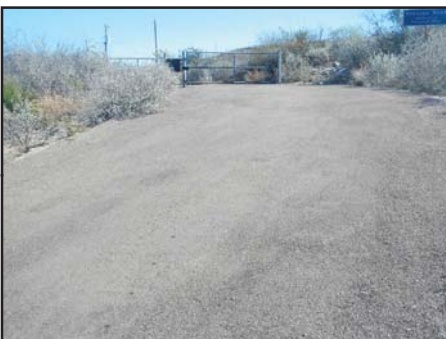
Inspection Date	FMSS Number	User Access	Surface Type
2/22/2017	52923	NONPUBLIC	ASPHALT
Area (Sq. Ft.)	Lane Miles (11' Widths)	Curb Reveal (Inches)	Curb Recommendation
11,213	0.193	NOT APPLICABLE	NOT APPLICABLE
Curb Type		Curb & Gutter Type	
NO CURB		NO CURB AND GUTTER	
Pavement Recommendation		Condition Rating / PCR	
PREVENTIVE MAINTENANCE		GOOD / 90

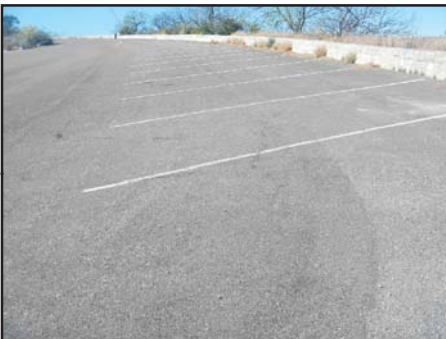
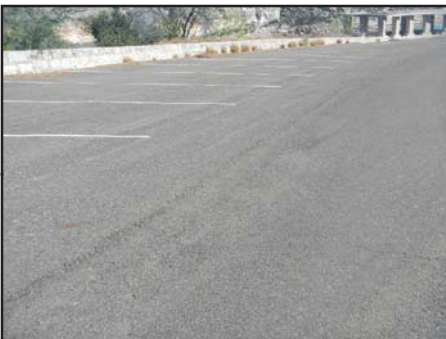
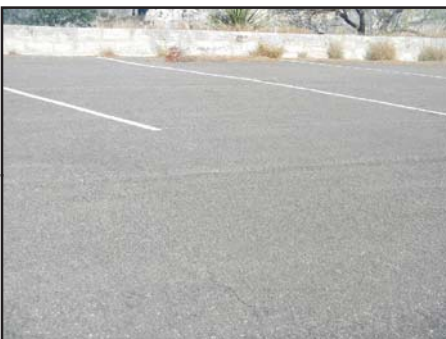
## ROUTE 0903A: PECOS BOAT RAMP PARKING A

Inspection Date	FMSS Number	User Access	Surface Type
2/22/2017	52941	PUBLIC	ASPHALT
Area (Sq. Ft.)	Lane Miles (11' Widths)	Curb Reveal (Inches)	Curb Recommendation
13,353	0.23	NOT APPLICABLE	NOT APPLICABLE
Curb Type		Curb & Gutter Type	
NO CURB		NO CURB AND GUTTER	
Pavement Recommendation		Condition Rating / PCR	
PREVENTIVE MAINTENANCE		GOOD / 90

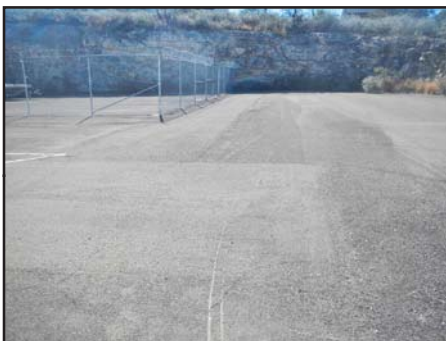
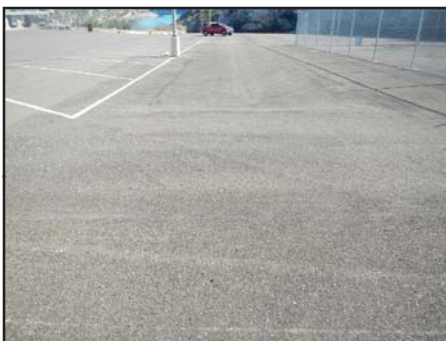
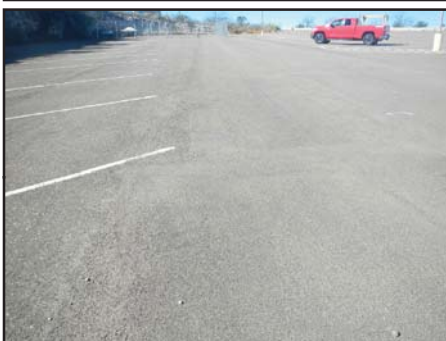
## ROUTE 0903B: PECOS BOAT RAMP PARKING B

Inspection Date	FMSS Number	User Access	Surface Type
2/22/2017	52942	PUBLIC	ASPHALT
Area (Sq. Ft.)	Lane Miles (11' Widths)	Curb Reveal (Inches)	Curb Recommendation
48,111	0.828	NOT APPLICABLE	NOT APPLICABLE
Curb Type		Curb & Gutter Type	
NO CURB		NO CURB AND GUTTER	
Pavement Recommendation		Condition Rating / PCR	
PREVENTIVE MAINTENANCE		GOOD / 90

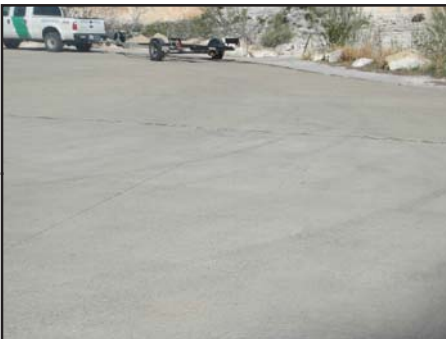
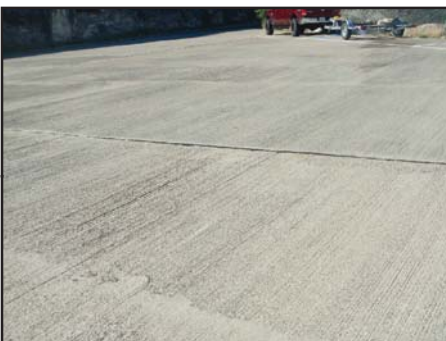
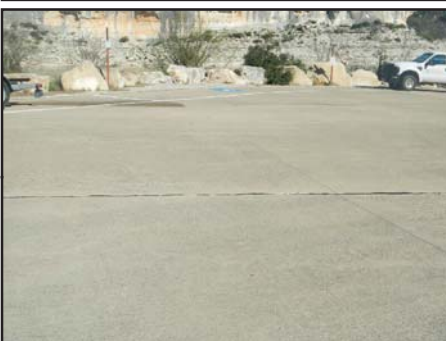
## ROUTE 0904: PECOS BOAT DOCK PARKING

Inspection Date	FMSS Number	User Access	Surface Type
2/22/2017	235751	PUBLIC	CONCRETE
Area (Sq. Ft.)	Lane Miles (11' Widths)	Curb Reveal (Inches)	Curb Recommendation
15,598	0.269	NOT APPLICABLE	NOT APPLICABLE
Curb Type		Curb & Gutter Type	
NO CURB		NO CURB AND GUTTER	
Pavement Recommendation		Condition Rating / PCR	
PREVENTIVE MAINTENANCE		GOOD / 90

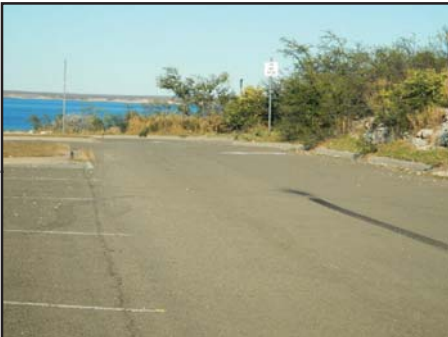
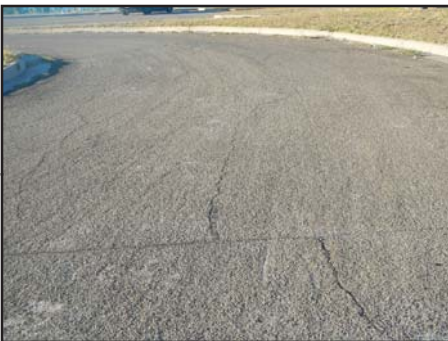
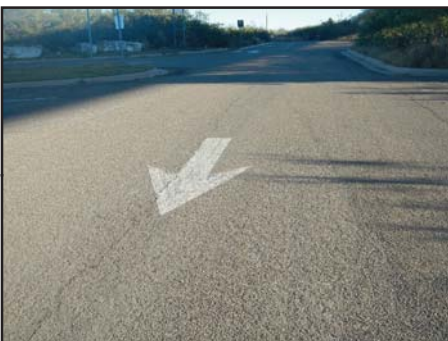
## ROUTE 0905: GOVERNORS LANDING PARKING AREA

Inspection Date	FMSS Number	User Access	Surface Type
2/21/2017	52925	PUBLIC	ASPHALT
Area (Sq. Ft.)	Lane Miles (11' Widths)	Curb Reveal (Inches)	Curb Recommendation
49,706	0.856	NOT APPLICABLE	DO NOTHING
Curb Type		Curb & Gutter Type	
NO CURB		CONCRETE	
Pavement Recommendation		Condition Rating / PCR	
PREVENTIVE MAINTENANCE		GOOD / 90

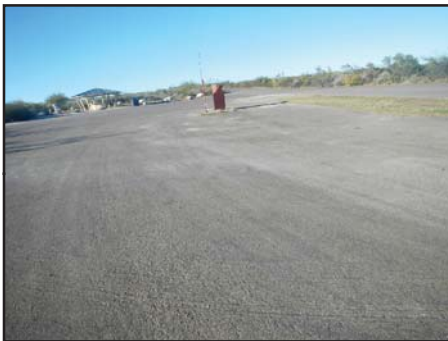
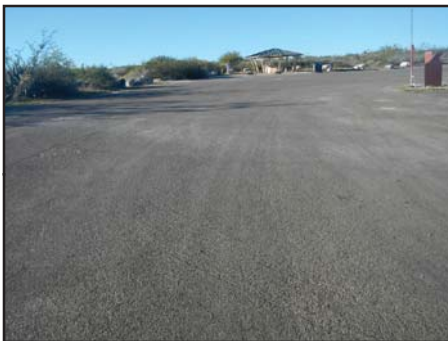
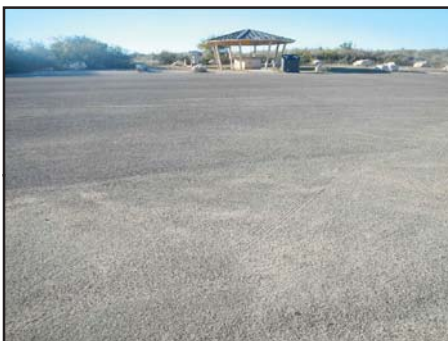
## ROUTE 0906: DUMP STATION PARKING

Inspection Date	FMSS Number	User Access	Surface Type
2/21/2017	52927	PUBLIC	ASPHALT
Area (Sq. Ft.)	Lane Miles (11' Widths)	Curb Reveal (Inches)	Curb Recommendation
17,433	0.3	NOT APPLICABLE	NOT APPLICABLE
Curb Type		Curb & Gutter Type	
NO CURB		NO CURB AND GUTTER	
Pavement Recommendation		Condition Rating / PCR	
PREVENTIVE MAINTENANCE		GOOD / 90

Note: Parking area consists of multiple surface types: 1 part Asphalt at 17,324 square feet; 1 part Concrete at 109 square feet.

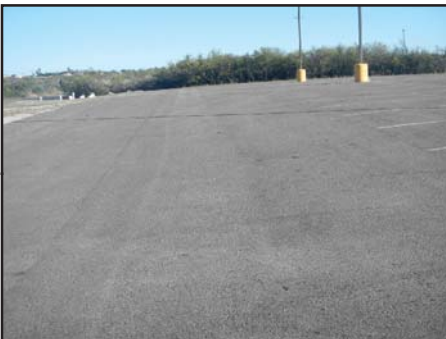
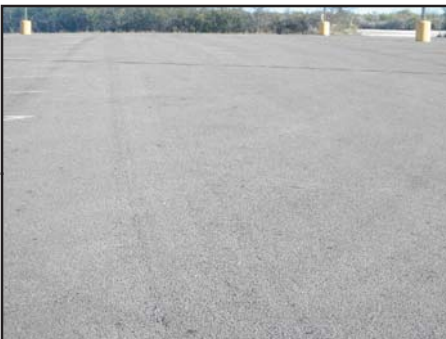
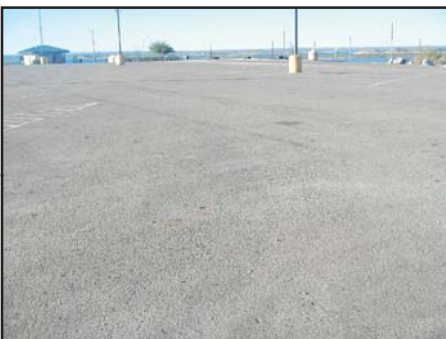
## ROUTE 0907A: DIABLO EAST UPPER PARKING LOT

Inspection Date	FMSS Number	User Access	Surface Type
2/21/2017	24956	PUBLIC	ASPHALT
Area (Sq. Ft.)	Lane Miles (11' Widths)	Curb Reveal (Inches)	Curb Recommendation
55,251	0.951	4	MODERATE REPAIR
Curb Type		Curb & Gutter Type	
CONCRETE		NO CURB AND GUTTER	
Pavement Recommendation		Condition Rating / PCR	
PREVENTIVE MAINTENANCE		GOOD / 90

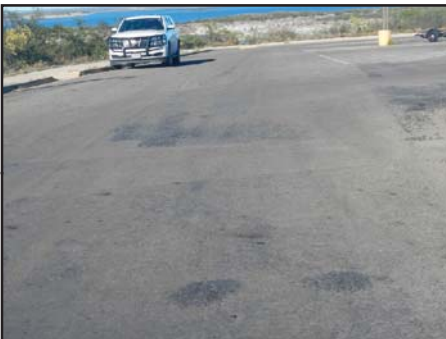
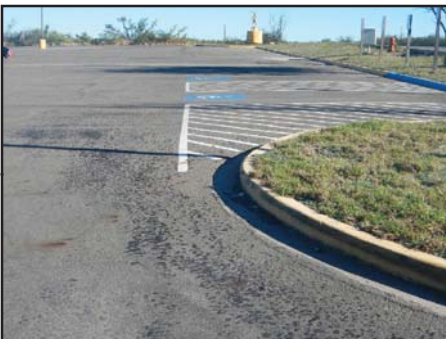
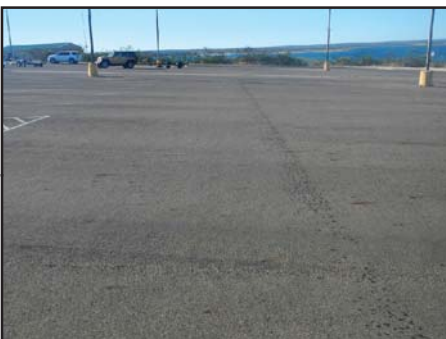
## ROUTE 0907B: DIABLO EAST LOWER PARKING LOT

Inspection Date	FMSS Number	User Access	Surface Type
2/21/2017	24957	PUBLIC	ASPHALT
Area (Sq. Ft.)	Lane Miles (11' Widths)	Curb Reveal (Inches)	Curb Recommendation
69,172	1.191	NOT APPLICABLE	DO NOTHING
Curb Type		Curb & Gutter Type	
NO CURB		CONCRETE	
Pavement Recommendation		Condition Rating / PCR	
PREVENTIVE MAINTENANCE		GOOD / 90
