AMME Cycle 6

Final Report

Road Inventory and Condition Assessments for American Memorial Park

**Federal Highway Administration
Eastern Federal Lands Highway Division
Road Inventory Program (RIP)**

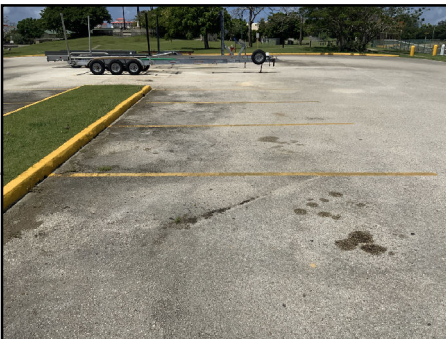
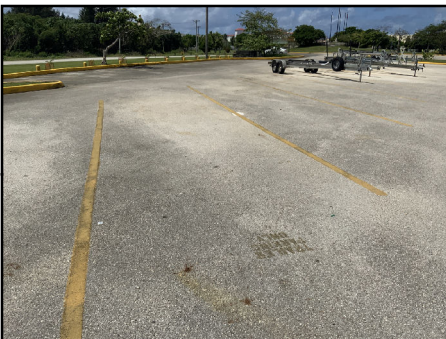
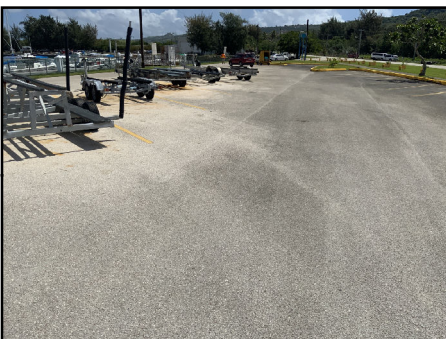
Inspection Date	FMSS Number	User Access	Surface Type
3/21/2022	70423	PUBLIC	ASPHALT
Area (Sq. Ft.)	Lane Miles (11' Widths)	Curb Reveal (Inches)	Curb Recommendation
48,109	0.828	5	LIGHT REPAIR
Curb Type		Curb & Gutter Type	
CONCRETE		NO CURB AND GUTTER	
Pavement Recommendation		Condition Rating / PCR	
LIGHT 3R TREATMENTS		FAIR / 73

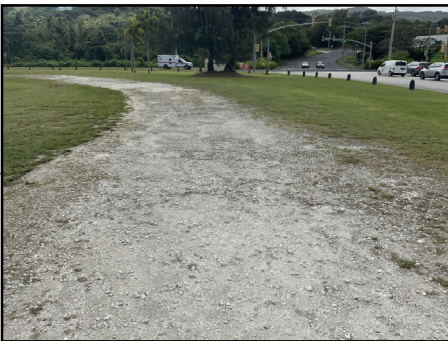
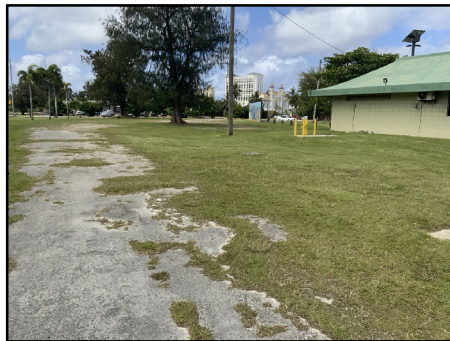
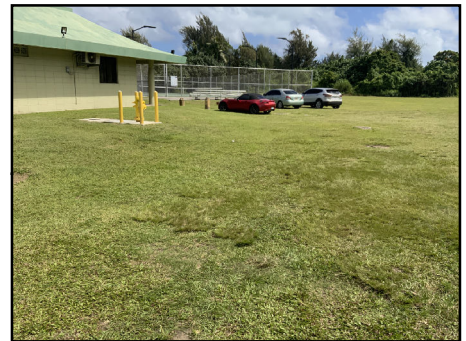
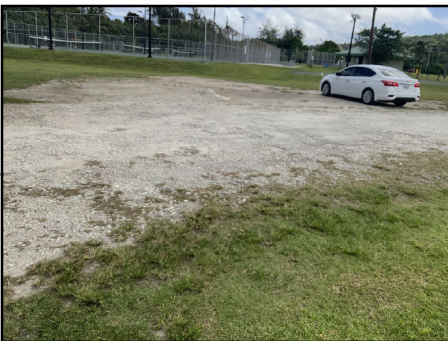
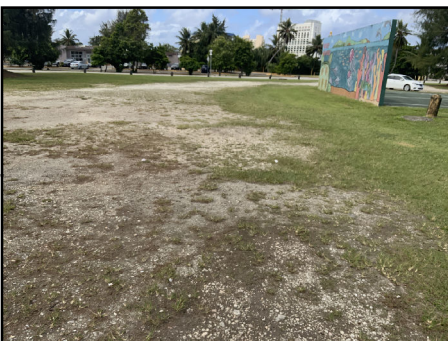
ROUTE 0902: UNPAVED TENNIS COURT PARKING

Inspection Date	FMSS Number	User Access	Surface Type
3/21/2022	70440	PUBLIC	GRAVEL
Area (Sq. Ft.)	Lane Miles (11' Widths)	Curb Reveal (Inches)	Curb Recommendation
28,437	0.490	NOT APPLICABLE	NOT APPLICABLE
Curb Type		Curb & Gutter Type	
NO CURB		NO CURB AND GUTTER	
Treatment Recommendation		Condition Rating	
HEAVY REHABILITATION		2

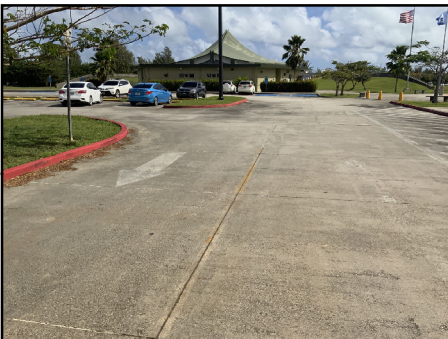
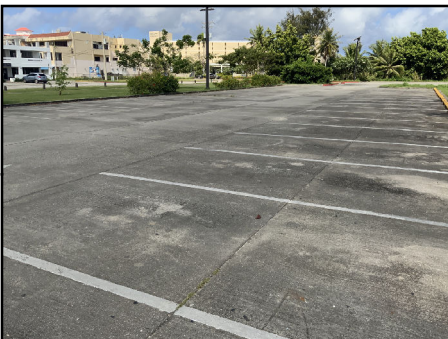
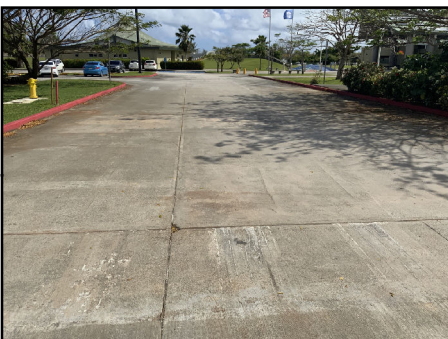
ROUTE 0903: VISITOR CENTER / AMPHITHEATER PARKING

Inspection Date	FMSS Number	User Access	Surface Type
3/21/2022	70451	PUBLIC	CONCRETE
Area (Sq. Ft.)	Lane Miles (11' Widths)	Curb Reveal (Inches)	Curb Recommendation
49,064	0.845	5	MODERATE REPAIR
Curb Type		Curb & Gutter Type	
CONCRETE		NO CURB AND GUTTER	
Pavement Recommendation		Condition Rating / PCR	
LIGHT 3R TREATMENTS		FAIR / 73

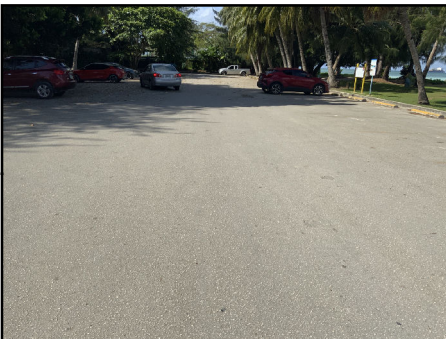
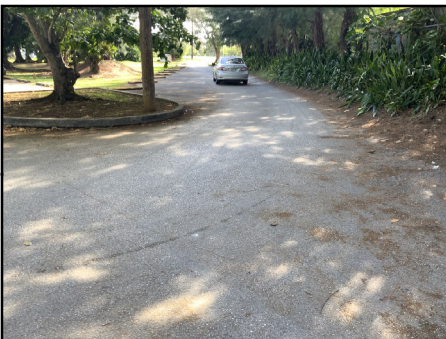
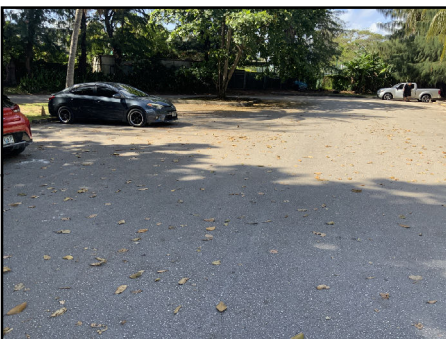
ROUTE 0904: MICRO BEACH PAVILION PARKING

Inspection Date	FMSS Number	User Access	Surface Type
3/21/2022	70461	PUBLIC	ASPHALT
Area (Sq. Ft.)	Lane Miles (11' Widths)	Curb Reveal (Inches)	Curb Recommendation
27,390	0.472	8	REPLACE
Curb Type		Curb & Gutter Type	
CONCRETE		NO CURB AND GUTTER	
Pavement Recommendation		Condition Rating / PCR	
HEAVY 3R TREATMENTS		POOR / 53

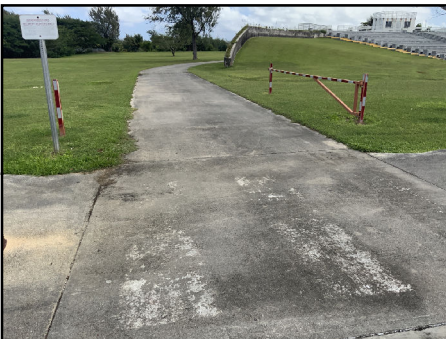
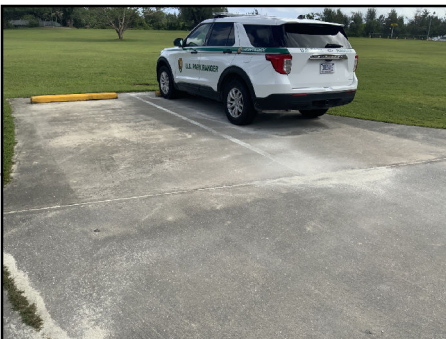
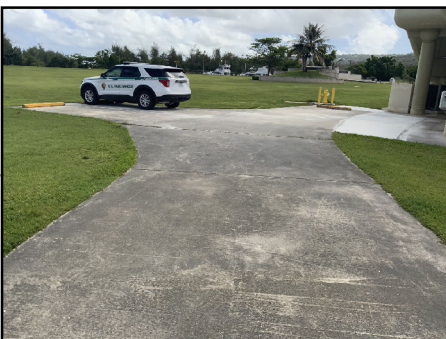
ROUTE 0905: ADMINISTRATIVE OFFICES PARKING

Inspection Date	FMSS Number	User Access	Surface Type
3/21/2022	104802	NONPUBLIC	CONCRETE
Area (Sq. Ft.)	Lane Miles (11' Widths)	Curb Reveal (Inches)	Curb Recommendation
3,351	0.058	NOT APPLICABLE	NOT APPLICABLE
Curb Type		Curb & Gutter Type	
NO CURB		NO CURB AND GUTTER	
Pavement Recommendation		Condition Rating / PCR	
LIGHT 3R TREATMENTS		FAIR / 73

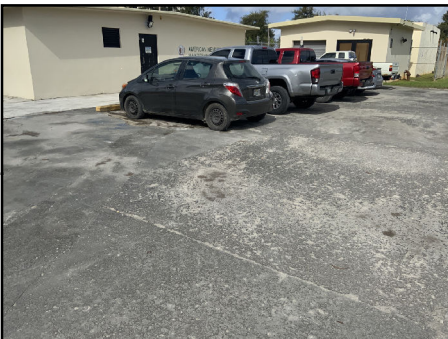
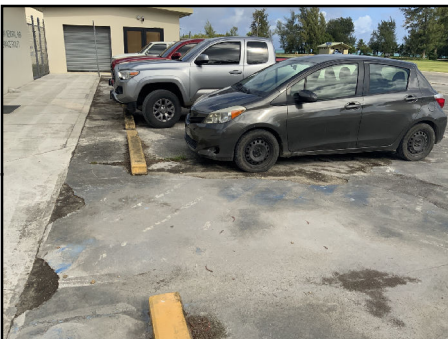
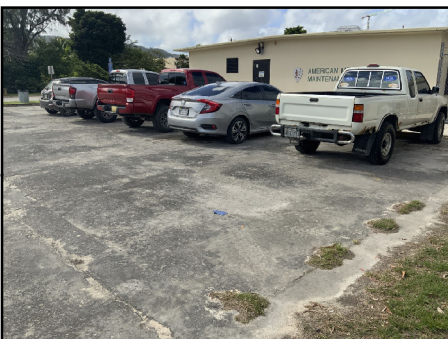
ROUTE 0906A: MAINTENANCE EMPLOYEE PARKING

Inspection Date	FMSS Number	User Access	Surface Type
3/21/2022	104814	PUBLIC	CONCRETE
Area (Sq. Ft.)	Lane Miles (11' Widths)	Curb Reveal (Inches)	Curb Recommendation
1,839	0.032	6	LIGHT REPAIR
Curb Type		Curb & Gutter Type	
CONCRETE		NO CURB AND GUTTER	
Pavement Recommendation		Condition Rating / PCR	
HEAVY 3R TREATMENTS		POOR / 53

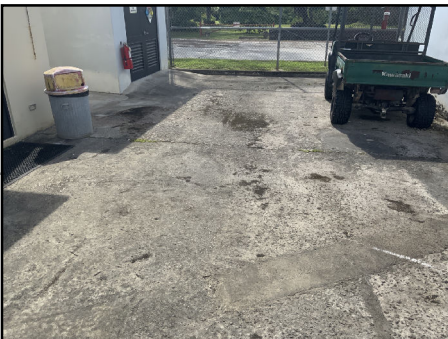
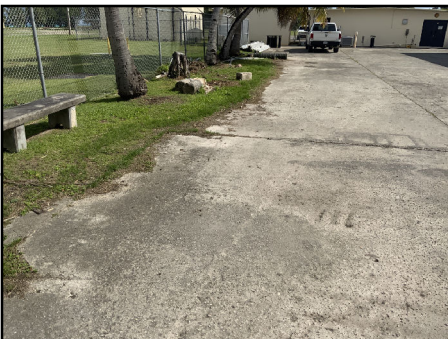
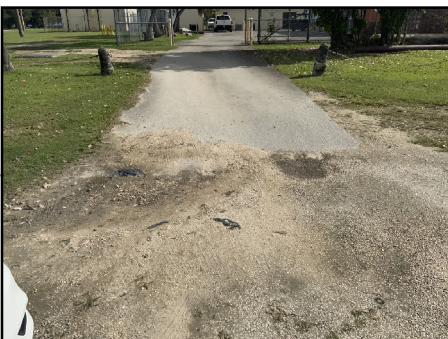
ROUTE 0906B: MAINTENANCE YARD

Inspection Date	FMSS Number	User Access	Surface Type
3/21/2022	104818	NONPUBLIC	CONCRETE
Area (Sq. Ft.)	Lane Miles (11' Widths)	Curb Reveal (Inches)	Curb Recommendation
7,744	0.133	5	DO NOTHING
Curb Type		Curb & Gutter Type	
CONCRETE		NO CURB AND GUTTER	
Pavement Recommendation		Condition Rating / PCR	
HEAVY 3R TREATMENTS		POOR / 53

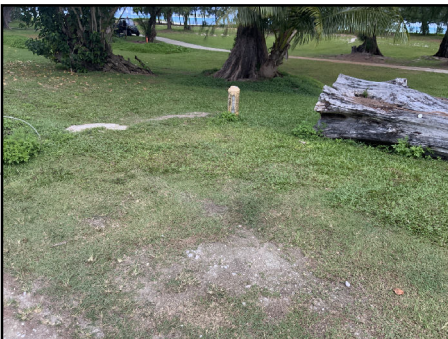
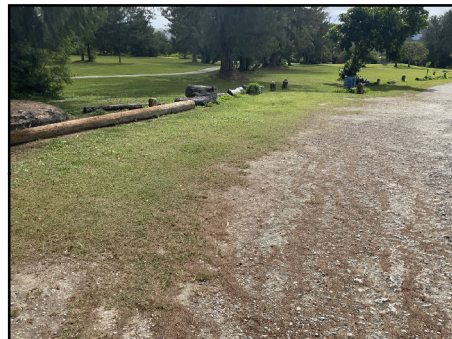
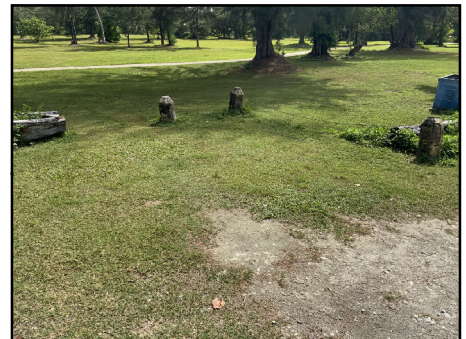
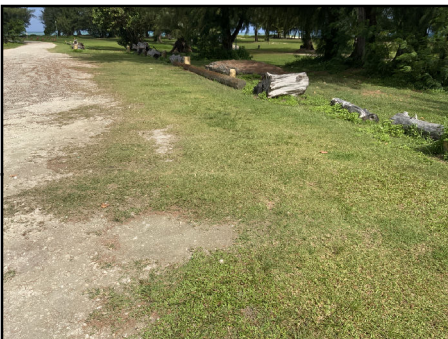
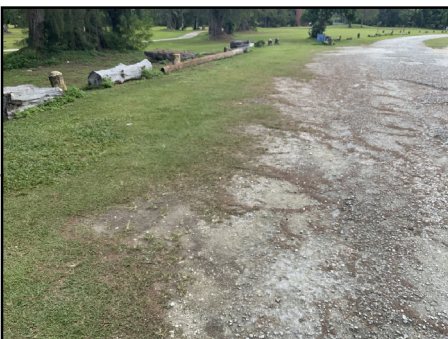
ROUTE 0907B: MICRO BEACH PARKING

Inspection Date	FMSS Number	User Access	Surface Type
3/21/2022	104839	PUBLIC	GRAVEL
Area (Sq. Ft.)	Lane Miles (11' Widths)	Curb Reveal (Inches)	Curb Recommendation
2,566	0.044	NOT APPLICABLE	NOT APPLICABLE
Curb Type		Curb & Gutter Type	
NO CURB		NO CURB AND GUTTER	
Treatment Recommendation		Condition Rating	
HEAVY REHABILITATION		2

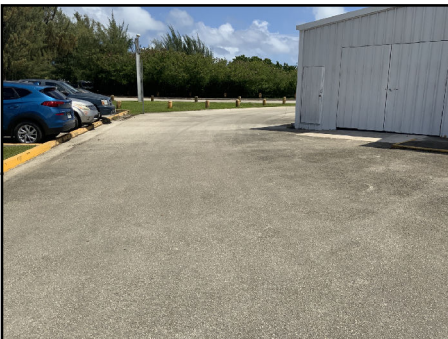
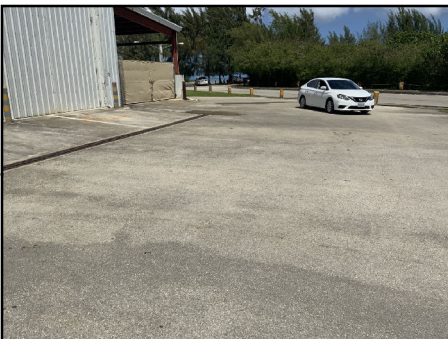
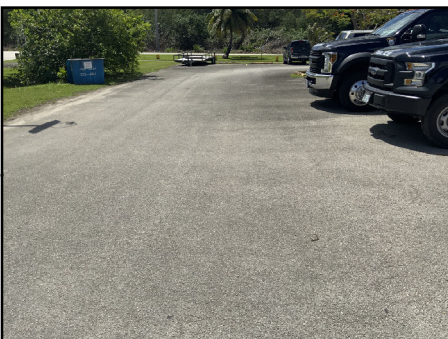
ROUTE 0908: POLICE STATION (BOATING SAFETY) PARKING

Inspection Date	FMSS Number	User Access	Surface Type
3/21/2022	104840	NONPUBLIC	ASPHALT
Area (Sq. Ft.)	Lane Miles (11' Widths)	Curb Reveal (Inches)	Curb Recommendation
25,956	0.447	5	LIGHT REPAIR
Curb Type		Curb & Gutter Type	
CONCRETE		NO CURB AND GUTTER	
Pavement Recommendation		Condition Rating / PCR	
PREVENTIVE MAINTENANCE		GOOD / 90

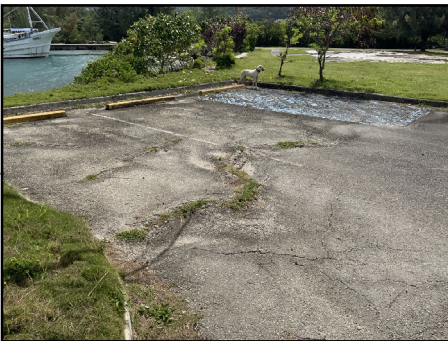
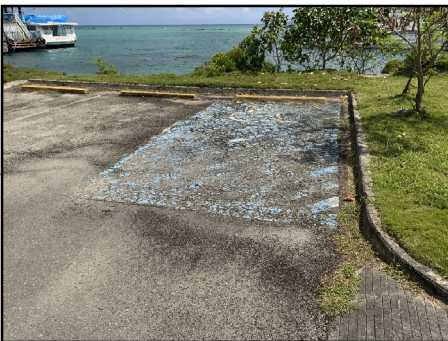
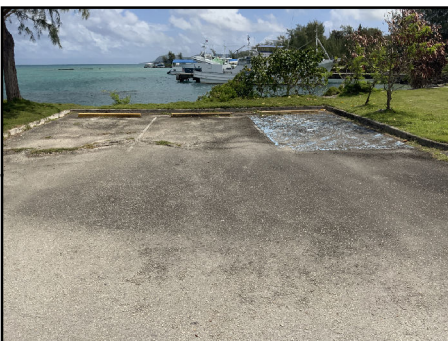
ROUTE 0909: COVE HANDICAPPED PARKING

Inspection Date	FMSS Number	User Access	Surface Type
3/21/2022	104841	PUBLIC	ASPHALT
Area (Sq. Ft.)	Lane Miles (11' Widths)	Curb Reveal (Inches)	Curb Recommendation
811	0.014	8	LIGHT REPAIR
Curb Type		Curb & Gutter Type	
CONCRETE		NO CURB AND GUTTER	
Pavement Recommendation		Condition Rating / PCR	
RECONSTRUCTION		POOR / 30

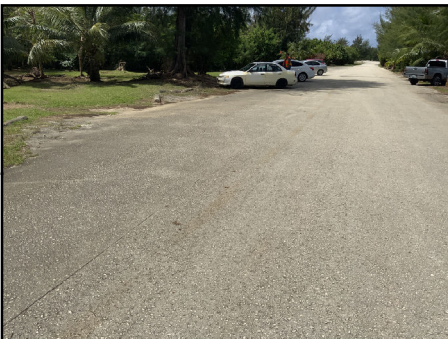
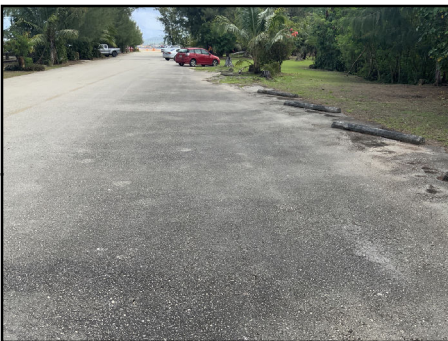
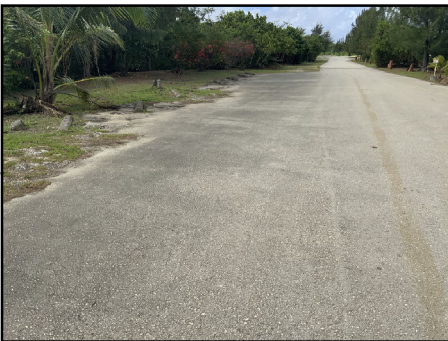
ROUTE 0910BZ: COVE EAST PARKING B

Inspection Date	FMSS Number	User Access	Surface Type
3/21/2022	104842	PUBLIC	ASPHALT
Area (Sq. Ft.)	Lane Miles (11' Widths)	Curb Reveal (Inches)	Curb Recommendation
672	0.012	NOT APPLICABLE	NOT APPLICABLE
Curb Type		Curb & Gutter Type	
NO CURB		NO CURB AND GUTTER	
Pavement Recommendation		Condition Rating / PCR	
LIGHT 3R TREATMENTS		FAIR / 73

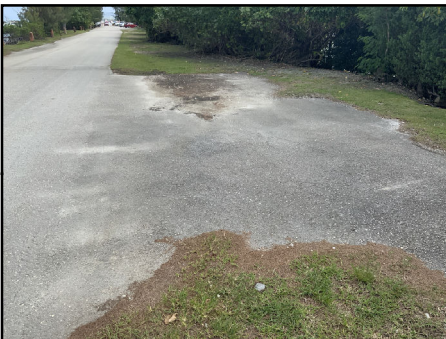
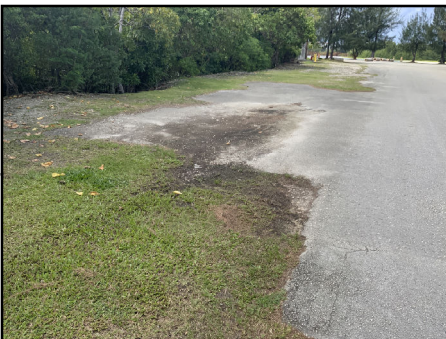
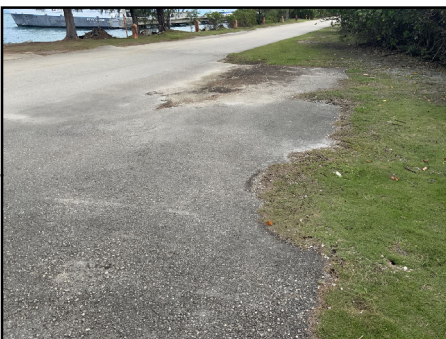
ROUTE 0911: MICRO BEACH OVERFLOW PARKING

Inspection Date	FMSS Number	User Access	Surface Type
3/21/2022	104837	PUBLIC	CONCRETE
Area (Sq. Ft.)	Lane Miles (11' Widths)	Curb Reveal (Inches)	Curb Recommendation
50,562	0.871	5	LIGHT REPAIR
Curb Type		Curb & Gutter Type	
CONCRETE		NO CURB AND GUTTER	
Pavement Recommendation		Condition Rating / PCR	
HEAVY 3R TREATMENTS		POOR / 53

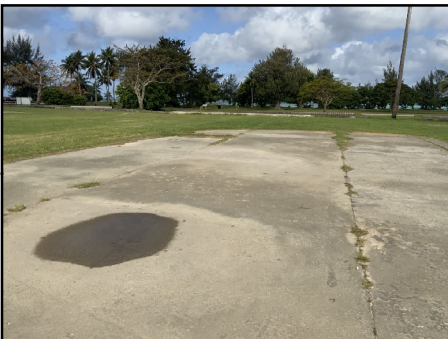
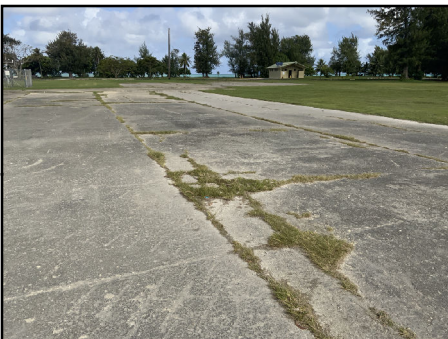
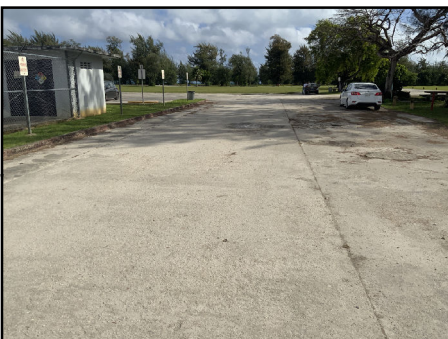
ROUTE 0913: MICRO BEACH RESTROOM PAVED PARKING

Inspection Date	FMSS Number	User Access	Surface Type
3/21/2022	239508	PUBLIC	CONCRETE
Area (Sq. Ft.)	Lane Miles (11' Widths)	Curb Reveal (Inches)	Curb Recommendation
1,134	0.020	NOT APPLICABLE	NOT APPLICABLE
Curb Type		Curb & Gutter Type	
NO CURB		NO CURB AND GUTTER	
Pavement Recommendation		Condition Rating / PCR	
PREVENTIVE MAINTENANCE		GOOD / 90
