BADL Cycle 6

Final Report

Road Inventory and Condition Assessment of Paved Routes Badlands National Park

Federal Highway Administration
Eastern Federal Lands Highway Division
Road Inventory Program (RIP)

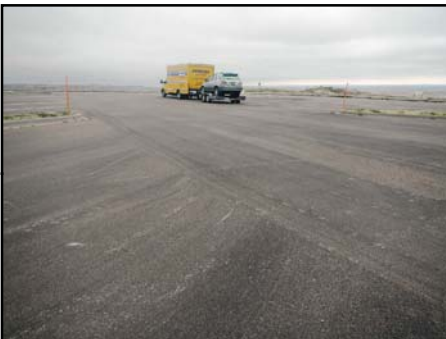
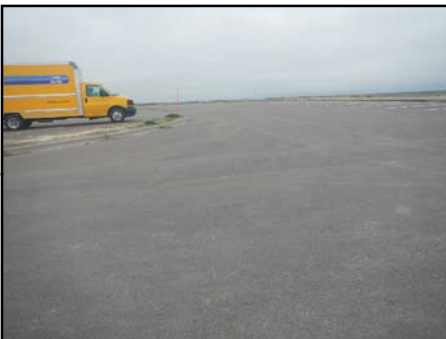
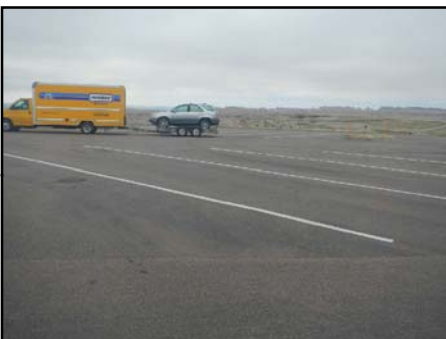
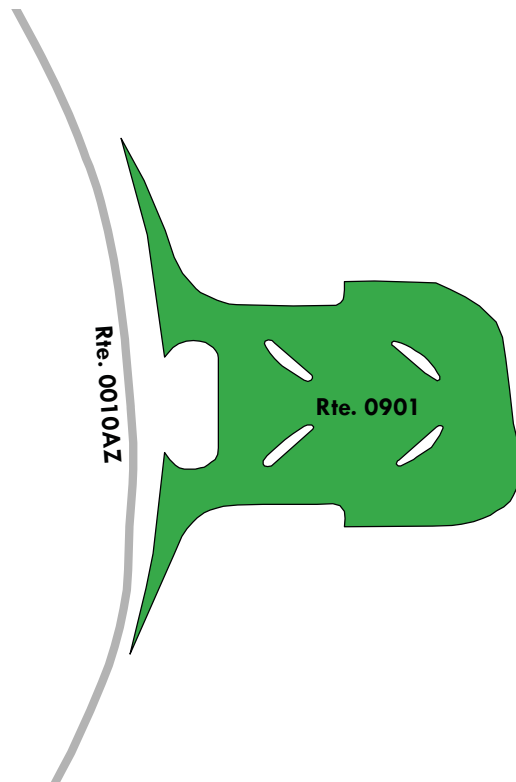
Inspection Date	FMSS Number	User Access	Surface Type
4/27/2017	53286	PUBLIC	ASPHALT
Area (Sq. Ft.)	Lane Miles (11' Widths)	Curb Reveal (Inches)	Curb Recommendation
40,509	0.697	5	DO NOTHING
Curb Type		Curb & Gutter Type	
WOOD		CONCRETE	
Pavement Recommendation		Condition Rating / PCR	
PREVENTIVE MAINTENANCE		GOOD / 90

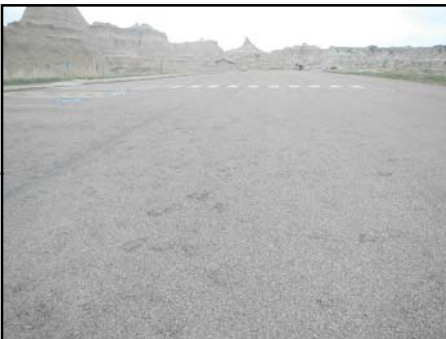
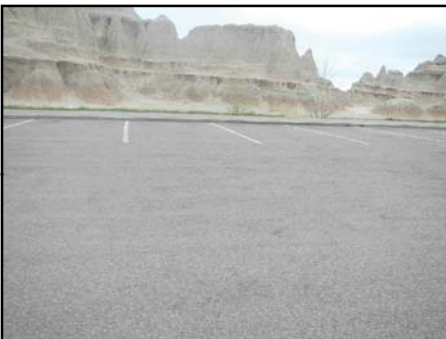
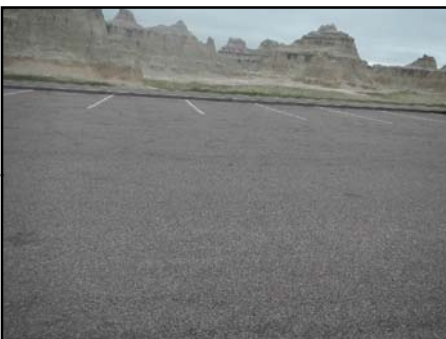
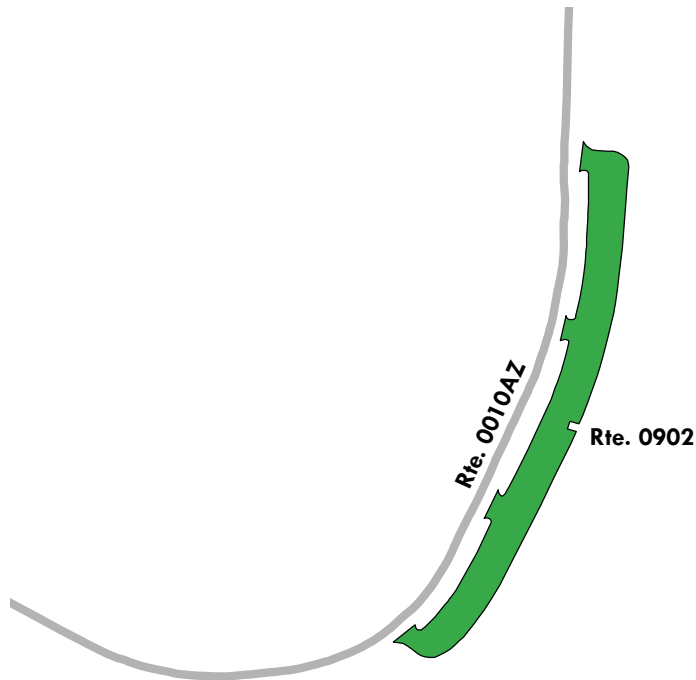
ROUTE 0902: DOOR AND WINDOW TRAIL PARKING

Inspection Date	FMSS Number	User Access	Surface Type
4/27/2017	28222	PUBLIC	ASPHALT
Area (Sq. Ft.)	Lane Miles (11' Widths)	Curb Reveal (Inches)	Curb Recommendation
115,614	1.991	5	DO NOTHING
Curb Type		Curb & Gutter Type	
WOOD		NO CURB AND GUTTER	
Pavement Recommendation		Condition Rating / PCR	
PREVENTIVE MAINTENANCE		GOOD / 90

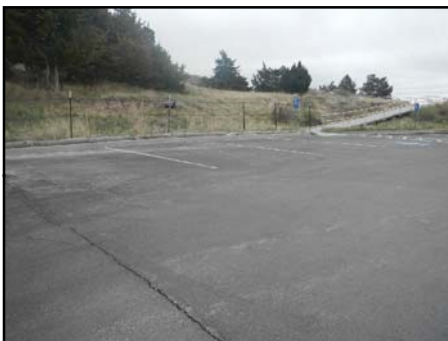
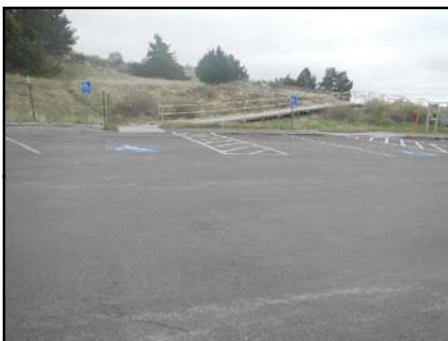
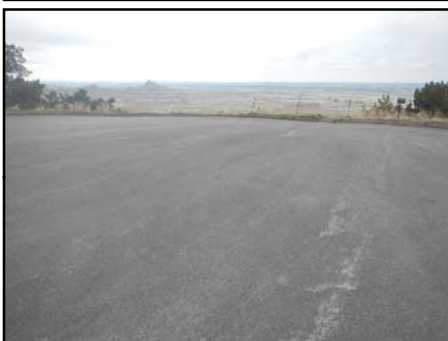
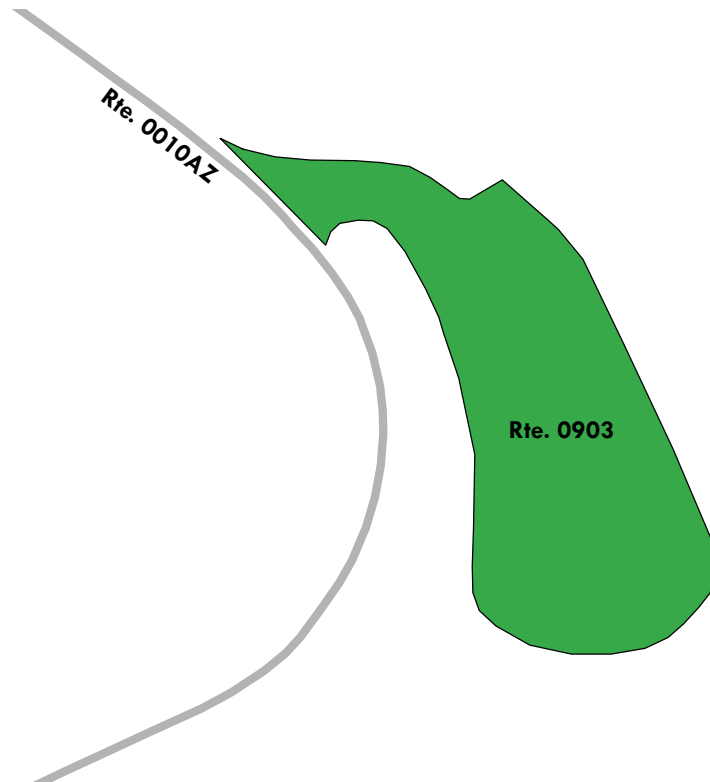
ROUTE 0903: CLIFF SHELF NATURE TRAIL PARKING

Inspection Date	FMSS Number	User Access	Surface Type
4/27/2017	43342	PUBLIC	ASPHALT
Area (Sq. Ft.)	Lane Miles (11' Widths)	Curb Reveal (Inches)	Curb Recommendation
19,281	0.332	5	DO NOTHING
Curb Type		Curb & Gutter Type	
CONCRETE AND WOOD		NO CURB AND GUTTER	
Pavement Recommendation		Condition Rating / PCR	
PREVENTIVE MAINTENANCE		GOOD / 90

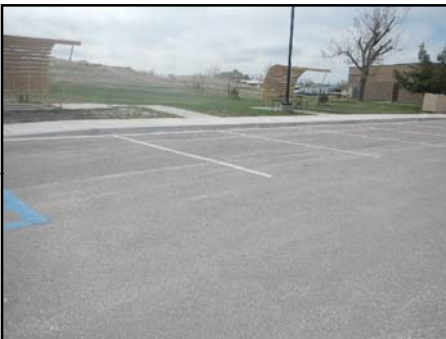
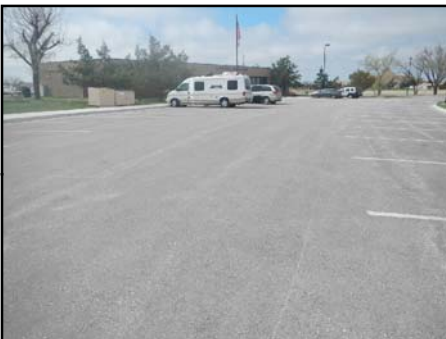
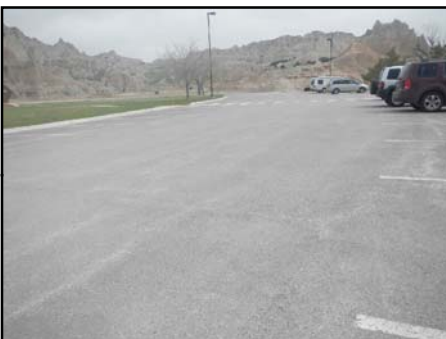
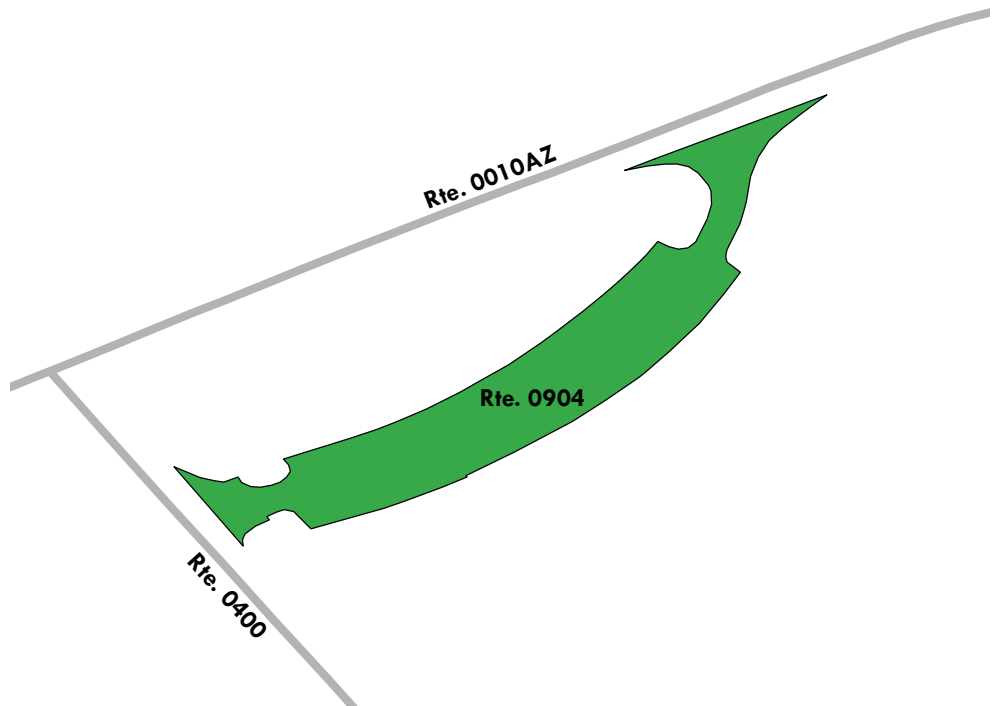
ROUTE 0904: BEN REIFEL VISITOR CENTER PARKING

Inspection Date	FMSS Number	User Access	Surface Type
4/27/2017	53288	PUBLIC	ASPHALT
Area (Sq. Ft.)	Lane Miles (11' Widths)	Curb Reveal (Inches)	Curb Recommendation
21,836	0.376	NOT APPLICABLE	DO NOTHING
Curb Type		Curb & Gutter Type	
NO CURB		CONCRETE	
Pavement Recommendation		Condition Rating / PCR	
PREVENTIVE MAINTENANCE		GOOD / 90

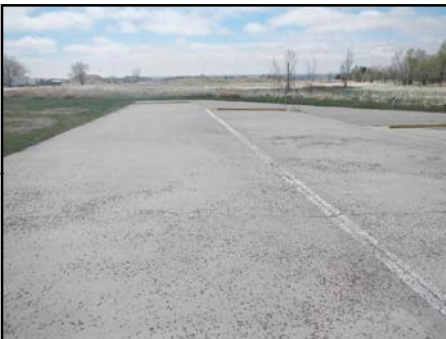
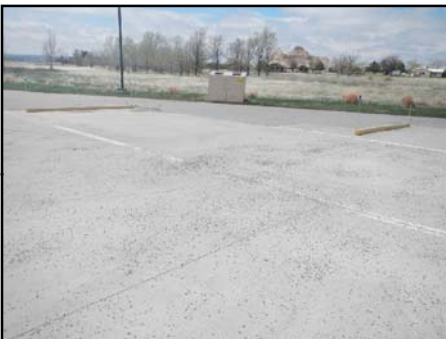
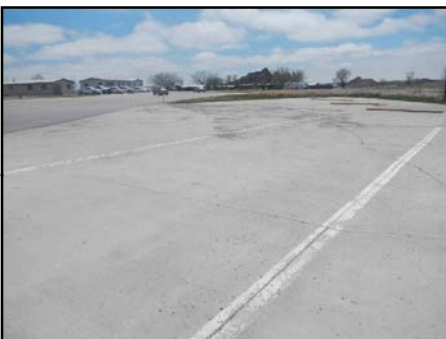
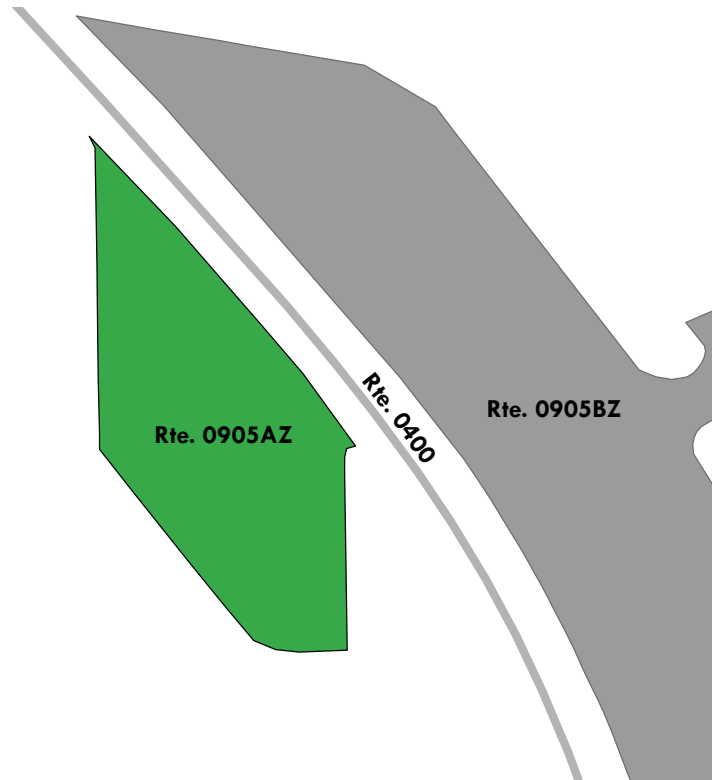
ROUTE 0905AZ: RV PARKING

Inspection Date	FMSS Number	User Access	Surface Type
4/27/2017	53292	PUBLIC	CONCRETE
Area (Sq. Ft.)	Lane Miles (11' Widths)	Curb Reveal (Inches)	Curb Recommendation
9,811	0.169	NOT APPLICABLE	NOT APPLICABLE
Curb Type		Curb & Gutter Type	
NO CURB		NO CURB AND GUTTER	
Pavement Recommendation		Condition Rating / PCR	
PREVENTIVE MAINTENANCE		GOOD / 90

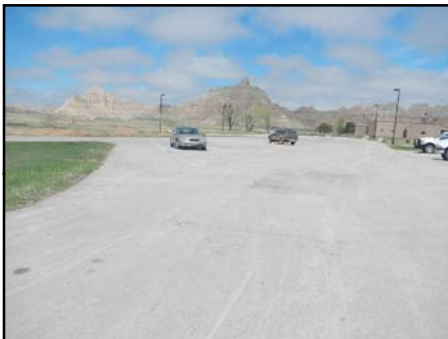
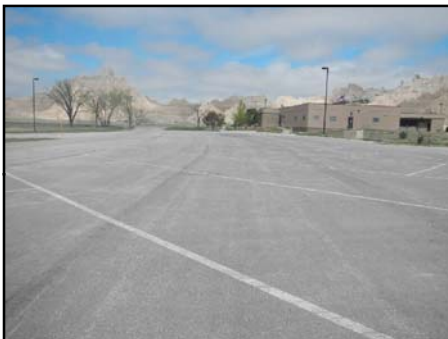
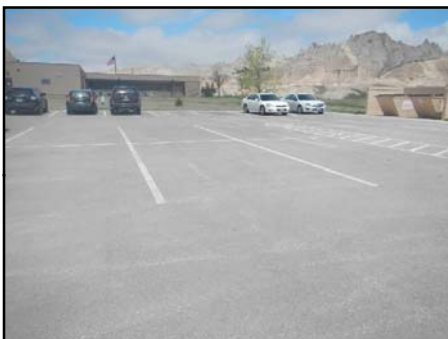
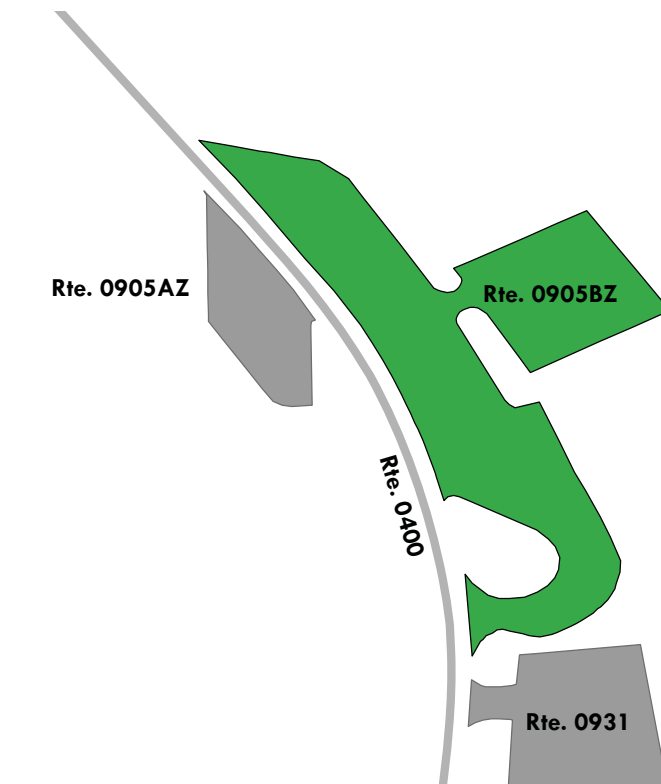
ROUTE 0905BZ: REAR VISITOR CENTER PARKING

Inspection Date	FMSS Number	User Access	Surface Type
4/27/2017	53292	PUBLIC	ASPHALT
Area (Sq. Ft.)	Lane Miles (11' Widths)	Curb Reveal (Inches)	Curb Recommendation
52,837	0.91	NOT APPLICABLE	NOT APPLICABLE
Curb Type		Curb & Gutter Type	
NO CURB		NO CURB AND GUTTER	
Pavement Recommendation		Condition Rating / PCR	
PREVENTIVE MAINTENANCE		GOOD / 90

Note: Parking area consists of multiple surface types: 2 parts Asphalt at 52,243 square feet; 1 part Concrete at 594 square feet.

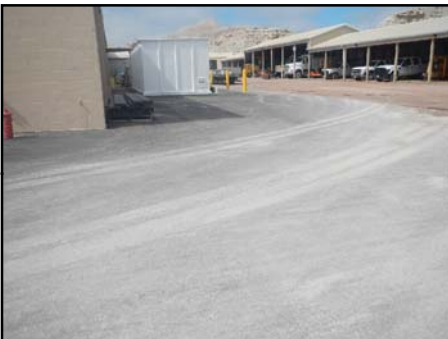
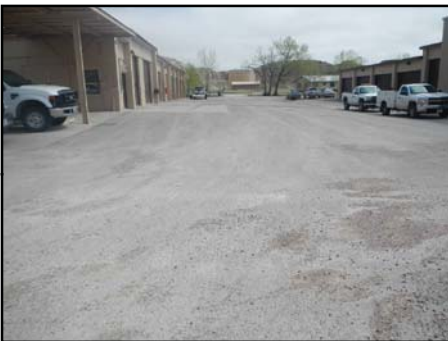
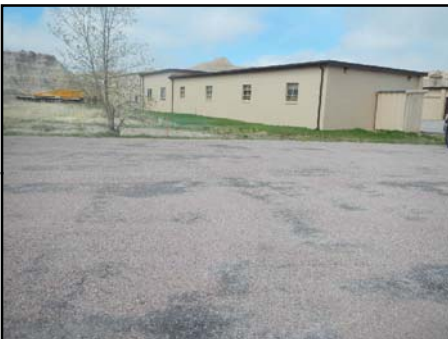
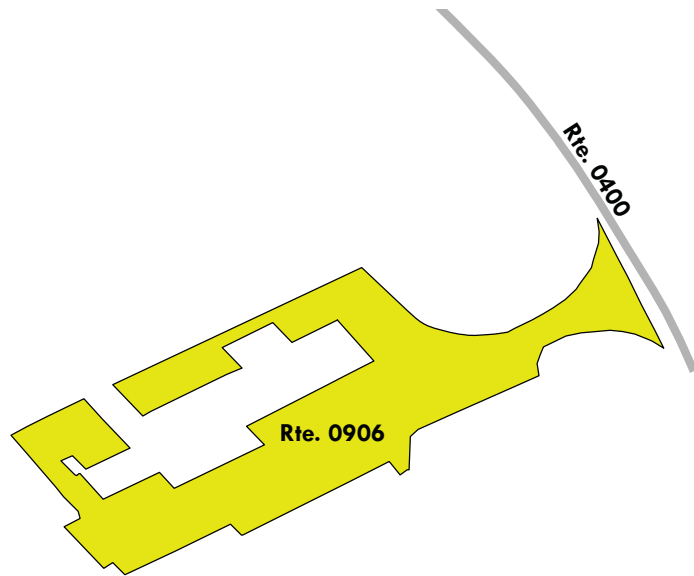
ROUTE 0906: MAINTENANCE AREA PARKING

Inspection Date	FMSS Number	User Access	Surface Type
4/27/2017	53293	NONPUBLIC	ASPHALT
Area (Sq. Ft.)	Lane Miles (11' Widths)	Curb Reveal (Inches)	Curb Recommendation
31,683	0.546	NOT APPLICABLE	NOT APPLICABLE
Curb Type		Curb & Gutter Type	
NO CURB		NO CURB AND GUTTER	
Pavement Recommendation		Condition Rating / PCR	
LIGHT 3R TREATMENTS		FAIR / 73

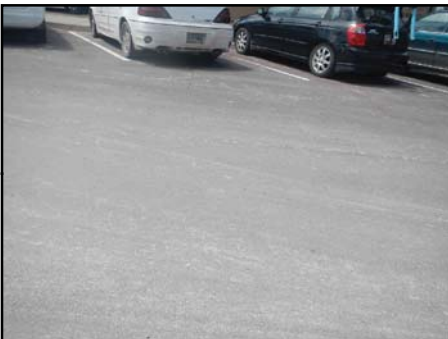
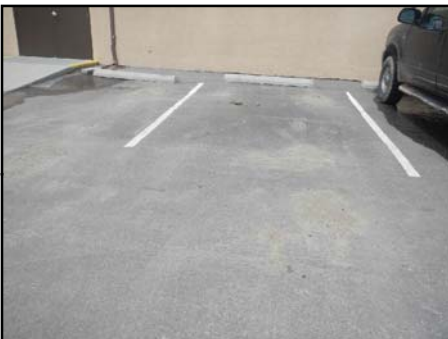
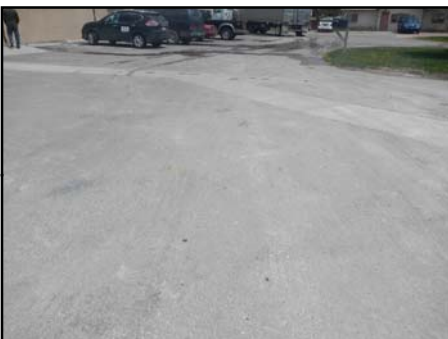
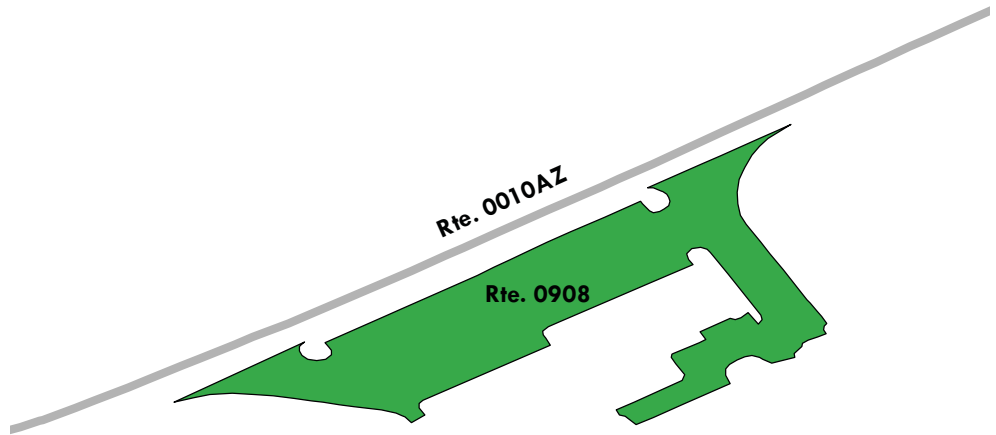
ROUTE 0908: CEDAR PASS LODGE PARKING

Inspection Date	FMSS Number	User Access	Surface Type
4/27/2017	53295	PUBLIC	ASPHALT
Area (Sq. Ft.)	Lane Miles (11' Widths)	Curb Reveal (Inches)	Curb Recommendation
56,192	0.967	NOT APPLICABLE	DO NOTHING
Curb Type		Curb & Gutter Type	
NO CURB		CONCRETE	
Pavement Recommendation		Condition Rating / PCR	
PREVENTIVE MAINTENANCE		GOOD / 90

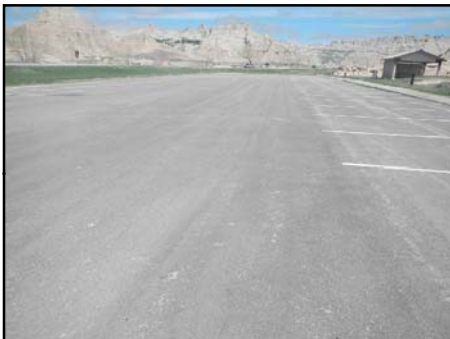
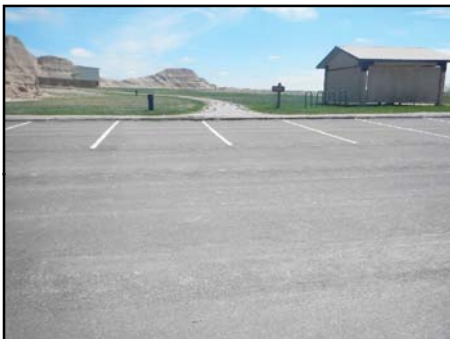
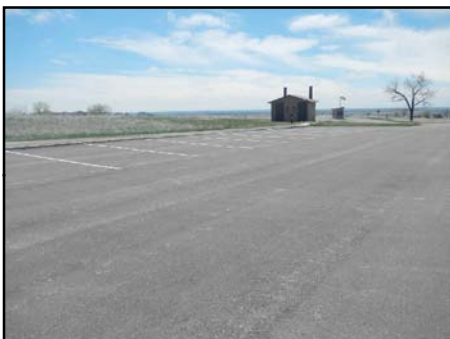
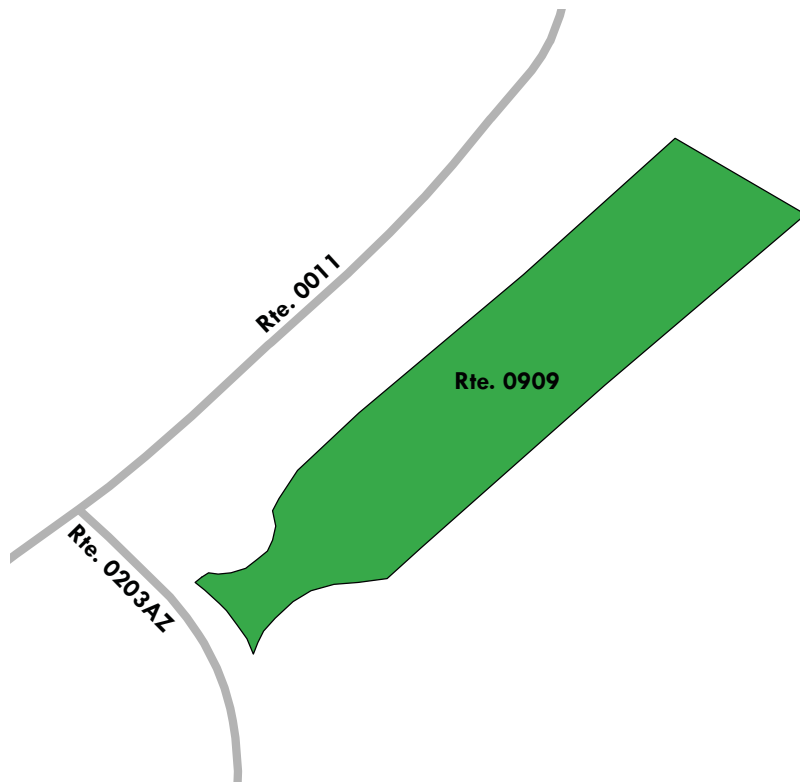
ROUTE 0909: AMPHITHEATER PARKING

Inspection Date	FMSS Number	User Access	Surface Type
4/27/2017	53296	PUBLIC	ASPHALT
Area (Sq. Ft.)	Lane Miles (11' Widths)	Curb Reveal (Inches)	Curb Recommendation
19,926	0.343	3	DO NOTHING
Curb Type		Curb & Gutter Type	
WOOD		NO CURB AND GUTTER	
Pavement Recommendation		Condition Rating / PCR	
PREVENTIVE MAINTENANCE		GOOD / 90

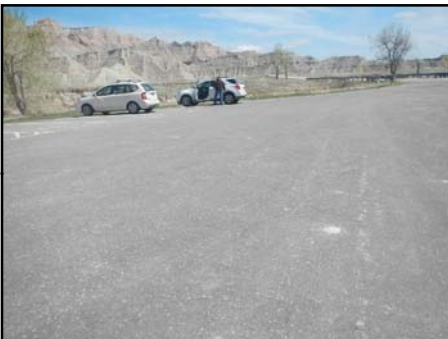
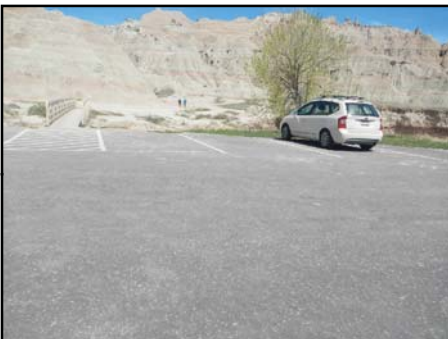
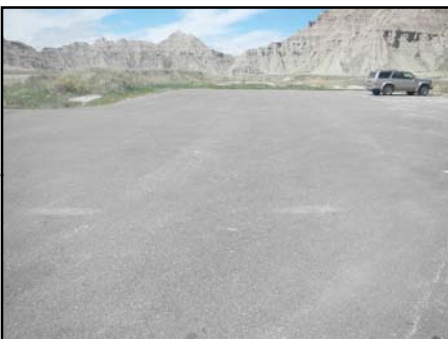
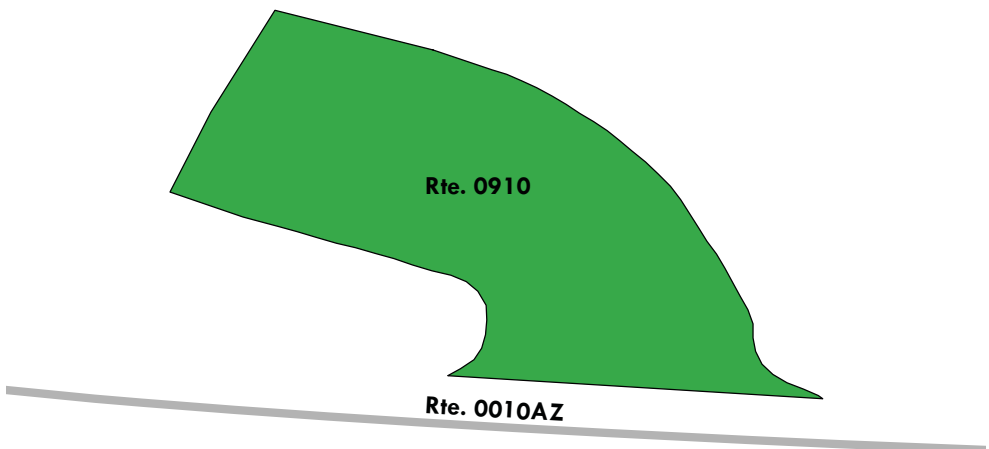
Inspection Date	FMSS Number	User Access	Surface Type
4/27/2017	92858	PUBLIC	ASPHALT
Area (Sq. Ft.)	Lane Miles (11' Widths)	Curb Reveal (Inches)	Curb Recommendation
9,023	0.155	NOT APPLICABLE	NOT APPLICABLE
Curb Type		Curb & Gutter Type	
NO CURB		NO CURB AND GUTTER	
Pavement Recommendation		Condition Rating / PCR	
PREVENTIVE MAINTENANCE		GOOD / 90

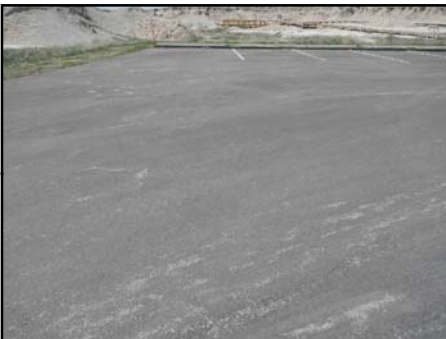
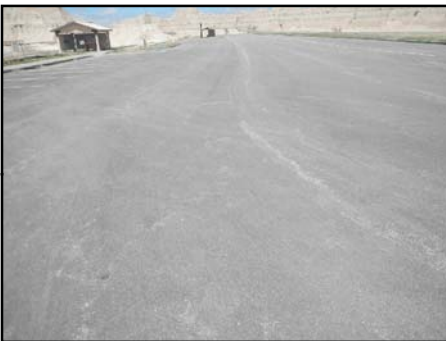
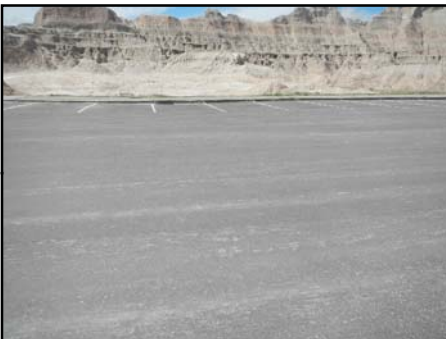
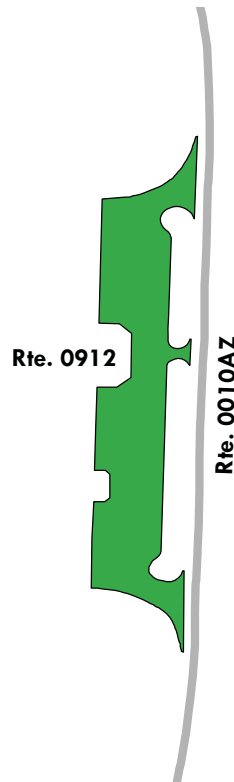
ROUTE 0912: FOSSIL TRAIL PARKING

Inspection Date	FMSS Number	User Access	Surface Type
4/27/2017	43187	PUBLIC	ASPHALT
Area (Sq. Ft.)	Lane Miles (11' Widths)	Curb Reveal (Inches)	Curb Recommendation
58,774	1.012	4	DO NOTHING
Curb Type		Curb & Gutter Type	
WOOD		NO CURB AND GUTTER	
Pavement Recommendation		Condition Rating / PCR	
PREVENTIVE MAINTENANCE		GOOD / 90

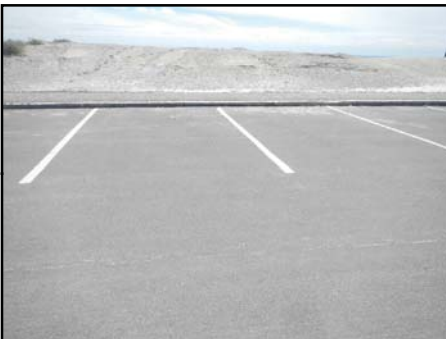
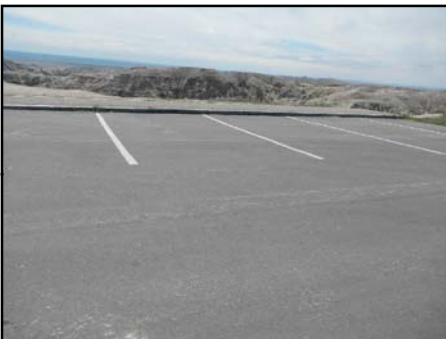
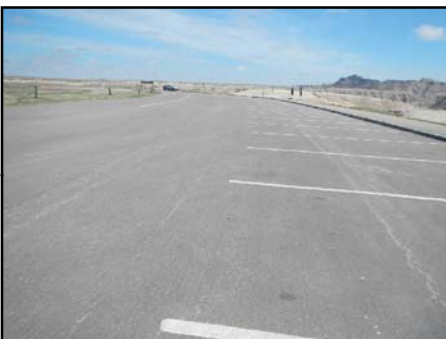
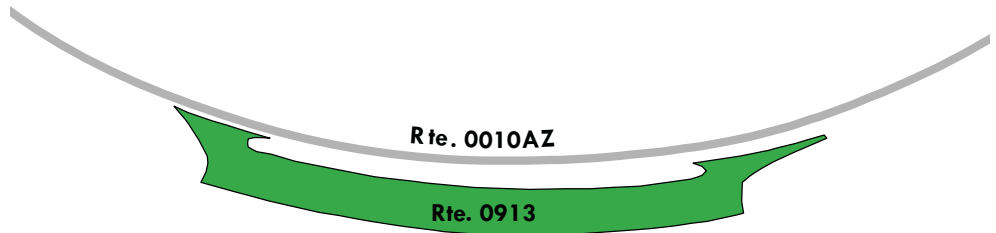
ROUTE 0913: WHITE RIVER VALLEY OVERLOOK PARKING

Inspection Date	FMSS Number	User Access	Surface Type
4/27/2017	53297	PUBLIC	ASPHALT
Area (Sq. Ft.)	Lane Miles (11' Widths)	Curb Reveal (Inches)	Curb Recommendation
22,915	0.395	4	DO NOTHING
Curb Type		Curb & Gutter Type	
WOOD		NO CURB AND GUTTER	
Pavement Recommendation		Condition Rating / PCR	
PREVENTIVE MAINTENANCE		GOOD / 90

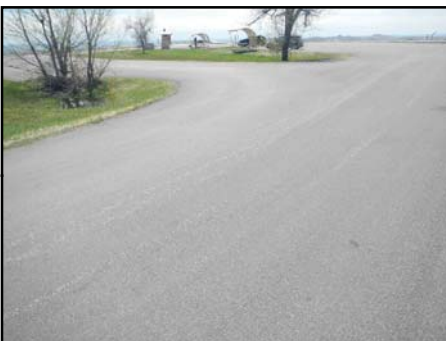
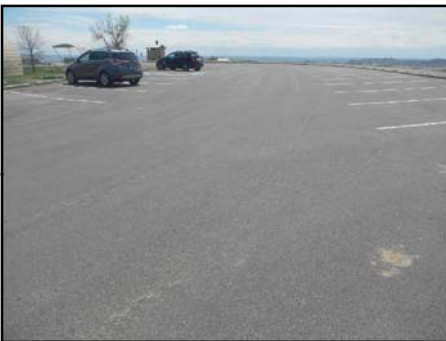
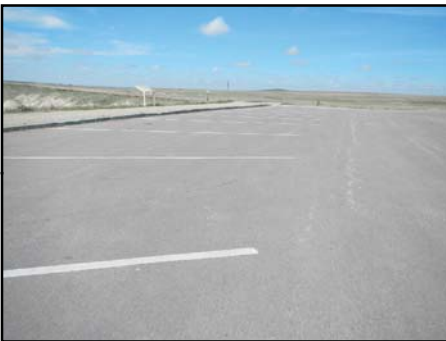
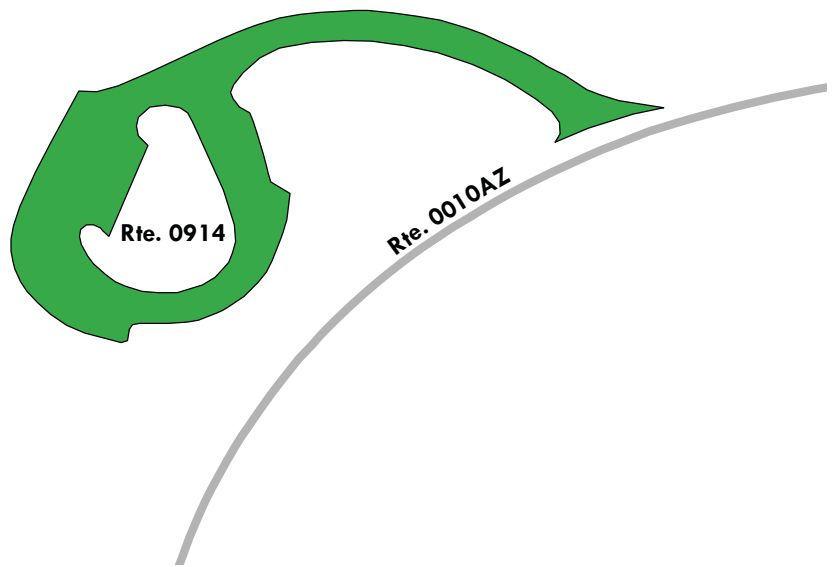
ROUTE 0914: BIGFOOT PASS PICNIC AREA

Inspection Date	FMSS Number	User Access	Surface Type
4/27/2017	53298	PUBLIC	ASPHALT
Area (Sq. Ft.)	Lane Miles (11' Widths)	Curb Reveal (Inches)	Curb Recommendation
32,374	0.557	5	DO NOTHING
Curb Type		Curb & Gutter Type	
WOOD		NO CURB AND GUTTER	
Pavement Recommendation		Condition Rating / PCR	
PREVENTIVE MAINTENANCE		GOOD / 90

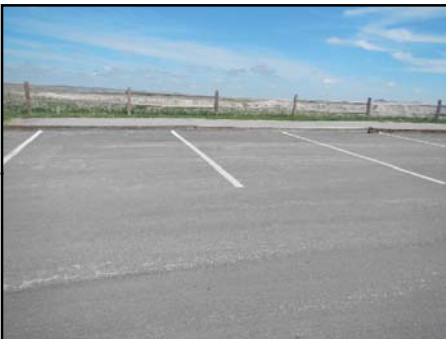
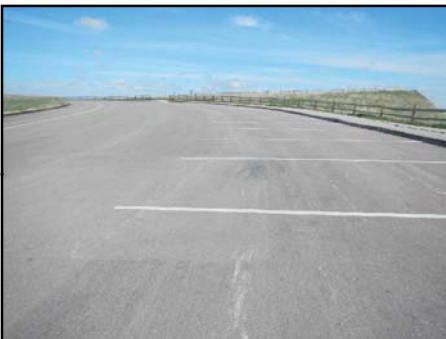
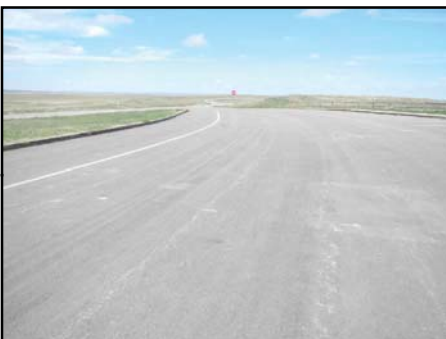
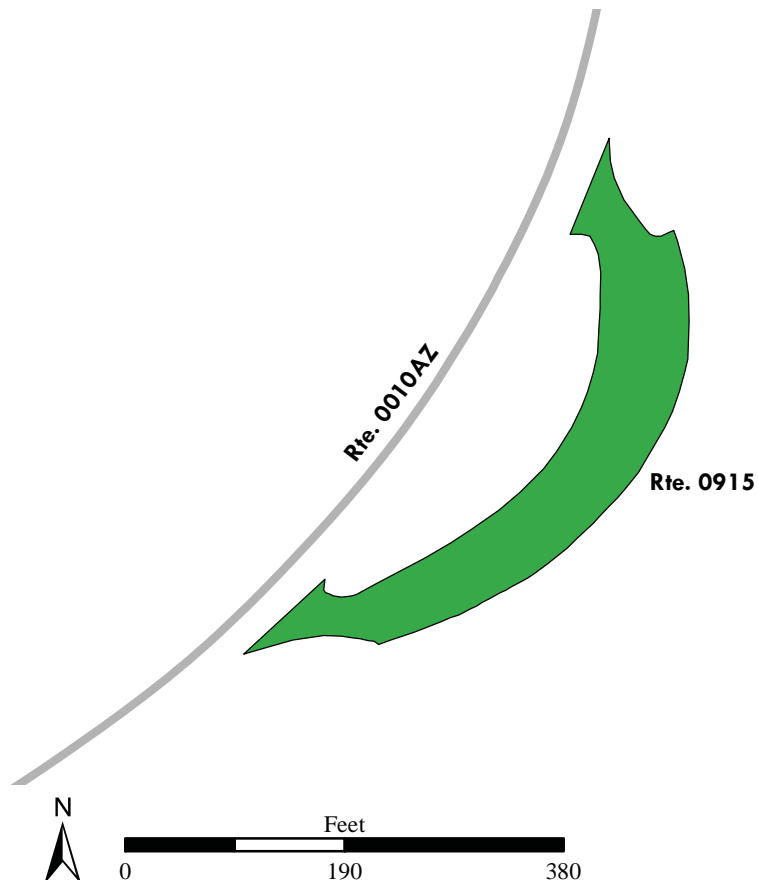
ROUTE 0915: PANORAMA POINT OVERLOOK PARKING

Inspection Date	FMSS Number	User Access	Surface Type
4/27/2017	53299	PUBLIC	ASPHALT
Area (Sq. Ft.)	Lane Miles (11' Widths)	Curb Reveal (Inches)	Curb Recommendation
25,532	0.44	5	DO NOTHING
Curb Type		Curb & Gutter Type	
WOOD		NO CURB AND GUTTER	
Pavement Recommendation		Condition Rating / PCR	
PREVENTIVE MAINTENANCE		GOOD / 90

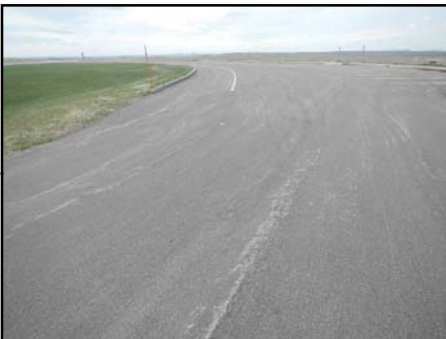
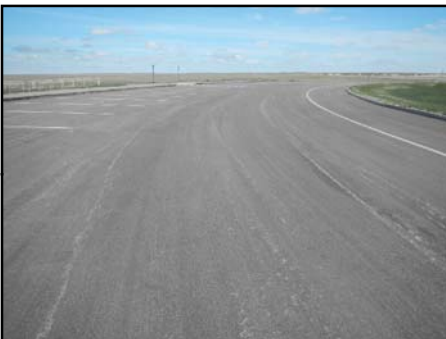
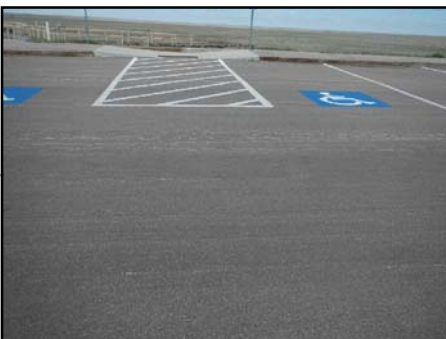
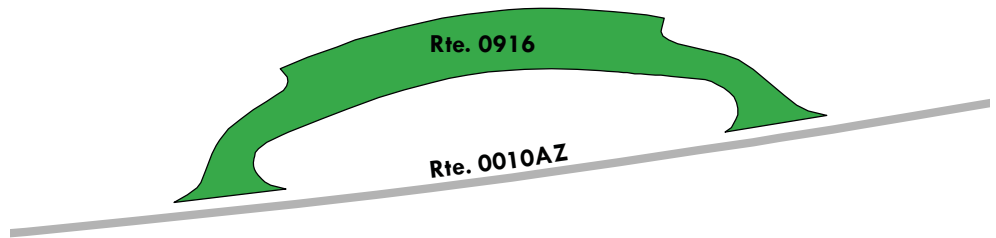
ROUTE 0916: PRAIRIE WIND OVERLOOK PARKING

Inspection Date	FMSS Number	User Access	Surface Type
4/27/2017	53300	PUBLIC	ASPHALT
Area (Sq. Ft.)	Lane Miles (11' Widths)	Curb Reveal (Inches)	Curb Recommendation
19,132	0.329	5	DO NOTHING
Curb Type		Curb & Gutter Type	
WOOD		NO CURB AND GUTTER	
Pavement Recommendation		Condition Rating / PCR	
PREVENTIVE MAINTENANCE		GOOD / 90

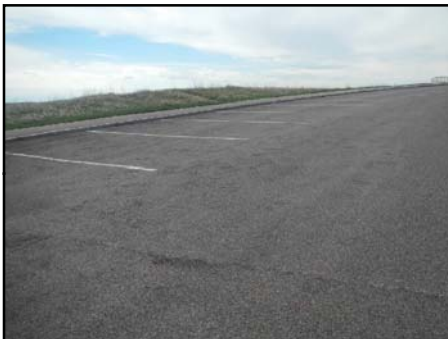
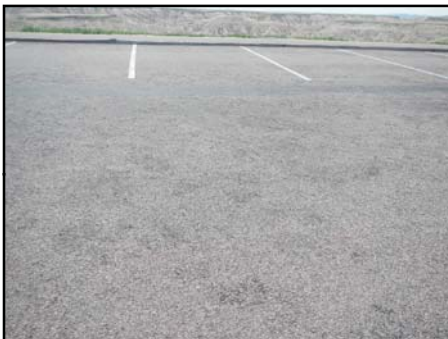
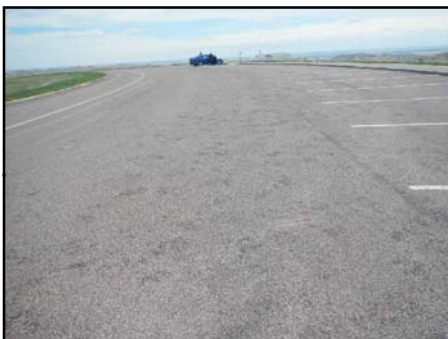
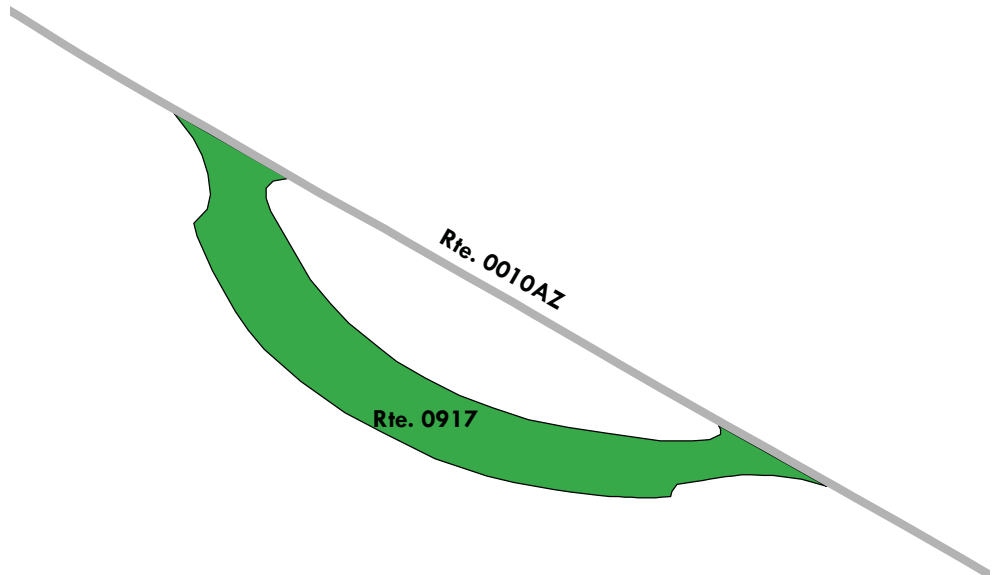
ROUTE 0917: BURNS BASIN OVERLOOK PARKING

Inspection Date	FMSS Number	User Access	Surface Type
4/27/2017	53301	PUBLIC	ASPHALT
Area (Sq. Ft.)	Lane Miles (11' Widths)	Curb Reveal (Inches)	Curb Recommendation
26,473	0.456	5	DO NOTHING
Curb Type		Curb & Gutter Type	
WOOD		NO CURB AND GUTTER	
Pavement Recommendation		Condition Rating / PCR	
PREVENTIVE MAINTENANCE		GOOD / 90

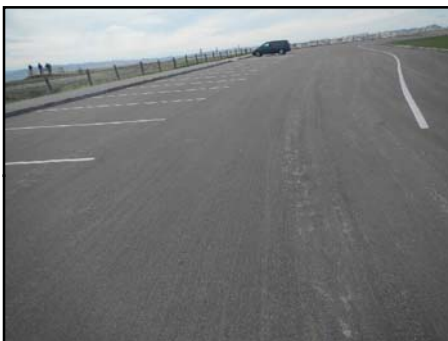
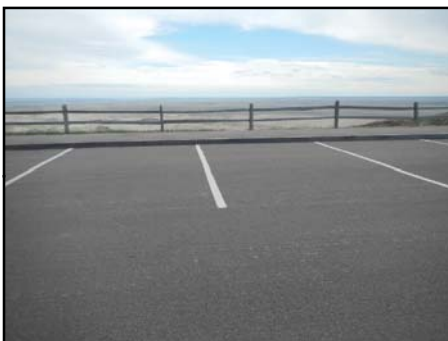
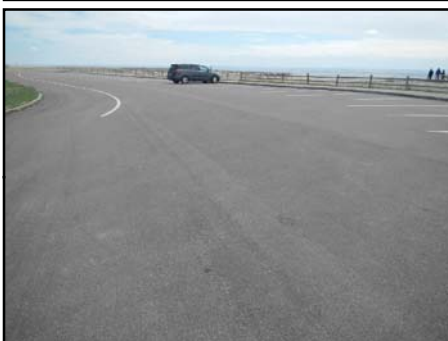
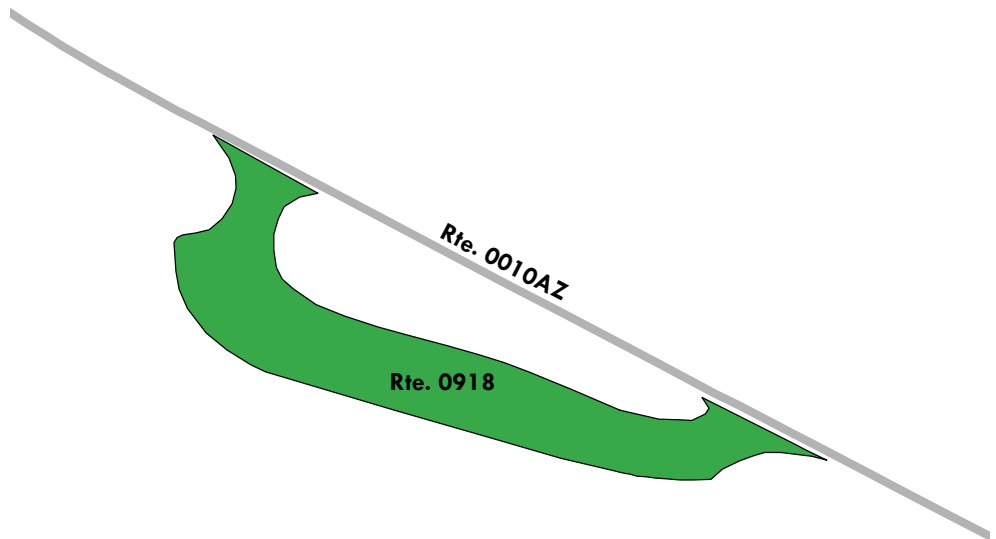
ROUTE 0918: HOMESTEAD OVERLOOK PARKING

Inspection Date	FMSS Number	User Access	Surface Type
4/27/2017	53302	PUBLIC	ASPHALT
Area (Sq. Ft.)	Lane Miles (11' Widths)	Curb Reveal (Inches)	Curb Recommendation
21,453	0.369	5	DO NOTHING
Curb Type		Curb & Gutter Type	
WOOD		NO CURB AND GUTTER	
Pavement Recommendation		Condition Rating / PCR	
PREVENTIVE MAINTENANCE		GOOD / 90

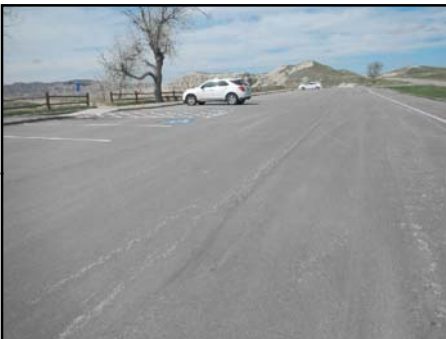
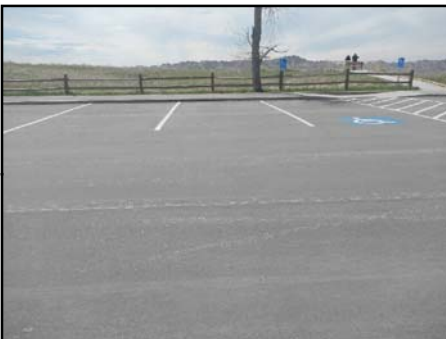
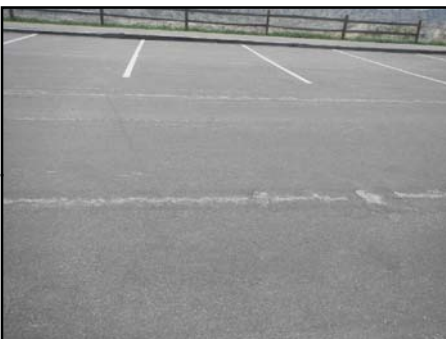
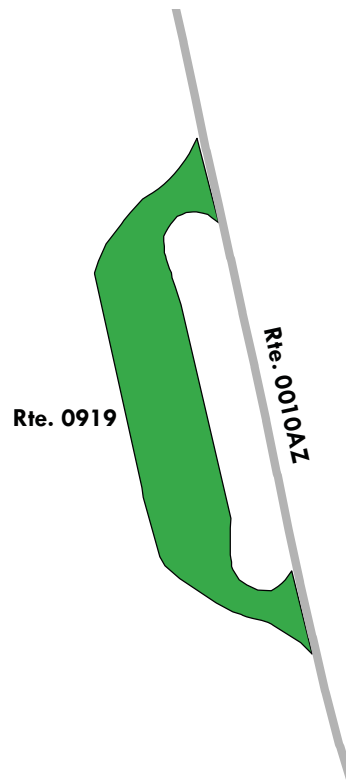
ROUTE 0919: CONATA BASIN OVERLOOK PARKING

Inspection Date	FMSS Number	User Access	Surface Type
4/27/2017	53303	PUBLIC	ASPHALT
Area (Sq. Ft.)	Lane Miles (11' Widths)	Curb Reveal (Inches)	Curb Recommendation
22,799	0.393	5	DO NOTHING
Curb Type		Curb & Gutter Type	
WOOD		NO CURB AND GUTTER	
Pavement Recommendation		Condition Rating / PCR	
PREVENTIVE MAINTENANCE		GOOD / 90

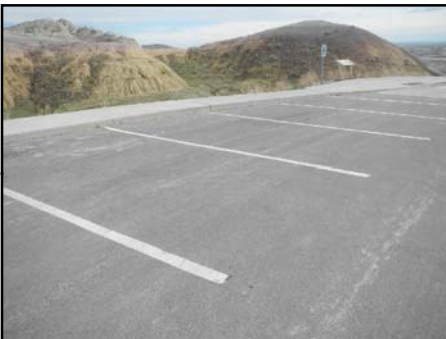
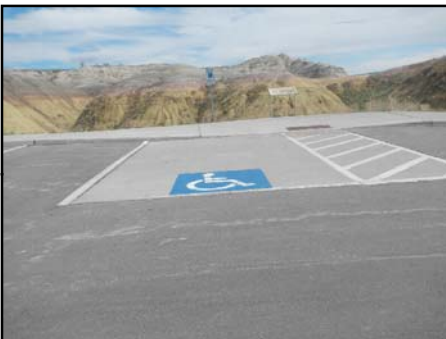
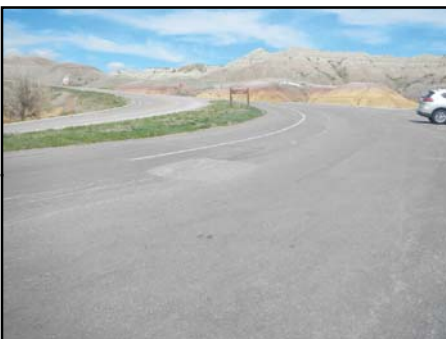
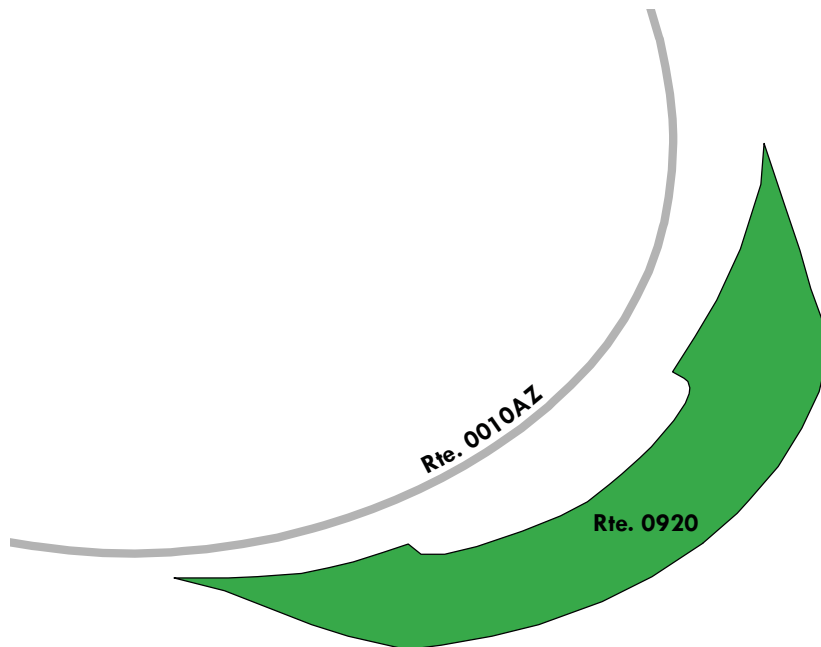
ROUTE 0920: YELLOW MOUNDS OVERLOOK PARKING

Inspection Date	FMSS Number	User Access	Surface Type
4/27/2017	53304	PUBLIC	ASPHALT
Area (Sq. Ft.)	Lane Miles (11' Widths)	Curb Reveal (Inches)	Curb Recommendation
12,877	0.222	NOT APPLICABLE	NOT APPLICABLE
Curb Type		Curb & Gutter Type	
NO CURB		NO CURB AND GUTTER	
Pavement Recommendation		Condition Rating / PCR	
PREVENTIVE MAINTENANCE		GOOD / 90

Note: Parking area consists of multiple surface types: 1 part Asphalt at 12,507 square feet; 1 part Concrete at 370 square feet.

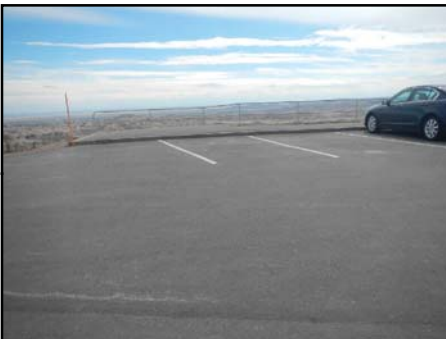
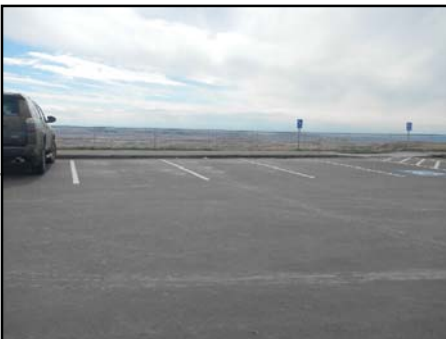
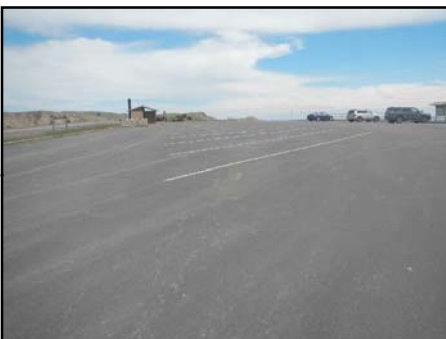
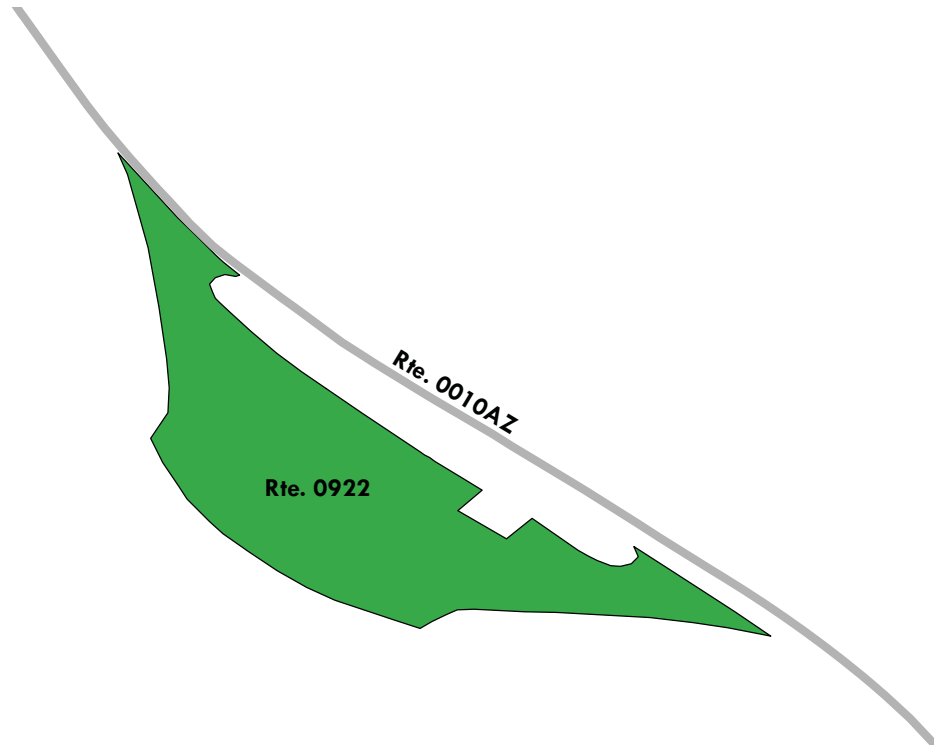
ROUTE 0922: PINNACLES OVERLOOK PARKING

Inspection Date	FMSS Number	User Access	Surface Type
4/27/2017	43338	PUBLIC	ASPHALT
Area (Sq. Ft.)	Lane Miles (11' Widths)	Curb Reveal (Inches)	Curb Recommendation
33,216	0.572	5	DO NOTHING
Curb Type		Curb & Gutter Type	
WOOD		NO CURB AND GUTTER	
Pavement Recommendation		Condition Rating / PCR	
PREVENTIVE MAINTENANCE		GOOD / 90

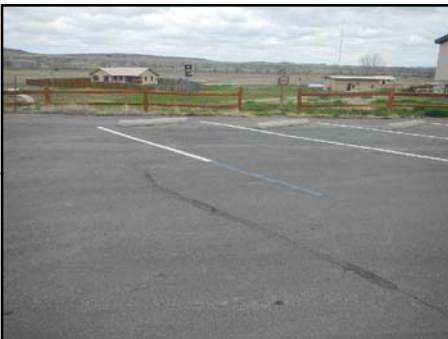
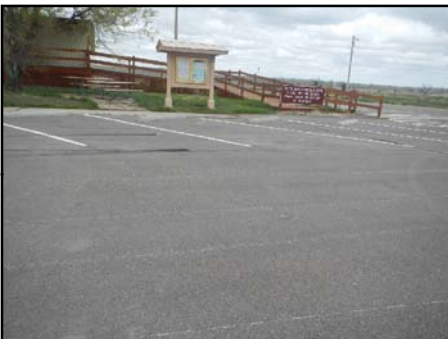
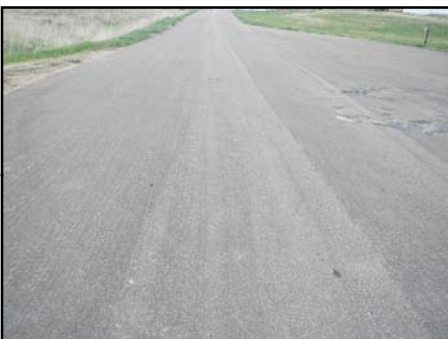
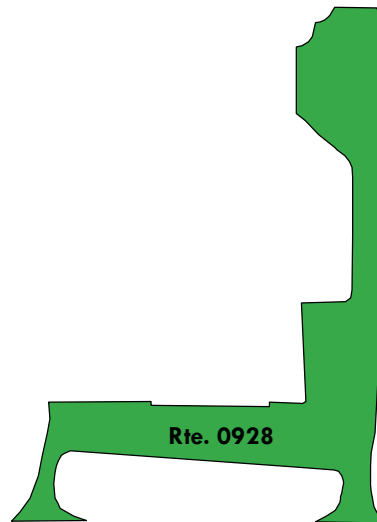
ROUTE 0928: WHITE RIVER VISITOR CENTER PARKING

Inspection Date	FMSS Number	User Access	Surface Type
4/28/2017	92863	PUBLIC	ASPHALT
Area (Sq. Ft.)	Lane Miles (11' Widths)	Curb Reveal (Inches)	Curb Recommendation
32,988	0.568	NOT APPLICABLE	NOT APPLICABLE
Curb Type		Curb & Gutter Type	
NO CURB		NO CURB AND GUTTER	
Pavement Recommendation		Condition Rating / PCR	
PREVENTIVE MAINTENANCE		GOOD / 90

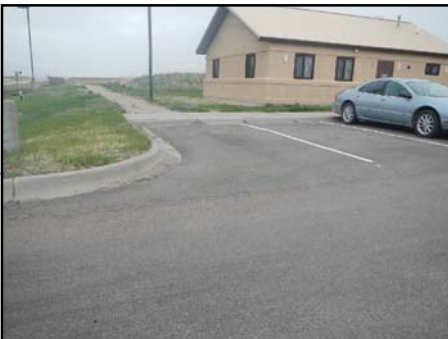
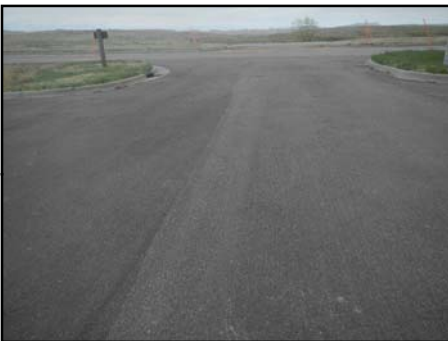
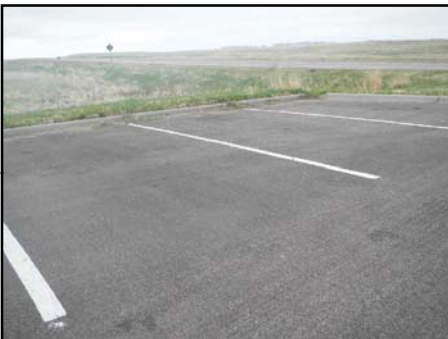
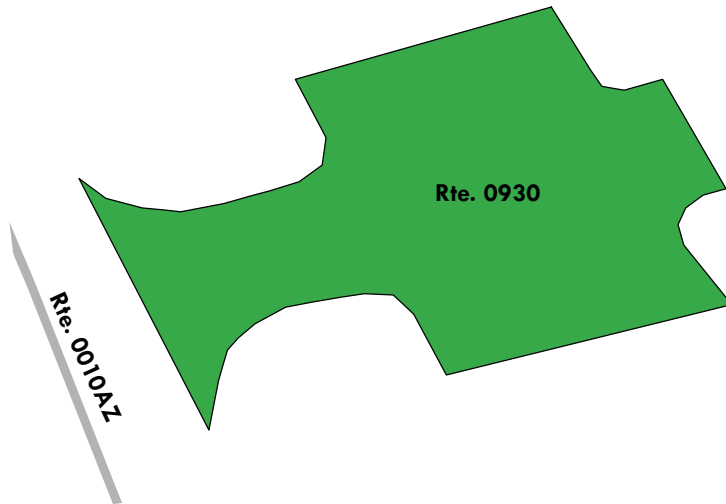
ROUTE 0930: NORTH ENTRANCE SUPPORT BUILDING PARKING

Inspection Date	FMSS Number	User Access	Surface Type
4/27/2017	92865	NONPUBLIC	ASPHALT
Area (Sq. Ft.)	Lane Miles (11' Widths)	Curb Reveal (Inches)	Curb Recommendation
3,986	0.069	NOT APPLICABLE	DO NOTHING
Curb Type		Curb & Gutter Type	
NO CURB		CONCRETE	
Pavement Recommendation		Condition Rating / PCR	
PREVENTIVE MAINTENANCE		GOOD / 90
