BADL Cycle 6

Final Report

Road Inventory and Condition Assessment of Paved Routes Badlands National Park

Federal Highway Administration
Eastern Federal Lands Highway Division
Road Inventory Program (RIP)

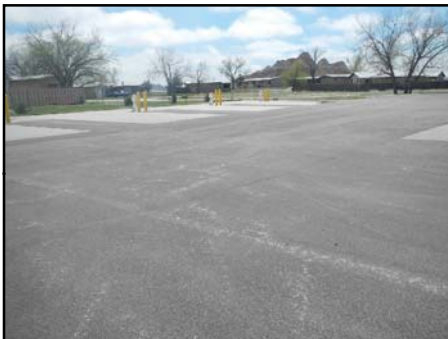
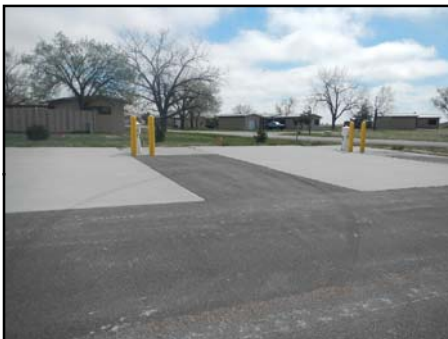
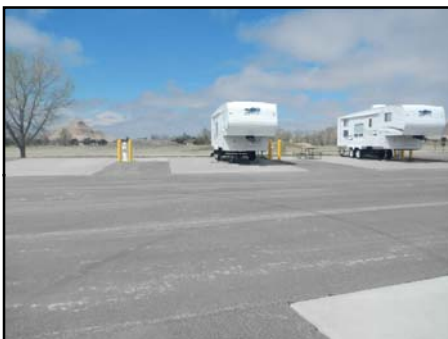
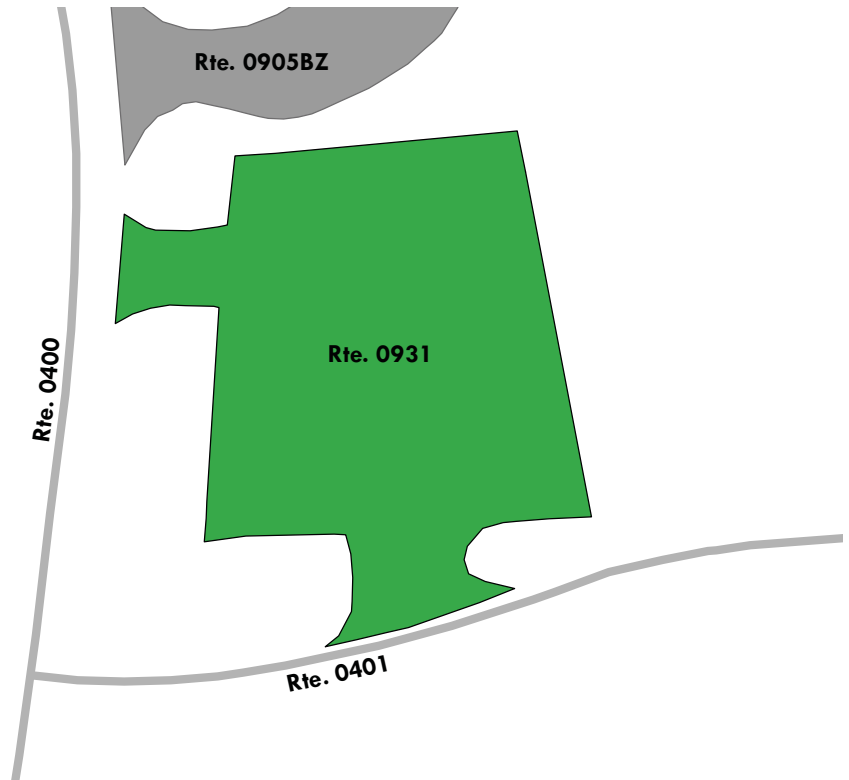
ROUTE 0931: VOLUNTEER RV PARKING

Inspection Date	FMSS Number	User Access	Surface Type
4/27/2017	97369	PUBLIC	ASPHALT
Area (Sq. Ft.)	Lane Miles (11' Widths)	Curb Reveal (Inches)	Curb Recommendation
20,718	0.357	NOT APPLICABLE	NOT APPLICABLE
Curb Type		Curb & Gutter Type	
NO CURB		NO CURB AND GUTTER	
Pavement Recommendation		Condition Rating / PCR	
PREVENTIVE MAINTENANCE		GOOD / 90

Note: Parking area consists of multiple surface types; 1 part Asphalt at 12,786 square feet; 3 parts Concrete at 8,045 square feet.

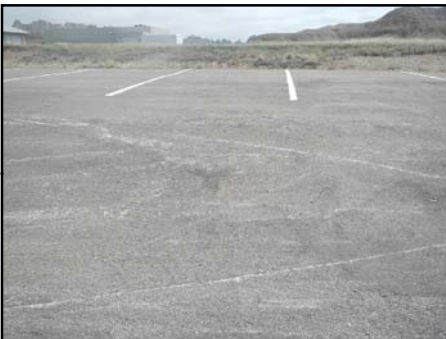
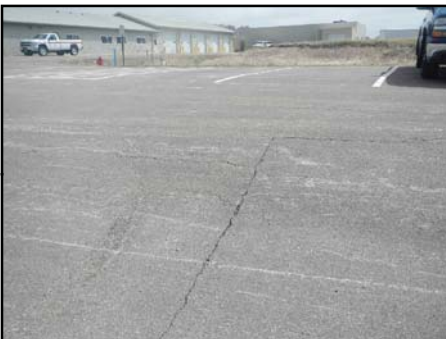
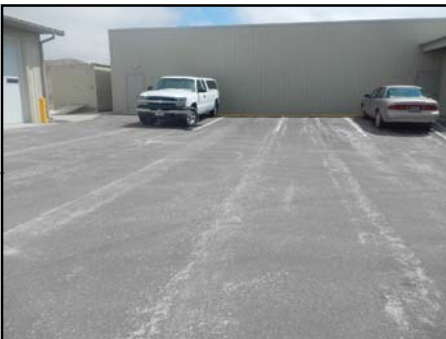
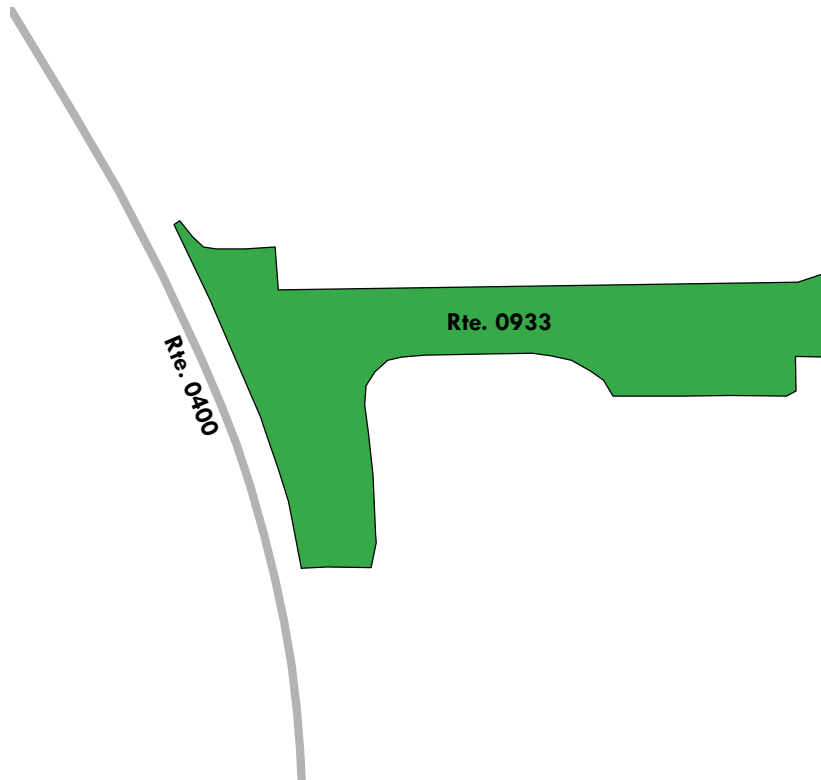
ROUTE 0933: CEDAR PASS FIRE CACHE COMPLEX PARKING

Inspection Date	FMSS Number	User Access	Surface Type
4/27/2017	115273	PUBLIC	ASPHALT
Area (Sq. Ft.)	Lane Miles (11' Widths)	Curb Reveal (Inches)	Curb Recommendation
18,554	0.319	NOT APPLICABLE	NOT APPLICABLE
Curb Type		Curb & Gutter Type	
NO CURB		NO CURB AND GUTTER	
Pavement Recommendation		Condition Rating / PCR	
PREVENTIVE MAINTENANCE		GOOD / 90

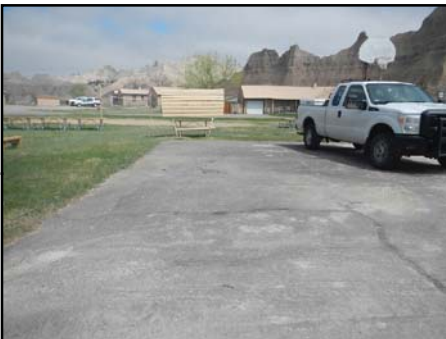
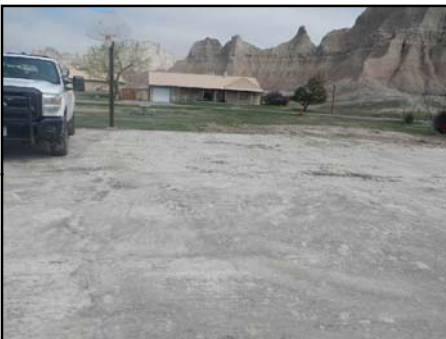
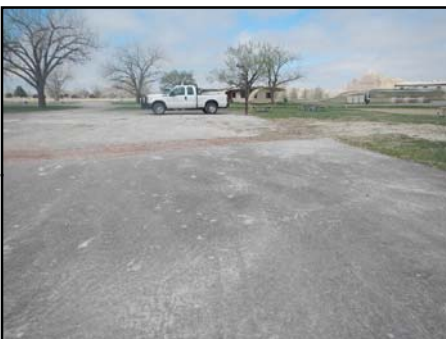
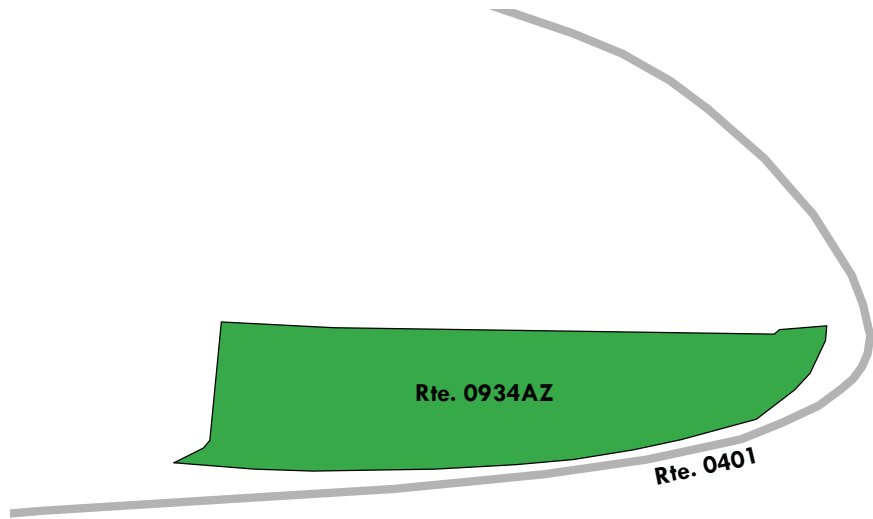
ROUTE 0934AZ: BEN REIFEL RESIDENCE AREA PARKING A

Inspection Date	FMSS Number	User Access	Surface Type
4/27/2017	248674	NONPUBLIC	ASPHALT
Area (Sq. Ft.)	Lane Miles (11' Widths)	Curb Reveal (Inches)	Curb Recommendation
4,737	0.082	NOT APPLICABLE	NOT APPLICABLE
Curb Type		Curb & Gutter Type	
NO CURB		NO CURB AND GUTTER	
Pavement Recommendation		Condition Rating / PCR	
PREVENTIVE MAINTENANCE		GOOD / 90

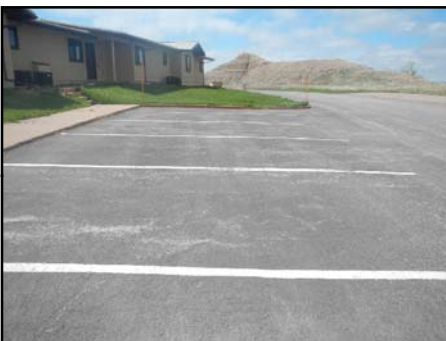
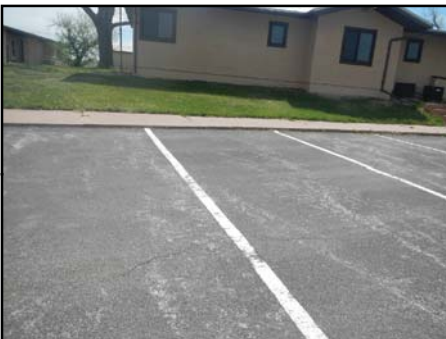
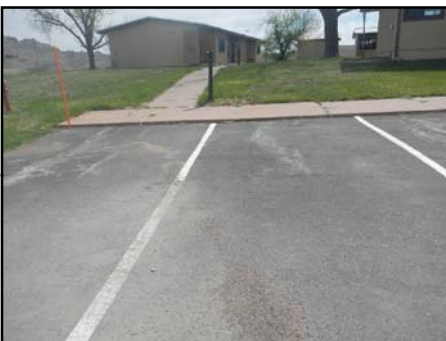
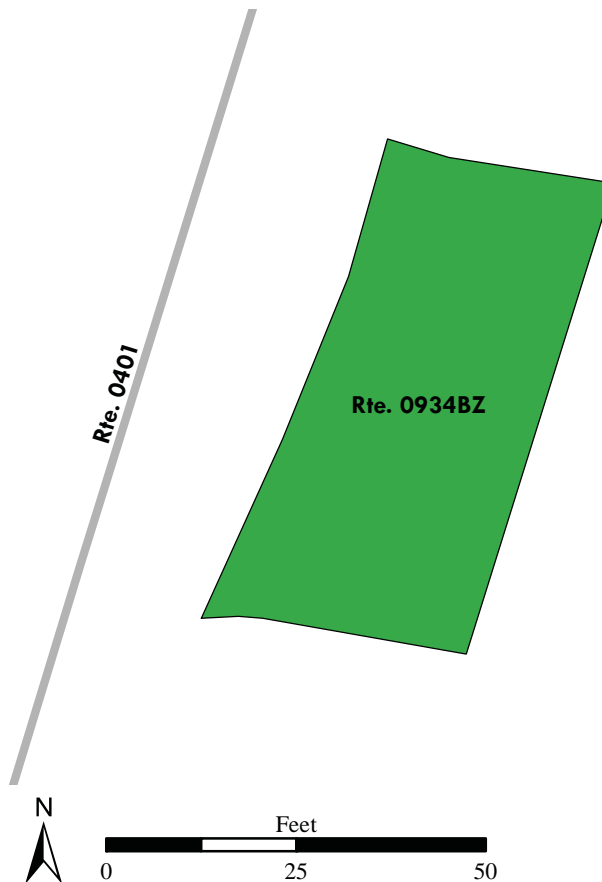
ROUTE 0934BZ: BEN REIFEL RESIDENCE AREA PARKING B

Inspection Date	FMSS Number	User Access	Surface Type
4/27/2017	248674	NONPUBLIC	ASPHALT
Area (Sq. Ft.)	Lane Miles (11' Widths)	Curb Reveal (Inches)	Curb Recommendation
1,480	0.025	NOT APPLICABLE	DO NOTHING
Curb Type		Curb & Gutter Type	
NO CURB		CONCRETE	
Pavement Recommendation		Condition Rating / PCR	
PREVENTIVE MAINTENANCE		GOOD / 90

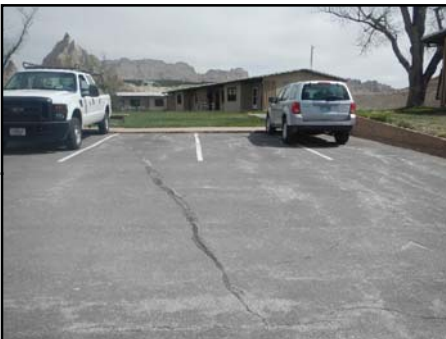
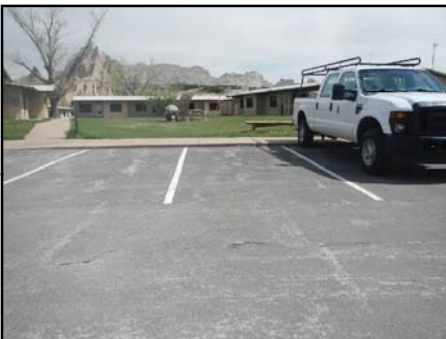
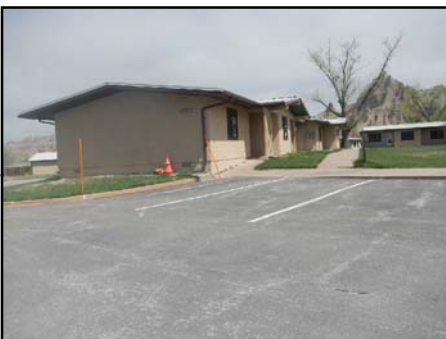
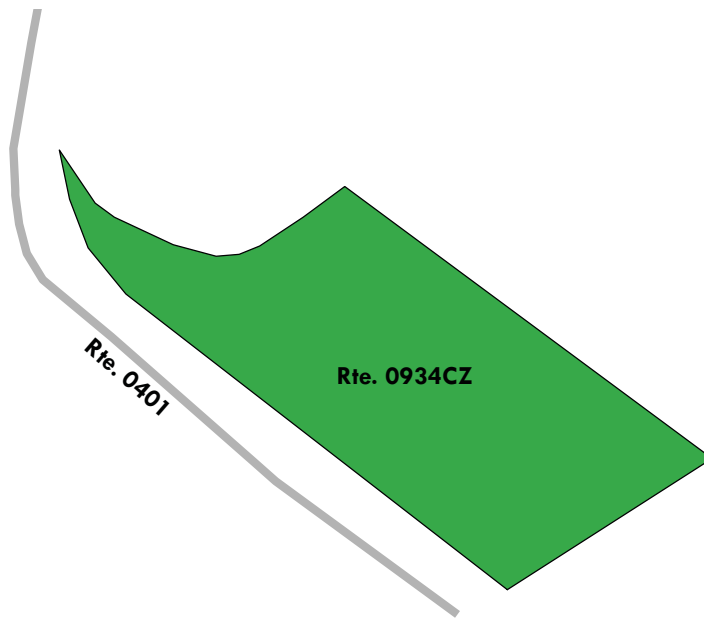
ROUTE 0934CZ: BEN REIFEL RESIDENCE AREA PARKING C

Inspection Date	FMSS Number	User Access	Surface Type
4/27/2017	248674	NONPUBLIC	ASPHALT
Area (Sq. Ft.)	Lane Miles (11' Widths)	Curb Reveal (Inches)	Curb Recommendation
2,822	0.049	5	DO NOTHING
Curb Type		Curb & Gutter Type	
CONCRETE		NO CURB AND GUTTER	
Pavement Recommendation		Condition Rating / PCR	
PREVENTIVE MAINTENANCE		GOOD / 90
