# BAND Cycle 6

## Final Report

# Road Inventory and Condition Assessment of Paved Routes Bandelier National Monument

Federal Highway Administration  
Eastern Federal Lands Highway Division  
Road Inventory Program (RIP)

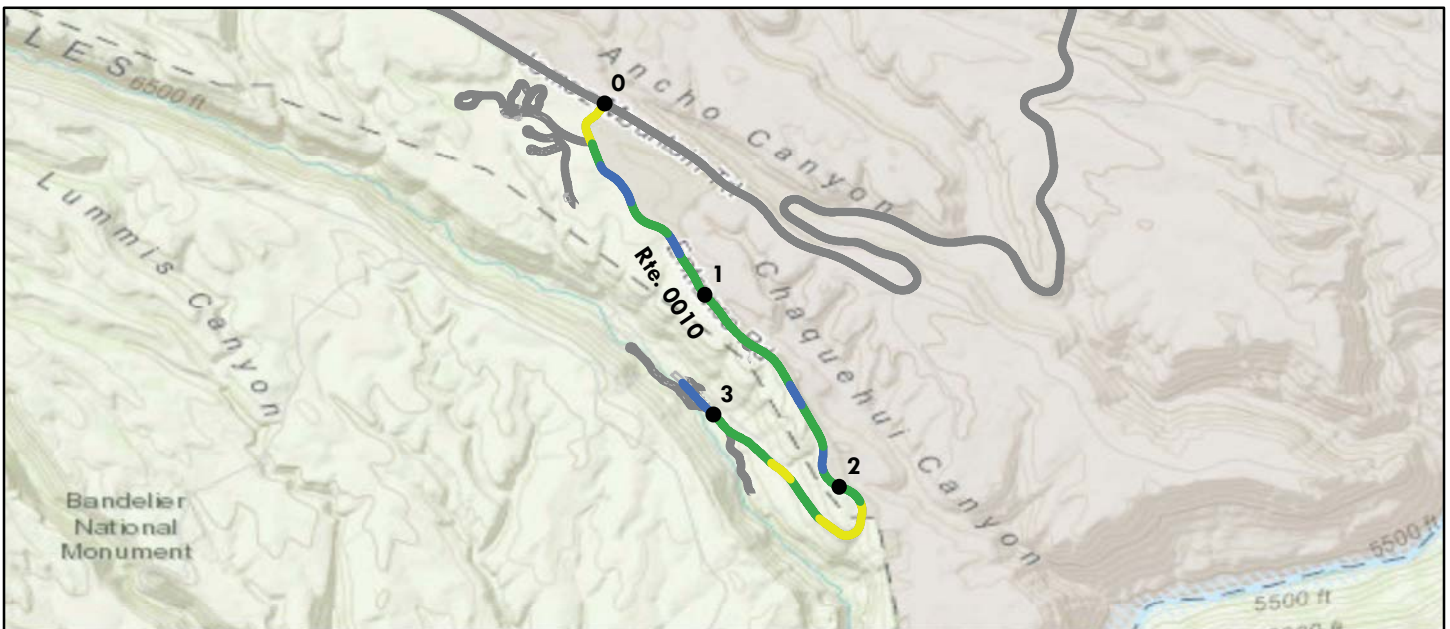
## ROUTE 0010: PARK ENTRANCE ROAD

Route Condition Legend – Pavement Condition Rating (PCR)						
Poor (0 - 60)	Fair (61- 84)	Good (85 - 94)	Excellent (95 - 100)	Not Rated		
See Appendix for definitions and formulas						
<b>Inspection Date:</b> 6/1/2017	<b>Beginning Section MP</b>	0	1	2	3	
<b>Paved Length (Miles):</b> 3.18	<b>Section Length (MI)</b>	1	1	1	0.18	
<b>Surface Type:</b> ASPHALT	<b>Route Summary</b>					
<b>Roadway Condition Information</b>						
Pavement Condition Rating (PCR)	90	91	92	85	97	
Surface Condition Rating (SCR)	91	91	92	90	97	
Roughness Condition Index (RCI)	88	91	93	78	98	
<b>Distress Index Values</b>						
Structural Crack Index	98	98	99	99	98	
Alligator Crack Index	100	100	100	100	100	
Longitudinal Crack Index	98	98	99	99	98	
Transverse Cracking Index	91	91	92	90	99	
Patching Index	98	100	100	93	100	
Rutting Index	97	99	99	93	97	
International Roughness Index (IRI)	147	138	133	175	120	
<b>Lane &amp; Width Information</b>

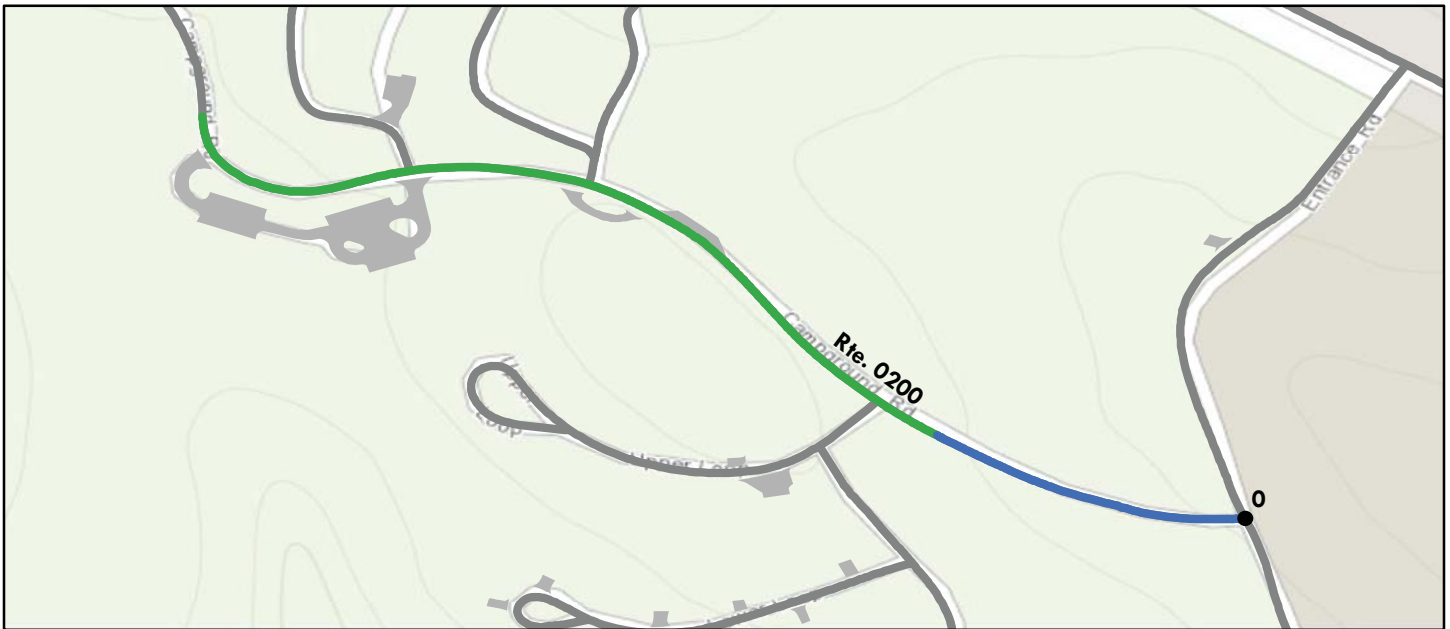
## ROUTE 0200: JUNIPER CAMPGROUND ACCESS ROAD

<b>Route Condition Legend – Pavement Condition Rating (PCR)</b>						
<b>Poor (0 - 60)</b>	<b>Fair (61- 84)</b>	<b>Good (85 - 94)</b>	<b>Excellent (95 - 100)</b>	<b>Not Rated</b>		
See Appendix for definitions and formulas						
<b>Inspection Date:</b> 6/1/2017	<b>Beginning Section MP</b>	0				
<b>Paved Length (Miles):</b> 0.38	<b>Section Length (MI)</b>	0.38				
<b>Surface Type:</b> ASPHALT	<b>Route Summary</b>					
<b>Roadway Condition Information</b>						
Pavement Condition Rating (PCR)	93	93				
Surface Condition Rating (SCR)	93	93				
Roughness Condition Index (RCI)	N/A	N/A				
<b>Distress Index Values</b>						
Structural Crack Index	98	98				
Alligator Crack Index	100	100				
Longitudinal Crack Index	98	98				
Transverse Cracking Index	93	93				
Patching Index	100	100				
Rutting Index	96	96				
International Roughness Index (IRI)	N/A	N/A				
<b>Lane &amp; Width Information</b>						
Number of Lanes	2	2

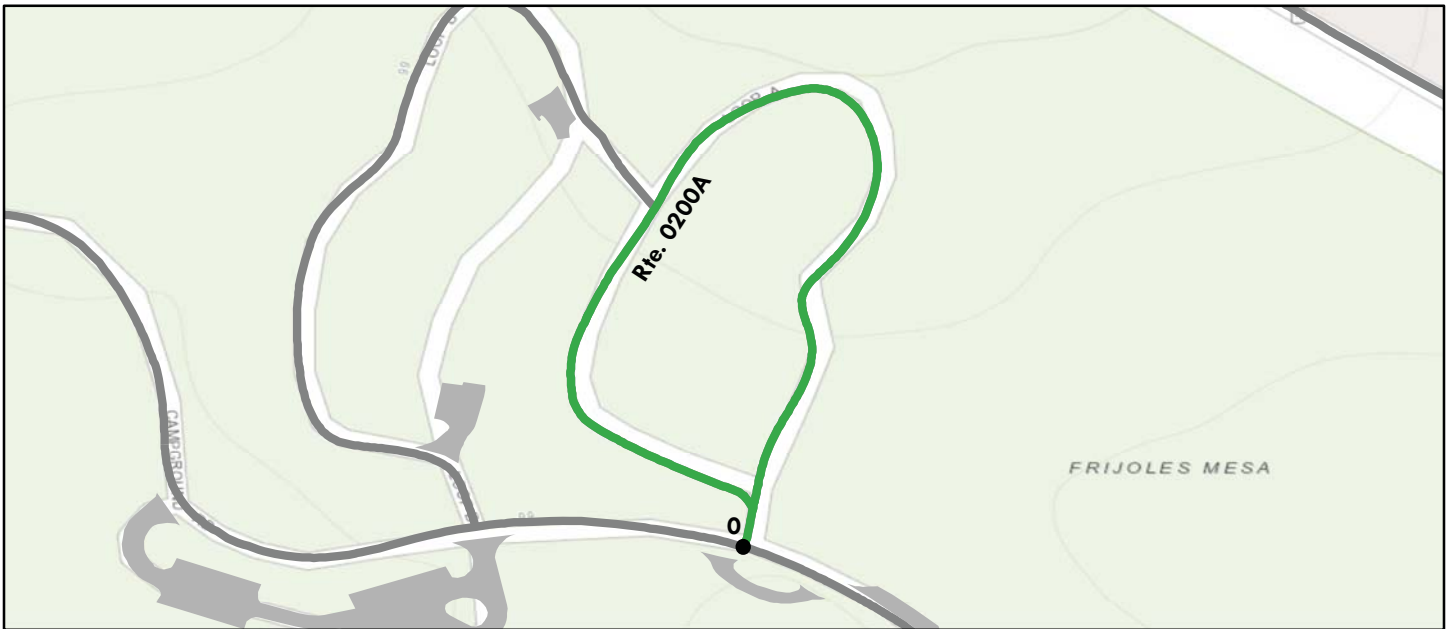
## ROUTE 0200A: JUNIPER CAMPGROUND - ABERT'S SQUIRREL LOOP

Route Condition Legend – Pavement Condition Rating (PCR)						
Poor (0 - 60)	Fair (61- 84)	Good (85 - 94)	Excellent (95 - 100)	Not Rated		
See Appendix for definitions and formulas						
<b>Inspection Date:</b> 6/1/2017	<b>Beginning Section MP</b>	0				
<b>Paved Length (Miles):</b> 0.27	<b>Section Length (MI)</b>	0.27				
<b>Surface Type:</b> ASPHALT	<b>Route Summary</b>					
<b>Roadway Condition Information</b>						
Pavement Condition Rating (PCR)	91	91				
Surface Condition Rating (SCR)	91	91				
Roughness Condition Index (RCI)	N/A	N/A				
<b>Distress Index Values</b>						
Structural Crack Index	100	100				
Alligator Crack Index	100	100				
Longitudinal Crack Index	100	100				
Transverse Cracking Index	91	91				
Patching Index	100	100				
Rutting Index	98	98				
International Roughness Index (IRI)	N/A	N/A				
<b>Lane &amp; Width Information</b>						
Number of Lanes	1	1				
Paved Width (ft)	17.2	17.2

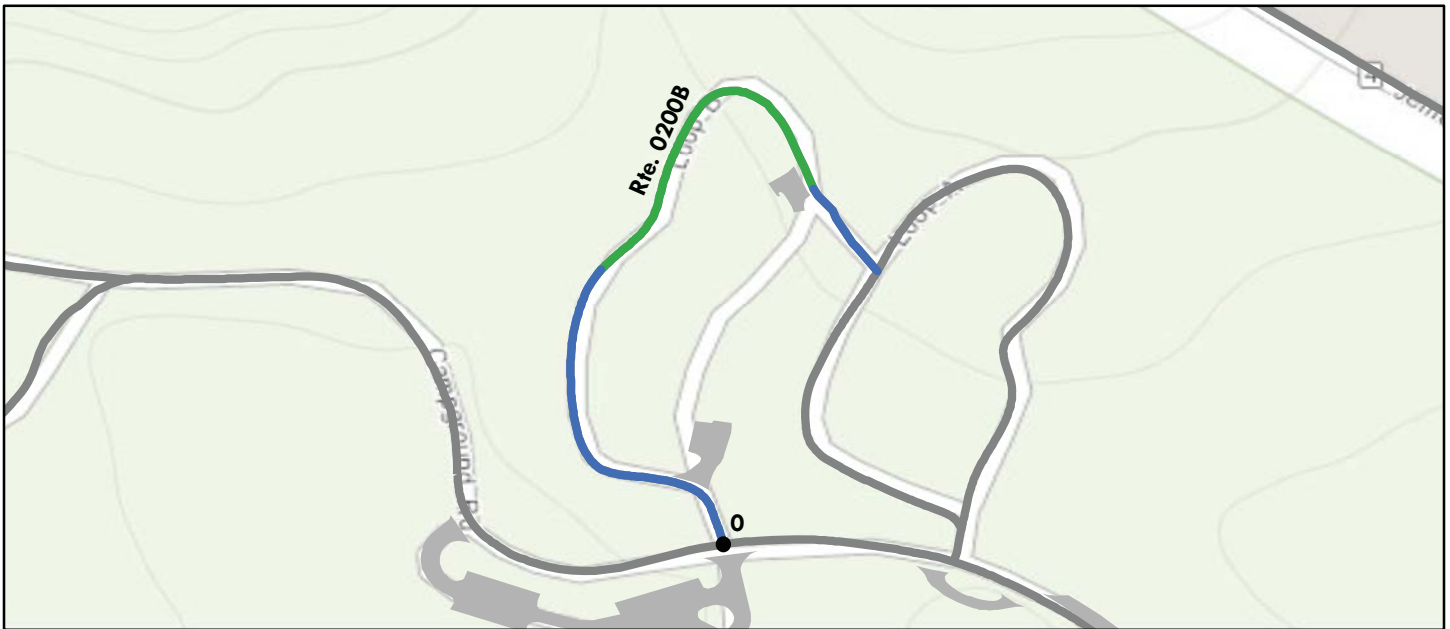
## ROUTE 0200B: JUNIPER CAMPGROUND - BLACK BEAR LOOP

Route Condition Legend – Pavement Condition Rating (PCR)						
Poor (0 - 60)	Fair (61- 84)	Good (85 - 94)	Excellent (95 - 100)	Not Rated		
See Appendix for definitions and formulas						
<b>Inspection Date:</b> 6/1/2017	<b>Beginning Section MP</b>	0				
<b>Paved Length (Miles):</b> 0.23	<b>Section Length (MI)</b>	0.23				
<b>Surface Type:</b> ASPHALT	<b>Route Summary</b>					
<b>Roadway Condition Information</b>						
Pavement Condition Rating (PCR)	96	96				
Surface Condition Rating (SCR)	96	96				
Roughness Condition Index (RCI)	N/A	N/A				
<b>Distress Index Values</b>						
Structural Crack Index	100	100				
Alligator Crack Index	100	100				
Longitudinal Crack Index	100	100				
Transverse Cracking Index	96	96				
Patching Index	100	100				
Rutting Index	98	98				
International Roughness Index (IRI)	N/A	N/A				
<b>Lane &amp; Width Information</b>						
Number of Lanes	1	1				
Paved Width (ft)	17.7	17.7

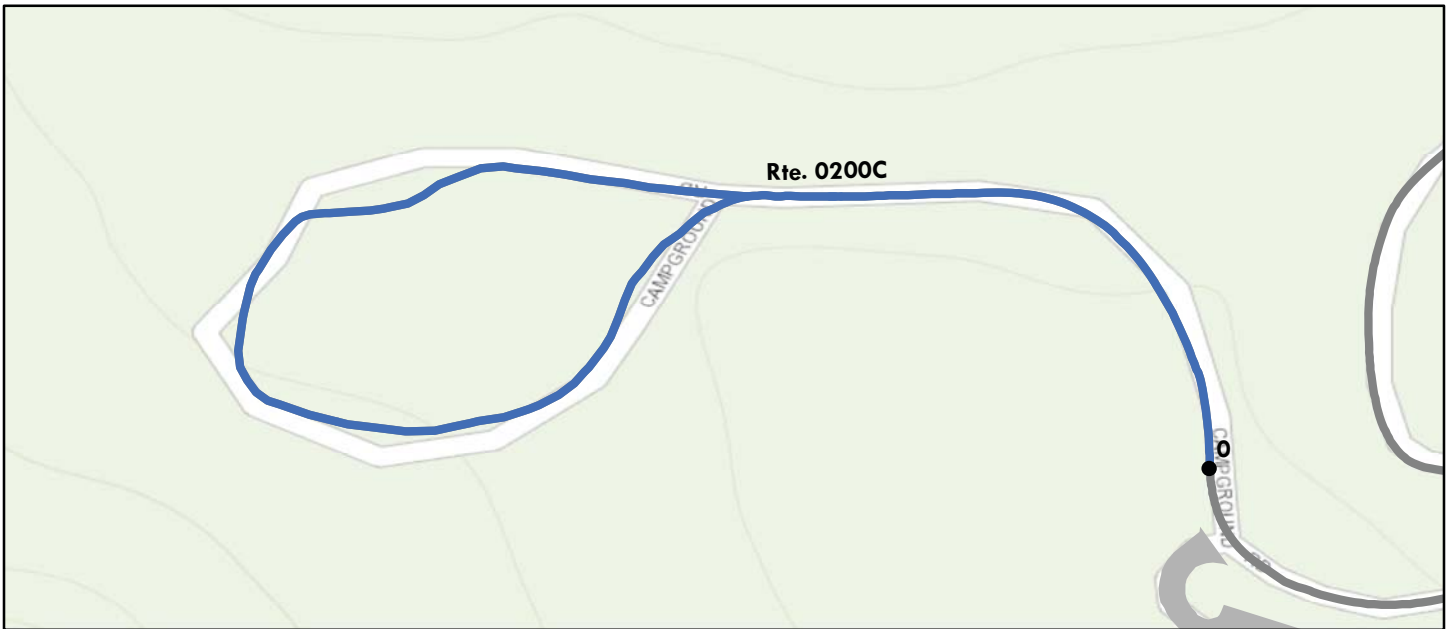
## ROUTE 0200C: JUNIPER CAMPGROUND - COYOTE LOOP

<b>Route Condition Legend – Pavement Condition Rating (PCR)</b>						
<b>Poor (0 - 60)</b>	<b>Fair (61- 84)</b>	<b>Good (85 - 94)</b>	<b>Excellent (95 - 100)</b>	<b>Not Rated</b>		
See Appendix for definitions and formulas						
<b>Inspection Date:</b> 6/1/2017	<b>Beginning Section MP</b>	0				
<b>Paved Length (Miles):</b> 0.33	<b>Section Length (MI)</b>	0.33				
<b>Surface Type:</b> ASPHALT	<b>Route Summary</b>					
<b>Roadway Condition Information</b>						
Pavement Condition Rating (PCR)	98	98				
Surface Condition Rating (SCR)	98	98				
Roughness Condition Index (RCI)	N/A	N/A				
<b>Distress Index Values</b>						
Structural Crack Index	100	100				
Alligator Crack Index	100	100				
Longitudinal Crack Index	100	100				
Transverse Cracking Index	99	99				
Patching Index	100	100				
Rutting Index	98	98				
International Roughness Index (IRI)	N/A	N/A				
<b>Lane &amp; Width Information</b>						
Number of Lanes	1	1

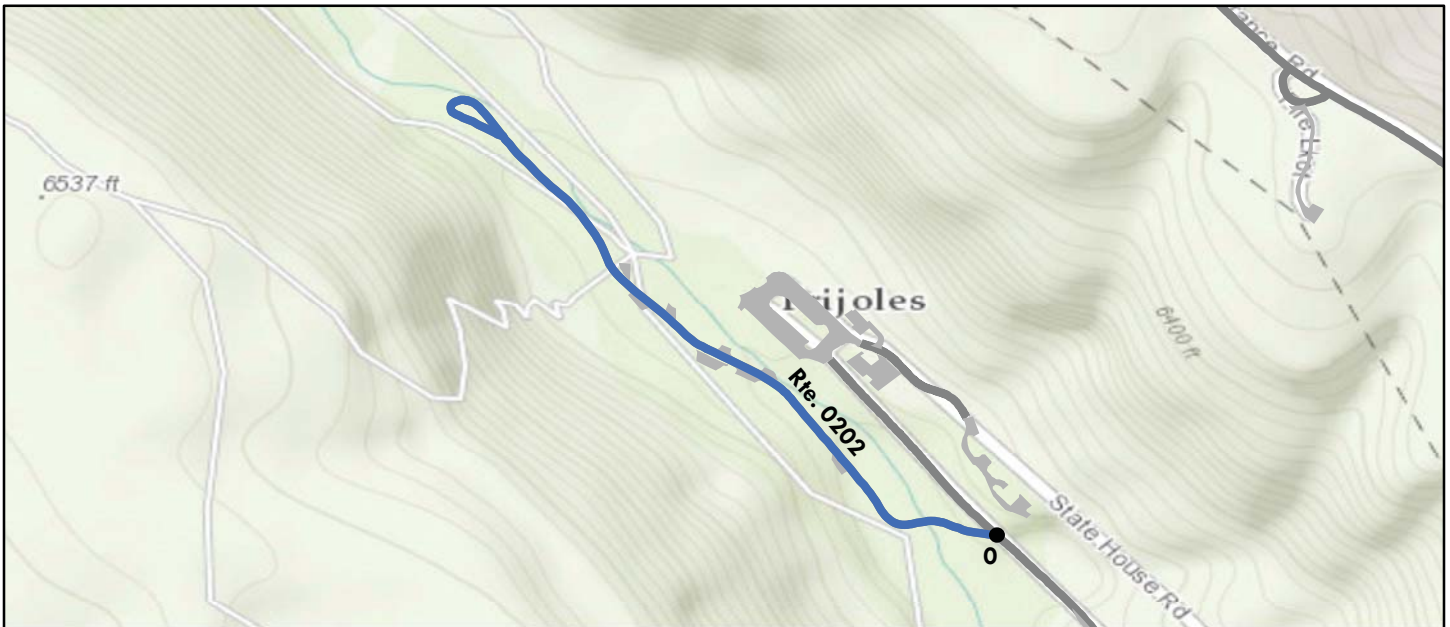
## ROUTE 0202: COTTONWOOD PICNIC AREA ROAD

<b>Route Condition Legend – Pavement Condition Rating (PCR)</b>						
<b>Poor (0 - 60)</b>	<b>Fair (61- 84)</b>	<b>Good (85 - 94)</b>	<b>Excellent (95 - 100)</b>	<b>Not Rated</b>		
See Appendix for definitions and formulas						
<b>Inspection Date:</b> 6/1/2017	<b>Beginning Section MP</b>	0				
<b>Paved Length (Miles):</b> 0.44	<b>Section Length (MI)</b>	0.44				
<b>Surface Type:</b> ASPHALT	<b>Route Summary</b>					
<b>Roadway Condition Information</b>						
Pavement Condition Rating (PCR)	98	98				
Surface Condition Rating (SCR)	98	98				
Roughness Condition Index (RCI)	N/A	N/A				
<b>Distress Index Values</b>						
Structural Crack Index	100	100				
Alligator Crack Index	100	100				
Longitudinal Crack Index	100	100				
Transverse Cracking Index	100	100				
Patching Index	100	100				
Rutting Index	98	98				
International Roughness Index (IRI)	N/A	N/A				
<b>Lane &amp; Width Information</b>						
Number of Lanes	2	2

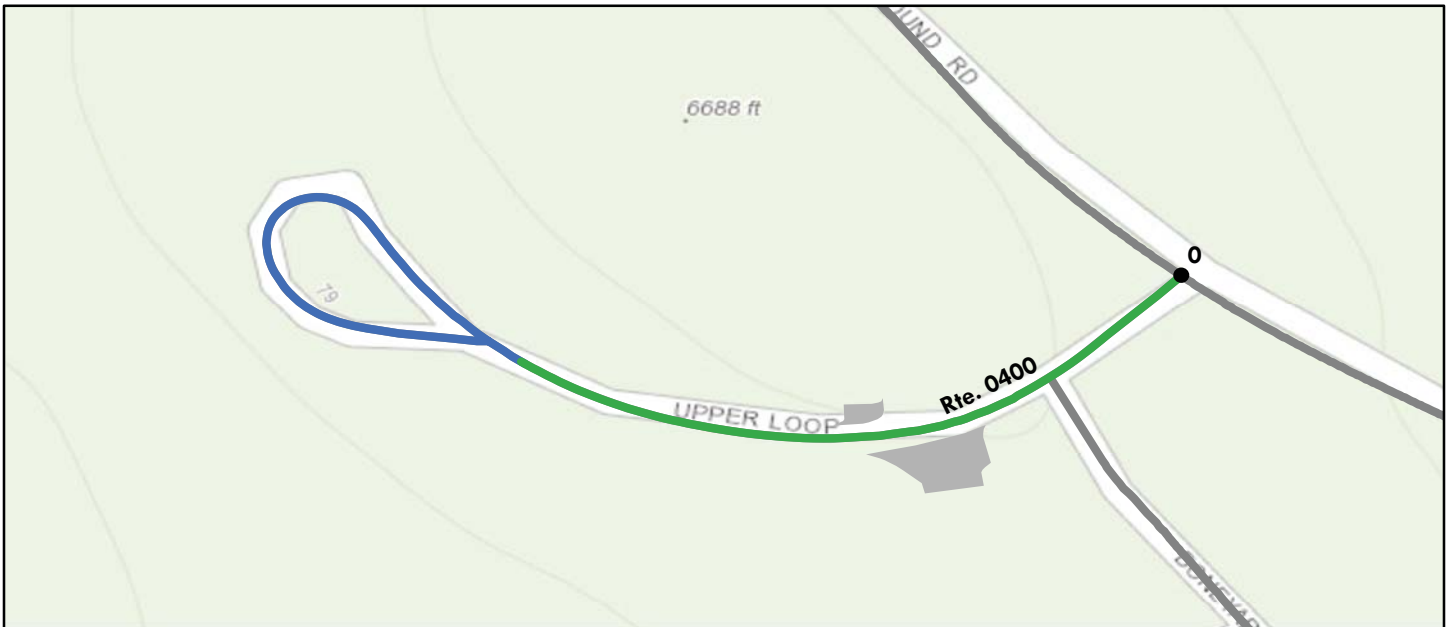
## ROUTE 0400: SALTBRUSH COURT

Route Condition Legend – Pavement Condition Rating (PCR)						
Poor (0 - 60)	Fair (61- 84)	Good (85 - 94)	Excellent (95 - 100)	Not Rated		
See Appendix for definitions and formulas						
<b>Inspection Date:</b> 6/1/2017	<b>Beginning Section MP</b>	0				
<b>Paved Length (Miles):</b> 0.19	<b>Section Length (MI)</b>	0.19				
<b>Surface Type:</b> ASPHALT	<b>Route Summary</b>					
<b>Roadway Condition Information</b>						
Pavement Condition Rating (PCR)	96	96				
Surface Condition Rating (SCR)	96	96				
Roughness Condition Index (RCI)	N/A	N/A				
<b>Distress Index Values</b>						
Structural Crack Index	100	100				
Alligator Crack Index	100	100				
Longitudinal Crack Index	100	100				
Transverse Cracking Index	96	96				
Patching Index	100	100				
Rutting Index	98	98				
International Roughness Index (IRI)	N/A	N/A				
<b>Lane &amp; Width Information</b>						
Number of Lanes	2	2				
Paved Width (ft)	24.1	24.1

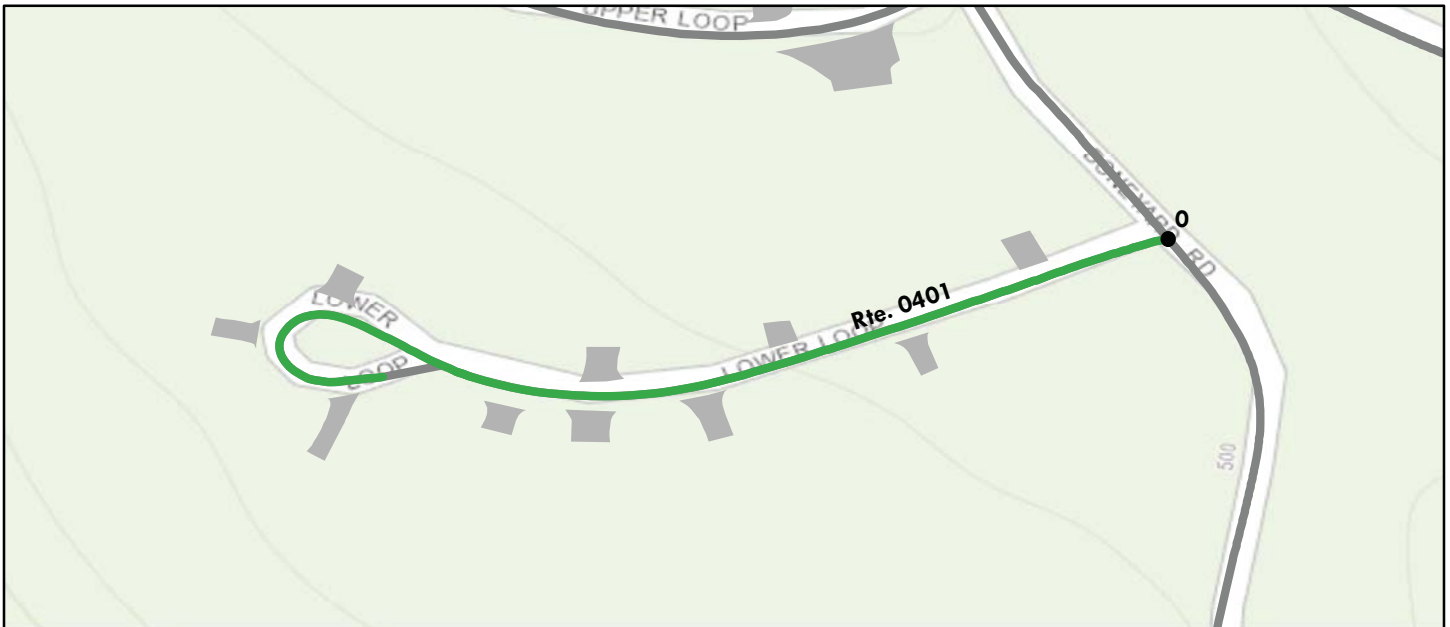
## ROUTE 0401: PAINTBRUSH COURT

Route Condition Legend – Pavement Condition Rating (PCR)						
Poor (0 - 60)	Fair (61- 84)	Good (85 - 94)	Excellent (95 - 100)	Not Rated		
See Appendix for definitions and formulas						
<b>Inspection Date:</b> 6/1/2017	<b>Beginning Section MP</b>	0				
<b>Paved Length (Miles):</b> 0.15	<b>Section Length (MI)</b>	0.14				
<b>Surface Type:</b> ASPHALT	<b>Route Summary</b>					
<b>Roadway Condition Information</b>						
Pavement Condition Rating (PCR)	92	92				
Surface Condition Rating (SCR)	92	92				
Roughness Condition Index (RCI)	N/A	N/A				
<b>Distress Index Values</b>						
Structural Crack Index	100	100				
Alligator Crack Index	100	100				
Longitudinal Crack Index	100	100				
Transverse Cracking Index	92	92				
Patching Index	100	100				
Rutting Index	98	98				
International Roughness Index (IRI)	N/A	N/A				
<b>Lane &amp; Width Information</b>						
Number of Lanes	2	2				
Paved Width (ft)	23.7	23.7

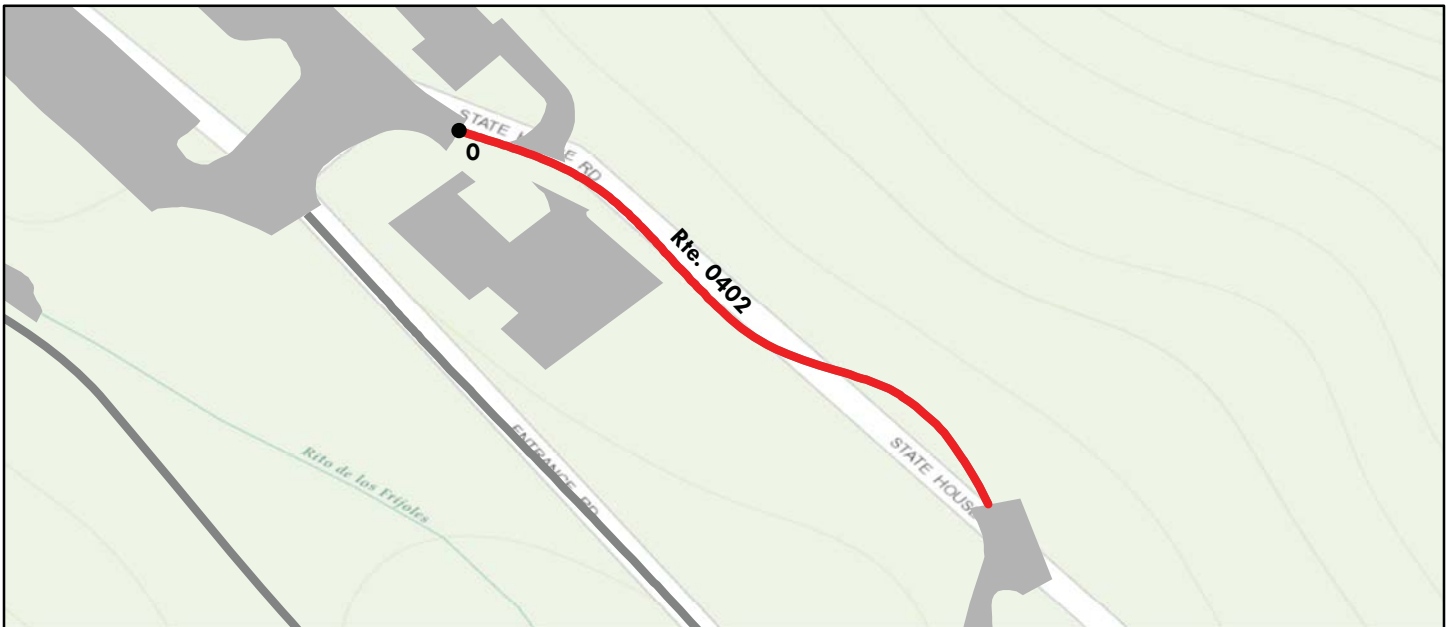
## ROUTE 0402: STONEHOUSE ROAD

Route Condition Legend – Pavement Condition Rating (PCR)						
Poor (0 - 60)	Fair (61- 84)	Good (85 - 94)	Excellent (95 - 100)	Not Rated		
See Appendix for definitions and formulas						
<b>Inspection Date:</b> 6/1/2017	<b>Beginning Section MP</b>	0				
<b>Paved Length (Miles):</b> 0.08	<b>Section Length (MI)</b>	0.08				
<b>Surface Type:</b> ASPHALT	<b>Route Summary</b>					
<b>Roadway Condition Information</b>						
Pavement Condition Rating (PCR)	26	26				
Surface Condition Rating (SCR)	26	26				
Roughness Condition Index (RCI)	N/A	N/A				
<b>Distress Index Values</b>						
Structural Crack Index	90	90				
Alligator Crack Index	100	100				
Longitudinal Crack Index	90	90				
Transverse Cracking Index	26	26				
Patching Index	88	88				
Rutting Index	92	92				
International Roughness Index (IRI)	N/A	N/A				
<b>Lane &amp; Width Information</b>						
Number of Lanes	1	1				
Paved Width (ft)	14.1	14.1				
Lane Width (ft)	14.1	14.1

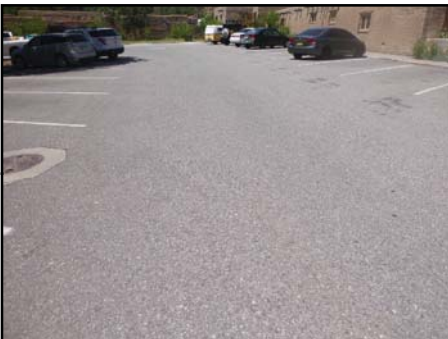
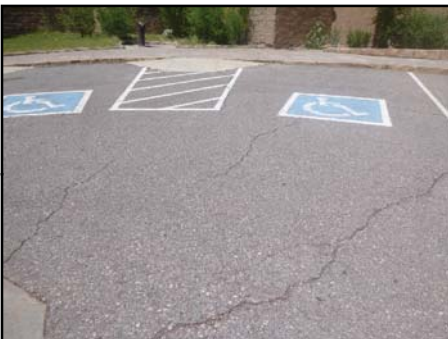
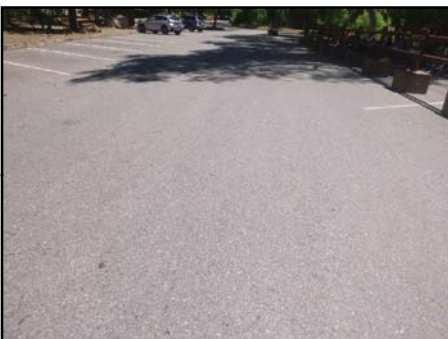
Inspection Date	FMSS Number	User Access	Surface Type
6/1/2017	31666	PUBLIC	ASPHALT
Area (Sq. Ft.)	Lane Miles (11' Widths)	Curb Reveal (Inches)	Curb Recommendation
37,030	0.638	6	LIGHT REPAIR
Curb Type		Curb & Gutter Type	
STONE		NO CURB AND GUTTER	
Pavement Recommendation		Condition Rating / PCR	
PREVENTIVE MAINTENANCE		GOOD / 90

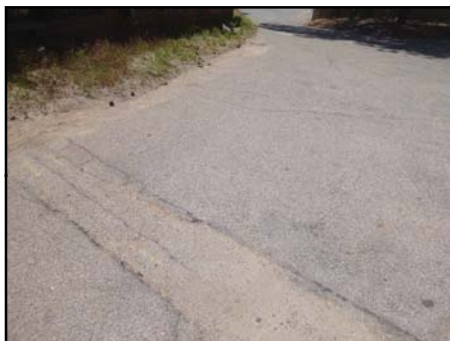
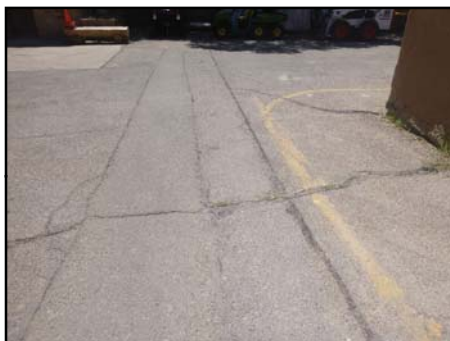
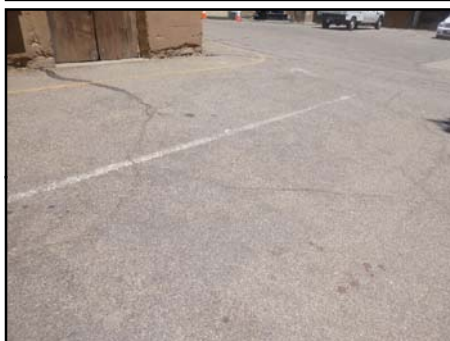
## ROUTE 0901: FRIJOLES CANYON MAINTENANCE AREA PARKING

Inspection Date	FMSS Number	User Access	Surface Type
6/1/2017	31670	NONPUBLIC	ASPHALT
Area (Sq. Ft.)	Lane Miles (11' Widths)	Curb Reveal (Inches)	Curb Recommendation
8,709	0.15	NOT APPLICABLE	NOT APPLICABLE
Curb Type		Curb & Gutter Type	
NO CURB		NO CURB AND GUTTER	
Pavement Recommendation		Condition Rating / PCR	
LIGHT 3R TREATMENTS		FAIR / 73

Note: Parking area consists of multiple surface types: 1 part Asphalt at 8,005 square feet; 1 part Concrete at 704 square feet.

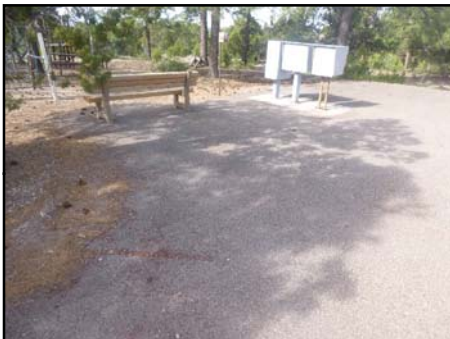
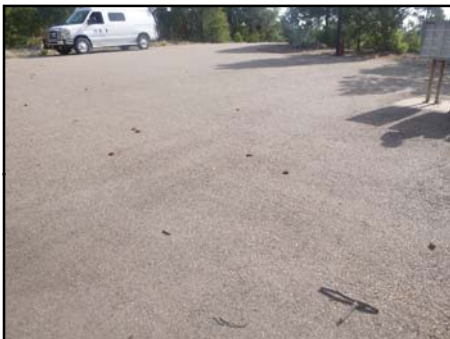
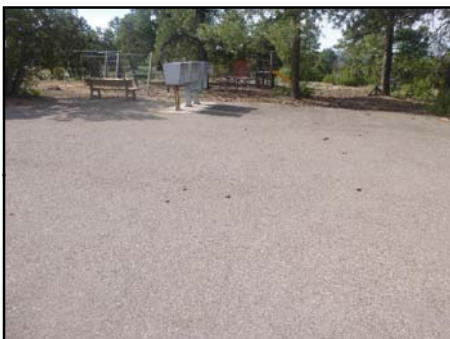
## ROUTE 0902AZ: MESA RESIDENCE PARKING A

Inspection Date	FMSS Number	User Access	Surface Type
6/1/2017	53623	NONPUBLIC	ASPHALT
Area (Sq. Ft.)	Lane Miles (11' Widths)	Curb Reveal (Inches)	Curb Recommendation
2,667	0.046	NOT APPLICABLE	NOT APPLICABLE
Curb Type		Curb & Gutter Type	
NO CURB		NO CURB AND GUTTER	
Pavement Recommendation		Condition Rating / PCR	
PREVENTIVE MAINTENANCE		GOOD / 90

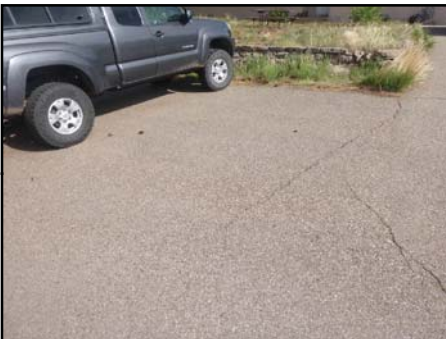
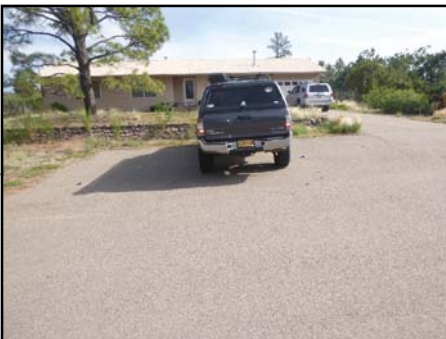
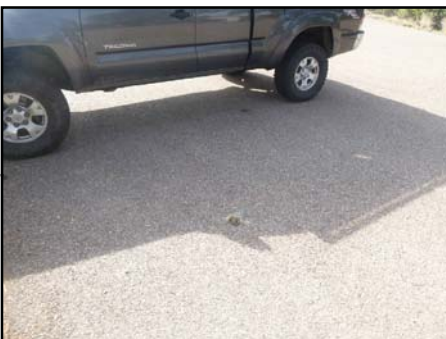
## ROUTE 0902BZ: MESA RESIDENCE PARKING B

Inspection Date	FMSS Number	User Access	Surface Type
6/2/2017	53623	NONPUBLIC	ASPHALT
Area (Sq. Ft.)	Lane Miles (11' Widths)	Curb Reveal (Inches)	Curb Recommendation
677	0.012	NOT APPLICABLE	NOT APPLICABLE
Curb Type		Curb & Gutter Type	
NO CURB		NO CURB AND GUTTER	
Pavement Recommendation		Condition Rating / PCR	
PREVENTIVE MAINTENANCE		GOOD / 90

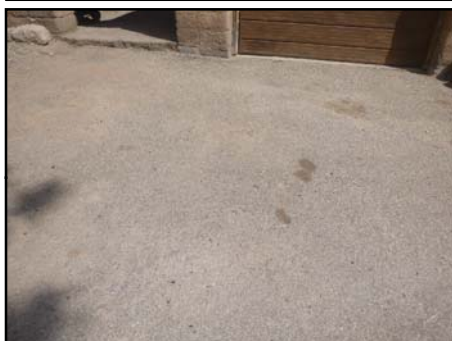
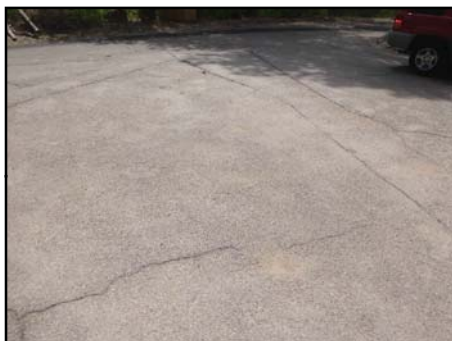
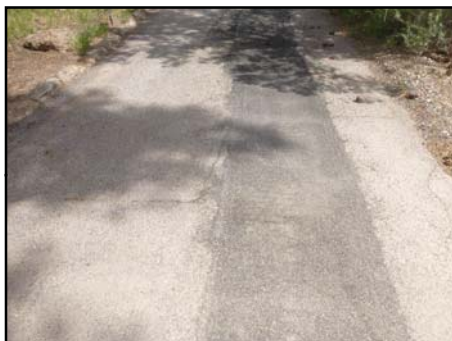
## ROUTE 0903A: STONEHOUSE ROAD PARKING AREA

Inspection Date	FMSS Number	User Access	Surface Type
6/1/2017	53624	NONPUBLIC	ASPHALT
Area (Sq. Ft.)	Lane Miles (11' Widths)	Curb Reveal (Inches)	Curb Recommendation
10,290	0.177	3	LIGHT REPAIR
Curb Type		Curb & Gutter Type	
STONE		NO CURB AND GUTTER	
Pavement Recommendation		Condition Rating / PCR	
HEAVY 3R TREATMENTS		POOR / 53

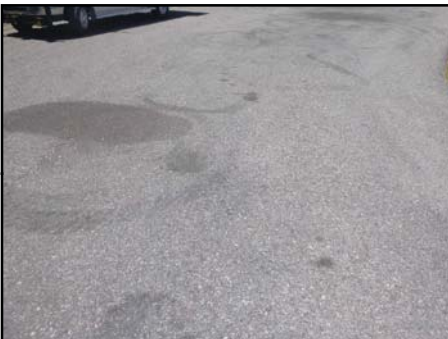
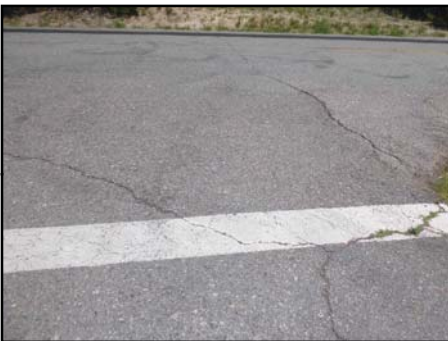
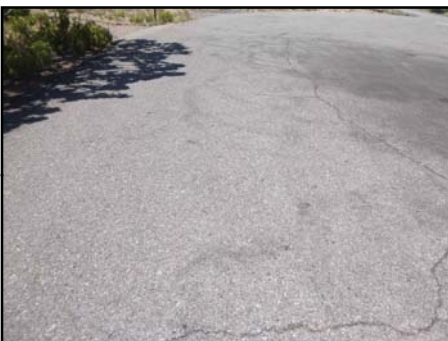
## ROUTE 0905: OVERLOOK PARKING AREA

Inspection Date	FMSS Number	User Access	Surface Type
6/1/2017	46937	PUBLIC	ASPHALT
Area (Sq. Ft.)	Lane Miles (11' Widths)	Curb Reveal (Inches)	Curb Recommendation
6,094	0.105	NOT APPLICABLE	NOT APPLICABLE
Curb Type		Curb & Gutter Type	
NO CURB		NO CURB AND GUTTER	
Pavement Recommendation		Condition Rating / PCR	
PREVENTIVE MAINTENANCE		GOOD / 90

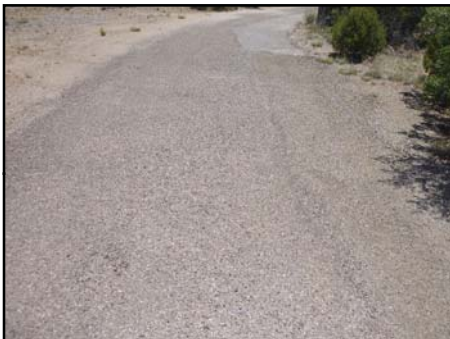
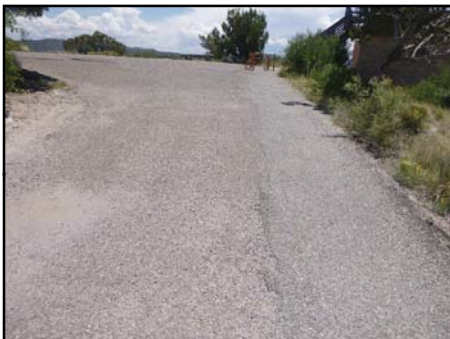
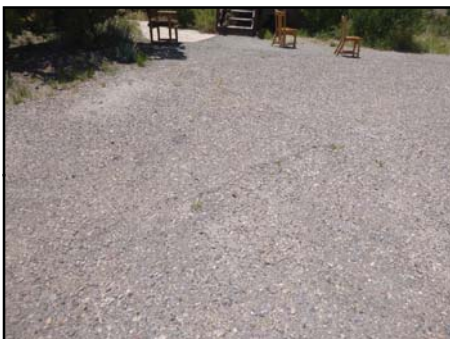
## ROUTE 0906: FIRE TOWER ACCESS ROAD PARKING

Inspection Date	FMSS Number	User Access	Surface Type
6/1/2017	46936	NONPUBLIC	ASPHALT
Area (Sq. Ft.)	Lane Miles (11' Widths)	Curb Reveal (Inches)	Curb Recommendation
6,561	0.113	NOT APPLICABLE	NOT APPLICABLE
Curb Type		Curb & Gutter Type	
NO CURB		NO CURB AND GUTTER	
Pavement Recommendation		Condition Rating / PCR	
LIGHT 3R TREATMENTS		FAIR / 73

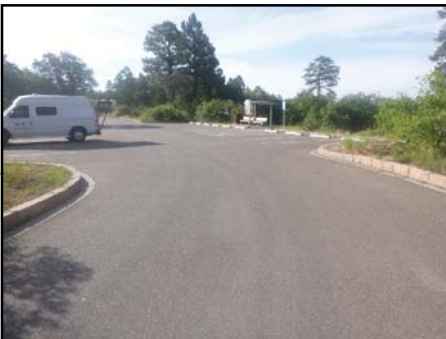
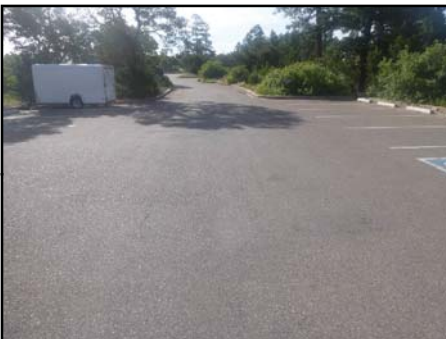
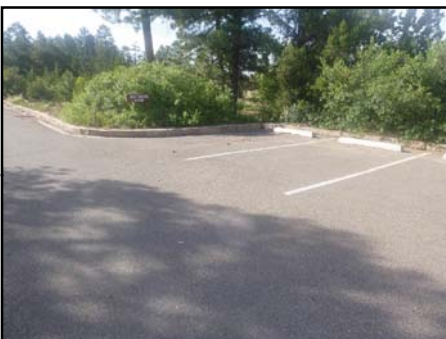
## ROUTE 0907: AMPHITHEATER PARKING

Inspection Date	FMSS Number	User Access	Surface Type
6/2/2017	53628	PUBLIC	ASPHALT
Area (Sq. Ft.)	Lane Miles (11' Widths)	Curb Reveal (Inches)	Curb Recommendation
29,958	0.516	NOT APPLICABLE	LIGHT REPAIR
Curb Type		Curb & Gutter Type	
NO CURB		STONE CURB AND CONCRETE GUTTER	
Pavement Recommendation		Condition Rating / PCR	
PREVENTIVE MAINTENANCE		GOOD / 90

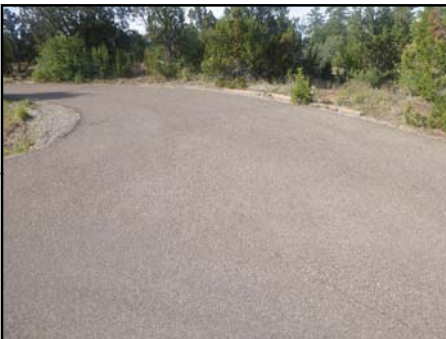
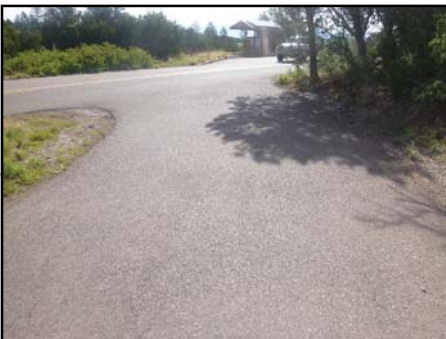
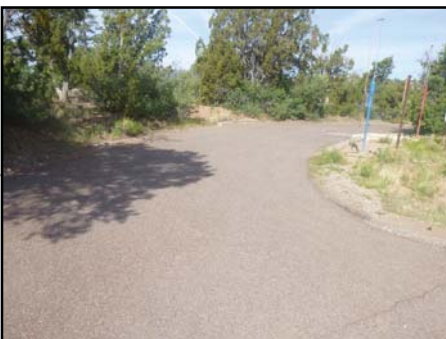
## ROUTE 0908: DUMP STATION AREA

Inspection Date	FMSS Number	User Access	Surface Type
6/2/2017	53630	PUBLIC	ASPHALT
Area (Sq. Ft.)	Lane Miles (11' Widths)	Curb Reveal (Inches)	Curb Recommendation
2,134	0.037	NOT APPLICABLE	NOT APPLICABLE
Curb Type		Curb & Gutter Type	
NO CURB		NO CURB AND GUTTER	
Pavement Recommendation		Condition Rating / PCR	
PREVENTIVE MAINTENANCE		GOOD / 90

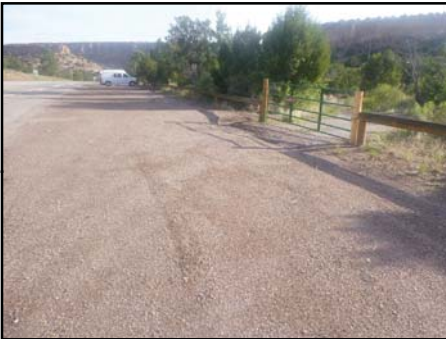
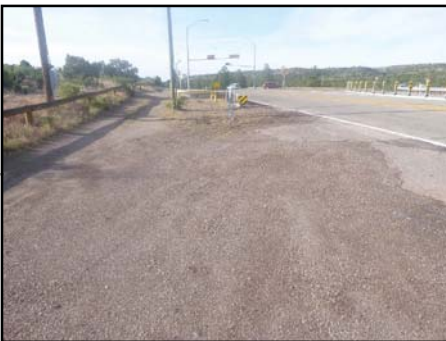
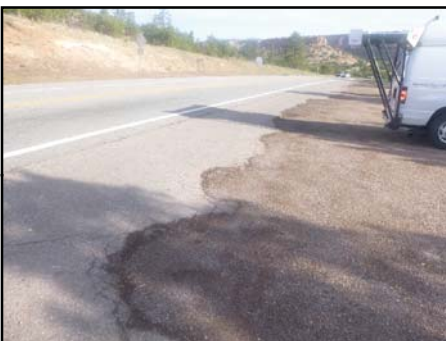
Inspection Date	FMSS Number	User Access	Surface Type
6/2/2017	53632	PUBLIC	ASPHALT
Area (Sq. Ft.)	Lane Miles (11' Widths)	Curb Reveal (Inches)	Curb Recommendation
18,171	0.313	NOT APPLICABLE	NOT APPLICABLE
Curb Type		Curb & Gutter Type	
NO CURB		NO CURB AND GUTTER	
Pavement Recommendation		Condition Rating / PCR	
RECONSTRUCTION		POOR / 0

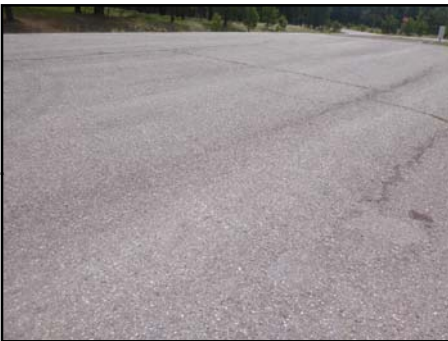
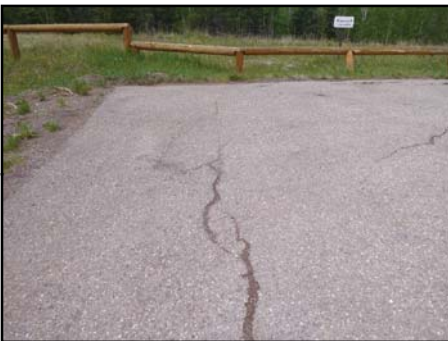
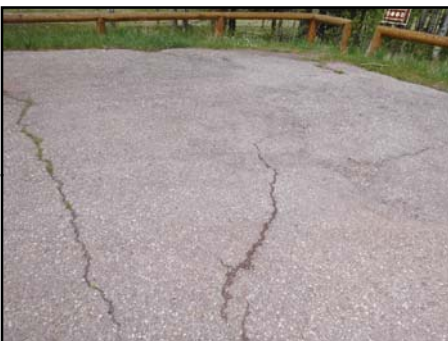
## ROUTE 0913: SKI TRAIL PARKING

Inspection Date	FMSS Number	User Access	Surface Type
6/1/2017	53634	PUBLIC	ASPHALT
Area (Sq. Ft.)	Lane Miles (11' Widths)	Curb Reveal (Inches)	Curb Recommendation
17,416	0.3	NOT APPLICABLE	NOT APPLICABLE
Curb Type		Curb & Gutter Type	
NO CURB		NO CURB AND GUTTER	
Pavement Recommendation		Condition Rating / PCR	
LIGHT 3R TREATMENTS		FAIR / 73

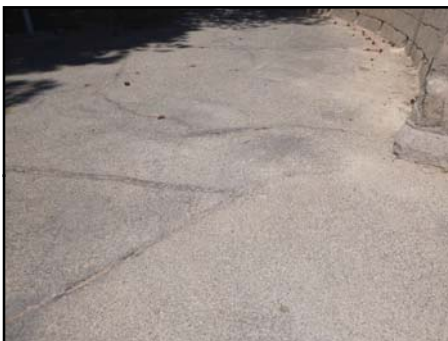
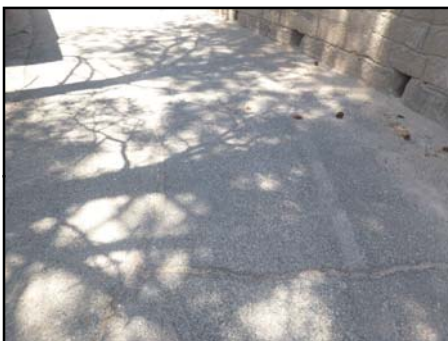
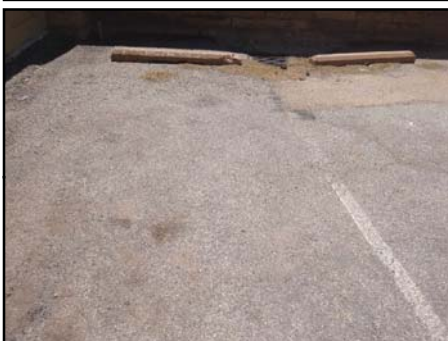
## ROUTE 0914: ADMINISTRATIVE EMPLOYEE PARKING

Inspection Date	FMSS Number	User Access	Surface Type
6/1/2017	53635	NONPUBLIC	ASPHALT
Area (Sq. Ft.)	Lane Miles (11' Widths)	Curb Reveal (Inches)	Curb Recommendation
4,278	0.074	NOT APPLICABLE	NOT APPLICABLE
Curb Type		Curb & Gutter Type	
NO CURB		NO CURB AND GUTTER	
Pavement Recommendation		Condition Rating / PCR	
HEAVY 3R TREATMENTS		POOR / 53

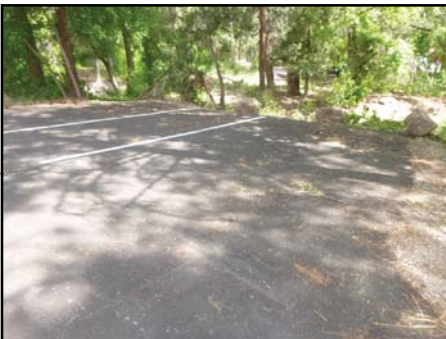
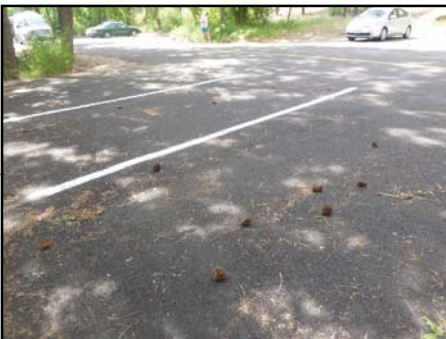
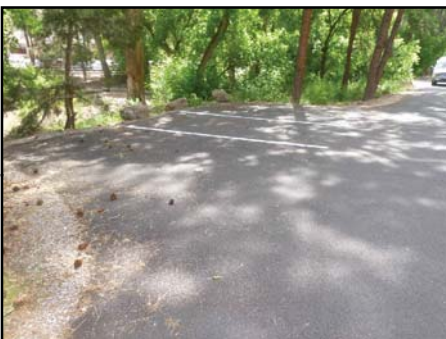
## ROUTE 0915AZ: COTTONWOOD PICNIC AREA PARKING A

Inspection Date	FMSS Number	User Access	Surface Type
6/2/2017	53636	PUBLIC	ASPHALT
Area (Sq. Ft.)	Lane Miles (11' Widths)	Curb Reveal (Inches)	Curb Recommendation
797	0.014	NOT APPLICABLE	NOT APPLICABLE
Curb Type		Curb & Gutter Type	
NO CURB		NO CURB AND GUTTER	
Pavement Recommendation		Condition Rating / PCR	
DO NOTHING		EXCELLENT / 97

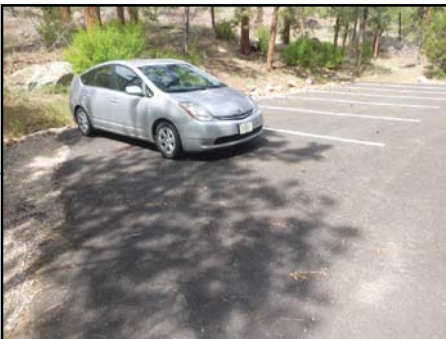
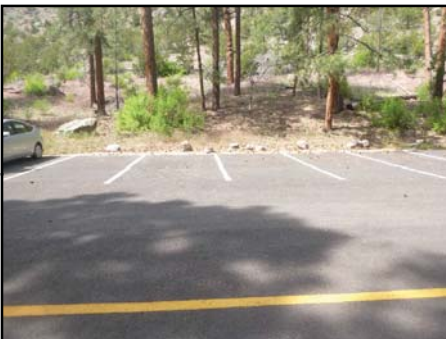
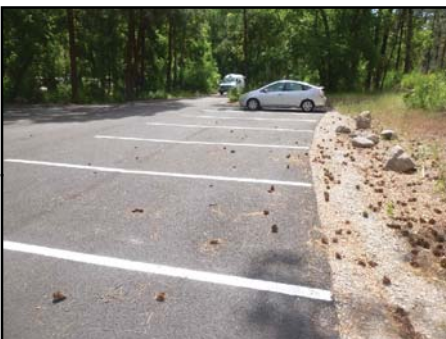
## ROUTE 0915BZ: COTTONWOOD PICNIC AREA PARKING B

Inspection Date	FMSS Number	User Access	Surface Type
6/2/2017	53636	PUBLIC	ASPHALT
Area (Sq. Ft.)	Lane Miles (11' Widths)	Curb Reveal (Inches)	Curb Recommendation
2,451	0.042	NOT APPLICABLE	NOT APPLICABLE
Curb Type		Curb & Gutter Type	
NO CURB		NO CURB AND GUTTER	
Pavement Recommendation		Condition Rating / PCR	
DO NOTHING		EXCELLENT / 97

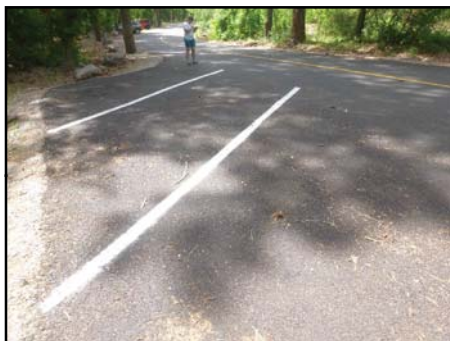
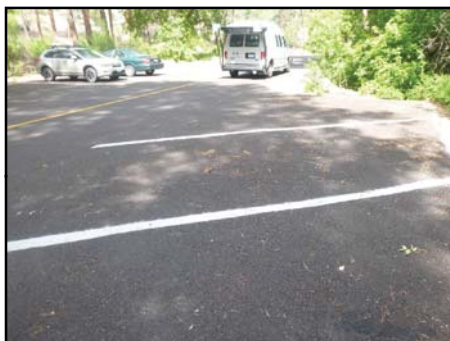
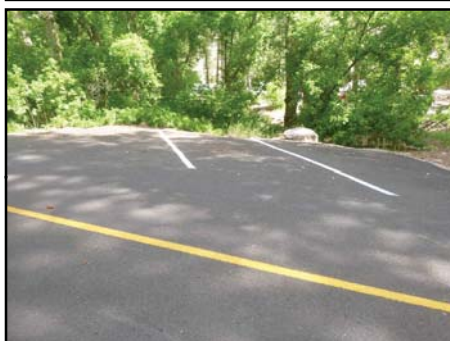
## ROUTE 0915CZ: COTTONWOOD PICNIC AREA PARKING C

Inspection Date	FMSS Number	User Access	Surface Type
6/2/2017	53636	PUBLIC	ASPHALT
Area (Sq. Ft.)	Lane Miles (11' Widths)	Curb Reveal (Inches)	Curb Recommendation
882	0.015	NOT APPLICABLE	NOT APPLICABLE
Curb Type		Curb & Gutter Type	
NO CURB		NO CURB AND GUTTER	
Pavement Recommendation		Condition Rating / PCR	
DO NOTHING		EXCELLENT / 97

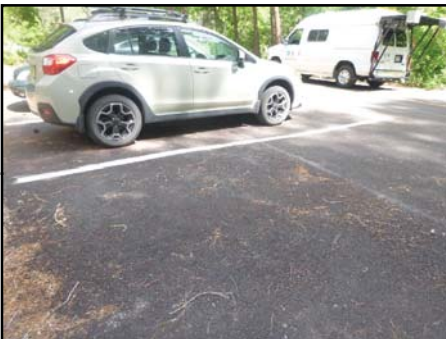
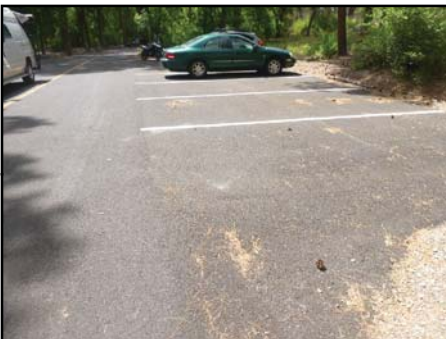
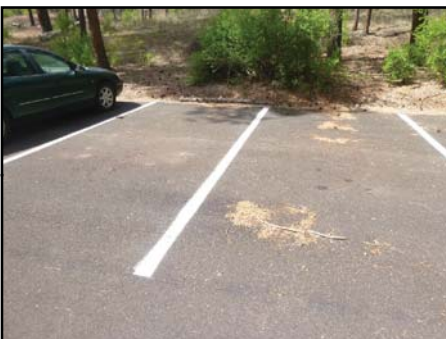
## ROUTE 0915DZ: COTTONWOOD PICNIC AREA PARKING D

Inspection Date	FMSS Number	User Access	Surface Type
6/2/2017	53636	PUBLIC	ASPHALT
Area (Sq. Ft.)	Lane Miles (11' Widths)	Curb Reveal (Inches)	Curb Recommendation
1,478	0.025	NOT APPLICABLE	NOT APPLICABLE
Curb Type		Curb & Gutter Type	
NO CURB		NO CURB AND GUTTER	
Pavement Recommendation		Condition Rating / PCR	
DO NOTHING		EXCELLENT / 97

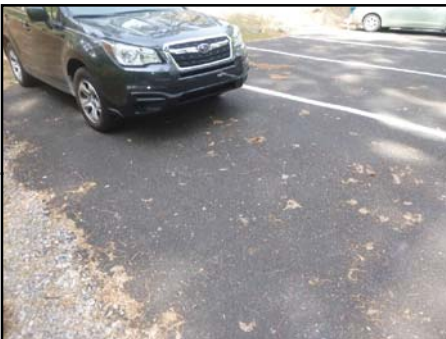
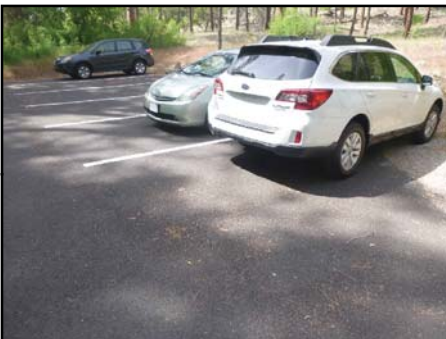
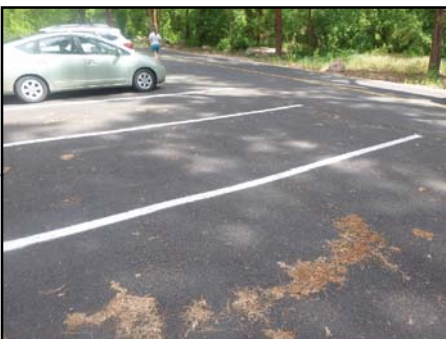
## ROUTE 0915EZ: COTTONWOOD PICNIC AREA PARKING E

Inspection Date	FMSS Number	User Access	Surface Type
6/2/2017	53636	PUBLIC	ASPHALT
Area (Sq. Ft.)	Lane Miles (11' Widths)	Curb Reveal (Inches)	Curb Recommendation
1,353	0.023	NOT APPLICABLE	NOT APPLICABLE
Curb Type		Curb & Gutter Type	
NO CURB		NO CURB AND GUTTER	
Pavement Recommendation		Condition Rating / PCR	
DO NOTHING		EXCELLENT / 97

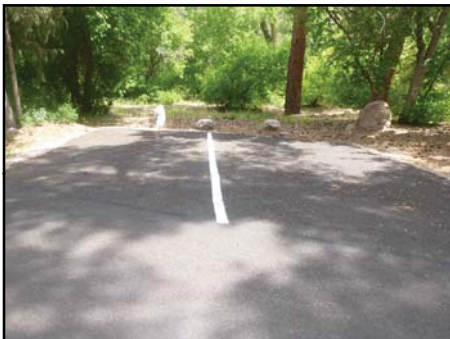
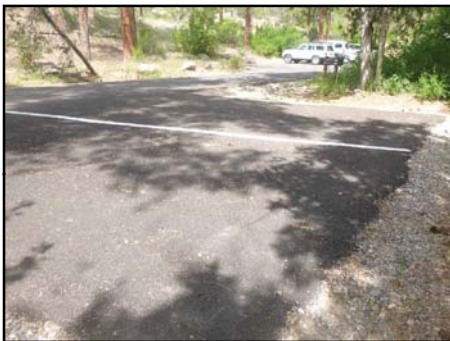
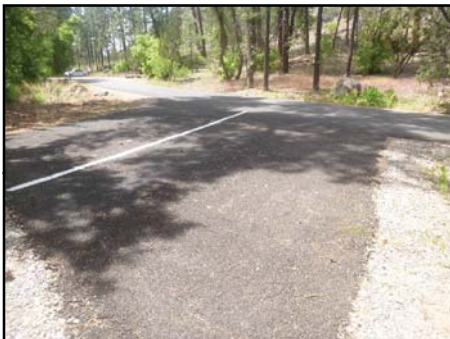
## ROUTE 0915FZ: COTTONWOOD PICNIC AREA PARKING F

Inspection Date	FMSS Number	User Access	Surface Type
6/2/2017	53636	PUBLIC	ASPHALT
Area (Sq. Ft.)	Lane Miles (11' Widths)	Curb Reveal (Inches)	Curb Recommendation
859	0.015	NOT APPLICABLE	NOT APPLICABLE
Curb Type		Curb & Gutter Type	
NO CURB		NO CURB AND GUTTER	
Pavement Recommendation		Condition Rating / PCR	
DO NOTHING		EXCELLENT / 97

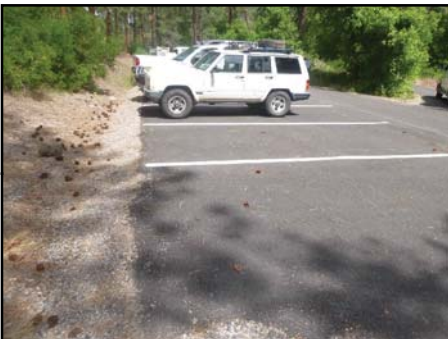
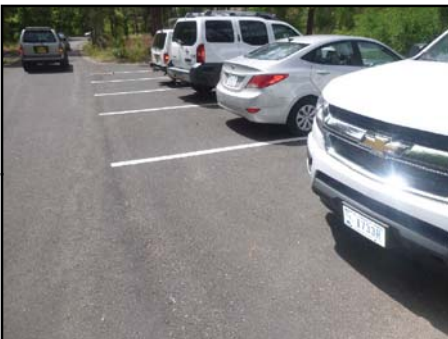
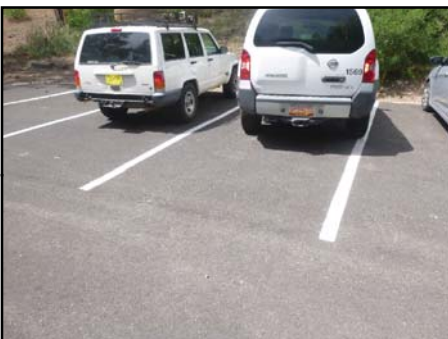
Inspection Date	FMSS Number	User Access	Surface Type
6/2/2017	53636	PUBLIC	ASPHALT
Area (Sq. Ft.)	Lane Miles (11' Widths)	Curb Reveal (Inches)	Curb Recommendation
1,274	0.022	NOT APPLICABLE	NOT APPLICABLE
Curb Type		Curb & Gutter Type	
NO CURB		NO CURB AND GUTTER	
Pavement Recommendation		Condition Rating / PCR	
DO NOTHING		EXCELLENT / 97

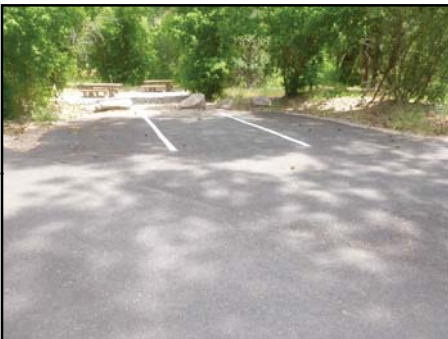
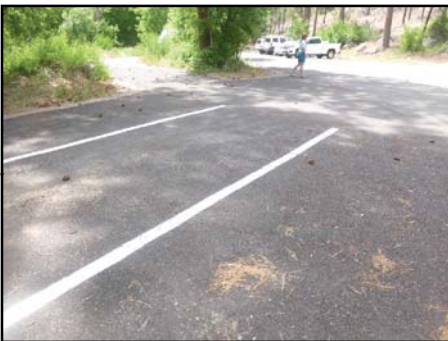
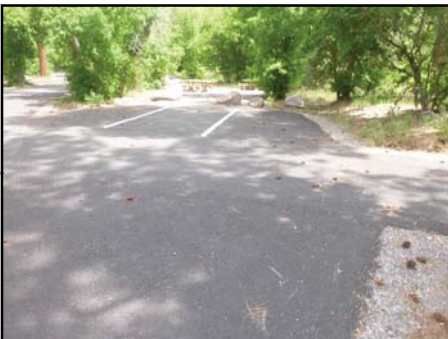
## ROUTE 0915HZ: COTTONWOOD PICNIC AREA PARKING H

Inspection Date	FMSS Number	User Access	Surface Type
6/2/2017	53636	PUBLIC	ASPHALT
Area (Sq. Ft.)	Lane Miles (11' Widths)	Curb Reveal (Inches)	Curb Recommendation
1,089	0.019	NOT APPLICABLE	NOT APPLICABLE
Curb Type		Curb & Gutter Type	
NO CURB		NO CURB AND GUTTER	
Pavement Recommendation		Condition Rating / PCR	
DO NOTHING		EXCELLENT / 97

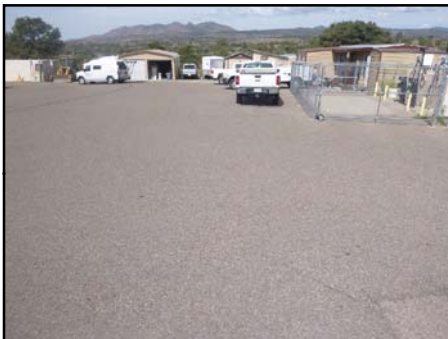
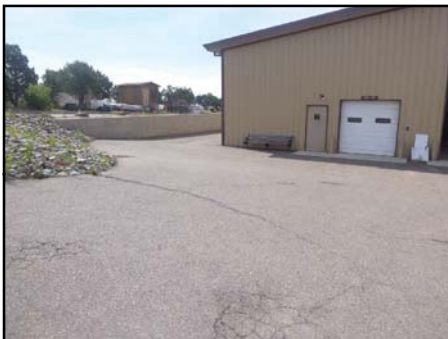
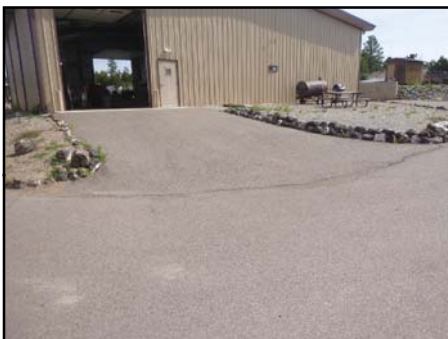
## ROUTE 0917: OPERATIONS CENTER PARKING

Inspection Date	FMSS Number	User Access	Surface Type
6/2/2017	111508	NONPUBLIC	ASPHALT
Area (Sq. Ft.)	Lane Miles (11' Widths)	Curb Reveal (Inches)	Curb Recommendation
18,637	0.321	NOT APPLICABLE	NOT APPLICABLE
Curb Type		Curb & Gutter Type	
NO CURB		NO CURB AND GUTTER	
Pavement Recommendation		Condition Rating / PCR	
PREVENTIVE MAINTENANCE		GOOD / 90

Note: Parking area consists of multiple surface types: 1 part Asphalt at 18,368 square feet; 1 part Concrete at 269 square feet.
