# BAND Cycle 6

## Final Report

# Road Inventory and Condition Assessment of Paved Routes Bandelier National Monument

Federal Highway Administration  
Eastern Federal Lands Highway Division  
Road Inventory Program (RIP)

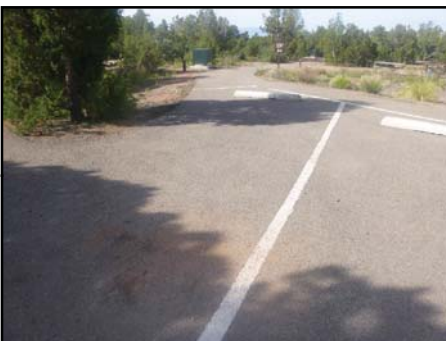
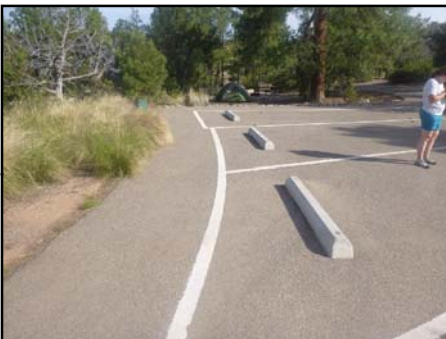
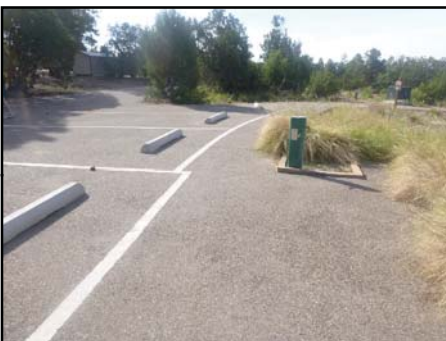
## ROUTE 0919: LOOP B PARKING NORTH

Inspection Date	FMSS Number	User Access	Surface Type
6/2/2017	237784	PUBLIC	ASPHALT
Area (Sq. Ft.)	Lane Miles (11' Widths)	Curb Reveal (Inches)	Curb Recommendation
1,981	0.034	NOT APPLICABLE	NOT APPLICABLE
Curb Type		Curb & Gutter Type	
NO CURB		NO CURB AND GUTTER	
Pavement Recommendation		Condition Rating / PCR	
PREVENTIVE MAINTENANCE		GOOD / 90

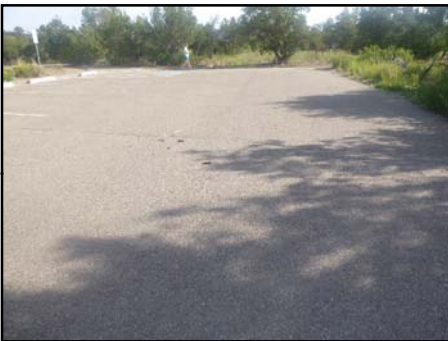
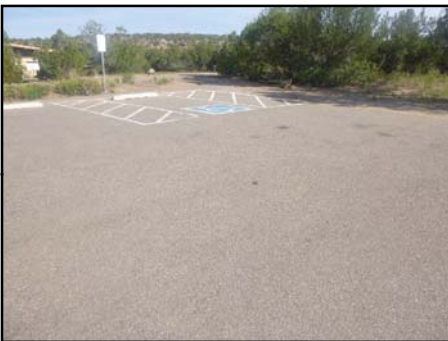
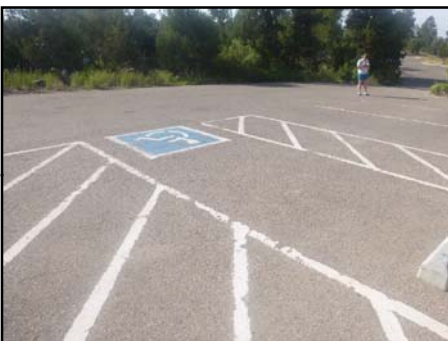
## ROUTE 0920: LOOP B PARKING SOUTH

Inspection Date	FMSS Number	User Access	Surface Type
6/2/2017	237785	PUBLIC	ASPHALT
Area (Sq. Ft.)	Lane Miles (11' Widths)	Curb Reveal (Inches)	Curb Recommendation
3,733	0.064	NOT APPLICABLE	NOT APPLICABLE
Curb Type		Curb & Gutter Type	
NO CURB		NO CURB AND GUTTER	
Pavement Recommendation		Condition Rating / PCR	
PREVENTIVE MAINTENANCE		GOOD / 90

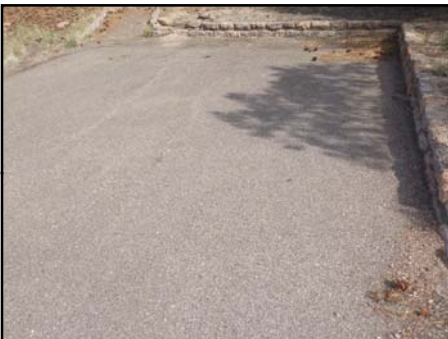
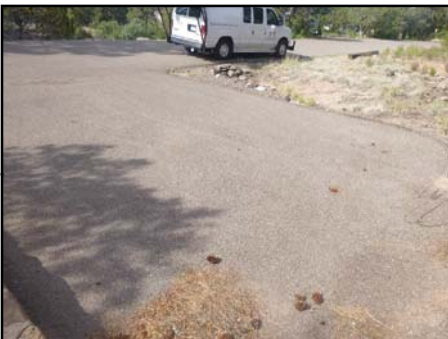
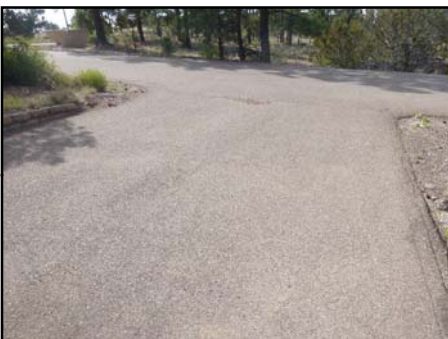
## ROUTE 0921AZ: MESA RESIDENCE LOWER LOOP PARKING A

Inspection Date	FMSS Number	User Access	Surface Type
6/2/2017	237786	NONPUBLIC	ASPHALT
Area (Sq. Ft.)	Lane Miles (11' Widths)	Curb Reveal (Inches)	Curb Recommendation
641	0.011	12	DO NOTHING
Curb Type		Curb & Gutter Type	
STONE		NO CURB AND GUTTER	
Pavement Recommendation		Condition Rating / PCR	
PREVENTIVE MAINTENANCE		GOOD / 90

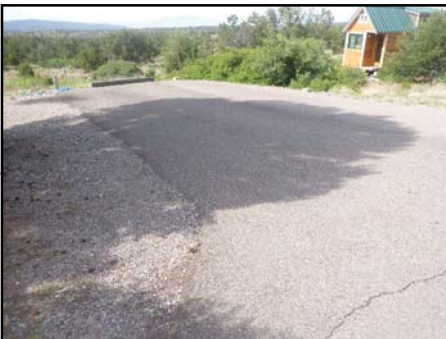
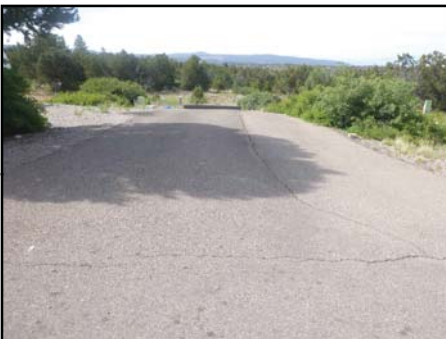
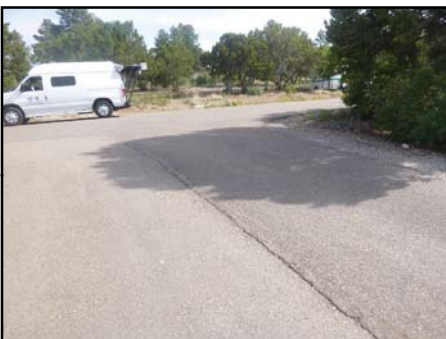
## ROUTE 0921BZ: MESA RESIDENCE LOWER LOOP PARKING B

Inspection Date	FMSS Number	User Access	Surface Type
6/2/2017	237786	NONPUBLIC	ASPHALT
Area (Sq. Ft.)	Lane Miles (11' Widths)	Curb Reveal (Inches)	Curb Recommendation
824	0.014	NOT APPLICABLE	NOT APPLICABLE
Curb Type		Curb & Gutter Type	
NO CURB		NO CURB AND GUTTER	
Pavement Recommendation		Condition Rating / PCR	
LIGHT 3R TREATMENTS		FAIR / 73

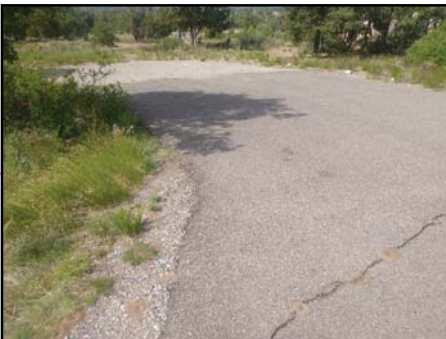
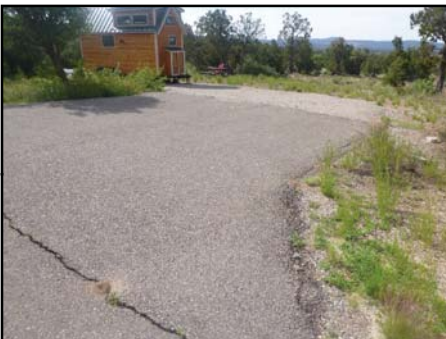
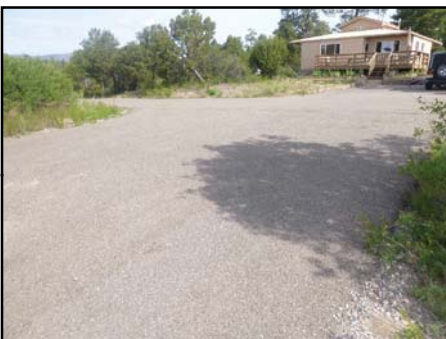
## ROUTE 0921CZ: MESA RESIDENCE LOWER LOOP PARKING C

Inspection Date	FMSS Number	User Access	Surface Type
6/2/2017	237786	NONPUBLIC	ASPHALT
Area (Sq. Ft.)	Lane Miles (11' Widths)	Curb Reveal (Inches)	Curb Recommendation
770	0.013	NOT APPLICABLE	NOT APPLICABLE
Curb Type		Curb & Gutter Type	
NO CURB		NO CURB AND GUTTER	
Pavement Recommendation		Condition Rating / PCR	
PREVENTIVE MAINTENANCE		GOOD / 90

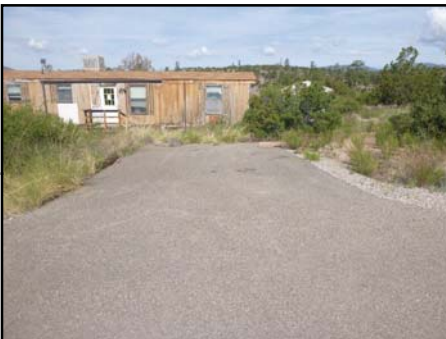
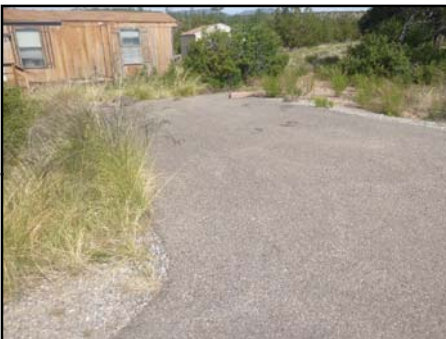
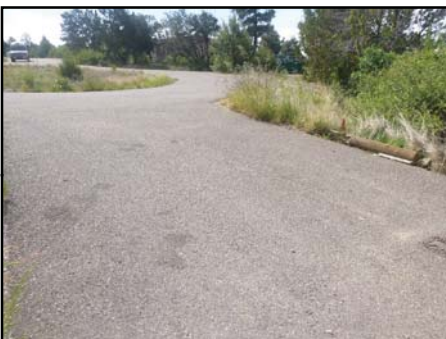
## ROUTE 0921DZ: MESA RESIDENCE LOWER LOOP PARKING D

Inspection Date	FMSS Number	User Access	Surface Type
6/2/2017	237786	NONPUBLIC	ASPHALT
Area (Sq. Ft.)	Lane Miles (11' Widths)	Curb Reveal (Inches)	Curb Recommendation
524	0.009	NOT APPLICABLE	NOT APPLICABLE
Curb Type		Curb & Gutter Type	
NO CURB		NO CURB AND GUTTER	
Pavement Recommendation		Condition Rating / PCR	
PREVENTIVE MAINTENANCE		GOOD / 90

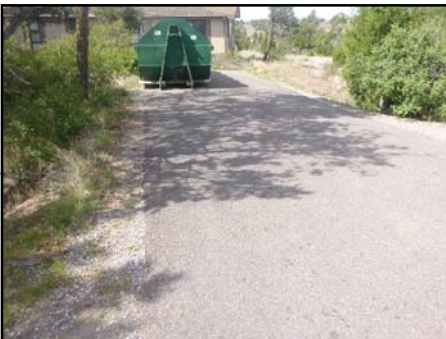
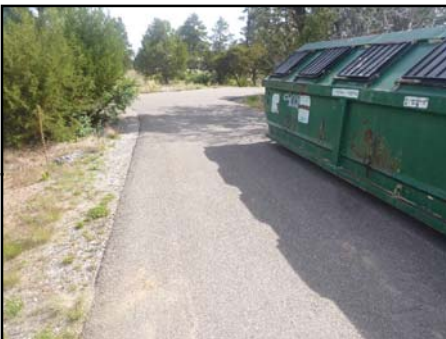
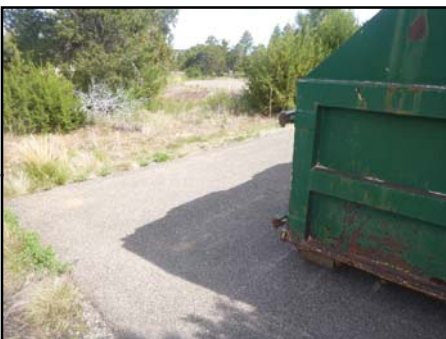
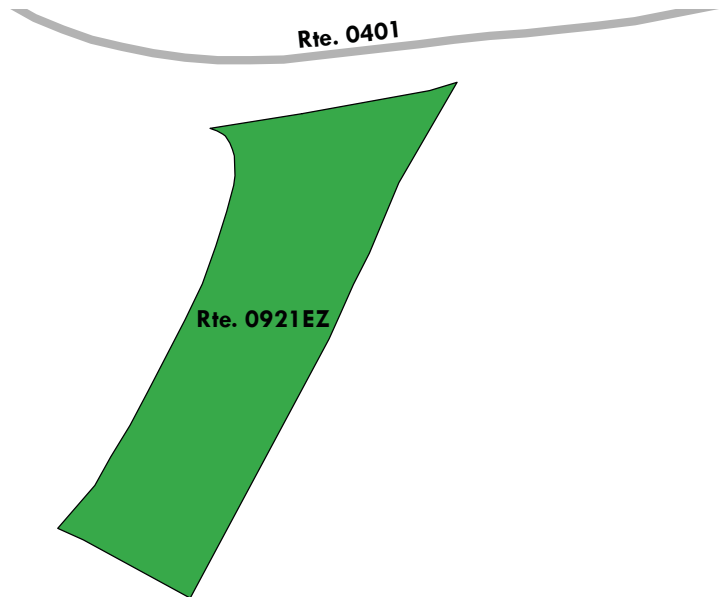
Inspection Date	FMSS Number	User Access	Surface Type
6/2/2017	237786	NONPUBLIC	ASPHALT
Area (Sq. Ft.)	Lane Miles (11' Widths)	Curb Reveal (Inches)	Curb Recommendation
794	0.014	NOT APPLICABLE	NOT APPLICABLE
Curb Type		Curb & Gutter Type	
NO CURB		NO CURB AND GUTTER	
Pavement Recommendation		Condition Rating / PCR	
PREVENTIVE MAINTENANCE		GOOD / 90

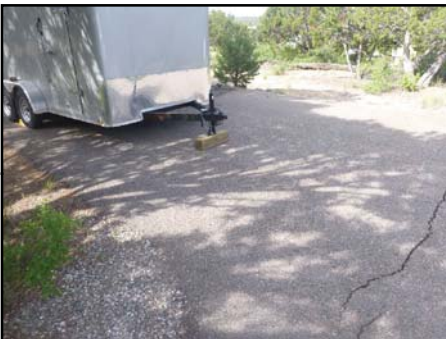
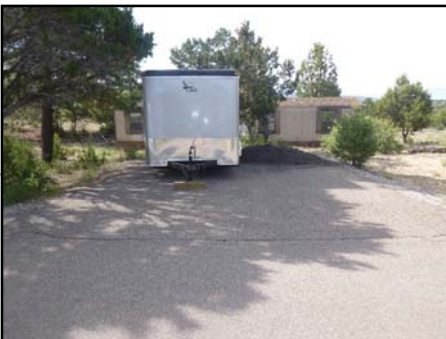
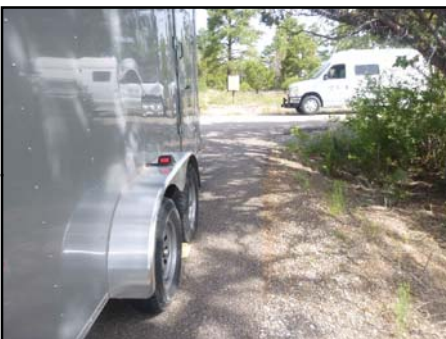
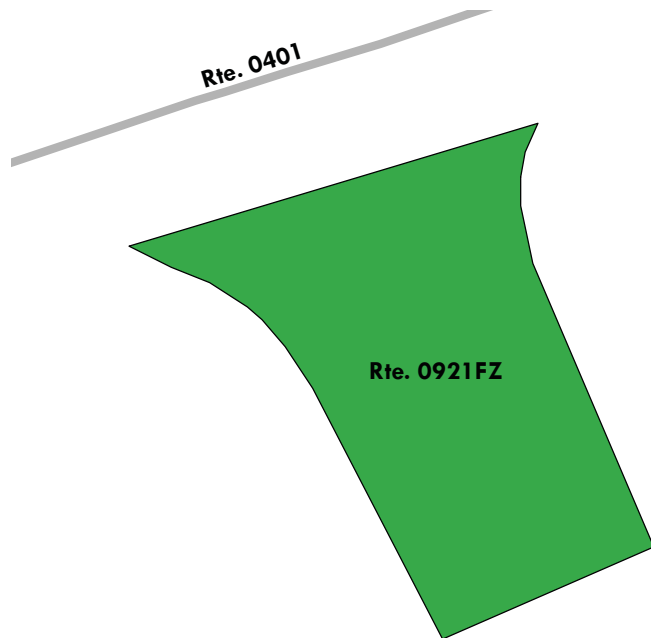
## ROUTE 0921FZ: MESA RESIDENCE LOWER LOOP PARKING F

Inspection Date	FMSS Number	User Access	Surface Type
6/2/2017	237786	NONPUBLIC	ASPHALT
Area (Sq. Ft.)	Lane Miles (11' Widths)	Curb Reveal (Inches)	Curb Recommendation
527	0.009	NOT APPLICABLE	NOT APPLICABLE
Curb Type		Curb & Gutter Type	
NO CURB		NO CURB AND GUTTER	
Pavement Recommendation		Condition Rating / PCR	
PREVENTIVE MAINTENANCE		GOOD / 90

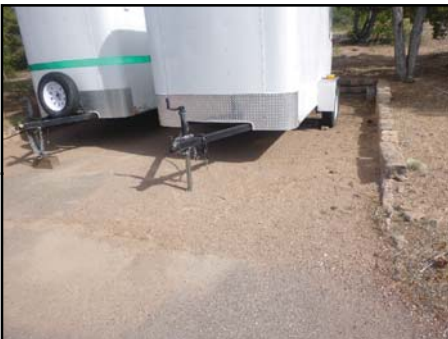
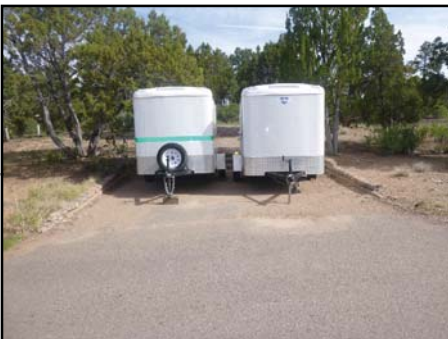
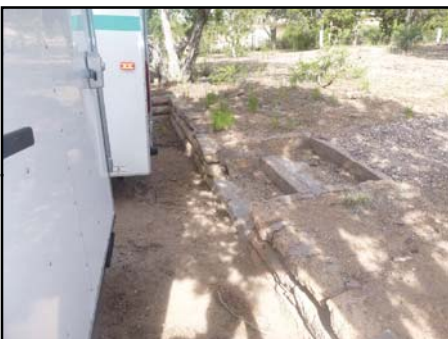
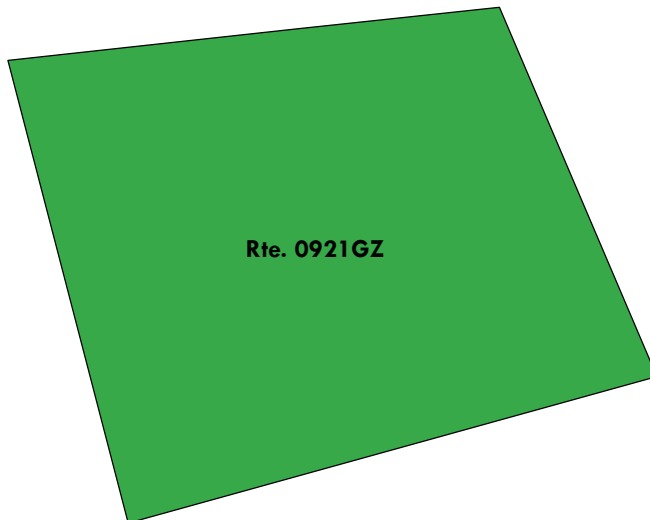
## ROUTE 0921GZ: MESA RESIDENCE LOWER LOOP PARKING G

Inspection Date	FMSS Number	User Access	Surface Type
6/2/2017	237786	NONPUBLIC	ASPHALT
Area (Sq. Ft.)	Lane Miles (11' Widths)	Curb Reveal (Inches)	Curb Recommendation
407	0.007	12	MODERATE REPAIR
Curb Type		Curb & Gutter Type	
STONE		NO CURB AND GUTTER	
Pavement Recommendation		Condition Rating / PCR	
PREVENTIVE MAINTENANCE		GOOD / 90

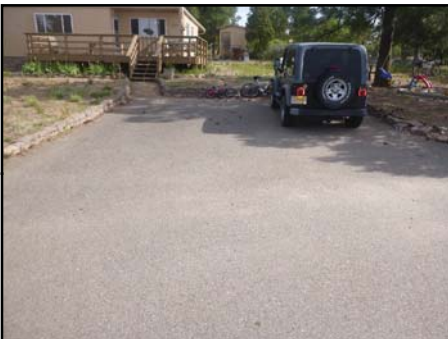
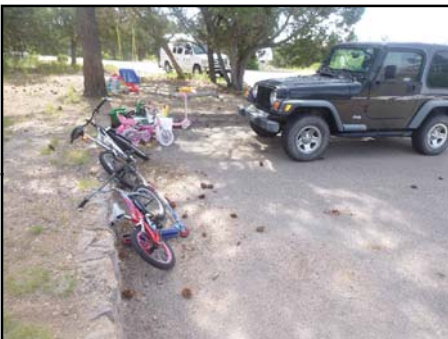
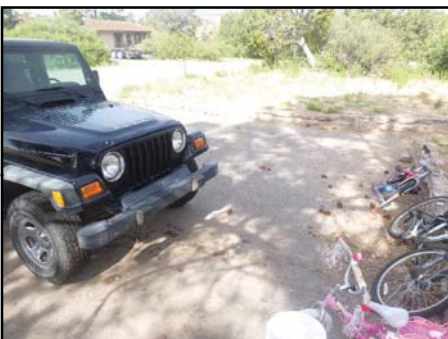
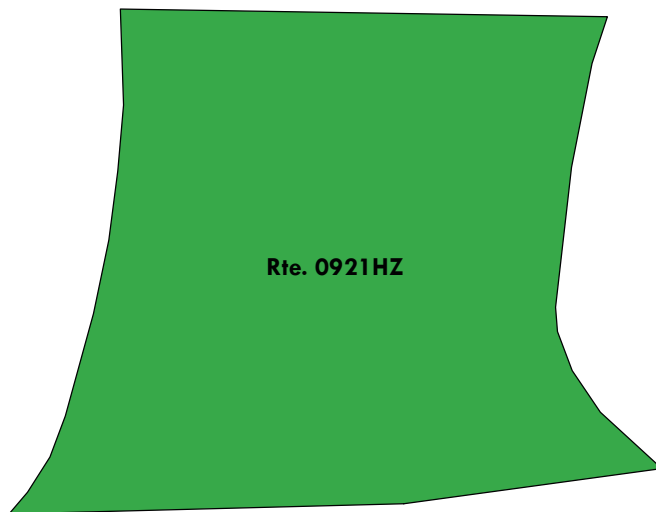
## ROUTE 0921HZ: MESA RESIDENCE LOWER LOOP PARKING H

Inspection Date	FMSS Number	User Access	Surface Type
6/2/2017	237786	NONPUBLIC	ASPHALT
Area (Sq. Ft.)	Lane Miles (11' Widths)	Curb Reveal (Inches)	Curb Recommendation
719	0.012	12	MODERATE REPAIR
Curb Type		Curb & Gutter Type	
STONE		NO CURB AND GUTTER	
Pavement Recommendation		Condition Rating / PCR	
PREVENTIVE MAINTENANCE		GOOD / 90

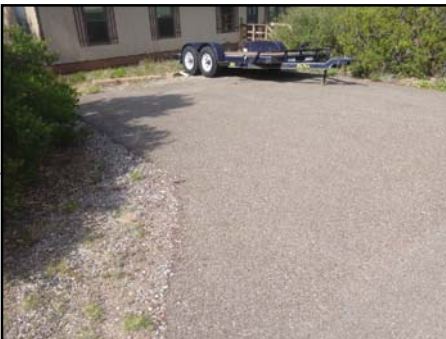
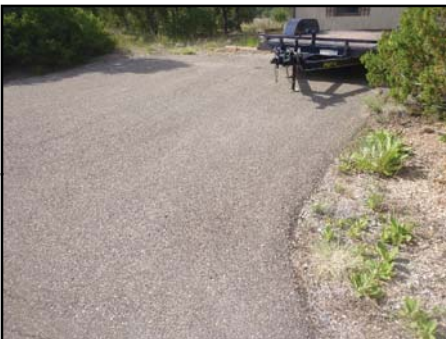
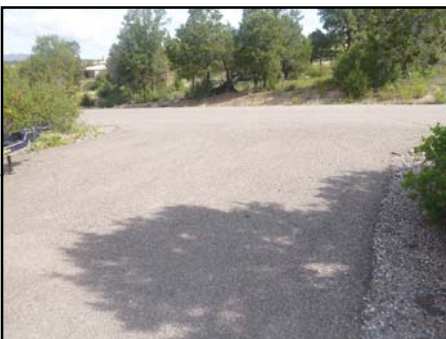
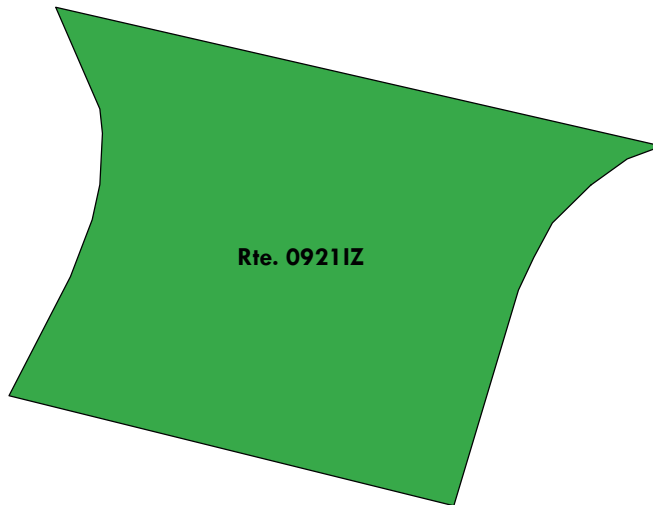
## ROUTE 0921IZ: MESA RESIDENCE LOWER LOOP PARKING I

Inspection Date	FMSS Number	User Access	Surface Type
6/2/2017	237786	NONPUBLIC	ASPHALT
Area (Sq. Ft.)	Lane Miles (11' Widths)	Curb Reveal (Inches)	Curb Recommendation
541	0.009	NOT APPLICABLE	NOT APPLICABLE
Curb Type		Curb & Gutter Type	
NO CURB		NO CURB AND GUTTER	
Pavement Recommendation		Condition Rating / PCR	
PREVENTIVE MAINTENANCE		GOOD / 90

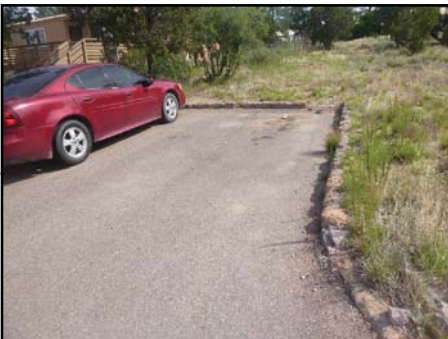
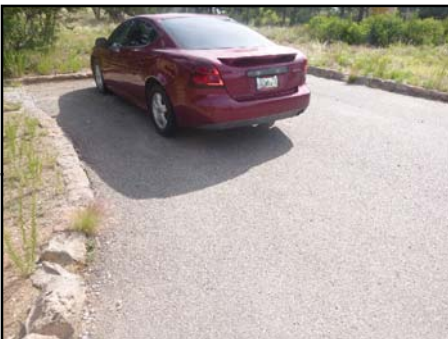
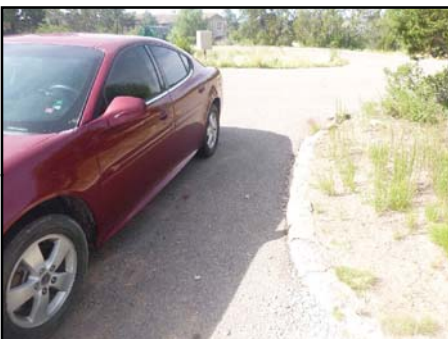
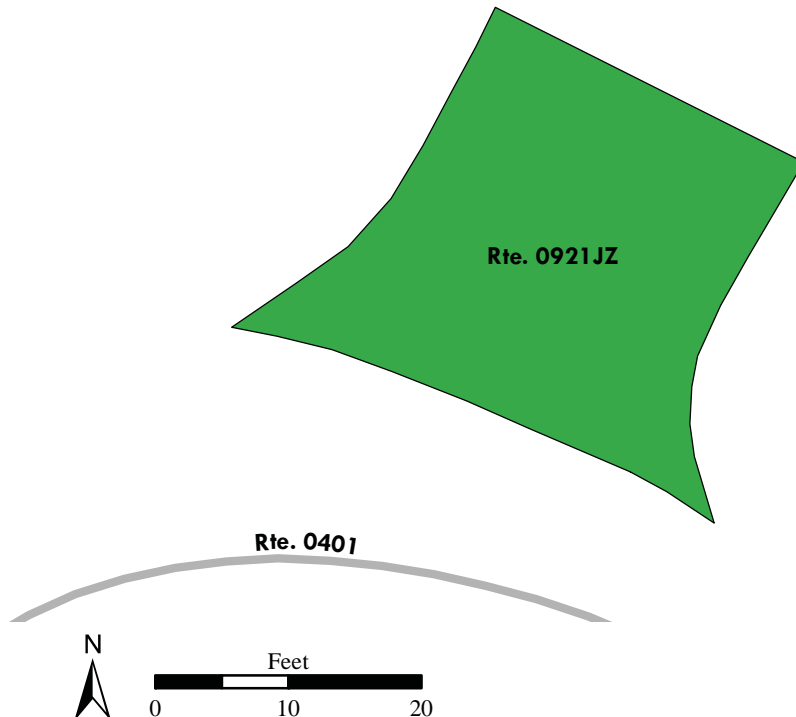
## ROUTE 0921JZ: MESA RESIDENCE LOWER LOOP PARKING J

Inspection Date	FMSS Number	User Access	Surface Type
6/2/2017	237786	NONPUBLIC	ASPHALT
Area (Sq. Ft.)	Lane Miles (11' Widths)	Curb Reveal (Inches)	Curb Recommendation
621	0.011	5	MODERATE REPAIR
Curb Type		Curb & Gutter Type	
STONE		NO CURB AND GUTTER	
Pavement Recommendation		Condition Rating / PCR	
PREVENTIVE MAINTENANCE		GOOD / 90

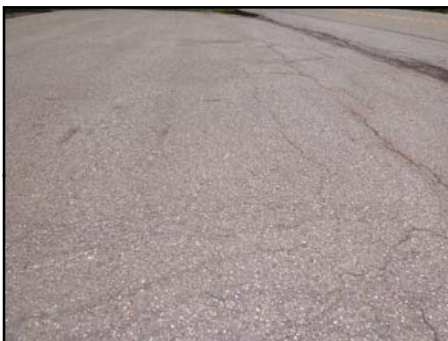
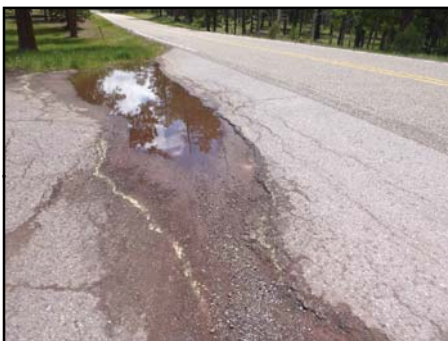
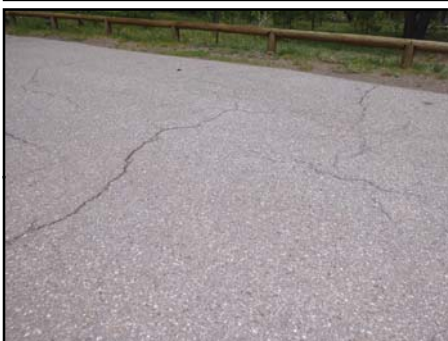
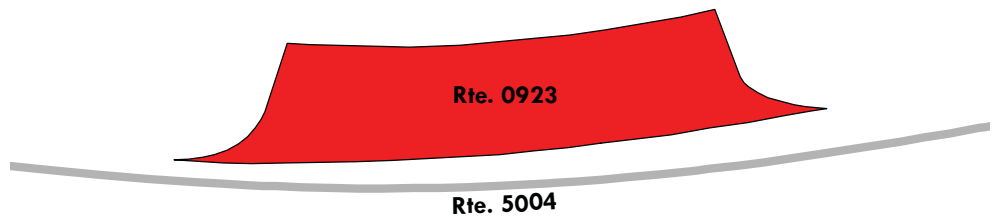
## ROUTE 0923: CERRO GRANDE TRAIL PARKING AREA

Inspection Date	FMSS Number	User Access	Surface Type
6/1/2017	237792	PUBLIC	ASPHALT
Area (Sq. Ft.)	Lane Miles (11' Widths)	Curb Reveal (Inches)	Curb Recommendation
9,054	0.156	NOT APPLICABLE	NOT APPLICABLE
Curb Type		Curb & Gutter Type	
NO CURB		NO CURB AND GUTTER	
Pavement Recommendation		Condition Rating / PCR	
HEAVY 3R TREATMENTS		POOR / 53

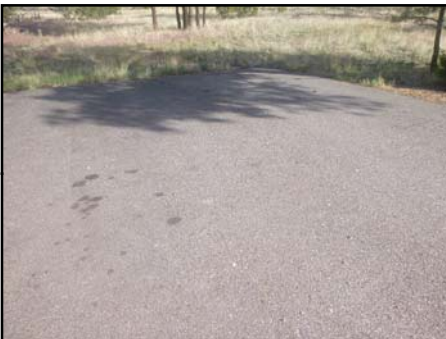
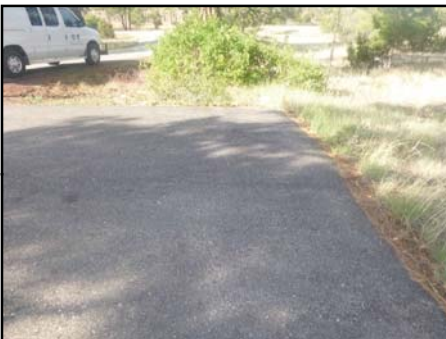
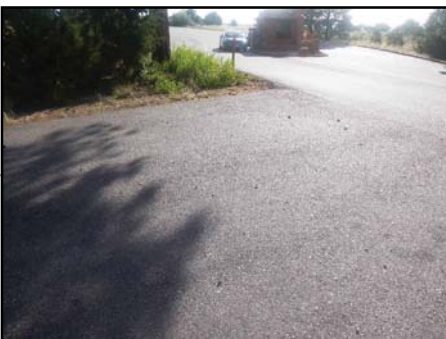
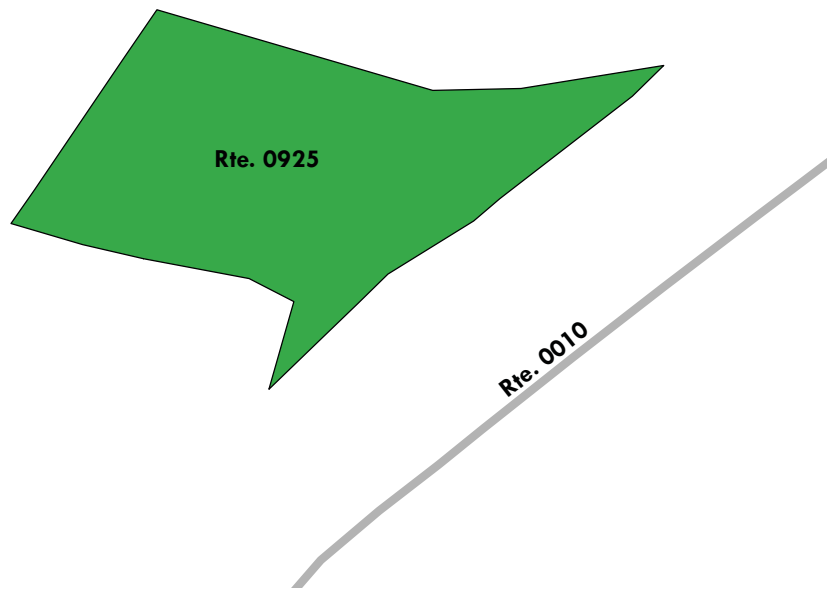
## ROUTE 0925: FEE STATION PARKING

Inspection Date	FMSS Number	User Access	Surface Type
6/2/2017	N/A	PUBLIC	ASPHALT
Area (Sq. Ft.)	Lane Miles (11' Widths)	Curb Reveal (Inches)	Curb Recommendation
871	0.015	NOT APPLICABLE	NOT APPLICABLE
Curb Type		Curb & Gutter Type	
NO CURB		NO CURB AND GUTTER	
Pavement Recommendation		Condition Rating / PCR	
PREVENTIVE MAINTENANCE		GOOD / 90

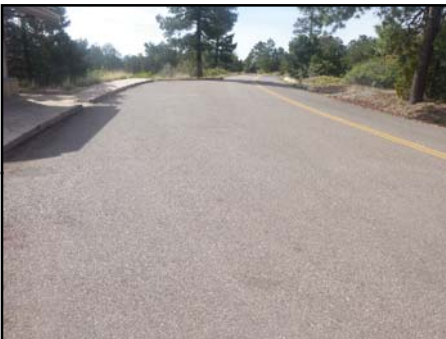
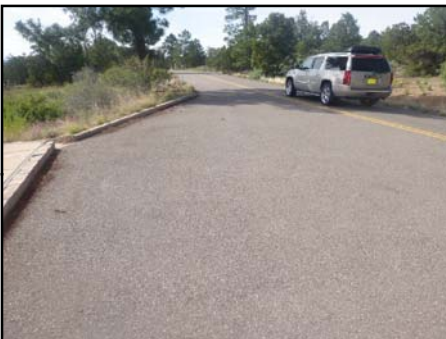
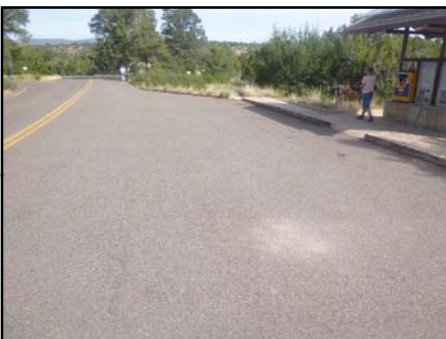
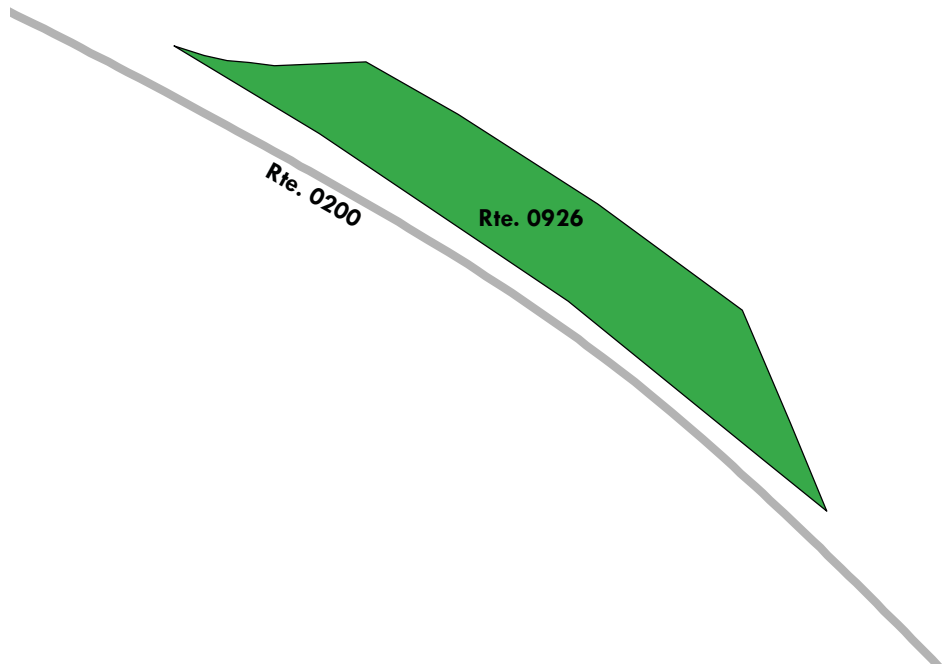
## ROUTE 0926: UPPER BUS STOP PARKING

Inspection Date	FMSS Number	User Access	Surface Type
6/2/2017	N/A	PUBLIC	ASPHALT
Area (Sq. Ft.)	Lane Miles (11' Widths)	Curb Reveal (Inches)	Curb Recommendation
2,072	0.036	4	DO NOTHING
Curb Type		Curb & Gutter Type	
STONE		NO CURB AND GUTTER	
Pavement Recommendation		Condition Rating / PCR	
PREVENTIVE MAINTENANCE		GOOD / 90

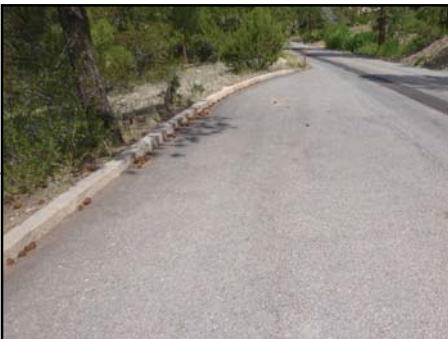
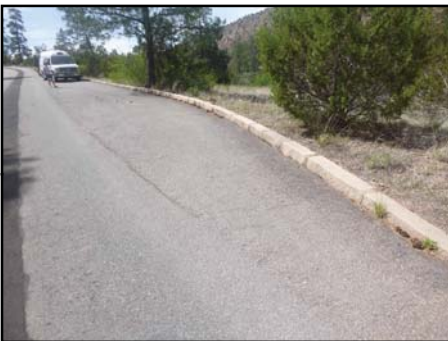
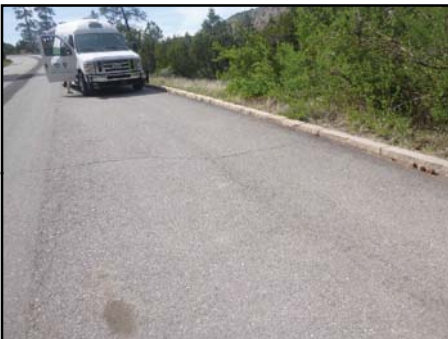
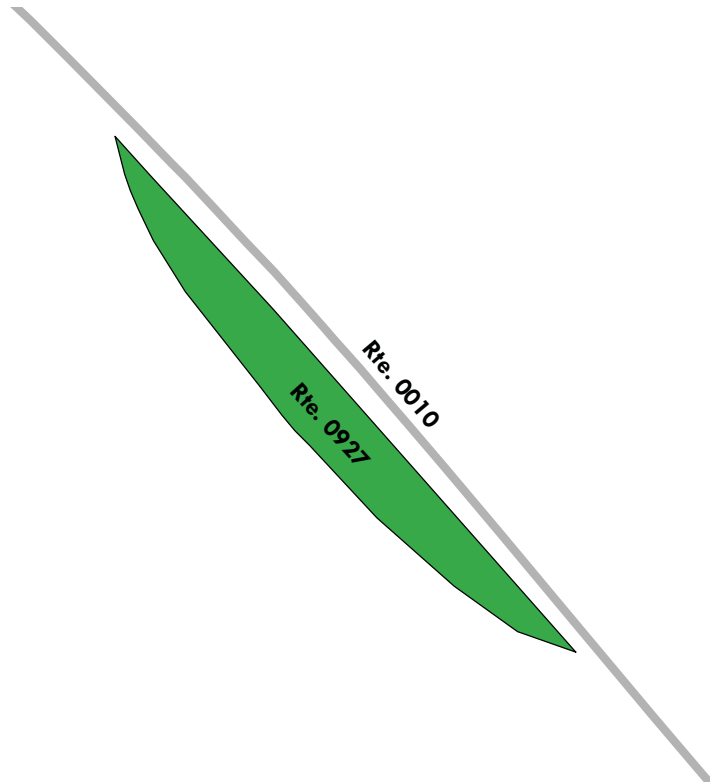
## ROUTE 0927: LOWER BUS STOP PARKING

Inspection Date	FMSS Number	User Access	Surface Type
6/2/2017	N/A	PUBLIC	ASPHALT
Area (Sq. Ft.)	Lane Miles (11' Widths)	Curb Reveal (Inches)	Curb Recommendation
1,626	0.028	6	DO NOTHING
Curb Type		Curb & Gutter Type	
STONE		NO CURB AND GUTTER	
Pavement Recommendation		Condition Rating / PCR	
PREVENTIVE MAINTENANCE		GOOD / 90
