Road Inventory and Condition Assessment of Paved Routes Black Canyon of the Gunnison National Park

Prepared By: Federal Highway Administration Eastern Federal Lands Highway Division Road Inventory Program (RIP)

Report Date: November 2015

Black Canyon of the Gunnison National Park in Colorado

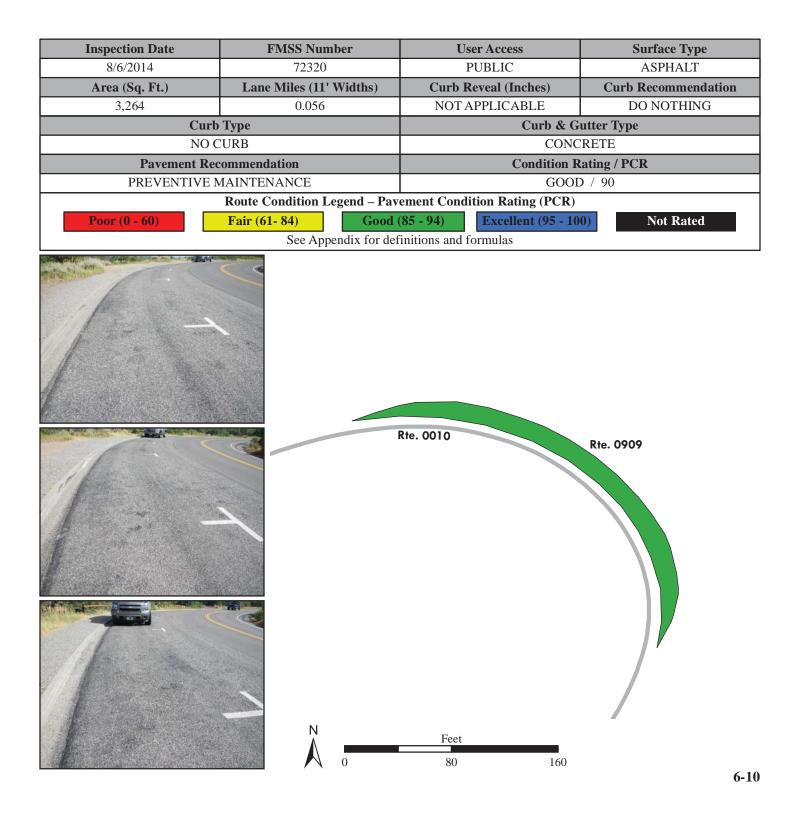
Black Canyon of the Gunnison National Park ROUTE 0909: CROSS FISSURES OVERLOOK

| Route No. | FMSS No. | Condition Rating Details for Parking Areas Route Name | User Access | Surf. Type | Area (Sq. Ft.) | Pavement Condition Rating (PCR) | Alligator Cracking | Longitudinal / Tranverse Cracking | Rutting / Distortions | Potholes / Patching | HMA Patching | Surface Raveling / Bleeding | Joint Faulting | Slab Cracking | Joint Distresses | Delamination / Pop-Outs | Potholes / Patching |
|---|---|---|---|---|---|---|---|---|---|---|---|---|---|---|---|---|---|
| BLCA-0909 | 72320 | CROSS FISSURES OVERLOOK | PUBLIC | AS | 3,264 | 90 | 97 | 97 | 97 | 97 | 97 | 90 | | | | | |

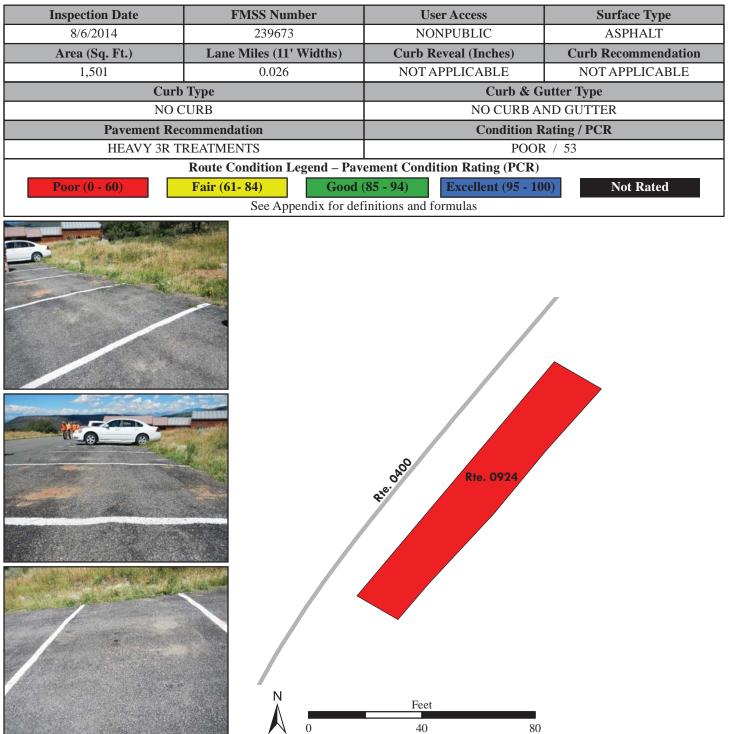
Black Canyon of the Gunnison National Park ROUTE 0924: SOUTH RIM RESIDENCE ROAD PARKING

| Route No. | FMSS No. | Condition Rating Details for Parking Areas Route Name | User Access | Surf. Type | Area (Sq. Ft.) | Pavement Condition Rating (PCR) | Alligator Cracking | Longitudinal / Tranverse Cracking | Rutting / Distortions | Potholes / Patching | HMA Patching | Surface Raveling / Bleeding | Joint Faulting | Slab Cracking | Joint Distresses | Delamination / Pop-Outs | Potholes / Patching |
|---|---|---|---|---|---|---|---|---|---|---|---|---|---|---|---|---|---|
| BLCA-0924 | 239673 | SOUTH RIM RESIDENCE ROAD PARKING | NONPUBLIC | C AS | 1,501 | 53 | 73 | 53 | 53 | 97 | 97 | 73 | | | | | |
