BRCA Cycle 6

Final Report

Road Inventory and Condition Assessment of Paved Routes Bryce Canyon National Park

Federal Highway Administration
Eastern Federal Lands Highway Division
Road Inventory Program (RIP)

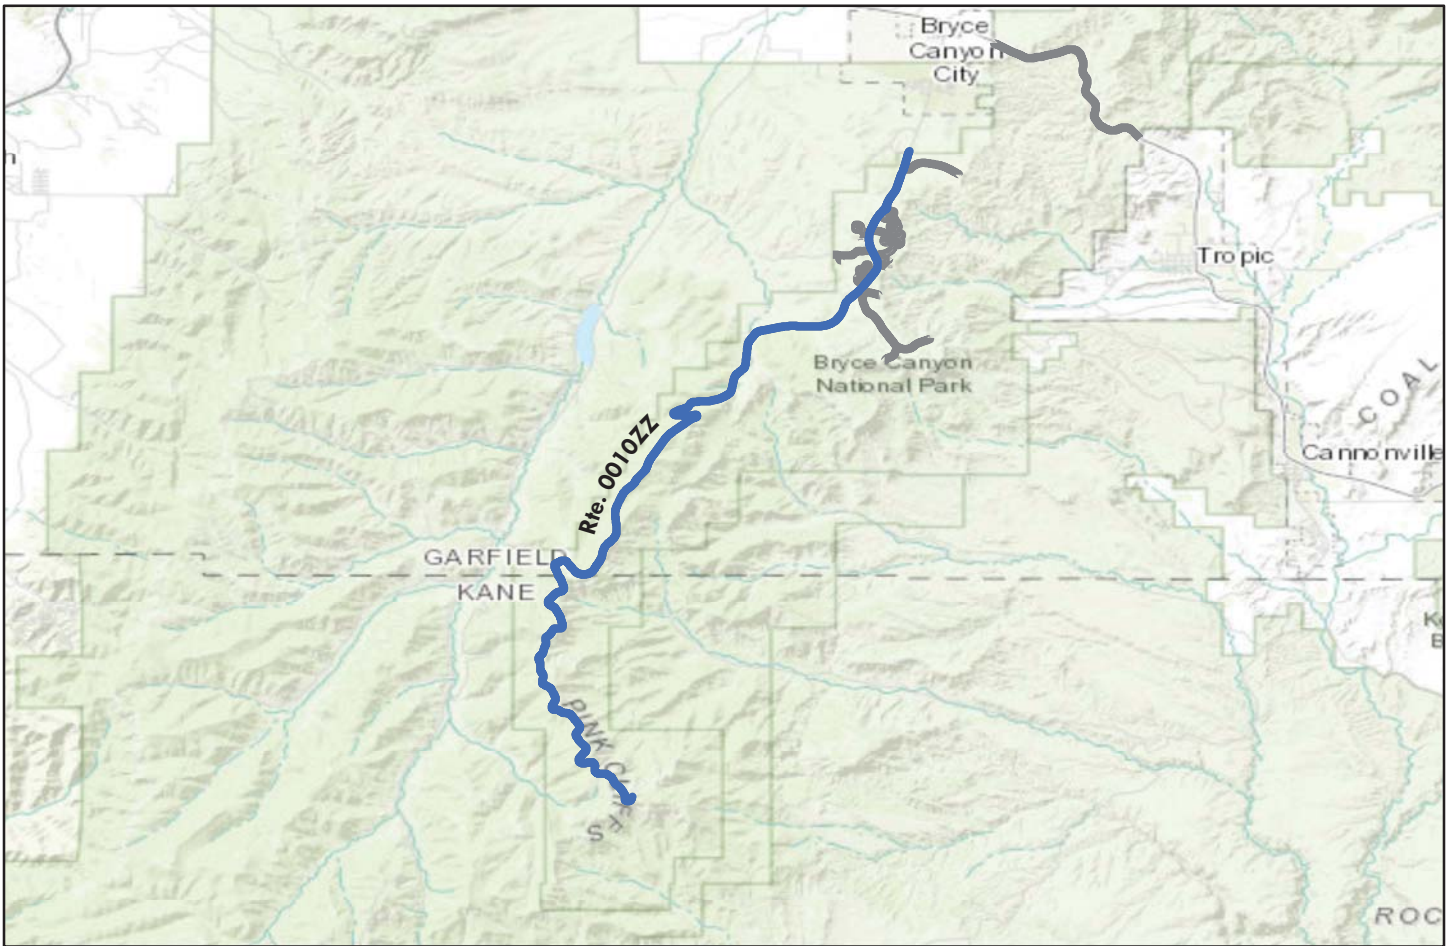
ROUTE 0010ZZ: MAIN PARK ROAD

Route Condition Legend – Pavement Condition Rating (PCR)						
Poor (0 - 60)	Fair (61- 84)	Good (85 - 94)	Excellent (95 - 100)	Not Rated		
See Appendix for definitions and formulas						
Inspection Date:	11/6/2016					
Paved Length (Miles):	18.33					
Surface Type:	ASPHALT	Route Summary				
Roadway Condition Information						
Pavement Condition Rating (PCR)	98					
Lane & Width Information						
Number of Lanes	2					
Paved Width (ft)	29.1					
Lane Width (ft)	10.8

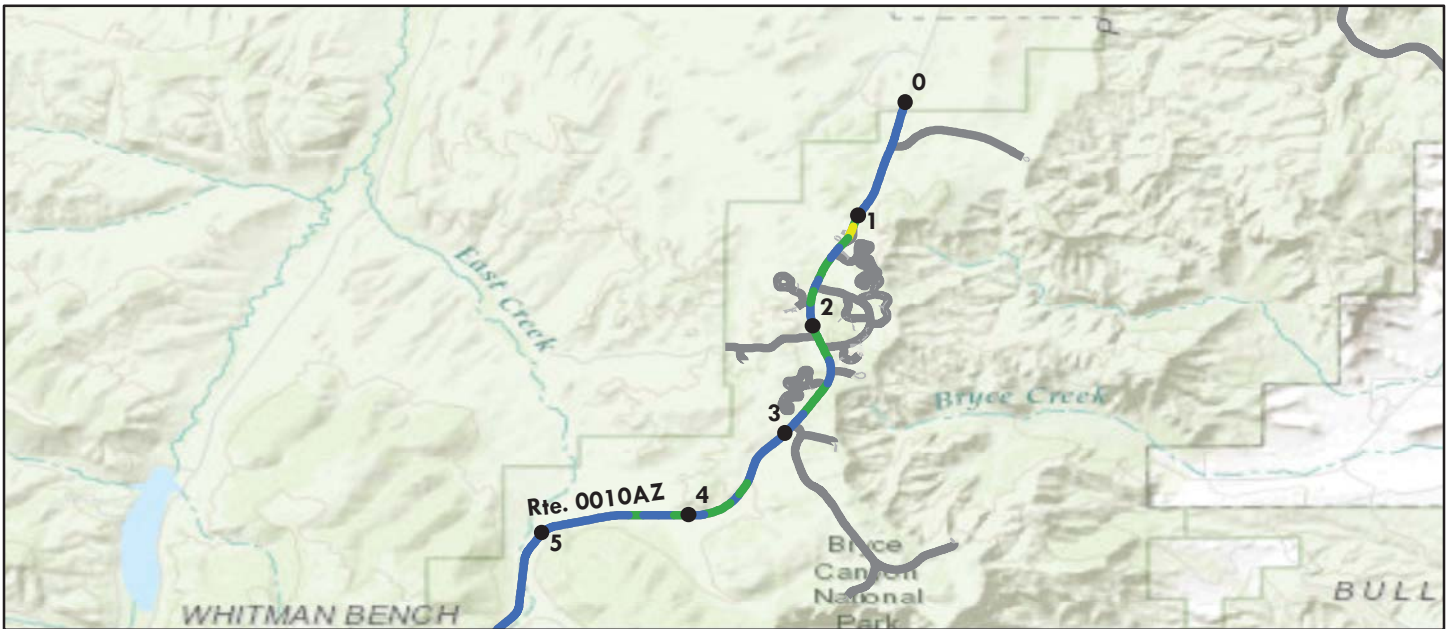
ROUTE 0010AZ: MAIN PARK ROAD (SOUTHBOUND)

Route Condition Legend – Pavement Condition Rating (PCR)						
Poor (0 - 60)	Fair (61- 84)	Good (85 - 94)	Excellent (95 - 100)	Not Rated		
See Appendix for definitions and formulas						
Inspection Date: 11/6/2016	Beginning Section MP	0	1	2	3	4
Paved Length (Miles): 18.20	Section Length (MI)	1	1	1	1	1
Surface Type: ASPHALT	Route Summary					
Roadway Condition Information						
Pavement Condition Rating (PCR)	98	97	95	95	98	96
Surface Condition Rating (SCR)	96	95	92	91	96	93
Roughness Condition Index (RCI)	100	100	99	100	100	100
Distress Index Values						
Structural Crack Index	99	99	98	99	100	100
Alligator Crack Index	100	100	100	100	100	100
Longitudinal Crack Index	99	99	98	99	100	100
Transverse Cracking Index	99	100	99	100	100	100
Patching Index	100	100	100	100	100	100
Rutting Index	96	95	92	91	96	93
International Roughness Index (IRI)	97	67	118	98	115	98
Lane & Width Information						
Number of Lanes	2	2	2	2	2	2

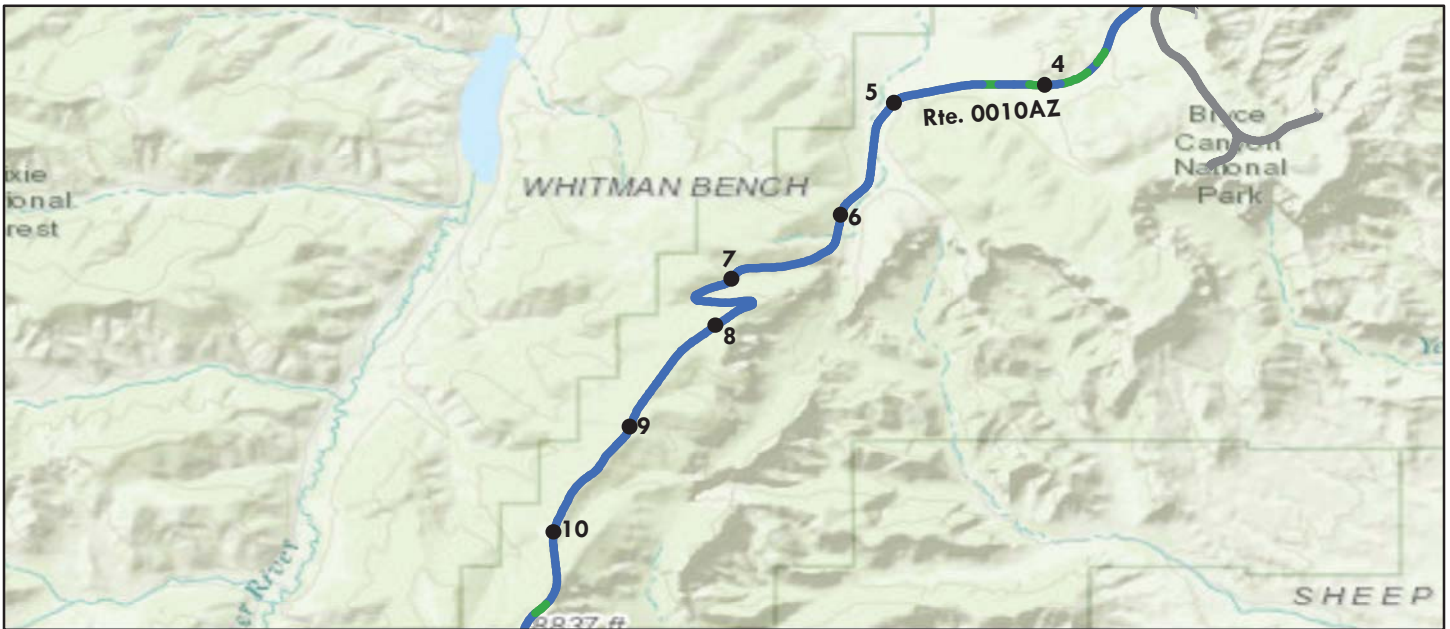
ROUTE 0010AZ: MAIN PARK ROAD (SOUTHBOUND)

Route Condition Legend – Pavement Condition Rating (PCR)									
Poor (0 - 60)		Fair (61- 84)		Good (85 - 94)		Excellent (95 - 100)		Not Rated	
See Appendix for definitions and formulas									
Inspection Date:	11/6/2016	Beginning Section MP	5	6	7	8	9		
Paved Length (Miles):	18.20	Section Length (MI)	1	1	1	1	1		
Surface Type:	ASPHALT	Route Summary							
Roadway Condition Information									
Pavement Condition Rating (PCR)	98	98	99	98	96	98			
Surface Condition Rating (SCR)	96	97	98	97	94	97			
Roughness Condition Index (RCI)	100	100	100	100	100	100			
Distress Index Values									
Structural Crack Index	99	100	100	100	100	100			
Alligator Crack Index	100	100	100	100	100	100			
Longitudinal Crack Index	99	100	100	100	100	100			
Transverse Cracking Index	99	100	100	100	100	100			
Patching Index	100	100	100	100	100	100			
Rutting Index	96	97	98	97	94	97			
International Roughness Index (IRI)	97	71	100	102	86	76

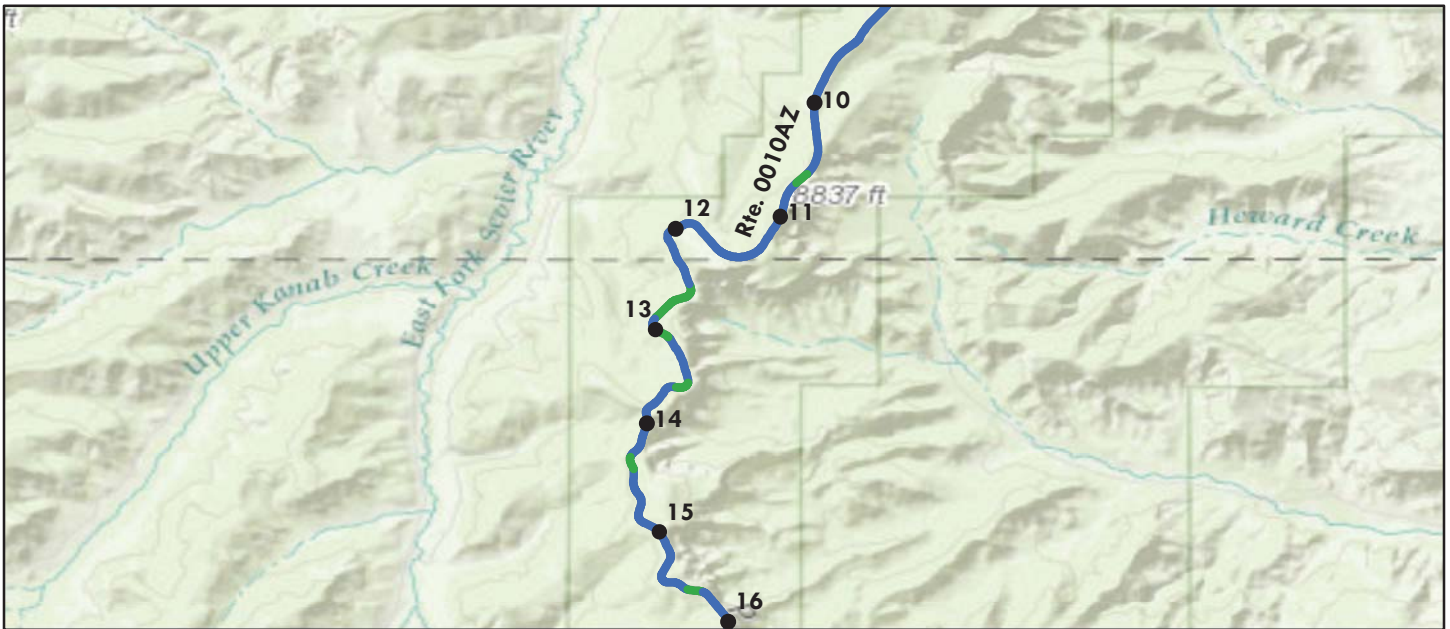
ROUTE 0010AZ: MAIN PARK ROAD (SOUTHBOUND)

Route Condition Legend – Pavement Condition Rating (PCR)						
Poor (0 - 60)	Fair (61- 84)	Good (85 - 94)	Excellent (95 - 100)	Not Rated		
See Appendix for definitions and formulas						
Inspection Date: 11/6/2016	Beginning Section MP	10	11	12	13	14
Paved Length (Miles): 18.20	Section Length (MI)	1	1	1	1	1
Surface Type: ASPHALT	Route Summary					
Roadway Condition Information						
Pavement Condition Rating (PCR)	98	98	98	97	98	98
Surface Condition Rating (SCR)	96	97	96	95	96	97
Roughness Condition Index (RCI)	100	100	100	100	100	100
Distress Index Values						
Structural Crack Index	99	98	100	95	96	97
Alligator Crack Index	100	100	100	100	100	100
Longitudinal Crack Index	99	98	100	95	96	97
Transverse Cracking Index	99	98	99	97	98	99
Patching Index	100	100	100	100	100	100
Rutting Index	96	97	96	96	96	97
International Roughness Index (IRI)	97	90	89	114	110	107
Lane & Width Information						
Number of Lanes	2	2	2	2	2	2

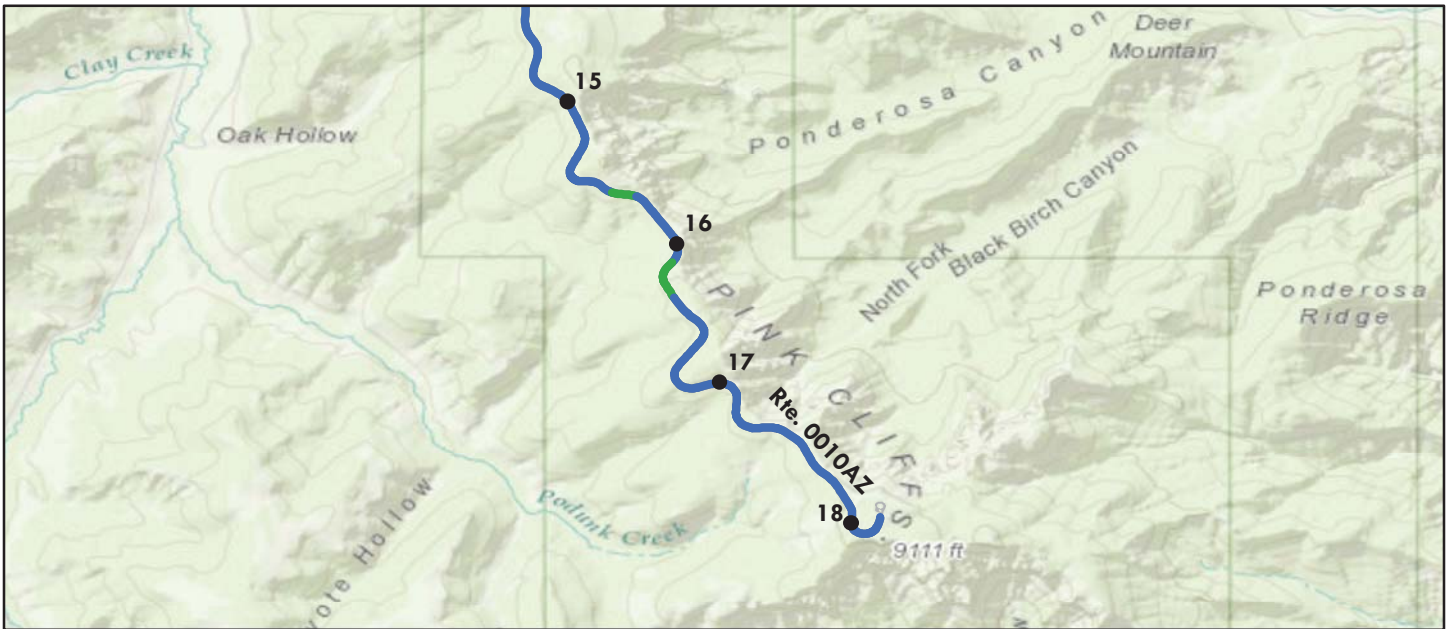
ROUTE 0010AZ: MAIN PARK ROAD (SOUTHBOUND)

Route Condition Legend – Pavement Condition Rating (PCR)						
Poor (0 - 60)	Fair (61- 84)	Good (85 - 94)	Excellent (95 - 100)	Not Rated		
See Appendix for definitions and formulas						
Inspection Date: 11/6/2016	Beginning Section MP	15	16	17	18	
Paved Length (Miles): 18.20	Section Length (MI)	1	1	1	0.2	
Surface Type: ASPHALT	Route Summary					
Roadway Condition Information						
Pavement Condition Rating (PCR)	98	99	98	99	99	
Surface Condition Rating (SCR)	96	98	97	98	98	
Roughness Condition Index (RCI)	100	100	100	100	100	
Distress Index Values						
Structural Crack Index	99	99	99	99	99	
Alligator Crack Index	100	100	100	100	100	
Longitudinal Crack Index	99	99	99	99	99	
Transverse Cracking Index	99	99	99	100	100	
Patching Index	100	100	100	100	100	
Rutting Index	96	98	97	98	98	
International Roughness Index (IRI)	97	104	110	92	109	
Lane & Width Information						
Number of Lanes	2	2	2	2	2	
Paved Width (ft)	29.2	28.6	27.6	29.2	27.4

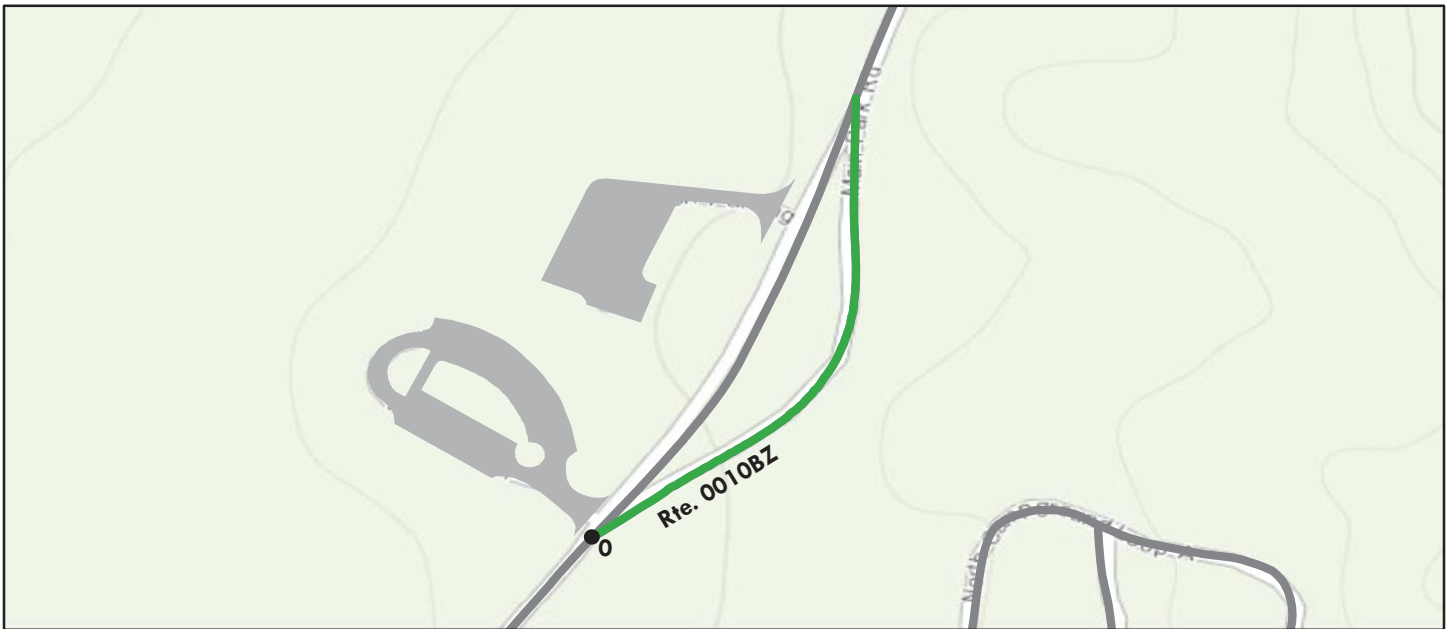
ROUTE 0010BZ: MAIN PARK ROAD (EXIT LANE)

Route Condition Legend – Pavement Condition Rating (PCR)						
Poor (0 - 60)	Fair (61- 84)	Good (85 - 94)	Excellent (95 - 100)	Not Rated		
See Appendix for definitions and formulas						
Inspection Date:	11/6/2016	Beginning Section MP	0			
Paved Length (Miles):	0.13	Section Length (MI)	0.13			
Surface Type:	ASPHALT	Route Summary				
Roadway Condition Information						
Pavement Condition Rating (PCR)	93	93				
Surface Condition Rating (SCR)	93	93				
Roughness Condition Index (RCI)	N/A	N/A				
Distress Index Values						
Structural Crack Index	93	93				
Alligator Crack Index	100	100				
Longitudinal Crack Index	93	93				
Transverse Cracking Index	94	94				
Patching Index	100	100				
Rutting Index	96	96				
International Roughness Index (IRI)	N/A	N/A				
Lane & Width Information						
Number of Lanes	1	1				
Paved Width (ft)	19.2	19.2				
Lane Width (ft)	14.8	14.8

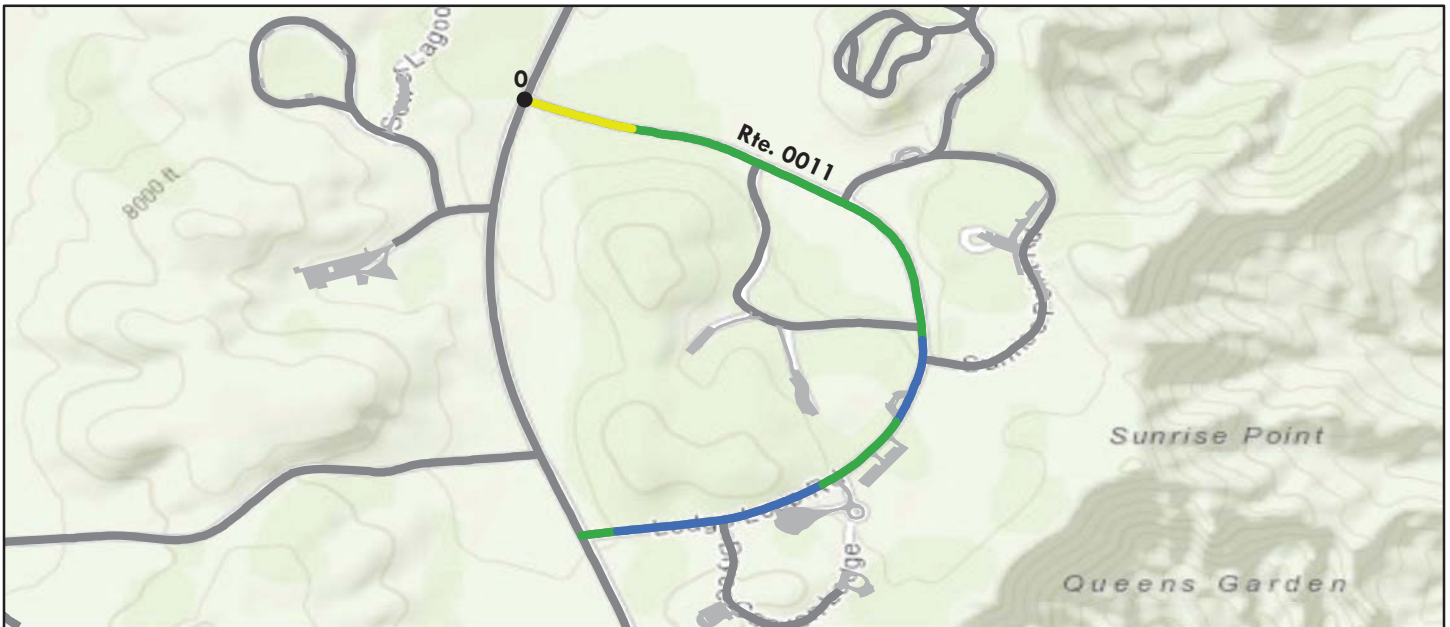
ROUTE 0011: LODGE LOOP ROAD

Route Condition Legend – Pavement Condition Rating (PCR)						
Poor (0 - 60)	Fair (61- 84)	Good (85 - 94)	Excellent (95 - 100)	Not Rated		
See Appendix for definitions and formulas						
Inspection Date: 11/6/2016	Beginning Section MP	0				
Paved Length (Miles): 0.93	Section Length (MI)	0.93				
Surface Type: ASPHALT	Route Summary					
Roadway Condition Information						
Pavement Condition Rating (PCR)	92	92				
Surface Condition Rating (SCR)	95	95				
Roughness Condition Index (RCI)	88	88				
Distress Index Values						
Structural Crack Index	97	97				
Alligator Crack Index	100	100				
Longitudinal Crack Index	97	97				
Transverse Cracking Index	95	95				
Patching Index	98	98				
Rutting Index	99	99				
International Roughness Index (IRI)	147	147				
Lane & Width Information						
Number of Lanes	2	2				
Paved Width (ft)	23.7	23.7				
Lane Width (ft)	10.3	10.3

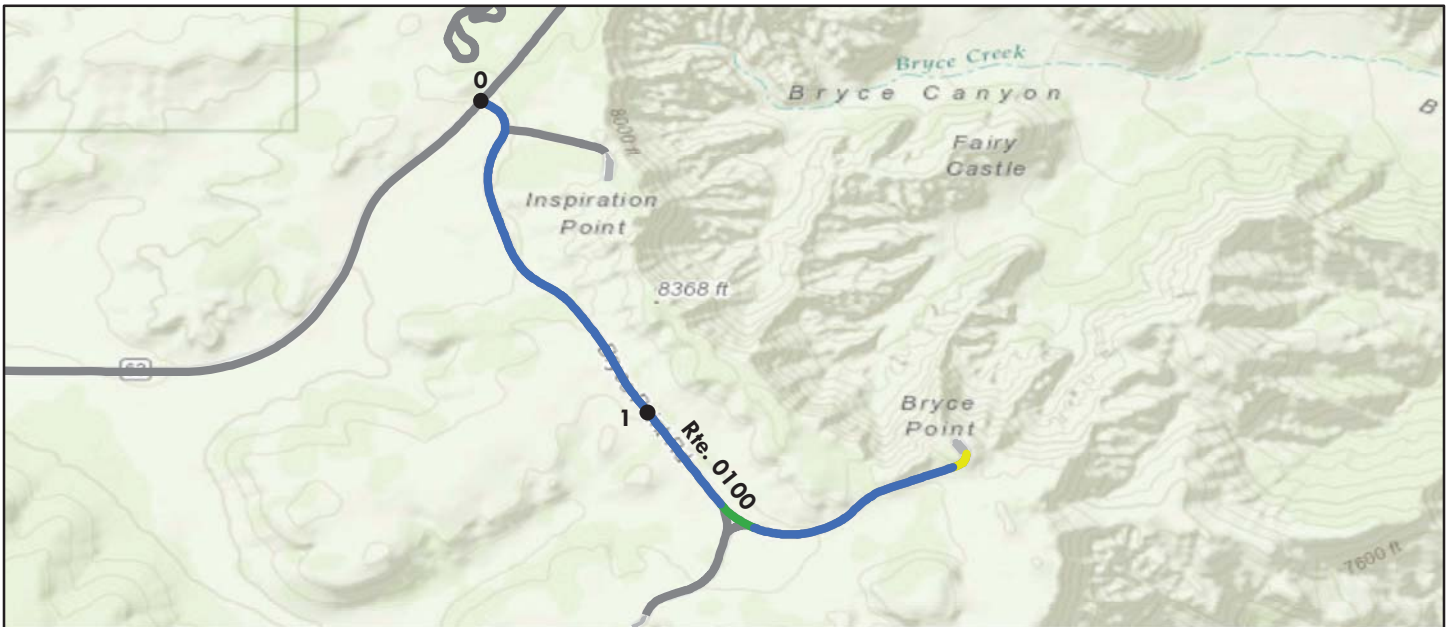
ROUTE 0100: BRYCE POINT ACCESS ROAD

Route Condition Legend – Pavement Condition Rating (PCR)						
Poor (0 - 60)	Fair (61- 84)	Good (85 - 94)	Excellent (95 - 100)	Not Rated		
See Appendix for definitions and formulas						
Inspection Date: 11/6/2016	Beginning Section MP	0	1			
Paved Length (Miles): 1.95	Section Length (MI)	1	0.95			
Surface Type: ASPHALT	Route Summary					
Roadway Condition Information						
Pavement Condition Rating (PCR)	99	99	99			
Surface Condition Rating (SCR)	99	99	98			
Roughness Condition Index (RCI)	100	100	100			
Distress Index Values						
Structural Crack Index	100	100	99			
Alligator Crack Index	100	100	100			
Longitudinal Crack Index	100	100	99			
Transverse Cracking Index	99	100	98			
Patching Index	100	100	100			
Rutting Index	99	99	99			
International Roughness Index (IRI)	109	107	111			
Lane & Width Information						
Number of Lanes	2	2	2			
Paved Width (ft)	23.4	24.3	22.5			
Lane Width (ft)	10	10.2	9.9

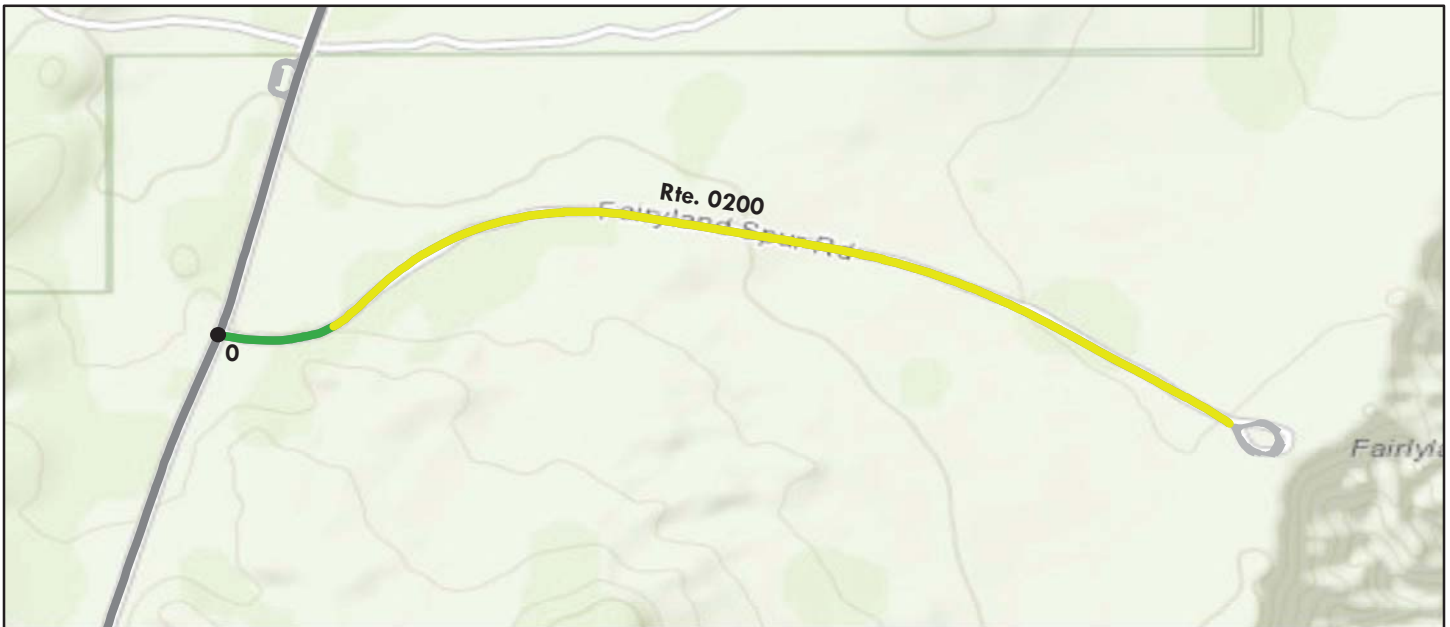
ROUTE 0200: FAIRYLAND ROAD

Route Condition Legend – Pavement Condition Rating (PCR)						
Poor (0 - 60)	Fair (61- 84)	Good (85 - 94)	Excellent (95 - 100)	Not Rated		
See Appendix for definitions and formulas						
Inspection Date:	11/6/2016	Beginning Section MP	0			
Paved Length (Miles):	0.97	Section Length (MI)	0.97			
Surface Type:	ASPHALT	Route Summary				
Roadway Condition Information						
Pavement Condition Rating (PCR)	77	77				
Surface Condition Rating (SCR)	82	82				
Roughness Condition Index (RCI)	69	69				
Distress Index Values						
Structural Crack Index	82	82				
Alligator Crack Index	100	100				
Longitudinal Crack Index	82	82				
Transverse Cracking Index	84	84				
Patching Index	100	100				
Rutting Index	98	98				
International Roughness Index (IRI)	205	205				
Lane & Width Information						
Number of Lanes	2	2				
Paved Width (ft)	22.5	22.5				
Lane Width (ft)	10.3	10.3

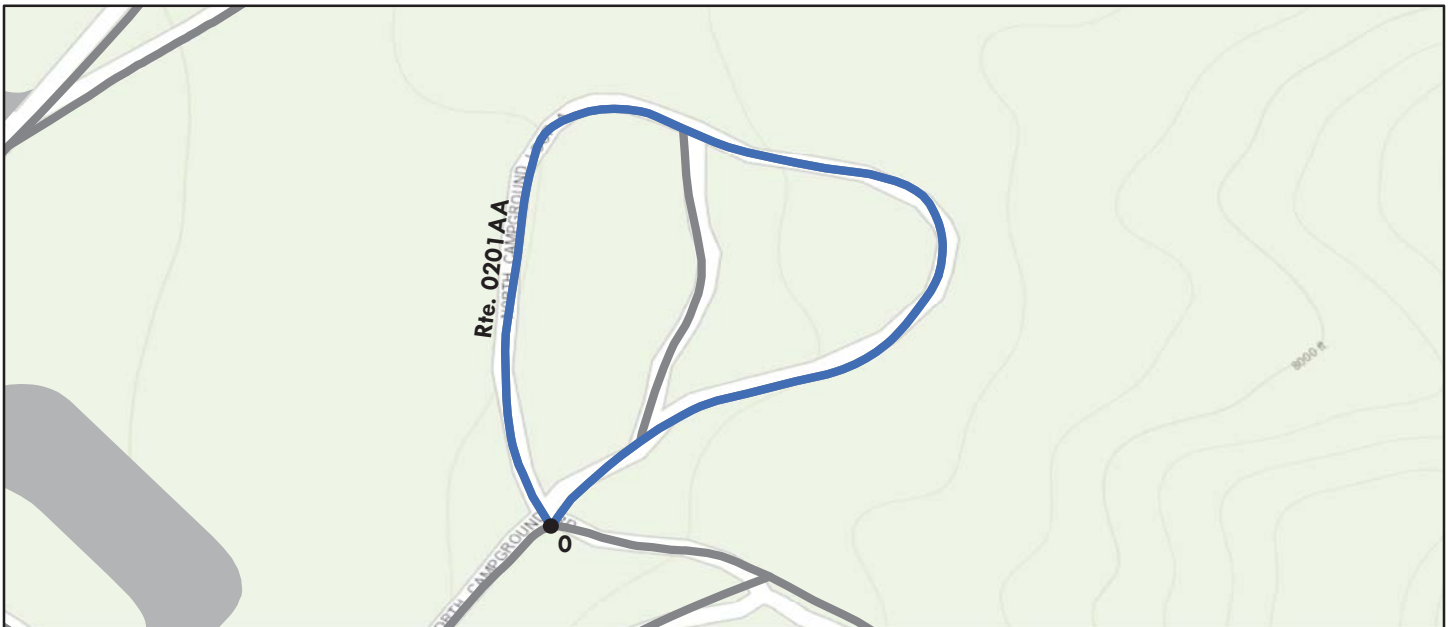
ROUTE 0201AA: NORTH CAMPGROUND LOOP ROAD A, OUTERLOOP

Route Condition Legend – Pavement Condition Rating (PCR)						
Poor (0 - 60)	Fair (61- 84)	Good (85 - 94)	Excellent (95 - 100)	Not Rated		
See Appendix for definitions and formulas						
Inspection Date: 11/6/2016	Beginning Section MP	0				
Paved Length (Miles): 0.29	Section Length (MI)	0.29				
Surface Type: ASPHALT	Route Summary					
Roadway Condition Information						
Pavement Condition Rating (PCR)	98	98				
Surface Condition Rating (SCR)	98	98				
Roughness Condition Index (RCI)	N/A	N/A				
Distress Index Values						
Structural Crack Index	100	100				
Alligator Crack Index	100	100				
Longitudinal Crack Index	100	100				
Transverse Cracking Index	100	100				
Patching Index	100	100				
Rutting Index	98	98				
International Roughness Index (IRI)	N/A	N/A				
Lane & Width Information						
Number of Lanes	1	1				
Paved Width (ft)	18.7	18.7				
Lane Width (ft)	18.7	18.7

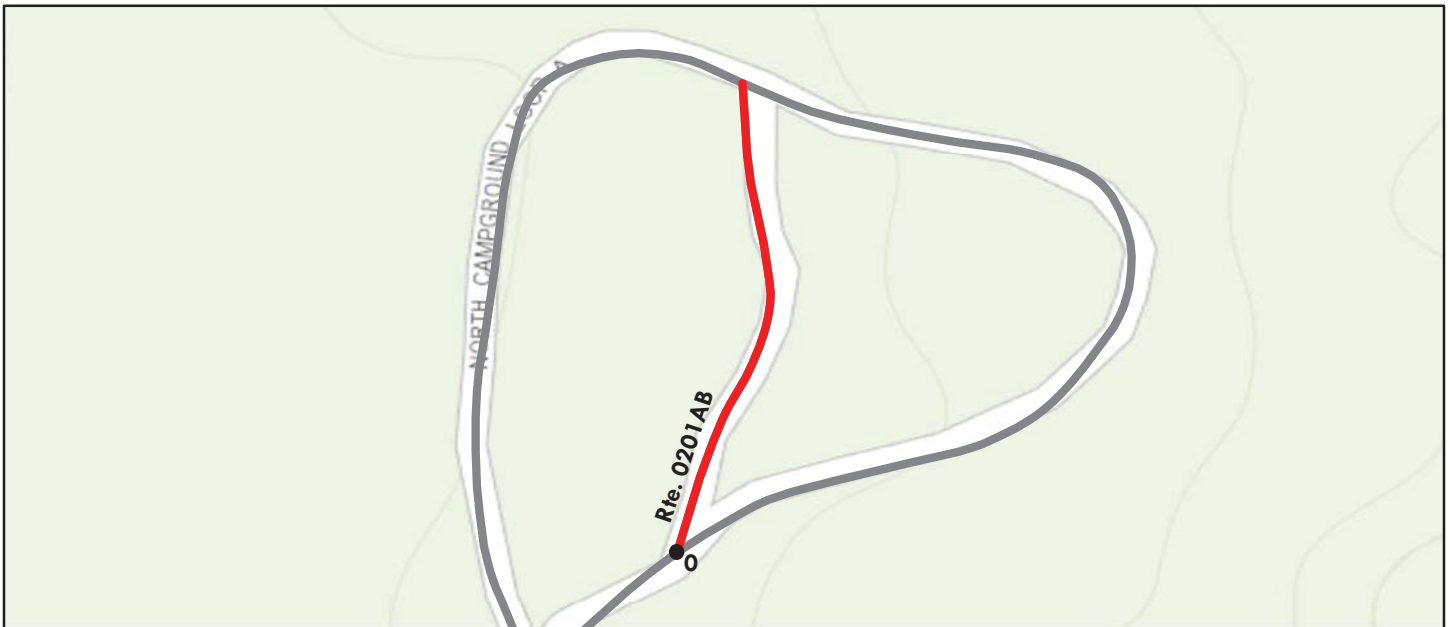
ROUTE 0201AB: NORTH CAMPGROUND LOOP ROAD A, CONNECTOR

Only a very small portion of the road received a condition rating. No distress indices are reported due to badly degraded asphalt where a manual PCR of 0 was recorded.

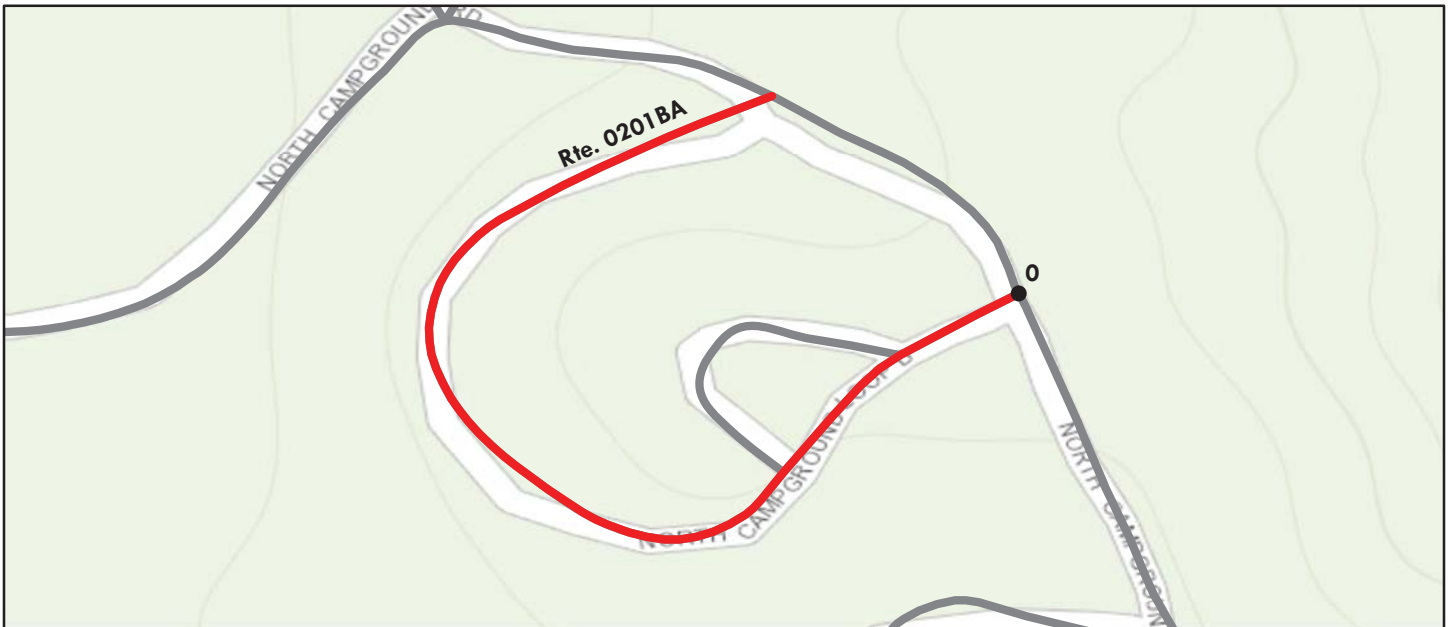
ROUTE 0201BA: NORTH CAMPGROUND LOOP ROAD B, OUTERLOOP

Only a very small portion of the road received a condition rating. No distress indices are reported due to badly degraded asphalt where a manual PCR of 0 was recorded.

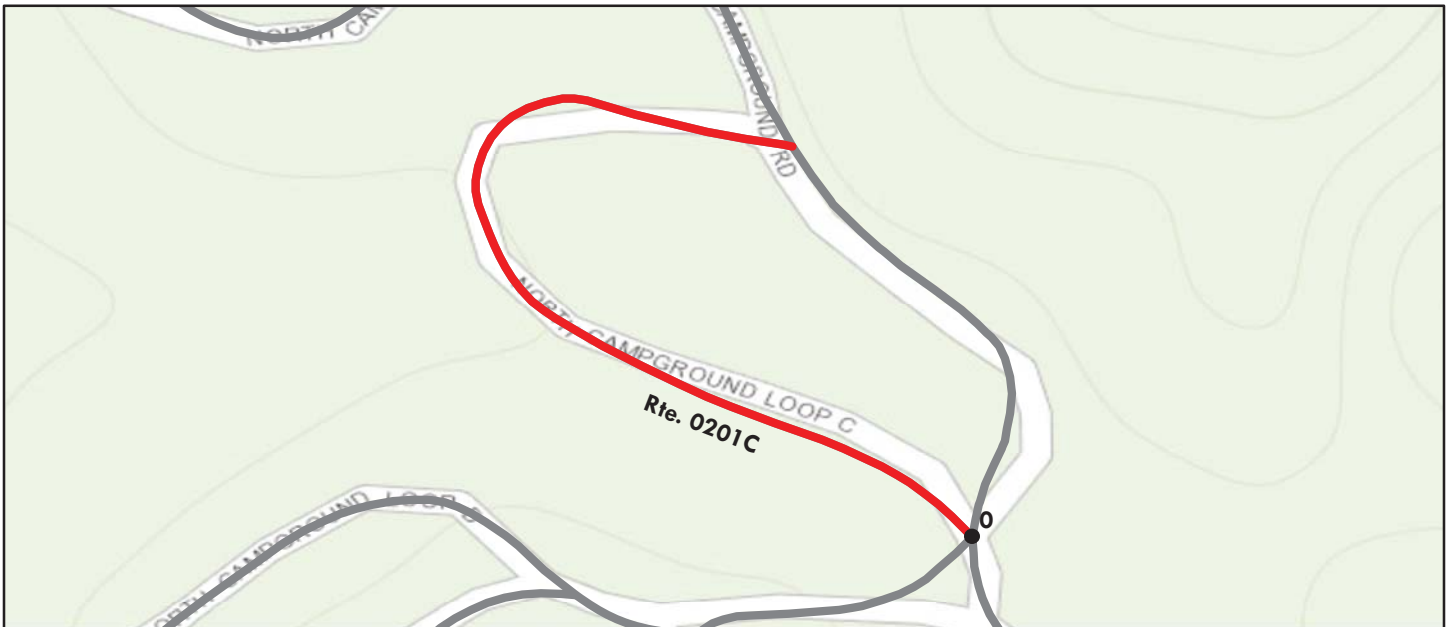
ROUTE 0201C: NORTH CAMPGROUND LOOP ROAD C

No distress indices are reported due to badly degraded asphalt where a manual PCR of 0 was recorded.

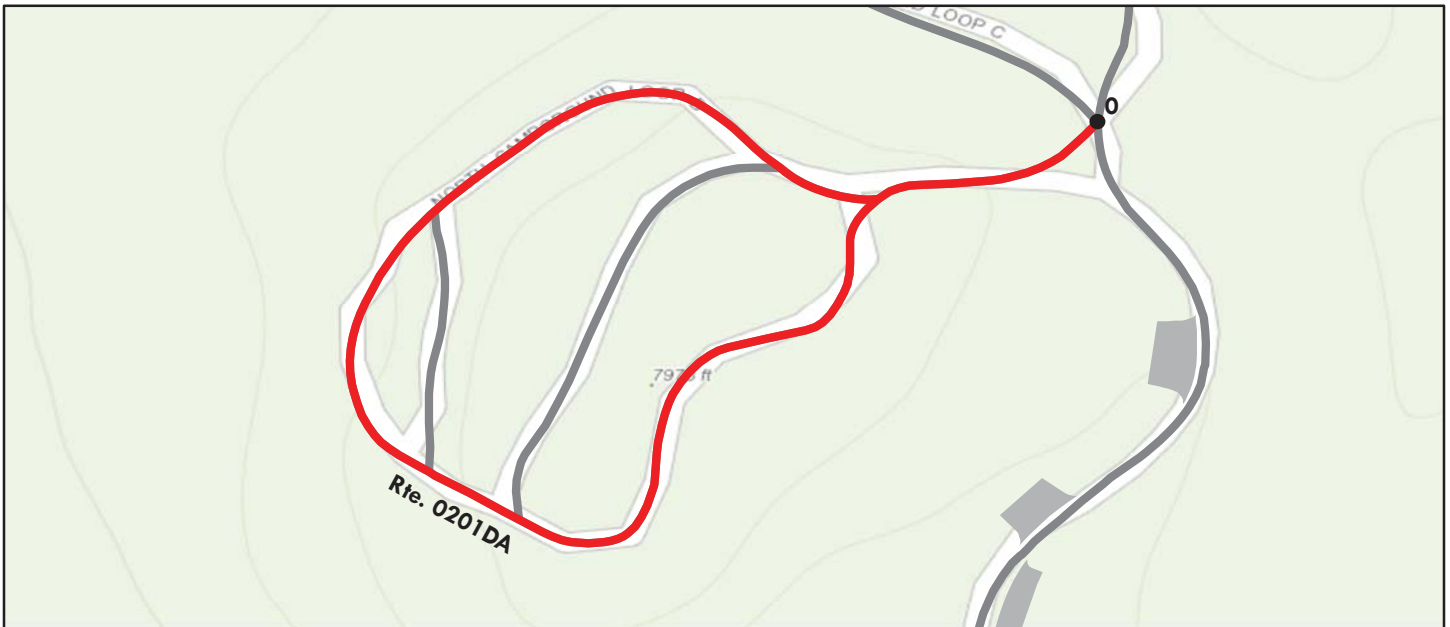
ROUTE 0201DA: NORTH CAMPGROUND LOOP ROAD D, OUTERLOOP

No distress indices are reported due to badly degraded asphalt where a manual PCR of 0 was recorded.

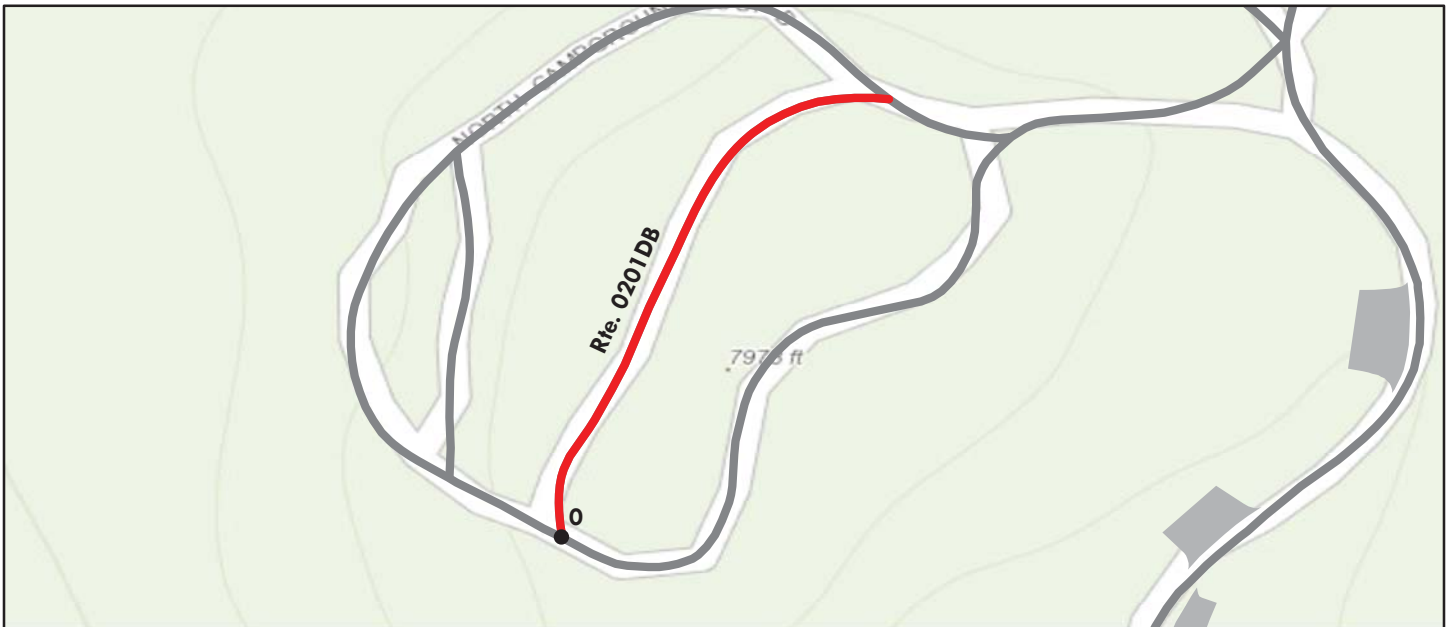
ROUTE 0201DB: NORTH CAMPGROUND LOOP ROAD D, CONNECTOR #1

No distress indices are reported due to badly degraded asphalt where a manual PCR of 0 was recorded.

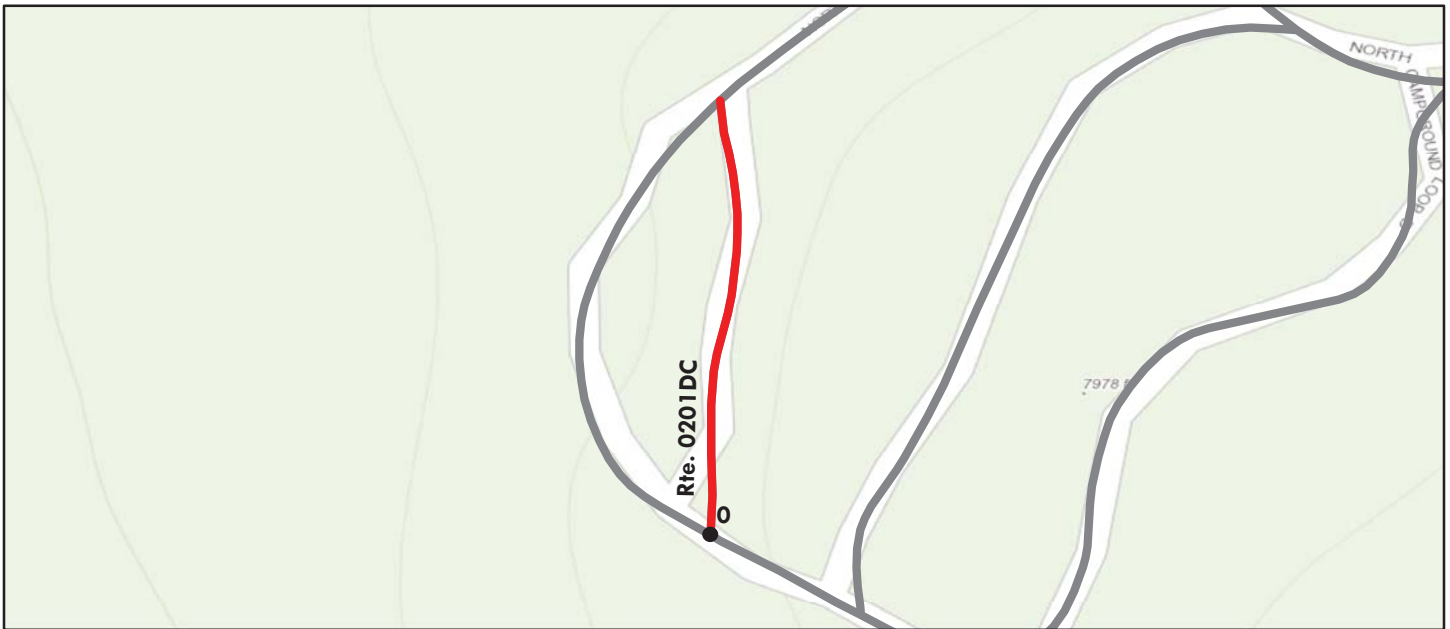
ROUTE 0201DC: NORTH CAMPGROUND LOOP ROAD D, CONNECTOR #2

No distress indices are reported due to badly degraded asphalt where a manual PCR of 0 was recorded.

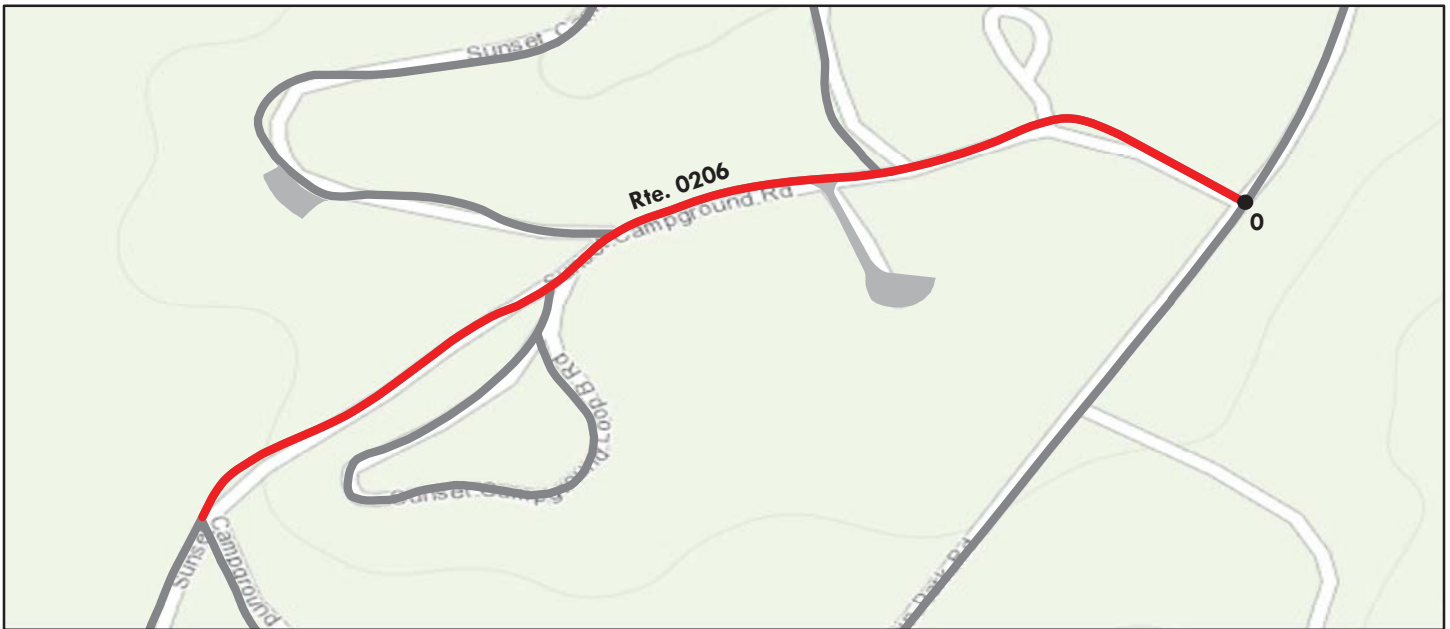
ROUTE 0206: SUNSET CAMPGROUND ROAD

Only a very small portion of the road received a condition rating. No distress indices are reported due to badly degraded asphalt where a manual PCR of 0 was recorded.

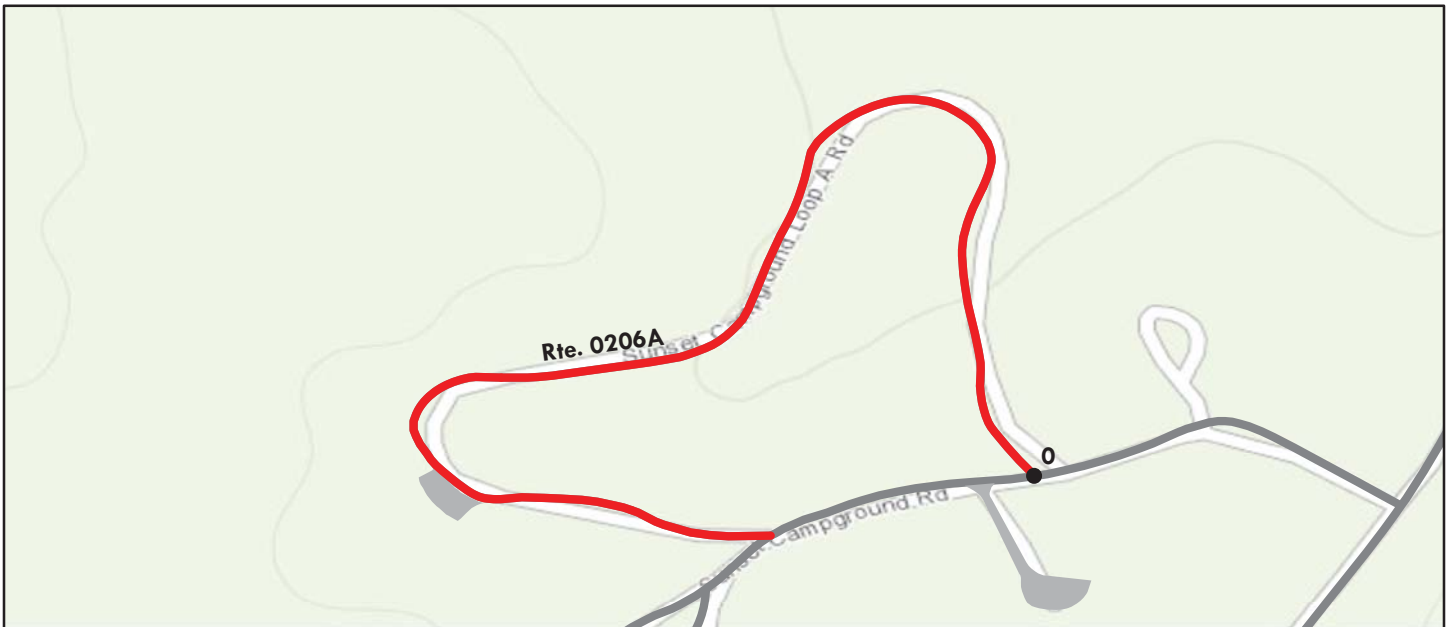
ROUTE 0206A: SUNSET CAMPGROUND ROAD LOOP A

No distress indices are reported due to badly degraded asphalt where a manual PCR of 0 was recorded.

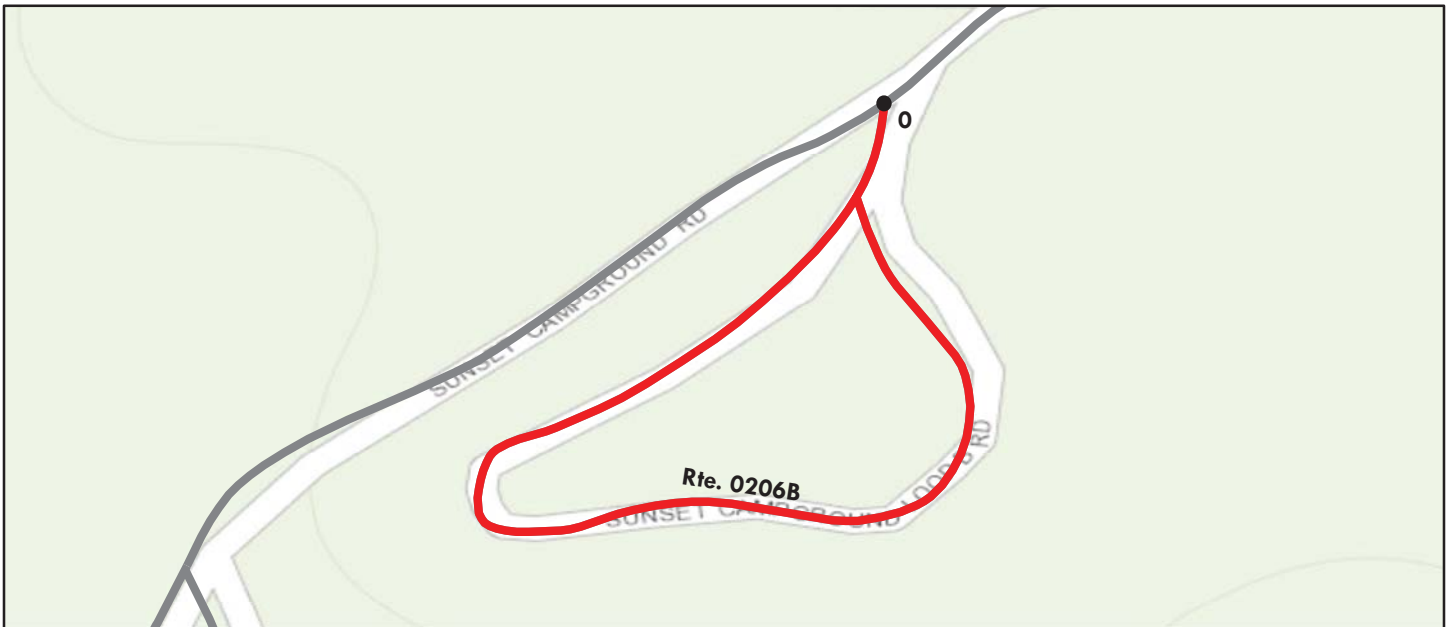
ROUTE 0206B: SUNSET CAMPGROUND ROAD LOOP B

No distress indices are reported due to badly degraded asphalt where a manual PCR of 0 was recorded.

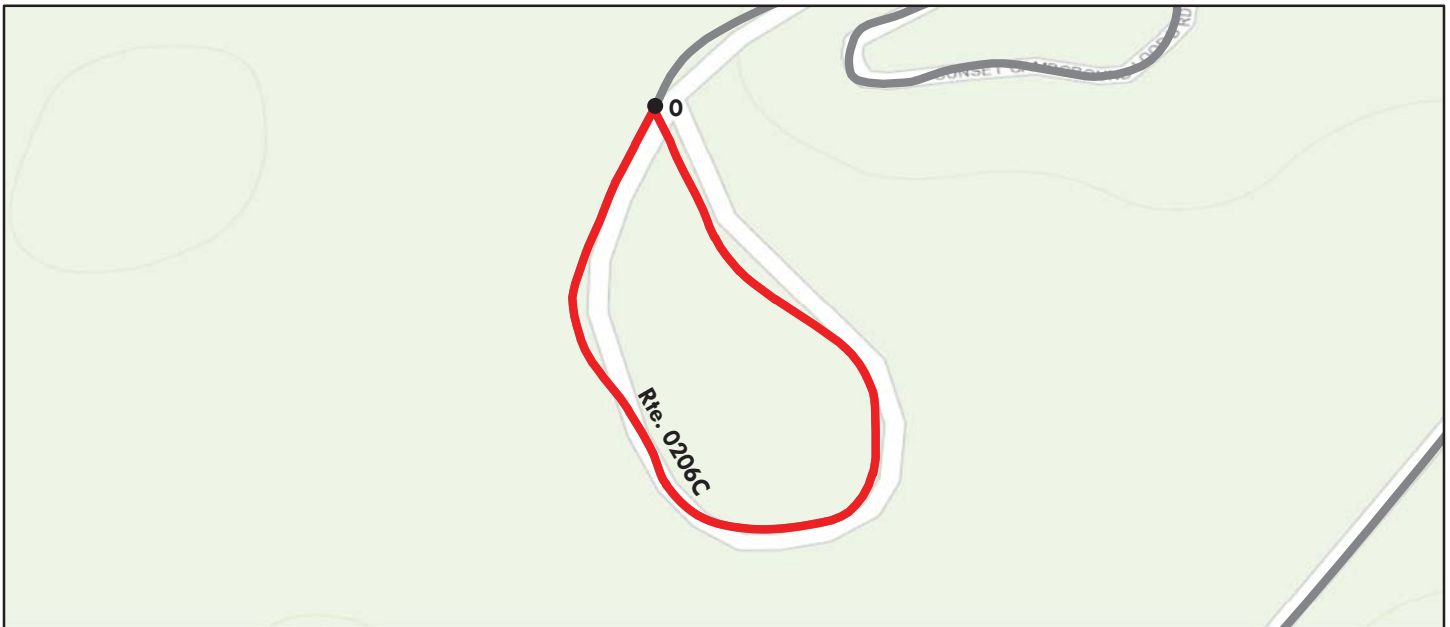
ROUTE 0206C: SUNSET CAMPGROUND ROAD LOOP C

No distress indices are reported due to badly degraded asphalt where a manual PCR of 0 was recorded.

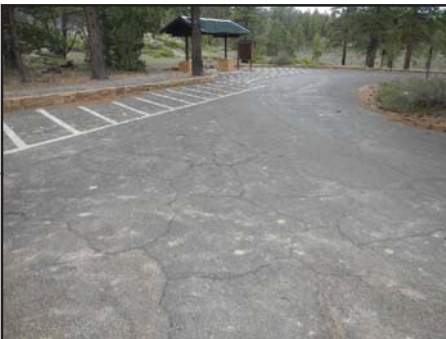
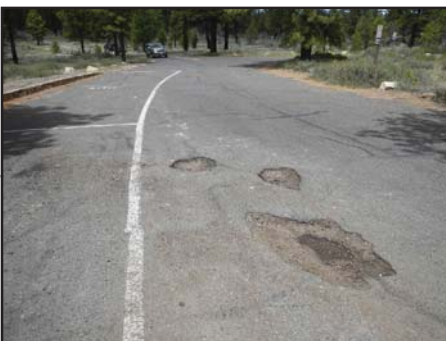
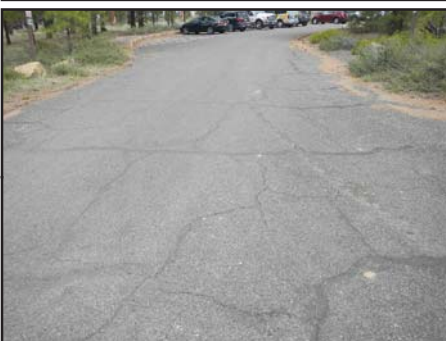
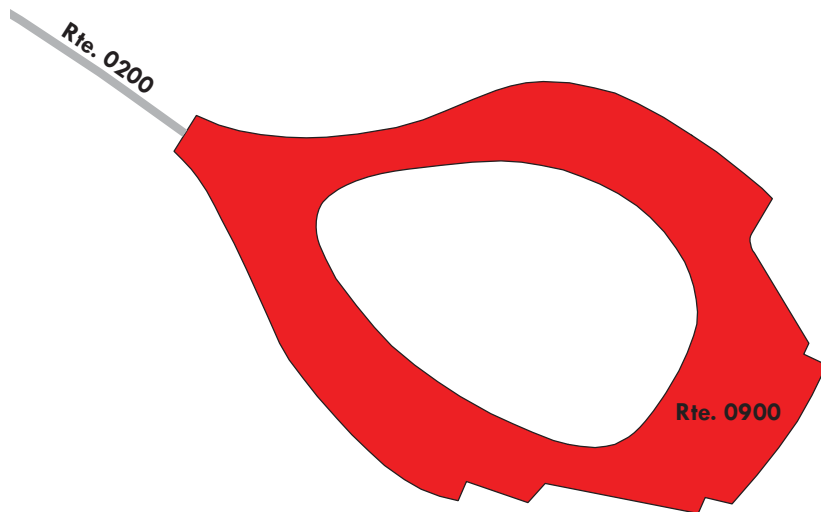
ROUTE 0901: VC ADMINISTRATION PARKING

Inspection Date	FMSS Number	User Access	Surface Type
5/19/2016	45916	NONPUBLIC	ASPHALT
Area (Sq. Ft.)	Lane Miles (11' Widths)	Curb Reveal (Inches)	Curb Recommendation
33,404	0.575	6	MODERATE REPAIR
Curb Type		Curb & Gutter Type	
ASPHALT		NO CURB AND GUTTER	
Pavement Recommendation		Condition Rating / PCR	
PREVENTIVE MAINTENANCE		GOOD / 90
