BRCA Cycle 6

Final Report

Road Inventory and Condition Assessment of Paved Routes Bryce Canyon National Park

Federal Highway Administration
Eastern Federal Lands Highway Division
Road Inventory Program (RIP)

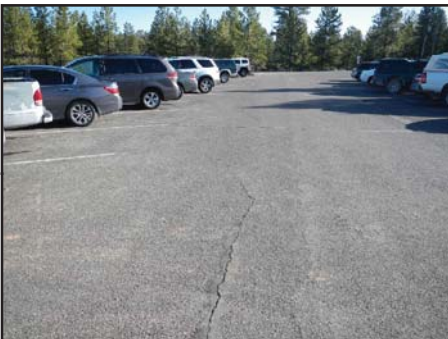
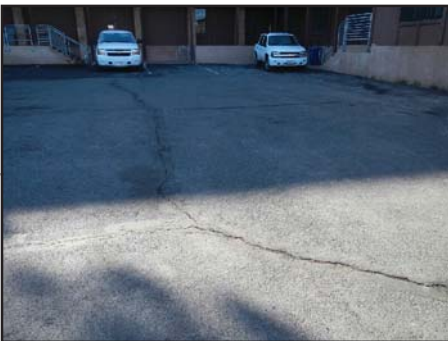
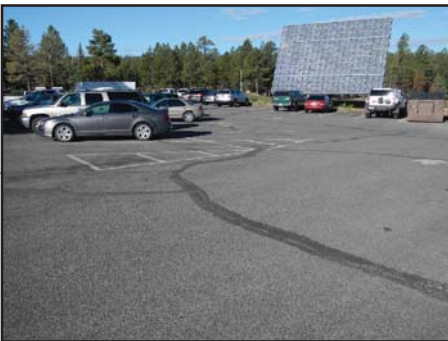
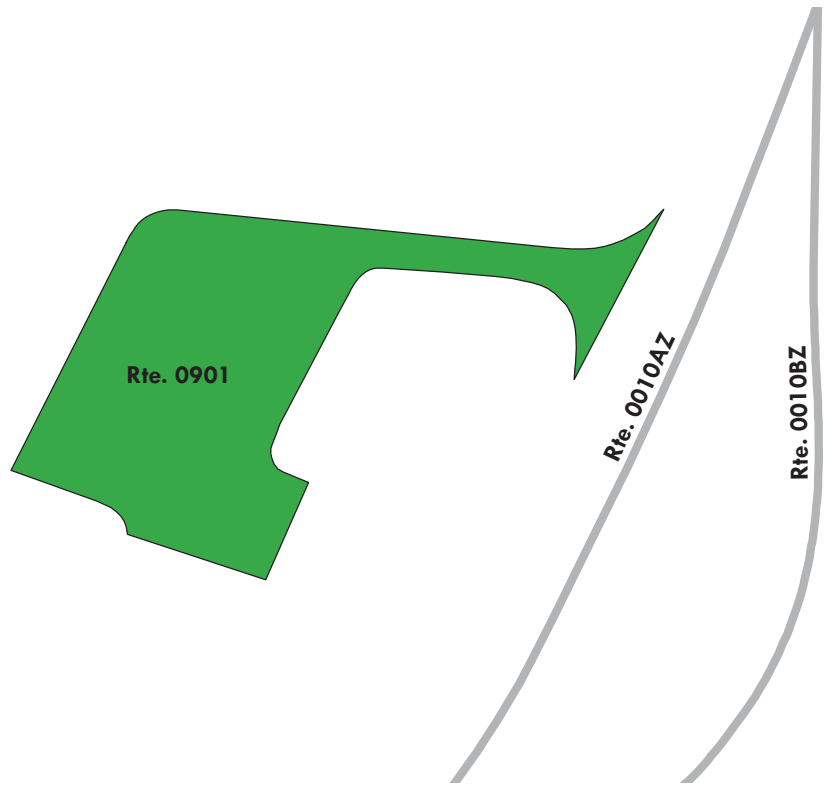
ROUTE 0902: VISITOR CENTER PARKING

Inspection Date	FMSS Number	User Access	Surface Type
5/19/2016	45918	PUBLIC	ASPHALT
Area (Sq. Ft.)	Lane Miles (11' Widths)	Curb Reveal (Inches)	Curb Recommendation
43,044	0.741	1	DO NOTHING
Curb Type		Curb & Gutter Type	
STONE		NO CURB AND GUTTER	
Pavement Recommendation		Condition Rating / PCR	
LIGHT 3R TREATMENTS		FAIR / 73

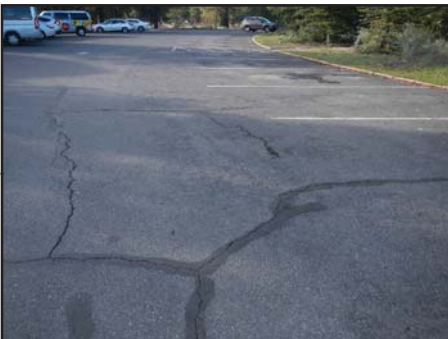
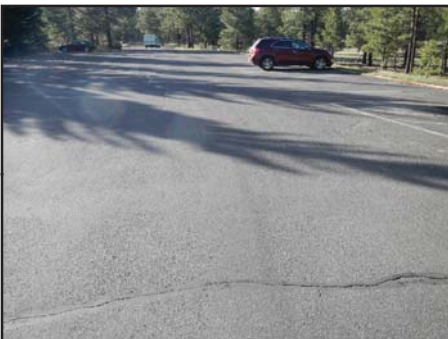
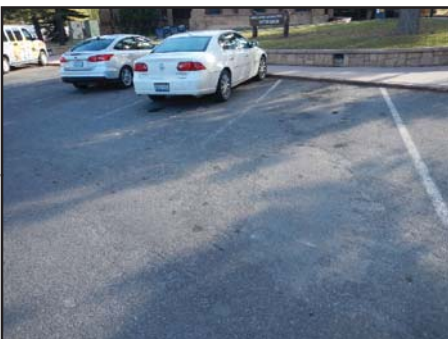
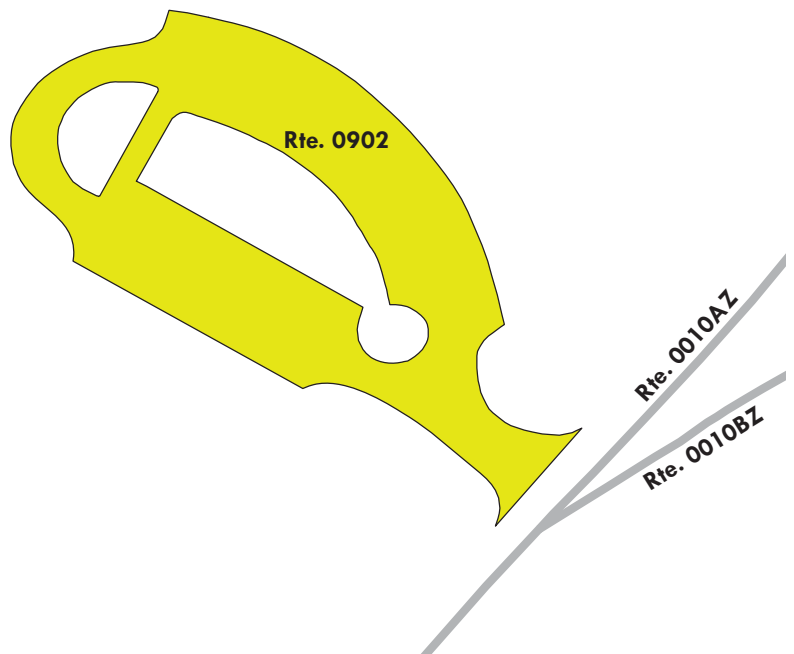
ROUTE 0903: SUNRISE POINT PARKING

Inspection Date	FMSS Number	User Access	Surface Type
5/19/2016	46283	PUBLIC	ASPHALT
Area (Sq. Ft.)	Lane Miles (11' Widths)	Curb Reveal (Inches)	Curb Recommendation
4,519	0.078	NOT APPLICABLE	NOT APPLICABLE
Curb Type		Curb & Gutter Type	
NO CURB		NO CURB AND GUTTER	
Pavement Recommendation		Condition Rating / PCR	
PREVENTIVE MAINTENANCE		GOOD / 90

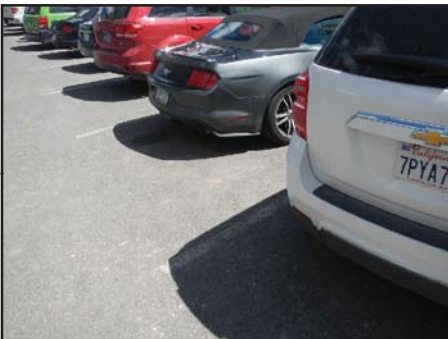
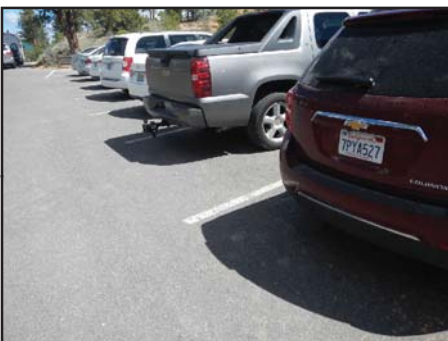
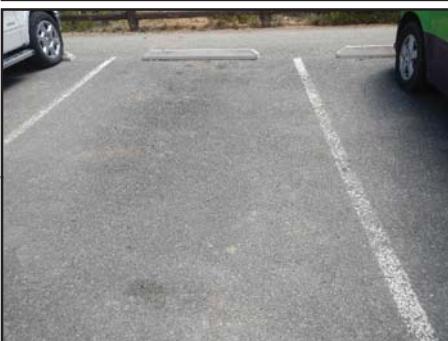
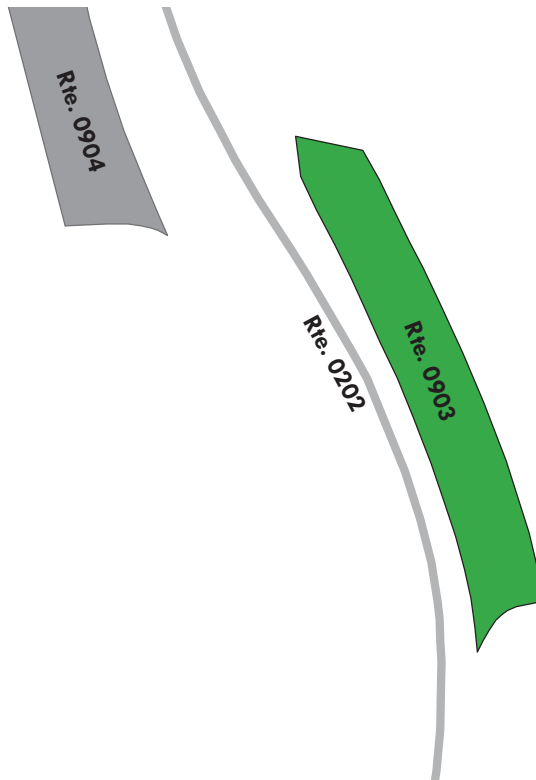
ROUTE 0904: HPI PARKING

Inspection Date	FMSS Number	User Access	Surface Type
5/19/2016	46285	PUBLIC	ASPHALT
Area (Sq. Ft.)	Lane Miles (11' Widths)	Curb Reveal (Inches)	Curb Recommendation
3,441	0.059	4	DO NOTHING
Curb Type		Curb & Gutter Type	
CONCRETE		NO CURB AND GUTTER	
Pavement Recommendation		Condition Rating / PCR	
PREVENTIVE MAINTENANCE		GOOD / 90

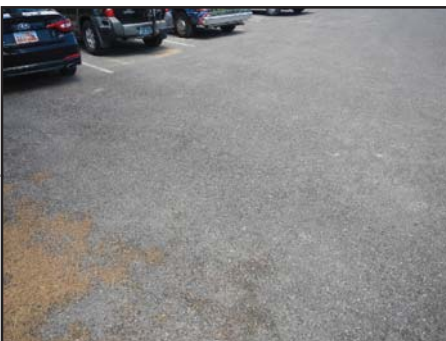
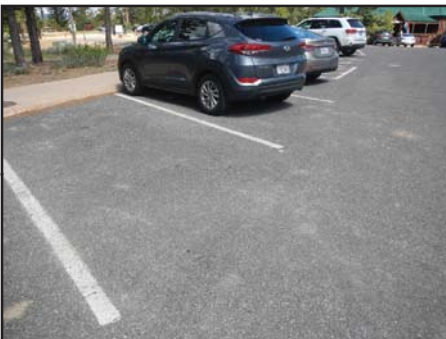
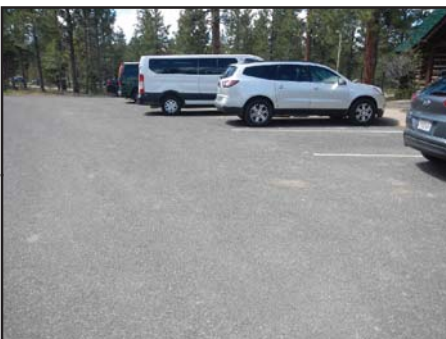
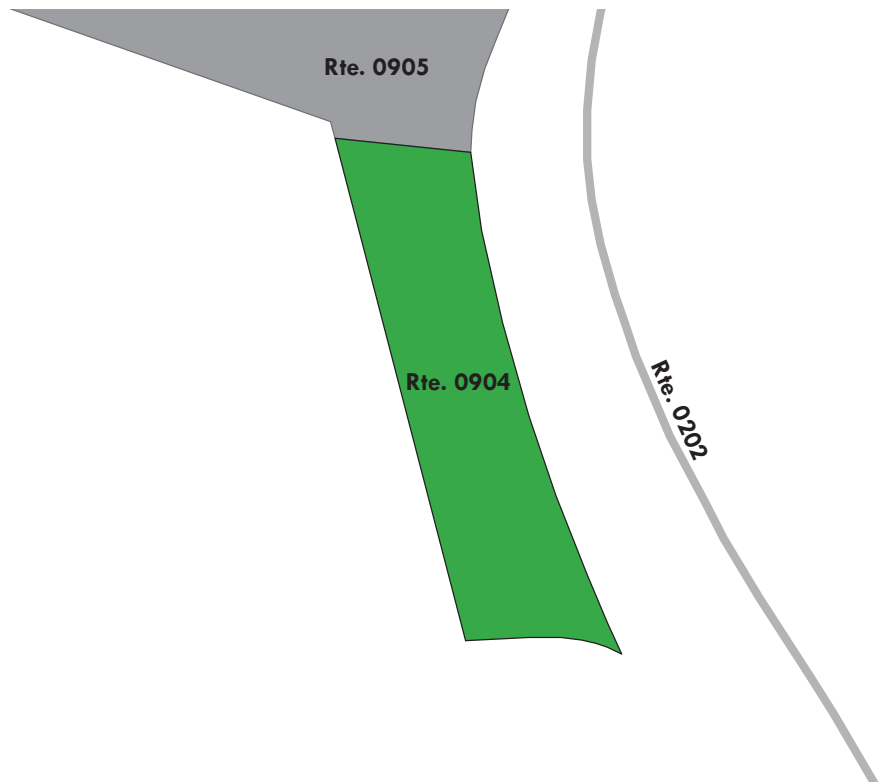
ROUTE 0905: GENERAL STORE PARKING

Inspection Date	FMSS Number	User Access	Surface Type
5/19/2016	46287	PUBLIC	ASPHALT
Area (Sq. Ft.)	Lane Miles (11' Widths)	Curb Reveal (Inches)	Curb Recommendation
26,279	0.452	5	DO NOTHING
Curb Type		Curb & Gutter Type	
CONCRETE AND STONE		NO CURB AND GUTTER	
Pavement Recommendation		Condition Rating / PCR	
PREVENTIVE MAINTENANCE		GOOD / 90

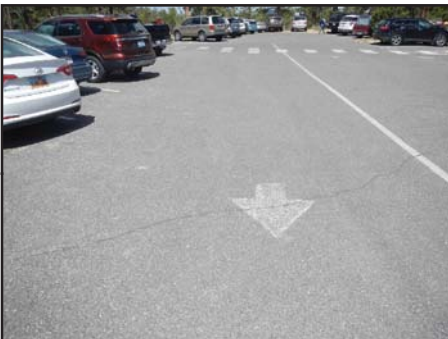
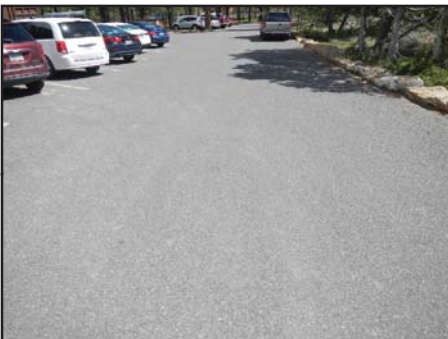
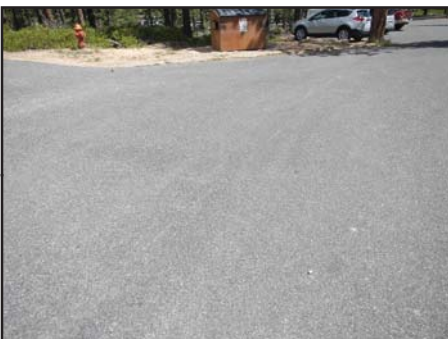
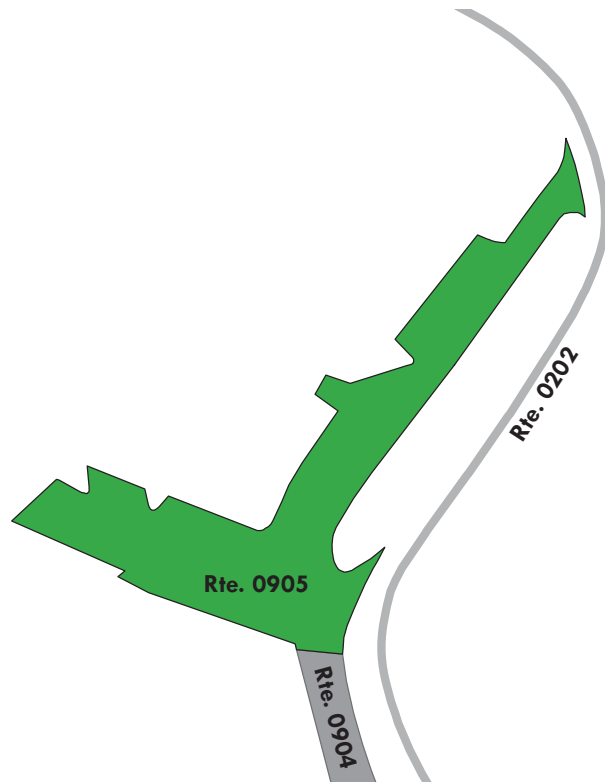
ROUTE 0906: OUTDOOR THEATRE PARKING

Inspection Date	FMSS Number	User Access	Surface Type
5/19/2016	45958	PUBLIC	ASPHALT
Area (Sq. Ft.)	Lane Miles (11' Widths)	Curb Reveal (Inches)	Curb Recommendation
2,712	0.047	NOT APPLICABLE	NOT APPLICABLE
Curb Type		Curb & Gutter Type	
NO CURB		NO CURB AND GUTTER	
Pavement Recommendation		Condition Rating / PCR	
PREVENTIVE MAINTENANCE		GOOD / 90

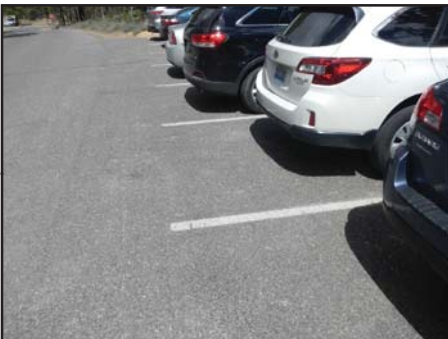
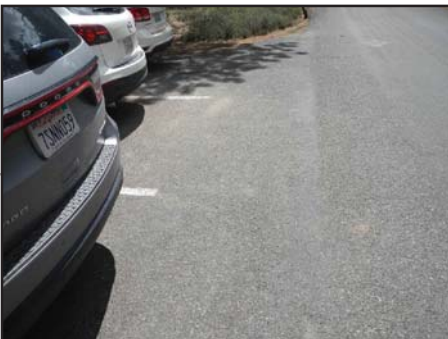
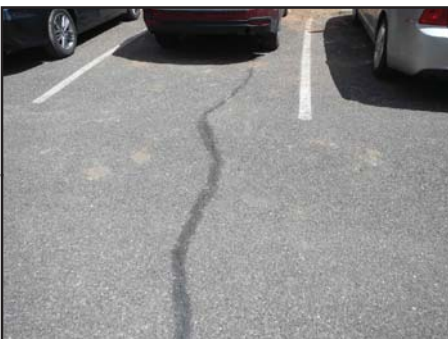
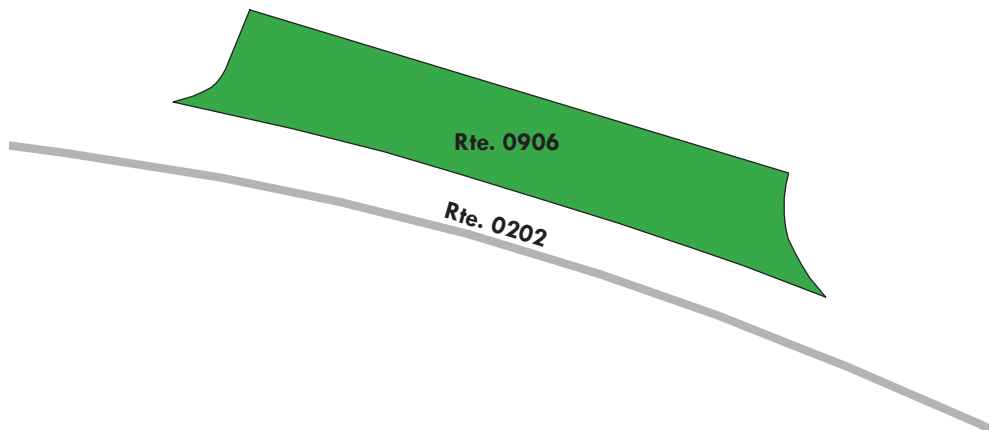
ROUTE 0907: DUMP STATION PARKING

Inspection Date	FMSS Number	User Access	Surface Type
5/19/2016	45959	PUBLIC	ASPHALT
Area (Sq. Ft.)	Lane Miles (11' Widths)	Curb Reveal (Inches)	Curb Recommendation
6,499	0.112	NOT APPLICABLE	NOT APPLICABLE
Curb Type		Curb & Gutter Type	
NO CURB		NO CURB AND GUTTER	
Pavement Recommendation		Condition Rating / PCR	
PREVENTIVE MAINTENANCE		GOOD / 90

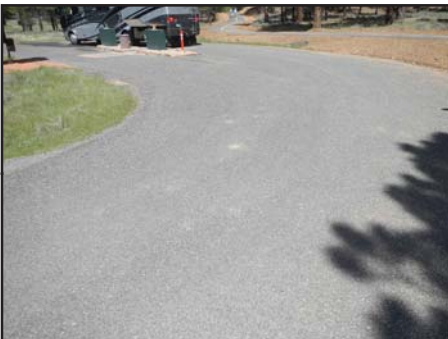
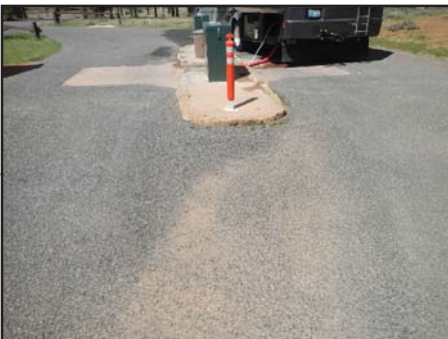
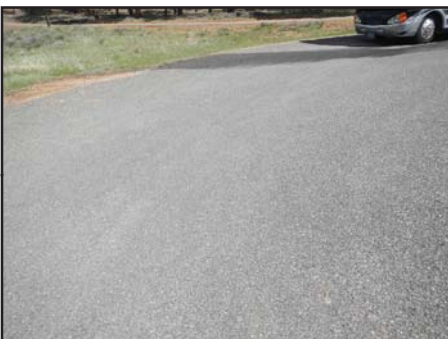
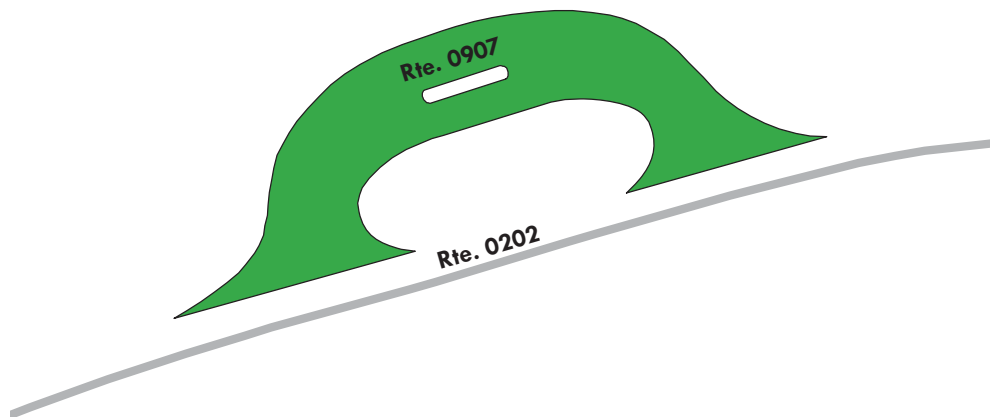
ROUTE 0908: SERVICE STATION PARKING

Inspection Date	FMSS Number	User Access	Surface Type
5/19/2016	45974	PUBLIC	ASPHALT
Area (Sq. Ft.)	Lane Miles (11' Widths)	Curb Reveal (Inches)	Curb Recommendation
9,652	0.166	5	DO NOTHING
Curb Type		Curb & Gutter Type	
STONE		NO CURB AND GUTTER	
Pavement Recommendation		Condition Rating / PCR	
LIGHT 3R TREATMENTS		FAIR / 73

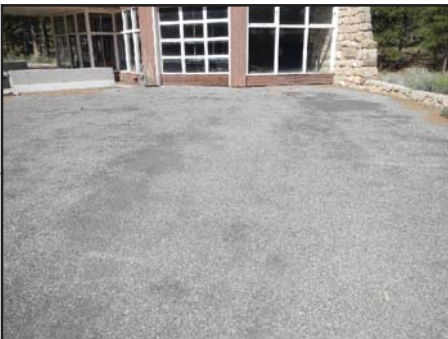
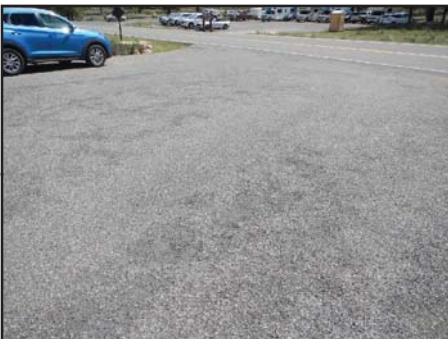
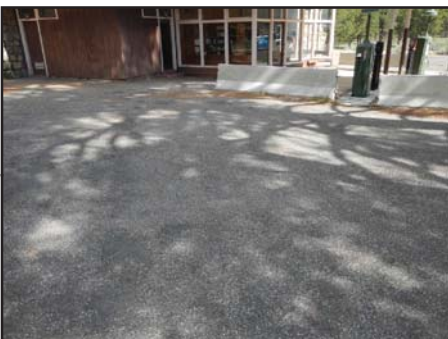
Parking area consists of multiple surface types: 1 part Asphalt at 8,663 square feet; 1 part Concrete at 989 square feet.

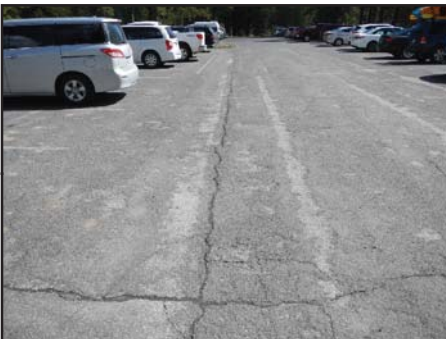
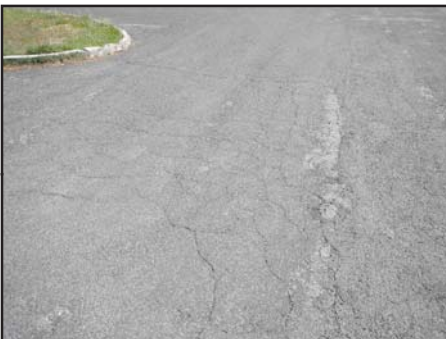
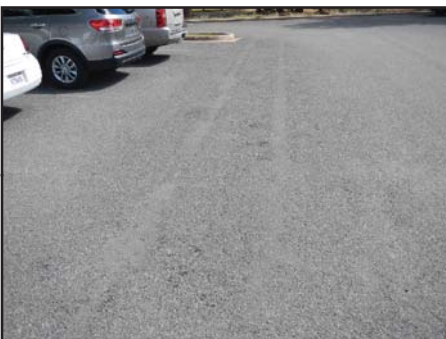
ROUTE 0909: SUNRISE MOTEL PARKING

Inspection Date	FMSS Number	User Access	Surface Type
5/19/2016	46202	PUBLIC	ASPHALT
Area (Sq. Ft.)	Lane Miles (11' Widths)	Curb Reveal (Inches)	Curb Recommendation
22,278	0.384	5	LIGHT REPAIR
Curb Type		Curb & Gutter Type	
CONCRETE		CONCRETE	
Pavement Recommendation		Condition Rating / PCR	
HEAVY 3R TREATMENTS		POOR / 53

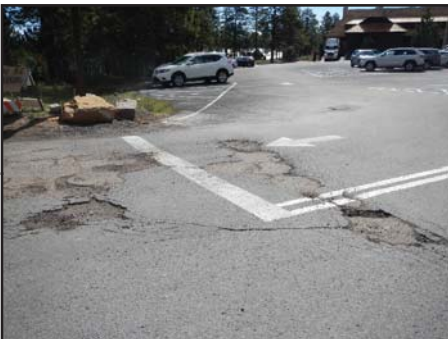
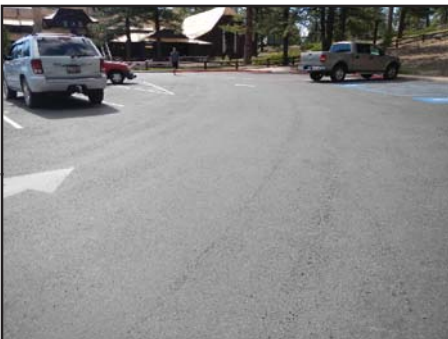
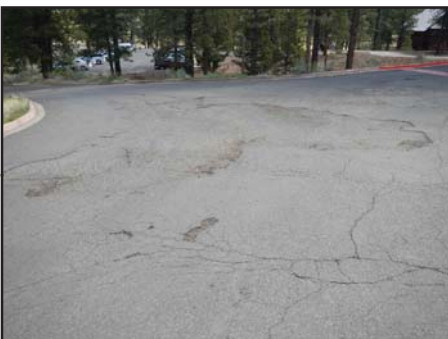
ROUTE 0910: LODGE PARKING

Inspection Date	FMSS Number	User Access	Surface Type
5/19/2016	46199	PUBLIC	ASPHALT
Area (Sq. Ft.)	Lane Miles (11' Widths)	Curb Reveal (Inches)	Curb Recommendation
42,168	0.726	5	LIGHT REPAIR
Curb Type		Curb & Gutter Type	
CONCRETE		CONCRETE	
Pavement Recommendation		Condition Rating / PCR	
HEAVY 3R TREATMENTS		POOR / 53

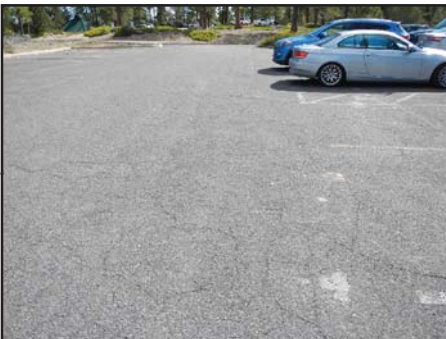
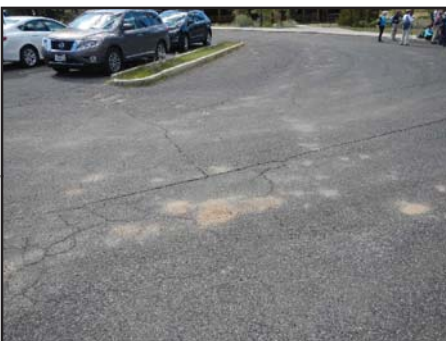
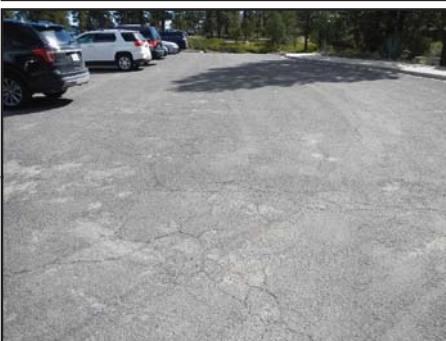
ROUTE 0911: SUNSET MOTEL PARKING

Inspection Date	FMSS Number	User Access	Surface Type
5/19/2016	46254	PUBLIC	ASPHALT
Area (Sq. Ft.)	Lane Miles (11' Widths)	Curb Reveal (Inches)	Curb Recommendation
18,844	0.324	5	LIGHT REPAIR
Curb Type		Curb & Gutter Type	
CONCRETE		CONCRETE	
Pavement Recommendation		Condition Rating / PCR	
HEAVY 3R TREATMENTS		POOR / 53

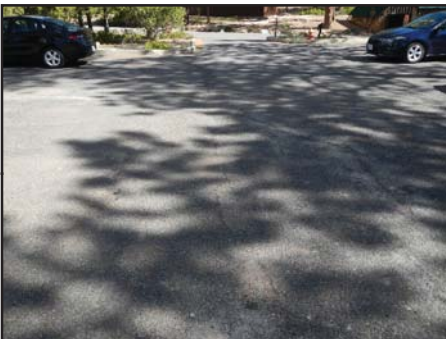
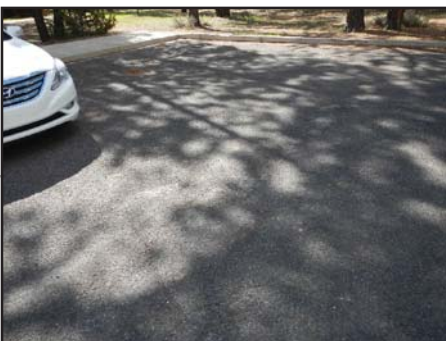
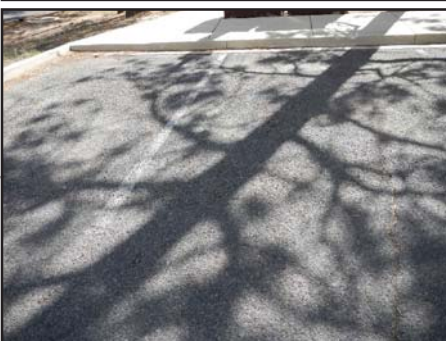
ROUTE 0912: WESTERN CABIN PARKING AREA WEST

Inspection Date	FMSS Number	User Access	Surface Type
5/19/2016	46255	PUBLIC	ASPHALT
Area (Sq. Ft.)	Lane Miles (11' Widths)	Curb Reveal (Inches)	Curb Recommendation
4,125	0.071	6	DO NOTHING
Curb Type		Curb & Gutter Type	
CONCRETE		CONCRETE	
Pavement Recommendation		Condition Rating / PCR	
PREVENTIVE MAINTENANCE		GOOD / 90

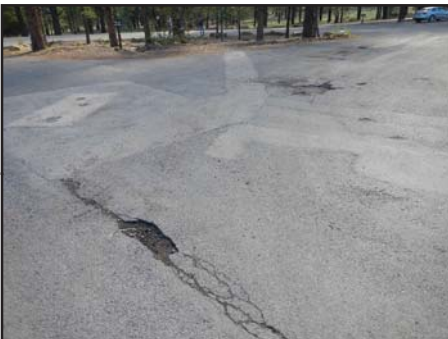
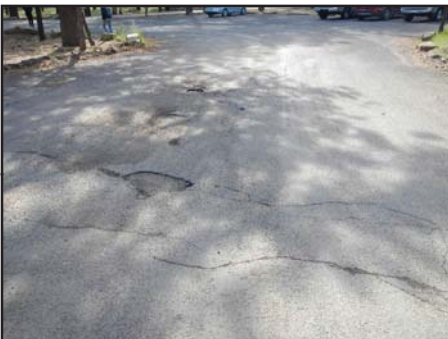
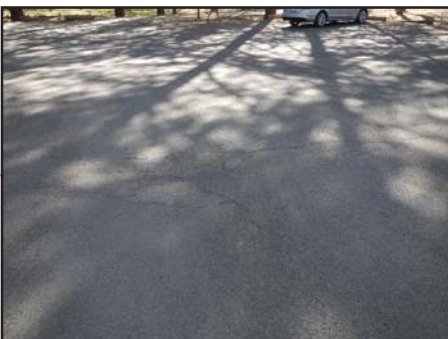
ROUTE 0913: WESTERN CABIN PARKING AREA NORTH

Inspection Date	FMSS Number	User Access	Surface Type
5/19/2016	46258	PUBLIC	ASPHALT
Area (Sq. Ft.)	Lane Miles (11' Widths)	Curb Reveal (Inches)	Curb Recommendation
13,868	0.239	NOT APPLICABLE	NOT APPLICABLE
Curb Type		Curb & Gutter Type	
NO CURB		NO CURB AND GUTTER	
Pavement Recommendation		Condition Rating / PCR	
LIGHT 3R TREATMENTS		FAIR / 73

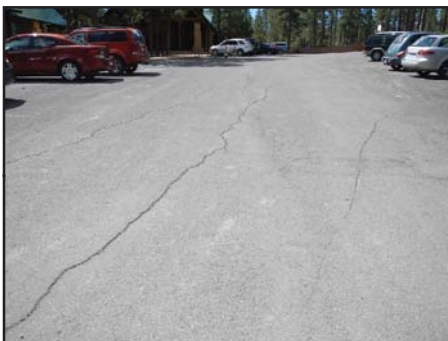
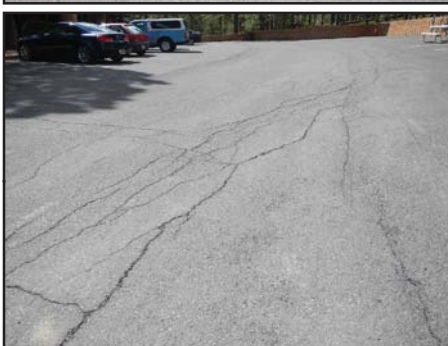
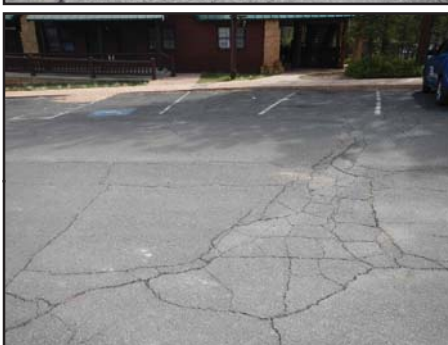
ROUTE 0916A: PONDEROSA AND WHISPERING PINES DORMITORIES PARKING

Inspection Date	FMSS Number	User Access	Surface Type
5/19/2016	46262	PUBLIC	ASPHALT
Area (Sq. Ft.)	Lane Miles (11' Widths)	Curb Reveal (Inches)	Curb Recommendation
24,392	0.42	NOT APPLICABLE	NOT APPLICABLE
Curb Type		Curb & Gutter Type	
NO CURB		NO CURB AND GUTTER	
Pavement Recommendation		Condition Rating / PCR	
RECONSTRUCTION		POOR / 30

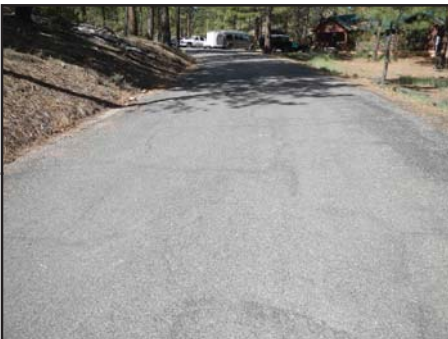
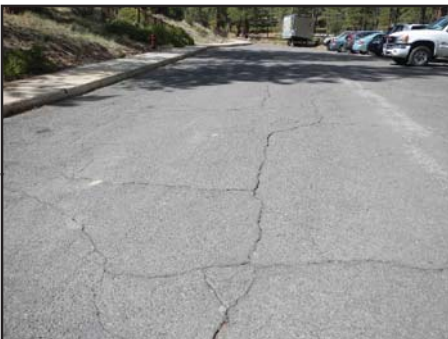
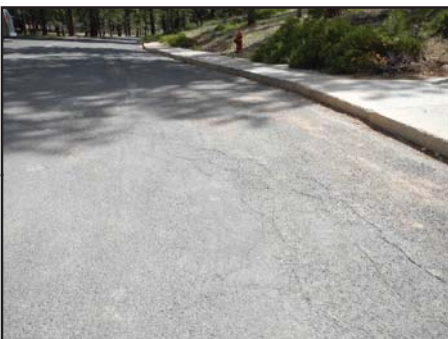
ROUTE 0916B: HS4 AND MANZANITA DORMITORY PARKING

Inspection Date	FMSS Number	User Access	Surface Type
5/19/2016	91737	PUBLIC	ASPHALT
Area (Sq. Ft.)	Lane Miles (11' Widths)	Curb Reveal (Inches)	Curb Recommendation
14,046	0.242	5	DO NOTHING
Curb Type		Curb & Gutter Type	
CONCRETE		NO CURB AND GUTTER	
Pavement Recommendation		Condition Rating / PCR	
RECONSTRUCTION		POOR / 30

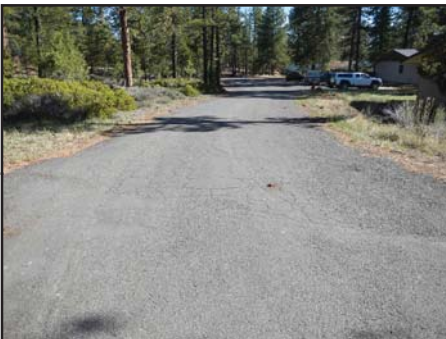
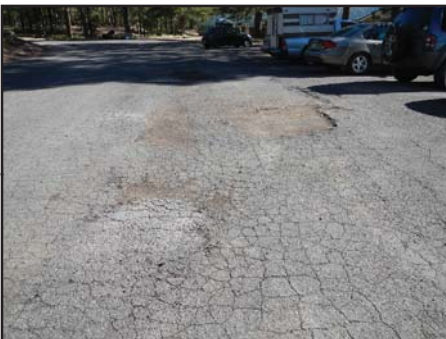
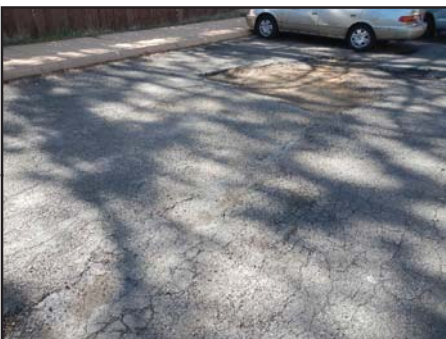
ROUTE 0917: APARTMENT / PICNIC AREA PARKING

Inspection Date	FMSS Number	User Access	Surface Type
5/19/2016	46342	PUBLIC	ASPHALT
Area (Sq. Ft.)	Lane Miles (11' Widths)	Curb Reveal (Inches)	Curb Recommendation
15,137	0.261	8	LIGHT REPAIR
Curb Type		Curb & Gutter Type	
CONCRETE		CONCRETE	
Pavement Recommendation		Condition Rating / PCR	
RECONSTRUCTION		POOR / 30

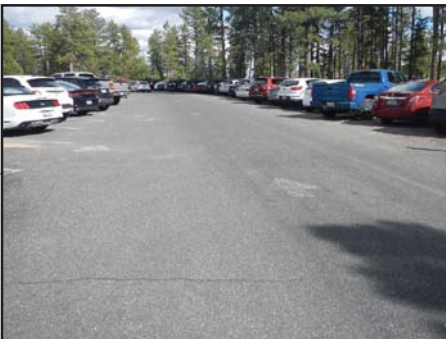
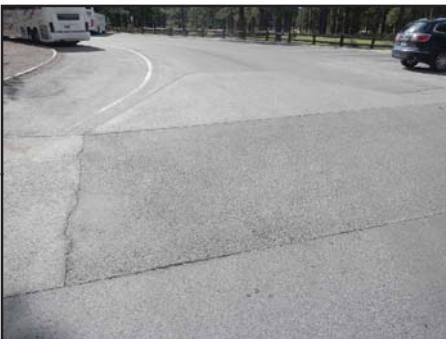
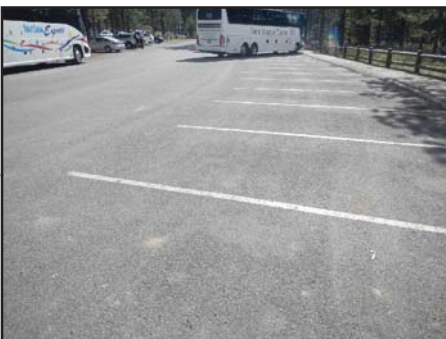
ROUTE 0918: SUNSET POINT PARKING

Inspection Date	FMSS Number	User Access	Surface Type
5/19/2016	46459	PUBLIC	ASPHALT
Area (Sq. Ft.)	Lane Miles (11' Widths)	Curb Reveal (Inches)	Curb Recommendation
59,306	1.021	3	MODERATE REPAIR
Curb Type		Curb & Gutter Type	
CONCRETE		NO CURB AND GUTTER	
Pavement Recommendation		Condition Rating / PCR	
PREVENTIVE MAINTENANCE		GOOD / 90

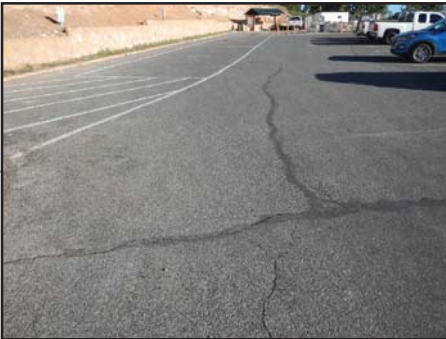
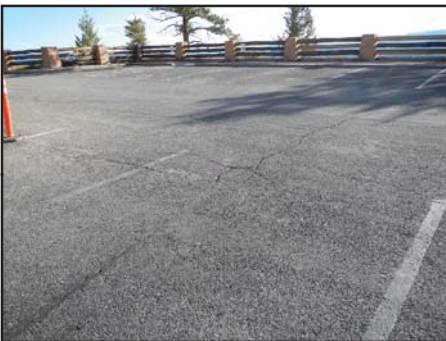
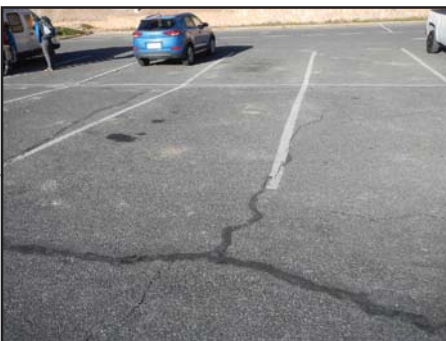
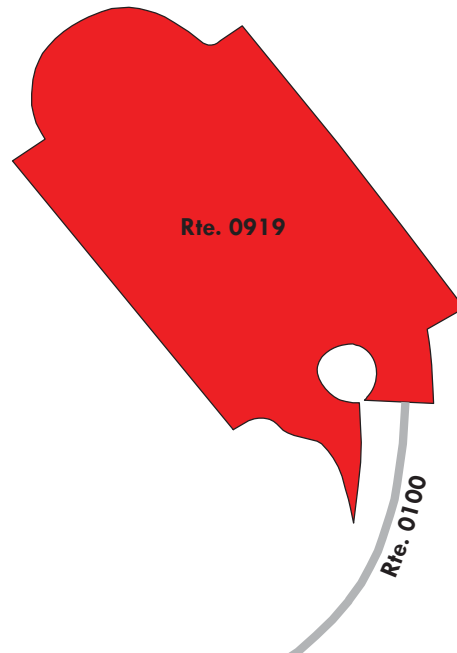
ROUTE 0920: PARIA POINT PARKING

Inspection Date	FMSS Number	User Access	Surface Type
5/19/2016	46478	PUBLIC	ASPHALT
Area (Sq. Ft.)	Lane Miles (11' Widths)	Curb Reveal (Inches)	Curb Recommendation
12,734	0.219	5	LIGHT REPAIR
Curb Type		Curb & Gutter Type	
ASPHALT AND CONCRETE		NO CURB AND GUTTER	
Pavement Recommendation		Condition Rating / PCR	
PREVENTIVE MAINTENANCE		GOOD / 90

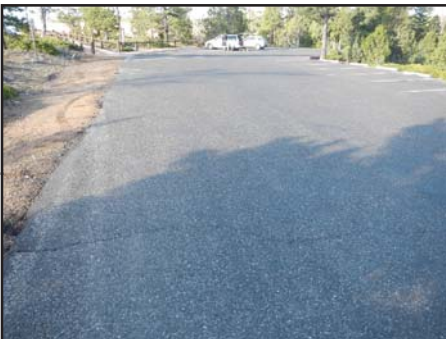
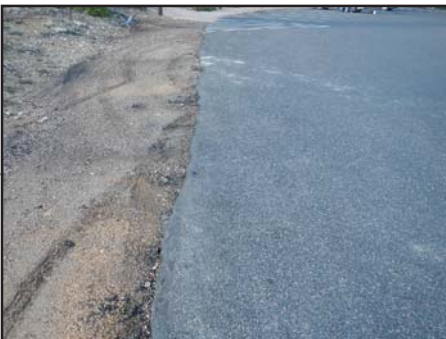
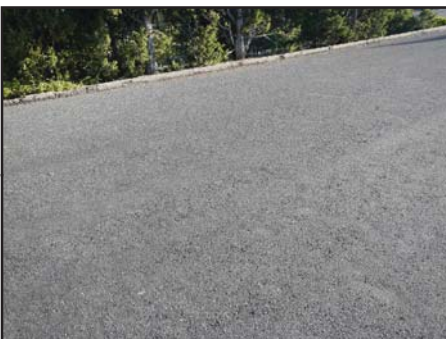
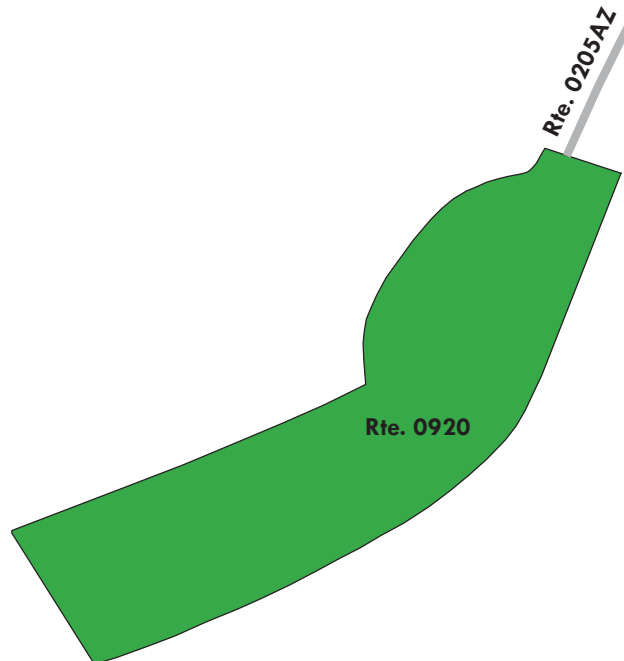
ROUTE 0921: INSPIRATION POINT PARKING

Inspection Date	FMSS Number	User Access	Surface Type
5/19/2016	46466	PUBLIC	ASPHALT
Area (Sq. Ft.)	Lane Miles (11' Widths)	Curb Reveal (Inches)	Curb Recommendation
33,767	0.581	6	DO NOTHING
Curb Type		Curb & Gutter Type	
ASPHALT		NO CURB AND GUTTER	
Pavement Recommendation		Condition Rating / PCR	
PREVENTIVE MAINTENANCE		GOOD / 90

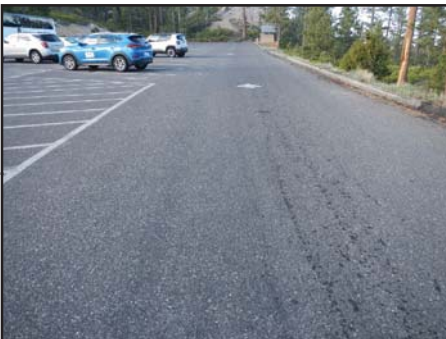
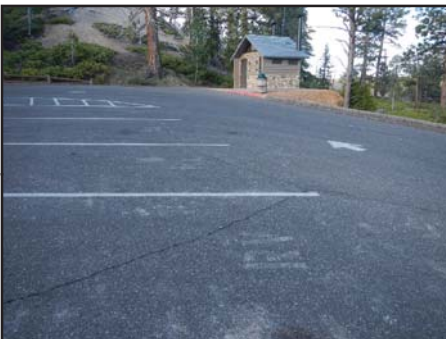
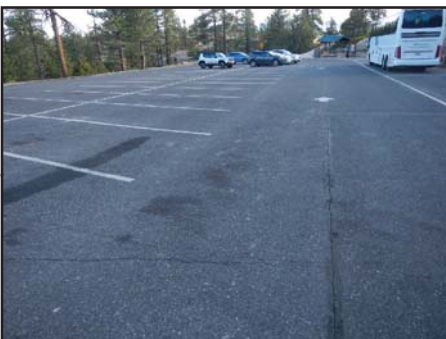
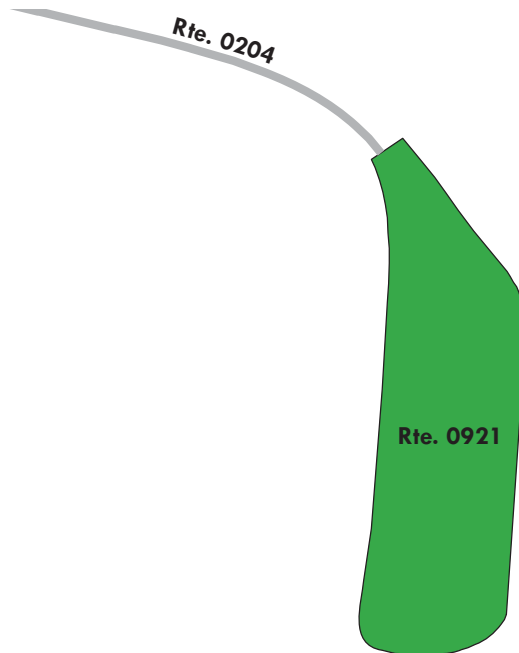
ROUTE 0922: FAIRVIEW POINT PARKING

Inspection Date	FMSS Number	User Access	Surface Type
5/19/2016	46460	PUBLIC	ASPHALT
Area (Sq. Ft.)	Lane Miles (11' Widths)	Curb Reveal (Inches)	Curb Recommendation
46,789	0.806	7	DO NOTHING
Curb Type		Curb & Gutter Type	
CONCRETE		NO CURB AND GUTTER	
Pavement Recommendation		Condition Rating / PCR	
PREVENTIVE MAINTENANCE		GOOD / 90

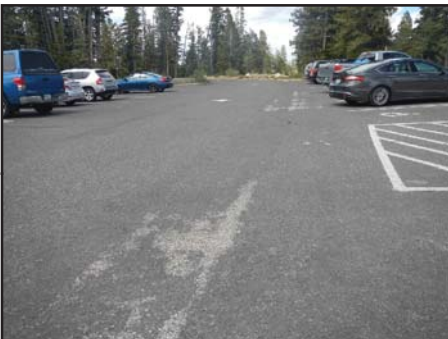
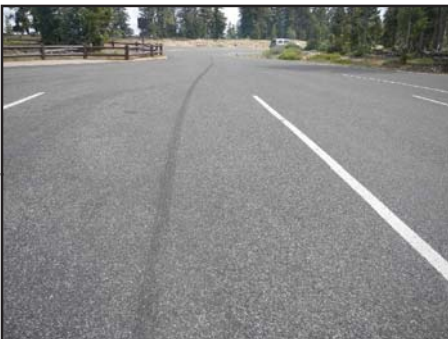
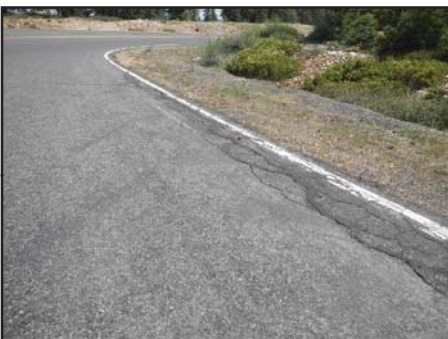
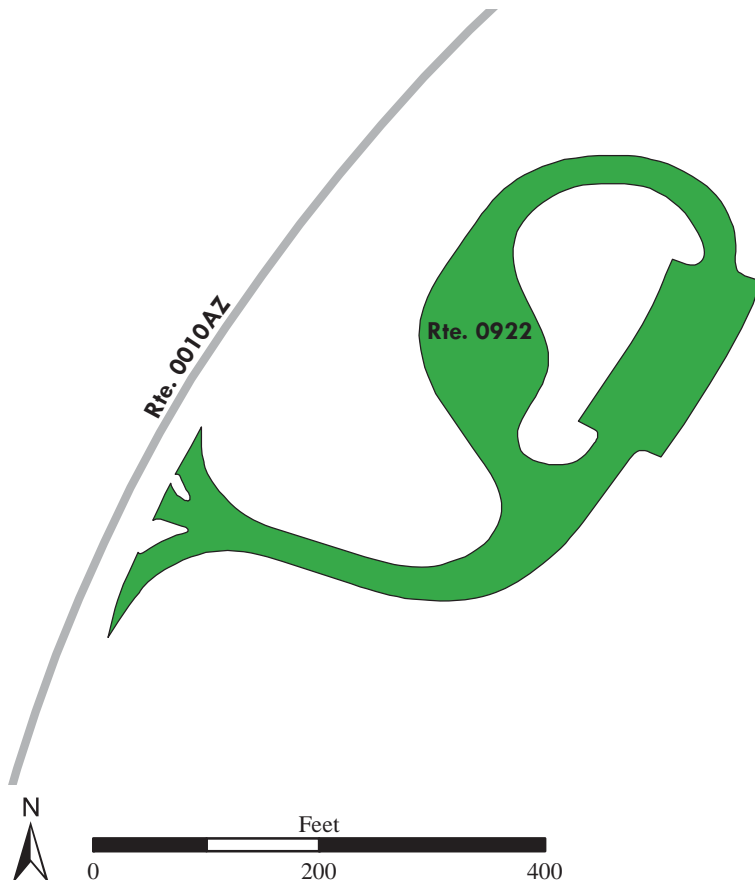
ROUTE 0923: NATURAL BRIDGE PARKING

Inspection Date	FMSS Number	User Access	Surface Type
5/19/2016	46454	PUBLIC	ASPHALT
Area (Sq. Ft.)	Lane Miles (11' Widths)	Curb Reveal (Inches)	Curb Recommendation
24,299	0.418	7	DO NOTHING
Curb Type		Curb & Gutter Type	
CONCRETE		NO CURB AND GUTTER	
Pavement Recommendation		Condition Rating / PCR	
PREVENTIVE MAINTENANCE		GOOD / 90

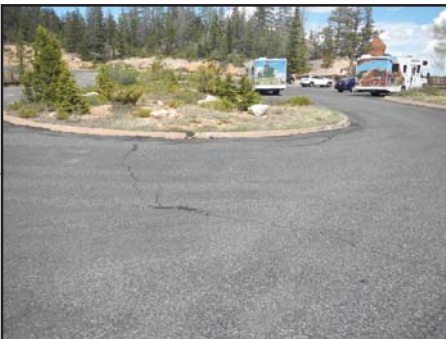
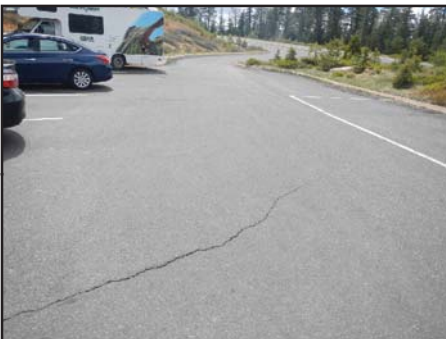
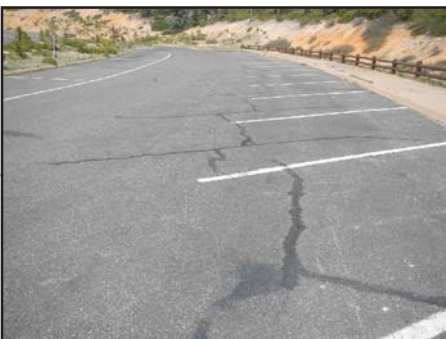
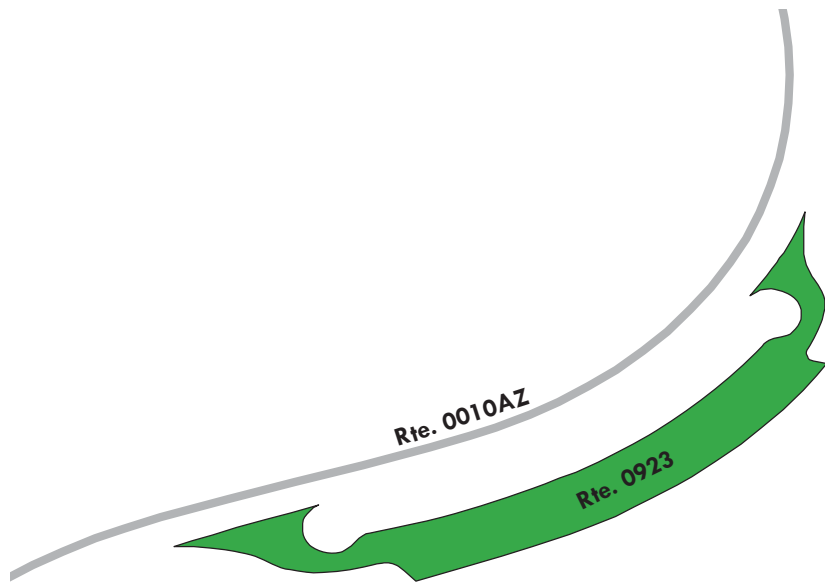
ROUTE 0924: AGUA CANYON PARKING

Inspection Date	FMSS Number	User Access	Surface Type
5/19/2016	46453	PUBLIC	ASPHALT
Area (Sq. Ft.)	Lane Miles (11' Widths)	Curb Reveal (Inches)	Curb Recommendation
11,375	0.196	7	DO NOTHING
Curb Type		Curb & Gutter Type	
CONCRETE		NO CURB AND GUTTER	
Pavement Recommendation		Condition Rating / PCR	
PREVENTIVE MAINTENANCE		GOOD / 90

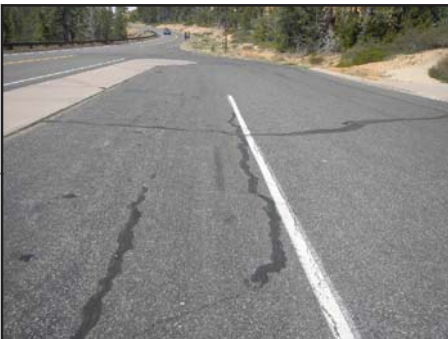
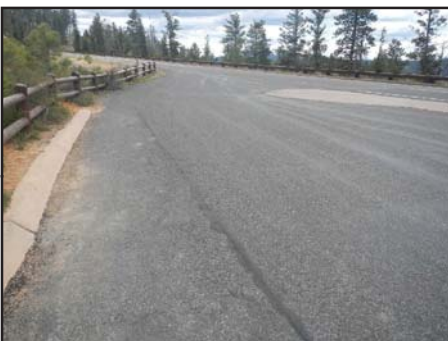
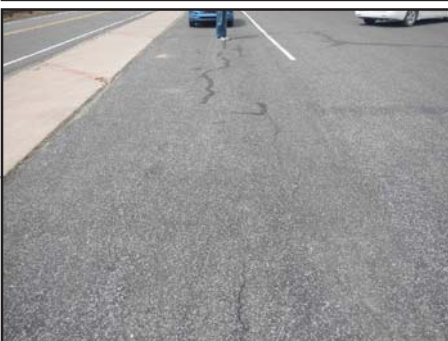
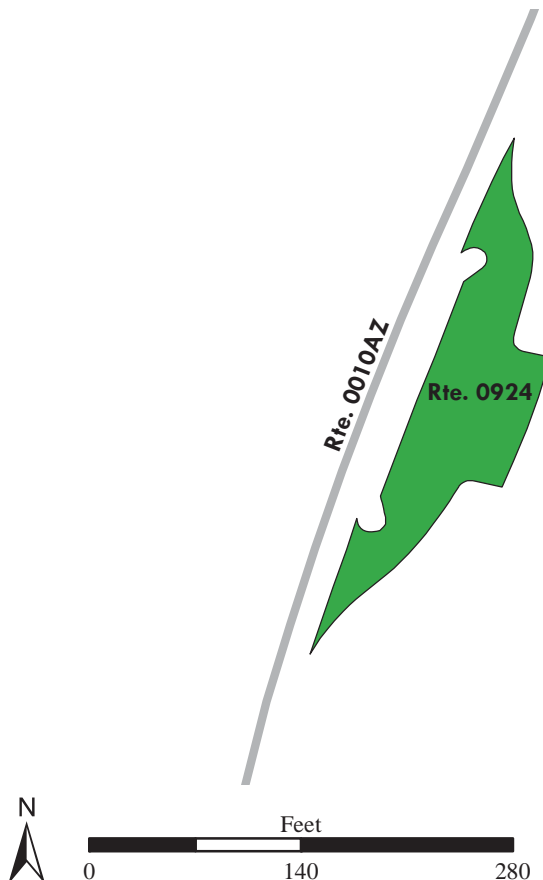
ROUTE 0925: PONDEROSA POINT PARKING

Inspection Date	FMSS Number	User Access	Surface Type
5/19/2016	46452	PUBLIC	ASPHALT
Area (Sq. Ft.)	Lane Miles (11' Widths)	Curb Reveal (Inches)	Curb Recommendation
12,370	0.213	6	LIGHT REPAIR
Curb Type		Curb & Gutter Type	
CONCRETE		NOT APPLICABLE	
Pavement Recommendation		Condition Rating / PCR	
PREVENTIVE MAINTENANCE		GOOD / 90

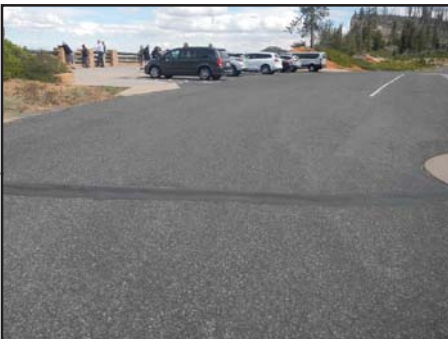
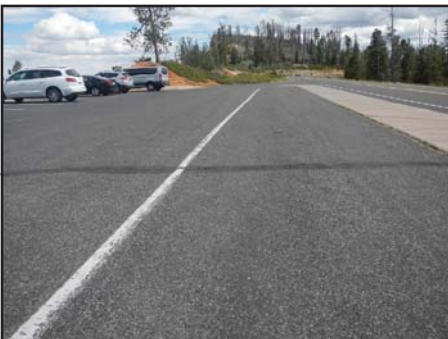
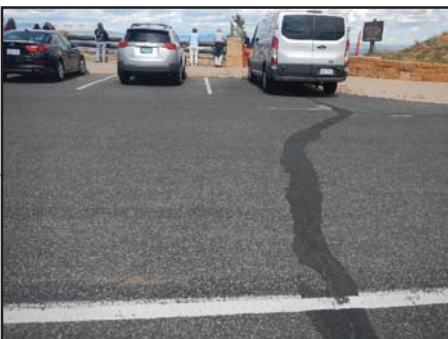
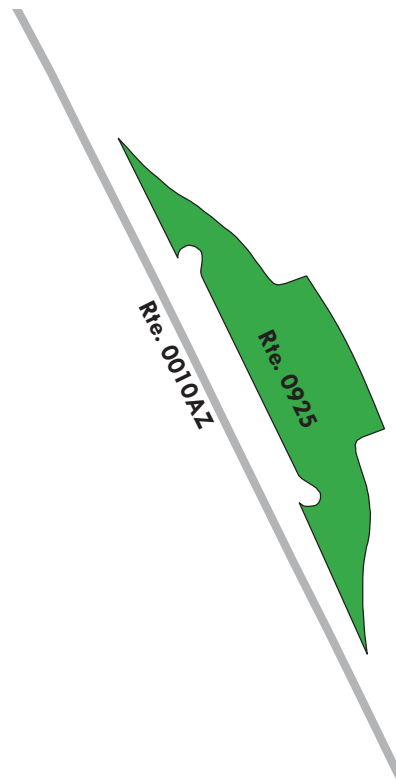
ROUTE 0926: RAINBOW POINT PARKING

Inspection Date	FMSS Number	User Access	Surface Type
5/19/2016	46436	PUBLIC	ASPHALT
Area (Sq. Ft.)	Lane Miles (11' Widths)	Curb Reveal (Inches)	Curb Recommendation
44,818	0.772	7	DO NOTHING
Curb Type		Curb & Gutter Type	
CONCRETE		NO CURB AND GUTTER	
Pavement Recommendation		Condition Rating / PCR	
PREVENTIVE MAINTENANCE		GOOD / 90

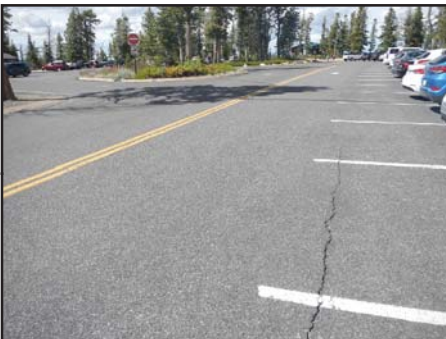
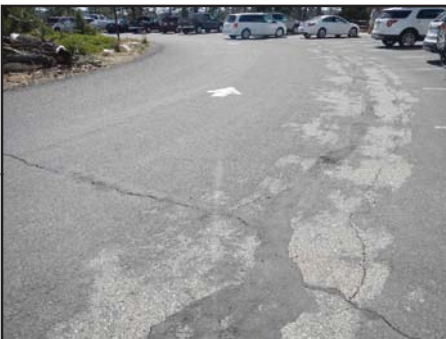
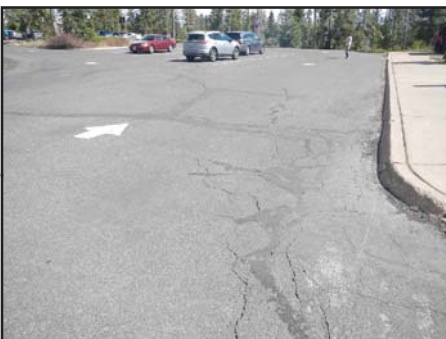
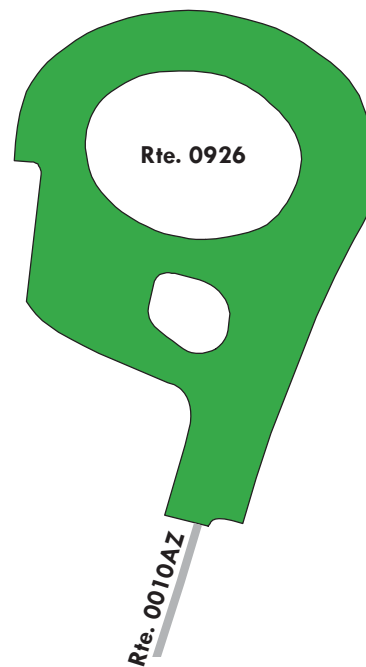
ROUTE 0927: PARK ENTRANCE PARKING

Inspection Date	FMSS Number	User Access	Surface Type
5/19/2016	91743	PUBLIC	ASPHALT
Area (Sq. Ft.)	Lane Miles (11' Widths)	Curb Reveal (Inches)	Curb Recommendation
14,800	0.255	7	DO NOTHING
Curb Type		Curb & Gutter Type	
CONCRETE		NO CURB AND GUTTER	
Pavement Recommendation		Condition Rating / PCR	
PREVENTIVE MAINTENANCE		GOOD / 90

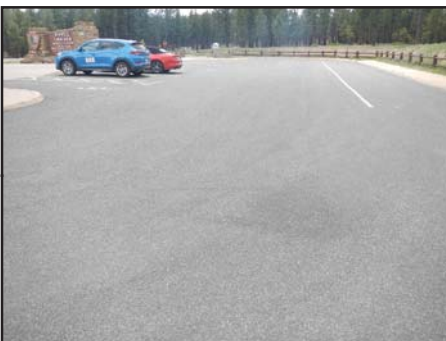
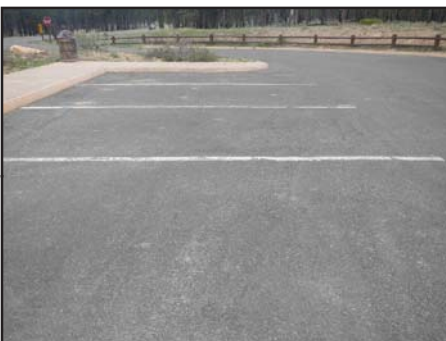
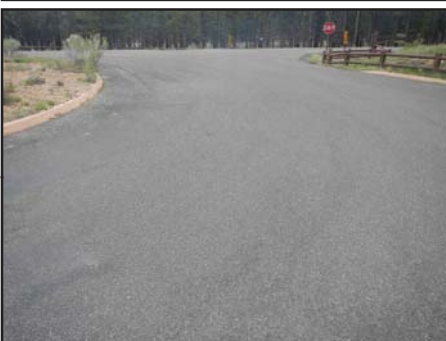
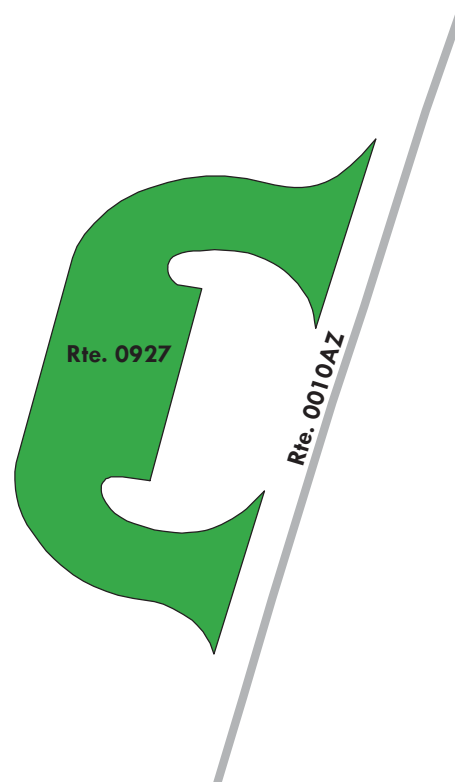
ROUTE 0928: NO-NAME SOUTH PARKING AT MP 17.2

Inspection Date	FMSS Number	User Access	Surface Type
5/19/2016	46484	PUBLIC	ASPHALT
Area (Sq. Ft.)	Lane Miles (11' Widths)	Curb Reveal (Inches)	Curb Recommendation
2,036	0.035	7	DO NOTHING
Curb Type		Curb & Gutter Type	
CONCRETE		NO CURB AND GUTTER	
Pavement Recommendation		Condition Rating / PCR	
PREVENTIVE MAINTENANCE		GOOD / 90

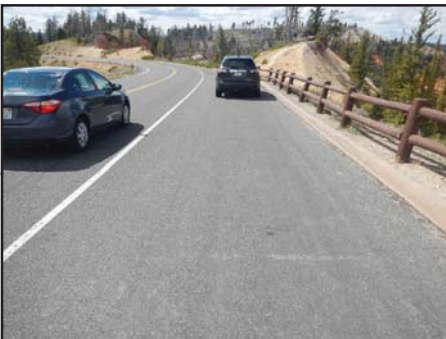
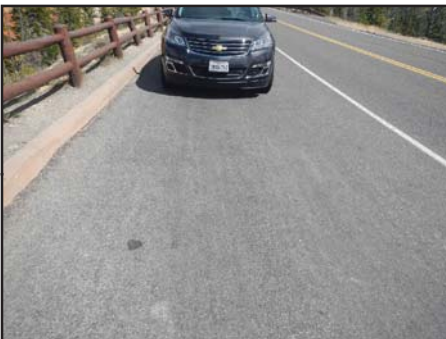
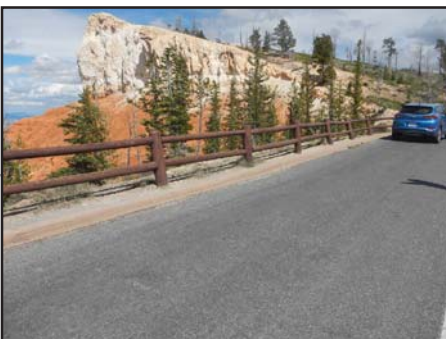
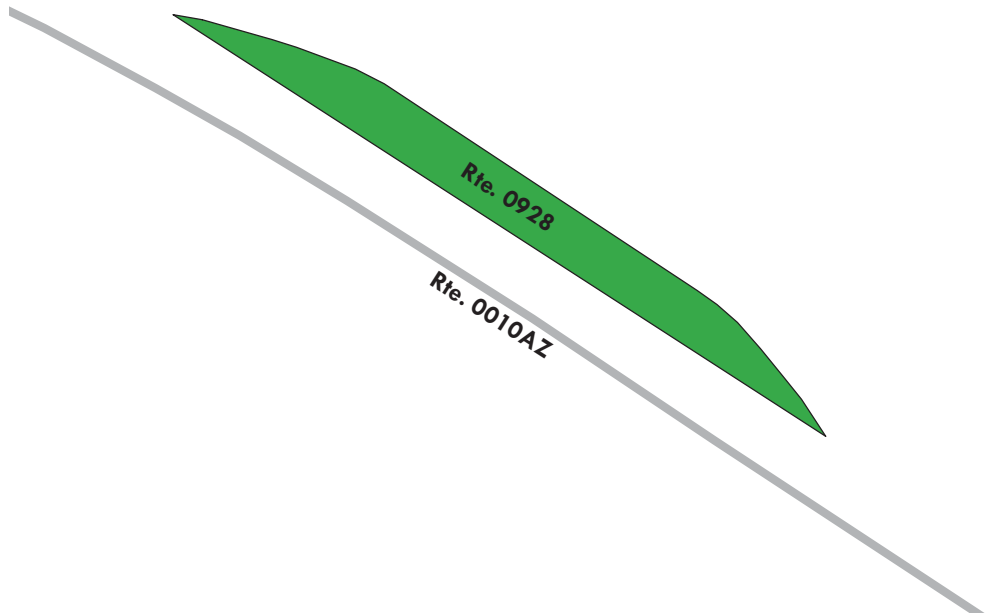
ROUTE 0929: BLACK BIRCH PARKING

Inspection Date	FMSS Number	User Access	Surface Type
5/19/2016	46495	PUBLIC	ASPHALT
Area (Sq. Ft.)	Lane Miles (11' Widths)	Curb Reveal (Inches)	Curb Recommendation
2,187	0.038	7	DO NOTHING
Curb Type		Curb & Gutter Type	
CONCRETE		NO CURB AND GUTTER	
Pavement Recommendation		Condition Rating / PCR	
LIGHT 3R TREATMENTS		FAIR / 73
