BRCA Cycle 6

Final Report

Road Inventory and Condition Assessment of Paved Routes Bryce Canyon National Park

Federal Highway Administration
Eastern Federal Lands Highway Division
Road Inventory Program (RIP)

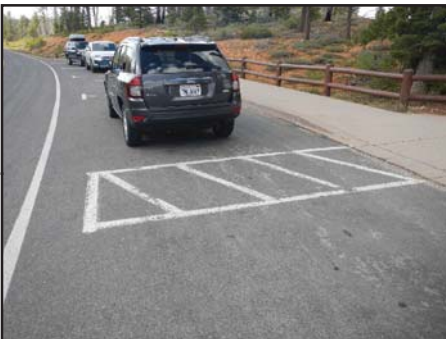
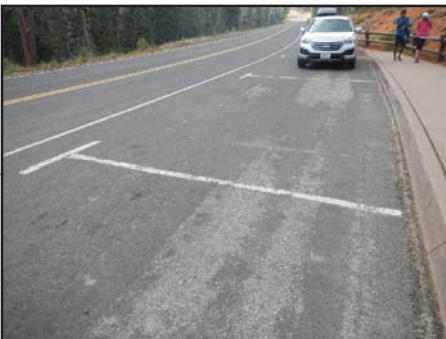
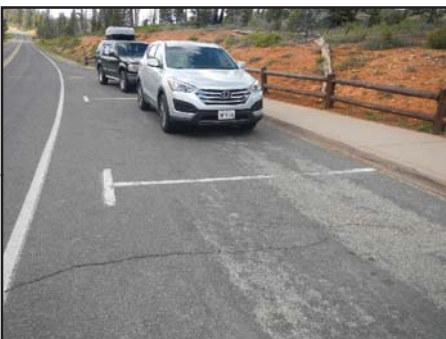
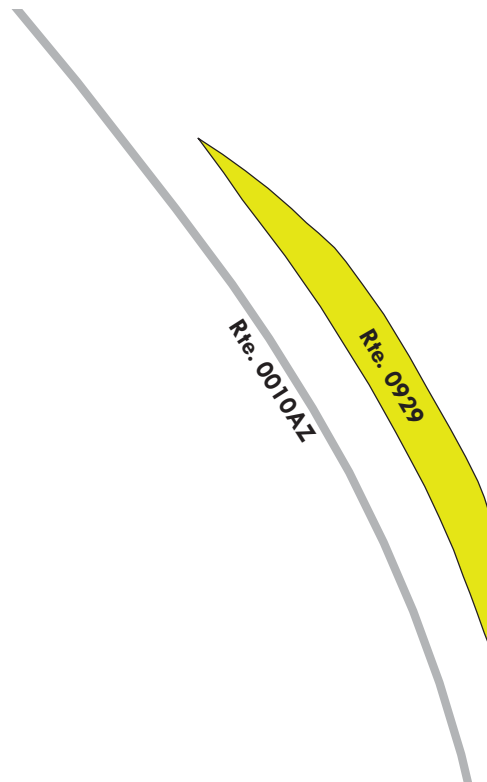
Inspection Date	FMSS Number	User Access	Surface Type
5/19/2016	46495	PUBLIC	ASPHALT
Area (Sq. Ft.)	Lane Miles (11' Widths)	Curb Reveal (Inches)	Curb Recommendation
2,187	0.038	7	DO NOTHING
Curb Type		Curb & Gutter Type	
CONCRETE		NO CURB AND GUTTER	
Pavement Recommendation		Condition Rating / PCR	
LIGHT 3R TREATMENTS		FAIR / 73

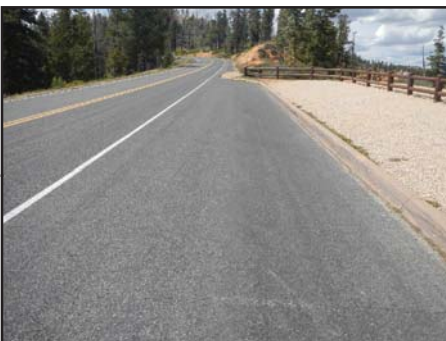
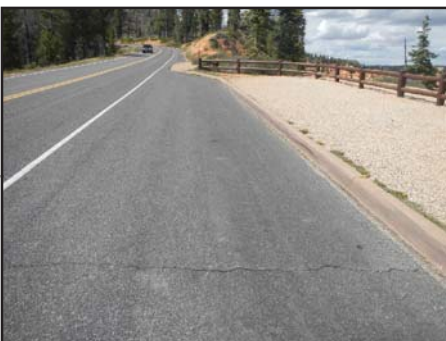
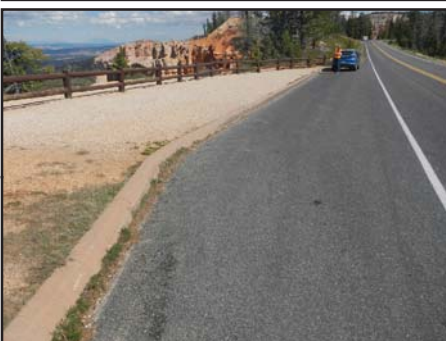
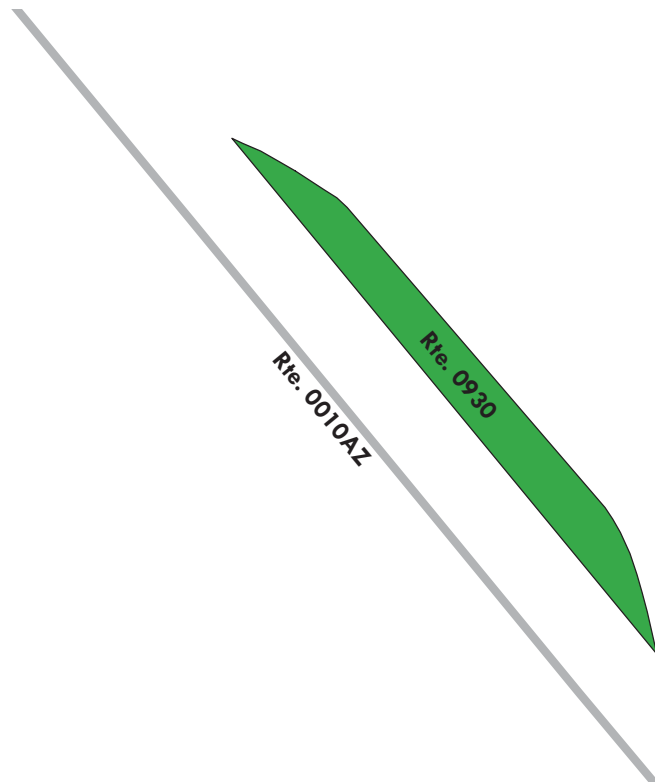
ROUTE 0930: NO-NAME NORTH PARKING AT MP 15.6

Inspection Date	FMSS Number	User Access	Surface Type
5/19/2016	46483	PUBLIC	ASPHALT
Area (Sq. Ft.)	Lane Miles (11' Widths)	Curb Reveal (Inches)	Curb Recommendation
1,700	0.029	7	DO NOTHING
Curb Type		Curb & Gutter Type	
CONCRETE		NO CURB AND GUTTER	
Pavement Recommendation		Condition Rating / PCR	
PREVENTIVE MAINTENANCE		GOOD / 90

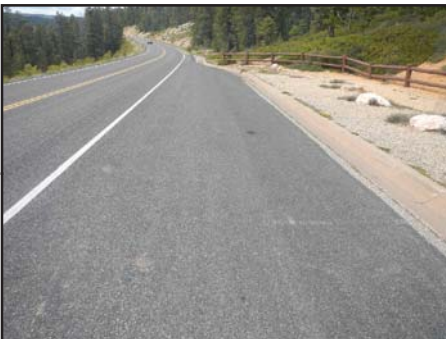
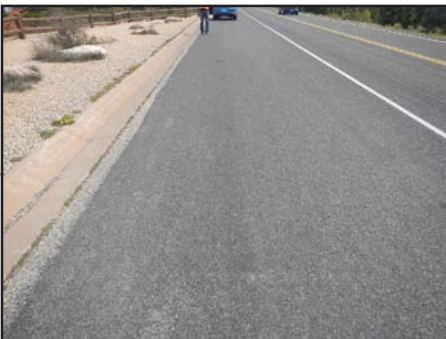
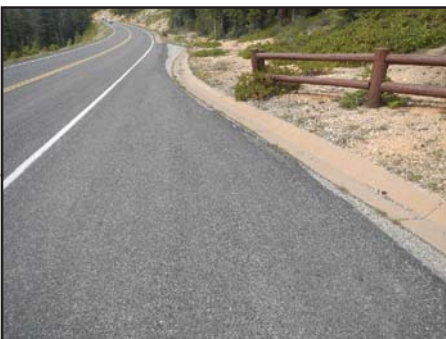
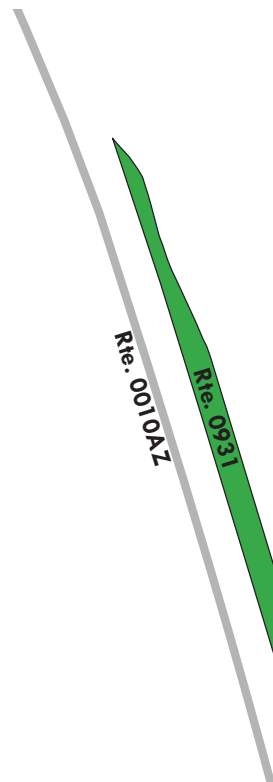
ROUTE 0931: NO-NAME MIDDLE PARKING AT MP 13.2

Inspection Date	FMSS Number	User Access	Surface Type
5/19/2016	56325	PUBLIC	ASPHALT
Area (Sq. Ft.)	Lane Miles (11' Widths)	Curb Reveal (Inches)	Curb Recommendation
2,518	0.043	NOT APPLICABLE	DO NOTHING
Curb Type		Curb & Gutter Type	
NO CURB		CONCRETE	
Pavement Recommendation		Condition Rating / PCR	
PREVENTIVE MAINTENANCE		GOOD / 90

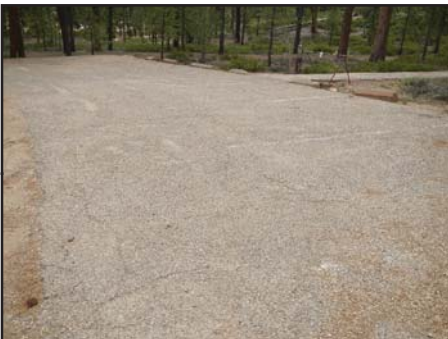
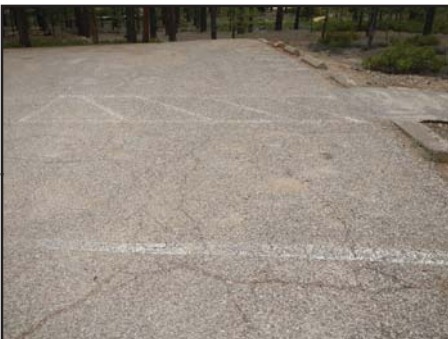
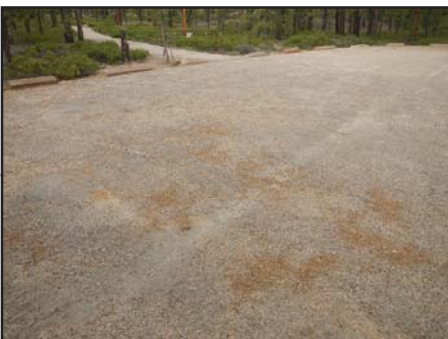
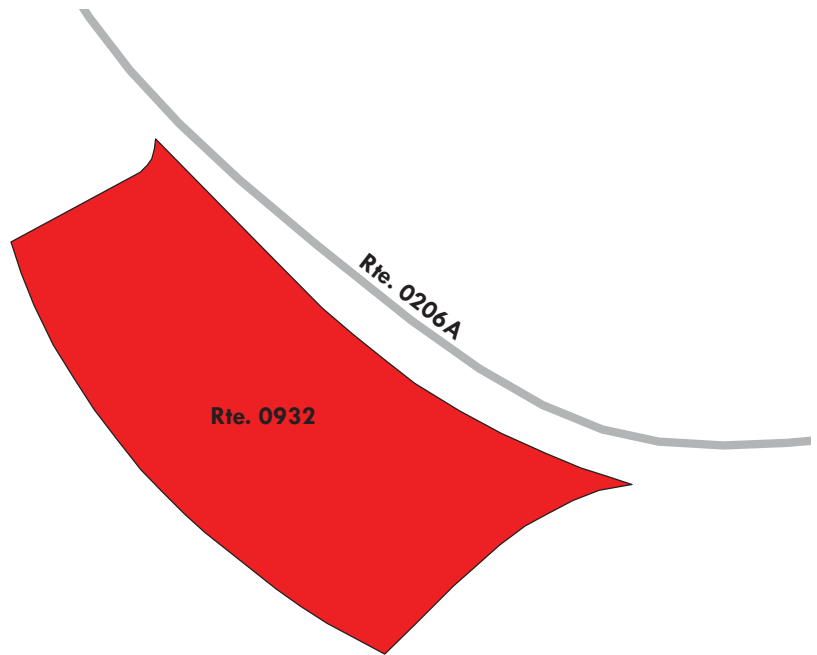
ROUTE 0932: WORK GROUP SITE PARKING

Inspection Date	FMSS Number	User Access	Surface Type
5/19/2016	91727	PUBLIC	ASPHALT
Area (Sq. Ft.)	Lane Miles (11' Widths)	Curb Reveal (Inches)	Curb Recommendation
3,470	0.06	NOT APPLICABLE	NOT APPLICABLE
Curb Type		Curb & Gutter Type	
NO CURB		NO CURB AND GUTTER	
Pavement Recommendation		Condition Rating / PCR	
RECONSTRUCTION		POOR / 30

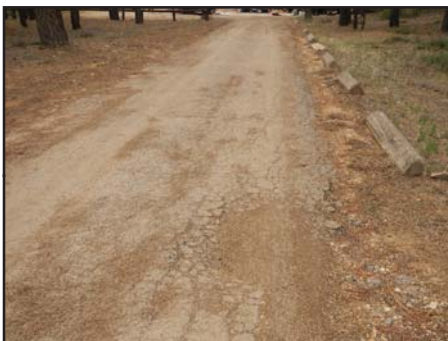
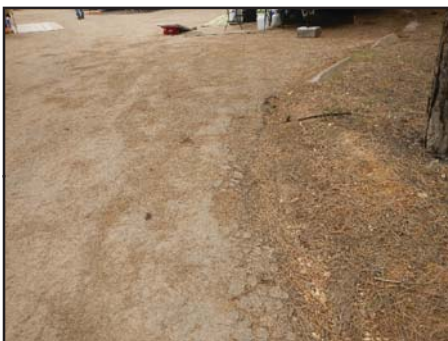
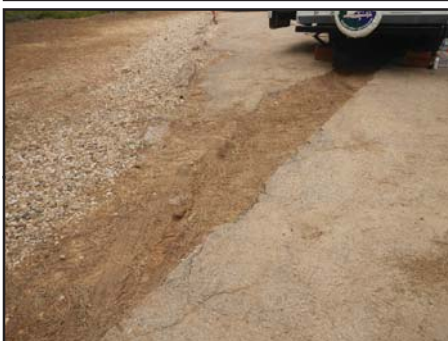
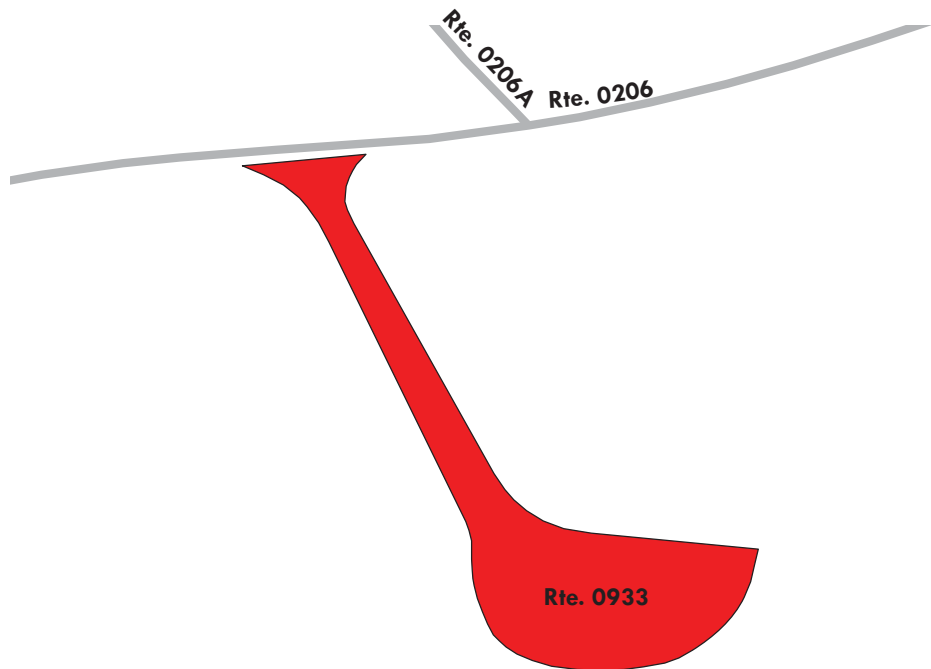
ROUTE 0933: SUNSET CAMPGROUND GROUP SITE PARKING

Inspection Date	FMSS Number	User Access	Surface Type
5/19/2016	91728	PUBLIC	ASPHALT
Area (Sq. Ft.)	Lane Miles (11' Widths)	Curb Reveal (Inches)	Curb Recommendation
7,239	0.125	NOT APPLICABLE	NOT APPLICABLE
Curb Type		Curb & Gutter Type	
NO CURB		NO CURB AND GUTTER	
Pavement Recommendation		Condition Rating / PCR	
RECONSTRUCTION		POOR / 30

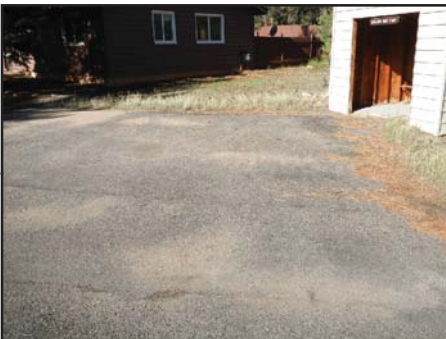
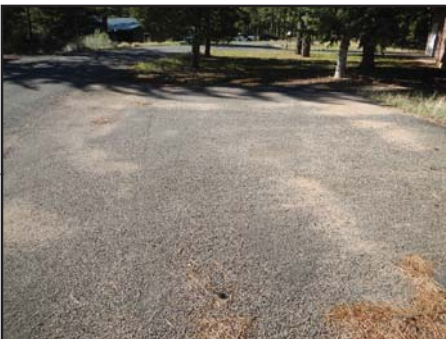
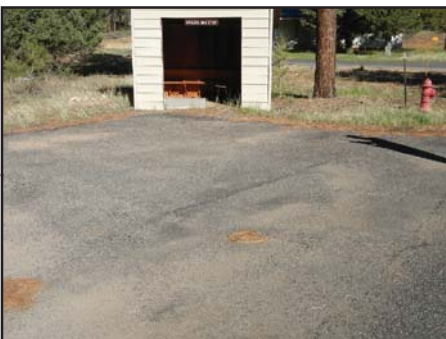
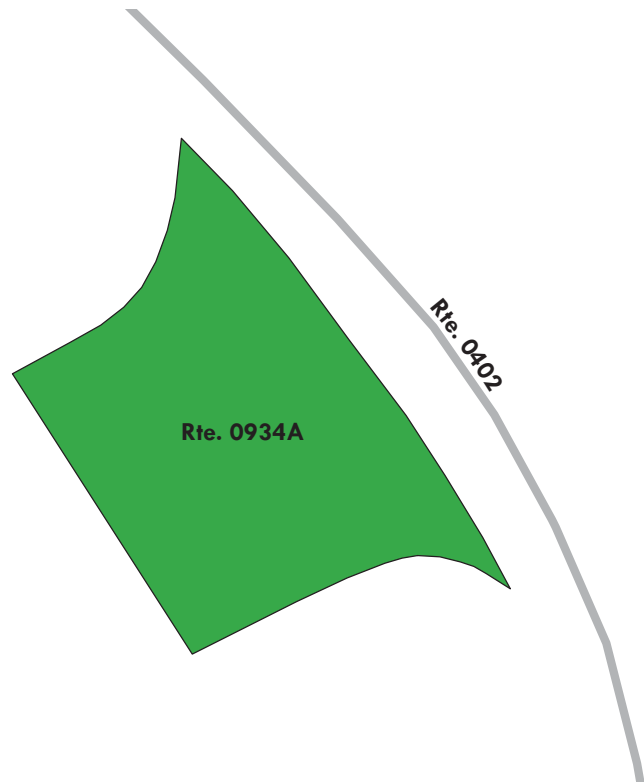
ROUTE 0934A: SCHOOL BUS STOP PARKING

Inspection Date	FMSS Number	User Access	Surface Type
5/19/2016	91748	PUBLIC	ASPHALT
Area (Sq. Ft.)	Lane Miles (11' Widths)	Curb Reveal (Inches)	Curb Recommendation
912	0.016	NOT APPLICABLE	NOT APPLICABLE
Curb Type		Curb & Gutter Type	
NO CURB		NO CURB AND GUTTER	
Pavement Recommendation		Condition Rating / PCR	
PREVENTIVE MAINTENANCE		GOOD / 90

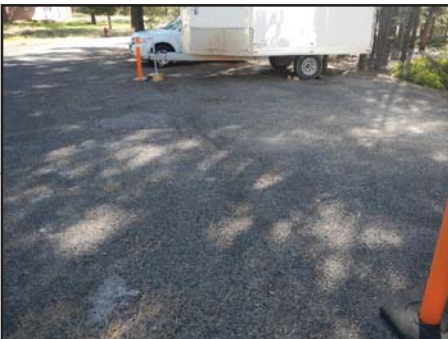
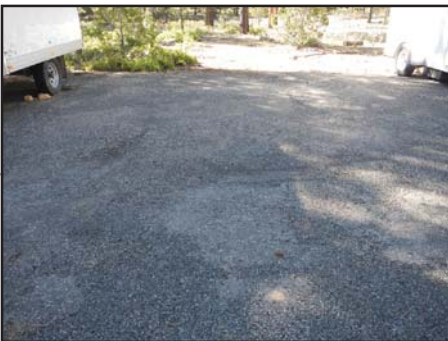
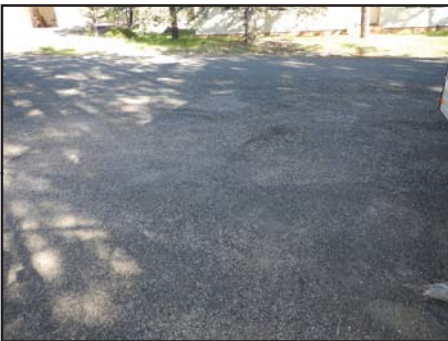
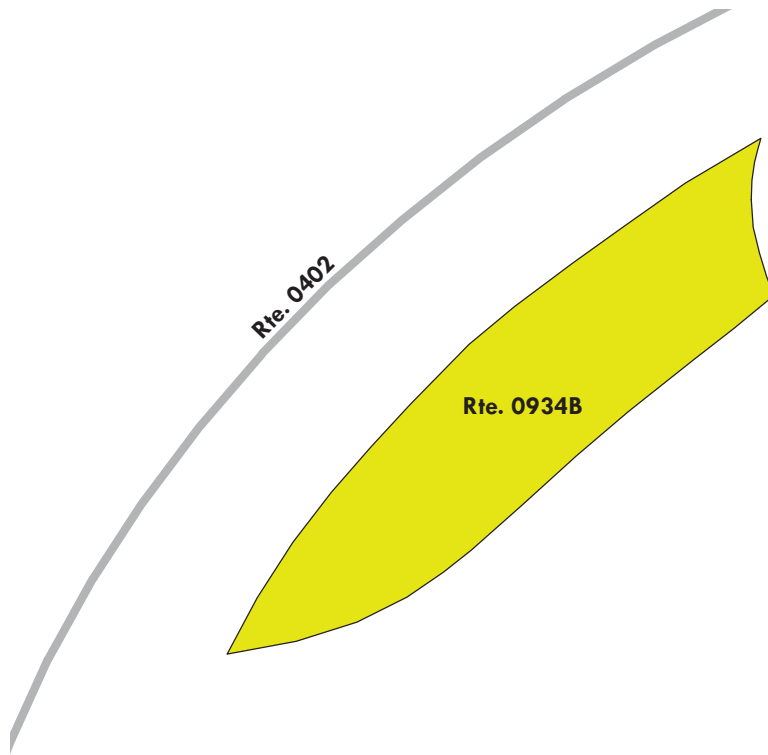
ROUTE 0934B: PARKING AREA ACROSS FROM Q-19

Inspection Date	FMSS Number	User Access	Surface Type
5/19/2016	91749	PUBLIC	ASPHALT
Area (Sq. Ft.)	Lane Miles (11' Widths)	Curb Reveal (Inches)	Curb Recommendation
1,612	0.028	NOT APPLICABLE	NOT APPLICABLE
Curb Type		Curb & Gutter Type	
NO CURB		NO CURB AND GUTTER	
Pavement Recommendation		Condition Rating / PCR	
LIGHT 3R TREATMENTS		FAIR / 73

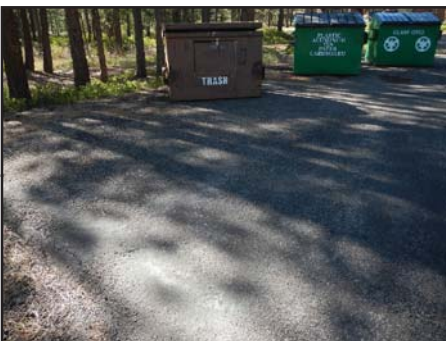
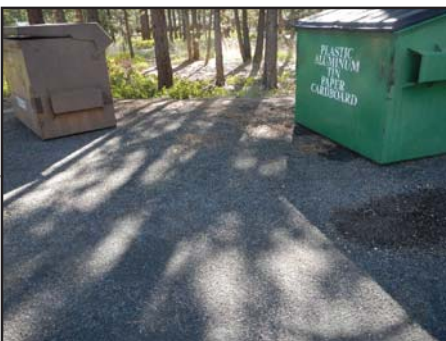
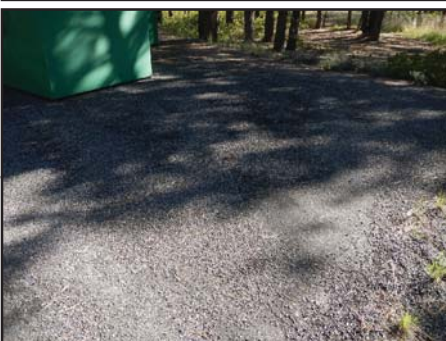
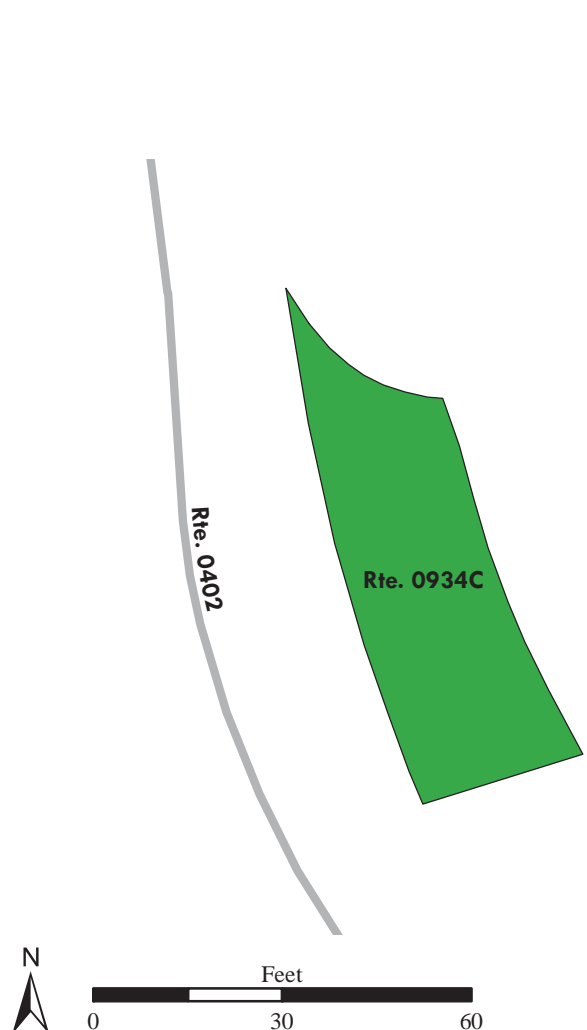
ROUTE 0934C: PARKING AREA ACROSS FROM Q-21

Inspection Date	FMSS Number	User Access	Surface Type
5/19/2016	91750	PUBLIC	ASPHALT
Area (Sq. Ft.)	Lane Miles (11' Widths)	Curb Reveal (Inches)	Curb Recommendation
1,295	0.022	NOT APPLICABLE	NOT APPLICABLE
Curb Type		Curb & Gutter Type	
NO CURB		NO CURB AND GUTTER	
Pavement Recommendation		Condition Rating / PCR	
PREVENTIVE MAINTENANCE		GOOD / 90

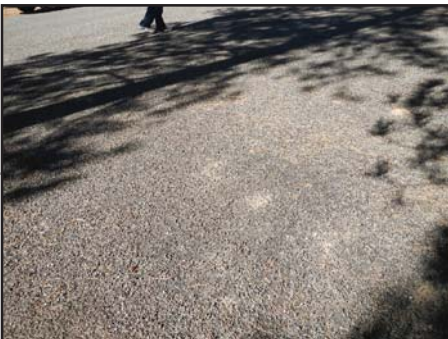
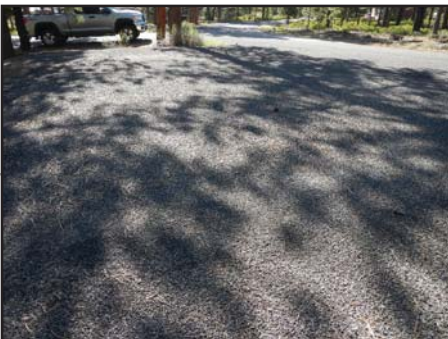
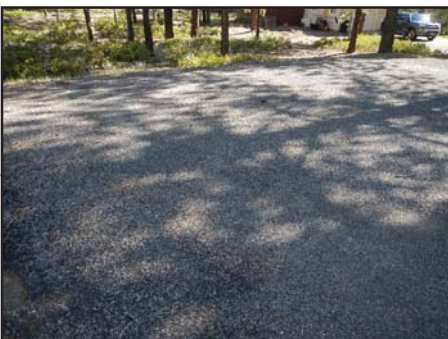
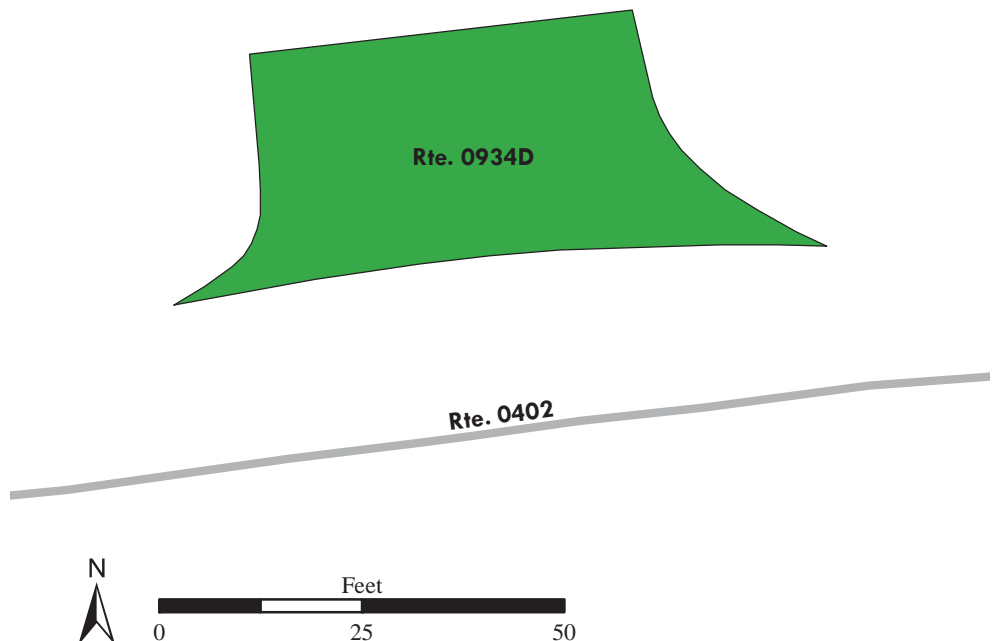
ROUTE 0934D: PARKING AREA ACROSS FROM Q-24

Inspection Date	FMSS Number	User Access	Surface Type
5/19/2016	91751	PUBLIC	ASPHALT
Area (Sq. Ft.)	Lane Miles (11' Widths)	Curb Reveal (Inches)	Curb Recommendation
1,235	0.021	NOT APPLICABLE	NOT APPLICABLE
Curb Type		Curb & Gutter Type	
NO CURB		NO CURB AND GUTTER	
Pavement Recommendation		Condition Rating / PCR	
PREVENTIVE MAINTENANCE		GOOD / 90

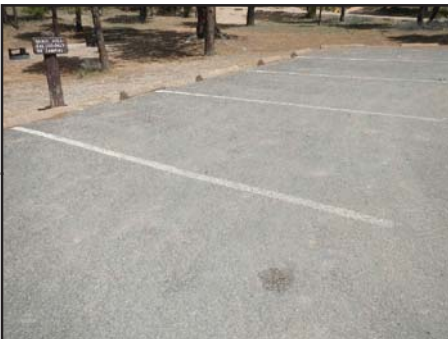
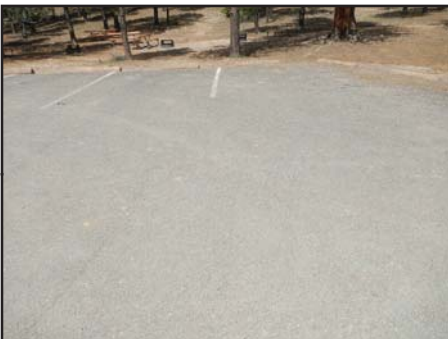
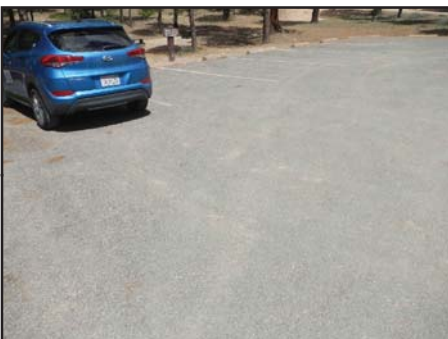
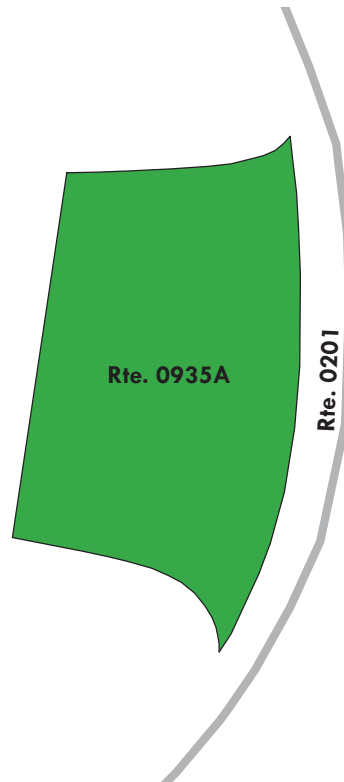
ROUTE 0935A: NORTH CAMPGROUND PICNIC AREA PARKING NORTH

Inspection Date	FMSS Number	User Access	Surface Type
5/19/2016	91724	PUBLIC	ASPHALT
Area (Sq. Ft.)	Lane Miles (11' Widths)	Curb Reveal (Inches)	Curb Recommendation
2,860	0.049	NOT APPLICABLE	NOT APPLICABLE
Curb Type		Curb & Gutter Type	
NO CURB		NO CURB AND GUTTER	
Pavement Recommendation		Condition Rating / PCR	
PREVENTIVE MAINTENANCE		GOOD / 90

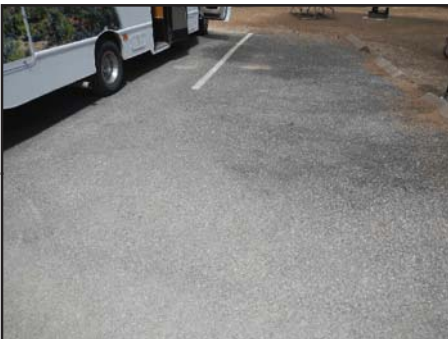
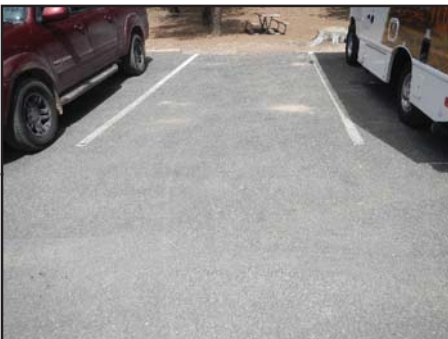
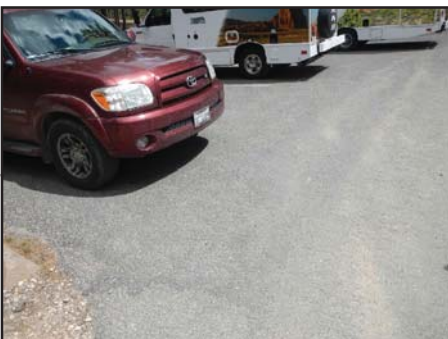
ROUTE 0936: NORTH CAMPGROUND PICNIC AREA PARKING

Inspection Date	FMSS Number	User Access	Surface Type
5/19/2016	91726	PUBLIC	ASPHALT
Area (Sq. Ft.)	Lane Miles (11' Widths)	Curb Reveal (Inches)	Curb Recommendation
2,725	0.047	NOT APPLICABLE	NOT APPLICABLE
Curb Type		Curb & Gutter Type	
NO CURB		NO CURB AND GUTTER	
Pavement Recommendation		Condition Rating / PCR	
PREVENTIVE MAINTENANCE		GOOD / 90

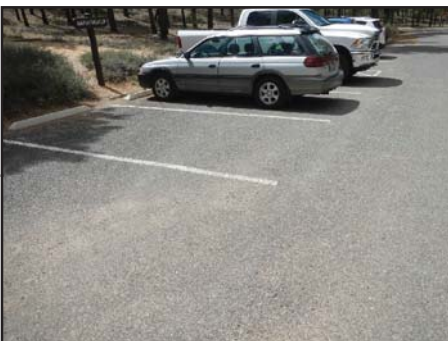
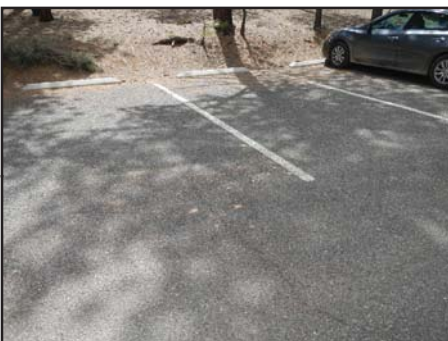
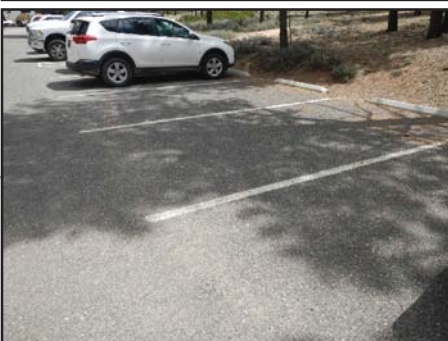
ROUTE 0937: LONG HOLLOW PICNIC PARKING AREA

Inspection Date	FMSS Number	User Access	Surface Type
5/19/2016	46469	PUBLIC	ASPHALT
Area (Sq. Ft.)	Lane Miles (11' Widths)	Curb Reveal (Inches)	Curb Recommendation
14,265	0.246	7	DO NOTHING
Curb Type		Curb & Gutter Type	
CONCRETE		NO CURB AND GUTTER	
Pavement Recommendation		Condition Rating / PCR	
LIGHT 3R TREATMENTS		FAIR / 73

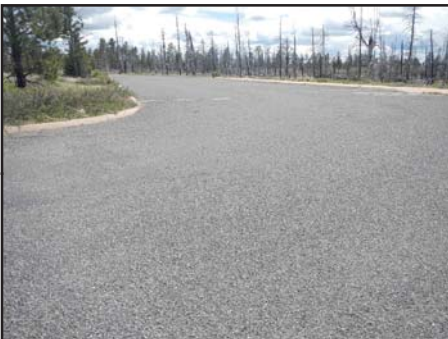
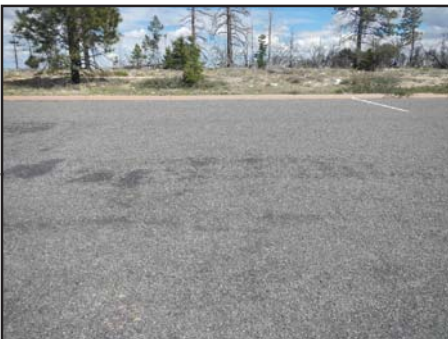
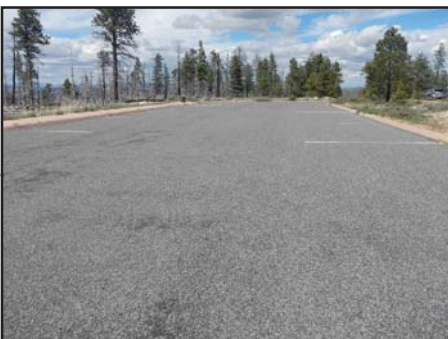
ROUTE 0938: WHITEMAN TRAILHEAD PARKING

Inspection Date	FMSS Number	User Access	Surface Type
5/19/2016	46471	PUBLIC	ASPHALT
Area (Sq. Ft.)	Lane Miles (11' Widths)	Curb Reveal (Inches)	Curb Recommendation
2,559	0.044	NOT APPLICABLE	NOT APPLICABLE
Curb Type		Curb & Gutter Type	
NO CURB		NO CURB AND GUTTER	
Pavement Recommendation		Condition Rating / PCR	
PREVENTIVE MAINTENANCE		GOOD / 90

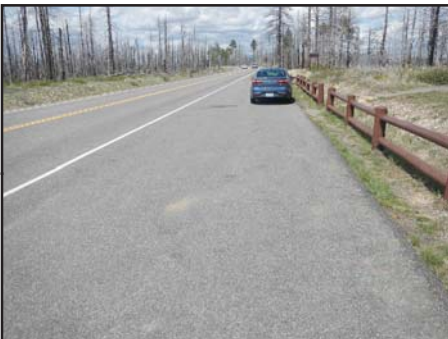
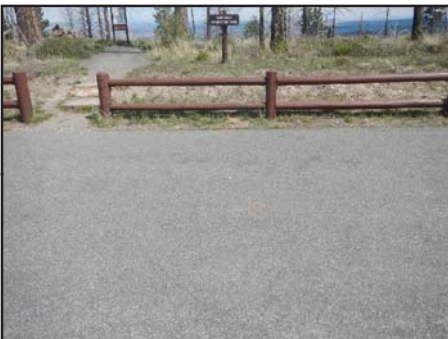
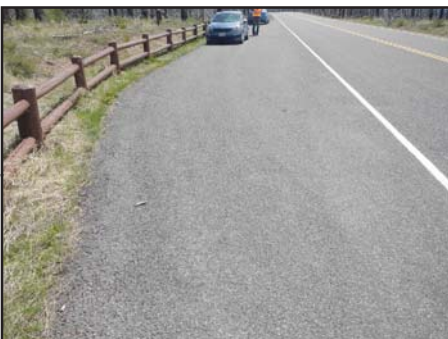
ROUTE 0939: SWAMP CANYON PARKING

Inspection Date	FMSS Number	User Access	Surface Type
5/19/2016	46472	PUBLIC	ASPHALT
Area (Sq. Ft.)	Lane Miles (11' Widths)	Curb Reveal (Inches)	Curb Recommendation
9,575	0.165	6	DO NOTHING
Curb Type		Curb & Gutter Type	
CONCRETE		NO CURB AND GUTTER	
Pavement Recommendation		Condition Rating / PCR	
PREVENTIVE MAINTENANCE		GOOD / 90

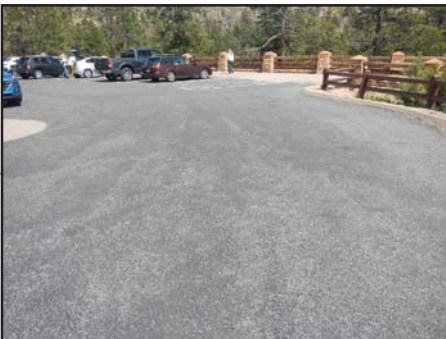
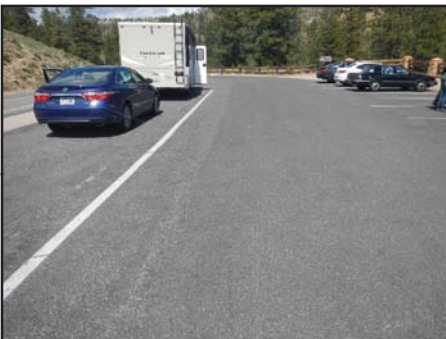
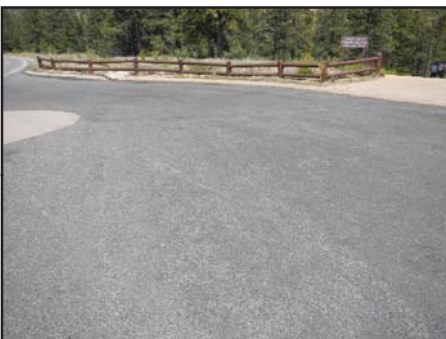
ROUTE 0940: CCC PICNIC AREA PARKING

Inspection Date	FMSS Number	User Access	Surface Type
5/19/2016	46476	PUBLIC	ASPHALT
Area (Sq. Ft.)	Lane Miles (11' Widths)	Curb Reveal (Inches)	Curb Recommendation
2,736	0.047	8	DO NOTHING
Curb Type		Curb & Gutter Type	
CONCRETE		NO CURB AND GUTTER	
Pavement Recommendation		Condition Rating / PCR	
PREVENTIVE MAINTENANCE		GOOD / 90

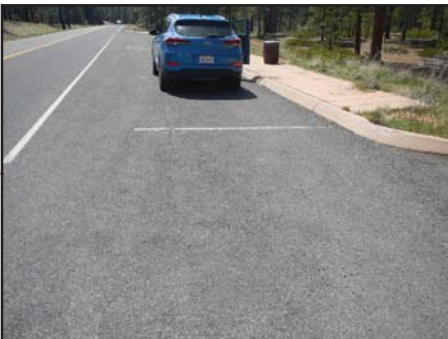
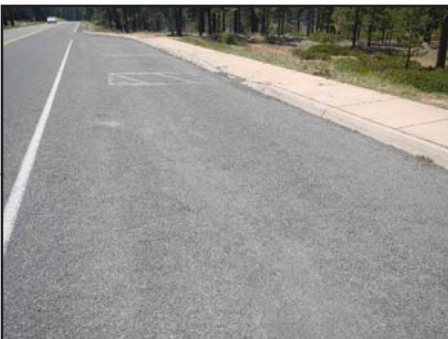
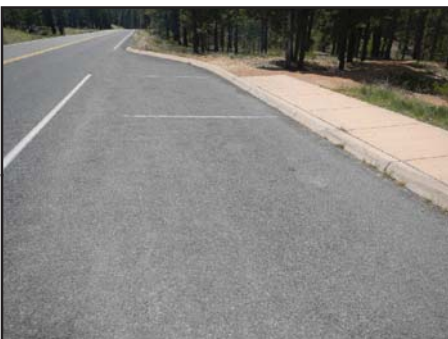
ROUTE 0941: MAINTENANCE COMPLEX PARKING

Inspection Date	FMSS Number	User Access	Surface Type
5/19/2016	N/A	NONPUBLIC	ASPHALT
Area (Sq. Ft.)	Lane Miles (11' Widths)	Curb Reveal (Inches)	Curb Recommendation
60,297	1.038	NOT APPLICABLE	NOT APPLICABLE
Curb Type		Curb & Gutter Type	
NO CURB		NO CURB AND GUTTER	
Pavement Recommendation		Condition Rating / PCR	
PREVENTIVE MAINTENANCE		GOOD / 90

Parking area consists of multiple surface types: 1 part Asphalt at 57,752 square feet; 1 part Concrete at 2,545 square feet.

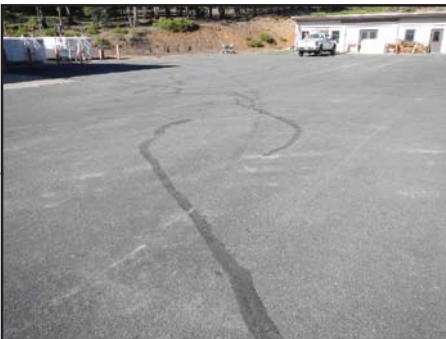
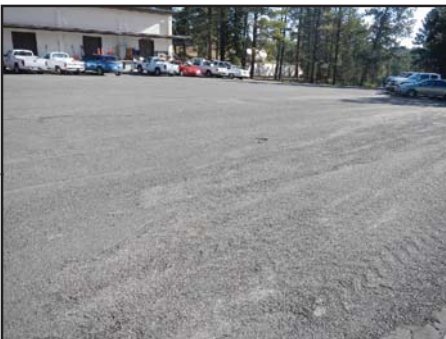
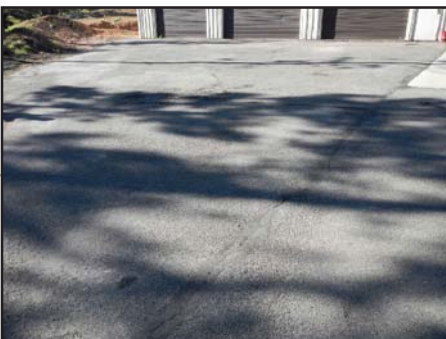
ROUTE 0942: VISITOR CENTER OVERFLOW PARKING

Inspection Date	FMSS Number	User Access	Surface Type
5/19/2016	246786	PUBLIC	ASPHALT
Area (Sq. Ft.)	Lane Miles (11' Widths)	Curb Reveal (Inches)	Curb Recommendation
47,837	0.824	NOT APPLICABLE	NOT APPLICABLE
Curb Type		Curb & Gutter Type	
NO CURB		NO CURB AND GUTTER	
Pavement Recommendation		Condition Rating / PCR	
PREVENTIVE MAINTENANCE		GOOD / 90
