CACH Cycle 6

Final Report

Road Inventory and Condition Assessment of Paved Routes Canyon de Chelly National Monument

Report Date: March 2017

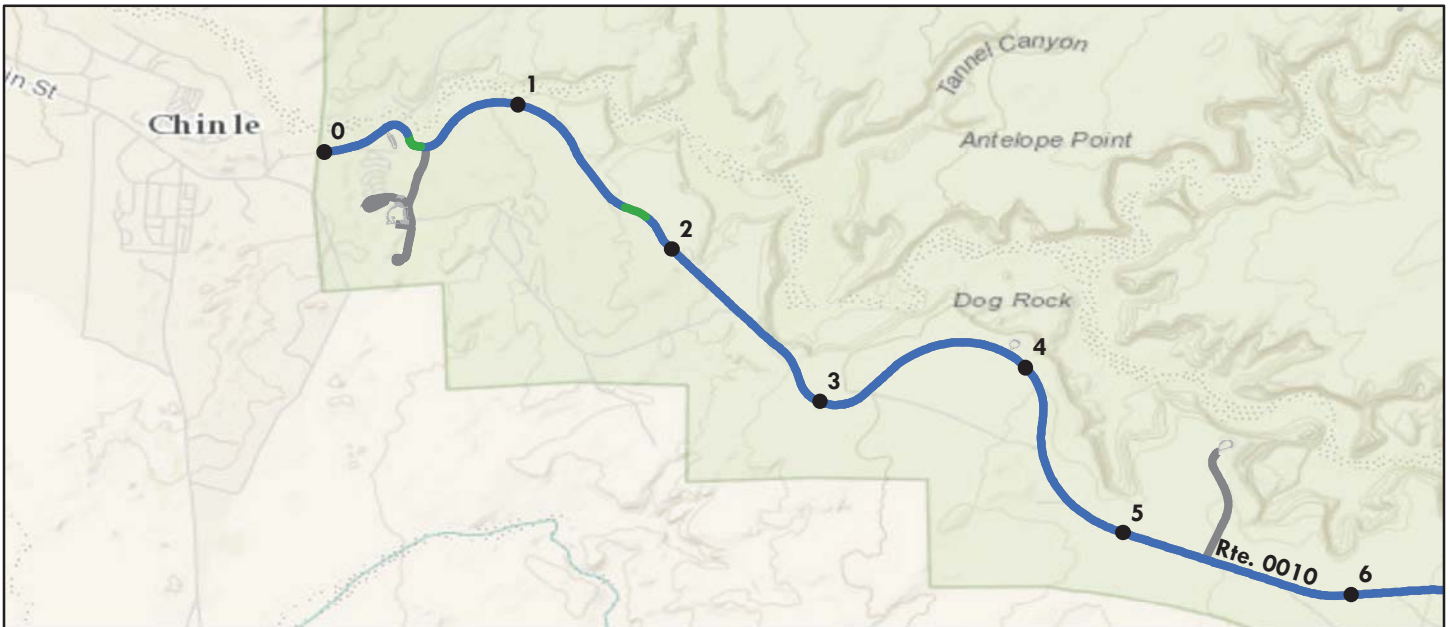
ROUTE 0010: INDIAN ROUTE 7 (SOUTH RIM DRIVE)

Route Condition Legend – Pavement Condition Rating (PCR)						
Poor (0 - 60)	Fair (61- 84)	Good (85 - 94)	Excellent (95 - 100)	Not Rated		
See Appendix for definitions and formulas						
Inspection Date: 11/3/2016	Beginning Section MP	0	1	2	3	4
Paved Length (Miles): 11.46	Section Length (MI)	1	1	1	1	1
Surface Type: ASPHALT	Route Summary					
Roadway Condition Information						
Pavement Condition Rating (PCR)	98	99	99	100	99	100
Surface Condition Rating (SCR)	96	99	99	100	99	100
Roughness Condition Index (RCI)	100	100	100	100	100	100
Distress Index Values						
Structural Crack Index	96	100	100	100	99	100
Alligator Crack Index	100	100	100	100	100	100
Longitudinal Crack Index	96	100	100	100	99	100
Transverse Cracking Index	97	100	100	100	100	100
Patching Index	100	99	99	100	100	100
Rutting Index	100	99	100	100	100	100
International Roughness Index (IRI)	67	81	71	48	57	81
Lane & Width Information						
Number of Lanes	2	2	2	2	2	2

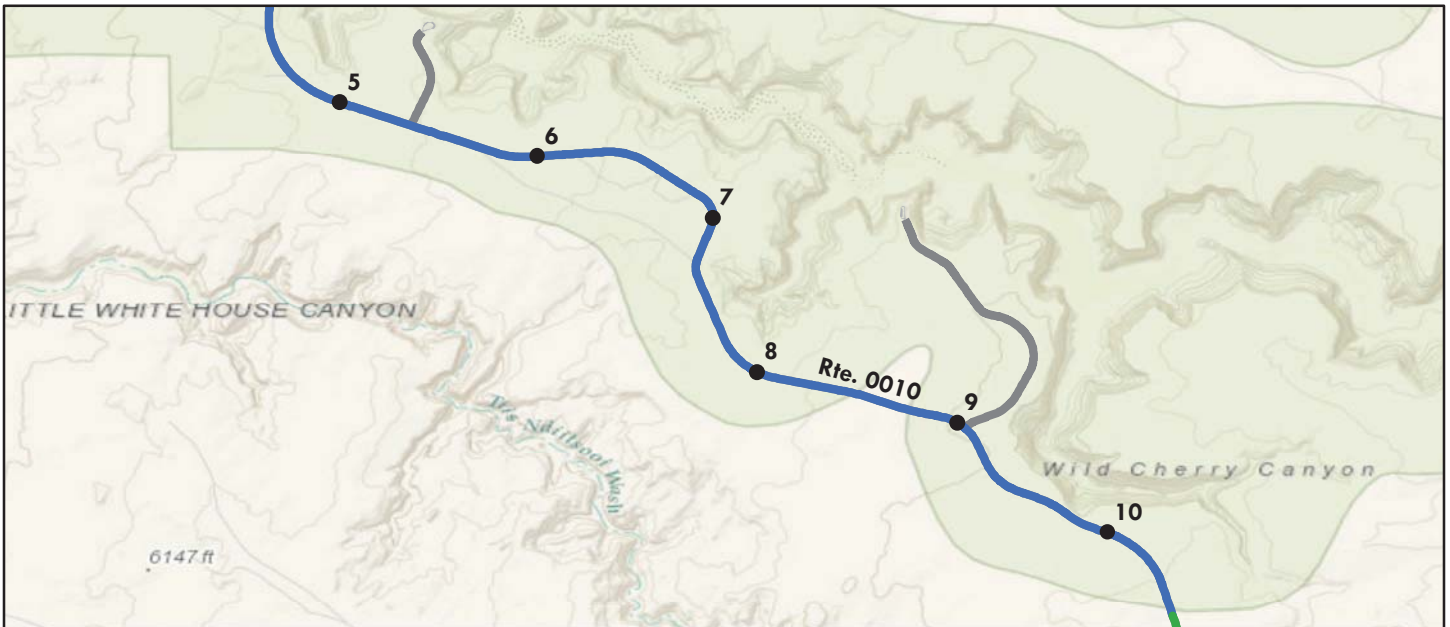
ROUTE 0010: INDIAN ROUTE 7 (SOUTH RIM DRIVE)

Route Condition Legend – Pavement Condition Rating (PCR)						
Poor (0 - 60)	Fair (61- 84)	Good (85 - 94)	Excellent (95 - 100)	Not Rated		
See Appendix for definitions and formulas						
Inspection Date: 11/3/2016	Beginning Section MP	5	6	7	8	9
Paved Length (Miles): 11.46	Section Length (MI)	1	1	1	1	1
Surface Type: ASPHALT	Route Summary					
Roadway Condition Information						
Pavement Condition Rating (PCR)	98	100	100	100	100	100
Surface Condition Rating (SCR)	96	100	100	100	100	100
Roughness Condition Index (RCI)	100	100	100	100	100	100
Distress Index Values						
Structural Crack Index	96	100	100	100	100	100
Alligator Crack Index	100	100	100	100	100	100
Longitudinal Crack Index	96	100	100	100	100	100
Transverse Cracking Index	97	100	100	100	100	100
Patching Index	100	100	100	100	100	100
Rutting Index	100	100	100	100	100	100
International Roughness Index (IRI)	67	60	62	55	52	56
Lane & Width Information

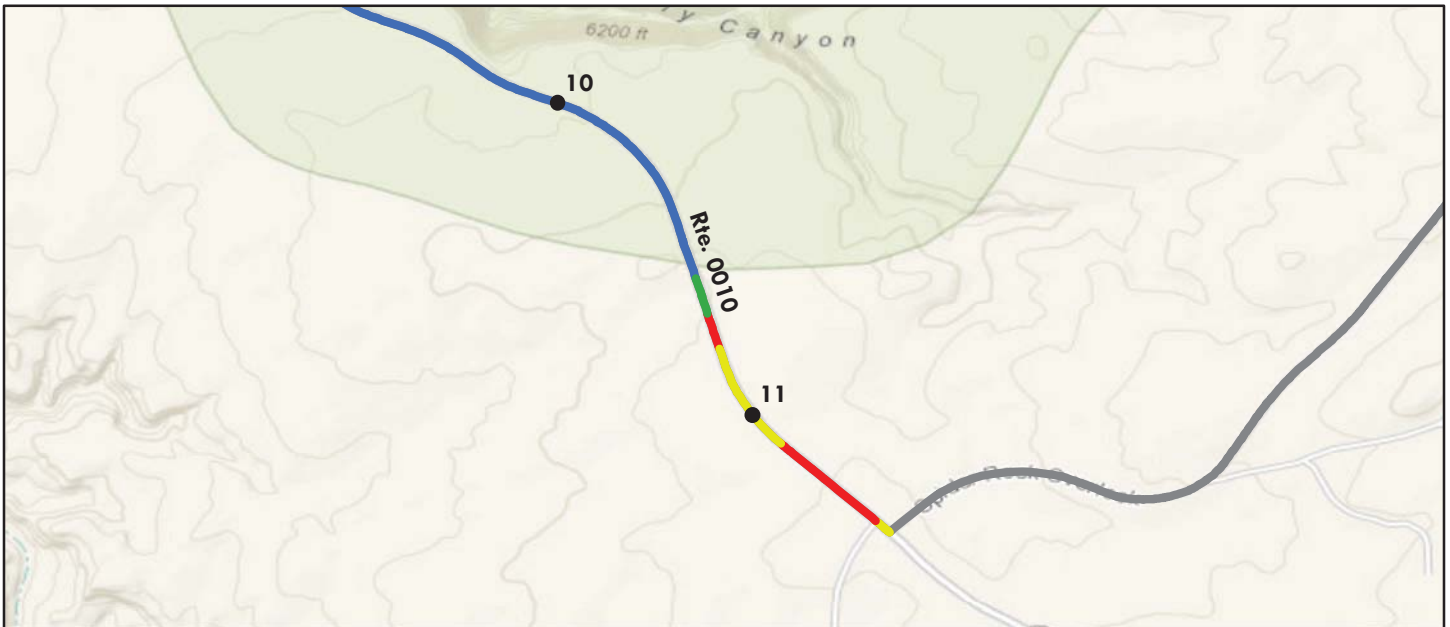
ROUTE 0010: INDIAN ROUTE 7 (SOUTH RIM DRIVE)

Route Condition Legend – Pavement Condition Rating (PCR)						
Poor (0 - 60)	Fair (61- 84)	Good (85 - 94)	Excellent (95 - 100)	Not Rated		
See Appendix for definitions and formulas						
Inspection Date:	11/3/2016	Beginning Section MP	10	11		
Paved Length (Miles):	11.46	Section Length (MI)	1	0.46		
Surface Type:	ASPHALT	Route Summary				
Roadway Condition Information						
Pavement Condition Rating (PCR)	98	91	60			
Surface Condition Rating (SCR)	96	85	38			
Roughness Condition Index (RCI)	100	100	93			
Distress Index Values						
Structural Crack Index	96	86	38			
Alligator Crack Index	100	100	100			
Longitudinal Crack Index	96	86	38			
Transverse Cracking Index	97	85	49			
Patching Index	100	100	100			
Rutting Index	100	99	97			
International Roughness Index (IRI)	67	87	133			
Lane & Width Information						
Number of Lanes	2	2	2			
Paved Width (ft)	24.1	26.1	26.8			
Lane Width (ft)	11.3	12.1	11.2

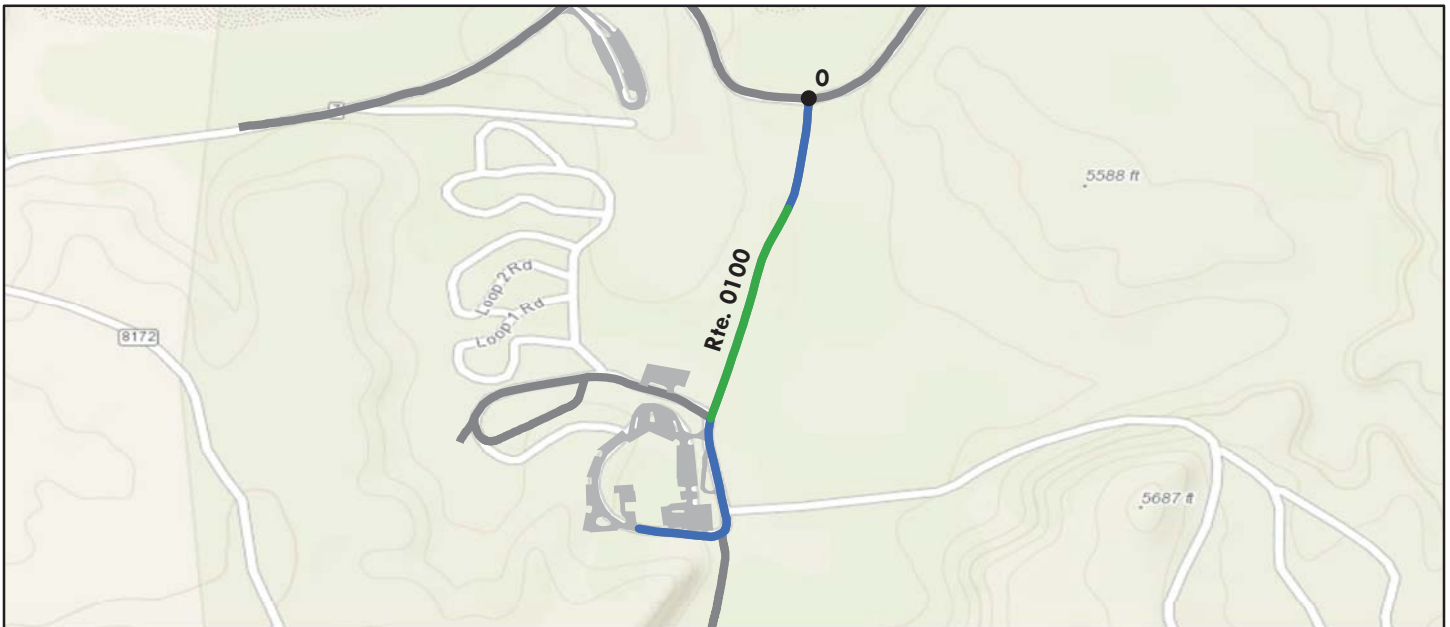
ROUTE 0100: LODGE CAMPGROUND ACCESS ROAD

Route Condition Legend – Pavement Condition Rating (PCR)						
Poor (0 - 60)	Fair (61- 84)	Good (85 - 94)	Excellent (95 - 100)	Not Rated		
See Appendix for definitions and formulas						
Inspection Date:	11/3/2016	Beginning Section MP	0			
Paved Length (Miles):	0.46	Section Length (MI)	0.46			
Surface Type:	ASPHALT	Route Summary				
Roadway Condition Information						
Pavement Condition Rating (PCR)	95	95				
Surface Condition Rating (SCR)	95	95				
Roughness Condition Index (RCI)	N/A	N/A				
Distress Index Values						
Structural Crack Index	99	99				
Alligator Crack Index	100	100				
Longitudinal Crack Index	99	99				
Transverse Cracking Index	95	95				
Patching Index	100	100				
Rutting Index	99	99				
International Roughness Index (IRI)	N/A	N/A				
Lane & Width Information						
Number of Lanes	2	2				
Paved Width (ft)	27.5	27.5				
Lane Width (ft)	13.8	13.8

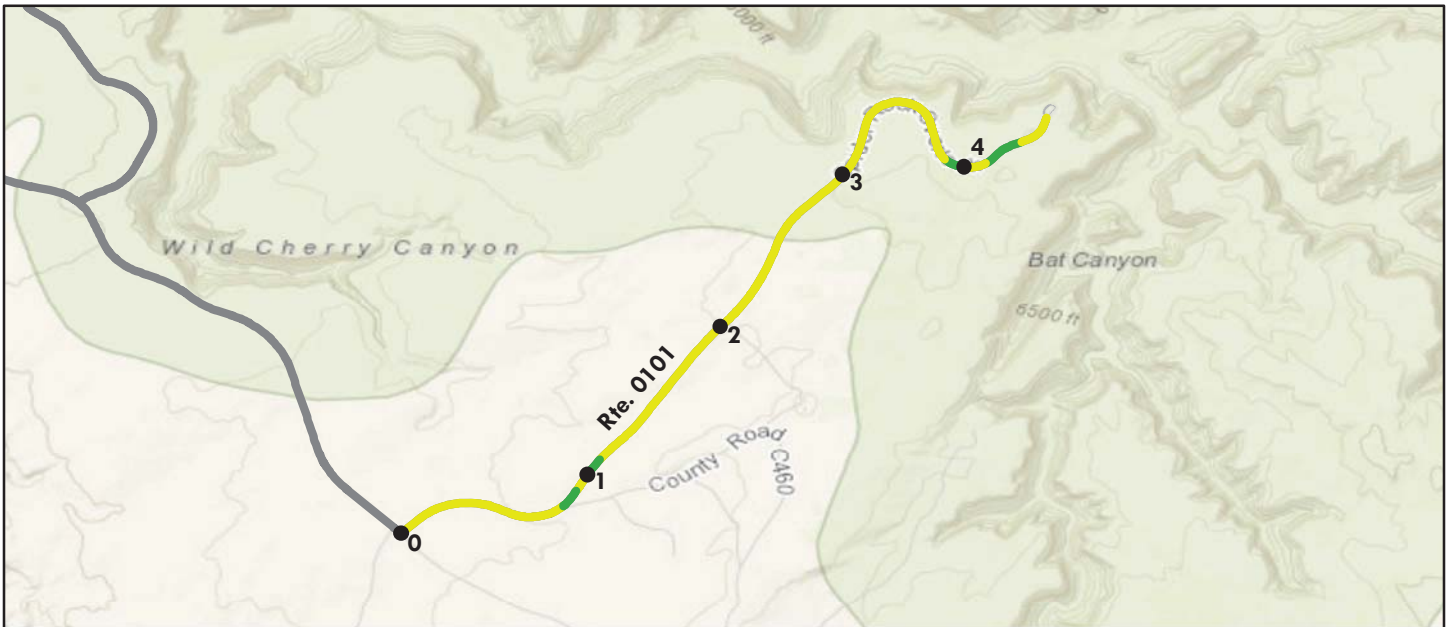
ROUTE 0101: SPIDER ROCK ROAD

Route Condition Legend – Pavement Condition Rating (PCR)						
Poor (0 - 60)	Fair (61- 84)	Good (85 - 94)	Excellent (95 - 100)	Not Rated		
See Appendix for definitions and formulas						
Inspection Date: 11/3/2016	Beginning Section MP	0	1	2	3	4
Paved Length (Miles): 4.48	Section Length (MI)	1	1	1	1	0.48
Surface Type: ASPHALT	Route Summary					
Roadway Condition Information						
Pavement Condition Rating (PCR)	76	78	75	69	78	84
Surface Condition Rating (SCR)	68	66	68	61	73	80
Roughness Condition Index (RCI)	88	97	86	82	86	89
Distress Index Values						
Structural Crack Index	85	81	85	80	92	95
Alligator Crack Index	100	100	100	100	100	100
Longitudinal Crack Index	85	81	85	80	92	95
Transverse Cracking Index	68	66	68	61	73	80
Patching Index	100	100	100	100	100	100
Rutting Index	98	98	97	97	97	98
International Roughness Index (IRI)	147	123	151	162	153	143
Lane & Width Information						
Number of Lanes	2	2	2	2	2	2

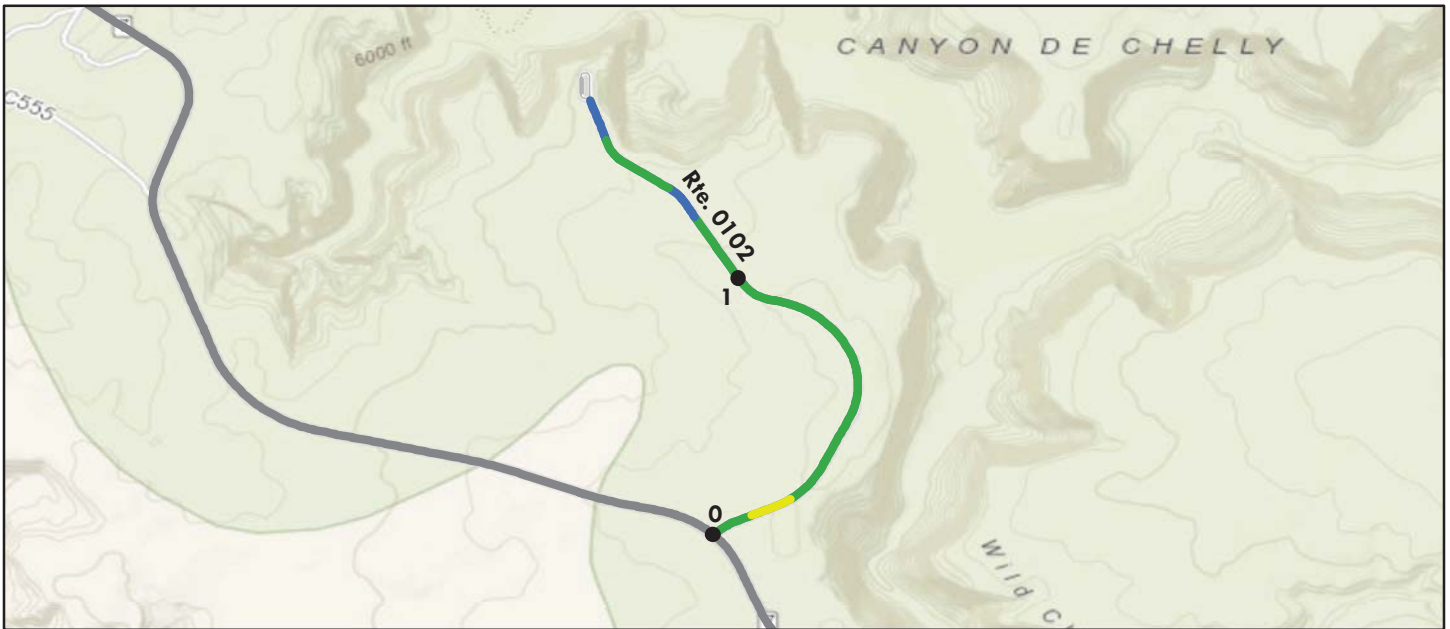
ROUTE 0102: SLIDING HOUSE OVERLOOK ROAD

Route Condition Legend – Pavement Condition Rating (PCR)									
Poor (0 - 60)		Fair (61- 84)		Good (85 - 94)		Excellent (95 - 100)		Not Rated	
See Appendix for definitions and formulas									
Inspection Date:	11/4/2016	Beginning Section MP	0	1					
Paved Length (Miles):	1.61	Section Length (MI)	1	0.61					
Surface Type:	ASPHALT	Route Summary							
Roadway Condition Information									
Pavement Condition Rating (PCR)	92	90	93						
Surface Condition Rating (SCR)	86	84	89						
Roughness Condition Index (RCI)	100	100	100						
Distress Index Values									
Structural Crack Index	88	86	91						
Alligator Crack Index	100	100	100						
Longitudinal Crack Index	88	86	91						
Transverse Cracking Index	86	84	89						
Patching Index	100	100	100						
Rutting Index	99	99	99						
International Roughness Index (IRI)	107	111	102						
Lane & Width Information									
Number of Lanes	2	2	2						
Paved Width (ft)	25.3	24.9	25.8

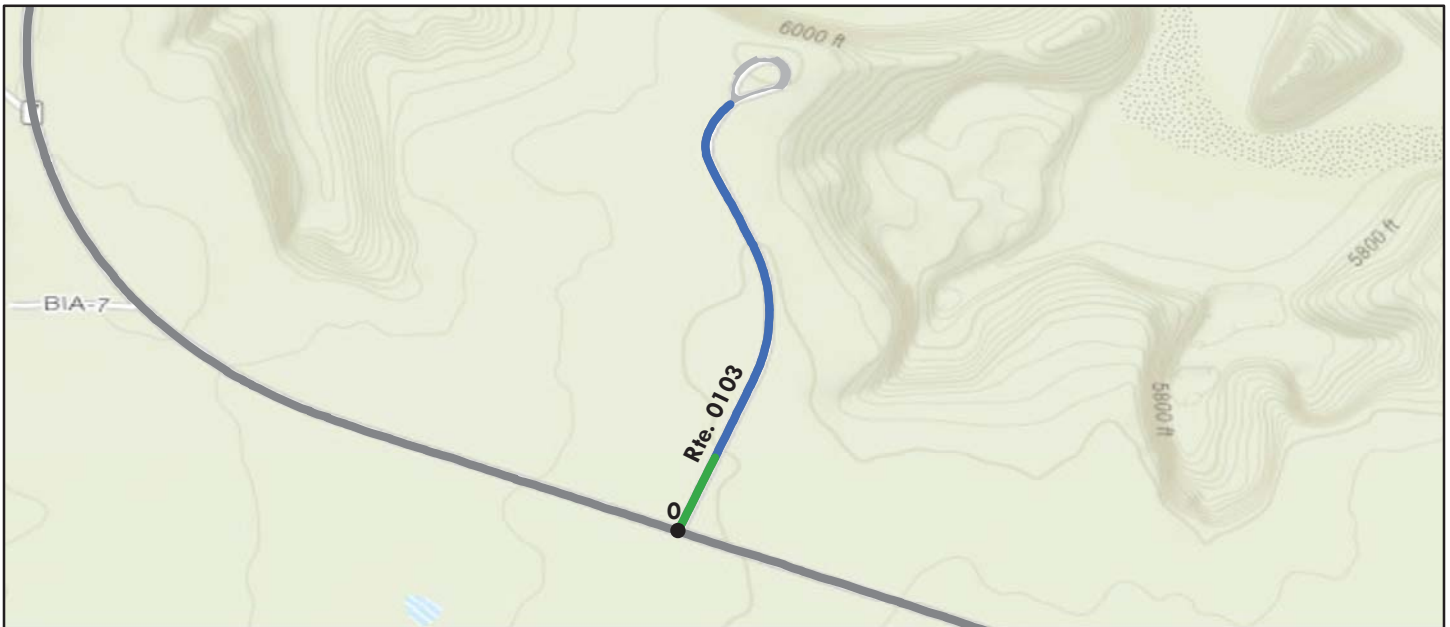
ROUTE 0103: WHITE HOUSE OVERLOOK ROAD

Route Condition Legend – Pavement Condition Rating (PCR)						
Poor (0 - 60)	Fair (61- 84)	Good (85 - 94)	Excellent (95 - 100)	Not Rated		
See Appendix for definitions and formulas						
Inspection Date: 11/4/2016	Beginning Section MP	0				
Paved Length (Miles): 0.58	Section Length (MI)	0.58				
Surface Type: ASPHALT	Route Summary					
Roadway Condition Information						
Pavement Condition Rating (PCR)	100	100				
Surface Condition Rating (SCR)	100	100				
Roughness Condition Index (RCI)	100	100				
Distress Index Values						
Structural Crack Index	100	100				
Alligator Crack Index	100	100				
Longitudinal Crack Index	100	100				
Transverse Cracking Index	100	100				
Patching Index	100	100				
Rutting Index	100	100				
International Roughness Index (IRI)	114	114				
Lane & Width Information						
Number of Lanes	2	2				
Paved Width (ft)	21.1	21.1				
Lane Width (ft)	10	10

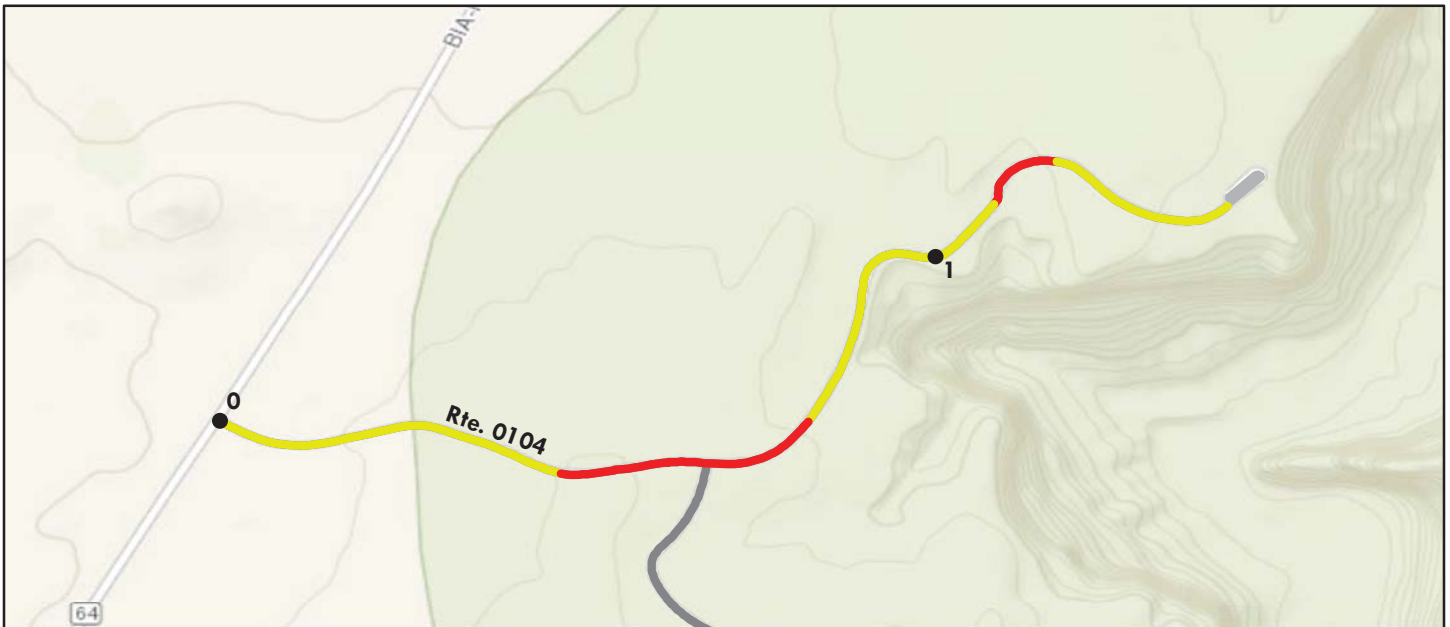
ROUTE 0104: MASSACRE CAVE OVERLOOK ROAD

Route Condition Legend – Pavement Condition Rating (PCR)						
Poor (0 - 60)	Fair (61- 84)	Good (85 - 94)	Excellent (95 - 100)	Not Rated		
See Appendix for definitions and formulas						
Inspection Date:	11/4/2016	Beginning Section MP	0	1		
Paved Length (Miles):	1.42	Section Length (MI)	1	0.42		
Surface Type:	ASPHALT	Route Summary				
Roadway Condition Information						
Pavement Condition Rating (PCR)	67	67	68			
Surface Condition Rating (SCR)	76	76	78			
Roughness Condition Index (RCI)	53	53	53			
Distress Index Values						
Structural Crack Index	76	76	78			
Alligator Crack Index	100	100	100			
Longitudinal Crack Index	76	76	78			
Transverse Cracking Index	87	88	86			
Patching Index	100	100	100			
Rutting Index	89	91	89			
International Roughness Index (IRI)	269	270	269			
Lane & Width Information						
Number of Lanes	2	2	2			
Paved Width (ft)	25.1	24.5	26.5			
Lane Width (ft)	11	10.5	12

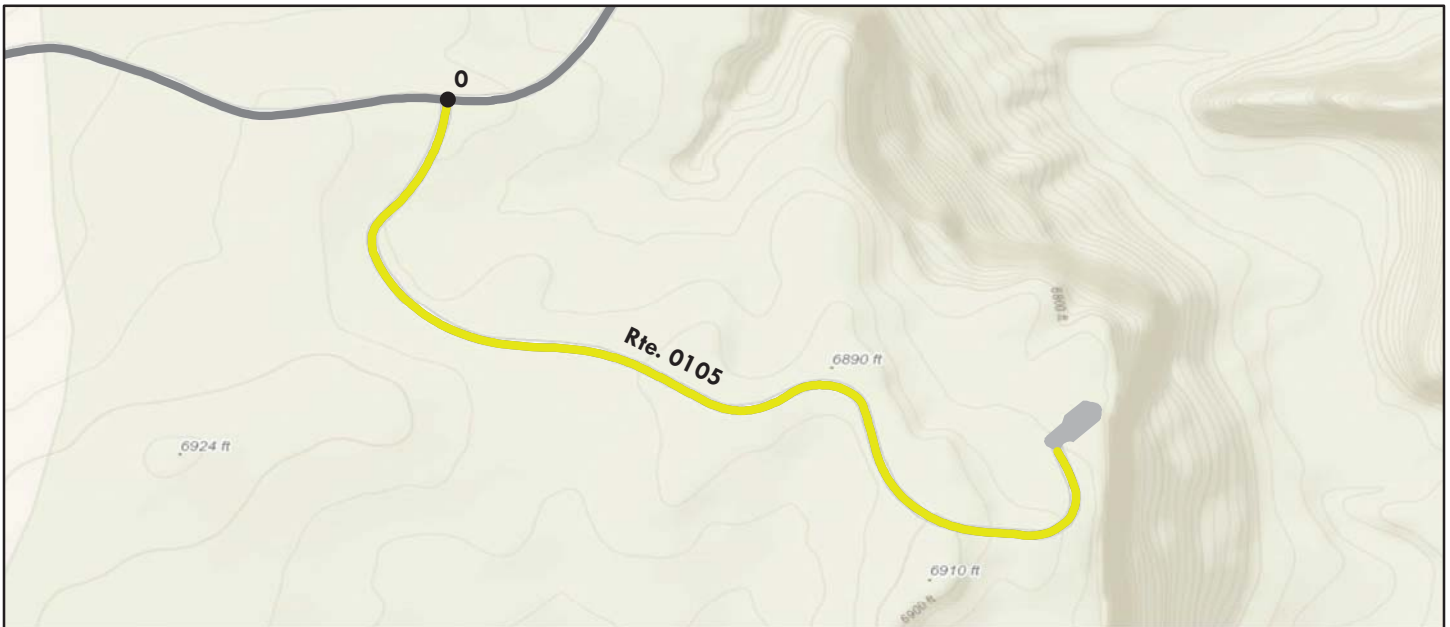
ROUTE 0105: MUMMY CAVE OVERLOOK ROAD

Route Condition Legend – Pavement Condition Rating (PCR)						
Poor (0 - 60)	Fair (61- 84)	Good (85 - 94)	Excellent (95 - 100)	Not Rated		
See Appendix for definitions and formulas						
Inspection Date: 11/4/2016	Beginning Section MP	0				
Paved Length (Miles): 0.94	Section Length (MI)	0.94				
Surface Type: ASPHALT	Route Summary					
Roadway Condition Information						
Pavement Condition Rating (PCR)	69	69				
Surface Condition Rating (SCR)	77	77				
Roughness Condition Index (RCI)	58	58				
Distress Index Values						
Structural Crack Index	77	77				
Alligator Crack Index	100	100				
Longitudinal Crack Index	77	77				
Transverse Cracking Index	83	83				
Patching Index	100	100				
Rutting Index	91	91				
International Roughness Index (IRI)	248	248				
Lane & Width Information						
Number of Lanes	2	2				
Paved Width (ft)	26.5	26.5				
Lane Width (ft)	11.3	11.3

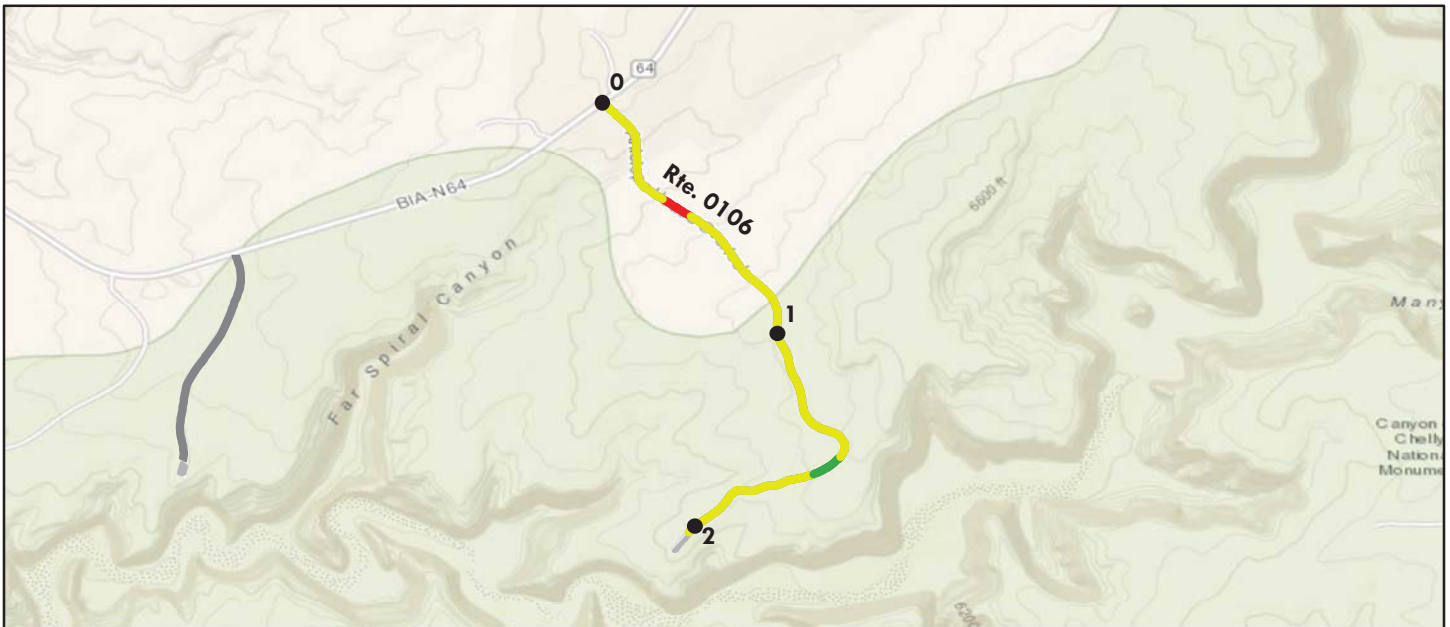
ROUTE 0106: ANTELOPE HOUSE OVERLOOK ROAD

Route Condition Legend – Pavement Condition Rating (PCR)									
Poor (0 - 60)		Fair (61- 84)		Good (85 - 94)		Excellent (95 - 100)		Not Rated	
See Appendix for definitions and formulas									
Inspection Date:	11/4/2016	Beginning Section MP	0	1	2				
Paved Length (Miles):	2.03	Section Length (MI)	1	1	0.03				
Surface Type:	ASPHALT	Route Summary							
Roadway Condition Information									
Pavement Condition Rating (PCR)	78	73	81	69					
Surface Condition Rating (SCR)	80	75	83	75					
Roughness Condition Index (RCI)	74	71	77	60					
Distress Index Values									
Structural Crack Index	81	79	83	75					
Alligator Crack Index	100	100	100	100					
Longitudinal Crack Index	81	79	83	75					
Transverse Cracking Index	80	75	84	82					
Patching Index	100	100	100	100					
Rutting Index	94	95	94	93					
International Roughness Index (IRI)	189	197	179	240					
Lane & Width Information									
Number of Lanes	2	2	2	2

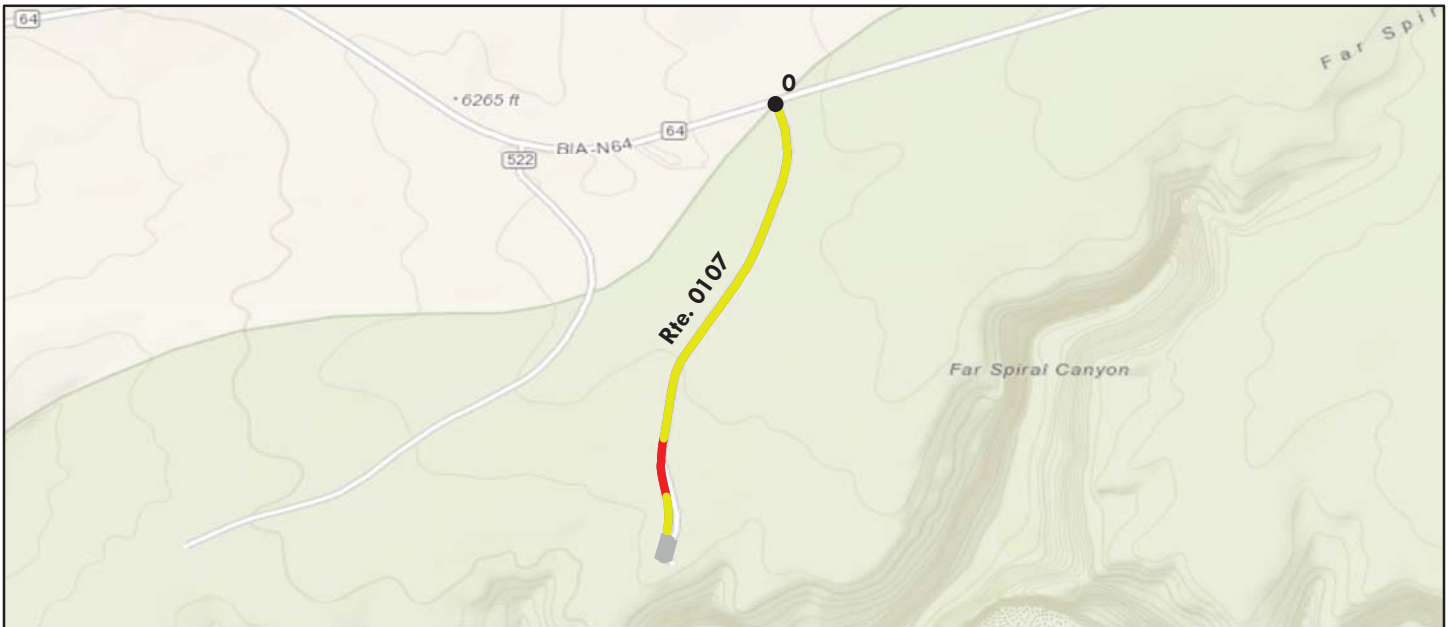
ROUTE 0107: LEDGE RUIN ROAD

Route Condition Legend – Pavement Condition Rating (PCR)						
Poor (0 - 60)	Fair (61- 84)	Good (85 - 94)	Excellent (95 - 100)	Not Rated		
See Appendix for definitions and formulas						
Inspection Date:	11/4/2016	Beginning Section MP	0			
Paved Length (Miles):	0.76	Section Length (MI)	0.76			
Surface Type:	ASPHALT	Route Summary				
Roadway Condition Information						
Pavement Condition Rating (PCR)	71	71				
Surface Condition Rating (SCR)	68	68				
Roughness Condition Index (RCI)	75	75				
Distress Index Values						
Structural Crack Index	80	80				
Alligator Crack Index	100	100				
Longitudinal Crack Index	80	80				
Transverse Cracking Index	68	68				
Patching Index	100	100				
Rutting Index	94	94				
International Roughness Index (IRI)	184	184				
Lane & Width Information						
Number of Lanes	2	2				
Paved Width (ft)	24.3	24.3				
Lane Width (ft)	11.3	11.3

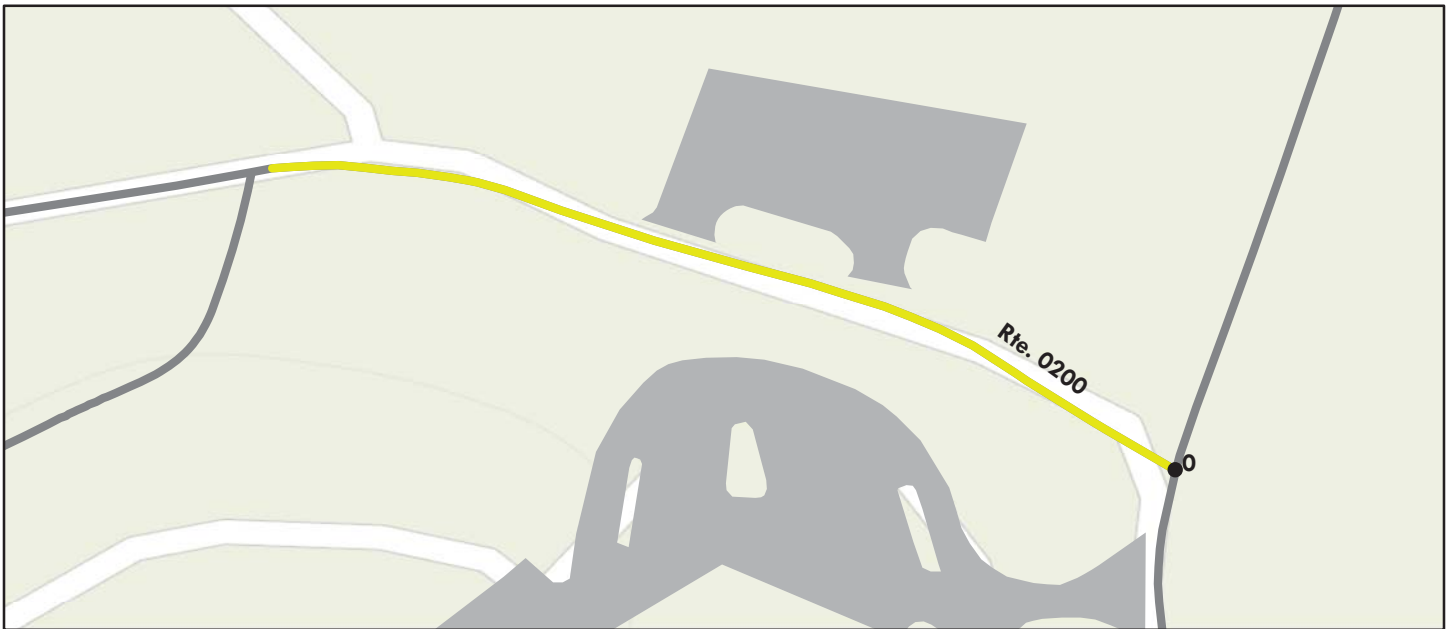
ROUTE 0200: CAMPGROUND / MAINTENANCE ACCESS ROAD

Route Condition Legend – Pavement Condition Rating (PCR)						
Poor (0 - 60)	Fair (61- 84)	Good (85 - 94)	Excellent (95 - 100)	Not Rated		
See Appendix for definitions and formulas						
Inspection Date:	11/3/2016	Beginning Section MP	0			
Paved Length (Miles):	0.1	Section Length (MI)	0.1			
Surface Type:	ASPHALT	Route Summary				
Roadway Condition Information						
Pavement Condition Rating (PCR)	71	71				
Surface Condition Rating (SCR)	71	71				
Roughness Condition Index (RCI)	N/A	N/A				
Distress Index Values						
Structural Crack Index	78	78				
Alligator Crack Index	100	100				
Longitudinal Crack Index	78	78				
Transverse Cracking Index	71	71				
Patching Index	100	100				
Rutting Index	99	99				
International Roughness Index (IRI)	N/A	N/A				
Lane & Width Information						
Number of Lanes	2	2				
Paved Width (ft)	21.4	21.4				
Lane Width (ft)	10.7	10.7

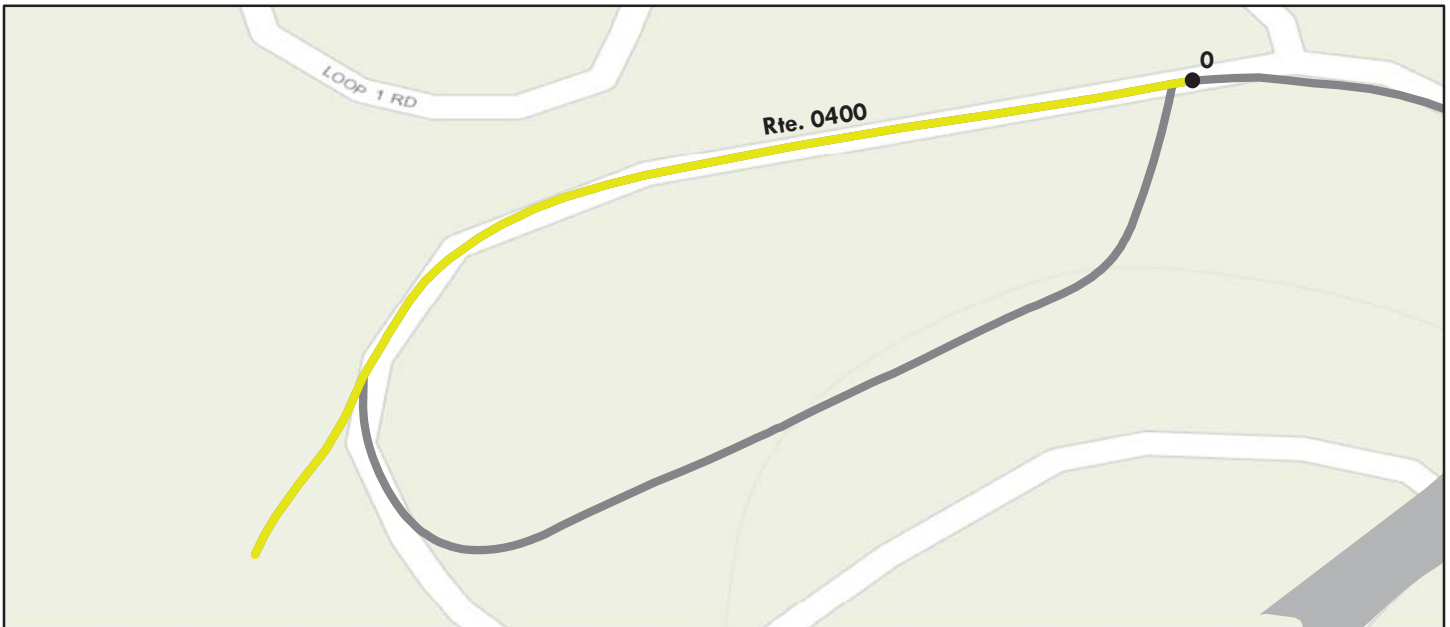
ROUTE 0400: PARK MAINTENANCE ACCESS ROAD

Route Condition Legend – Pavement Condition Rating (PCR)						
Poor (0 - 60)	Fair (61- 84)	Good (85 - 94)	Excellent (95 - 100)	Not Rated		
See Appendix for definitions and formulas						
Inspection Date: 11/3/2016	Beginning Section MP	0				
Paved Length (Miles): 0.12	Section Length (MI)	0.12				
Surface Type: ASPHALT	Route Summary					
Roadway Condition Information						
Pavement Condition Rating (PCR)	66	66				
Surface Condition Rating (SCR)	66	66				
Roughness Condition Index (RCI)	N/A	N/A				
Distress Index Values						
Structural Crack Index	95	95				
Alligator Crack Index	100	100				
Longitudinal Crack Index	95	95				
Transverse Cracking Index	66	66				
Patching Index	99	99				
Rutting Index	97	97				
International Roughness Index (IRI)	N/A	N/A				
Lane & Width Information						
Number of Lanes	2	2				
Paved Width (ft)	18.5	18.5				
Lane Width (ft)	9.3	9.3

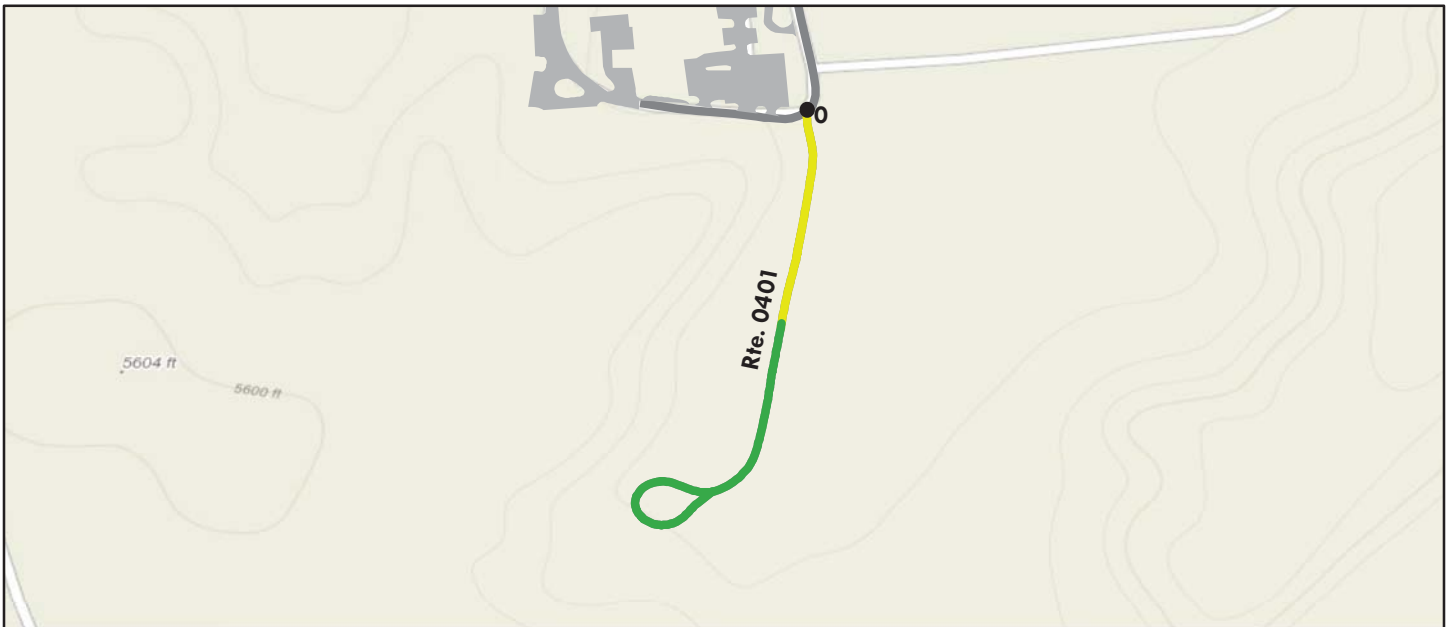
ROUTE 0401: RESIDENCE ROAD

Route Condition Legend – Pavement Condition Rating (PCR)						
Poor (0 - 60)	Fair (61- 84)	Good (85 - 94)	Excellent (95 - 100)	Not Rated		
See Appendix for definitions and formulas						
Inspection Date: 11/3/2016	Beginning Section MP	0				
Paved Length (Miles): 0.25	Section Length (MI)	0.25				
Surface Type: ASPHALT	Route Summary					
Roadway Condition Information						
Pavement Condition Rating (PCR)	83	83				
Surface Condition Rating (SCR)	83	83				
Roughness Condition Index (RCI)	N/A	N/A				
Distress Index Values						
Structural Crack Index	83	83				
Alligator Crack Index	100	100				
Longitudinal Crack Index	83	83				
Transverse Cracking Index	88	88				
Patching Index	100	100				
Rutting Index	96	96				
International Roughness Index (IRI)	N/A	N/A				
Lane & Width Information						
Number of Lanes	2	2				
Paved Width (ft)	18.3	18.3				
Lane Width (ft)	9.2	9.2

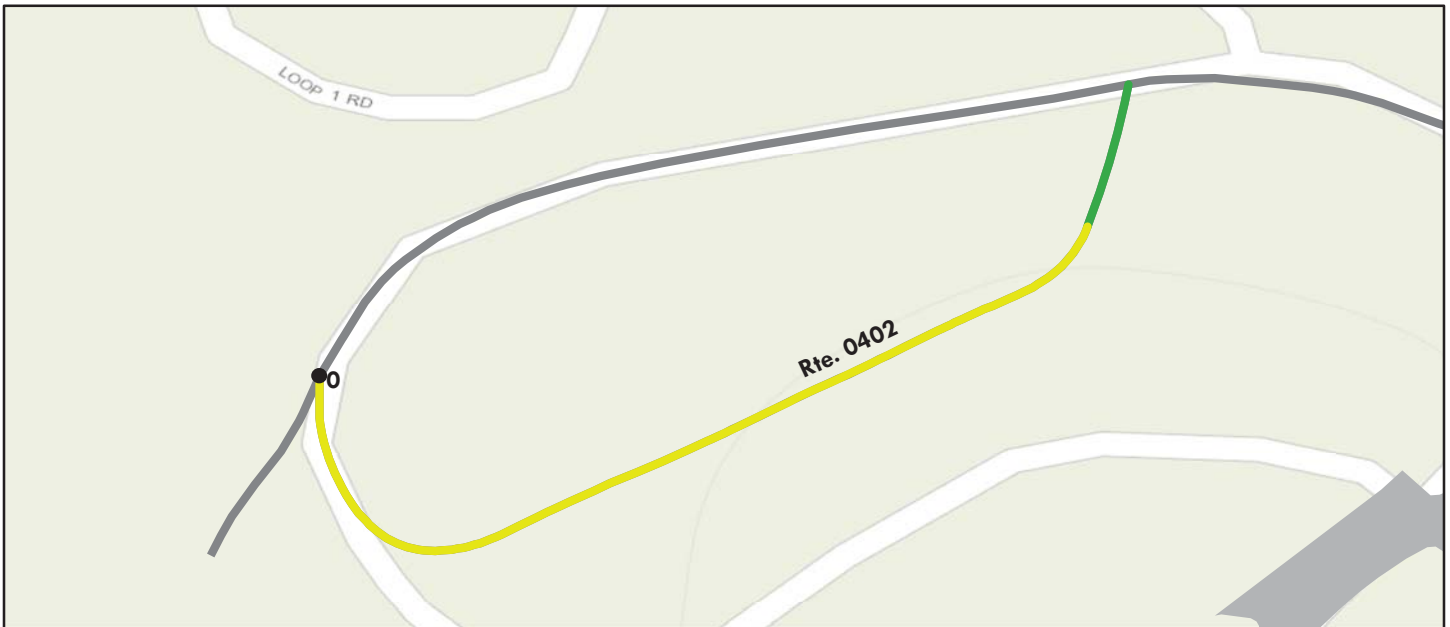
ROUTE 0402: CONCESSION RESIDENCE ROAD

Route Condition Legend – Pavement Condition Rating (PCR)						
Poor (0 - 60)	Fair (61- 84)	Good (85 - 94)	Excellent (95 - 100)	Not Rated		
See Appendix for definitions and formulas						
Inspection Date: 11/3/2016	Beginning Section MP	0				
Paved Length (Miles): 0.11	Section Length (MI)	0.11				
Surface Type: ASPHALT	Route Summary					
Roadway Condition Information						
Pavement Condition Rating (PCR)	85	85				
Surface Condition Rating (SCR)	85	85				
Roughness Condition Index (RCI)	N/A	N/A				
Distress Index Values						
Structural Crack Index	95	95				
Alligator Crack Index	100	100				
Longitudinal Crack Index	95	95				
Transverse Cracking Index	85	85				
Patching Index	99	99				
Rutting Index	92	92				
International Roughness Index (IRI)	N/A	N/A				
Lane & Width Information						
Number of Lanes	2	2				
Paved Width (ft)	25.8	25.8				
Lane Width (ft)	12.9	12.9

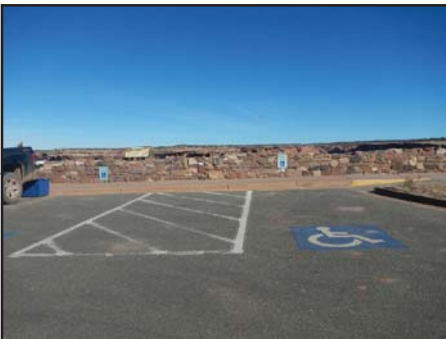
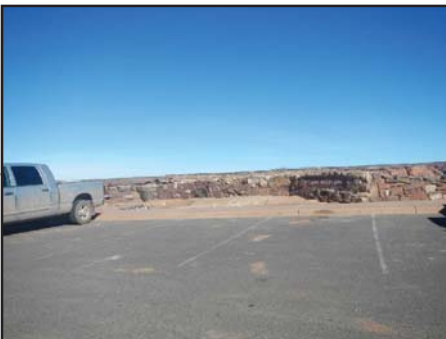
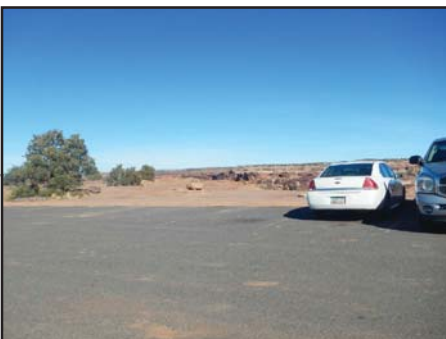
ROUTE 0903: JUNCTION OVERLOOK PARKING

Inspection Date	FMSS Number	User Access	Surface Type
1/13/2016	68861	PUBLIC	ASPHALT
Area (Sq. Ft.)	Lane Miles (11' Widths)	Curb Reveal (Inches)	Curb Recommendation
21,498	0.37	4	DO NOTHING
Curb Type		Curb & Gutter Type	
CONCRETE		CONCRETE	
Pavement Recommendation		Condition Rating / PCR	
HEAVY 3R TREATMENTS		POOR / 53

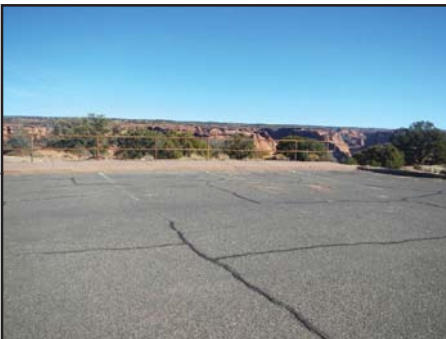
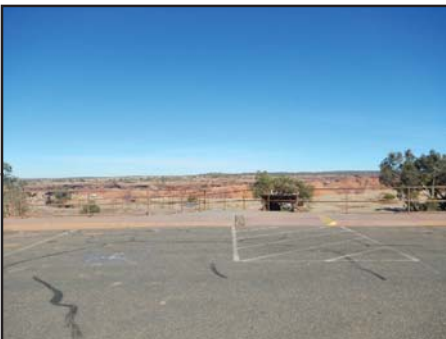
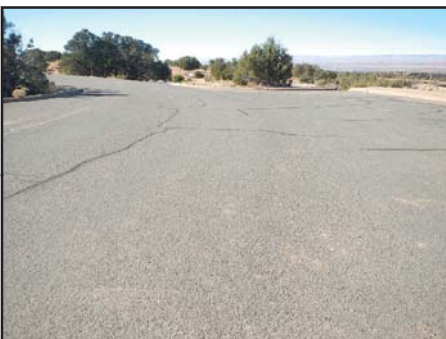
ROUTE 0904: COTTONWOOD PICNIC AREA PARKING

Inspection Date	FMSS Number	User Access	Surface Type
1/13/2016	79403	PUBLIC	ASPHALT
Area (Sq. Ft.)	Lane Miles (11' Widths)	Curb Reveal (Inches)	Curb Recommendation
16,282	0.28	NOT APPLICABLE	NOT APPLICABLE
Curb Type		Curb & Gutter Type	
NO CURB		NO CURB AND GUTTER	
Pavement Recommendation		Condition Rating / PCR	
PREVENTIVE MAINTENANCE		GOOD / 90

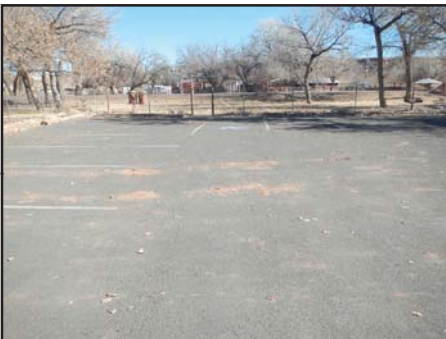
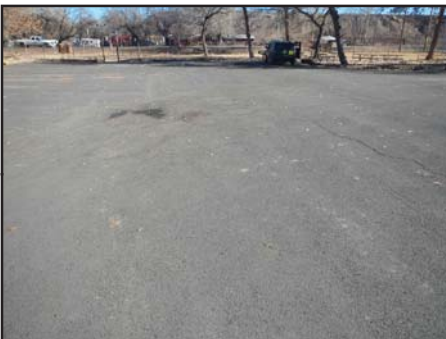
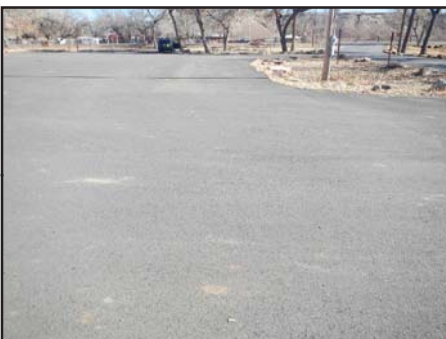
ROUTE 0906: THUNDERBIRD LODGE PARKING

Inspection Date	FMSS Number	User Access	Surface Type
1/13/2016	68955	PUBLIC	ASPHALT
Area (Sq. Ft.)	Lane Miles (11' Widths)	Curb Reveal (Inches)	Curb Recommendation
108,750	1.872	NOT APPLICABLE	DO NOTHING
Curb Type		Curb & Gutter Type	
NO CURB		CONCRETE	
Pavement Recommendation		Condition Rating / PCR	
PREVENTIVE MAINTENANCE		GOOD / 90

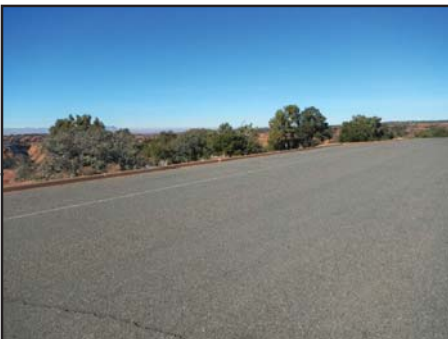
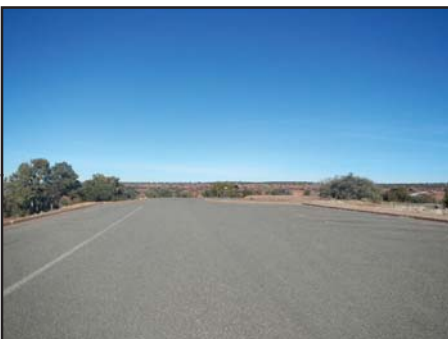
ROUTE 0909: WHITE HOUSE OVERLOOK PARKING

Inspection Date	FMSS Number	User Access	Surface Type
1/13/2016	68862	PUBLIC	ASPHALT
Area (Sq. Ft.)	Lane Miles (11' Widths)	Curb Reveal (Inches)	Curb Recommendation
31,064	0.535	4	DO NOTHING
Curb Type		Curb & Gutter Type	
CONCRETE		CONCRETE	
Pavement Recommendation		Condition Rating / PCR	
PREVENTIVE MAINTENANCE		GOOD / 90

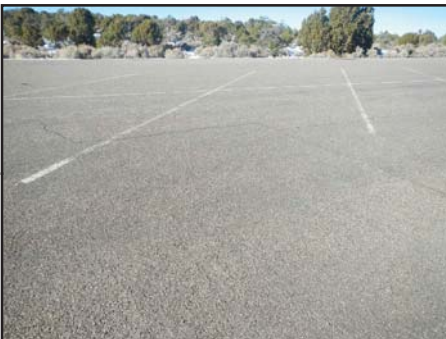
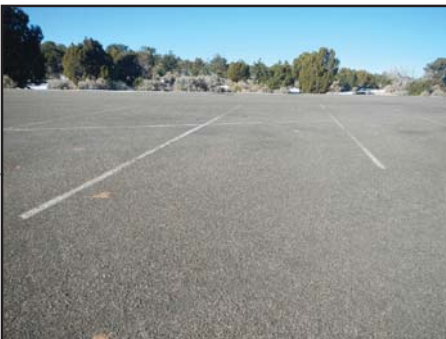
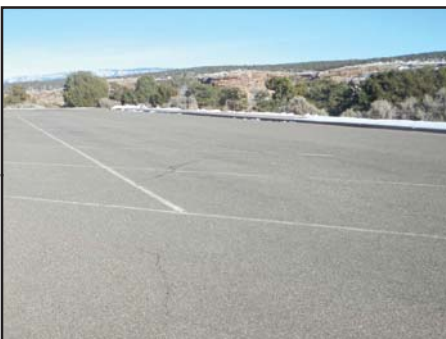
ROUTE 0911: MUMMY CAVE OVERLOOK PARKING

Inspection Date	FMSS Number	User Access	Surface Type
1/13/2016	77090	PUBLIC	ASPHALT
Area (Sq. Ft.)	Lane Miles (11' Widths)	Curb Reveal (Inches)	Curb Recommendation
31,190	0.537	NOT APPLICABLE	DO NOTHING
Curb Type		Curb & Gutter Type	
NO CURB		CONCRETE	
Pavement Recommendation		Condition Rating / PCR	
PREVENTIVE MAINTENANCE		GOOD / 90

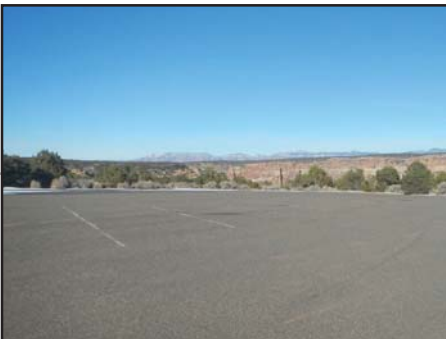
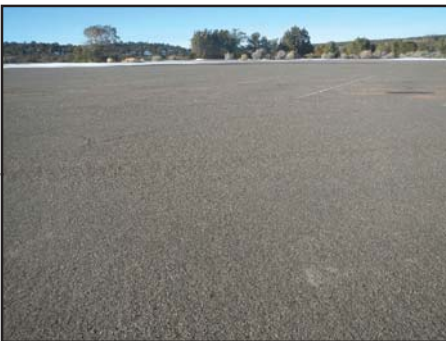
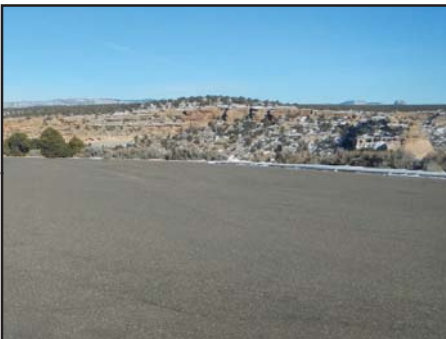
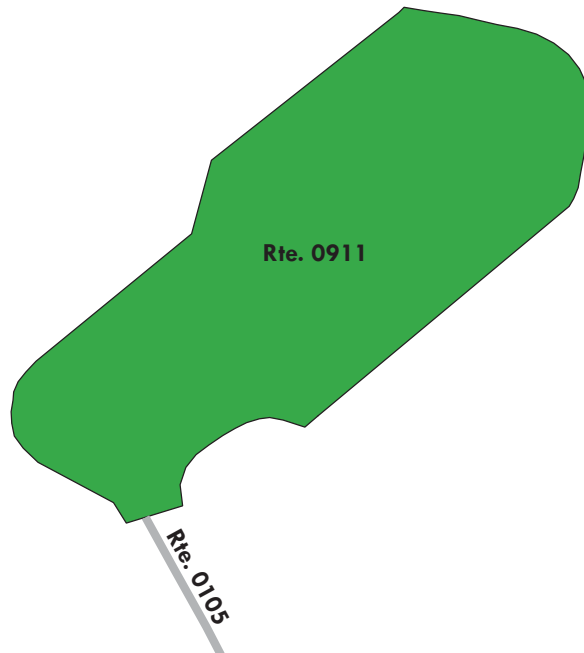
ROUTE 0912: LEDGE RUIN OVERLOOK PARKING

Inspection Date	FMSS Number	User Access	Surface Type
1/13/2016	68873	NONPUBLIC	ASPHALT
Area (Sq. Ft.)	Lane Miles (11' Widths)	Curb Reveal (Inches)	Curb Recommendation
30,599	0.527	NOT APPLICABLE	DO NOTHING
Curb Type		Curb & Gutter Type	
NO CURB		CONCRETE	
Pavement Recommendation		Condition Rating / PCR	
PREVENTIVE MAINTENANCE		GOOD / 90

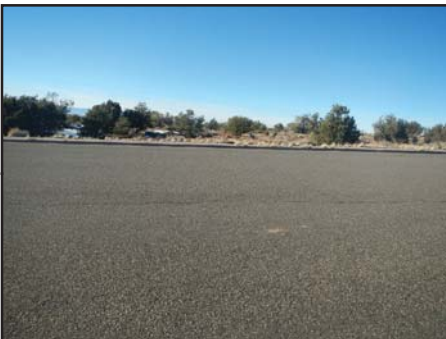
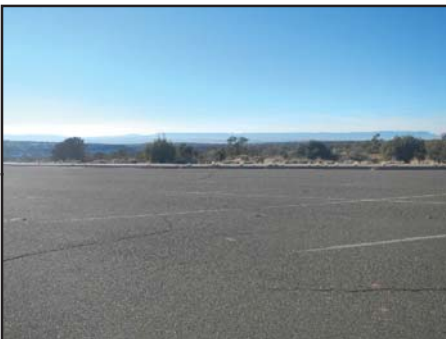
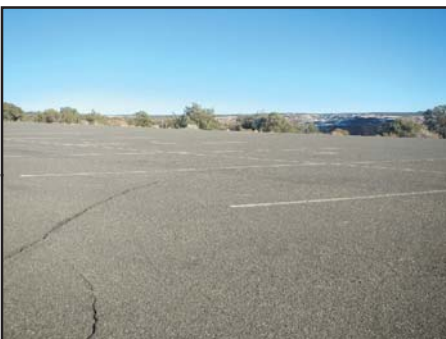
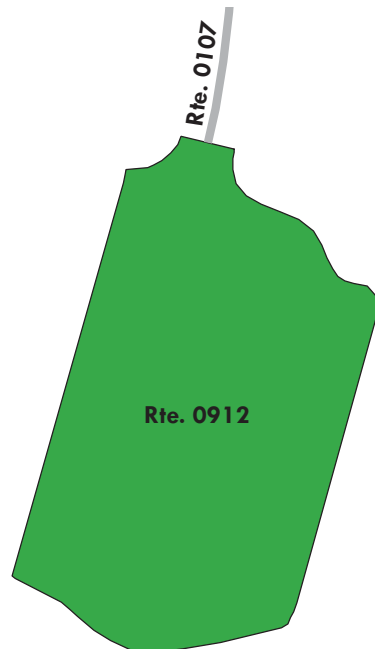
ROUTE 0914: CANYON TOUR LOADING AREA

Inspection Date	FMSS Number	User Access	Surface Type
1/13/2016	68956	PUBLIC	ASPHALT
Area (Sq. Ft.)	Lane Miles (11' Widths)	Curb Reveal (Inches)	Curb Recommendation
4,370	0.075	NOT APPLICABLE	DO NOTHING
Curb Type		Curb & Gutter Type	
NO CURB		CONCRETE	
Pavement Recommendation		Condition Rating / PCR	
PREVENTIVE MAINTENANCE		GOOD / 90
