CACH Cycle 6

Final Report

Road Inventory and Condition Assessment of Paved Routes Canyon de Chelly National Monument

Report Date: March 2017

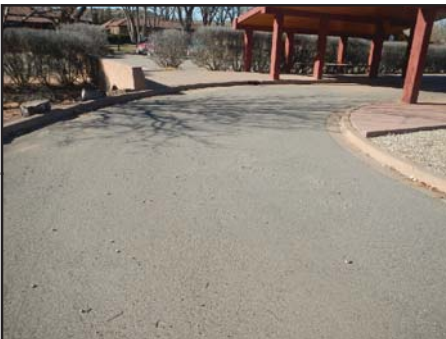
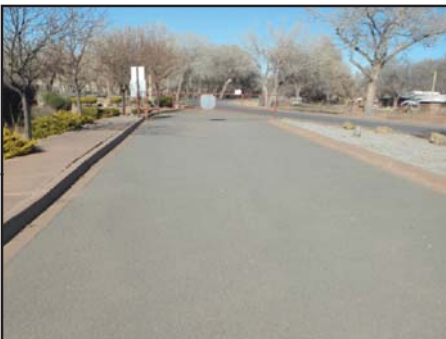
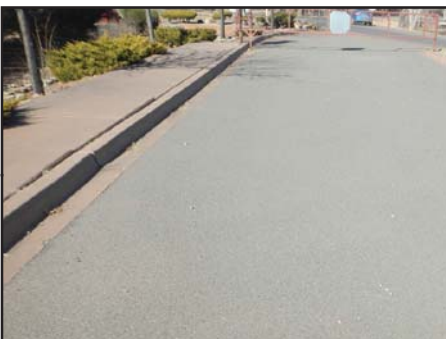
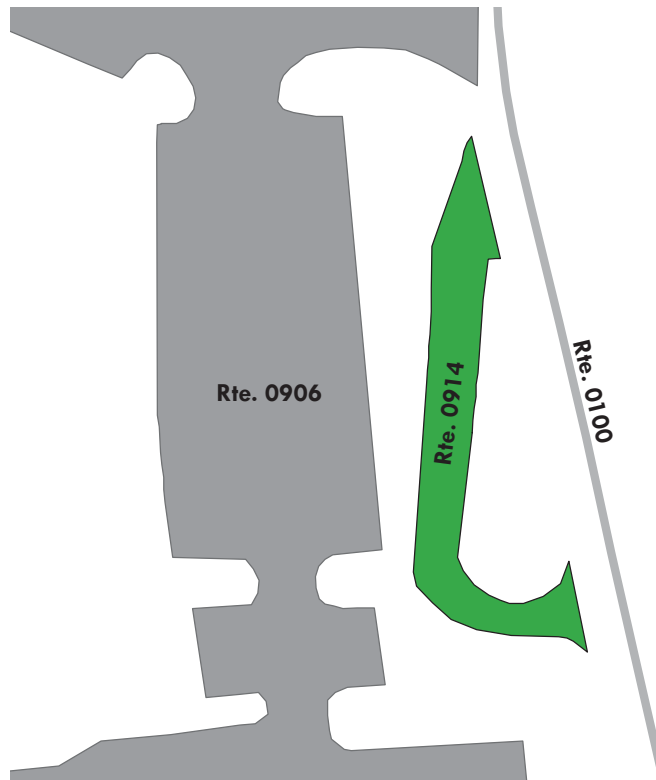
ROUTE 0915: FACE ROCK OVERLOOK PARKING

Inspection Date	FMSS Number	User Access	Surface Type
1/13/2016	68868	PUBLIC	ASPHALT
Area (Sq. Ft.)	Lane Miles (11' Widths)	Curb Reveal (Inches)	Curb Recommendation
2,138	0.037	NOT APPLICABLE	DO NOTHING
Curb Type		Curb & Gutter Type	
NO CURB		CONCRETE	
Pavement Recommendation		Condition Rating / PCR	
PREVENTIVE MAINTENANCE		GOOD / 90

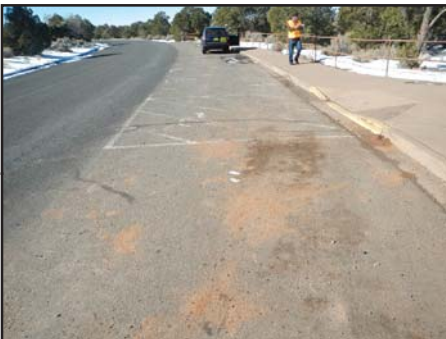
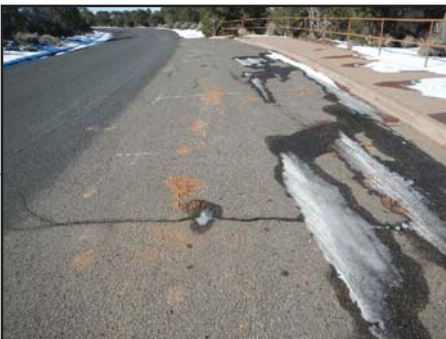
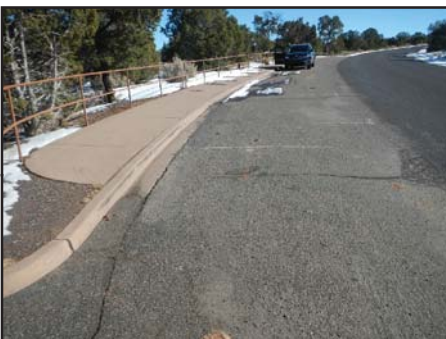
ROUTE 0916: ANTELOPE HOUSE OVERLOOK PARKING

Inspection Date	FMSS Number	User Access	Surface Type
1/13/2016	68874	PUBLIC	ASPHALT
Area (Sq. Ft.)	Lane Miles (11' Widths)	Curb Reveal (Inches)	Curb Recommendation
33,018	0.568	NOT APPLICABLE	DO NOTHING
Curb Type		Curb & Gutter Type	
NO CURB		CONCRETE	
Pavement Recommendation		Condition Rating / PCR	
PREVENTIVE MAINTENANCE		GOOD / 90
