CACO Cycle 6

Final Report

Road Inventory and Condition Assessment of Paved Routes Cape Cod National Seashore

Cape Cod National Seashore in Massachusetts

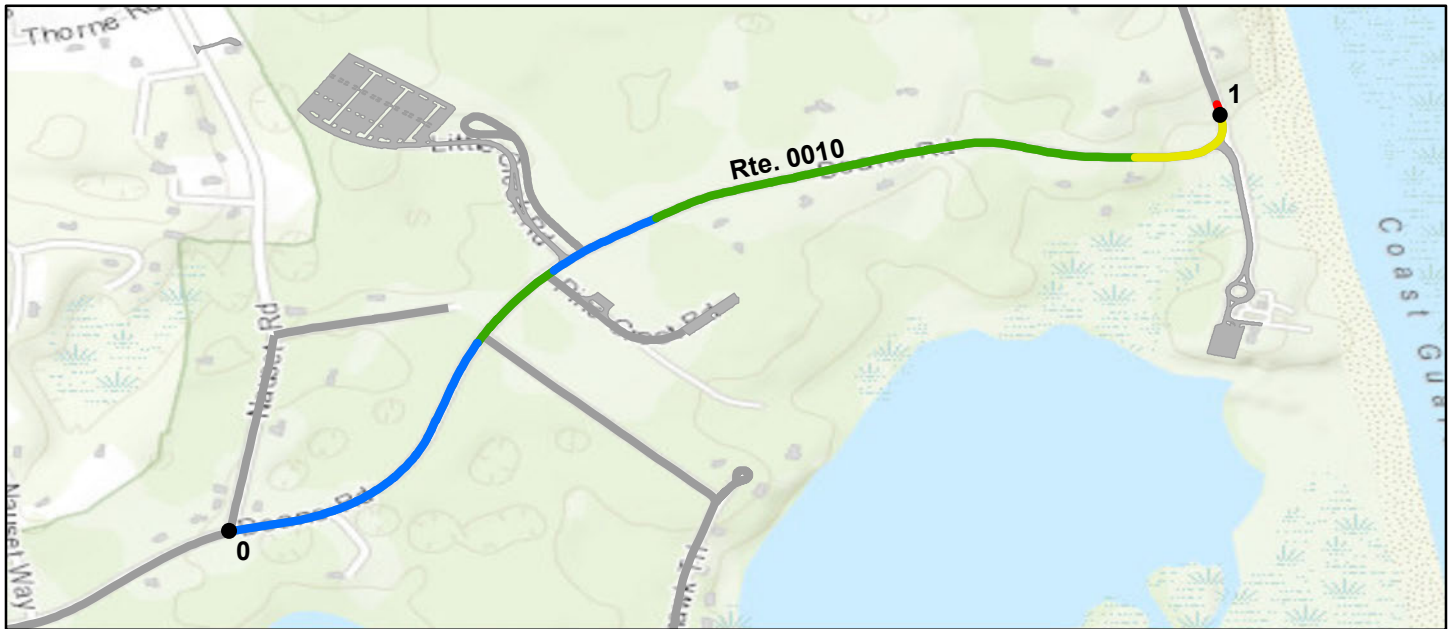
ROUTE 0010: DOANE ROAD

| Route Condition Legend – Pavement Condition Rating (PCR) | | | | | | | | | |
|---|---|---|---|---|--|---|--|---|--|
| Pavement Condition Rating (PCR) | 95 | 95 | 23 | | | | | | |
| Surface Condition Rating (SCR) | 91 | 91 | 4 | | | | | | |
| Roughness Condition Index (RCI) | 100 | 100 | 51 | | | | | | |
| Structural Crack Index | 93 | 94 | 47 | | | | | | |
| Longitudinal Crack Index | 93 | 94 | 47 | | | | | | |
| Transverse Cracking Index | 95 | 96 | 4 | | | | | | |

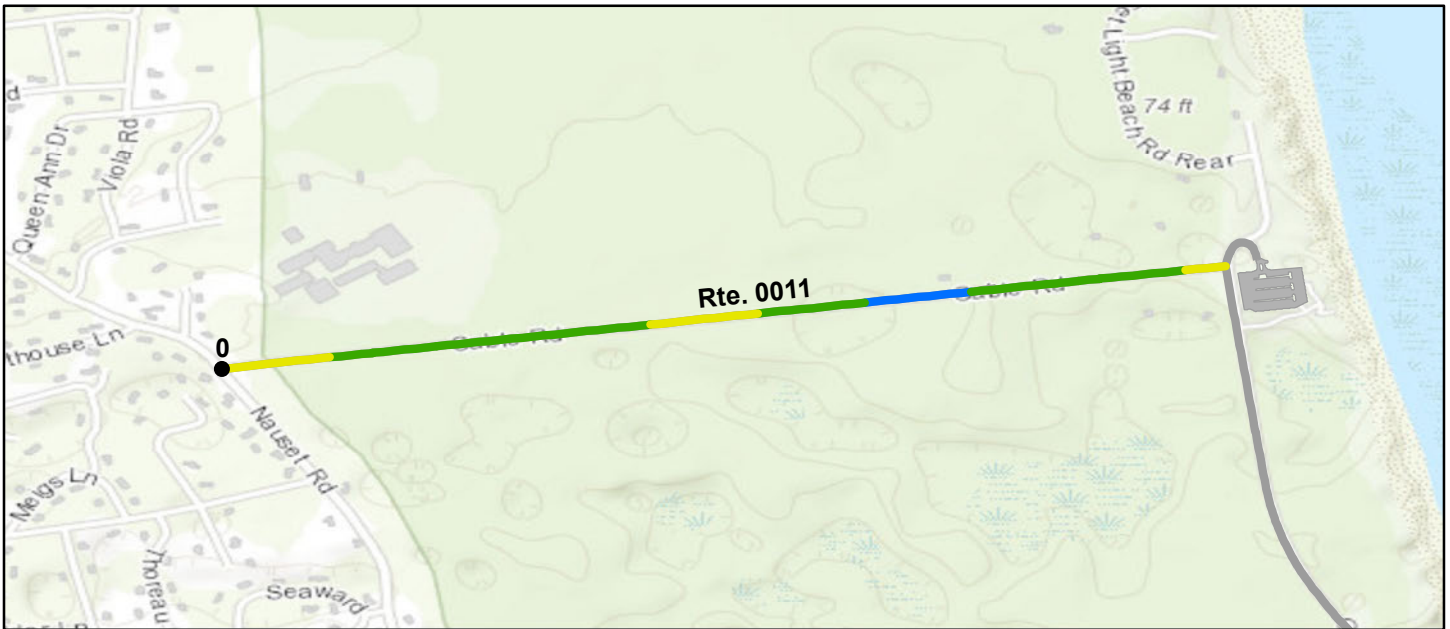
ROUTE 0011: CABLE ROAD

| Pavement Condition Rating (PCR) | | 90 | 90 | | | | |
| Surface Condition Rating (SCR) | | 84 | 84 | | | | |

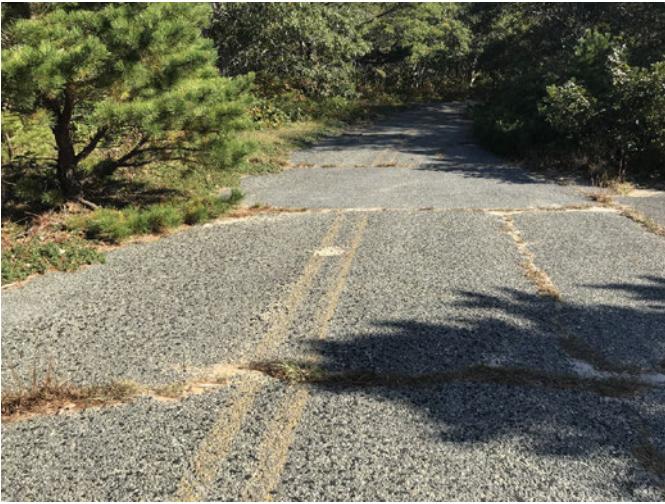
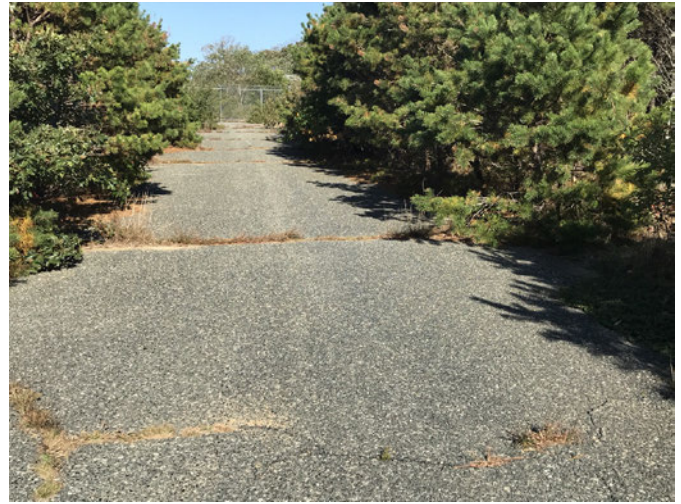
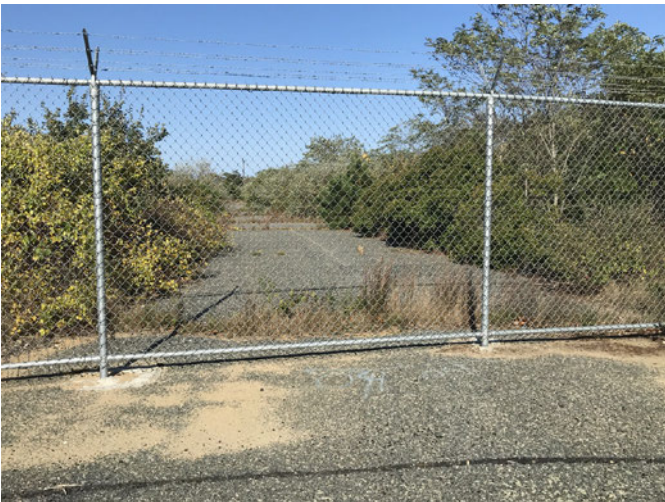
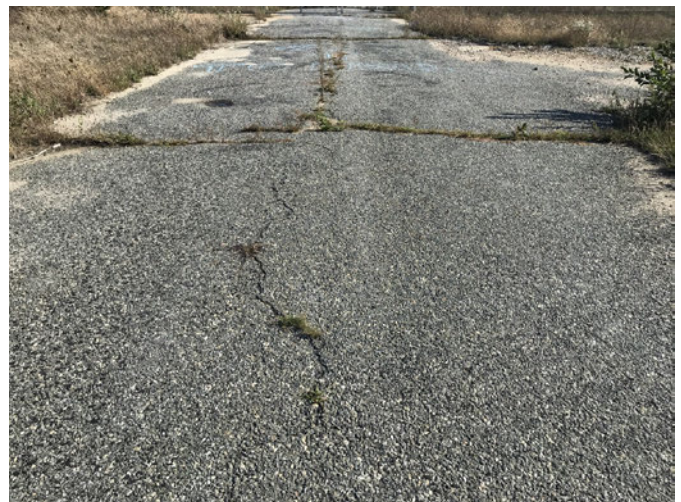
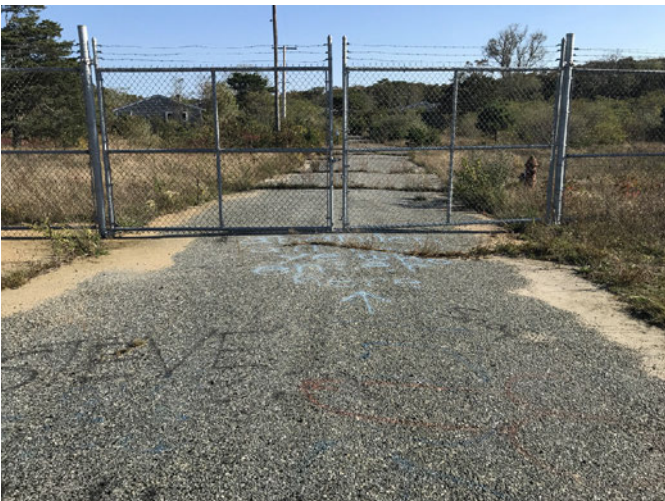
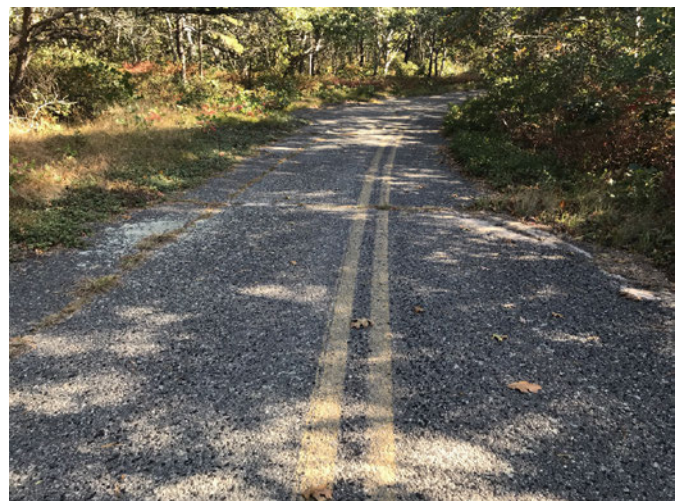
| Route Condition Legend – Pavement Condition Rating (PCR) | | | | | | |
|---|---|---|---|---|--|--|
| Pavement Condition Rating (PCR) | 53 | 53 | | | | |
| Alligator Crack Index | 73 | 73 | | | | |
| Longitudinal Crack Index | 73 | 73 | | | | |
| Transverse Cracking Index | 73 | 73 | | | | |

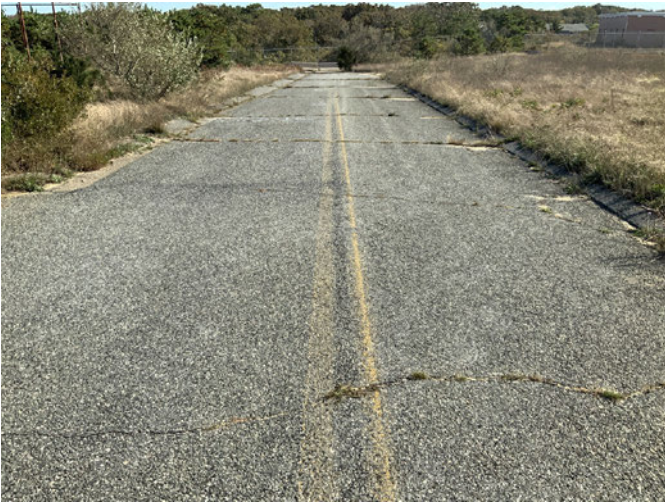
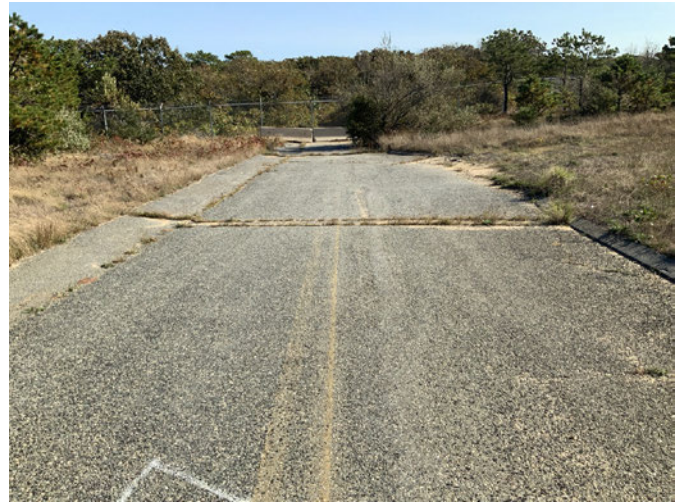
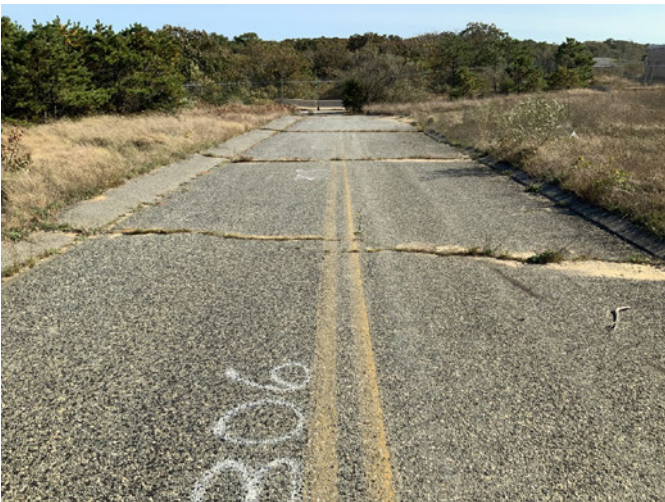
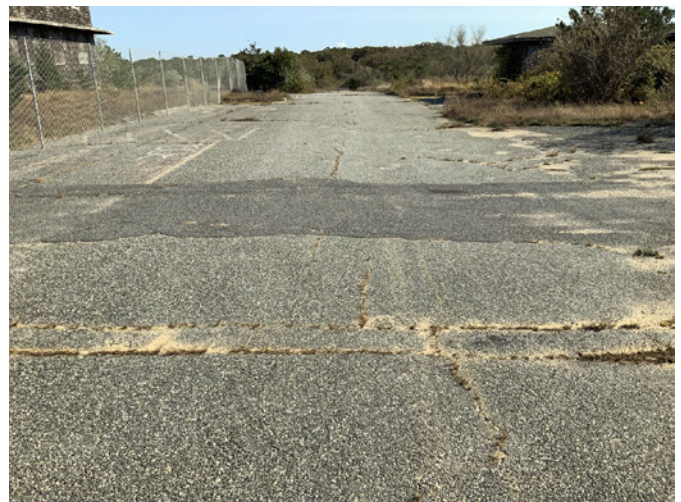
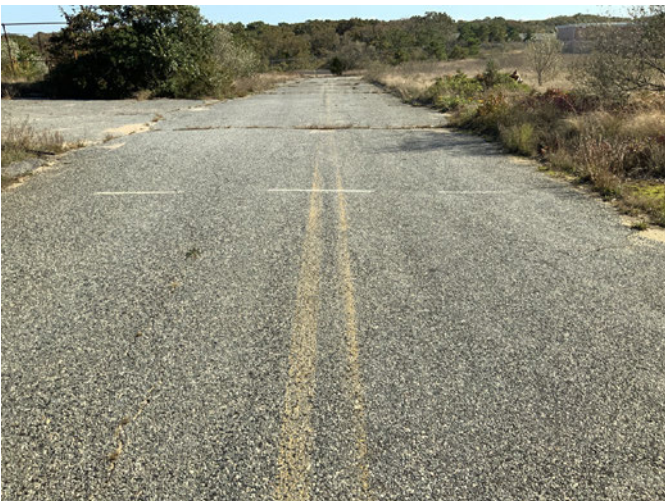
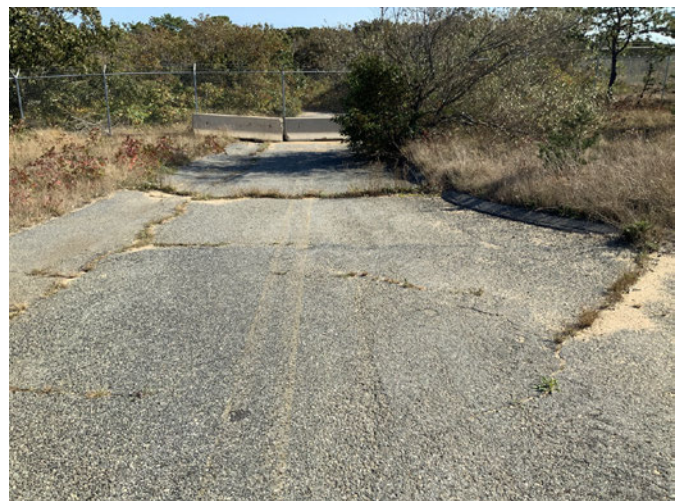
ROUTE 0233: NTAFS FUEL HOUSE ROAD

| Pavement Condition Rating (PCR) | 53 | 53 | | | | | |
| Alligator Crack Index | 90 | 90 | | | | | |
| Longitudinal Crack Index | 73 | 73 | | | | | |
| Transverse Cracking Index | 53 | 53 | | | | | |

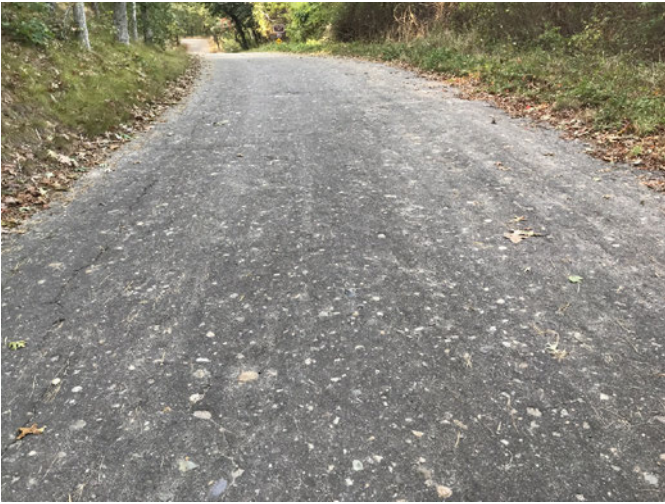
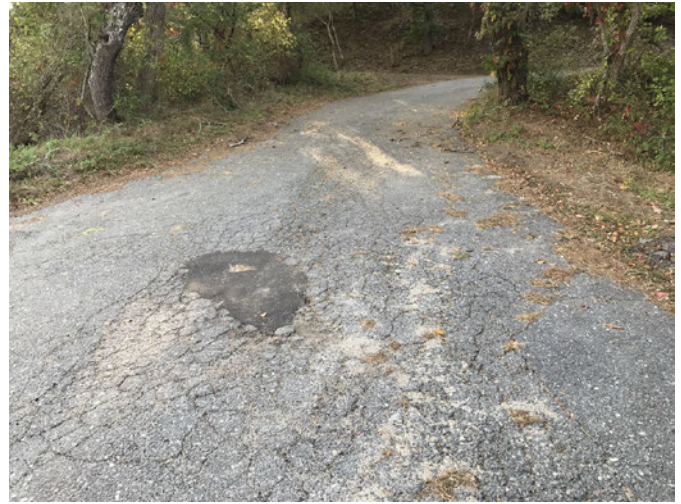
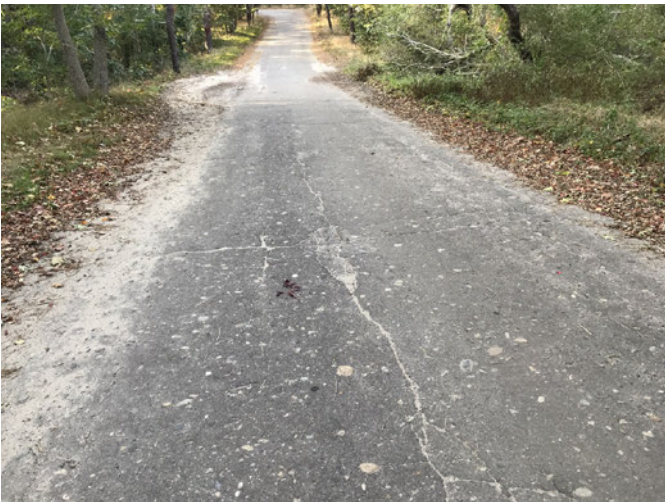
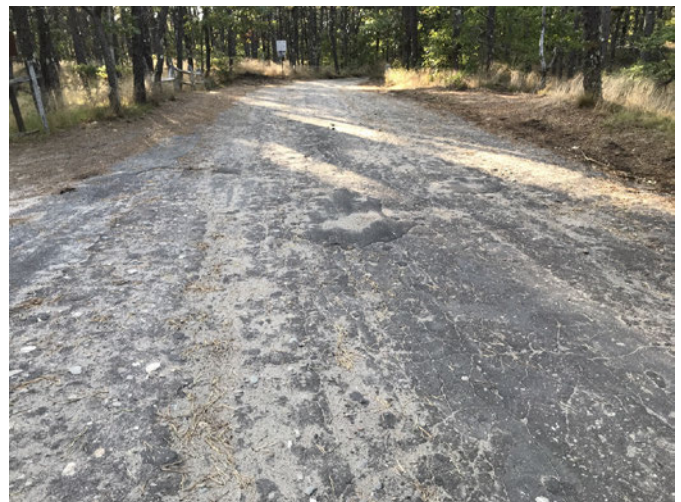
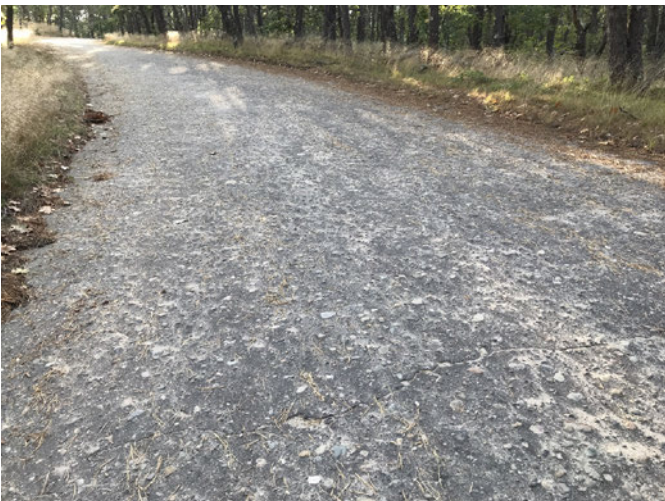
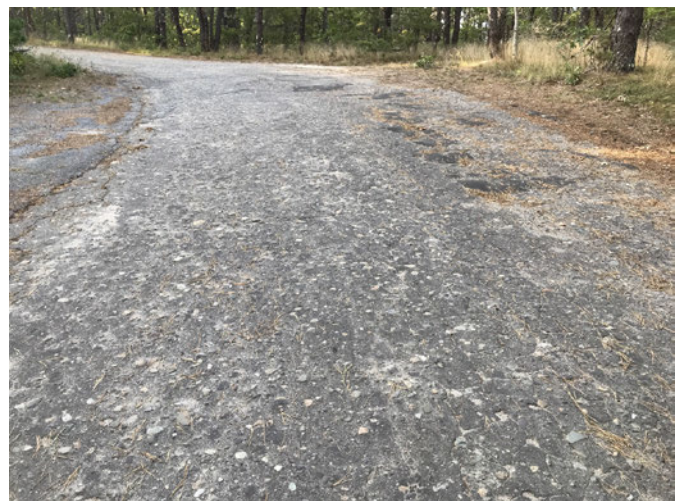
Subcomponent of Route CACO-0236ZZ

| Route Condition Legend – Pavement Condition Rating (PCR) | | | | | | |
|---|---|---|---|---|--|--|
| Pavement Condition Rating (PCR) | 53 | 53 | | | | |
| Alligator Crack Index | 53 | 53 | | | | |
| Longitudinal Crack Index | 90 | 90 | | | | |
| Transverse Cracking Index | 90 | 90 | | | | |

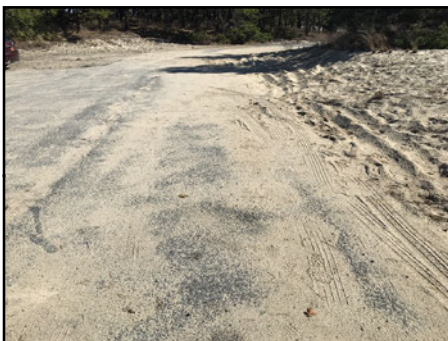
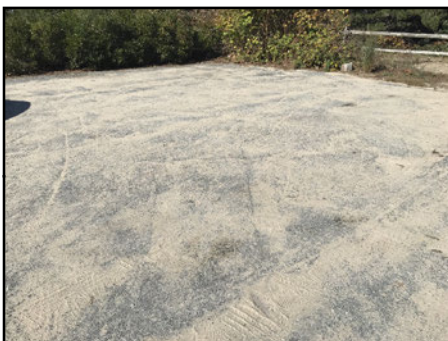
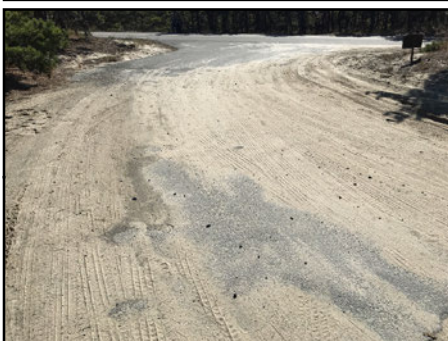
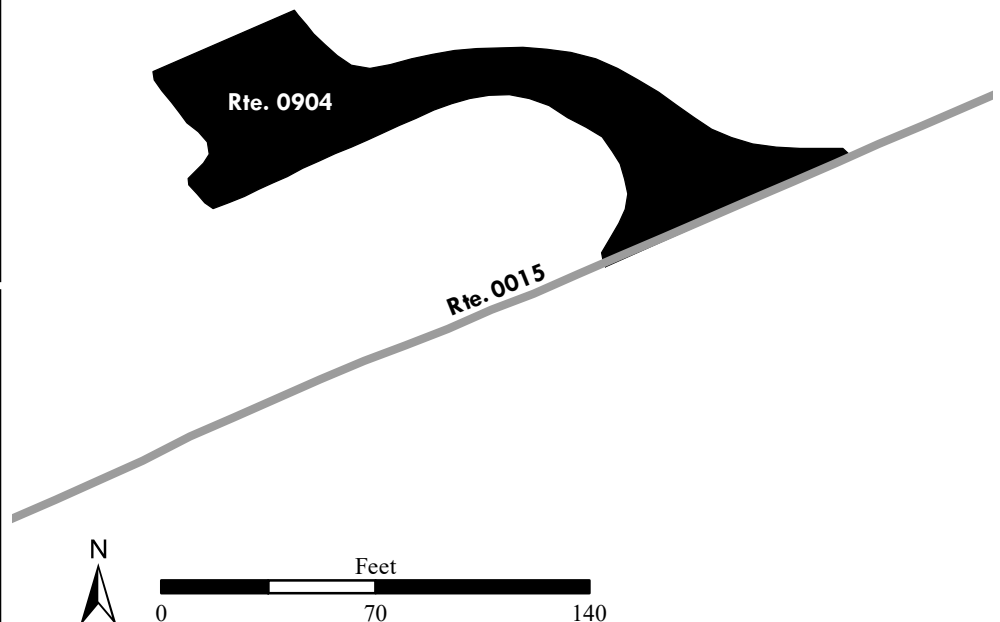
ROUTE 0905AZZ: PILGRIM HEIGHTS WEST PARKING AREAS

PARKING LOT WAS COVERED WITH SAND AND WAS NOT RATED.
CRACKING/POTHOLES VISIBLE IN AREAS WHERE PAVEMENT WAS OBSERVED.

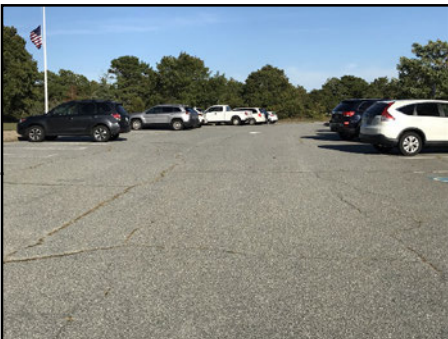
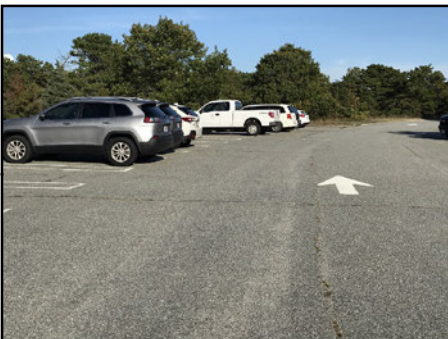
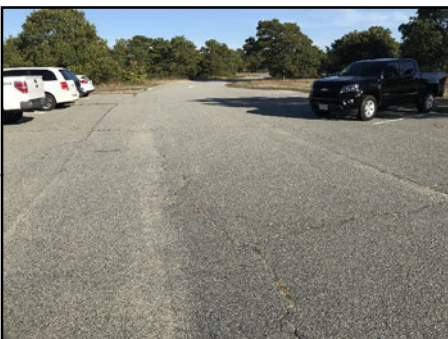
ROUTE 0908: PARK HEADQUARTERS PARKING

| Inspection Date | FMSS Number | User Access | Surface Type |
|---|---|---|---|
| 22,892 | 0.394 | 6 | LIGHT REPAIR |

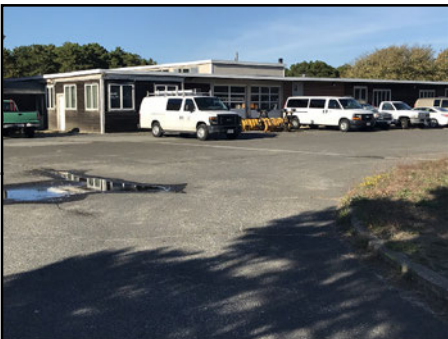
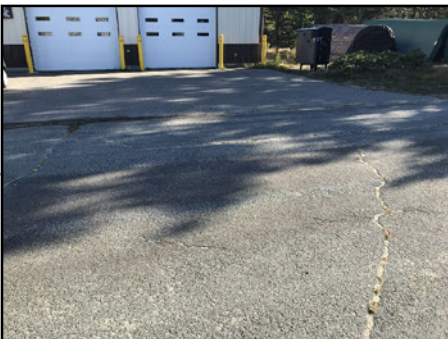
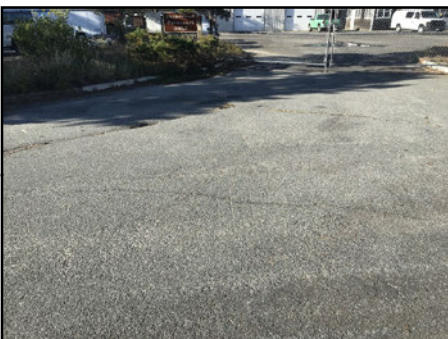
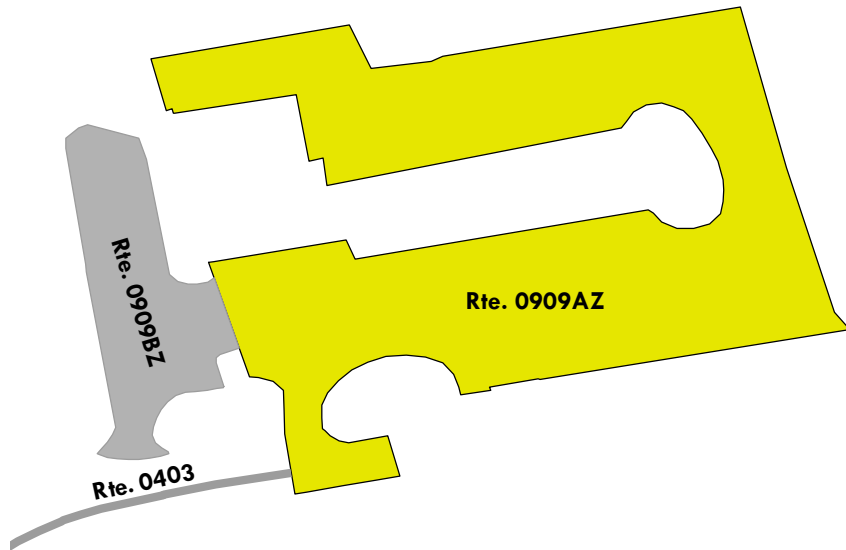
ROUTE 0909AZ: MARCONI MAINTENANCE PARKING A

| Inspection Date | FMSS Number | User Access | Surface Type |
|---|---|---|---|
| 48,486 | 0.835 | 4 | LIGHT REPAIR |

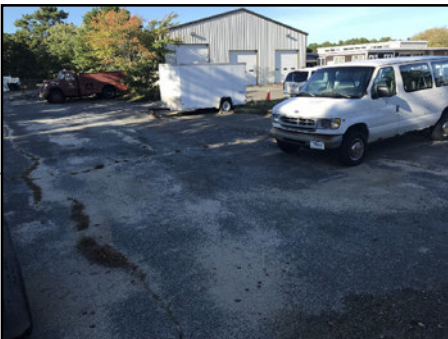
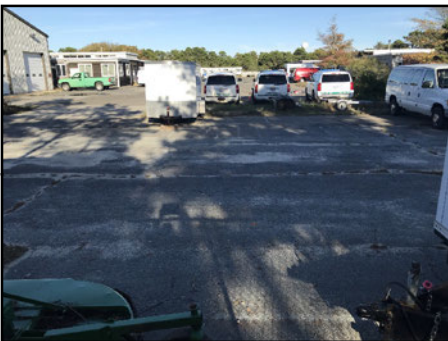
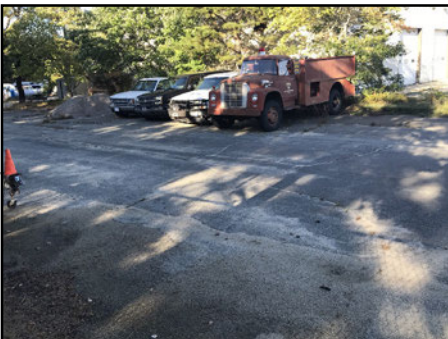
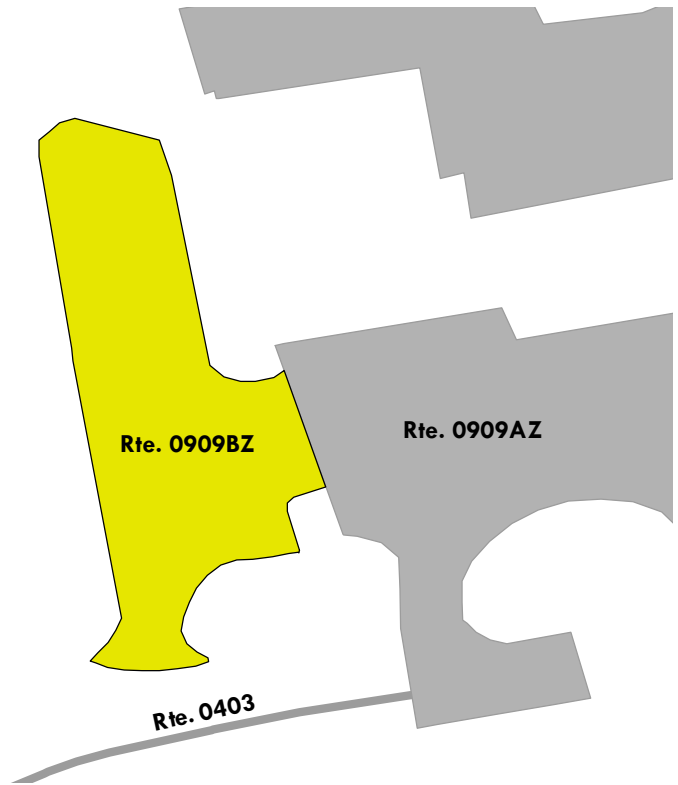
ROUTE 0909BZ: MARCONI MAINTENANCE PARKING B

| Inspection Date | FMSS Number | User Access | Surface Type |
|---|---|---|---|
| 9,388 | 0.162 | 5 | LIGHT REPAIR |

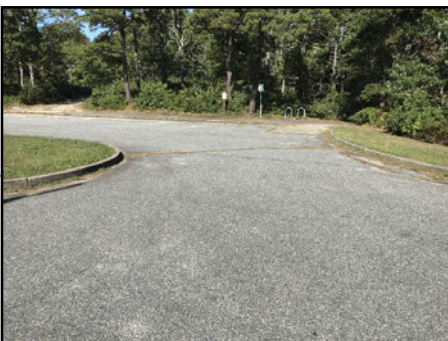
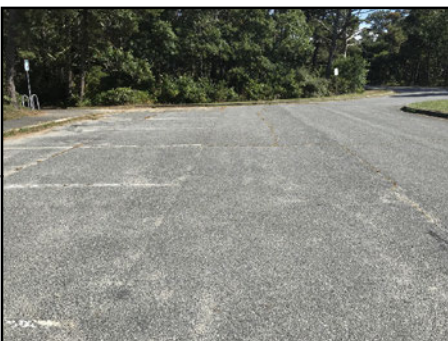
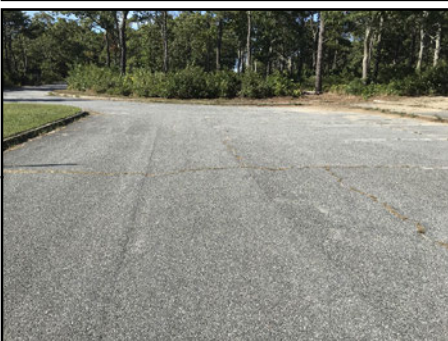
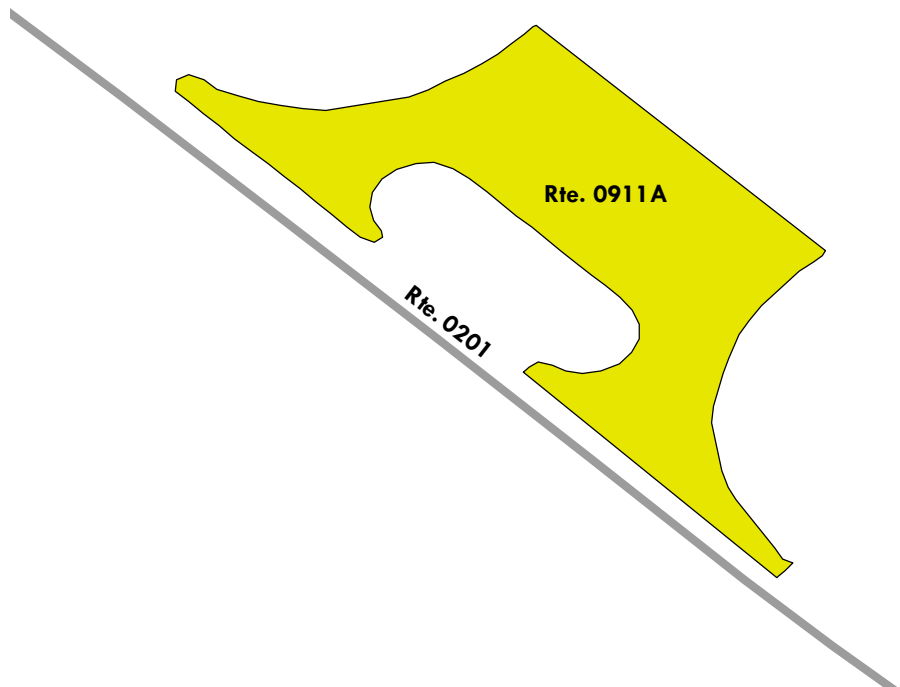
ROUTE 0911A: DOANE ROCK AREA 1 PARKING

| Inspection Date | FMSS Number | User Access | Surface Type |
|---|---|---|---|
| 7,352 | 0.127 | 7 | LIGHT REPAIR |

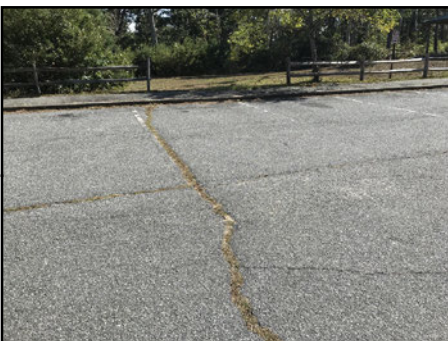
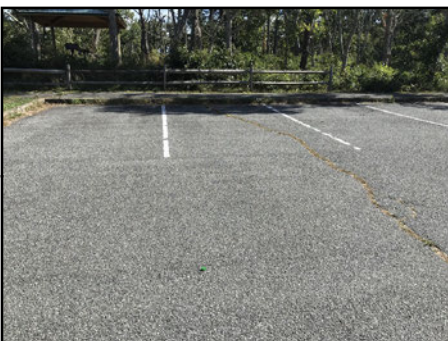
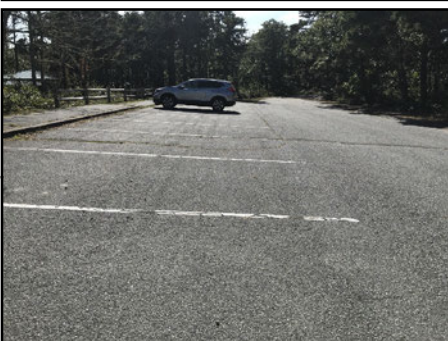
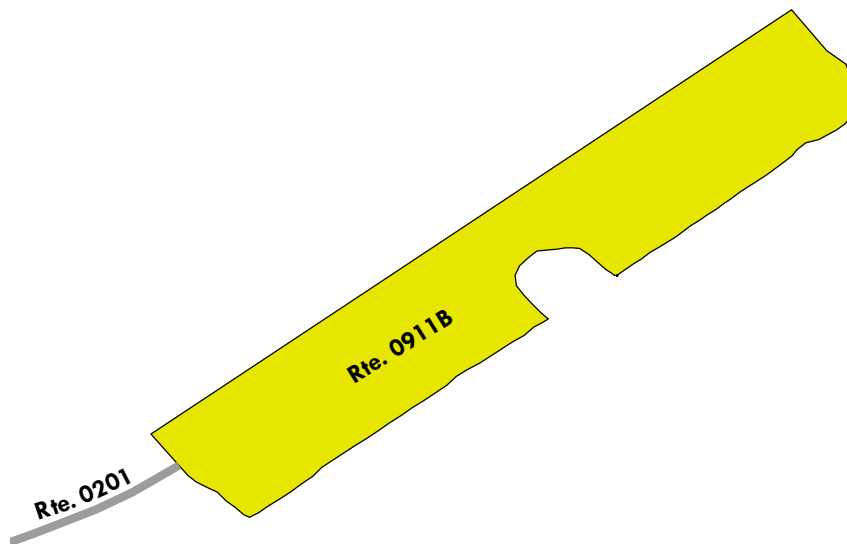
ROUTE 0911B: DOANE ROCK AREA 2 PARKING

| Inspection Date | FMSS Number | User Access | Surface Type |
|---|---|---|---|
| 14,635 | 0.252 | 5 | LIGHT REPAIR |

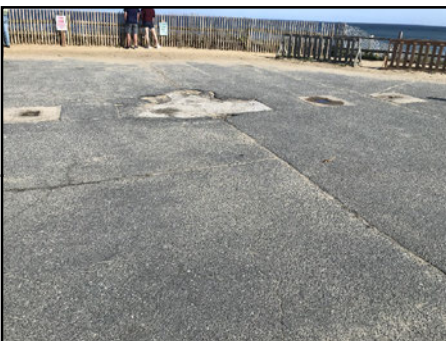
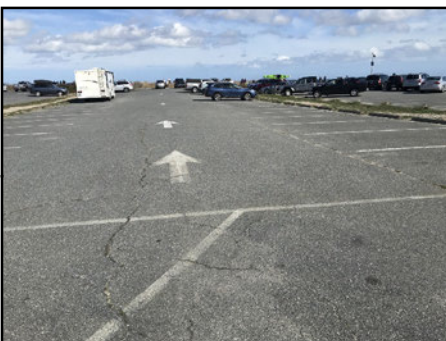
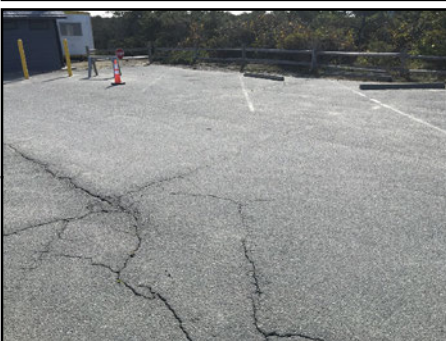
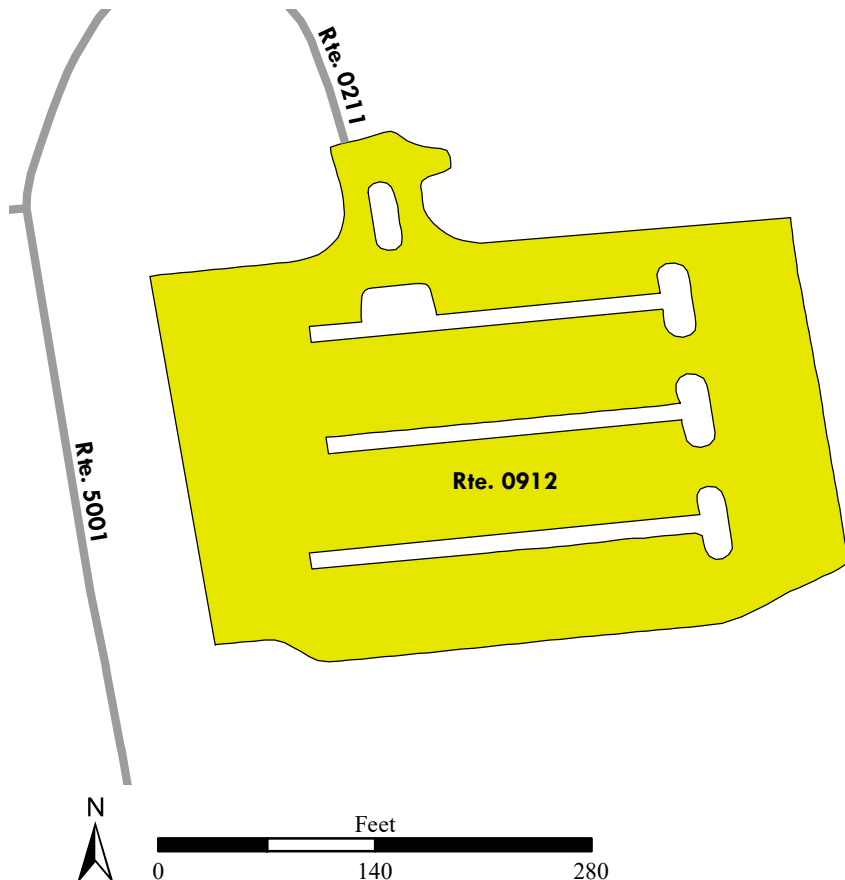
ROUTE 0912: NAUSET LIGHT BEACH PARKING

| Inspection Date | FMSS Number | User Access | Surface Type |
|---|---|---|---|
| 73,171 | 1.26 | 6 | LIGHT REPAIR |

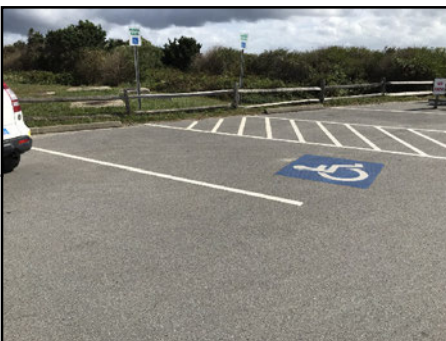
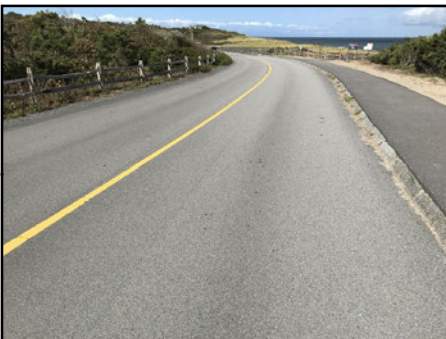
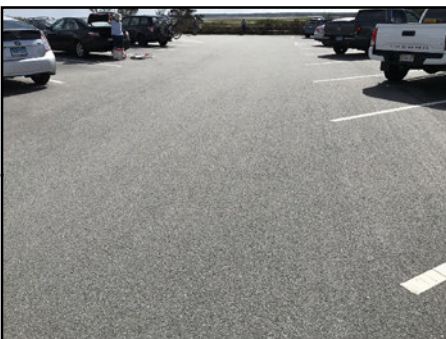
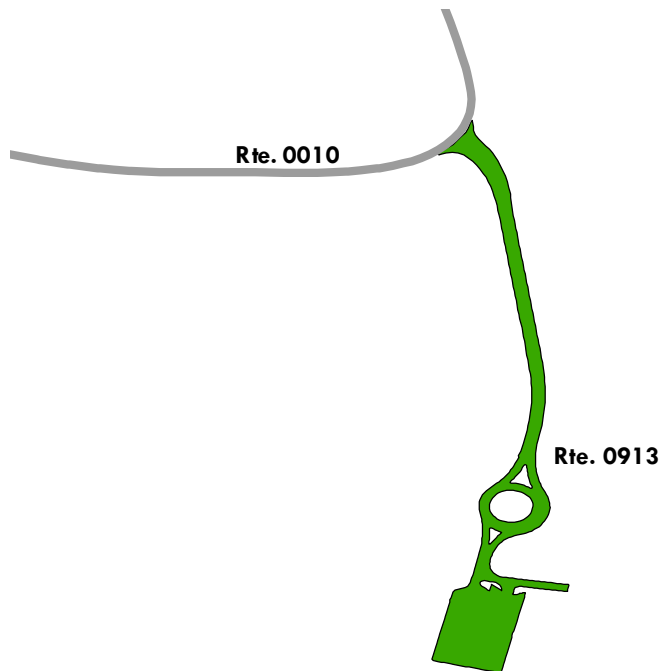
ROUTE 0913: COAST GUARD BEACH ENVIRONMENTAL EDUCATION CENTER PARKING

| Inspection Date | FMSS Number | User Access | Surface Type |
|---|---|---|---|
| 57,107 | 0.983 | 5 | MODERATE REPAIR |

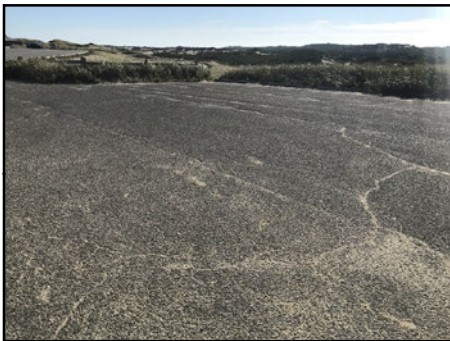
PARKING LOT HAD PORTIONS COVERED WITH SAND.

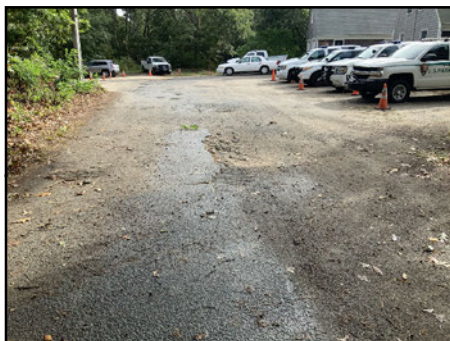
PARKING AREA IS PARTIALLY PAVED.

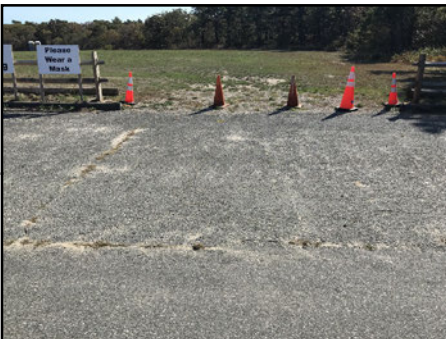
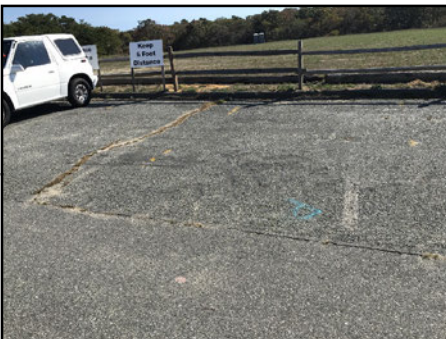
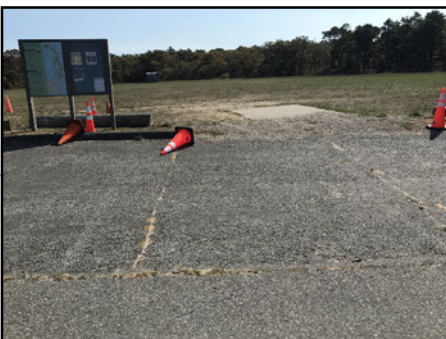
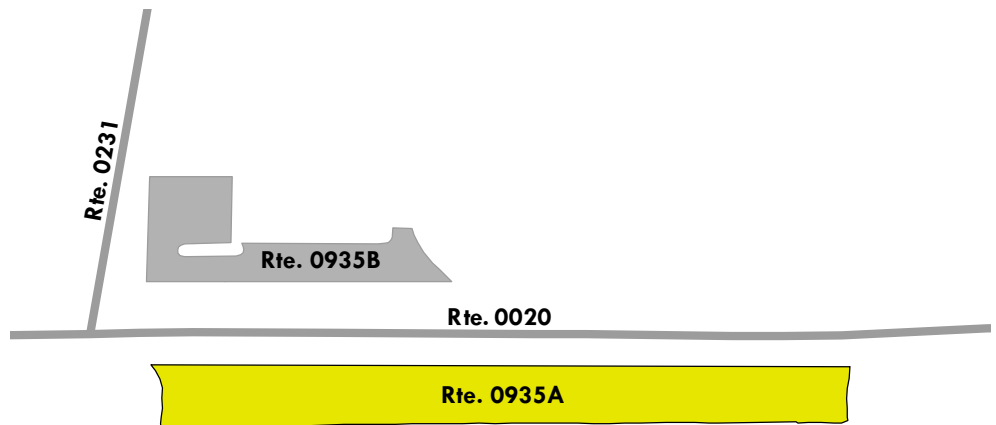
ROUTE 0935A: OLD DEWLINE ROAD PARKING A

| Inspection Date | FMSS Number | User Access | Surface Type |
|---|---|---|---|
| 3,810 | 0.066 | 4 | LIGHT REPAIR |

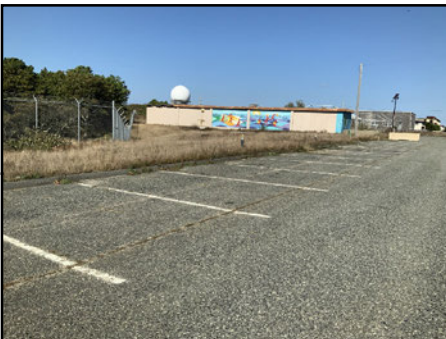
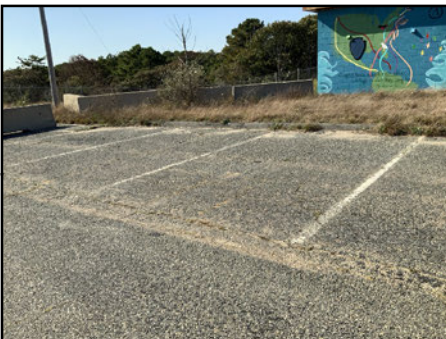
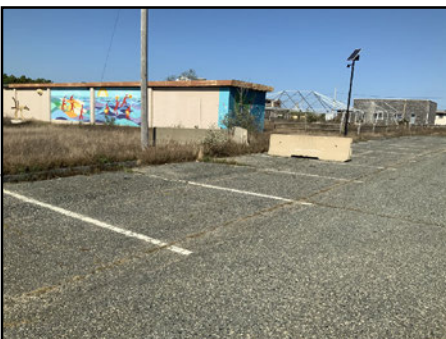
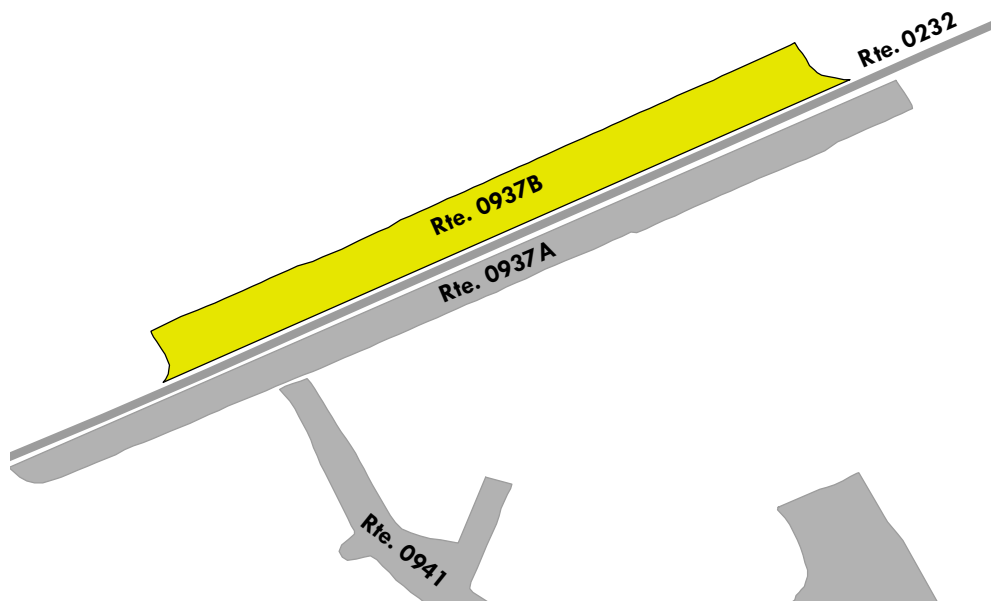
ROUTE 0937B: NTAFS ACCESS ROAD B PARKING

| Inspection Date | FMSS Number | User Access | Surface Type |
|---|---|---|---|
| 9,742 | 0.168 | 5 | LIGHT REPAIR |

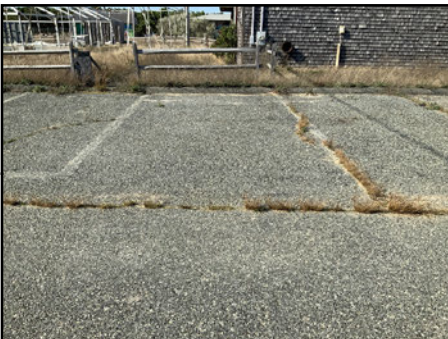
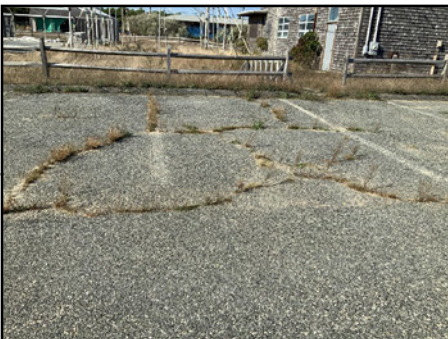
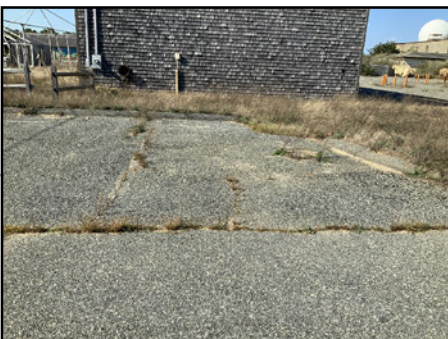
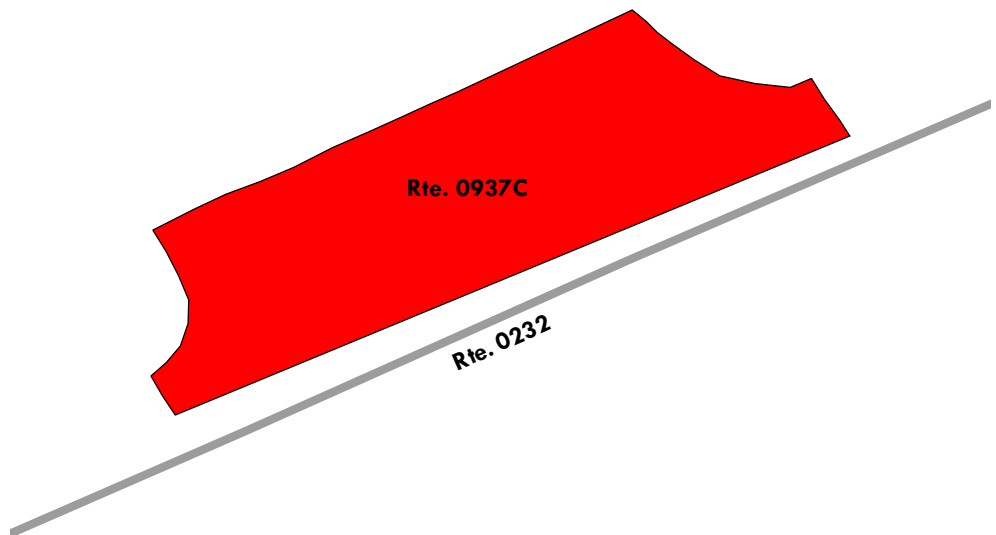
ROUTE 0937C: NTAFS ACCESS ROAD C PARKING

| Inspection Date | FMSS Number | User Access | Surface Type |
|---|---|---|---|
| 2,201 | 0.038 | 5 | LIGHT REPAIR |

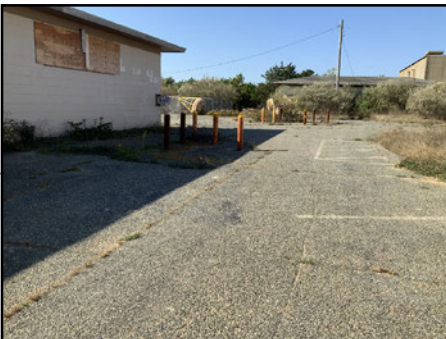
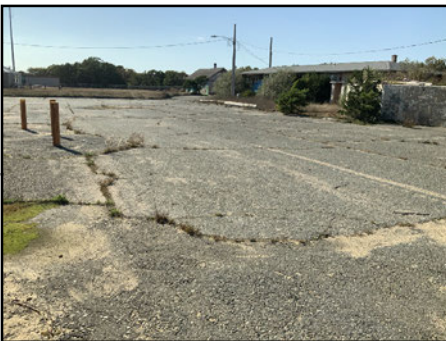
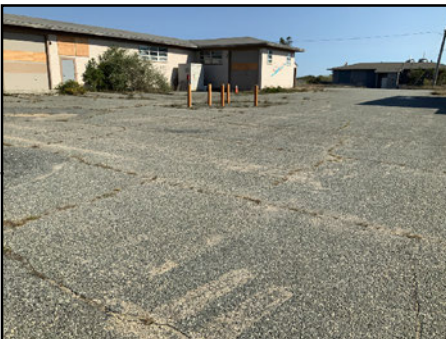
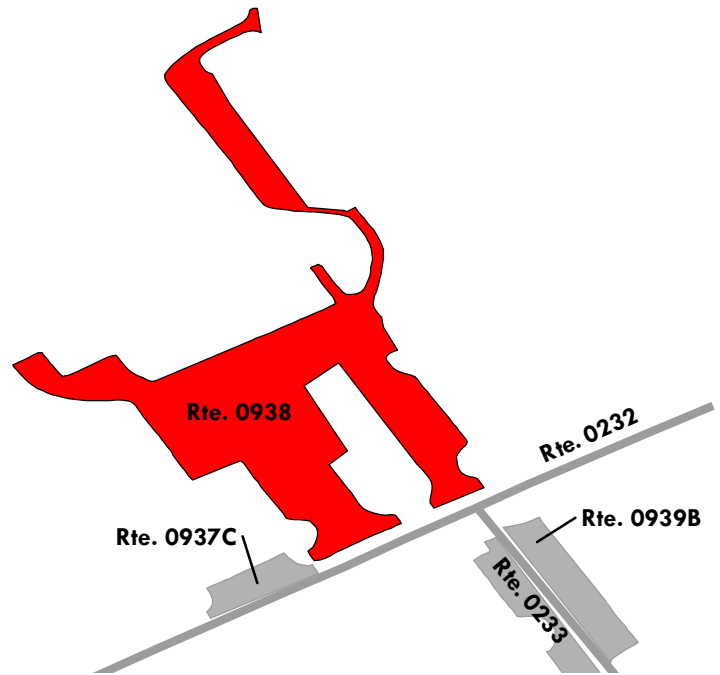
ROUTE 0938: AIR FORCE MAINTENANCE AREA PARKING

| Inspection Date | FMSS Number | User Access | Surface Type |
|---|---|---|---|
| 38,399 | 0.661 | 5 | LIGHT REPAIR |

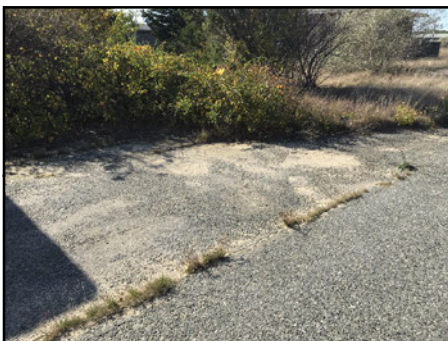
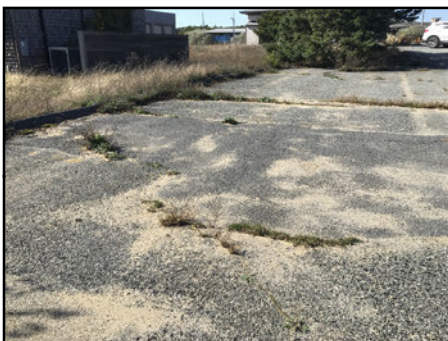
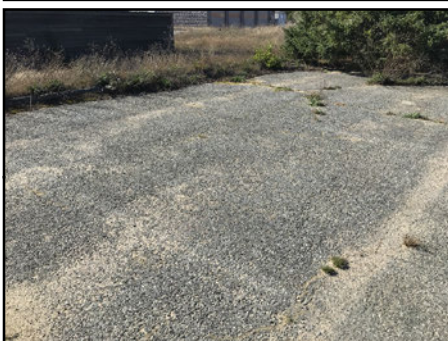
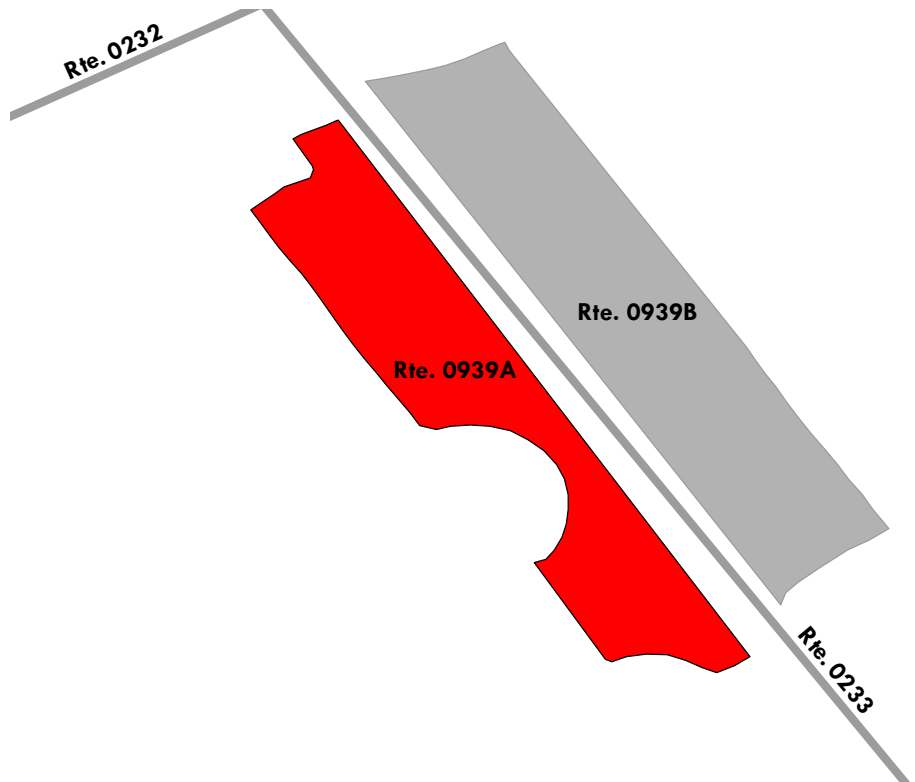
ROUTE 0939A: NTAFS FUEL HOUSE ROAD A PARKING

| Inspection Date | FMSS Number | User Access | Surface Type |
|---|---|---|---|
| 3,126 | 0.054 | 4 | LIGHT REPAIR |

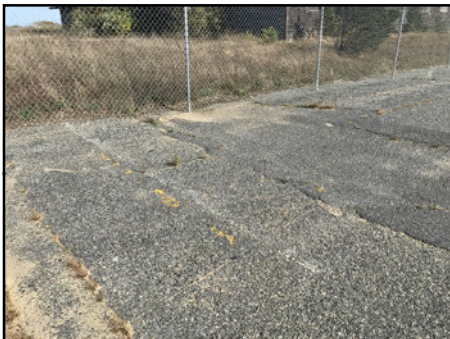
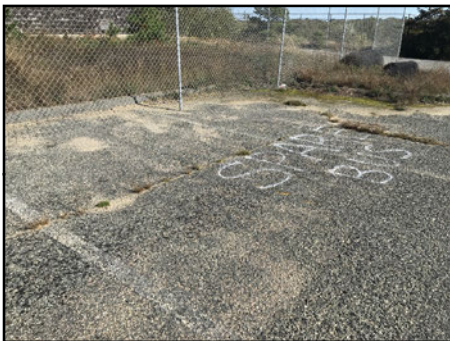
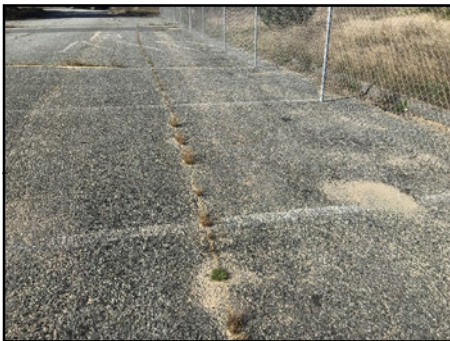
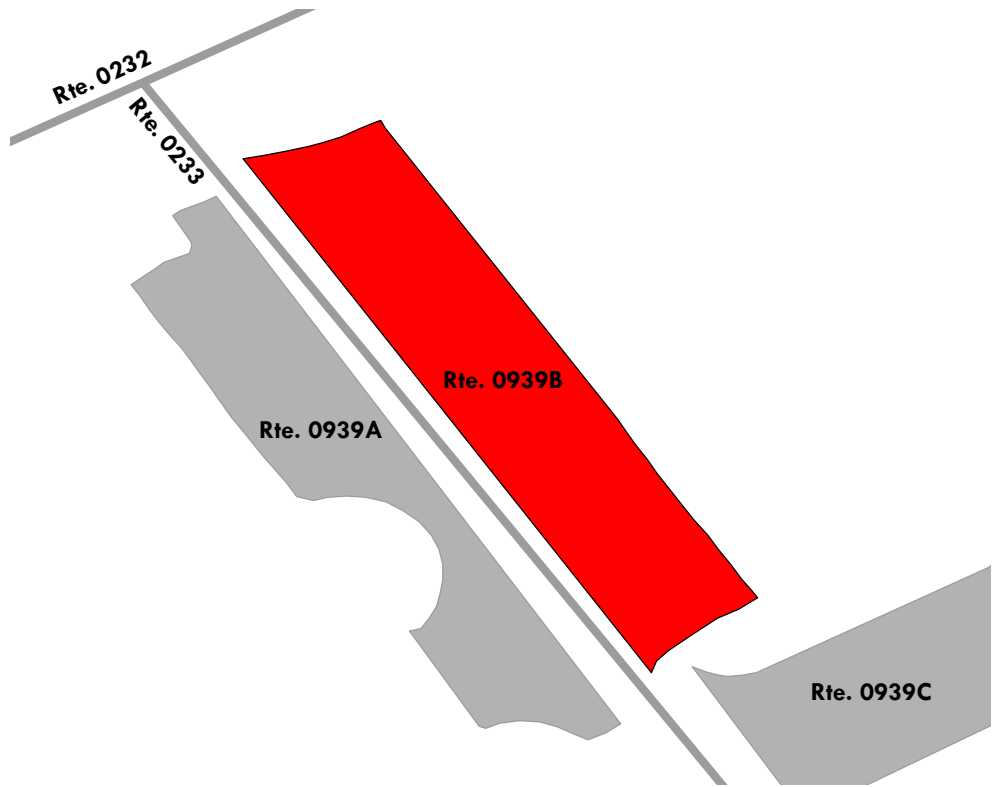
ROUTE 0939B: NTAFS FUEL HOUSE ROAD B PARKING

| Inspection Date | FMSS Number | User Access | Surface Type |
|---|---|---|---|
| 4,083 | 0.07 | 4 | MODERATE REPAIR |

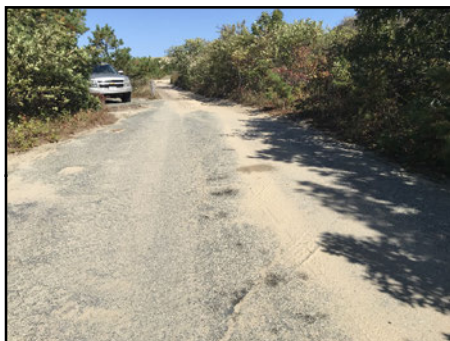
PARKING LOT IS ABANDONED.
