**CANA
Cycle 6**

**Road Inventory and Condition Assessment of Paved Routes
Canaveral National Seashore**

**Federal Lands Highway
Road Inventory Program**

Report Date: April 2020

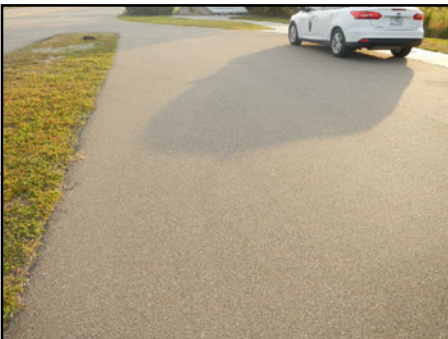
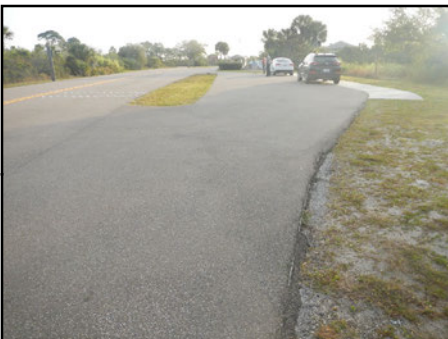
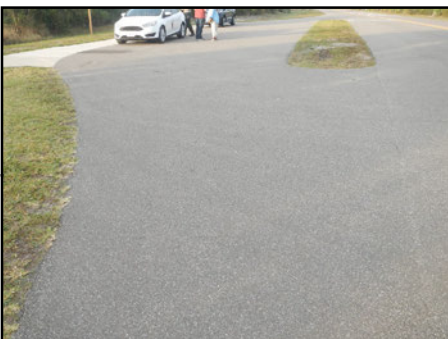
Inspection Date	FMSS Number	User Access	Surface Type
3/11/2019	60799	PUBLIC	ASPHALT
Area (Sq. Ft.)	Lane Miles (11' Widths)	Curb Reveal (Inches)	Curb Recommendation
3,810	0.066	NOT APPLICABLE	NOT APPLICABLE
Curb Type		Curb & Gutter Type	
NO CURB		NO CURB AND GUTTER	
Pavement Recommendation		Condition Rating / PCR	
PREVENTIVE MAINTENANCE		GOOD / 90

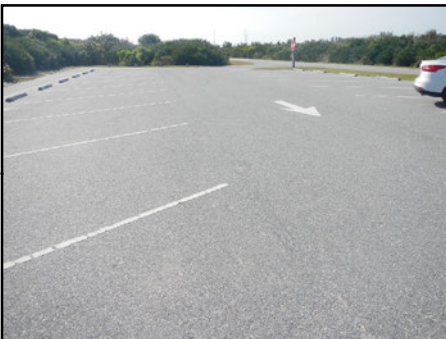
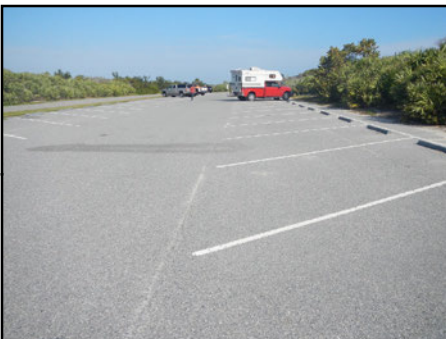
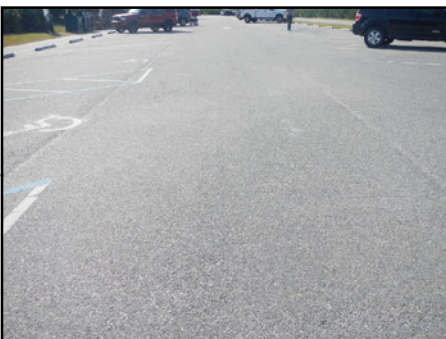
ROUTE 0901: PD PARKING #1

Inspection Date	FMSS Number	User Access	Surface Type
3/11/2019	60815	PUBLIC	ASPHALT
Area (Sq. Ft.)	Lane Miles (11' Widths)	Curb Reveal (Inches)	Curb Recommendation
28,772	0.495	NOT APPLICABLE	NOT APPLICABLE
Curb Type		Curb & Gutter Type	
NO CURB		NO CURB AND GUTTER	
Pavement Recommendation		Condition Rating / PCR	
LIGHT 3R TREATMENTS		FAIR / 73

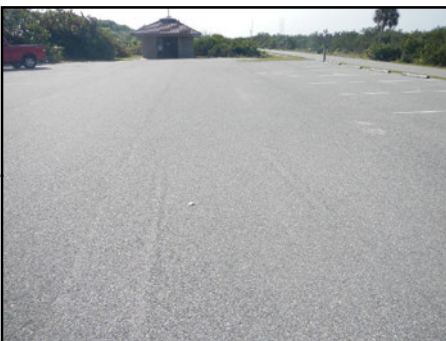
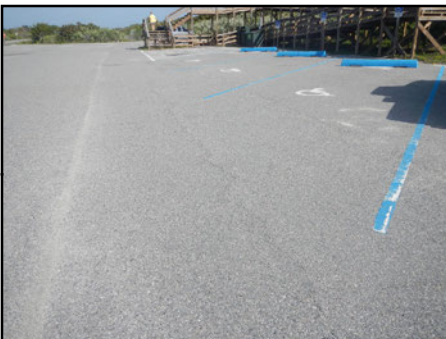
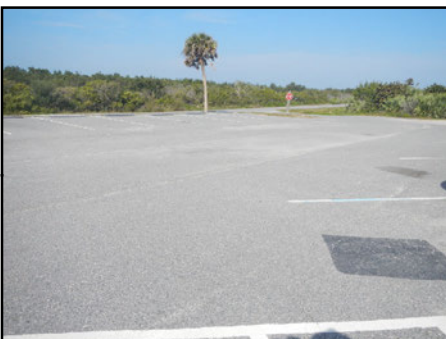
ROUTE 0902: PD PARKING #2

Inspection Date	FMSS Number	User Access	Surface Type
3/11/2019	60817	PUBLIC	ASPHALT
Area (Sq. Ft.)	Lane Miles (11' Widths)	Curb Reveal (Inches)	Curb Recommendation
36,304	0.625	NOT APPLICABLE	NOT APPLICABLE
Curb Type		Curb & Gutter Type	
NO CURB		NO CURB AND GUTTER	
Pavement Recommendation		Condition Rating / PCR	
LIGHT 3R TREATMENTS		FAIR / 73

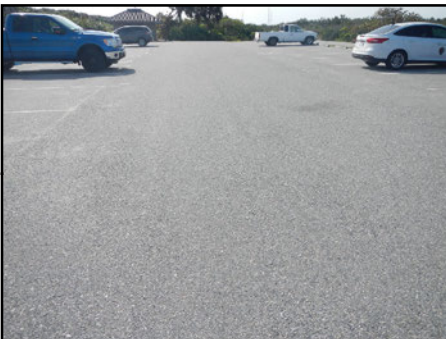
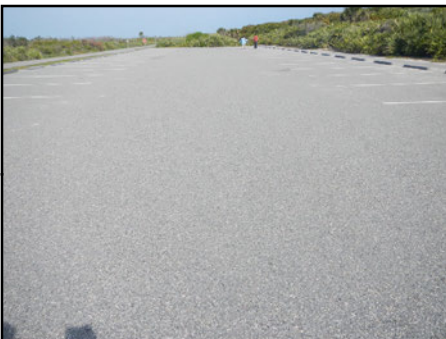
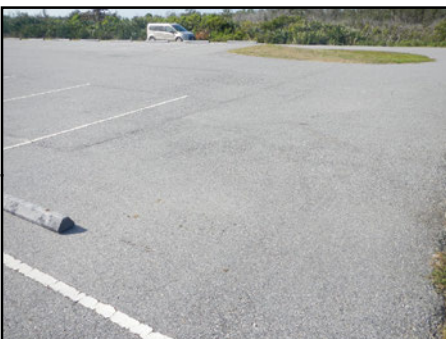
ROUTE 0903: PD PARKING #3

Inspection Date	FMSS Number	User Access	Surface Type
3/11/2019	60818	PUBLIC	ASPHALT
Area (Sq. Ft.)	Lane Miles (11' Widths)	Curb Reveal (Inches)	Curb Recommendation
31,067	0.535	NOT APPLICABLE	NOT APPLICABLE
Curb Type		Curb & Gutter Type	
NO CURB		NO CURB AND GUTTER	
Pavement Recommendation		Condition Rating / PCR	
LIGHT 3R TREATMENTS		FAIR / 73

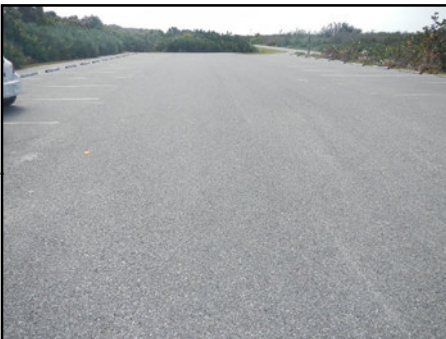
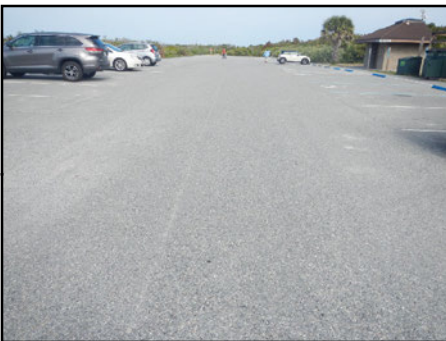
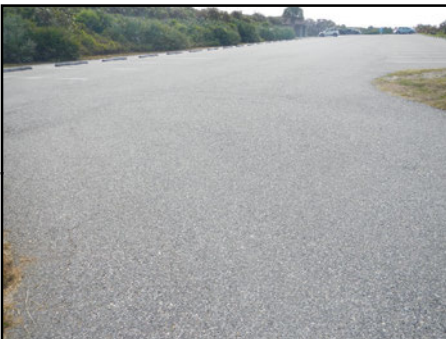
ROUTE 0904: PD PARKING #4

Inspection Date	FMSS Number	User Access	Surface Type
3/11/2019	60819	PUBLIC	ASPHALT
Area (Sq. Ft.)	Lane Miles (11' Widths)	Curb Reveal (Inches)	Curb Recommendation
39,969	0.688	NOT APPLICABLE	NOT APPLICABLE
Curb Type		Curb & Gutter Type	
NO CURB		NO CURB AND GUTTER	
Pavement Recommendation		Condition Rating / PCR	
LIGHT 3R TREATMENTS		FAIR / 73

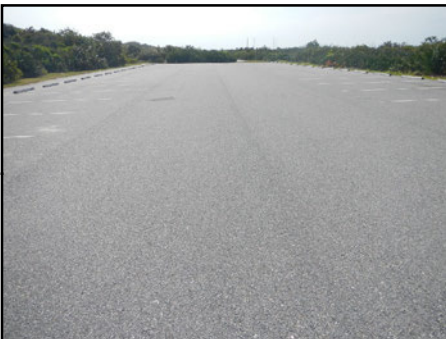
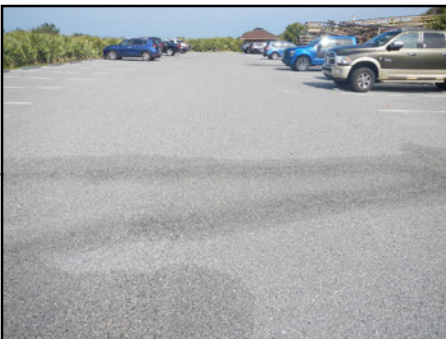
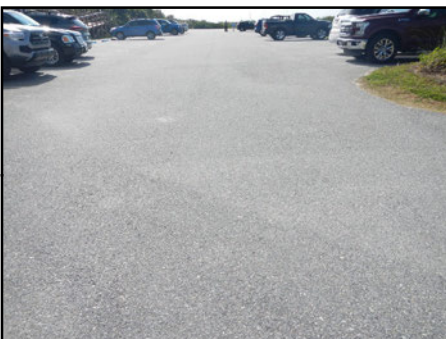
ROUTE 0905: PD PARKING #5

Inspection Date	FMSS Number	User Access	Surface Type
3/11/2019	60820	PUBLIC	ASPHALT
Area (Sq. Ft.)	Lane Miles (11' Widths)	Curb Reveal (Inches)	Curb Recommendation
33,407	0.575	NOT APPLICABLE	NOT APPLICABLE
Curb Type		Curb & Gutter Type	
NO CURB		NO CURB AND GUTTER	
Pavement Recommendation		Condition Rating / PCR	
LIGHT 3R TREATMENTS		FAIR / 73

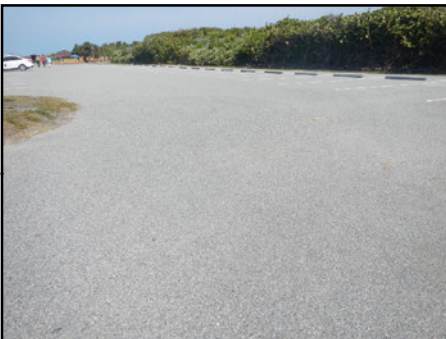
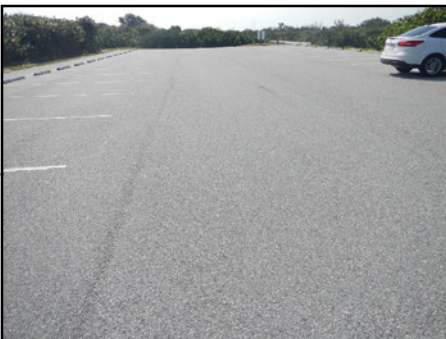
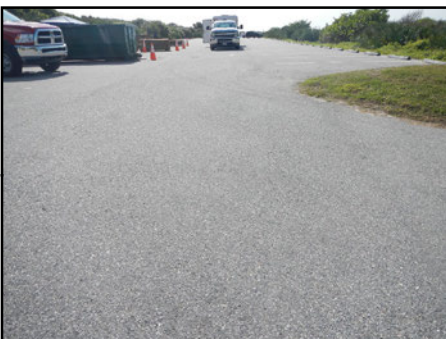
ROUTE 0907: PD PARKING #7

Inspection Date	FMSS Number	User Access	Surface Type
3/11/2019	60826	PUBLIC	ASPHALT
Area (Sq. Ft.)	Lane Miles (11' Widths)	Curb Reveal (Inches)	Curb Recommendation
34,681	0.597	NOT APPLICABLE	NOT APPLICABLE
Curb Type		Curb & Gutter Type	
NO CURB		NO CURB AND GUTTER	
Pavement Recommendation		Condition Rating / PCR	
PREVENTIVE MAINTENANCE		GOOD / 90

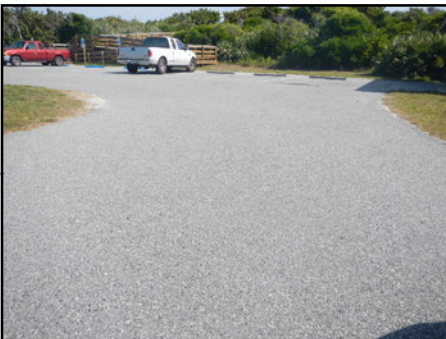
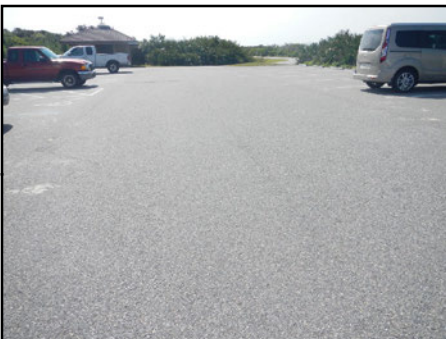
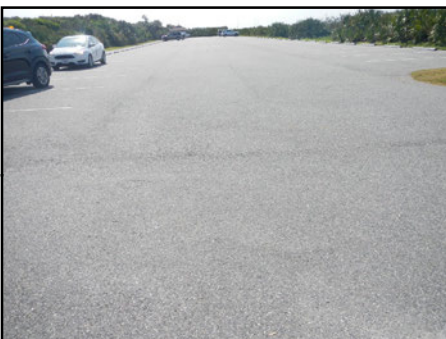
ROUTE 0908: PD PARKING #8

Inspection Date	FMSS Number	User Access	Surface Type
3/11/2019	60829	PUBLIC	ASPHALT
Area (Sq. Ft.)	Lane Miles (11' Widths)	Curb Reveal (Inches)	Curb Recommendation
43,430	0.748	NOT APPLICABLE	NOT APPLICABLE
Curb Type		Curb & Gutter Type	
NO CURB		NO CURB AND GUTTER	
Pavement Recommendation		Condition Rating / PCR	
PREVENTIVE MAINTENANCE		GOOD / 90

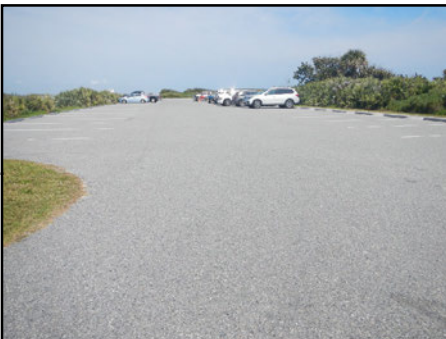
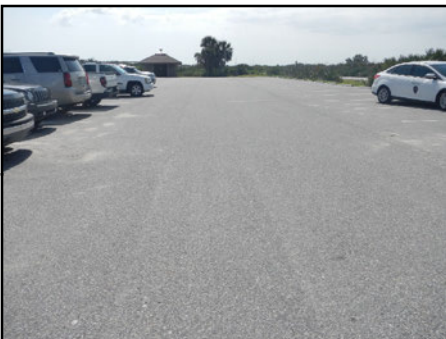
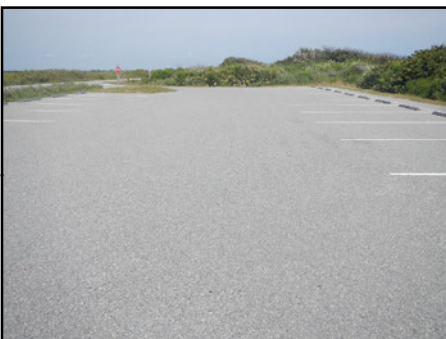
ROUTE 0909: PD PARKING #9

Inspection Date	FMSS Number	User Access	Surface Type
3/11/2019	60831	PUBLIC	ASPHALT
Area (Sq. Ft.)	Lane Miles (11' Widths)	Curb Reveal (Inches)	Curb Recommendation
29,732	0.512	NOT APPLICABLE	NOT APPLICABLE
Curb Type		Curb & Gutter Type	
NO CURB		NO CURB AND GUTTER	
Pavement Recommendation		Condition Rating / PCR	
LIGHT 3R TREATMENTS		FAIR / 73

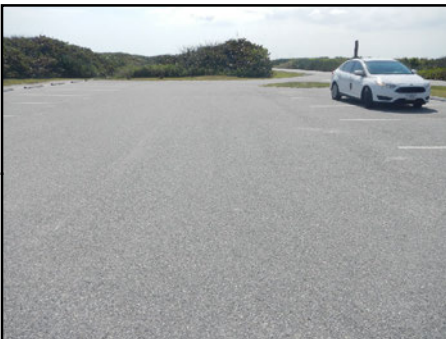
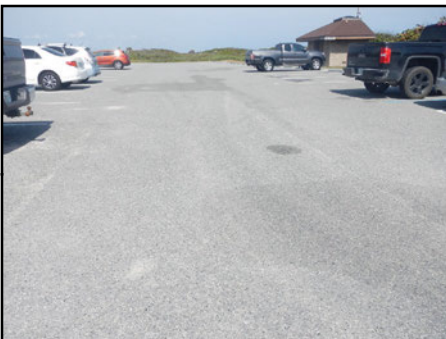
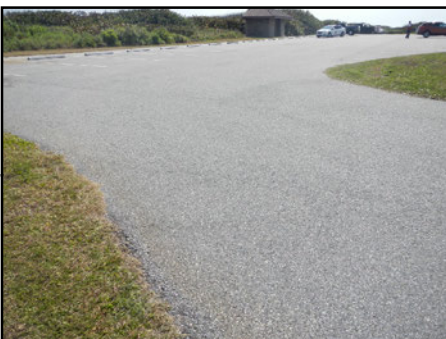
ROUTE 0910: PD PARKING #10

Inspection Date	FMSS Number	User Access	Surface Type
3/11/2019	60832	PUBLIC	ASPHALT
Area (Sq. Ft.)	Lane Miles (11' Widths)	Curb Reveal (Inches)	Curb Recommendation
30,054	0.517	NOT APPLICABLE	NOT APPLICABLE
Curb Type		Curb & Gutter Type	
NO CURB		NO CURB AND GUTTER	
Pavement Recommendation		Condition Rating / PCR	
PREVENTIVE MAINTENANCE		GOOD / 90

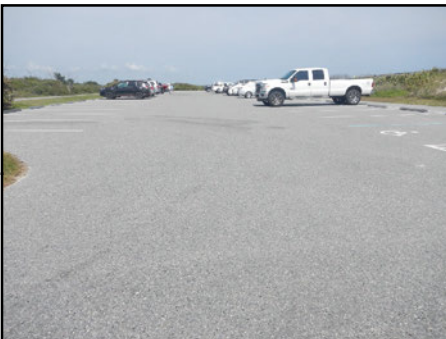
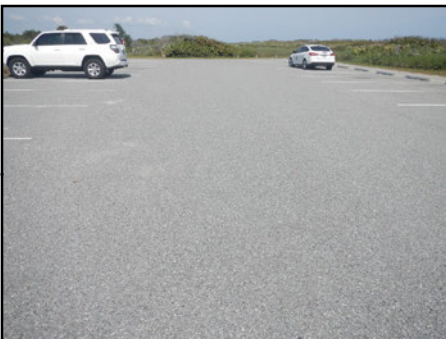
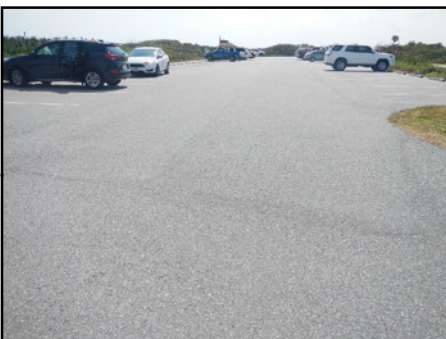
ROUTE 0911: PD PARKING #11

Inspection Date	FMSS Number	User Access	Surface Type
3/11/2019	60833	PUBLIC	ASPHALT
Area (Sq. Ft.)	Lane Miles (11' Widths)	Curb Reveal (Inches)	Curb Recommendation
13,174	0.227	NOT APPLICABLE	NOT APPLICABLE
Curb Type		Curb & Gutter Type	
NO CURB		NO CURB AND GUTTER	
Pavement Recommendation		Condition Rating / PCR	
LIGHT 3R TREATMENTS		FAIR / 73

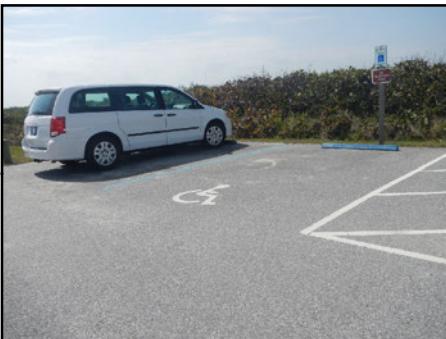
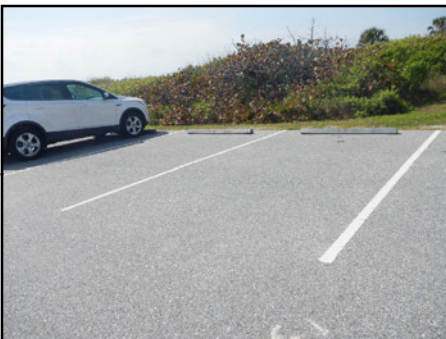
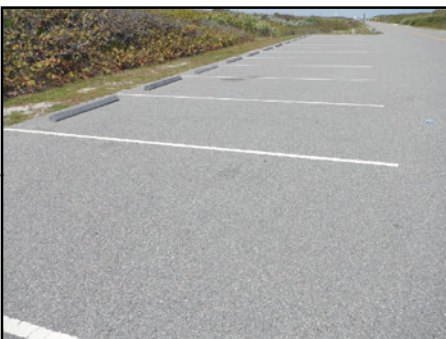
ROUTE 0912: PD PARKING #12

Inspection Date	FMSS Number	User Access	Surface Type
3/11/2019	60834	PUBLIC	ASPHALT
Area (Sq. Ft.)	Lane Miles (11' Widths)	Curb Reveal (Inches)	Curb Recommendation
16,057	0.276	NOT APPLICABLE	NOT APPLICABLE
Curb Type		Curb & Gutter Type	
NO CURB		NO CURB AND GUTTER	
Pavement Recommendation		Condition Rating / PCR	
PREVENTIVE MAINTENANCE		GOOD / 90

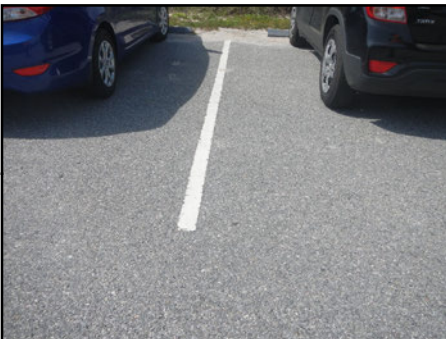
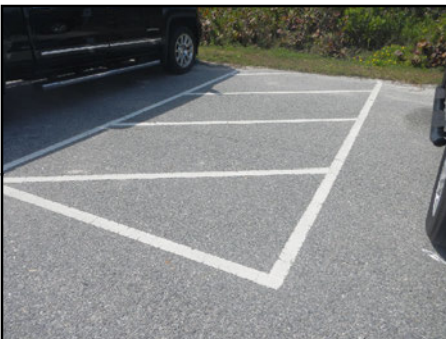
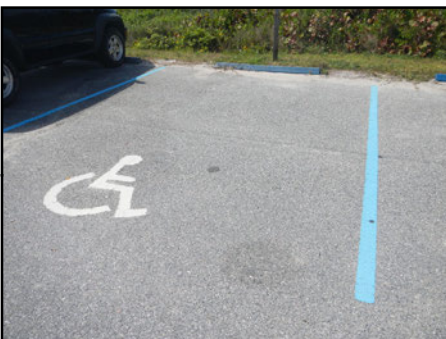
ROUTE 0913: PD PARKING #13

Inspection Date	FMSS Number	User Access	Surface Type
3/11/2019	60835	PUBLIC	ASPHALT
Area (Sq. Ft.)	Lane Miles (11' Widths)	Curb Reveal (Inches)	Curb Recommendation
12,742	0.219	NOT APPLICABLE	NOT APPLICABLE
Curb Type		Curb & Gutter Type	
NO CURB		NO CURB AND GUTTER	
Pavement Recommendation		Condition Rating / PCR	
LIGHT 3R TREATMENTS		FAIR / 73

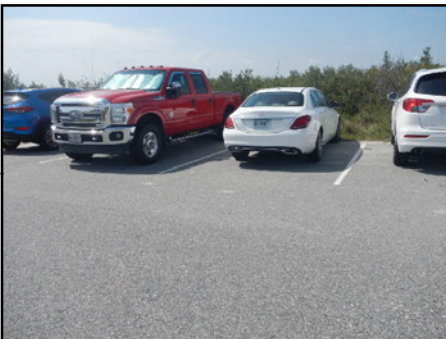
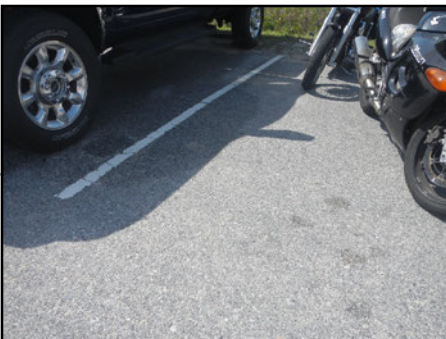
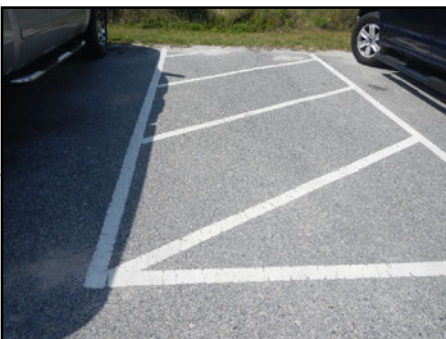
ROUTE 0914: PD RANGER STATION PARKING

Inspection Date	FMSS Number	User Access	Surface Type
3/11/2019	60801	NONPUBLIC	ASPHALT
Area (Sq. Ft.)	Lane Miles (11' Widths)	Curb Reveal (Inches)	Curb Recommendation
13,201	0.227	4	DO NOTHING
Curb Type		Curb & Gutter Type	
CONCRETE		NO CURB AND GUTTER	
Pavement Recommendation		Condition Rating / PCR	
PREVENTIVE MAINTENANCE		GOOD / 90

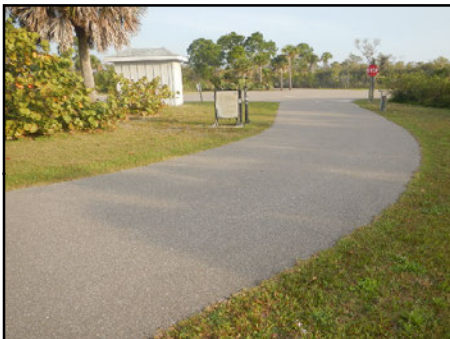
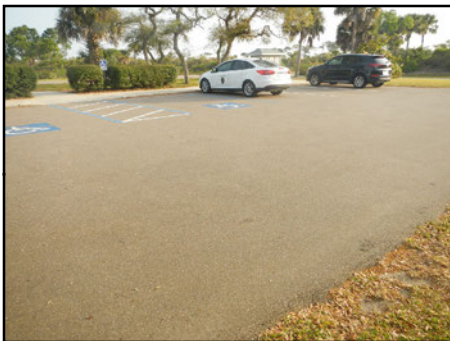
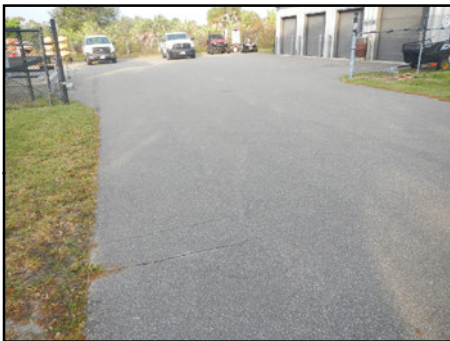
ROUTE 0915: PD CONTACT STATION RV PULLOUT

Inspection Date	FMSS Number	User Access	Surface Type
3/11/2019	60802	PUBLIC	ASPHALT
Area (Sq. Ft.)	Lane Miles (11' Widths)	Curb Reveal (Inches)	Curb Recommendation
2,816	0.048	NOT APPLICABLE	NOT APPLICABLE
Curb Type		Curb & Gutter Type	
NO CURB		NO CURB AND GUTTER	
Pavement Recommendation		Condition Rating / PCR	
PREVENTIVE MAINTENANCE		GOOD / 90

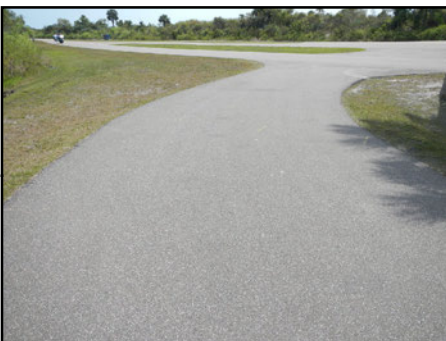
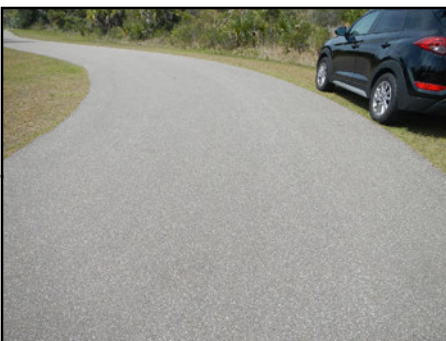
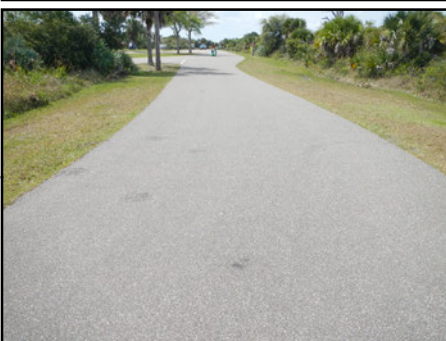
ROUTE 0916: PD VISTA #1

Inspection Date	FMSS Number	User Access	Surface Type
3/11/2019	60803	PUBLIC	ASPHALT
Area (Sq. Ft.)	Lane Miles (11' Widths)	Curb Reveal (Inches)	Curb Recommendation
7,412	0.128	NOT APPLICABLE	NOT APPLICABLE
Curb Type		Curb & Gutter Type	
NO CURB		NO CURB AND GUTTER	
Pavement Recommendation		Condition Rating / PCR	
PREVENTIVE MAINTENANCE		GOOD / 90

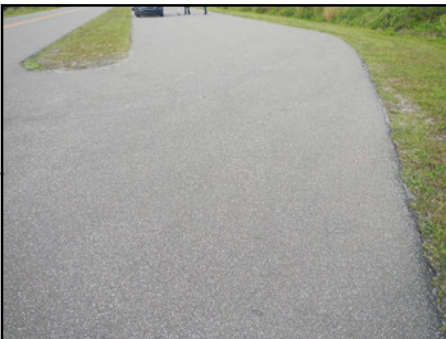
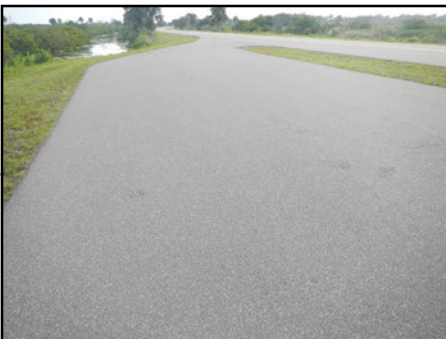
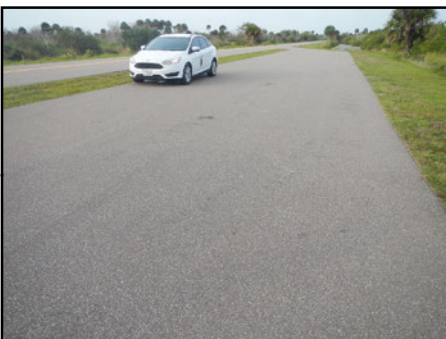
ROUTE 0918: PD VISTA #3

Inspection Date	FMSS Number	User Access	Surface Type
3/11/2019	60806	PUBLIC	ASPHALT
Area (Sq. Ft.)	Lane Miles (11' Widths)	Curb Reveal (Inches)	Curb Recommendation
6,586	0.113	NOT APPLICABLE	NOT APPLICABLE
Curb Type		Curb & Gutter Type	
NO CURB		NO CURB AND GUTTER	
Pavement Recommendation		Condition Rating / PCR	
PREVENTIVE MAINTENANCE		GOOD / 90

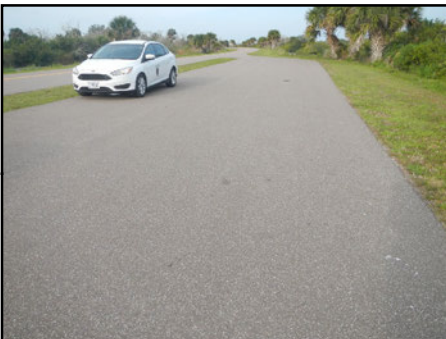
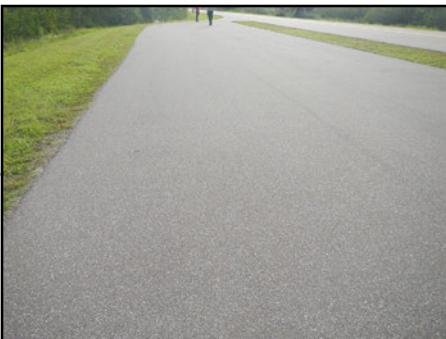
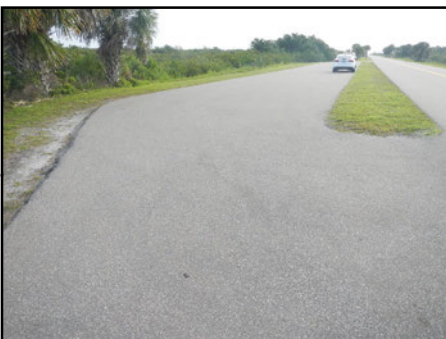
ROUTE 0919: PD VISTA #4

Inspection Date	FMSS Number	User Access	Surface Type
3/11/2019	60808	PUBLIC	ASPHALT
Area (Sq. Ft.)	Lane Miles (11' Widths)	Curb Reveal (Inches)	Curb Recommendation
6,363	0.11	NOT APPLICABLE	NOT APPLICABLE
Curb Type		Curb & Gutter Type	
NO CURB		NO CURB AND GUTTER	
Pavement Recommendation		Condition Rating / PCR	
PREVENTIVE MAINTENANCE		GOOD / 90

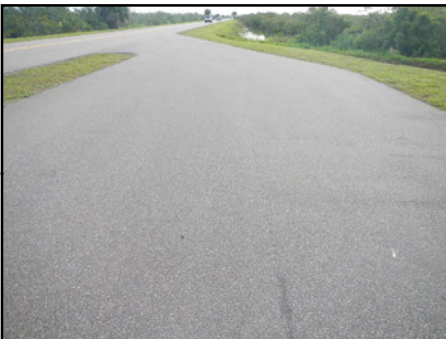
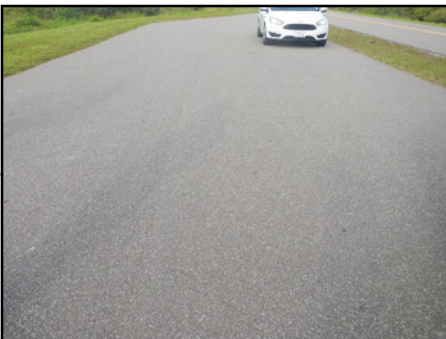
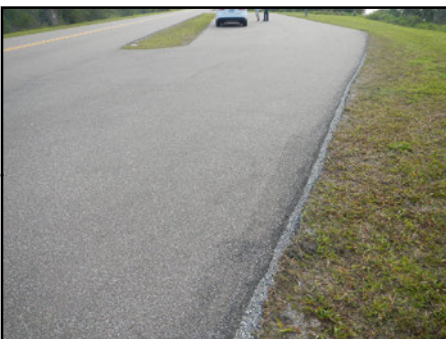
ROUTE 0920: PD VISTA #5

Inspection Date	FMSS Number	User Access	Surface Type
3/11/2019	60809	PUBLIC	ASPHALT
Area (Sq. Ft.)	Lane Miles (11' Widths)	Curb Reveal (Inches)	Curb Recommendation
9,647	0.166	NOT APPLICABLE	NOT APPLICABLE
Curb Type		Curb & Gutter Type	
NO CURB		NO CURB AND GUTTER	
Pavement Recommendation		Condition Rating / PCR	
PREVENTIVE MAINTENANCE		GOOD / 90

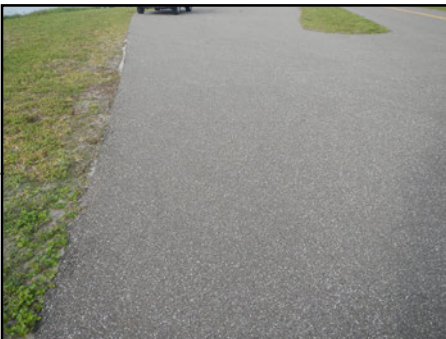
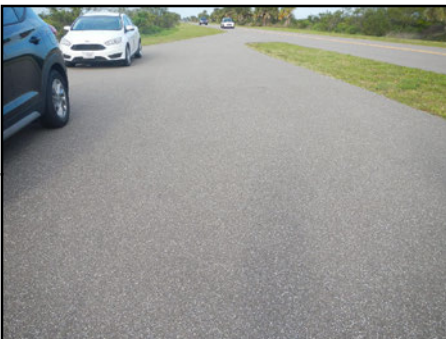
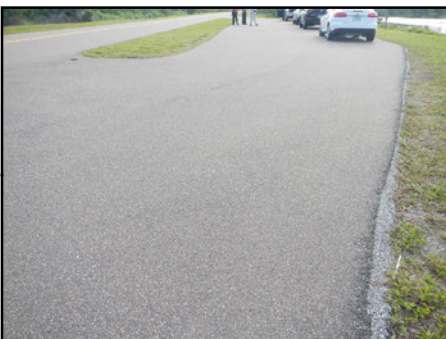
ROUTE 0921: PD VISTA #6

Inspection Date	FMSS Number	User Access	Surface Type
3/11/2019	60810	PUBLIC	ASPHALT
Area (Sq. Ft.)	Lane Miles (11' Widths)	Curb Reveal (Inches)	Curb Recommendation
4,592	0.079	NOT APPLICABLE	NOT APPLICABLE
Curb Type		Curb & Gutter Type	
NO CURB		NO CURB AND GUTTER	
Pavement Recommendation		Condition Rating / PCR	
PREVENTIVE MAINTENANCE		GOOD / 90

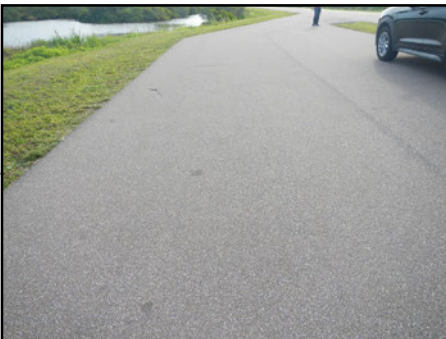
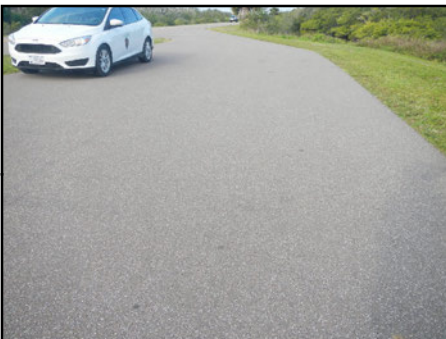
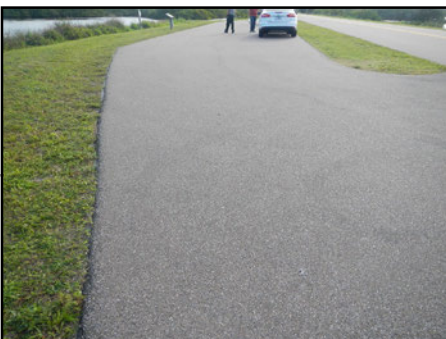
ROUTE 0922: PD VISTA #7

Inspection Date	FMSS Number	User Access	Surface Type
3/11/2019	60812	PUBLIC	ASPHALT
Area (Sq. Ft.)	Lane Miles (11' Widths)	Curb Reveal (Inches)	Curb Recommendation
5,264	0.091	NOT APPLICABLE	NOT APPLICABLE
Curb Type		Curb & Gutter Type	
NO CURB		NO CURB AND GUTTER	
Pavement Recommendation		Condition Rating / PCR	
PREVENTIVE MAINTENANCE		GOOD / 90

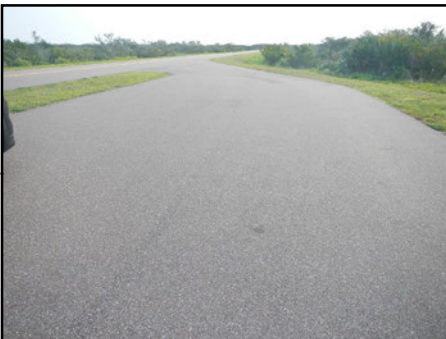
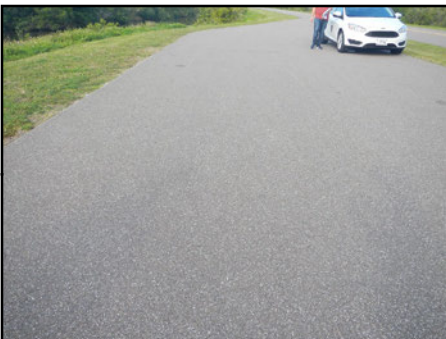
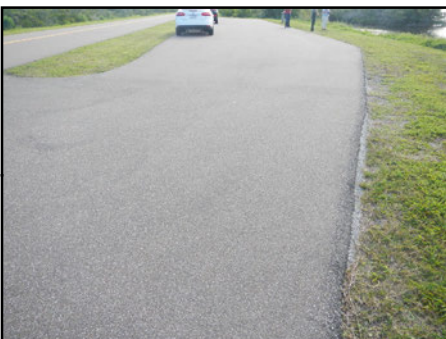
ROUTE 0923: PD VISTA #8

Inspection Date	FMSS Number	User Access	Surface Type
3/11/2019	60813	PUBLIC	ASPHALT
Area (Sq. Ft.)	Lane Miles (11' Widths)	Curb Reveal (Inches)	Curb Recommendation
5,284	0.091	NOT APPLICABLE	NOT APPLICABLE
Curb Type		Curb & Gutter Type	
NO CURB		NO CURB AND GUTTER	
Pavement Recommendation		Condition Rating / PCR	
PREVENTIVE MAINTENANCE		GOOD / 90

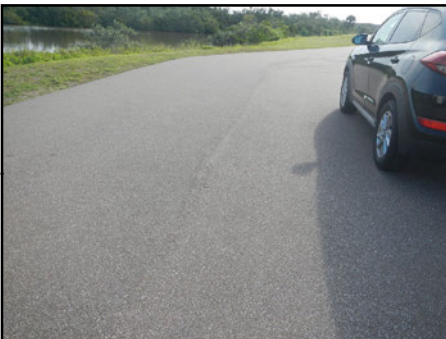
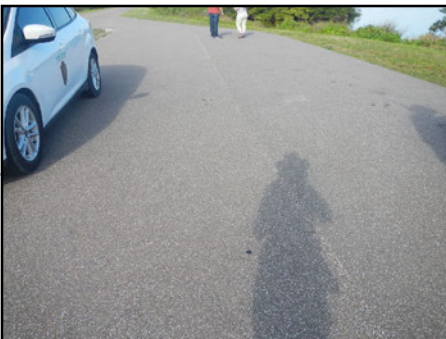
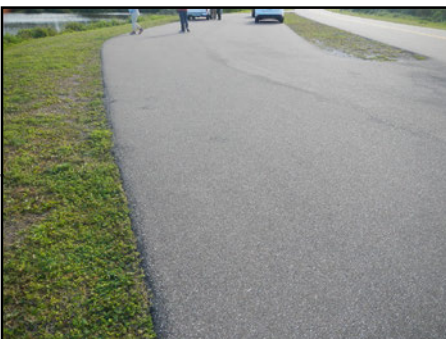
ROUTE 0924: PD BEACH OFFICE COMPLEX PARKING

Inspection Date	FMSS Number	User Access	Surface Type
3/11/2019	60837	NONPUBLIC	ASPHALT
Area (Sq. Ft.)	Lane Miles (11' Widths)	Curb Reveal (Inches)	Curb Recommendation
5,419	0.093	NOT APPLICABLE	NOT APPLICABLE
Curb Type		Curb & Gutter Type	
NO CURB		NO CURB AND GUTTER	
Pavement Recommendation		Condition Rating / PCR	
RECONSTRUCTION		POOR / 30

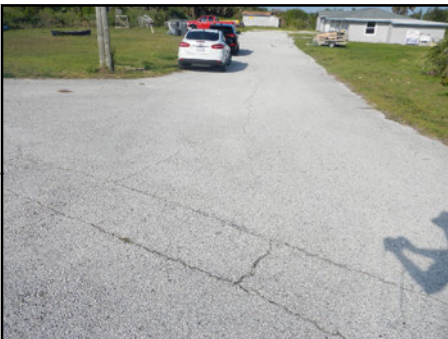
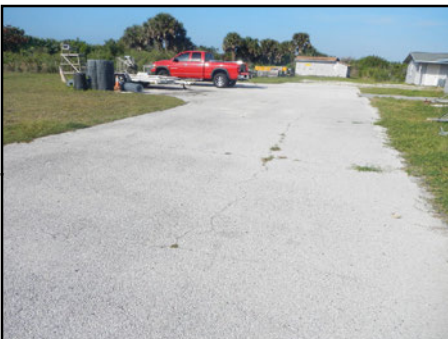
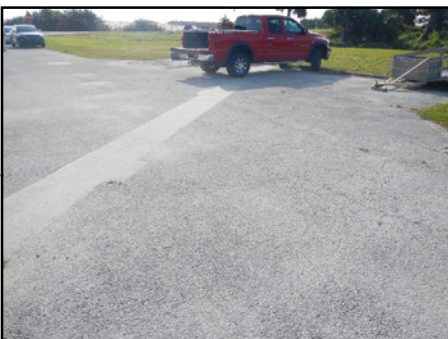
ROUTE 0931: AD PARKING #1

Inspection Date	FMSS Number	User Access	Surface Type
3/11/2019	60786	PUBLIC	ASPHALT
Area (Sq. Ft.)	Lane Miles (11' Widths)	Curb Reveal (Inches)	Curb Recommendation
49,482	0.852	4	DO NOTHING
Curb Type		Curb & Gutter Type	
CONCRETE		NO CURB AND GUTTER	
Pavement Recommendation		Condition Rating / PCR	
PREVENTIVE MAINTENANCE		GOOD / 90

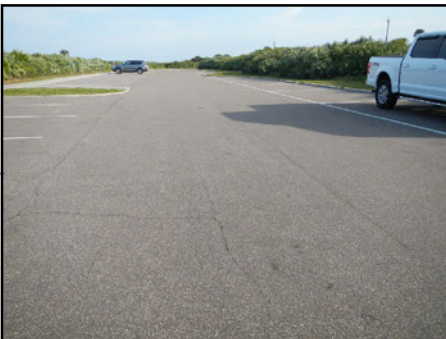
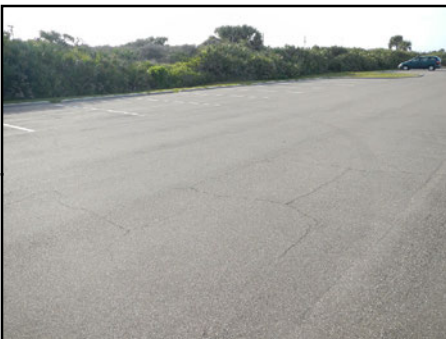
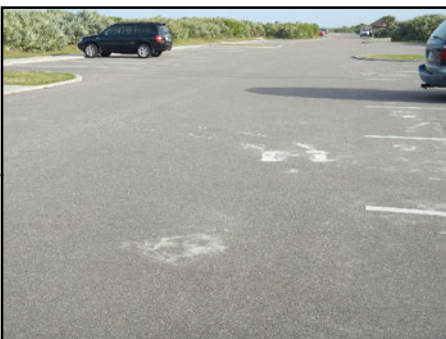
ROUTE 0932: AD PARKING #2

Inspection Date	FMSS Number	User Access	Surface Type
3/11/2019	60789	PUBLIC	ASPHALT
Area (Sq. Ft.)	Lane Miles (11' Widths)	Curb Reveal (Inches)	Curb Recommendation
12,839	0.221	NOT APPLICABLE	NOT APPLICABLE
Curb Type		Curb & Gutter Type	
NO CURB		NO CURB AND GUTTER	
Pavement Recommendation		Condition Rating / PCR	
PREVENTIVE MAINTENANCE		GOOD / 90

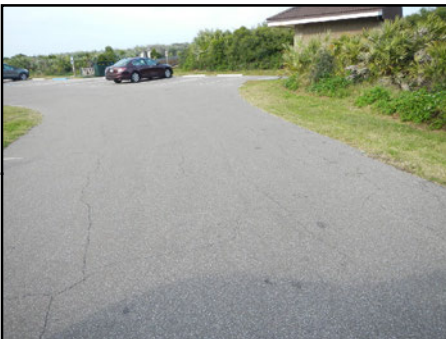
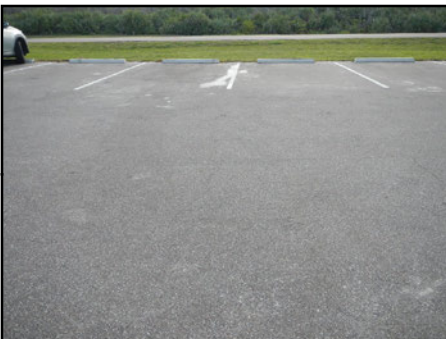
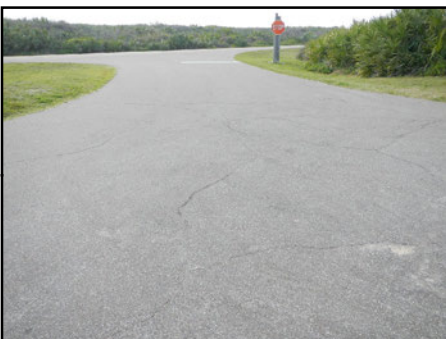
ROUTE 0933: AD PARKING #3

Inspection Date	FMSS Number	User Access	Surface Type
3/11/2019	60790	PUBLIC	ASPHALT
Area (Sq. Ft.)	Lane Miles (11' Widths)	Curb Reveal (Inches)	Curb Recommendation
12,984	0.224	NOT APPLICABLE	NOT APPLICABLE
Curb Type		Curb & Gutter Type	
NO CURB		NO CURB AND GUTTER	
Pavement Recommendation		Condition Rating / PCR	
PREVENTIVE MAINTENANCE		GOOD / 90

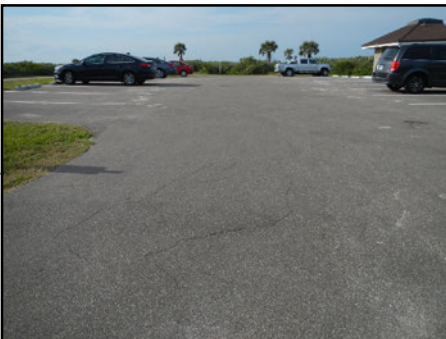
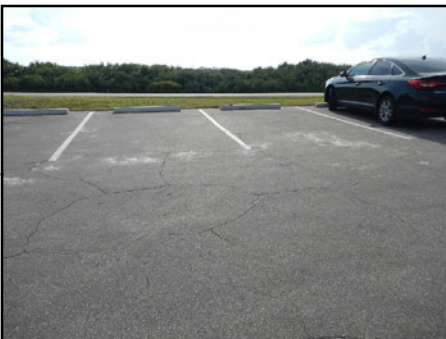
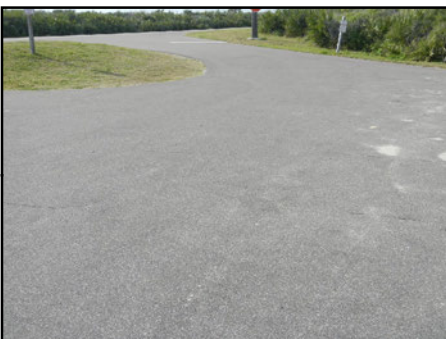
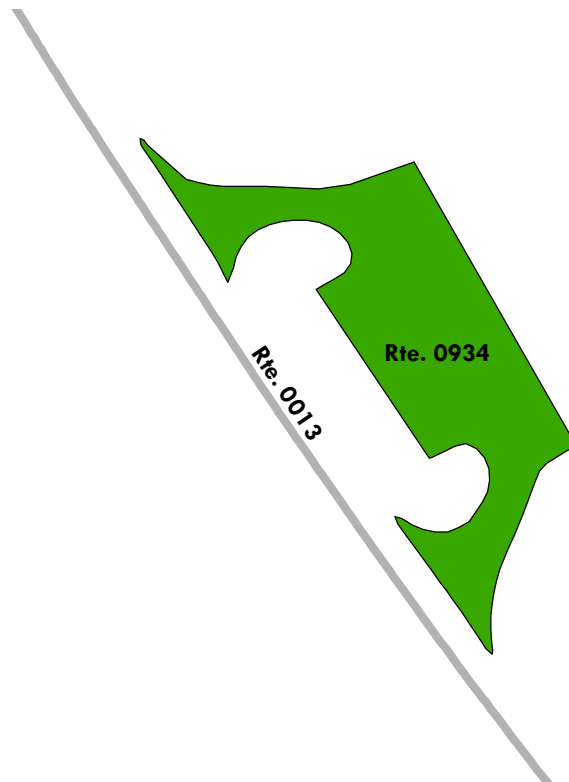
ROUTE 0935ZZ: AD PARKING #5

Inspection Date	FMSS Number	User Access	Surface Type
3/11/2019	60792	PUBLIC	ASPHALT
Area (Sq. Ft.)	Lane Miles (11' Widths)	Condition Rating / PCR	
7,430	0.129	SUMMARY / 90

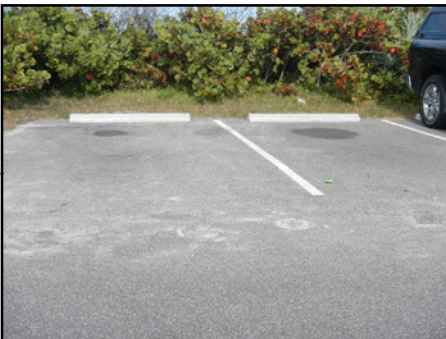
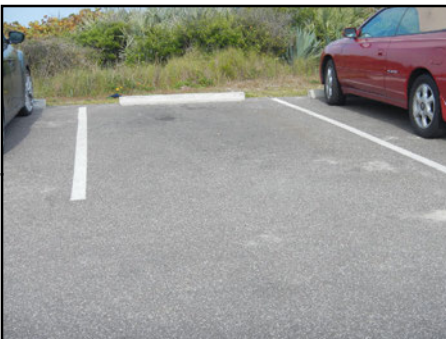
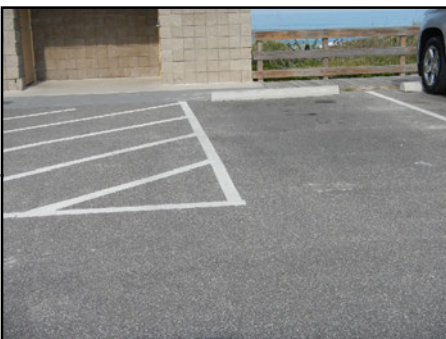
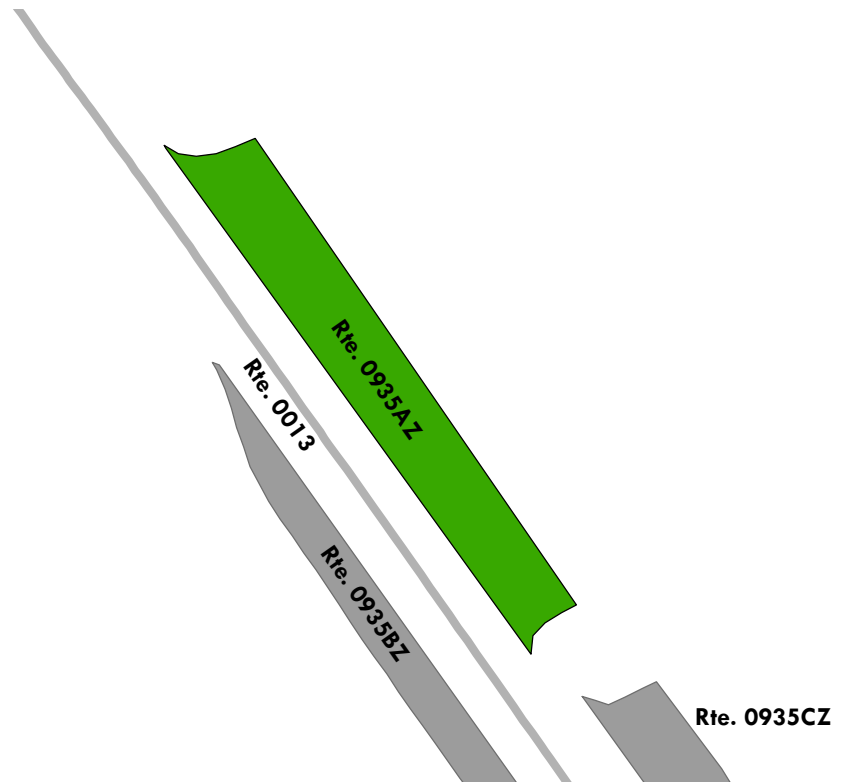
ROUTE 0935BZ: AD PARKING #5 B

Inspection Date	FMSS Number	User Access	Surface Type
3/11/2019	60792	PUBLIC	ASPHALT
Area (Sq. Ft.)	Lane Miles (11' Widths)	Curb Reveal (Inches)	Curb Recommendation
1,494	0.026	NOT APPLICABLE	NOT APPLICABLE
Curb Type		Curb & Gutter Type	
NO CURB		NO CURB AND GUTTER	
Pavement Recommendation		Condition Rating / PCR	
PREVENTIVE MAINTENANCE		GOOD / 90

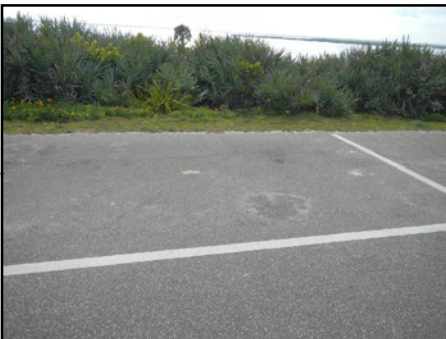
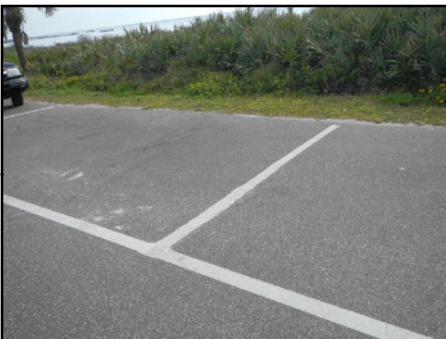
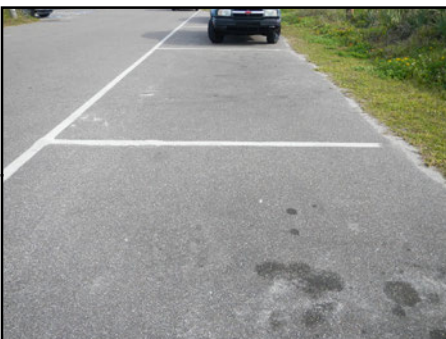
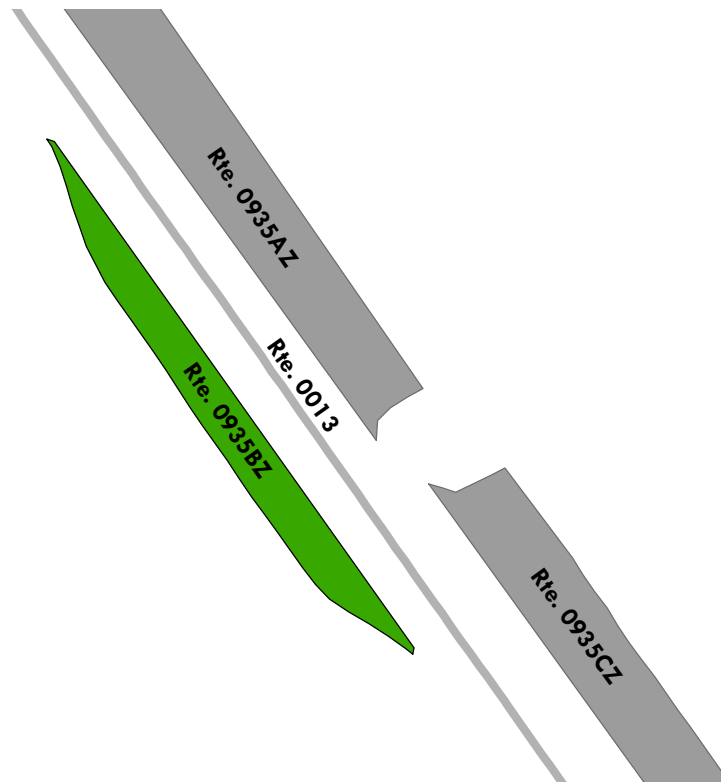
ROUTE 0935CZ: AD PARKING #5 C

Inspection Date	FMSS Number	User Access	Surface Type
3/11/2019	60792	PUBLIC	ASPHALT
Area (Sq. Ft.)	Lane Miles (11' Widths)	Curb Reveal (Inches)	Curb Recommendation
2,939	0.051	NOT APPLICABLE	NOT APPLICABLE
Curb Type		Curb & Gutter Type	
NO CURB		NO CURB AND GUTTER	
Pavement Recommendation		Condition Rating / PCR	
PREVENTIVE MAINTENANCE		GOOD / 90

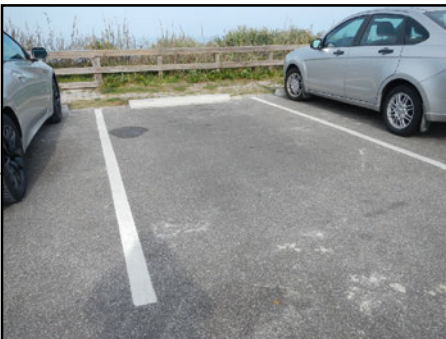
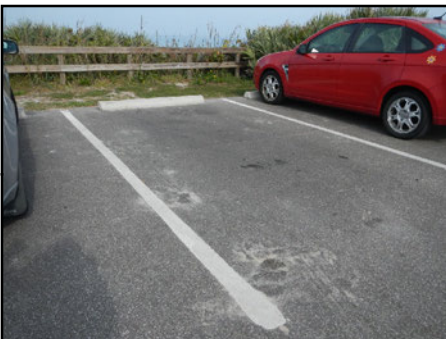
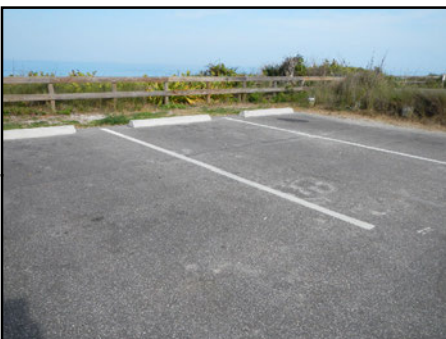
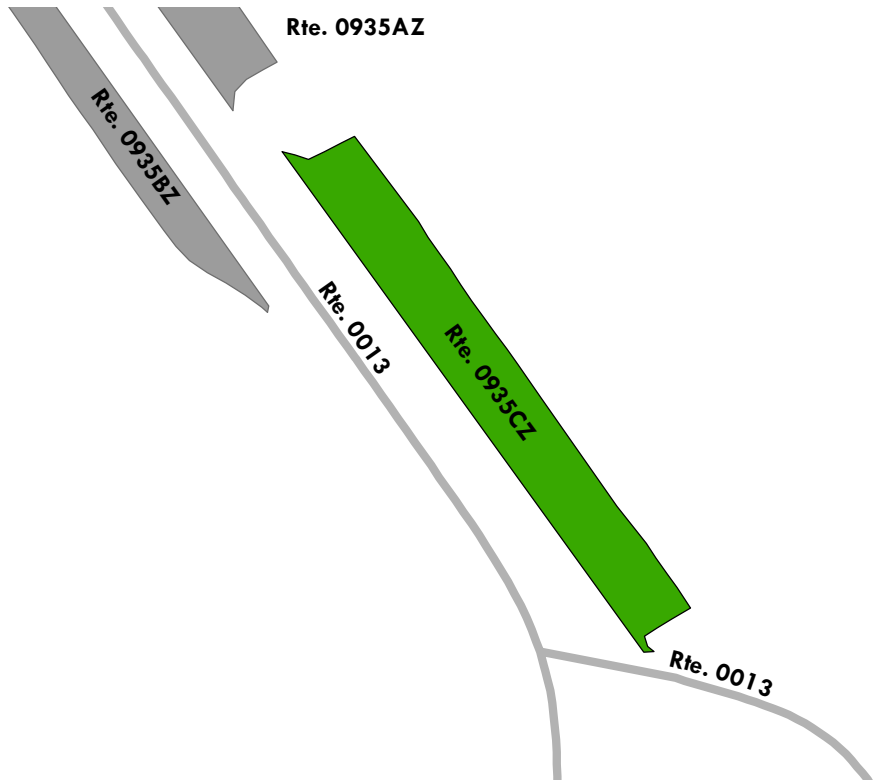
ROUTE 0936: AD PARKING #6

Inspection Date	FMSS Number	User Access	Surface Type
3/11/2019	60793	PUBLIC	ASPHALT
Area (Sq. Ft.)	Lane Miles (11' Widths)	Curb Reveal (Inches)	Curb Recommendation
9,336	0.161	NOT APPLICABLE	NOT APPLICABLE
Curb Type		Curb & Gutter Type	
NO CURB		NO CURB AND GUTTER	
Pavement Recommendation		Condition Rating / PCR	
HEAVY 3R TREATMENTS		POOR / 53

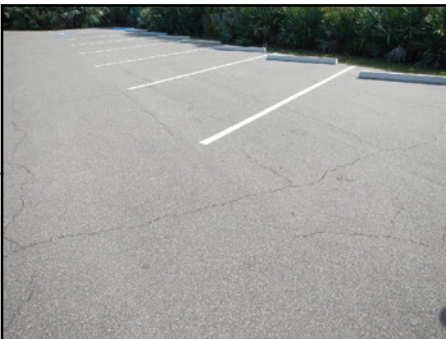
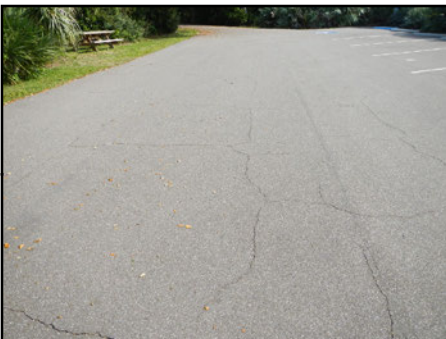
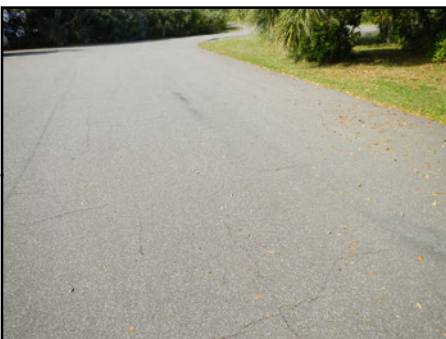
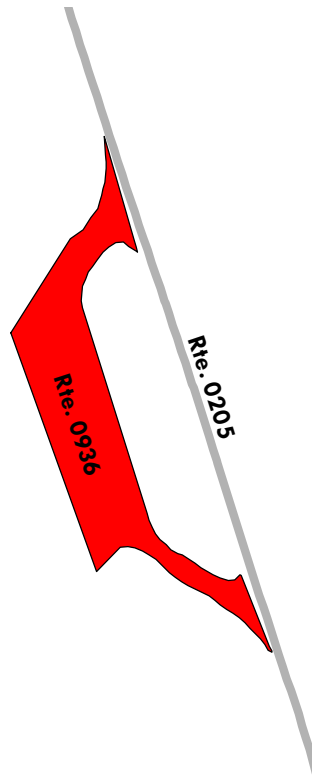
ROUTE 0937: AD PARKING #7

Inspection Date	FMSS Number	User Access	Surface Type
3/11/2019	60794	PUBLIC	ASPHALT
Area (Sq. Ft.)	Lane Miles (11' Widths)	Curb Reveal (Inches)	Curb Recommendation
10,660	0.184	NOT APPLICABLE	NOT APPLICABLE
Curb Type		Curb & Gutter Type	
NO CURB		NO CURB AND GUTTER	
Pavement Recommendation		Condition Rating / PCR	
HEAVY 3R TREATMENTS		POOR / 53

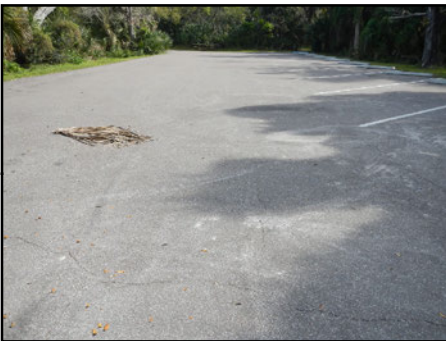
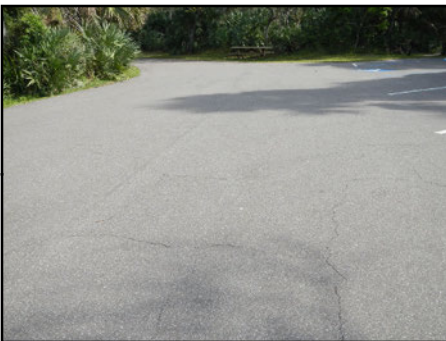
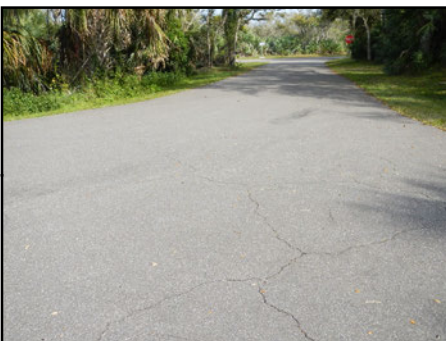
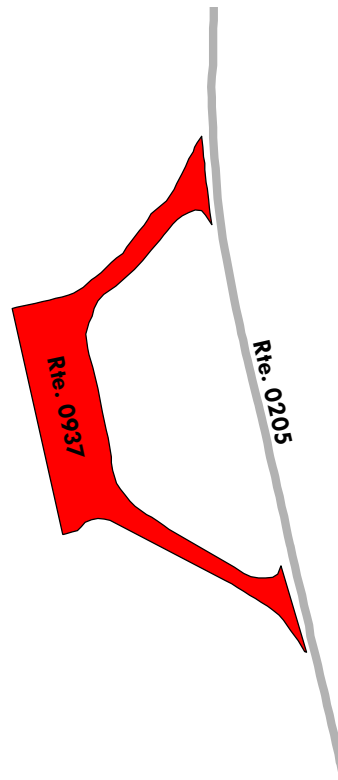
ROUTE 0938: AD PARKING #8

Inspection Date	FMSS Number	User Access	Surface Type
3/11/2019	60795	PUBLIC	ASPHALT
Area (Sq. Ft.)	Lane Miles (11' Widths)	Curb Reveal (Inches)	Curb Recommendation
13,557	0.233	NOT APPLICABLE	NOT APPLICABLE
Curb Type		Curb & Gutter Type	
NO CURB		NO CURB AND GUTTER	
Pavement Recommendation		Condition Rating / PCR	
PREVENTIVE MAINTENANCE		GOOD / 90

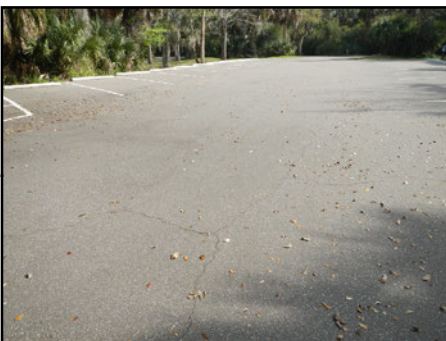
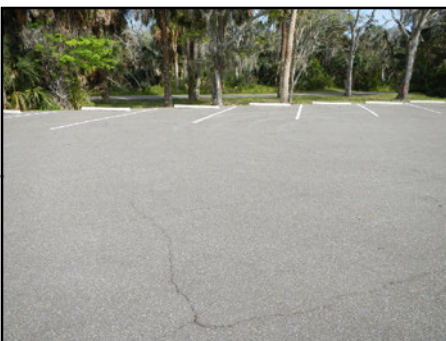
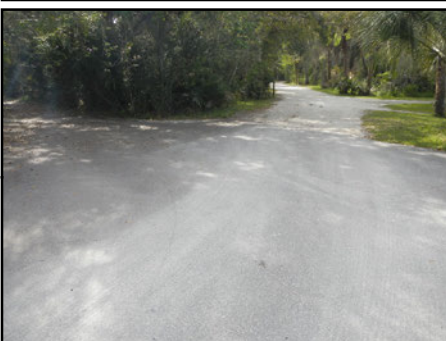
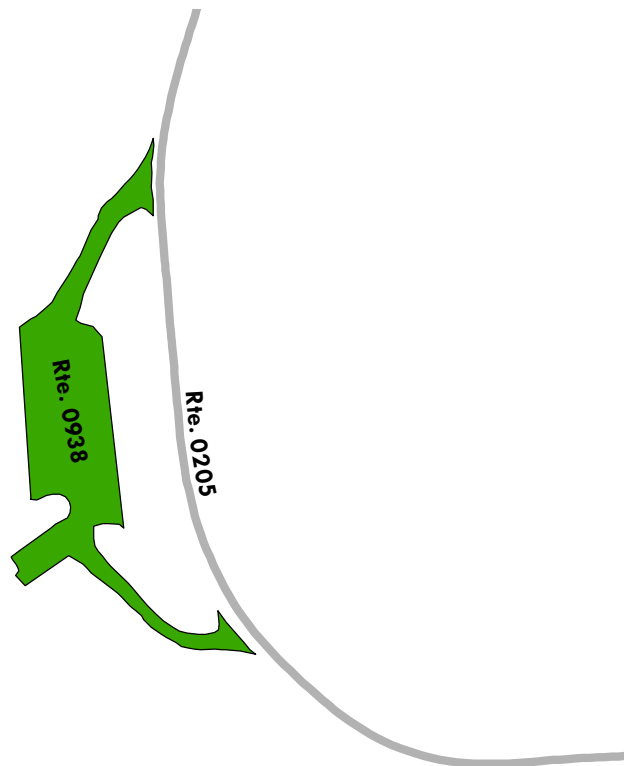
ROUTE 0939: AD PARKING #9

Inspection Date	FMSS Number	User Access	Surface Type
3/11/2019	60796	PUBLIC	ASPHALT
Area (Sq. Ft.)	Lane Miles (11' Widths)	Curb Reveal (Inches)	Curb Recommendation
8,874	0.153	NOT APPLICABLE	NOT APPLICABLE
Curb Type		Curb & Gutter Type	
NO CURB		NO CURB AND GUTTER	
Pavement Recommendation		Condition Rating / PCR	
HEAVY 3R TREATMENTS		POOR / 53

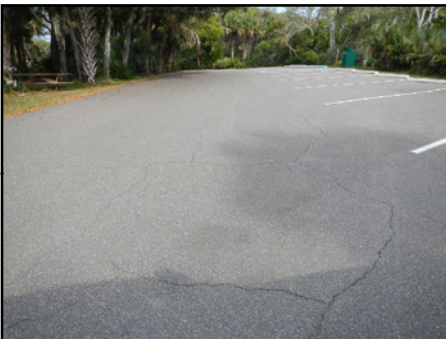
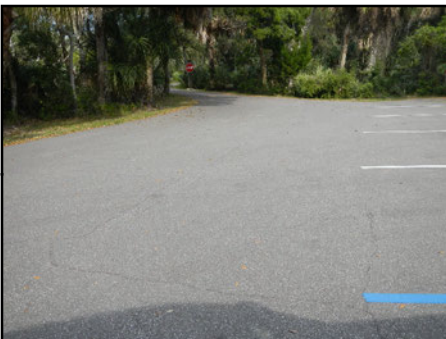
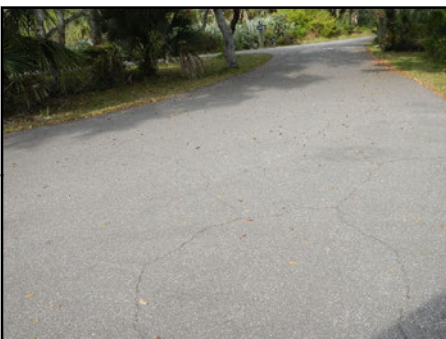
ROUTE 0940: AD BOAT RAMP PARKING

Inspection Date	FMSS Number	User Access	Surface Type
3/11/2019	60787	PUBLIC	ASPHALT
Area (Sq. Ft.)	Lane Miles (11' Widths)	Curb Reveal (Inches)	Curb Recommendation
32,553	0.56	NOT APPLICABLE	NOT APPLICABLE
Curb Type		Curb & Gutter Type	
NO CURB		NO CURB AND GUTTER	
Pavement Recommendation		Condition Rating / PCR	
PREVENTIVE MAINTENANCE		GOOD / 90
