**CANA
Cycle 6**

**Road Inventory and Condition Assessment of Paved Routes
Canaveral National Seashore**

**Federal Lands Highway
Road Inventory Program**

Report Date: April 2020

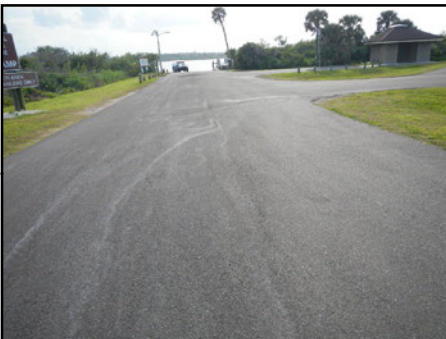
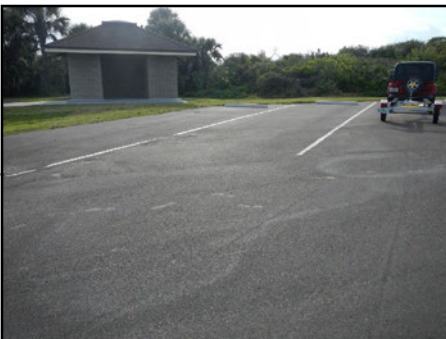
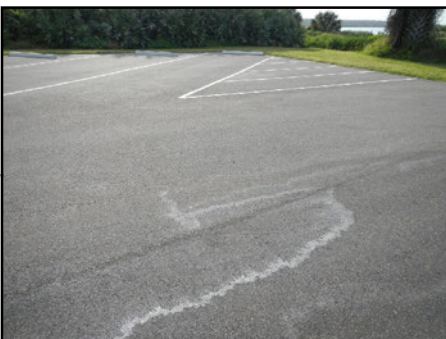
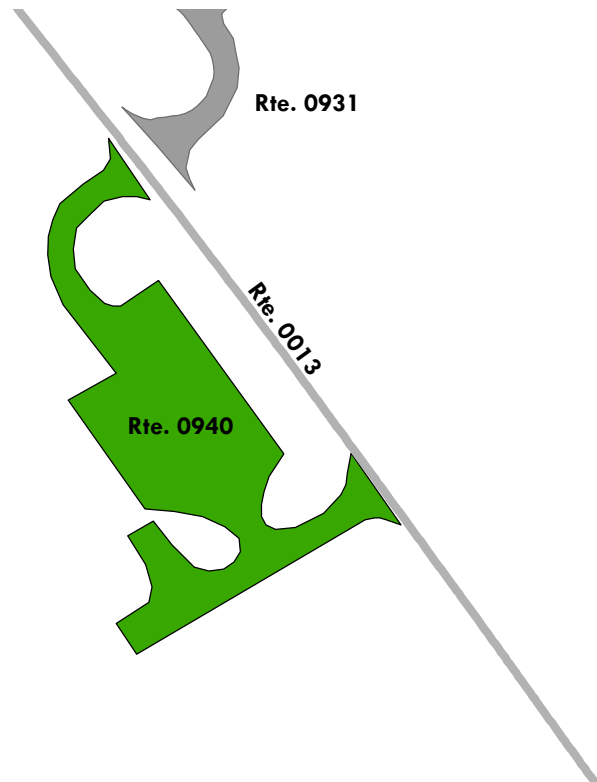
ROUTE 0941: AD TURTLE MOUND PARKING

Inspection Date	FMSS Number	User Access	Surface Type
3/11/2019	60797	PUBLIC	ASPHALT
Area (Sq. Ft.)	Lane Miles (11' Widths)	Curb Reveal (Inches)	Curb Recommendation
6,359	0.109	NOT APPLICABLE	NOT APPLICABLE
Curb Type		Curb & Gutter Type	
NO CURB		NO CURB AND GUTTER	
Pavement Recommendation		Condition Rating / PCR	
PREVENTIVE MAINTENANCE		GOOD / 90

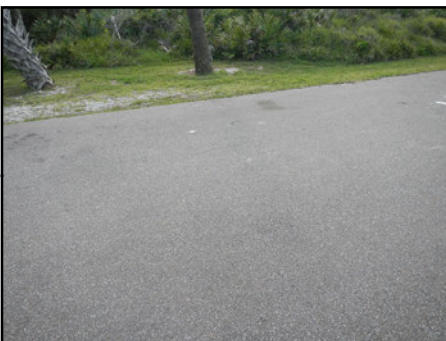
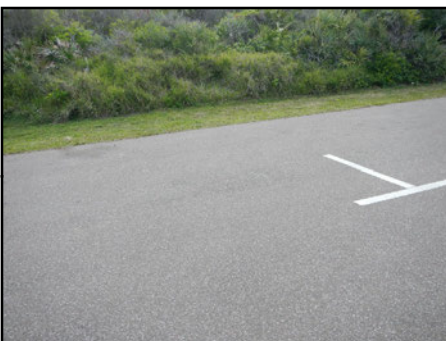
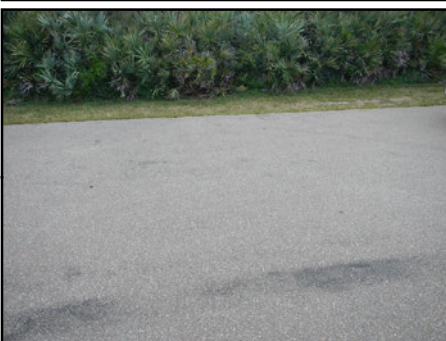
ROUTE 0942: SR SEMINOLE REST MAIN PARKING

Inspection Date	FMSS Number	User Access	Surface Type
3/11/2019	73396	PUBLIC	CONCRETE
Area (Sq. Ft.)	Lane Miles (11' Widths)	Curb Reveal (Inches)	Curb Recommendation
15,089	0.26	NOT APPLICABLE	DO NOTHING
Curb Type		Curb & Gutter Type	
NO CURB		CONCRETE	
Pavement Recommendation		Condition Rating / PCR	
LIGHT 3R TREATMENTS		FAIR / 73

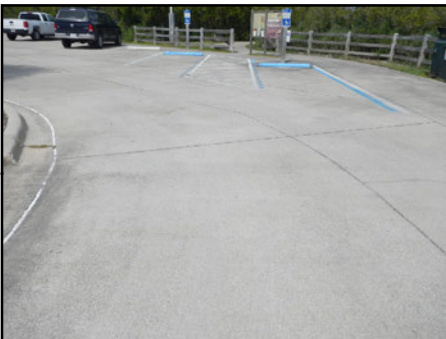
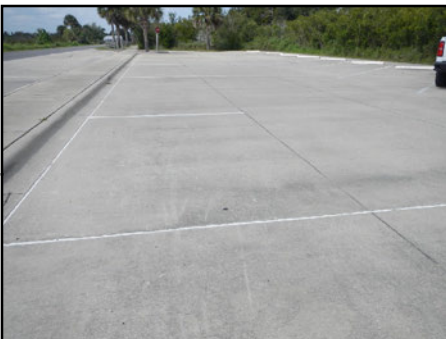
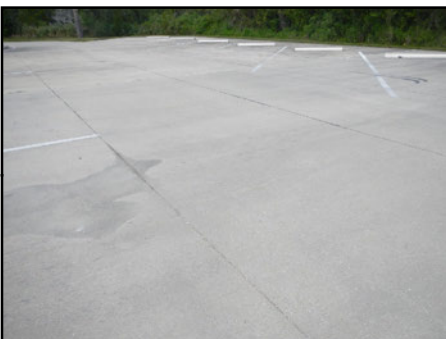
ROUTE 0945: AD VISITOR CENTER PARKING

Inspection Date	FMSS Number	User Access	Surface Type
3/11/2019	242094	PUBLIC	ASPHALT
Area (Sq. Ft.)	Lane Miles (11' Widths)	Curb Reveal (Inches)	Curb Recommendation
18,936	0.326	5	LIGHT REPAIR
Curb Type		Curb & Gutter Type	
CONCRETE		NO CURB AND GUTTER	
Pavement Recommendation		Condition Rating / PCR	
PREVENTIVE MAINTENANCE		GOOD / 90

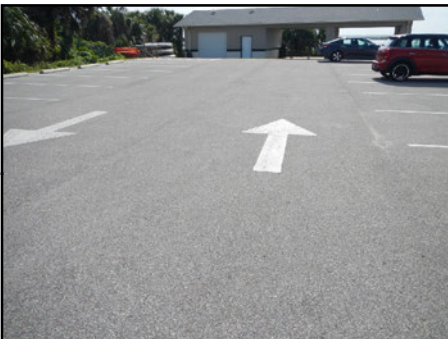
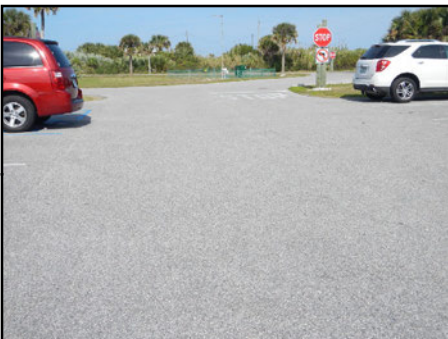
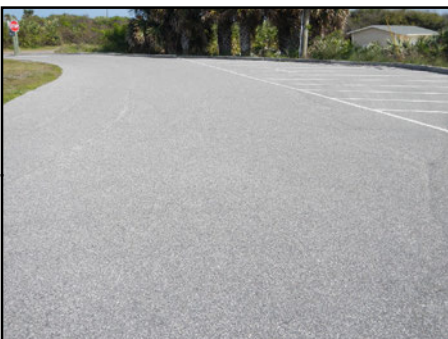
ROUTE 0947: PD EDDY CREEK PARKING

Inspection Date	FMSS Number	User Access	Surface Type
3/11/2019	60828	PUBLIC	ASPHALT
Area (Sq. Ft.)	Lane Miles (11' Widths)	Curb Reveal (Inches)	Curb Recommendation
29,197	0.503	NOT APPLICABLE	NOT APPLICABLE
Curb Type		Curb & Gutter Type	
NO CURB		NO CURB AND GUTTER	
Pavement Recommendation		Condition Rating / PCR	
PREVENTIVE MAINTENANCE		GOOD / 90
