CASA Cycle 6

Final Report

Road Inventory and Condition Assessment of Paved Routes Castillo de San Marcos National Monument

Report Date: April 2020

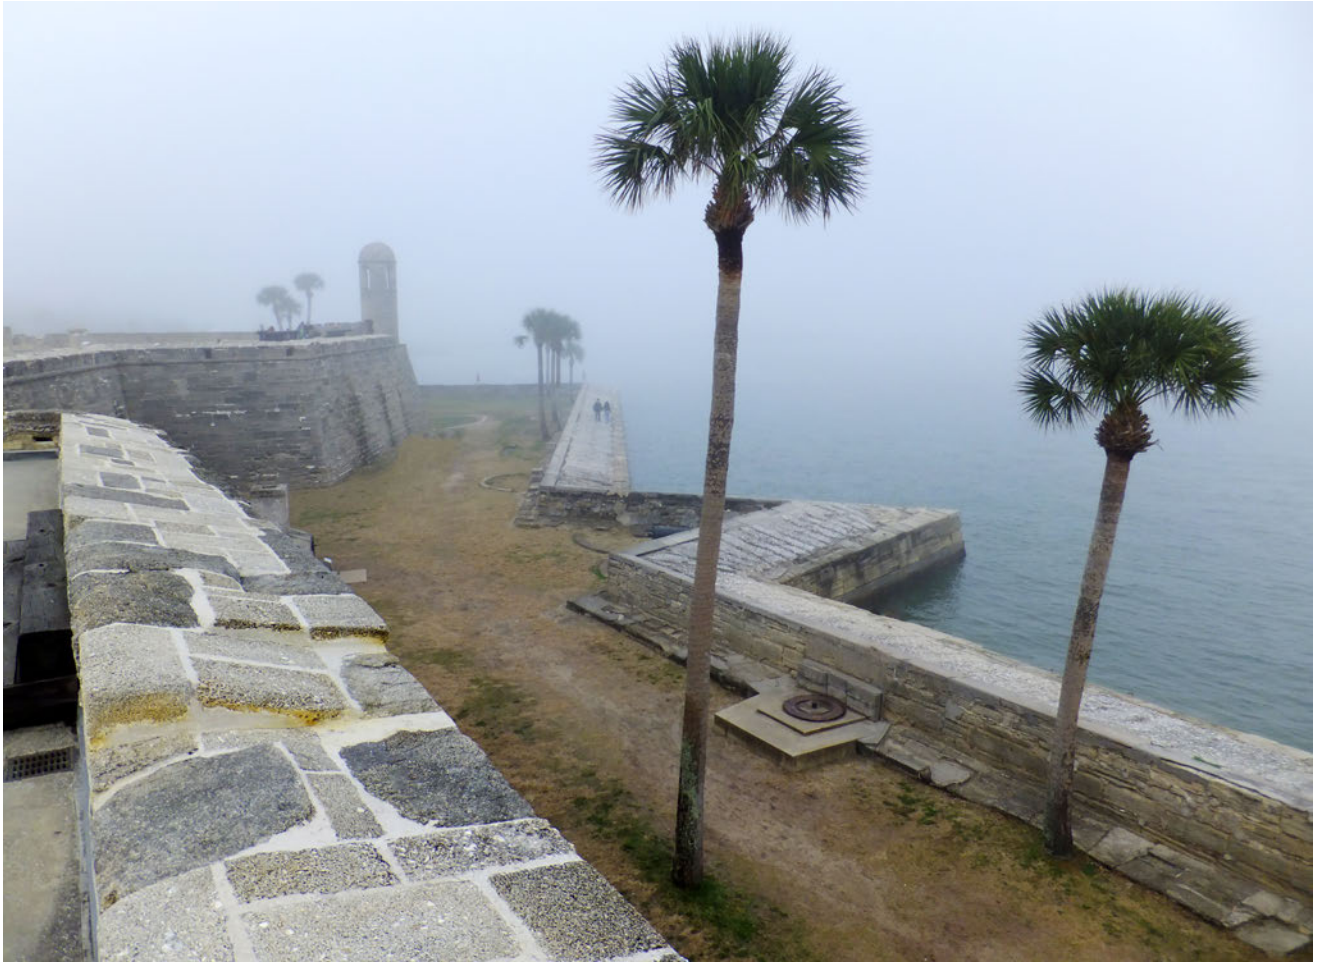
Inspection Date: 4/4/2019	Beginning Section MP	0				
Paved Length (Miles): 0.11	Section Length (MI)	0.11				
Surface Type: ASPHALT	Route Summary					
Roadway Condition Information						
Pavement Condition Rating (PCR)	47	47				
Surface Condition Rating (SCR)	47	47				
Roughness Condition Index (RCI)	N/A	N/A				
Distress Index Values						
Structural Crack Index	49	49				
Alligator Crack Index	100	100				
Longitudinal Crack Index	49	49				
Transverse Cracking Index	47	47				
Patching Index	100	100				
Rutting Index	93	93				
International Roughness Index (IRI)	N/A	N/A				
Lane & Width Information						
Number of Lanes	2	2				
Paved Width (ft)	17.4	17.4				
Lane Width (ft)	9.4	9.4

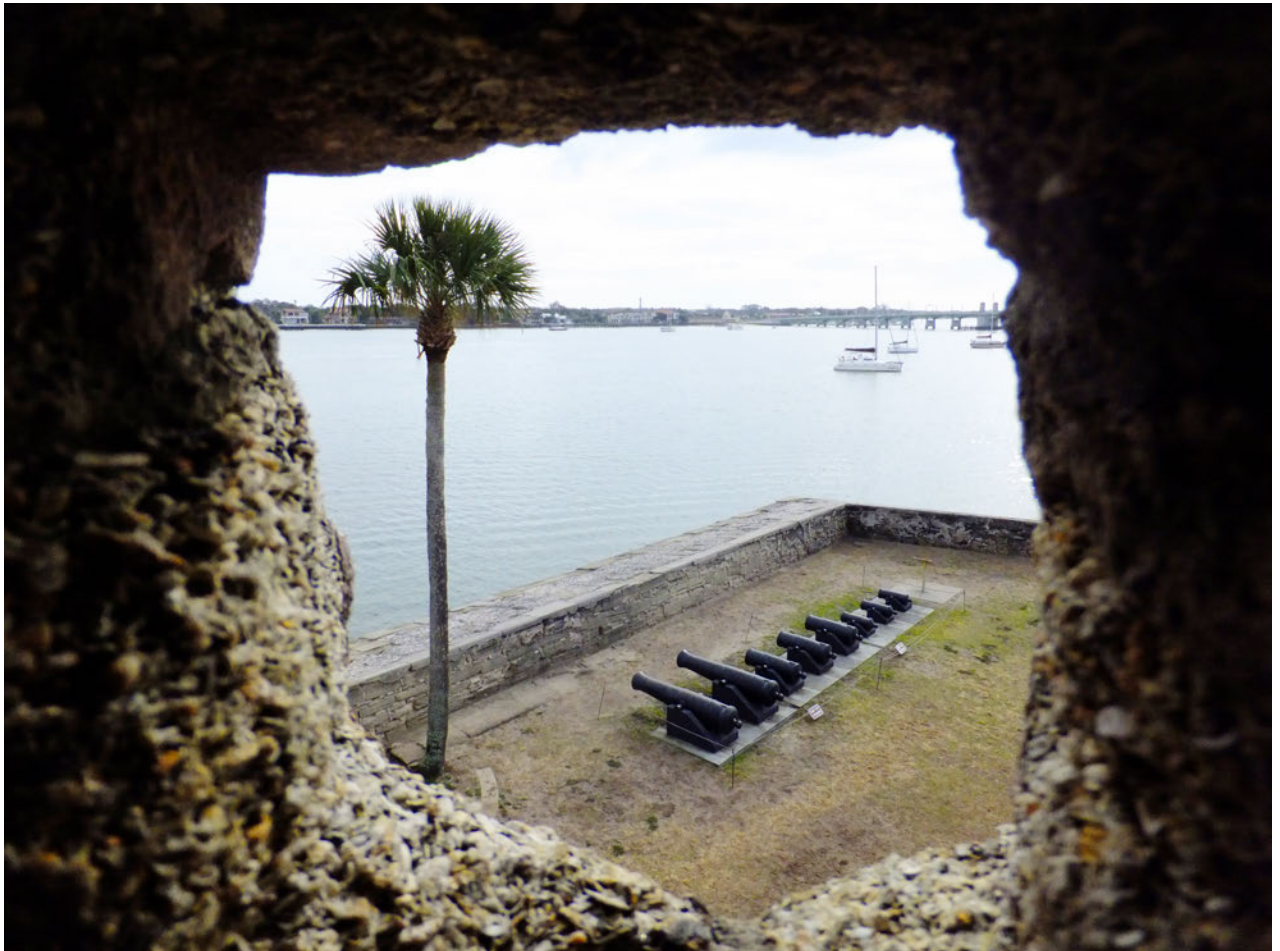
Inspection Date	FMSS Number	User Access	Surface Type
4/4/2019	37033	NONPUBLIC	ASPHALT
Area (Sq. Ft.)	Lane Miles (11' Widths)	Condition Rating / PCR	
5,156	0.089	SUMMARY / 73

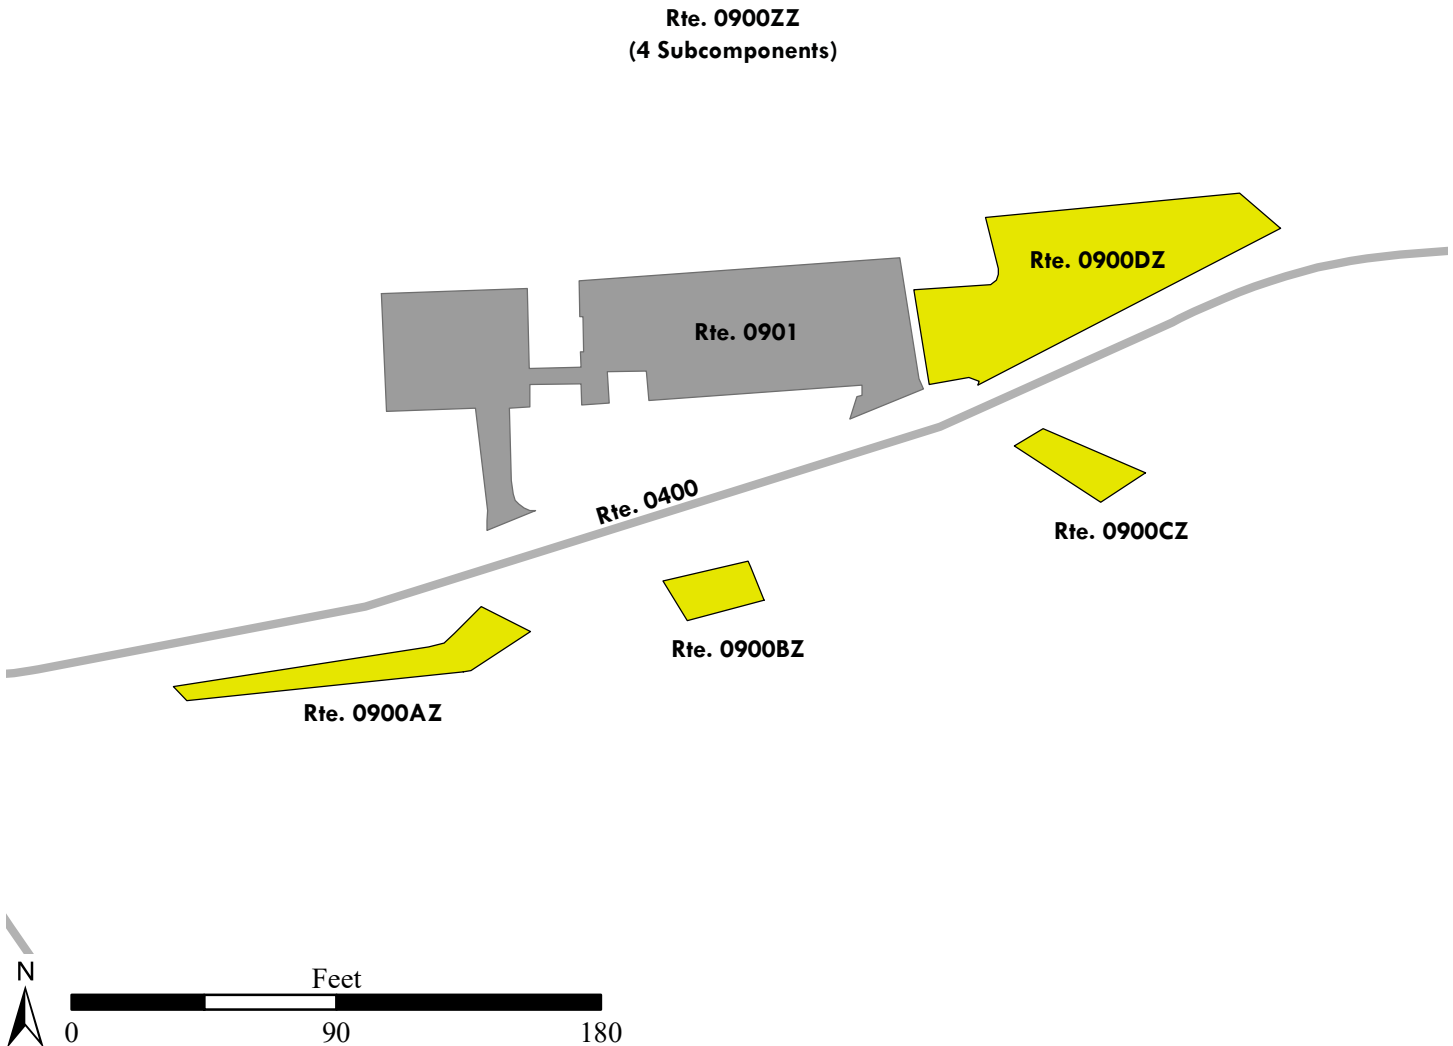
ROUTE 0900AZ: ADMINISTRATIVE AREA A

Inspection Date	FMSS Number	User Access	Surface Type
4/4/2019	37033	NONPUBLIC	ASPHALT
Area (Sq. Ft.)	Lane Miles (11' Widths)	Curb Reveal (Inches)	Curb Recommendation
919	0.016	3	DO NOTHING
Curb Type		Curb & Gutter Type	
CONCRETE		NO CURB AND GUTTER	
Pavement Recommendation		Condition Rating / PCR	
LIGHT 3R TREATMENTS		FAIR / 73
