CATO Cycle 6

Final Report

Road Inventory and Condition Assessment of Paved Routes Catoctin Mountain Park

**Federal Highway Administration
Eastern Federal Lands Highway Division
Road Inventory Program (RIP)**

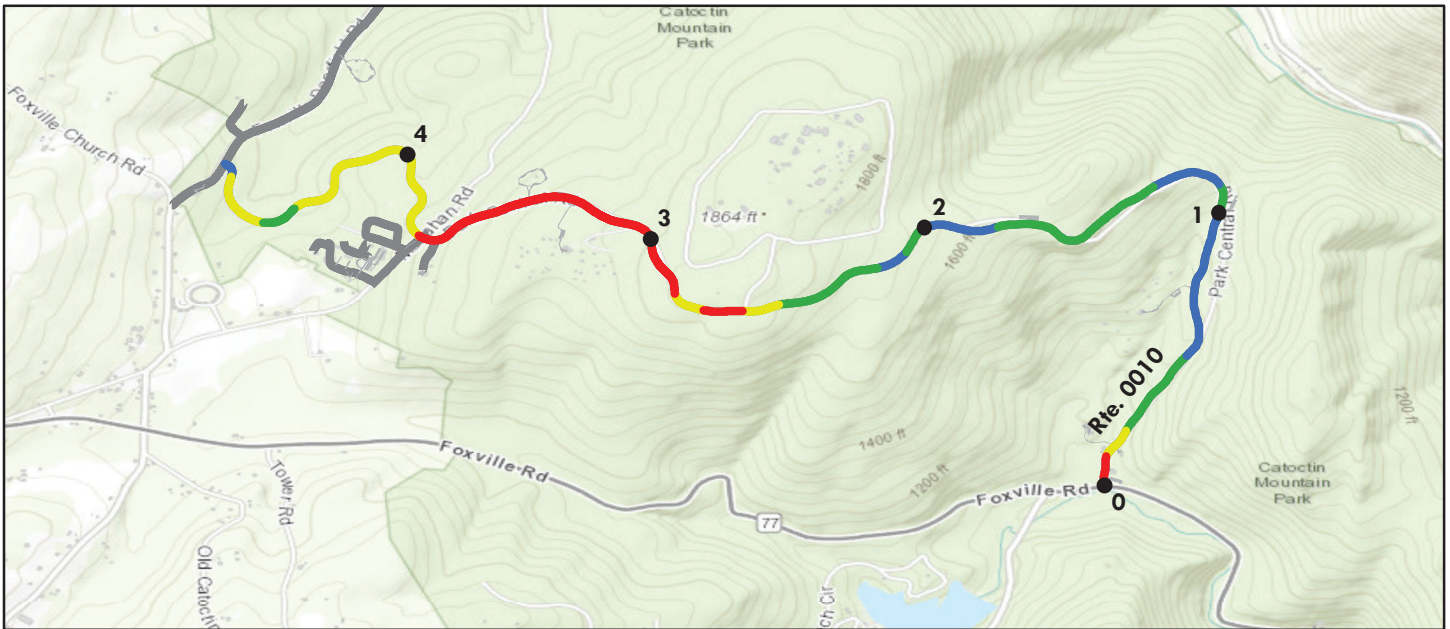
ROUTE 0010: PARK CENTRAL ROAD

Inspection Date:	Beginning Section MP					
	0	1	2	3	4	
Paved Length (Miles): 4.75	Section Length (MI)					
Surface Type: ASPHALT	Route Summary					
Roadway Condition Information						
Pavement Condition Rating (PCR)	68	89	95	69	23	77
Surface Condition Rating (SCR)	64	94	99	65	0	76
Roughness Condition Index (RCI)	75	82	88	74	57	79
Distress Index Values						
Structural Crack Index	64	94	99	65	0	76
Alligator Crack Index	91	100	100	97	61	100
Longitudinal Crack Index	73	94	99	68	28	76
Transverse Cracking Index	96	96	100	98	87	99
Patching Index	100	100	100	100	99	100
Rutting Index	96	99	99	93	92	98
International Roughness Index (IRI)	185	162	147	188	253	172
Lane & Width Information						
Number of Lanes	2	2	2	2	2	2
Paved Width (ft)	21.8	20.4	20.9	20.7	24.8	22.2
Lane Width (ft)	9.4	9.1	8.9	8.8	10.5	9.8

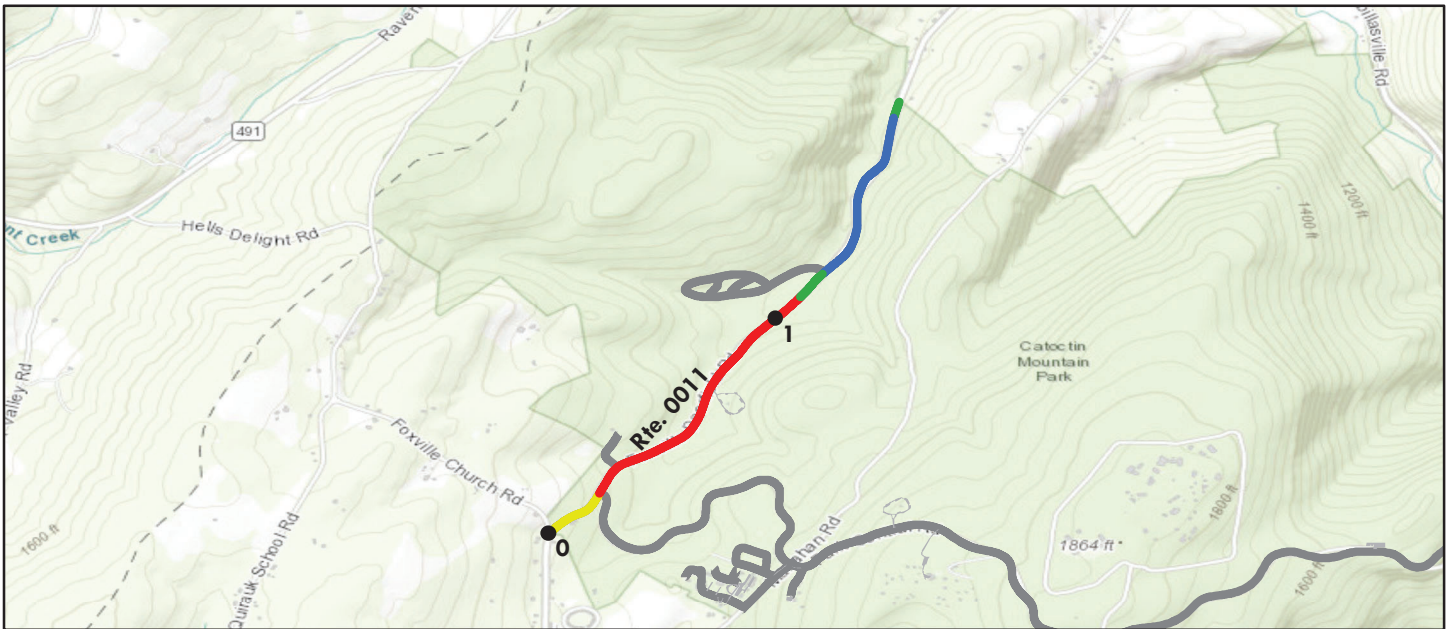
ROUTE 0011: FOXVILLE - DEERFIELD ROAD

Route Condition Legend – Pavement Condition Rating (PCR)						
Poor (0 - 60)	Fair (61- 84)	Good (85 - 94)	Excellent (95 - 100)	Not Rated		
Colors on map represent condition scores at 0.10-mile intervals. See Appendix for definitions and formulas.						
Inspection Date: 7/30/2018	Beginning Section MP	0	1			
Paved Length (Miles): 1.86	Section Length (MI)	1	0.86			
Surface Type: ASPHALT	Route Summary					
Roadway Condition Information						
Pavement Condition Rating (PCR)	55	27	91			
Surface Condition Rating (SCR)	43	5	88			
Roughness Condition Index (RCI)	74	59	96			
Distress Index Values						
Structural Crack Index	43	5	88			
Alligator Crack Index	90	82	99			
Longitudinal Crack Index	53	23	89			
Transverse Cracking Index	97	95	100			
Patching Index	100	99	100			
Rutting Index	95	92	98			
International Roughness Index (IRI)	187	242	125			
Lane & Width Information						
Number of Lanes	2	2	2			
Paved Width (ft)	18.3	18.4	18.1

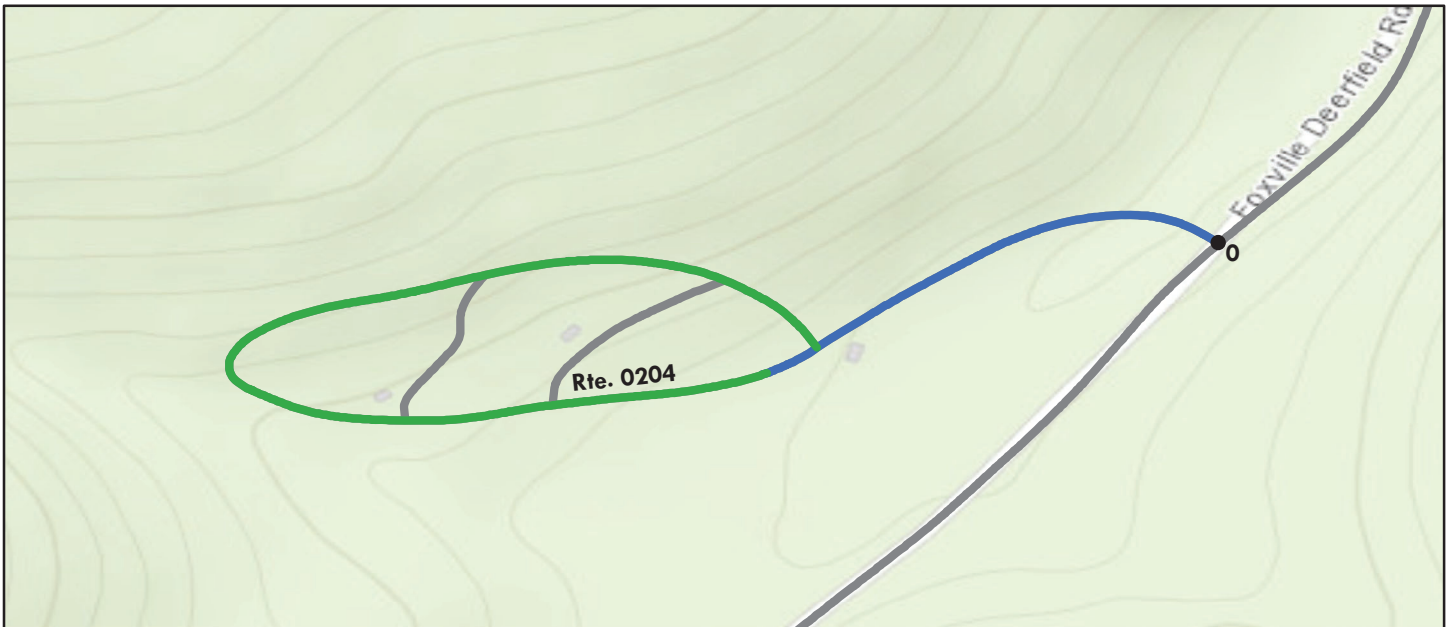
ROUTE 0204: OWENS CREEK CAMPGROUND

Route Condition Legend – Pavement Condition Rating (PCR)						
Poor (0 - 60)	Fair (61- 84)	Good (85 - 94)	Excellent (95 - 100)	Not Rated		
Colors on map represent condition scores at 0.10-mile intervals. See Appendix for definitions and formulas.						
Inspection Date: 7/30/2018	Beginning Section MP	0				
Paved Length (Miles): 0.67	Section Length (MI)	0.67				
Surface Type: ASPHALT	Route Summary					
Roadway Condition Information						
Pavement Condition Rating (PCR)	90	90				
Surface Condition Rating (SCR)	90	90				
Roughness Condition Index (RCI)	N/A	N/A				
Distress Index Values						
Structural Crack Index	99	99				
Alligator Crack Index	100	100				
Longitudinal Crack Index	99	99				
Transverse Cracking Index	99	99				
Patching Index	100	100				
Rutting Index	90	90				
International Roughness Index (IRI)	N/A	N/A				
Lane & Width Information						
Number of Lanes	1	1				
Paved Width (ft)	14.5	14.5				
Lane Width (ft)	10.9	10.9

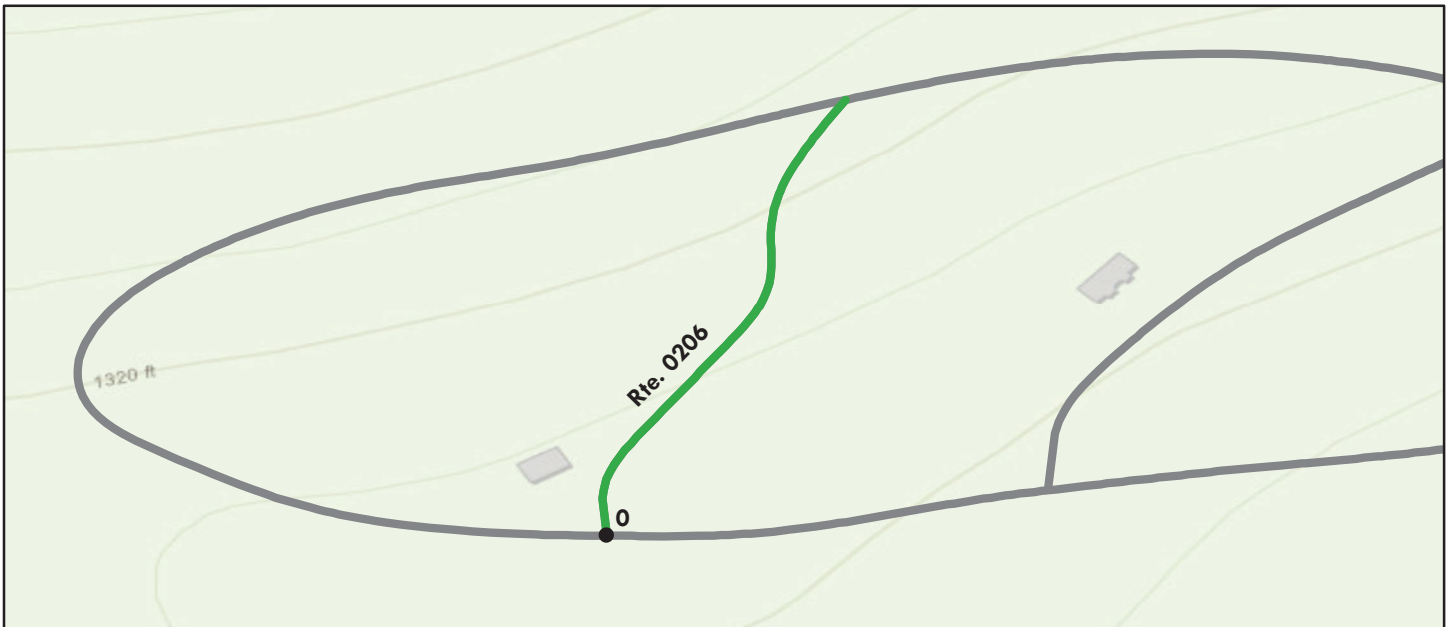
ROUTE 0206: OWENS CREEK CAMPGROUND CUTOFF B

Inspection Date: 7/30/2018	Beginning Section MP	0				
Paved Length (Miles): 0.08	Section Length (MI)	0.08				
Surface Type: ASPHALT	Route Summary					
Roadway Condition Information						
Pavement Condition Rating (PCR)	88	88				
Surface Condition Rating (SCR)	88	88				
Roughness Condition Index (RCI)	N/A	N/A				
Distress Index Values						
Structural Crack Index	98	98				
Alligator Crack Index	100	100				
Longitudinal Crack Index	98	98				
Transverse Cracking Index	97	97				
Patching Index	97	97				
Rutting Index	88	88				
International Roughness Index (IRI)	N/A	N/A				
Lane & Width Information						
Number of Lanes	1	1				
Paved Width (ft)	12.3	12.3				
Lane Width (ft)	12.3	12.3

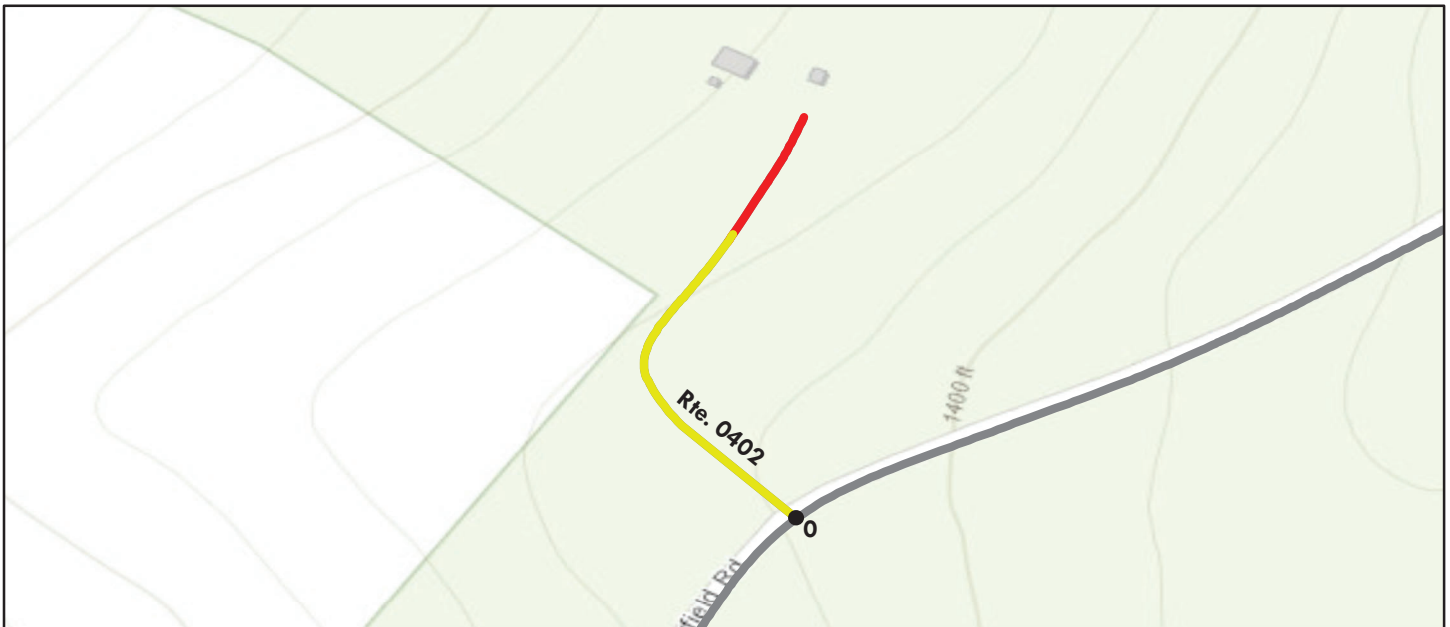
ROUTE 0402: QUARTERS #6 ACCESS ROAD

Route Condition Legend – Pavement Condition Rating (PCR)						
Poor (0 - 60)	Fair (61- 84)	Good (85 - 94)	Excellent (95 - 100)	Not Rated		
Colors on map represent condition scores at 0.10-mile intervals. See Appendix for definitions and formulas.						
Inspection Date: 7/30/2018	Beginning Section MP	0				
Paved Length (Miles): 0.14	Section Length (MI)	0.14				
Surface Type: ASPHALT	Route Summary					
Roadway Condition Information						
Pavement Condition Rating (PCR)	59	59				
Surface Condition Rating (SCR)	59	59				
Roughness Condition Index (RCI)	N/A	N/A				
Distress Index Values						
Structural Crack Index	59	59				
Alligator Crack Index	100	100				
Longitudinal Crack Index	59	59				
Transverse Cracking Index	100	100				
Patching Index	100	100				
Rutting Index	93	93				
International Roughness Index (IRI)	N/A	N/A				
Lane & Width Information						
Number of Lanes	1	1				
Paved Width (ft)	12.8	12.8				
Lane Width (ft)	12.8	12.8

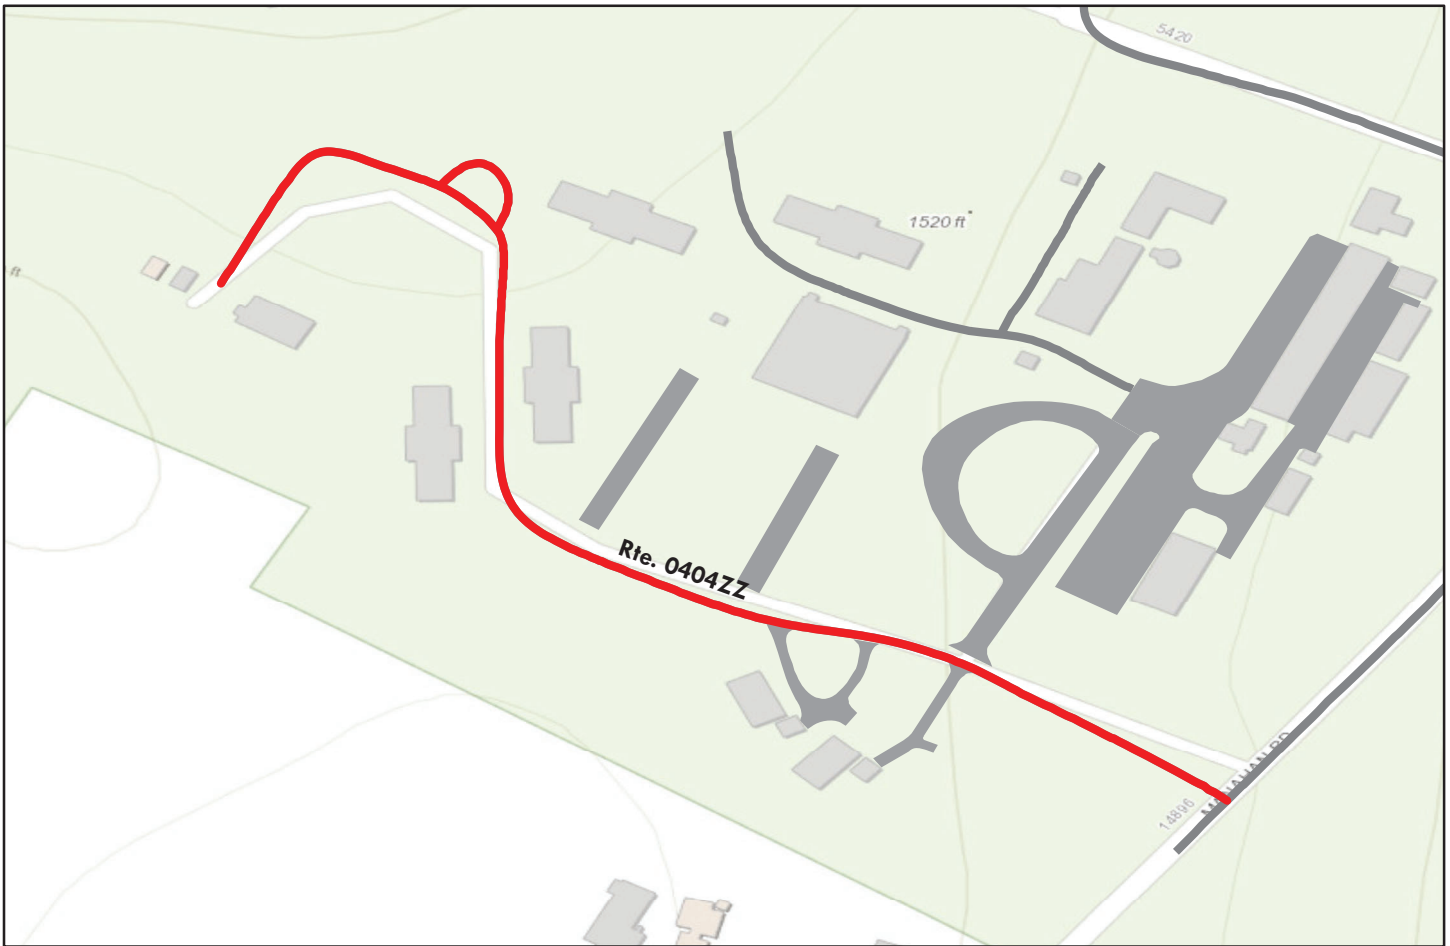
ROUTE 0404ZZ: ROUND MEADOW ROADS

Route Condition Legend – Pavement Condition Rating (PCR)						
Poor (0 - 60)	Fair (61- 84)	Good (85 - 94)	Excellent (95 - 100)	Not Rated		
See Appendix for definitions and formulas						
Inspection Date:	8/9/2018					
Paved Length (Miles):	0.27					
Surface Type:	ASPHALT	Route Summary				
Roadway Condition Information						
Pavement Condition Rating (PCR)	2					
Lane & Width Information						
Number of Lanes	1					
Paved Width (ft)	17					
Lane Width (ft)	11

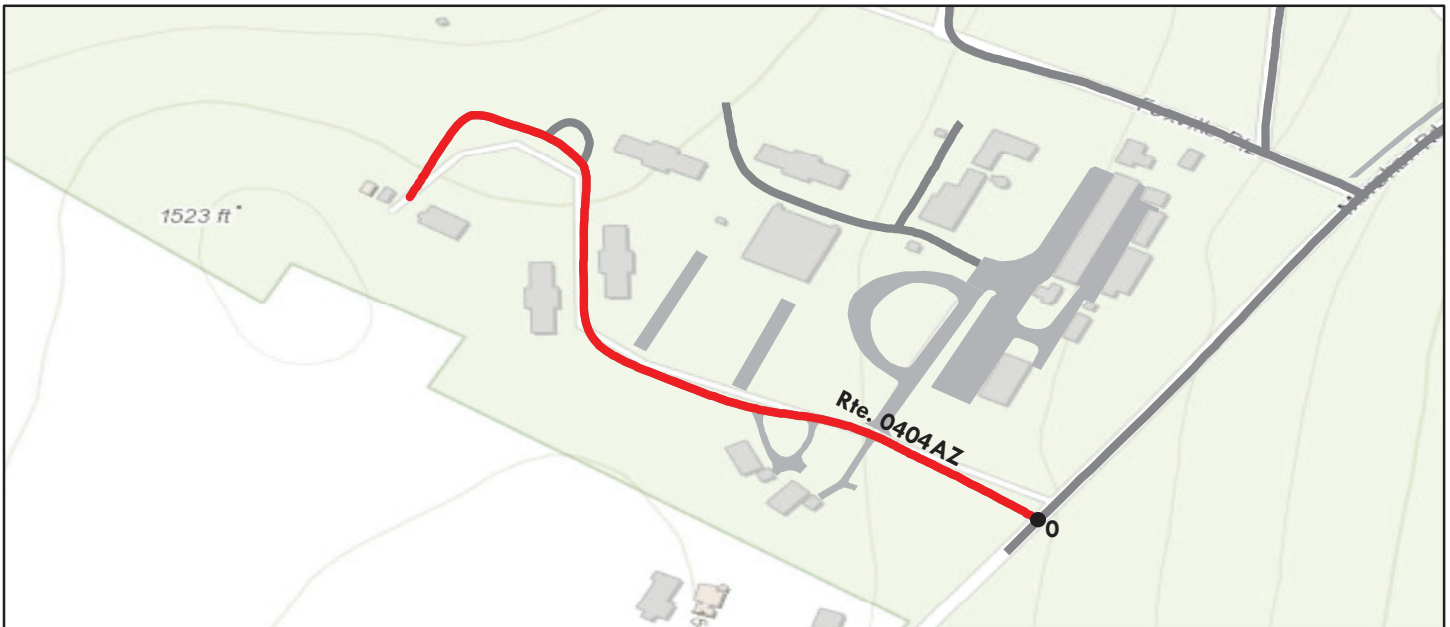
ROUTE 0404AZ: ROUND MEADOW ROAD

Route Condition Legend – Pavement Condition Rating (PCR)						
Poor (0 - 60)	Fair (61- 84)	Good (85 - 94)	Excellent (95 - 100)	Not Rated		
Colors on map represent condition scores at 0.10-mile intervals. See Appendix for definitions and formulas.						
Inspection Date: 7/30/2018	Beginning Section MP	0				
Paved Length (Miles): 0.25	Section Length (MI)	0.25				
Surface Type: ASPHALT	Route Summary					
Roadway Condition Information						
Pavement Condition Rating (PCR)	0	0				
Surface Condition Rating (SCR)	0	0				
Roughness Condition Index (RCI)	N/A	N/A				
Distress Index Values						
Structural Crack Index	0	0				
Alligator Crack Index	67	67				
Longitudinal Crack Index	1	1				
Transverse Cracking Index	56	56				
Patching Index	98	98				
Rutting Index	88	88				
International Roughness Index (IRI)	N/A	N/A				
Lane & Width Information						
Number of Lanes	2	2				
Paved Width (ft)	17.4	17.4				
Lane Width (ft)	10.9	10.9

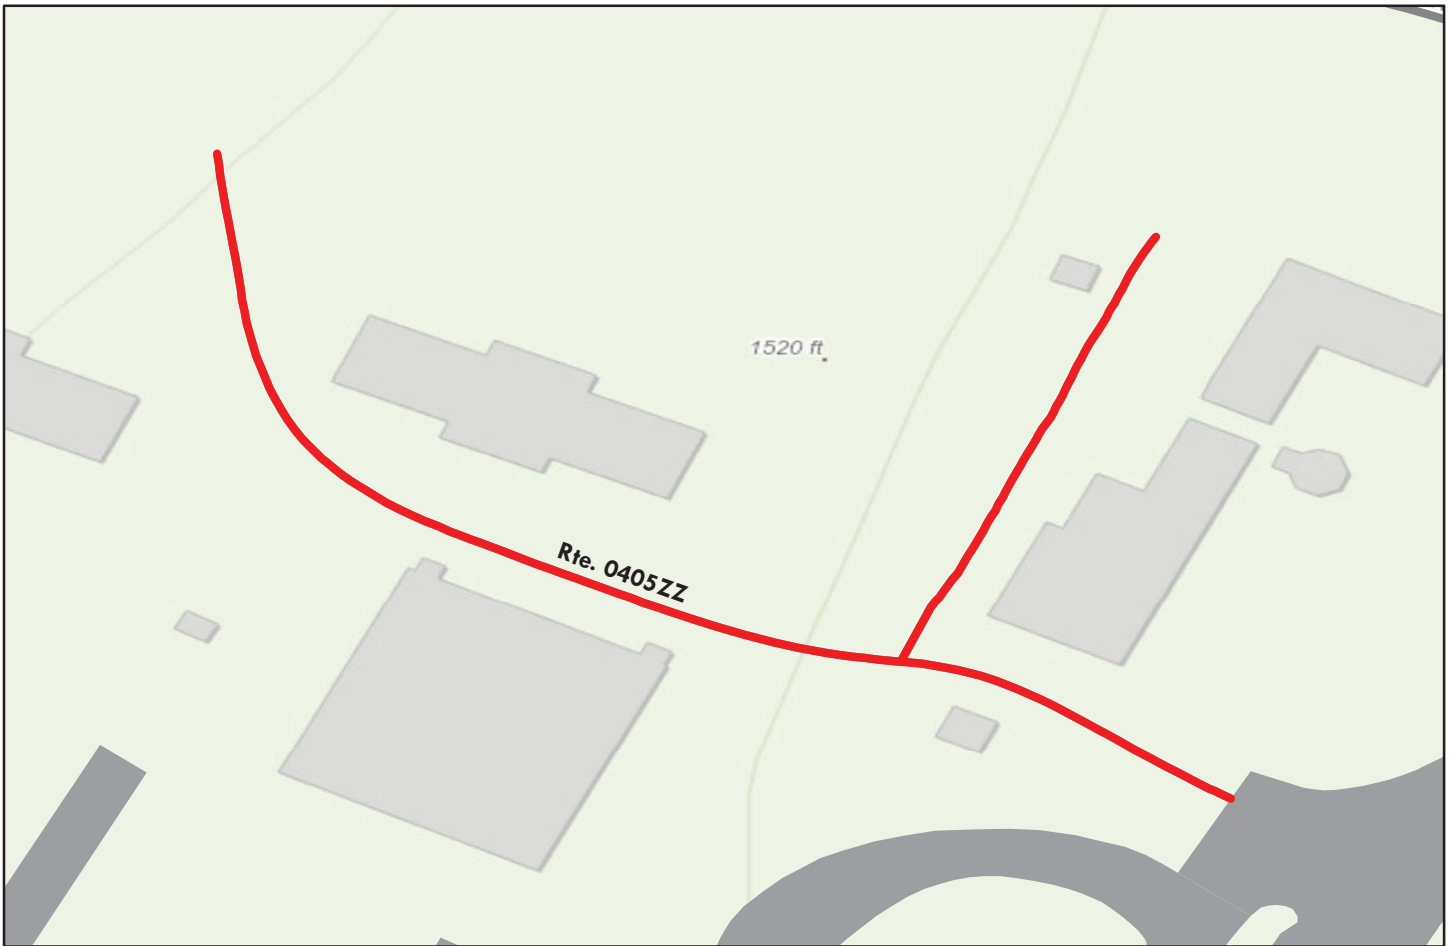
ROUTE 0405ZZ: ROUND MEADOW MAINTENANCE ROADS

Inspection Date:	7/30/2018					
Paved Length (Miles):	0.12					
Surface Type:	ASPHALT	Route Summary				
Roadway Condition Information						
Pavement Condition Rating (PCR)	32					
Lane & Width Information						
Number of Lanes	2					
Paved Width (ft)	15.1					
Lane Width (ft)	7.6

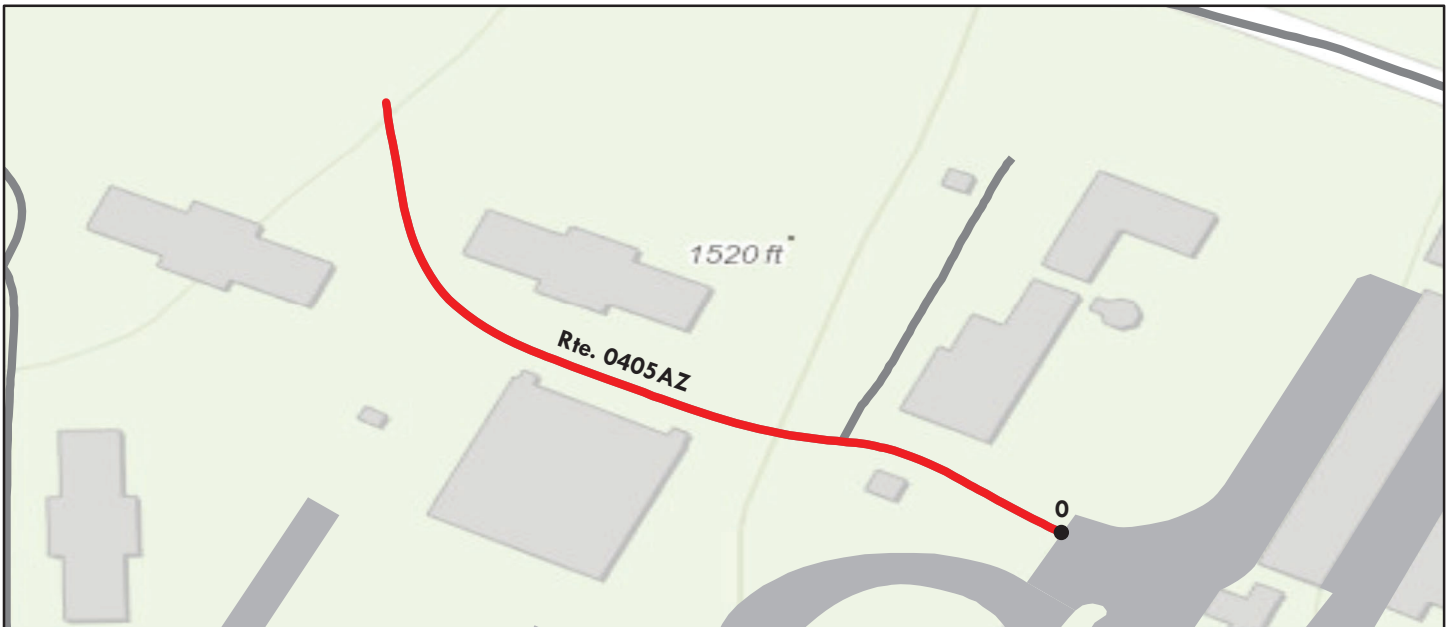
ROUTE 0405AZ: ROUND MEADOW MAINTENANCE ROAD A

Inspection Date: 7/30/2018	Beginning Section MP	0				
Paved Length (Miles): 0.09	Section Length (MI)	0.09				
Surface Type: ASPHALT	Route Summary					
Roadway Condition Information						
Pavement Condition Rating (PCR)	44	44				
Surface Condition Rating (SCR)	44	44				
Roughness Condition Index (RCI)	N/A	N/A				
Distress Index Values						
Structural Crack Index	44	44				
Alligator Crack Index	88	88				
Longitudinal Crack Index	56	56				
Transverse Cracking Index	85	85				
Patching Index	96	96				
Rutting Index	85	85				
International Roughness Index (IRI)	N/A	N/A				
Lane & Width Information						
Number of Lanes	2	2				
Paved Width (ft)	15	15				
Lane Width (ft)	7.5	7.5

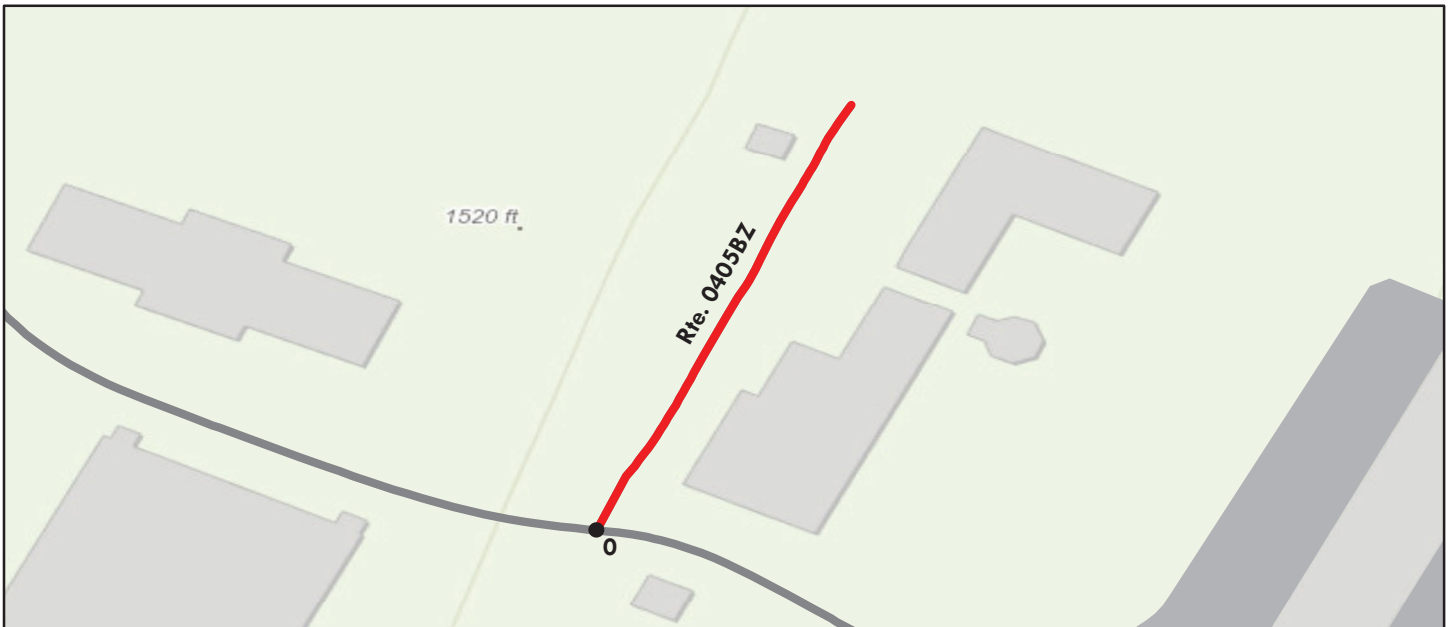
ROUTE 0405BZ: ROUND MEADOW MAINTENANCE ROAD B

Inspection Date: 7/30/2018	Beginning Section MP	0				
Paved Length (Miles): 0.03	Section Length (MI)	0.03				
Surface Type: ASPHALT	Route Summary					
Roadway Condition Information						
Pavement Condition Rating (PCR)	0	0				
Surface Condition Rating (SCR)	0	0				
Roughness Condition Index (RCI)	N/A	N/A				
Distress Index Values						
Structural Crack Index	0	0				
Alligator Crack Index	35	35				
Longitudinal Crack Index	20	20				
Transverse Cracking Index	7	7				
Patching Index	98	98				
Rutting Index	91	91				
International Roughness Index (IRI)	N/A	N/A				
Lane & Width Information						
Number of Lanes	2	2				
Paved Width (ft)	15.5	15.5				
Lane Width (ft)	7.8	7.8

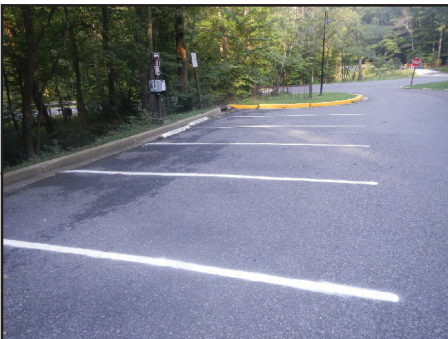
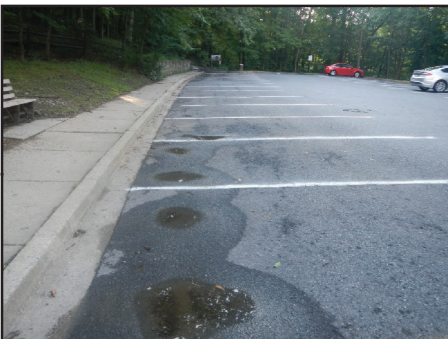
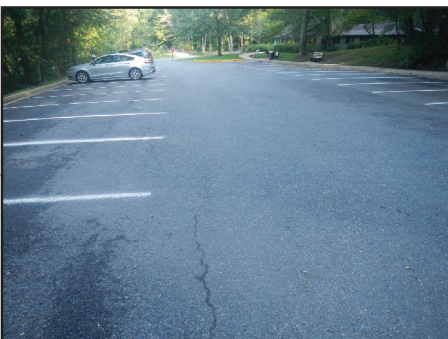
Inspection Date	FMSS Number	User Access	Surface Type
8/9/2018	15998	PUBLIC	ASPHALT
Area (Sq. Ft.)	Lane Miles (11' Widths)	Curb Reveal (Inches)	Curb Recommendation
13,004	0.224	NOT APPLICABLE	DO NOTHING
Curb Type		Curb & Gutter Type	
NO CURB		CONCRETE	
Pavement Recommendation		Condition Rating / PCR	
PREVENTIVE MAINTENANCE		GOOD / 90

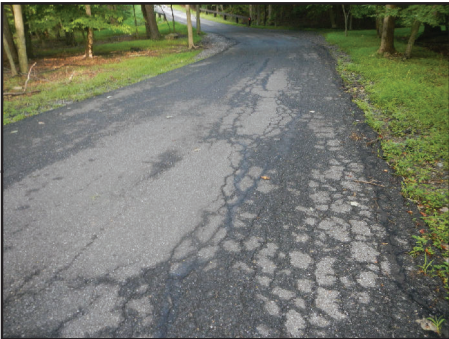
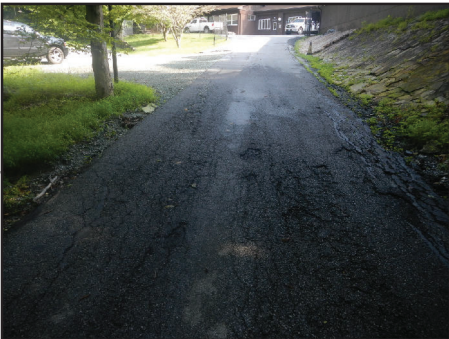
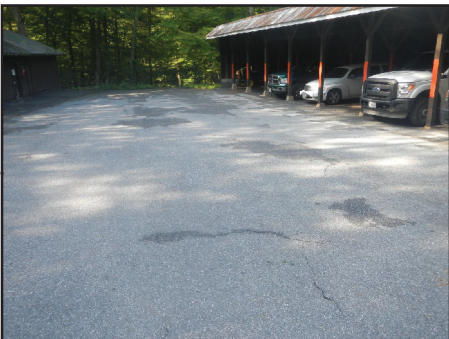
ROUTE 0901: MAINTENANCE AREA PARKING

Inspection Date	FMSS Number	User Access	Surface Type
8/9/2018	16952	NONPUBLIC	ASPHALT
Area (Sq. Ft.)	Lane Miles (11' Widths)	Curb Reveal (Inches)	Curb Recommendation
16,997	0.293	NOT APPLICABLE	NOT APPLICABLE
Curb Type		Curb & Gutter Type	
NO CURB		NO CURB AND GUTTER	
Pavement Recommendation		Condition Rating / PCR	
HEAVY 3R TREATMENTS		POOR / 53

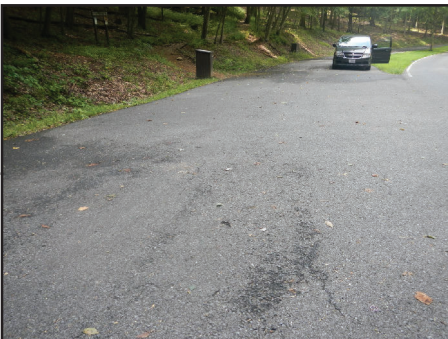
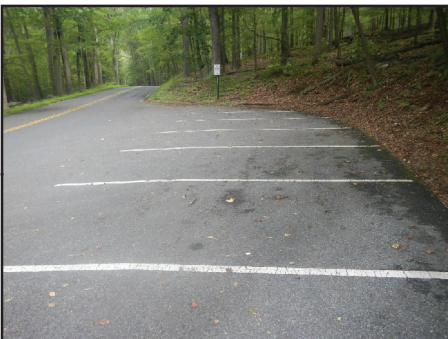
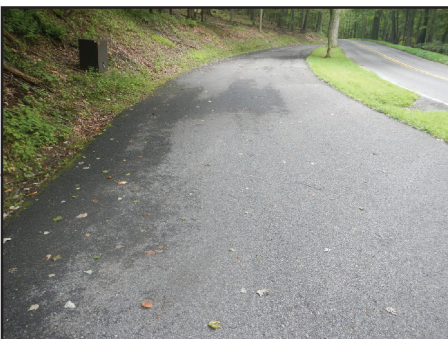
ROUTE 0903: WOLF ROCK PARKING

Inspection Date	FMSS Number	User Access	Surface Type
8/9/2018	15987	PUBLIC	ASPHALT
Area (Sq. Ft.)	Lane Miles (11' Widths)	Curb Reveal (Inches)	Curb Recommendation
7,443	0.128	NOT APPLICABLE	NOT APPLICABLE
Curb Type		Curb & Gutter Type	
NO CURB		NO CURB AND GUTTER	
Pavement Recommendation		Condition Rating / PCR	
PREVENTIVE MAINTENANCE		GOOD / 90

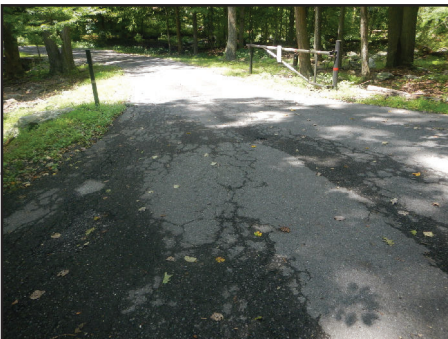
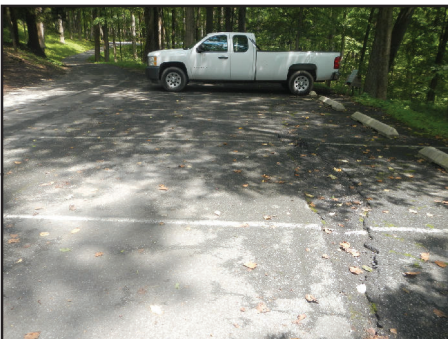
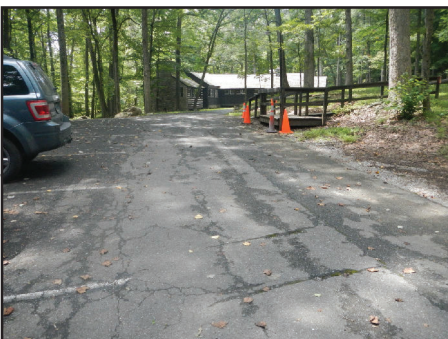
ROUTE 0904: MISTY MOUNT PARKING

Inspection Date	FMSS Number	User Access	Surface Type
8/9/2018	91221	PUBLIC	ASPHALT
Area (Sq. Ft.)	Lane Miles (11' Widths)	Curb Reveal (Inches)	Curb Recommendation
27,993	0.482	NOT APPLICABLE	NOT APPLICABLE
Curb Type		Curb & Gutter Type	
NO CURB		NO CURB AND GUTTER	
Pavement Recommendation		Condition Rating / PCR	
HEAVY 3R TREATMENTS		POOR / 53

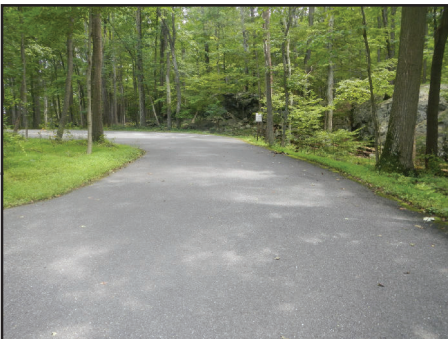
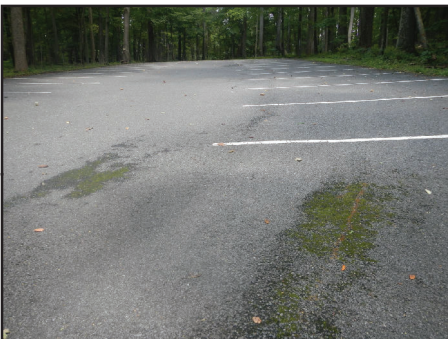
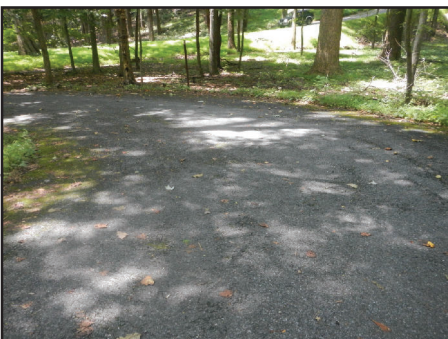
ROUTE 0905: THURMONT VISTA PARKING

Inspection Date	FMSS Number	User Access	Surface Type
8/9/2018	15988	PUBLIC	ASPHALT
Area (Sq. Ft.)	Lane Miles (11' Widths)	Curb Reveal (Inches)	Curb Recommendation
13,367	0.23	NOT APPLICABLE	NOT APPLICABLE
Curb Type		Curb & Gutter Type	
NO CURB		NO CURB AND GUTTER	
Pavement Recommendation		Condition Rating / PCR	
PREVENTIVE MAINTENANCE		GOOD / 90

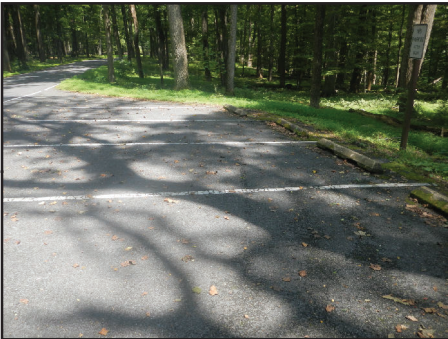
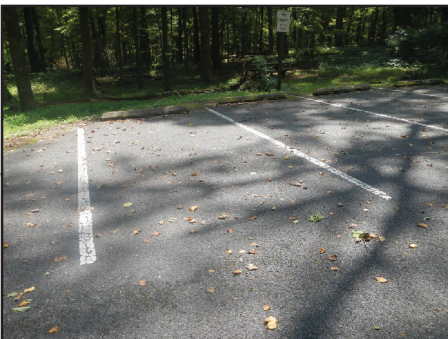
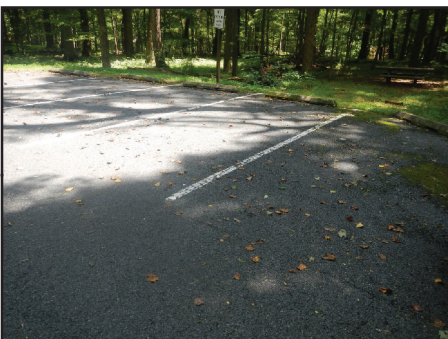
ROUTE 0906: PARK CENTRAL PICNIC PARKING

Inspection Date	FMSS Number	User Access	Surface Type
8/9/2018	91222	PUBLIC	ASPHALT
Area (Sq. Ft.)	Lane Miles (11' Widths)	Curb Reveal (Inches)	Curb Recommendation
2,536	0.044	NOT APPLICABLE	NOT APPLICABLE
Curb Type		Curb & Gutter Type	
NO CURB		NO CURB AND GUTTER	
Pavement Recommendation		Condition Rating / PCR	
PREVENTIVE MAINTENANCE		GOOD / 90

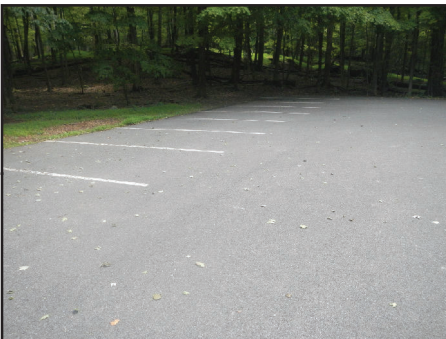
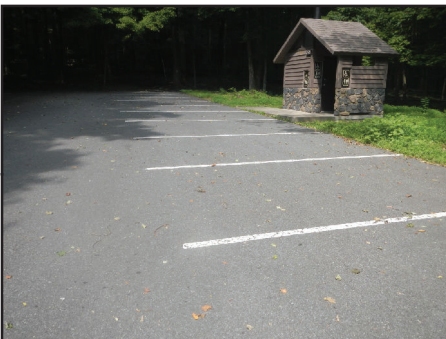
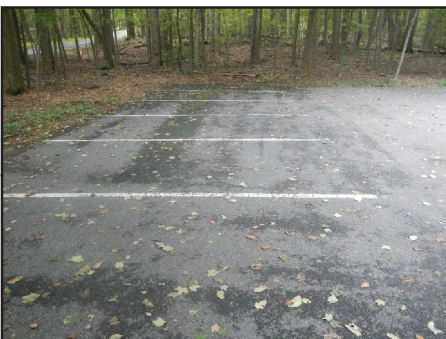
ROUTE 0907: HOG ROCK PARKING

Inspection Date	FMSS Number	User Access	Surface Type
8/9/2018	15989	PUBLIC	ASPHALT
Area (Sq. Ft.)	Lane Miles (11' Widths)	Curb Reveal (Inches)	Curb Recommendation
20,487	0.353	NOT APPLICABLE	NOT APPLICABLE
Curb Type		Curb & Gutter Type	
NO CURB		NO CURB AND GUTTER	
Pavement Recommendation		Condition Rating / PCR	
PREVENTIVE MAINTENANCE		GOOD / 90

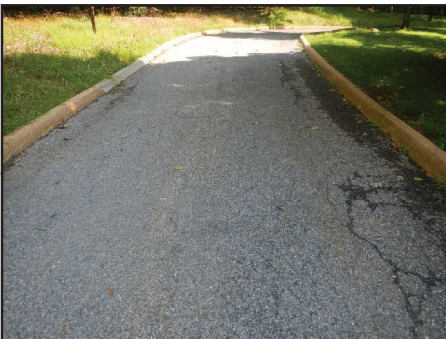
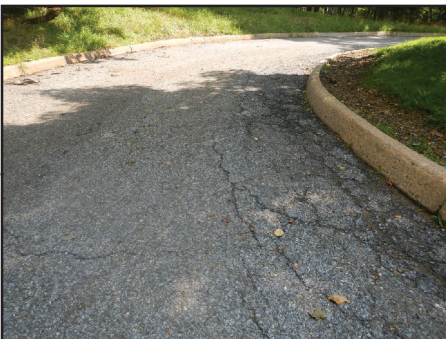
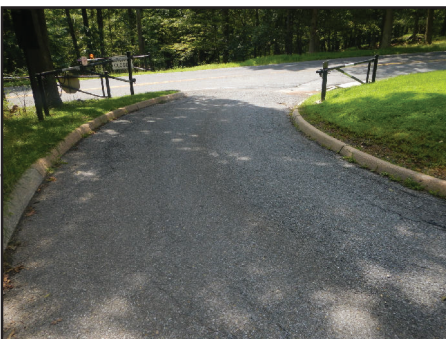
Inspection Date	FMSS Number	User Access	Surface Type
8/9/2018	91223	PUBLIC	ASPHALT
Area (Sq. Ft.)	Lane Miles (11' Widths)	Curb Reveal (Inches)	Curb Recommendation
2,347	0.04	7	DO NOTHING
Curb Type		Curb & Gutter Type	
CONCRETE		NO CURB AND GUTTER	
Pavement Recommendation		Condition Rating / PCR	
HEAVY 3R TREATMENTS		POOR / 53

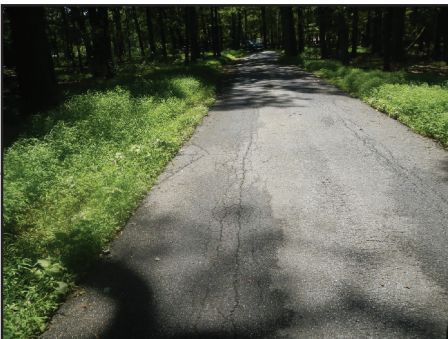
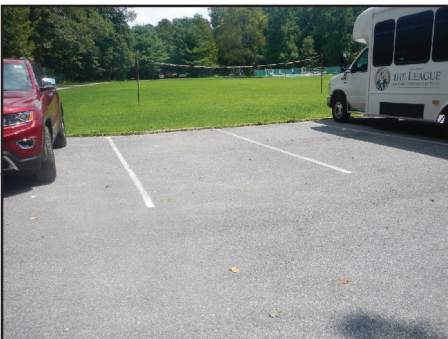
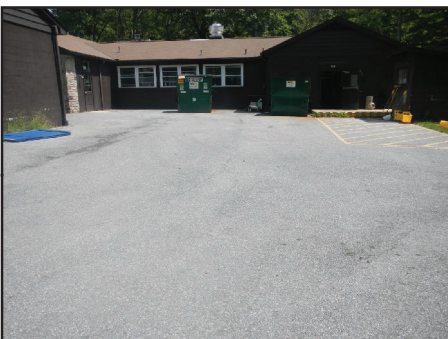
ROUTE 0909: GREENTOP CAMPGROUND PARKING

Inspection Date	FMSS Number	User Access	Surface Type
8/9/2018	91224	PUBLIC	ASPHALT
Area (Sq. Ft.)	Lane Miles (11' Widths)	Curb Reveal (Inches)	Curb Recommendation
26,820	0.462	2	LIGHT REPAIR
Curb Type		Curb & Gutter Type	
CONCRETE		NO CURB AND GUTTER	
Pavement Recommendation		Condition Rating / PCR	
LIGHT 3R TREATMENTS		FAIR / 73

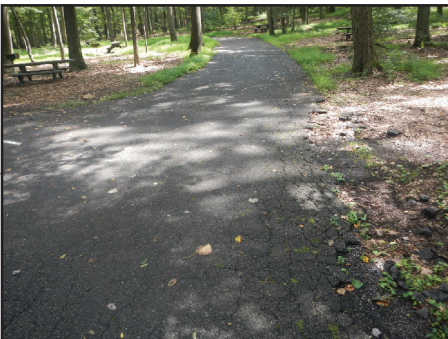
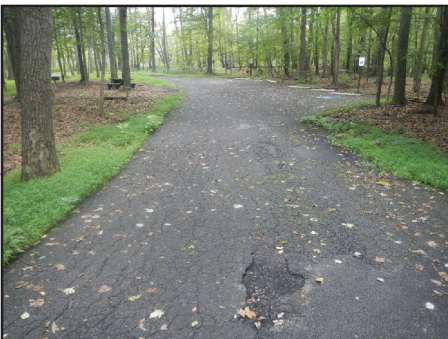
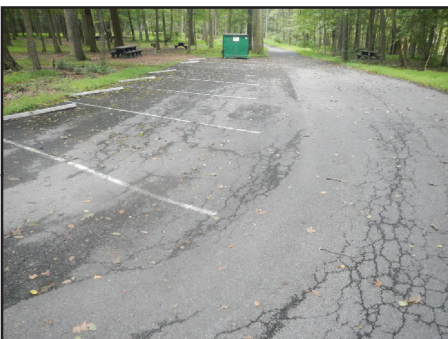
ROUTE 0910: CHESTNUT PICNIC PARKING

Inspection Date	FMSS Number	User Access	Surface Type
8/9/2018	60188	PUBLIC	ASPHALT
Area (Sq. Ft.)	Lane Miles (11' Widths)	Curb Reveal (Inches)	Curb Recommendation
32,415	0.558	NOT APPLICABLE	NOT APPLICABLE
Curb Type		Curb & Gutter Type	
NO CURB		NO CURB AND GUTTER	
Pavement Recommendation		Condition Rating / PCR	
RECONSTRUCTION		POOR / 30

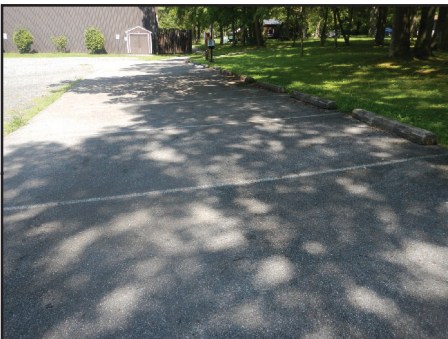
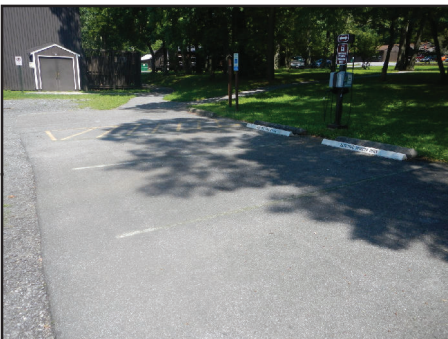
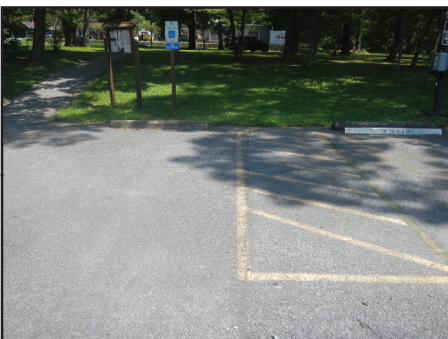
ROUTE 0912BZ: ROUND MEADOW GYM PARKING B

Inspection Date	FMSS Number	User Access	Surface Type
8/9/2018	91226	PUBLIC	ASPHALT
Area (Sq. Ft.)	Lane Miles (11' Widths)	Curb Reveal (Inches)	Curb Recommendation
3,651	0.063	NOT APPLICABLE	NOT APPLICABLE
Curb Type		Curb & Gutter Type	
NO CURB		NO CURB AND GUTTER	
Pavement Recommendation		Condition Rating / PCR	
PREVENTIVE MAINTENANCE		GOOD / 90

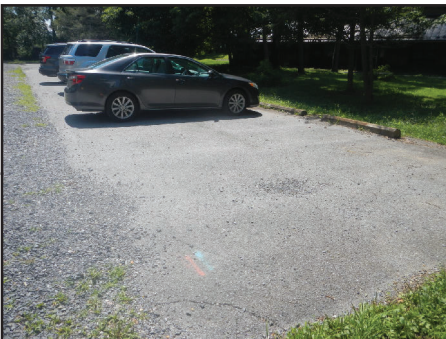
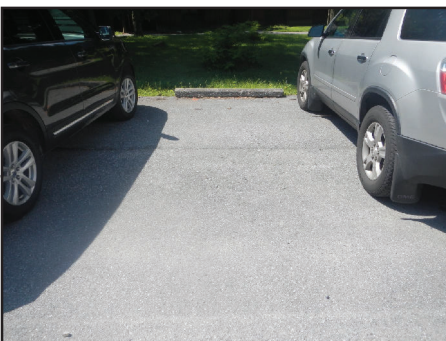
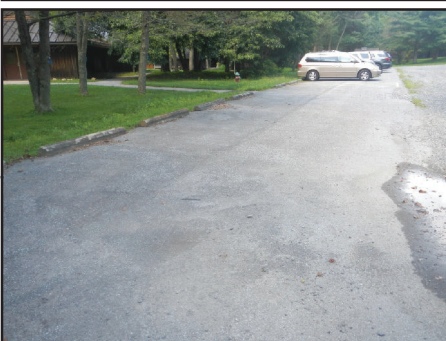
ROUTE 0913: OWENS PICNIC PARKING AREA

Inspection Date	FMSS Number	User Access	Surface Type
8/9/2018	37293	PUBLIC	ASPHALT
Area (Sq. Ft.)	Lane Miles (11' Widths)	Curb Reveal (Inches)	Curb Recommendation
33,918	0.584	NOT APPLICABLE	NOT APPLICABLE
Curb Type		Curb & Gutter Type	
NO CURB		NO CURB AND GUTTER	
Pavement Recommendation		Condition Rating / PCR	
HEAVY 3R TREATMENTS		POOR / 53

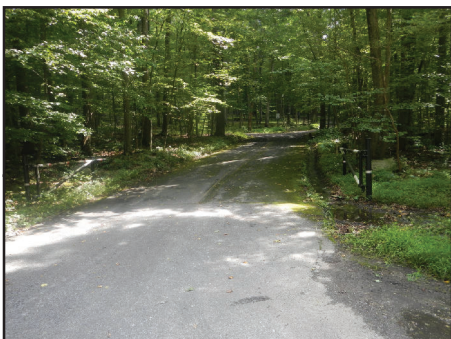
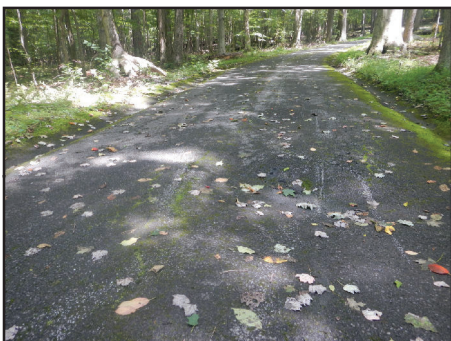
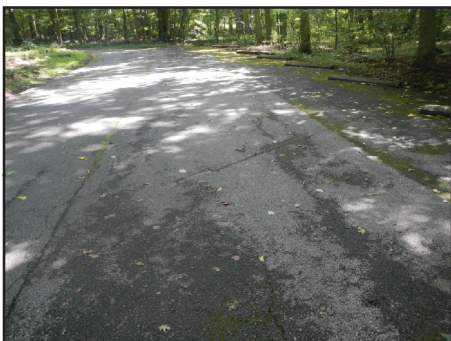
ROUTE 0915: VISITOR CENTER EMPLOYEE PARKING

Inspection Date	FMSS Number	User Access	Surface Type
8/9/2018	91230	NONPUBLIC	ASPHALT
Area (Sq. Ft.)	Lane Miles (11' Widths)	Curb Reveal (Inches)	Curb Recommendation
2,999	0.052	NOT APPLICABLE	LIGHT REPAIR
Curb Type		Curb & Gutter Type	
NO CURB		CONCRETE	
Pavement Recommendation		Condition Rating / PCR	
LIGHT 3R TREATMENTS		FAIR / 73

Note: Parking area consists of multiple surface types: 1 part Asphalt at 2,650 square feet; 1 part Concrete at 349 square feet.

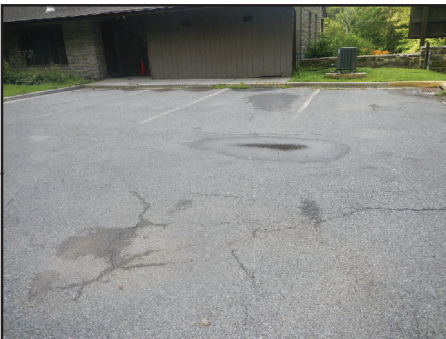
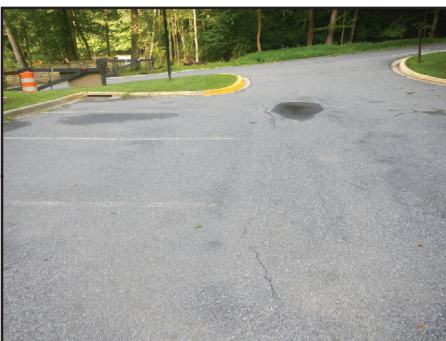
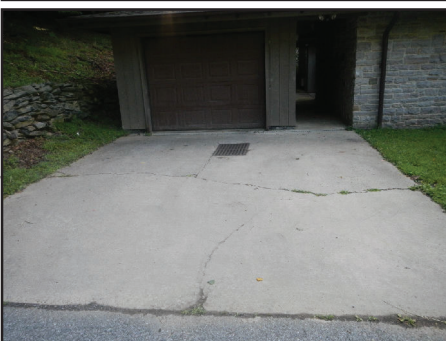
ROUTE 0917: ADMINISTRATIVE PARKING

Inspection Date	FMSS Number	User Access	Surface Type
8/9/2018	15981	PUBLIC	BRICK PAVERS
Area (Sq. Ft.)	Lane Miles (11' Widths)	Curb Reveal (Inches)	Curb Recommendation
10,835	0.187	NOT APPLICABLE	NOT APPLICABLE
Curb Type		Curb & Gutter Type	
NO CURB		NO CURB AND GUTTER	
Pavement Recommendation		Condition Rating / PCR	
PREVENTIVE MAINTENANCE		GOOD / 90

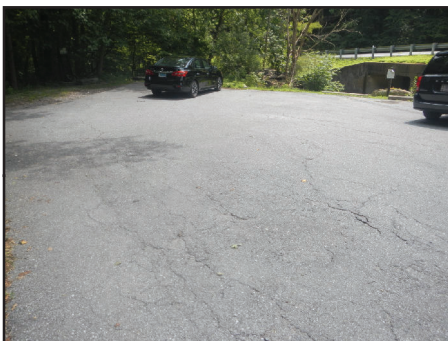
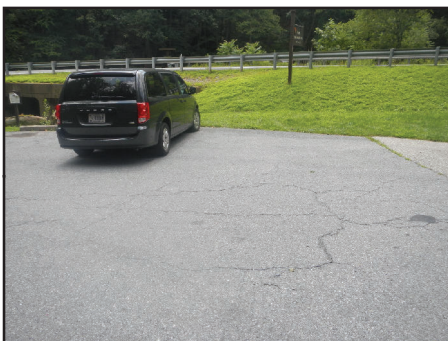
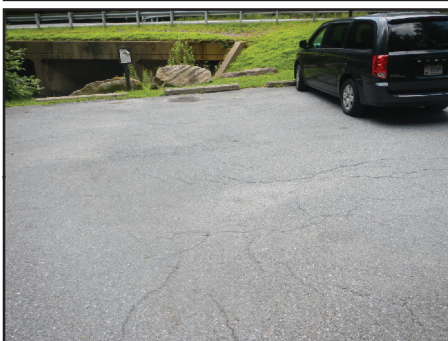
ROUTE 0919: JIM BROWN ROAD PARKING

Inspection Date	FMSS Number	User Access	Surface Type
8/9/2018	91233	NONPUBLIC	ASPHALT
Area (Sq. Ft.)	Lane Miles (11' Widths)	Curb Reveal (Inches)	Curb Recommendation
6,543	0.113	NOT APPLICABLE	NOT APPLICABLE
Curb Type		Curb & Gutter Type	
NO CURB		NO CURB AND GUTTER	
Pavement Recommendation		Condition Rating / PCR	
PREVENTIVE MAINTENANCE		GOOD / 90

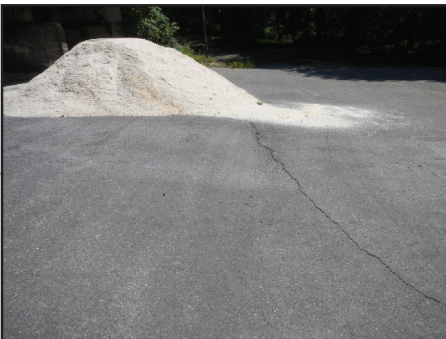
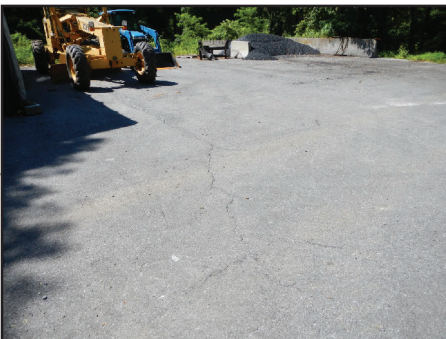
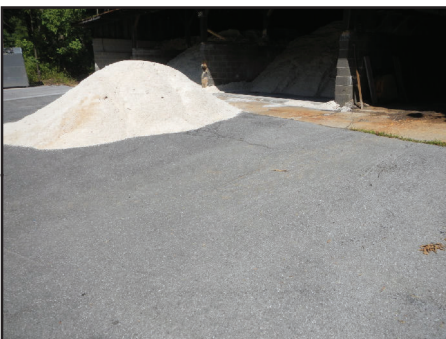
ROUTE 0920: ROUND MEADOW MAINTENANCE AREA

Inspection Date	FMSS Number	User Access	Surface Type
8/9/2018	242027	NONPUBLIC	ASPHALT
Area (Sq. Ft.)	Lane Miles (11' Widths)	Curb Reveal (Inches)	Curb Recommendation
33,241	0.572	NOT APPLICABLE	DO NOTHING
Curb Type		Curb & Gutter Type	
NO CURB		CONCRETE	
Pavement Recommendation		Condition Rating / PCR	
HEAVY 3R TREATMENTS		POOR / 53

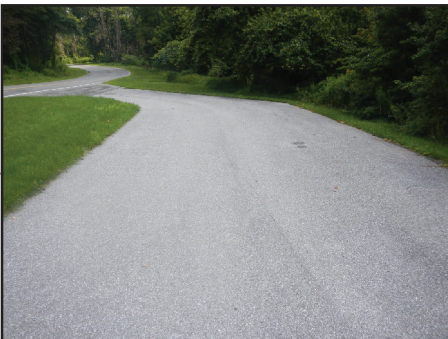
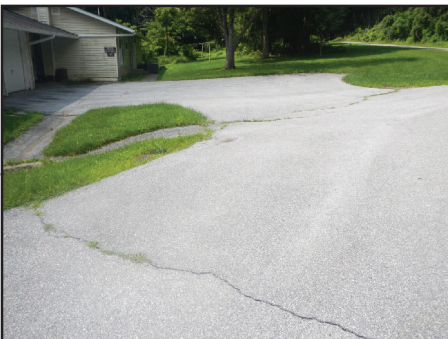
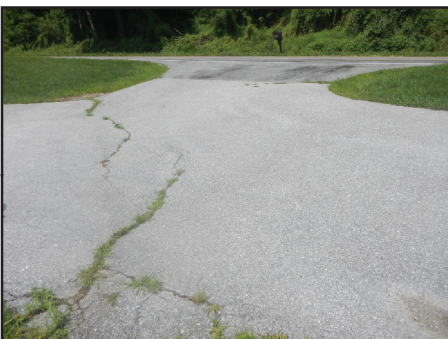
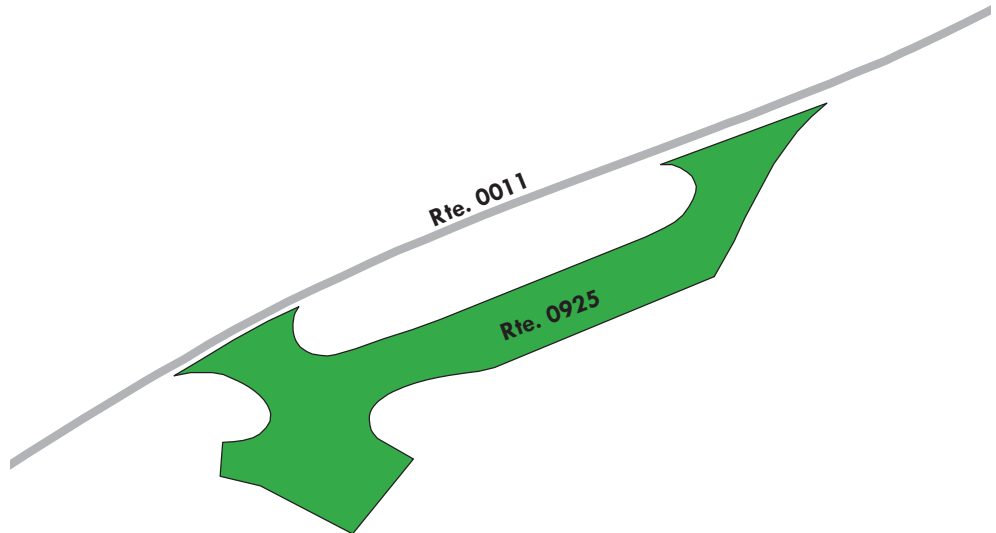
ROUTE 0926: QUARTERS #1 ACCESS

Inspection Date	FMSS Number	User Access	Surface Type
8/9/2018	17021	NONPUBLIC	ASPHALT
Area (Sq. Ft.)	Lane Miles (11' Widths)	Curb Reveal (Inches)	Curb Recommendation
4,529	0.078	NOT APPLICABLE	NOT APPLICABLE
Curb Type		Curb & Gutter Type	
NO CURB		NO CURB AND GUTTER	
Pavement Recommendation		Condition Rating / PCR	
RECONSTRUCTION		POOR / 30
