CATO Cycle 6

Final Report

Road Inventory and Condition Assessment of Paved Routes Catoctin Mountain Park

**Federal Highway Administration
Eastern Federal Lands Highway Division
Road Inventory Program (RIP)**

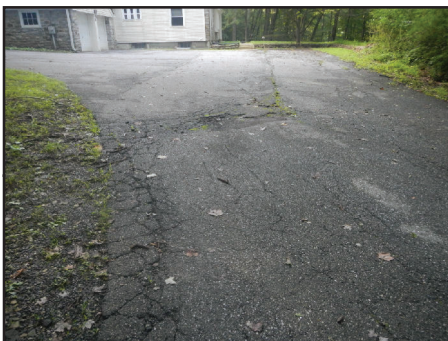
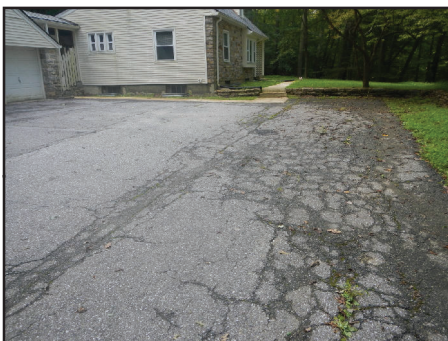
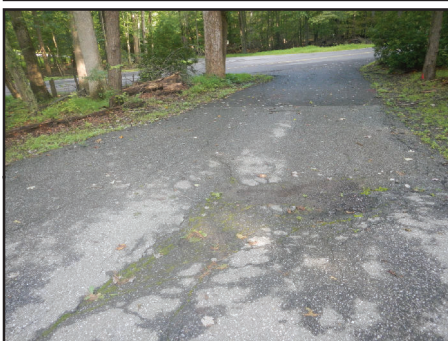
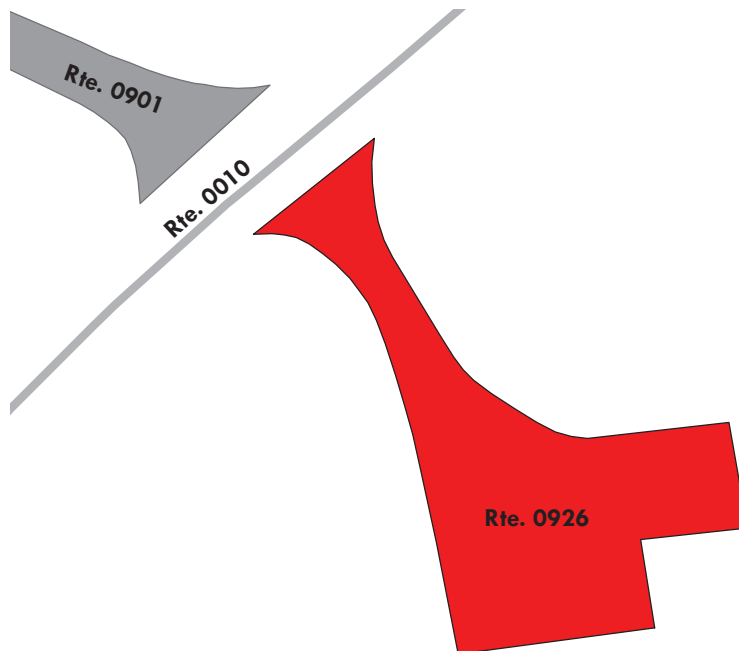
ROUTE 0927: BUILDING 167 ACCESS

Inspection Date	FMSS Number	User Access	Surface Type
8/9/2018	16946	NONPUBLIC	ASPHALT
Area (Sq. Ft.)	Lane Miles (11' Widths)	Curb Reveal (Inches)	Curb Recommendation
1,601	0.028	NOT APPLICABLE	NOT APPLICABLE
Curb Type		Curb & Gutter Type	
NO CURB		NO CURB AND GUTTER	
Pavement Recommendation		Condition Rating / PCR	
RECONSTRUCTION		POOR / 30

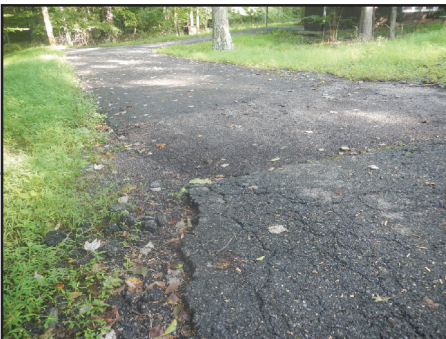
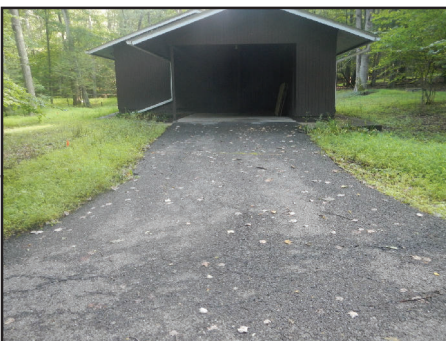
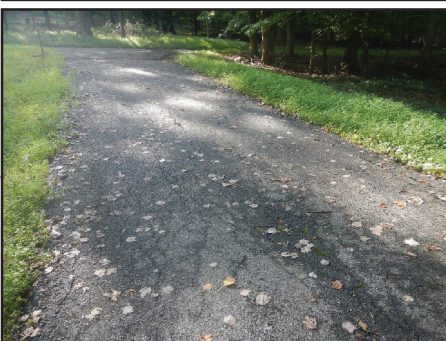
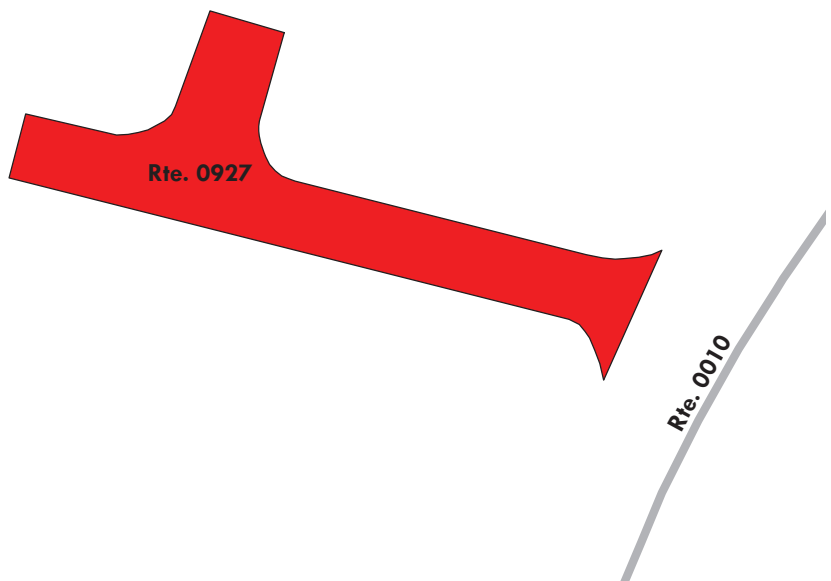
ROUTE 0928: VISITORS SERVICE ACCESS

Inspection Date	FMSS Number	User Access	Surface Type
8/9/2018	242025	PUBLIC	ASPHALT
Area (Sq. Ft.)	Lane Miles (11' Widths)	Curb Reveal (Inches)	Curb Recommendation
2,734	0.047	NOT APPLICABLE	NOT APPLICABLE
Curb Type		Curb & Gutter Type	
NO CURB		NO CURB AND GUTTER	
Pavement Recommendation		Condition Rating / PCR	
RECONSTRUCTION		POOR / 30

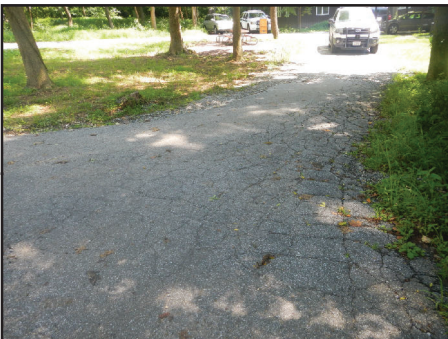
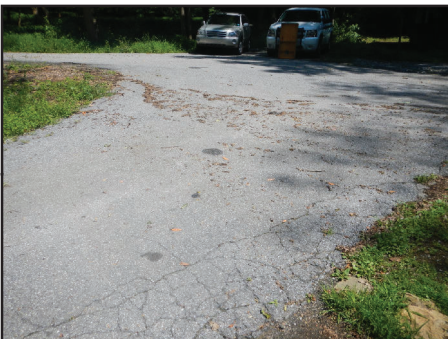
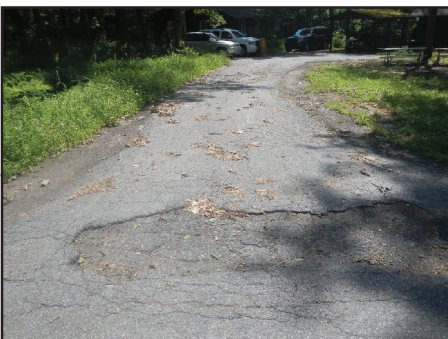
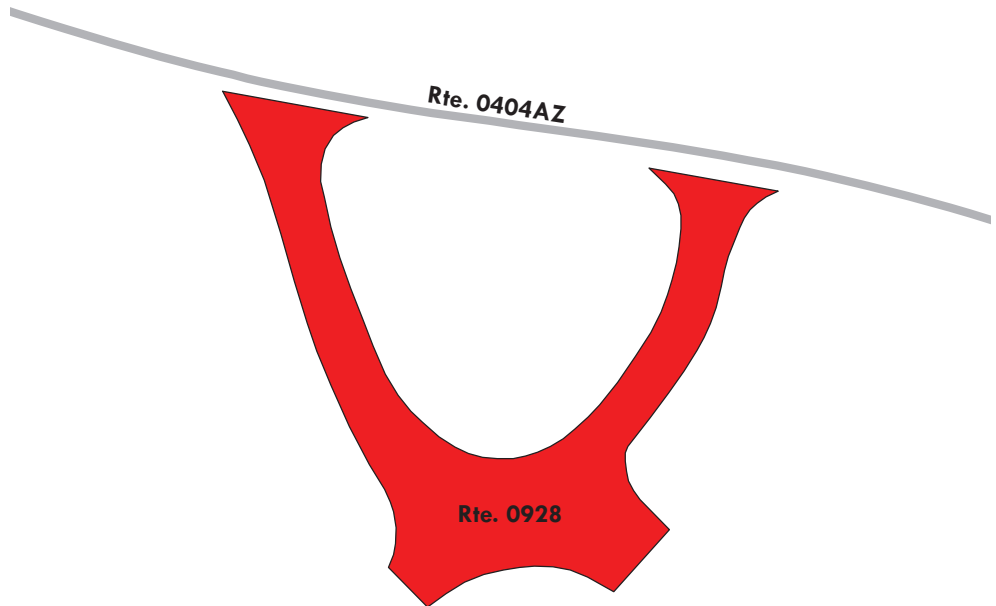
ROUTE 0929: QUARTER #7 ACCESS

Inspection Date	FMSS Number	User Access	Surface Type
8/9/2018	242026	NONPUBLIC	ASPHALT
Area (Sq. Ft.)	Lane Miles (11' Widths)	Curb Reveal (Inches)	Curb Recommendation
1,585	0.027	NOT APPLICABLE	NOT APPLICABLE
Curb Type		Curb & Gutter Type	
NO CURB		NO CURB AND GUTTER	
Pavement Recommendation		Condition Rating / PCR	
HEAVY 3R TREATMENTS		POOR / 53
