CEBR Cycle 6

Final Report

Road Inventory and Condition Assessment of Paved Routes Cedar Breaks National Monument

Report Date: December 2016

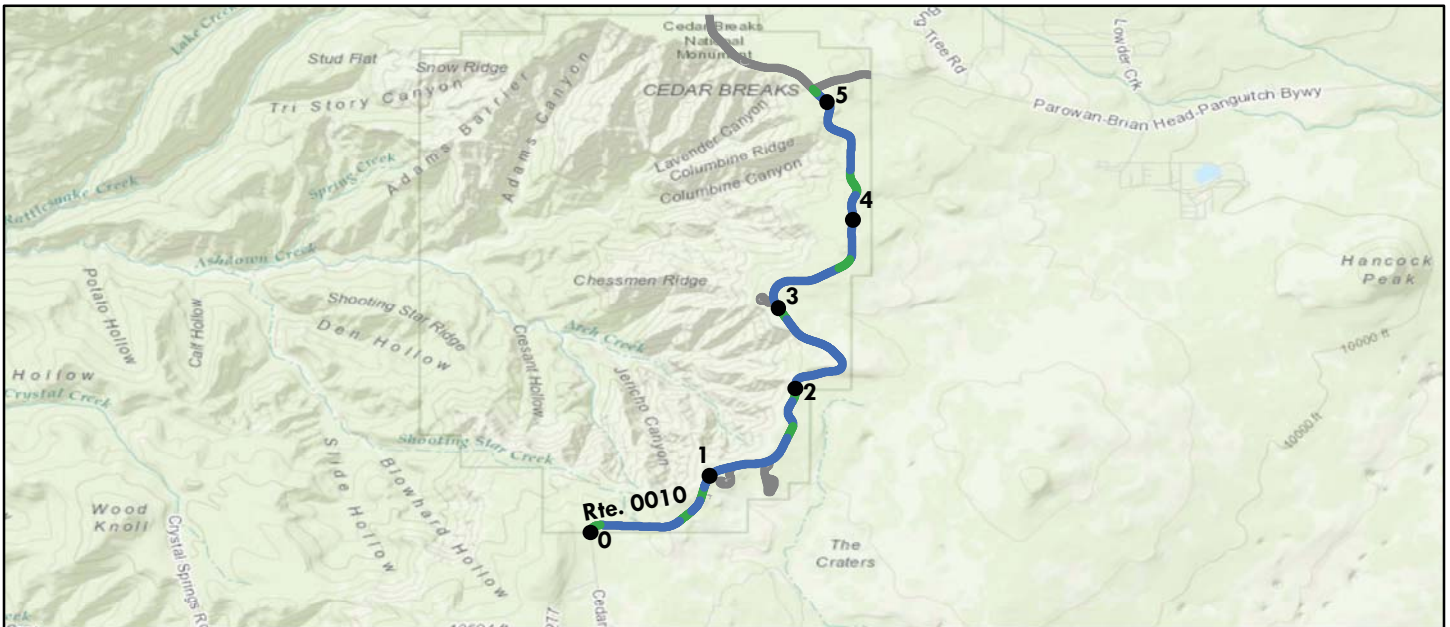
ROUTE 0010: HIGHWAY 18

Route Condition Legend – Pavement Condition Rating (PCR)						
Poor (0 - 60)	Fair (61- 84)	Good (85 - 94)	Excellent (95 - 100)	Not Rated		
See Appendix for definitions and formulas						
Inspection Date: 7/12/2016	Beginning Section MP	0	1	2	3	4
Paved Length (Miles): 5.13	Section Length (MI)	1	1	1	1	1
Surface Type: ASPHALT	Route Summary					
Roadway Condition Information						
Pavement Condition Rating (PCR)	98	98	98	99	98	99
Surface Condition Rating (SCR)	98	99	98	99	98	99
Roughness Condition Index (RCI)	99	96	97	100	99	100
Distress Index Values						
Structural Crack Index	100	100	100	100	100	100
Alligator Crack Index	100	100	100	100	100	100
Longitudinal Crack Index	100	100	100	100	100	100
Transverse Cracking Index	100	100	100	100	100	100
Patching Index	100	100	100	100	100	100
Rutting Index	98	99	98	99	98	99
International Roughness Index (IRI)	118	125	122	108	117	114
Lane & Width Information						
Number of Lanes	2	2	2	2	2	2

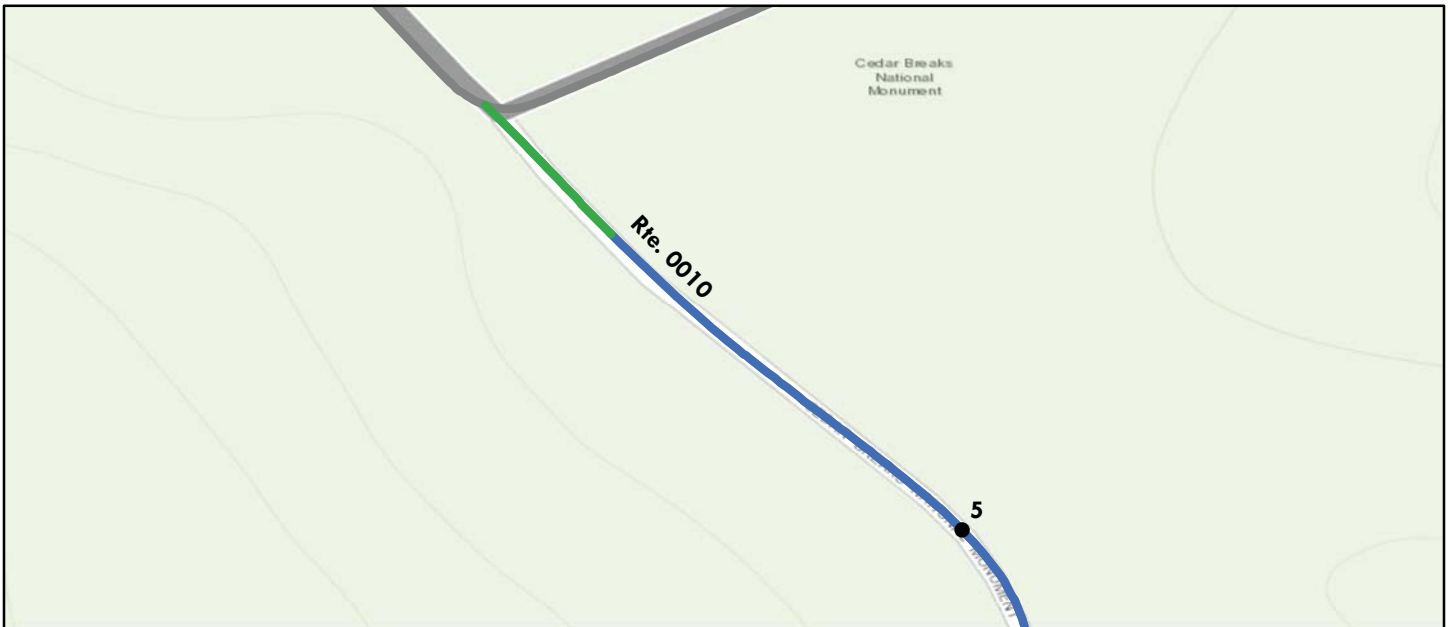
ROUTE 0010: HIGHWAY 18

Route Condition Legend – Pavement Condition Rating (PCR)						
Poor (0 - 60)	Fair (61- 84)	Good (85 - 94)	Excellent (95 - 100)	Not Rated		
See Appendix for definitions and formulas						
Inspection Date: 7/12/2016	Beginning Section MP	5				
Paved Length (Miles): 5.13	Section Length (MI)	0.13				
Surface Type: ASPHALT	Route Summary					
Roadway Condition Information						
Pavement Condition Rating (PCR)	98	95				
Surface Condition Rating (SCR)	98	99				
Roughness Condition Index (RCI)	99	89				
Distress Index Values						
Structural Crack Index	100	100				
Alligator Crack Index	100	100				
Longitudinal Crack Index	100	100				
Transverse Cracking Index	100	100				
Patching Index	100	100				
Rutting Index	98	99				
International Roughness Index (IRI)	118	142				
Lane & Width Information						
Number of Lanes	2	2				
Paved Width (ft)	23.5	24.7				
Lane Width (ft)	9.7	9

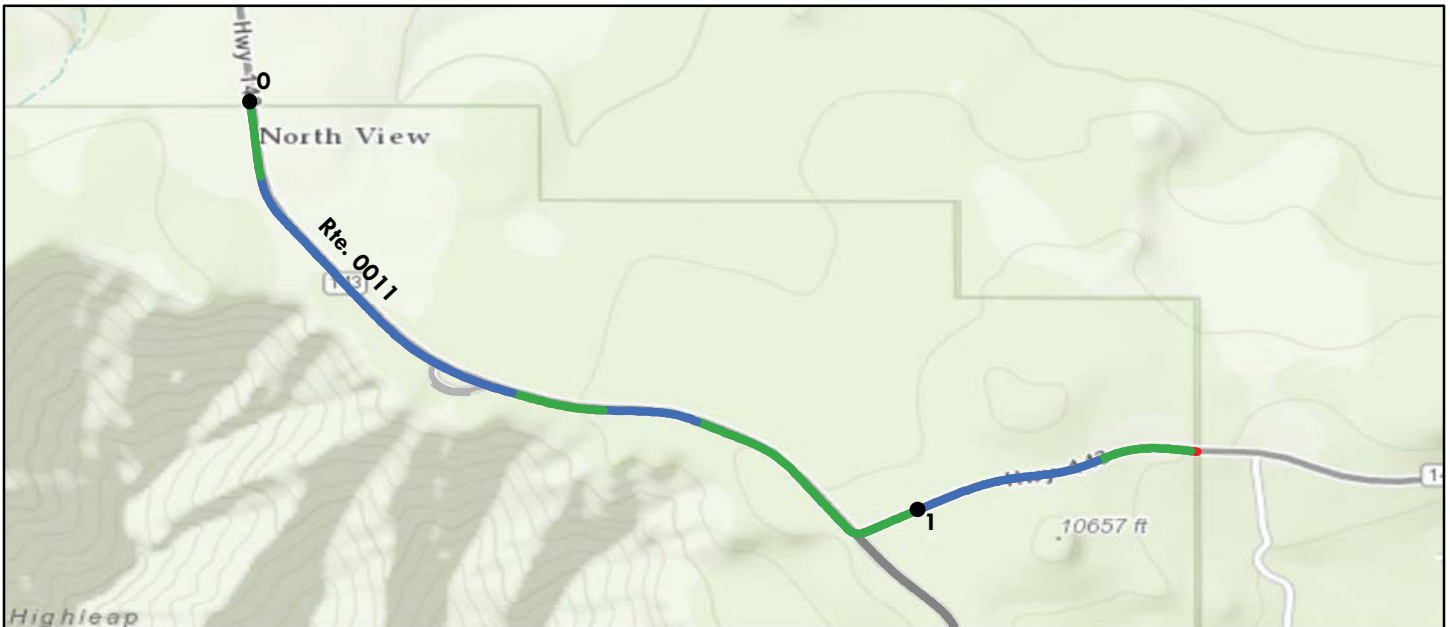
ROUTE 0011: HIGHWAY 143

Route Condition Legend – Pavement Condition Rating (PCR)									
Poor (0 - 60)		Fair (61- 84)		Good (85 - 94)		Excellent (95 - 100)		Not Rated	
See Appendix for definitions and formulas									
Inspection Date:	7/12/2016	Beginning Section MP	0	1					
Paved Length (Miles):	1.31	Section Length (MI)	1	0.31					
Surface Type:	ASPHALT	Route Summary							
Roadway Condition Information									
Pavement Condition Rating (PCR)	94	93	94						
Surface Condition Rating (SCR)	96	95	97						
Roughness Condition Index (RCI)	90	90	90						
Distress Index Values									
Structural Crack Index	100	100	100						
Alligator Crack Index	100	100	100						
Longitudinal Crack Index	100	100	100						
Transverse Cracking Index	100	100	100						
Patching Index	100	100	100						
Rutting Index	96	95	97						
International Roughness Index (IRI)	140	140	140						
Lane & Width Information									
Number of Lanes	2	2	2						
Paved Width (ft)	25.1	24.9	25.7

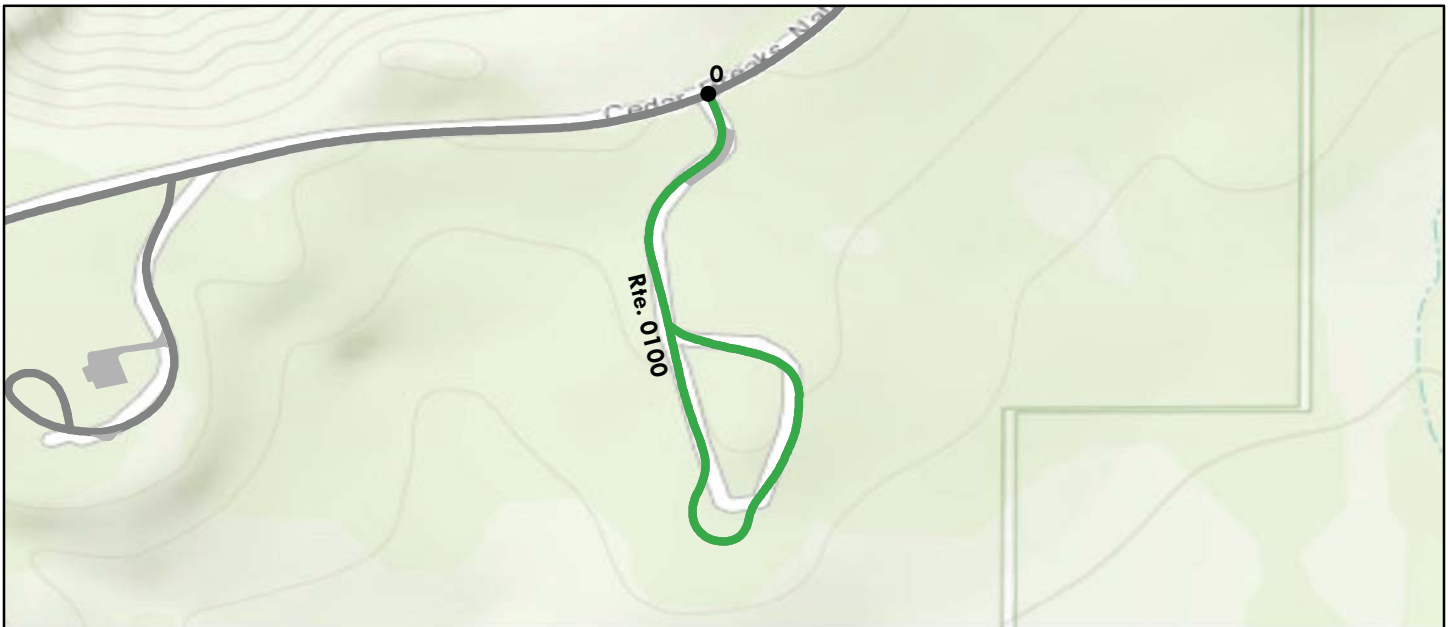
ROUTE 0100: POINT SUPREME CAMPGROUND LOOP

Route Condition Legend – Pavement Condition Rating (PCR)						
Poor (0 - 60)	Fair (61- 84)	Good (85 - 94)	Excellent (95 - 100)	Not Rated		
See Appendix for definitions and formulas						
Inspection Date: 7/14/2016	Beginning Section MP	0				
Paved Length (Miles): 0.41	Section Length (MI)	0.41				
Surface Type: ASPHALT	Route Summary					
Roadway Condition Information						
Pavement Condition Rating (PCR)	91	91				
Surface Condition Rating (SCR)	91	91				
Roughness Condition Index (RCI)	N/A	N/A				
Distress Index Values						
Structural Crack Index	100	100				
Alligator Crack Index	100	100				
Longitudinal Crack Index	100	100				
Transverse Cracking Index	100	100				
Patching Index	100	100				
Rutting Index	91	91				
International Roughness Index (IRI)	N/A	N/A				
Lane & Width Information						
Number of Lanes	1	1				
Paved Width (ft)	15.5	15.5				
Lane Width (ft)	11.4	11.4

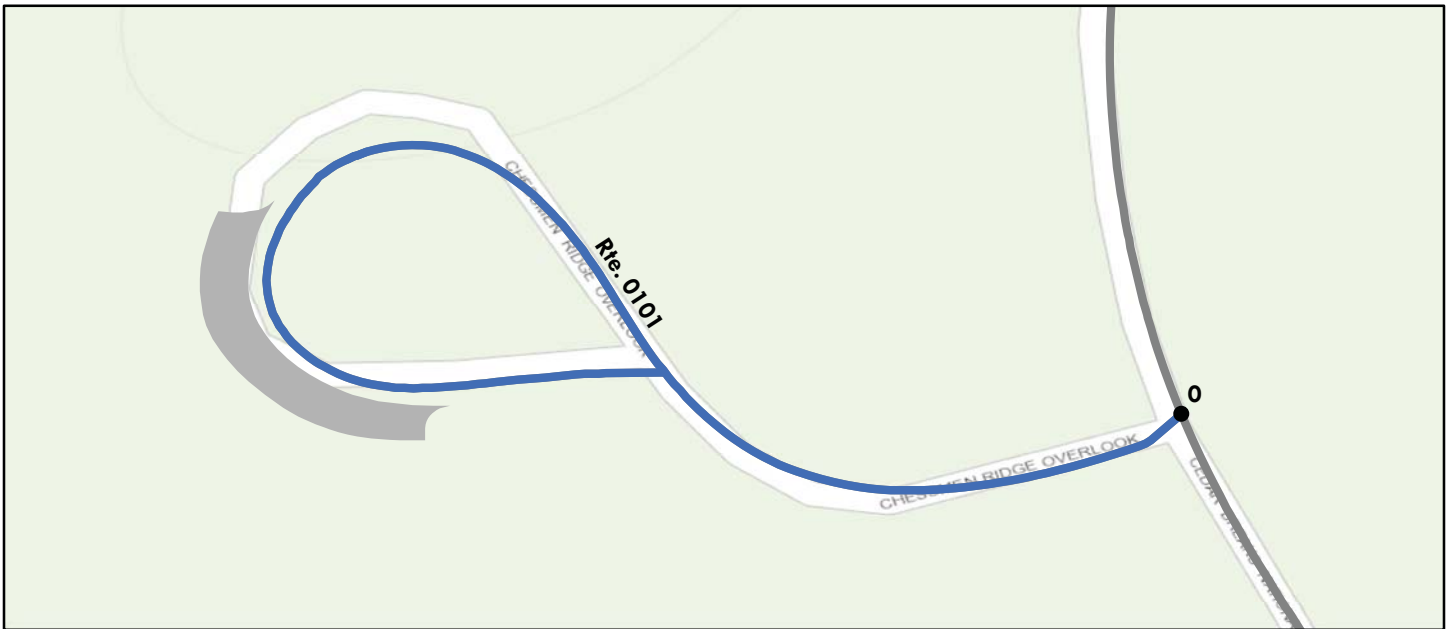
ROUTE 0101: CHESSMAN OVERLOOK ACCESS ROAD

Route Condition Legend – Pavement Condition Rating (PCR)						
Poor (0 - 60)	Fair (61- 84)	Good (85 - 94)	Excellent (95 - 100)	Not Rated		
See Appendix for definitions and formulas						
Inspection Date: 7/13/2016	Beginning Section MP	0				
Paved Length (Miles): 0.16	Section Length (MI)	0.16				
Surface Type: ASPHALT	Route Summary					
Roadway Condition Information						
Pavement Condition Rating (PCR)	96	96				
Surface Condition Rating (SCR)	96	96				
Roughness Condition Index (RCI)	N/A	N/A				
Distress Index Values						
Structural Crack Index	100	100				
Alligator Crack Index	100	100				
Longitudinal Crack Index	100	100				
Transverse Cracking Index	100	100				
Patching Index	100	100				
Rutting Index	96	96				
International Roughness Index (IRI)	N/A	N/A				
Lane & Width Information						
Number of Lanes	2	2				
Paved Width (ft)	26.2	26.2				
Lane Width (ft)	13.1	13.1

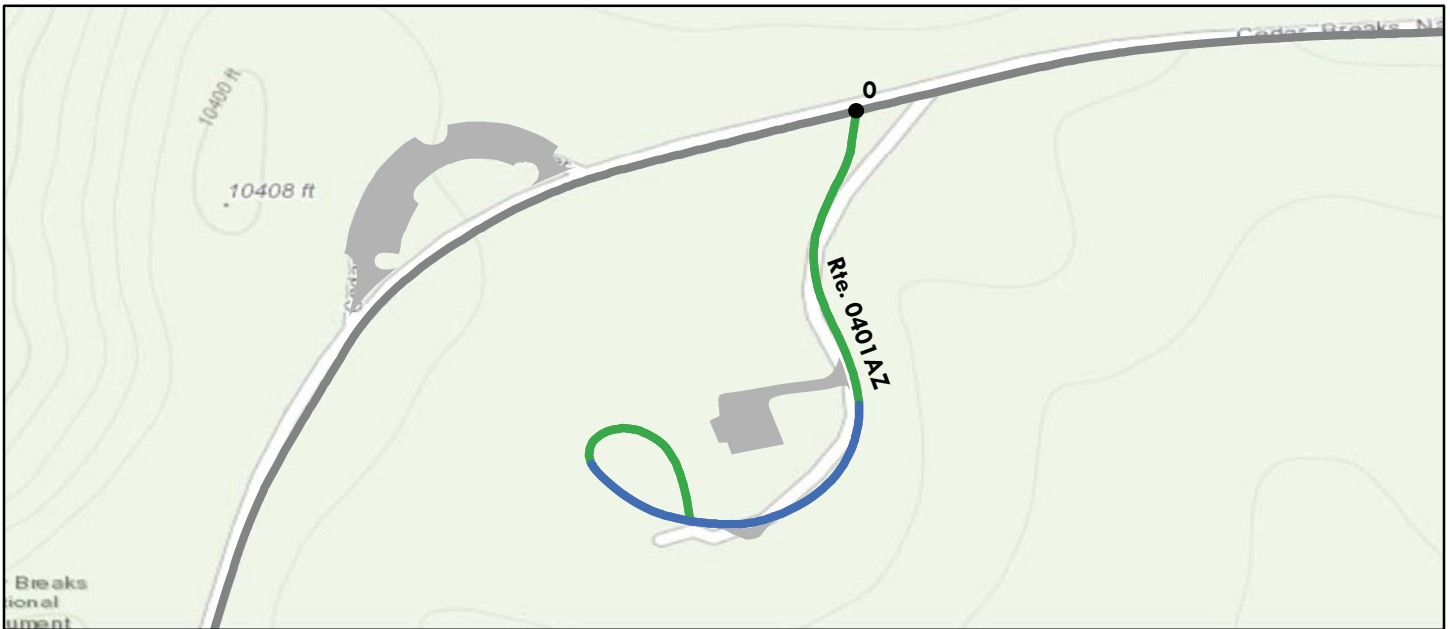
ROUTE 0401AZ: MAINTENANCE AREA SERVICE ROAD

Route Condition Legend – Pavement Condition Rating (PCR)						
Poor (0 - 60)	Fair (61- 84)	Good (85 - 94)	Excellent (95 - 100)	Not Rated		
See Appendix for definitions and formulas						
Inspection Date: 7/14/2016	Beginning Section MP	0				
Paved Length (Miles): 0.26	Section Length (MI)	0.26				
Surface Type: ASPHALT	Route Summary					
Roadway Condition Information						
Pavement Condition Rating (PCR)	94	94				
Surface Condition Rating (SCR)	94	94				
Roughness Condition Index (RCI)	N/A	N/A				
Distress Index Values						
Structural Crack Index	99	99				
Alligator Crack Index	100	100				
Longitudinal Crack Index	99	99				
Transverse Cracking Index	100	100				
Patching Index	100	100				
Rutting Index	94	94				
International Roughness Index (IRI)	N/A	N/A				
Lane & Width Information						
Number of Lanes	2	2				
Paved Width (ft)	18.1	18.1				
Lane Width (ft)	9	9

Note: Subcomponent Route 0401BZ is unpaved and not shown on the map above. Condition and GPS is not collected for unpaved routes.
