CRLA Cycle 6

Final Report

Road Inventory and Condition Assessment of Paved Routes Crater Lake National Park

Report Date: February 2016

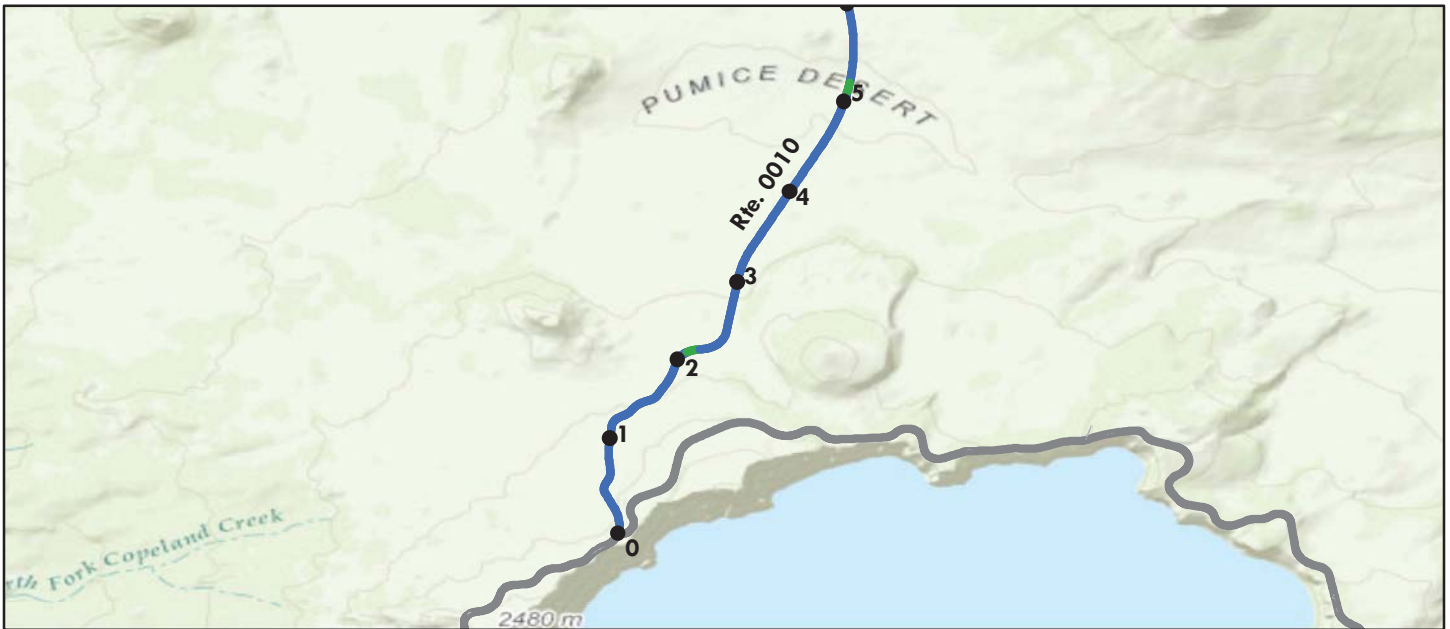
ROUTE 0010: NORTH ENTRANCE ROAD

Route Condition Legend – Pavement Condition Rating (PCR)						
Poor (0 - 60)	Fair (61- 84)	Good (85 - 94)	Excellent (95 - 100)	Not Rated		
See Appendix for definitions and formulas						
Inspection Date: 7/31/2015	Beginning Section MP	0	1	2	3	4
Paved Length (Miles): 9.15	Section Length (MI)	1	1	1	1	1
Surface Type: ASPHALT	Route Summary					
Roadway Condition Information						
Pavement Condition Rating (PCR)	99	100	100	99	99	98
Surface Condition Rating (SCR)	98	100	100	99	98	97
Roughness Condition Index (RCI)	100	100	100	100	100	100
Distress Index Values						
Structural Crack Index	100	100	100	100	100	100
Alligator Crack Index	100	100	100	100	100	100
Longitudinal Crack Index	100	100	100	100	100	100
Transverse Cracking Index	100	100	100	100	100	100
Patching Index	100	100	100	100	100	100
Rutting Index	98	100	100	99	98	97
International Roughness Index (IRI)	89	84	101	103	86	81
Lane & Width Information						
Number of Lanes	2	2	2	2	2	2

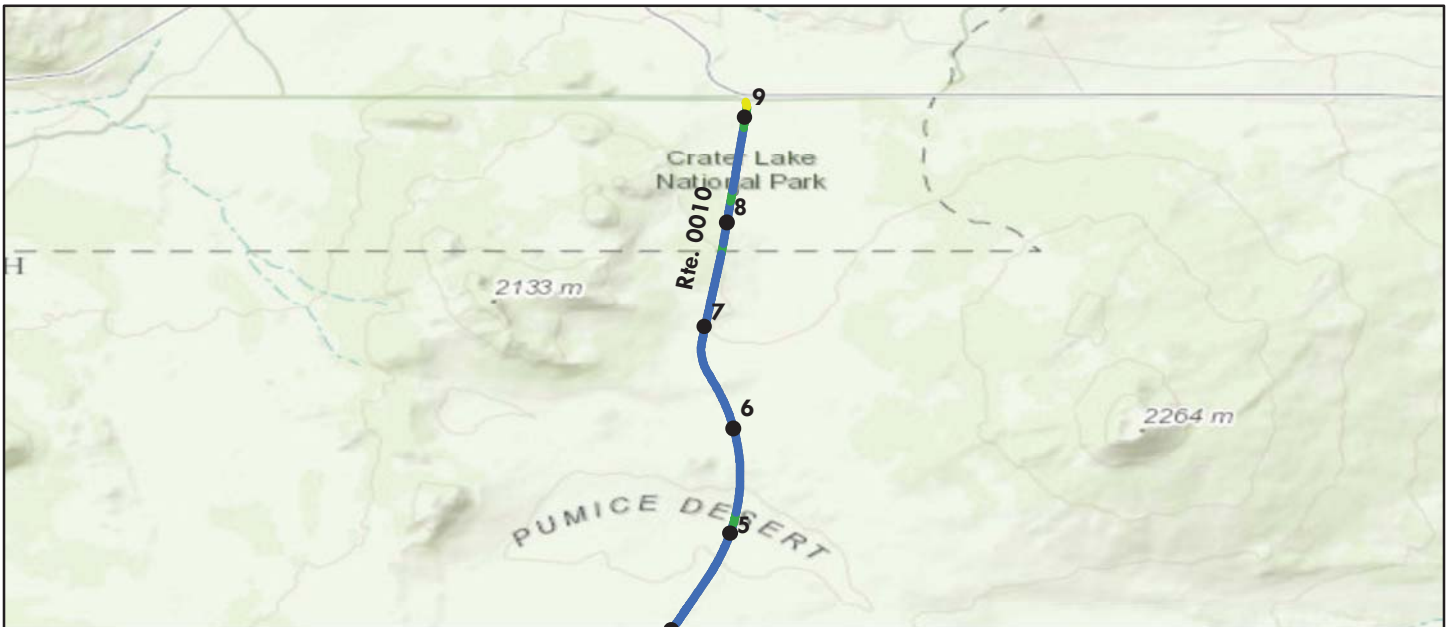
ROUTE 0010: NORTH ENTRANCE ROAD

Route Condition Legend – Pavement Condition Rating (PCR)						
Poor (0 - 60)	Fair (61- 84)	Good (85 - 94)	Excellent (95 - 100)	Not Rated		
See Appendix for definitions and formulas						
Inspection Date: 7/31/2015	Beginning Section MP	5	6	7	8	9
Paved Length (Miles): 9.15	Section Length (MI)	1	1	1	1	0.15
Surface Type: ASPHALT	Route Summary					
Roadway Condition Information						
Pavement Condition Rating (PCR)	99	98	99	99	96	79
Surface Condition Rating (SCR)	98	96	99	98	93	82
Roughness Condition Index (RCI)	100	100	100	100	100	74
Distress Index Values						
Structural Crack Index	100	100	100	100	100	97
Alligator Crack Index	100	100	100	100	100	100
Longitudinal Crack Index	100	100	100	100	100	97
Transverse Cracking Index	100	99	100	100	100	82
Patching Index	100	100	100	100	100	100
Rutting Index	98	96	99	98	93	95
International Roughness Index (IRI)	89	83	83	91	77	187
Lane & Width Information						
Number of Lanes	2	2	2	2	2	2

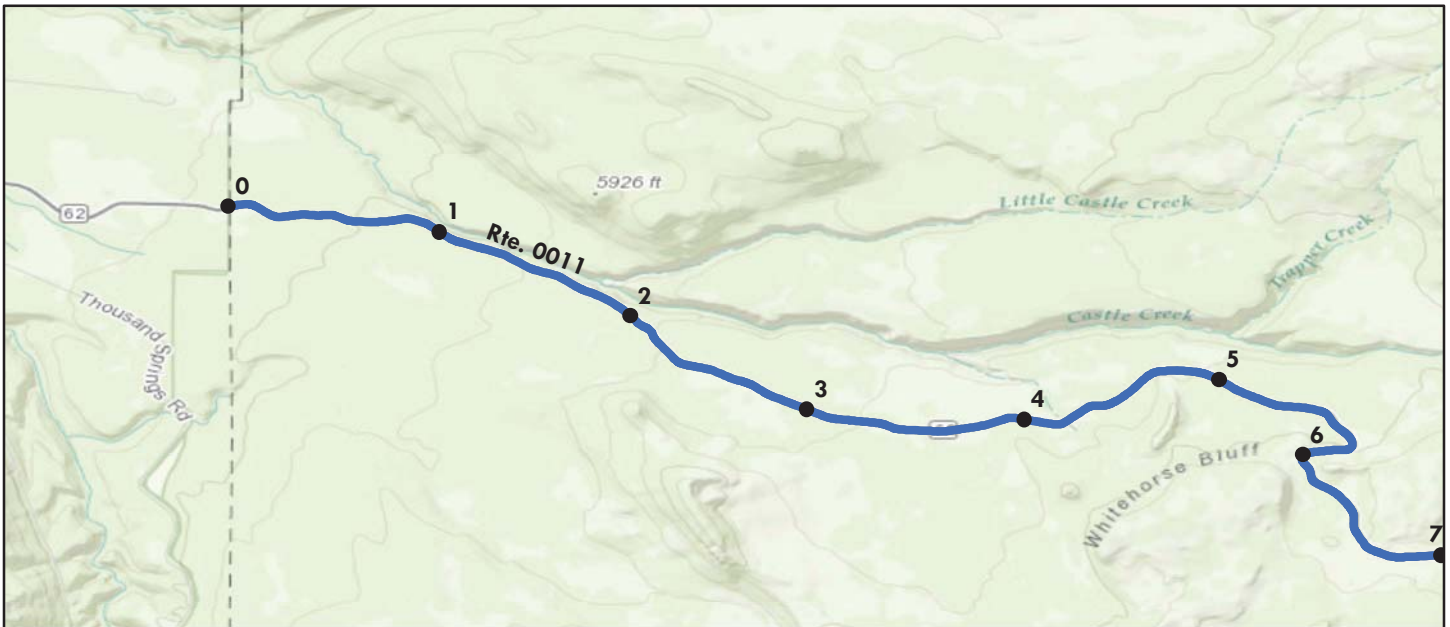
ROUTE 0011: CRATER LAKE HIGHWAY

Route Condition Legend – Pavement Condition Rating (PCR)						
Poor (0 - 60)	Fair (61- 84)	Good (85 - 94)	Excellent (95 - 100)	Not Rated		
See Appendix for definitions and formulas						
Inspection Date: 7/31/2015	Beginning Section MP	0	1	2	3	4
Paved Length (Miles): 17.43	Section Length (MI)	1	1	1	1	1
Surface Type: ASPHALT	Route Summary					
Roadway Condition Information						
Pavement Condition Rating (PCR)	95	100	98	98	98	99
Surface Condition Rating (SCR)	94	100	97	97	96	98
Roughness Condition Index (RCI)	97	100	100	100	100	100
Distress Index Values						
Structural Crack Index	100	100	100	100	100	100
Alligator Crack Index	100	100	100	100	100	100
Longitudinal Crack Index	100	100	100	100	100	100
Transverse Cracking Index	98	100	100	100	100	100
Patching Index	100	100	100	100	100	100
Rutting Index	94	100	97	97	96	98
International Roughness Index (IRI)	123	80	86	84	86	85
Lane & Width Information						
Number of Lanes	2	2	2	2	2	2

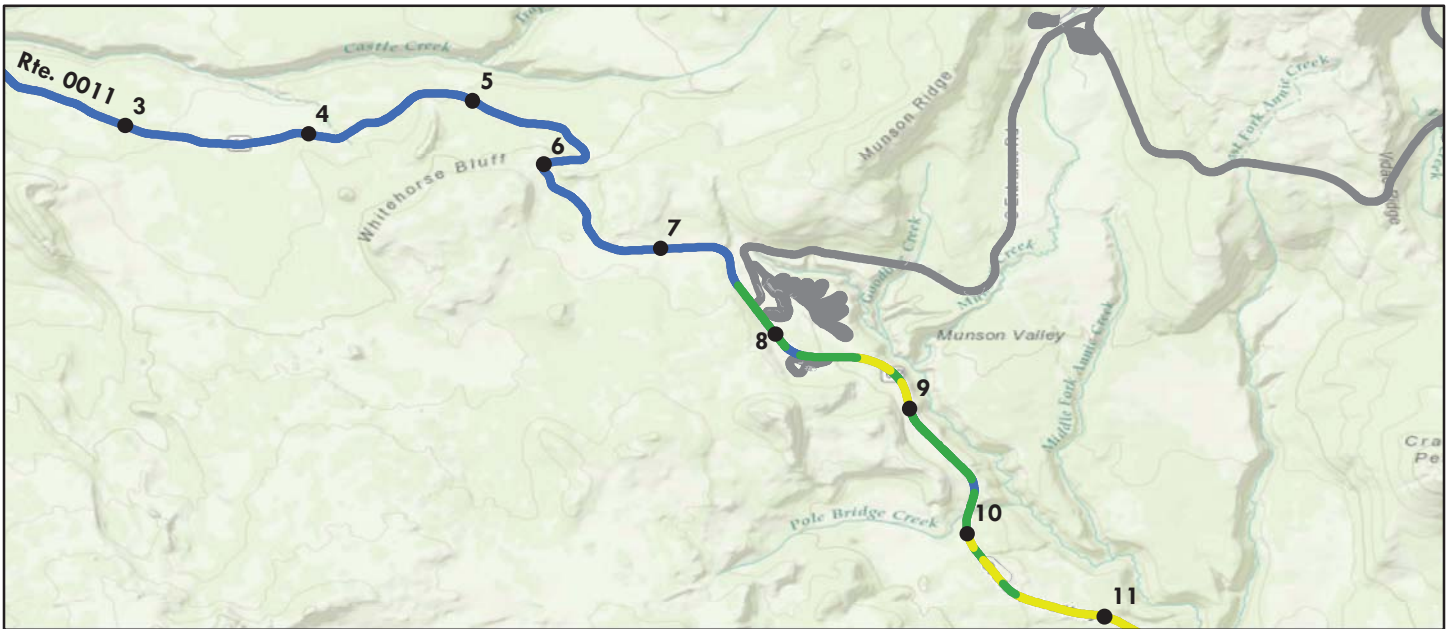
ROUTE 0011: CRATER LAKE HIGHWAY

Route Condition Legend – Pavement Condition Rating (PCR)						
Poor (0 - 60)	Fair (61- 84)	Good (85 - 94)	Excellent (95 - 100)	Not Rated		
See Appendix for definitions and formulas						
Inspection Date: 7/31/2015	Beginning Section MP	5	6	7	8	9
Paved Length (Miles): 17.43	Section Length (MI)	1	1	1	1	1
Surface Type: ASPHALT	Route Summary					
Roadway Condition Information						
Pavement Condition Rating (PCR)	95	99	99	97	86	90
Surface Condition Rating (SCR)	94	98	98	97	91	93
Roughness Condition Index (RCI)	97	100	100	98	79	86
Distress Index Values						
Structural Crack Index	100	100	100	100	99	99
Alligator Crack Index	100	100	100	100	100	100
Longitudinal Crack Index	100	100	100	100	99	99
Transverse Cracking Index	98	100	100	100	97	95
Patching Index	100	100	100	100	100	100
Rutting Index	94	98	98	97	91	93
International Roughness Index (IRI)	123	79	88	121	171	150
Lane & Width Information						
Number of Lanes	2	2	2	2	2	2

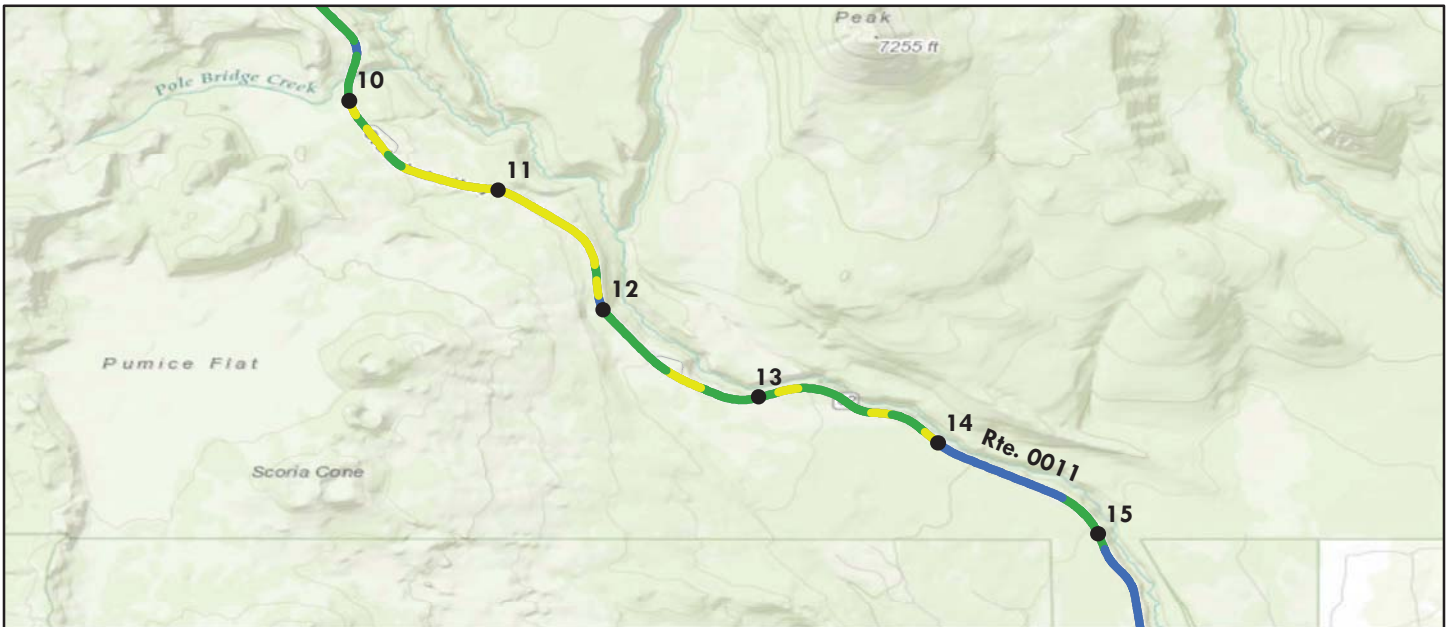
ROUTE 0011: CRATER LAKE HIGHWAY

Route Condition Legend – Pavement Condition Rating (PCR)						
Poor (0 - 60)	Fair (61- 84)	Good (85 - 94)	Excellent (95 - 100)	Not Rated		
See Appendix for definitions and formulas						
Inspection Date: 7/31/2015	Beginning Section MP	10	11	12	13	14
Paved Length (Miles): 17.43	Section Length (MI)	1	1	1	1	1
Surface Type: ASPHALT	Route Summary					
Roadway Condition Information						
Pavement Condition Rating (PCR)	95	80	82	88	87	97
Surface Condition Rating (SCR)	94	86	87	90	89	95
Roughness Condition Index (RCI)	97	72	74	84	83	99
Distress Index Values						
Structural Crack Index	100	100	100	100	99	100
Alligator Crack Index	100	100	100	100	100	100
Longitudinal Crack Index	100	100	100	100	99	100
Transverse Cracking Index	98	93	95	94	98	100
Patching Index	100	100	100	100	100	100
Rutting Index	94	86	87	90	89	95
International Roughness Index (IRI)	123	196	187	158	159	117
Lane & Width Information						
Number of Lanes	2	2	2	2	2	2

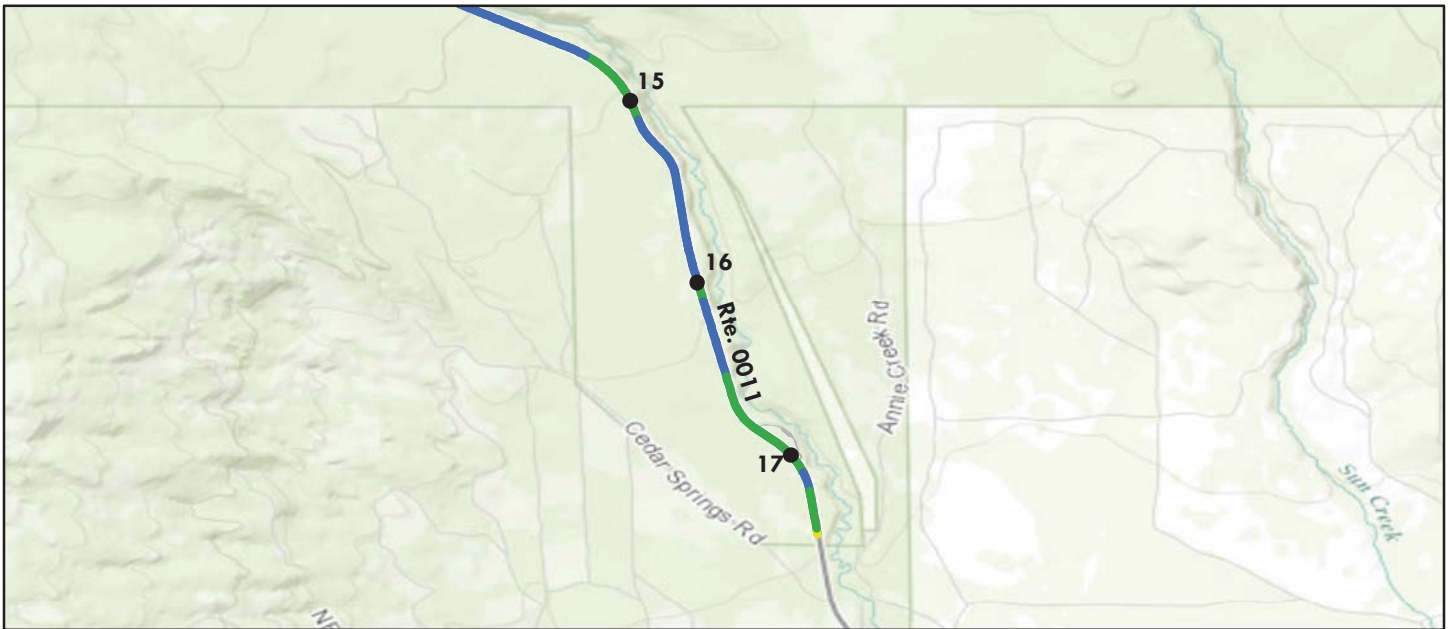
ROUTE 0011: CRATER LAKE HIGHWAY

Route Condition Legend – Pavement Condition Rating (PCR)						
Poor (0 - 60)	Fair (61- 84)	Good (85 - 94)	Excellent (95 - 100)	Not Rated		
See Appendix for definitions and formulas						
Inspection Date: 7/31/2015	Beginning Section MP	15	16	17		
Paved Length (Miles): 17.43	Section Length (MI)	1	1	0.43		
Surface Type: ASPHALT	Route Summary					
Roadway Condition Information						
Pavement Condition Rating (PCR)	95	98	94	92		
Surface Condition Rating (SCR)	94	96	92	92		
Roughness Condition Index (RCI)	97	100	96	91		
Distress Index Values						
Structural Crack Index	100	100	100	100		
Alligator Crack Index	100	100	100	100		
Longitudinal Crack Index	100	100	100	100		
Transverse Cracking Index	98	100	100	100		
Patching Index	100	100	100	100		
Rutting Index	94	96	92	92		
International Roughness Index (IRI)	123	109	124	138		
Lane & Width Information						
Number of Lanes	2	2	2	2		
Paved Width (ft)	27	26.7	26.9	27.1

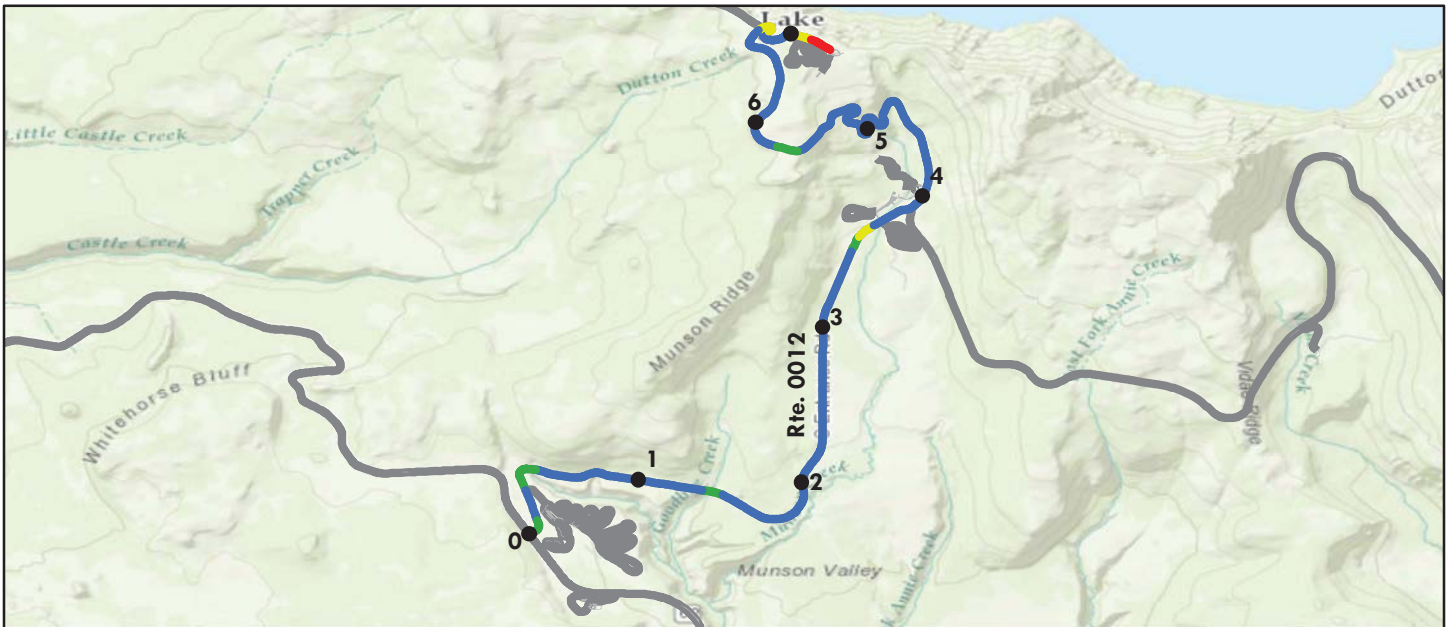
ROUTE 0012: MUNSON VALLEY ROAD

Route Condition Legend – Pavement Condition Rating (PCR)						
Poor (0 - 60)	Fair (61- 84)	Good (85 - 94)	Excellent (95 - 100)	Not Rated		
See Appendix for definitions and formulas						
Inspection Date: 7/31/2015	Beginning Section MP	0	1	2	3	4
Paved Length (Miles): 7.21	Section Length (MI)	1	1	1	1	1
Surface Type: ASPHALT	Route Summary					
Roadway Condition Information						
Pavement Condition Rating (PCR)	97	96	99	99	97	99
Surface Condition Rating (SCR)	98	98	99	98	97	99
Roughness Condition Index (RCI)	96	94	99	100	96	100
Distress Index Values						
Structural Crack Index	99	100	100	100	100	100
Alligator Crack Index	100	100	100	100	100	100
Longitudinal Crack Index	99	100	100	100	100	100
Transverse Cracking Index	99	100	100	100	100	100
Patching Index	100	100	100	100	100	100
Rutting Index	98	98	99	98	97	99
International Roughness Index (IRI)	124	130	117	102	126	115
Lane & Width Information						
Number of Lanes	2	2	2	2	2	2

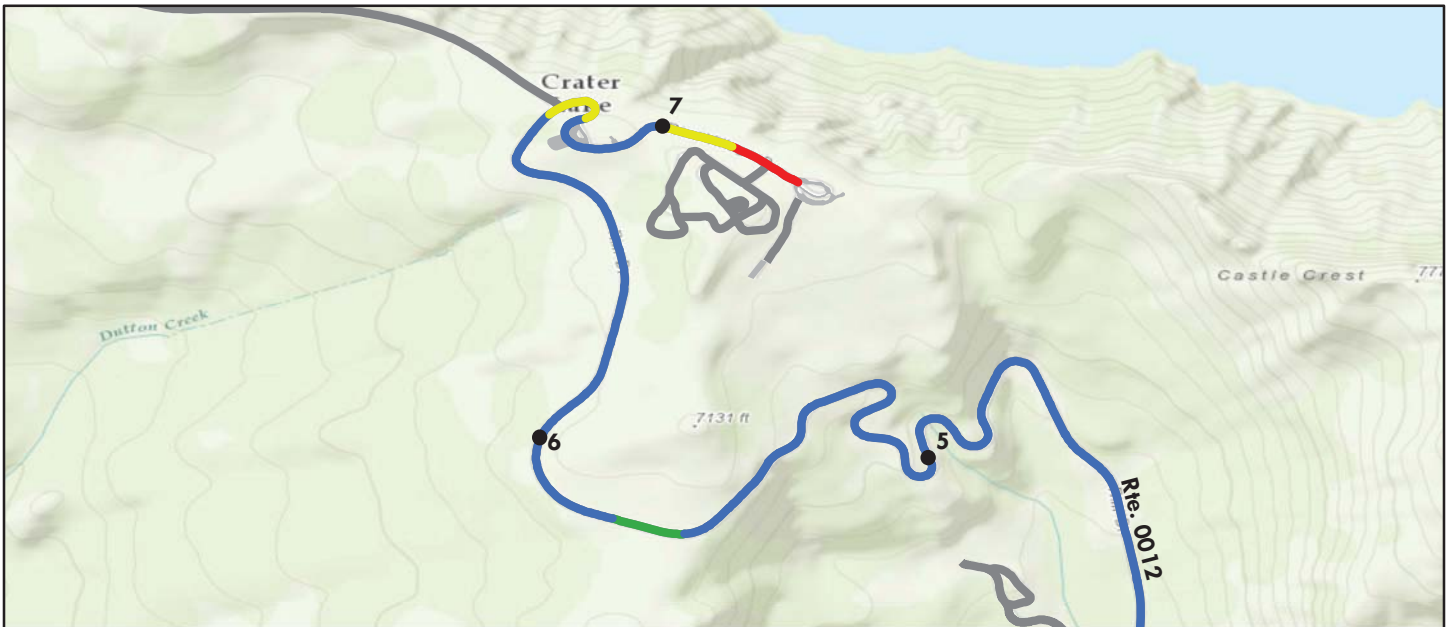
ROUTE 0012: MUNSON VALLEY ROAD

Route Condition Legend – Pavement Condition Rating (PCR)						
Poor (0 - 60)	Fair (61- 84)	Good (85 - 94)	Excellent (95 - 100)	Not Rated		
See Appendix for definitions and formulas						
Inspection Date: 7/31/2015	Beginning Section MP	5	6	7		
Paved Length (Miles): 7.21	Section Length (MI)	1	1	0.21		
Surface Type: ASPHALT	Route Summary					
Roadway Condition Information						
Pavement Condition Rating (PCR)	97	98	96	56		
Surface Condition Rating (SCR)	98	98	98	56		
Roughness Condition Index (RCI)	96	98	92	N/A		
Distress Index Values						
Structural Crack Index	99	100	100	56		
Alligator Crack Index	100	100	100	98		
Longitudinal Crack Index	99	100	100	58		
Transverse Cracking Index	99	99	100	71		
Patching Index	100	100	100	92		
Rutting Index	98	98	98	83		
International Roughness Index (IRI)	124	121	136	N/A		
Lane & Width Information						
Number of Lanes	2	2	2	2		
Paved Width (ft)	27.5	26.8	27.6	28.1		
Lane Width (ft)	10.9	10.4	11.1	11.2

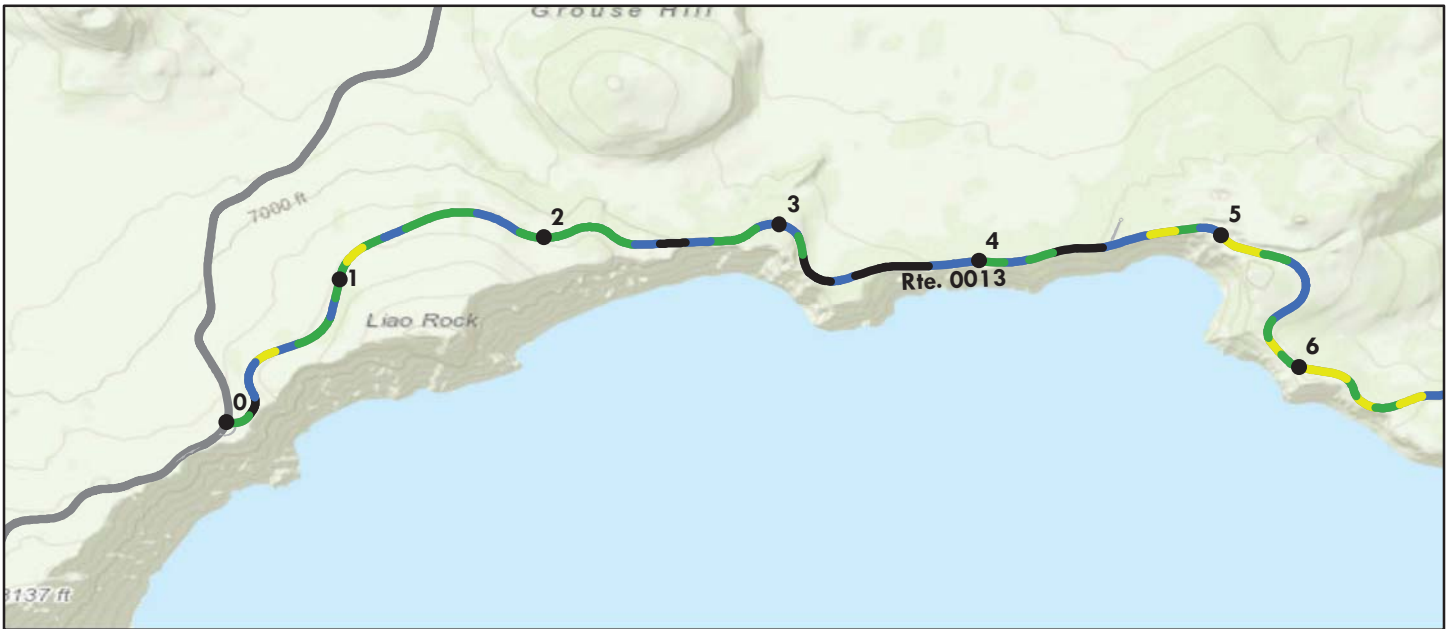
ROUTE 0013: EAST RIM DRIVE

Route Condition Legend – Pavement Condition Rating (PCR)						
Poor (0 - 60)	Fair (61- 84)	Good (85 - 94)	Excellent (95 - 100)	Not Rated		
See Appendix for definitions and formulas						
Inspection Date: 7/30/2015	Beginning Section MP	0	1	2	3	4
Paved Length (Miles): 23.19	Section Length (MI)	1	1	1	1	1
Surface Type: ASPHALT	Route Summary					
Roadway Condition Information						
Pavement Condition Rating (PCR)	87	92	92	92	98	92
Surface Condition Rating (SCR)	95	98	98	98	98	96
Roughness Condition Index (RCI)	76	83	83	83	N/A	86
Distress Index Values						
Structural Crack Index	97	99	99	100	100	99
Alligator Crack Index	100	100	100	100	100	100
Longitudinal Crack Index	97	99	99	100	100	99
Transverse Cracking Index	97	99	100	100	100	96
Patching Index	99	100	100	100	100	100
Rutting Index	95	98	98	98	98	98
International Roughness Index (IRI)	181	159	161	161	N/A	150
Lane & Width Information						
Number of Lanes	2	2	2	2	2	2

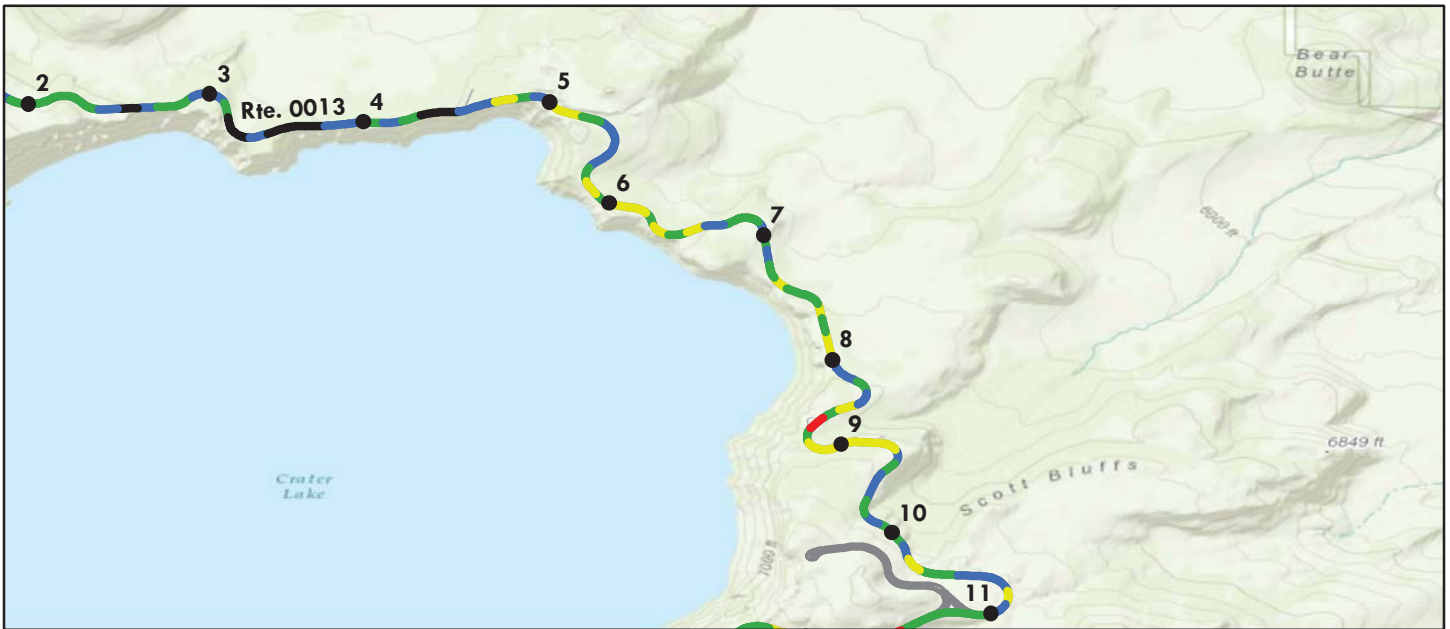
ROUTE 0013: EAST RIM DRIVE

Route Condition Legend – Pavement Condition Rating (PCR)						
Poor (0 - 60)	Fair (61- 84)	Good (85 - 94)	Excellent (95 - 100)	Not Rated		
See Appendix for definitions and formulas						
Inspection Date: 7/30/2015	Beginning Section MP	5	6	7	8	9
Paved Length (Miles): 23.19	Section Length (MI)	1	1	1	1	1
Surface Type: ASPHALT	Route Summary					
Roadway Condition Information						
Pavement Condition Rating (PCR)	87	90	87	88	85	91
Surface Condition Rating (SCR)	95	97	95	94	93	97
Roughness Condition Index (RCI)	76	80	75	78	73	83
Distress Index Values						
Structural Crack Index	97	100	98	97	98	97
Alligator Crack Index	100	100	100	100	100	100
Longitudinal Crack Index	97	100	98	97	98	97
Transverse Cracking Index	97	98	95	96	93	100
Patching Index	99	99	99	99	100	100
Rutting Index	95	97	96	94	94	97
International Roughness Index (IRI)	181	170	185	176	190	161
Lane & Width Information						
Number of Lanes	2	2	2	2	2	2
Paved Width (ft)	21.1	20.6	21.2	21.2	21.1	20.2

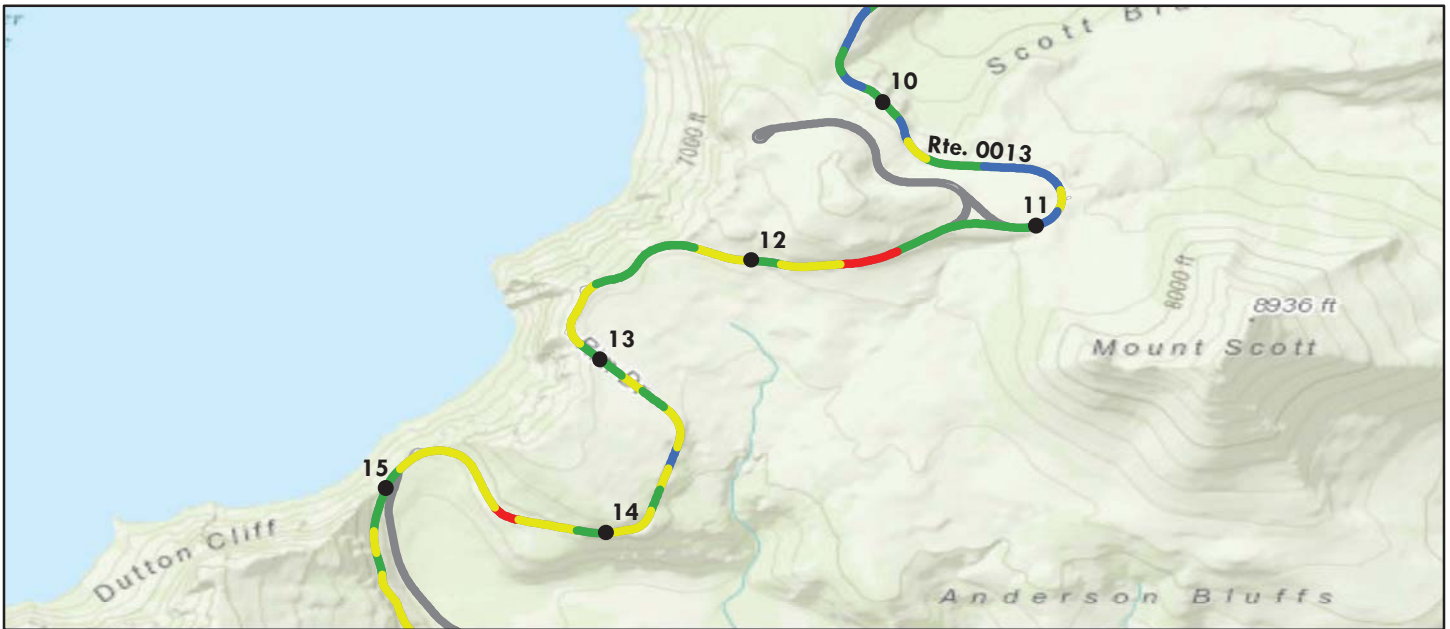
ROUTE 0013: EAST RIM DRIVE

Route Condition Legend – Pavement Condition Rating (PCR)						
Poor (0 - 60)	Fair (61- 84)	Good (85 - 94)	Excellent (95 - 100)	Not Rated		
See Appendix for definitions and formulas						
Inspection Date: 7/30/2015	Beginning Section MP	10	11	12	13	14
Paved Length (Miles): 23.19	Section Length (MI)	1	1	1	1	1
Surface Type: ASPHALT	Route Summary					
Roadway Condition Information						
Pavement Condition Rating (PCR)	87	93	80	85	82	75
Surface Condition Rating (SCR)	95	96	89	93	92	92
Roughness Condition Index (RCI)	76	89	66	72	68	50
Distress Index Values						
Structural Crack Index	97	98	94	93	93	92
Alligator Crack Index	100	100	98	100	100	100
Longitudinal Crack Index	97	98	96	93	93	92
Transverse Cracking Index	97	99	96	93	96	97
Patching Index	99	100	100	100	99	100
Rutting Index	95	96	89	94	92	93
International Roughness Index (IRI)	181	144	216	195	210	283
Lane & Width Information						
Number of Lanes	2	2	2	2	2	2

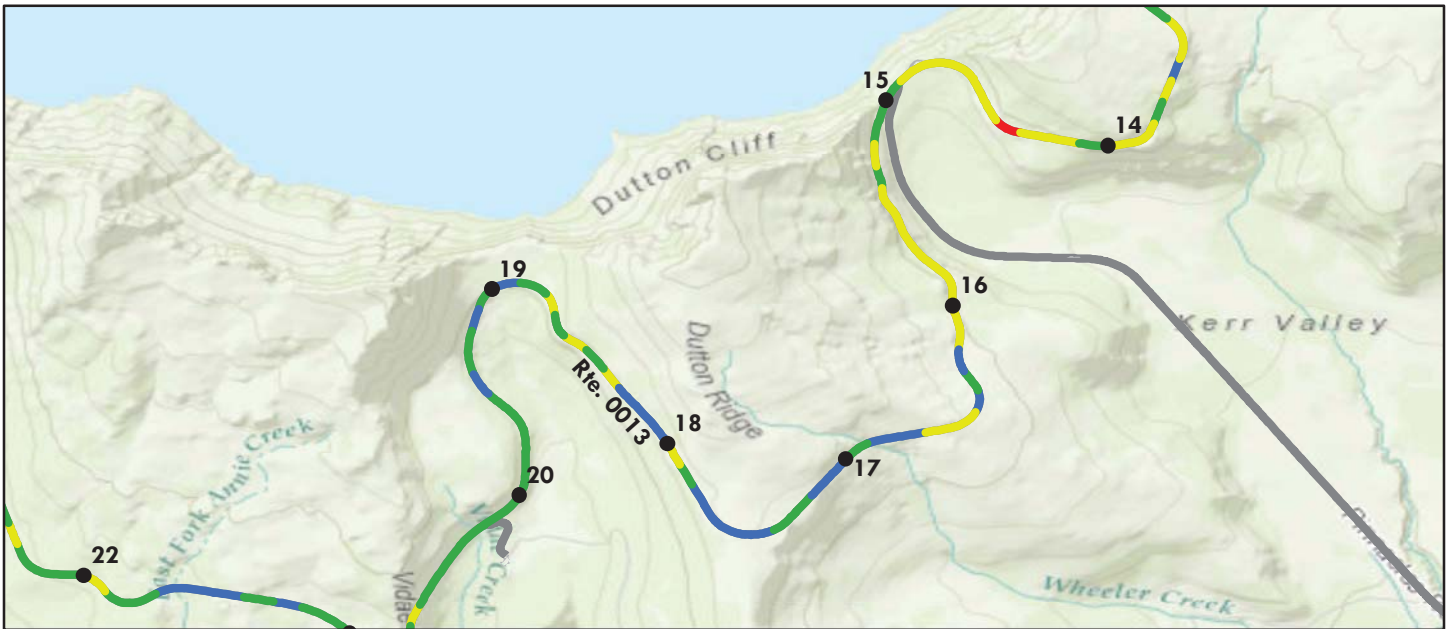
ROUTE 0013: EAST RIM DRIVE

Route Condition Legend – Pavement Condition Rating (PCR)						
Poor (0 - 60)	Fair (61- 84)	Good (85 - 94)	Excellent (95 - 100)	Not Rated		
See Appendix for definitions and formulas						
Inspection Date: 7/30/2015	Beginning Section MP	15	16	17	18	19
Paved Length (Miles): 23.19	Section Length (MI)	1	1	1	1	1
Surface Type: ASPHALT	Route Summary					
Roadway Condition Information						
Pavement Condition Rating (PCR)	87	82	89	93	90	92
Surface Condition Rating (SCR)	95	97	95	97	96	97
Roughness Condition Index (RCI)	76	59	80	88	80	84
Distress Index Values						
Structural Crack Index	97	99	99	97	98	98
Alligator Crack Index	100	100	100	100	100	100
Longitudinal Crack Index	97	99	99	97	98	98
Transverse Cracking Index	97	99	99	97	99	99
Patching Index	99	97	100	100	99	100
Rutting Index	95	97	95	98	96	97
International Roughness Index (IRI)	181	245	170	147	170	158
Lane & Width Information						
Number of Lanes	2	2	2	2	2	2

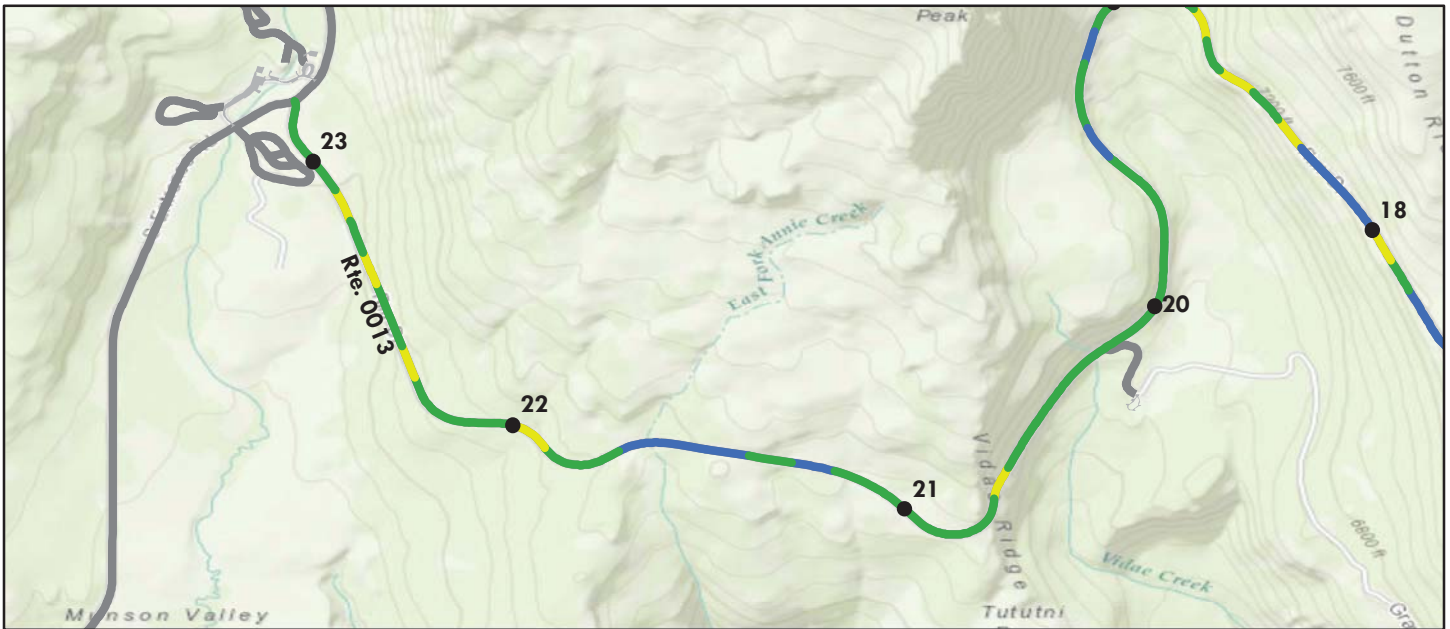
ROUTE 0013: EAST RIM DRIVE

Route Condition Legend – Pavement Condition Rating (PCR)						
Poor (0 - 60)	Fair (61- 84)	Good (85 - 94)	Excellent (95 - 100)	Not Rated		
See Appendix for definitions and formulas						
Inspection Date: 7/30/2015	Beginning Section MP	20	21	22	23	
Paved Length (Miles): 23.19	Section Length (MI)	1	1	1	0.19	
Surface Type: ASPHALT	Route Summary					
Roadway Condition Information						
Pavement Condition Rating (PCR)	87	88	92	84	93	
Surface Condition Rating (SCR)	95	94	94	97	91	
Roughness Condition Index (RCI)	76	79	88	64	95	
Distress Index Values						
Structural Crack Index	97	94	94	98	94	
Alligator Crack Index	100	100	100	100	100	
Longitudinal Crack Index	97	94	94	98	94	
Transverse Cracking Index	97	96	96	99	91	
Patching Index	99	100	100	98	100	
Rutting Index	95	97	97	97	97	
International Roughness Index (IRI)	181	173	146	222	128	
Lane & Width Information						
Number of Lanes	2	2	2	2	2	
Paved Width (ft)	21.1	21.6	22.1	22	25.1

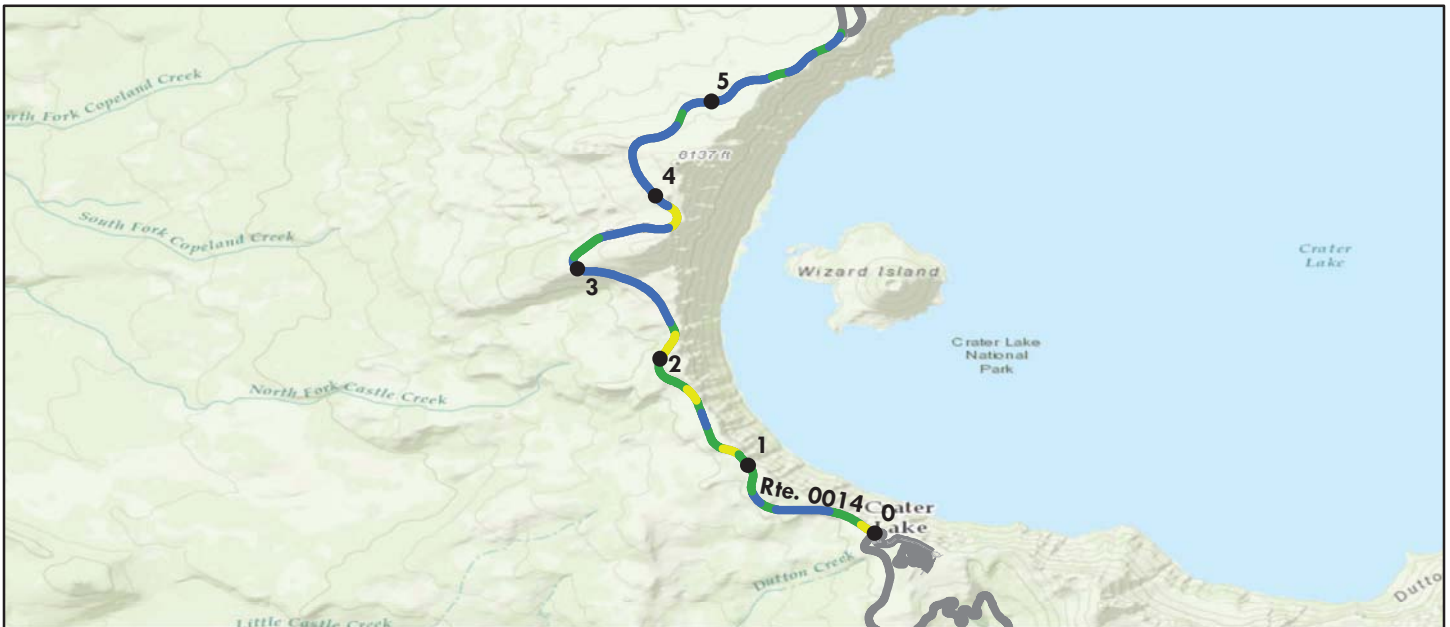
ROUTE 0014: WEST RIM DRIVE

Route Condition Legend – Pavement Condition Rating (PCR)						
Poor (0 - 60)	Fair (61- 84)	Good (85 - 94)	Excellent (95 - 100)	Not Rated		
See Appendix for definitions and formulas						
Inspection Date: 7/31/2015	Beginning Section MP	0	1	2	3	4
Paved Length (Miles): 5.92	Section Length (MI)	1	1	1	1	1
Surface Type: ASPHALT	Route Summary					
Roadway Condition Information						
Pavement Condition Rating (PCR)	94	91	87	94	94	99
Surface Condition Rating (SCR)	97	95	92	98	98	99
Roughness Condition Index (RCI)	89	85	80	88	88	100
Distress Index Values						
Structural Crack Index	99	99	98	99	100	100
Alligator Crack Index	100	100	100	100	100	100
Longitudinal Crack Index	99	99	98	99	100	100
Transverse Cracking Index	97	95	92	99	98	100
Patching Index	100	100	100	100	100	100
Rutting Index	99	99	98	98	99	99
International Roughness Index (IRI)	142	155	170	146	147	106
Lane & Width Information						
Number of Lanes	2	2	2	2	2	2

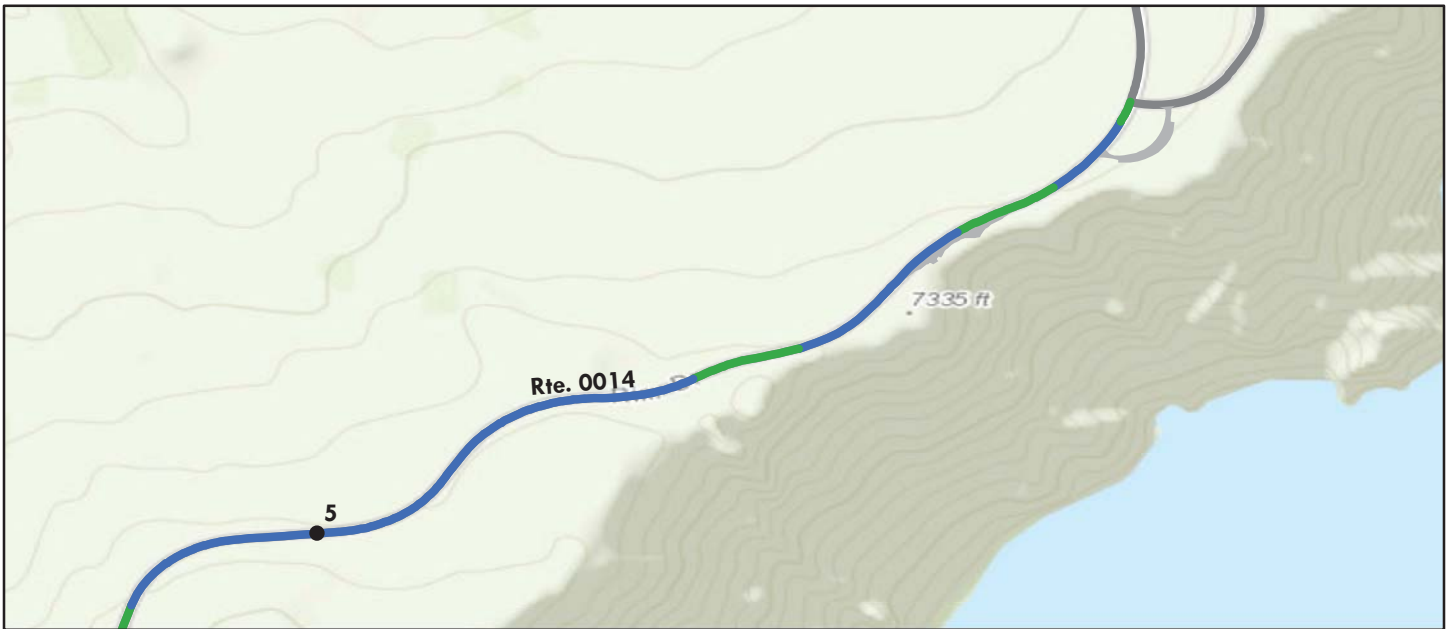
ROUTE 0014: WEST RIM DRIVE

Route Condition Legend – Pavement Condition Rating (PCR)						
Poor (0 - 60)	Fair (61- 84)	Good (85 - 94)	Excellent (95 - 100)	Not Rated		
See Appendix for definitions and formulas						
Inspection Date: 7/31/2015	Beginning Section MP	5				
Paved Length (Miles): 5.92	Section Length (MI)	0.92				
Surface Type: ASPHALT	Route Summary					
Roadway Condition Information						
Pavement Condition Rating (PCR)	94	97				
Surface Condition Rating (SCR)	97	99				
Roughness Condition Index (RCI)	89	94				
Distress Index Values						
Structural Crack Index	99	100				
Alligator Crack Index	100	100				
Longitudinal Crack Index	99	100				
Transverse Cracking Index	97	100				
Patching Index	100	100				
Rutting Index	99	99				
International Roughness Index (IRI)	142	129				
Lane & Width Information						
Number of Lanes	2	2				
Paved Width (ft)	25.2	27.2				
Lane Width (ft)	10	10.5

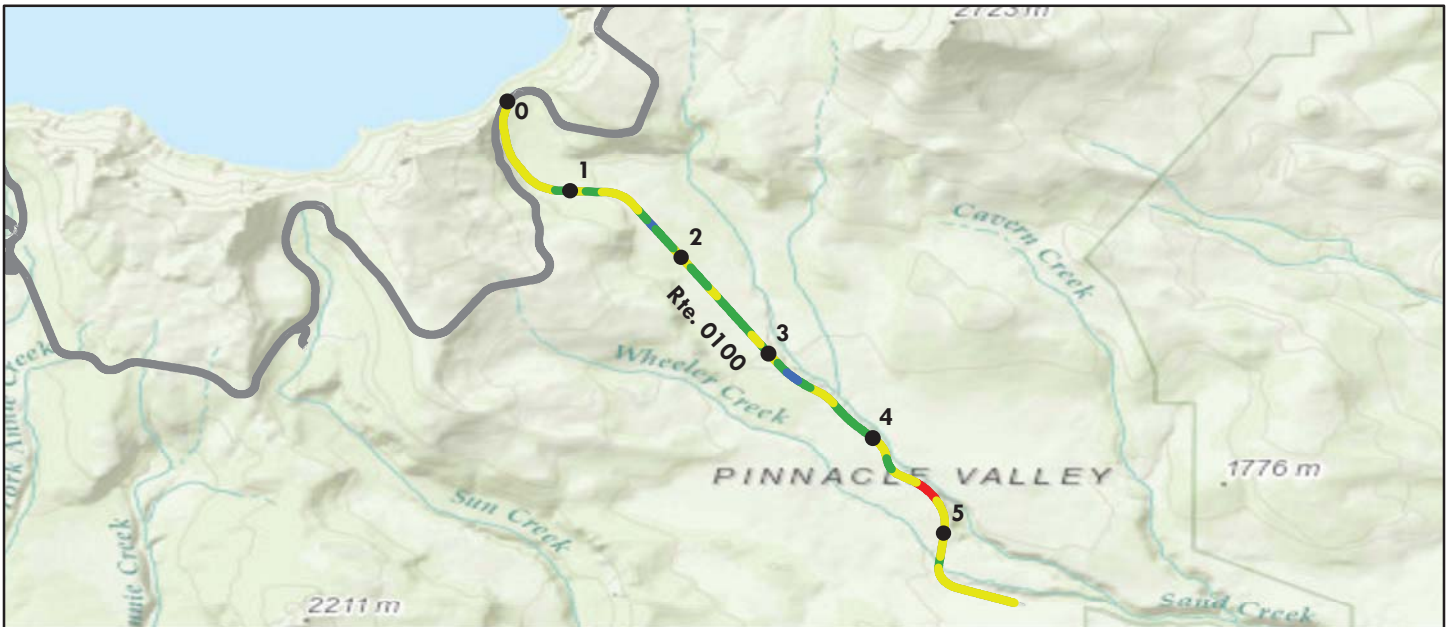
ROUTE 0100: PINNACLES ROAD

Route Condition Legend – Pavement Condition Rating (PCR)						
Poor (0 - 60)	Fair (61- 84)	Good (85 - 94)	Excellent (95 - 100)	Not Rated		
See Appendix for definitions and formulas						
Inspection Date: 7/30/2015	Beginning Section MP	0	1	2	3	4
Paved Length (Miles): 5.92	Section Length (MI)	1	1	1	1	1
Surface Type: ASPHALT	Route Summary					
Roadway Condition Information						
Pavement Condition Rating (PCR)	80	75	83	87	88	74
Surface Condition Rating (SCR)	96	98	97	97	95	94
Roughness Condition Index (RCI)	56	40	62	73	78	44
Distress Index Values						
Structural Crack Index	97	98	99	99	98	94
Alligator Crack Index	100	100	100	100	100	100
Longitudinal Crack Index	97	98	99	99	98	94
Transverse Cracking Index	97	98	97	97	95	96
Patching Index	100	100	100	100	100	100
Rutting Index	96	98	98	99	99	94
International Roughness Index (IRI)	257	338	232	192	176	314
Lane & Width Information						
Number of Lanes	2	2	2	2	2	2
Paved Width (ft)	18.3	18.4	18.6	18.8	18.3	18

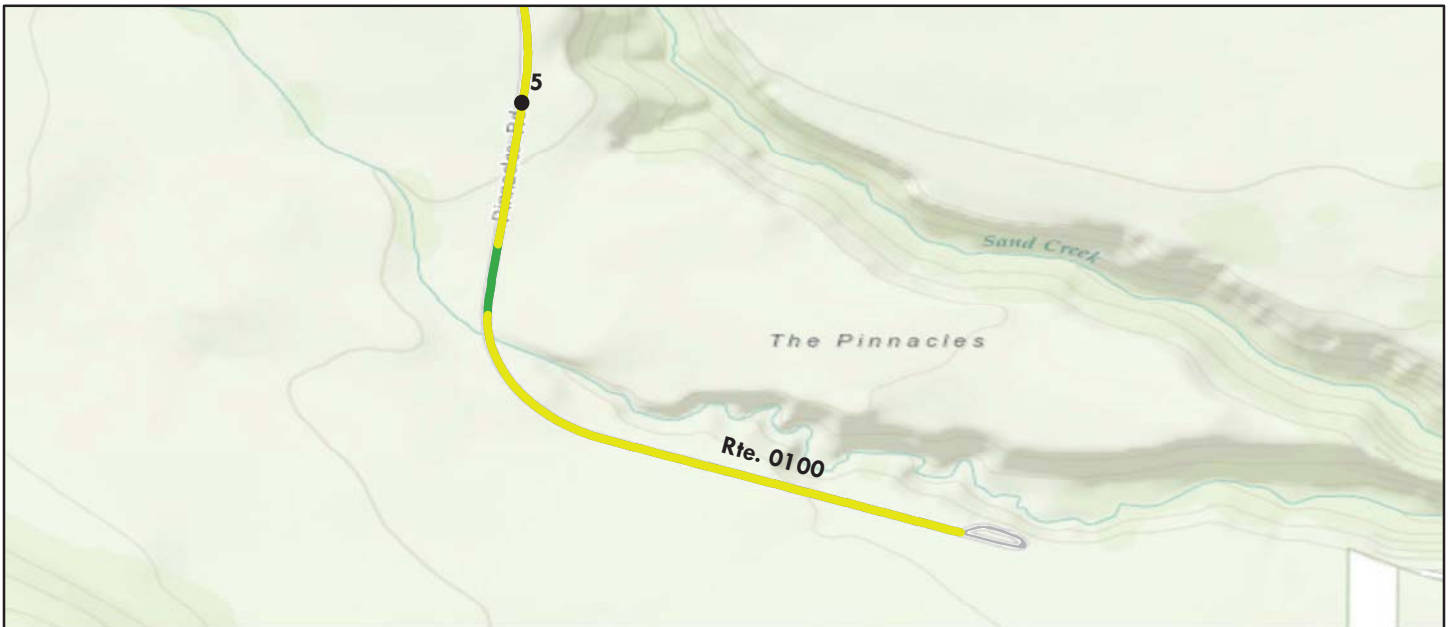
ROUTE 0100: PINNACLES ROAD

Route Condition Legend – Pavement Condition Rating (PCR)						
Poor (0 - 60)	Fair (61- 84)	Good (85 - 94)	Excellent (95 - 100)	Not Rated		
See Appendix for definitions and formulas						
Inspection Date: 7/30/2015	Beginning Section MP	5				
Paved Length (Miles): 5.92	Section Length (MI)	0.92				
Surface Type: ASPHALT	Route Summary					
Roadway Condition Information						
Pavement Condition Rating (PCR)	80	73				
Surface Condition Rating (SCR)	96	91				
Roughness Condition Index (RCI)	56	47				
Distress Index Values						
Structural Crack Index	97	93				
Alligator Crack Index	100	100				
Longitudinal Crack Index	97	93				
Transverse Cracking Index	97	100				
Patching Index	100	100				
Rutting Index	96	91				
International Roughness Index (IRI)	257	297				
Lane & Width Information						
Number of Lanes	2	2				
Paved Width (ft)	18.3	17.9				
Lane Width (ft)	8	7.5

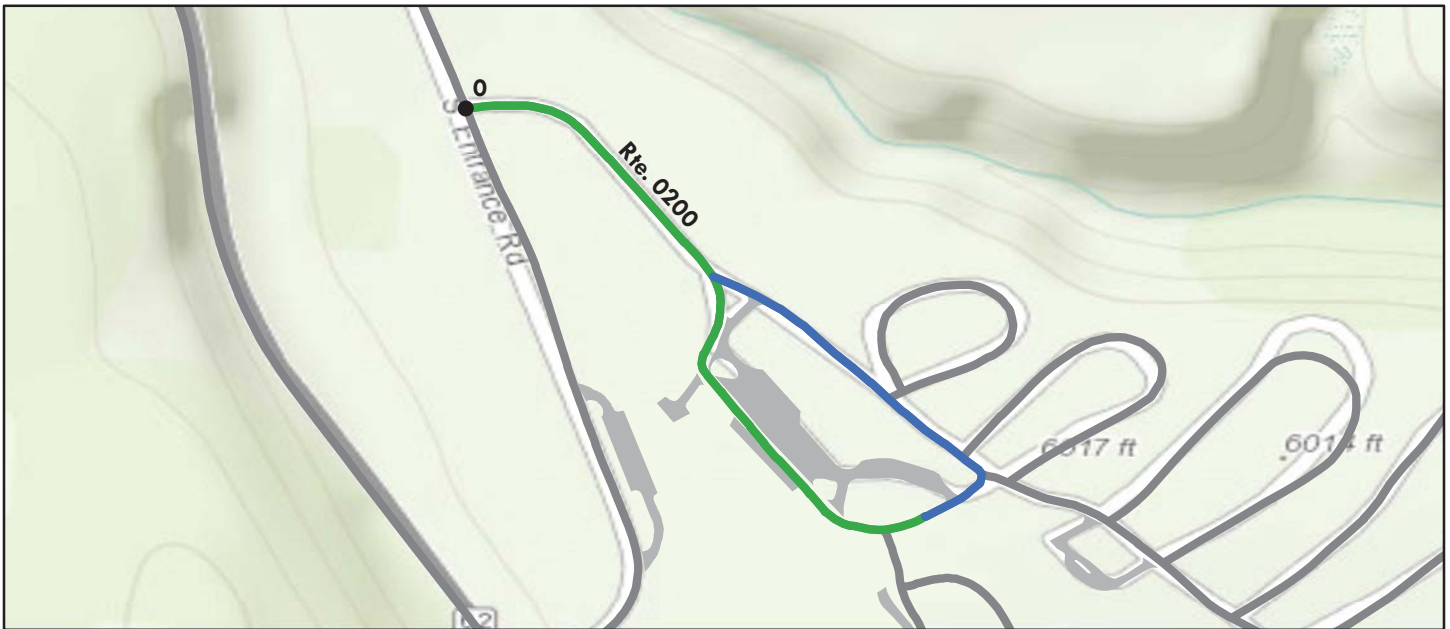
ROUTE 0200: MAZAMA VILLAGE ENTRANCE ROAD

Route Condition Legend – Pavement Condition Rating (PCR)						
Poor (0 - 60)	Fair (61- 84)	Good (85 - 94)	Excellent (95 - 100)	Not Rated		
See Appendix for definitions and formulas						
Inspection Date: 7/31/2015	Beginning Section MP	0				
Paved Length (Miles): 0.46	Section Length (MI)	0.46				
Surface Type: ASPHALT	Route Summary					
Roadway Condition Information						
Pavement Condition Rating (PCR)	95	95				
Surface Condition Rating (SCR)	95	95				
Roughness Condition Index (RCI)	N/A	N/A				
Distress Index Values						
Structural Crack Index	100	100				
Alligator Crack Index	100	100				
Longitudinal Crack Index	100	100				
Transverse Cracking Index	97	97				
Patching Index	99	99				
Rutting Index	95	95				
International Roughness Index (IRI)	N/A	N/A				
Lane & Width Information						
Number of Lanes	2	2				
Paved Width (ft)	22	22				
Lane Width (ft)	12.4	12.4

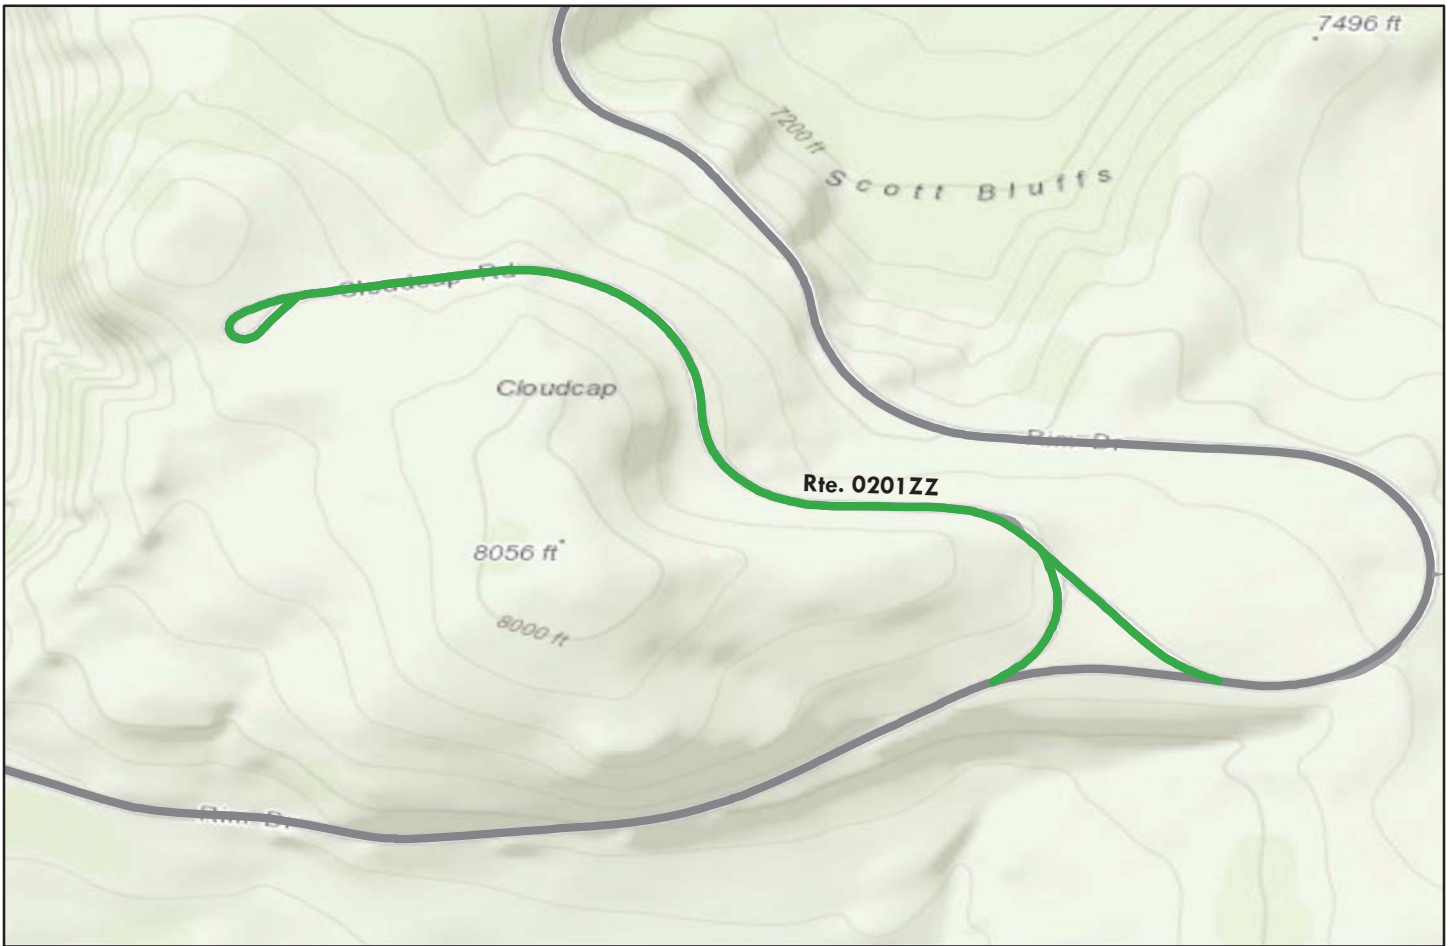
ROUTE 0201ZZ: CLOUDCAP VIEWPOINT ROADS

Route Condition Legend – Pavement Condition Rating (PCR)						
Poor (0 - 60)	Fair (61- 84)	Good (85 - 94)	Excellent (95 - 100)	Not Rated		
See Appendix for definitions and formulas						
Inspection Date:	7/30/2015					
Paved Length (Miles):	1.33					
Surface Type:	ASPHALT	Route Summary				
Roadway Condition Information						
Pavement Condition Rating (PCR)	90					
Lane & Width Information						
Number of Lanes	2					
Paved Width (ft)	20.9					
Lane Width (ft)	9.4
