CRLA Cycle 6

Final Report

Road Inventory and Condition Assessment of Paved Routes Crater Lake National Park

Report Date: February 2016

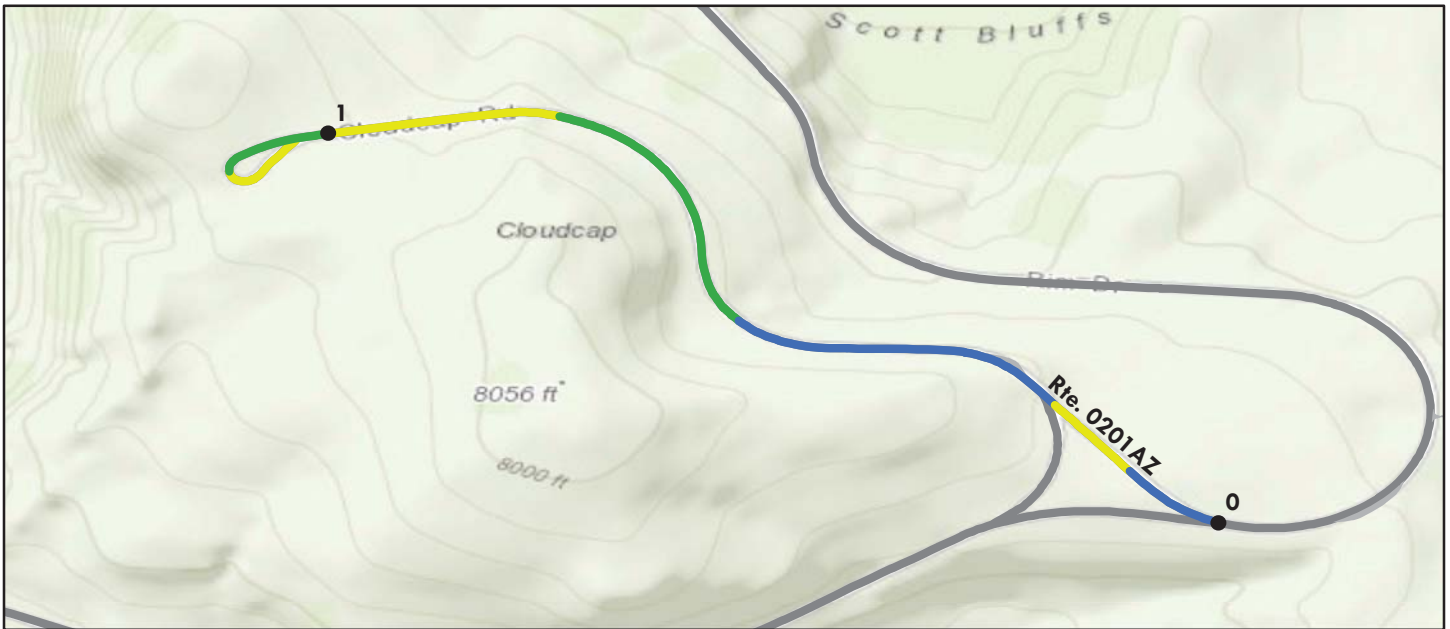
ROUTE 0201AZ: CLOUDCAP VIEWPOINT ROAD

Route Condition Legend – Pavement Condition Rating (PCR)						
Poor (0 - 60)	Fair (61- 84)	Good (85 - 94)	Excellent (95 - 100)	Not Rated		
See Appendix for definitions and formulas						
Inspection Date: 7/30/2015	Beginning Section MP	0	1			
Paved Length (Miles): 1.17	Section Length (MI)	1	0.17			
Surface Type: ASPHALT	Route Summary					
Roadway Condition Information						
Pavement Condition Rating (PCR)	89	90	85			
Surface Condition Rating (SCR)	94	94	95			
Roughness Condition Index (RCI)	82	84	71			
Distress Index Values						
Structural Crack Index	100	100	99			
Alligator Crack Index	100	100	100			
Longitudinal Crack Index	100	100	99			
Transverse Cracking Index	99	99	99			
Patching Index	100	100	100			
Rutting Index	94	94	95			
International Roughness Index (IRI)	162	158	200			
Lane & Width Information						
Number of Lanes	2	2	2			
Paved Width (ft)	20.9	20.7	22.5			
Lane Width (ft)	9.9	9.6	11.2

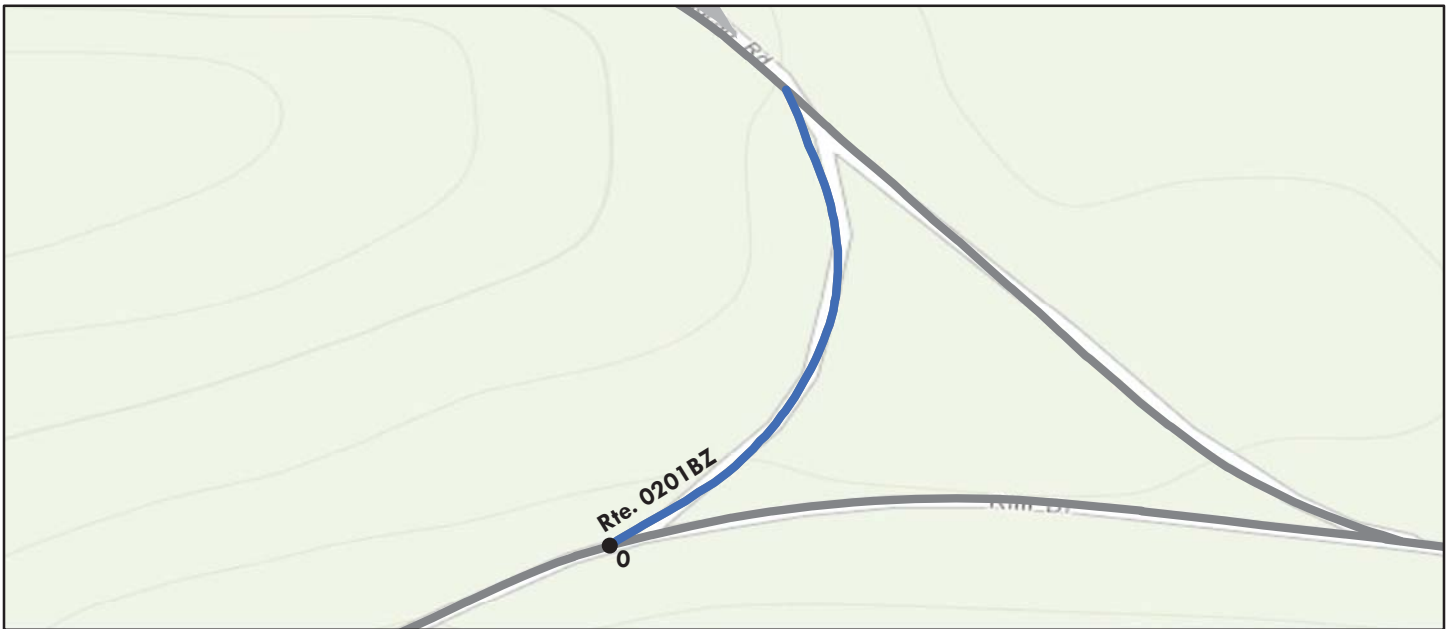
ROUTE 0201BZ: CLOUDCAP VIEWPOINT ROAD SPUR

Route Condition Legend – Pavement Condition Rating (PCR)						
Poor (0 - 60)	Fair (61- 84)	Good (85 - 94)	Excellent (95 - 100)	Not Rated		
See Appendix for definitions and formulas						
Inspection Date: 7/30/2015	Beginning Section MP	0				
Paved Length (Miles): 0.16	Section Length (MI)	0.16				
Surface Type: ASPHALT	Route Summary					
Roadway Condition Information						
Pavement Condition Rating (PCR)	96	96				
Surface Condition Rating (SCR)	96	96				
Roughness Condition Index (RCI)	N/A	N/A				
Distress Index Values						
Structural Crack Index	100	100				
Alligator Crack Index	100	100				
Longitudinal Crack Index	100	100				
Transverse Cracking Index	100	100				
Patching Index	100	100				
Rutting Index	96	96				
International Roughness Index (IRI)	N/A	N/A				
Lane & Width Information						
Number of Lanes	2	2				
Paved Width (ft)	20.9	20.9				
Lane Width (ft)	5.8	5.8

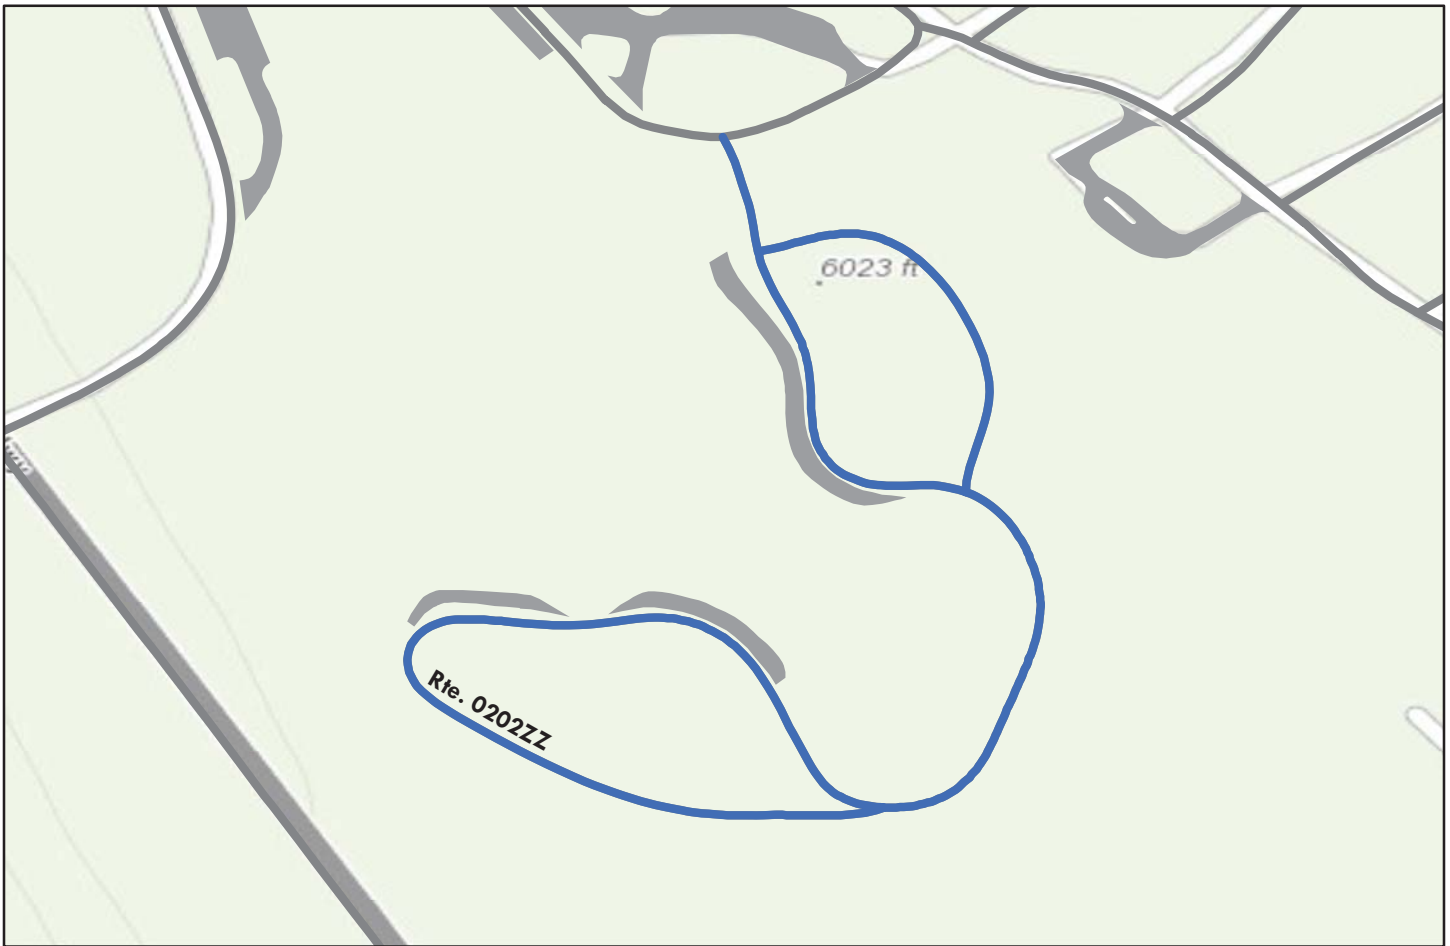
ROUTE 0202ZZ: MAZAMA MOTOR LODGE ROADS

Route Condition Legend – Pavement Condition Rating (PCR)						
Poor (0 - 60)	Fair (61- 84)	Good (85 - 94)	Excellent (95 - 100)	Not Rated		
See Appendix for definitions and formulas						
Inspection Date: 7/31/2015						
Paved Length (Miles): 0.5						
Surface Type: ASPHALT	Route Summary					
Roadway Condition Information						
Pavement Condition Rating (PCR)	95					
Lane & Width Information						
Number of Lanes	1					
Paved Width (ft)	12.7					
Lane Width (ft)	11.6

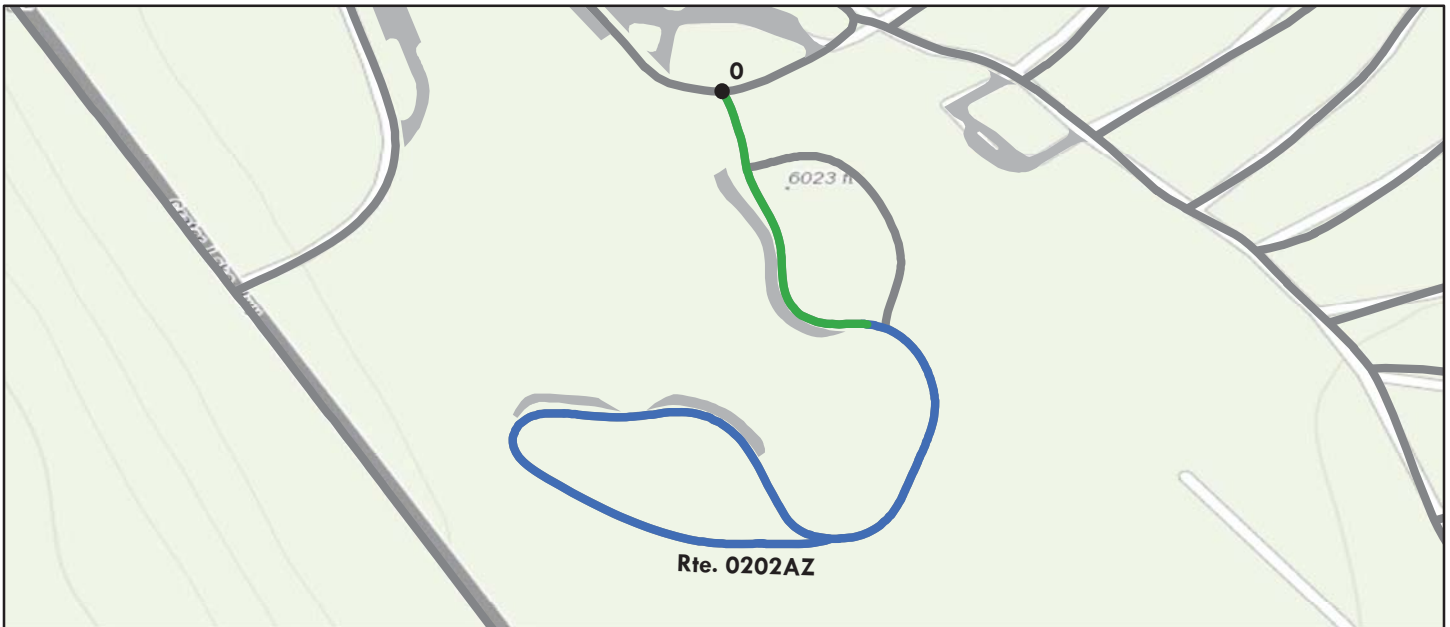
ROUTE 0202AZ: MAZAMA MOTOR LODGE LOOP ROAD

Route Condition Legend – Pavement Condition Rating (PCR)						
Poor (0 - 60)	Fair (61- 84)	Good (85 - 94)	Excellent (95 - 100)	Not Rated		
See Appendix for definitions and formulas						
Inspection Date: 7/31/2015	Beginning Section MP	0				
Paved Length (Miles): 0.42	Section Length (MI)	0.41				
Surface Type: ASPHALT	Route Summary					
Roadway Condition Information						
Pavement Condition Rating (PCR)	95	95				
Surface Condition Rating (SCR)	95	95				
Roughness Condition Index (RCI)	N/A	N/A				
Distress Index Values						
Structural Crack Index	98	98				
Alligator Crack Index	100	100				
Longitudinal Crack Index	98	98				
Transverse Cracking Index	95	95				
Patching Index	100	100				
Rutting Index	98	98				
International Roughness Index (IRI)	N/A	N/A				
Lane & Width Information						
Number of Lanes	1	1				
Paved Width (ft)	13.3	13.3				
Lane Width (ft)	12	12

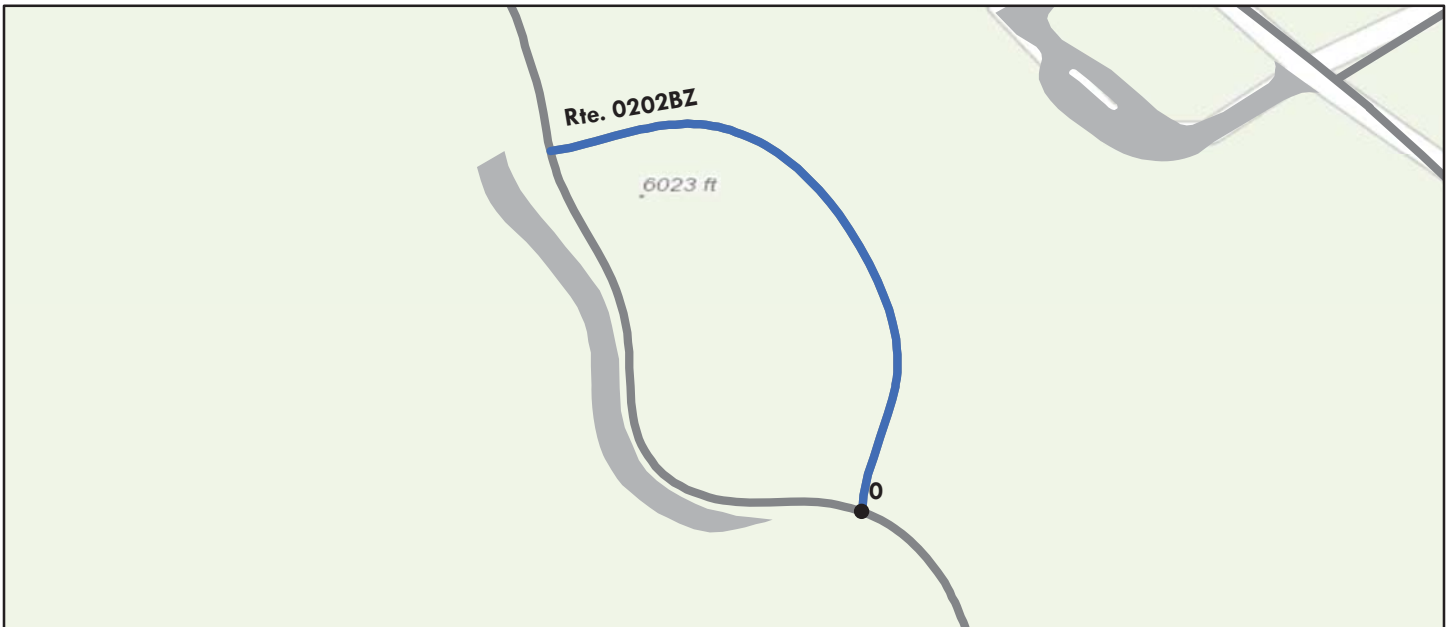
ROUTE 0202BZ: MAZAMA MOTOR LODGE ROAD

Route Condition Legend – Pavement Condition Rating (PCR)						
Poor (0 - 60)	Fair (61- 84)	Good (85 - 94)	Excellent (95 - 100)	Not Rated		
See Appendix for definitions and formulas						
Inspection Date: 7/31/2015	Beginning Section MP	0				
Paved Length (Miles): 0.09	Section Length (MI)	0.09				
Surface Type: ASPHALT	Route Summary					
Roadway Condition Information						
Pavement Condition Rating (PCR)	98	98				
Surface Condition Rating (SCR)	98	98				
Roughness Condition Index (RCI)	N/A	N/A				
Distress Index Values						
Structural Crack Index	100	100				
Alligator Crack Index	100	100				
Longitudinal Crack Index	100	100				
Transverse Cracking Index	98	98				
Patching Index	100	100				
Rutting Index	99	99				
International Roughness Index (IRI)	N/A	N/A				
Lane & Width Information						
Number of Lanes	1	1				
Paved Width (ft)	9.8	9.8				
Lane Width (ft)	9.8	9.8

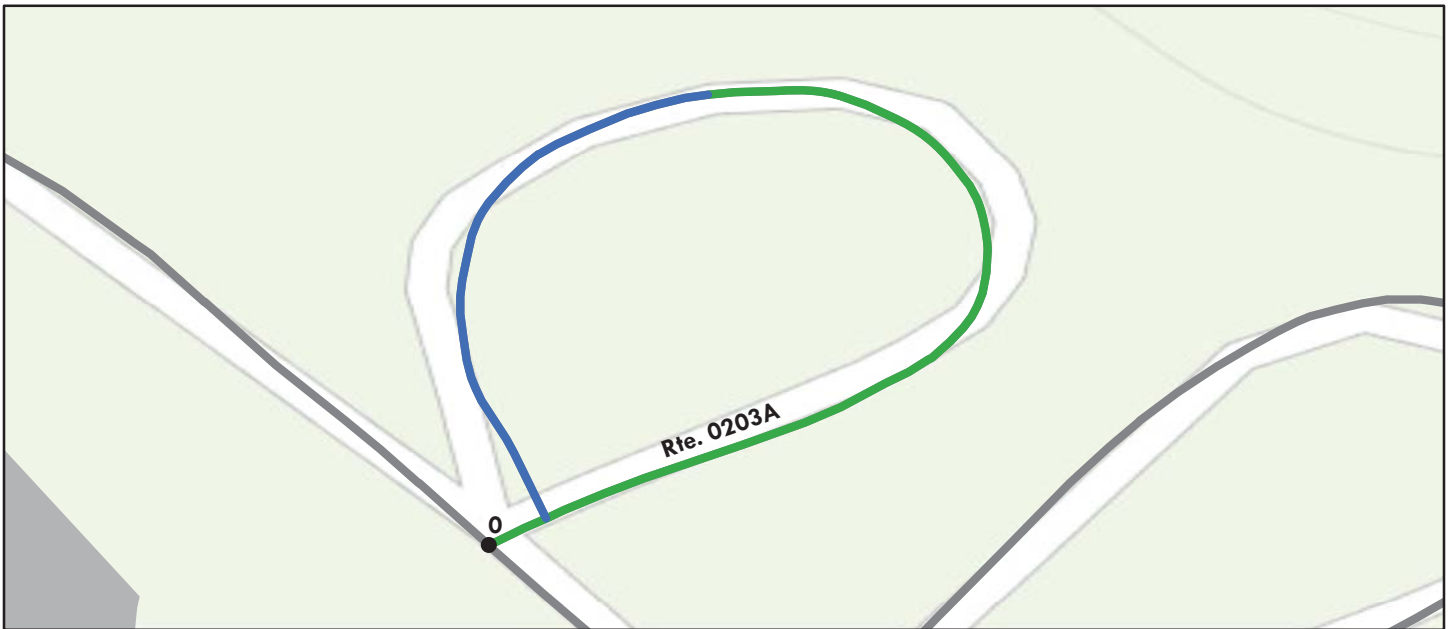
ROUTE 0203A: MAZAMA CAMPGROUND LOOPA

Route Condition Legend – Pavement Condition Rating (PCR)						
Poor (0 - 60)	Fair (61- 84)	Good (85 - 94)	Excellent (95 - 100)	Not Rated		
See Appendix for definitions and formulas						
Inspection Date: 7/31/2015	Beginning Section MP	0				
Paved Length (Miles): 0.16	Section Length (MI)	0.16				
Surface Type: ASPHALT	Route Summary					
Roadway Condition Information						
Pavement Condition Rating (PCR)	94	94				
Surface Condition Rating (SCR)	94	94				
Roughness Condition Index (RCI)	N/A	N/A				
Distress Index Values						
Structural Crack Index	100	100				
Alligator Crack Index	100	100				
Longitudinal Crack Index	100	100				
Transverse Cracking Index	100	100				
Patching Index	100	100				
Rutting Index	94	94				
International Roughness Index (IRI)	N/A	N/A				
Lane & Width Information						
Number of Lanes	1	1				
Paved Width (ft)	15.1	15.1				
Lane Width (ft)	15.1	15.1

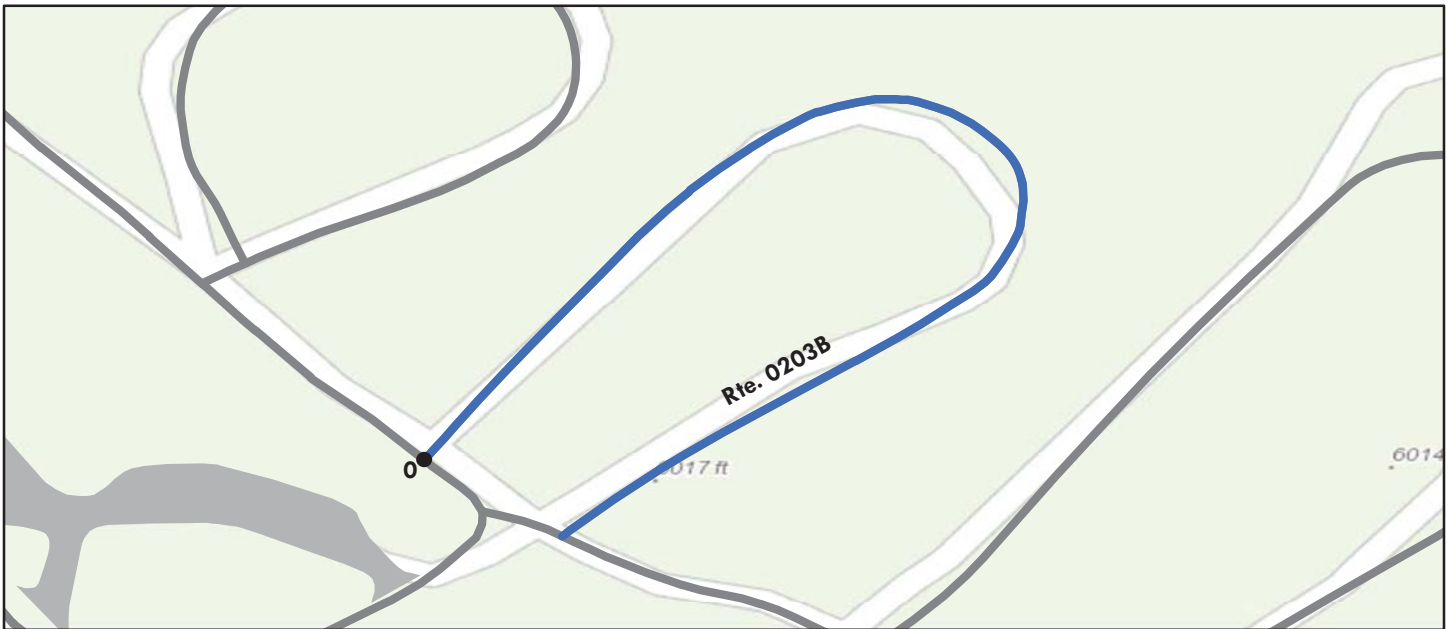
ROUTE 0203B: MAZAMA CAMPGROUND LOOP B

Route Condition Legend – Pavement Condition Rating (PCR)						
Poor (0 - 60)	Fair (61- 84)	Good (85 - 94)	Excellent (95 - 100)	Not Rated		
See Appendix for definitions and formulas						
Inspection Date: 7/31/2015	Beginning Section MP	0				
Paved Length (Miles): 0.18	Section Length (MI)	0.18				
Surface Type: ASPHALT	Route Summary					
Roadway Condition Information						
Pavement Condition Rating (PCR)	99	99				
Surface Condition Rating (SCR)	99	99				
Roughness Condition Index (RCI)	N/A	N/A				
Distress Index Values						
Structural Crack Index	100	100				
Alligator Crack Index	100	100				
Longitudinal Crack Index	100	100				
Transverse Cracking Index	100	100				
Patching Index	100	100				
Rutting Index	99	99				
International Roughness Index (IRI)	N/A	N/A				
Lane & Width Information						
Number of Lanes	1	1				
Paved Width (ft)	17.5	17.5				
Lane Width (ft)	17.5	17.5

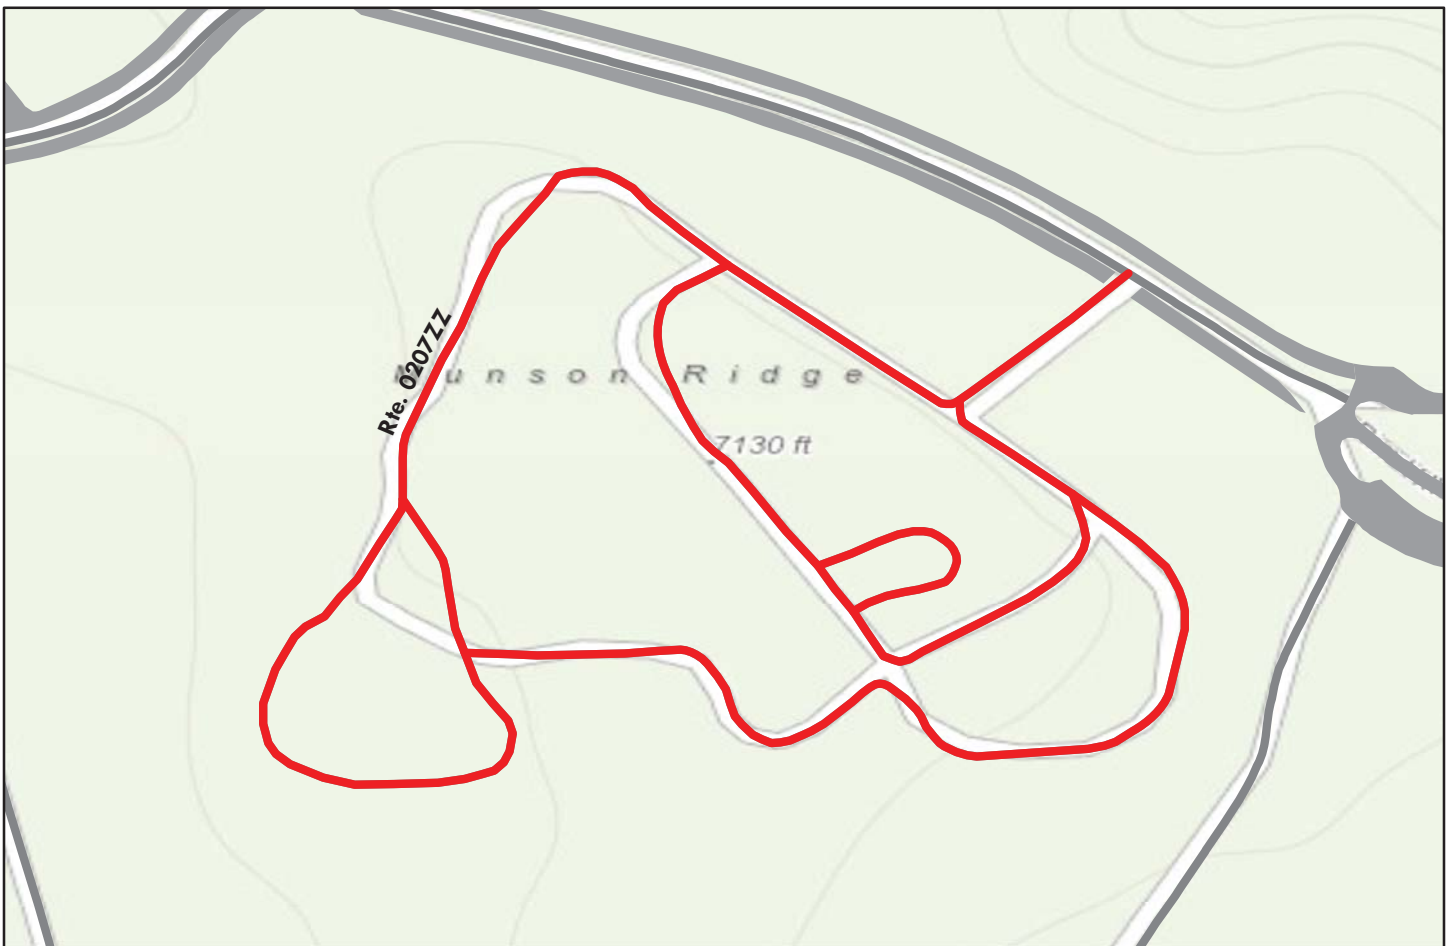
ROUTE 0207ZZ: PICNIC HILL LOOPS

Route was manually rated in cycle 6 due to the poor condition of the road

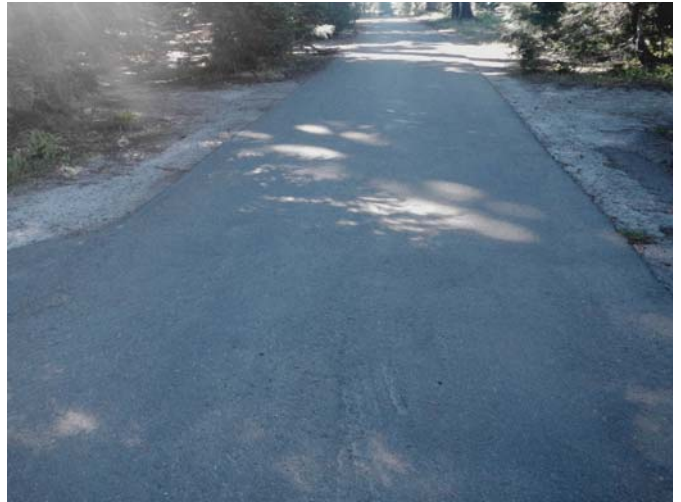
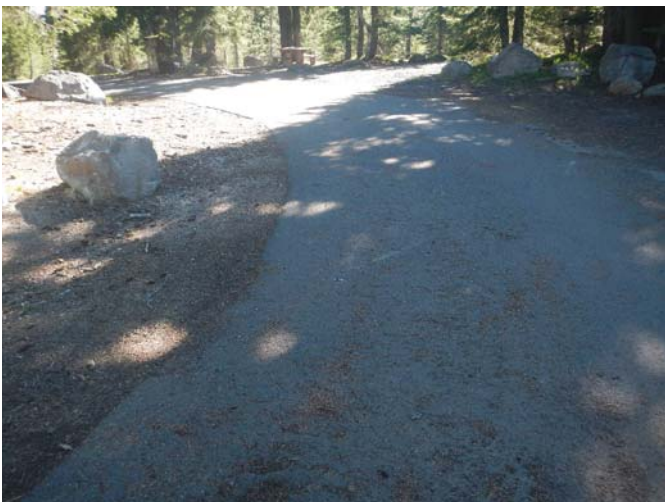
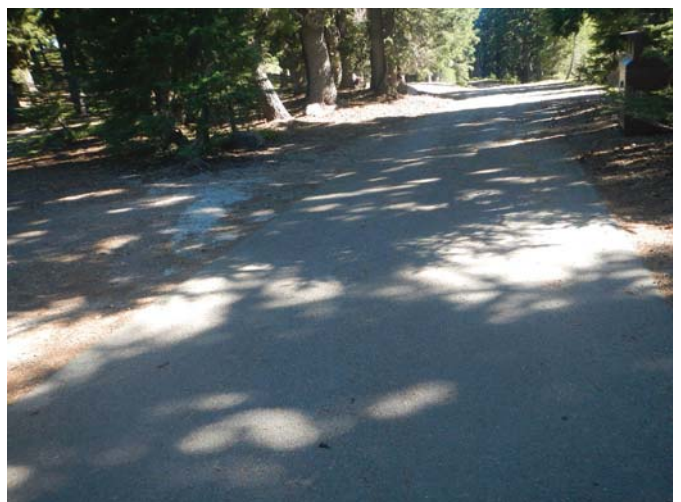
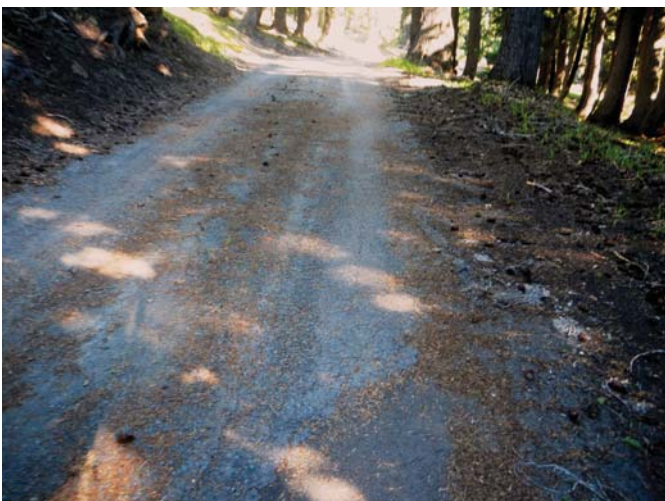
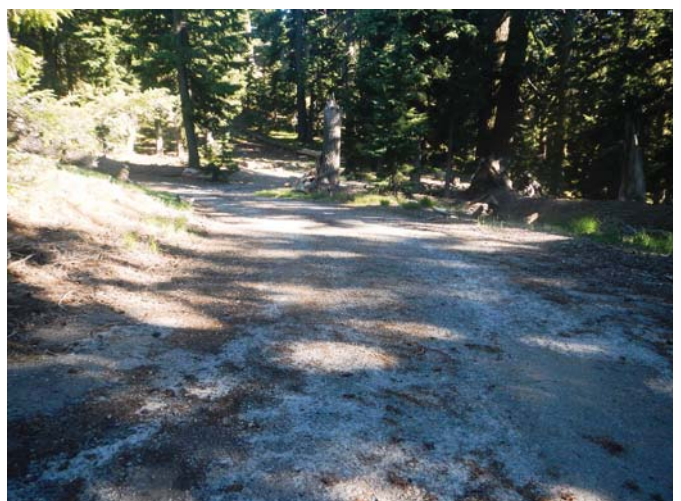
Inspection Date: 6/12/2015	Beginning Section MP	0.00				
Paved Length (Miles): 0.41	Section Length (MI)	0.41				
Surface Type: ASPHALT	Route Summary					
Roadway Condition Information						
Pavement Condition Rating (PCR)	73	73				
Surface Condition Rating (SCR)	73	73				
Roughness Condition Index (RCI)	N/A	N/A				
Distress Index Values						
Structural Crack Index	N/A	N/A				
Alligator Crack Index	73	73				
Longitudinal Crack Index	73	73				
Transverse Cracking Index	73	73				
Patching Index	97	97				
Rutting Index	73	73				
International Roughness Index (IRI)	N/A	N/A				
Lane & Width Information						
Number of Lanes	1	1				
Paved Width (ft)	12	12				
Lane Width (ft)	12	12

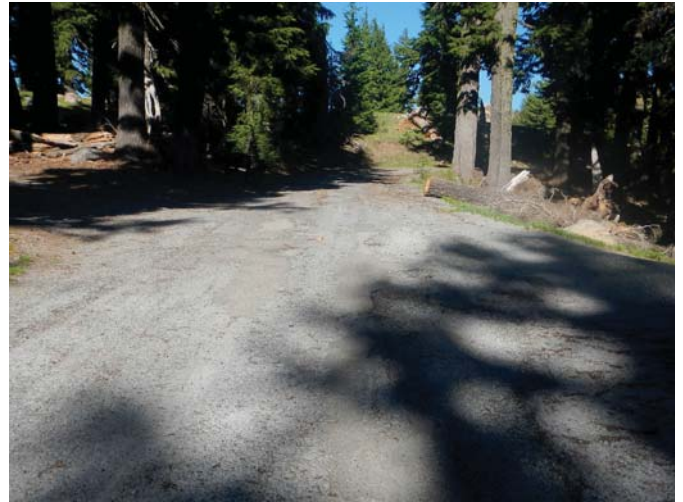
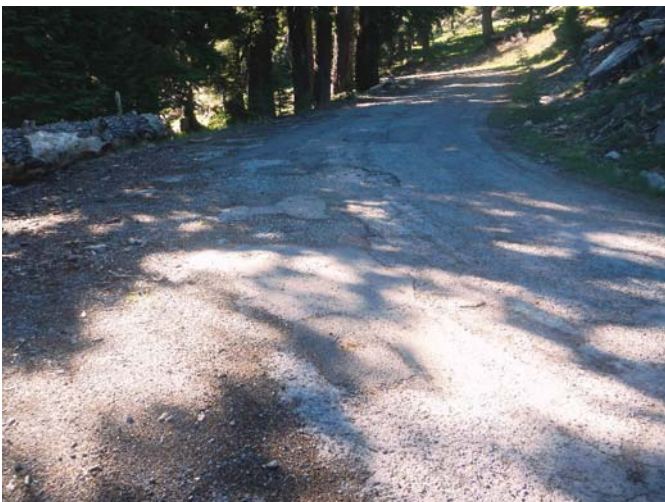
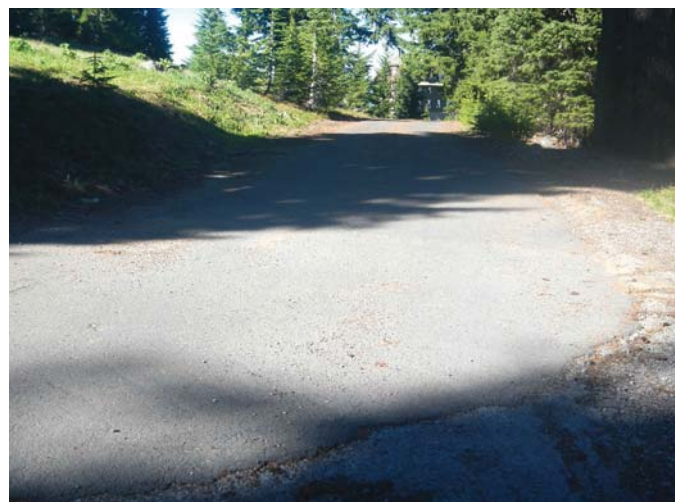
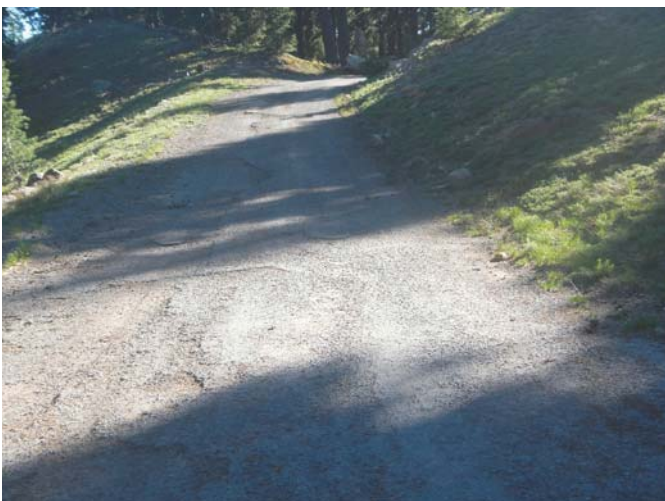
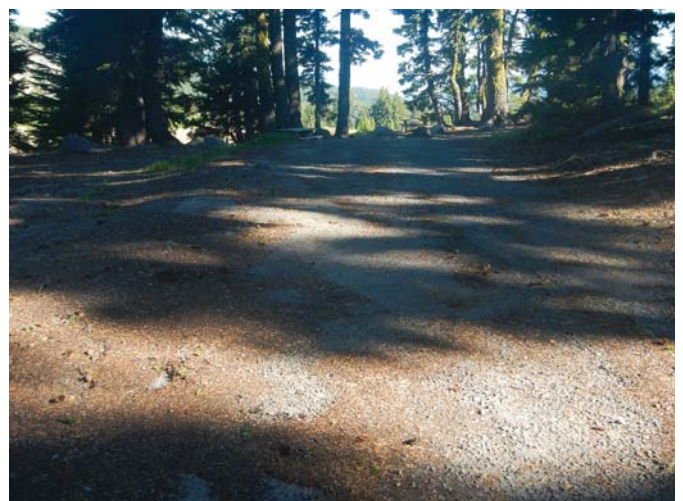
Route was given a Pavement Condition Rating (PCR) of 0 because it is in very poor condition. Individual distress indices could not be determined because of the excessive distress quantity and missing sections of pavement.

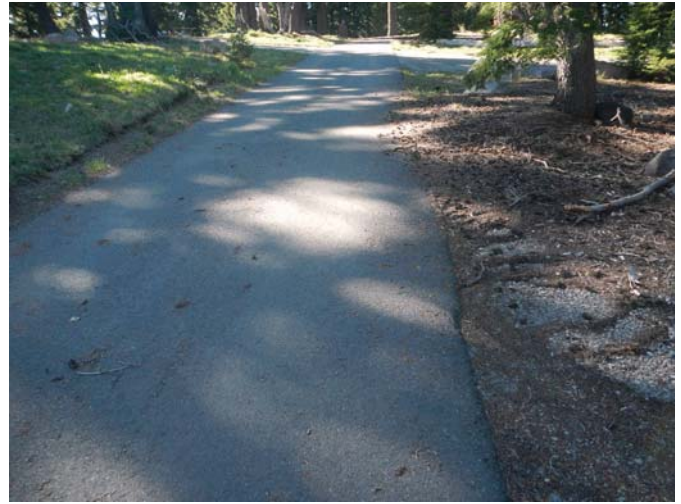
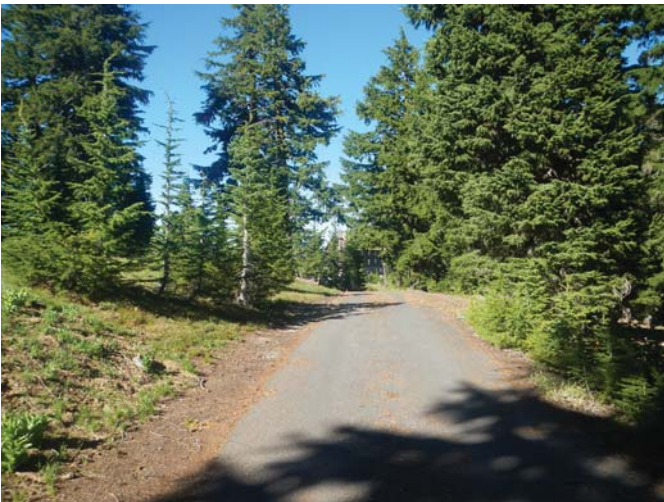
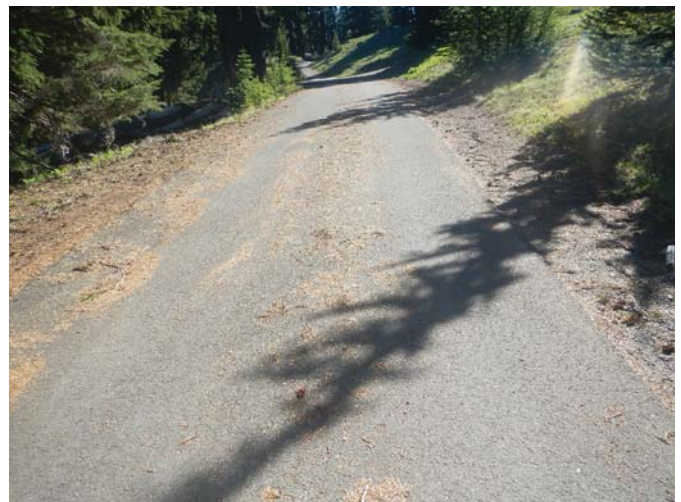
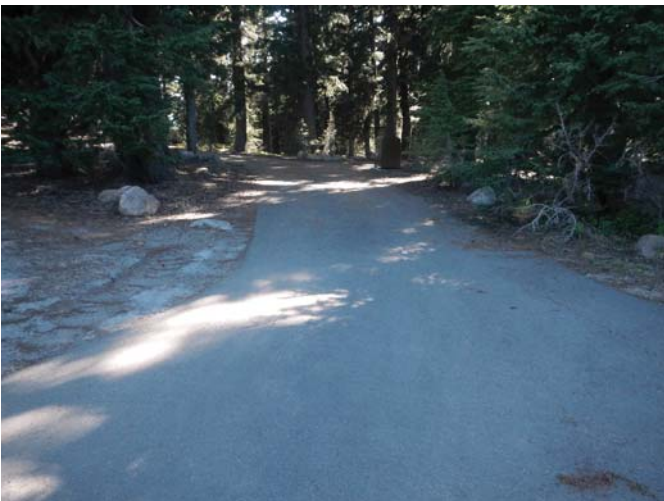
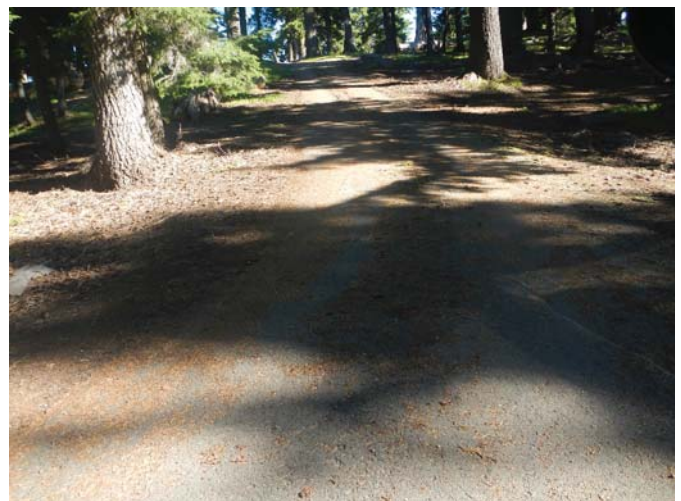
Inspection Date: 6/12/2015	Beginning Section MP	0.00				
Paved Length (Miles): 0.17	Section Length (MI)	0.17				
Surface Type: ASPHALT	Route Summary					
Roadway Condition Information						
Pavement Condition Rating (PCR)	53	53				
Surface Condition Rating (SCR)	53	53				
Roughness Condition Index (RCI)	N/A	N/A				
Distress Index Values						
Structural Crack Index	N/A	N/A				
Alligator Crack Index	53	53				
Longitudinal Crack Index	73	73				
Transverse Cracking Index	73	73				
Patching Index	97	97				
Rutting Index	73	73				
International Roughness Index (IRI)	N/A	N/A				
Lane & Width Information						
Number of Lanes	1	1				
Paved Width (ft)	10	10				
Lane Width (ft)	10	10

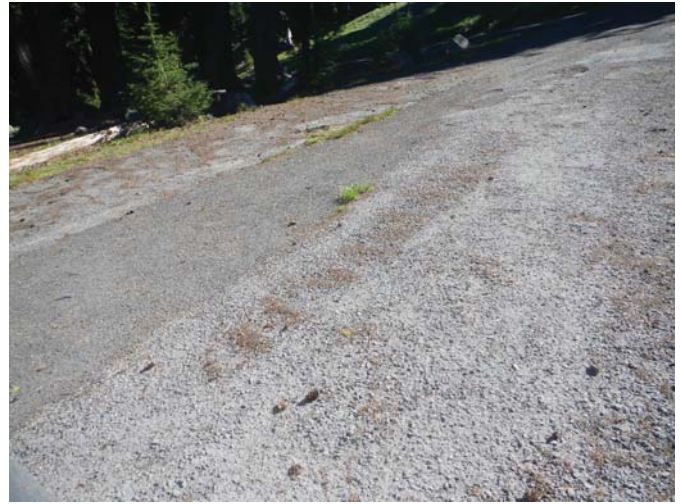
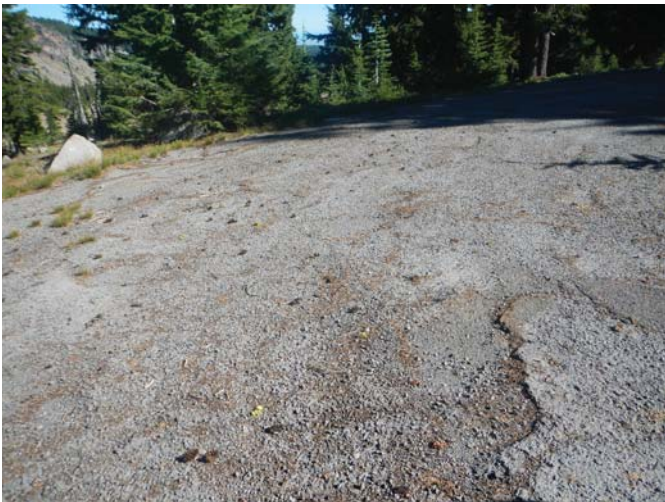
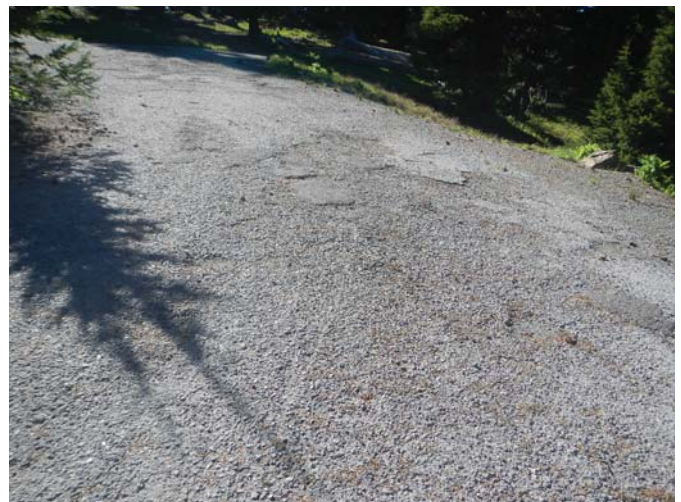
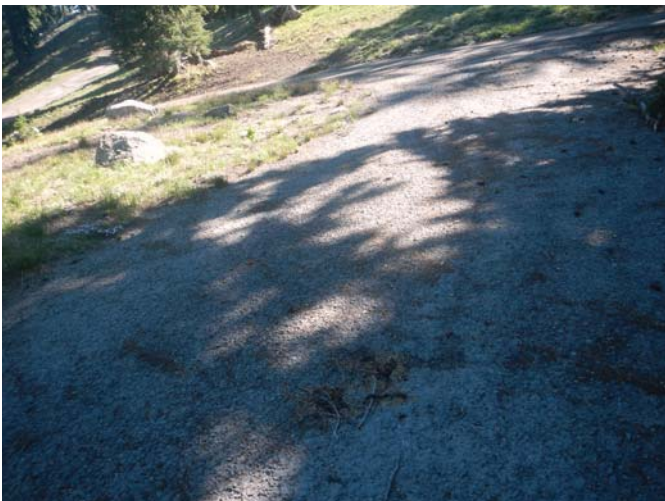
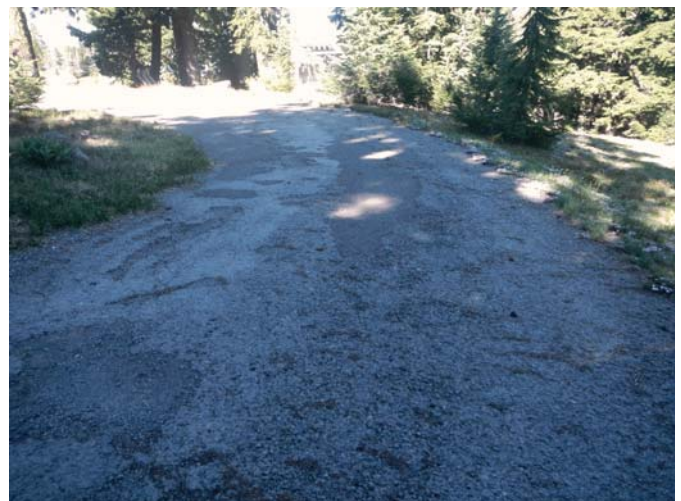
Route was given a Pavement Condition Rating (PCR) of 0 because it is in very poor condition. Individual distress indices could not be determined because of the excessive distress quantity and missing sections of pavement.

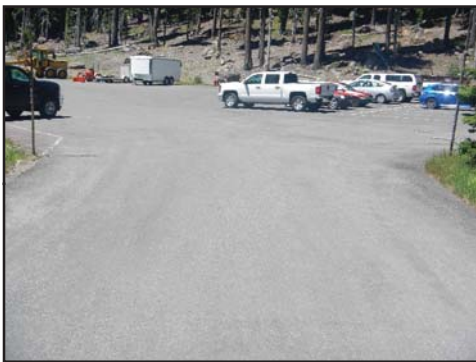
Inspection Date	FMSS Number	User Access	Surface Type
6/11/2015	75141	NONPUBLIC	ASPHALT
Area (Sq. Ft.)	Lane Miles (11' Widths)	Pavement Recommendation	
92,626	1.595	PREVENTIVE MAINTENANCE	
Condition Rating / PCR			
GOOD / 90			
Route Condition Legend – Pavement Condition Rating (PCR)			
Poor (0 - 60)	Fair (61- 84)	Good (85 - 94)	Excellent (95 - 100)
			Not Rated
See Appendix for definitions and formulas

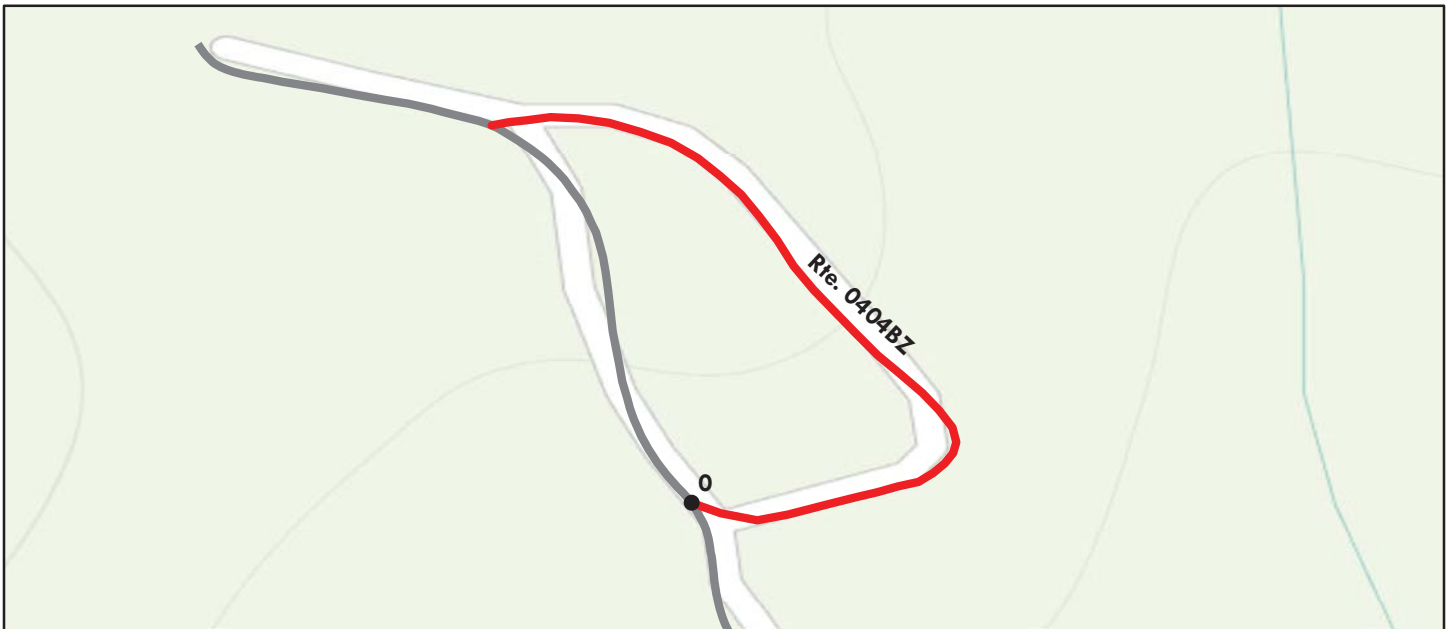
ROUTE 0404BZ: HEADQUARTERS RESIDENCE LOOP

Route Condition Legend – Pavement Condition Rating (PCR)						
Poor (0 - 60)	Fair (61- 84)	Good (85 - 94)	Excellent (95 - 100)	Not Rated		
See Appendix for definitions and formulas						
Inspection Date: 6/11/2015	Beginning Section MP	0.00				
Paved Length (Miles): 0.12	Section Length (MI)	0.12				
Surface Type: ASPHALT	Route Summary					
Roadway Condition Information						
Pavement Condition Rating (PCR)	0	0				
Surface Condition Rating (SCR)	0	0				
Roughness Condition Index (RCI)	N/A	N/A				
Distress Index Values						
Structural Crack Index	N/A	N/A				
Alligator Crack Index	N/A	N/A				
Longitudinal Crack Index	N/A	N/A				
Transverse Cracking Index	N/A	N/A				
Patching Index	N/A	N/A				
Rutting Index	N/A	N/A				
International Roughness Index (IRI)	N/A	N/A				
Lane & Width Information						
Number of Lanes	1	1				
Paved Width (ft)	18	18				
Lane Width (ft)	18	18

Route was given a Pavement Condition Rating (PCR) of 0 because it is in very poor condition. Individual distress indices could not be determined because of the excessive distress quantity and missing sections of pavement.

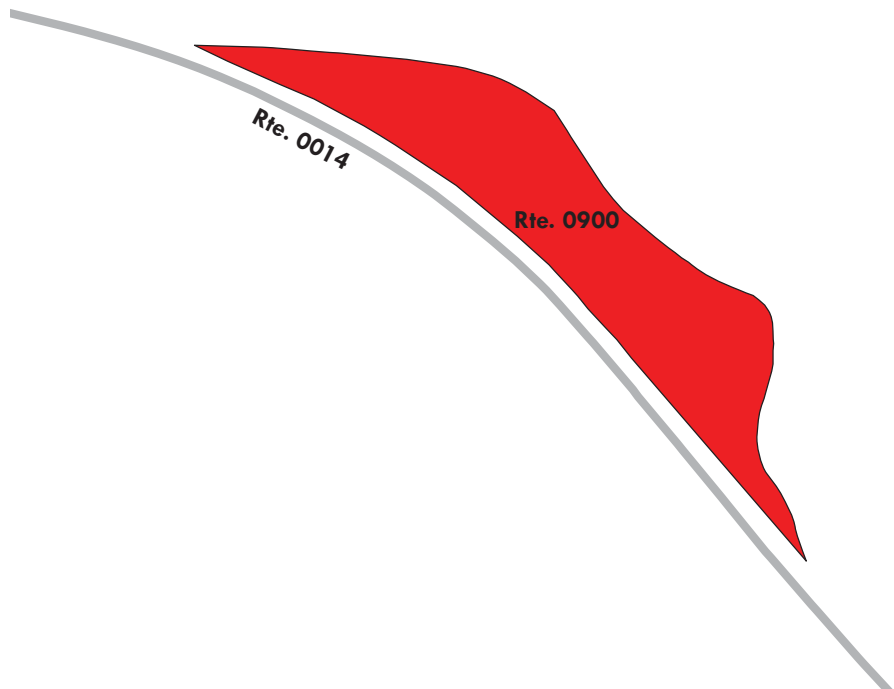
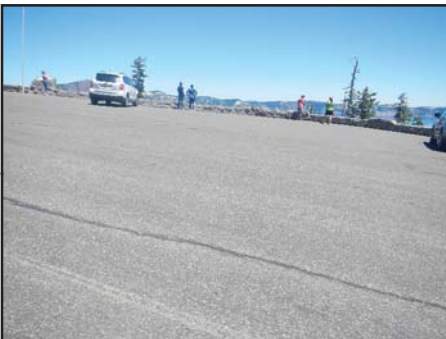
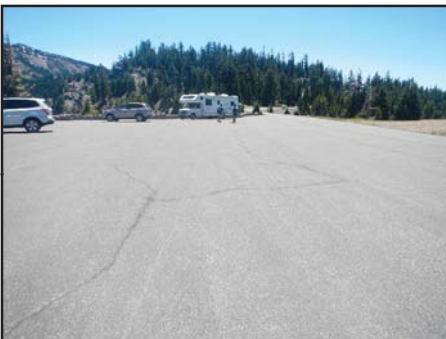
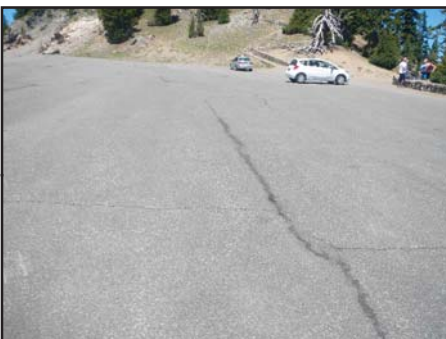
Inspection Date	FMSS Number	User Access	Surface Type
6/12/2015	75343	PUBLIC	ASPHALT
Area (Sq. Ft.)	Lane Miles (11' Widths)	Curb Reveal (Inches)	Curb Recommendation
32,497	0.56	NOT APPLICABLE	NOT APPLICABLE
Curb Type		Curb & Gutter Type	
NO CURB		NO CURB AND GUTTER	
Pavement Recommendation		Condition Rating / PCR	
HEAVY 3R TREATMENTS		POOR / 53

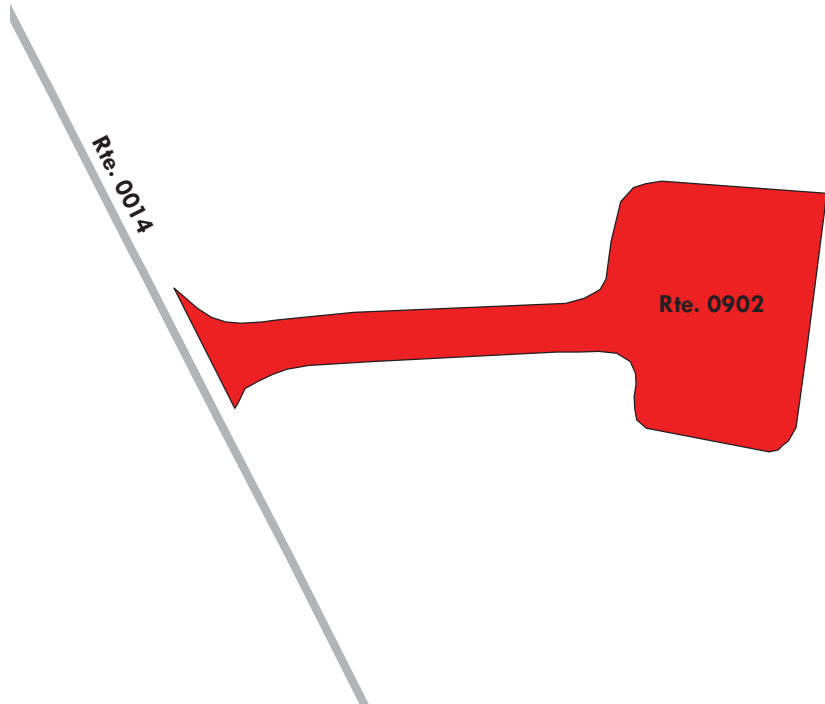
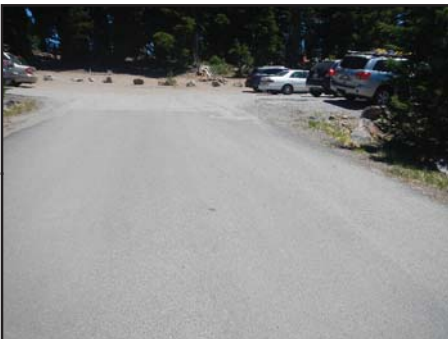
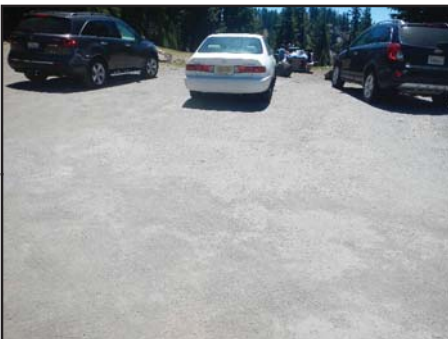
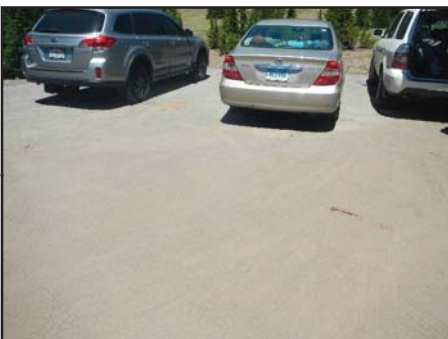
ROUTE 0902: DISCOVERY POINT PICNIC AREA

Inspection Date	FMSS Number	User Access	Surface Type
6/12/2015	75353	PUBLIC	ASPHALT
Area (Sq. Ft.)	Lane Miles (11' Widths)	Curb Reveal (Inches)	Curb Recommendation
5,285	0.091	NOT APPLICABLE	NOT APPLICABLE
Curb Type		Curb & Gutter Type	
NO CURB		NO CURB AND GUTTER	
Pavement Recommendation		Condition Rating / PCR	
HEAVY 3R TREATMENTS		POOR / 53

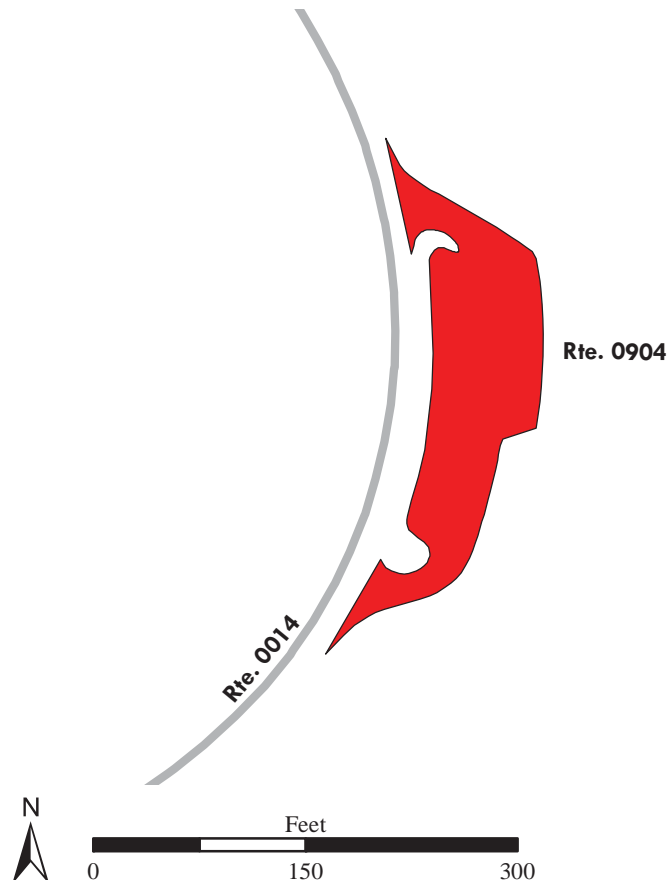
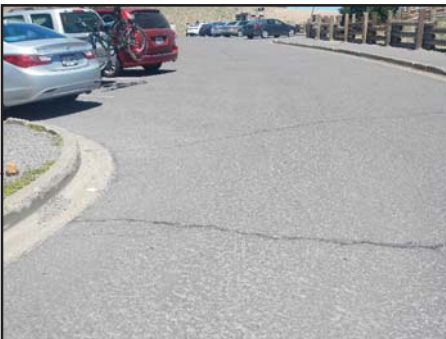
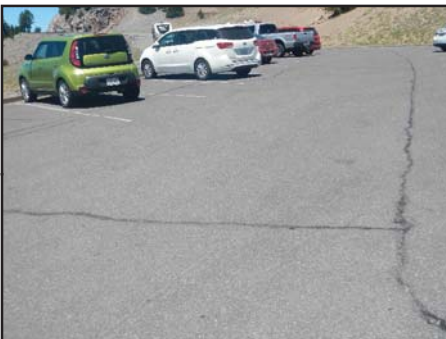
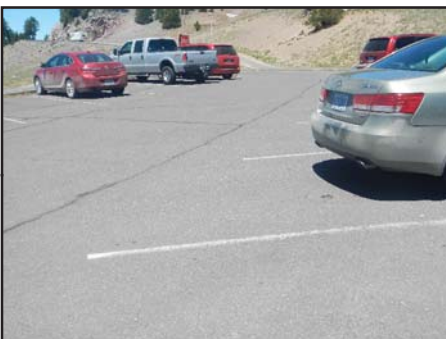
ROUTE 0904: WATCHMAN OVERLOOK PARKING

Inspection Date	FMSS Number	User Access	Surface Type
6/12/2015	75355	PUBLIC	ASPHALT
Area (Sq. Ft.)	Lane Miles (11' Widths)	Curb Reveal (Inches)	Curb Recommendation
13,637	0.235	NOT APPLICABLE	MODERATE REPAIR
Curb Type		Curb & Gutter Type	
NO CURB		CONCRETE	
Pavement Recommendation		Condition Rating / PCR	
HEAVY 3R TREATMENTS		POOR / 53
