CRLA Cycle 6

Final Report

Road Inventory and Condition Assessment of Paved Routes Crater Lake National Park

Report Date: February 2016

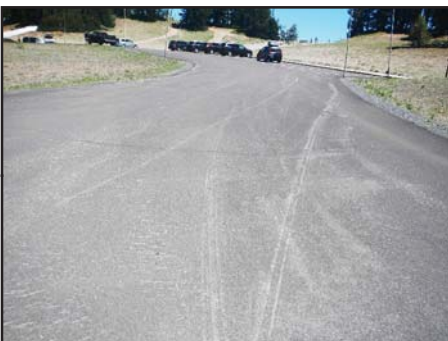
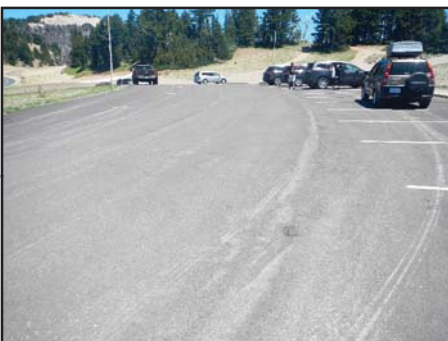
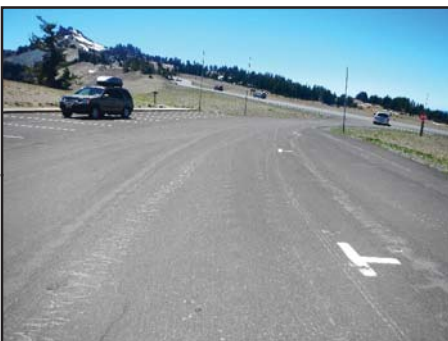
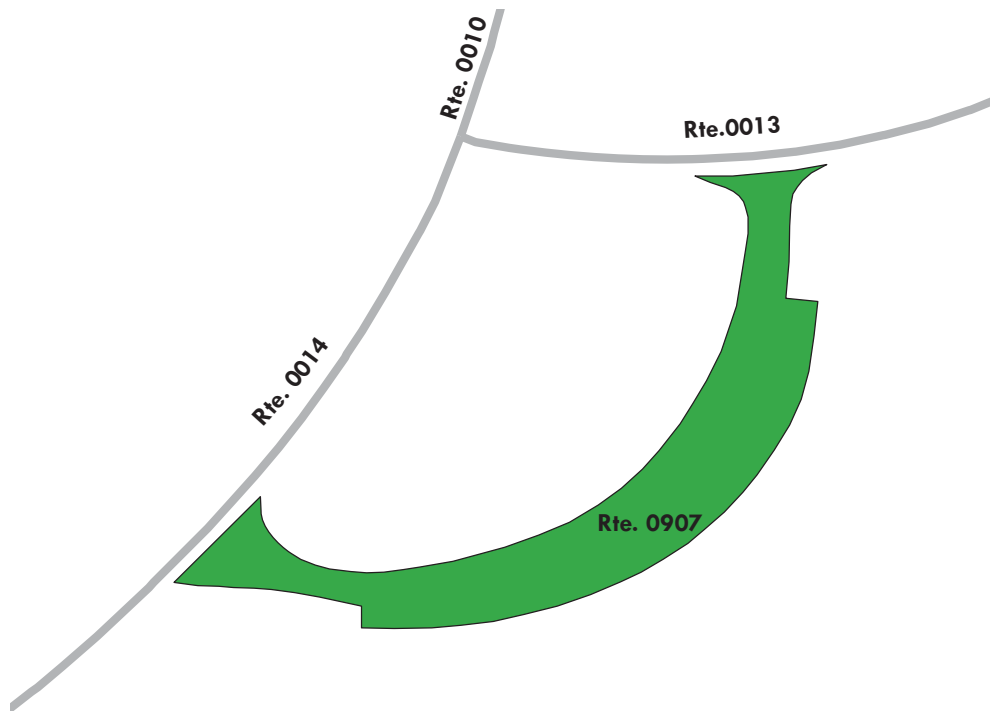
ROUTE 0907: NORTH JUNCTION PARKING

Inspection Date	FMSS Number	User Access	Surface Type
6/12/2015	75363	PUBLIC	ASPHALT
Area (Sq. Ft.)	Lane Miles (11' Widths)	Curb Reveal (Inches)	Curb Recommendation
26,047	0.448	6	LIGHT REPAIR
Curb Type		Curb & Gutter Type	
CONCRETE		NO CURB AND GUTTER	
Pavement Recommendation		Condition Rating / PCR	
PREVENTIVE MAINTENANCE		GOOD / 90

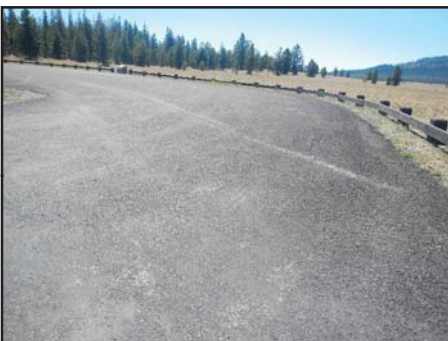
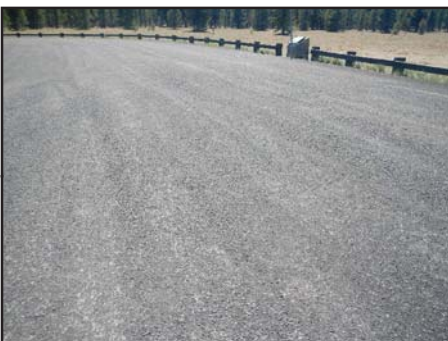
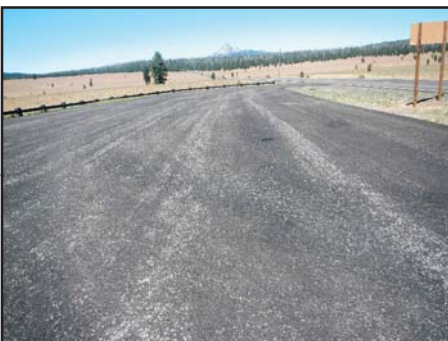
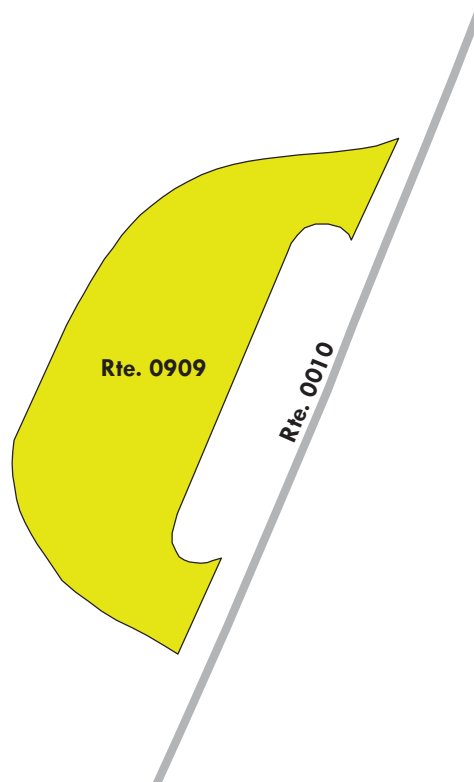
ROUTE 0909: PUMICE DESERT

Inspection Date	FMSS Number	User Access	Surface Type
6/12/2015	75367	PUBLIC	ASPHALT
Area (Sq. Ft.)	Lane Miles (11' Widths)	Curb Reveal (Inches)	Curb Recommendation
11,094	0.191	NOT APPLICABLE	NOT APPLICABLE
Curb Type		Curb & Gutter Type	
NO CURB		NO CURB AND GUTTER	
Pavement Recommendation		Condition Rating / PCR	
LIGHT 3R TREATMENTS		FAIR / 73

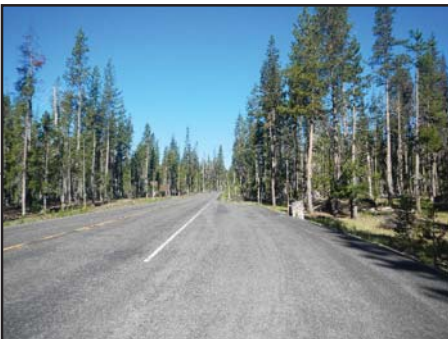
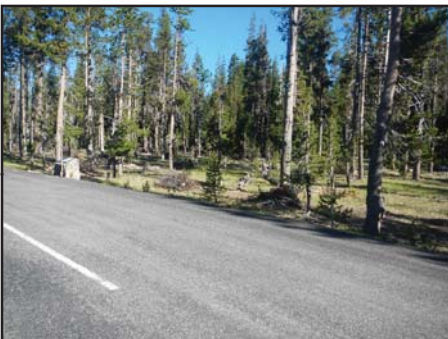
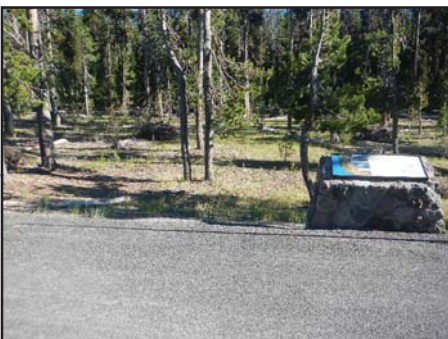
ROUTE 0910: PACIFIC CREST TRAIL PULLOUT

Inspection Date	FMSS Number	User Access	Surface Type
6/12/2015	75369	PUBLIC	ASPHALT
Area (Sq. Ft.)	Lane Miles (11' Widths)	Curb Reveal (Inches)	Curb Recommendation
2,338	0.04	NOT APPLICABLE	NOT APPLICABLE
Curb Type		Curb & Gutter Type	
NO CURB		NO CURB AND GUTTER	
Pavement Recommendation		Condition Rating / PCR	
PREVENTIVE MAINTENANCE		GOOD / 90

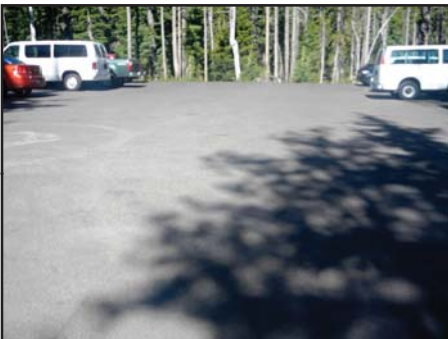
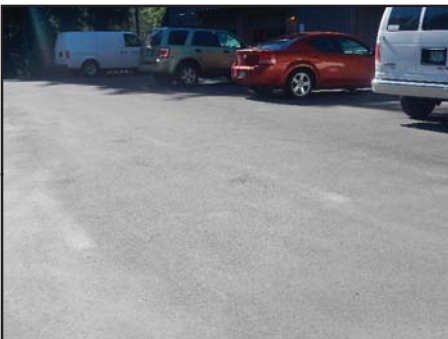
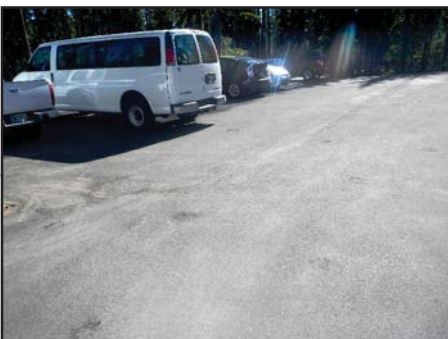
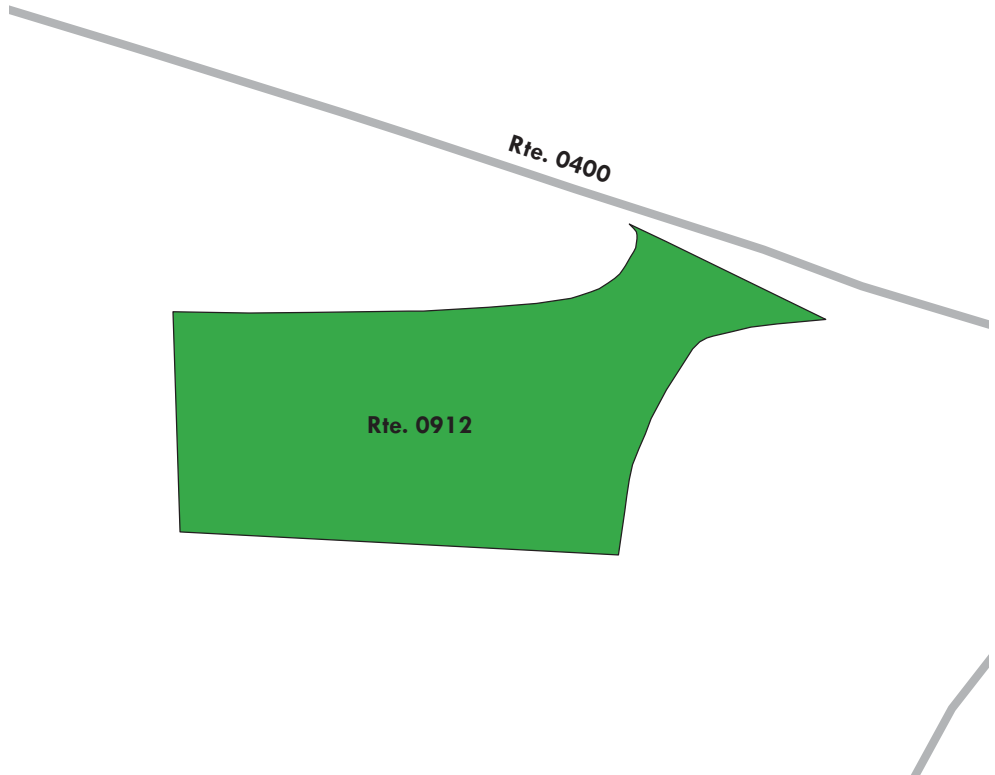
ROUTE 0912: MAZAMA DORM, BUILDING A, REAR PARKING

Inspection Date	FMSS Number	User Access	Surface Type
6/11/2015	78343	NONPUBLIC	ASPHALT
Area (Sq. Ft.)	Lane Miles (11' Widths)	Curb Reveal (Inches)	Curb Recommendation
10,513	0.181	NOT APPLICABLE	NOT APPLICABLE
Curb Type		Curb & Gutter Type	
NO CURB		NO CURB AND GUTTER	
Pavement Recommendation		Condition Rating / PCR	
PREVENTIVE MAINTENANCE		GOOD / 90

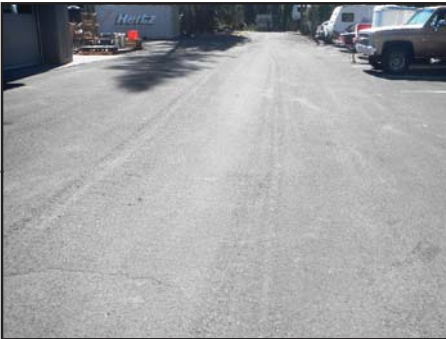
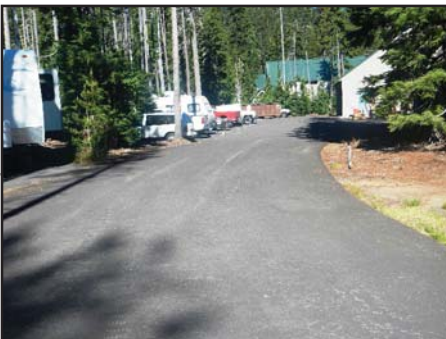
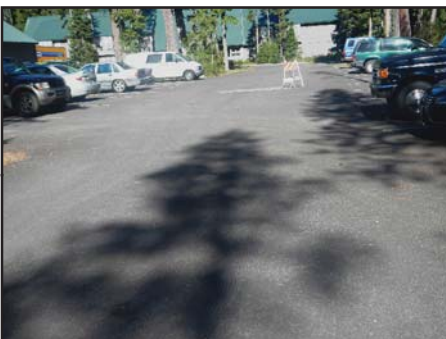
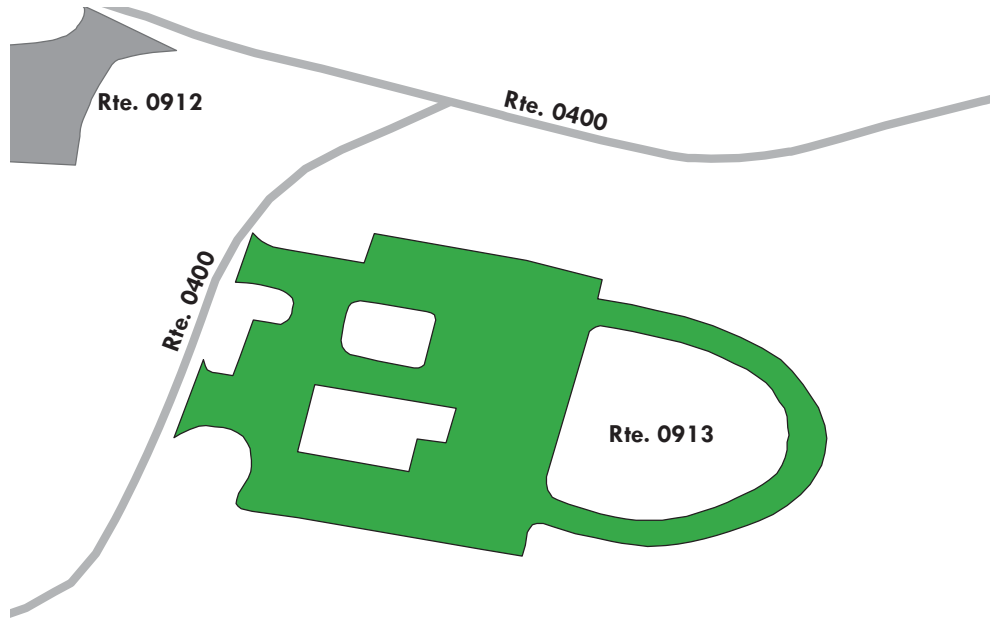
ROUTE 0913: MAZAMA DORM EMPLOYEE PARKING AND RV

Inspection Date	FMSS Number	User Access	Surface Type
6/11/2015	78347	NONPUBLIC	ASPHALT
Area (Sq. Ft.)	Lane Miles (11' Widths)	Curb Reveal (Inches)	Curb Recommendation
34,631	0.596	NOT APPLICABLE	NOT APPLICABLE
Curb Type		Curb & Gutter Type	
NO CURB		NO CURB AND GUTTER	
Pavement Recommendation		Condition Rating / PCR	
PREVENTIVE MAINTENANCE		GOOD / 90

Parking area consists of multiple surface types: 1 part Asphalt at 34,349 square feet; 1 part Concrete at 282 square feet.

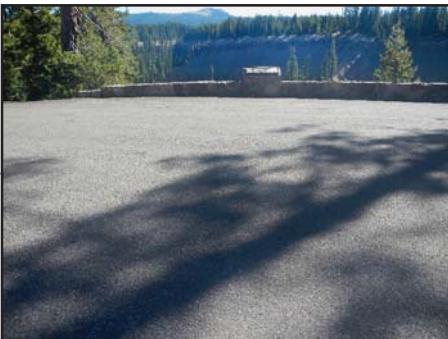
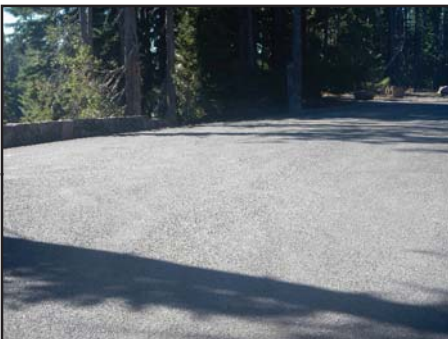
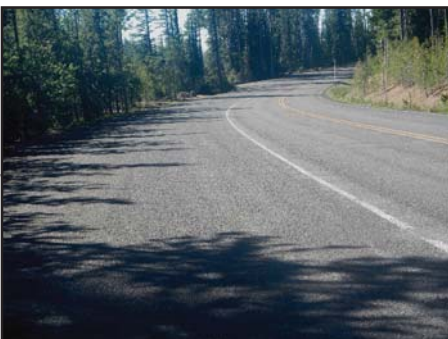
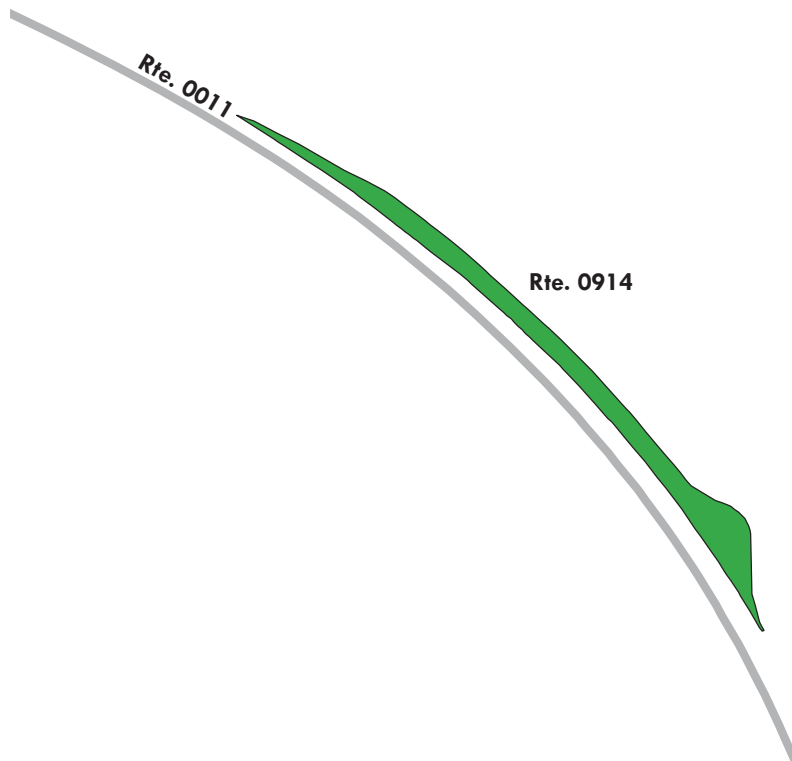
ROUTE 0914: FOSSIL FUMARoles - GODFREY GLEN OVERLOOK

Inspection Date	FMSS Number	User Access	Surface Type
6/11/2015	75373	PUBLIC	ASPHALT
Area (Sq. Ft.)	Lane Miles (11' Widths)	Curb Reveal (Inches)	Curb Recommendation
15,880	0.273	NOT APPLICABLE	NOT APPLICABLE
Curb Type		Curb & Gutter Type	
NO CURB		NO CURB AND GUTTER	
Pavement Recommendation		Condition Rating / PCR	
PREVENTIVE MAINTENANCE		GOOD / 90

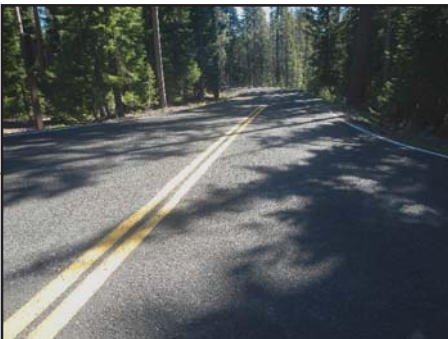
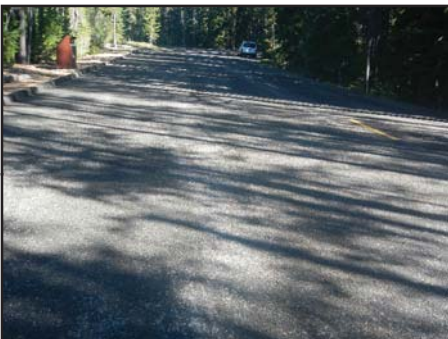
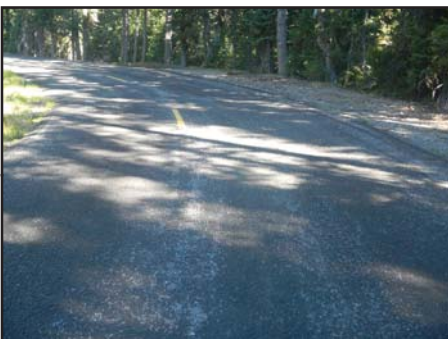
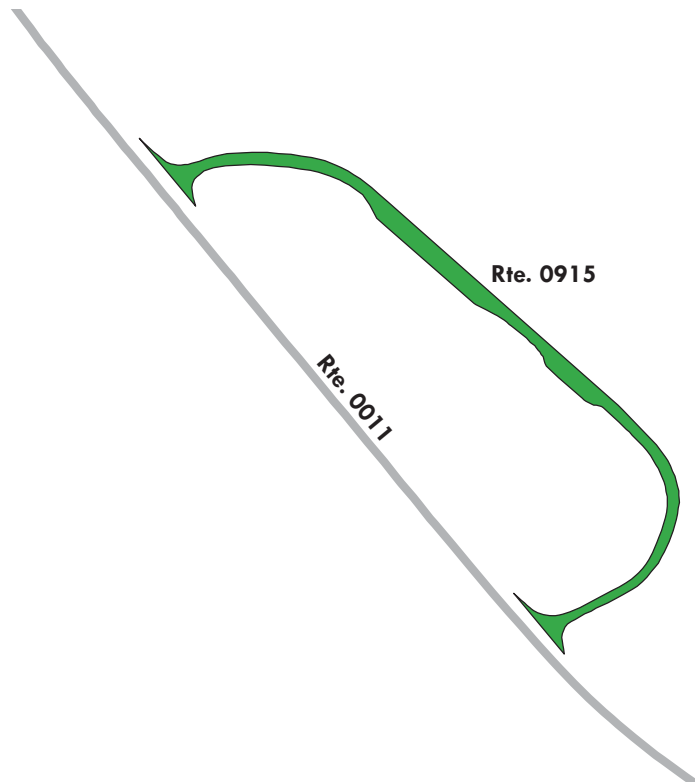
ROUTE 0915: LODGE POLE PICNIC AREA

Inspection Date	FMSS Number	User Access	Surface Type
6/11/2015	75376	PUBLIC	ASPHALT
Area (Sq. Ft.)	Lane Miles (11' Widths)	Curb Reveal (Inches)	Curb Recommendation
42,082	0.725	7	DO NOTHING
Curb Type		Curb & Gutter Type	
ASPHALT		NO CURB AND GUTTER	
Pavement Recommendation		Condition Rating / PCR	
PREVENTIVE MAINTENANCE		GOOD / 90

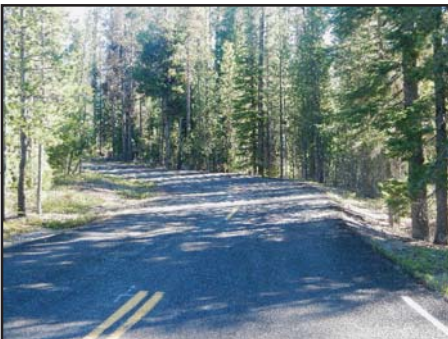
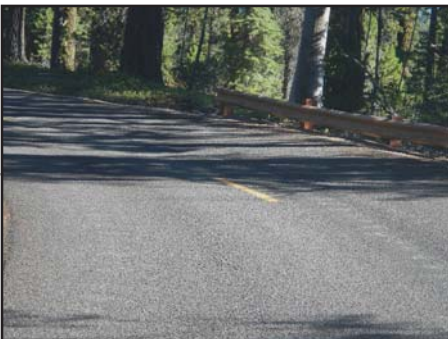
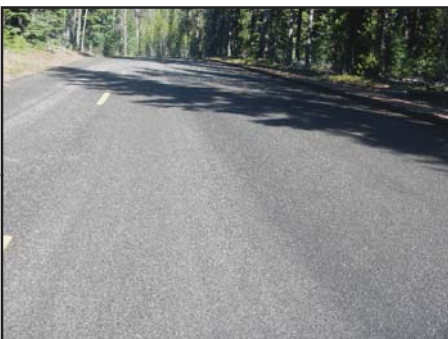
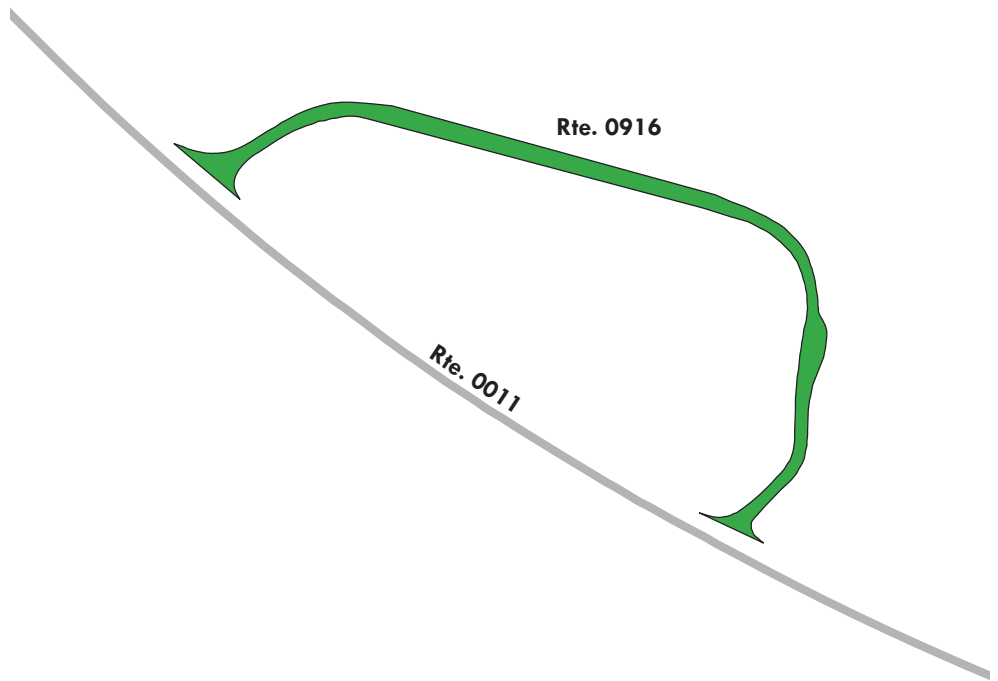
ROUTE 0916: ANNIE FALLS PICNIC AREA

Inspection Date	FMSS Number	User Access	Surface Type
6/11/2015	75378	PUBLIC	ASPHALT
Area (Sq. Ft.)	Lane Miles (11' Widths)	Curb Reveal (Inches)	Curb Recommendation
33,111	0.57	7	DO NOTHING
Curb Type		Curb & Gutter Type	
ASPHALT		NO CURB AND GUTTER	
Pavement Recommendation		Condition Rating / PCR	
PREVENTIVE MAINTENANCE		GOOD / 90

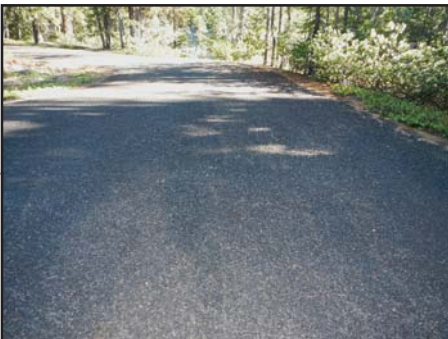
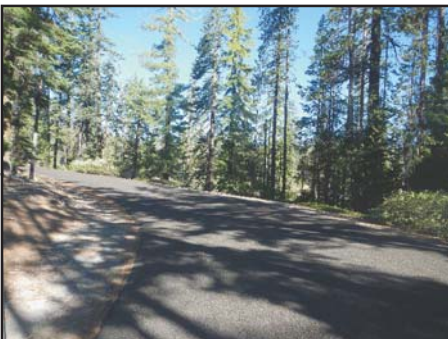
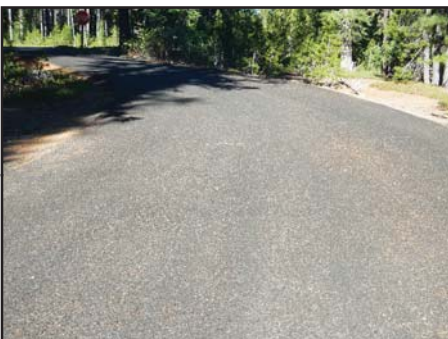
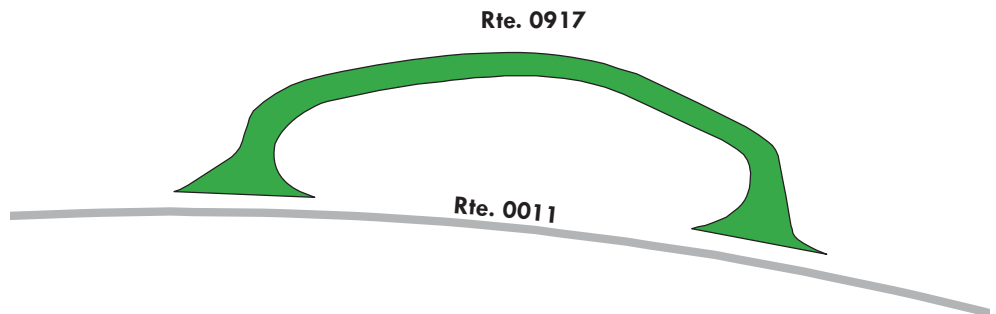
ROUTE 0917: NO NAME PICNIC AREA

Inspection Date	FMSS Number	User Access	Surface Type
6/11/2015	78383	PUBLIC	ASPHALT
Area (Sq. Ft.)	Lane Miles (11' Widths)	Curb Reveal (Inches)	Curb Recommendation
9,728	0.167	NOT APPLICABLE	NOT APPLICABLE
Curb Type		Curb & Gutter Type	
NO CURB		NO CURB AND GUTTER	
Pavement Recommendation		Condition Rating / PCR	
PREVENTIVE MAINTENANCE		GOOD / 90

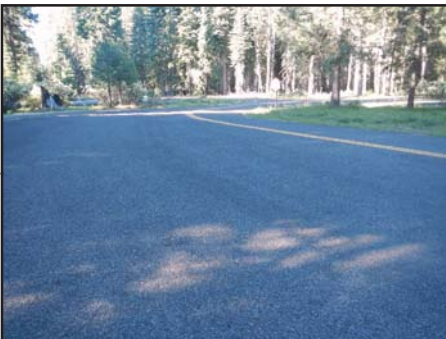
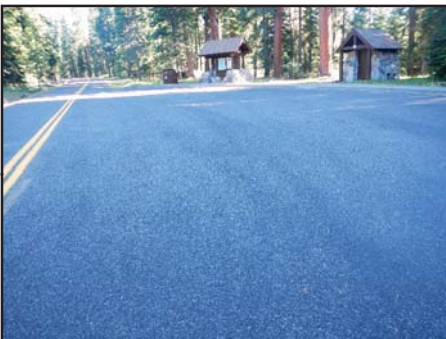
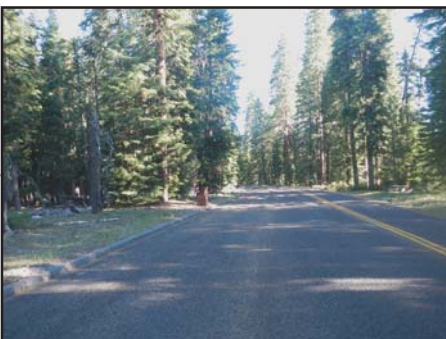
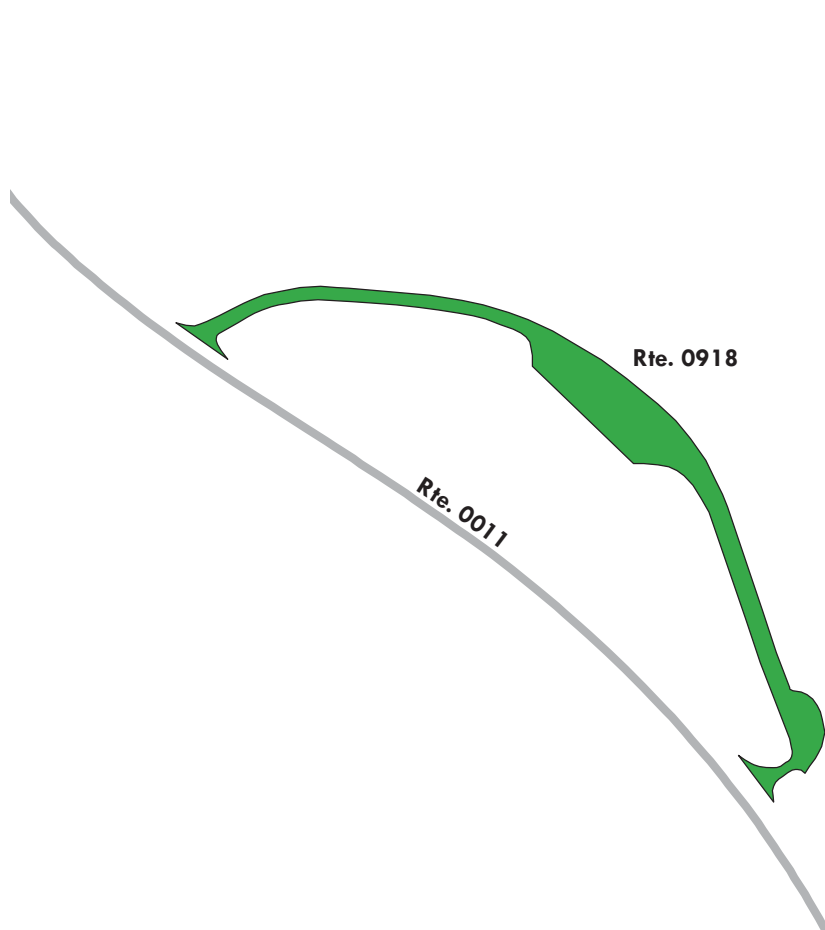
Inspection Date	FMSS Number	User Access	Surface Type
6/11/2015	75380	PUBLIC	ASPHALT
Area (Sq. Ft.)	Lane Miles (11' Widths)	Curb Reveal (Inches)	Curb Recommendation
68,175	1.174	NOT APPLICABLE	DO NOTHING
Curb Type		Curb & Gutter Type	
NO CURB		CONCRETE	
Pavement Recommendation		Condition Rating / PCR	
PREVENTIVE MAINTENANCE		GOOD / 90

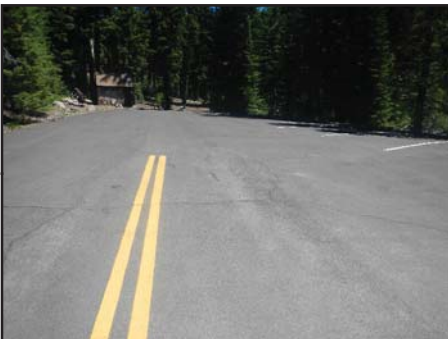
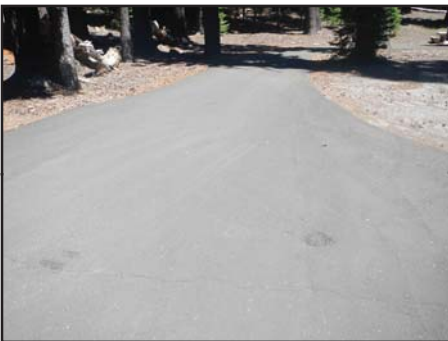
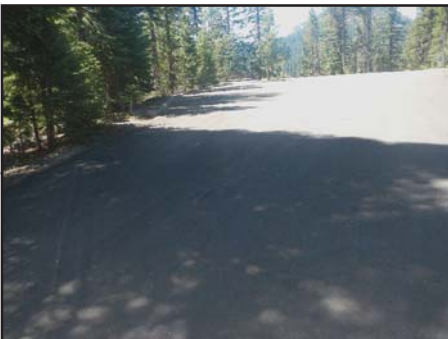
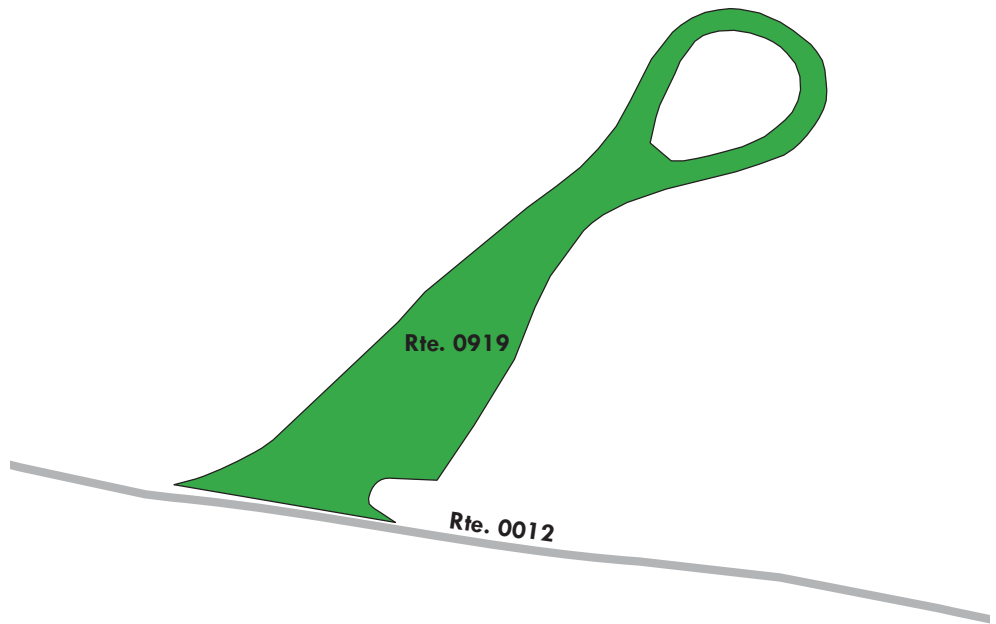
ROUTE 0919: GOODBYE PICNIC AREA

Inspection Date	FMSS Number	User Access	Surface Type
6/11/2015	75383	PUBLIC	ASPHALT
Area (Sq. Ft.)	Lane Miles (11' Widths)	Curb Reveal (Inches)	Curb Recommendation
9,084	0.156	5	DO NOTHING
Curb Type		Curb & Gutter Type	
ASPHALT		NO CURB AND GUTTER	
Pavement Recommendation		Condition Rating / PCR	
PREVENTIVE MAINTENANCE		GOOD / 90

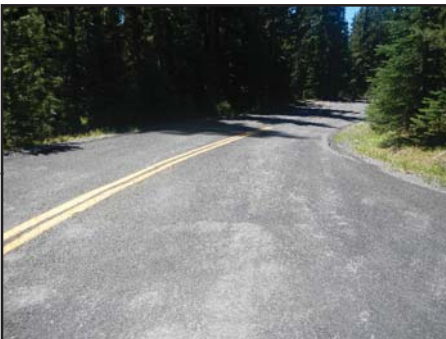
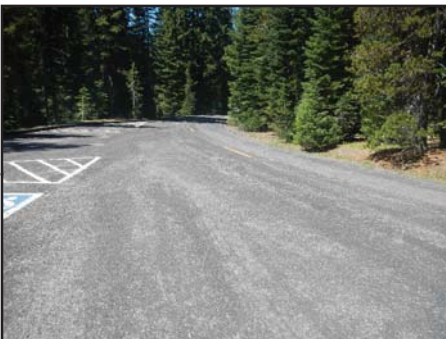
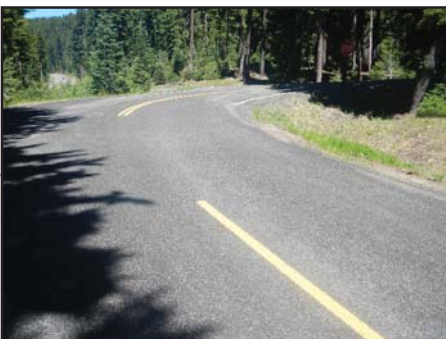
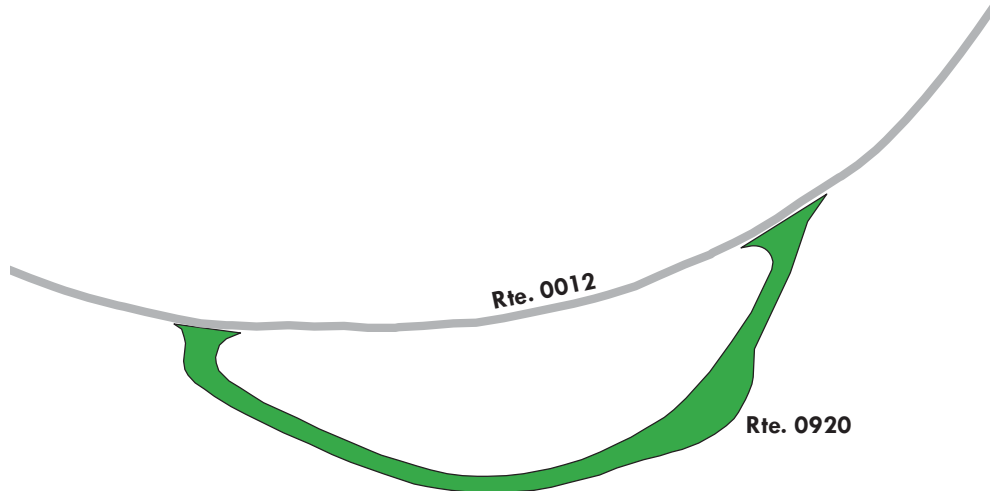
ROUTE 0920: GODFREY GLEN TRAIL PARKING

Inspection Date	FMSS Number	User Access	Surface Type
6/11/2015	75386	PUBLIC	ASPHALT
Area (Sq. Ft.)	Lane Miles (11' Widths)	Curb Reveal (Inches)	Curb Recommendation
23,915	0.412	6	DO NOTHING
Curb Type		Curb & Gutter Type	
ASPHALT		NO CURB AND GUTTER	
Pavement Recommendation		Condition Rating / PCR	
PREVENTIVE MAINTENANCE		GOOD / 90

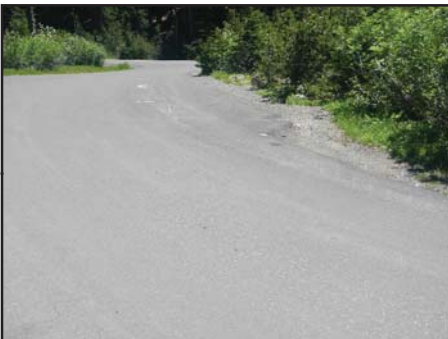
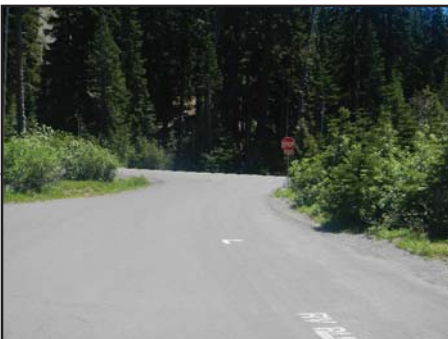
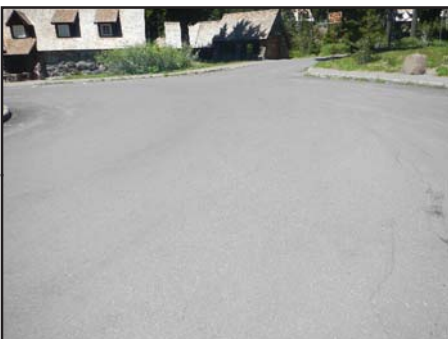
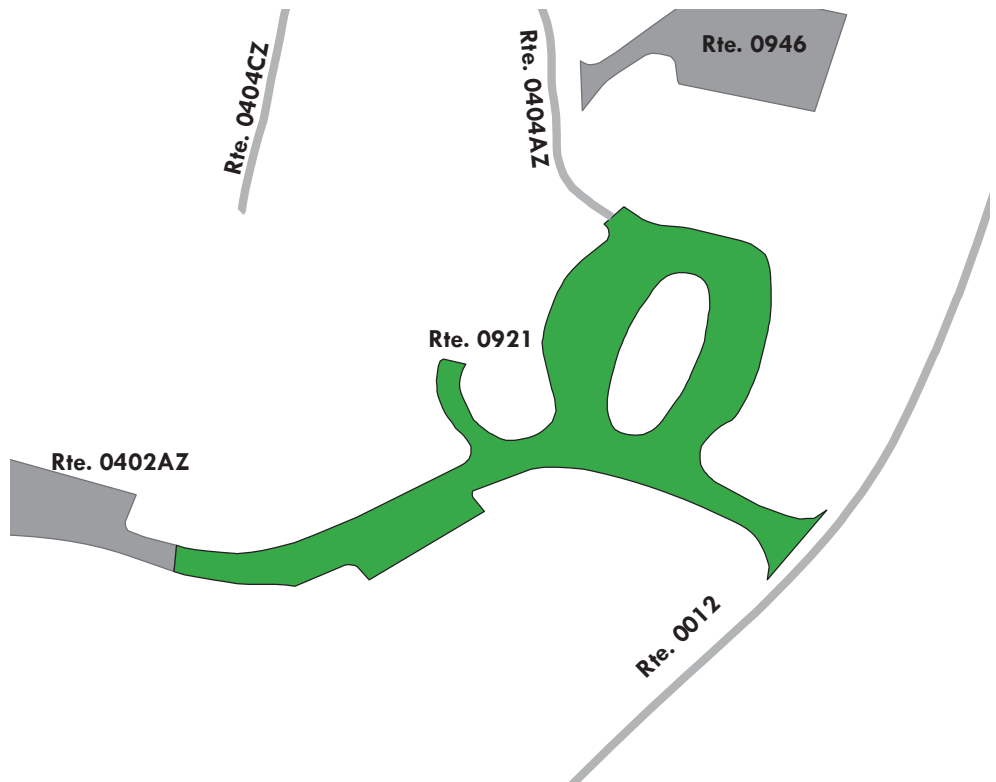
ROUTE 0921: HEADQUARTERS VISITOR CENTER PARKING

Inspection Date	FMSS Number	User Access	Surface Type
6/11/2015	75388	PUBLIC	ASPHALT
Area (Sq. Ft.)	Lane Miles (11' Widths)	Curb Reveal (Inches)	Curb Recommendation
34,338	0.591	8	DO NOTHING
Curb Type		Curb & Gutter Type	
STONE		NO CURB AND GUTTER	
Pavement Recommendation		Condition Rating / PCR	
PREVENTIVE MAINTENANCE		GOOD / 90

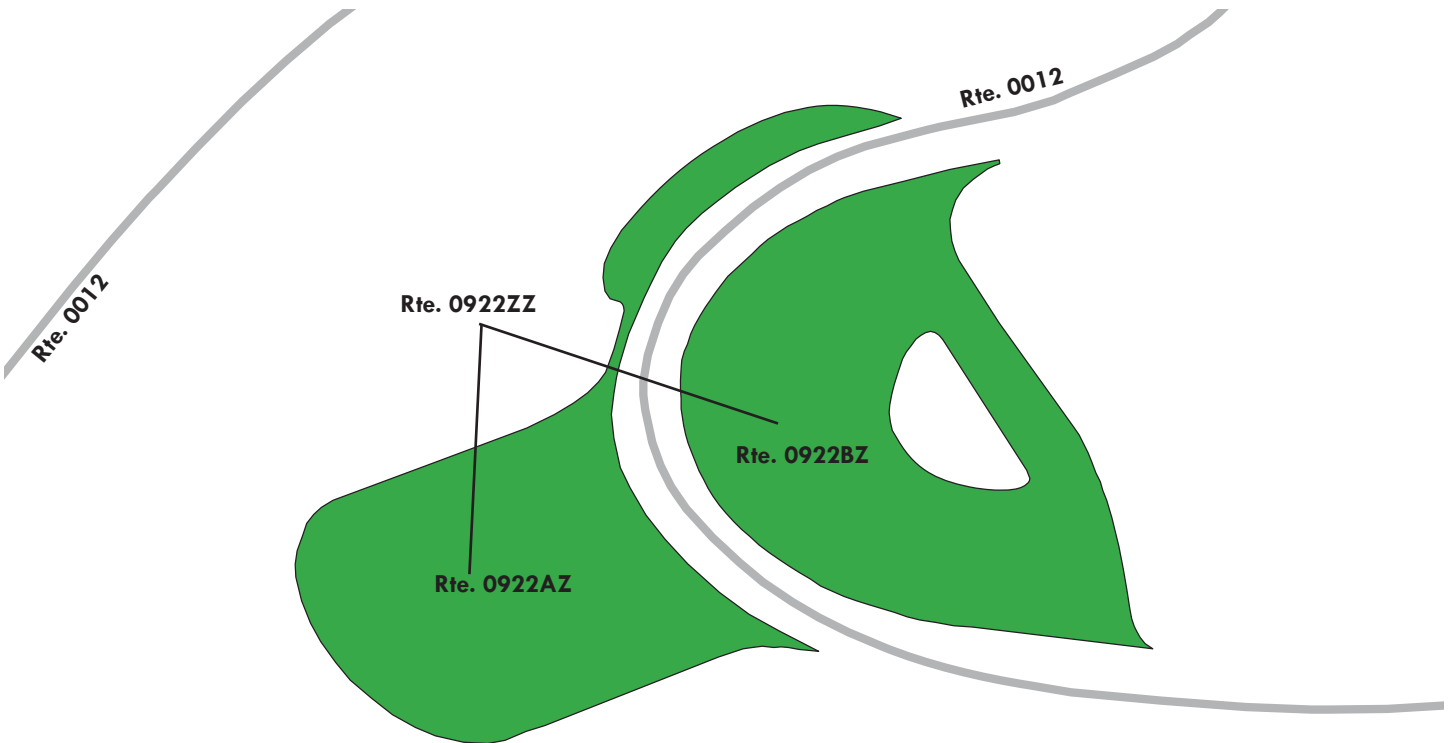
ROUTE 0922ZZ: CAFETERIA AND GIFT SHOP PARKING AREAS

Inspection Date	FMSS Number	User Access	Surface Type
6/12/2015	75389	PUBLIC	ASPHALT
Area (Sq. Ft.)	Lane Miles (11' Widths)	Condition Rating / PCR	
39,844	0.686	SUMMARY / 90

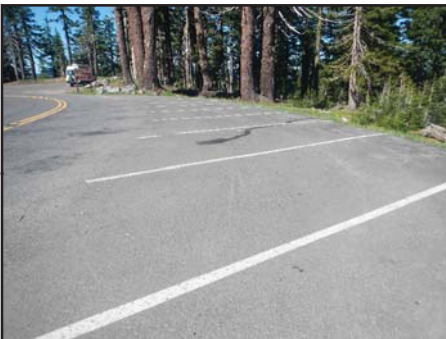
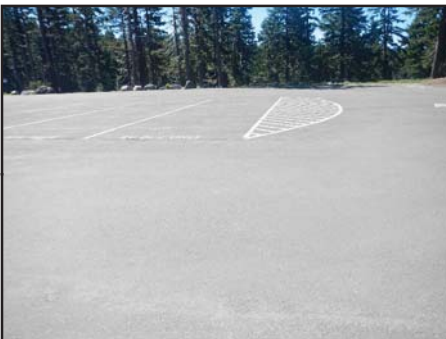
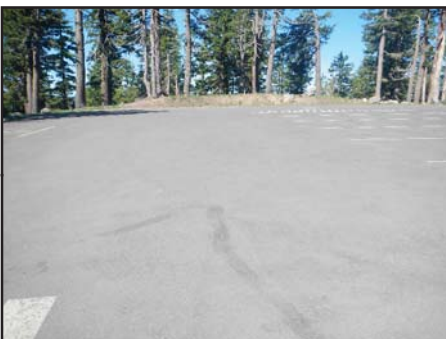
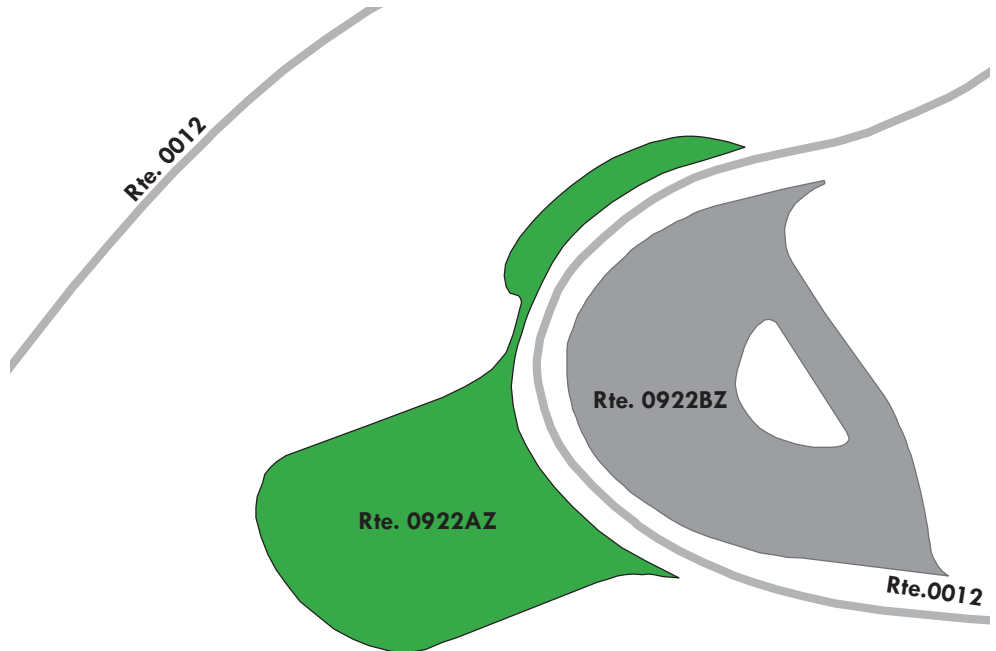
ROUTE 0922AZ: CAFETERIA AND GIFT SHOP PARKING A

Inspection Date	FMSS Number	User Access	Surface Type
6/12/2015	75389	PUBLIC	ASPHALT
Area (Sq. Ft.)	Lane Miles (11' Widths)	Curb Reveal (Inches)	Curb Recommendation
19,049	0.328	NOT APPLICABLE	NOT APPLICABLE
Curb Type		Curb & Gutter Type	
NO CURB		NO CURB AND GUTTER	
Pavement Recommendation		Condition Rating / PCR	
PREVENTIVE MAINTENANCE		GOOD / 90

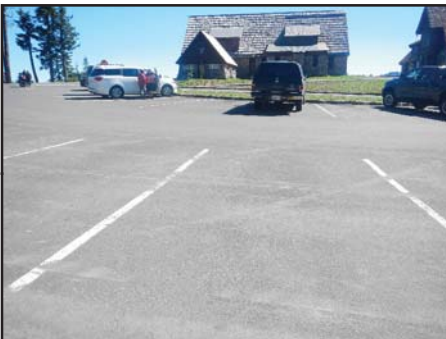
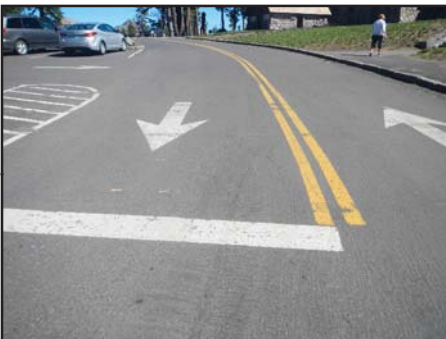
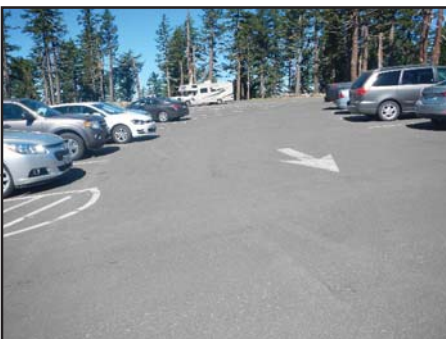
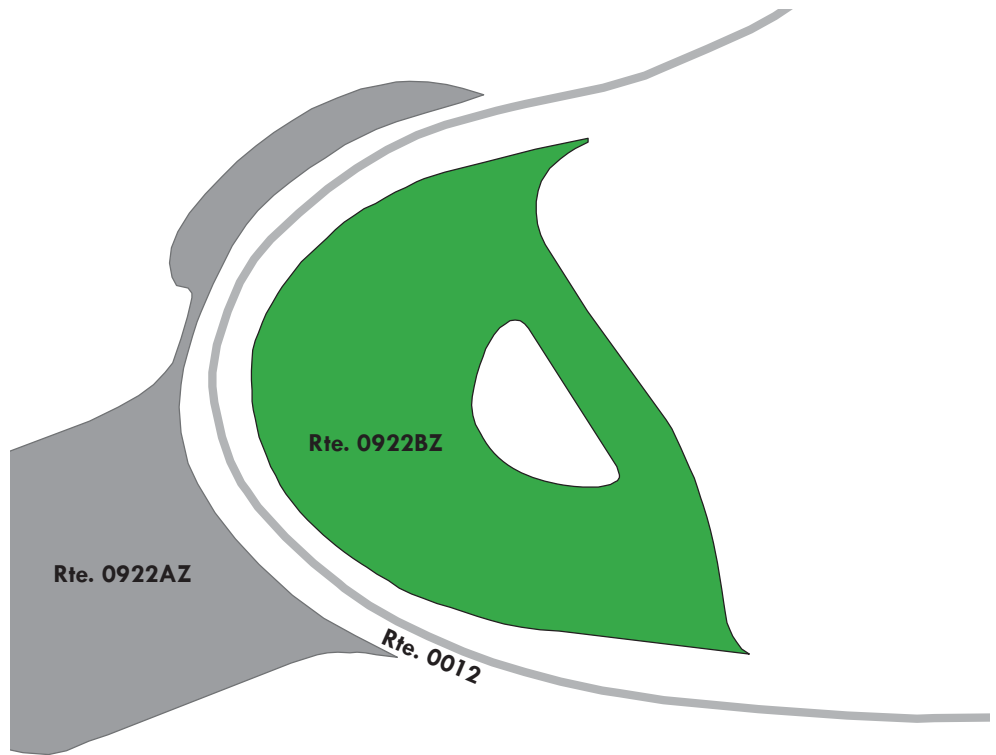
ROUTE 0922BZ: CAFETERIA AND GIFT SHOP PARKING B

Inspection Date	FMSS Number	User Access	Surface Type
6/12/2015	75389	PUBLIC	ASPHALT
Area (Sq. Ft.)	Lane Miles (11' Widths)	Curb Reveal (Inches)	Curb Recommendation
20,795	0.358	7	DO NOTHING
Curb Type		Curb & Gutter Type	
STONE		NO CURB AND GUTTER	
Pavement Recommendation		Condition Rating / PCR	
PREVENTIVE MAINTENANCE		GOOD / 90

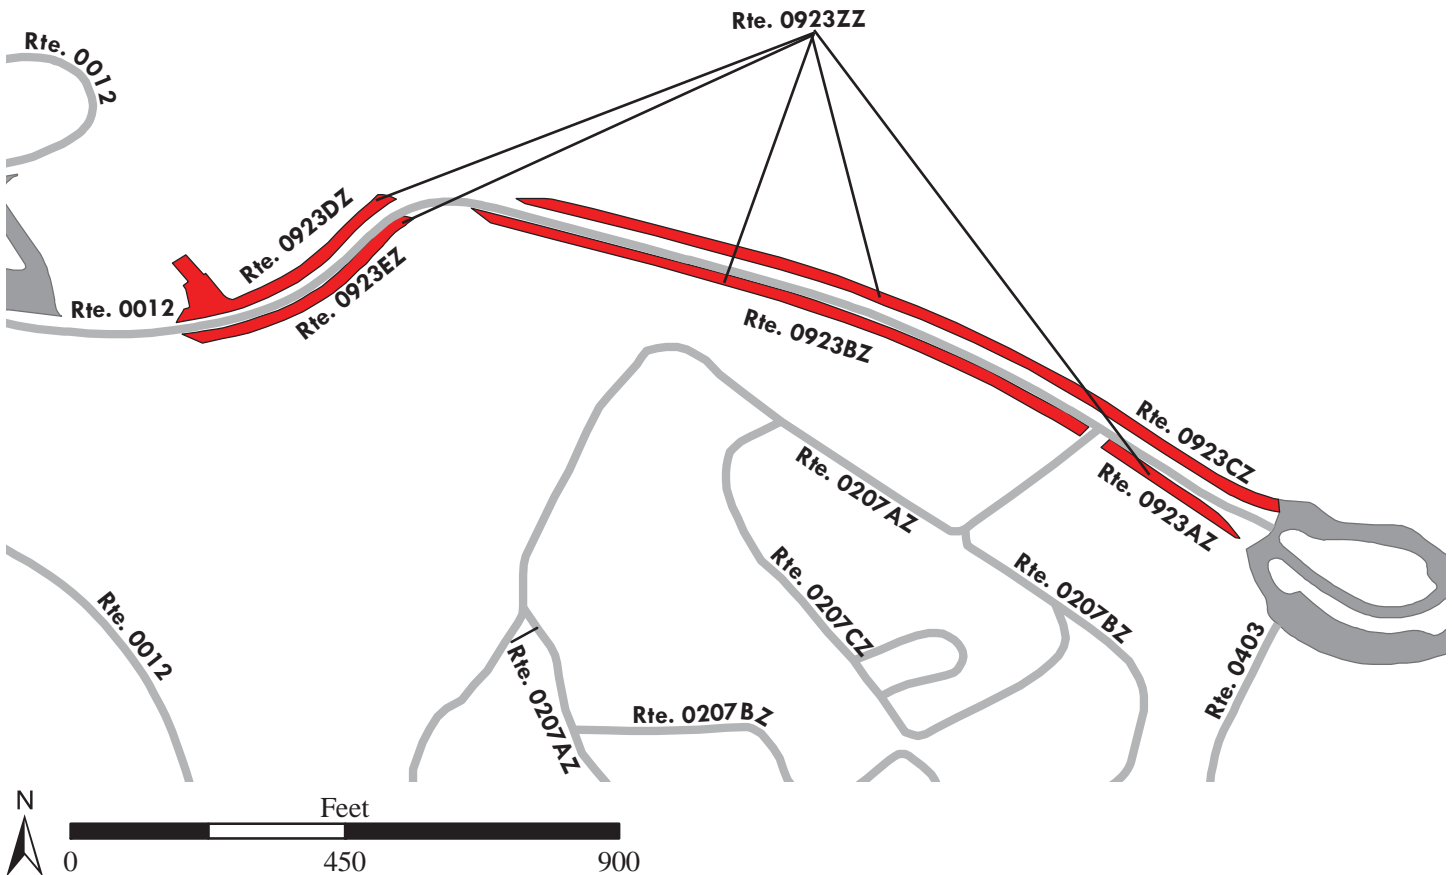
ROUTE 0923ZZ: VISITOR CENTER AND SINNOTT OVERLOOK PARKING AREAS

Inspection Date	FMSS Number	User Access	Surface Type
6/12/2015	75390	PUBLIC	ASPHALT
Area (Sq. Ft.)	Lane Miles (11' Widths)	Condition Rating / PCR	
49,492	0.853	SUMMARY / 47	
Route Condition Legend – Pavement Condition Rating (PCR)			
Poor (0 - 60)	Fair (61- 84)	Good (85 - 94)	Excellent (95 - 100)
Not Rated			
See Appendix for definitions and formulas

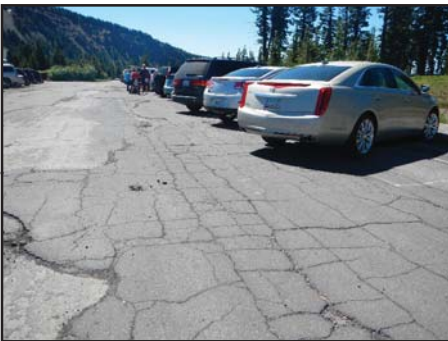
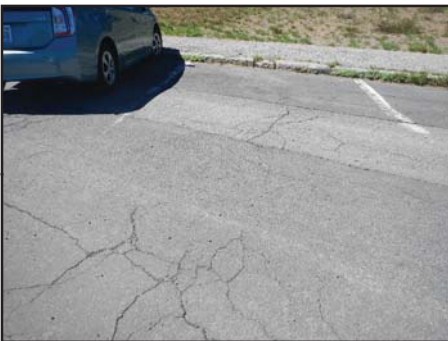
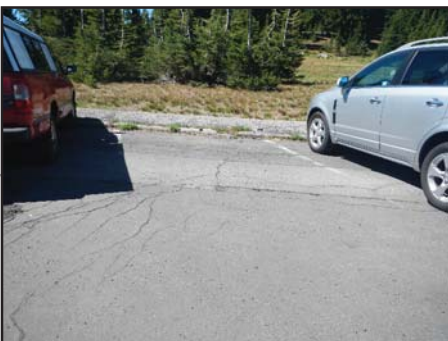
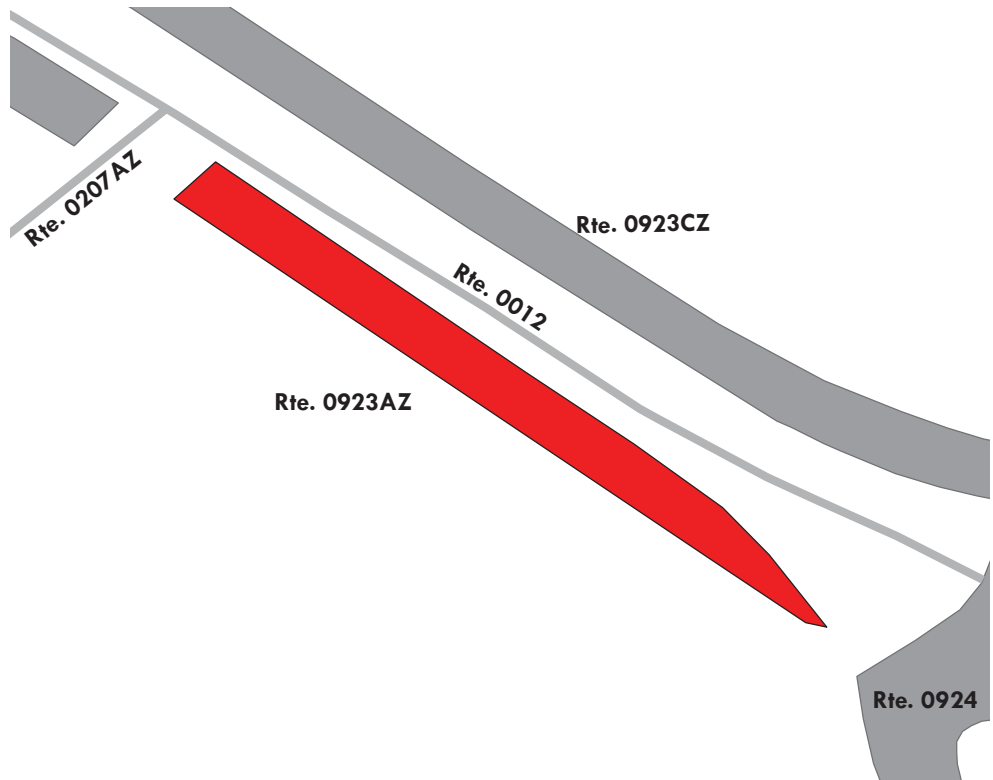
ROUTE 0923AZ: VISITOR CENTER AND SINNOTT OVERLOOK PARKING A

Inspection Date	FMSS Number	User Access	Surface Type
6/12/2015	75390	PUBLIC	ASPHALT
Area (Sq. Ft.)	Lane Miles (11' Widths)	Curb Reveal (Inches)	Curb Recommendation
3,359	0.058	5	DO NOTHING
Curb Type		Curb & Gutter Type	
STONE		NO CURB AND GUTTER	
Pavement Recommendation		Condition Rating / PCR	
RECONSTRUCTION		POOR / 30

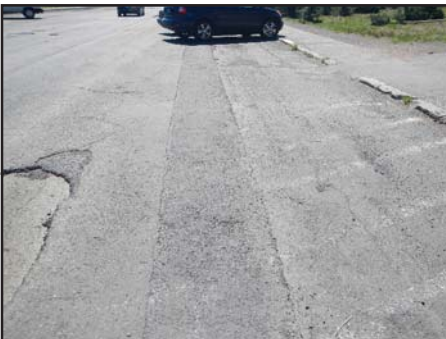
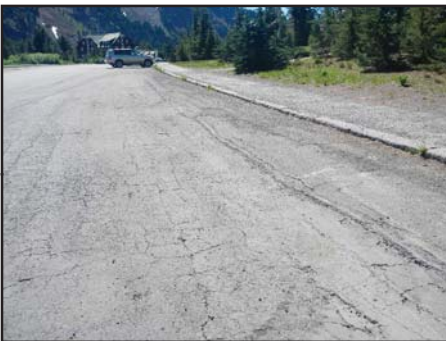
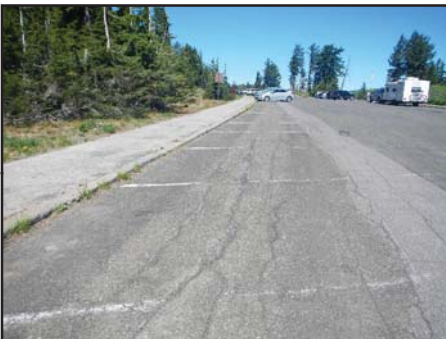
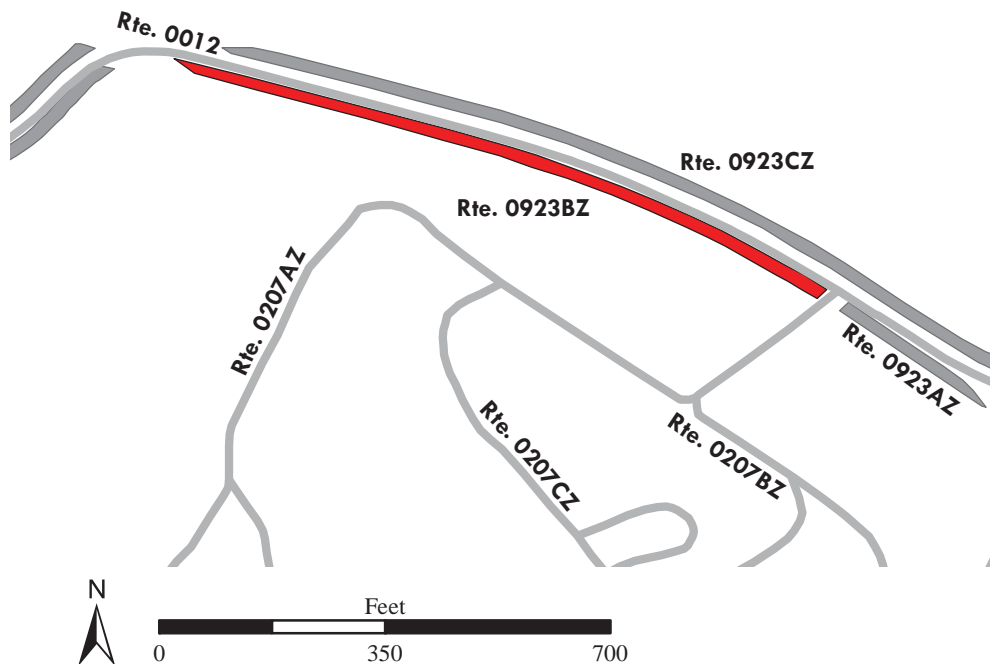
ROUTE 0923BZ: VISITOR CENTER AND SINNOTT OVERLOOK PARKING B

Inspection Date	FMSS Number	User Access	Surface Type
6/12/2015	75390	PUBLIC	ASPHALT
Area (Sq. Ft.)	Lane Miles (11' Widths)	Curb Reveal (Inches)	Curb Recommendation
13,682	0.236	3	LIGHT REPAIR
Curb Type		Curb & Gutter Type	
STONE		NO CURB AND GUTTER	
Pavement Recommendation		Condition Rating / PCR	
RECONSTRUCTION		POOR / 30
