CRLA Cycle 6

Final Report

Road Inventory and Condition Assessment of Paved Routes Crater Lake National Park

Report Date: February 2016

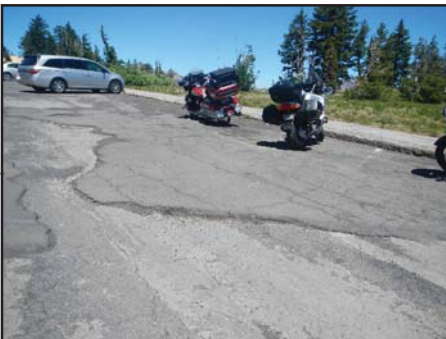
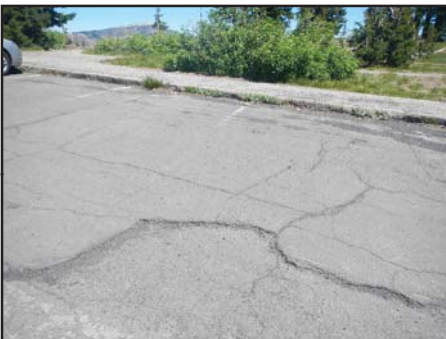
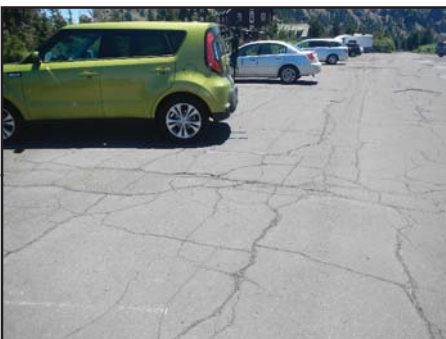
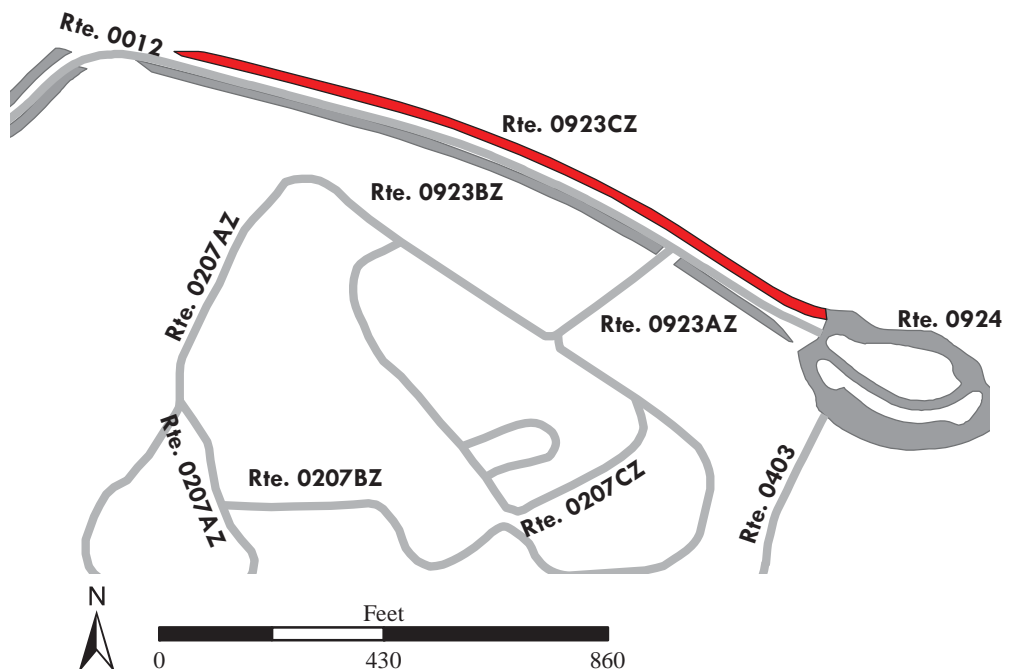
ROUTE 0923CZ: VISITOR CENTER AND SINNOTT OVERLOOK PARKING C

Inspection Date	FMSS Number	User Access	Surface Type
6/12/2015	75390	PUBLIC	ASPHALT
Area (Sq. Ft.)	Lane Miles (11' Widths)	Curb Reveal (Inches)	Curb Recommendation
18,106	0.312	6	DO NOTHING
Curb Type		Curb & Gutter Type	
STONE		NO CURB AND GUTTER	
Pavement Recommendation		Condition Rating / PCR	
RECONSTRUCTION		POOR / 30

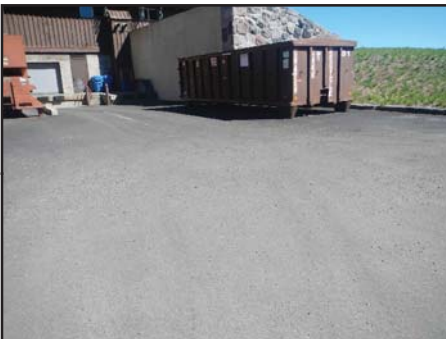
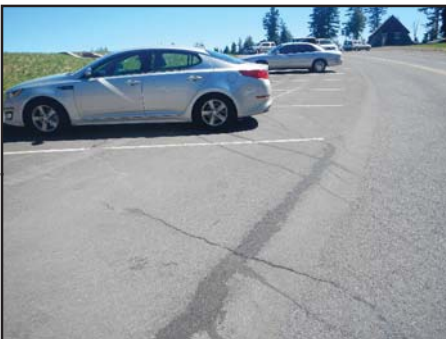
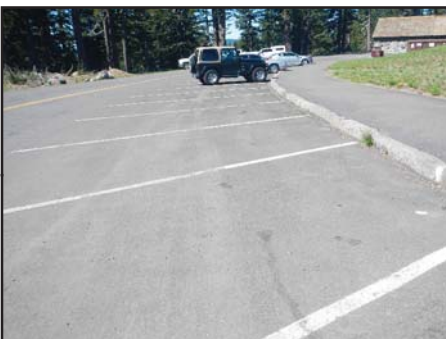
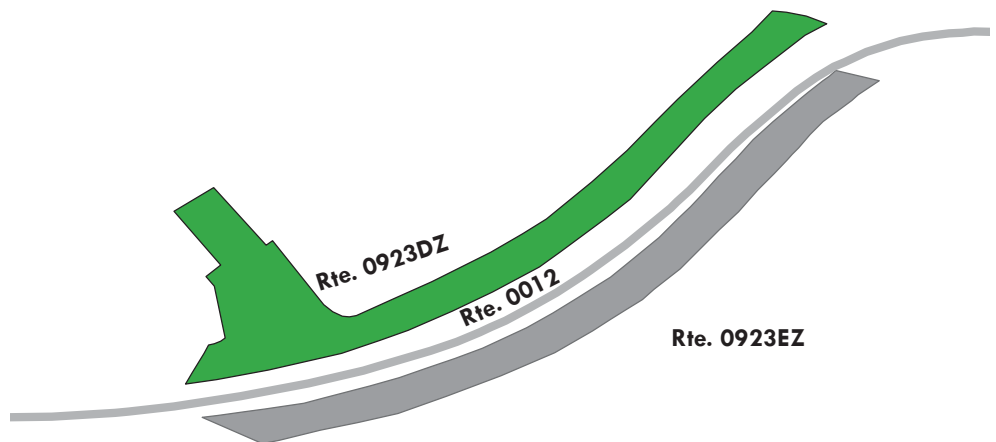
Inspection Date	FMSS Number	User Access	Surface Type
6/12/2015	75390	PUBLIC	ASPHALT
Area (Sq. Ft.)	Lane Miles (11' Widths)	Curb Reveal (Inches)	Curb Recommendation
8,398	0.145	6	DO NOTHING
Curb Type		Curb & Gutter Type	
STONE		NO CURB AND GUTTER	
Pavement Recommendation		Condition Rating / PCR	
PREVENTIVE MAINTENANCE		GOOD / 90

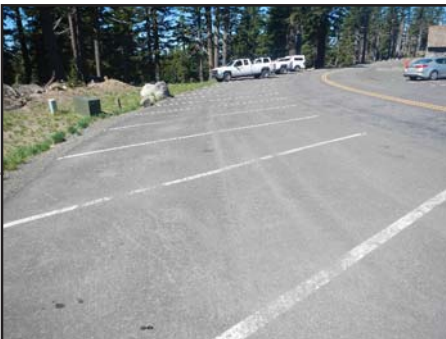
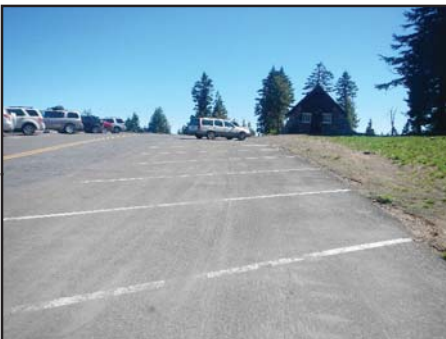
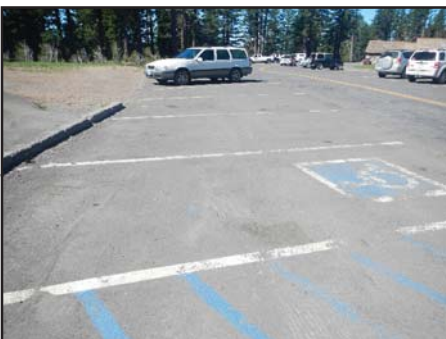
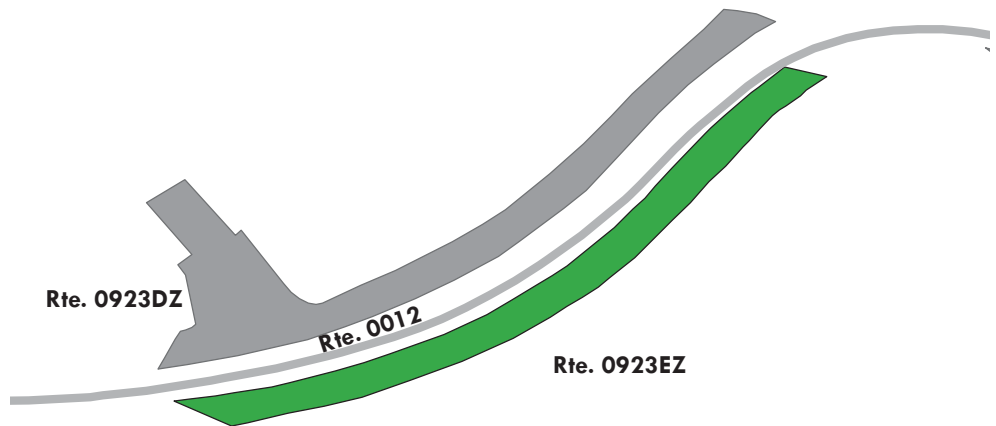
ROUTE 0923EZ: VISITOR CENTER AND SINNOTT OVERLOOK PARKING E

Inspection Date	FMSS Number	User Access	Surface Type
6/12/2015	75390	PUBLIC	ASPHALT
Area (Sq. Ft.)	Lane Miles (11' Widths)	Curb Reveal (Inches)	Curb Recommendation
5,947	0.102	6	DO NOTHING
Curb Type		Curb & Gutter Type	
STONE		NO CURB AND GUTTER	
Pavement Recommendation		Condition Rating / PCR	
PREVENTIVE MAINTENANCE		GOOD / 90

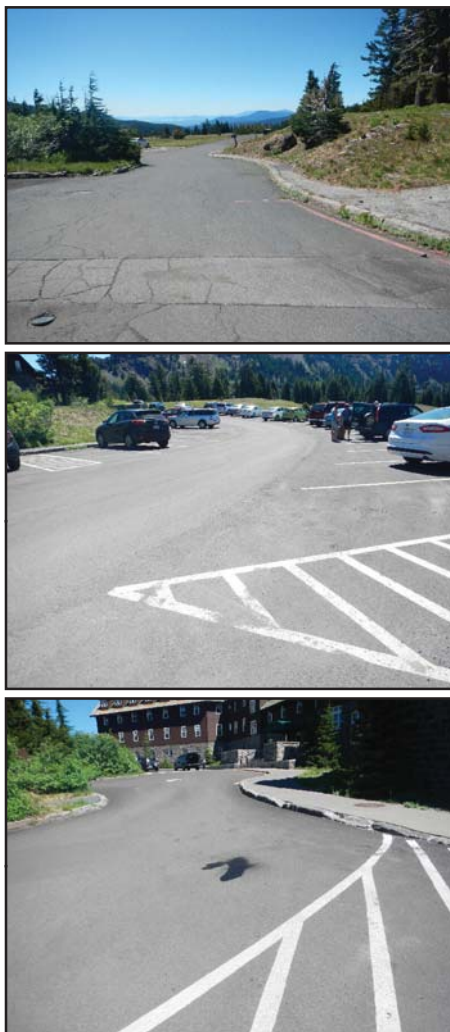
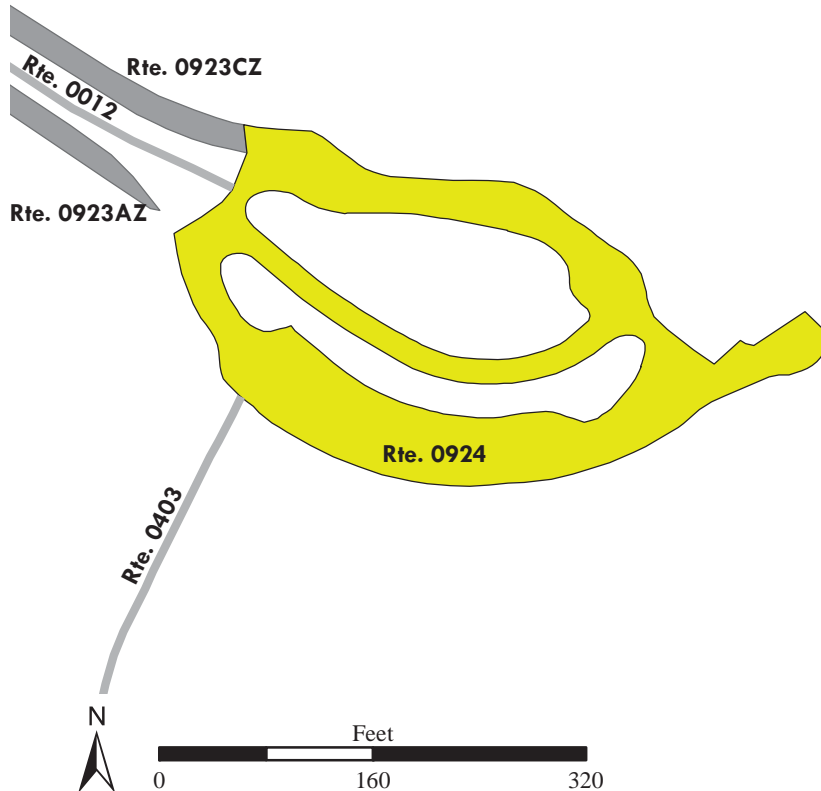
ROUTE 0924: CRATER LAKE LODGE PARKING

Inspection Date	FMSS Number	User Access	Surface Type
6/12/2015	75391	PUBLIC	ASPHALT
Area (Sq. Ft.)	Lane Miles (11' Widths)	Curb Reveal (Inches)	Curb Recommendation
33,826	0.582	5	DO NOTHING
Curb Type		Curb & Gutter Type	
STONE		NO CURB AND GUTTER	
Pavement Recommendation		Condition Rating / PCR	
LIGHT 3R TREATMENTS		FAIR / 73

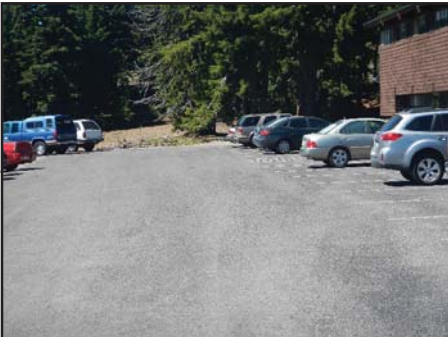
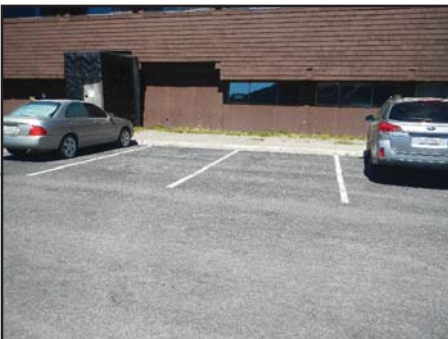
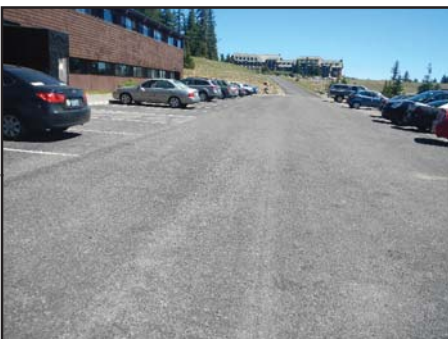
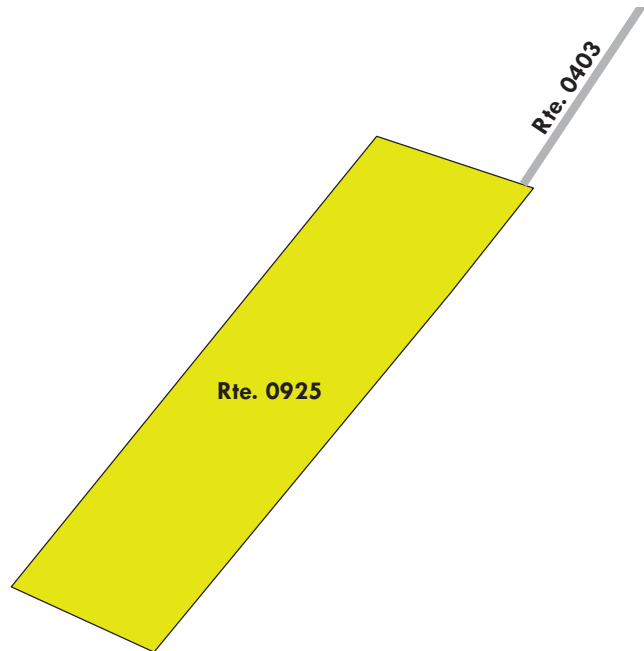
ROUTE 0925: CRATER LAKE LODGE RESIDENCE PARKING

Inspection Date	FMSS Number	User Access	Surface Type
6/12/2015	75392	NONPUBLIC	ASPHALT
Area (Sq. Ft.)	Lane Miles (11' Widths)	Curb Reveal (Inches)	Curb Recommendation
8,203	0.141	5	DO NOTHING
Curb Type		Curb & Gutter Type	
CONCRETE		NO CURB AND GUTTER	
Pavement Recommendation		Condition Rating / PCR	
LIGHT 3R TREATMENTS		FAIR / 73

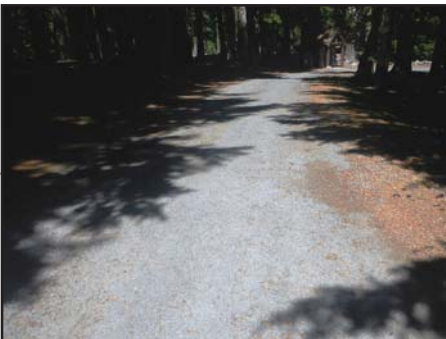
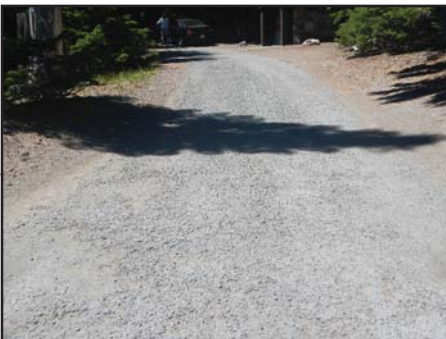
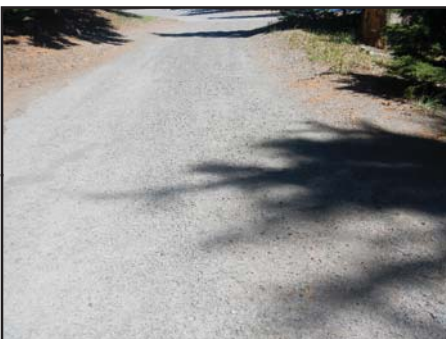
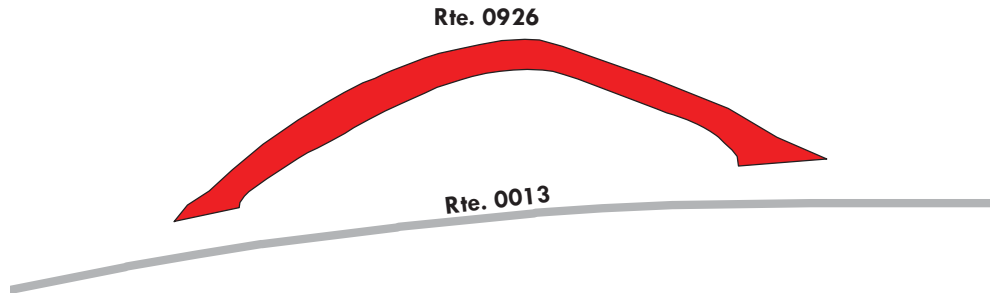
ROUTE 0926: CLEETWOOD (PUMICE POINT) PICNIC AREA

Inspection Date	FMSS Number	User Access	Surface Type
6/12/2015	75493	PUBLIC	ASPHALT
Area (Sq. Ft.)	Lane Miles (11' Widths)	Curb Reveal (Inches)	Curb Recommendation
3,941	0.068	NOT APPLICABLE	NOT APPLICABLE
Curb Type		Curb & Gutter Type	
NO CURB		NO CURB AND GUTTER	
Pavement Recommendation		Condition Rating / PCR	
RECONSTRUCTION		POOR / 0

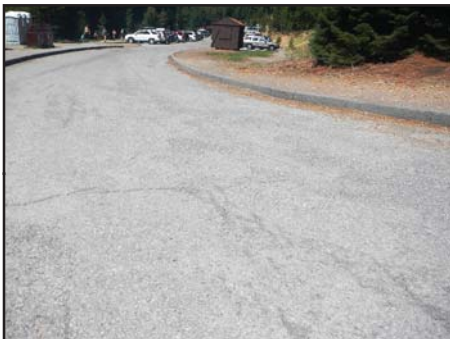
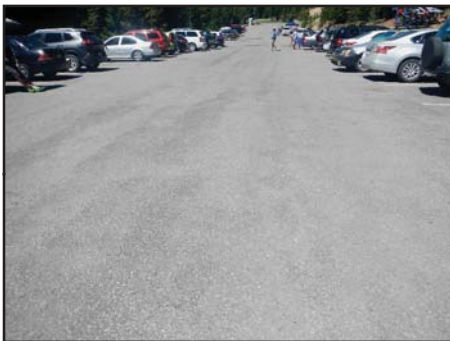
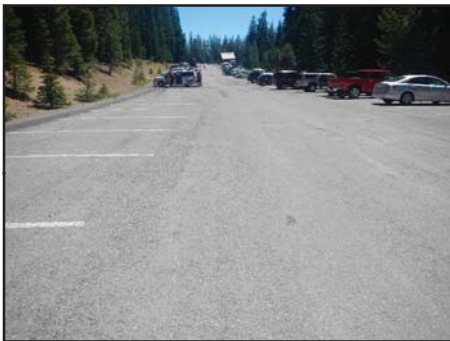
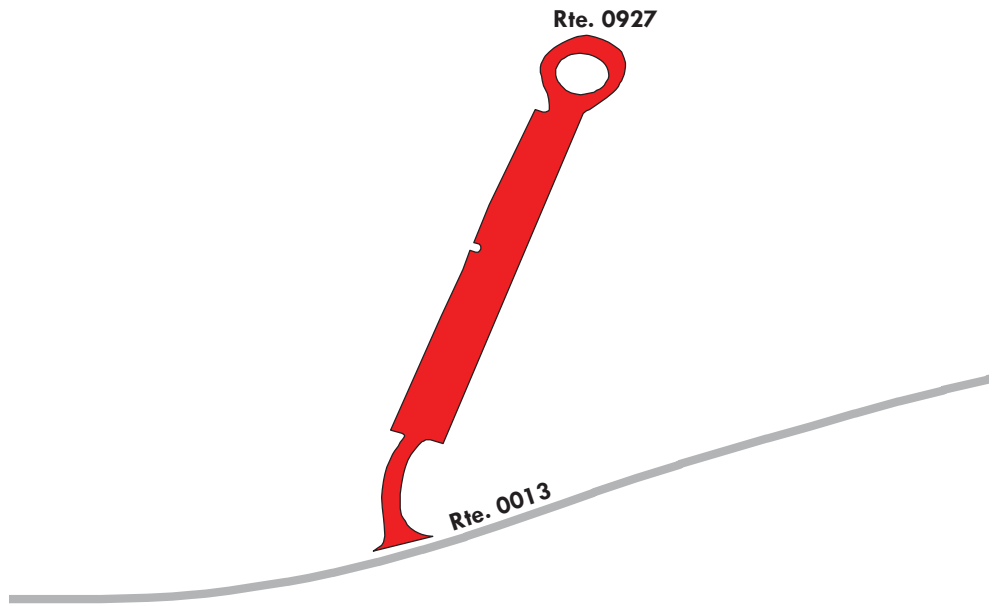
ROUTE 0927: CLEETWOOD TRAIL PARKING

Inspection Date	FMSS Number	User Access	Surface Type
6/12/2015	75496	PUBLIC	ASPHALT
Area (Sq. Ft.)	Lane Miles (11' Widths)	Curb Reveal (Inches)	Curb Recommendation
39,231	0.675	7	REPLACE
Curb Type		Curb & Gutter Type	
ASPHALT		CONCRETE	
Pavement Recommendation		Condition Rating / PCR	
HEAVY 3R TREATMENTS		POOR / 53

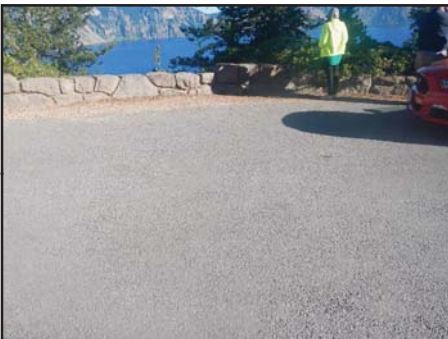
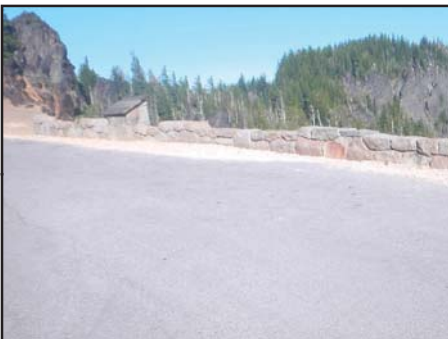
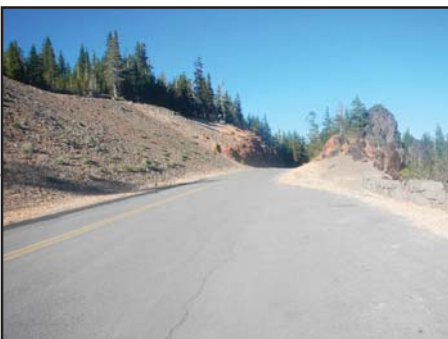
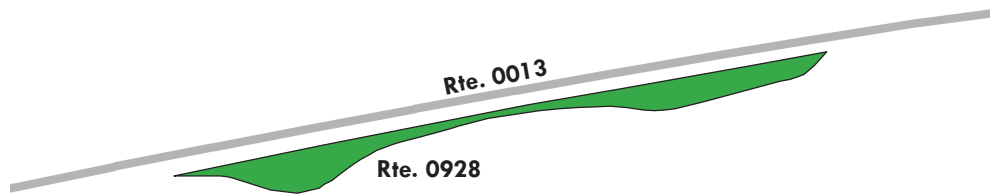
ROUTE 0928: THE CLEETWOOD OVER FLOW PARKING

Inspection Date	FMSS Number	User Access	Surface Type
6/12/2015	75497	PUBLIC	ASPHALT
Area (Sq. Ft.)	Lane Miles (11' Widths)	Curb Reveal (Inches)	Curb Recommendation
4,263	0.073	NOT APPLICABLE	NOT APPLICABLE
Curb Type		Curb & Gutter Type	
NO CURB		NO CURB AND GUTTER	
Pavement Recommendation		Condition Rating / PCR	
PREVENTIVE MAINTENANCE		GOOD / 90

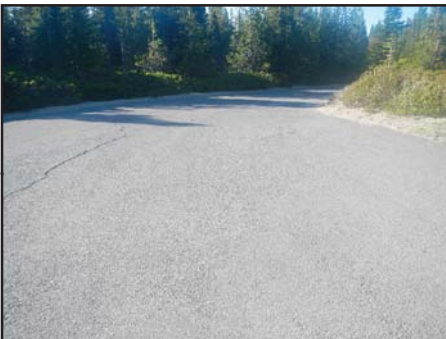
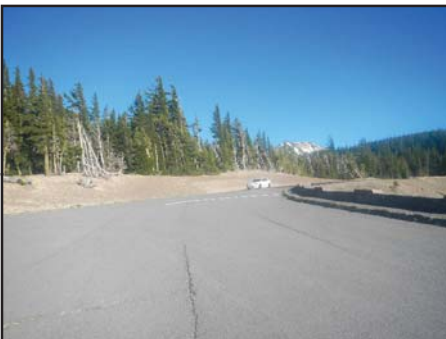
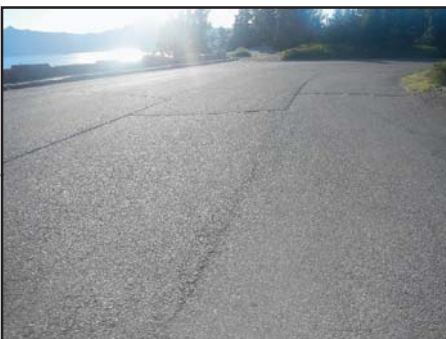
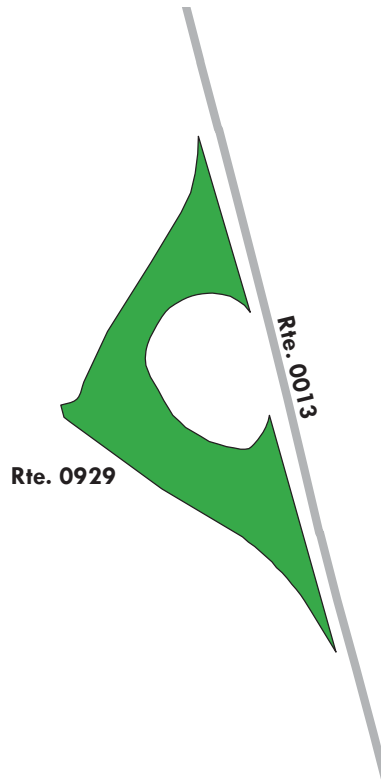
ROUTE 0929: LOWER SKELL OVERLOOK

Inspection Date	FMSS Number	User Access	Surface Type
6/12/2015	75498	PUBLIC	ASPHALT
Area (Sq. Ft.)	Lane Miles (11' Widths)	Curb Reveal (Inches)	Curb Recommendation
13,974	0.241	8	DO NOTHING
Curb Type		Curb & Gutter Type	
STONE		NO CURB AND GUTTER	
Pavement Recommendation		Condition Rating / PCR	
PREVENTIVE MAINTENANCE		GOOD / 90

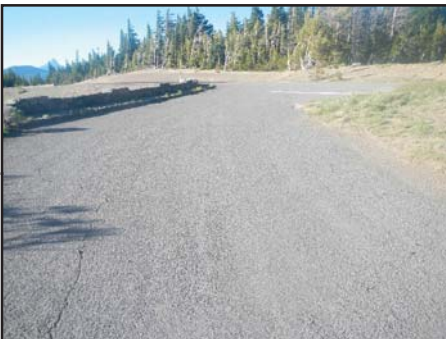
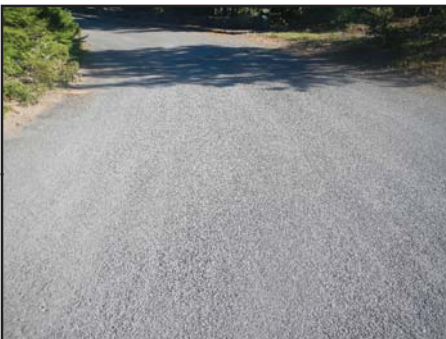
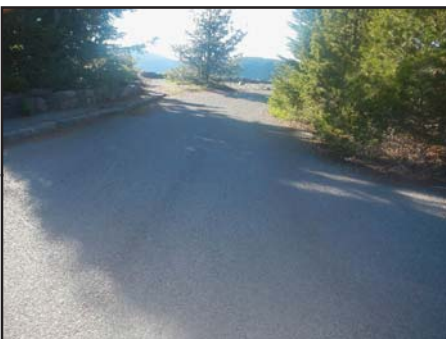
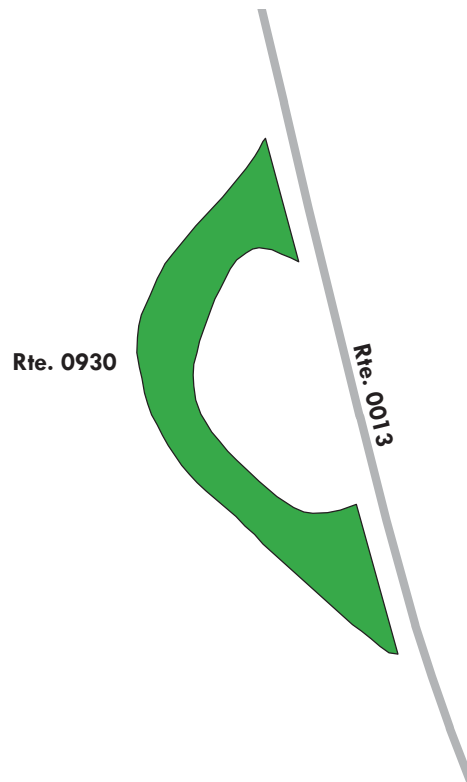
ROUTE 0930: OVERLOOK PARKING

Inspection Date	FMSS Number	User Access	Surface Type
6/12/2015	75499	PUBLIC	ASPHALT
Area (Sq. Ft.)	Lane Miles (11' Widths)	Curb Reveal (Inches)	Curb Recommendation
5,825	0.1	3	DO NOTHING
Curb Type		Curb & Gutter Type	
STONE		NO CURB AND GUTTER	
Pavement Recommendation		Condition Rating / PCR	
PREVENTIVE MAINTENANCE		GOOD / 90

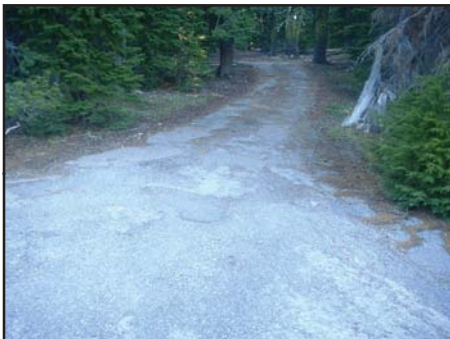
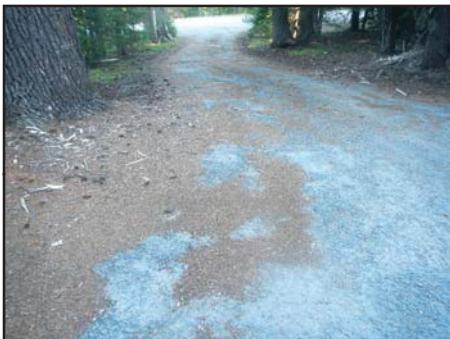
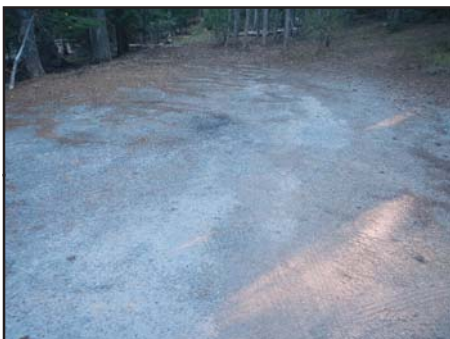
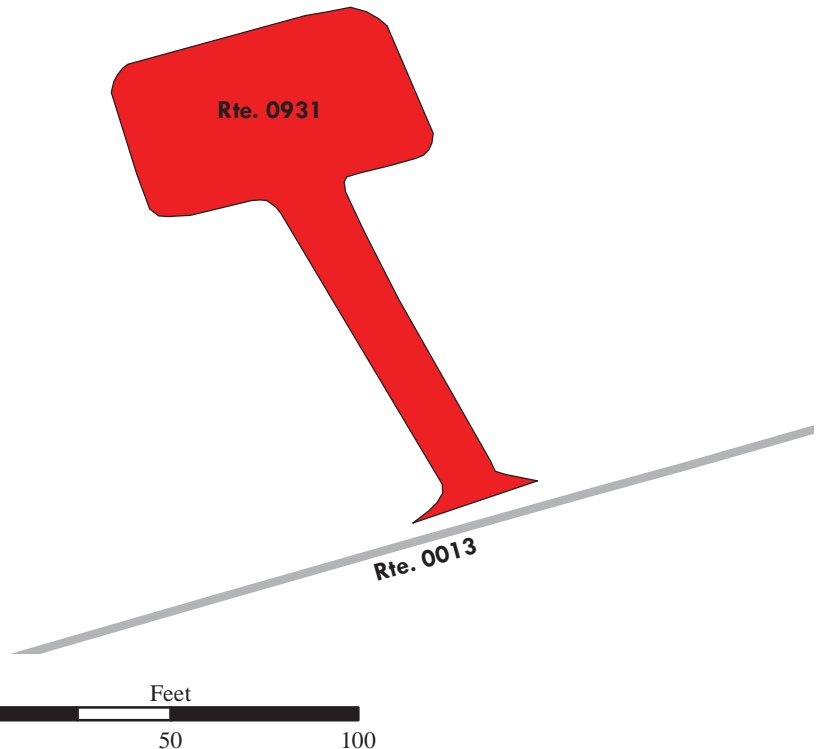
ROUTE 0931: SKELL HEAD PICNIC AREA

Inspection Date	FMSS Number	User Access	Surface Type
6/12/2015	75500	PUBLIC	ASPHALT
Area (Sq. Ft.)	Lane Miles (11' Widths)	Curb Reveal (Inches)	Curb Recommendation
3,564	0.061	NOT APPLICABLE	NOT APPLICABLE
Curb Type		Curb & Gutter Type	
NO CURB		NO CURB AND GUTTER	
Pavement Recommendation		Condition Rating / PCR	
RECONSTRUCTION		POOR / 0

Parking area was given a Pavement Condition Rating (PCR) of 0 because it is in very poor condition. Individual distress indices could not be determined because of the excessive distress quantity and missing sections of pavement.

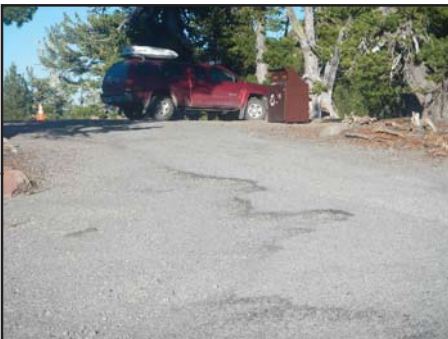
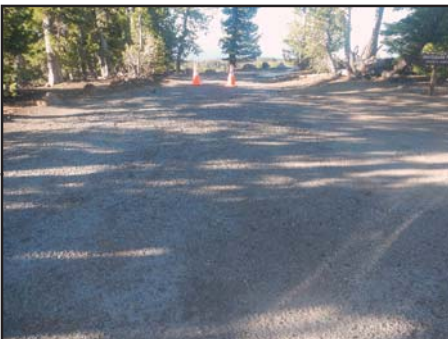
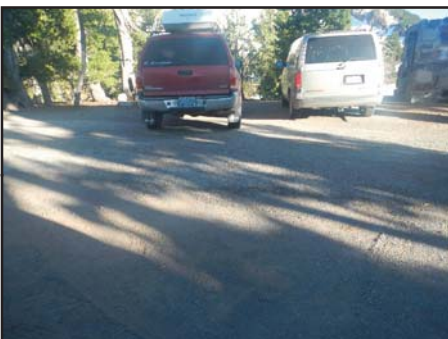
Inspection Date	FMSS Number	User Access	Surface Type
6/12/2015	75502	PUBLIC	ASPHALT
Area (Sq. Ft.)	Lane Miles (11' Widths)	Curb Reveal (Inches)	Curb Recommendation
5,875	0.101	NOT APPLICABLE	NOT APPLICABLE
Curb Type		Curb & Gutter Type	
NO CURB		NO CURB AND GUTTER	
Pavement Recommendation		Condition Rating / PCR	
RECONSTRUCTION		POOR / 0

Parking area was given a Pavement Condition Rating (PCR) of 0 because it is in very poor condition. Individual distress indices could not be determined because of the excessive distress quantity and missing sections of pavement.

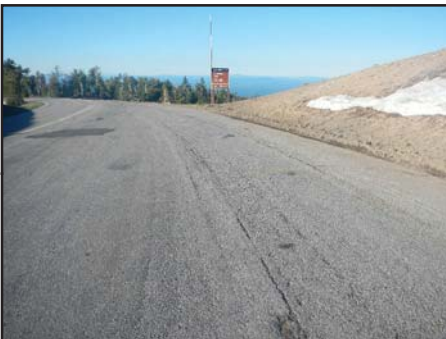
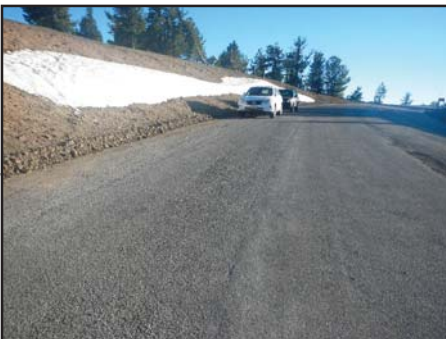
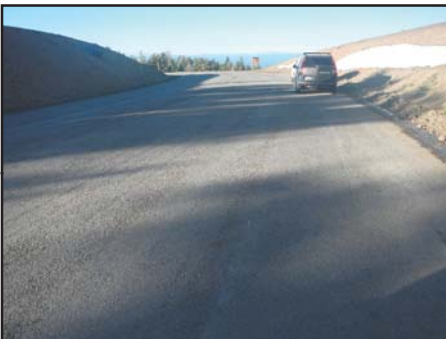
ROUTE 0934: MOUNT SCOTT TRAIL PARKING

Inspection Date	FMSS Number	User Access	Surface Type
6/12/2015	75503	PUBLIC	ASPHALT
Area (Sq. Ft.)	Lane Miles (11' Widths)	Curb Reveal (Inches)	Curb Recommendation
10,636	0.183	NOT APPLICABLE	NOT APPLICABLE
Curb Type		Curb & Gutter Type	
NO CURB		NO CURB AND GUTTER	
Pavement Recommendation		Condition Rating / PCR	
HEAVY 3R TREATMENTS		POOR / 53

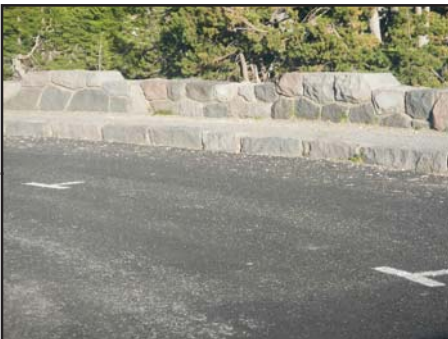
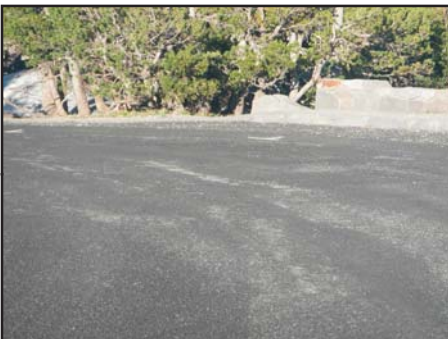
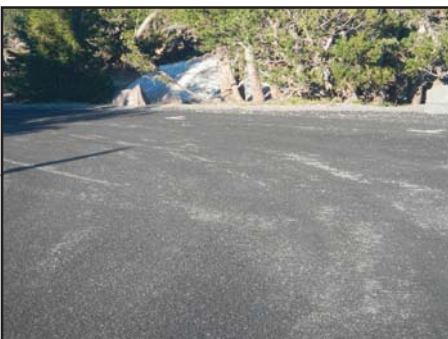
ROUTE 0935: CLOUDCAP OVERLOOK

Inspection Date	FMSS Number	User Access	Surface Type
6/12/2015	75504	PUBLIC	ASPHALT
Area (Sq. Ft.)	Lane Miles (11' Widths)	Curb Reveal (Inches)	Curb Recommendation
3,955	0.068	7	DO NOTHING
Curb Type		Curb & Gutter Type	
STONE		NO CURB AND GUTTER	
Pavement Recommendation		Condition Rating / PCR	
PREVENTIVE MAINTENANCE		GOOD / 90

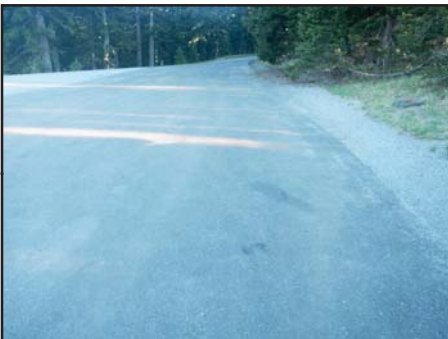
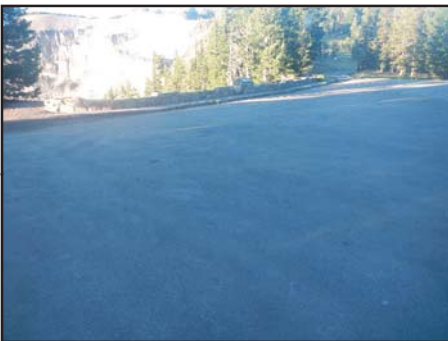
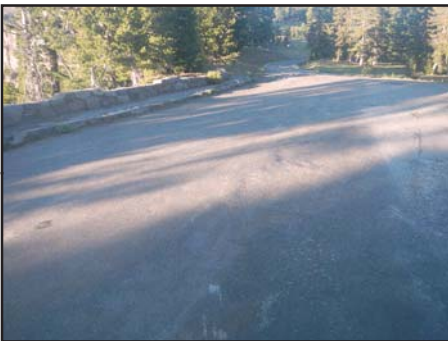
ROUTE 0936: PUMICE CASTLE

Inspection Date	FMSS Number	User Access	Surface Type
6/12/2015	75506	PUBLIC	ASPHALT
Area (Sq. Ft.)	Lane Miles (11' Widths)	Curb Reveal (Inches)	Curb Recommendation
15,925	0.274	7	DO NOTHING
Curb Type		Curb & Gutter Type	
STONE		NO CURB AND GUTTER	
Pavement Recommendation		Condition Rating / PCR	
PREVENTIVE MAINTENANCE		GOOD / 90

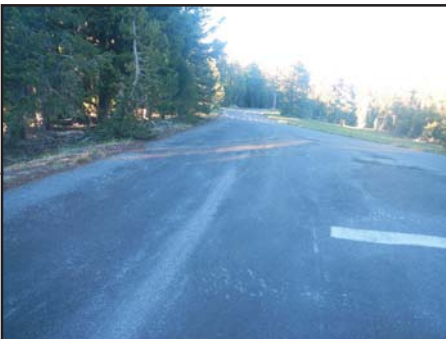
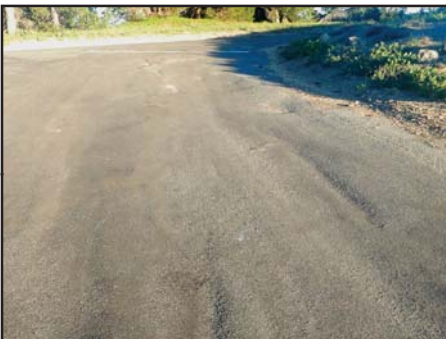
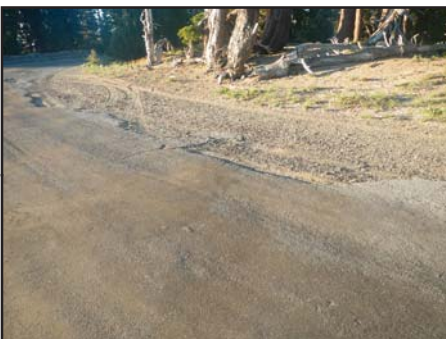
ROUTE 0937: CASTLE ROCK OVERLOOK

Inspection Date	FMSS Number	User Access	Surface Type
6/12/2015	75507	PUBLIC	ASPHALT
Area (Sq. Ft.)	Lane Miles (11' Widths)	Curb Reveal (Inches)	Curb Recommendation
12,731	0.219	7	DO NOTHING
Curb Type		Curb & Gutter Type	
STONE		NO CURB AND GUTTER	
Pavement Recommendation		Condition Rating / PCR	
HEAVY 3R TREATMENTS		POOR / 53

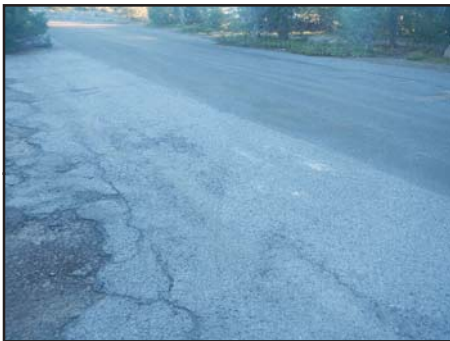
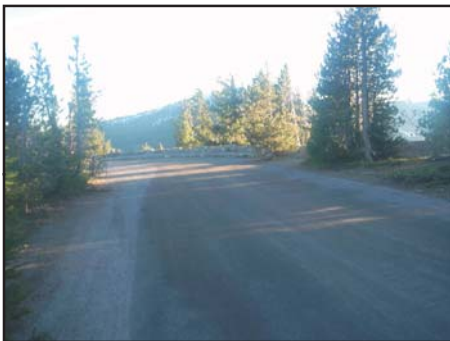
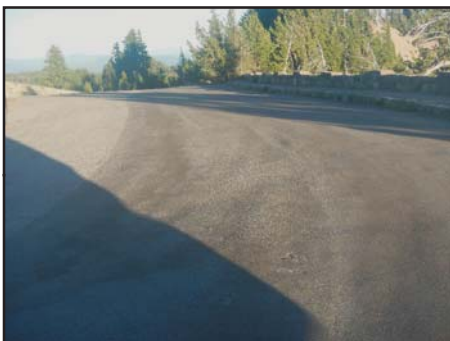
ROUTE 0938: SENTINEL POINT OVERLOOK

Inspection Date	FMSS Number	User Access	Surface Type
6/12/2015	75508	PUBLIC	ASPHALT
Area (Sq. Ft.)	Lane Miles (11' Widths)	Curb Reveal (Inches)	Curb Recommendation
13,386	0.23	8	DO NOTHING
Curb Type		Curb & Gutter Type	
STONE		NO CURB AND GUTTER	
Pavement Recommendation		Condition Rating / PCR	
HEAVY 3R TREATMENTS		POOR / 53

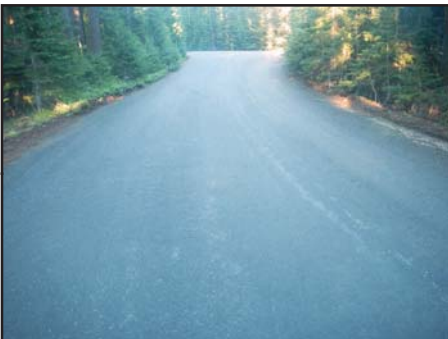
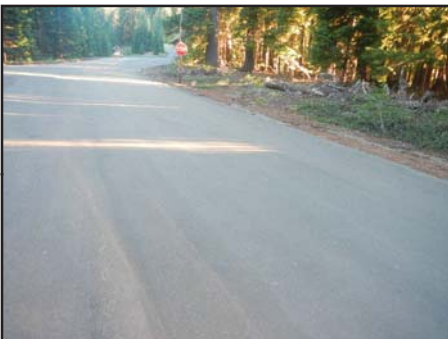
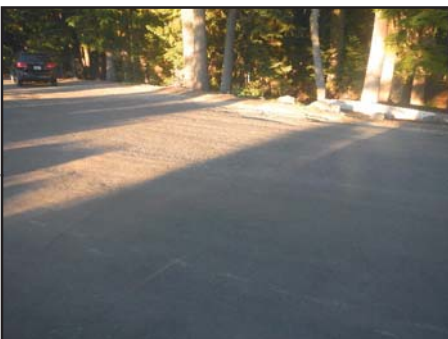
ROUTE 0939: PHANTOM SHIP OVERLOOK

Inspection Date	FMSS Number	User Access	Surface Type
6/11/2015	75509	PUBLIC	ASPHALT
Area (Sq. Ft.)	Lane Miles (11' Widths)	Curb Reveal (Inches)	Curb Recommendation
23,095	0.398	8	DO NOTHING
Curb Type		Curb & Gutter Type	
STONE		NO CURB AND GUTTER	
Pavement Recommendation		Condition Rating / PCR	
LIGHT 3R TREATMENTS		FAIR / 73

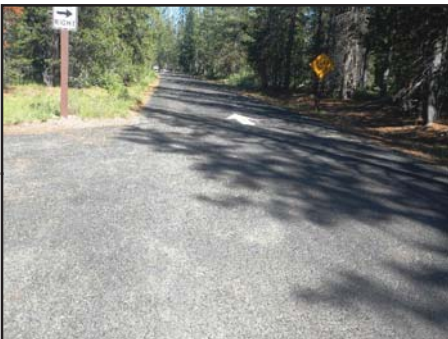
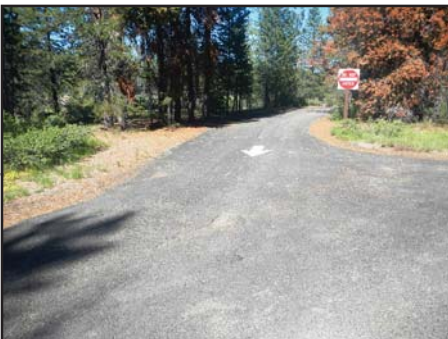
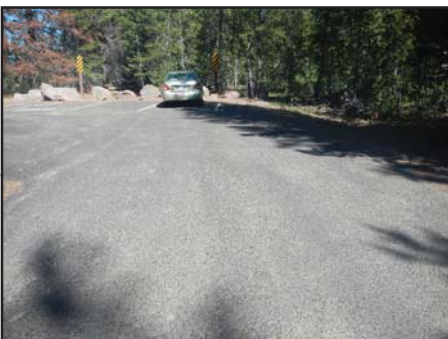
ROUTE 0940: THE PINNACLES OVERLOOK

Inspection Date	FMSS Number	User Access	Surface Type
6/11/2015	75510	PUBLIC	ASPHALT
Area (Sq. Ft.)	Lane Miles (11' Widths)	Curb Reveal (Inches)	Curb Recommendation
14,227	0.245	NOT APPLICABLE	NOT APPLICABLE
Curb Type		Curb & Gutter Type	
NO CURB		NO CURB AND GUTTER	
Pavement Recommendation		Condition Rating / PCR	
LIGHT 3R TREATMENTS		FAIR / 73

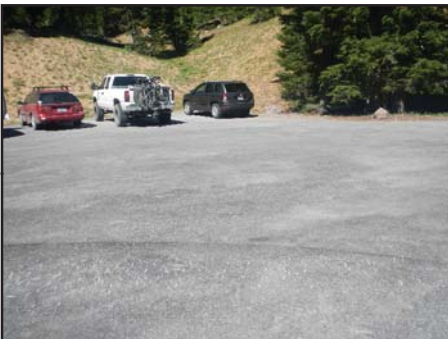
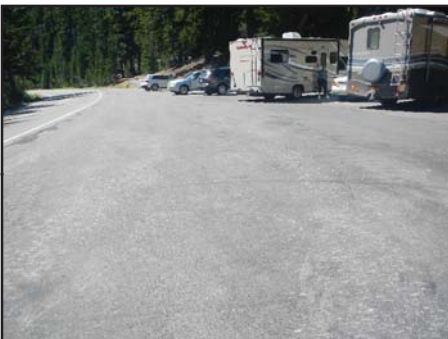
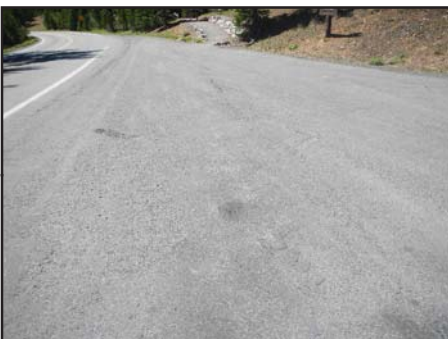
ROUTE 0941: SUN NOTCH PARKING

Inspection Date	FMSS Number	User Access	Surface Type
6/11/2015	75511	PUBLIC	ASPHALT
Area (Sq. Ft.)	Lane Miles (11' Widths)	Curb Reveal (Inches)	Curb Recommendation
10,951	0.189	NOT APPLICABLE	NOT APPLICABLE
Curb Type		Curb & Gutter Type	
NO CURB		NO CURB AND GUTTER	
Pavement Recommendation		Condition Rating / PCR	
PREVENTIVE MAINTENANCE		GOOD / 90

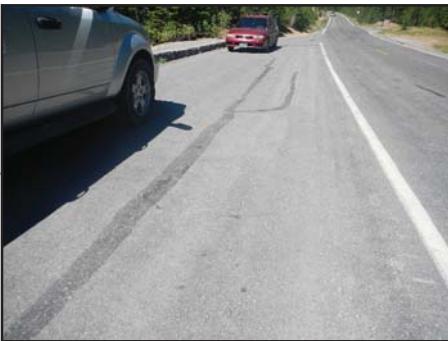
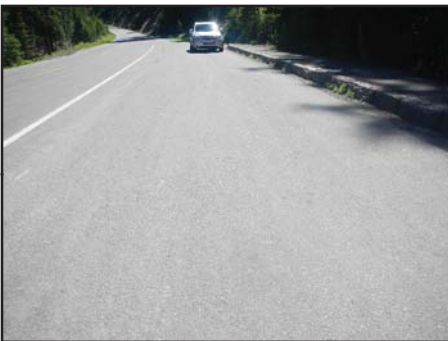
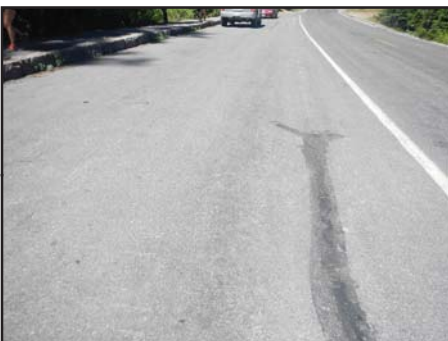
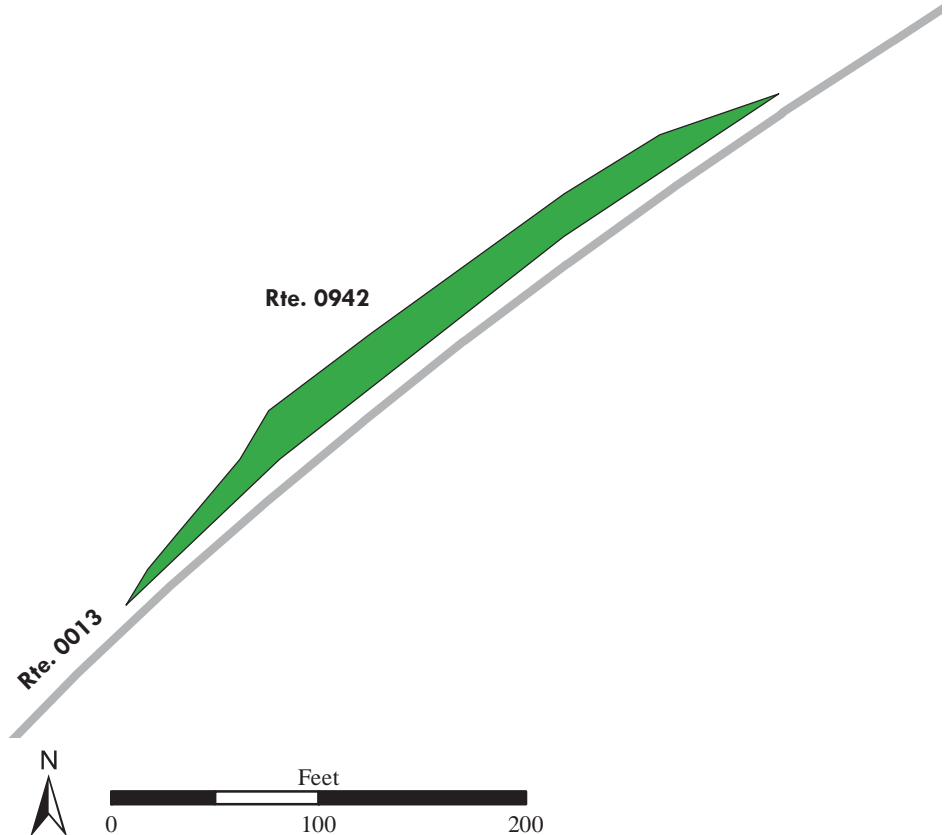
Inspection Date	FMSS Number	User Access	Surface Type
6/11/2015	75512	PUBLIC	ASPHALT
Area (Sq. Ft.)	Lane Miles (11' Widths)	Curb Reveal (Inches)	Curb Recommendation
4,278	0.074	9	DO NOTHING
Curb Type		Curb & Gutter Type	
STONE		NO CURB AND GUTTER	
Pavement Recommendation		Condition Rating / PCR	
PREVENTIVE MAINTENANCE		GOOD / 90

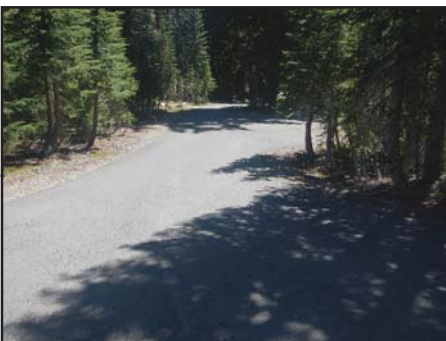
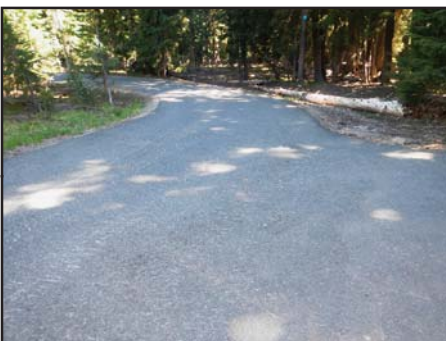
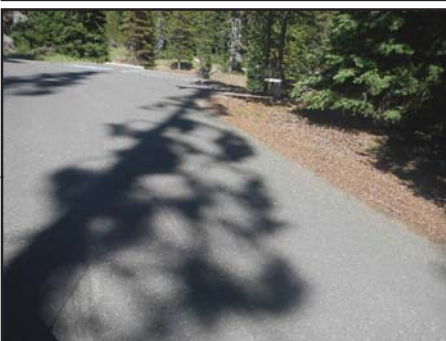
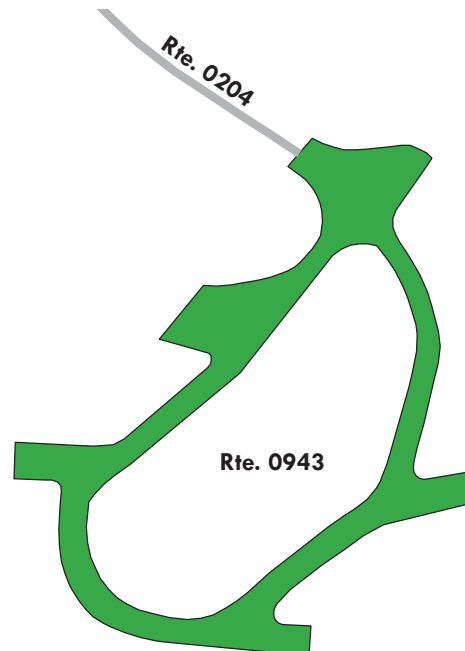
ROUTE 0943: CRATER PEAK TRAIL PARKING

Inspection Date	FMSS Number	User Access	Surface Type
6/11/2015	75513	PUBLIC	ASPHALT
Area (Sq. Ft.)	Lane Miles (11' Widths)	Curb Reveal (Inches)	Curb Recommendation
10,134	0.174	NOT APPLICABLE	NOT APPLICABLE
Curb Type		Curb & Gutter Type	
NO CURB		NO CURB AND GUTTER	
Pavement Recommendation		Condition Rating / PCR	
PREVENTIVE MAINTENANCE		GOOD / 90

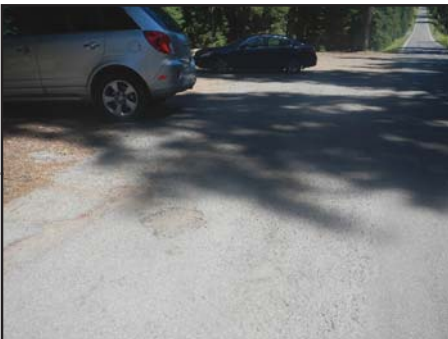
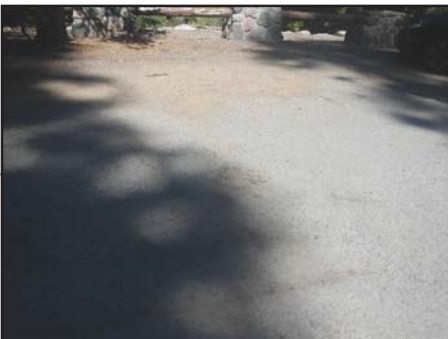
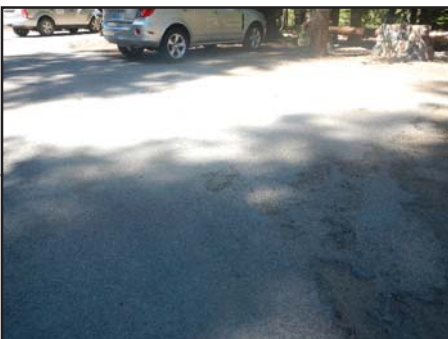
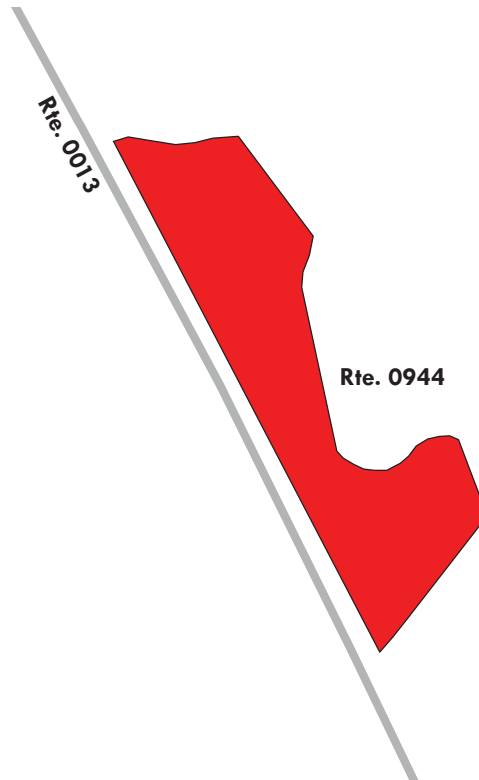
ROUTE 0944: CASTLE CREST PARKING

Inspection Date	FMSS Number	User Access	Surface Type
6/11/2015	75514	PUBLIC	ASPHALT
Area (Sq. Ft.)	Lane Miles (11' Widths)	Curb Reveal (Inches)	Curb Recommendation
1,489	0.026	NOT APPLICABLE	NOT APPLICABLE
Curb Type		Curb & Gutter Type	
NO CURB		NO CURB AND GUTTER	
Pavement Recommendation		Condition Rating / PCR	
HEAVY 3R TREATMENTS		POOR / 53

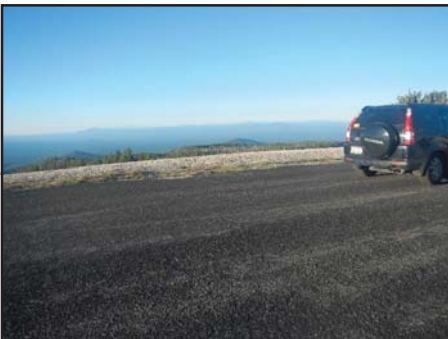
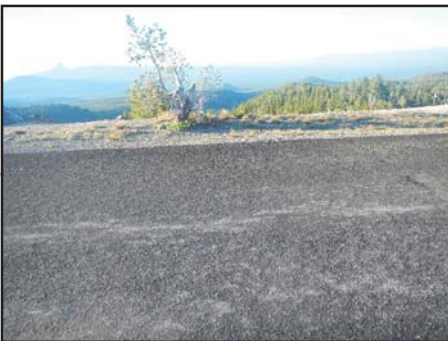
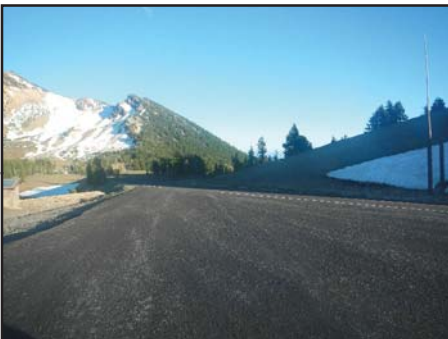
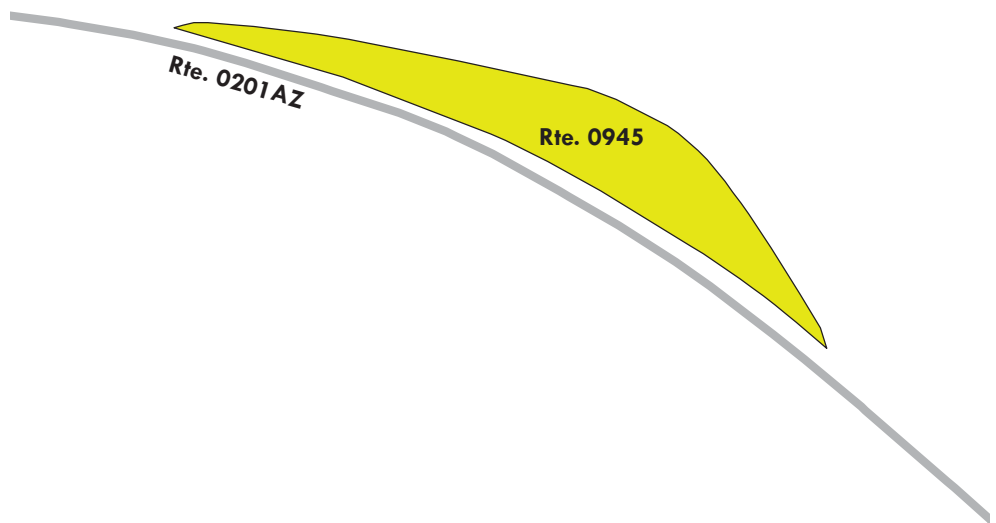
ROUTE 0945: MOUNT SCOTT OVERLOOK

Inspection Date	FMSS Number	User Access	Surface Type
6/12/2015	75515	PUBLIC	ASPHALT
Area (Sq. Ft.)	Lane Miles (11' Widths)	Curb Reveal (Inches)	Curb Recommendation
7,427	0.128	NOT APPLICABLE	NOT APPLICABLE
Curb Type		Curb & Gutter Type	
NO CURB		NO CURB AND GUTTER	
Pavement Recommendation		Condition Rating / PCR	
LIGHT 3R TREATMENTS		FAIR / 73

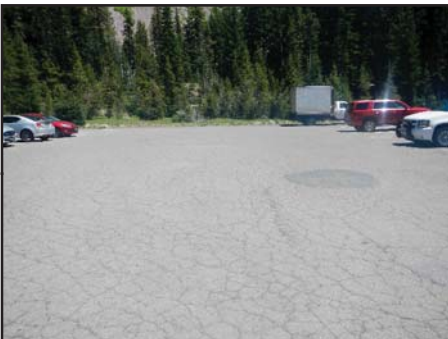
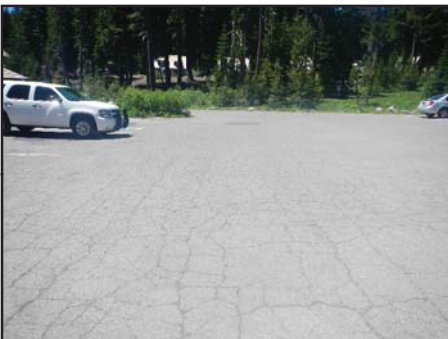
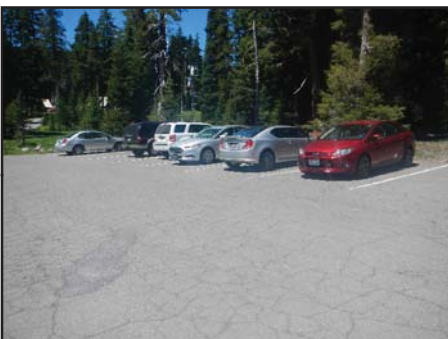
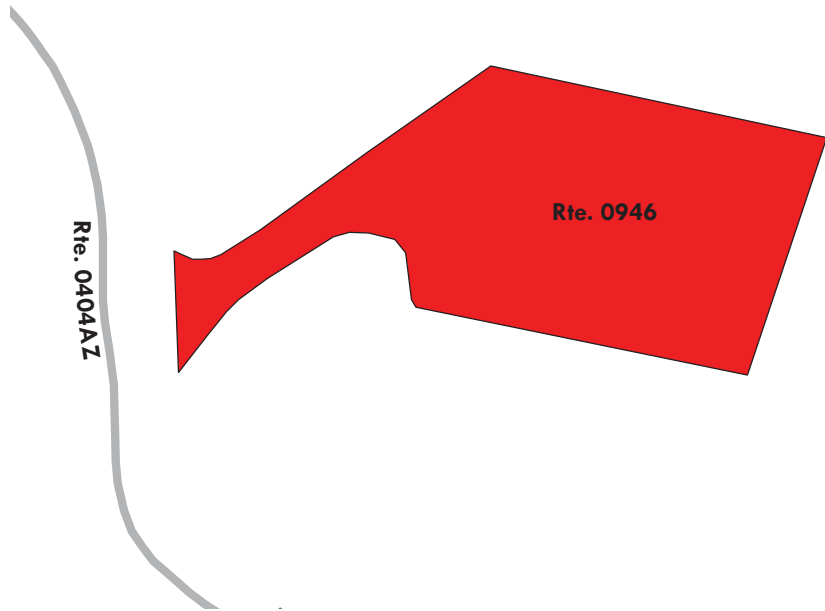
ROUTE 0946: ADMINISTRATION PARKING

Inspection Date	FMSS Number	User Access	Surface Type
6/11/2015	75516	NONPUBLIC	ASPHALT
Area (Sq. Ft.)	Lane Miles (11' Widths)	Curb Reveal (Inches)	Curb Recommendation
10,459	0.18	NOT APPLICABLE	NOT APPLICABLE
Curb Type		Curb & Gutter Type	
NO CURB		NO CURB AND GUTTER	
Pavement Recommendation		Condition Rating / PCR	
RECONSTRUCTION		POOR / 30

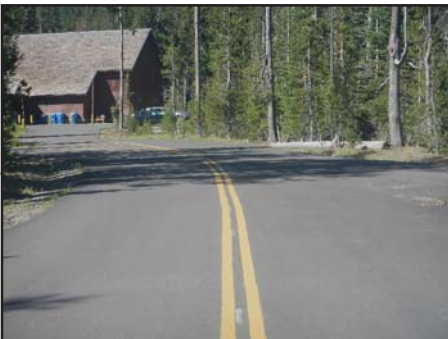
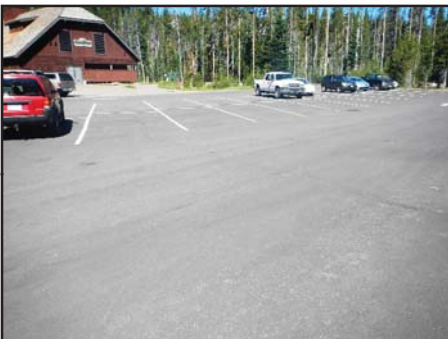
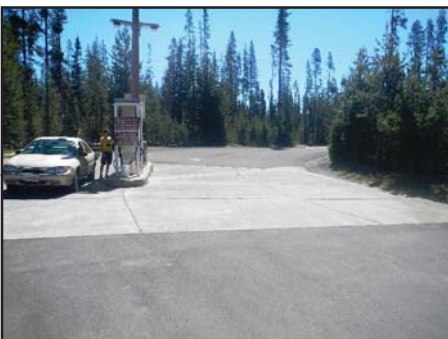
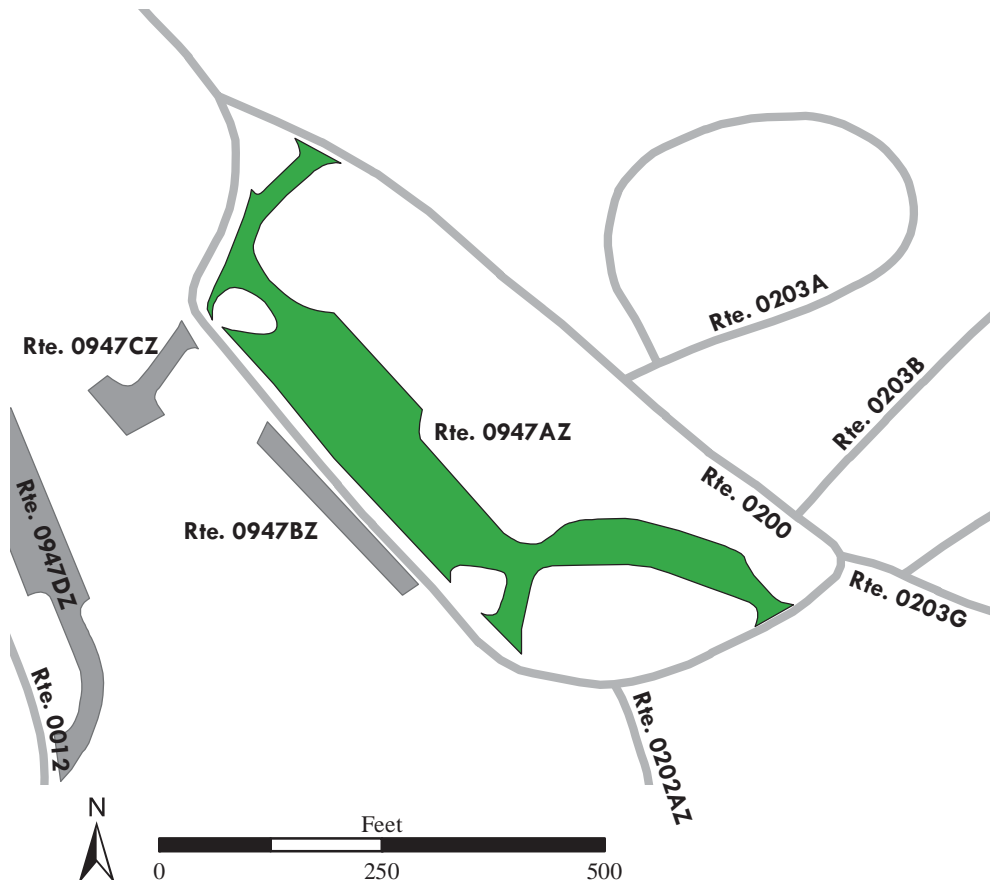
ROUTE 0947AZ: MAZAMA VILLAGE STORE PARKING A

Inspection Date	FMSS Number	User Access	Surface Type
6/11/2015	99597	PUBLIC	ASPHALT
Area (Sq. Ft.)	Lane Miles (11' Widths)	Curb Reveal (Inches)	Curb Recommendation
42,165	0.726	NOT APPLICABLE	NOT APPLICABLE
Curb Type		Curb & Gutter Type	
NO CURB		NO CURB AND GUTTER	
Pavement Recommendation		Condition Rating / PCR	
PREVENTIVE MAINTENANCE		GOOD / 90

Parking area consists of multiple surface types: 1 part Asphalt at 39,776 square feet; 1 part Concrete at 2,389 square feet.
