CRLA Cycle 6

Final Report

Road Inventory and Condition Assessment of Paved Routes Crater Lake National Park

Report Date: February 2016

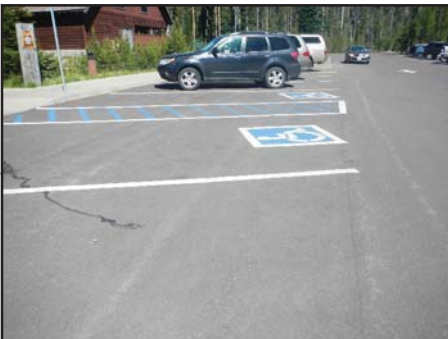
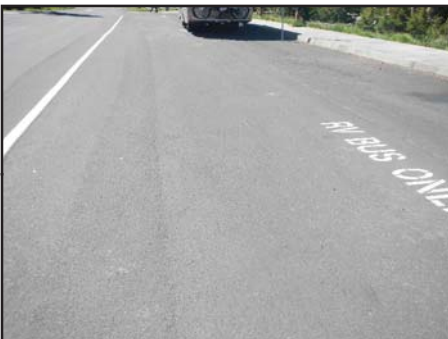
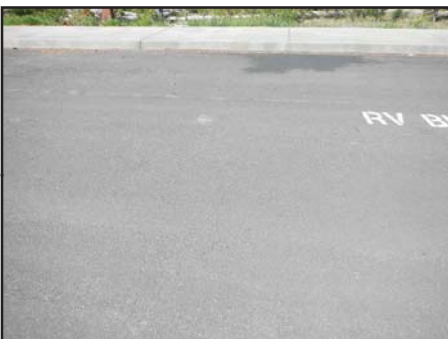
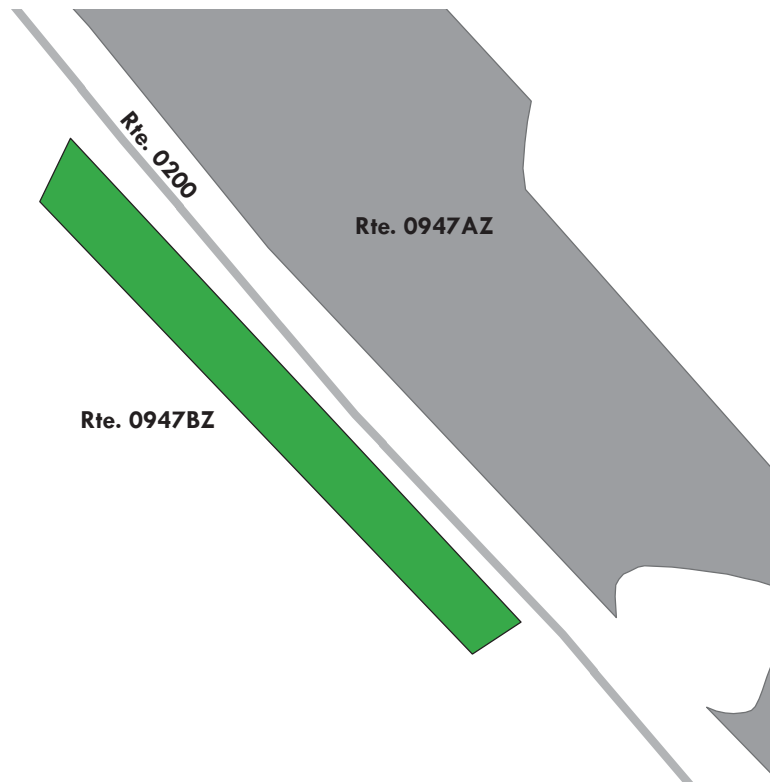
ROUTE 0947BZ: MAZAMA VILLAGE STORE PARKING B

Inspection Date	FMSS Number	User Access	Surface Type
6/11/2015	99597	PUBLIC	ASPHALT
Area (Sq. Ft.)	Lane Miles (11' Widths)	Curb Reveal (Inches)	Curb Recommendation
4,138	0.071	NOT APPLICABLE	NOT APPLICABLE
Curb Type		Curb & Gutter Type	
NO CURB		NO CURB AND GUTTER	
Pavement Recommendation		Condition Rating / PCR	
PREVENTIVE MAINTENANCE		GOOD / 90

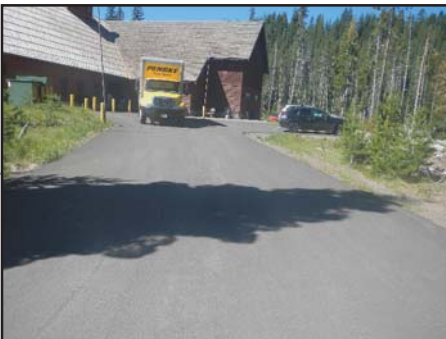
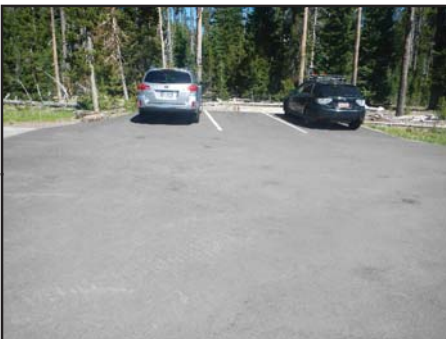
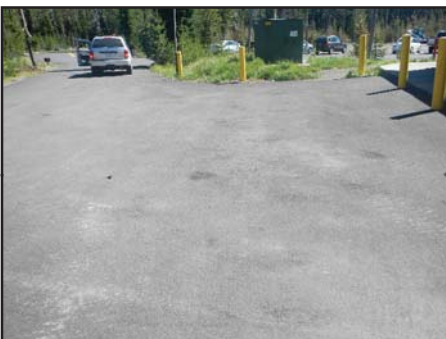
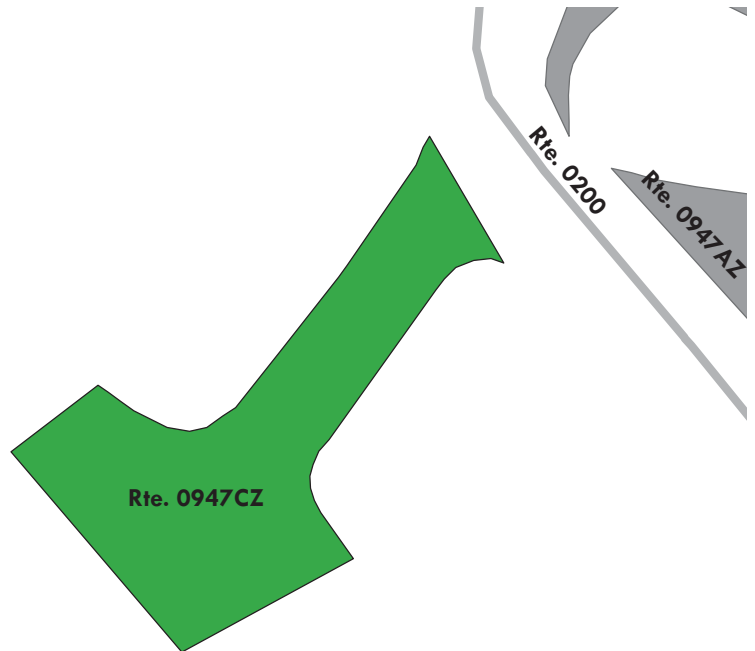
ROUTE 0947CZ: MAZAMA VILLAGE STORE PARKING C

Inspection Date	FMSS Number	User Access	Surface Type
6/11/2015	99597	PUBLIC	ASPHALT
Area (Sq. Ft.)	Lane Miles (11' Widths)	Curb Reveal (Inches)	Curb Recommendation
3,600	0.062	NOT APPLICABLE	NOT APPLICABLE
Curb Type		Curb & Gutter Type	
NO CURB		NO CURB AND GUTTER	
Pavement Recommendation		Condition Rating / PCR	
PREVENTIVE MAINTENANCE		GOOD / 90

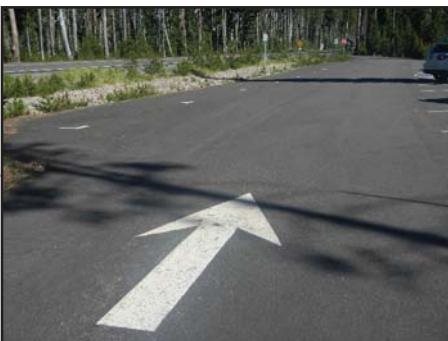
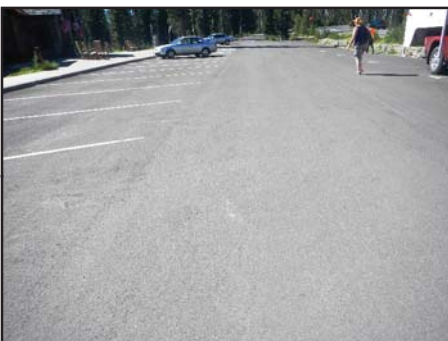
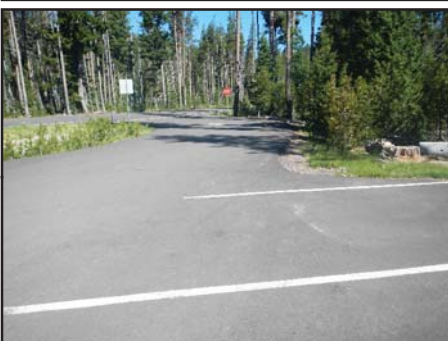
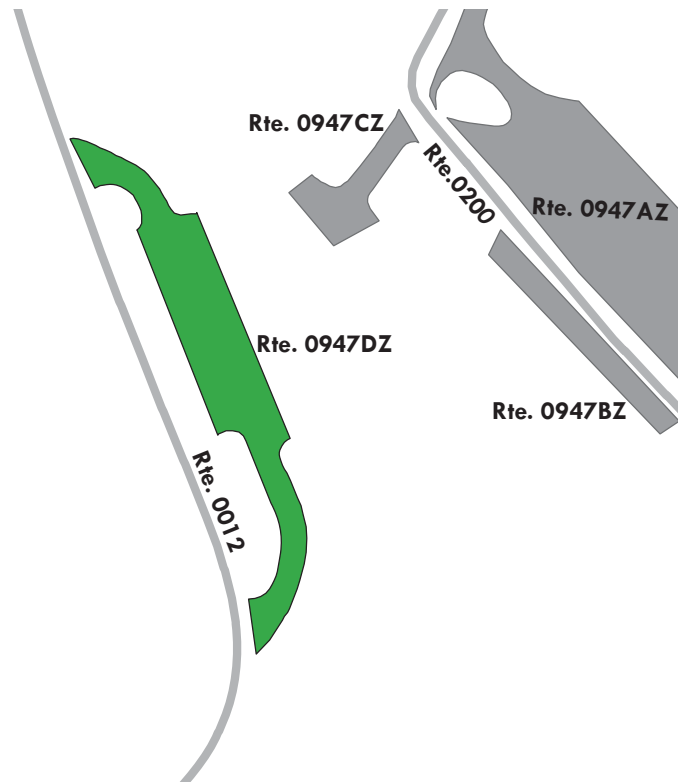
ROUTE 0947DZ: ANNIE CREEK RESTAURANT PARKING

Inspection Date	FMSS Number	User Access	Surface Type
6/11/2015	99597	PUBLIC	ASPHALT
Area (Sq. Ft.)	Lane Miles (11' Widths)	Curb Reveal (Inches)	Curb Recommendation
15,899	0.274	NOT APPLICABLE	NOT APPLICABLE
Curb Type		Curb & Gutter Type	
NO CURB		NO CURB AND GUTTER	
Pavement Recommendation		Condition Rating / PCR	
PREVENTIVE MAINTENANCE		GOOD / 90

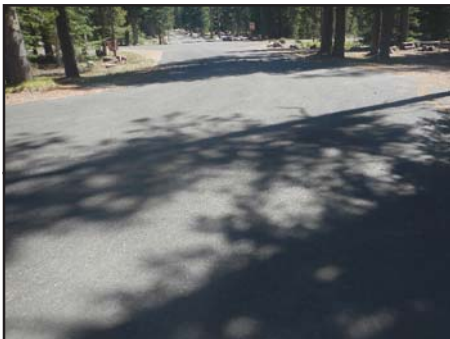
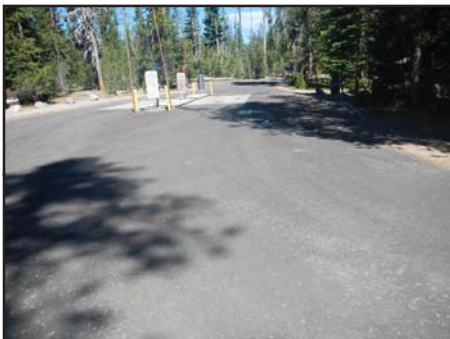
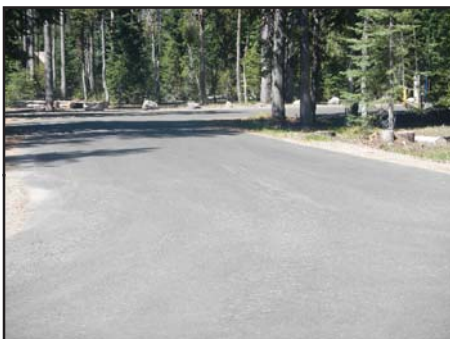
ROUTE 0947EZ: MAZAMA DUMP STATION

Inspection Date	FMSS Number	User Access	Surface Type
6/11/2015	99597	PUBLIC	ASPHALT
Area (Sq. Ft.)	Lane Miles (11' Widths)	Curb Reveal (Inches)	Curb Recommendation
9,273	0.16	NOT APPLICABLE	NOT APPLICABLE
Curb Type		Curb & Gutter Type	
NO CURB		NO CURB AND GUTTER	
Pavement Recommendation		Condition Rating / PCR	
PREVENTIVE MAINTENANCE		GOOD / 90

Parking area consists of multiple surface types: 1 part Asphalt at 8,910 square feet; 2 parts Concrete at 363 square feet.

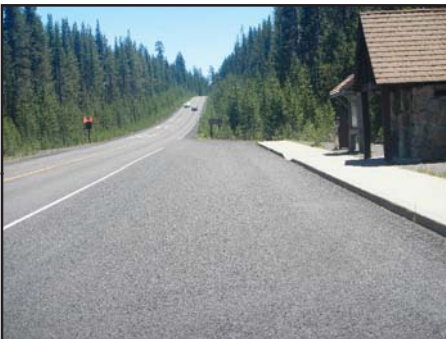
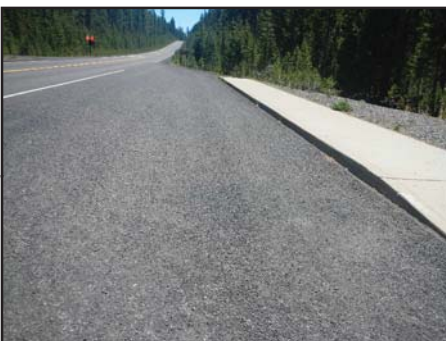
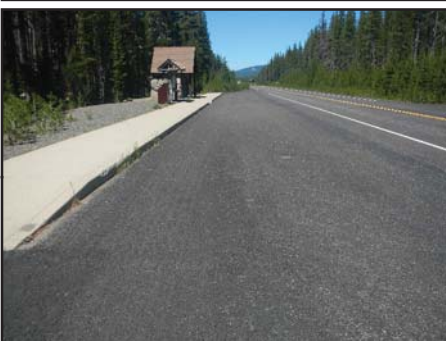
ROUTE 0951: WEST ENTRANCE PARKING AREA

Inspection Date	FMSS Number	User Access	Surface Type
6/12/2015	99603	PUBLIC	ASPHALT
Area (Sq. Ft.)	Lane Miles (11' Widths)	Curb Reveal (Inches)	Curb Recommendation
3,650	0.063	NOT APPLICABLE	NOT APPLICABLE
Curb Type		Curb & Gutter Type	
NO CURB		NO CURB AND GUTTER	
Pavement Recommendation		Condition Rating / PCR	
PREVENTIVE MAINTENANCE		GOOD / 90

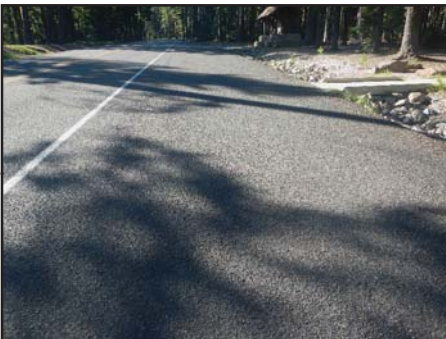
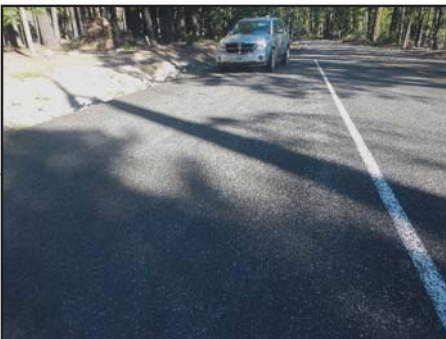
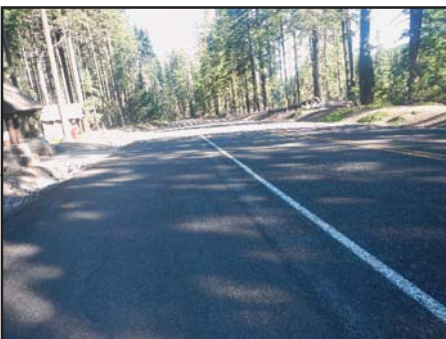
ROUTE 0955AZ: MOTOR LODGE PARKING A

Inspection Date	FMSS Number	User Access	Surface Type
6/11/2015	N/A	PUBLIC	ASPHALT
Area (Sq. Ft.)	Lane Miles (11' Widths)	Curb Reveal (Inches)	Curb Recommendation
7,300	0.126	NOT APPLICABLE	NOT APPLICABLE
Curb Type		Curb & Gutter Type	
NO CURB		NO CURB AND GUTTER	
Pavement Recommendation		Condition Rating / PCR	
PREVENTIVE MAINTENANCE		GOOD / 90

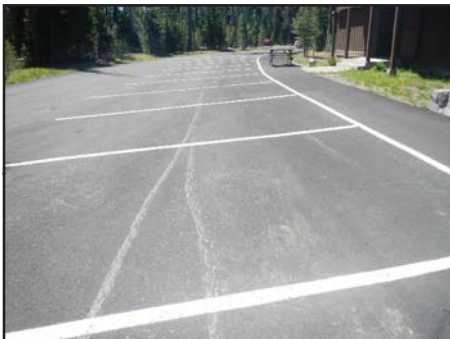
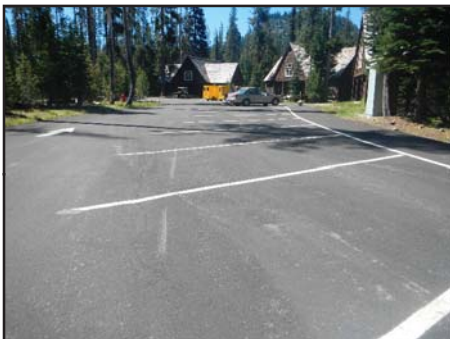
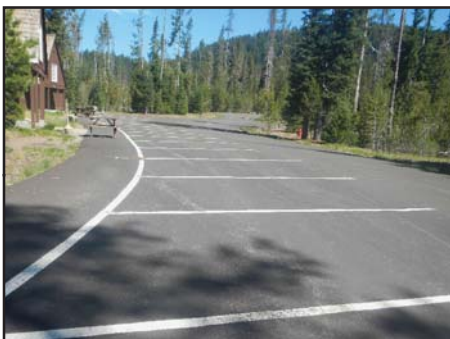
ROUTE 0955BZ: MOTOR LODGE PARKING B

Inspection Date	FMSS Number	User Access	Surface Type
6/11/2015	N/A	PUBLIC	ASPHALT
Area (Sq. Ft.)	Lane Miles (11' Widths)	Curb Reveal (Inches)	Curb Recommendation
3,771	0.065	NOT APPLICABLE	NOT APPLICABLE
Curb Type		Curb & Gutter Type	
NO CURB		NO CURB AND GUTTER	
Pavement Recommendation		Condition Rating / PCR	
PREVENTIVE MAINTENANCE		GOOD / 90

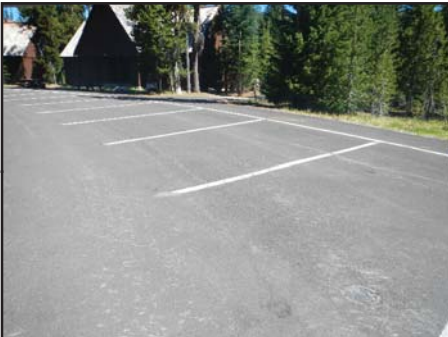
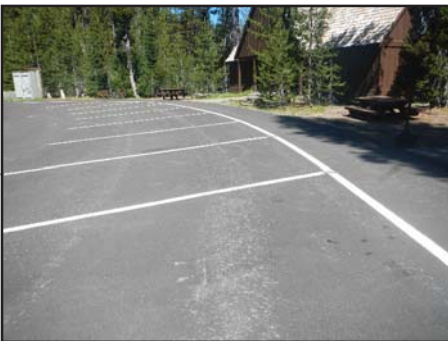
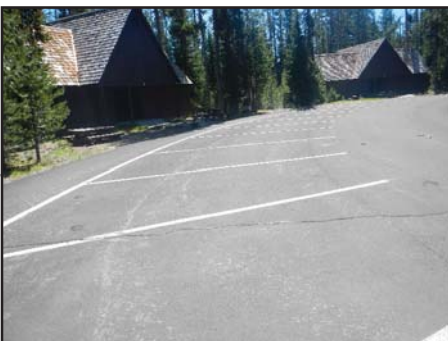
ROUTE 0955CZ: MOTOR LODGE PARKING C

Inspection Date	FMSS Number	User Access	Surface Type
6/11/2015	N/A	PUBLIC	ASPHALT
Area (Sq. Ft.)	Lane Miles (11' Widths)	Curb Reveal (Inches)	Curb Recommendation
2,499	0.043	NOT APPLICABLE	NOT APPLICABLE
Curb Type		Curb & Gutter Type	
NO CURB		NO CURB AND GUTTER	
Pavement Recommendation		Condition Rating / PCR	
PREVENTIVE MAINTENANCE		GOOD / 90

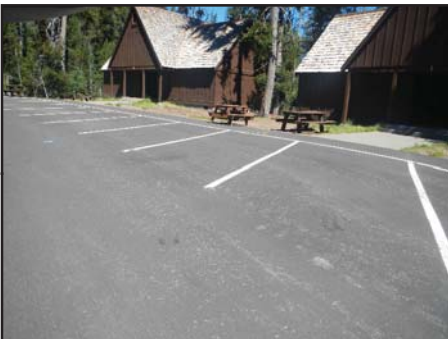
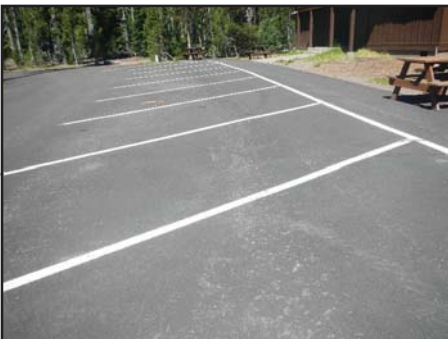
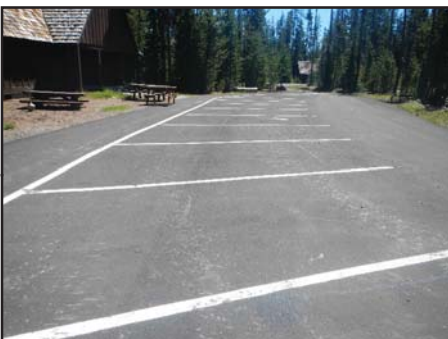
ROUTE 0956: PLAIKNI TRAIL PARKING

Inspection Date	FMSS Number	User Access	Surface Type
6/12/2015	228419	PUBLIC	ASPHALT
Area (Sq. Ft.)	Lane Miles (11' Widths)	Curb Reveal (Inches)	Curb Recommendation
6,182	0.106	NOT APPLICABLE	NOT APPLICABLE
Curb Type		Curb & Gutter Type	
NO CURB		NO CURB AND GUTTER	
Pavement Recommendation		Condition Rating / PCR	
DO NOTHING		EXCELLENT / 97
