Final Report

Road Inventory and Condition Assessment of Paved Routes Craters of the Moon National Monument and Preserve

Federal Lands Highway Road Inventory Program Prepared By: Federal Highway Administration Eastern Federal Lands Highway Division Road Inventory Program (RIP)

Report Date: February 2017

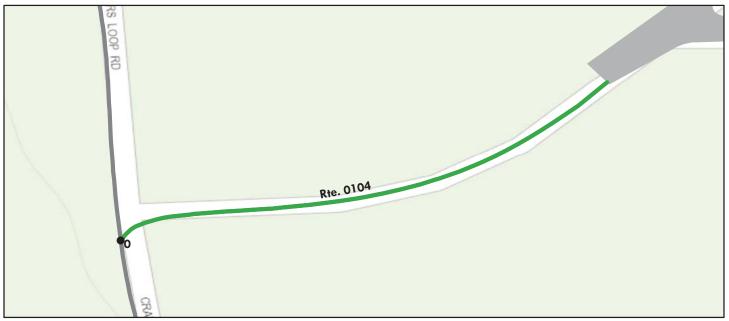
Craters of the Moon National Monument and Preserve ROUTE 0104: CAVES TRAIL ROAD

| Route Condition Legend – Pavement Condition Rating (PCR) | | | | | | |
|--|---|---|---|---|--|--|
| Pavement Condition Rating (PCR) | 92 | 92 | | | | |
| Surface Condition Rating (SCR) | 92 | 92 | | | | |
| Transverse Cracking Index | 92 | 92 | | | | |
