CUGA Cycle 6

Final Report

Road Inventory and Condition Assessment of Paved Routes Cumberland Gap National Historical Park

Report Date: March 2022

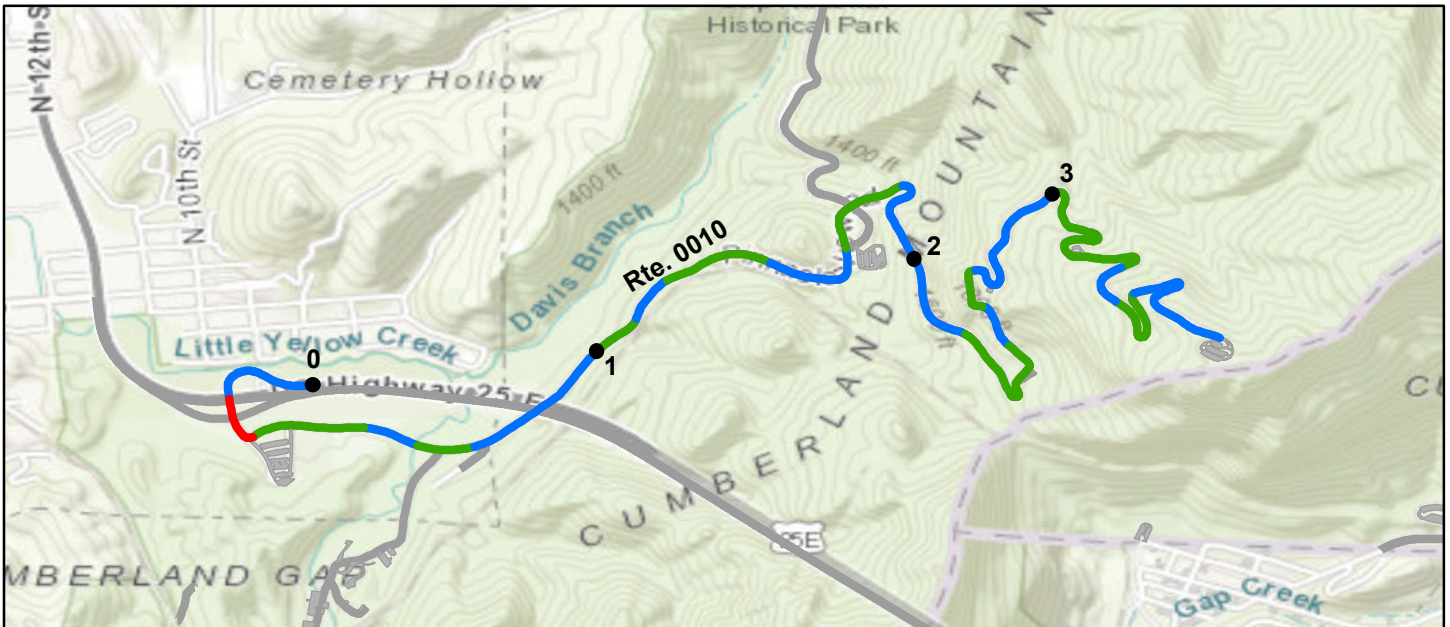
ROUTE 0010: PINNACLE ROAD

Route Condition Legend – Pavement Condition Rating (PCR)						
Poor (0 - 60)	Fair (61- 84)	Good (85 - 94)	Excellent (95 - 100)	Not Rated		
Colors on map represent condition scores at 0.10-mile intervals. See Appendix for definitions and formulas.						
Inspection Date: 7/15/2021	Beginning Section MP	0	1	2	3	
Paved Length (Miles): 3.99	Section Length (MI)	1	1	1	0.99	
Surface Type: ASPHALT	Route Summary					
Roadway Condition Information						
Pavement Condition Rating (PCR)	96	94	97	95	93	
Surface Condition Rating (SCR)	96	92	95	97	95	
Roughness Condition Index (RCI)	95	97	100	91	90	
Distress Index Values						
Structural Crack Index	97	92	95	100	100	
Alligator Crack Index	100	100	100	100	100	
Longitudinal Crack Index	97	92	95	100	100	
Transverse Cracking Index	100	99	100	100	100	
Patching Index	100	100	99	100	100	
Rutting Index	96	96	98	97	95	
International Roughness Index (IRI)	127	122	113	138	140	
Lane & Width Information

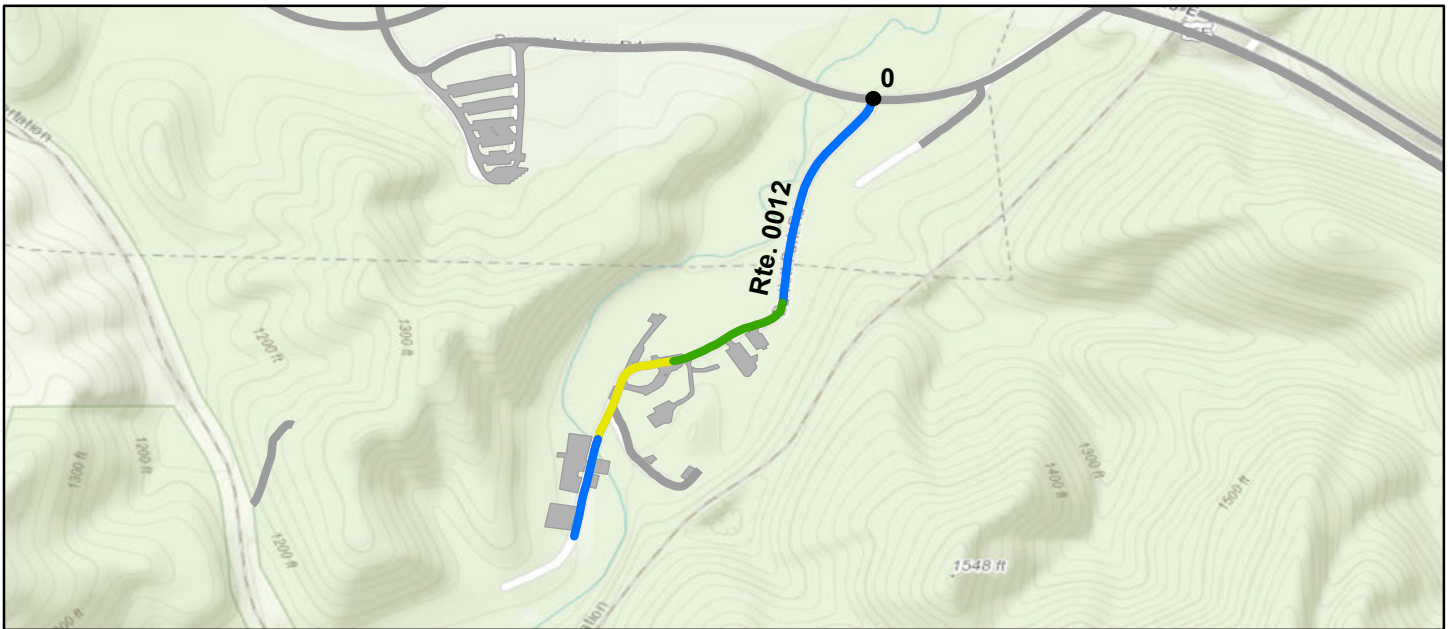
ROUTE 0012: BARTLETT PARK ROAD

Inspection Date: 7/15/2021	Beginning Section MP	0				
Paved Length (Miles): 0.49	Section Length (MI)	0.49				
Surface Type: ASPHALT	Route Summary					
Roadway Condition Information						
Pavement Condition Rating (PCR)	94	94				
Surface Condition Rating (SCR)	94	94				
Roughness Condition Index (RCI)	N/A	N/A				
Distress Index Values						
Structural Crack Index	94	94				
Alligator Crack Index	100	100				
Longitudinal Crack Index	94	94				
Transverse Cracking Index	100	100				
Patching Index	99	99				
Rutting Index	96	96				
International Roughness Index (IRI)	N/A	N/A				
Lane & Width Information						
Number of Lanes	2	2				
Paved Width (ft)	19.3	19.3				
Lane Width (ft)	8.6	8.6

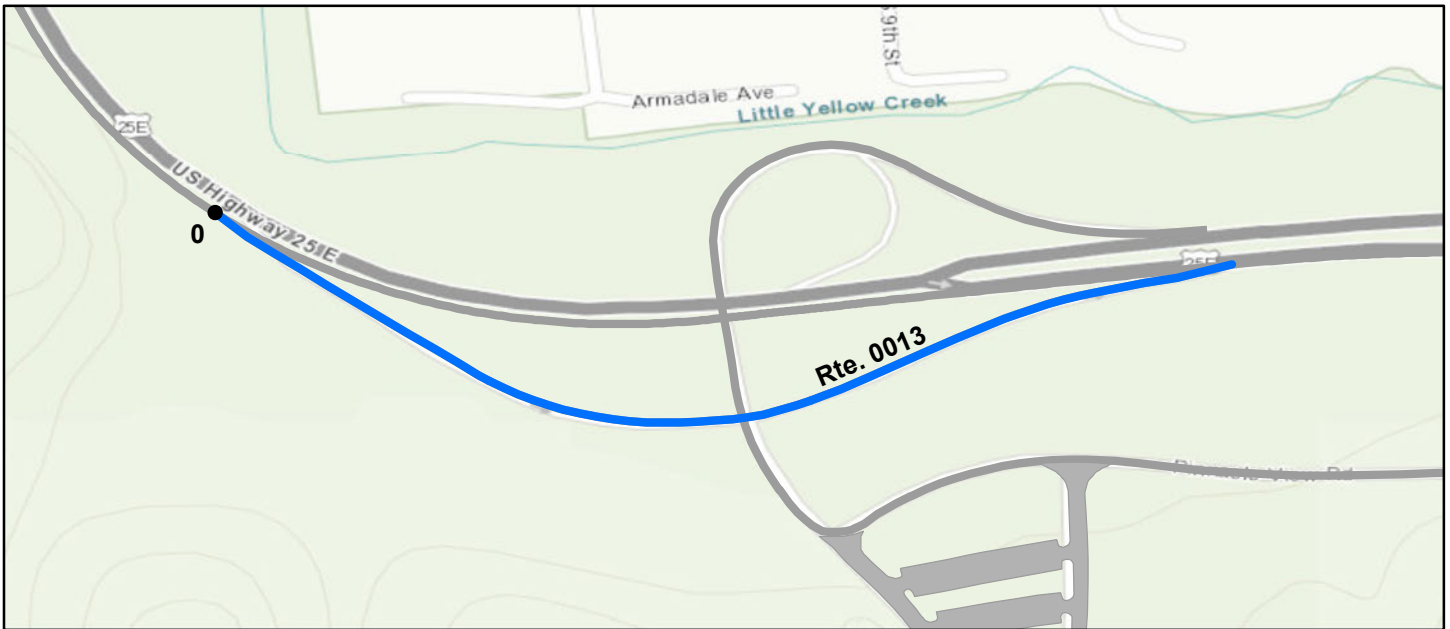
ROUTE 0013: U.S. HIGHWAY 25E SOUTHBOUND ACCESS ROAD

Inspection Date: 7/15/2021	Beginning Section MP	0				
Paved Length (Miles): 0.33	Section Length (MI)	0.33				
Surface Type: ASPHALT	Route Summary					
Roadway Condition Information						
Pavement Condition Rating (PCR)	98	98				
Surface Condition Rating (SCR)	98	98				
Roughness Condition Index (RCI)	N/A	N/A				
Distress Index Values						
Structural Crack Index	99	99				
Alligator Crack Index	100	100				
Longitudinal Crack Index	99	99				
Transverse Cracking Index	98	98				
Patching Index	100	100				
Rutting Index	99	99				
International Roughness Index (IRI)	N/A	N/A				
Lane & Width Information						
Number of Lanes	1	1				
Paved Width (ft)	29.2	29.2				
Lane Width (ft)	17.8	17.8

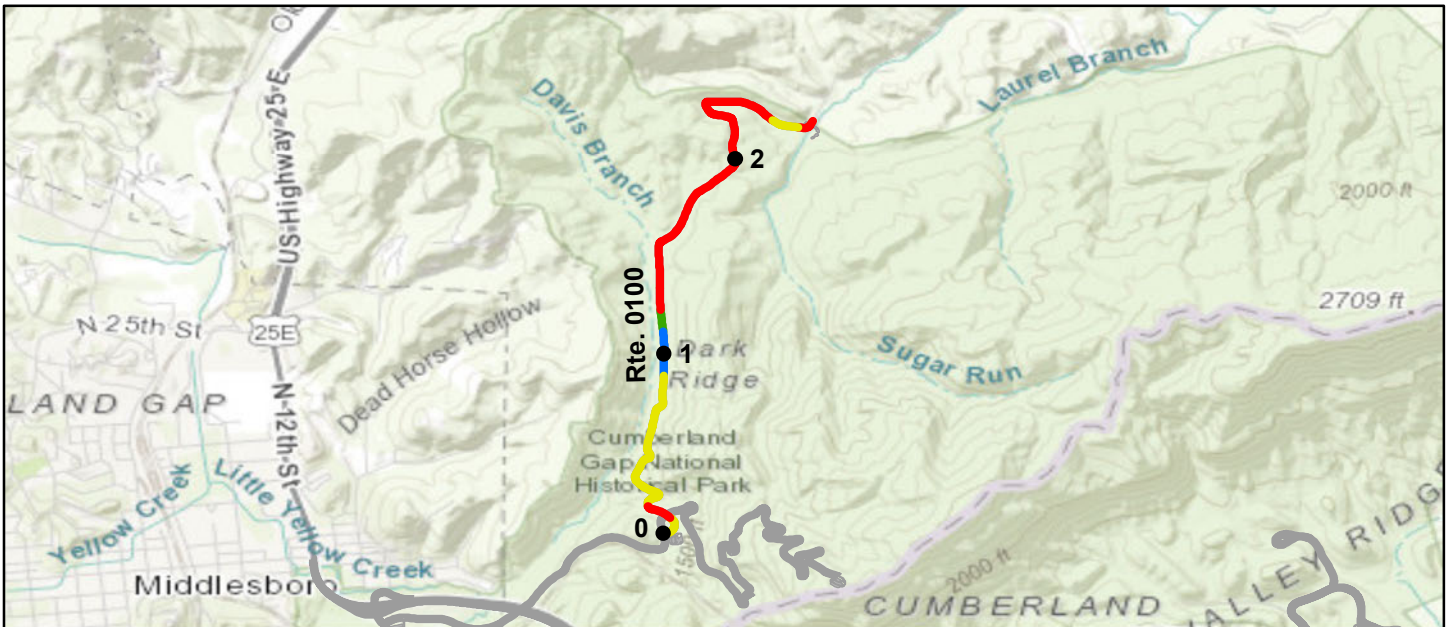
ROUTE 0100: HIGHWAY 988 (SUGAR RUN ROAD)

Route Condition Legend – Pavement Condition Rating (PCR)										
Poor (0 - 60)		Fair (61- 84)		Good (85 - 94)		Excellent (95 - 100)		Not Rated		
Colors on map represent condition scores at 0.10-mile intervals. See Appendix for definitions and formulas.										
Inspection Date:	7/15/2021	Beginning Section MP	0	1	2					
Paved Length (Miles):	2.77	Section Length (MI)	1	1	0.77					
Surface Type:	ASPHALT	Route Summary								
Roadway Condition Information										
Pavement Condition Rating (PCR)	59	72	56	48						
Surface Condition Rating (SCR)	55	67	53	43						
Roughness Condition Index (RCI)	64	80	60	55						
Distress Index Values										
Structural Crack Index	55	67	53	43						
Alligator Crack Index	100	100	100	100						
Longitudinal Crack Index	55	67	53	43						
Transverse Cracking Index	96	95	97	97						
Patching Index	95	94	96	94						
Rutting Index	87	91	86	85						
International Roughness Index (IRI)	223	168	238	261

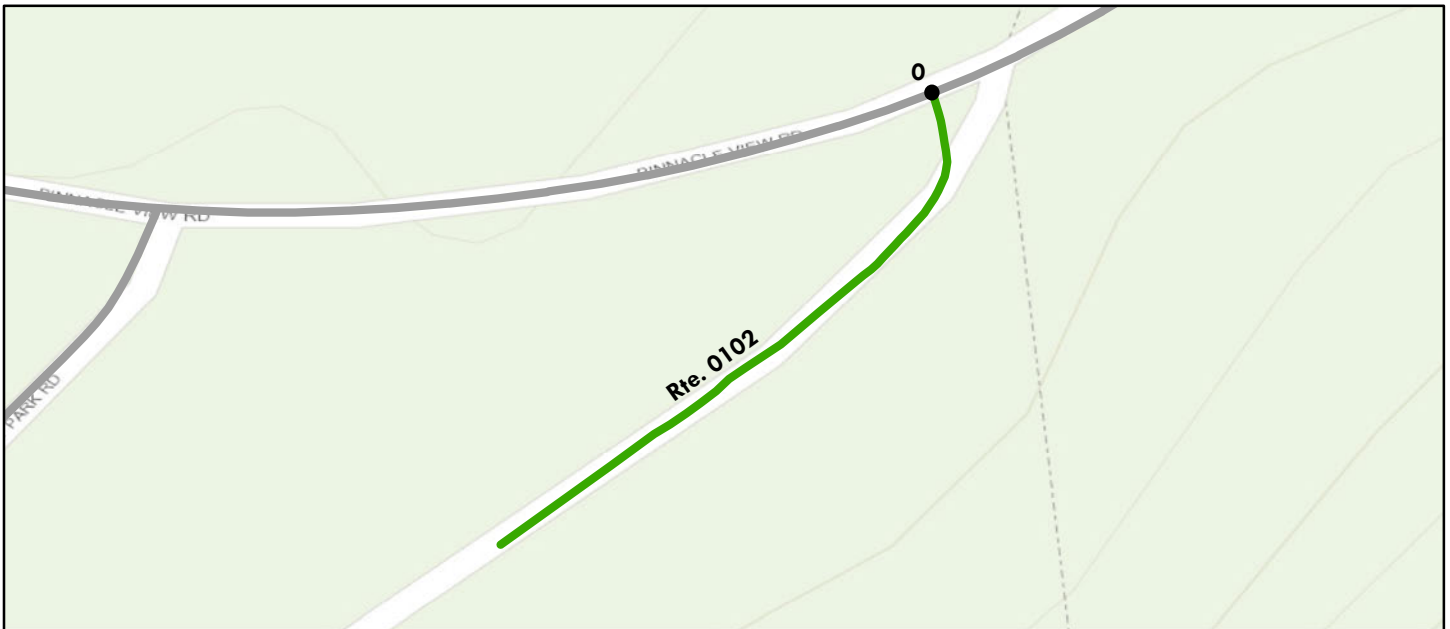
ROUTE 0102: LITTLE YELLOW CREEK ROAD

Route Condition Legend – Pavement Condition Rating (PCR)						
Poor (0 - 60)	Fair (61- 84)	Good (85 - 94)	Excellent (95 - 100)	Not Rated		
See Appendix for definitions and formulas						
Inspection Date: 4/13/2021	Beginning Section MP	0.00				
Paved Length (Miles): 0.07	Section Length (MI)	0.07				
Surface Type: ASPHALT	Route Summary					
Roadway Condition Information						
Pavement Condition Rating (PCR)	90	90				
Surface Condition Rating (SCR)	90	90				
Roughness Condition Index (RCI)	N/A	N/A				
Distress Index Values						
Structural Crack Index	N/A	N/A				
Alligator Crack Index	90	90				
Longitudinal Crack Index	90	90				
Transverse Cracking Index	90	90				
Patching Index	90	90				
Rutting Index	97	97				
International Roughness Index (IRI)	N/A	N/A				
Lane & Width Information						
Number of Lanes	2	2				
Paved Width (ft)	21	21				
Lane Width (ft)	10.5	10.5

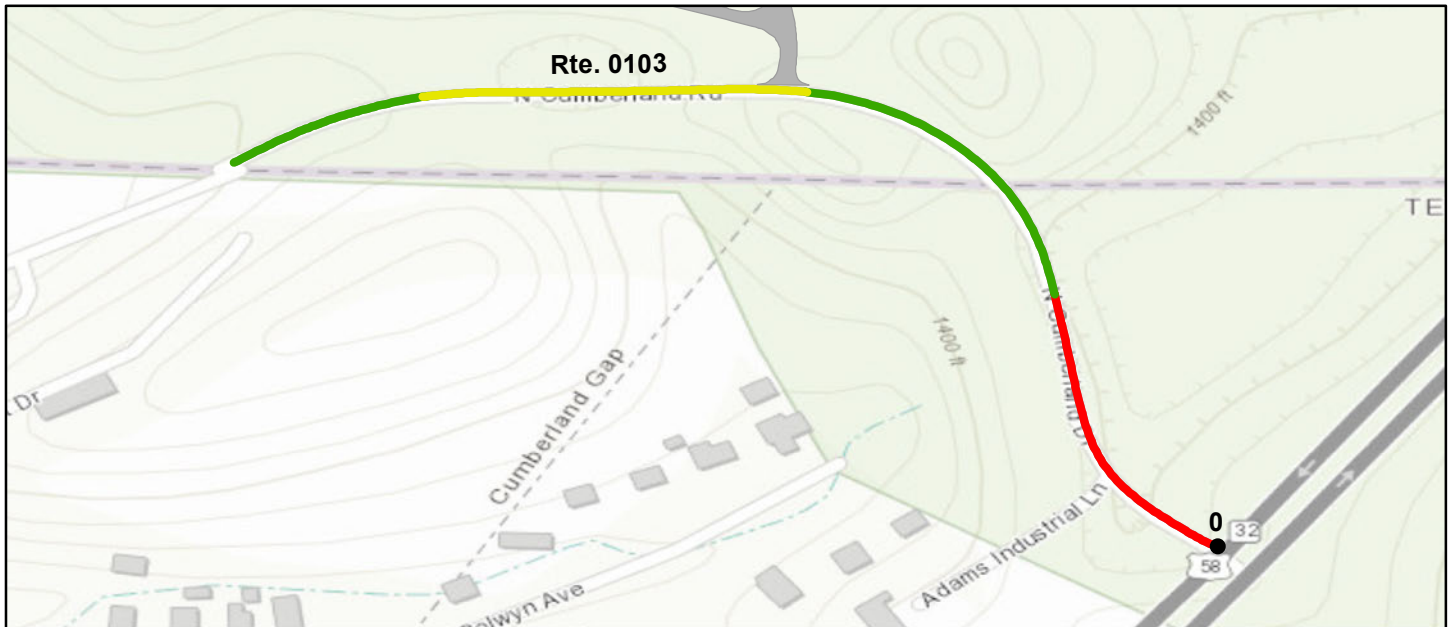
ROUTE 0103: DANIEL BOONE (N CUMBERLAND DRIVE) PARKING ACCESS ROAD

Inspection Date: 7/15/2021	Beginning Section MP	0				
Paved Length (Miles): 0.36	Section Length (MI)	0.36				
Surface Type: ASPHALT	Route Summary					
Roadway Condition Information						
Pavement Condition Rating (PCR)	57	57				
Surface Condition Rating (SCR)	57	57				
Roughness Condition Index (RCI)	N/A	N/A				
Distress Index Values						
Structural Crack Index	57	57				
Alligator Crack Index	100	100				
Longitudinal Crack Index	57	57				
Transverse Cracking Index	87	87				
Patching Index	95	95				
Rutting Index	97	97				
International Roughness Index (IRI)	N/A	N/A				
Lane & Width Information						
Number of Lanes	2	2				
Paved Width (ft)	32.3	32.3				
Lane Width (ft)	12.2	12.2

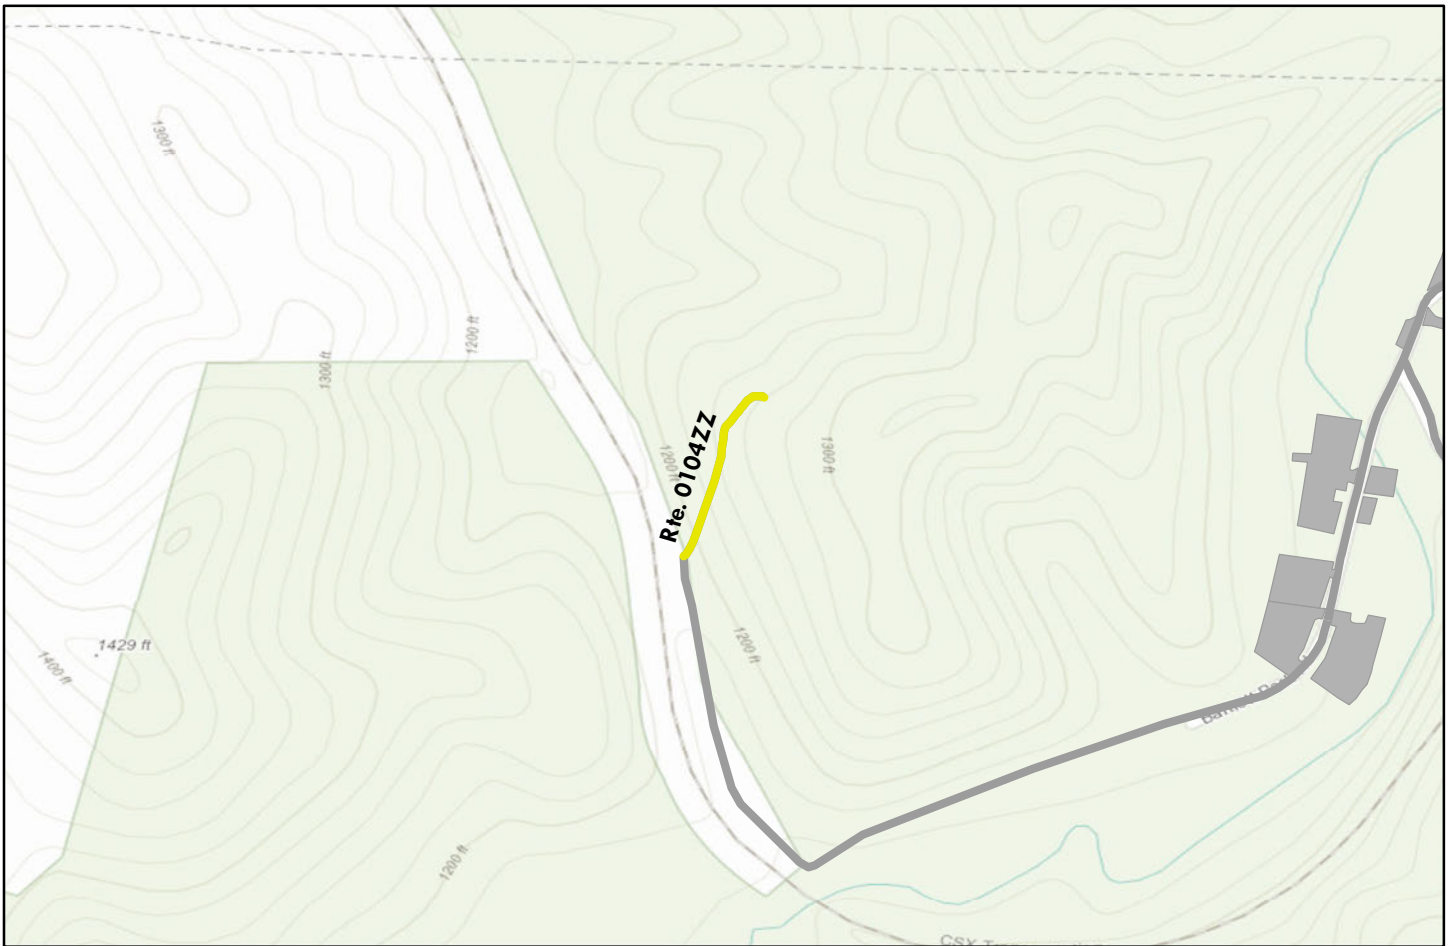
ROUTE 0104ZZ: CEMETERY ROAD

Route Condition Legend – Pavement Condition Rating (PCR)						
Poor (0 - 60)	Fair (61- 84)	Good (85 - 94)	Excellent (95 - 100)	Not Rated		
See Appendix for definitions and formulas						
Inspection Date:	4/13/2021					
Paved Length (Miles):	0.08					
Surface Type:	ASPHALT	Route Summary				
Roadway Condition Information						
Pavement Condition Rating (PCR)	72					
Lane & Width Information						
Number of Lanes	1					
Paved Width (ft)	8					
Lane Width (ft)	8

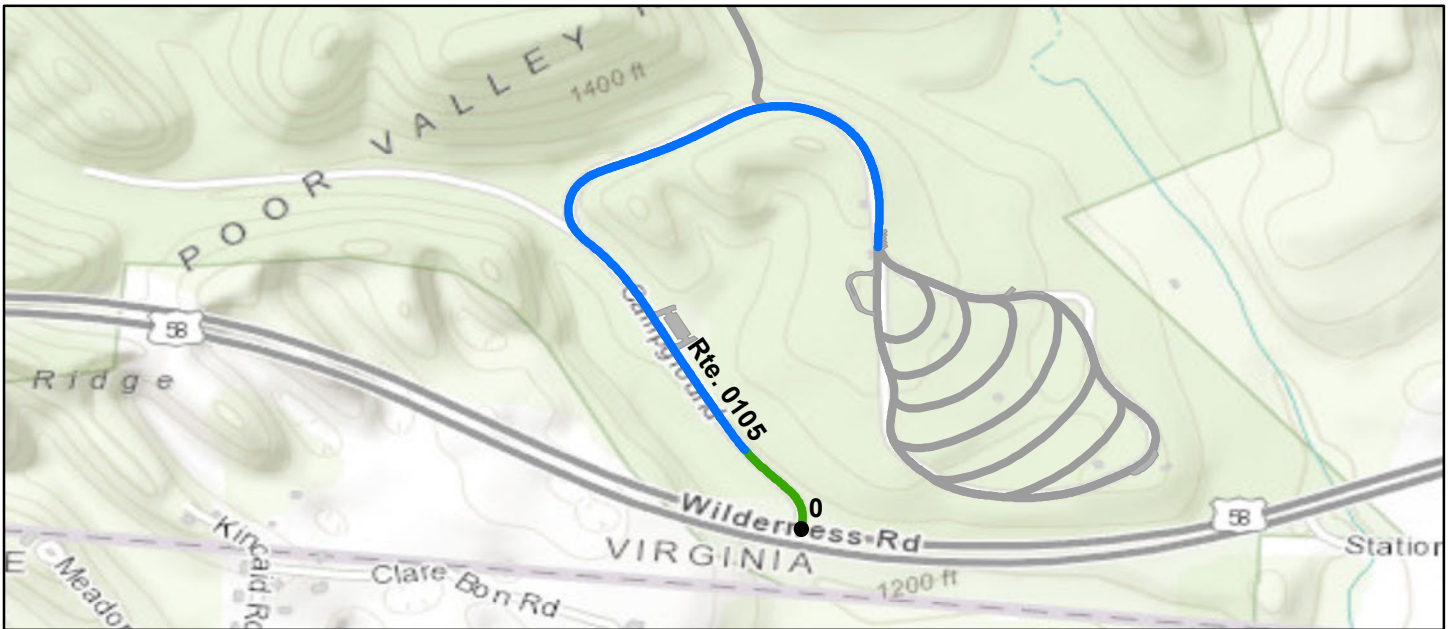
ROUTE 0105: WILDERNESS ROAD CAMPGROUND ACCESS ROAD

Route Condition Legend – Pavement Condition Rating (PCR)						
Poor (0 - 60)	Fair (61- 84)	Good (85 - 94)	Excellent (95 - 100)	Not Rated		
Colors on map represent condition scores at 0.10-mile intervals. See Appendix for definitions and formulas.						
Inspection Date: 7/15/2021	Beginning Section MP	0				
Paved Length (Miles): 0.8	Section Length (MI)	0.8				
Surface Type: ASPHALT	Route Summary					
Roadway Condition Information						
Pavement Condition Rating (PCR)	98	98				
Surface Condition Rating (SCR)	97	97				
Roughness Condition Index (RCI)	100	100				
Distress Index Values						
Structural Crack Index	97	97				
Alligator Crack Index	100	100				
Longitudinal Crack Index	97	97				
Transverse Cracking Index	100	100				
Patching Index	100	100				
Rutting Index	100	100				
International Roughness Index (IRI)	112	112				
Lane & Width Information						
Number of Lanes	2	2				
Paved Width (ft)	23.5	23.5				
Lane Width (ft)	9.7	9.7

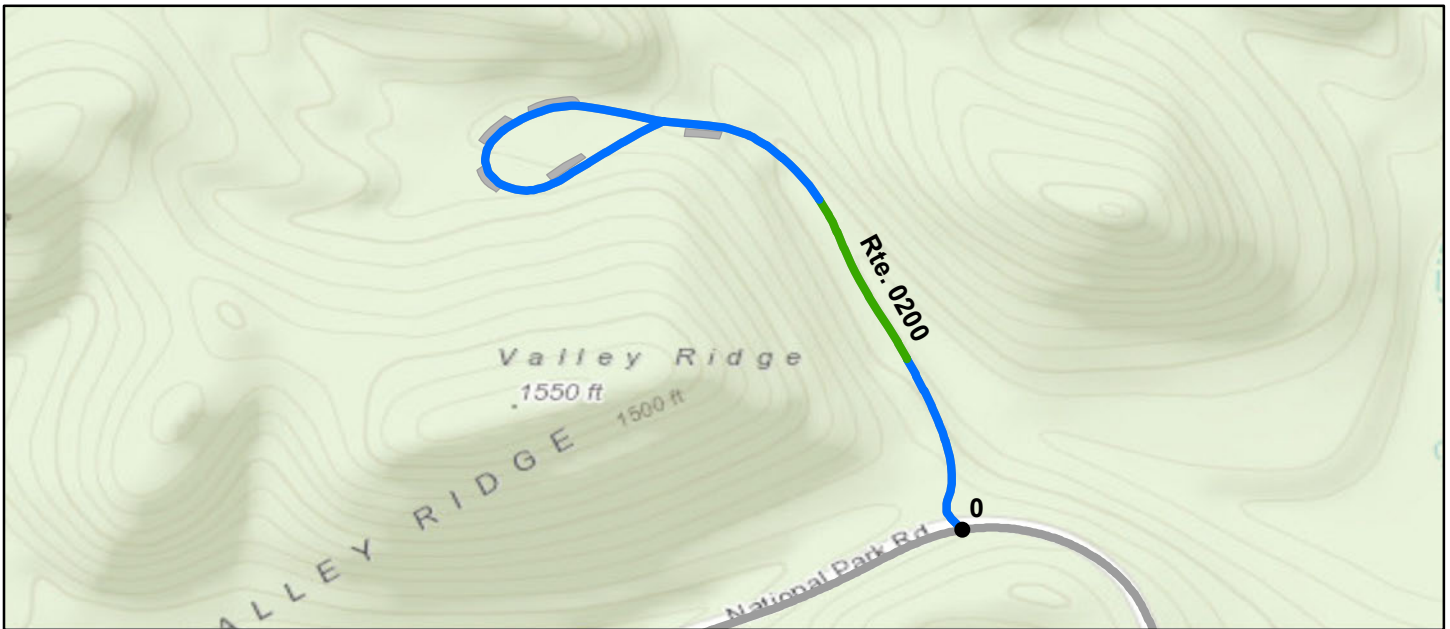
ROUTE 0200: LEWIS HOLLOW PICNIC AREA ROAD

Route Condition Legend – Pavement Condition Rating (PCR)						
Poor (0 - 60)	Fair (61- 84)	Good (85 - 94)	Excellent (95 - 100)	Not Rated		
Colors on map represent condition scores at 0.10-mile intervals. See Appendix for definitions and formulas.						
Inspection Date: 7/15/2021	Beginning Section MP	0				
Paved Length (Miles): 0.49	Section Length (MI)	0.49				
Surface Type: ASPHALT	Route Summary					
Roadway Condition Information						
Pavement Condition Rating (PCR)	98	98				
Surface Condition Rating (SCR)	98	98				
Roughness Condition Index (RCI)	N/A	N/A				
Distress Index Values						
Structural Crack Index	99	99				
Alligator Crack Index	100	100				
Longitudinal Crack Index	99	99				
Transverse Cracking Index	100	100				
Patching Index	100	100				
Rutting Index	98	98				
International Roughness Index (IRI)	N/A	N/A				
Lane & Width Information						
Number of Lanes	2	2				
Paved Width (ft)	17.3	17.3				
Lane Width (ft)	9.7	9.7

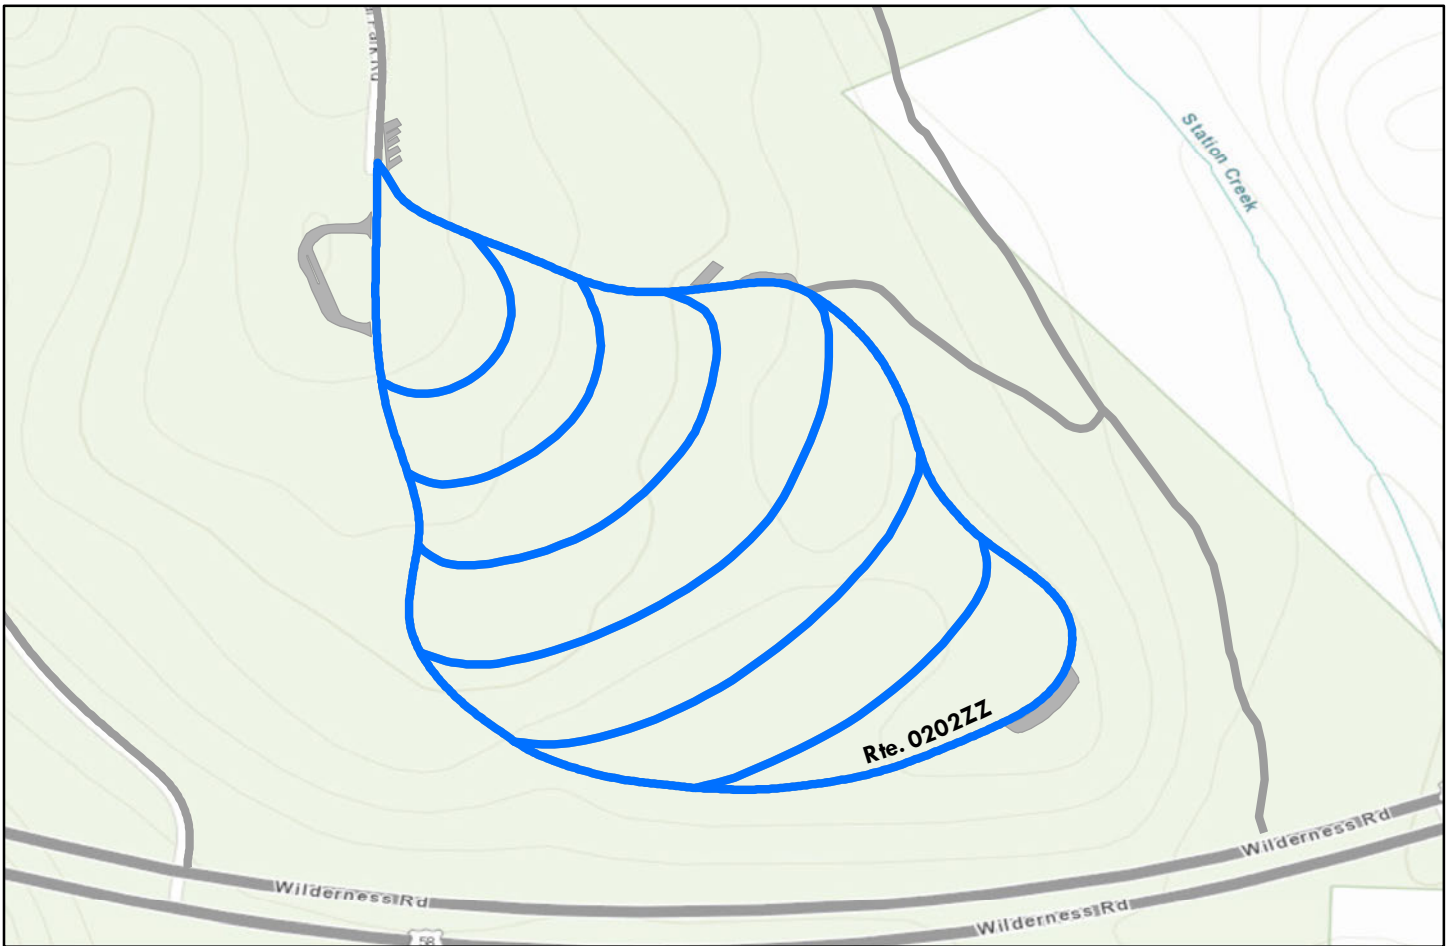
ROUTE 0202ZZ: WILDERNESS ROAD CAMPGROUND

Route Condition Legend – Pavement Condition Rating (PCR)						
Poor (0 - 60)	Fair (61- 84)	Good (85 - 94)	Excellent (95 - 100)	Not Rated		
See Appendix for definitions and formulas						
Inspection Date: 7/15/2021						
Paved Length (Miles): 1.74						
Surface Type: ASPHALT	Route Summary					
Roadway Condition Information						
Pavement Condition Rating (PCR)	98					
Lane & Width Information						
Number of Lanes	1					
Paved Width (ft)	15.8					
Lane Width (ft)	14.4

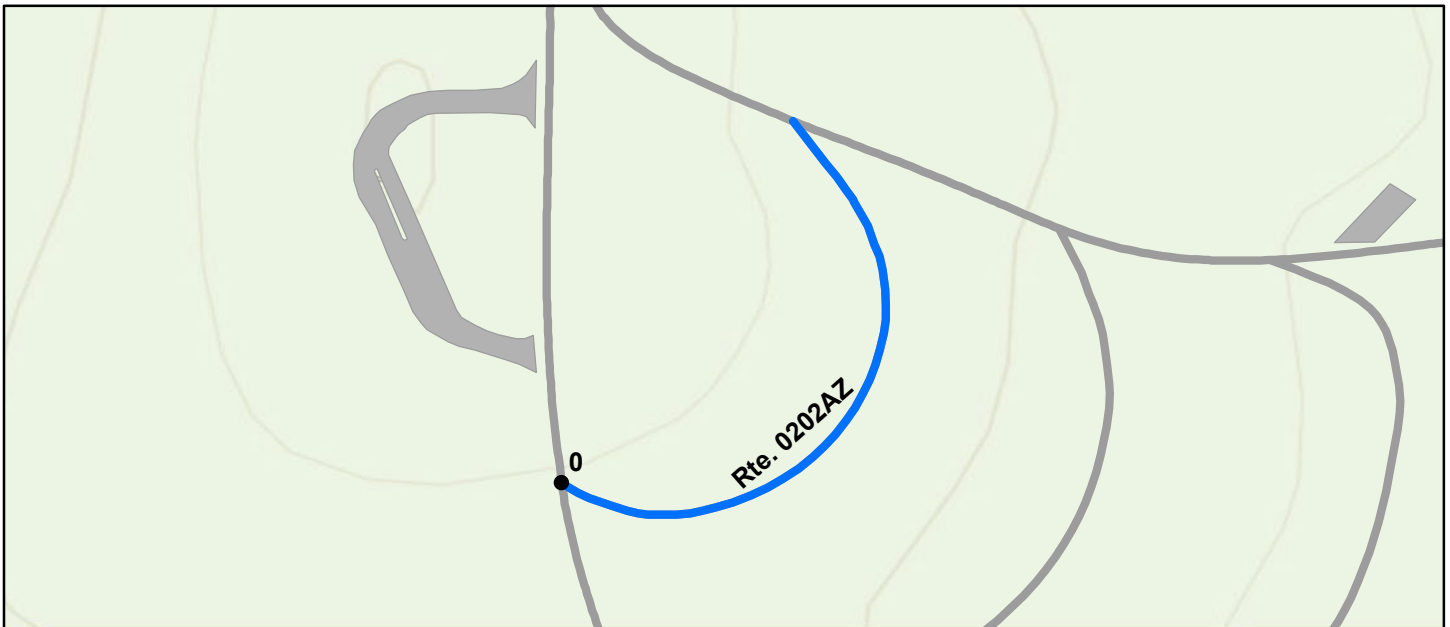
Inspection Date: 7/15/2021	Beginning Section MP	0				
Paved Length (Miles): 0.09	Section Length (MI)	0.09				
Surface Type: ASPHALT	Route Summary					
Roadway Condition Information						
Pavement Condition Rating (PCR)	99	99				
Surface Condition Rating (SCR)	99	99				
Roughness Condition Index (RCI)	N/A	N/A				
Distress Index Values						
Structural Crack Index	99	99				
Alligator Crack Index	100	100				
Longitudinal Crack Index	99	99				
Transverse Cracking Index	100	100				
Patching Index	100	100				
Rutting Index	100	100				
International Roughness Index (IRI)	N/A	N/A				
Lane & Width Information						
Number of Lanes	1	1				
Paved Width (ft)	15.2	15.2				
Lane Width (ft)	15.2	15.2

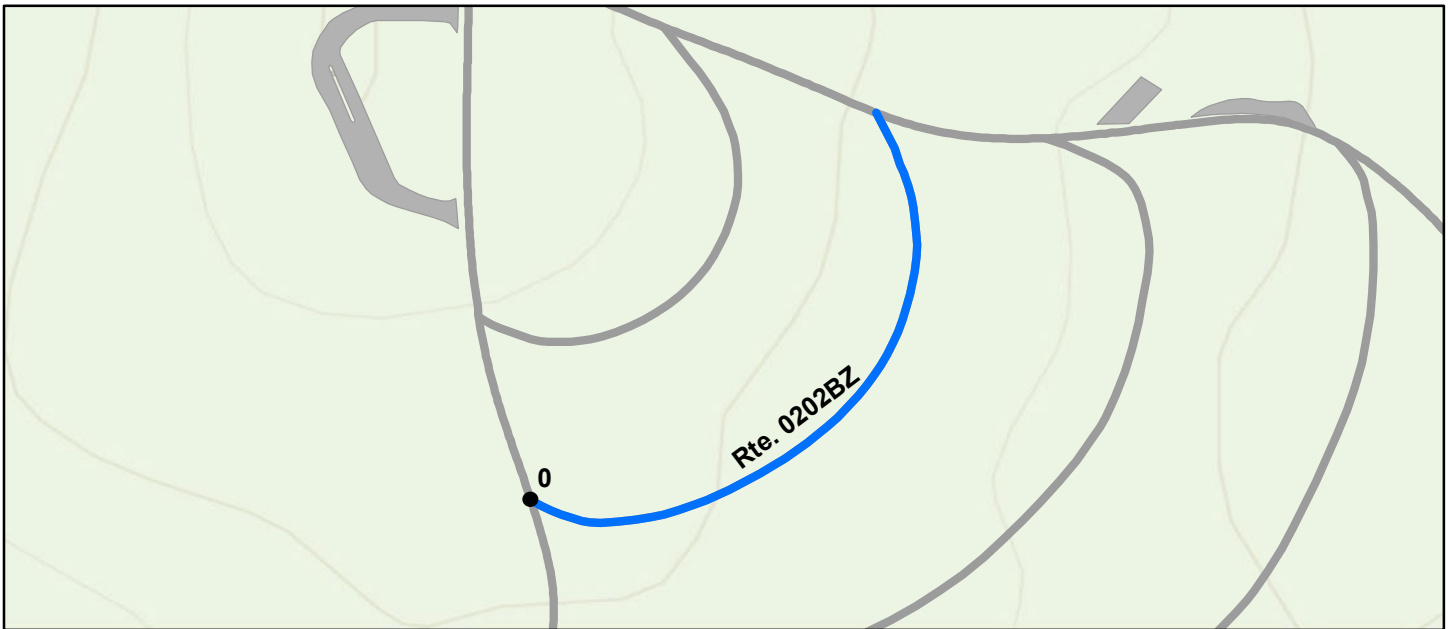
Inspection Date: 7/15/2021	Beginning Section MP	0				
Paved Length (Miles): 0.12	Section Length (MI)	0.12				
Surface Type: ASPHALT	Route Summary					
Roadway Condition Information						
Pavement Condition Rating (PCR)	99	99				
Surface Condition Rating (SCR)	99	99				
Roughness Condition Index (RCI)	N/A	N/A				
Distress Index Values						
Structural Crack Index	100	100				
Alligator Crack Index	100	100				
Longitudinal Crack Index	100	100				
Transverse Cracking Index	100	100				
Patching Index	100	100				
Rutting Index	99	99				
International Roughness Index (IRI)	N/A	N/A				
Lane & Width Information						
Number of Lanes	1	1				
Paved Width (ft)	14.5	14.5				
Lane Width (ft)	14.5	14.5

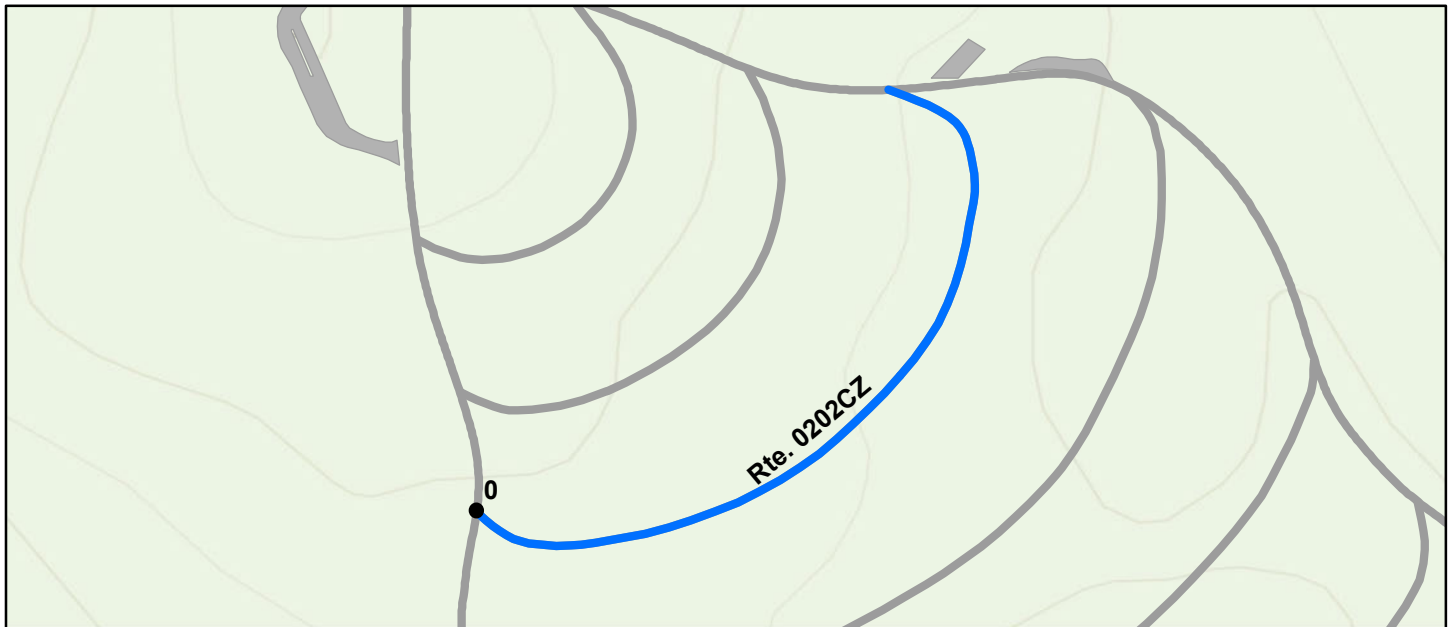
Inspection Date: 7/15/2021	Beginning Section MP	0				
Paved Length (Miles): 0.18	Section Length (MI)	0.18				
Surface Type: ASPHALT	Route Summary					
Roadway Condition Information						
Pavement Condition Rating (PCR)	98	98				
Surface Condition Rating (SCR)	98	98				
Roughness Condition Index (RCI)	N/A	N/A				
Distress Index Values						
Structural Crack Index	98	98				
Alligator Crack Index	99	99				
Longitudinal Crack Index	99	99				
Transverse Cracking Index	100	100				
Patching Index	100	100				
Rutting Index	99	99				
International Roughness Index (IRI)	N/A	N/A				
Lane & Width Information						
Number of Lanes	1	1				
Paved Width (ft)	18.2	18.2				
Lane Width (ft)	18.2	18.2

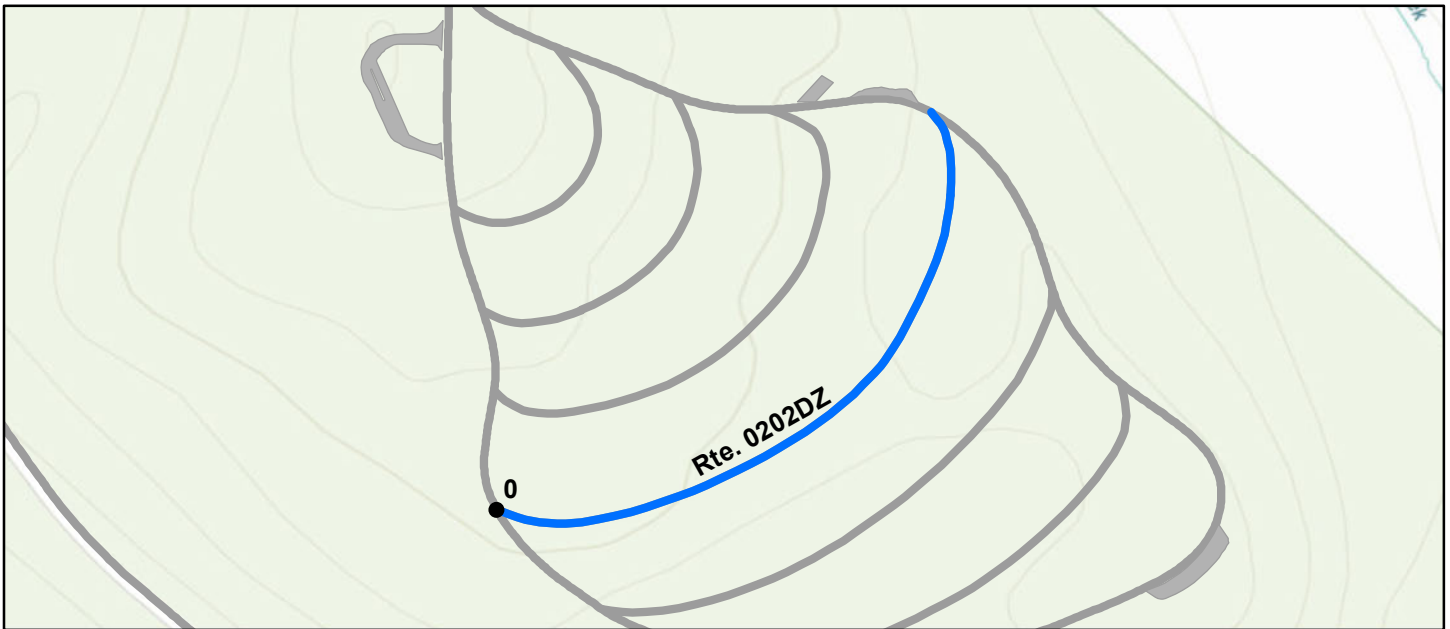
Inspection Date: 7/15/2021	Beginning Section MP	0				
Paved Length (Miles): 0.23	Section Length (MI)	0.23				
Surface Type: ASPHALT	Route Summary					
Roadway Condition Information						
Pavement Condition Rating (PCR)	100	100				
Surface Condition Rating (SCR)	100	100				
Roughness Condition Index (RCI)	N/A	N/A				
Distress Index Values						
Structural Crack Index	100	100				
Alligator Crack Index	100	100				
Longitudinal Crack Index	100	100				
Transverse Cracking Index	100	100				
Patching Index	100	100				
Rutting Index	100	100				
International Roughness Index (IRI)	N/A	N/A				
Lane & Width Information						
Number of Lanes	1	1				
Paved Width (ft)	16.5	16.5				
Lane Width (ft)	16.5	16.5

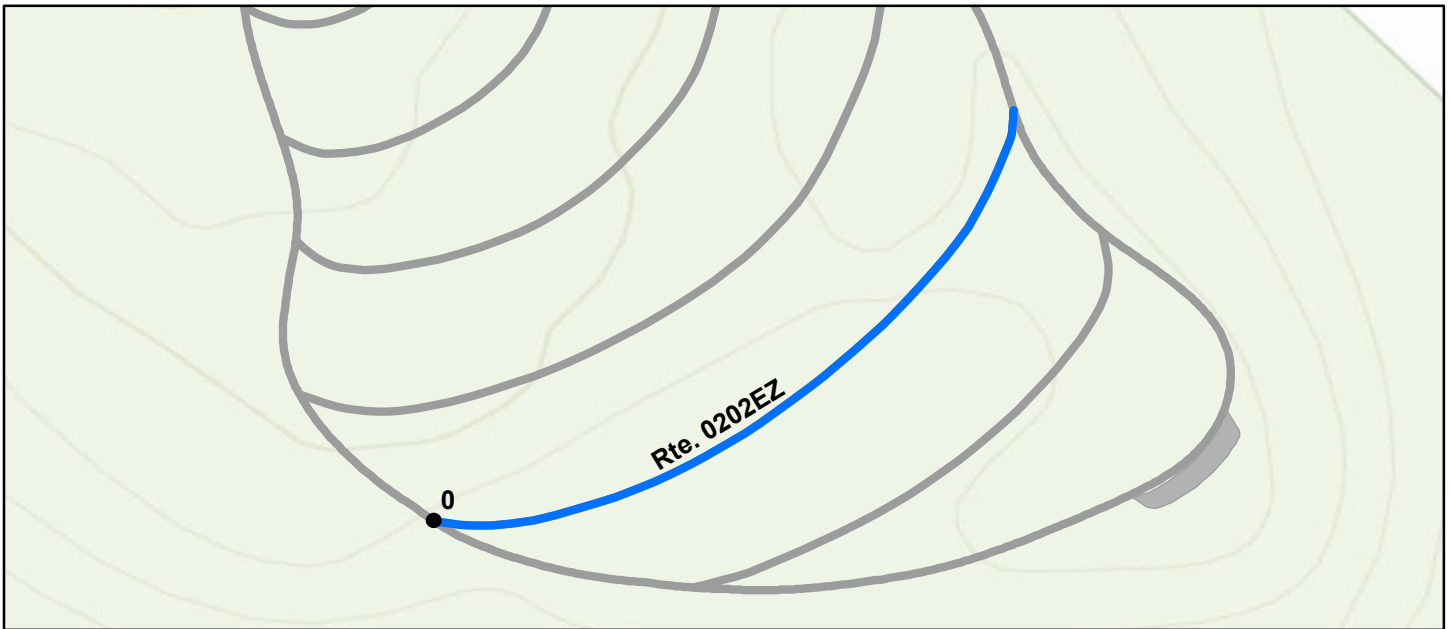
Inspection Date: 7/15/2021	Beginning Section MP	0				
Paved Length (Miles): 0.19	Section Length (MI)	0.19				
Surface Type: ASPHALT	Route Summary					
Roadway Condition Information						
Pavement Condition Rating (PCR)	99	99				
Surface Condition Rating (SCR)	99	99				
Roughness Condition Index (RCI)	N/A	N/A				
Distress Index Values						
Structural Crack Index	99	99				
Alligator Crack Index	100	100				
Longitudinal Crack Index	99	99				
Transverse Cracking Index	100	100				
Patching Index	100	100				
Rutting Index	100	100				
International Roughness Index (IRI)	N/A	N/A				
Lane & Width Information						
Number of Lanes	1	1				
Paved Width (ft)	16.2	16.2				
Lane Width (ft)	16.2	16.2

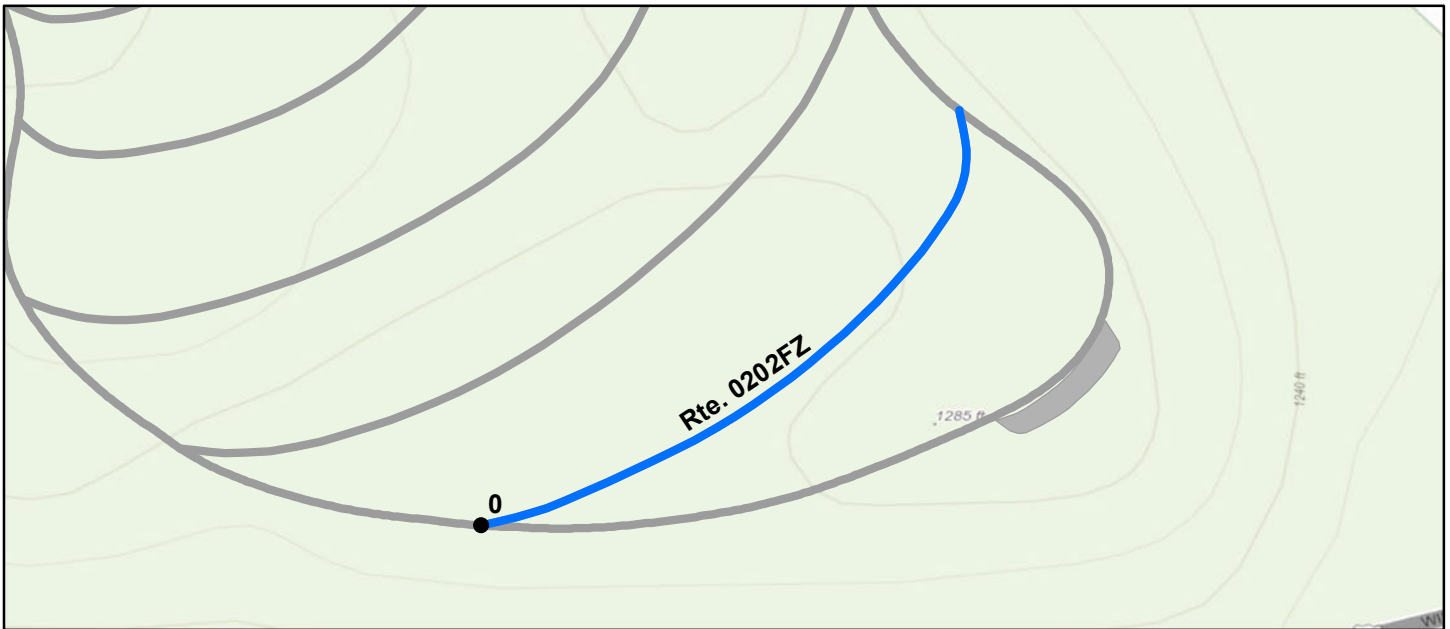
Inspection Date: 7/15/2021	Beginning Section MP	0				
Paved Length (Miles): 0.14	Section Length (MI)	0.14				
Surface Type: ASPHALT	Route Summary					
Roadway Condition Information						
Pavement Condition Rating (PCR)	99	99				
Surface Condition Rating (SCR)	99	99				
Roughness Condition Index (RCI)	N/A	N/A				
Distress Index Values						
Structural Crack Index	100	100				
Alligator Crack Index	100	100				
Longitudinal Crack Index	100	100				
Transverse Cracking Index	100	100				
Patching Index	100	100				
Rutting Index	99	99				
International Roughness Index (IRI)	N/A	N/A				
Lane & Width Information						
Number of Lanes	1	1				
Paved Width (ft)	15.2	15.2				
Lane Width (ft)	15.2	15.2

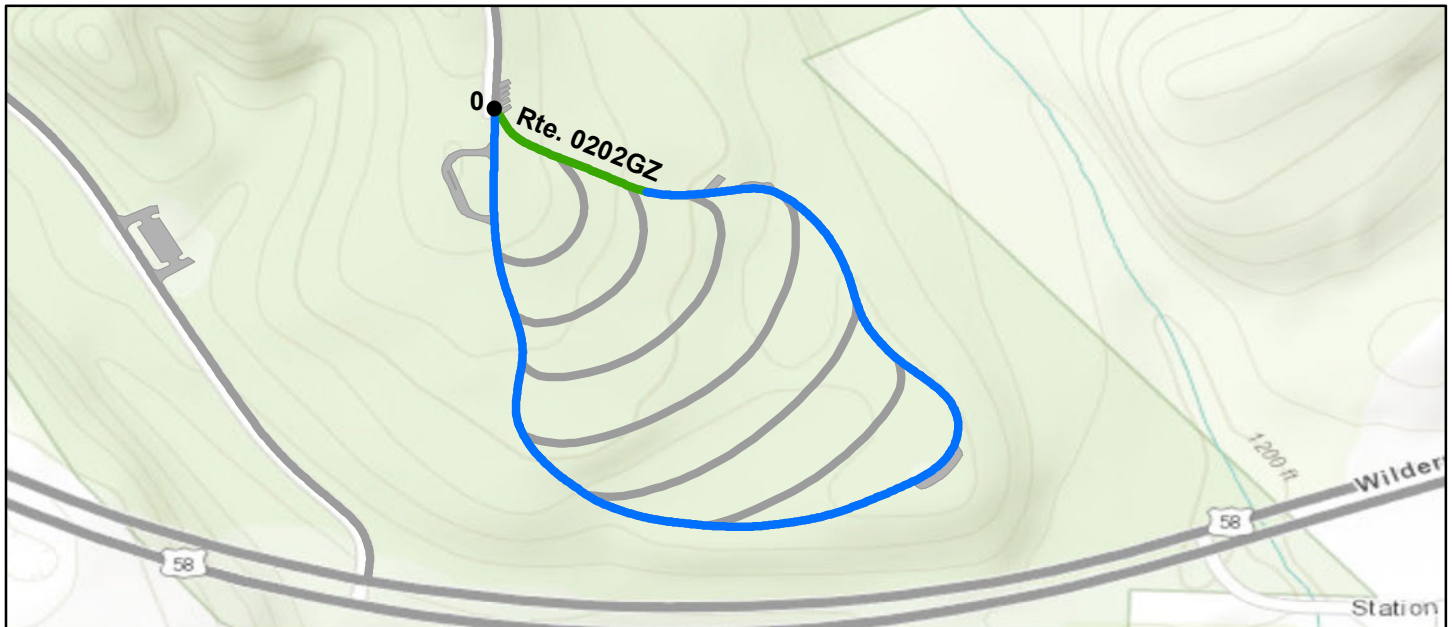
Inspection Date:	7/15/2021	Beginning Section MP	0				
Paved Length (Miles):	0.79	Section Length (MI)	0.79				
Surface Type:	ASPHALT	Route Summary					
Roadway Condition Information							
Pavement Condition Rating (PCR)		97	97				
Surface Condition Rating (SCR)		97	97				
Roughness Condition Index (RCI)		N/A	N/A				
Distress Index Values							
Structural Crack Index		97	97				
Alligator Crack Index		100	100				
Longitudinal Crack Index		97	97				
Transverse Cracking Index		100	100				
Patching Index		100	100				
Rutting Index		100	100				
International Roughness Index (IRI)		N/A	N/A				
Lane & Width Information							
Number of Lanes		1	1				
Paved Width (ft)		15.3	15.3				
Lane Width (ft)		12.2	12.2

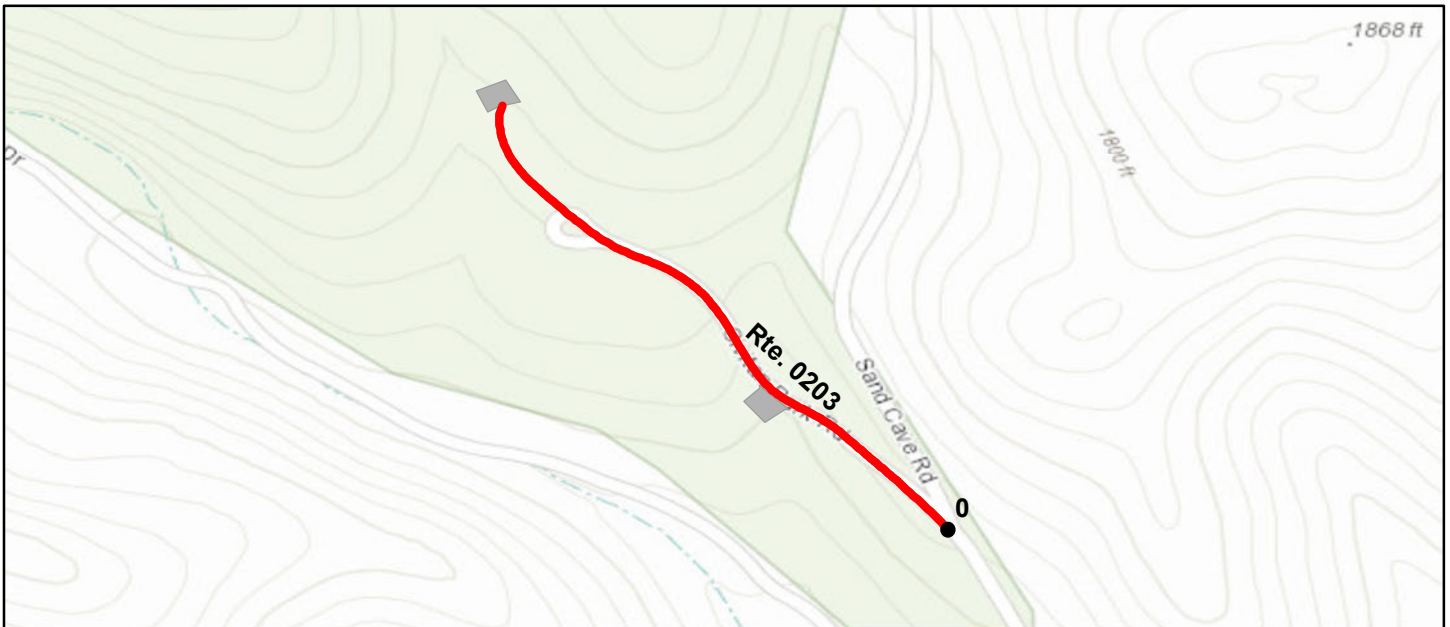
ROUTE 0203: ENTRANCE ROAD AT TWCP

Inspection Date: 7/15/2021	Beginning Section MP	0				
Paved Length (Miles): 0.19	Section Length (MI)	0.19				
Surface Type: ASPHALT	Route Summary					
Roadway Condition Information						
Pavement Condition Rating (PCR)	42	42				
Surface Condition Rating (SCR)	42	42				
Roughness Condition Index (RCI)	N/A	N/A				
Distress Index Values						
Structural Crack Index	42	42				
Alligator Crack Index	71	71				
Longitudinal Crack Index	71	71				
Transverse Cracking Index	89	89				
Patching Index	100	100				
Rutting Index	78	78				
International Roughness Index (IRI)	N/A	N/A				
Lane & Width Information						
Number of Lanes	1	1				
Paved Width (ft)	14.8	14.8				
Lane Width (ft)	10.2	10.2

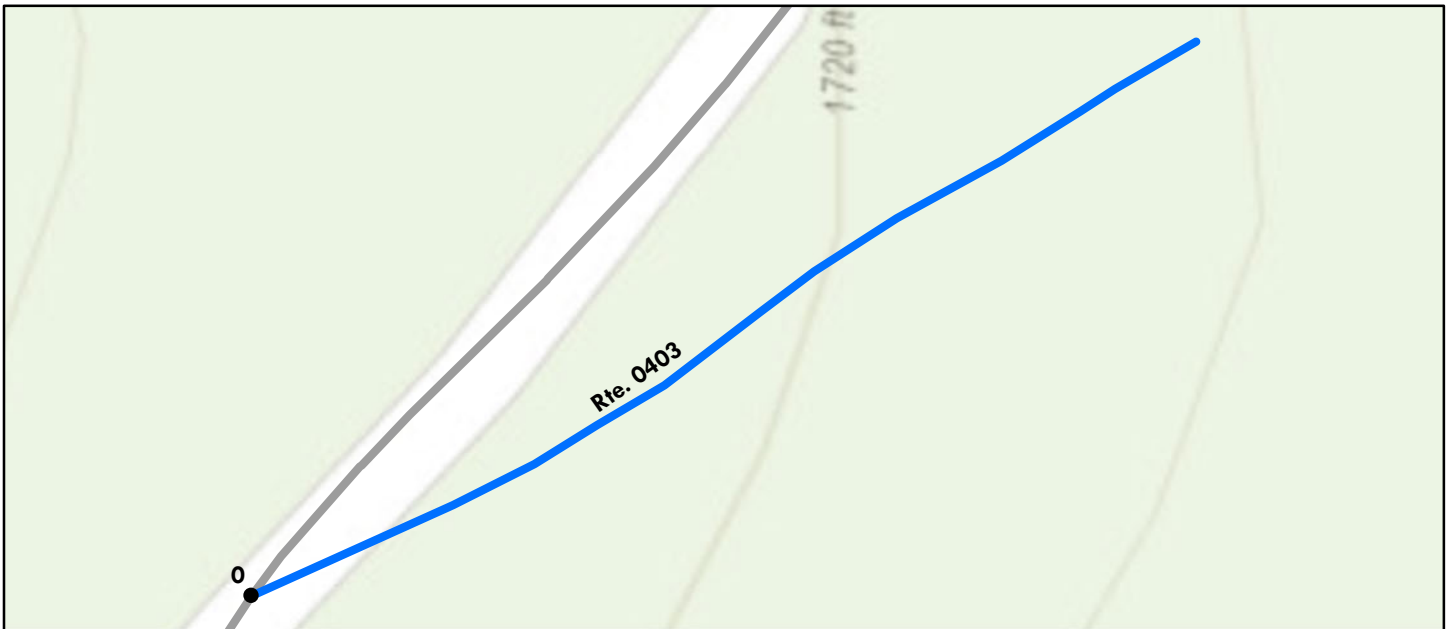
ROUTE 0403: PUMP HOUSE SERVICE ROAD

Inspection Date: 4/13/2021	Beginning Section MP	0.00				
Paved Length (Miles): 0.04	Section Length (MI)	0.04				
Surface Type: ASPHALT	Route Summary					
Roadway Condition Information						
Pavement Condition Rating (PCR)	97	97				
Surface Condition Rating (SCR)	97	97				
Roughness Condition Index (RCI)	N/A	N/A				
Distress Index Values						
Structural Crack Index	N/A	N/A				
Alligator Crack Index	97	97				
Longitudinal Crack Index	97	97				
Transverse Cracking Index	97	97				
Patching Index	97	97				
Rutting Index	97	97				
International Roughness Index (IRI)	N/A	N/A				
Lane & Width Information						
Number of Lanes	1	1				
Paved Width (ft)	9	9				
Lane Width (ft)	9	9
