CUGA Cycle 6

Final Report

Road Inventory and Condition Assessment of Paved Routes Cumberland Gap National Historical Park

Report Date: March 2022

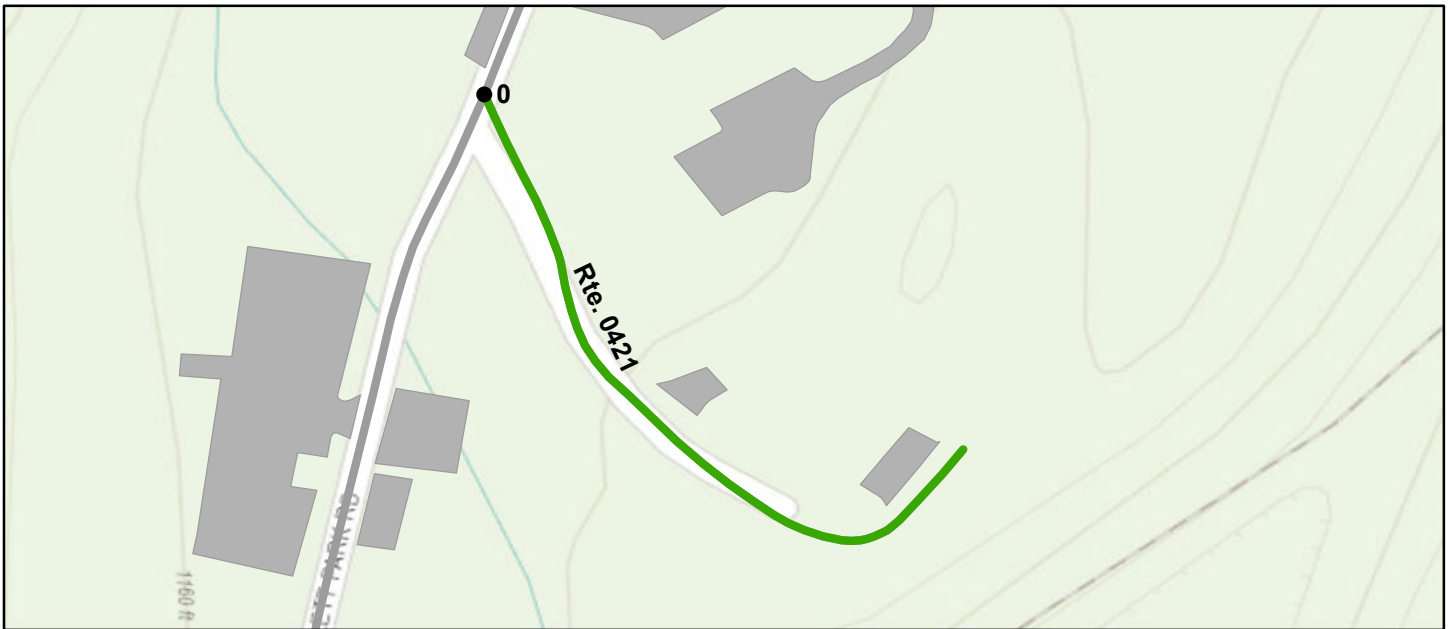
ROUTE 0421: DUPLEX DRIVE

Inspection Date: 7/15/2021	Beginning Section MP	0				
Paved Length (Miles): 0.11	Section Length (MI)	0.11				
Surface Type: ASPHALT	Route Summary					
Roadway Condition Information						
Pavement Condition Rating (PCR)	88	88				
Surface Condition Rating (SCR)	88	88				
Roughness Condition Index (RCI)	N/A	N/A				
Distress Index Values						
Structural Crack Index	88	88				
Alligator Crack Index	100	100				
Longitudinal Crack Index	88	88				
Transverse Cracking Index	99	99				
Patching Index	100	100				
Rutting Index	97	97				
International Roughness Index (IRI)	N/A	N/A				
Lane & Width Information						
Number of Lanes	2	2				
Paved Width (ft)	16.7	16.7				
Lane Width (ft)	8.3	8.3

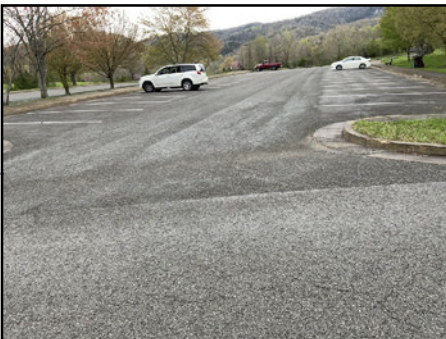
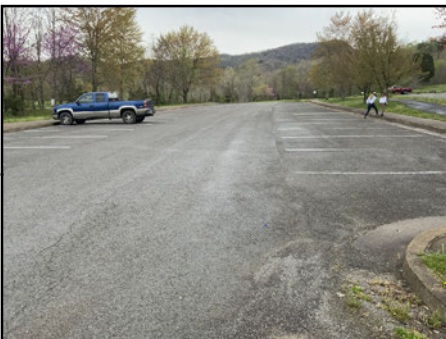
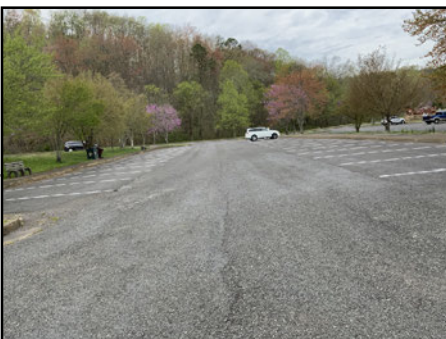
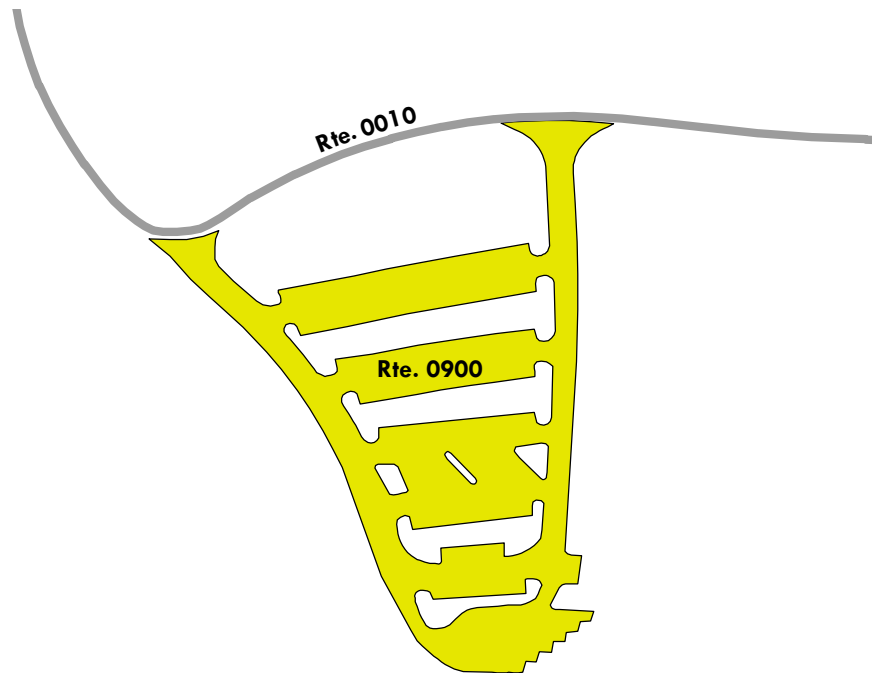
Inspection Date	FMSS Number	User Access	Surface Type
4/13/2021	100247	PUBLIC	ASPHALT
Area (Sq. Ft.)	Lane Miles (11' Widths)	Curb Reveal (Inches)	Curb Recommendation
94,302	1.624	NOT APPLICABLE	DO NOTHING
Curb Type		Curb & Gutter Type	
NO CURB		CONCRETE	
Pavement Recommendation		Condition Rating / PCR	
LIGHT 3R TREATMENTS		FAIR / 73

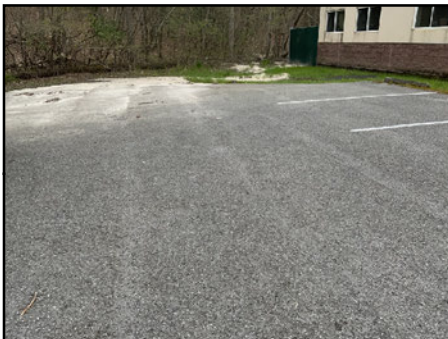
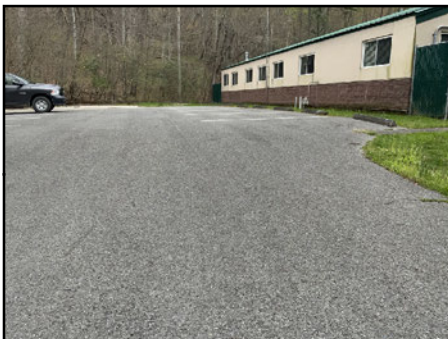
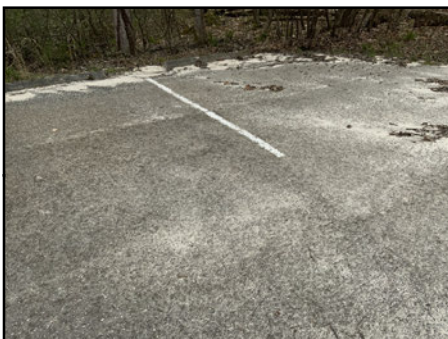
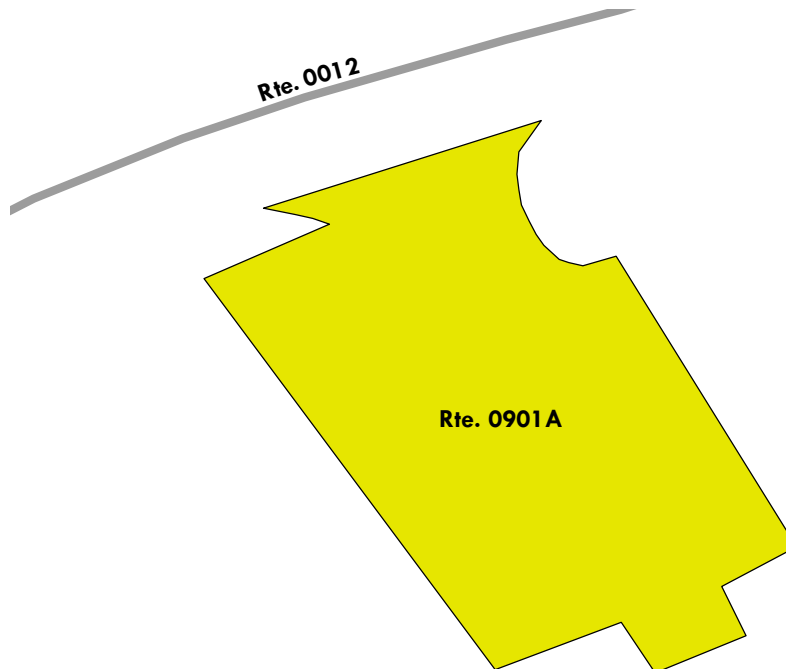
ROUTE 0901A: RANGER STATION GOVERNMENT PARKING A

Inspection Date	FMSS Number	User Access	Surface Type
4/13/2021	100406	NONPUBLIC	ASPHALT
Area (Sq. Ft.)	Lane Miles (11' Widths)	Curb Reveal (Inches)	Curb Recommendation
4,935	0.085	NOT APPLICABLE	NOT APPLICABLE
Curb Type		Curb & Gutter Type	
NO CURB		NO CURB AND GUTTER	
Pavement Recommendation		Condition Rating / PCR	
LIGHT 3R TREATMENTS		FAIR / 73

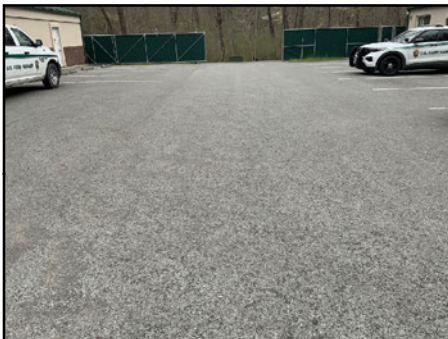
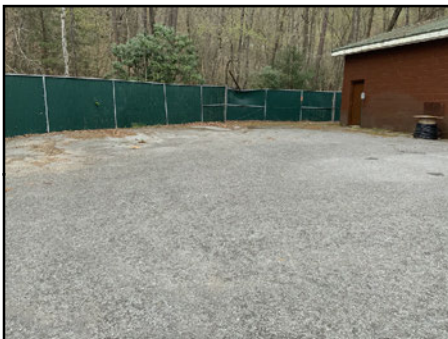
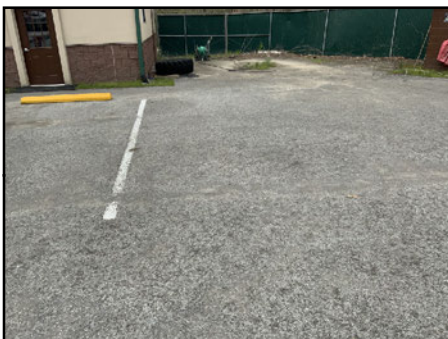
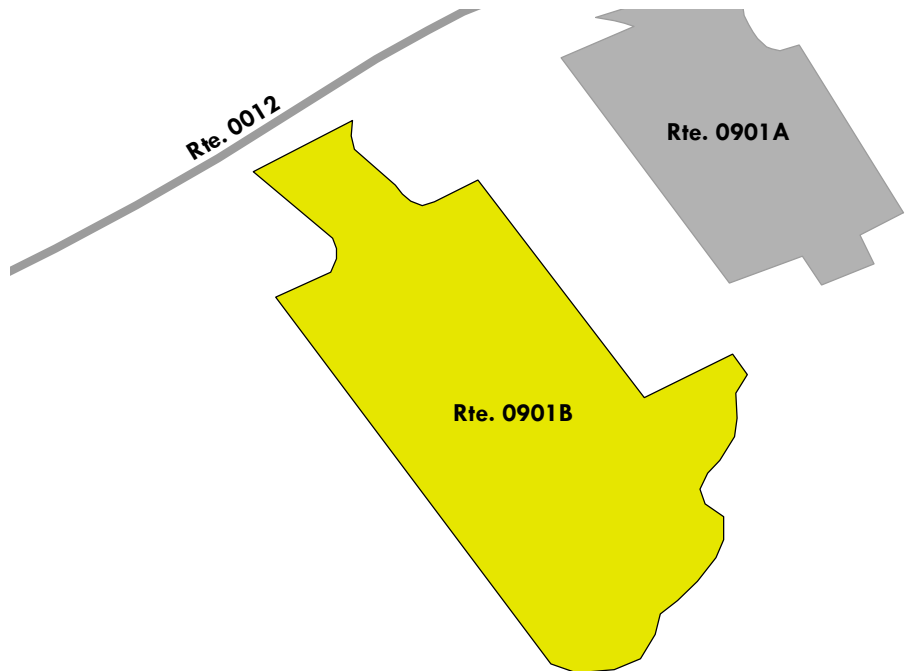
ROUTE 0901B: RANGER STATION GOVERNMENT PARKING B

Inspection Date	FMSS Number	User Access	Surface Type
4/13/2021	100407	NONPUBLIC	ASPHALT
Area (Sq. Ft.)	Lane Miles (11' Widths)	Curb Reveal (Inches)	Curb Recommendation
10,924	0.188	NOT APPLICABLE	NOT APPLICABLE
Curb Type		Curb & Gutter Type	
NO CURB		NO CURB AND GUTTER	
Pavement Recommendation		Condition Rating / PCR	
LIGHT 3R TREATMENTS		FAIR / 73

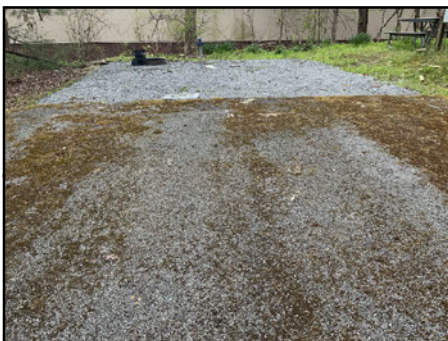
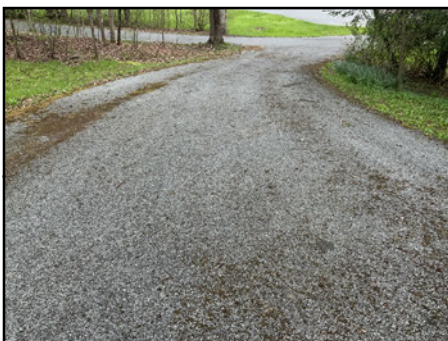
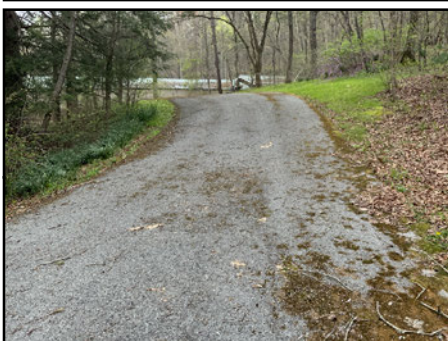
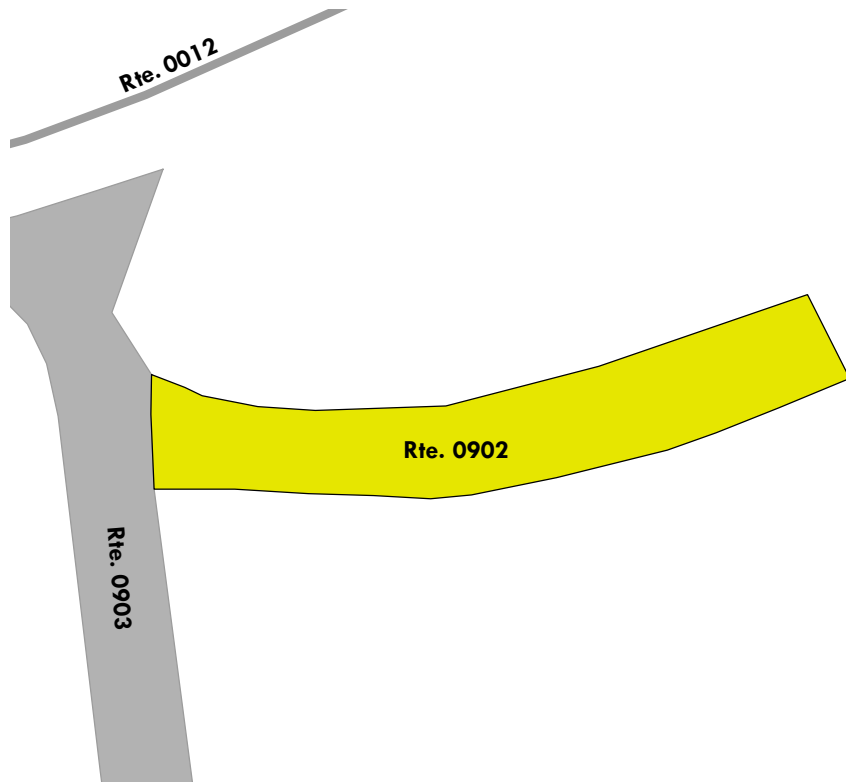
ROUTE 0902: VIP CAMPSITE PARKING

Inspection Date	FMSS Number	User Access	Surface Type
4/13/2021	100408	NONPUBLIC	ASPHALT
Area (Sq. Ft.)	Lane Miles (11' Widths)	Curb Reveal (Inches)	Curb Recommendation
1,893	0.033	NOT APPLICABLE	NOT APPLICABLE
Curb Type		Curb & Gutter Type	
NO CURB		NO CURB AND GUTTER	
Pavement Recommendation		Condition Rating / PCR	
LIGHT 3R TREATMENTS		FAIR / 73

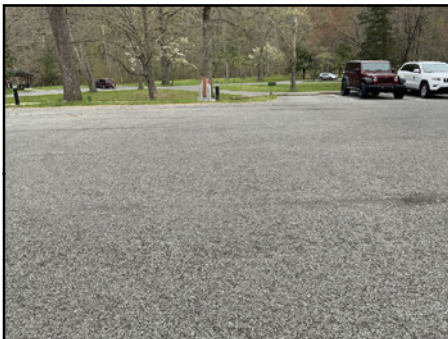
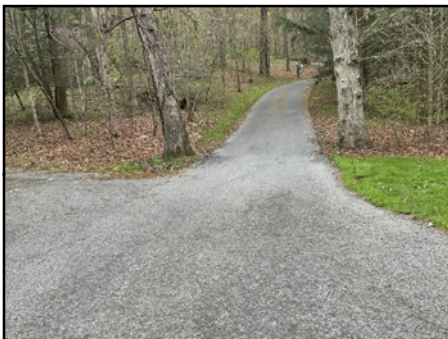
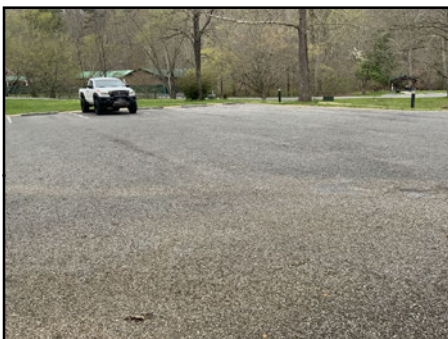
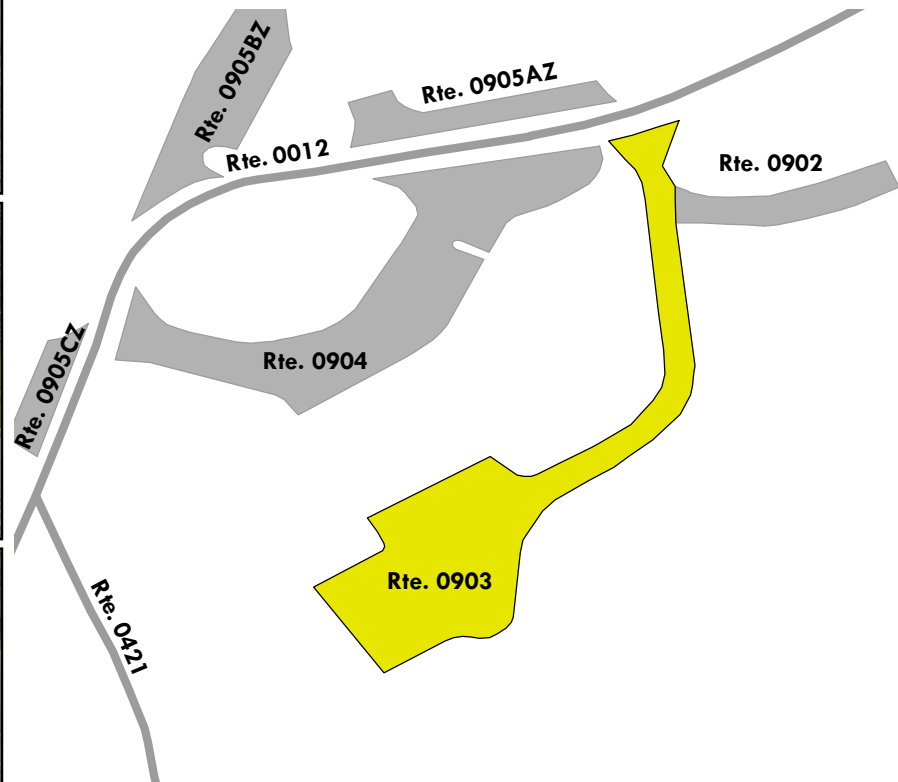
ROUTE 0903: HEADQUARTERS PARKING A

Inspection Date	FMSS Number	User Access	Surface Type
4/13/2021	100409	PUBLIC	ASPHALT
Area (Sq. Ft.)	Lane Miles (11' Widths)	Curb Reveal (Inches)	Curb Recommendation
11,577	0.199	NOT APPLICABLE	NOT APPLICABLE
Curb Type		Curb & Gutter Type	
NO CURB		NO CURB AND GUTTER	
Pavement Recommendation		Condition Rating / PCR	
LIGHT 3R TREATMENTS		FAIR / 73

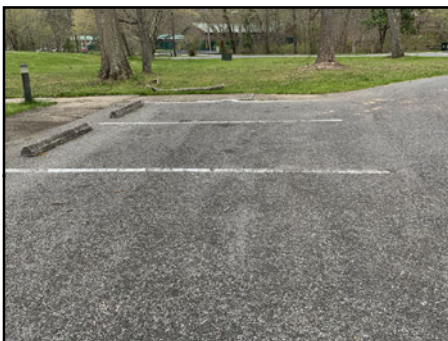
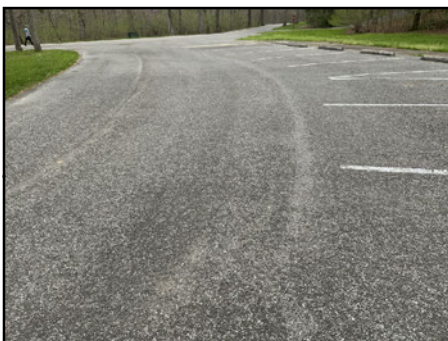
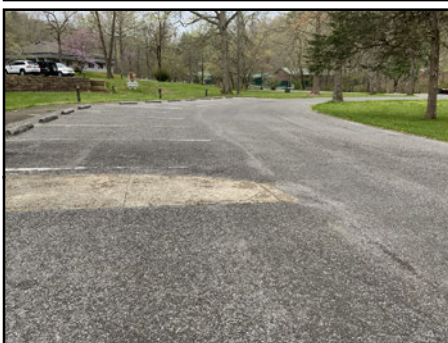
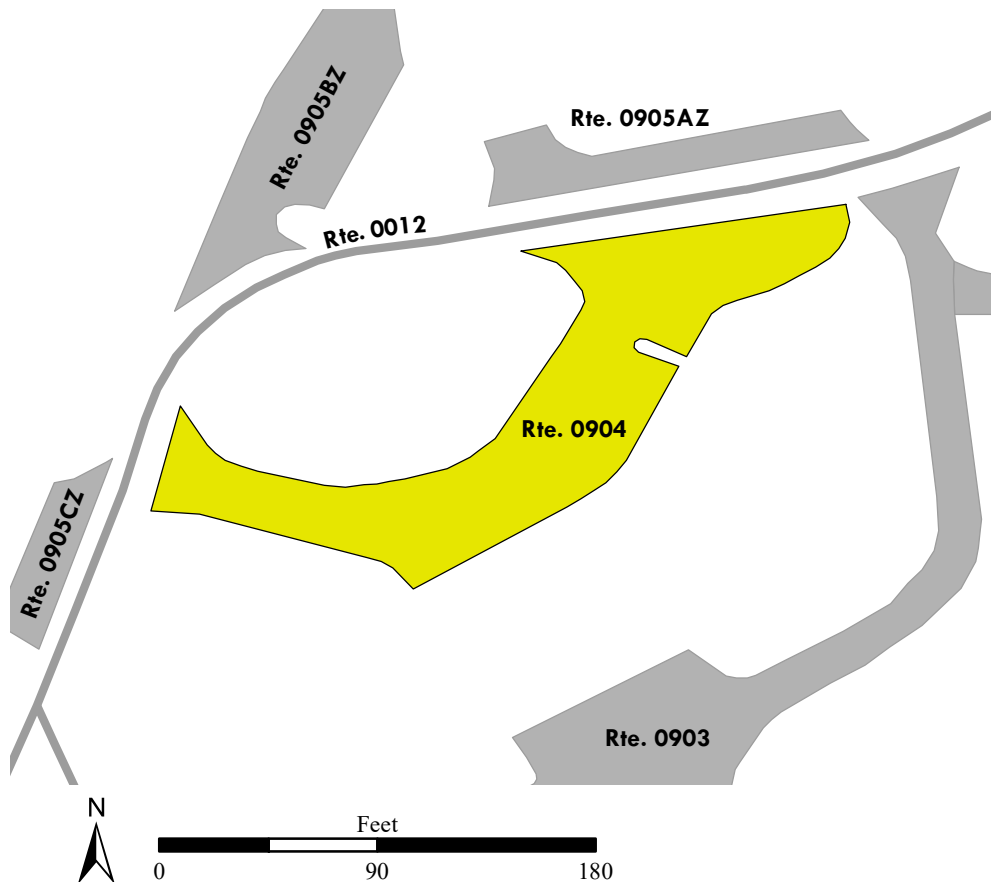
Inspection Date	FMSS Number	User Access	Surface Type
4/13/2021	100410	PUBLIC	ASPHALT
Area (Sq. Ft.)	Lane Miles (11' Widths)	Curb Reveal (Inches)	Curb Recommendation
10,033	0.173	NOT APPLICABLE	NOT APPLICABLE
Curb Type		Curb & Gutter Type	
NO CURB		NO CURB AND GUTTER	
Pavement Recommendation		Condition Rating / PCR	
LIGHT 3R TREATMENTS		FAIR / 73

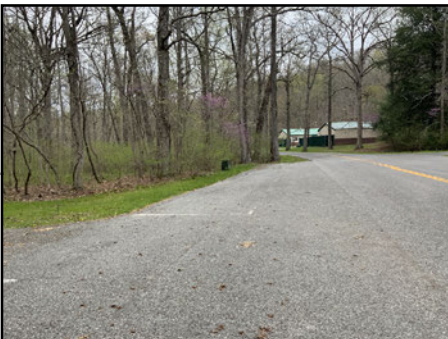
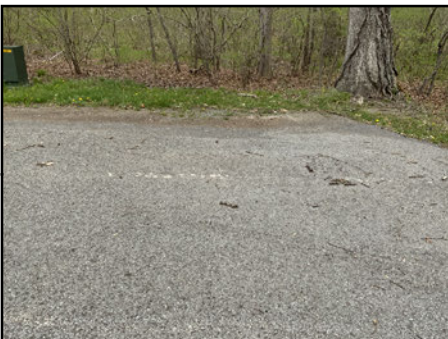
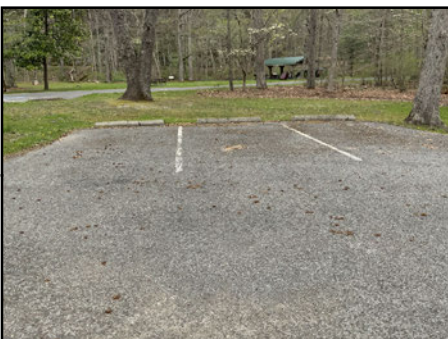
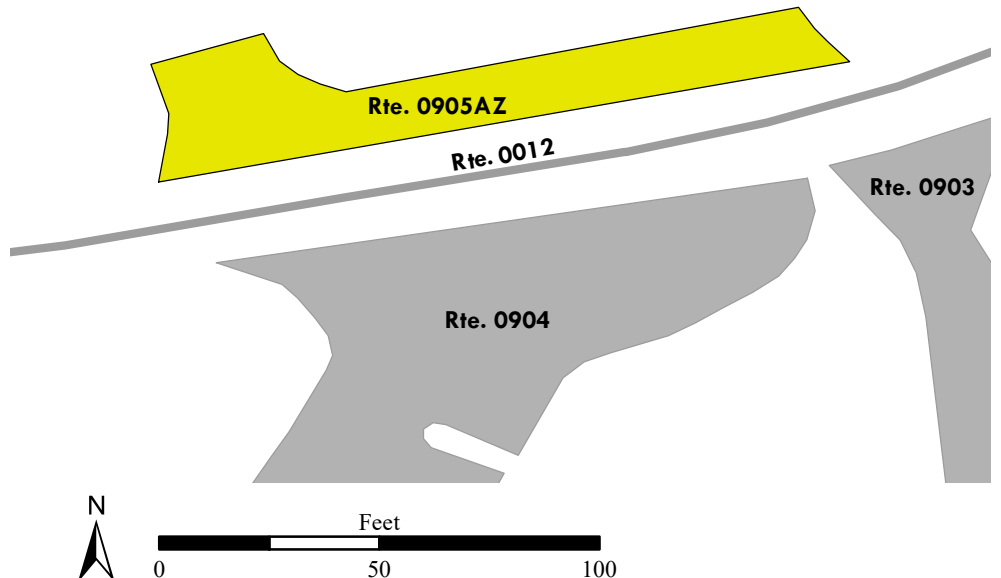
ROUTE 0905AZ: BARTLETT PARK PICNIC AREA PARKING A

Inspection Date	FMSS Number	User Access	Surface Type
4/13/2021	100411	PUBLIC	ASPHALT
Area (Sq. Ft.)	Lane Miles (11' Widths)	Curb Reveal (Inches)	Curb Recommendation
2,005	0.035	NOT APPLICABLE	NOT APPLICABLE
Curb Type		Curb & Gutter Type	
NO CURB		NO CURB AND GUTTER	
Pavement Recommendation		Condition Rating / PCR	
LIGHT 3R TREATMENTS		FAIR / 73

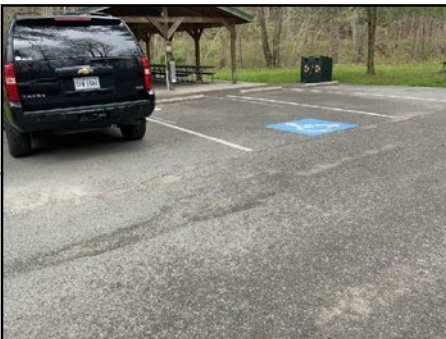
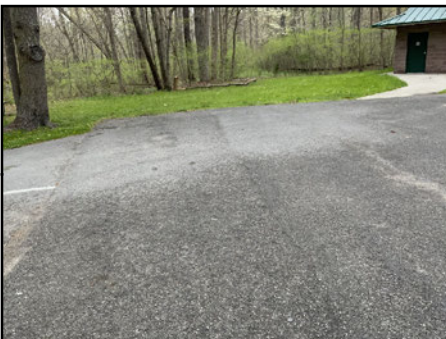
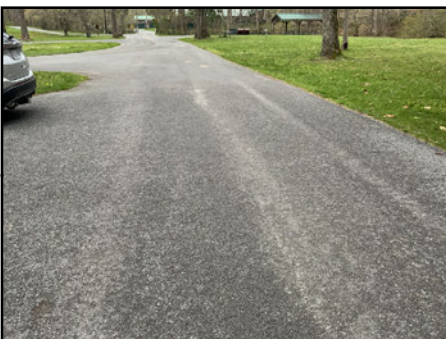
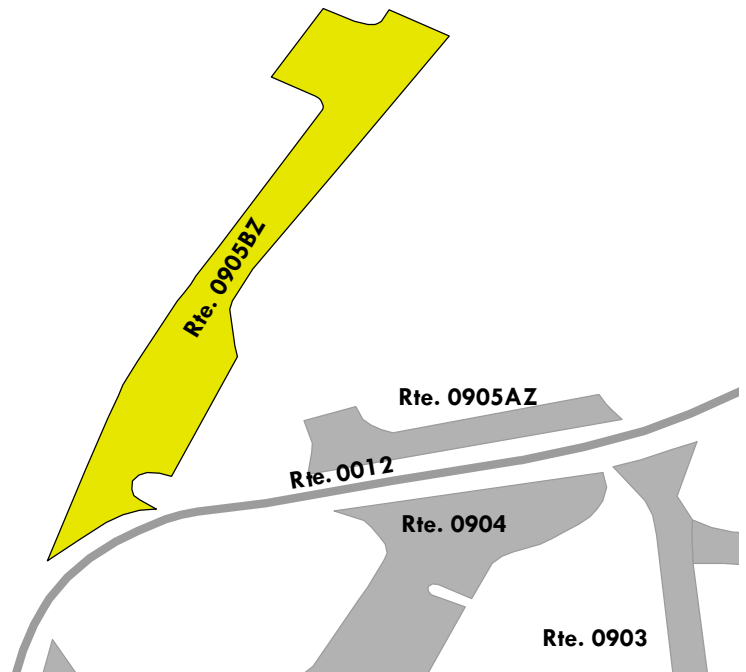
ROUTE 0905BZ: BARTLETT PARK PICNIC AREA PARKING B

Inspection Date	FMSS Number	User Access	Surface Type
4/13/2021	100411	PUBLIC	ASPHALT
Area (Sq. Ft.)	Lane Miles (11' Widths)	Curb Reveal (Inches)	Curb Recommendation
8,250	0.142	NOT APPLICABLE	NOT APPLICABLE
Curb Type		Curb & Gutter Type	
NO CURB		NO CURB AND GUTTER	
Pavement Recommendation		Condition Rating / PCR	
LIGHT 3R TREATMENTS		FAIR / 73

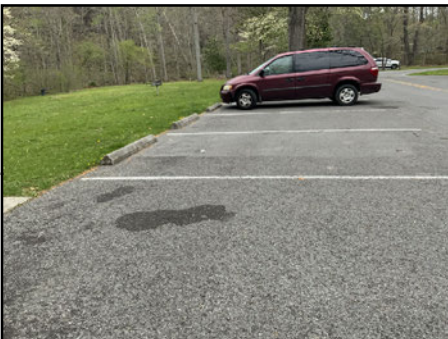
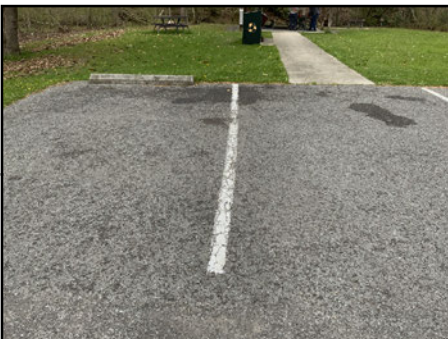
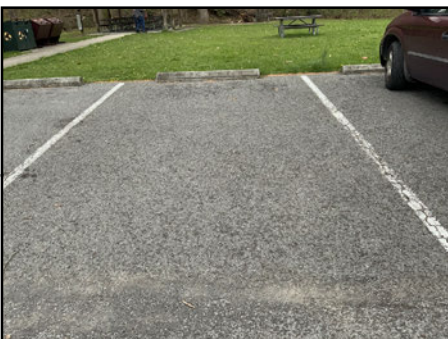
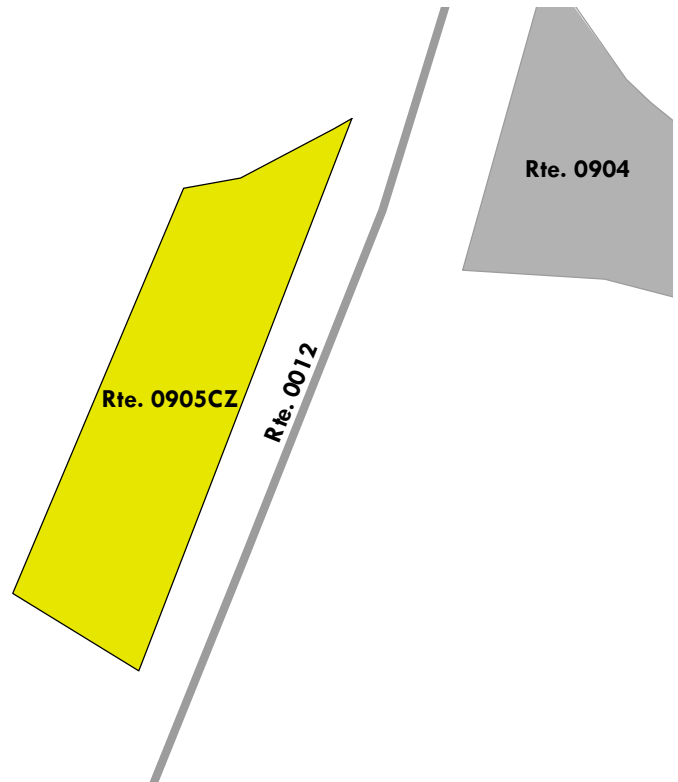
ROUTE 0905CZ: BARTLETT PARK PICNIC AREA PARKING C

Inspection Date	FMSS Number	User Access	Surface Type
4/13/2021	100411	PUBLIC	ASPHALT
Area (Sq. Ft.)	Lane Miles (11' Widths)	Curb Reveal (Inches)	Curb Recommendation
1,145	0.02	NOT APPLICABLE	NOT APPLICABLE
Curb Type		Curb & Gutter Type	
NO CURB		NO CURB AND GUTTER	
Pavement Recommendation		Condition Rating / PCR	
LIGHT 3R TREATMENTS		FAIR / 73

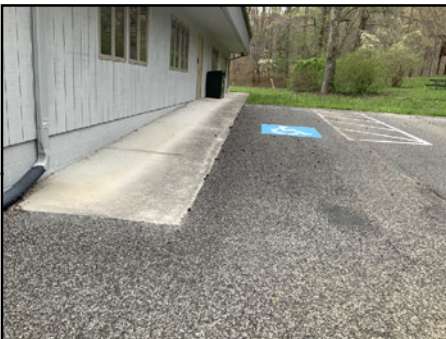
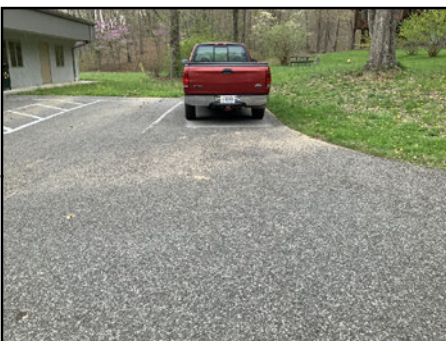
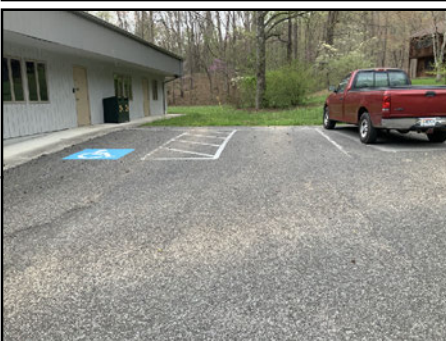
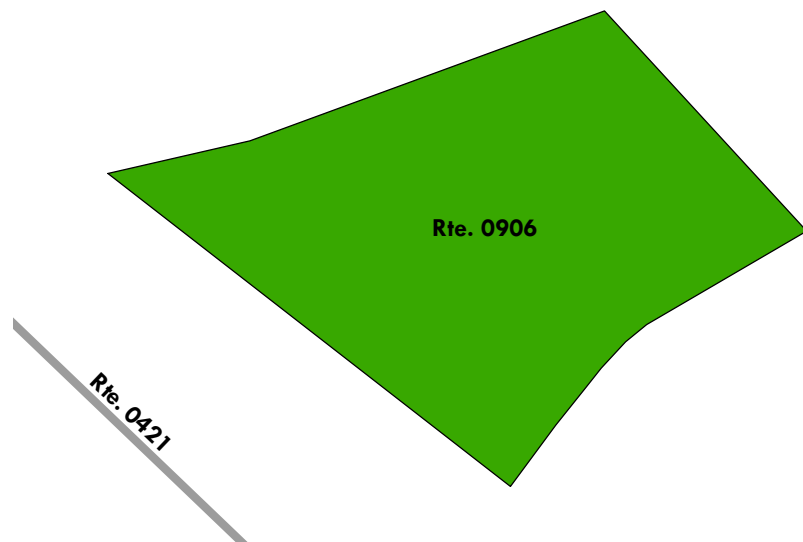
ROUTE 0906: HEADQUARTERS HANDICAPPED PARKING

Inspection Date	FMSS Number	User Access	Surface Type
4/13/2021	100414	PUBLIC	ASPHALT
Area (Sq. Ft.)	Lane Miles (11' Widths)	Curb Reveal (Inches)	Curb Recommendation
970	0.017	NOT APPLICABLE	NOT APPLICABLE
Curb Type		Curb & Gutter Type	
NO CURB		NO CURB AND GUTTER	
Pavement Recommendation		Condition Rating / PCR	
PREVENTIVE MAINTENANCE		GOOD / 90

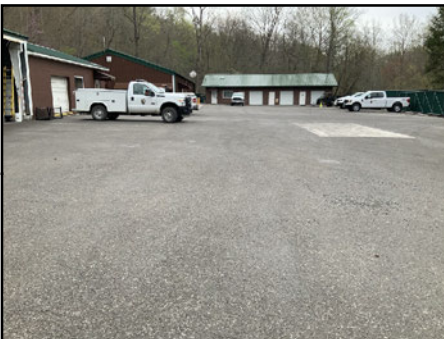
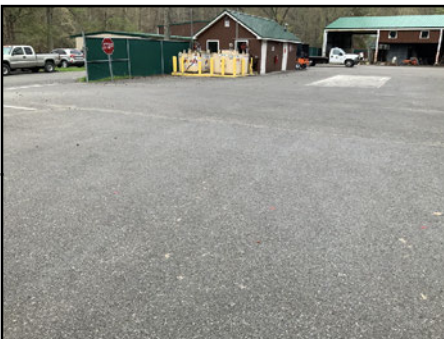
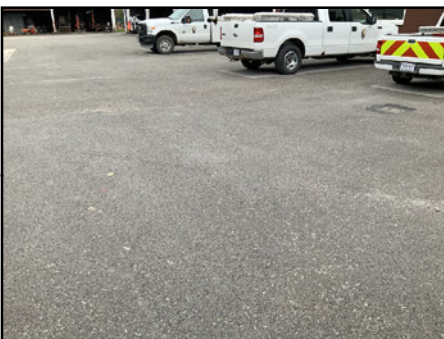
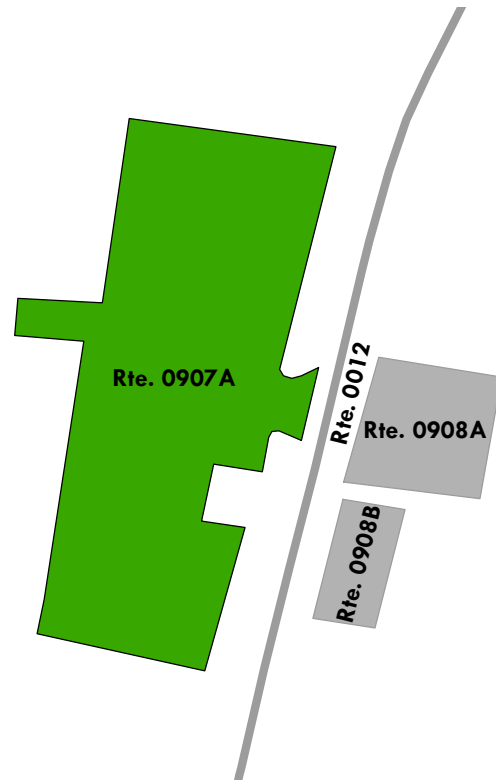
ROUTE 0907A: MAINTENANCE AREA A

Inspection Date	FMSS Number	User Access	Surface Type
4/13/2021	100416	NONPUBLIC	ASPHALT
Area (Sq. Ft.)	Lane Miles (11' Widths)	Curb Reveal (Inches)	Curb Recommendation
22,448	0.387	NOT APPLICABLE	NOT APPLICABLE
Curb Type		Curb & Gutter Type	
NO CURB		NO CURB AND GUTTER	
Pavement Recommendation		Condition Rating / PCR	
PREVENTIVE MAINTENANCE		GOOD / 90

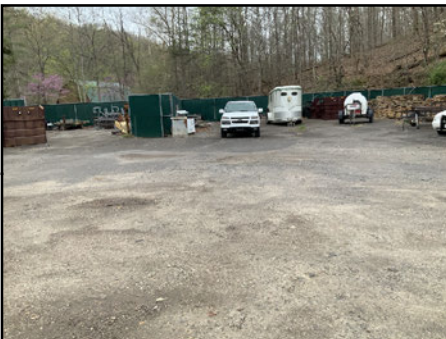
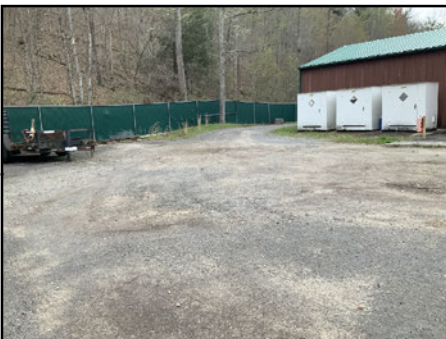
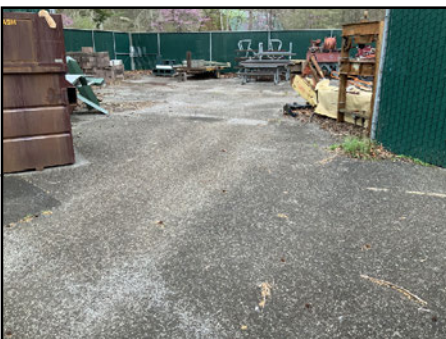
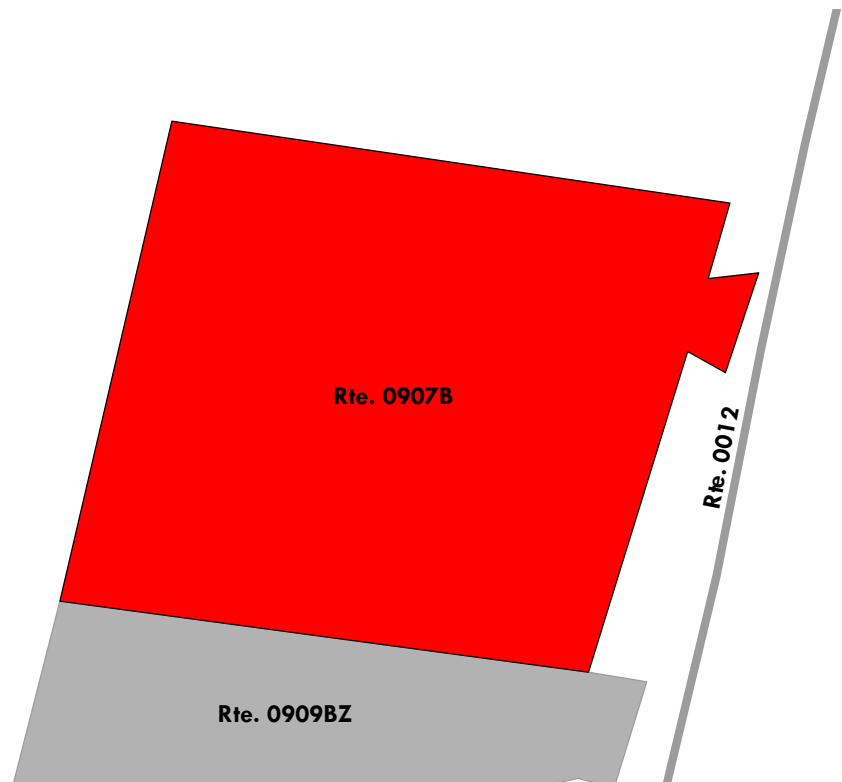
ROUTE 0907B: MAINTENANCE AREA B

Inspection Date	FMSS Number	User Access	Surface Type
4/13/2021	100576	NONPUBLIC	ASPHALT
Area (Sq. Ft.)	Lane Miles (11' Widths)	Curb Reveal (Inches)	Curb Recommendation
11,916	0.205	NOT APPLICABLE	NOT APPLICABLE
Curb Type		Curb & Gutter Type	
NO CURB		NO CURB AND GUTTER	
Pavement Recommendation		Condition Rating / PCR	
RECONSTRUCTION		POOR / 30

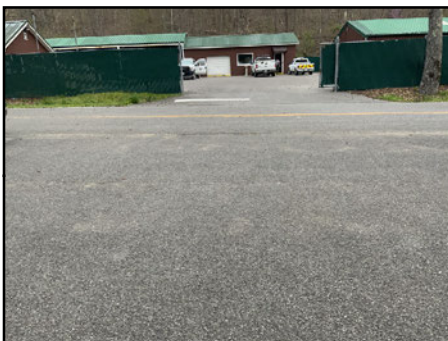
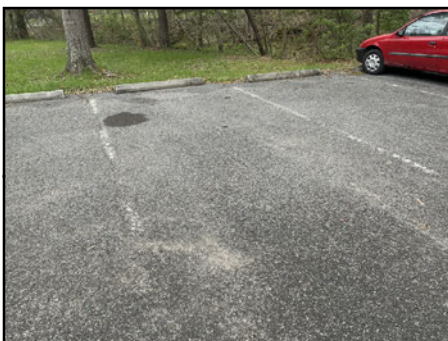
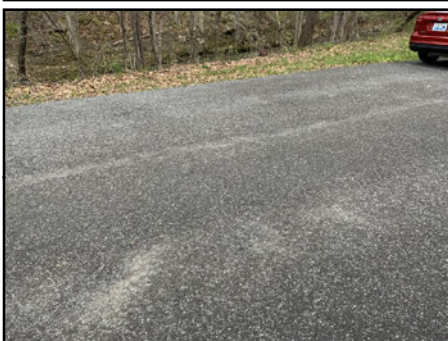
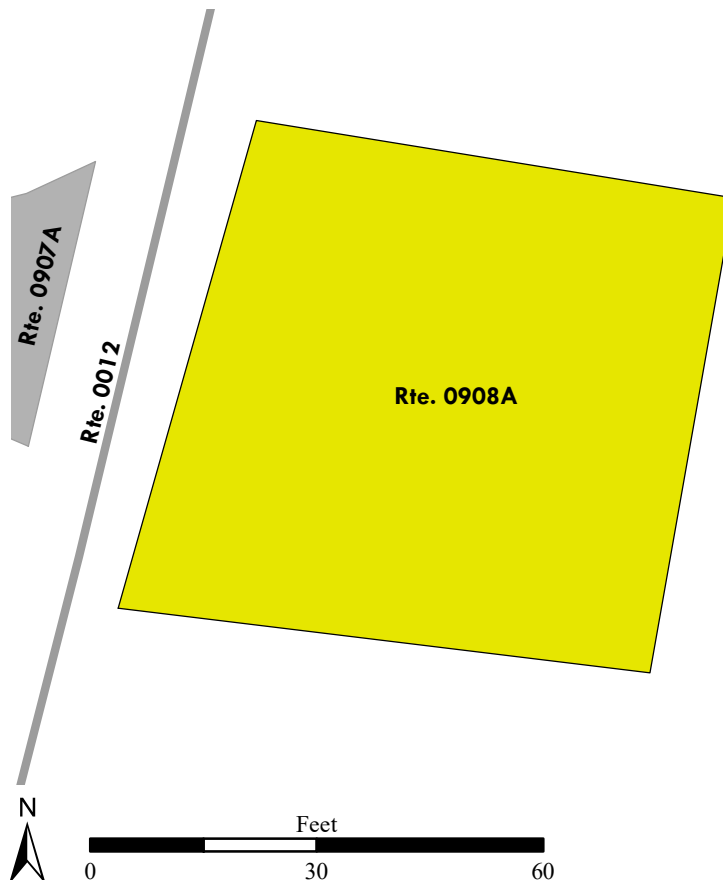
ROUTE 0908A: FACILITY MANAGEMENT EMPLOYEE PARKING

Inspection Date	FMSS Number	User Access	Surface Type
4/13/2021	100578	NONPUBLIC	ASPHALT
Area (Sq. Ft.)	Lane Miles (11' Widths)	Curb Reveal (Inches)	Curb Recommendation
3,539	0.061	NOT APPLICABLE	NOT APPLICABLE
Curb Type		Curb & Gutter Type	
NO CURB		NO CURB AND GUTTER	
Pavement Recommendation		Condition Rating / PCR	
LIGHT 3R TREATMENTS		FAIR / 73

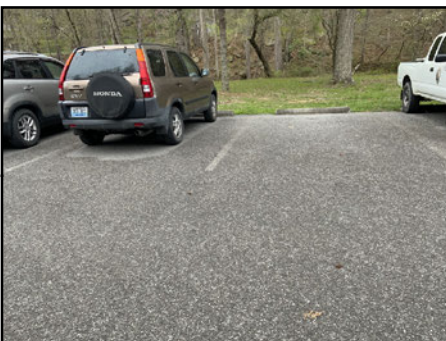
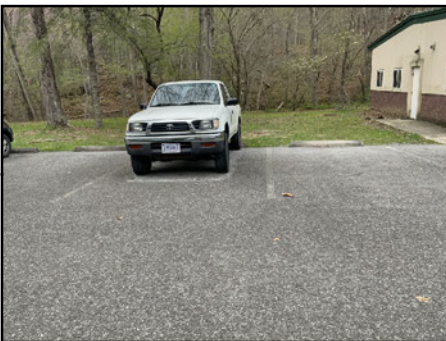
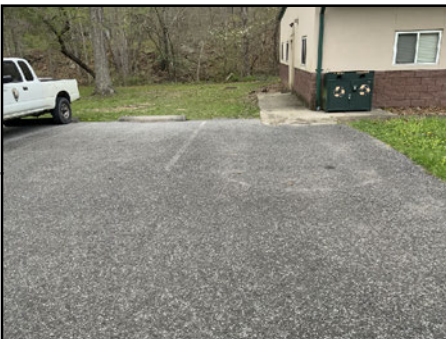
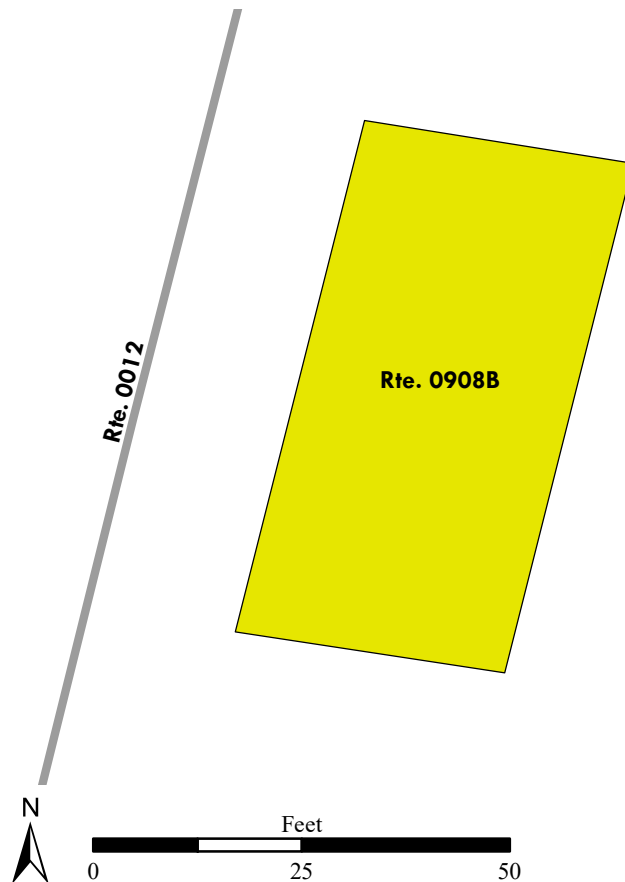
ROUTE 0908B: RESOURCE MANAGEMENT PARKING

Inspection Date	FMSS Number	User Access	Surface Type
4/13/2021	100592	NONPUBLIC	ASPHALT
Area (Sq. Ft.)	Lane Miles (11' Widths)	Curb Reveal (Inches)	Curb Recommendation
1,654	0.028	NOT APPLICABLE	NOT APPLICABLE
Curb Type		Curb & Gutter Type	
NO CURB		NO CURB AND GUTTER	
Pavement Recommendation		Condition Rating / PCR	
LIGHT 3R TREATMENTS		FAIR / 73

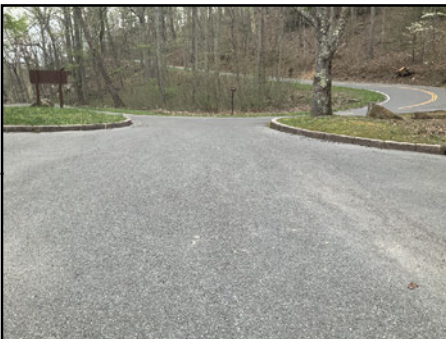
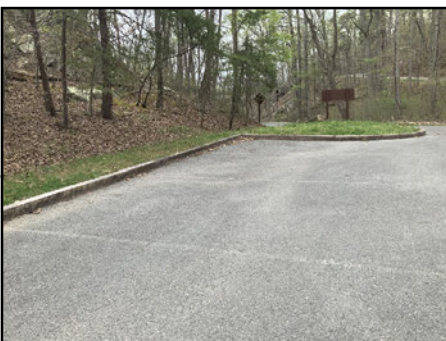
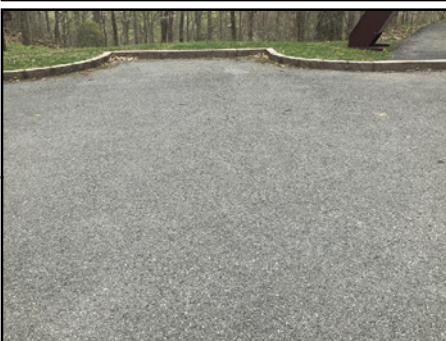
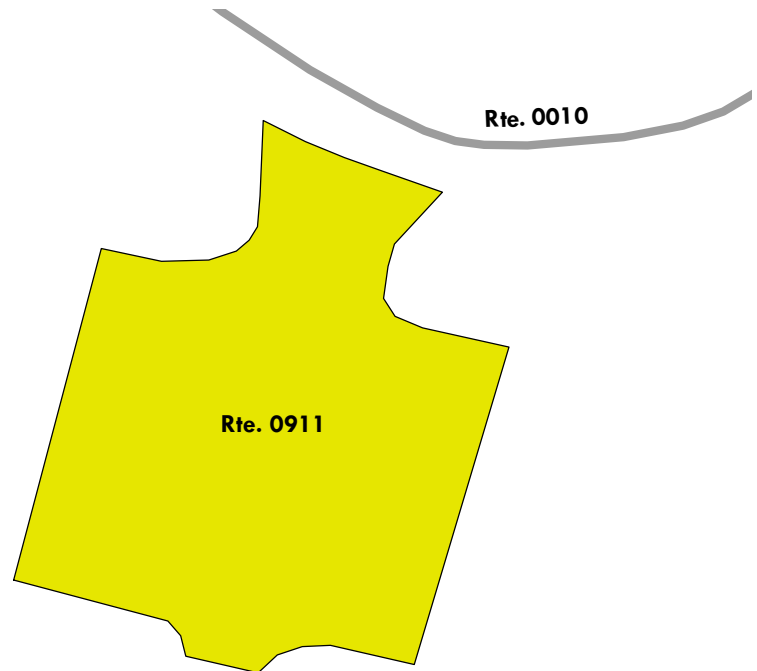
ROUTE 0912: MIDWAY PARKING

Inspection Date	FMSS Number	User Access	Surface Type
4/13/2021	101151	PUBLIC	ASPHALT
Area (Sq. Ft.)	Lane Miles (11' Widths)	Curb Reveal (Inches)	Curb Recommendation
6,056	0.104	8	DO NOTHING
Curb Type		Curb & Gutter Type	
STONE		NO CURB AND GUTTER	
Pavement Recommendation		Condition Rating / PCR	
LIGHT 3R TREATMENTS		FAIR / 73

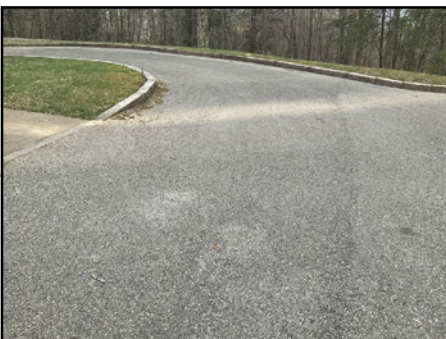
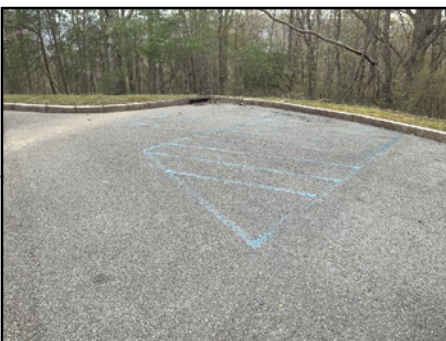
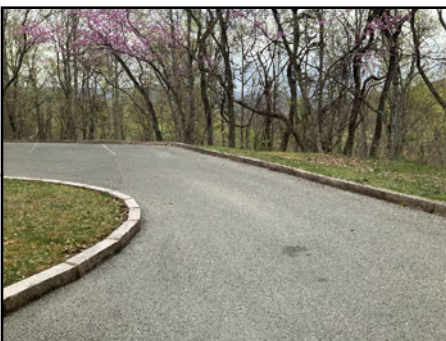
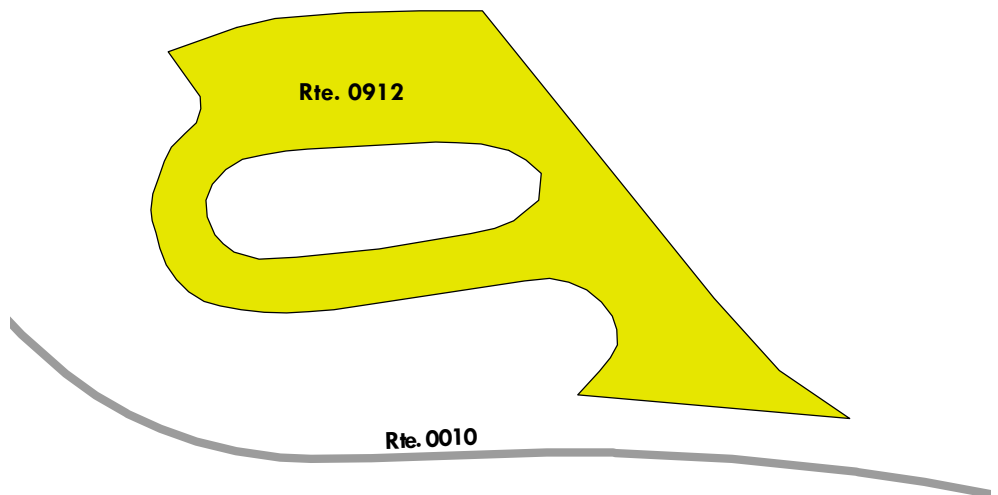
ROUTE 0913: PINNACLE PARKING

Inspection Date	FMSS Number	User Access	Surface Type
4/13/2021	101152	PUBLIC	ASPHALT
Area (Sq. Ft.)	Lane Miles (11' Widths)	Curb Reveal (Inches)	Curb Recommendation
41,735	0.719	8	DO NOTHING
Curb Type		Curb & Gutter Type	
STONE		NO CURB AND GUTTER	
Pavement Recommendation		Condition Rating / PCR	
LIGHT 3R TREATMENTS		FAIR / 73

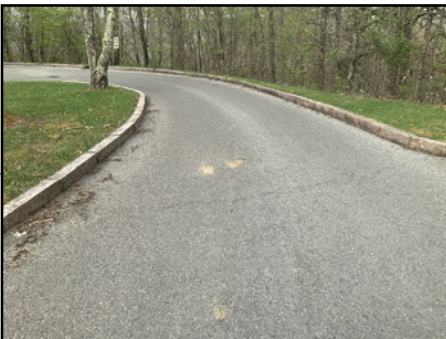
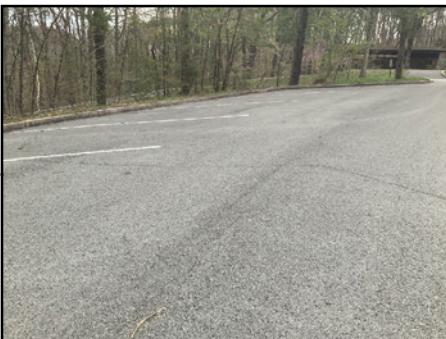
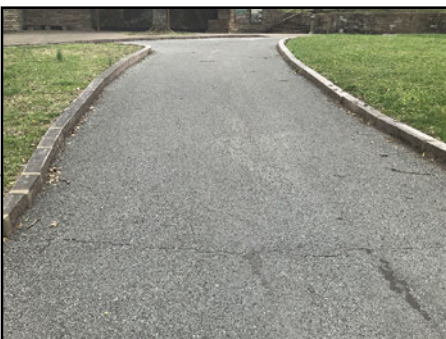
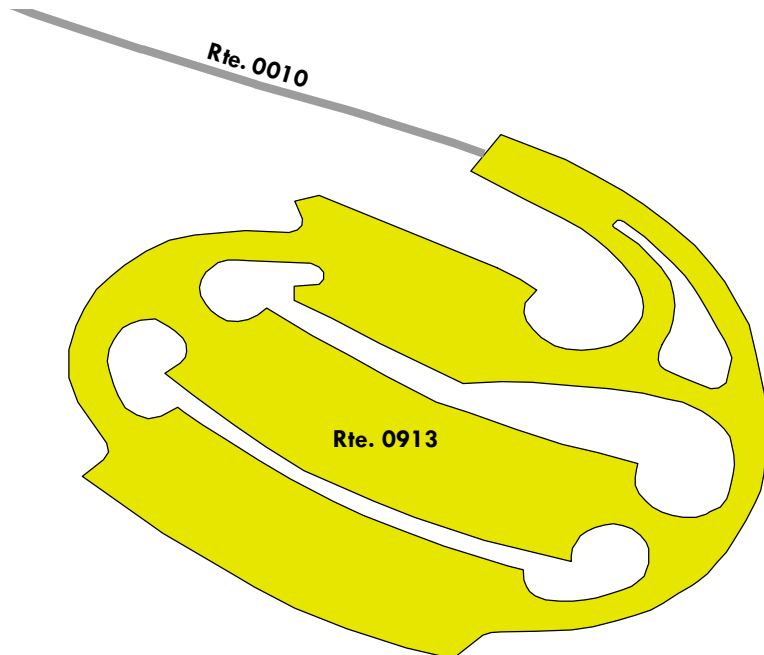
ROUTE 0914: THOMAS WALKER PARKING

Inspection Date	FMSS Number	User Access	Surface Type
4/13/2021	93475	PUBLIC	ASPHALT
Area (Sq. Ft.)	Lane Miles (11' Widths)	Curb Reveal (Inches)	Curb Recommendation
51,382	0.885	8	DO NOTHING
Curb Type		Curb & Gutter Type	
STONE		NO CURB AND GUTTER	
Pavement Recommendation		Condition Rating / PCR	
LIGHT 3R TREATMENTS		FAIR / 73

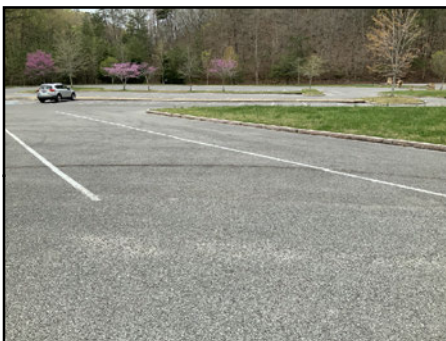
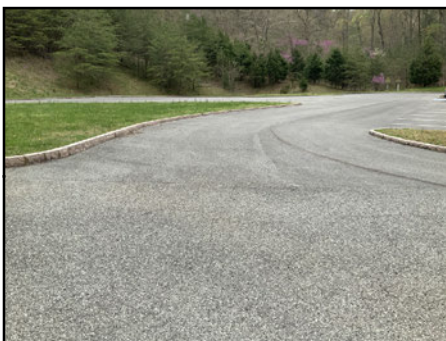
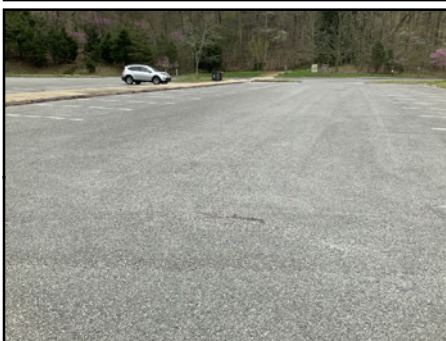
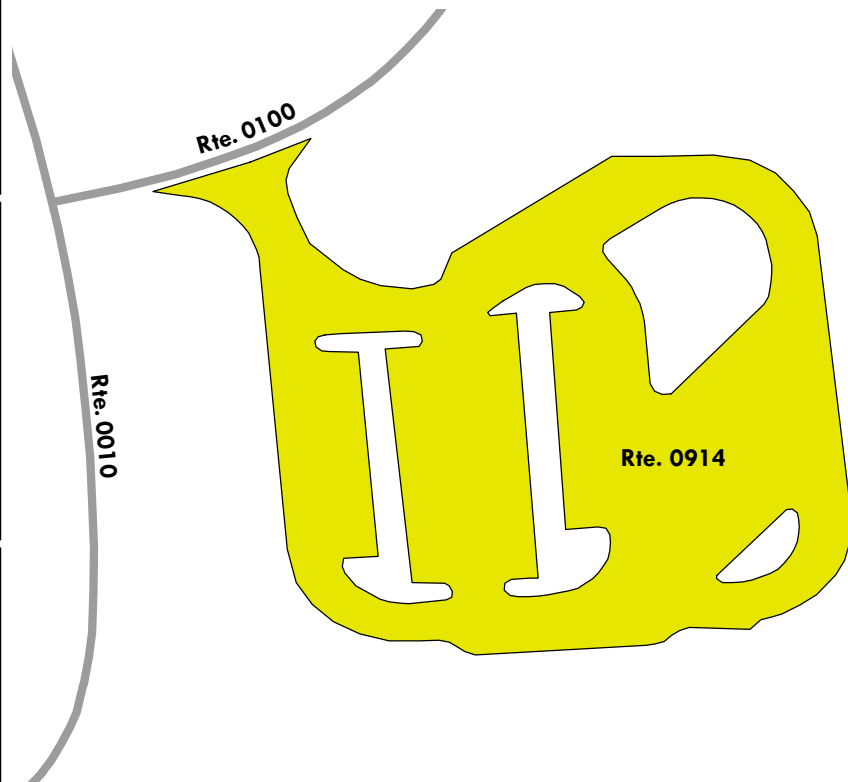
ROUTE 0915: DARK RIDGE OVERLOOK PARKING

Inspection Date	FMSS Number	User Access	Surface Type
4/13/2021	101153	PUBLIC	ASPHALT
Area (Sq. Ft.)	Lane Miles (11' Widths)	Curb Reveal (Inches)	Curb Recommendation
4,653	0.08	4	DO NOTHING
Curb Type		Curb & Gutter Type	
CONCRETE		NO CURB AND GUTTER	
Pavement Recommendation		Condition Rating / PCR	
LIGHT 3R TREATMENTS		FAIR / 73

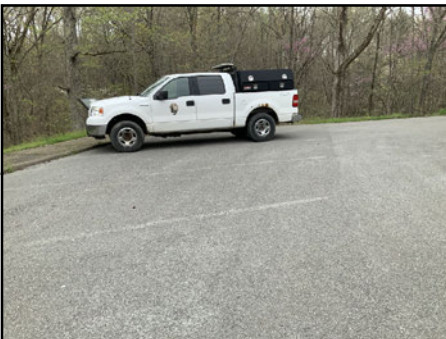
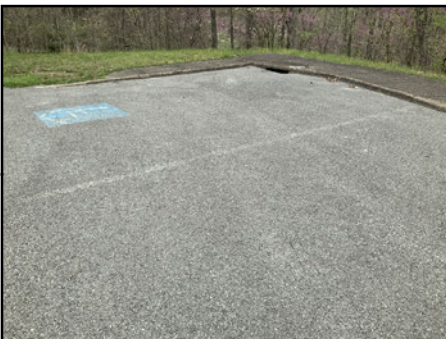
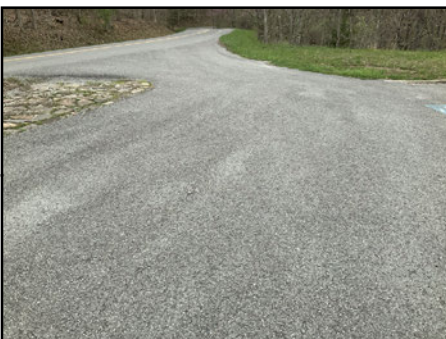
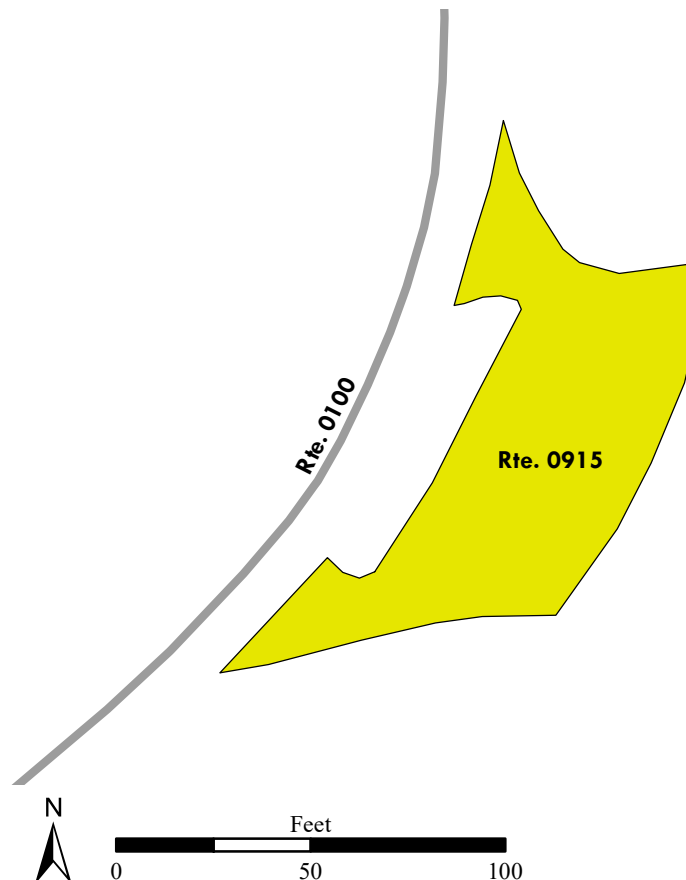
ROUTE 0916: SUGAR RUN TURNAROUND

Inspection Date	FMSS Number	User Access	Surface Type
4/13/2021	101154	PUBLIC	ASPHALT
Area (Sq. Ft.)	Lane Miles (11' Widths)	Curb Reveal (Inches)	Curb Recommendation
5,559	0.096	NOT APPLICABLE	NOT APPLICABLE
Curb Type		Curb & Gutter Type	
NO CURB		NO CURB AND GUTTER	
Pavement Recommendation		Condition Rating / PCR	
LIGHT 3R TREATMENTS		FAIR / 73
