CUGA Cycle 6

Final Report

Road Inventory and Condition Assessment of Paved Routes Cumberland Gap National Historical Park

Report Date: March 2022

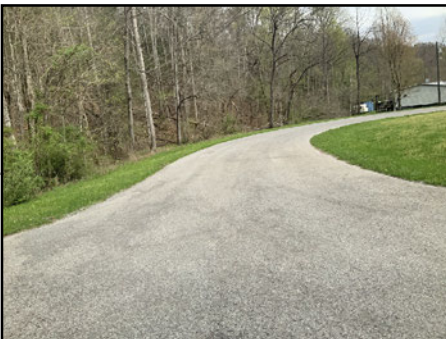
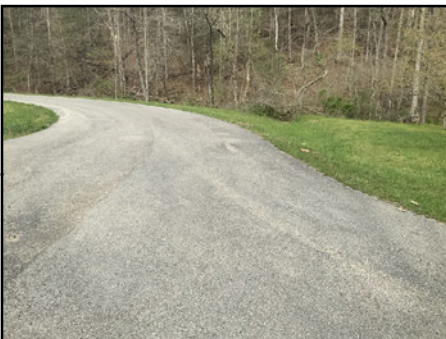
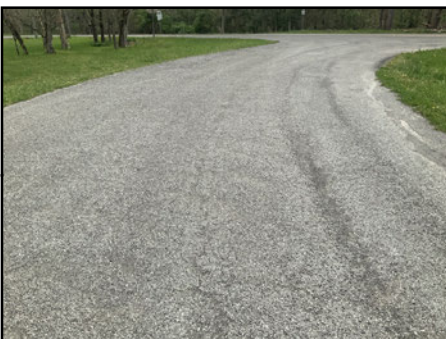
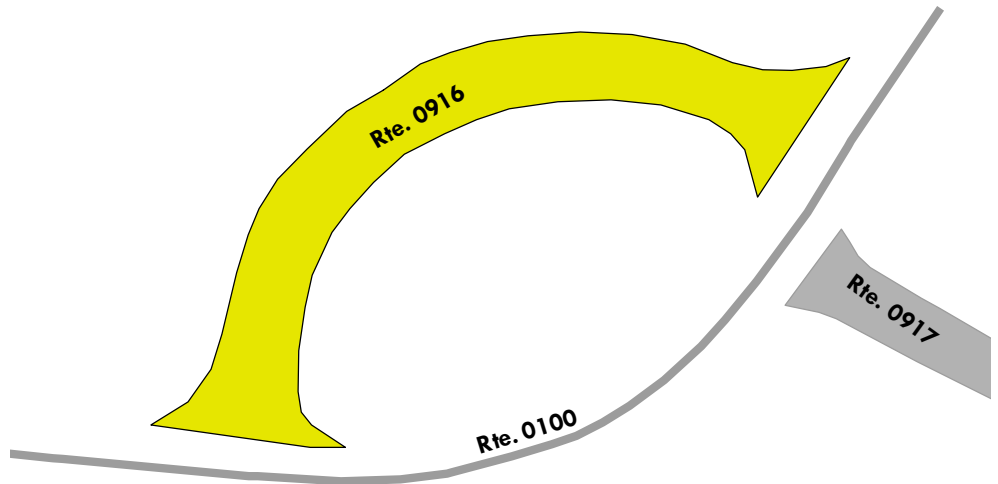
ROUTE 0917: SUGAR RUN PICNIC AREA PARKING

Inspection Date	FMSS Number	User Access	Surface Type
4/13/2021	101155	PUBLIC	ASPHALT
Area (Sq. Ft.)	Lane Miles (11' Widths)	Curb Reveal (Inches)	Curb Recommendation
17,060	0.294	NOT APPLICABLE	NOT APPLICABLE
Curb Type		Curb & Gutter Type	
NO CURB		NO CURB AND GUTTER	
Pavement Recommendation		Condition Rating / PCR	
LIGHT 3R TREATMENTS		FAIR / 73

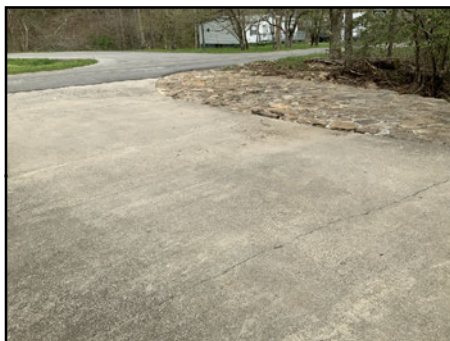
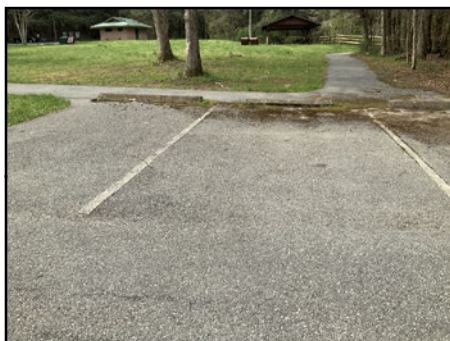
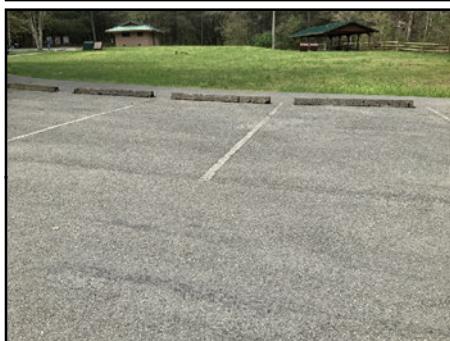
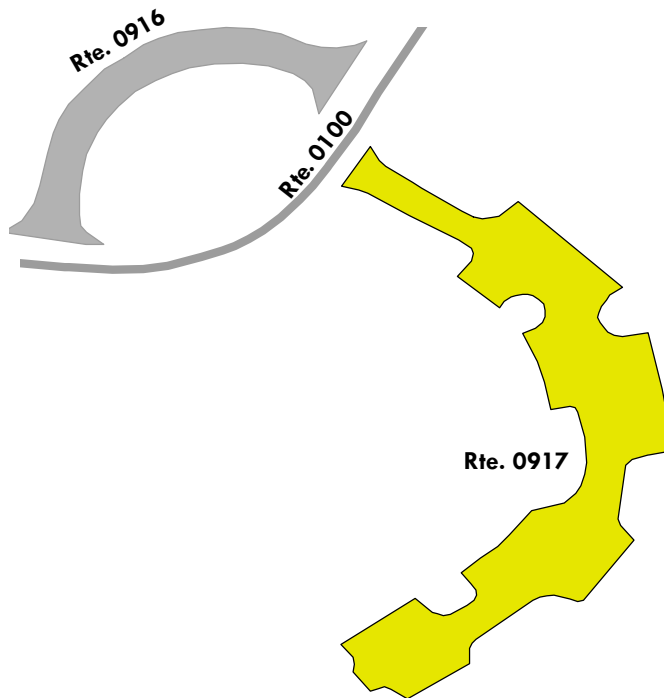
ROUTE 0918A: WILDERNESS ROAD TRAILHEAD PARKING A

Inspection Date	FMSS Number	User Access	Surface Type
4/13/2021	101156	PUBLIC	ASPHALT
Area (Sq. Ft.)	Lane Miles (11' Widths)	Curb Reveal (Inches)	Curb Recommendation
15,637	0.269	NOT APPLICABLE	NOT APPLICABLE
Curb Type		Curb & Gutter Type	
NO CURB		NO CURB AND GUTTER	
Pavement Recommendation		Condition Rating / PCR	
LIGHT 3R TREATMENTS		FAIR / 73

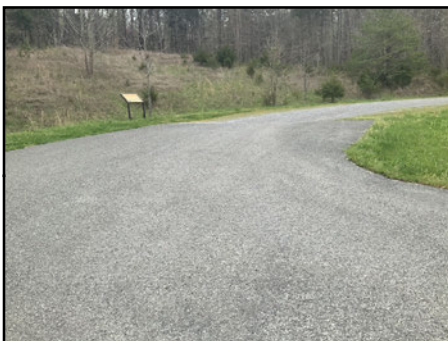
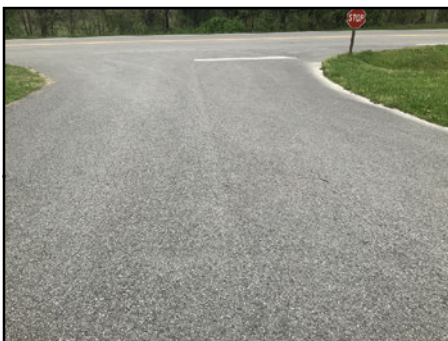
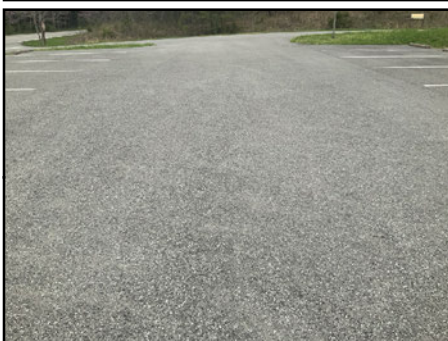
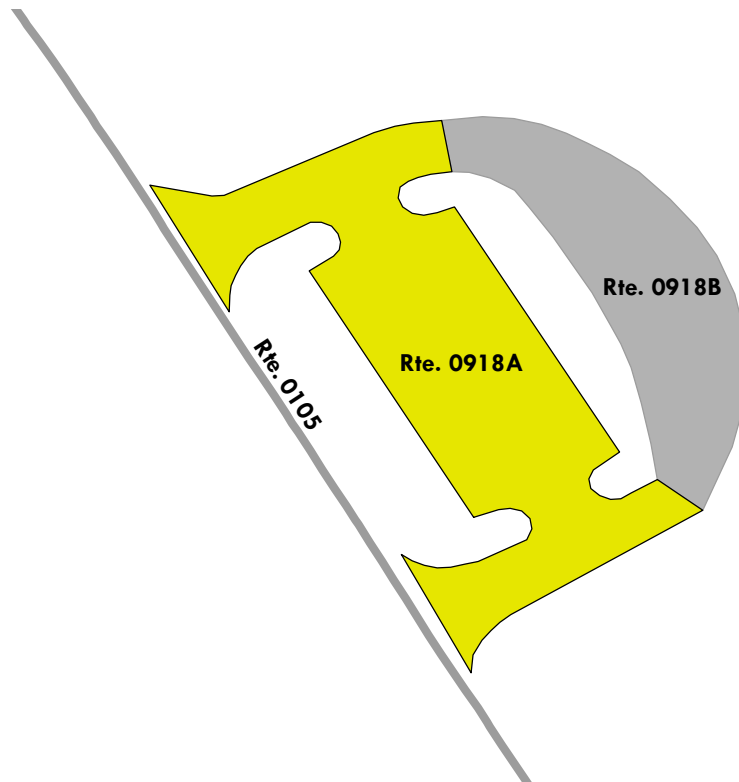
ROUTE 0919: WILDERNESS ROAD CAMPGROUND DUMP STATION

Inspection Date	FMSS Number	User Access	Surface Type
4/13/2021	101158	PUBLIC	ASPHALT
Area (Sq. Ft.)	Lane Miles (11' Widths)	Curb Reveal (Inches)	Curb Recommendation
8,987	0.155	NOT APPLICABLE	NOT APPLICABLE
Curb Type		Curb & Gutter Type	
NO CURB		NO CURB AND GUTTER	
Pavement Recommendation		Condition Rating / PCR	
PREVENTIVE MAINTENANCE		GOOD / 90

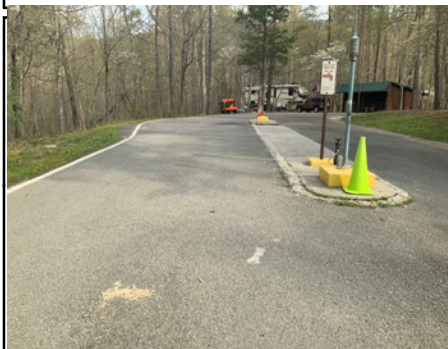
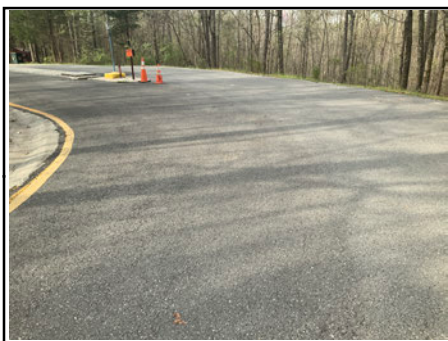
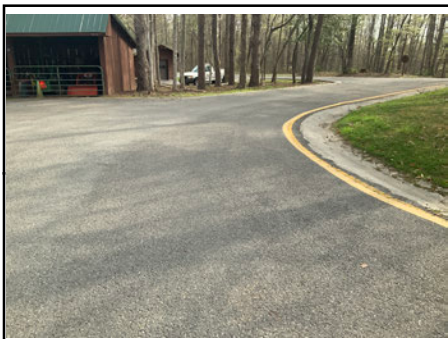
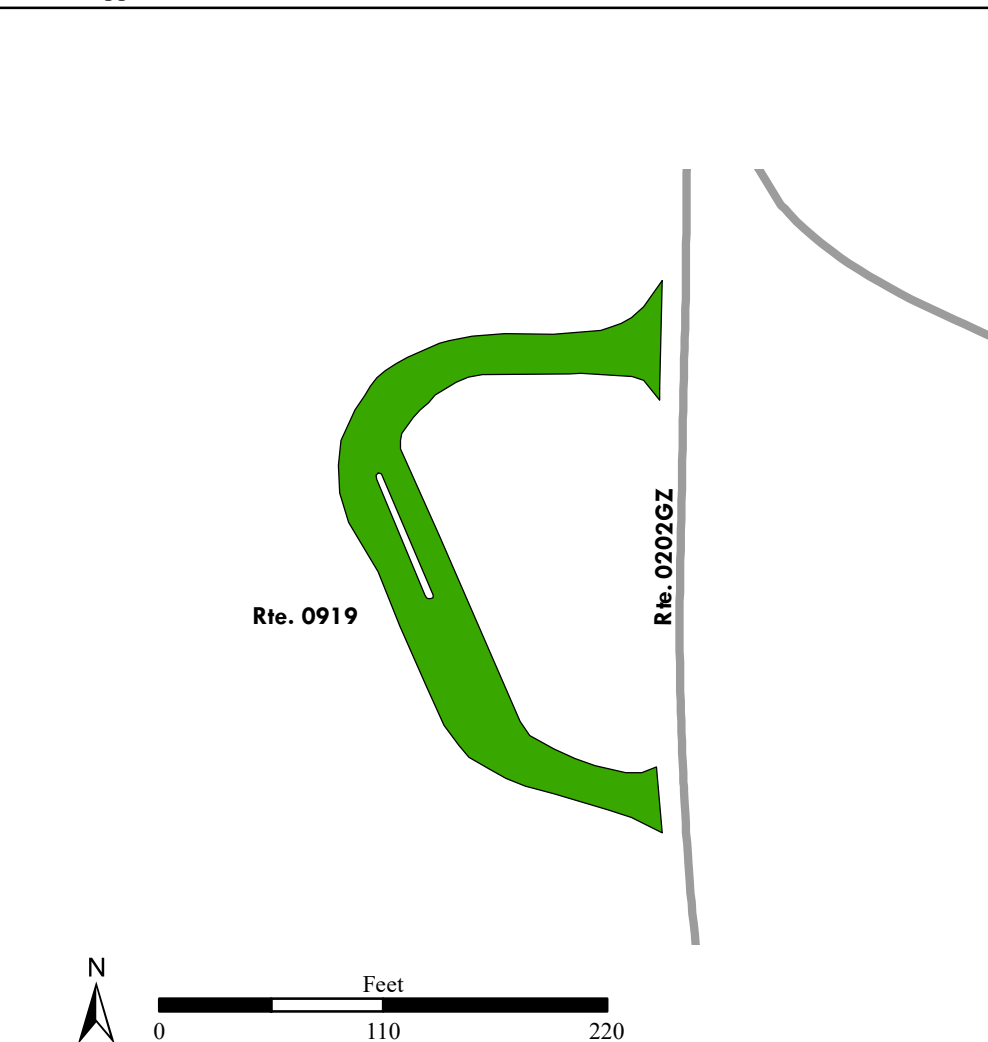
ROUTE 0920: GROUP CAMPING PARKING

Inspection Date	FMSS Number	User Access	Surface Type
4/13/2021	101159	PUBLIC	ASPHALT
Area (Sq. Ft.)	Lane Miles (11' Widths)	Curb Reveal (Inches)	Curb Recommendation
4,852	0.084	NOT APPLICABLE	NOT APPLICABLE
Curb Type		Curb & Gutter Type	
NO CURB		NO CURB AND GUTTER	
Pavement Recommendation		Condition Rating / PCR	
PREVENTIVE MAINTENANCE		GOOD / 90

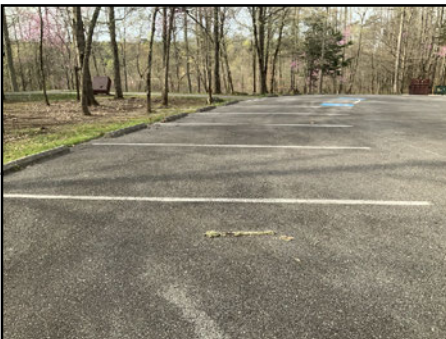
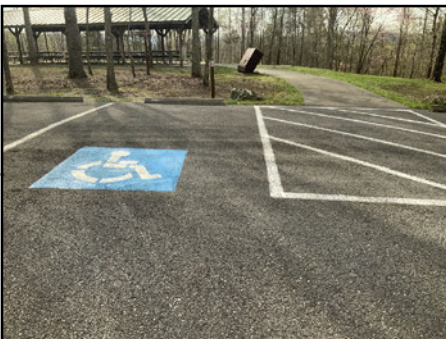
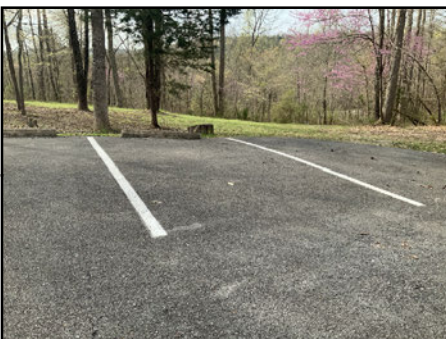
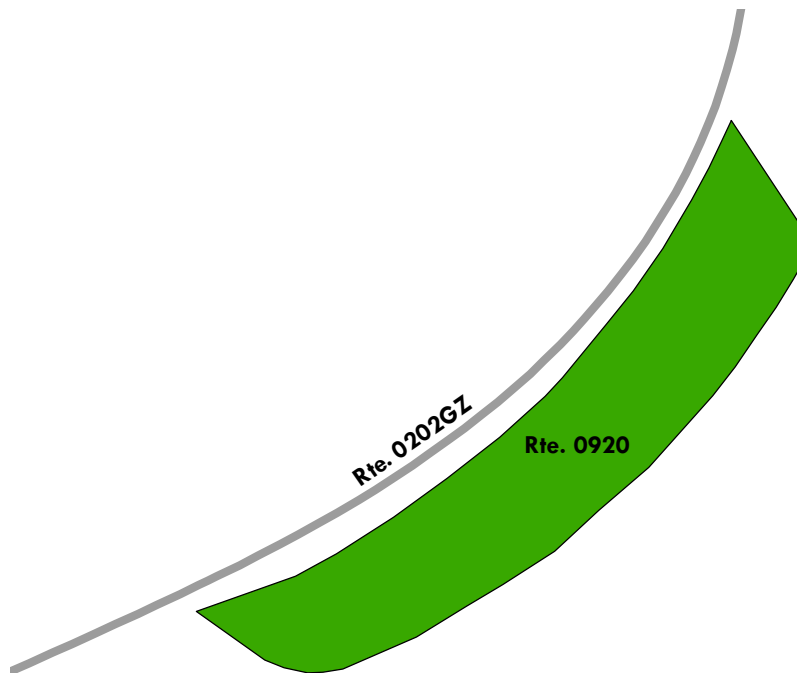
ROUTE 0921: AMPHITHEATER HANDICAPPED PARKING

Inspection Date	FMSS Number	User Access	Surface Type
4/13/2021	101160	PUBLIC	ASPHALT
Area (Sq. Ft.)	Lane Miles (11' Widths)	Curb Reveal (Inches)	Curb Recommendation
1,238	0.021	NOT APPLICABLE	NOT APPLICABLE
Curb Type		Curb & Gutter Type	
NO CURB		NO CURB AND GUTTER	
Pavement Recommendation		Condition Rating / PCR	
PREVENTIVE MAINTENANCE		GOOD / 90

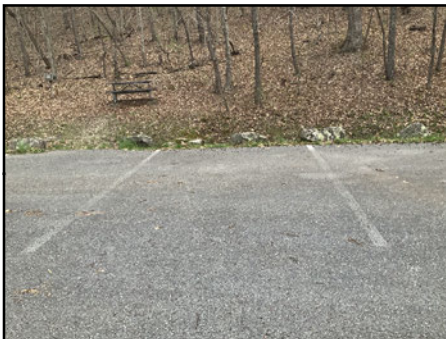
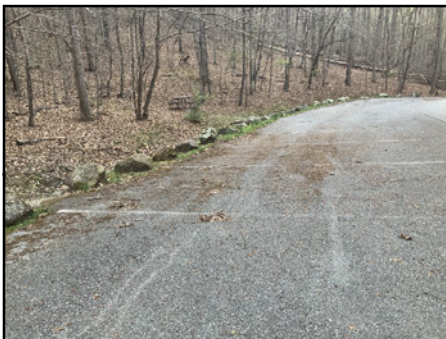
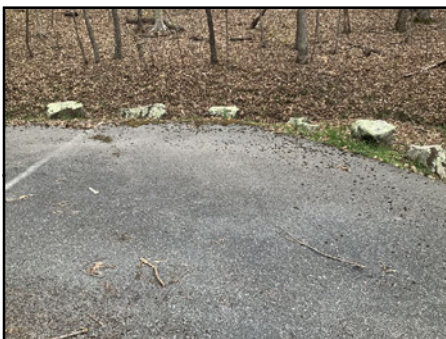
ROUTE 0922AZ: LEWIS HOLLOW PICNIC AREA PARKING A

Inspection Date	FMS Number	User Access	Surface Type
4/13/2021	101161	PUBLIC	ASPHALT
Area (Sq. Ft.)	Lane Miles (11' Widths)	Curb Reveal (Inches)	Curb Recommendation
2,654	0.046	NOT APPLICABLE	NOT APPLICABLE
Curb Type		Curb & Gutter Type	
NO CURB		NO CURB AND GUTTER	
Pavement Recommendation		Condition Rating / PCR	
PREVENTIVE MAINTENANCE		GOOD / 90

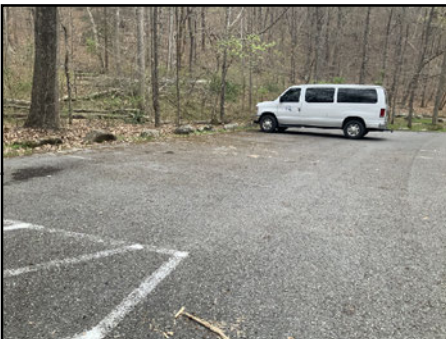
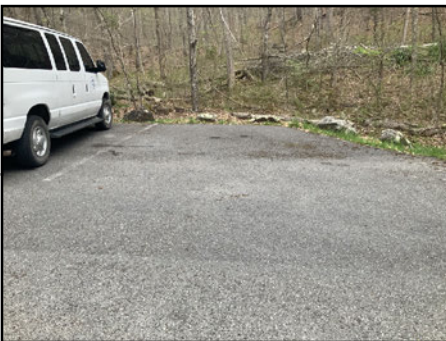
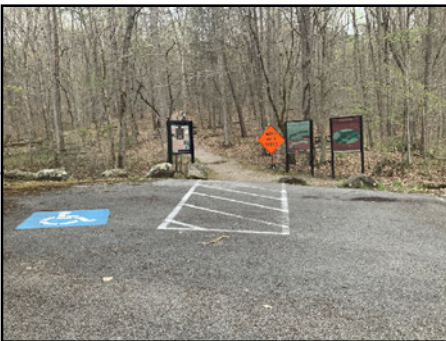
ROUTE 0922BZ: LEWIS HOLLOW PICNIC AREA PARKING B

Inspection Date	FMSS Number	User Access	Surface Type
4/13/2021	101161	PUBLIC	ASPHALT
Area (Sq. Ft.)	Lane Miles (11' Widths)	Curb Reveal (Inches)	Curb Recommendation
2,130	0.037	NOT APPLICABLE	NOT APPLICABLE
Curb Type		Curb & Gutter Type	
NO CURB		NO CURB AND GUTTER	
Pavement Recommendation		Condition Rating / PCR	
PREVENTIVE MAINTENANCE		GOOD / 90

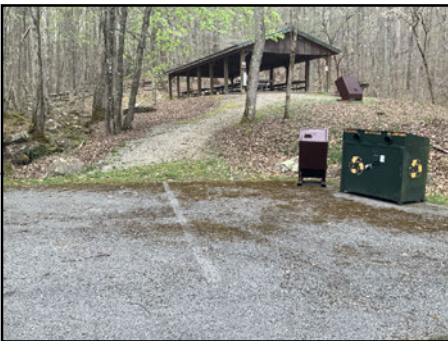
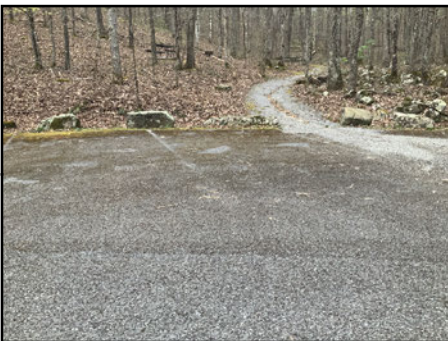
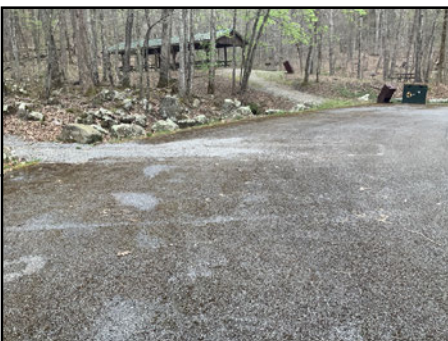
ROUTE 0922CZ: LEWIS HOLLOW PICNIC AREA PARKING C

Inspection Date	FMISS Number	User Access	Surface Type
4/13/2021	101161	PUBLIC	ASPHALT
Area (Sq. Ft.)	Lane Miles (11' Widths)	Curb Reveal (Inches)	Curb Recommendation
1,814	0.031	NOT APPLICABLE	NOT APPLICABLE
Curb Type		Curb & Gutter Type	
NO CURB		NO CURB AND GUTTER	
Pavement Recommendation		Condition Rating / PCR	
PREVENTIVE MAINTENANCE		GOOD / 90

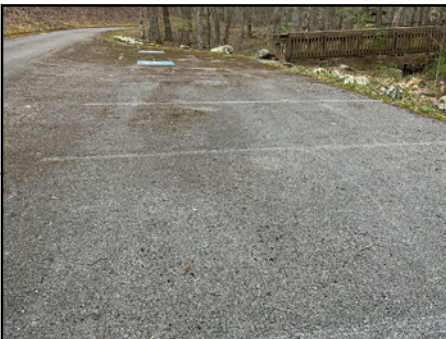
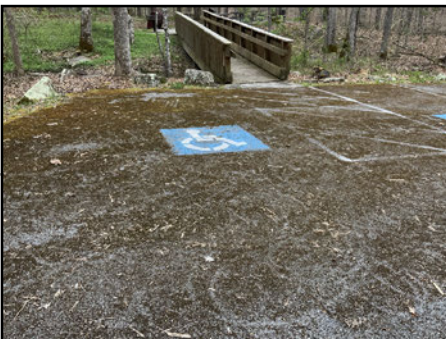
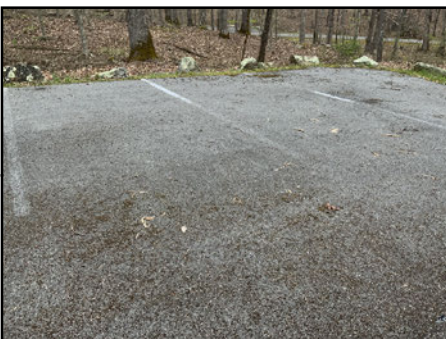
ROUTE 0922DZ: LEWIS HOLLOW PICNIC AREA PARKING D

Inspection Date	FMSS Number	User Access	Surface Type
4/13/2021	101161	PUBLIC	ASPHALT
Area (Sq. Ft.)	Lane Miles (11' Widths)	Curb Reveal (Inches)	Curb Recommendation
2,145	0.037	NOT APPLICABLE	NOT APPLICABLE
Curb Type		Curb & Gutter Type	
NO CURB		NO CURB AND GUTTER	
Pavement Recommendation		Condition Rating / PCR	
PREVENTIVE MAINTENANCE		GOOD / 90

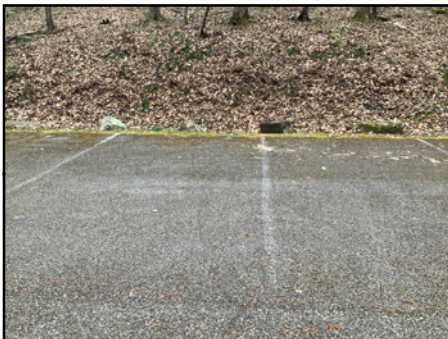
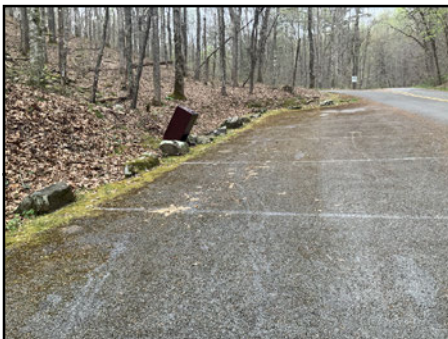
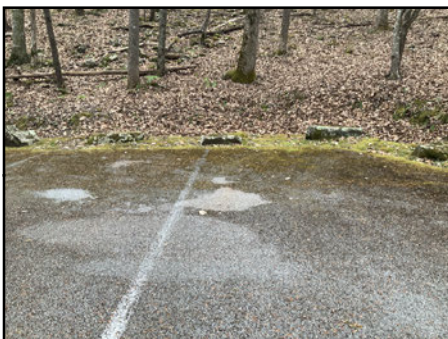
ROUTE 0922EZ: LEWIS HOLLOW PICNIC AREA PARKING E

Inspection Date	FMSS Number	User Access	Surface Type
4/13/2021	101161	PUBLIC	ASPHALT
Area (Sq. Ft.)	Lane Miles (11' Widths)	Curb Reveal (Inches)	Curb Recommendation
1,995	0.034	NOT APPLICABLE	NOT APPLICABLE
Curb Type		Curb & Gutter Type	
NO CURB		NO CURB AND GUTTER	
Pavement Recommendation		Condition Rating / PCR	
PREVENTIVE MAINTENANCE		GOOD / 90

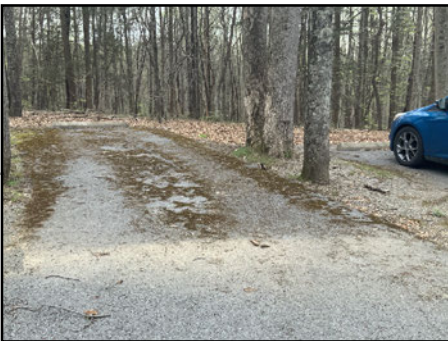
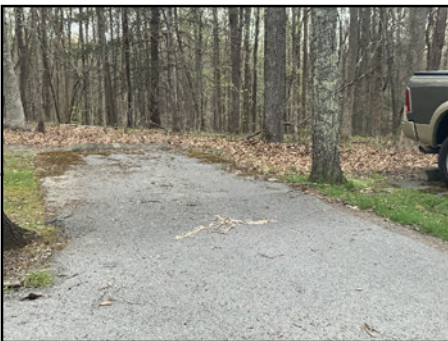
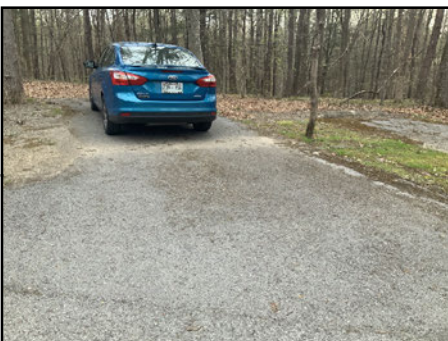
ROUTE 0923: WILDERNESS ROAD CAMPGROUND REGISTRATION PARKING

Inspection Date	FMSS Number	User Access	Surface Type
4/13/2021	101166	PUBLIC	ASPHALT
Area (Sq. Ft.)	Lane Miles (11' Widths)	Curb Reveal (Inches)	Curb Recommendation
2,076	0.036	NOT APPLICABLE	NOT APPLICABLE
Curb Type		Curb & Gutter Type	
NO CURB		NO CURB AND GUTTER	
Pavement Recommendation		Condition Rating / PCR	
PREVENTIVE MAINTENANCE		GOOD / 90

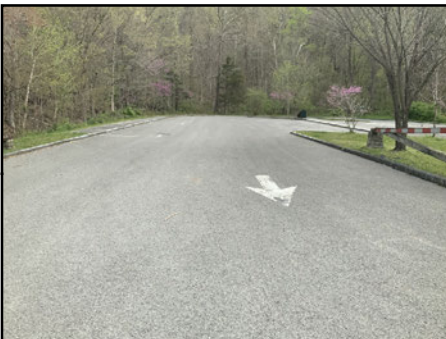
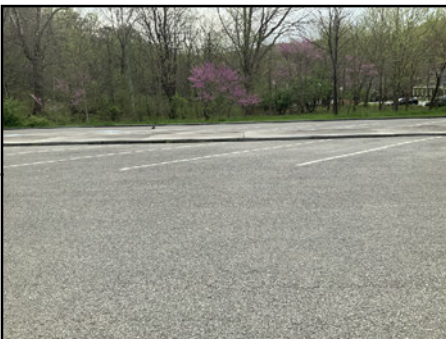
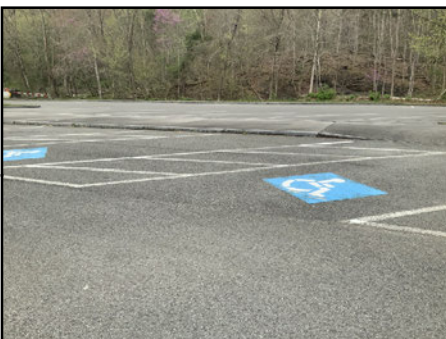
ROUTE 0925: IRON FURNACE PARKING LOT

Inspection Date	FMSS Number	User Access	Surface Type
4/13/2021	101389	PUBLIC	ASPHALT
Area (Sq. Ft.)	Lane Miles (11' Widths)	Curb Reveal (Inches)	Curb Recommendation
15,218	0.262	7	DO NOTHING
Curb Type		Curb & Gutter Type	
STONE		NO CURB AND GUTTER	
Pavement Recommendation		Condition Rating / PCR	
LIGHT 3R TREATMENTS		FAIR / 73

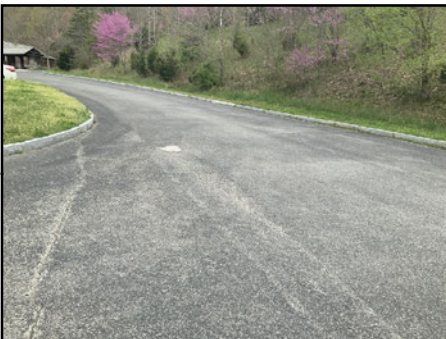
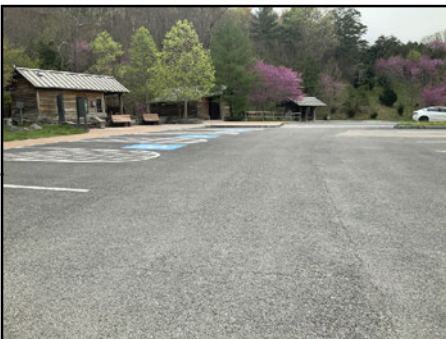
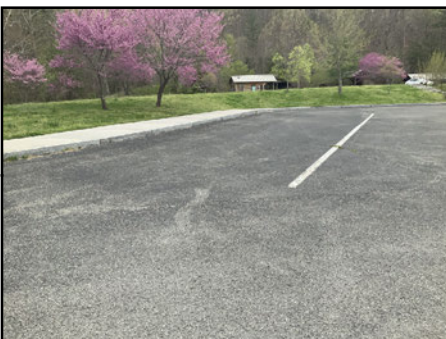
ROUTE 0926: DANIEL BOONE PARKING

Inspection Date	FMSS Number	User Access	Surface Type
4/13/2021	93433	PUBLIC	ASPHALT
Area (Sq. Ft.)	Lane Miles (11' Widths)	Curb Reveal (Inches)	Curb Recommendation
54,489	0.938	7	DO NOTHING
Curb Type		Curb & Gutter Type	
STONE		NO CURB AND GUTTER	
Pavement Recommendation		Condition Rating / PCR	
LIGHT 3R TREATMENTS		FAIR / 73

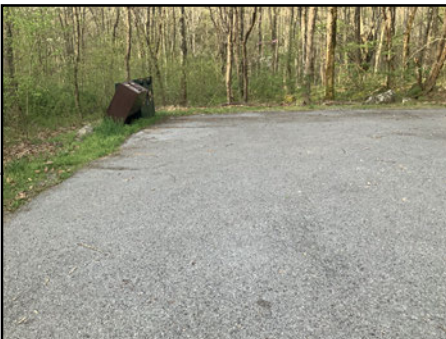
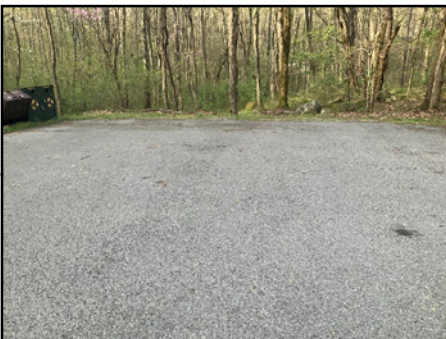
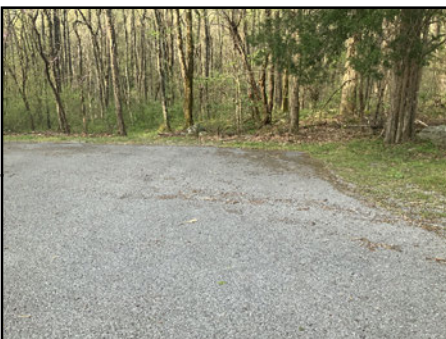
ROUTE 0928: DUPLEX PARKING

Inspection Date	FMSS Number	User Access	Surface Type
4/13/2021	240416	NONPUBLIC	CONCRETE
Area (Sq. Ft.)	Lane Miles (11' Widths)	Curb Reveal (Inches)	Curb Recommendation
1,569	0.027	NOT APPLICABLE	NOT APPLICABLE
Curb Type		Curb & Gutter Type	
NO CURB		NO CURB AND GUTTER	
Pavement Recommendation		Condition Rating / PCR	
PREVENTIVE MAINTENANCE		GOOD / 90

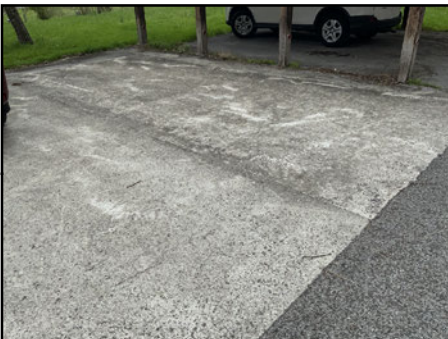
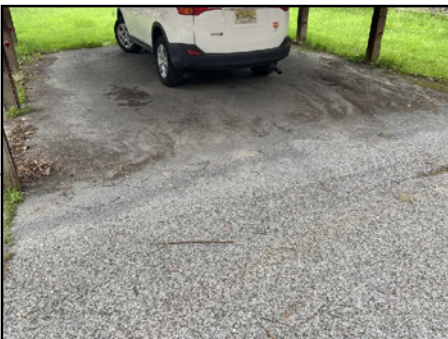
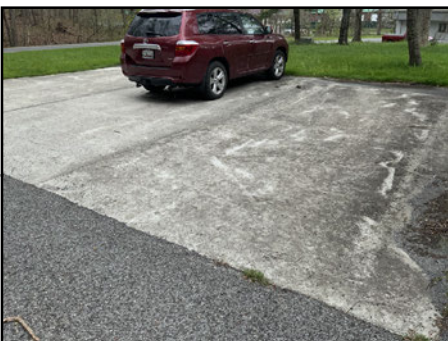
ROUTE 0929: AMPHITHEATER BUS PARKING

Inspection Date	FMSS Number	User Access	Surface Type
4/13/2021	240418	PUBLIC	ASPHALT
Area (Sq. Ft.)	Lane Miles (11' Widths)	Curb Reveal (Inches)	Curb Recommendation
1,503	0.026	NOT APPLICABLE	NOT APPLICABLE
Curb Type		Curb & Gutter Type	
NO CURB		NO CURB AND GUTTER	
Pavement Recommendation		Condition Rating / PCR	
PREVENTIVE MAINTENANCE		GOOD / 90
