CUIS Cycle 6

Final Report

Road Inventory and Condition Assessment for Cumberland Island National Seashore

Report Date: July 2021

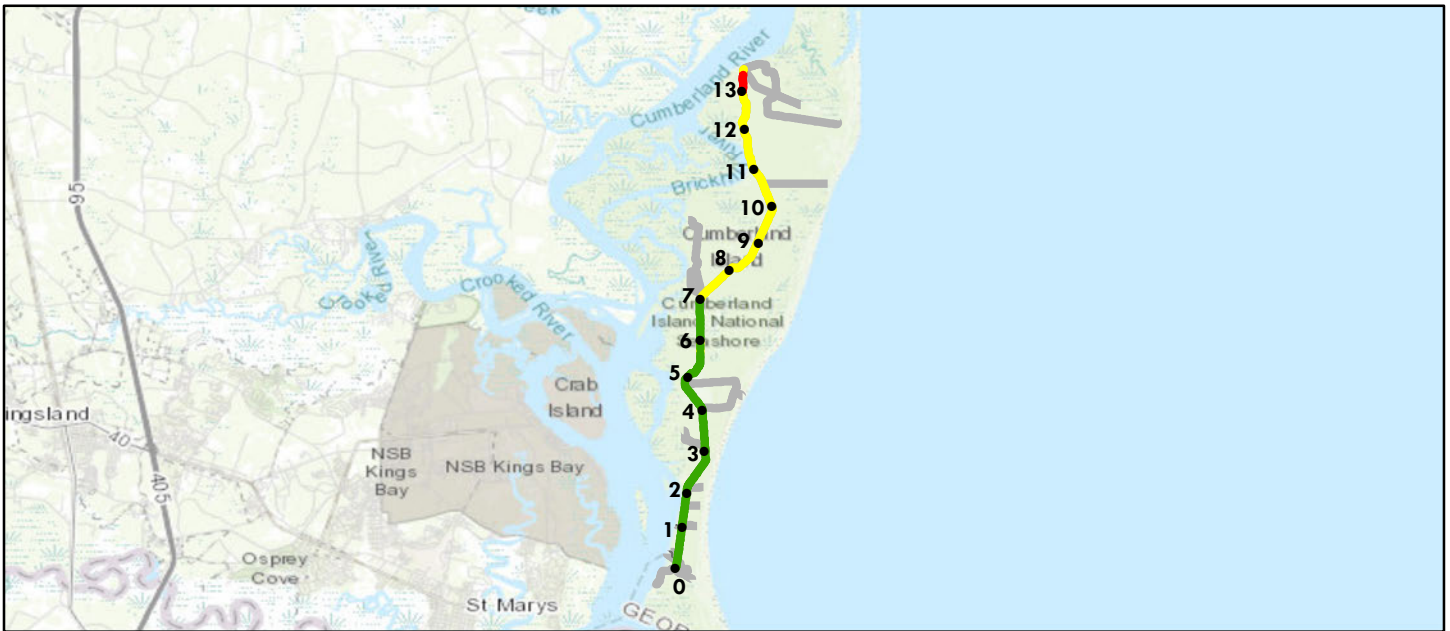
ROUTE 0010: GRAND AVENUE (ISLAND MAIN ROAD)

Route Condition Legend				
Poor (1)	Fair (2)	Good (3)	Excellent (4)	Not Rated
See Appendix for definitions and formulas				
Inspection Date: 2/5/2021	Unpaved Length (Miles): 13.55		Surface Type: NV

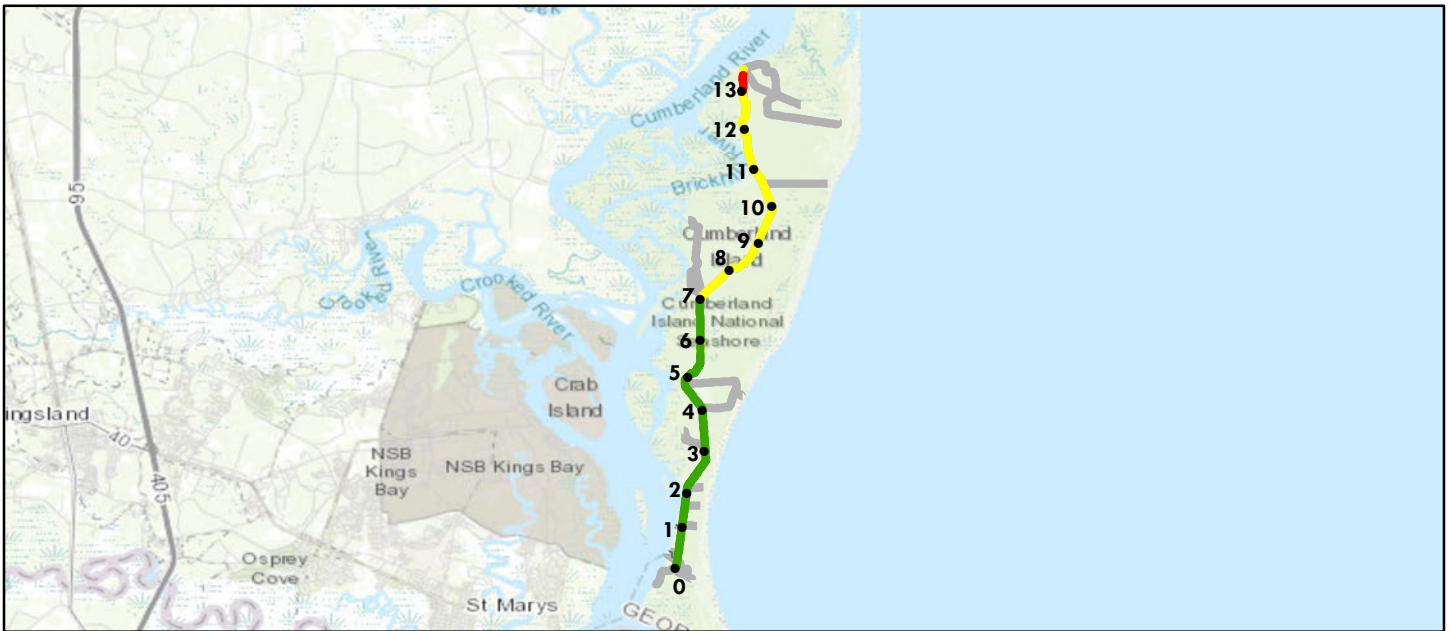
ROUTE 0010: GRAND AVENUE (ISLAND MAIN ROAD)

Begin MP	End MP	Section Length	# of Lanes	Lane Width	Road Width	Treatment Recommendation	Treatment Cost	Unpaved Rating (Paser +)	Crown Severity	Drainage Severity	Rutting, Washboard Severity	Potholes / Loose Aggregate Severity
10.00	11.00	1.00	1	8.0	8.0	Light Rehabilitation	\$10,000	2	Med	High	Med	Med
11.00	12.00	1.00	1	8.0	8.0	Light Rehabilitation	\$10,000	2	Med	High	Low	Med
12.00	13.00	1.00	1	8.0	8.0	Light Rehabilitation	\$10,000	2	Med	High	Low	Med
13.00	13.55	0.55	1	8.0	8.0	Heavy Rehabilitation	\$22,040	1	Med	High	Low	High
Route Level Data:		13.55	1	8.0	8.0	Light Rehabilitation	\$96,040	2	Med	High	Low	Med

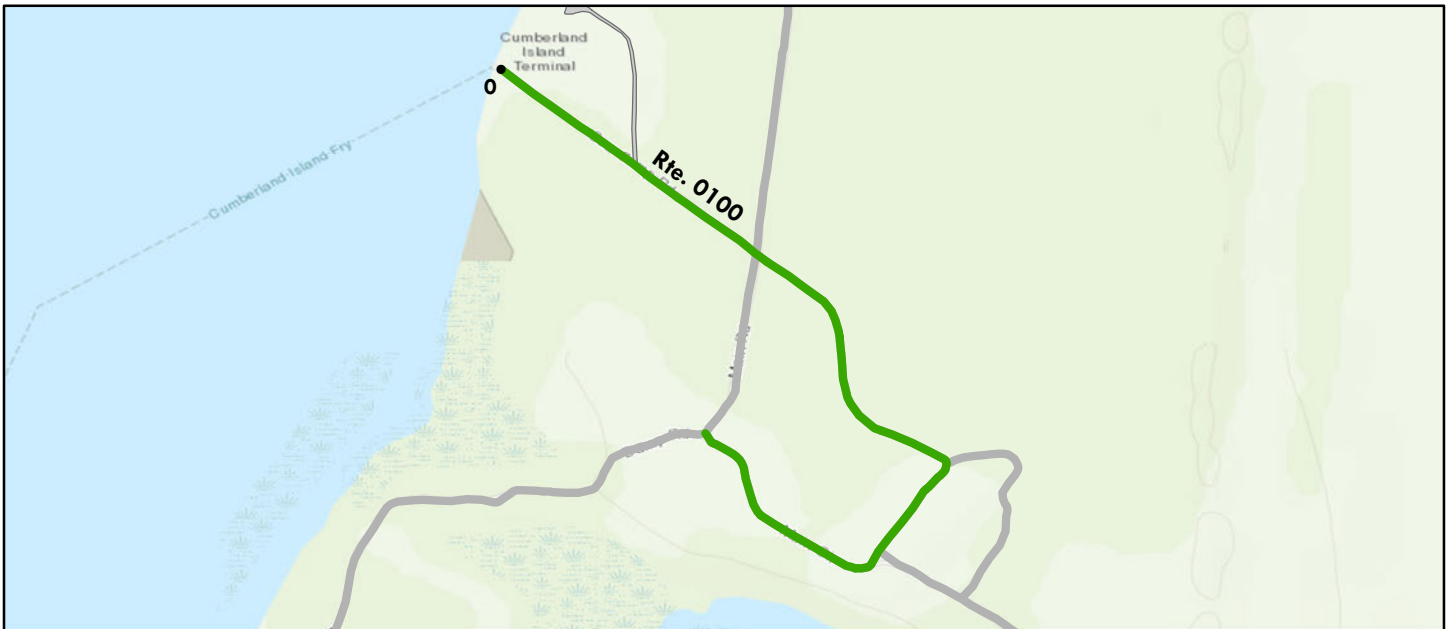
ROUTE 0100: DUNGENESS COLEMAN AVENUE ROAD

Begin MP	End MP	Section Length	# of Lanes	Lane Width	Road Width	Treatment Recommendation	Treatment Cost	Unpaved Rating (Paser +)	Crown Severity	Drainage Severity	Rutting, Washboard Severity	Potholes / Loose Aggregate Severity
0.00	0.90	0.90	1	8.0	8.0	Routine Maintenance	\$1,790	3	Med	Med	Low	Med

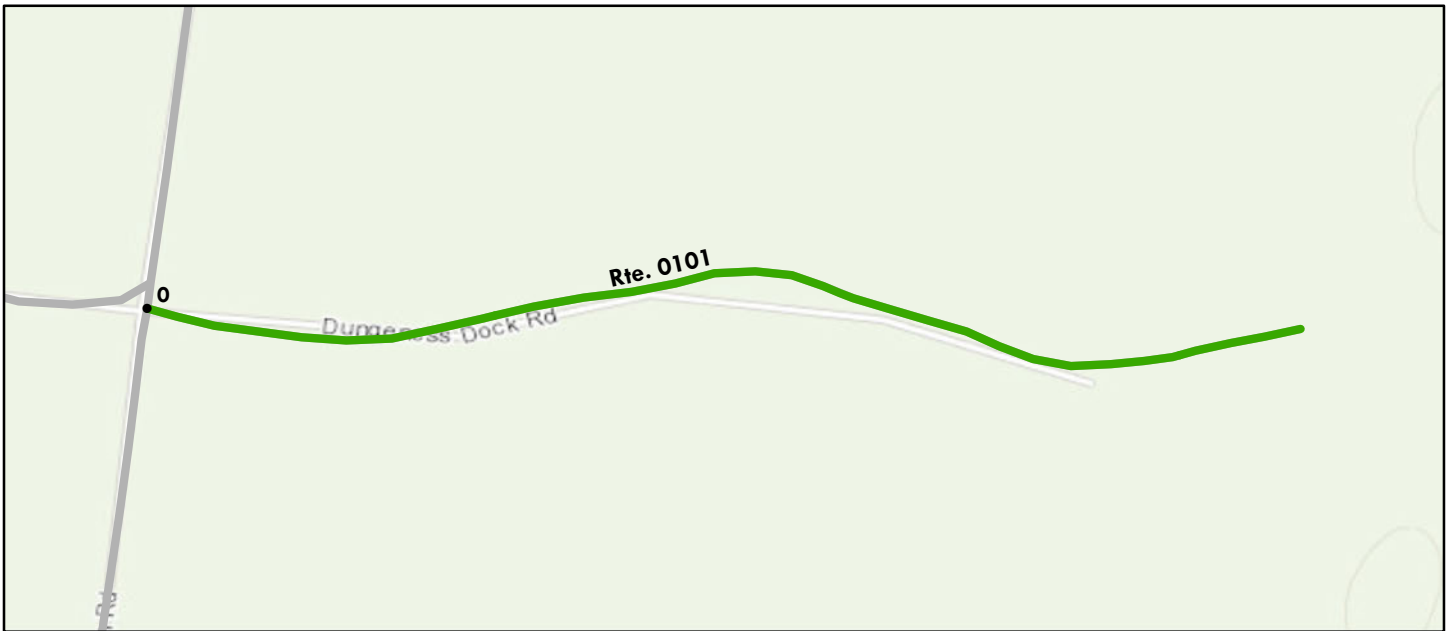
ROUTE 0101: SEACAMP CAMPGROUND ACCESS ROAD

Route Condition Legend				
Poor (1)	Fair (2)	Good (3)	Excellent (4)	Not Rated
See Appendix for definitions and formulas				
Inspection Date: 2/5/2021	Unpaved Length (Miles): 0.34		Surface Type: NV

Begin MP	End MP	Section Length	# of Lanes	Lane Width	Road Width	Treatment Recommendation	Treatment Cost	Unpaved Rating (Paser +)	Crown Severity	Drainage Severity	Rutting, Washboard Severity	Potholes / Loose Aggregate Severity
0.00	0.34	0.34	1	7.0	7.0	Routine Maintenance	\$670	3	Med	Med	Low	Low
Route Level Data:		0.34	1	7.0	7.0	Routine Maintenance	\$670	3	Med	Med	Low	Low

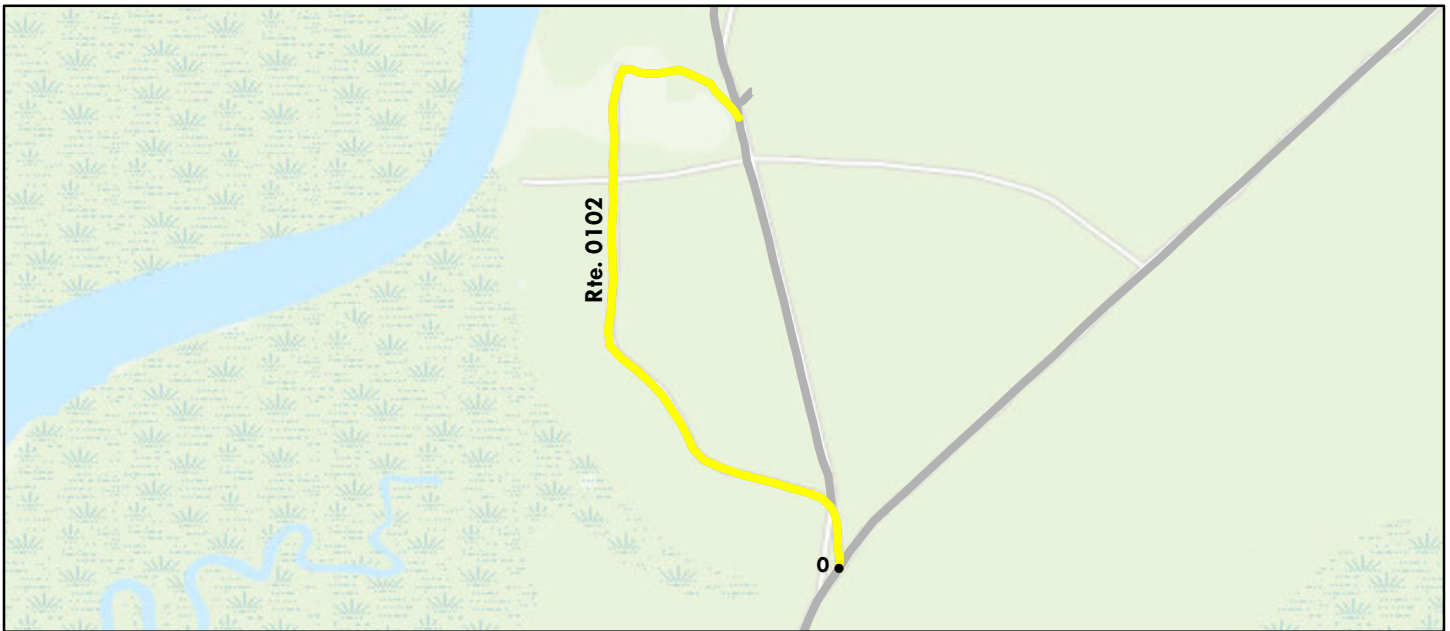
ROUTE 0102: PLUM ORCHARD SPUR ROAD

Begin MP	End MP	Section Length	# of Lanes	Lane Width	Road Width	Treatment Recommendation	Treatment Cost	Unpaved Rating (Paser +)	Crown Severity	Drainage Severity	Rutting, Washboard Severity	Potholes / Loose Aggregate Severity
0.00	0.90	0.90	1	8.0	8.0	Light Rehabilitation	\$9,000	2	Med	High	Low	Med
Route Level Data:		0.90	1	8.0	8.0	Light Rehabilitation	\$9,000	2	Med	High	Low	Med

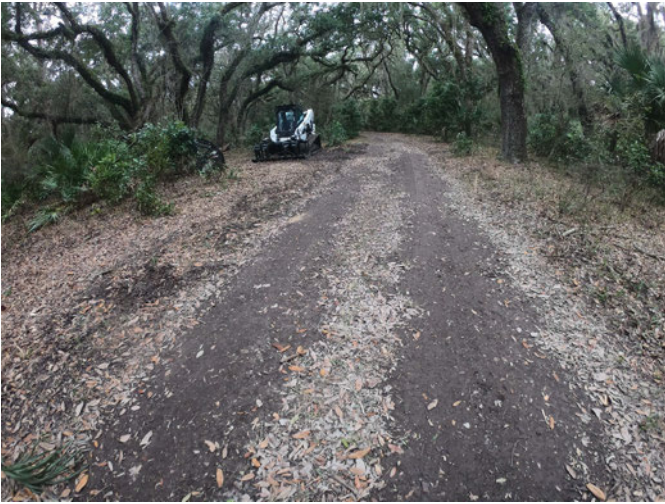
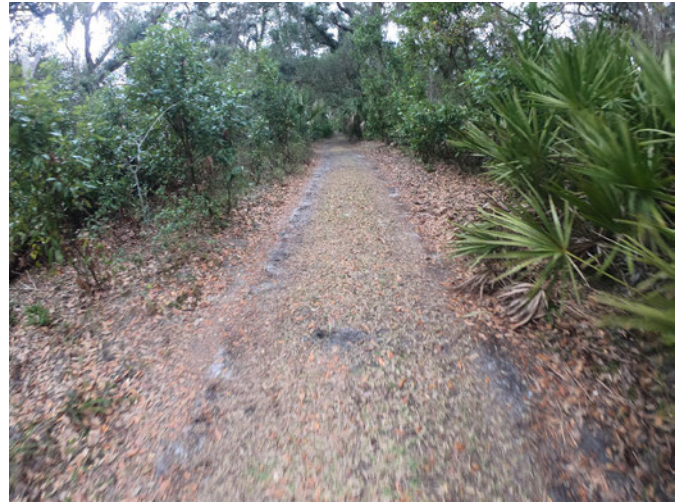
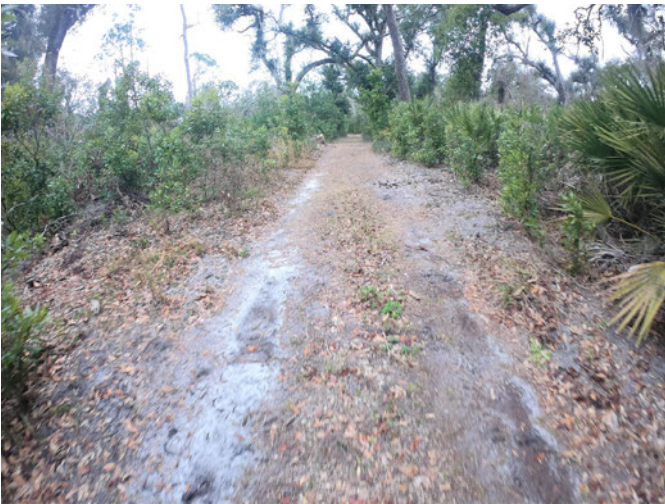
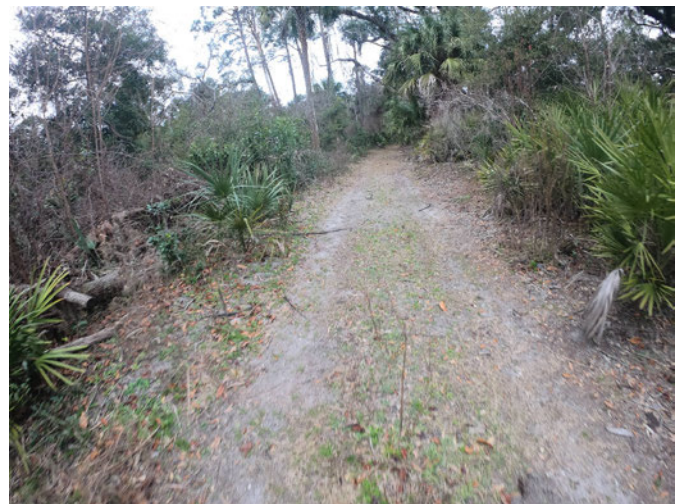
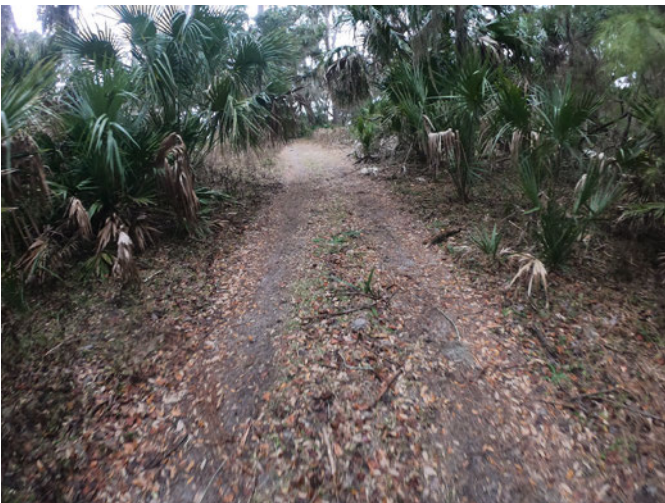
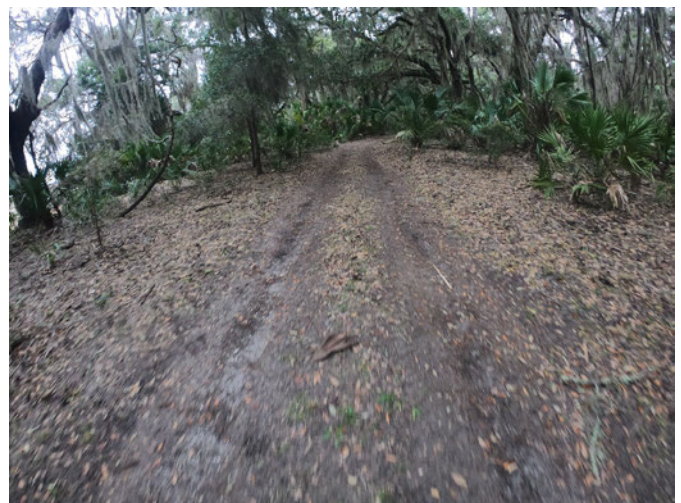
ROUTE 0213: OLD HOUSE CREEK ACCESS ROAD

Begin MP	End MP	Section Length	# of Lanes	Lane Width	Road Width	Treatment Recommendation	Treatment Cost	Unpaved Rating (Paser +)	Crown Severity	Drainage Severity	Rutting, Washboard Severity	Potholes / Loose Aggregate Severity
0.00	0.70	0.70	1	7.0	7.0	Routine Maintenance	\$1,398	3	Med	High	Low	Low
Route Level Data:		0.70	1	7.0	7.0	Routine Maintenance	\$1,398	3	Med	High	Low	Low

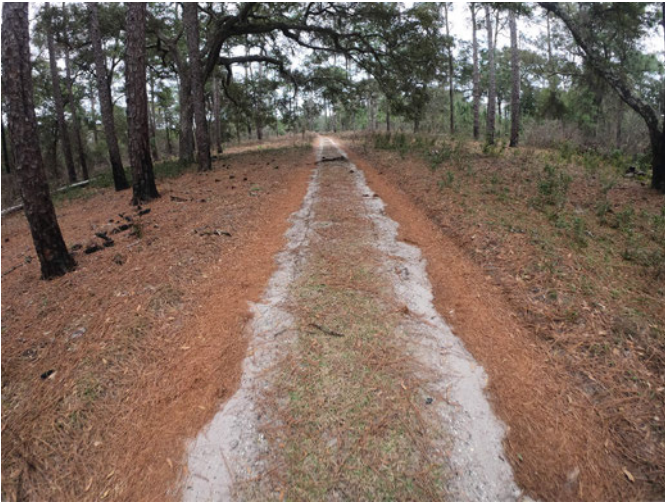
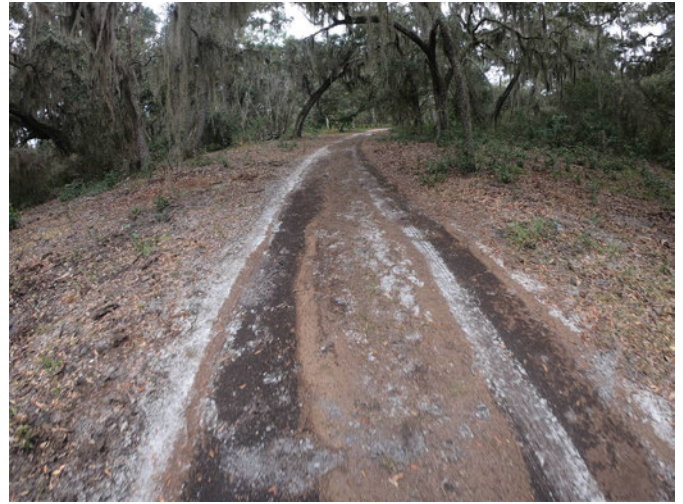
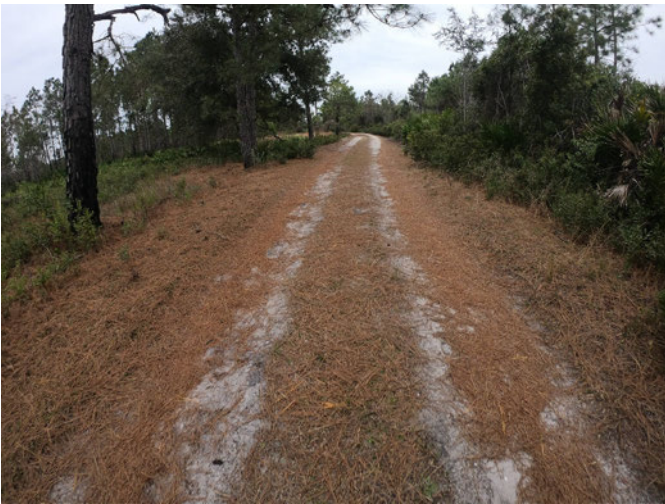
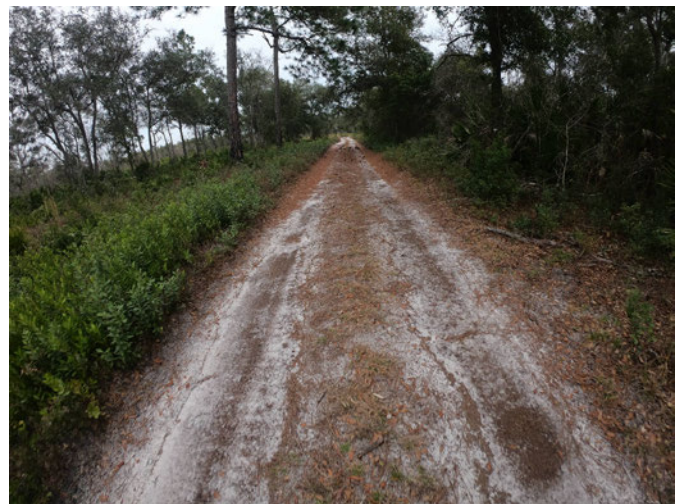
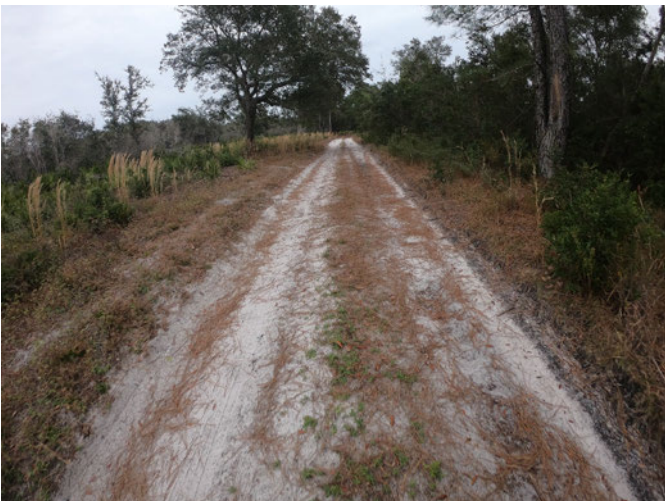
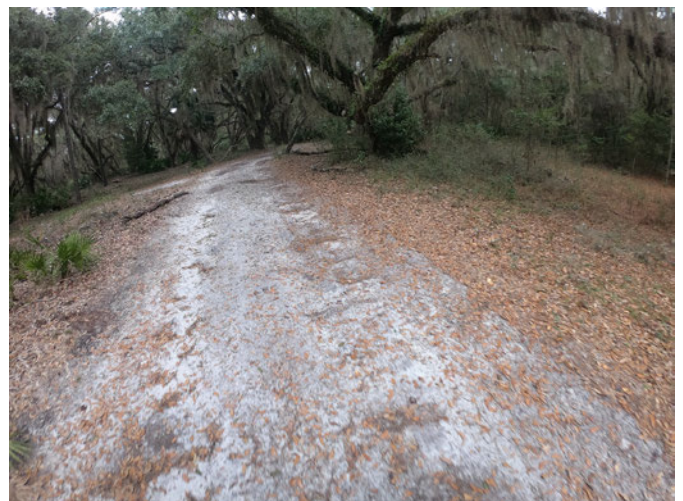
ROUTE 0215: NORTH CUT ROAD

Begin MP	End MP	Section Length	# of Lanes	Lane Width	Road Width	Treatment Recommendation	Treatment Cost	Unpaved Rating (Paser +)	Crown Severity	Drainage Severity	Rutting, Washboard Severity	Potholes / Loose Aggregate Severity
0.00	1.00	1.00	1	8.0	8.0	Routine Maintenance	\$2,000	3	Low	High	Low	Med
1.00	2.00	1.00	1	8.0	8.0	Light Rehabilitation	\$10,000	2	Med	High	Low	Med
2.00	3.00	1.00	1	8.0	8.0	Routine Maintenance	\$2,000	3	Med	Med	Low	Med
3.00	3.17	0.17	1	8.0	8.0	Routine Maintenance	\$342	3	Med	Med	Low	Med
Route Level Data:		3.17	1	8.0	8.0	Light Rehabilitation	\$14,342	2	Med	High	Low	Med

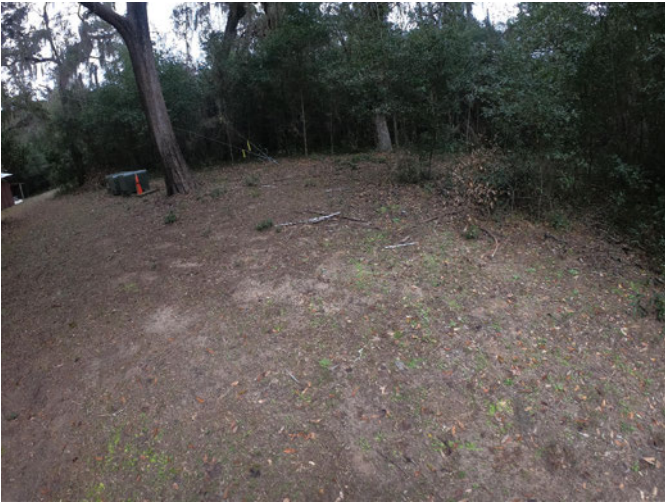
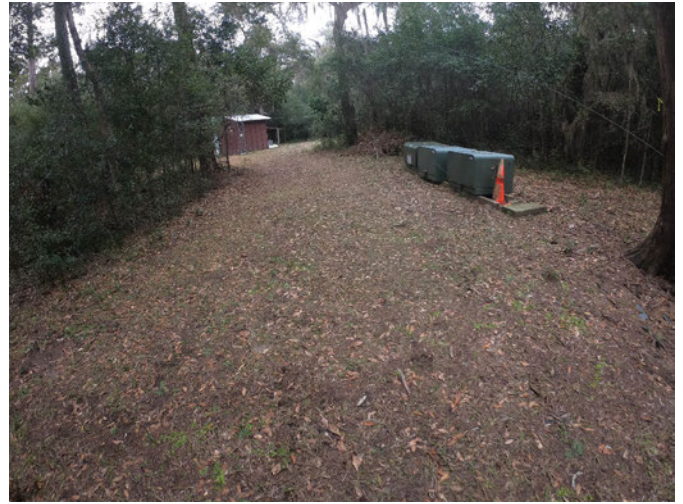
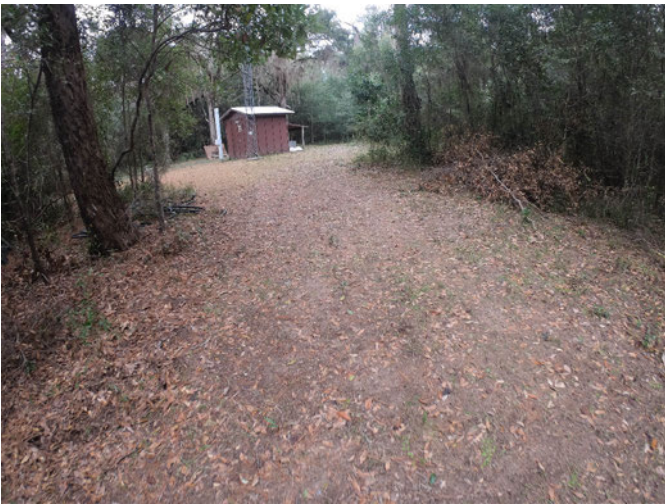
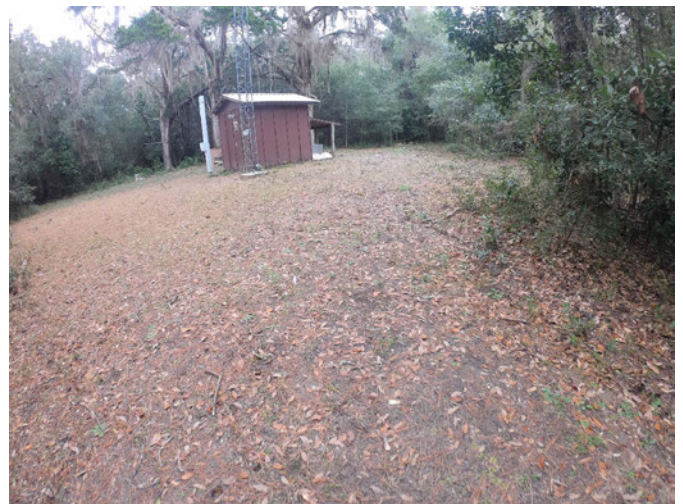
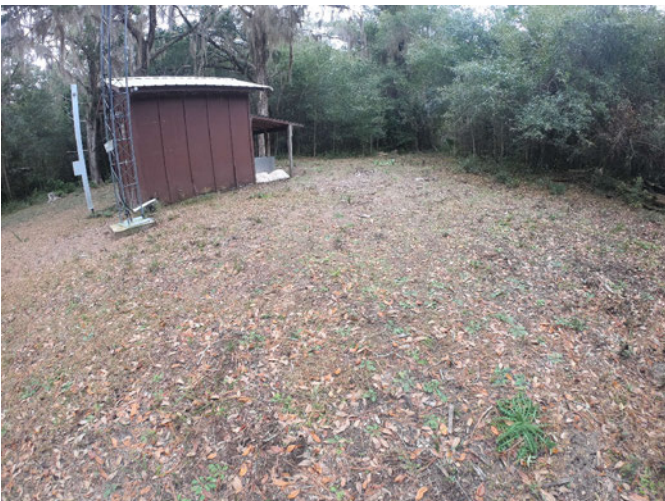
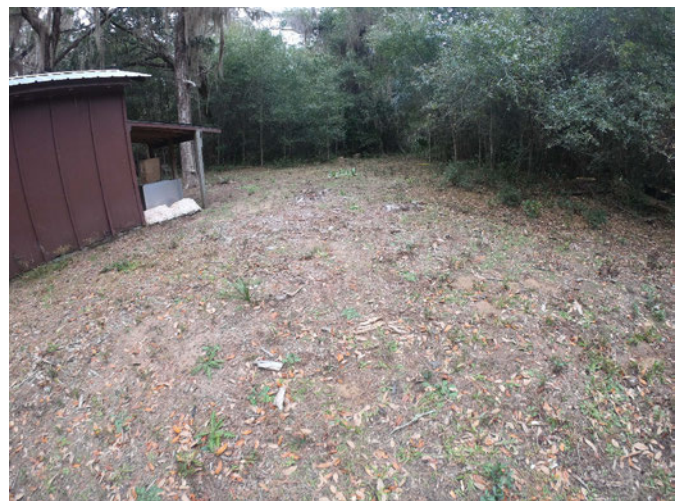
ROUTE 0400: REPEATER ACCESS ROAD

Begin MP	End MP	Section Length	# of Lanes	Lane Width	Road Width	Treatment Recommendation	Treatment Cost	Unpaved Rating (Paser +)	Crown Severity	Drainage Severity	Rutting, Washboard Severity	Potholes / Loose Aggregate Severity
0.00	0.02	0.02	1	8.0	8.0	Routine Maintenance	\$48	3	Med	Med	Low	Med
Route Level Data:		0.02	1	8.0	8.0	Routine Maintenance	\$48	3	Med	Med	Low	Med

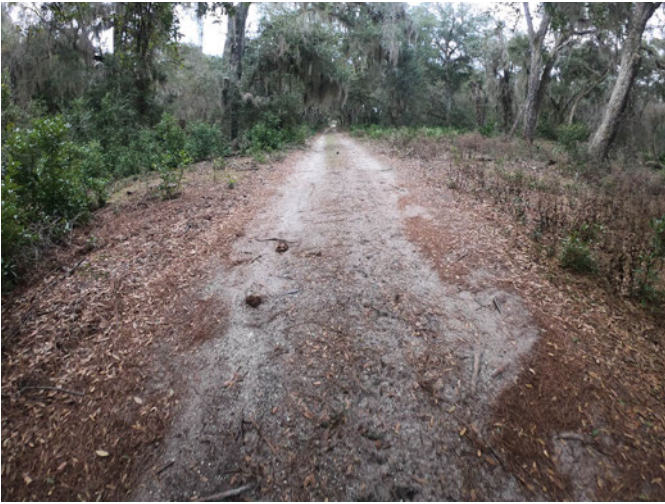
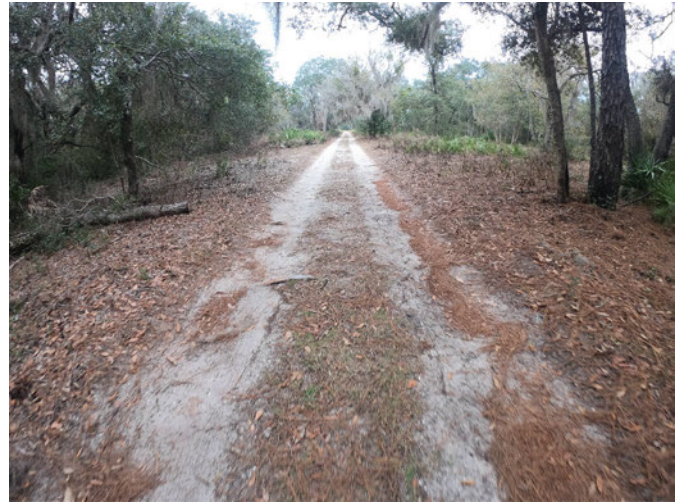
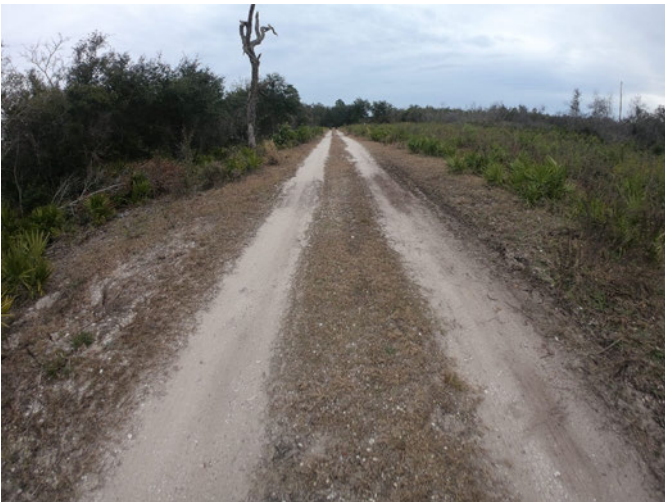
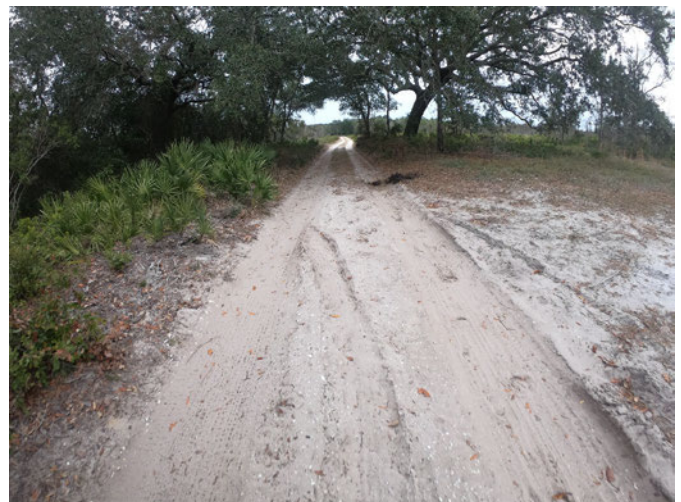
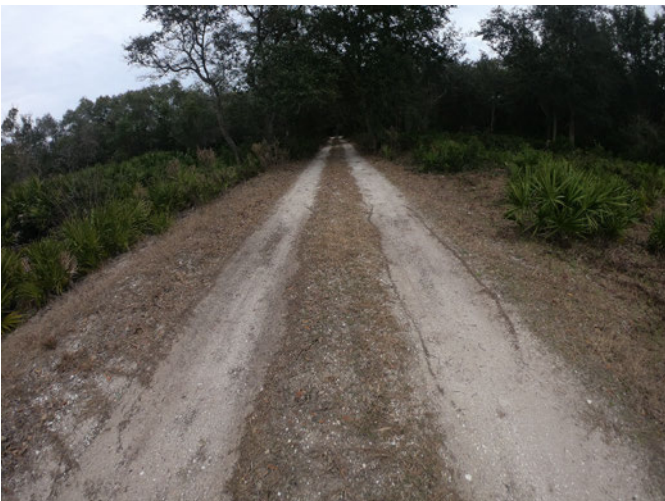
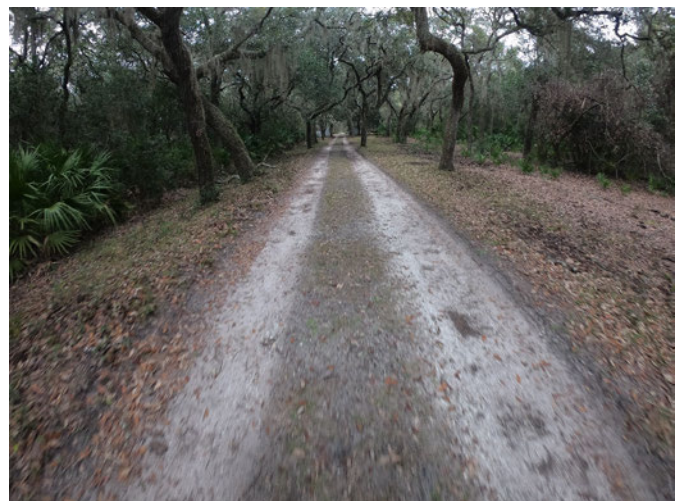
ROUTE 0401: HIGH POINT ROAD

Begin MP	End MP	Section Length	# of Lanes	Lane Width	Road Width	Treatment Recommendation	Treatment Cost	Unpaved Rating (Paser +)	Crown Severity	Drainage Severity	Rutting, Washboard Severity	Potholes / Loose Aggregate Severity
0.00	0.60	0.60	1	8.0	8.0	Light Rehabilitation	\$5,960	2	Med	High	Low	Med
Route Level Data:		0.60	1	8.0	8.0	Light Rehabilitation	\$5,960	2	Med	High	Low	Med

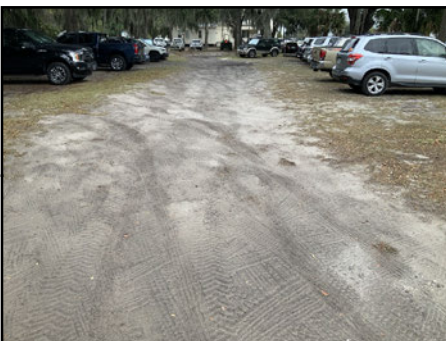
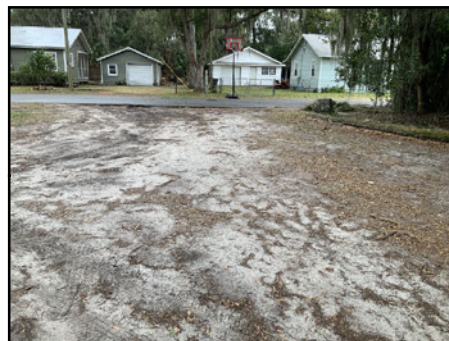
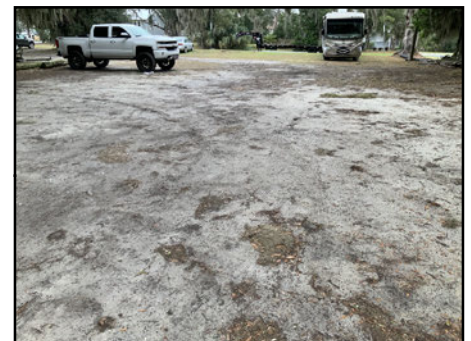
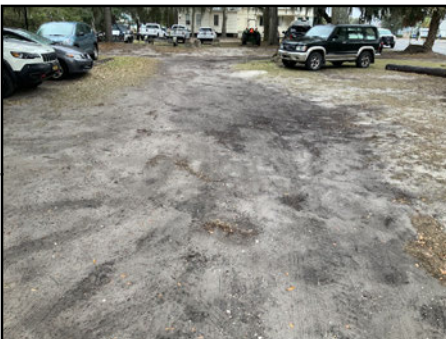
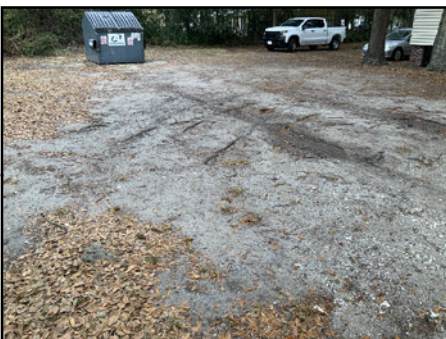
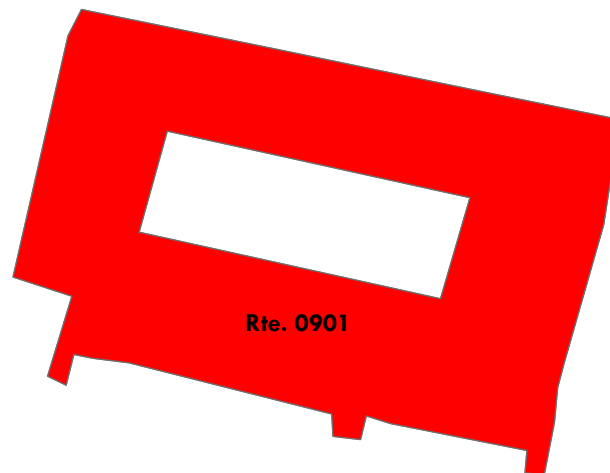
Inspection Date	FMSS Number	User Access	Surface Type
2/5/2021	109009	PUBLIC	NATIVE
Area (Sq. Ft.)	Lane Miles (11' Widths)	Curb Reveal (Inches)	Curb Recommendation
49,017	0.844		NOT APPLICABLE
Curb Type		Curb & Gutter Type	
NO CURB		NO CURB AND GUTTER	
Treatment Recommendation		Condition Rating	
Heavy Rehabilitation		1

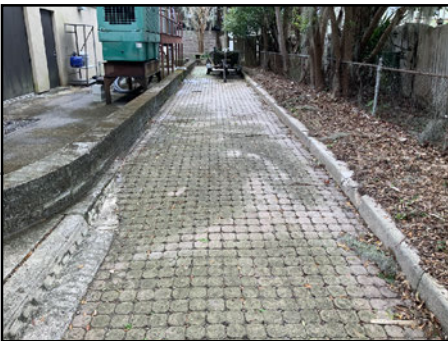
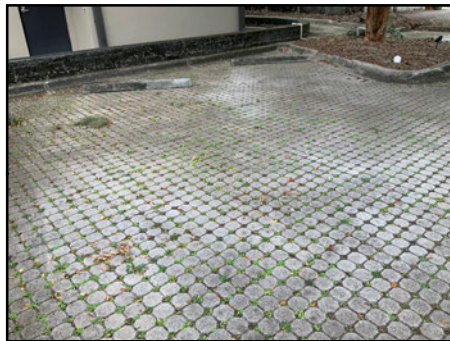
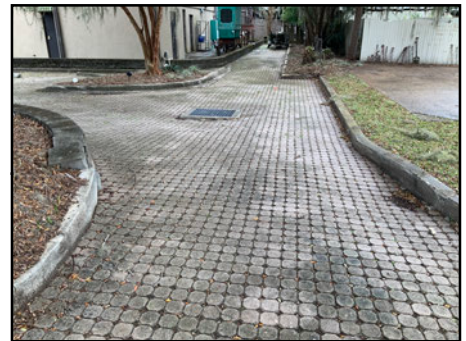
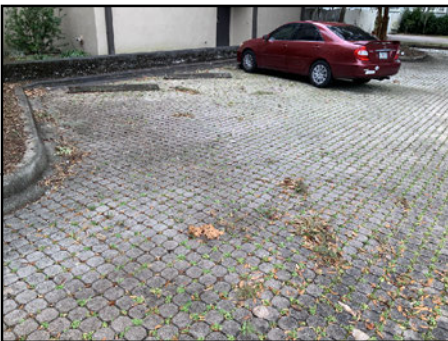
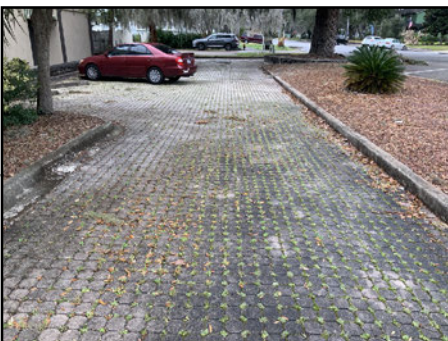
ROUTE 0903: SEACAMP RANGER STATION PARKING

Inspection Date	FMSS Number	User Access	Surface Type
2/5/2021	112957	PUBLIC	NATIVE
Area (Sq. Ft.)	Lane Miles (11' Widths)	Curb Reveal (Inches)	Curb Recommendation
8,573	0.148		NOT APPLICABLE
Curb Type		Curb & Gutter Type	
NO CURB		NO CURB AND GUTTER	
Treatment Recommendation		Condition Rating	
Routine Maintenance		3

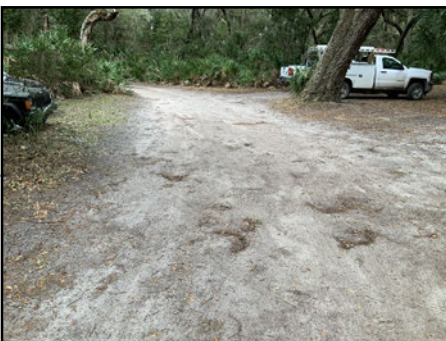
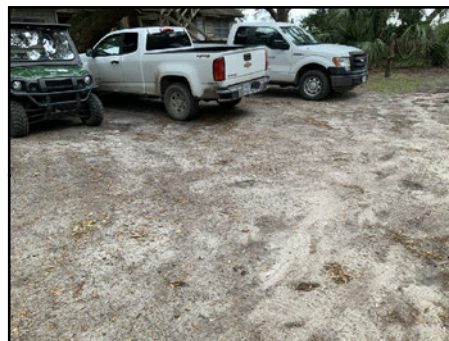
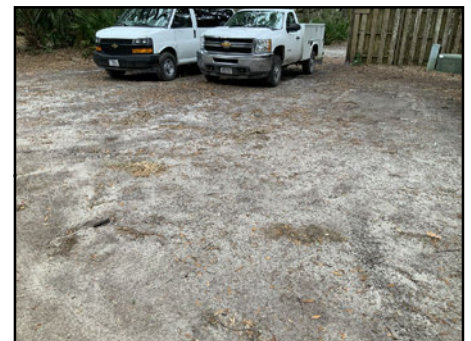
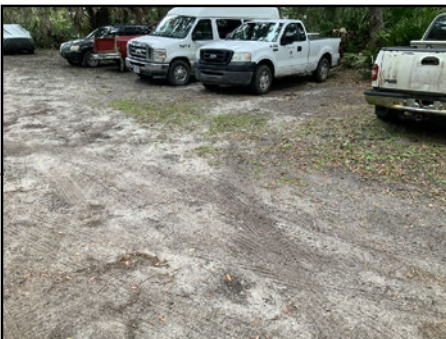
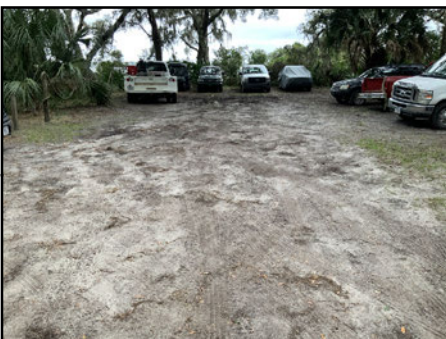
ROUTE 0904: DUNGENESS CAPTAINS HOUSE PARKING

Inspection Date	FMSS Number	User Access	Surface Type
2/5/2021	114706	PUBLIC	NATIVE
Area (Sq. Ft.)	Lane Miles (11' Widths)	Curb Reveal (Inches)	Curb Recommendation
22,428	0.386		NOT APPLICABLE
Curb Type		Curb & Gutter Type	
NO CURB		NO CURB AND GUTTER	
Treatment Recommendation		Condition Rating	
Light Rehabilitation		2
